# IndianOil

## JOURNEY RISK MANAGEMENT (JRM) STUDY

### Salem Terminal to ALAGUMALAI MUTHUKUMARAN FUELS

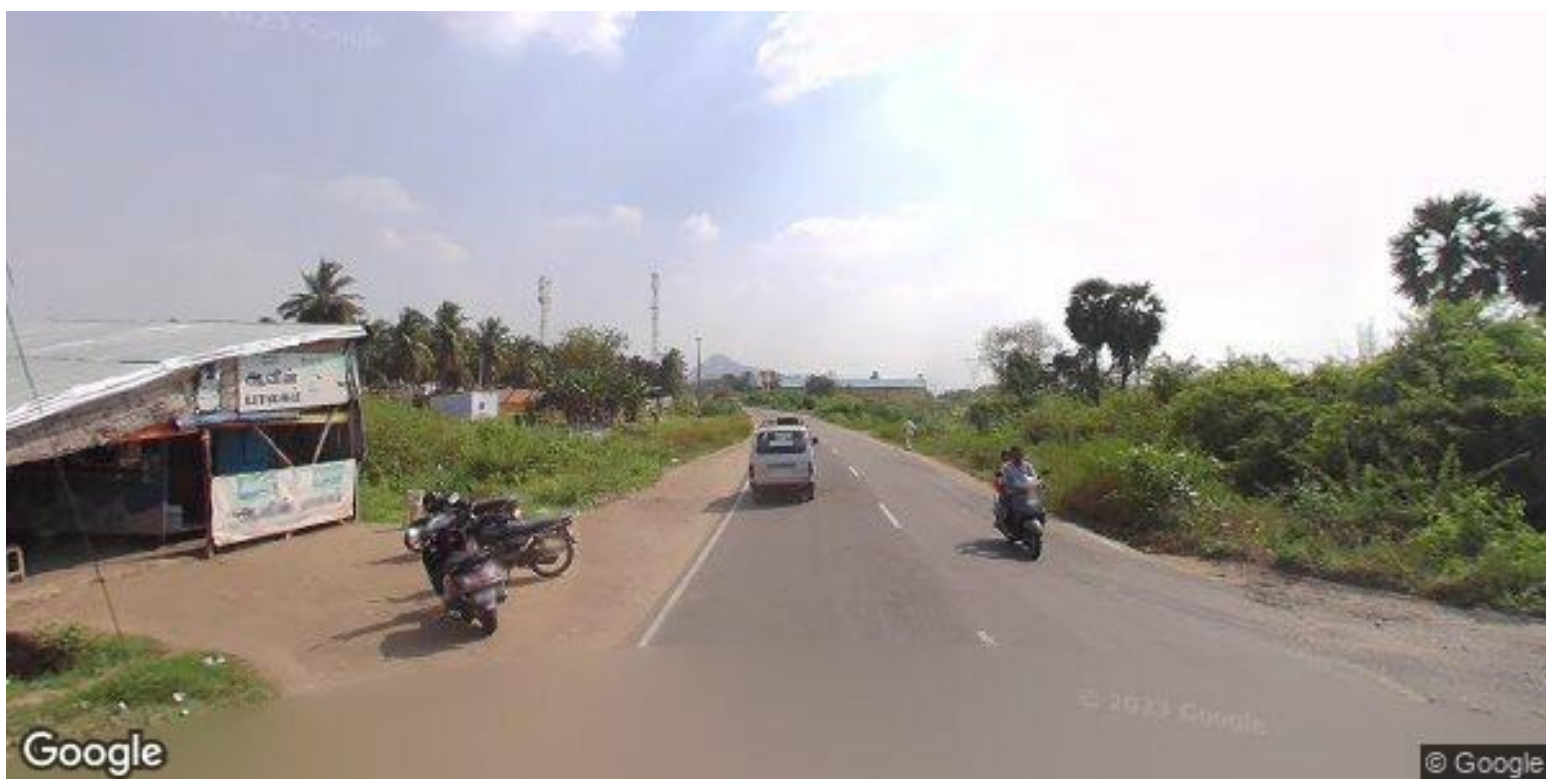
**Coordinates:** 11.44022, 77.87546

**Risk Type:** Turn

**Risk Level:** High

**Speed Limit:** 15 KM/Hr

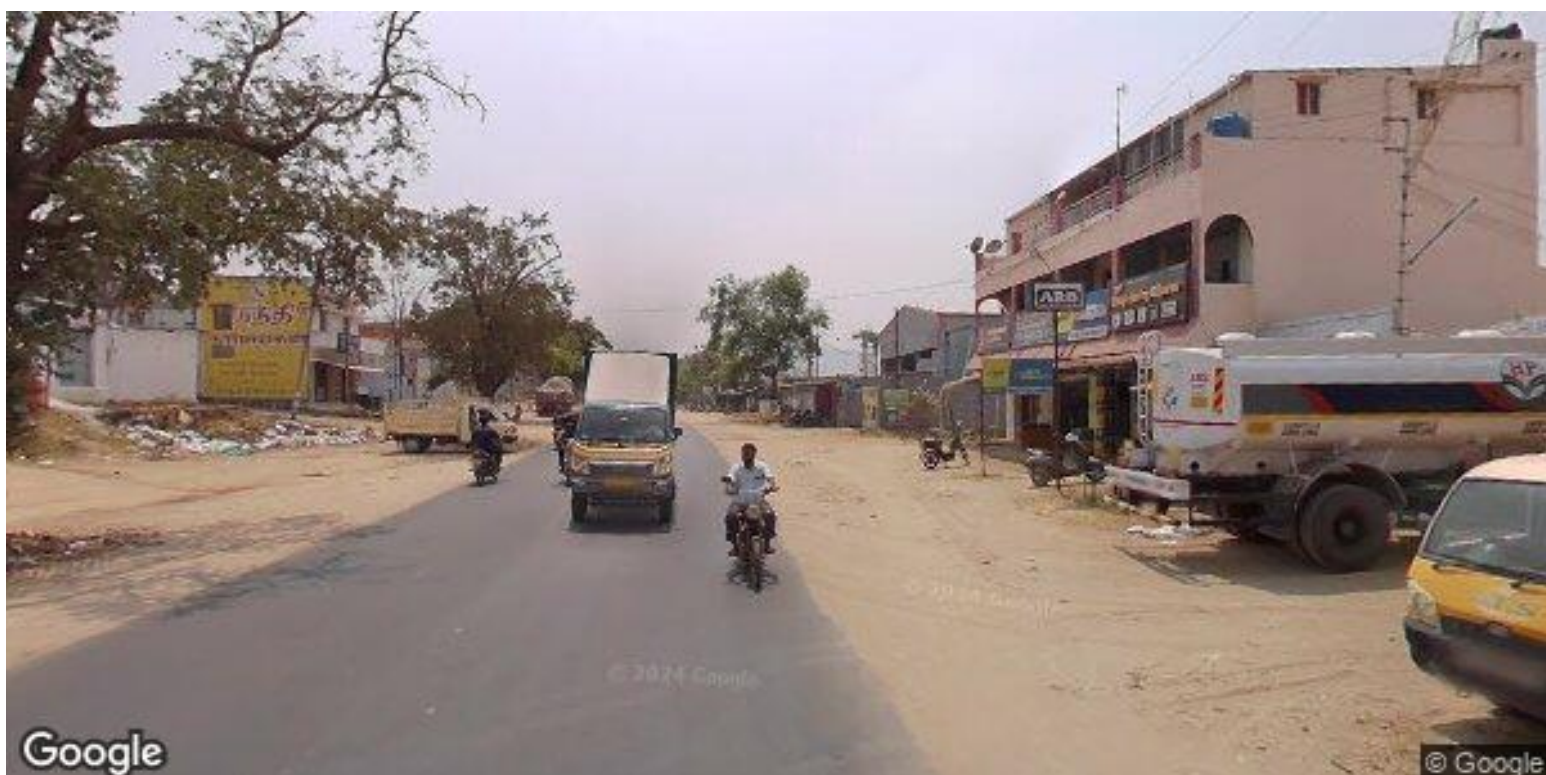
**Coordinates: 11.39976, 77.88382**

**Risk Type: Turn**

**Risk Level: Medium**

**Speed Limit: 30 KM/Hr**

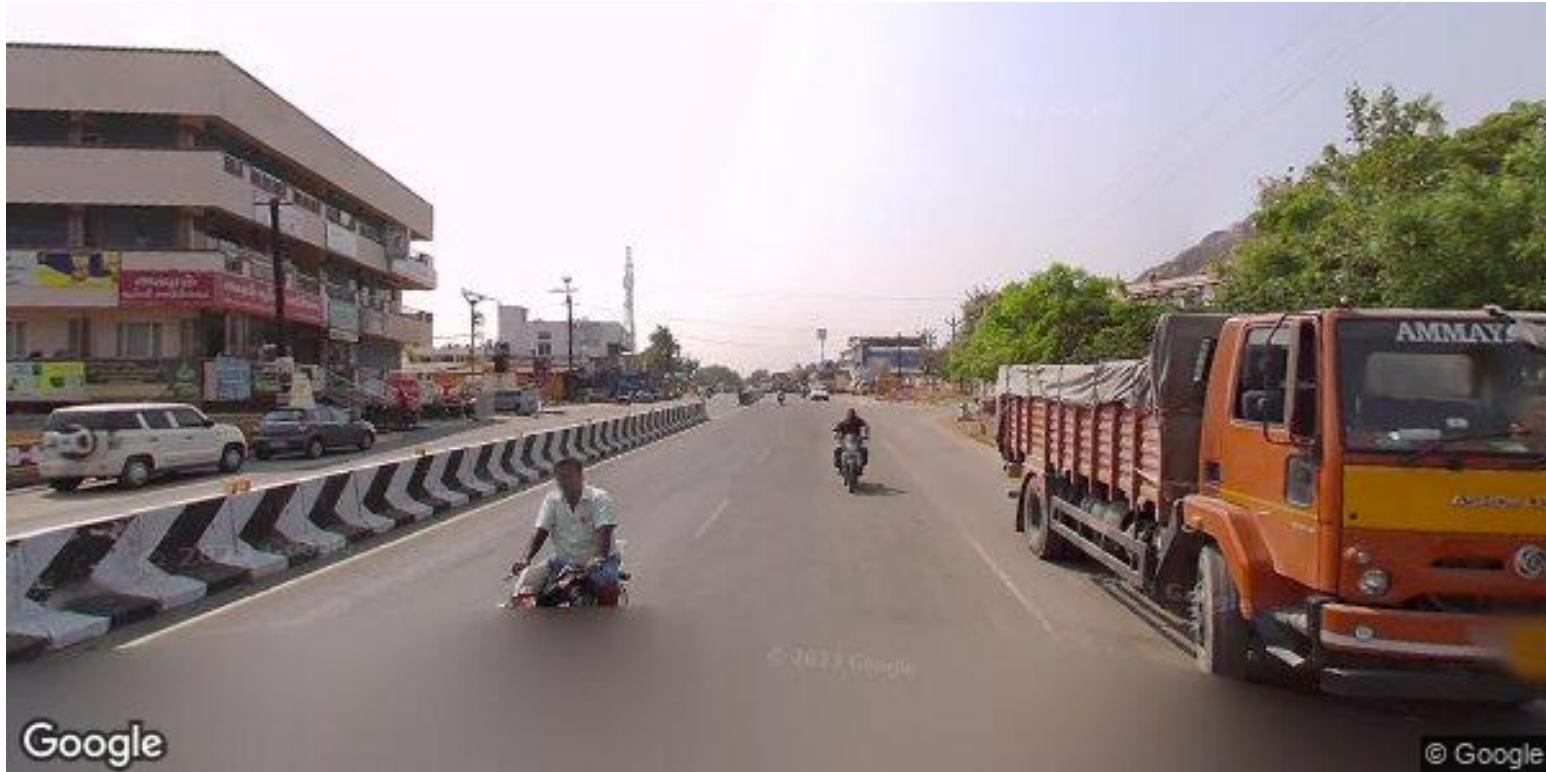
**Coordinates: 11.39690, 77.88852**

**Risk Type: Turn**

**Risk Level: Medium**

**Speed Limit: 30 KM/Hr**

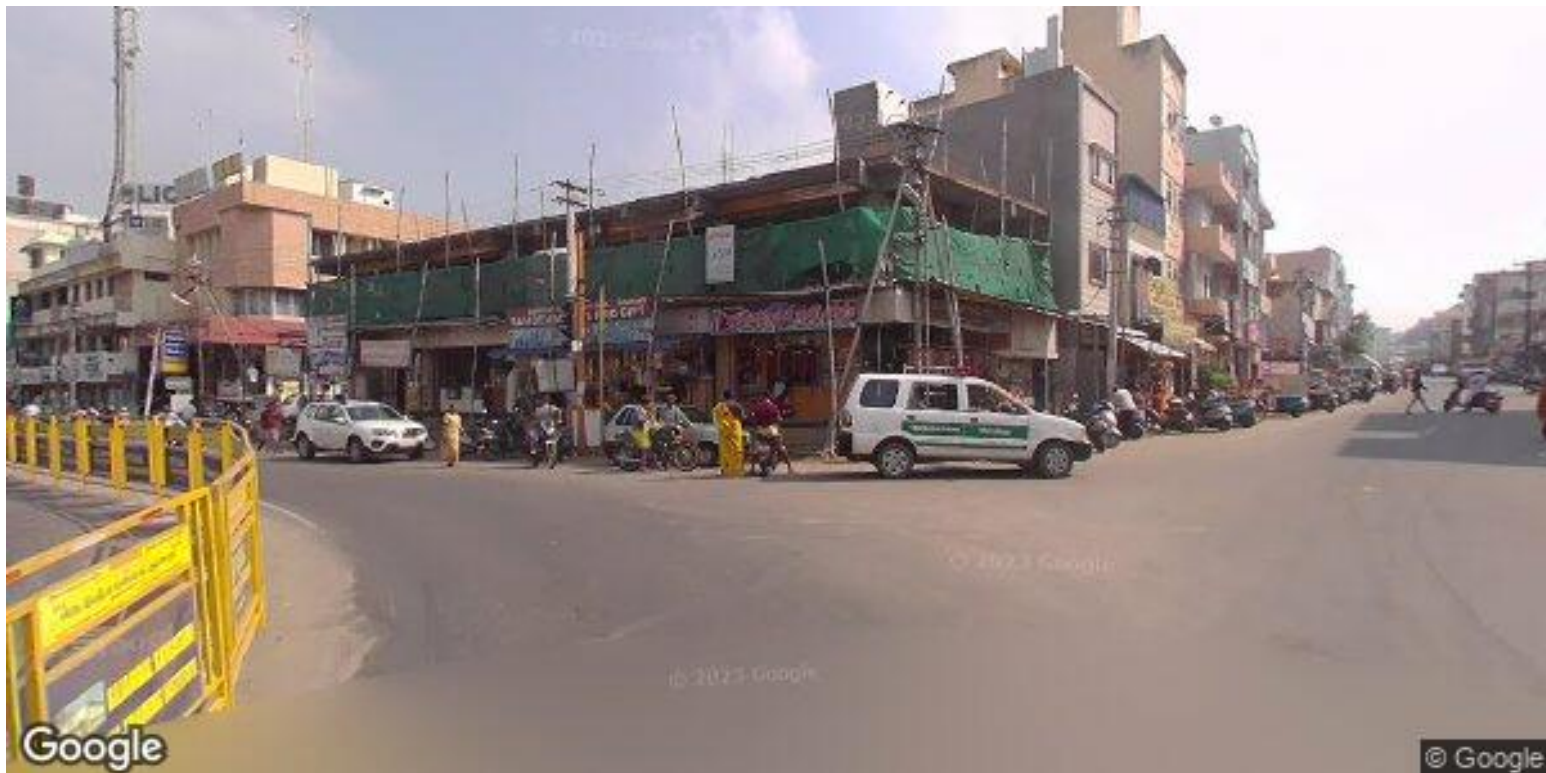
**Coordinates: 11.37868, 77.89498**

**Risk Type: Turn**

**Risk Level: High**

**Speed Limit: 15 KM/Hr**

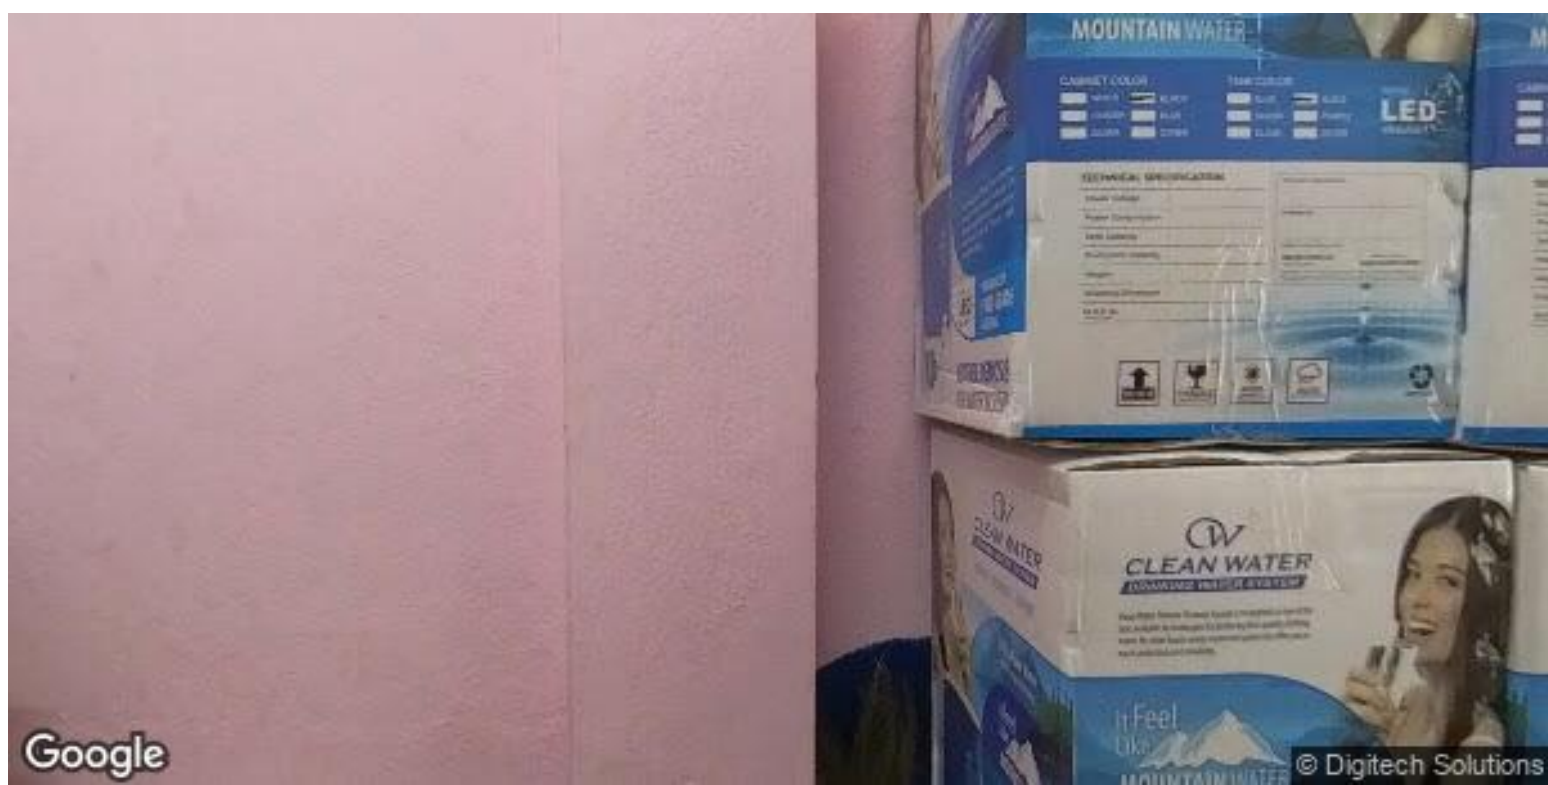
**Coordinates:** 11.37862, 77.89530

**Risk Type:** Blind Spot

**Risk Level:** Blind Spot

**Speed Limit:** 10 KM/Hr

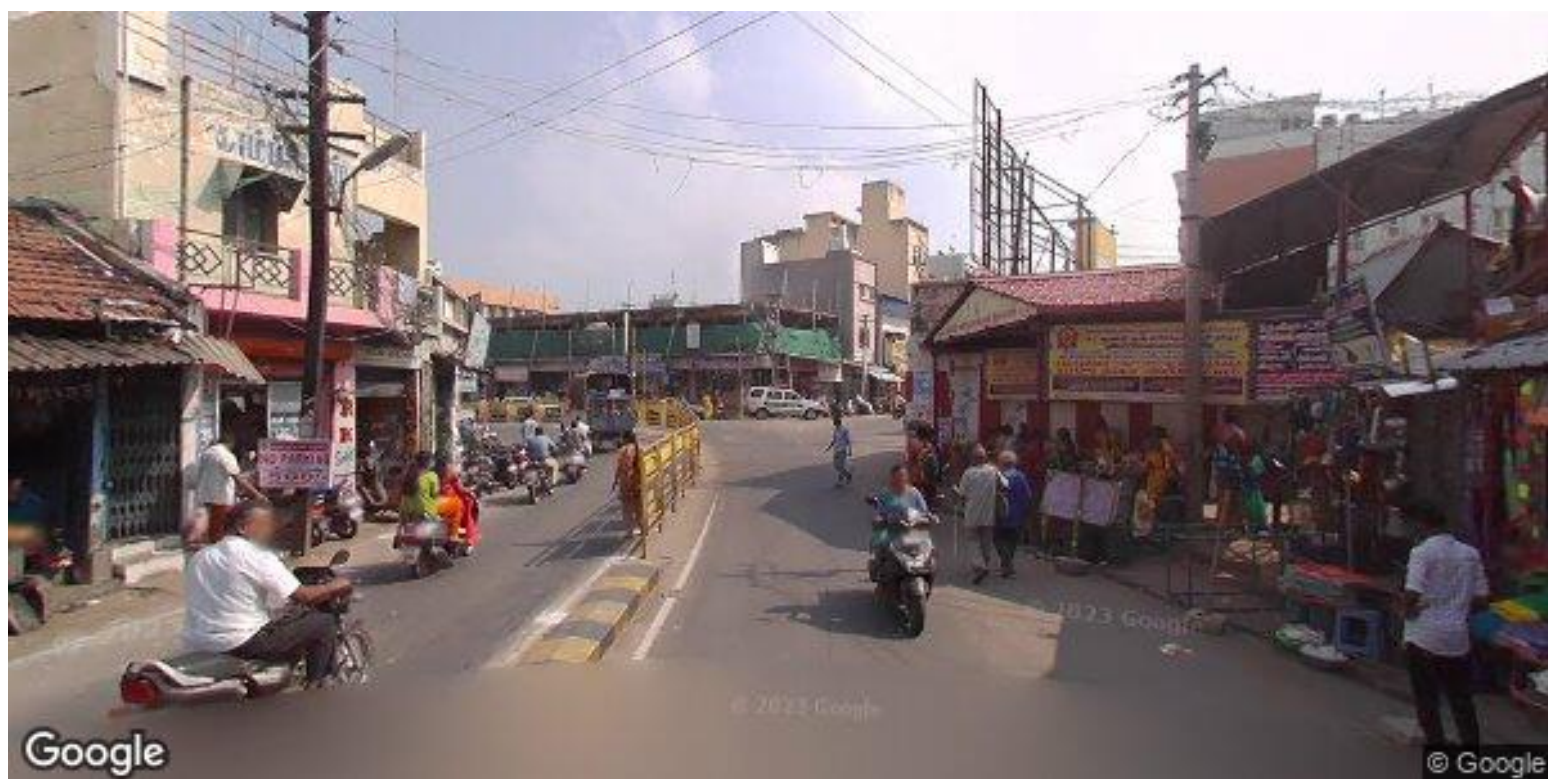
**Coordinates:** 11.37857, 77.89473

**Risk Type:** Turn

**Risk Level:** High

**Speed Limit:** 15 KM/Hr

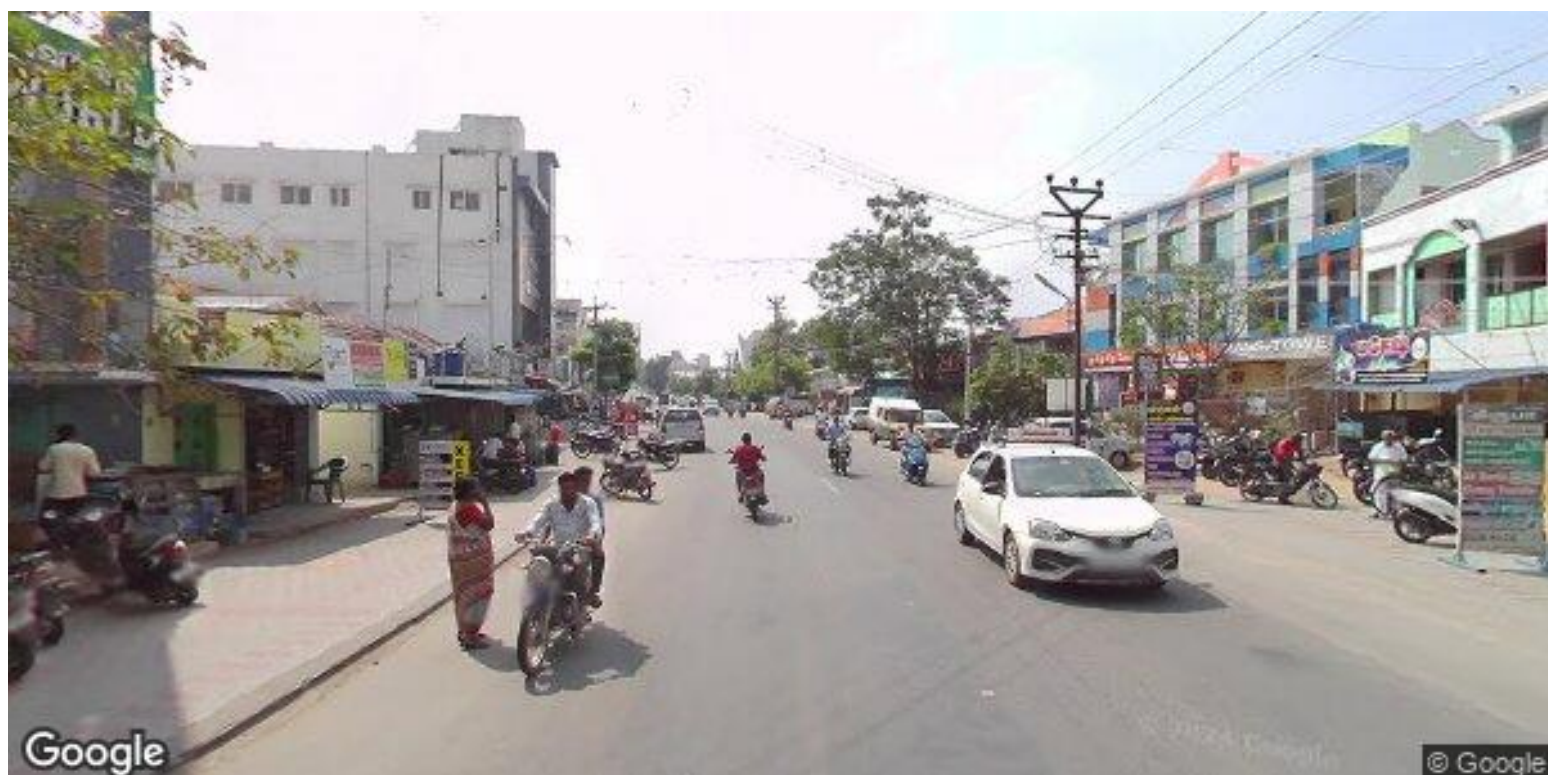
**Coordinates: 11.36919, 77.88934**

**Risk Type: Turn**

**Risk Level: Medium**

**Speed Limit: 30 KM/Hr**

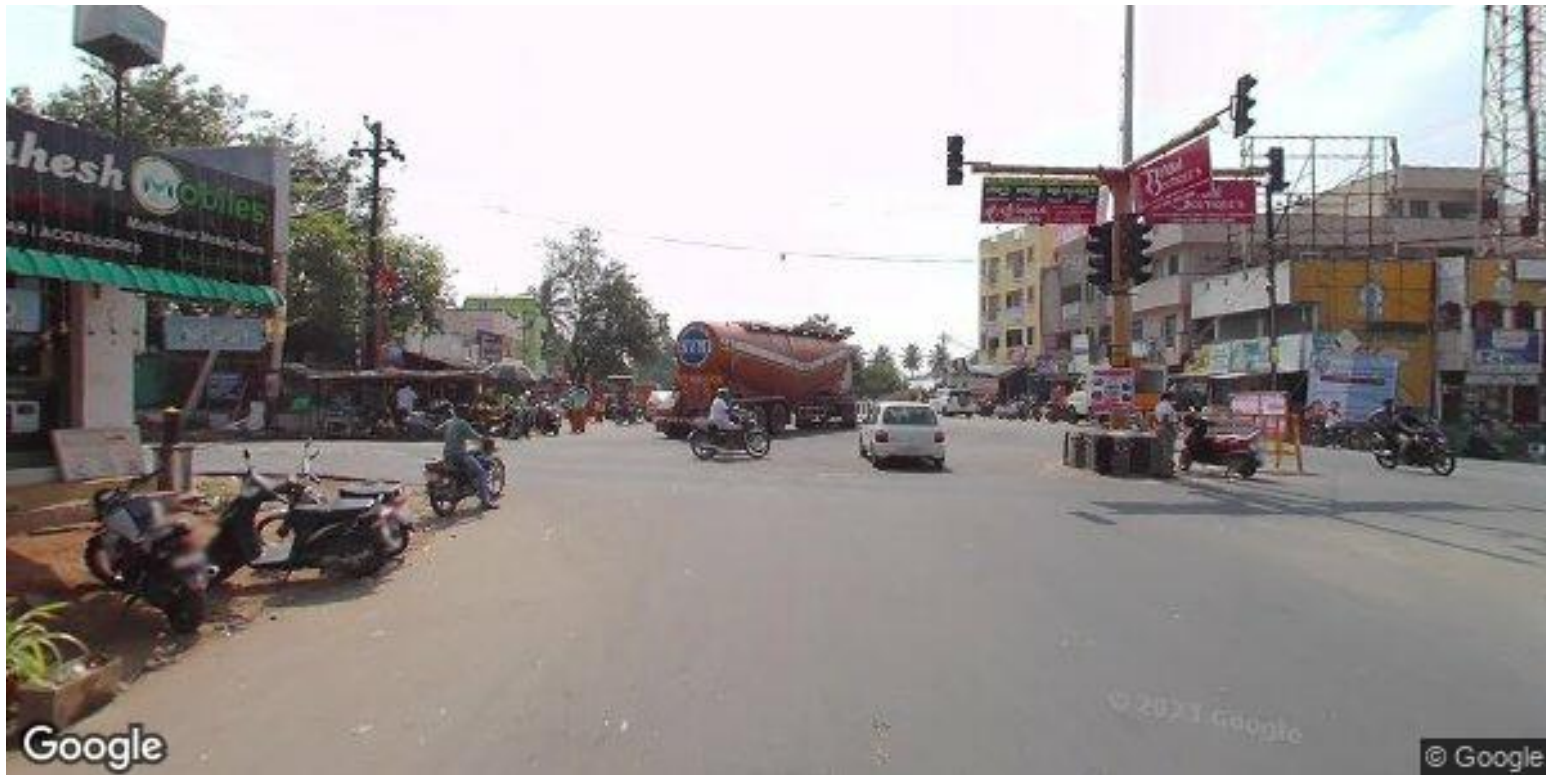
**Coordinates: 11.36616, 77.88885**

**Risk Type: Turn**

**Risk Level: High**

**Speed Limit: 15 KM/Hr**

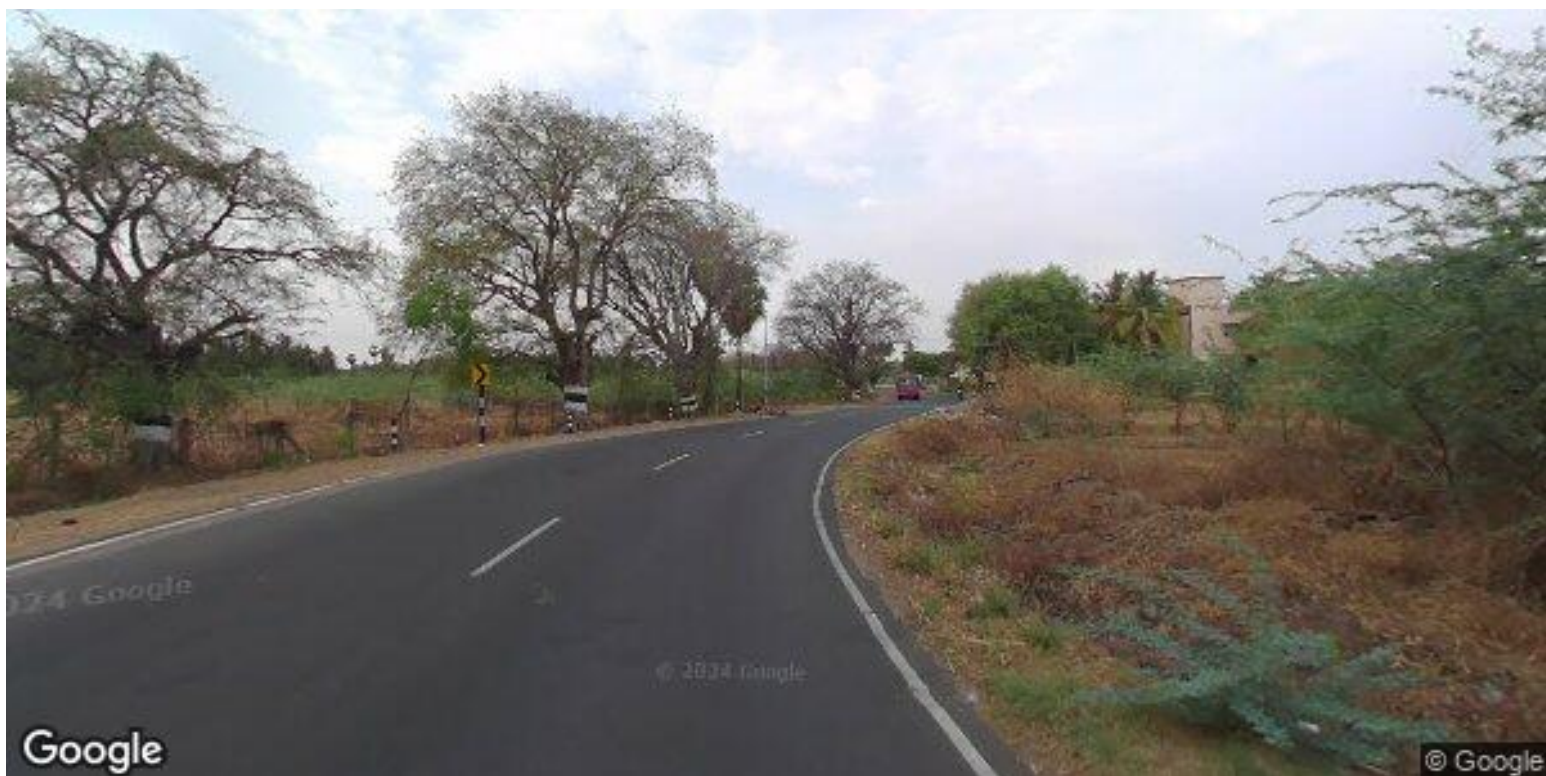
**Coordinates: 11.34067, 77.86347**

**Risk Type: Turn**

**Risk Level: Medium**

**Speed Limit: 30 KM/Hr**

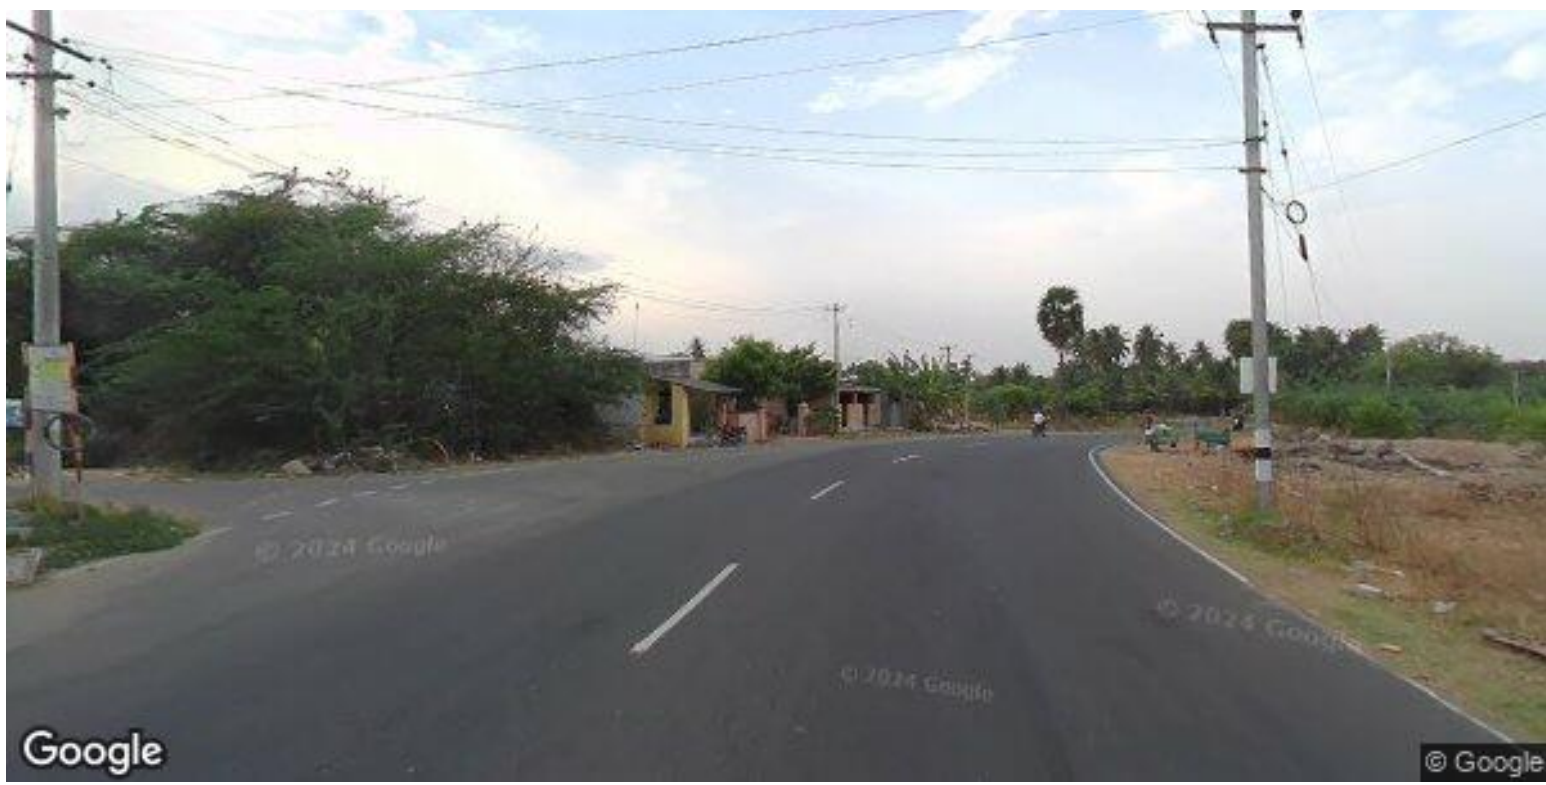
**Coordinates:** 11.33854, 77.86216

**Risk Type:** Turn

**Risk Level:** Medium

**Speed Limit:** 30 KM/Hr

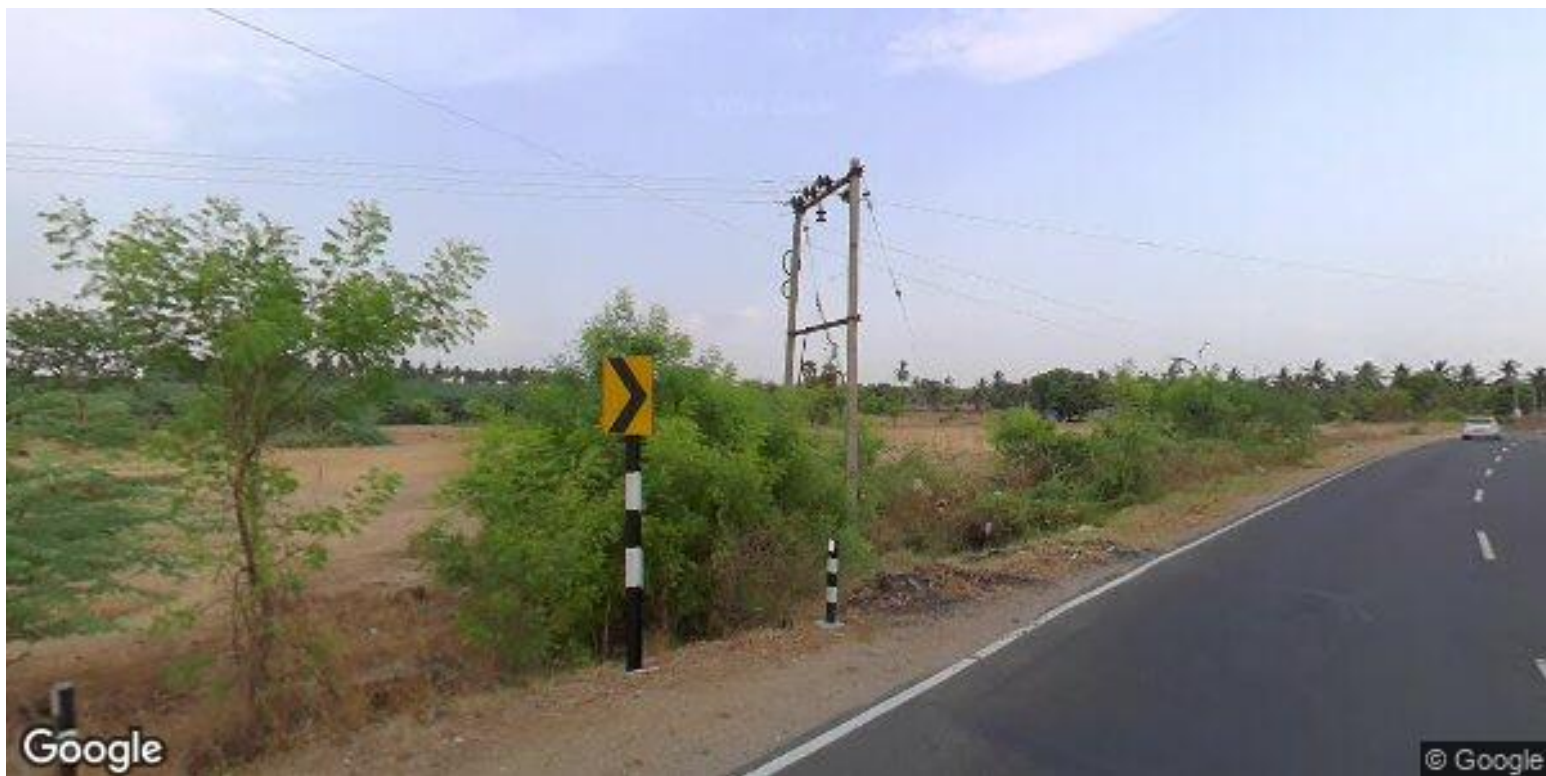
**Coordinates:** 11.33778, 77.86236

**Risk Type:** Turn

**Risk Level:** Medium

**Speed Limit:** 30 KM/Hr

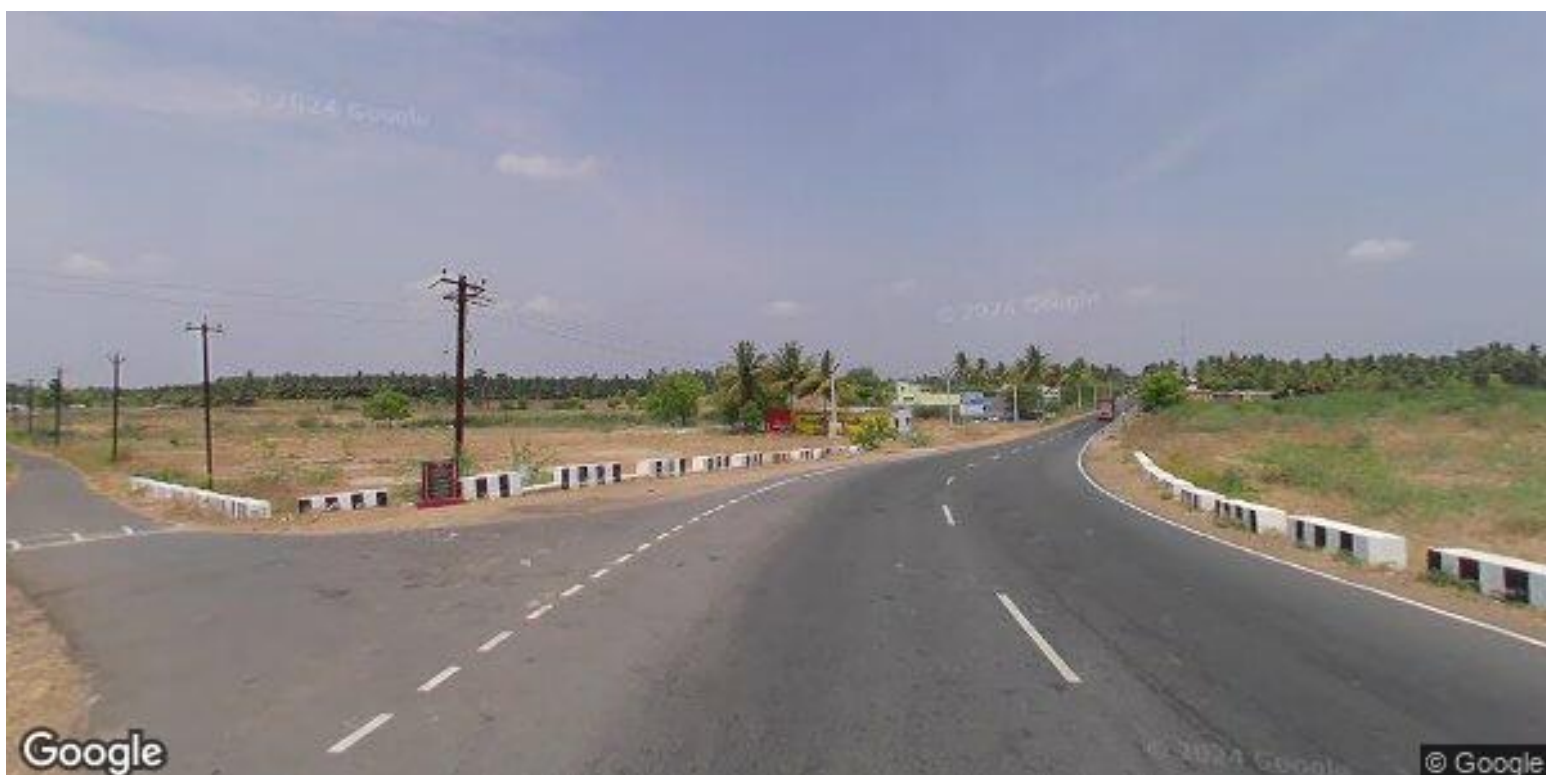
**Risk Type:** Turn  
**Risk Level:** Medium  
**Speed Limit:** 30 KM/Hr  
**Coordinates:** 11.31752, 77.84260

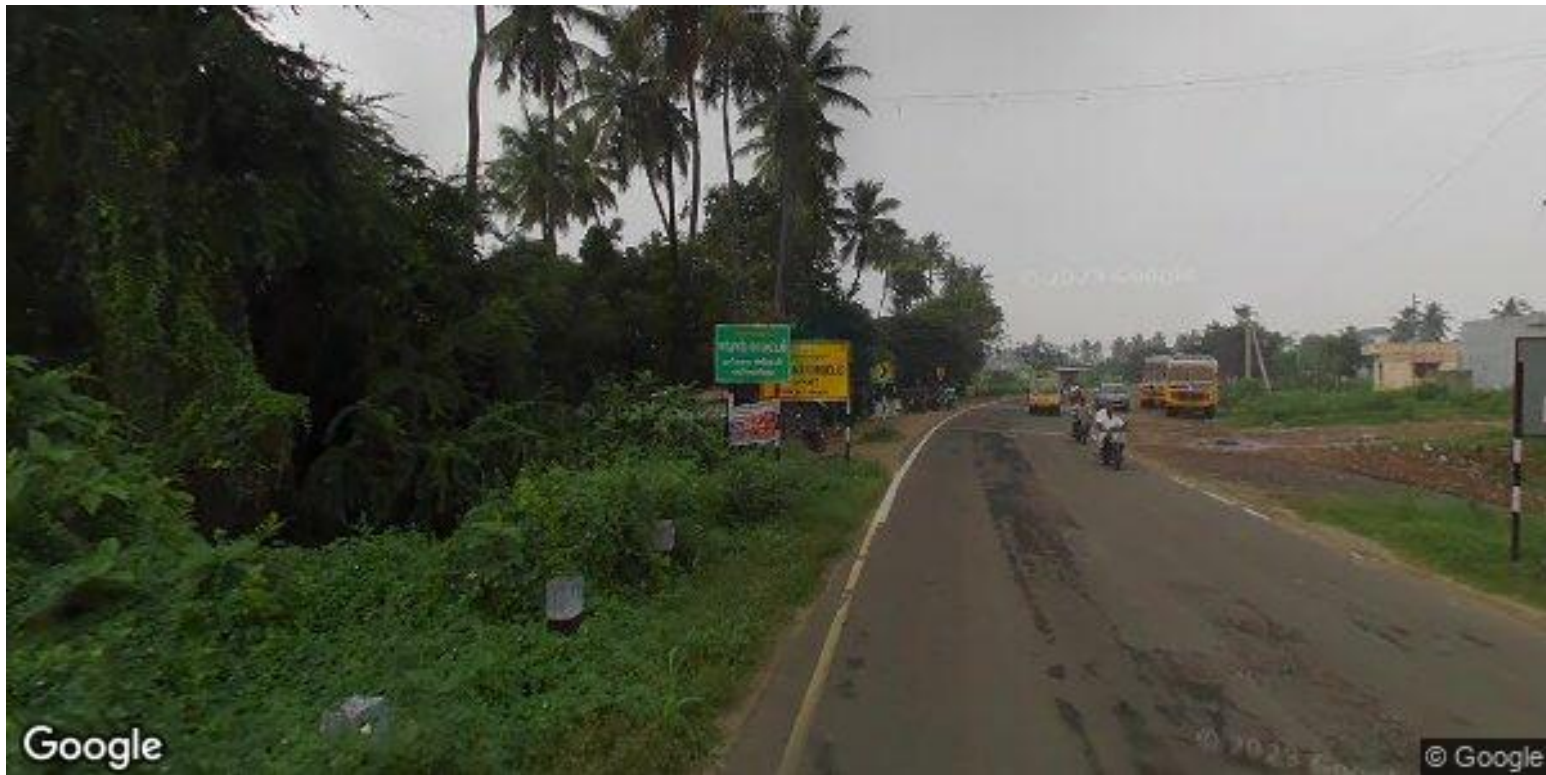
**Risk Type:** Turn  
**Risk Level:** Medium  
**Speed Limit:** 30 KM/Hr  
**Coordinates:** 11.30955, 77.77637

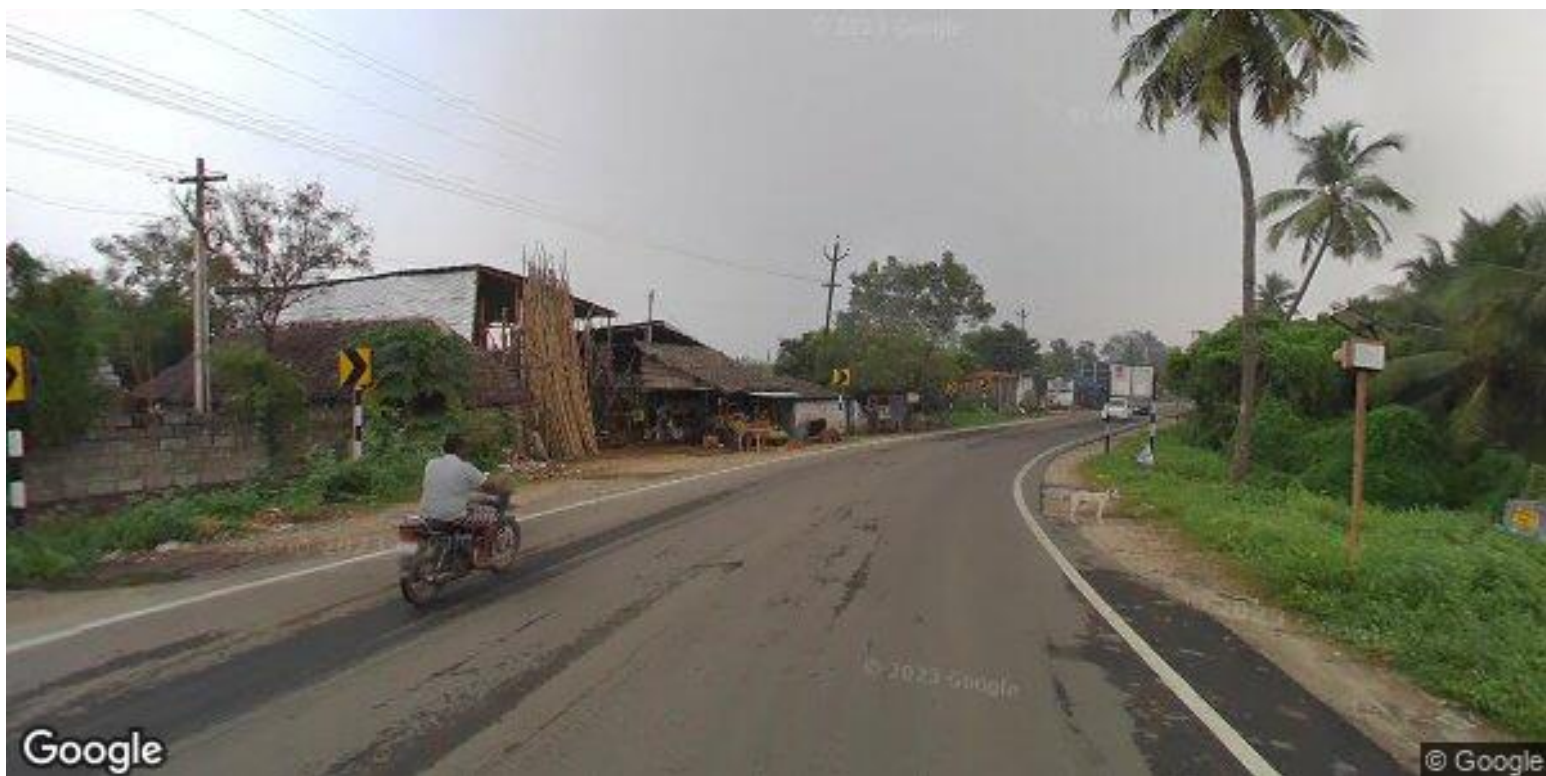
**Risk Type:** Turn  
**Risk Level:** Medium  
**Speed Limit:** 30 KM/Hr  
**Coordinates:** 11.30963, 77.76695

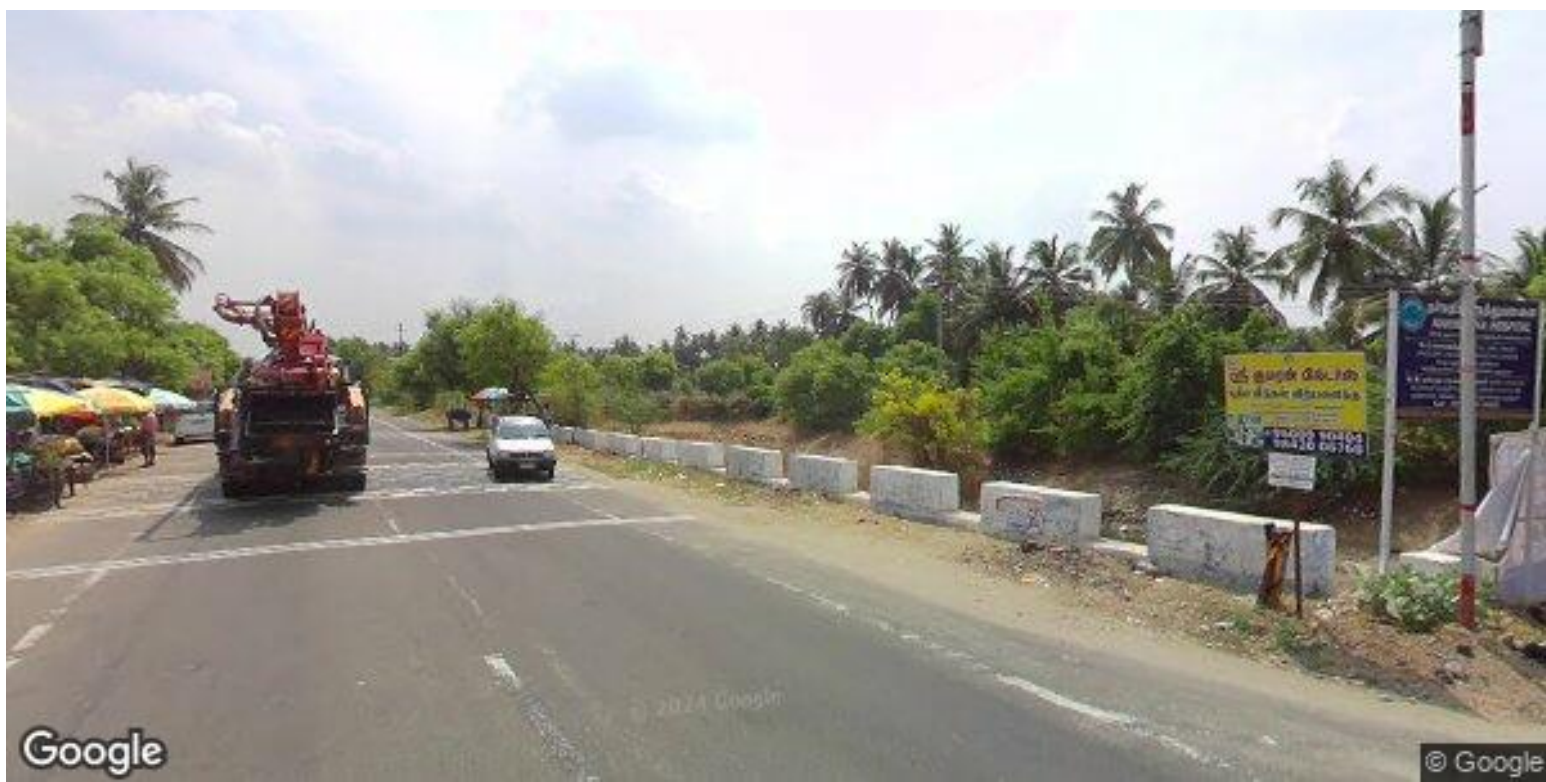
**Coordinates:** 11.29490, 77.74685

**Risk Type:** Turn

**Risk Level:** High

**Speed Limit:** 15 KM/Hr

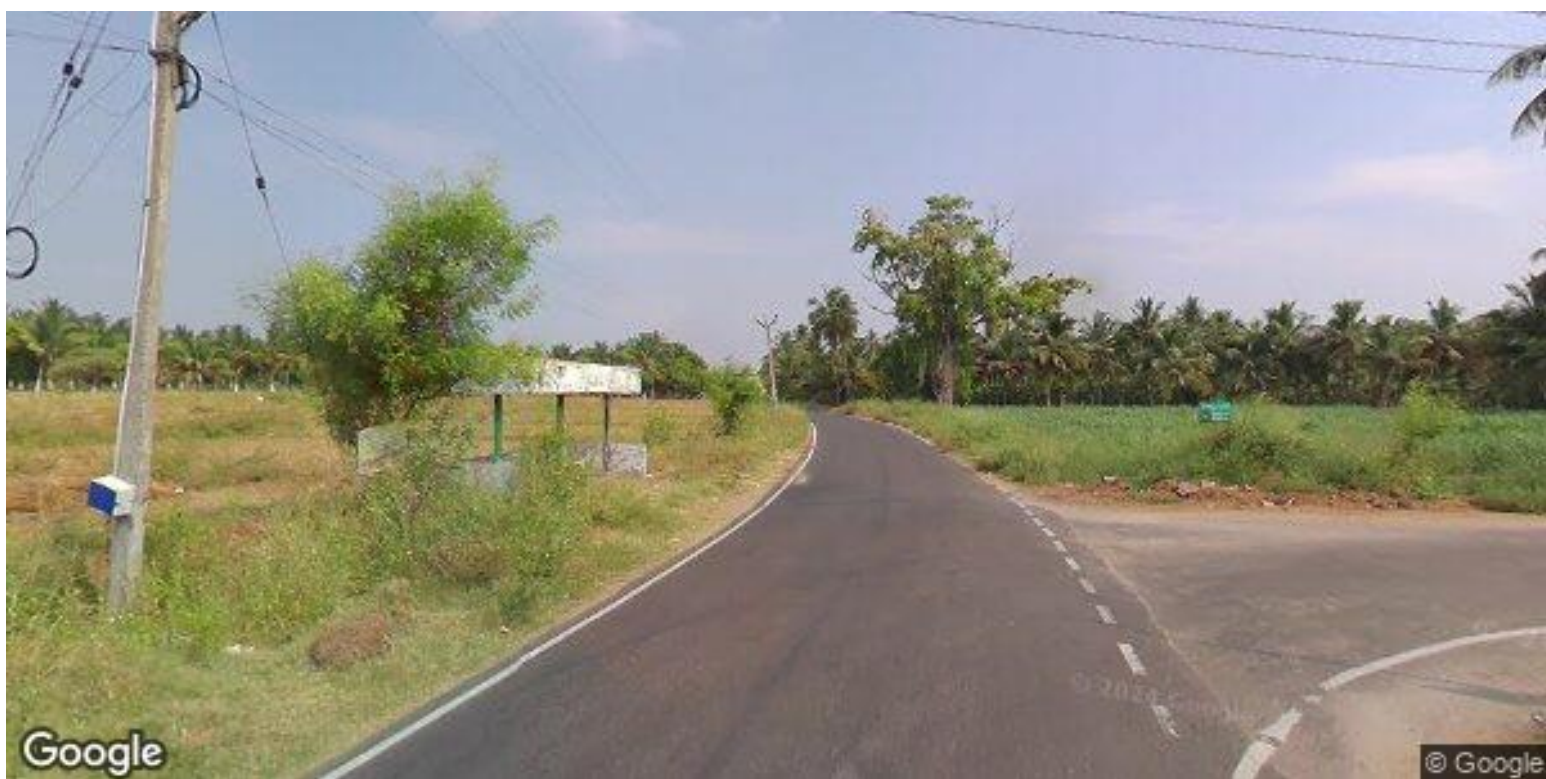
**Coordinates:** 11.29141, 77.74662

**Risk Type:** Turn

**Risk Level:** High

**Speed Limit:** 15 KM/Hr

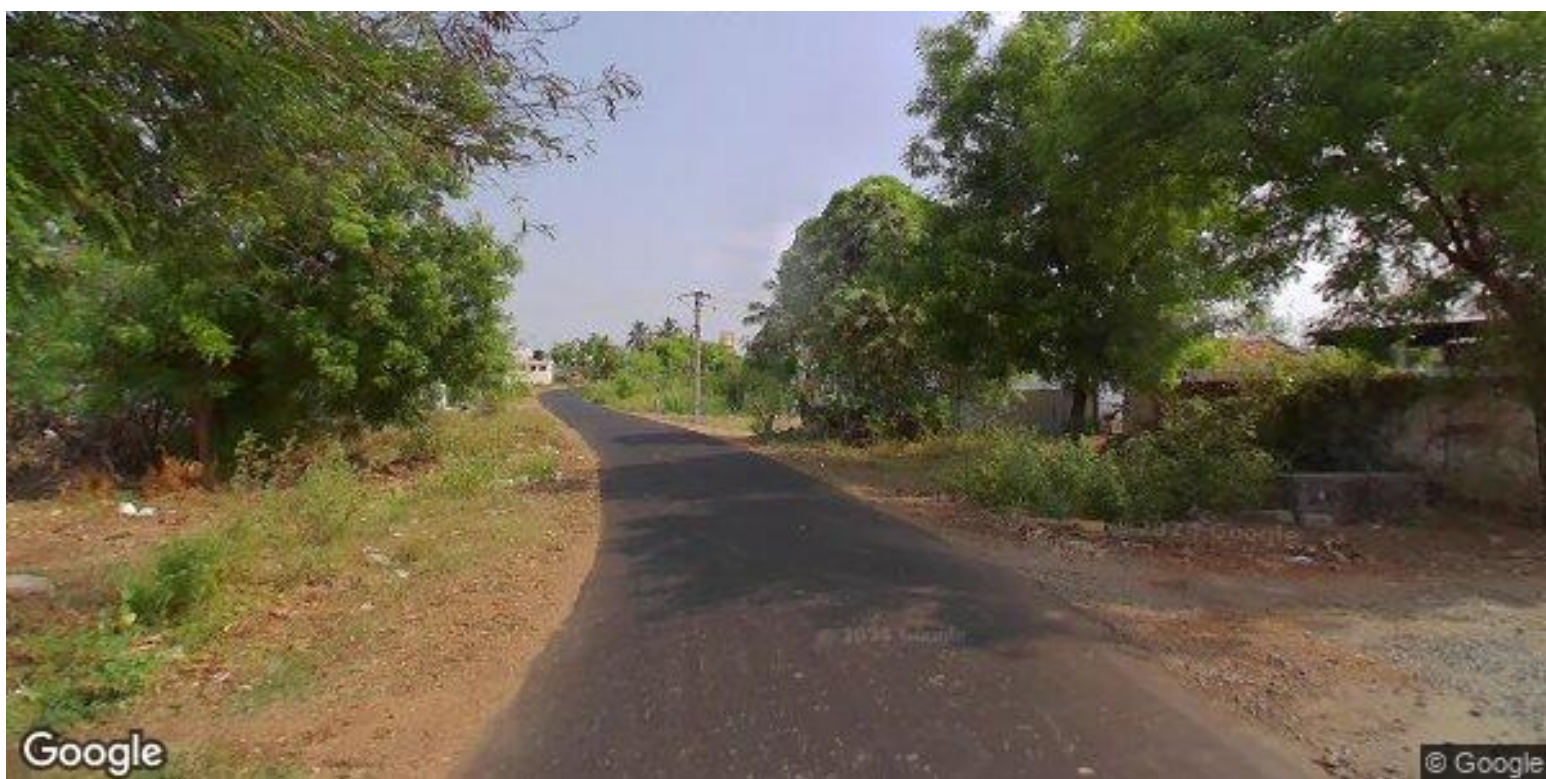
**Risk Type:** Turn  
**Risk Level:** Medium  
**Speed Limit:** 30 KM/Hr  
**Coordinates:** 11.28844, 77.74319

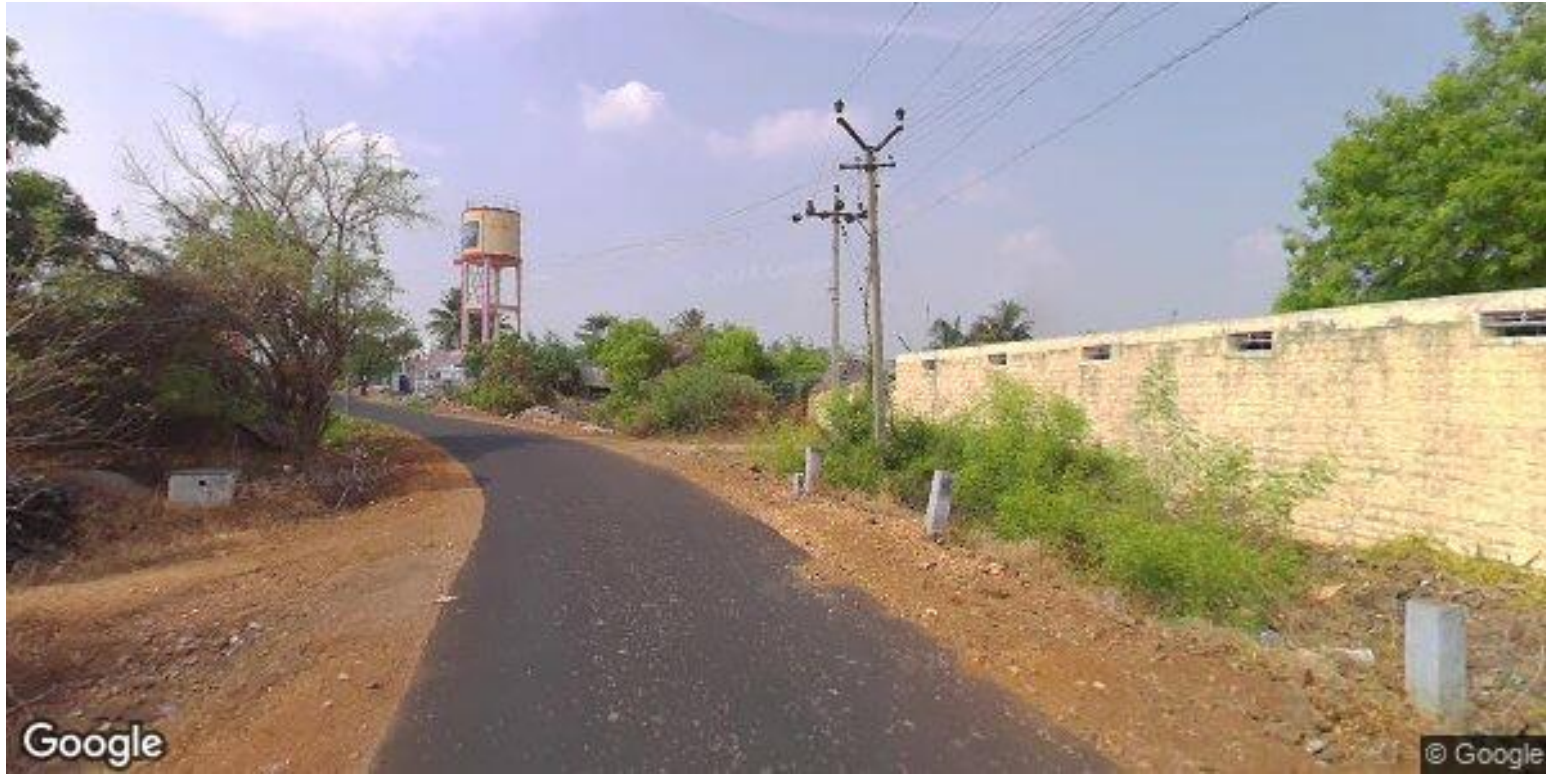
**Risk Type:** Turn  
**Risk Level:** Medium  
**Speed Limit:** 30 KM/Hr  
**Coordinates:** 11.28573, 77.74281
