# IndianOil

## JOURNEY RISK MANAGEMENT (JRM) STUDY

### Salem Terminal to ALAGUMALAI MUTHUKUMARAN FUELS

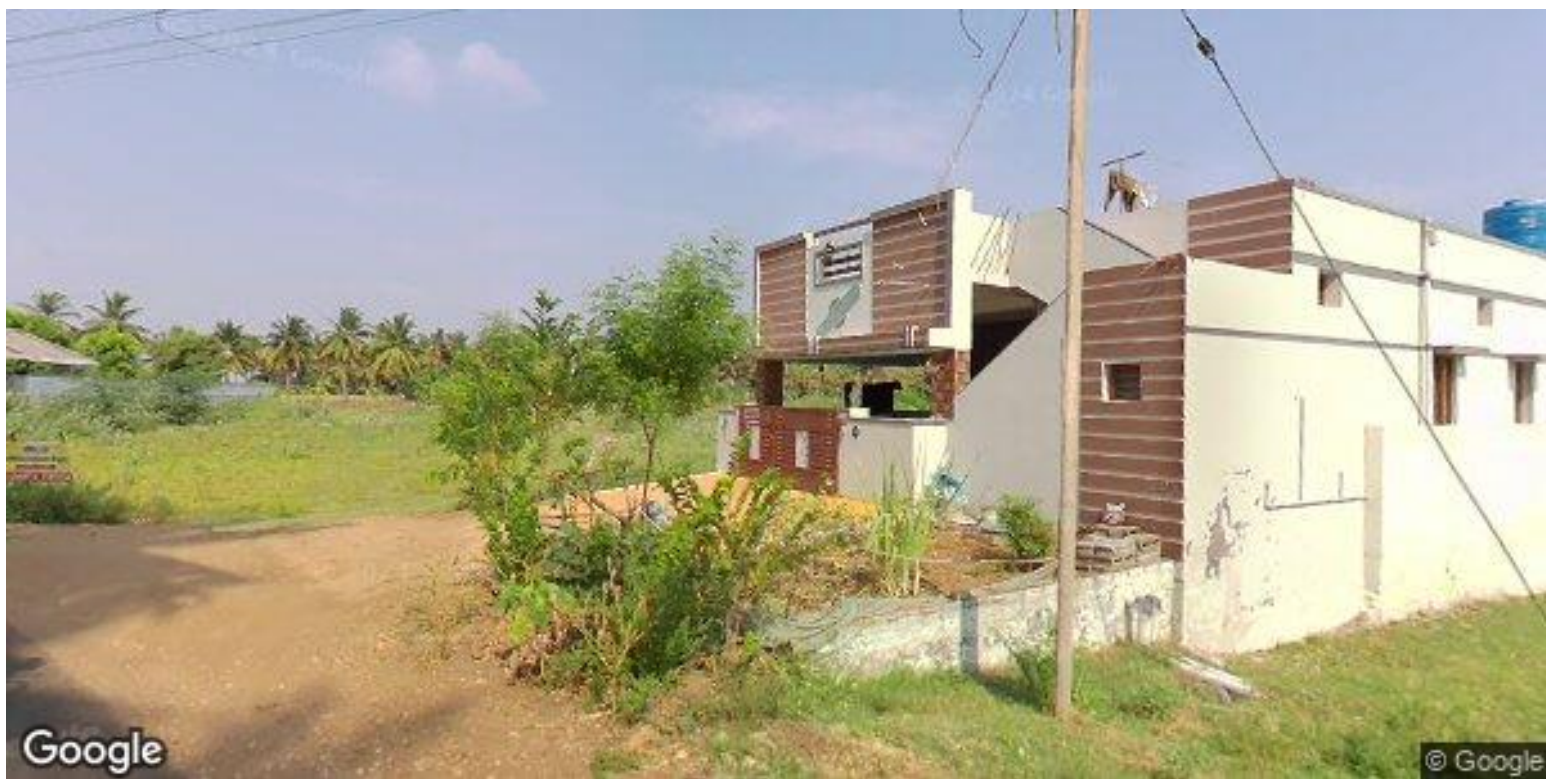
**Risk Type:** Turn  
**Risk Level:** High  
**Speed Limit:** 15 KM/Hr  
**Coordinates:** 11.27319, 77.72981

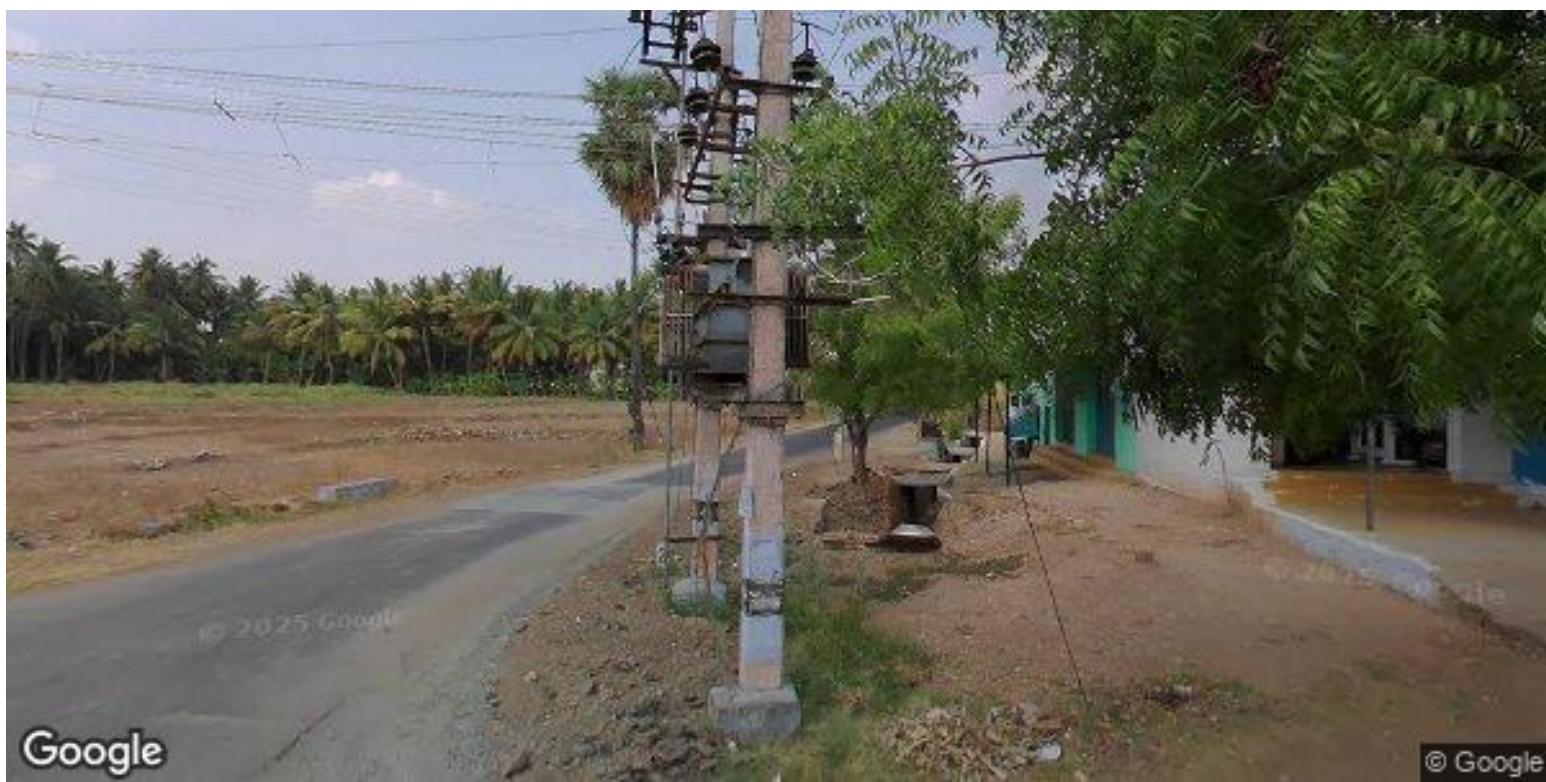
**Coordinates:** 11.27330, 77.72715

**Risk Type:** Blind Spot

**Risk Level:** Blind Spot

**Speed Limit:** 10 KM/Hr

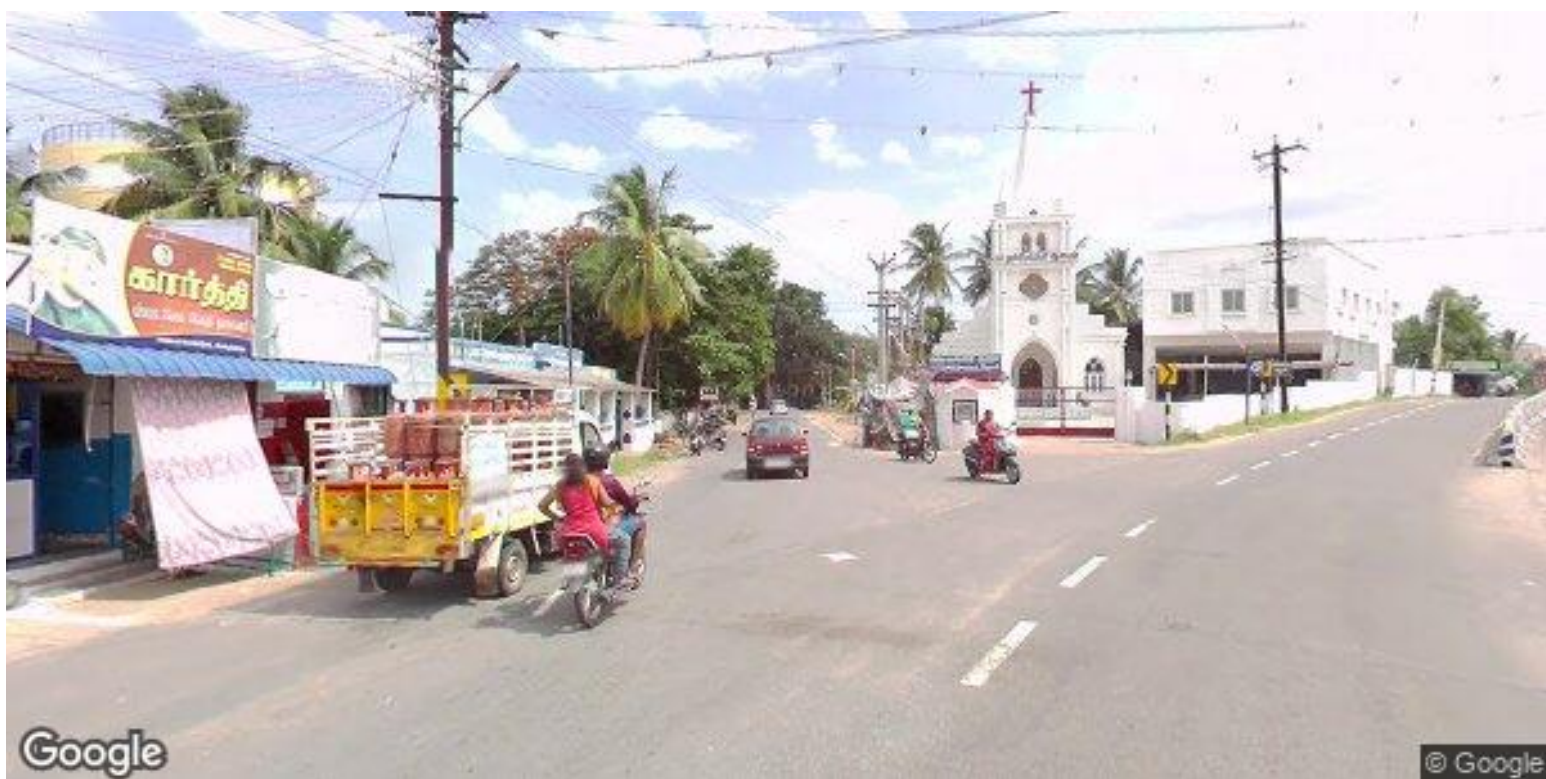
**Coordinates:** 11.23054, 77.71796

**Risk Type:** Turn

**Risk Level:** Medium

**Speed Limit:** 30 KM/Hr

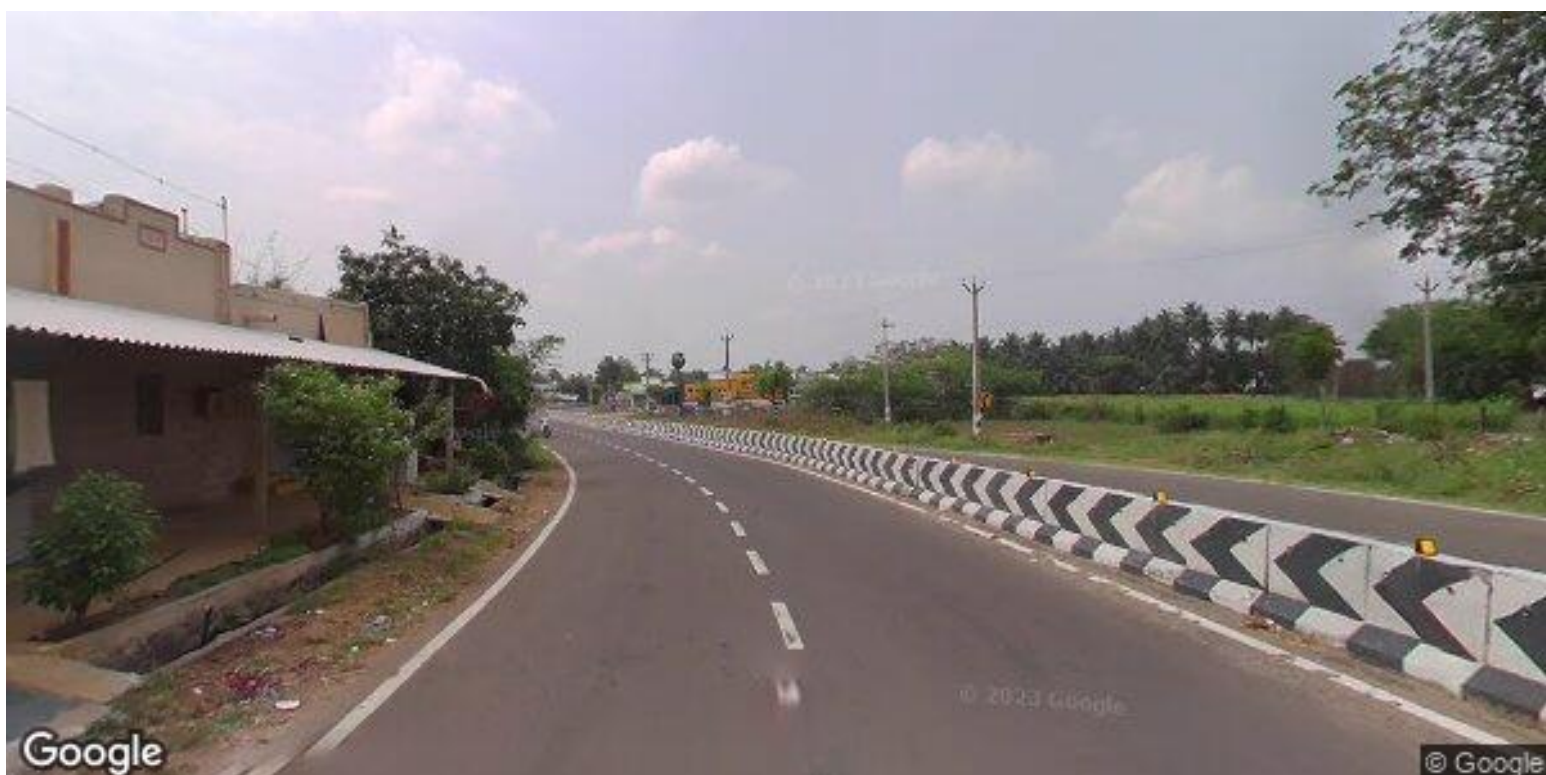
**Risk Type:** Turn  
**Risk Level:** Medium  
**Speed Limit:** 30 KM/Hr  
**Coordinates:** 11.22387, 77.71385

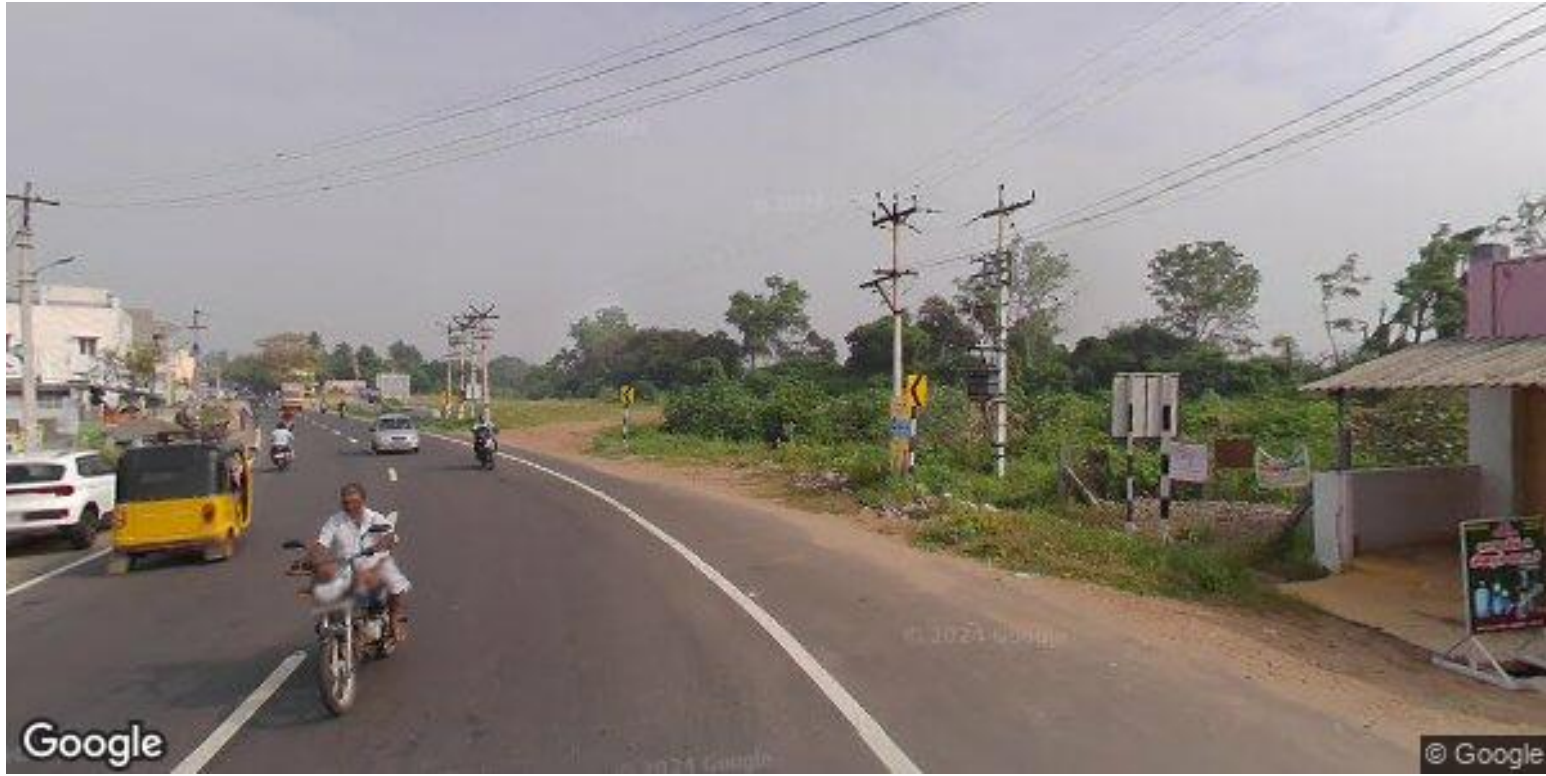
**Risk Type:** Turn  
**Risk Level:** Medium  
**Speed Limit:** 30 KM/Hr  
**Coordinates:** 11.16078, 77.70122

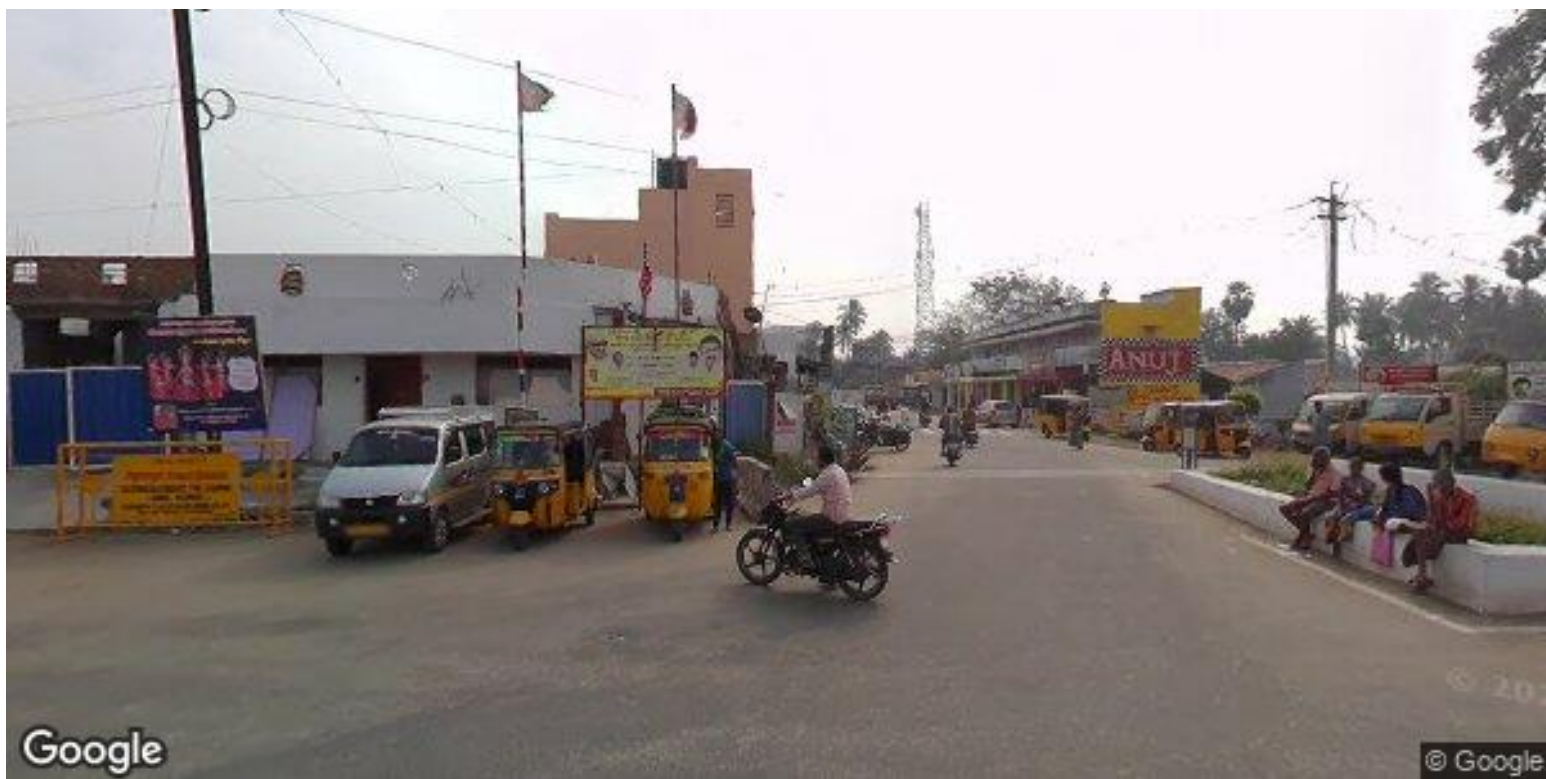
**Risk Type:** Turn  
**Risk Level:** Medium  
**Speed Limit:** 30 KM/Hr  
**Coordinates:** 11.15953, 77.70067

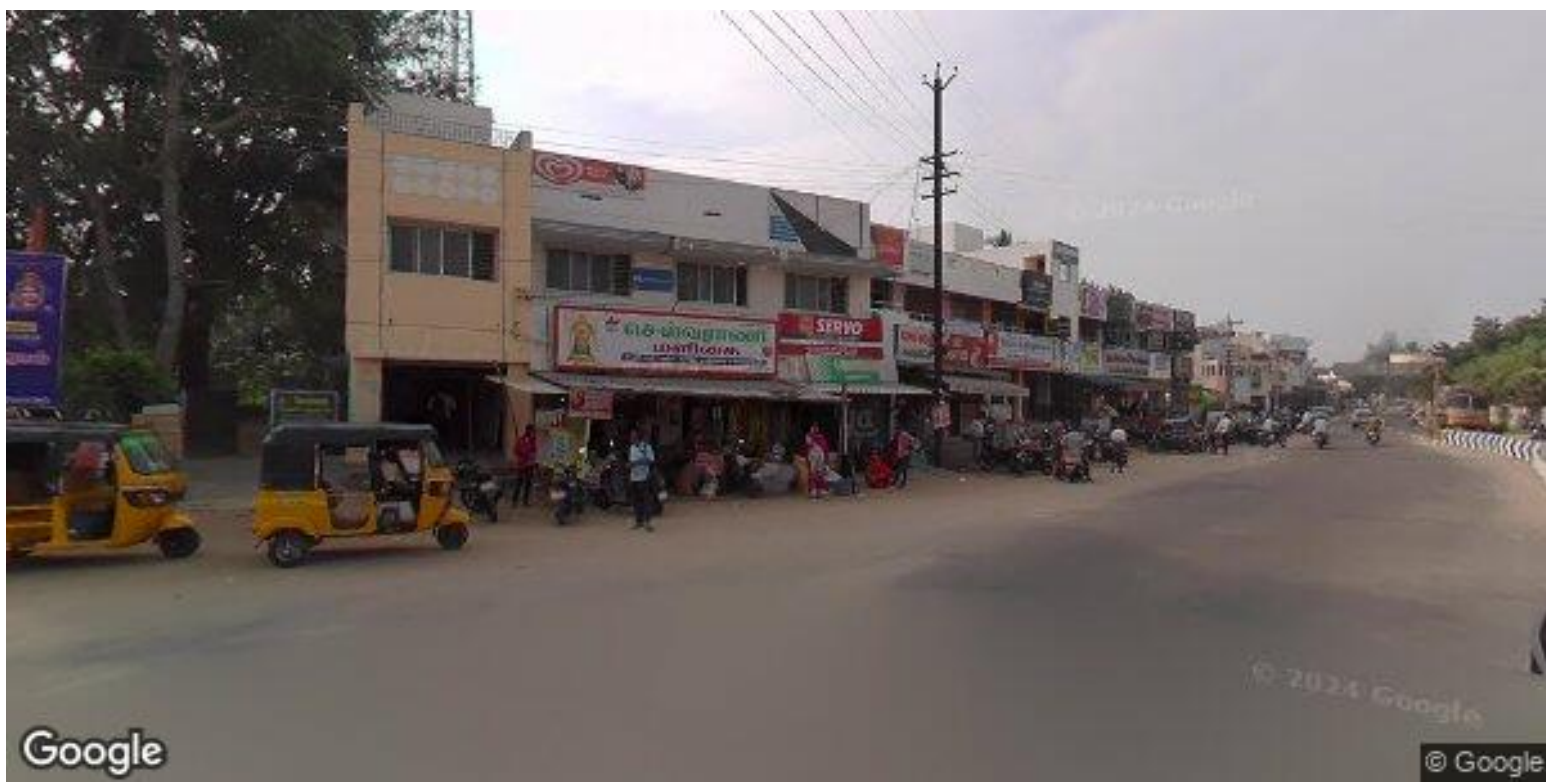
**Coordinates:** 11.15944, 77.70068

**Risk Type:** Turn

**Risk Level:** High

**Speed Limit:** 15 KM/Hr

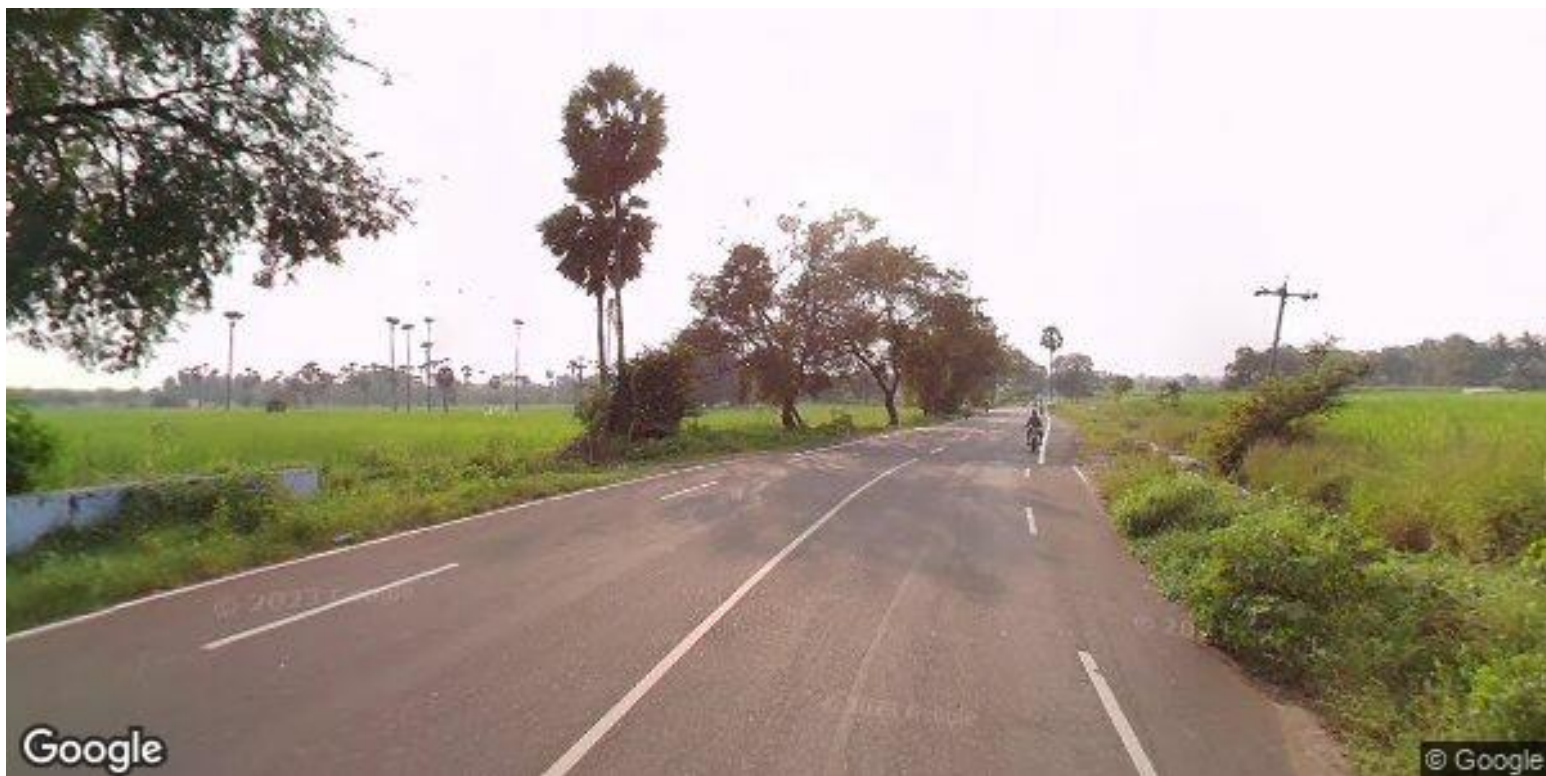
**Coordinates:** 11.11918, 77.67766

**Risk Type:** Turn

**Risk Level:** Medium

**Speed Limit:** 30 KM/Hr

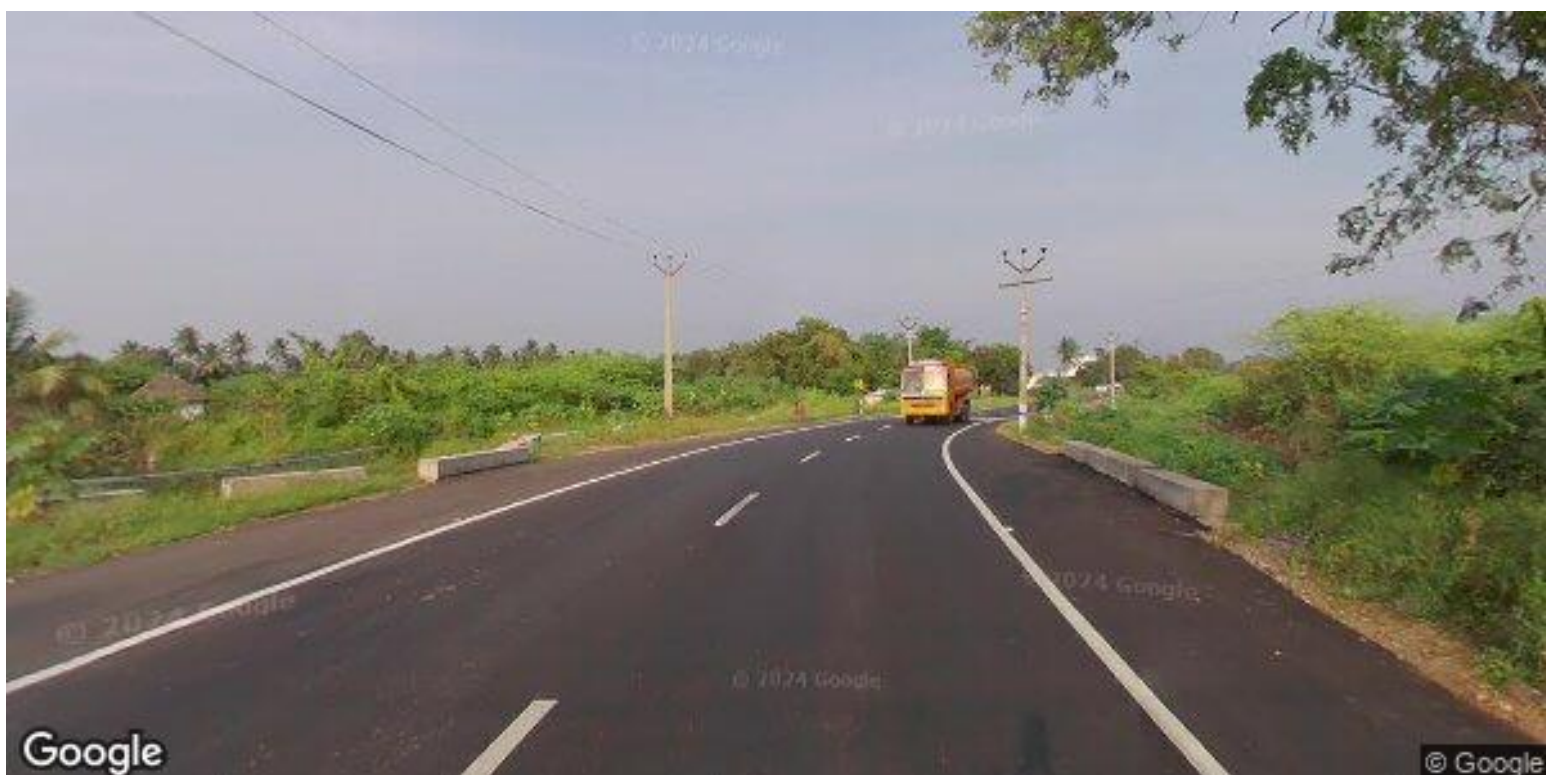
**Coordinates: 11.11740, 77.67198**

**Risk Type: Turn**

**Risk Level: Medium**

**Speed Limit: 30 KM/Hr**

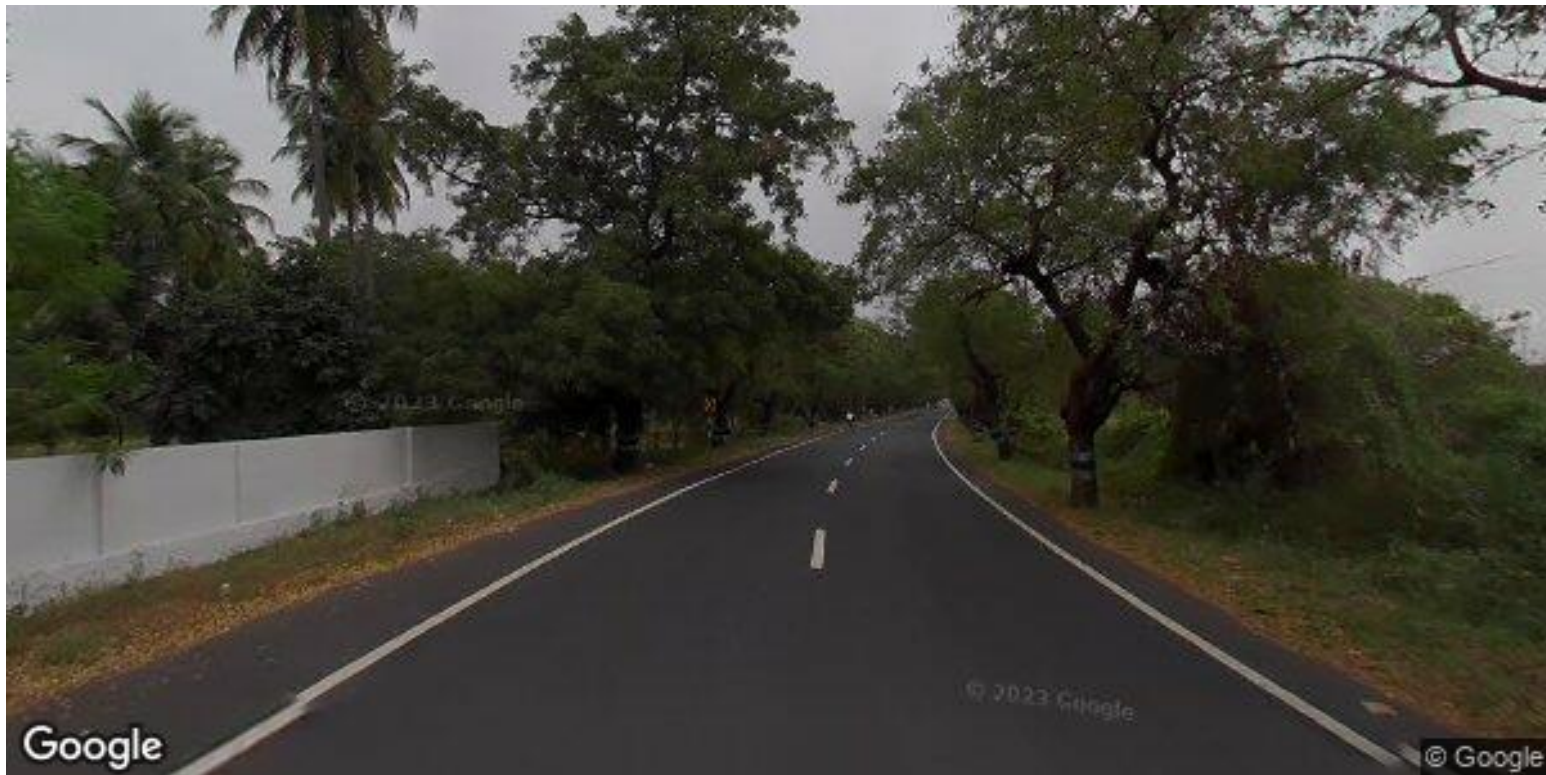
**Coordinates: 11.10481, 77.67060**

**Risk Type: Turn**

**Risk Level: Medium**

**Speed Limit: 30 KM/Hr**

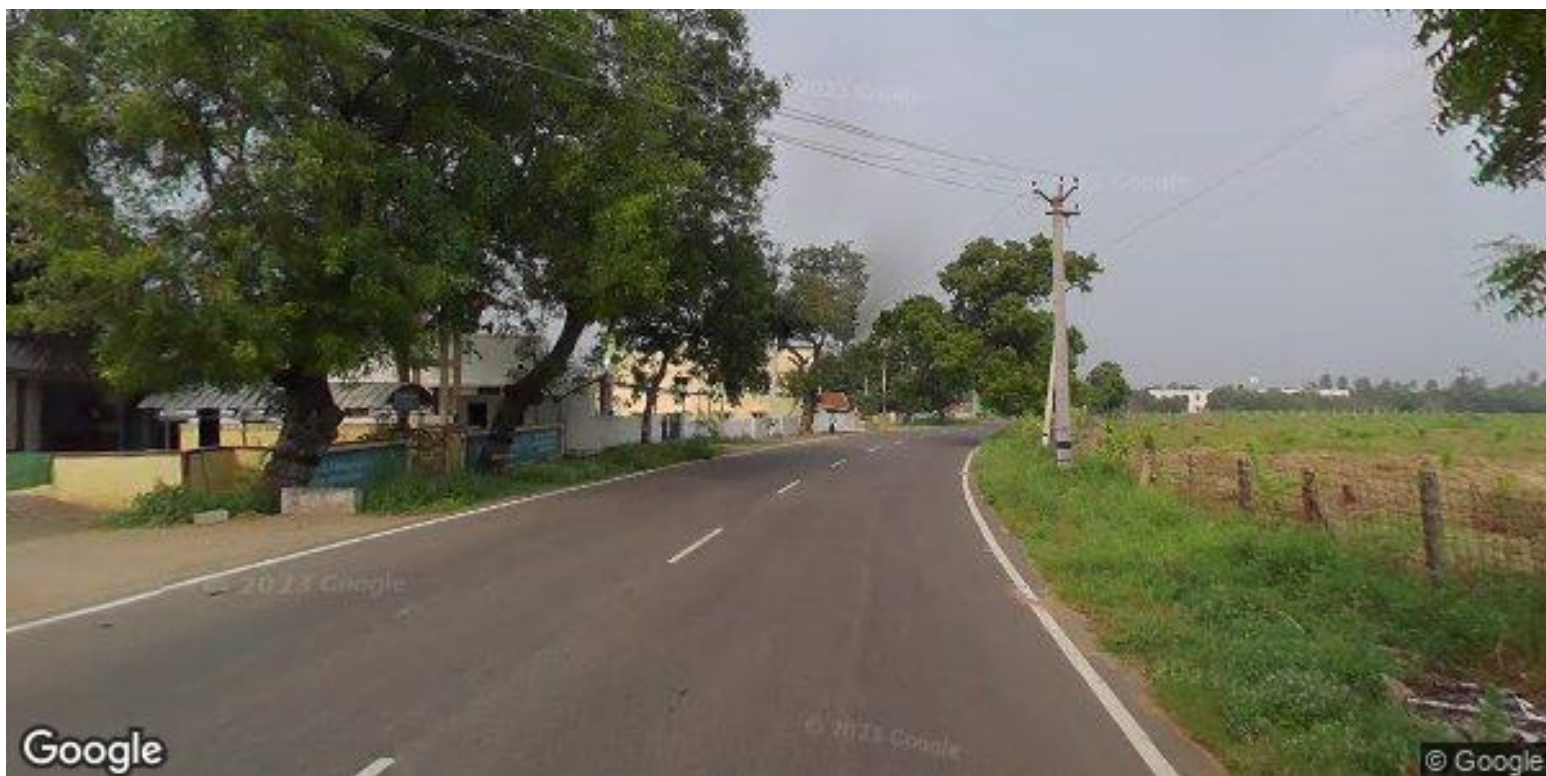
**Coordinates: 11.09509, 77.66612**

**Risk Type: Turn**

**Risk Level: Medium**

**Speed Limit: 30 KM/Hr**

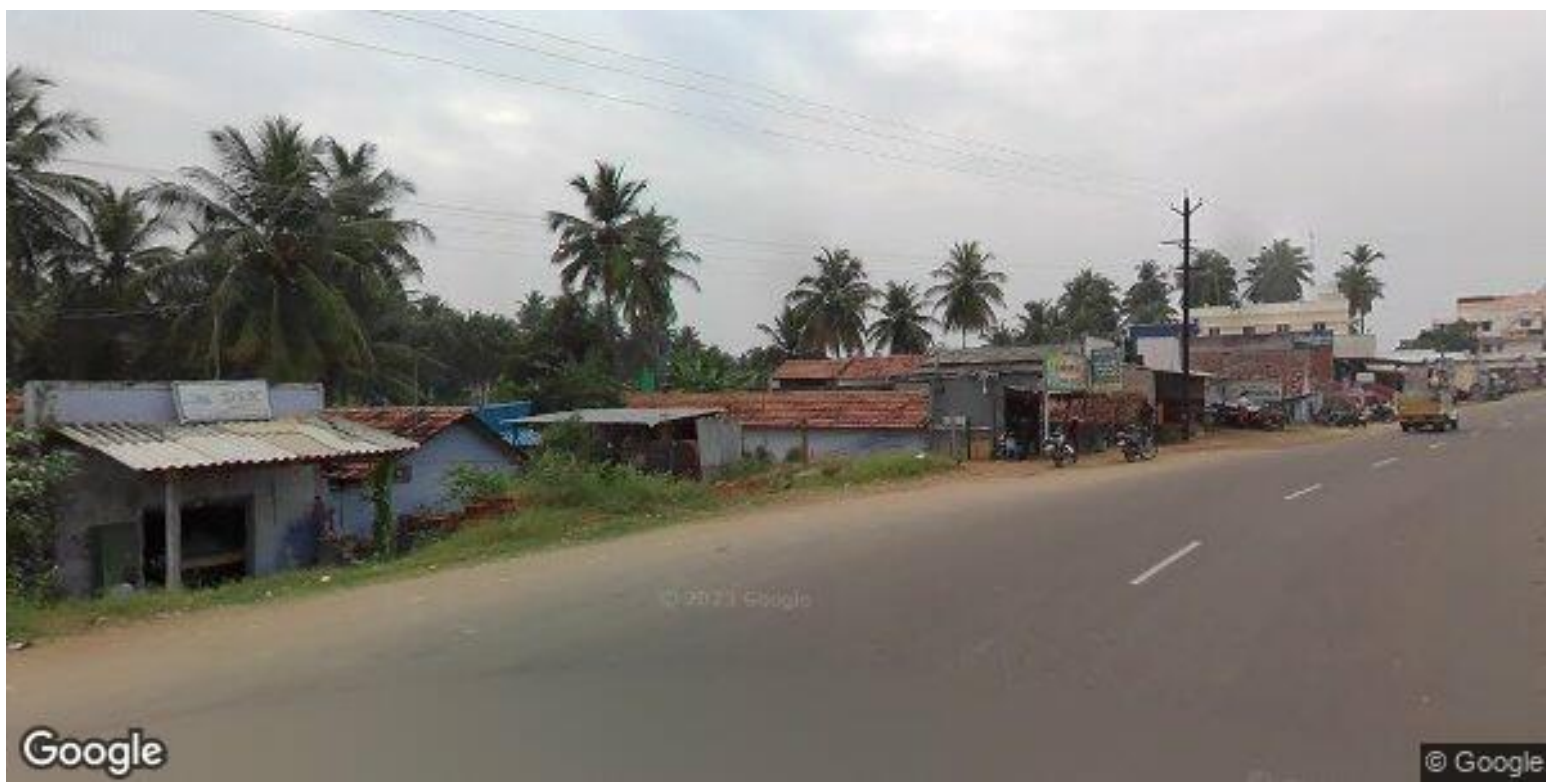
**Coordinates:** 11.08730, 77.66436

**Risk Type:** Turn

**Risk Level:** Medium

**Speed Limit:** 30 KM/Hr

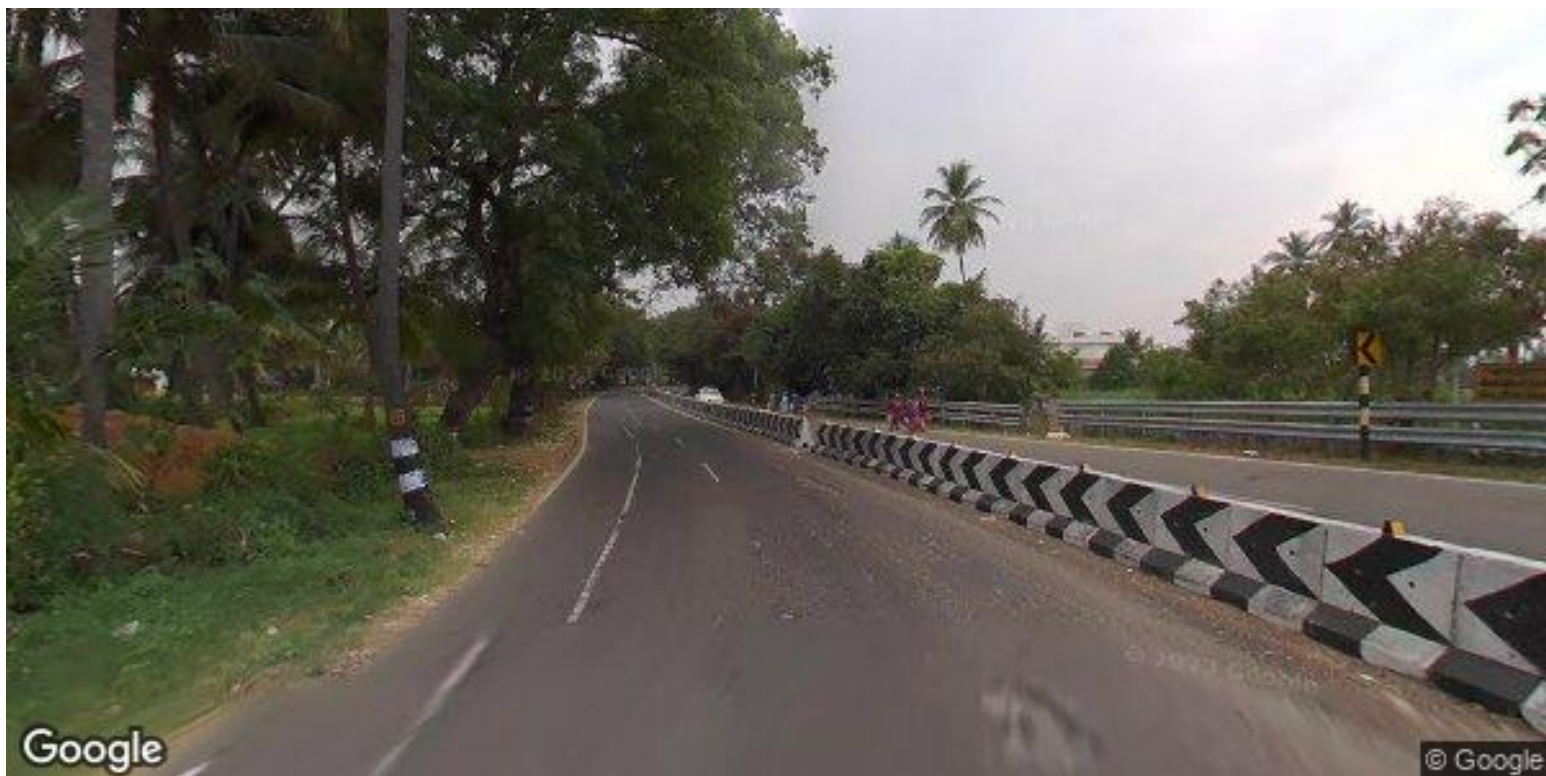
**Coordinates:** 11.08282, 77.65837

**Risk Type:** Turn

**Risk Level:** Medium

**Speed Limit:** 30 KM/Hr

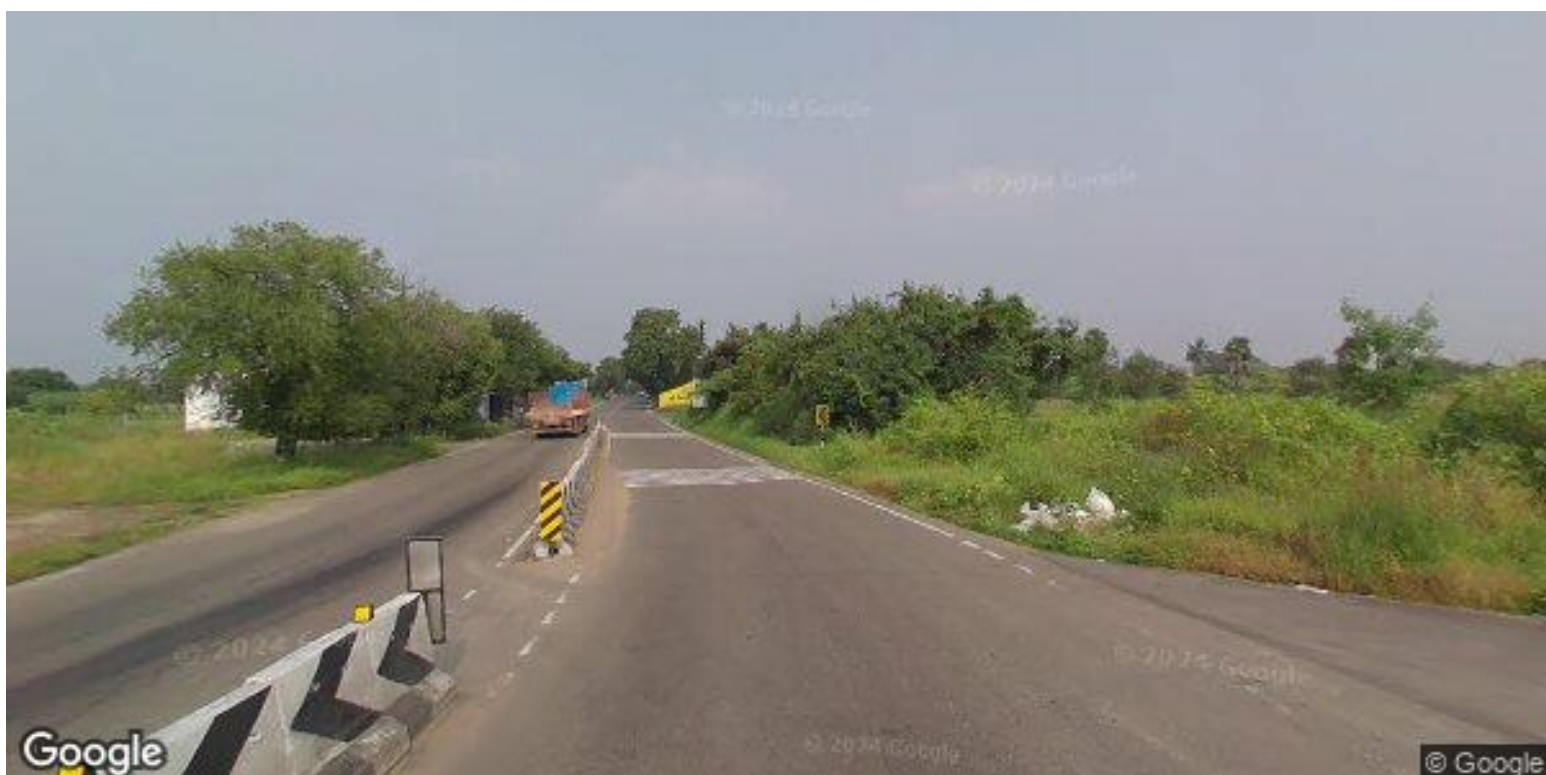
**Risk Type:** Turn  
**Risk Level:** High  
**Speed Limit:** 15 KM/Hr  
**Coordinates:** 11.06189, 77.63943

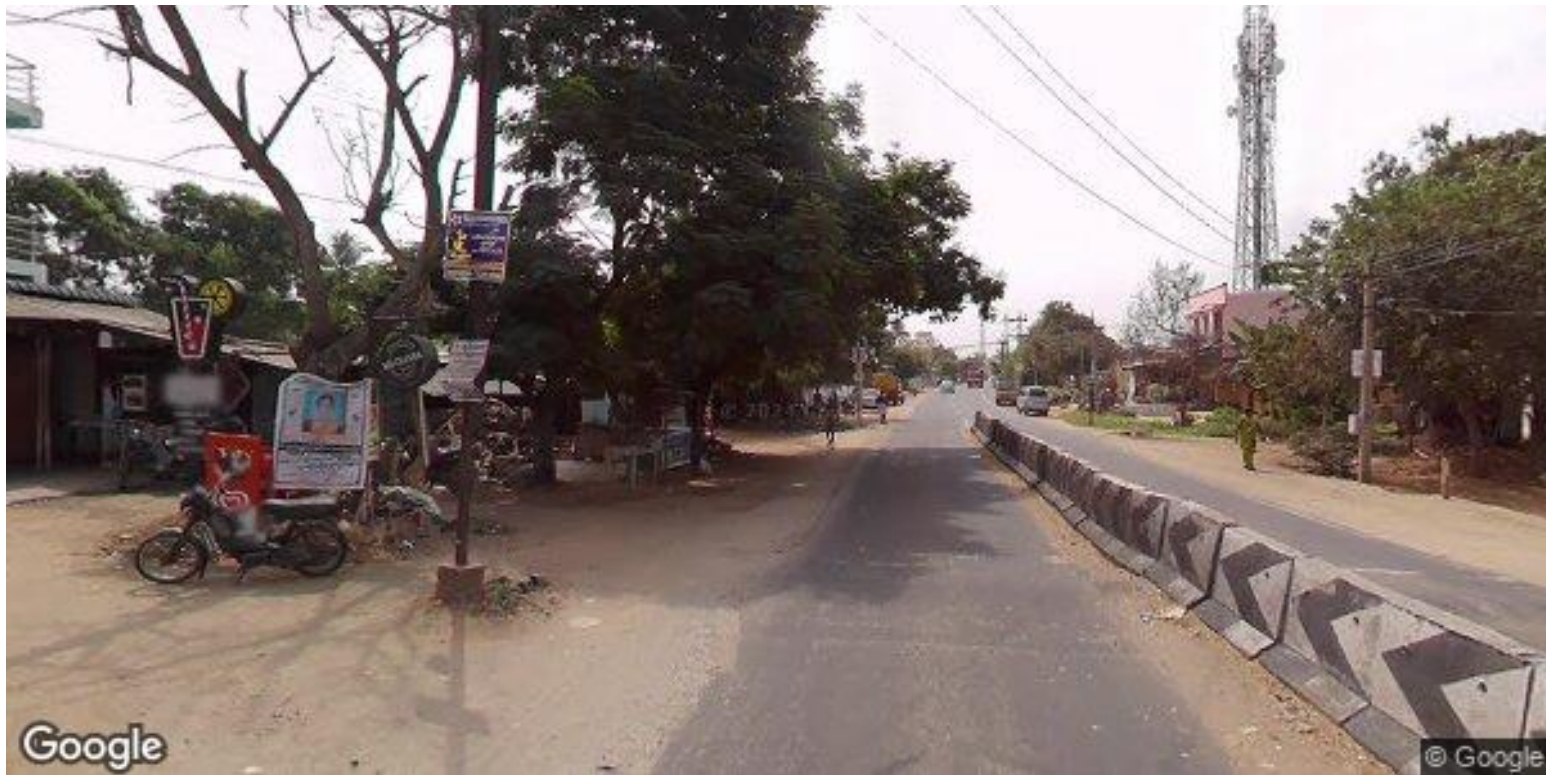
**Risk Type:** Turn  
**Risk Level:** High  
**Speed Limit:** 15 KM/Hr  
**Coordinates:** 11.00826, 77.56962

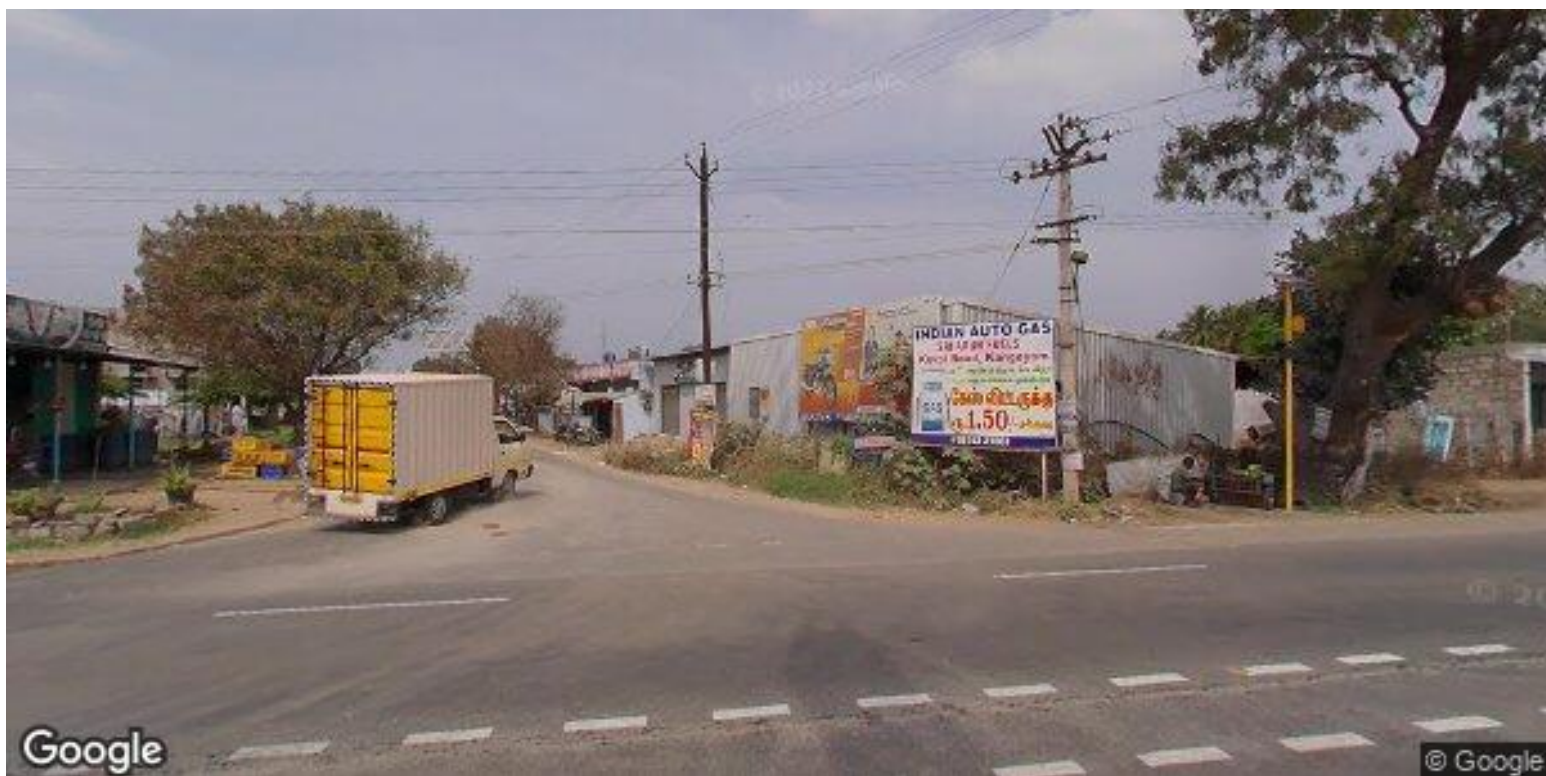
**Risk Type:** Blind Spot  
**Risk Level:** Blind Spot  
**Speed Limit:** 10 KM/Hr  
**Coordinates:** 11.00058, 77.56882

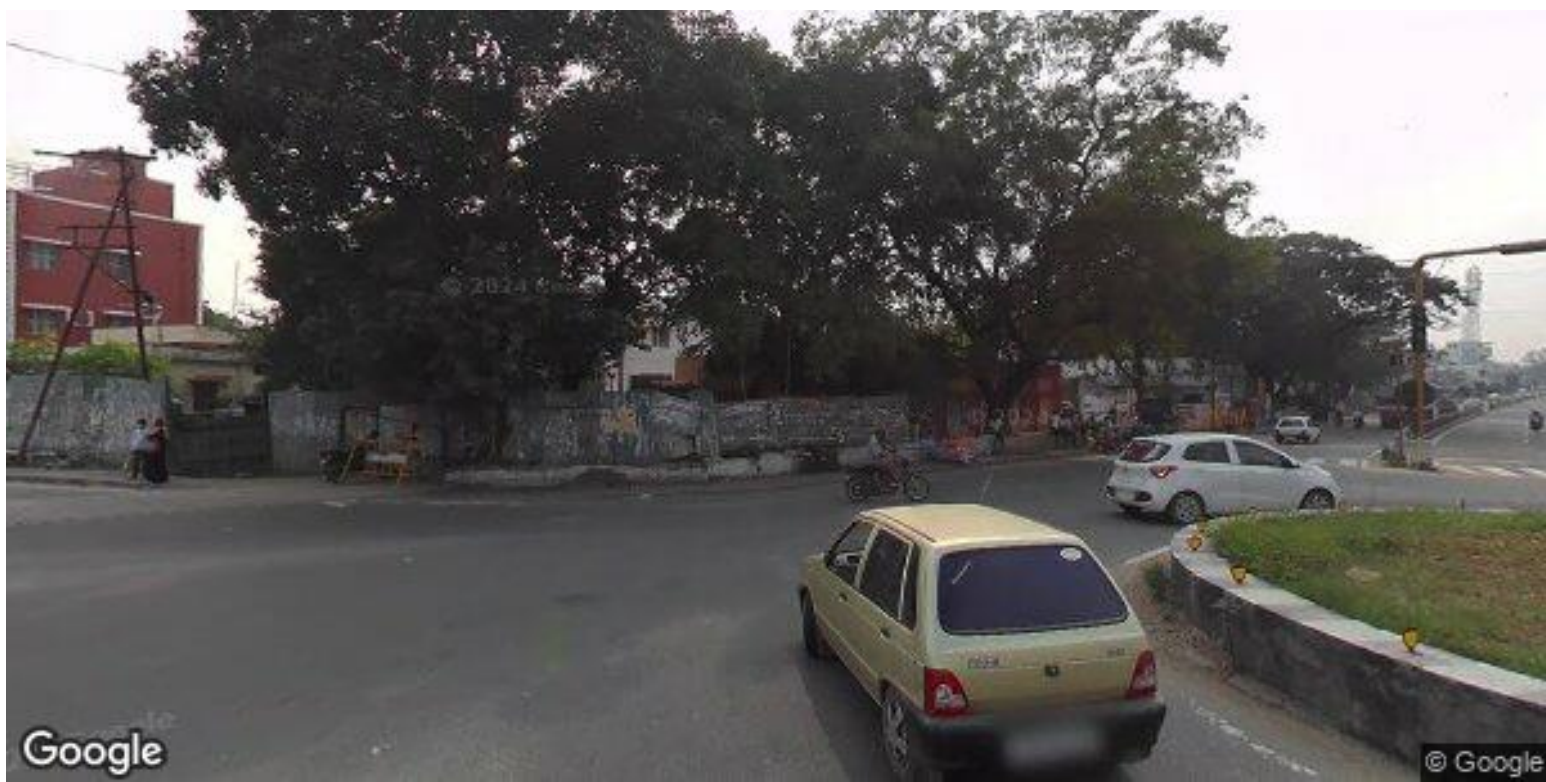
**Coordinates:** 11.00171, 77.56267

**Risk Type:** Turn

**Risk Level:** High

**Speed Limit:** 15 KM/Hr

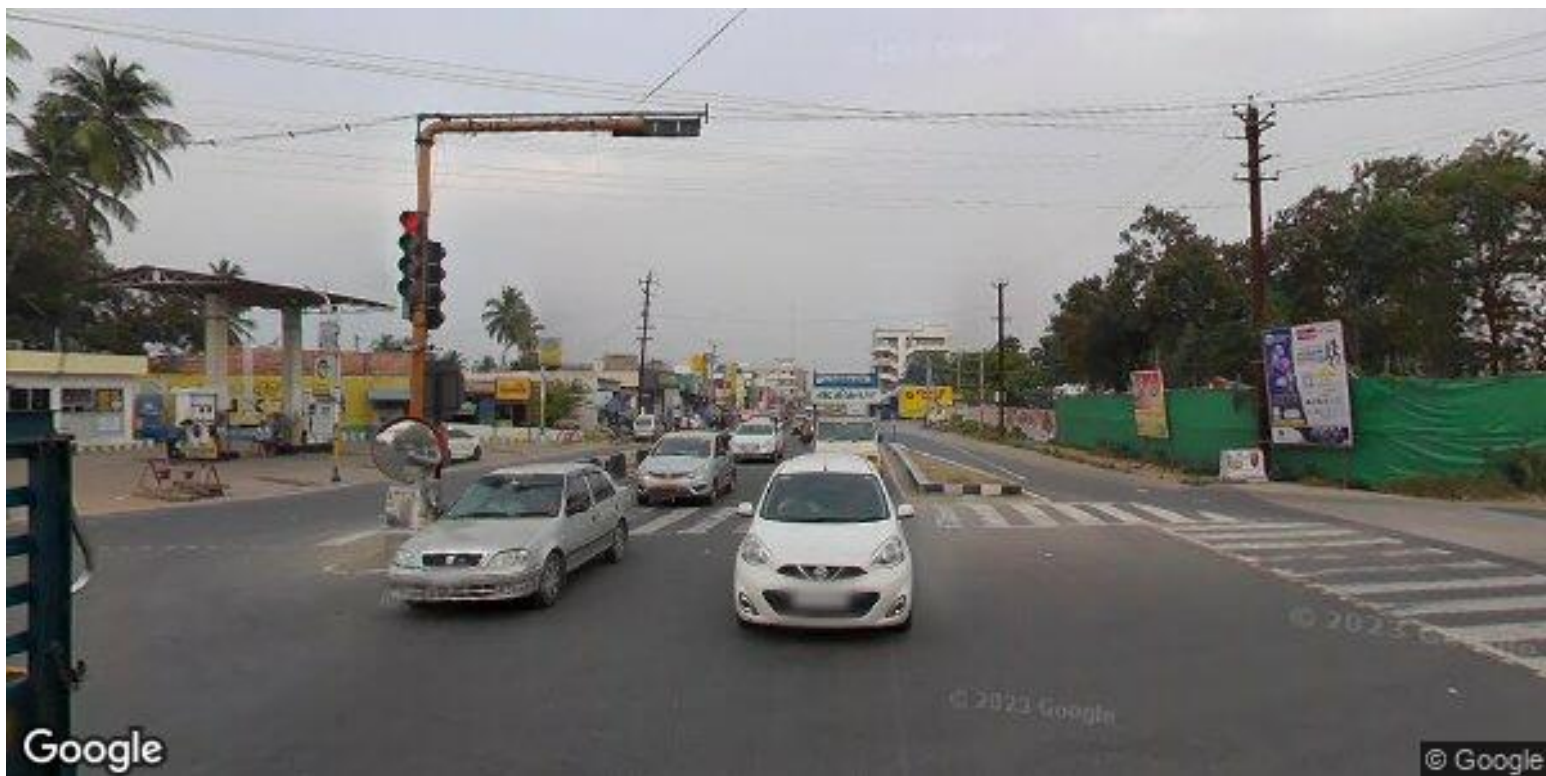
**Coordinates:** 11.00168, 77.56265

**Risk Type:** Turn

**Risk Level:** Medium

**Speed Limit:** 30 KM/Hr
