# IndianOil

## JOURNEY RISK MANAGEMENT (JRM) STUDY

### Salem Terminal to ALAGUMALAI MUTHUKUMARAN FUELS

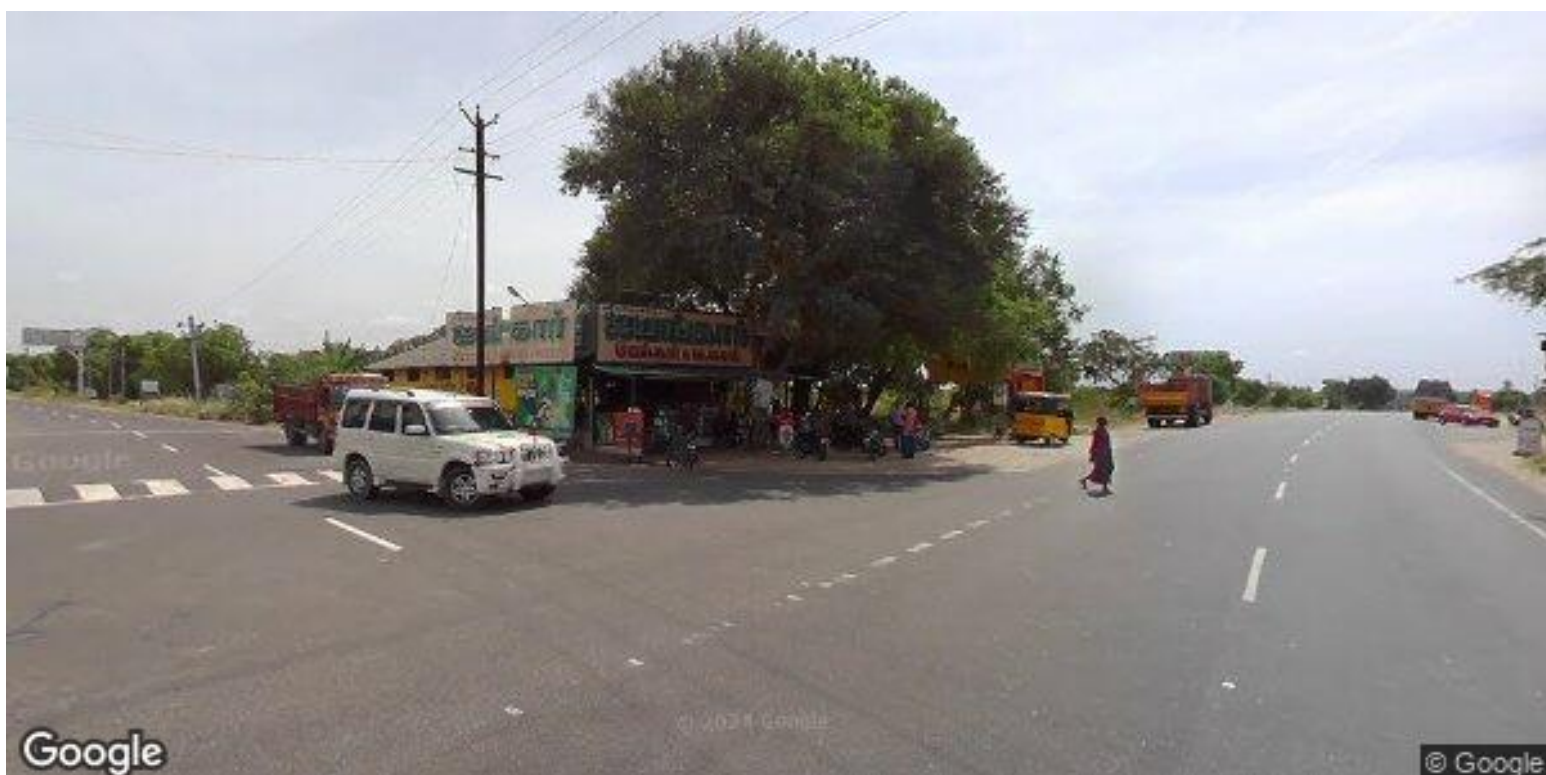
**Risk Type:** Blind Spot  
**Risk Level:** Blind Spot  
**Speed Limit:** 10 KM/Hr  
**Coordinates:** 10.97407, 77.44310

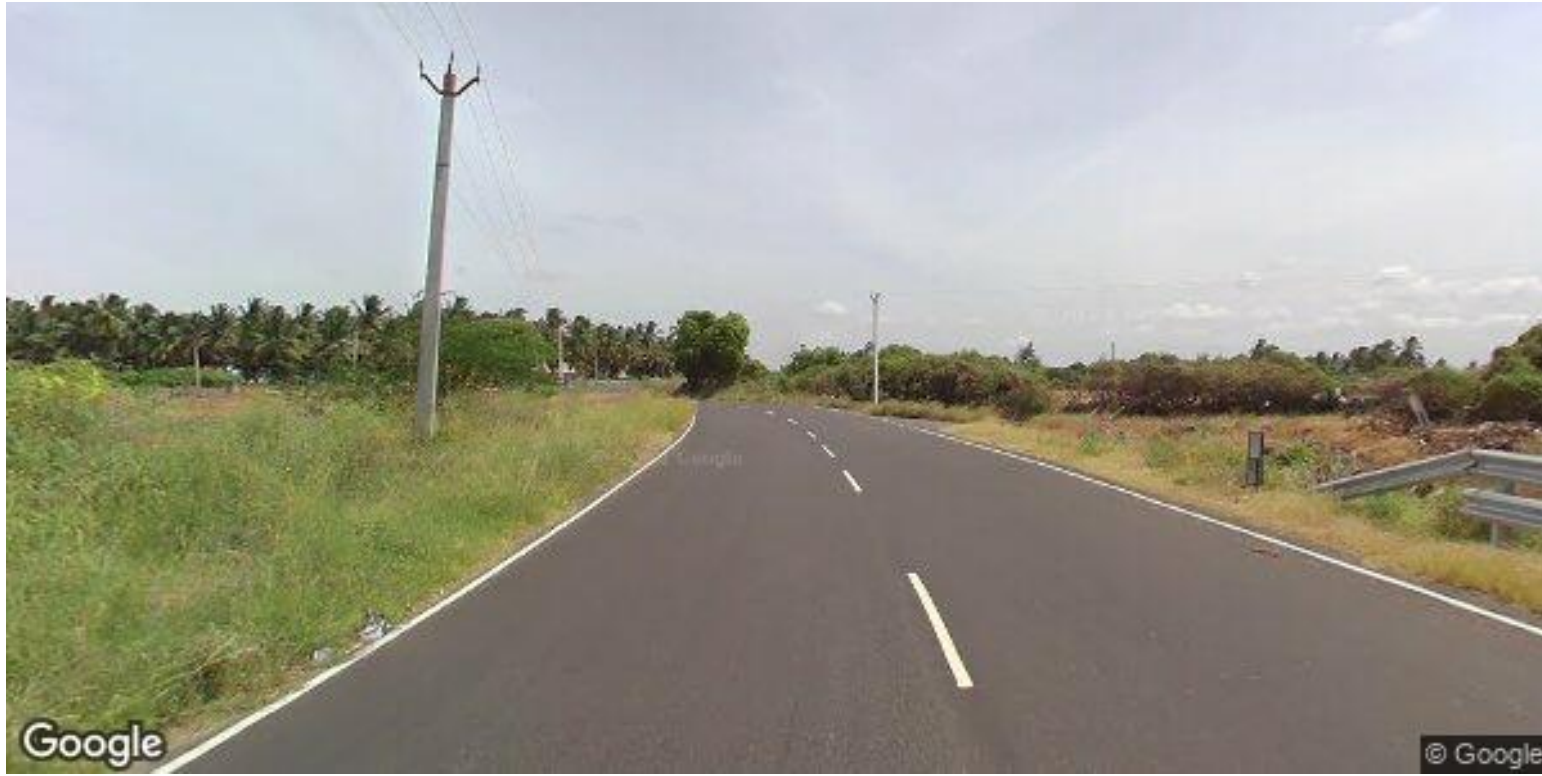
**Risk Type:** Turn  
**Risk Level:** High  
**Speed Limit:** 15 KM/Hr  
**Coordinates:** 10.99839, 77.43708
