# IndianOil

## JOURNEY RISK MANAGEMENT (JRM) STUDY

### Salem Terminal TO NKK FUELS ADHOC

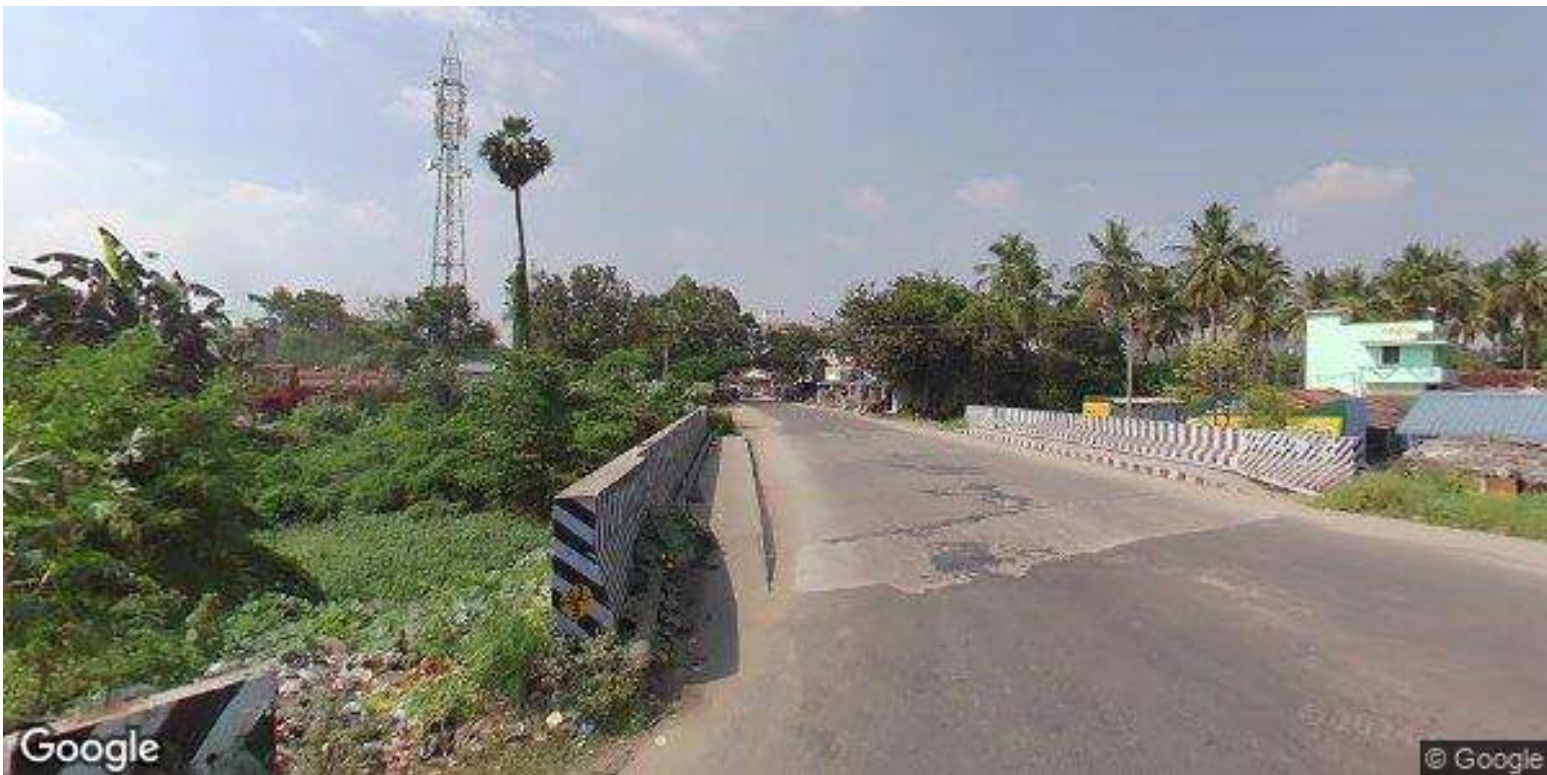
**Risk Type:** Turn  
**Risk Level:** High  
**Speed Limit:** 15 KM/Hr  
**Coordinates:** 11.44900, 77.87406

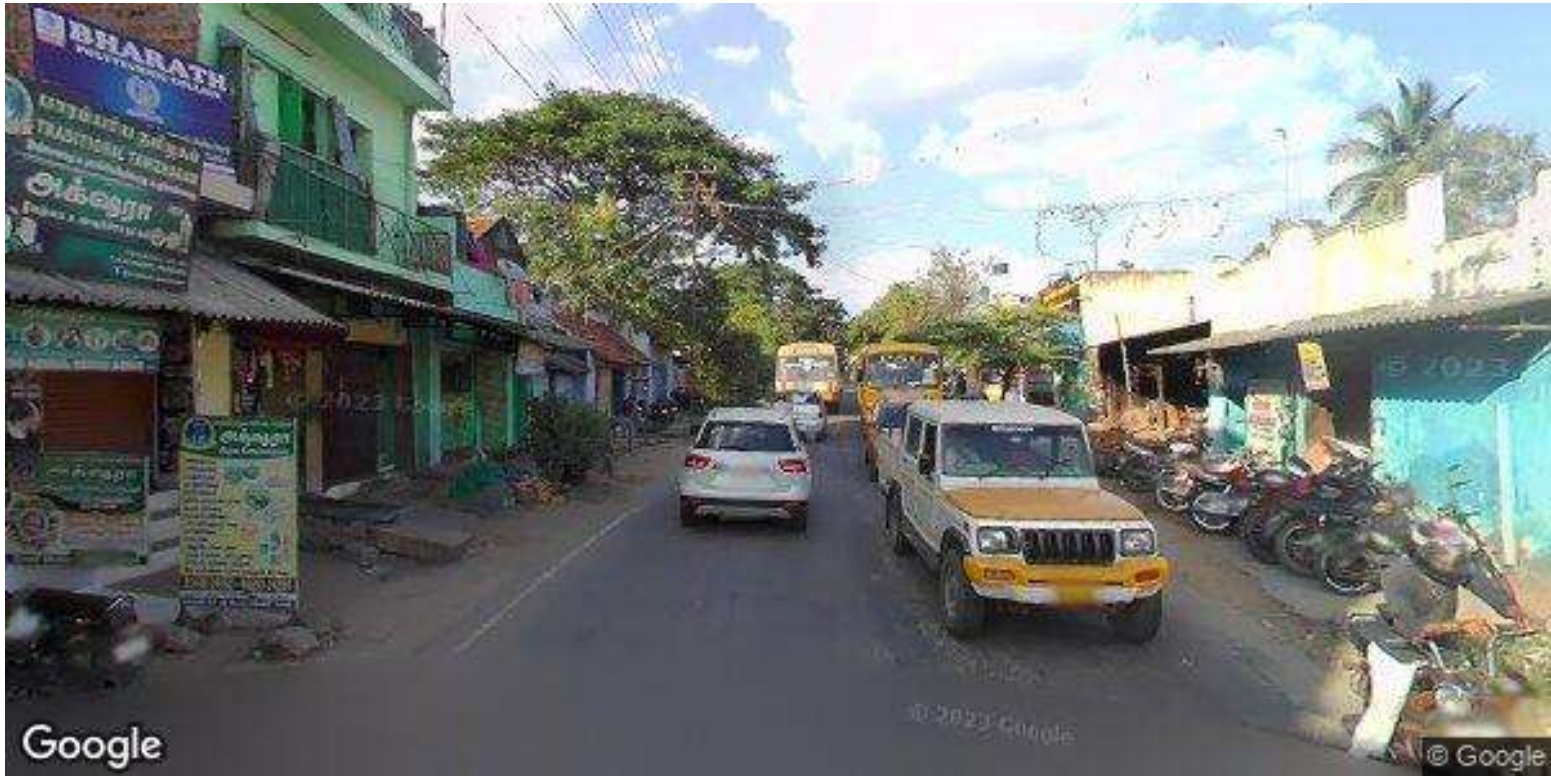
**Risk Type:** Turn  
**Risk Level:** High  
**Speed Limit:** 15 KM/Hr  
**Coordinates:** 11.45028, 77.87202

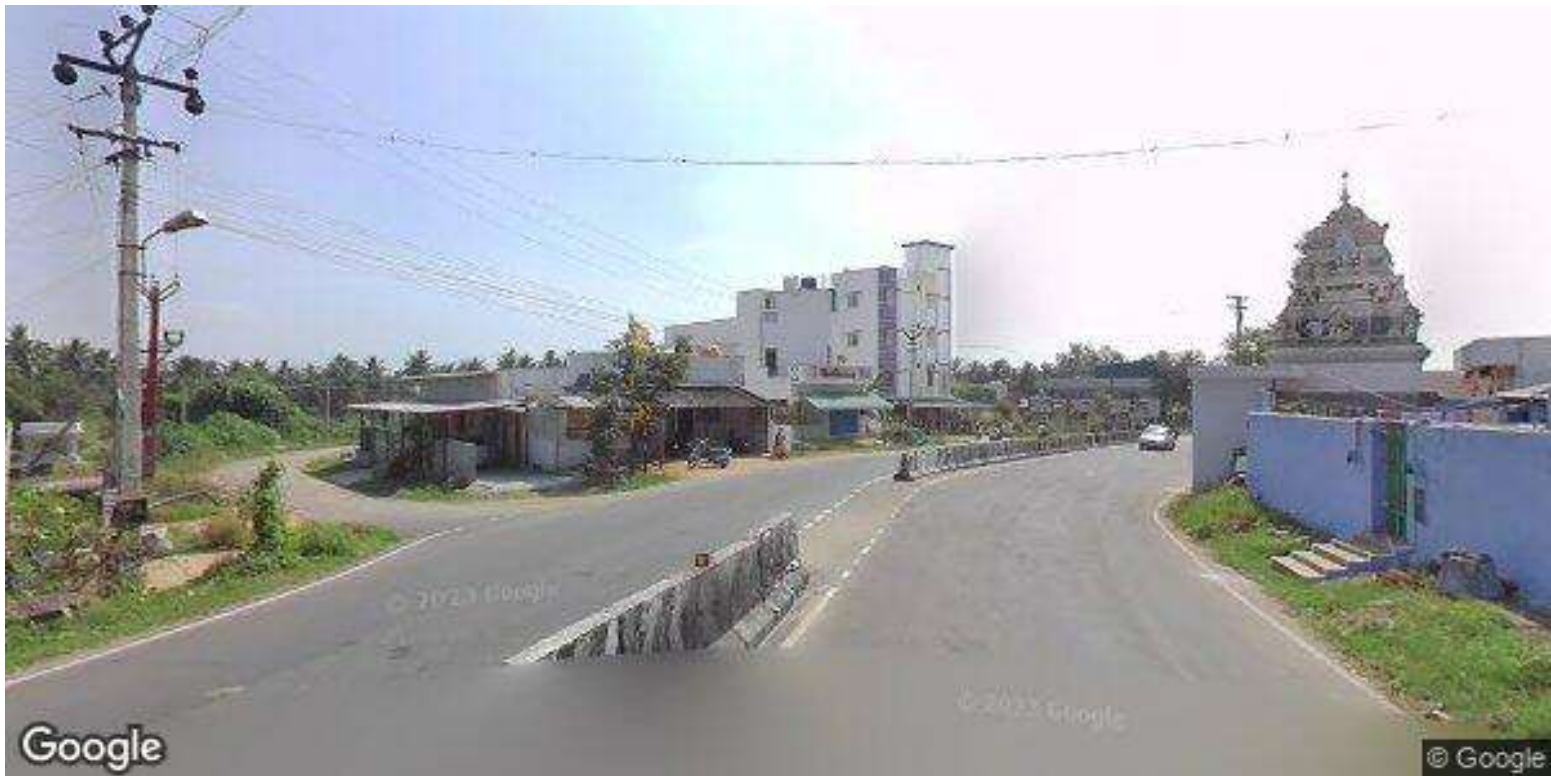
**Risk Type:** Turn  
**Risk Level:** Medium  
**Speed Limit:** 30 KM/Hr  
**Coordinates:** 11.46400, 77.87323

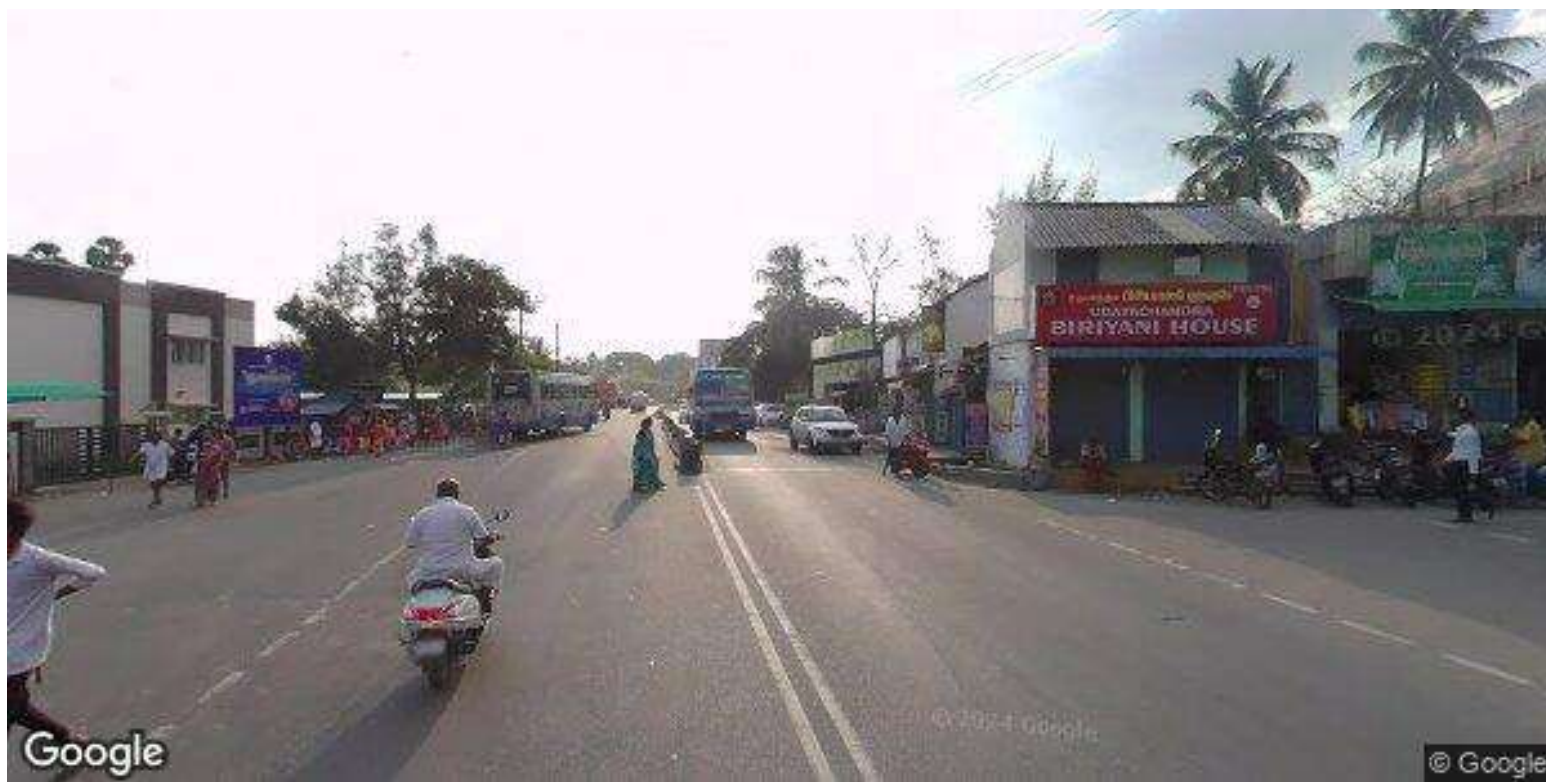
**Coordinates: 11.47403, 77.86841**

**Risk Type: Turn**

**Risk Level: High**

**Speed Limit: 15 KM/Hr**

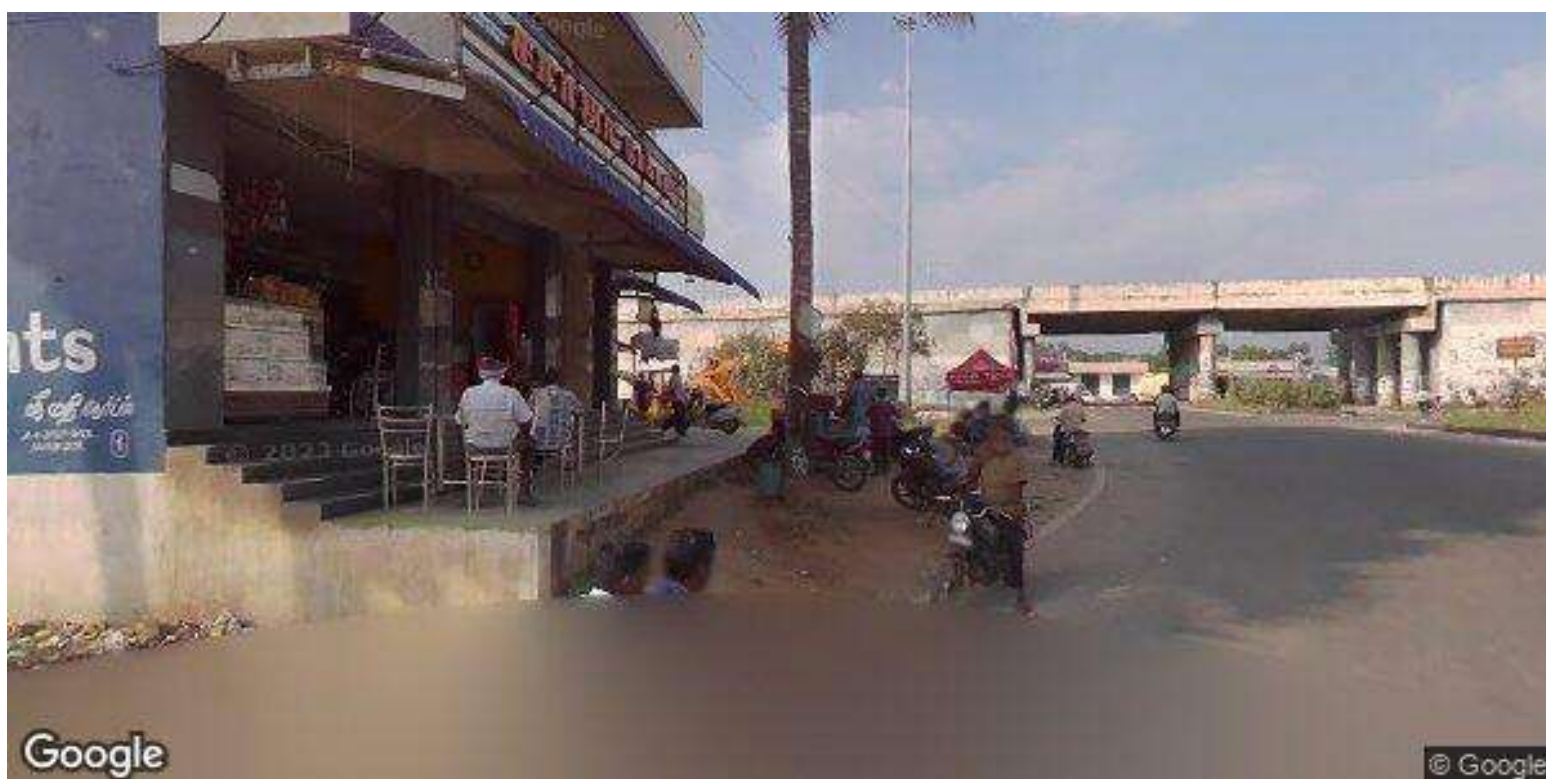
**Coordinates: 11.49149, 77.89601**

**Risk Type: Turn**

**Risk Level: High**

**Speed Limit: 15 KM/Hr**

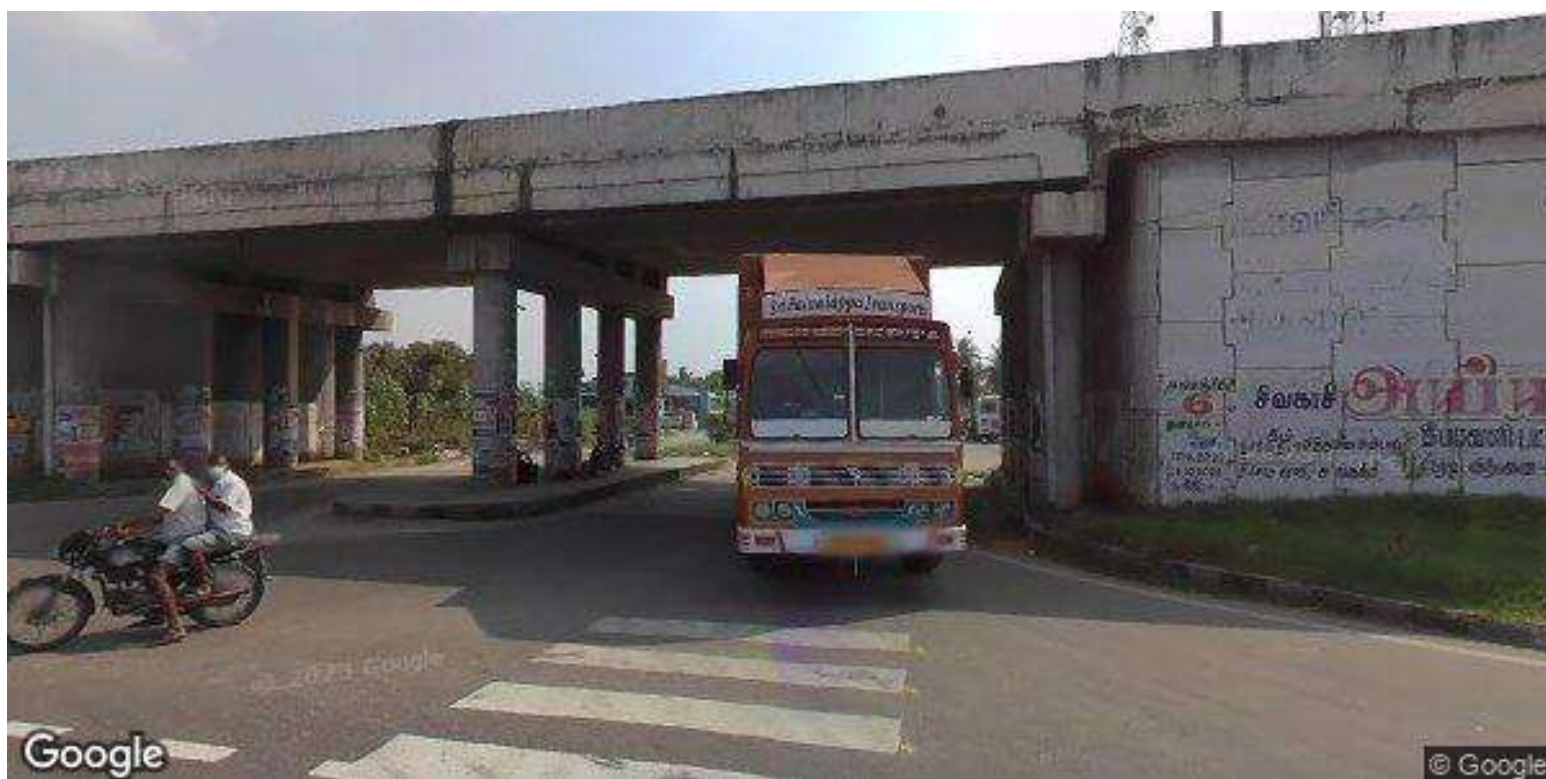
**Risk Type:** Turn  
**Risk Level:** High  
**Speed Limit:** 15 KM/Hr  
**Coordinates:** 11.49224, 77.89601

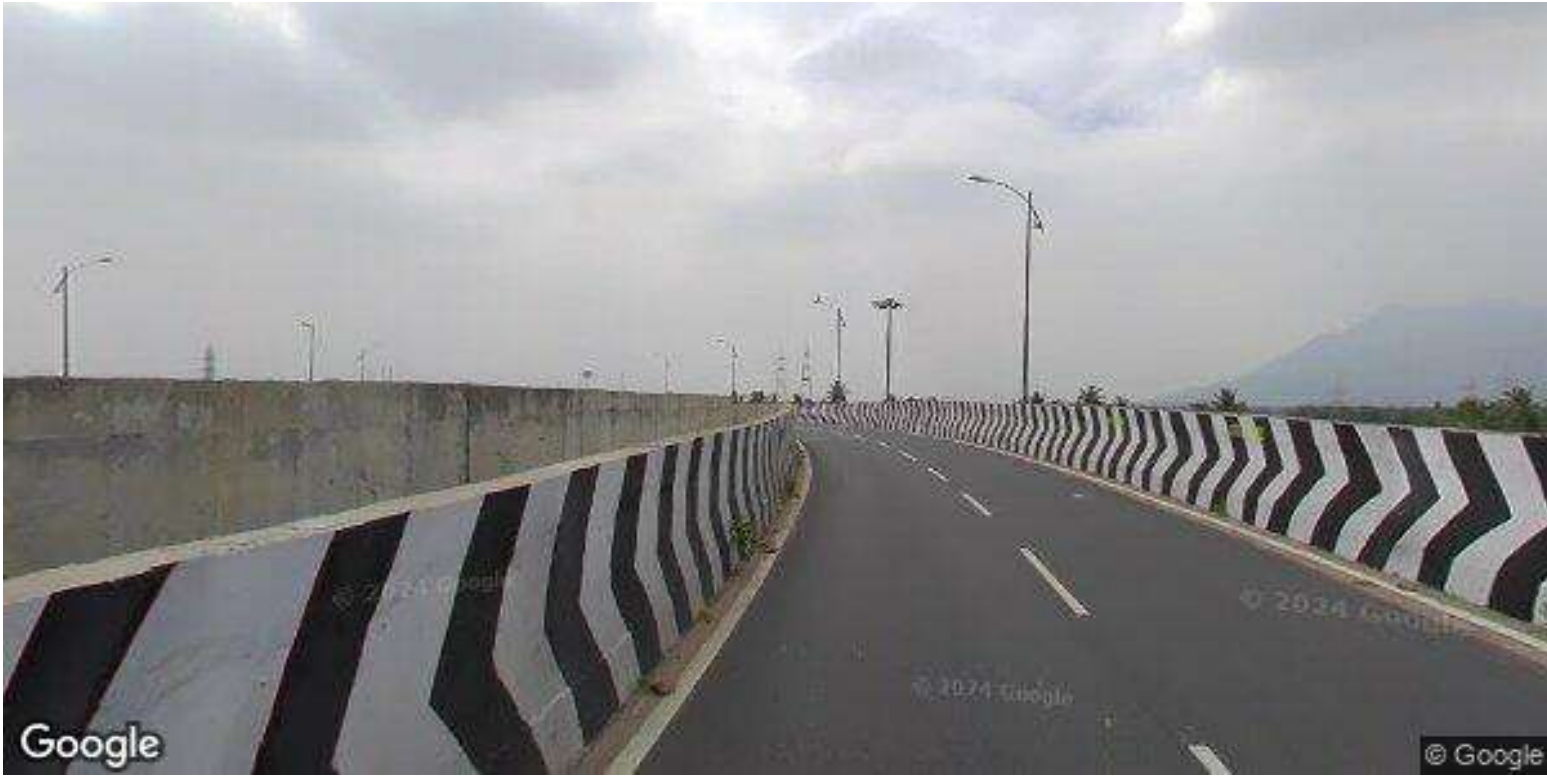
**Risk Type:** Turn  
**Risk Level:** High  
**Speed Limit:** 15 KM/Hr  
**Coordinates:** 11.64180, 78.11808

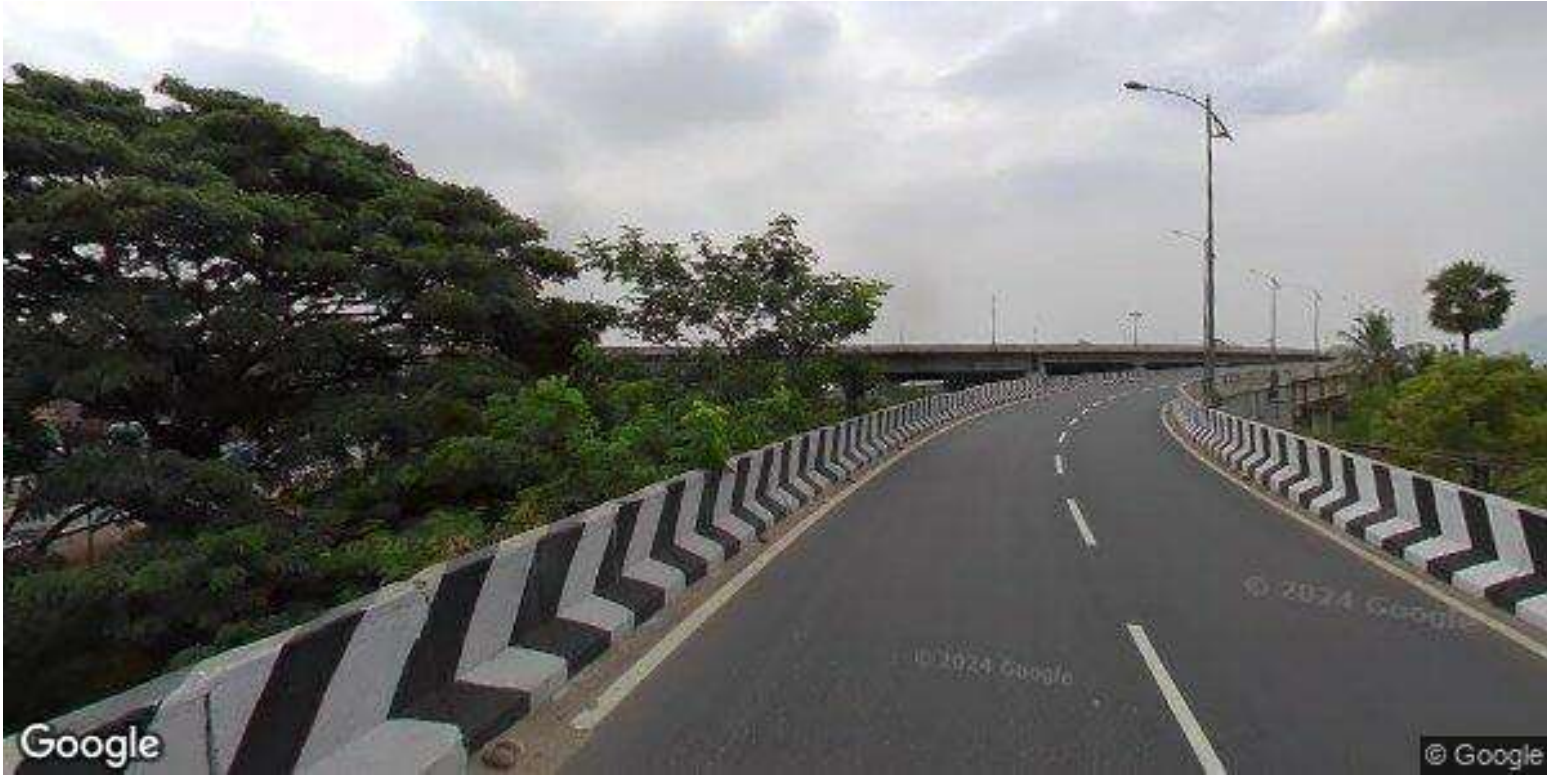
**Risk Type:** Turn  
**Risk Level:** High  
**Speed Limit:** 15 KM/Hr  
**Coordinates:** 11.64325, 78.11993

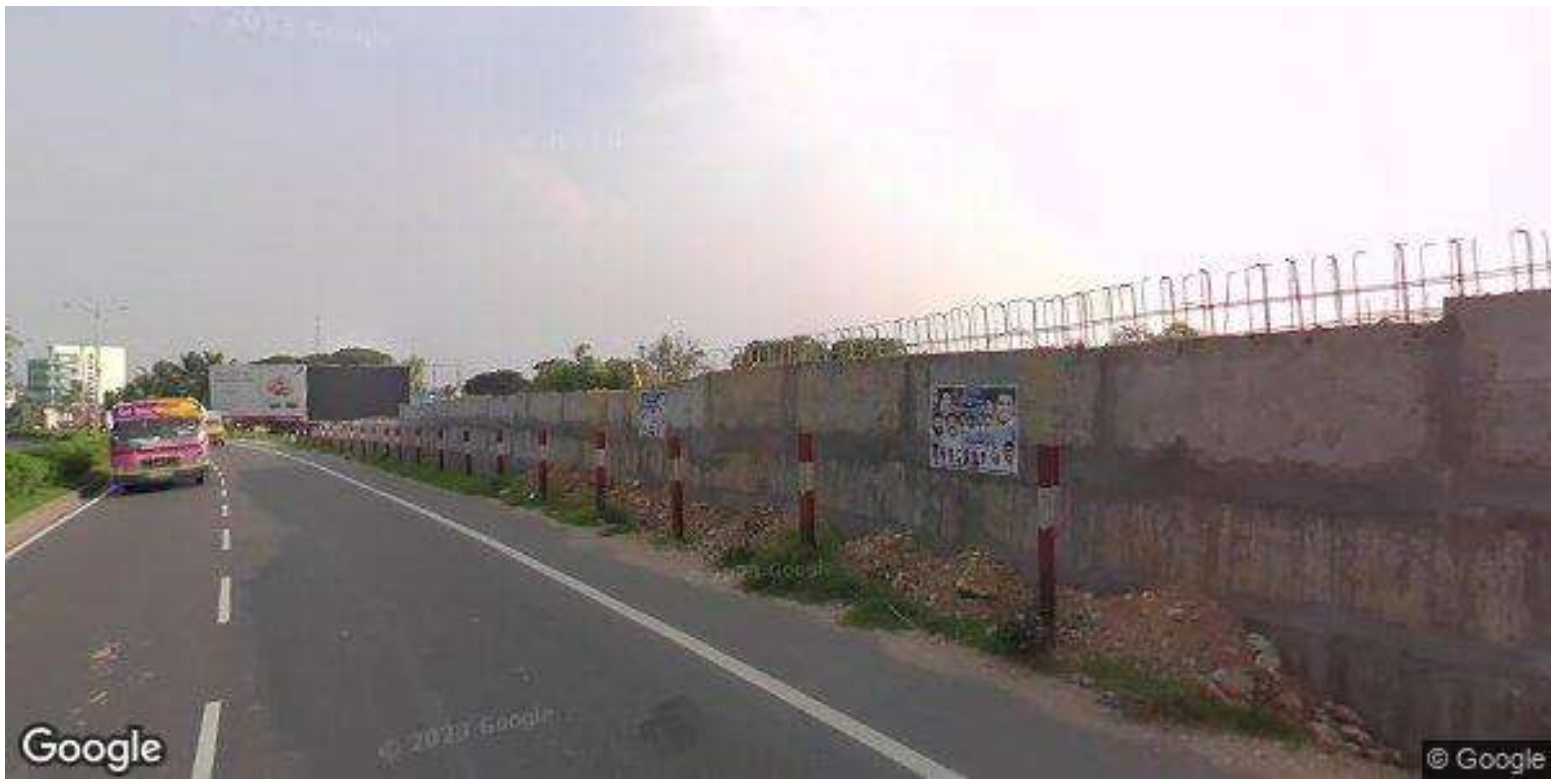
**Risk Type:** Turn  
**Risk Level:** Medium  
**Speed Limit:** 30 KM/Hr  
**Coordinates:** 11.69519, 78.10775

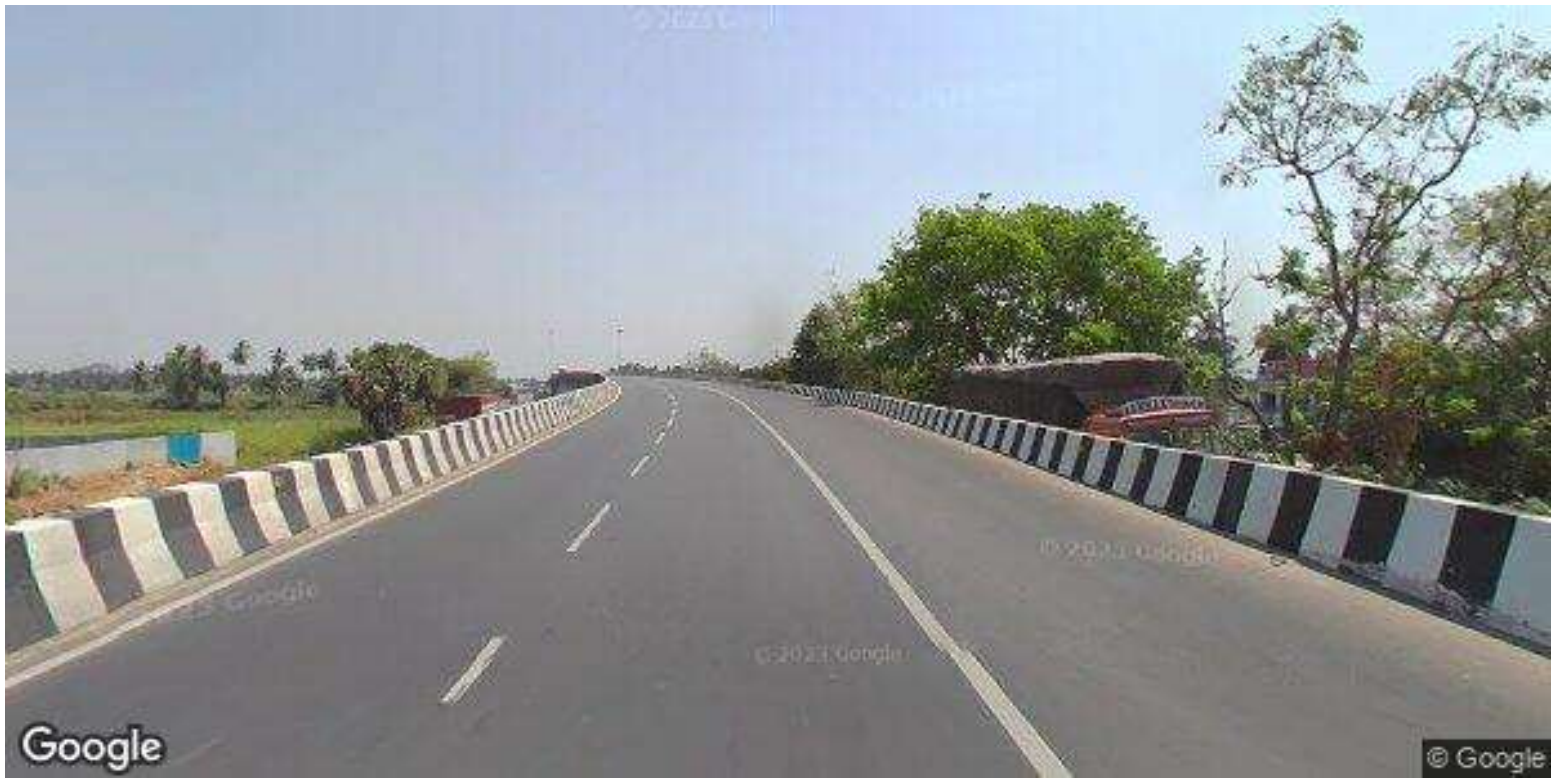
**Risk Type:** Turn  
**Risk Level:** Medium  
**Speed Limit:** 30 KM/Hr  
**Coordinates:** 11.73958, 78.05105

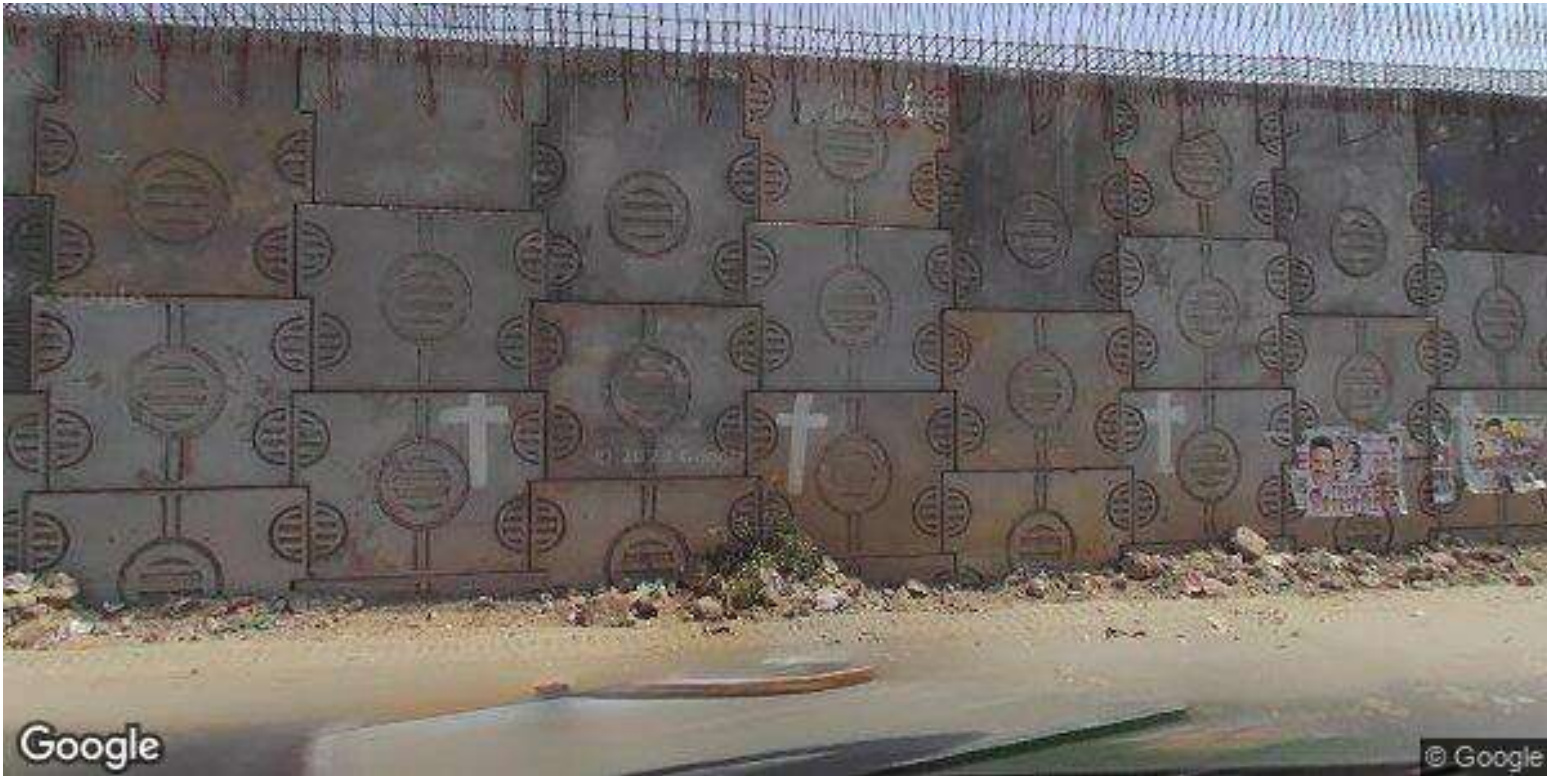
**Risk Type:** Turn  
**Risk Level:** Medium  
**Speed Limit:** 30 KM/Hr  
**Coordinates:** 11.75835, 78.05016

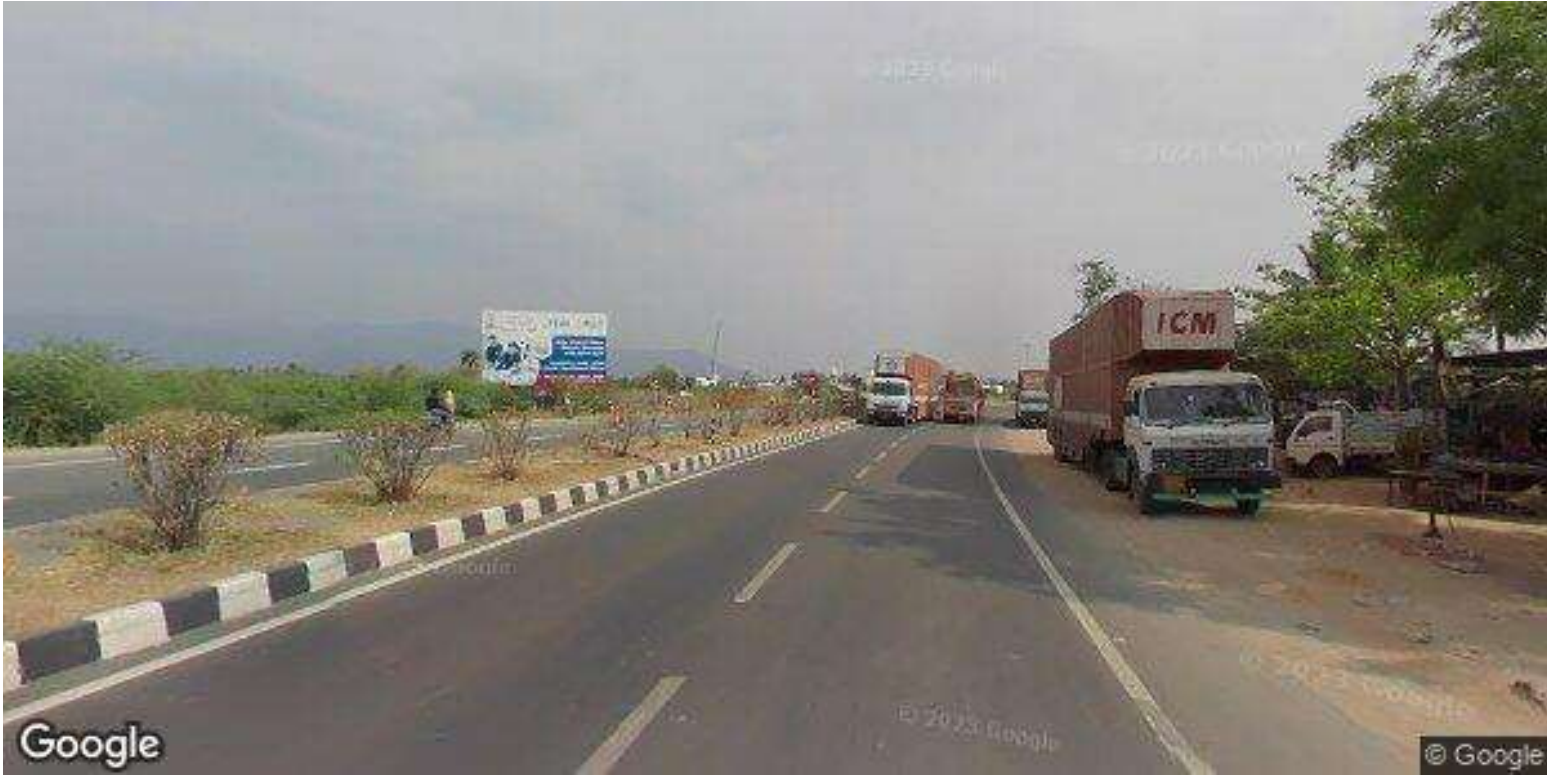
**Risk Type:** Turn  
**Risk Level:** Medium  
**Speed Limit:** 30 KM/Hr  
**Coordinates:** 11.87942, 78.08197

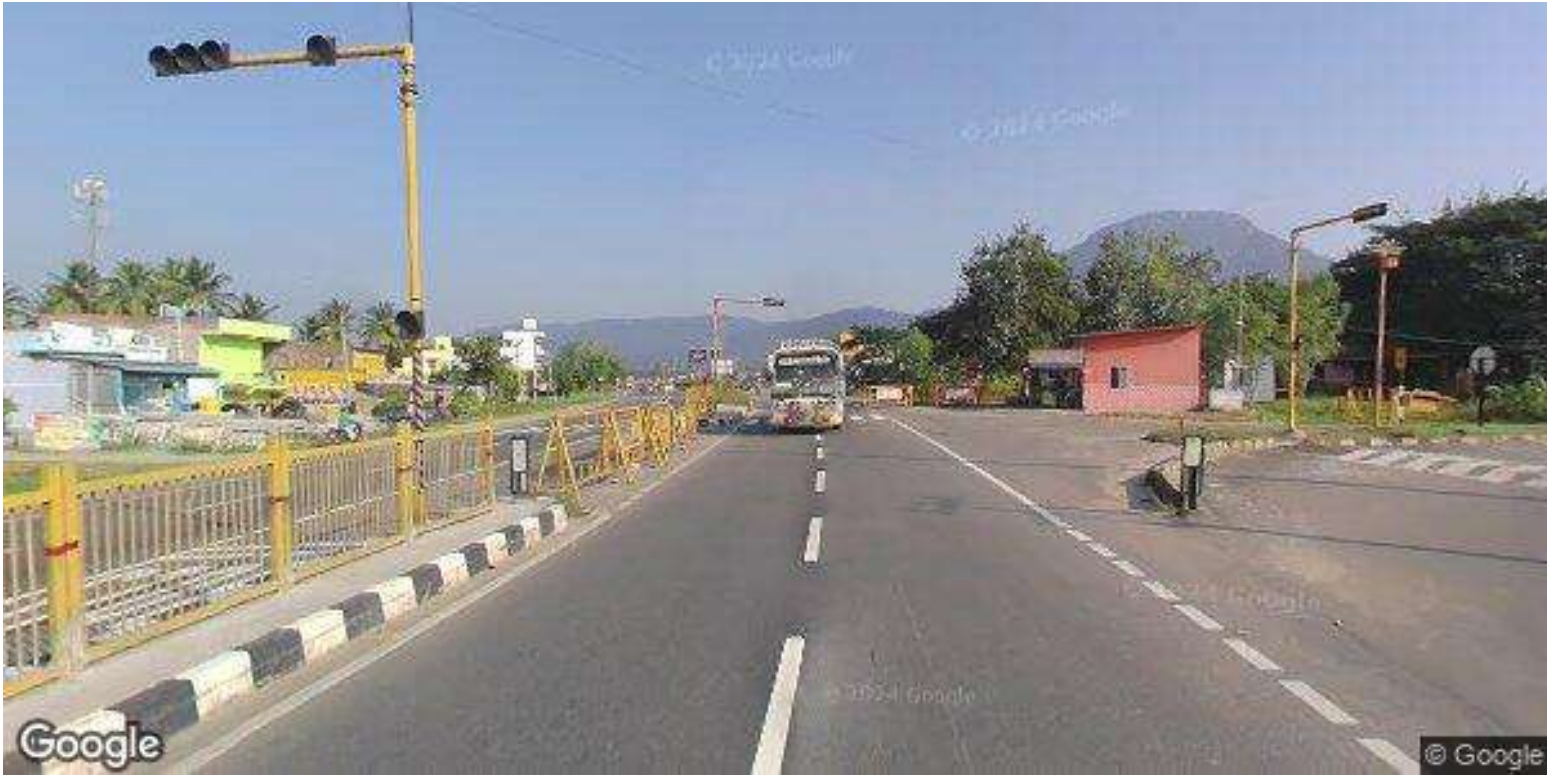
**Risk Type:** Turn  
**Risk Level:** Medium  
**Speed Limit:** 30 KM/Hr  
**Coordinates:** 11.93704, 78.05402

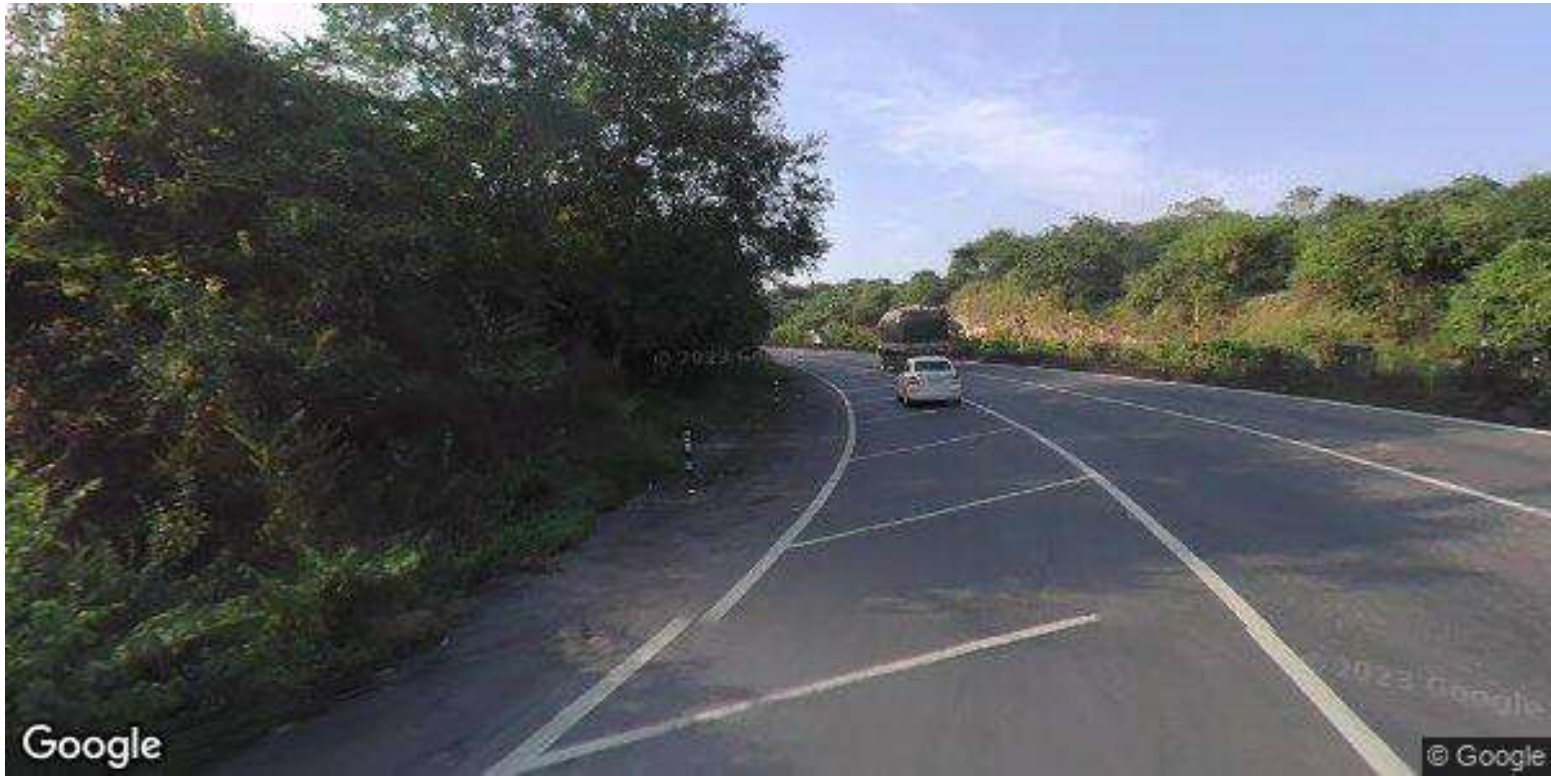
**Risk Type:** Turn  
**Risk Level:** High  
**Speed Limit:** 15 KM/Hr  
**Coordinates:** 11.96399, 78.05135

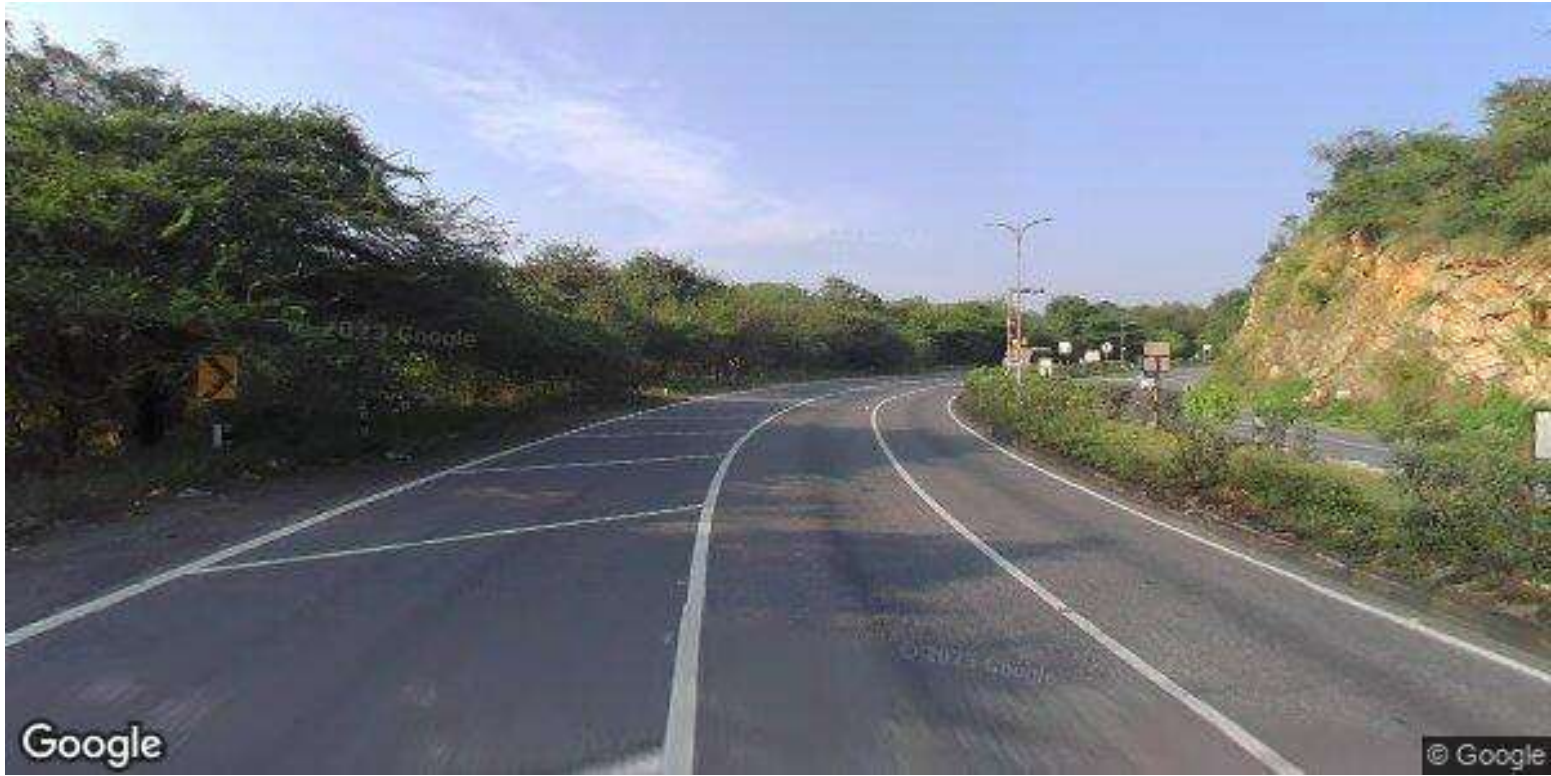
**Risk Type:** Turn  
**Risk Level:** High  
**Speed Limit:** 15 KM/Hr  
**Coordinates:** 11.96580, 78.04923

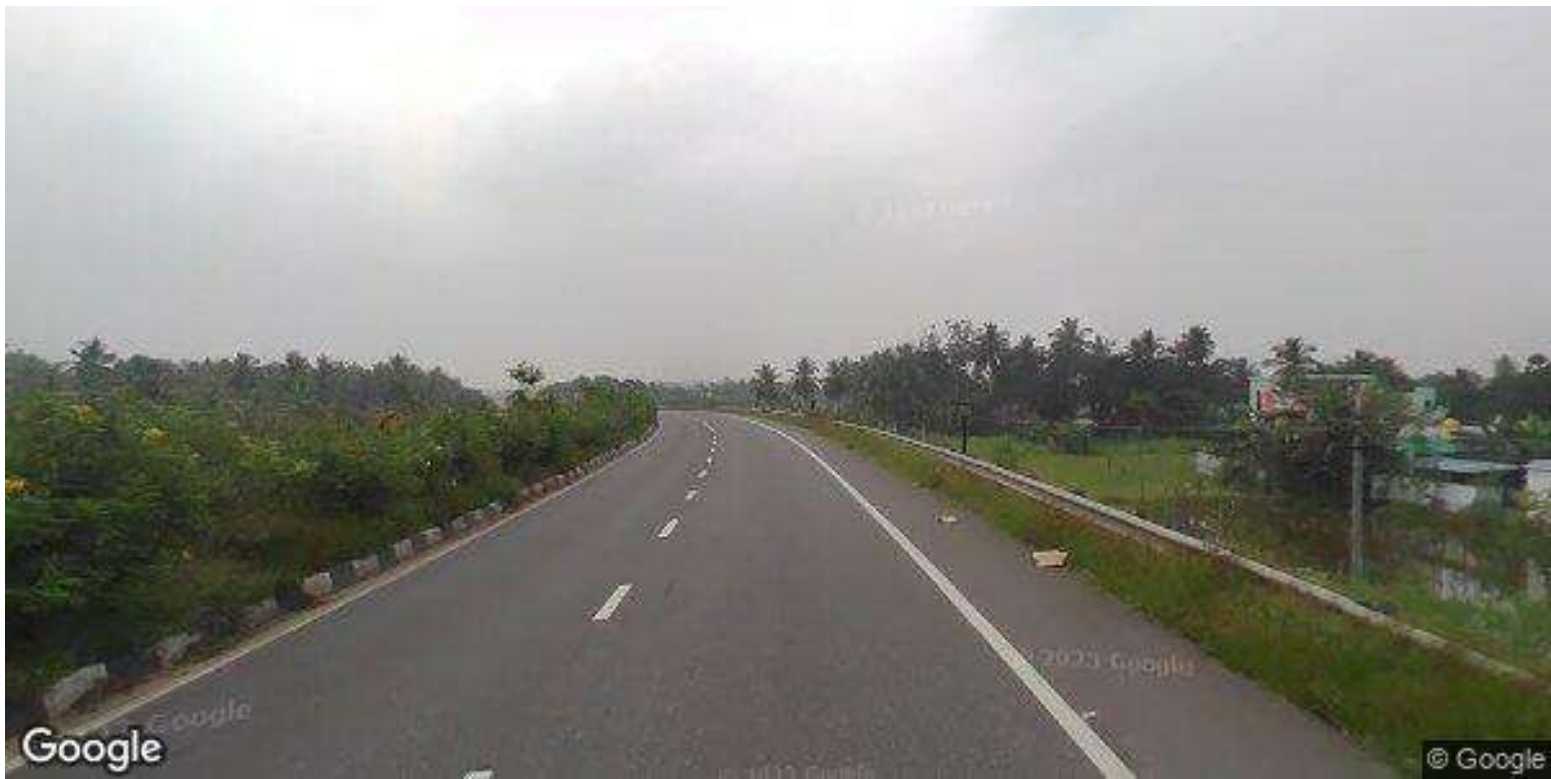
**Risk Type:** Turn  
**Risk Level:** Medium  
**Speed Limit:** 30 KM/Hr  
**Coordinates:** 12.22459, 78.19136

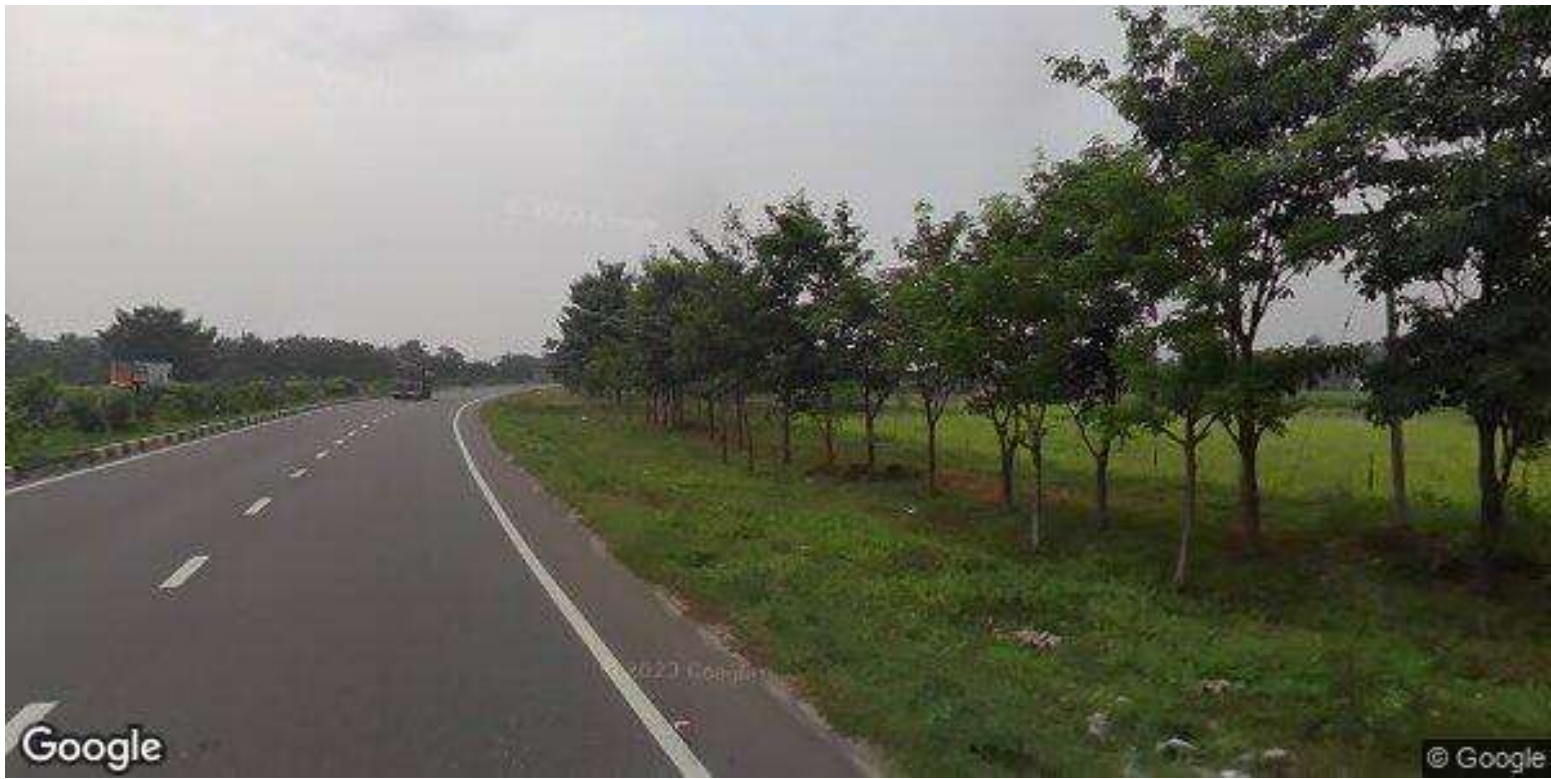
**Risk Type:** Turn  
**Risk Level:** Medium  
**Speed Limit:** 30 KM/Hr  
**Coordinates:** 12.25060, 78.19977

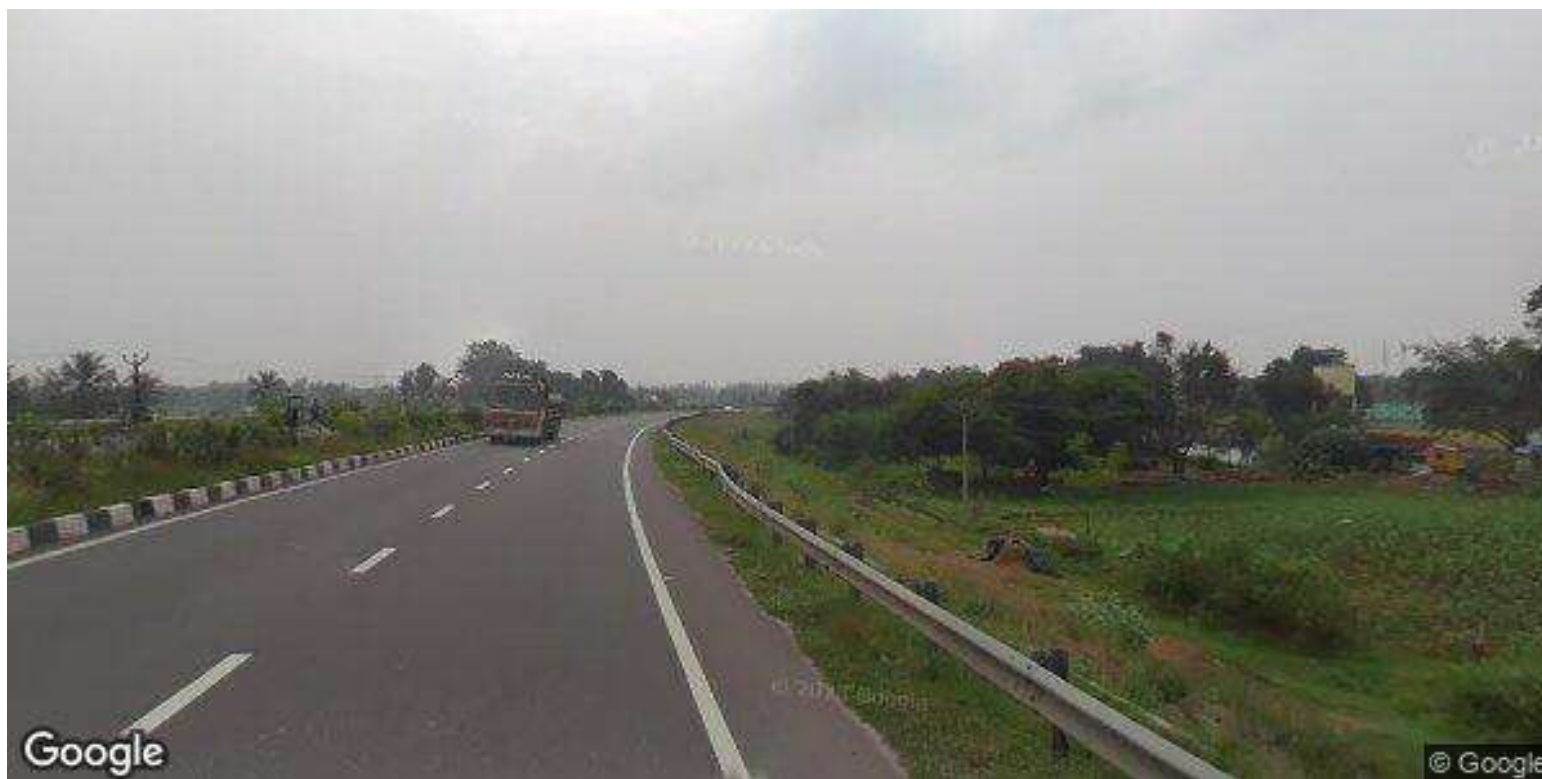
**Coordinates:** 12.25329, 78.20039

**Risk Type:** Turn

**Risk Level:** Medium

**Speed Limit:** 30 KM/Hr
