# IndianOil

## JOURNEY RISK MANAGEMENT (JRM) STUDY

### Salem Terminal TO NKK FUELS ADHOC

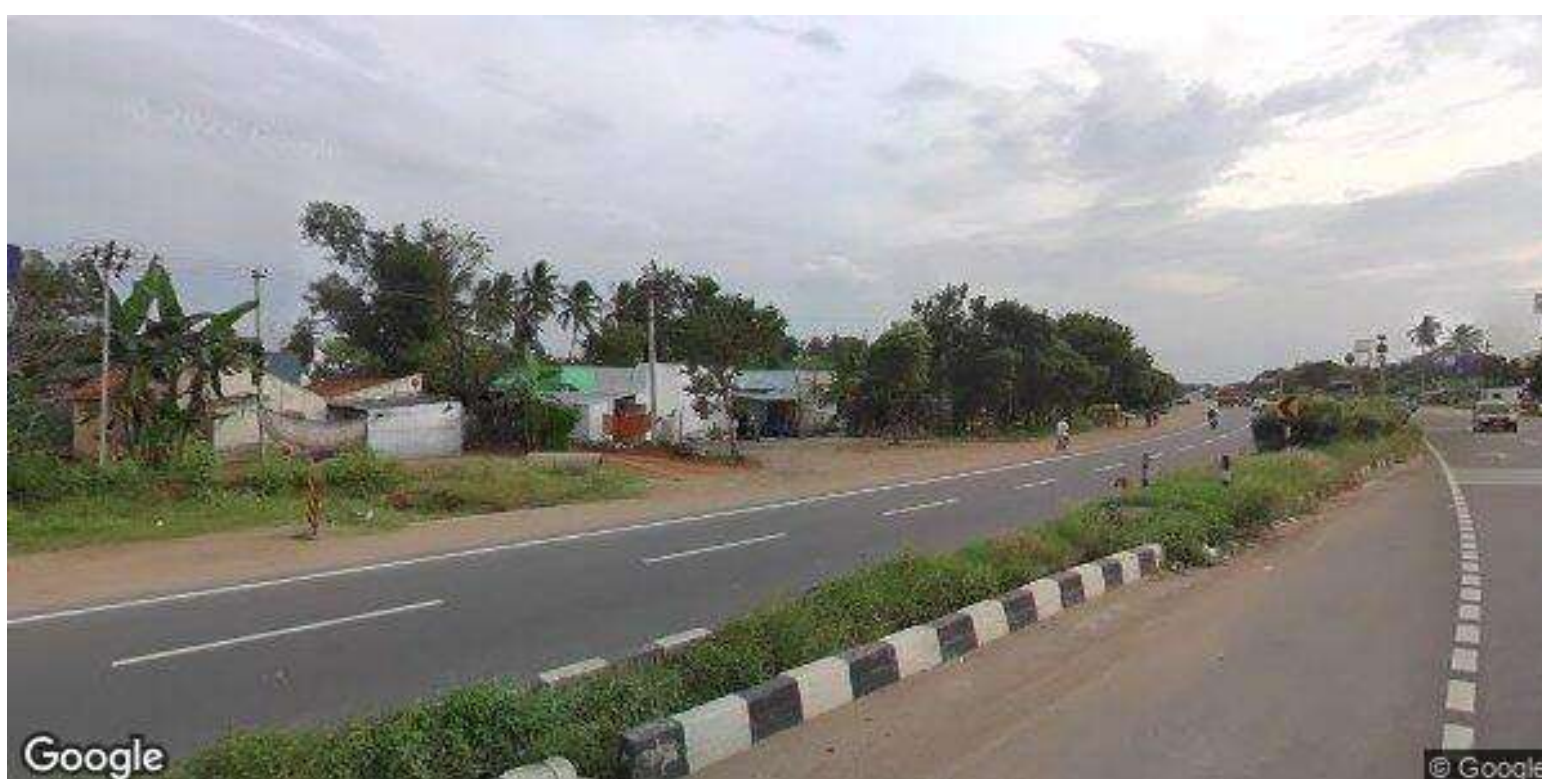
**Coordinates:** 12.29110, 78.19909

**Risk Type:** Turn

**Risk Level:** Medium

**Speed Limit:** 30 KM/Hr

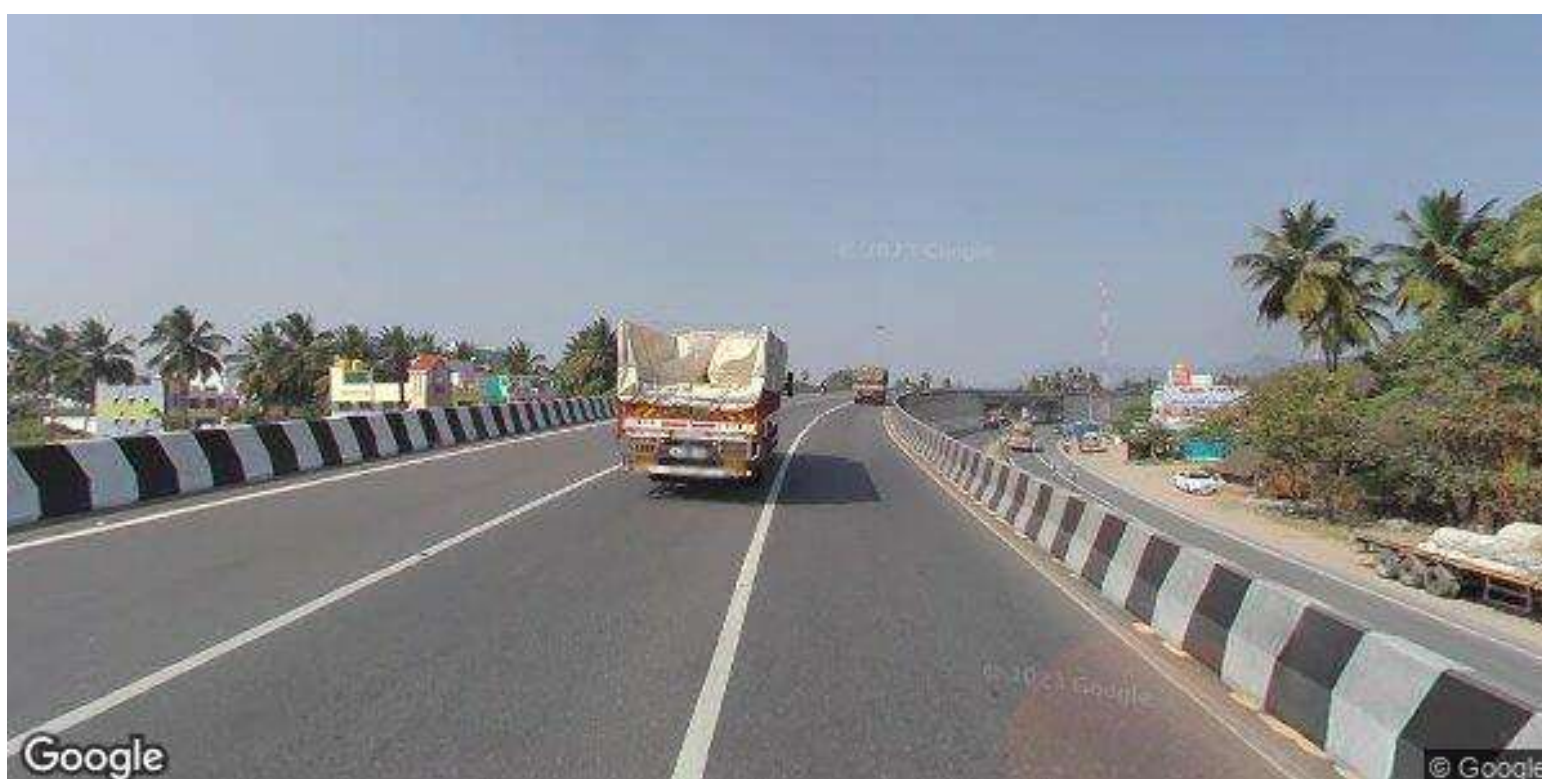
**Risk Type:** Turn  
**Risk Level:** Medium  
**Speed Limit:** 30 KM/Hr  
**Coordinates:** 12.39904, 78.21764

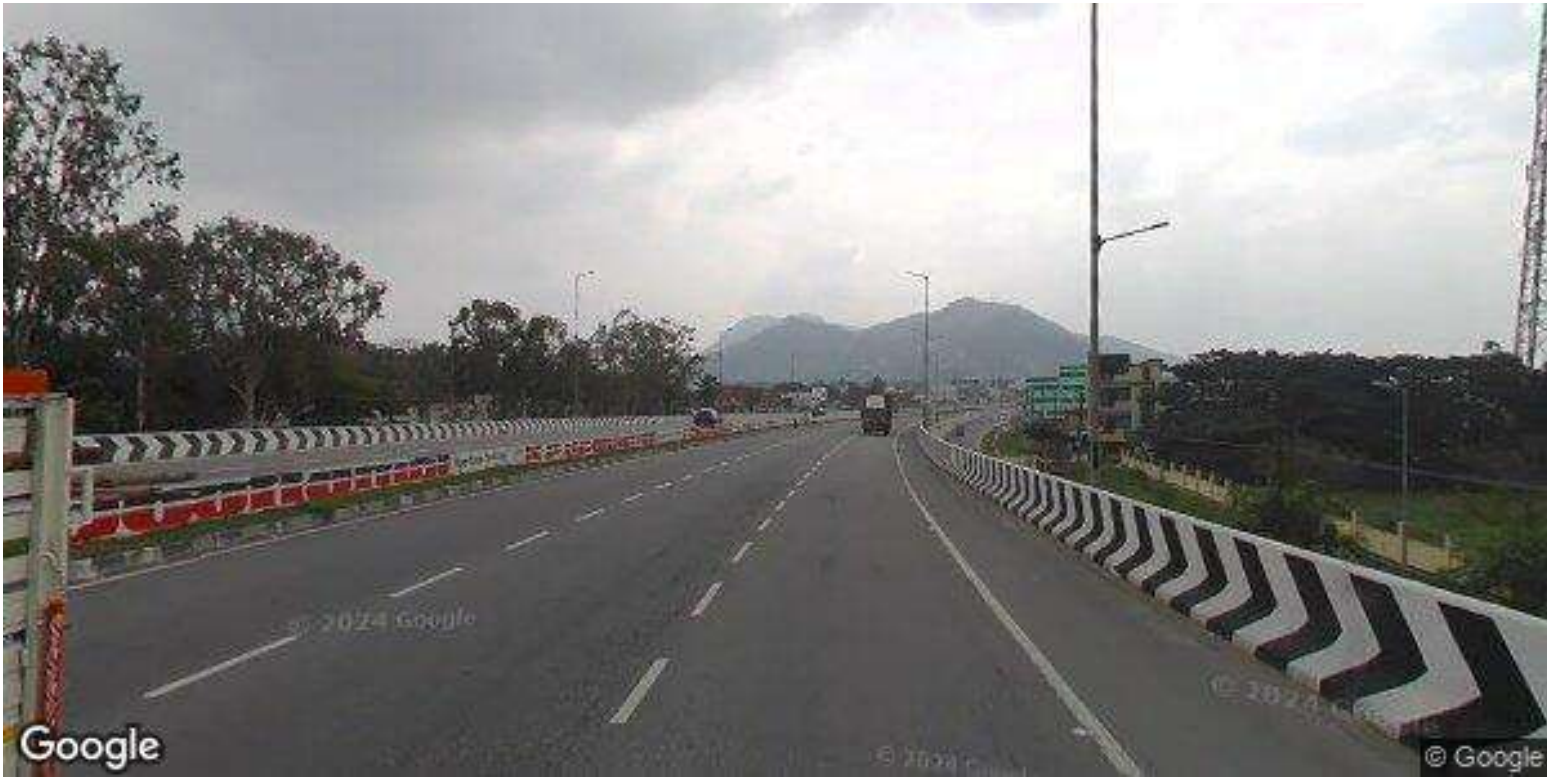
**Coordinates:** 12.50553, 78.22318

**Risk Type:** Turn

**Risk Level:** Medium

**Speed Limit:** 30 KM/Hr
