# IndianOil

## JOURNEY RISK MANAGEMENT (JRM) STUDY

### Salem Terminal TO SHRI RAMESH BABU AGENCY UNIT II

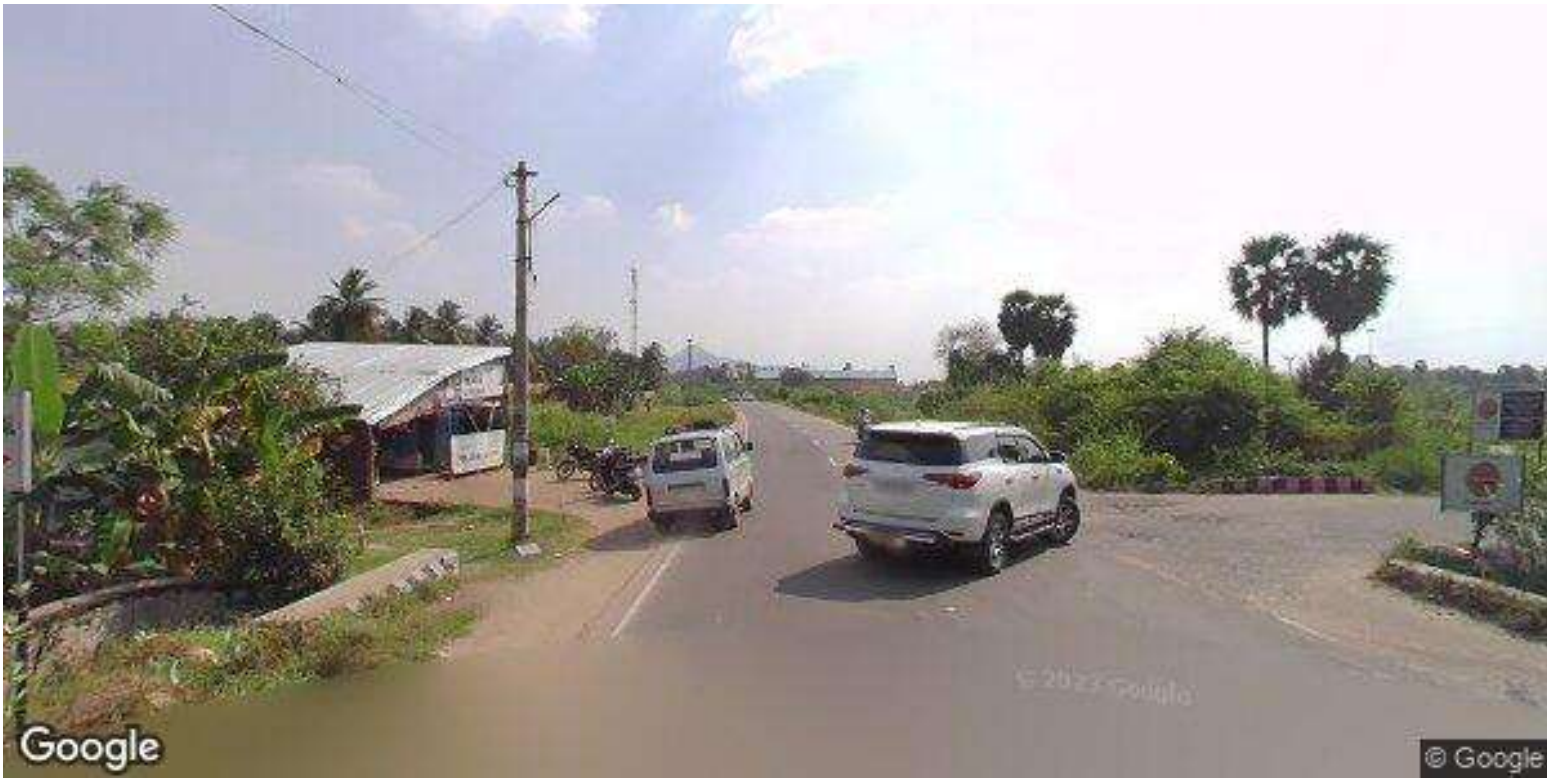
Risk Type: Turn

Risk Level: High

Speed Limit: 15 KM/Hr

Coordinates: 11.44029, 77.87544

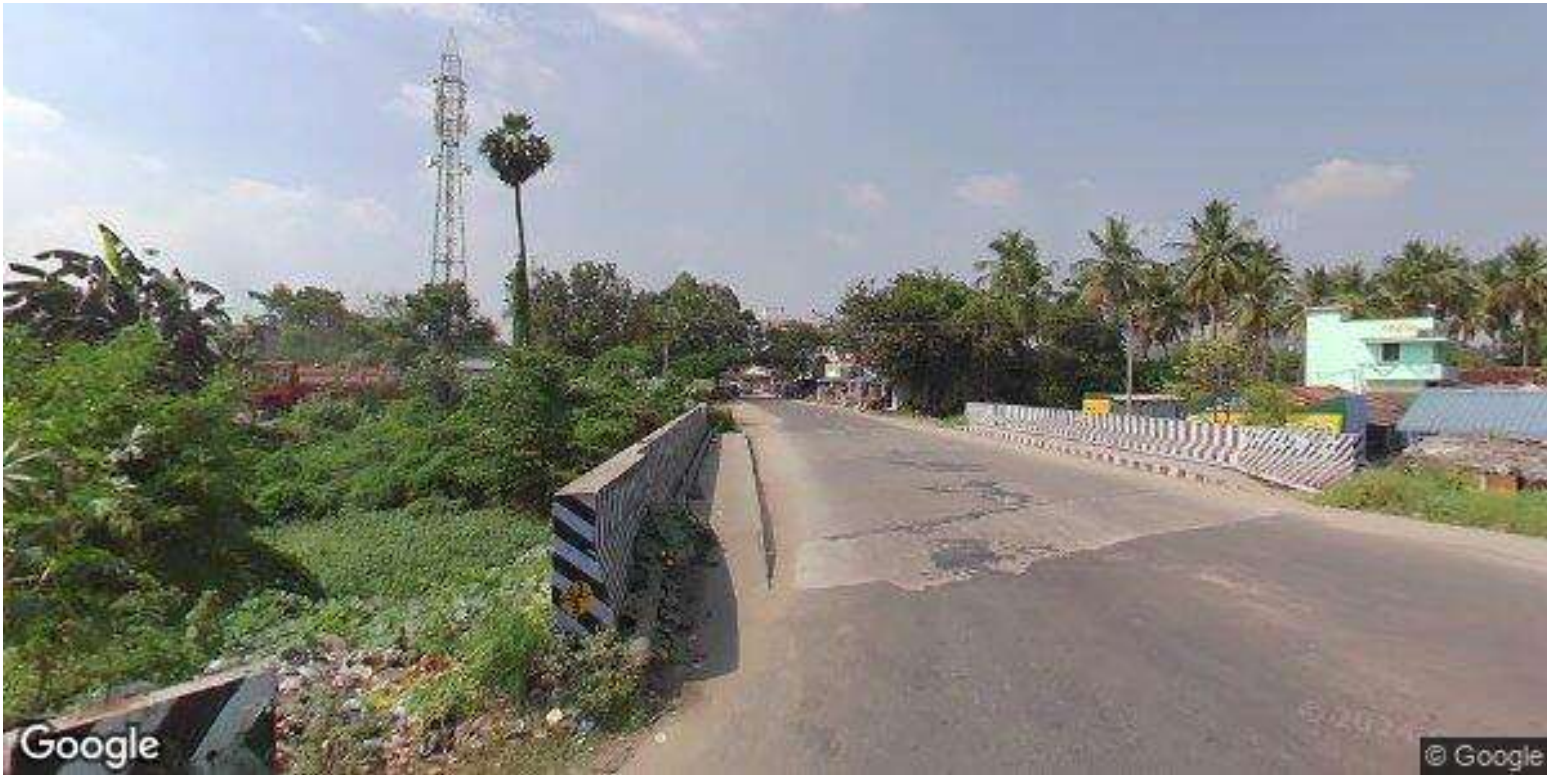
Risk Type: Turn

Risk Level: High

Speed Limit: 15 KM/Hr

Coordinates: 11.44900, 77.87406

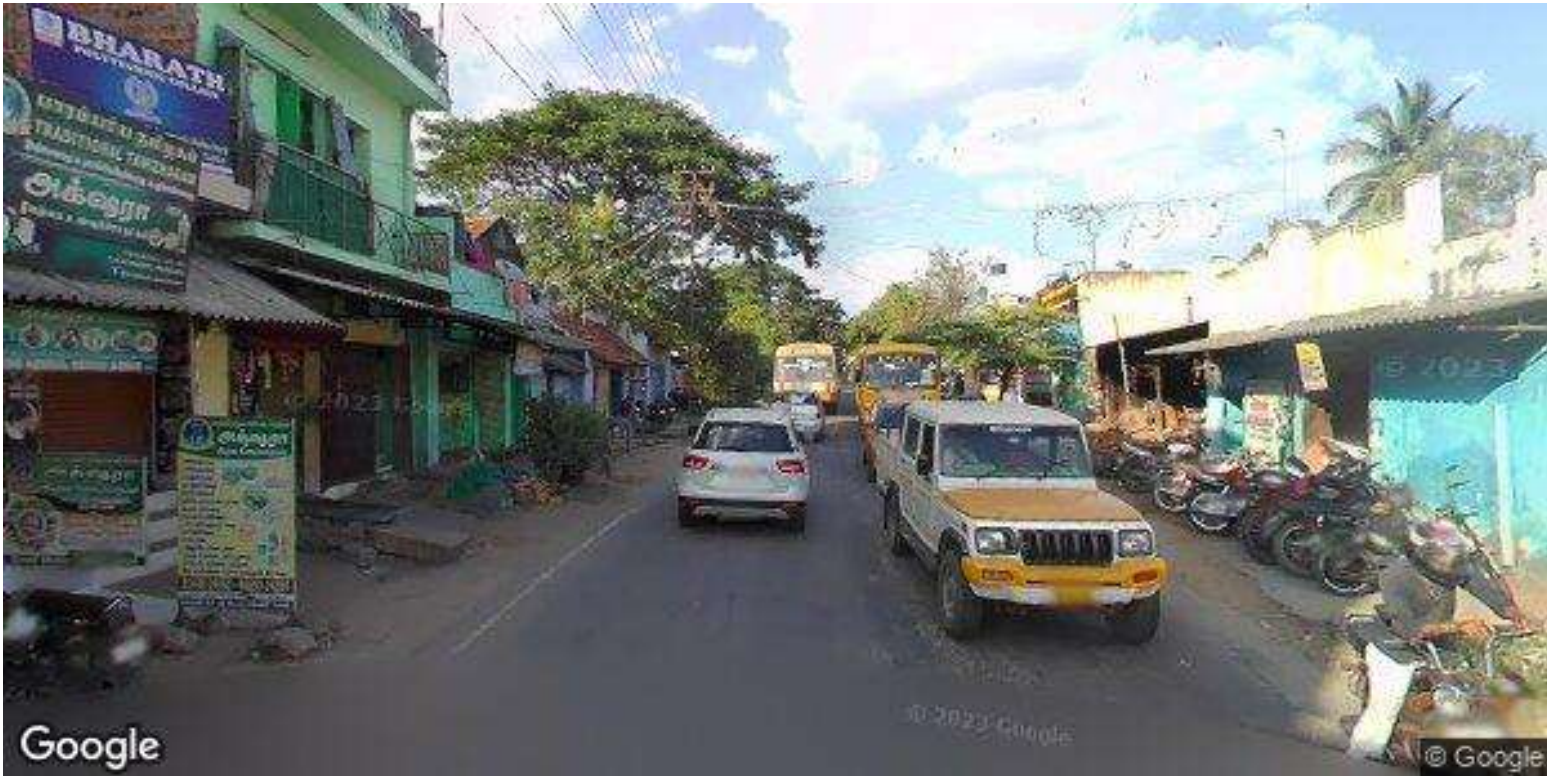
**Risk Type:** Turn  
**Risk Level:** High  
**Speed Limit:** 15 KM/Hr  
**Coordinates:** 11.45028, 77.87202

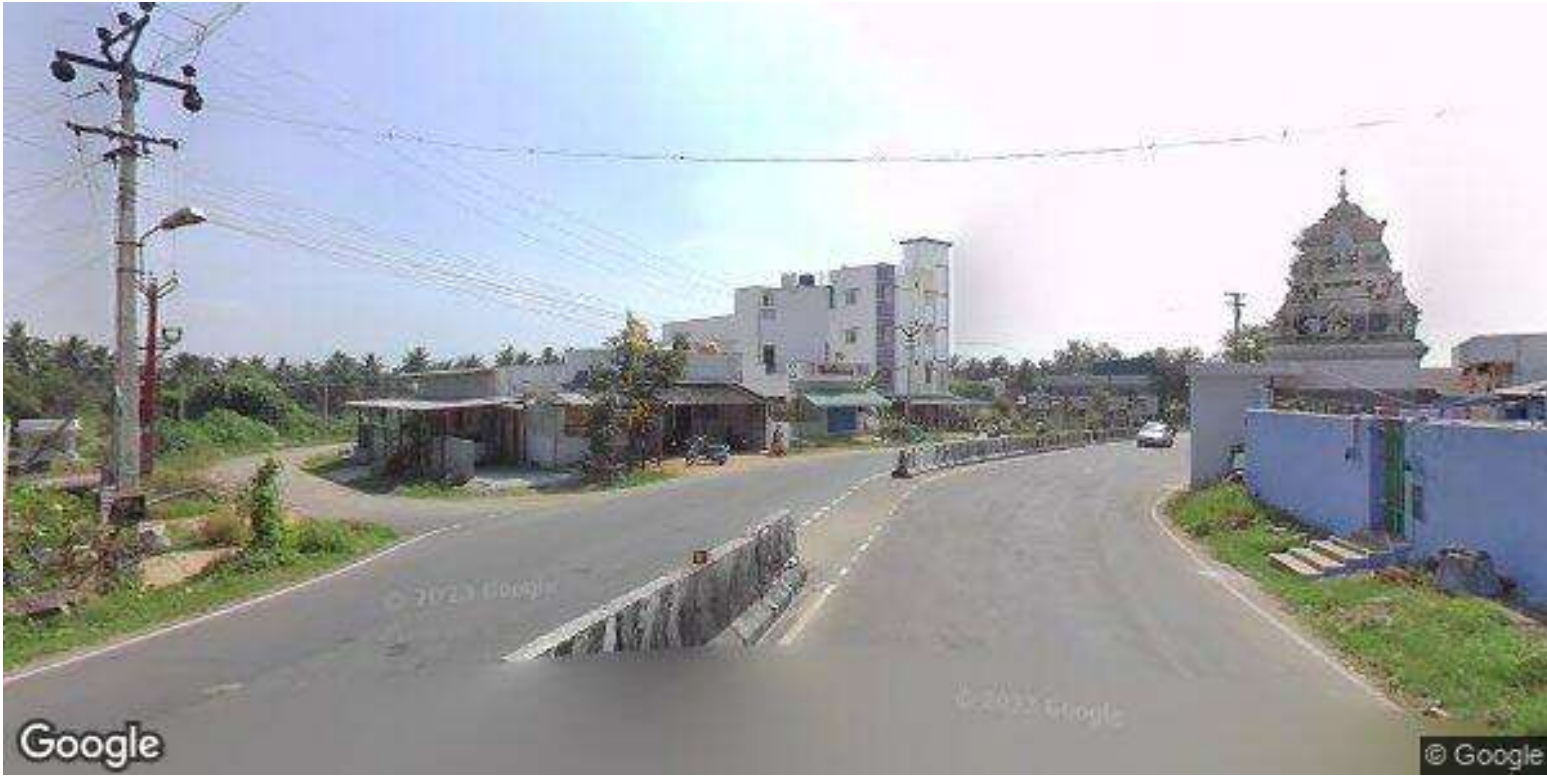
**Risk Type:** Turn  
**Risk Level:** Medium  
**Speed Limit:** 30 KM/Hr  
**Coordinates:** 11.46400, 77.87323

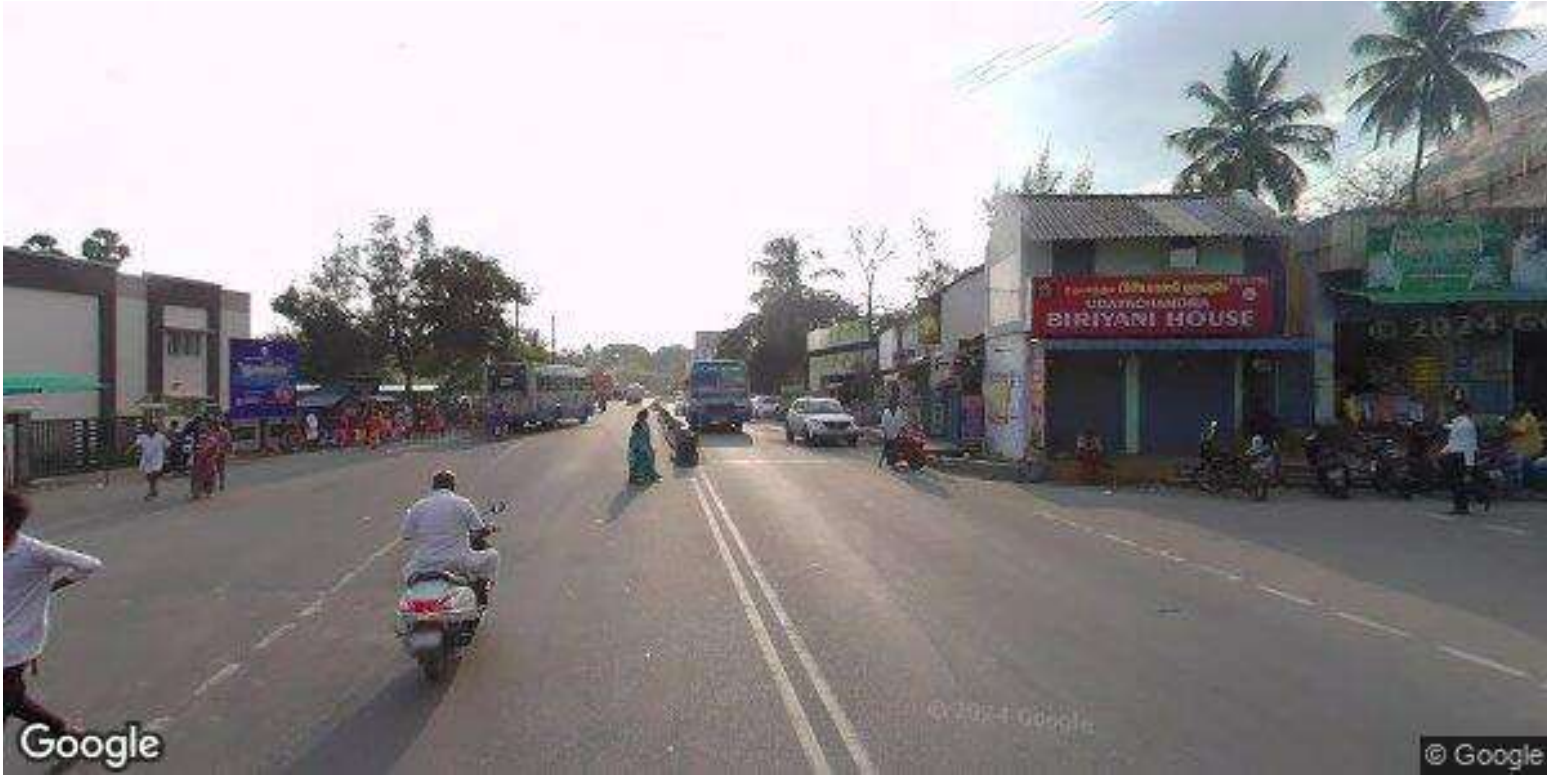
Risk Type: Turn  
Risk Level: High  
Speed Limit: 15 KM/Hr  
Coordinates: 11.47403, 77.86841

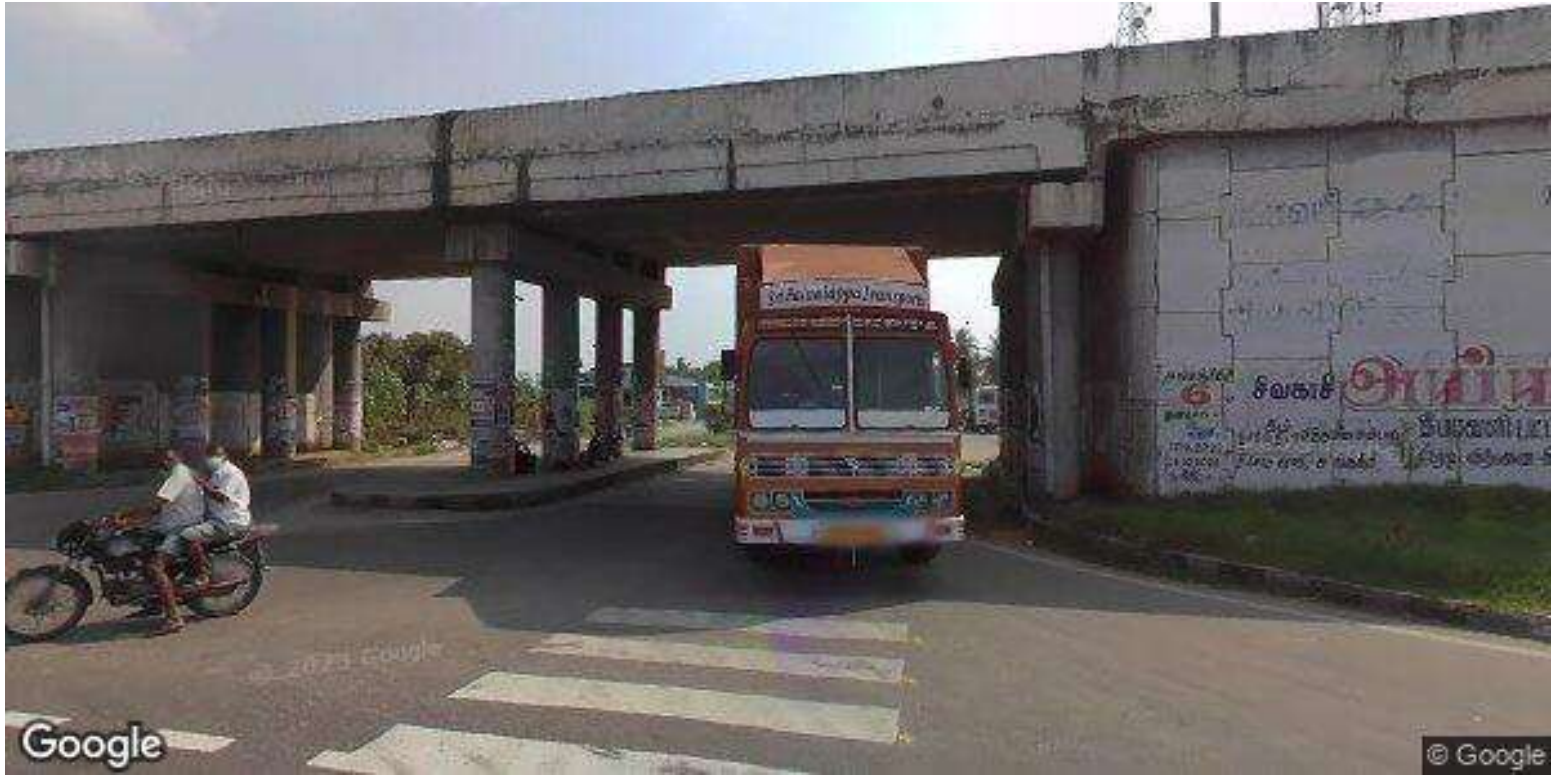
Risk Type: Turn  
Risk Level: High  
Speed Limit: 15 KM/Hr  
Coordinates: 11.49224, 77.89601

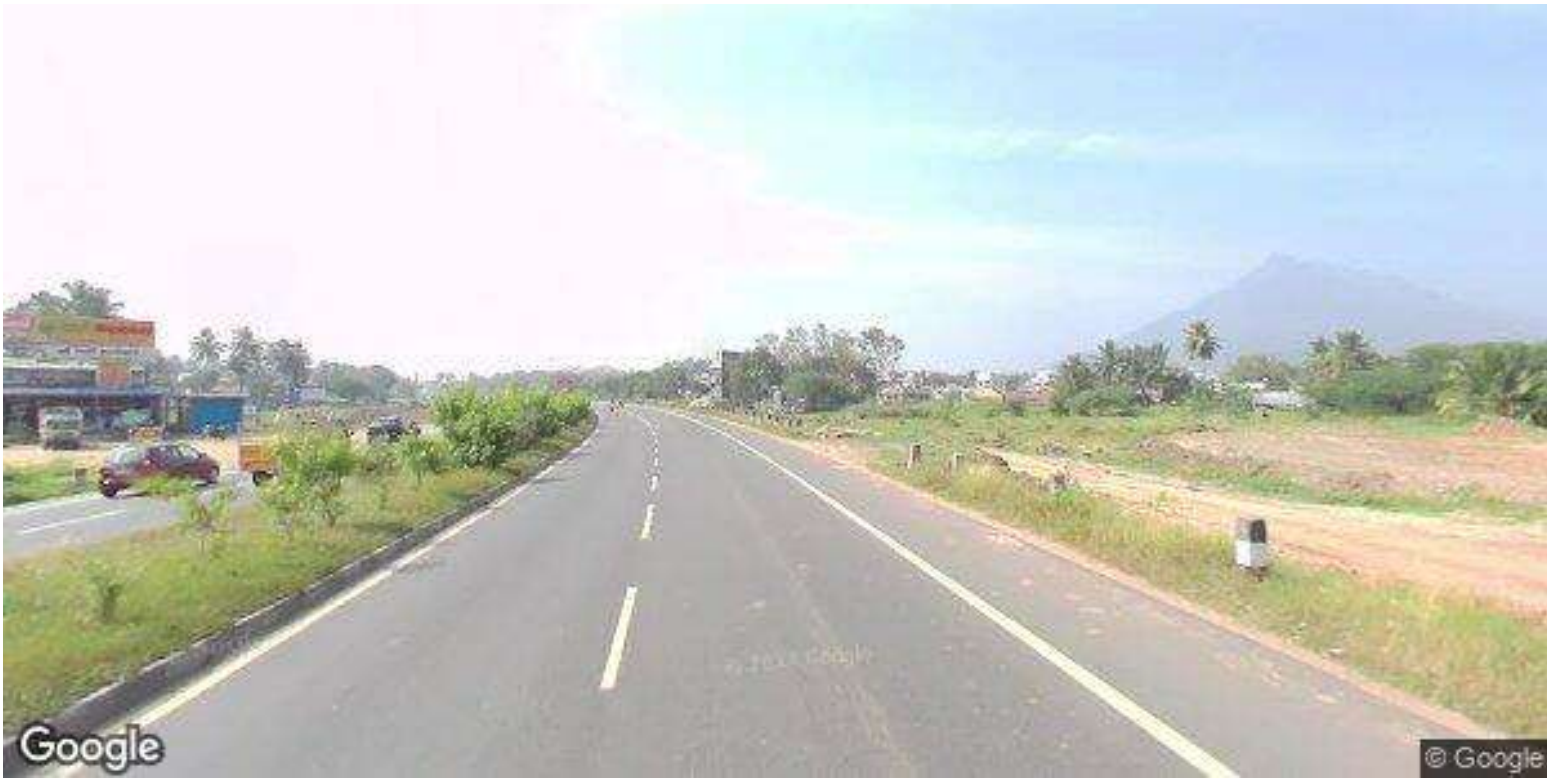
**Risk Type:** Turn  
**Risk Level:** Medium  
**Speed Limit:** 30 KM/Hr  
**Coordinates:** 11.62403, 78.10893

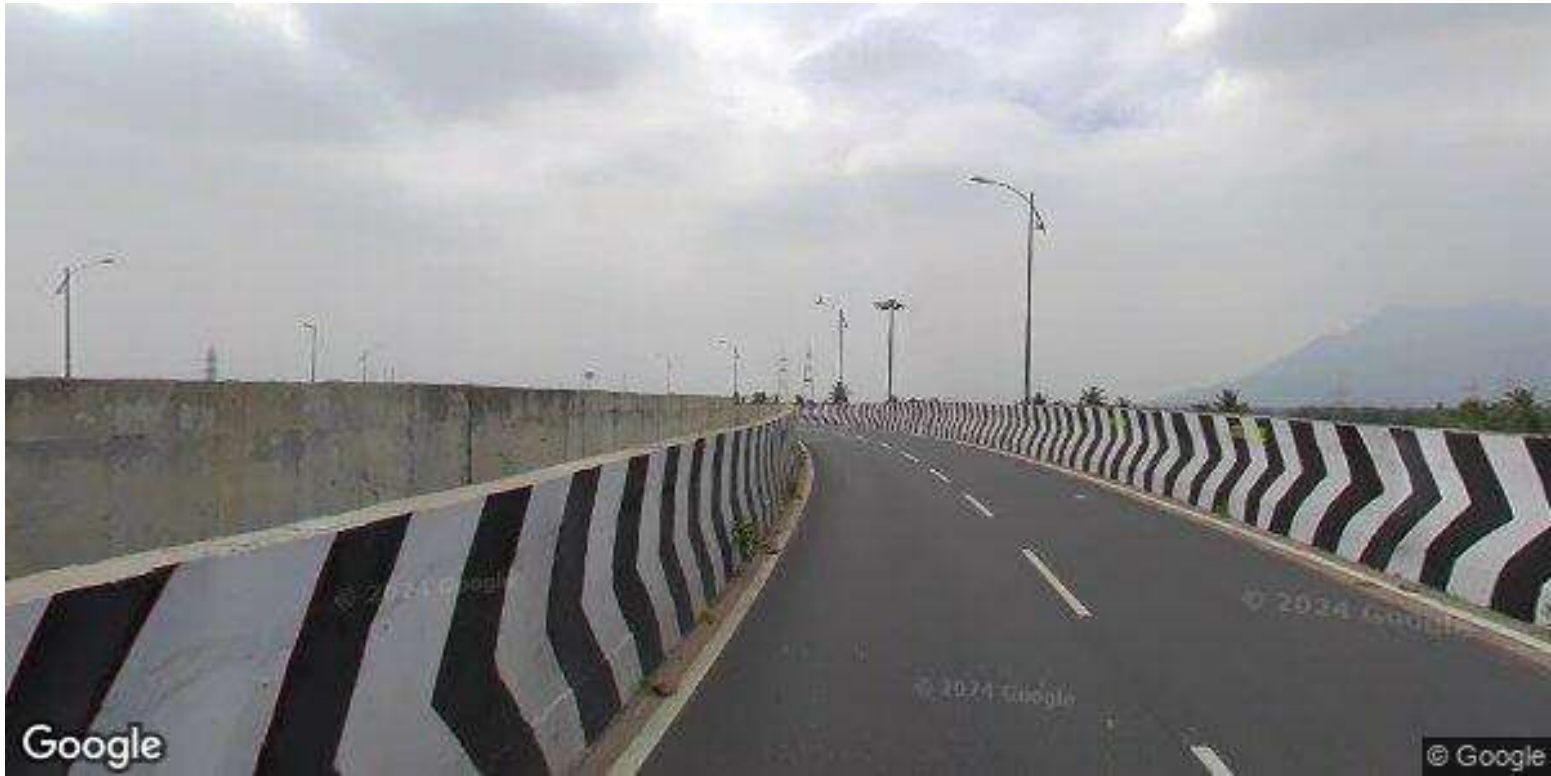
**Risk Type:** Turn  
**Risk Level:** High  
**Speed Limit:** 15 KM/Hr  
**Coordinates:** 11.64180, 78.11808

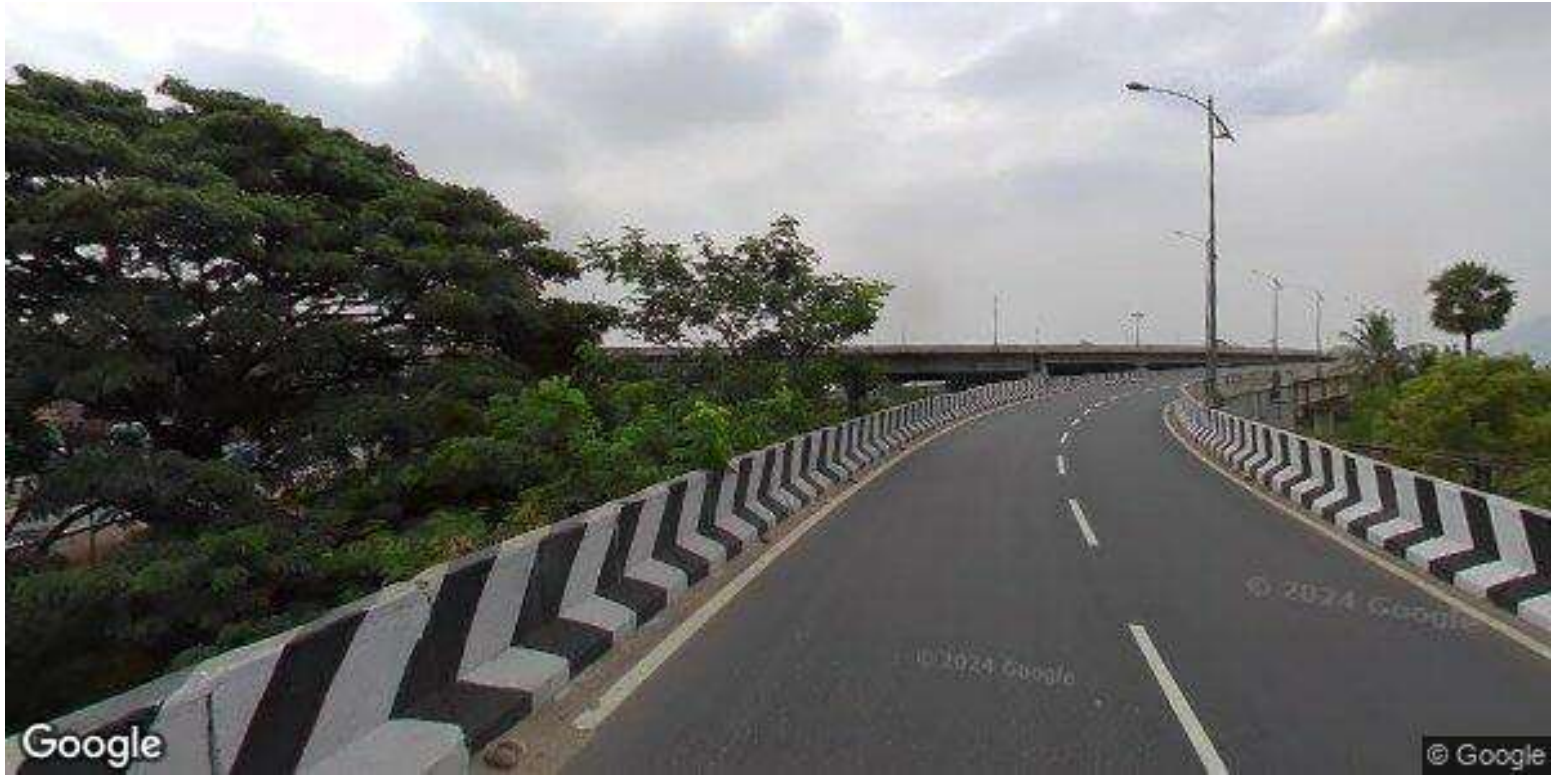
**Risk Type:** Turn  
**Risk Level:** High  
**Speed Limit:** 15 KM/Hr  
**Coordinates:** 11.64325, 78.11993

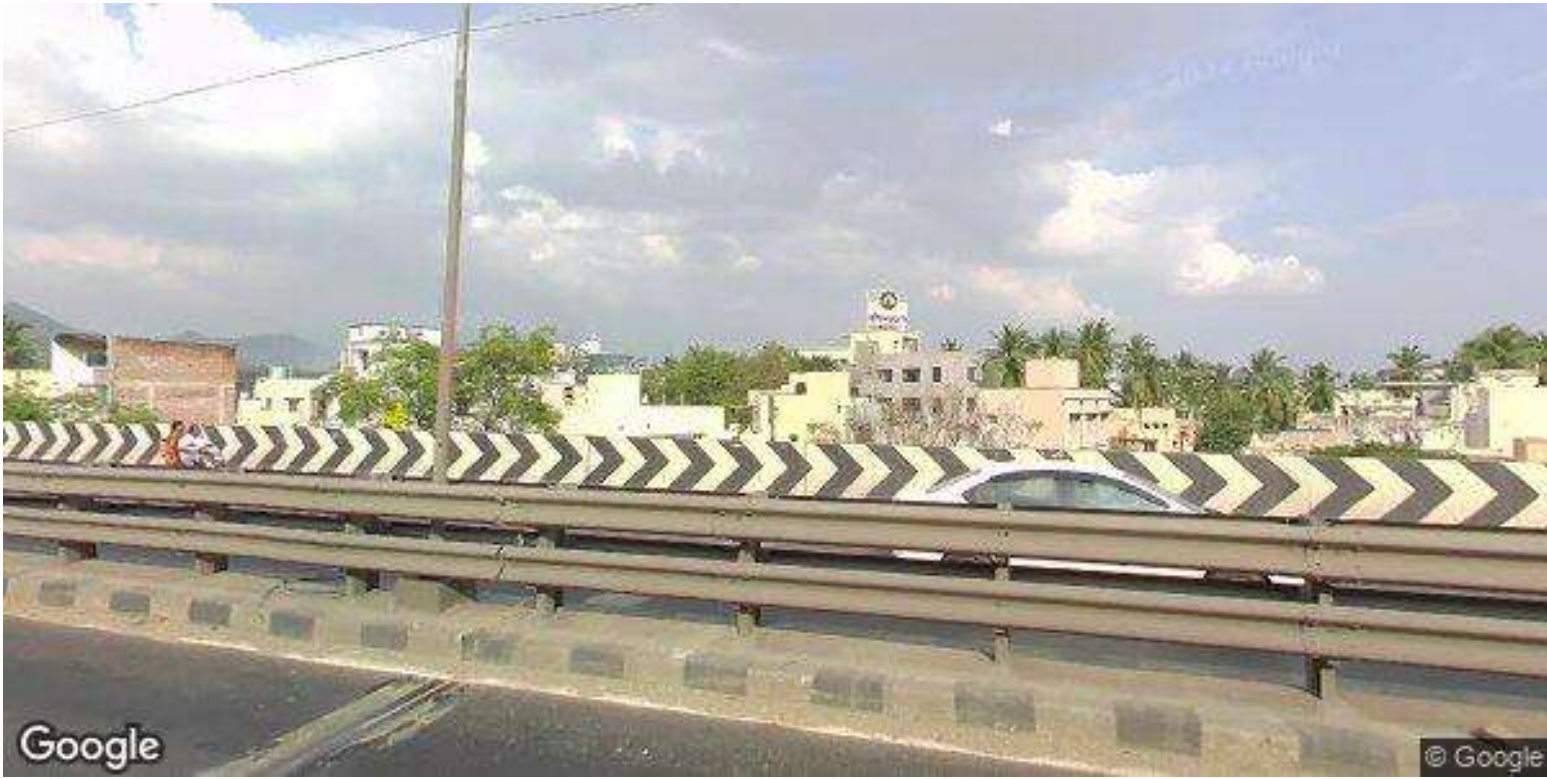
**Risk Type:** Turn  
**Risk Level:** Medium  
**Speed Limit:** 30 KM/Hr  
**Coordinates:** 11.67865, 78.12803

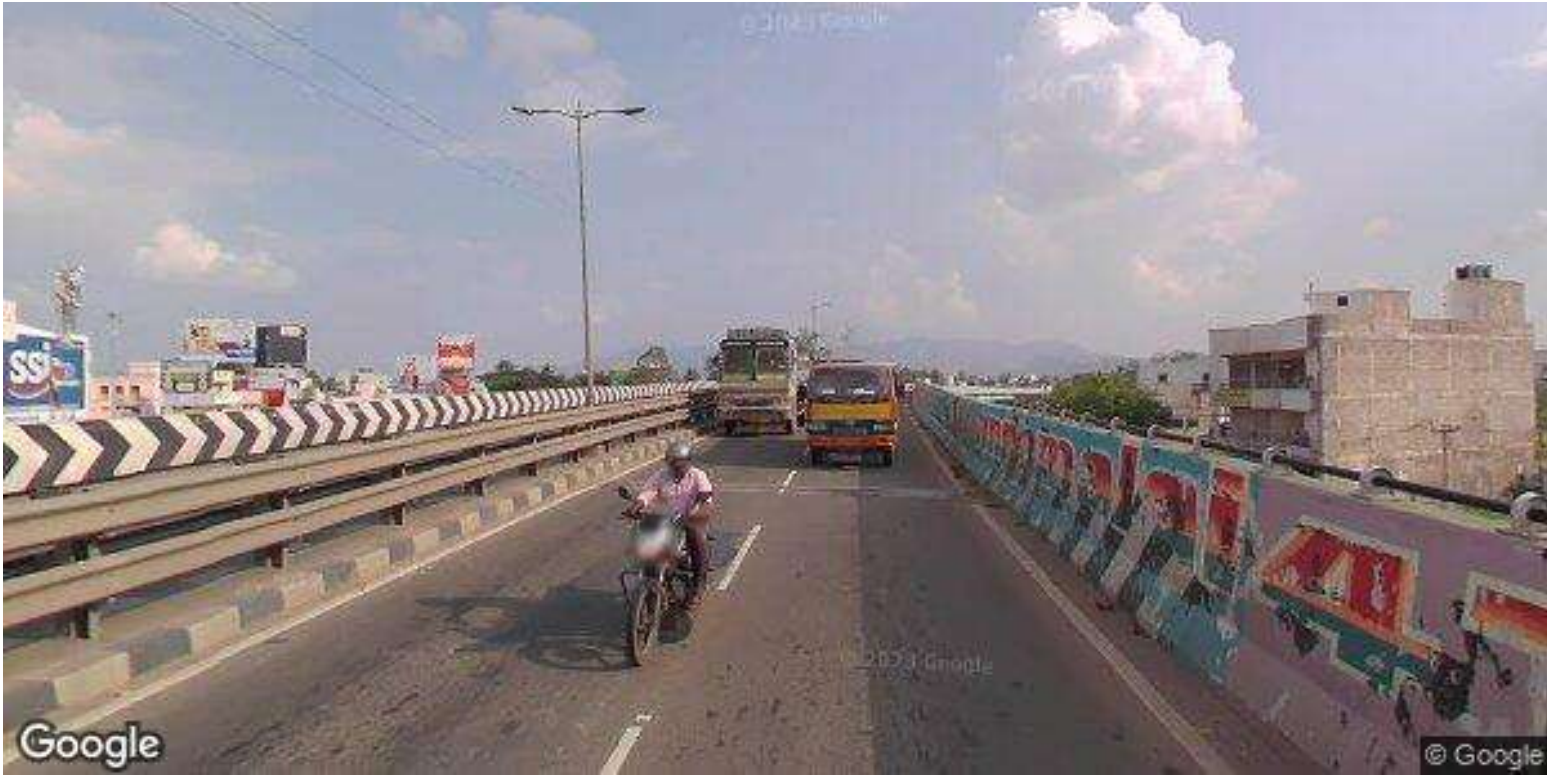
**Risk Type:** Turn  
**Risk Level:** Medium  
**Speed Limit:** 30 KM/Hr  
**Coordinates:** 11.68201, 78.12639

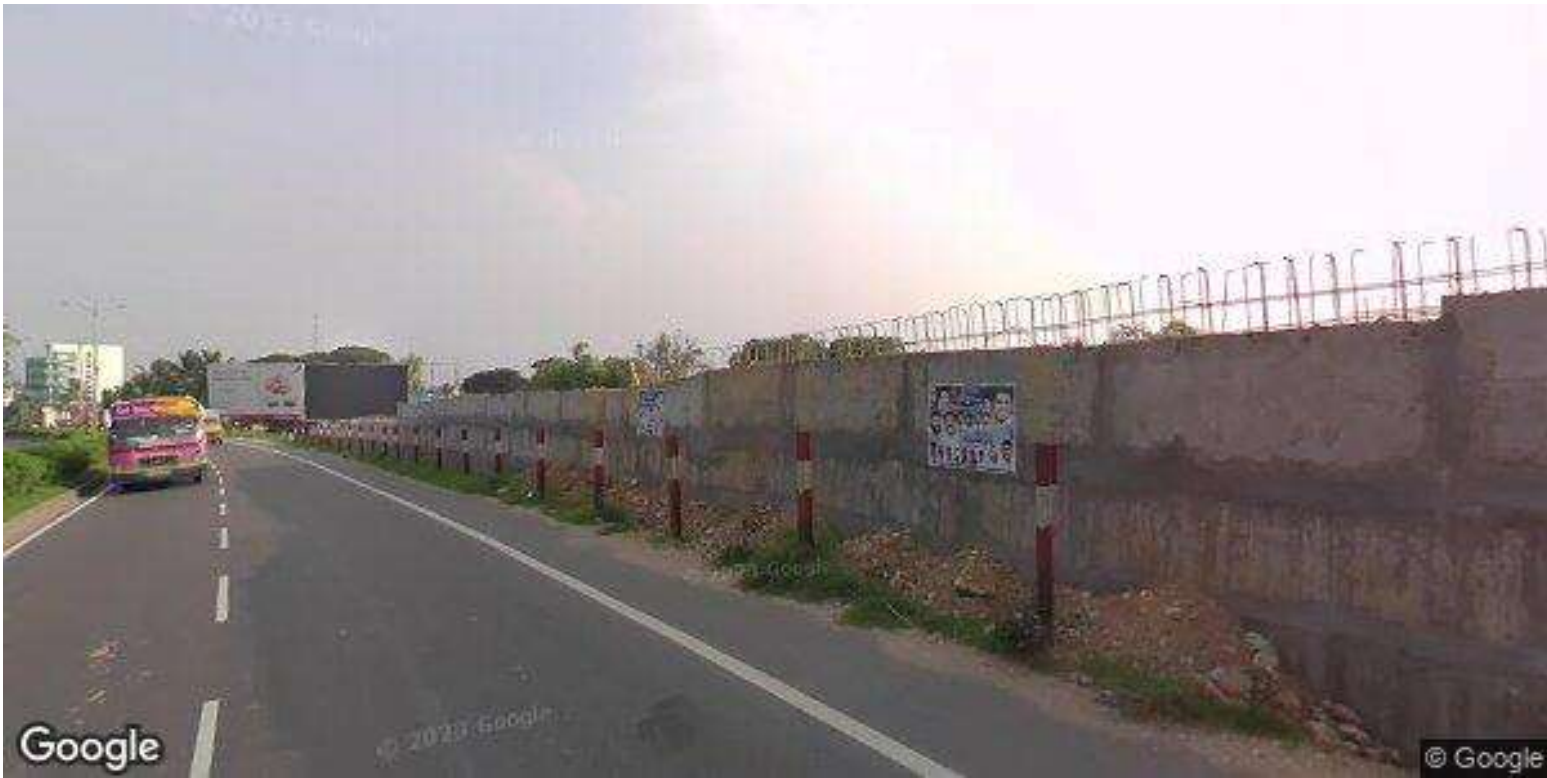
**Risk Type:** Turn  
**Risk Level:** Medium  
**Speed Limit:** 30 KM/Hr  
**Coordinates:** 11.69519, 78.10775

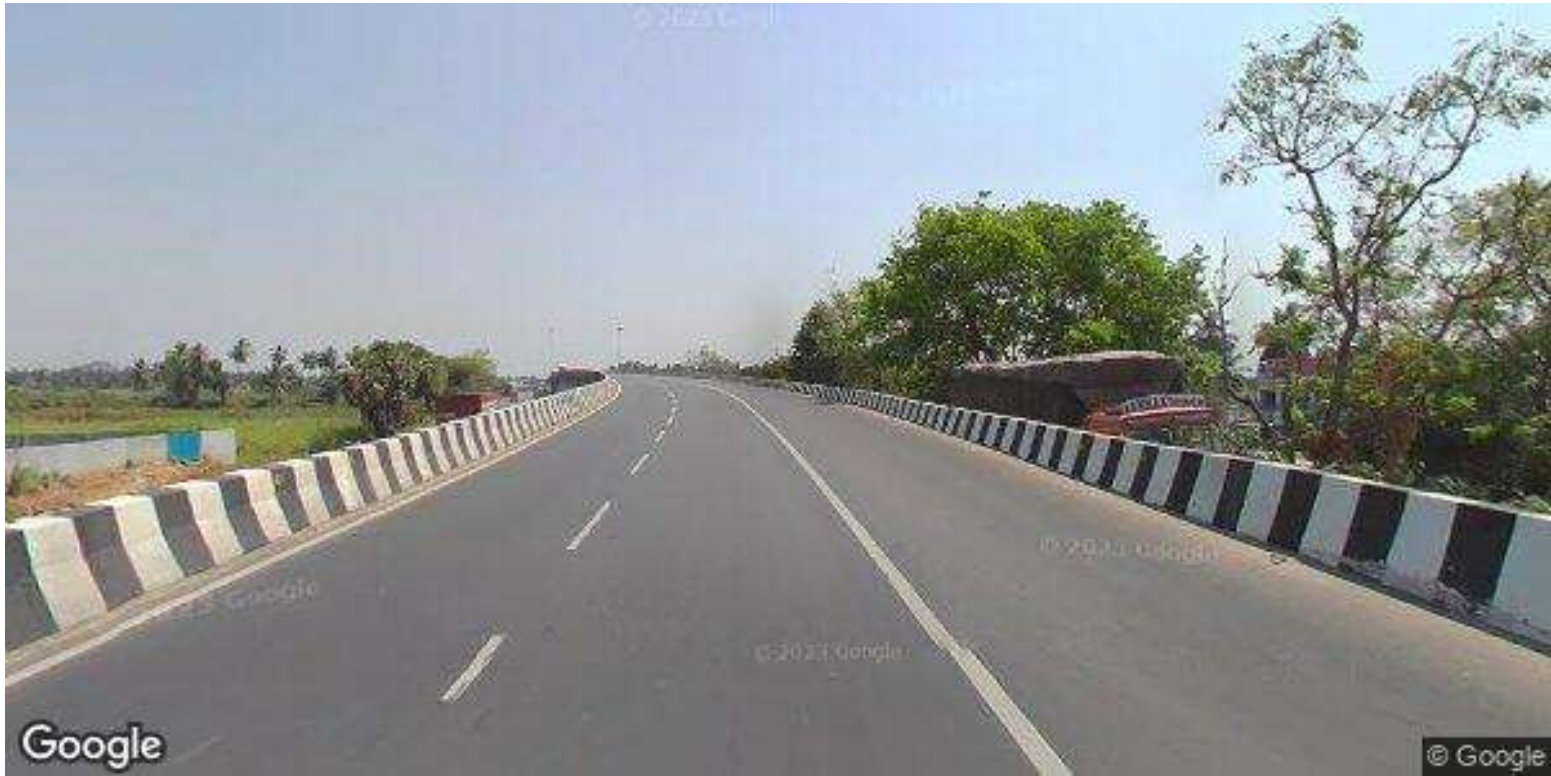
**Risk Type:** Turn  
**Risk Level:** Medium  
**Speed Limit:** 30 KM/Hr  
**Coordinates:** 11.73958, 78.05105

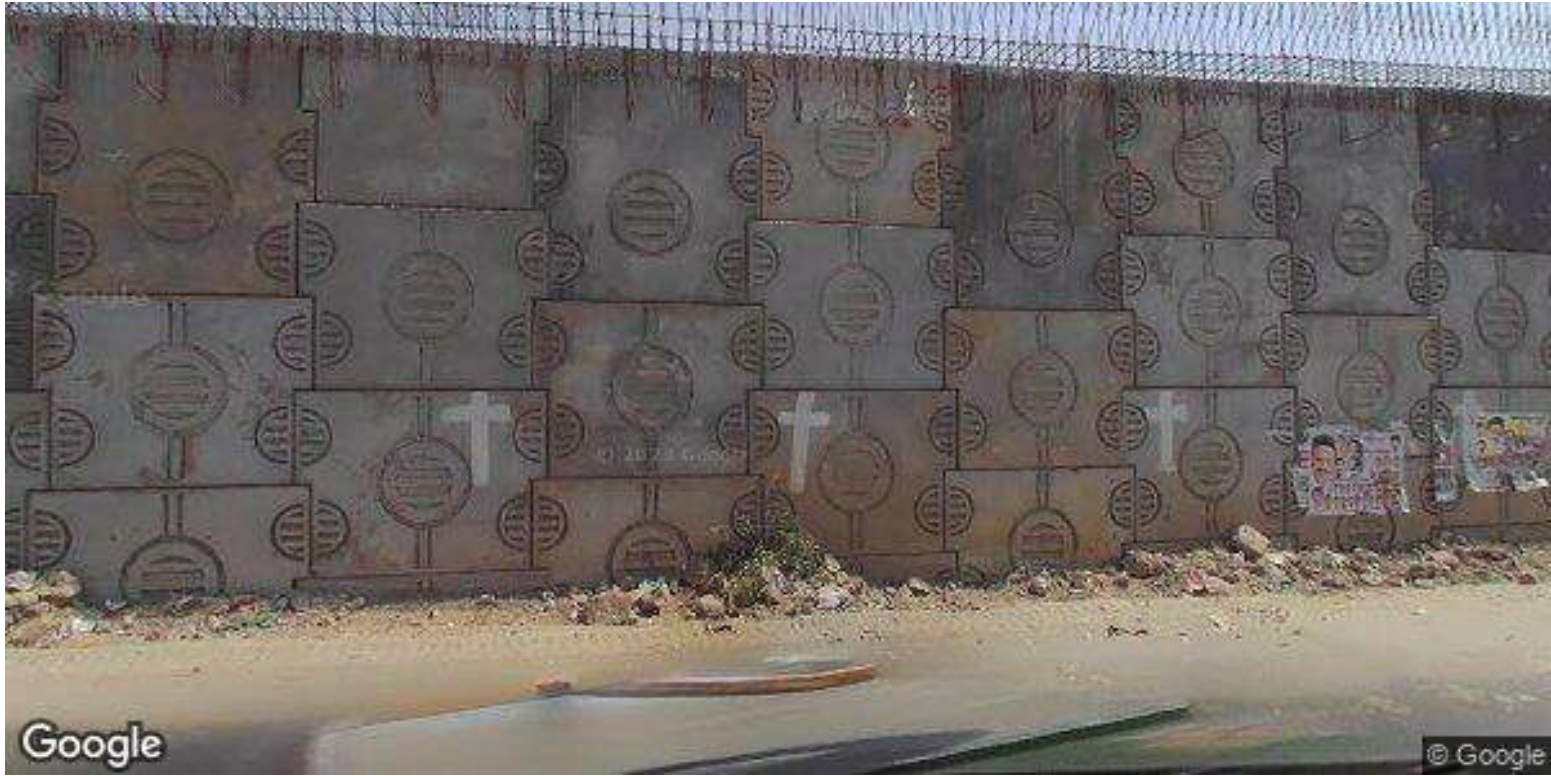
**Risk Type:** Turn  
**Risk Level:** Medium  
**Speed Limit:** 30 KM/Hr  
**Coordinates:** 11.75835, 78.05016

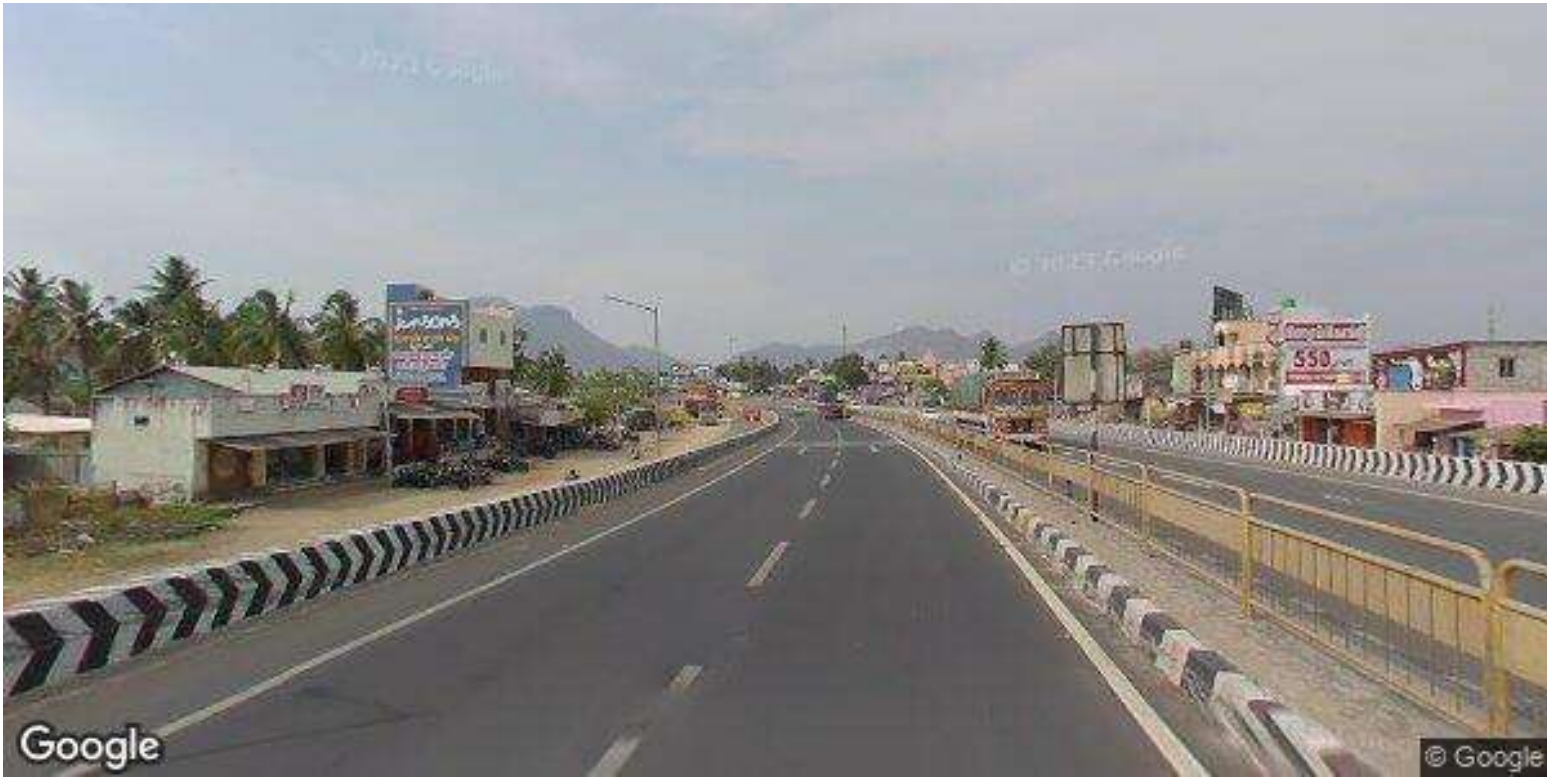
**Risk Type:** Turn  
**Risk Level:** Medium  
**Speed Limit:** 30 KM/Hr  
**Coordinates:** 11.86847, 78.08367

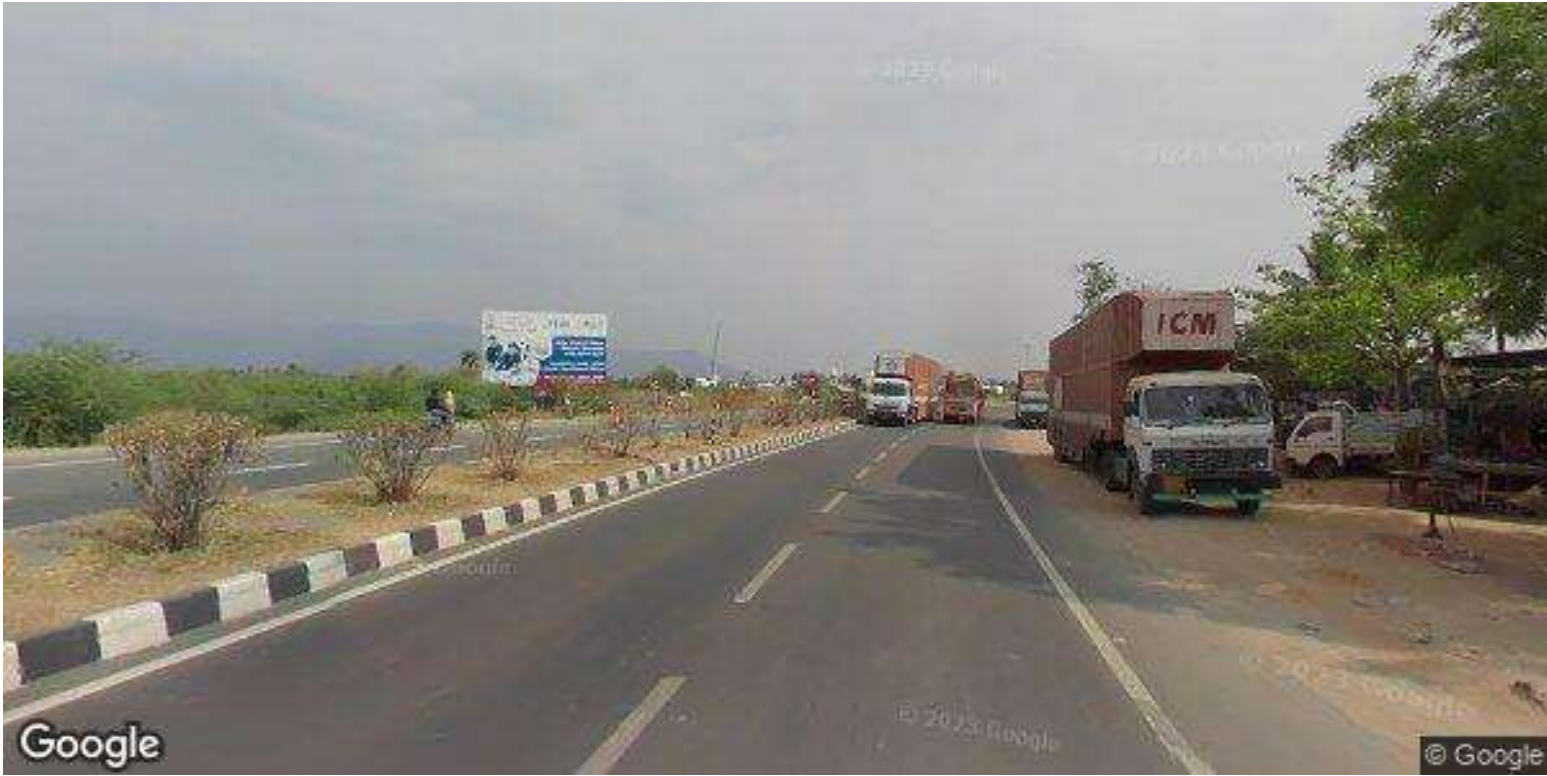
**Risk Type:** Turn  
**Risk Level:** Medium  
**Speed Limit:** 30 KM/Hr  
**Coordinates:** 11.87942, 78.08197

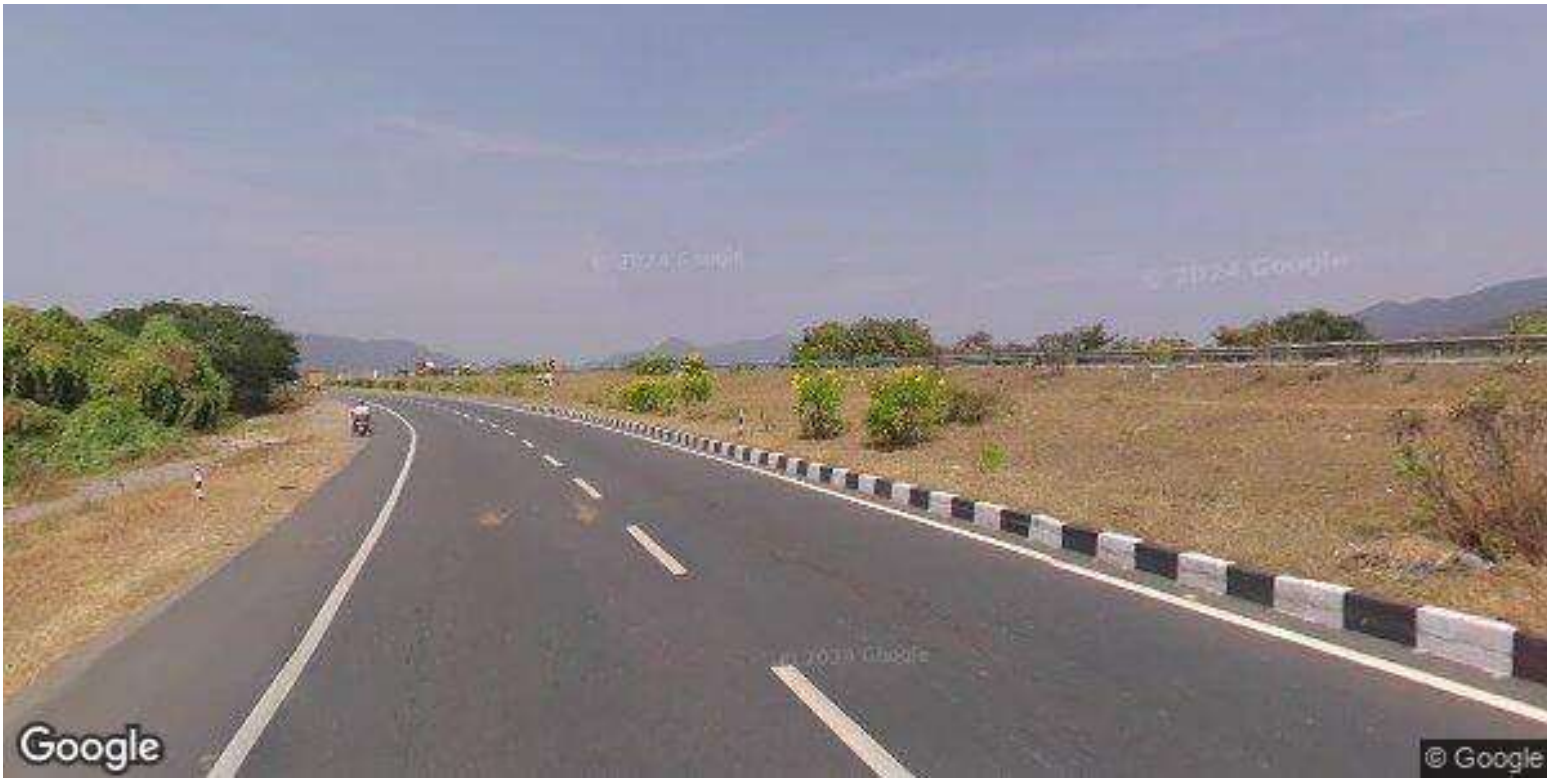
**Risk Type:** Turn  
**Risk Level:** Medium  
**Speed Limit:** 30 KM/Hr  
**Coordinates:** 11.92585, 78.06507

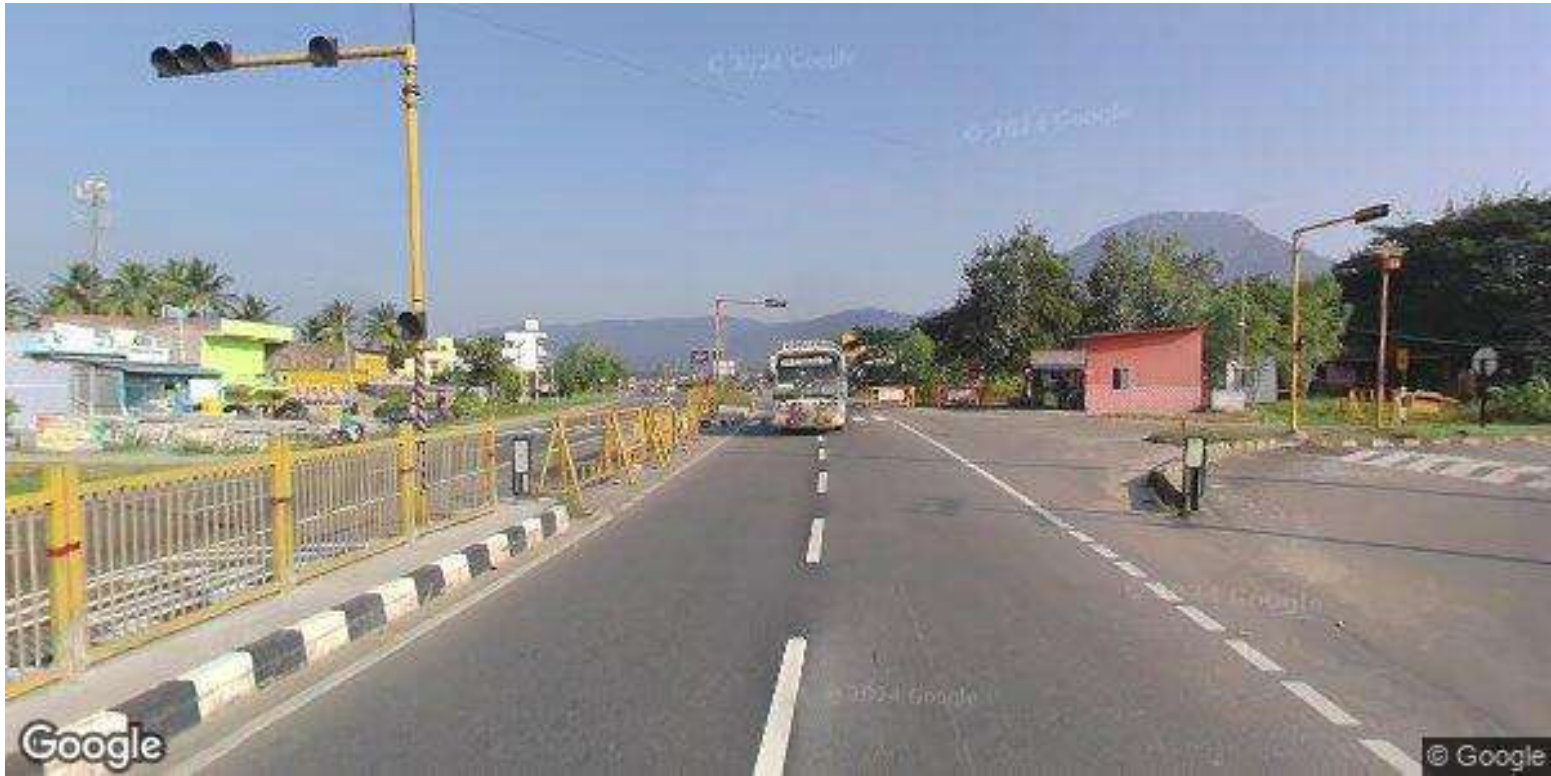
**Risk Type:** Turn  
**Risk Level:** Medium  
**Speed Limit:** 30 KM/Hr  
**Coordinates:** 11.93704, 78.05402
