# IndianOil

## JOURNEY RISK MANAGEMENT (JRM) STUDY

### Salem Terminal TO SHRI RAMESH BABU AGENCY UNIT II

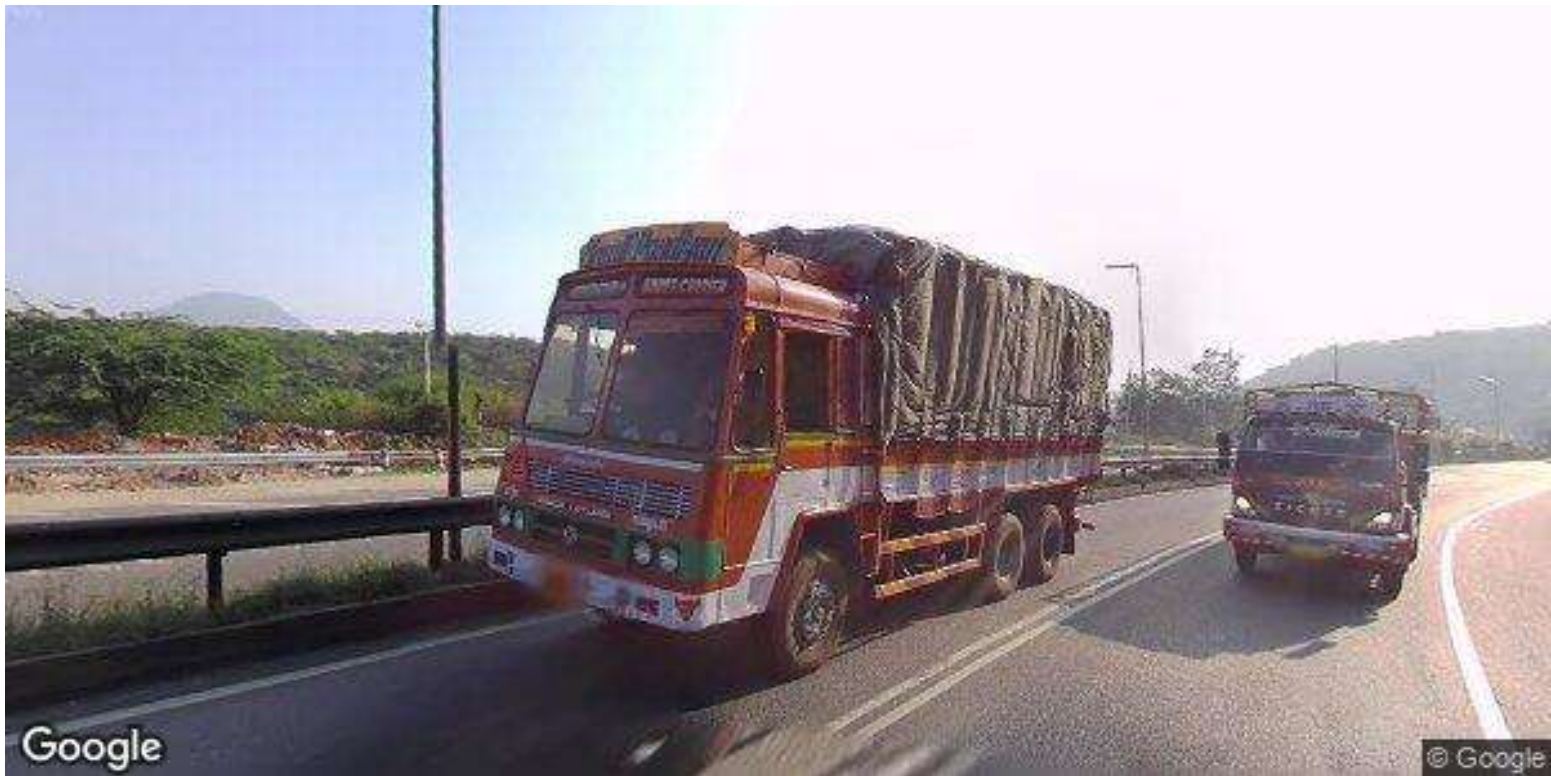
**Risk Type:** Turn  
**Risk Level:** High  
**Speed Limit:** 15 KM/Hr  
**Coordinates:** 11.95818, 78.04978

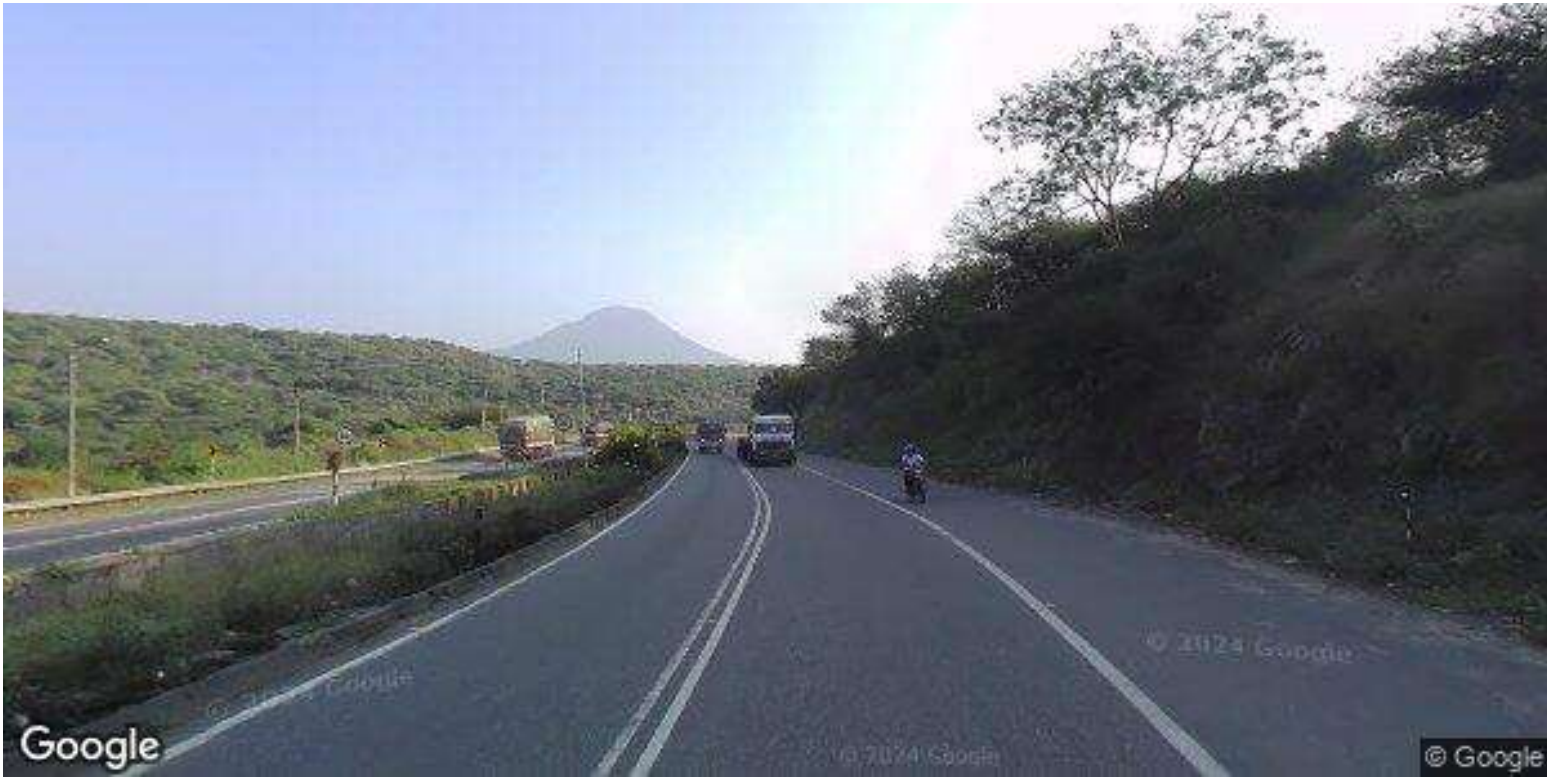
**Risk Type:** Turn  
**Risk Level:** Medium  
**Speed Limit:** 30 KM/Hr  
**Coordinates:** 11.95988, 78.04948

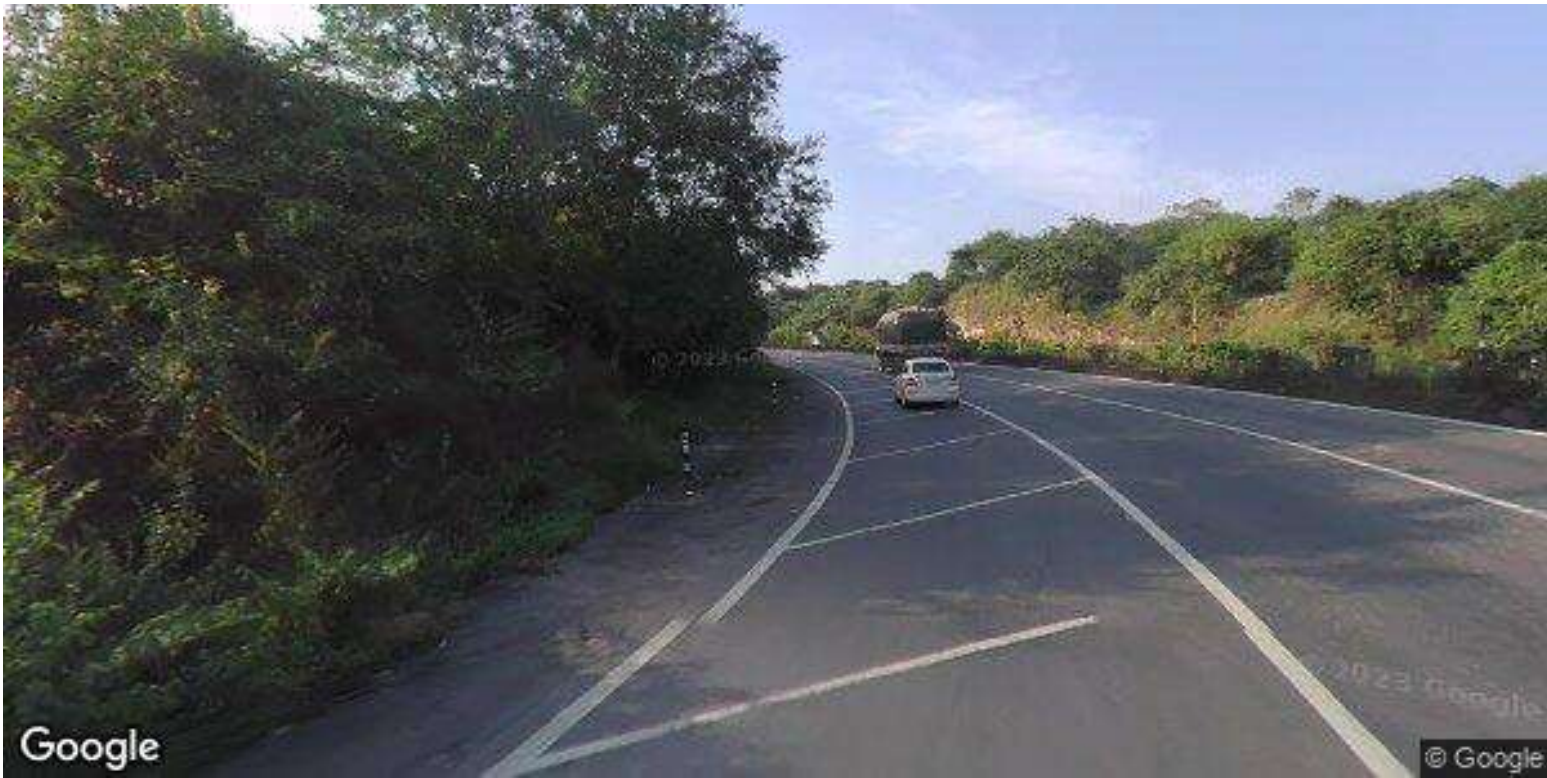
**Risk Type:** Turn  
**Risk Level:** High  
**Speed Limit:** 15 KM/Hr  
**Coordinates:** 11.96399, 78.05135

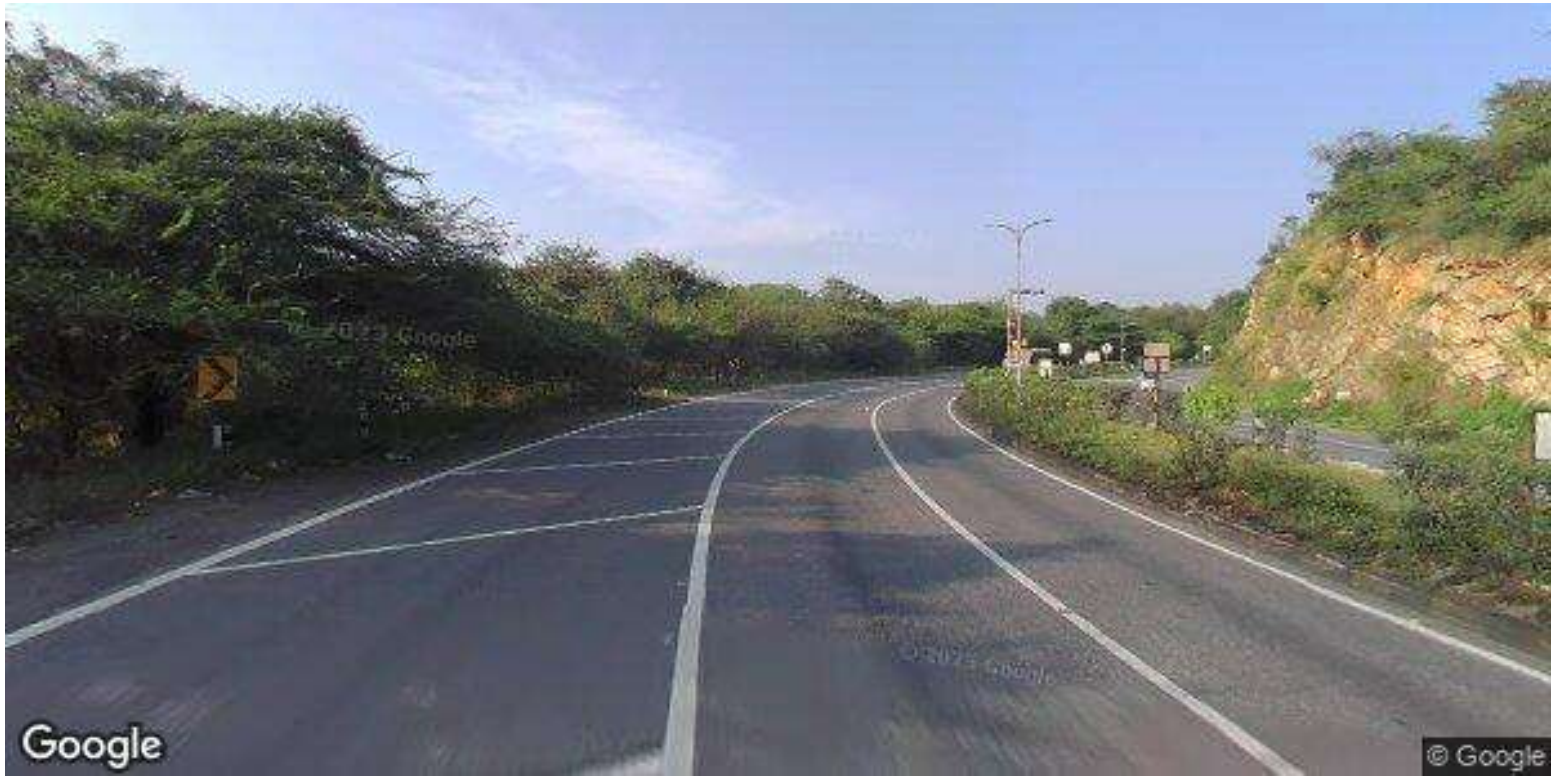
**Risk Type:** Turn  
**Risk Level:** High  
**Speed Limit:** 15 KM/Hr  
**Coordinates:** 11.96580, 78.04923

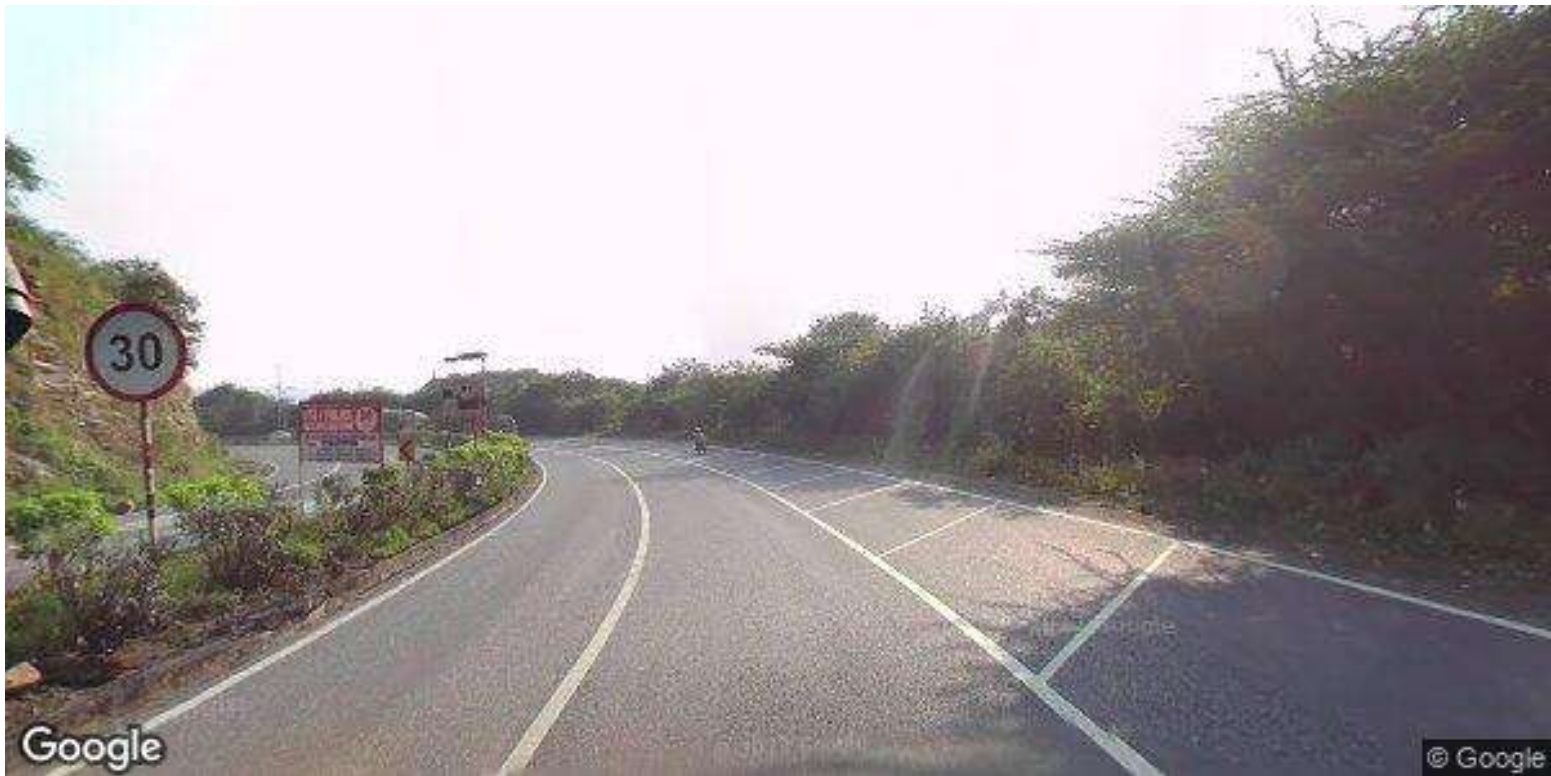
**Risk Type:** Turn  
**Risk Level:** Medium  
**Speed Limit:** 30 KM/Hr  
**Coordinates:** 11.96675, 78.04939

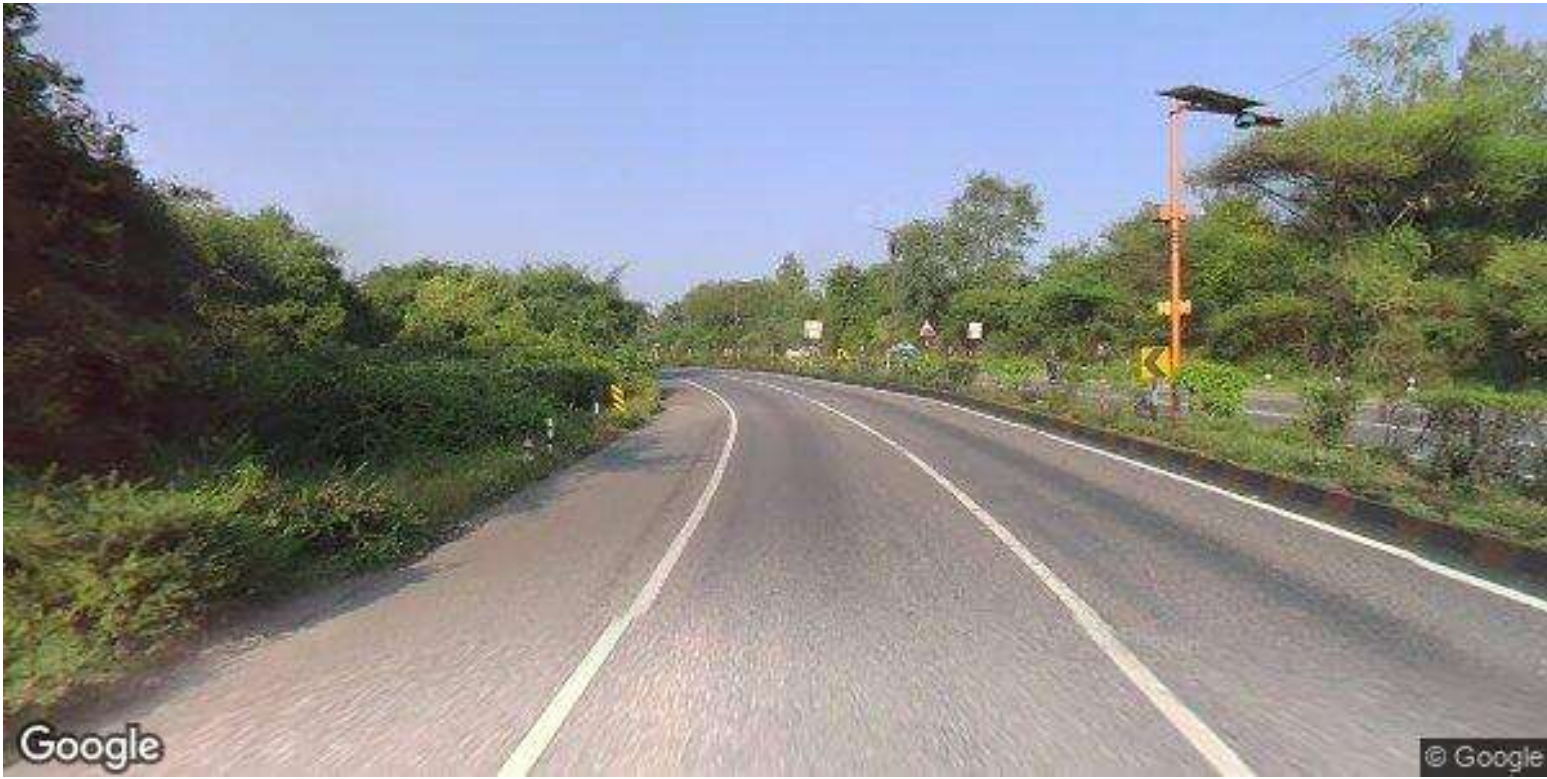
**Risk Type:** Turn  
**Risk Level:** Medium  
**Speed Limit:** 30 KM/Hr  
**Coordinates:** 11.96791, 78.05070

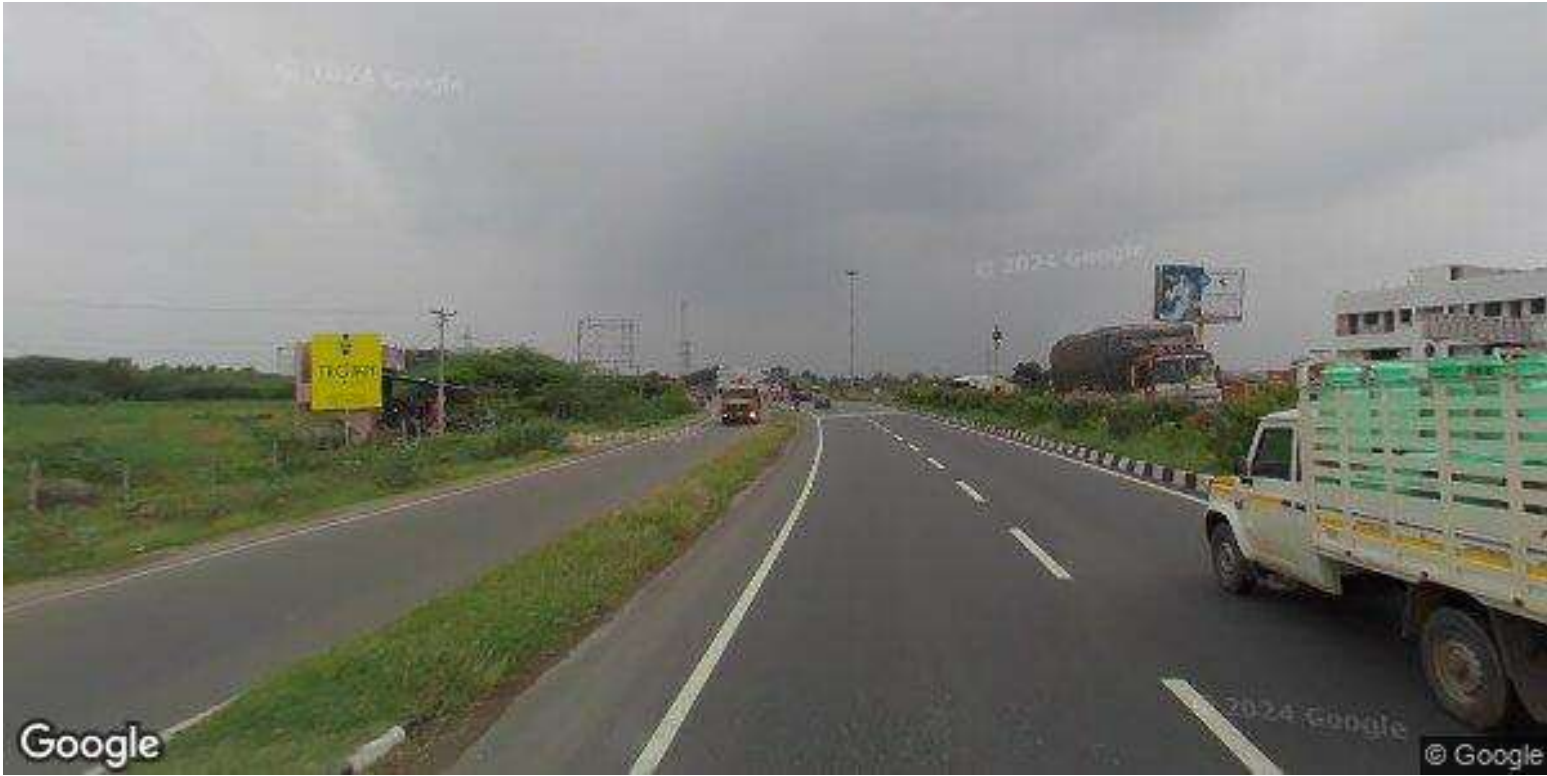
**Risk Type:** Turn  
**Risk Level:** Medium  
**Speed Limit:** 30 KM/Hr  
**Coordinates:** 12.16983, 78.16769

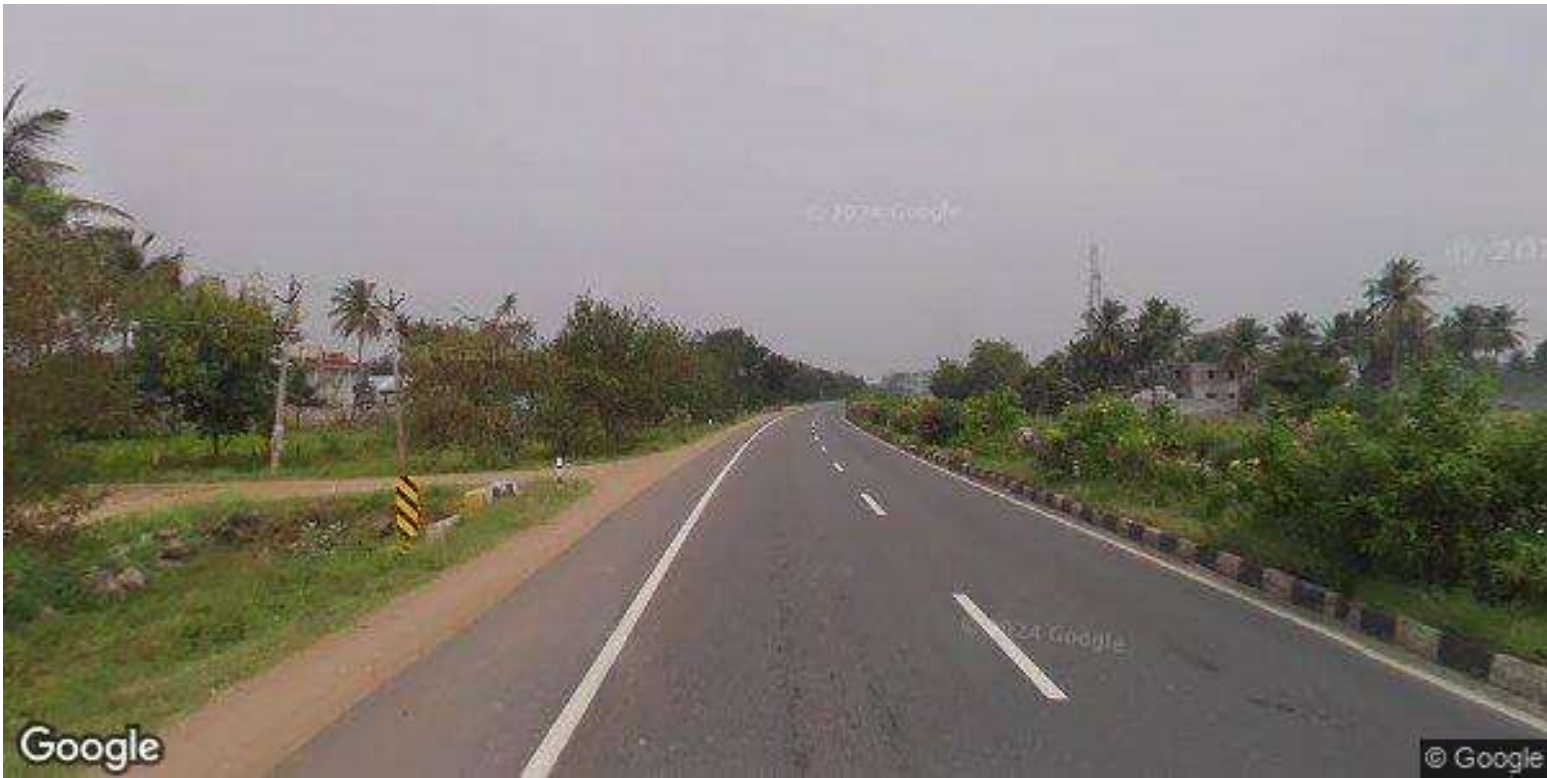
**Risk Type:** Turn  
**Risk Level:** Medium  
**Speed Limit:** 30 KM/Hr  
**Coordinates:** 12.19881, 78.18157

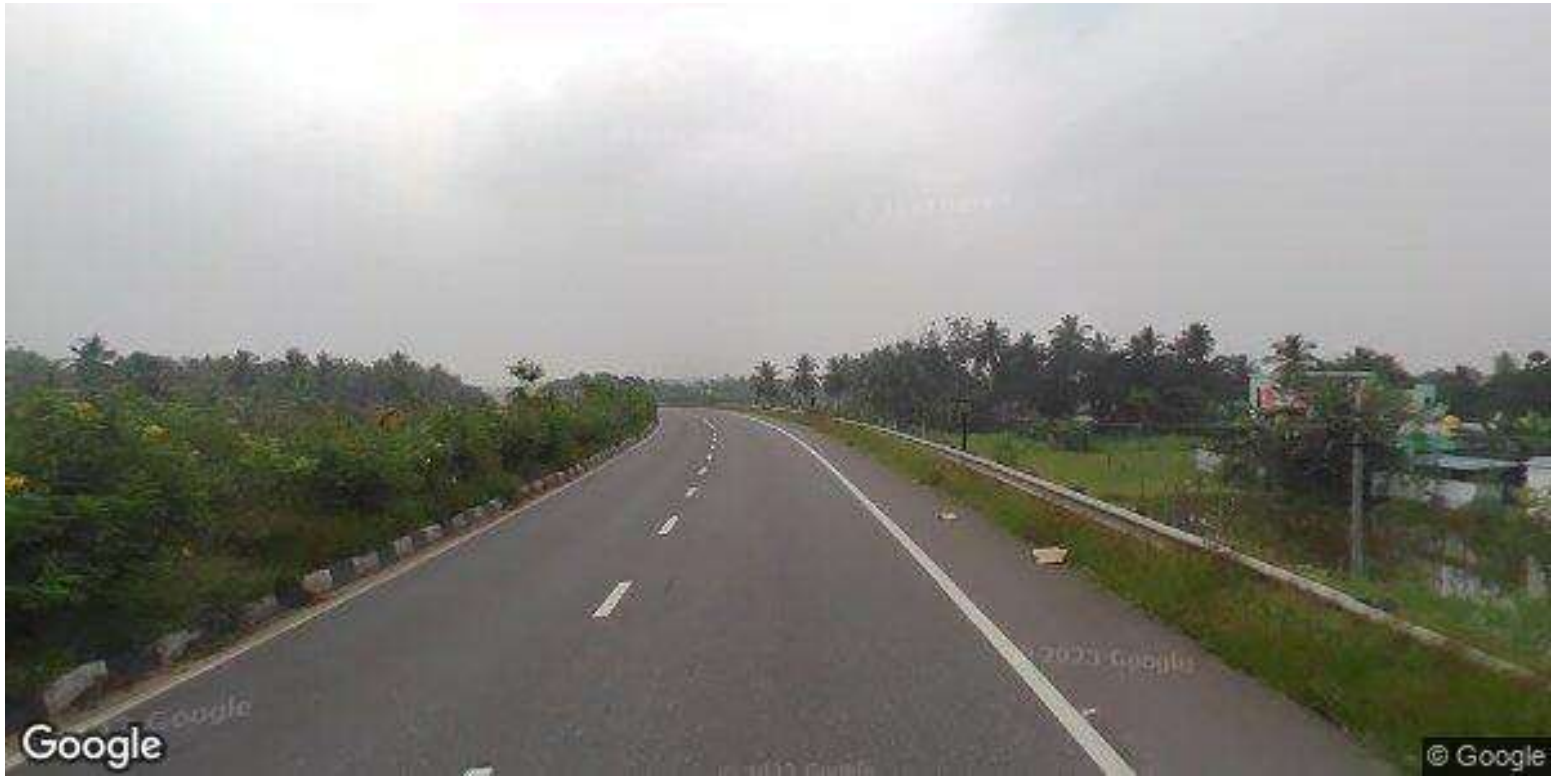
**Risk Type:** Turn  
**Risk Level:** Medium  
**Speed Limit:** 30 KM/Hr  
**Coordinates:** 12.22459, 78.19136

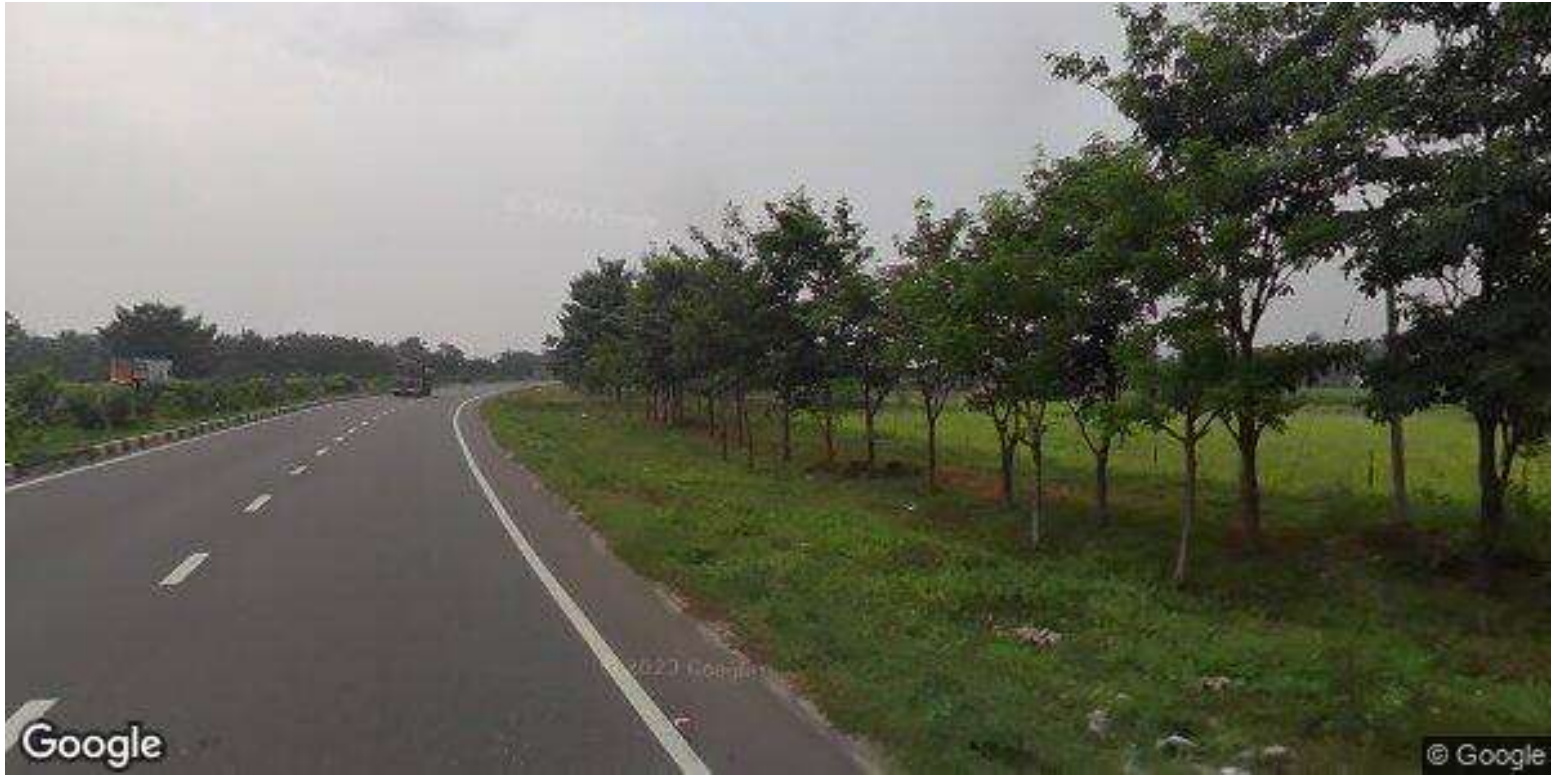
**Risk Type:** Turn  
**Risk Level:** Medium  
**Speed Limit:** 30 KM/Hr  
**Coordinates:** 12.25060, 78.19977

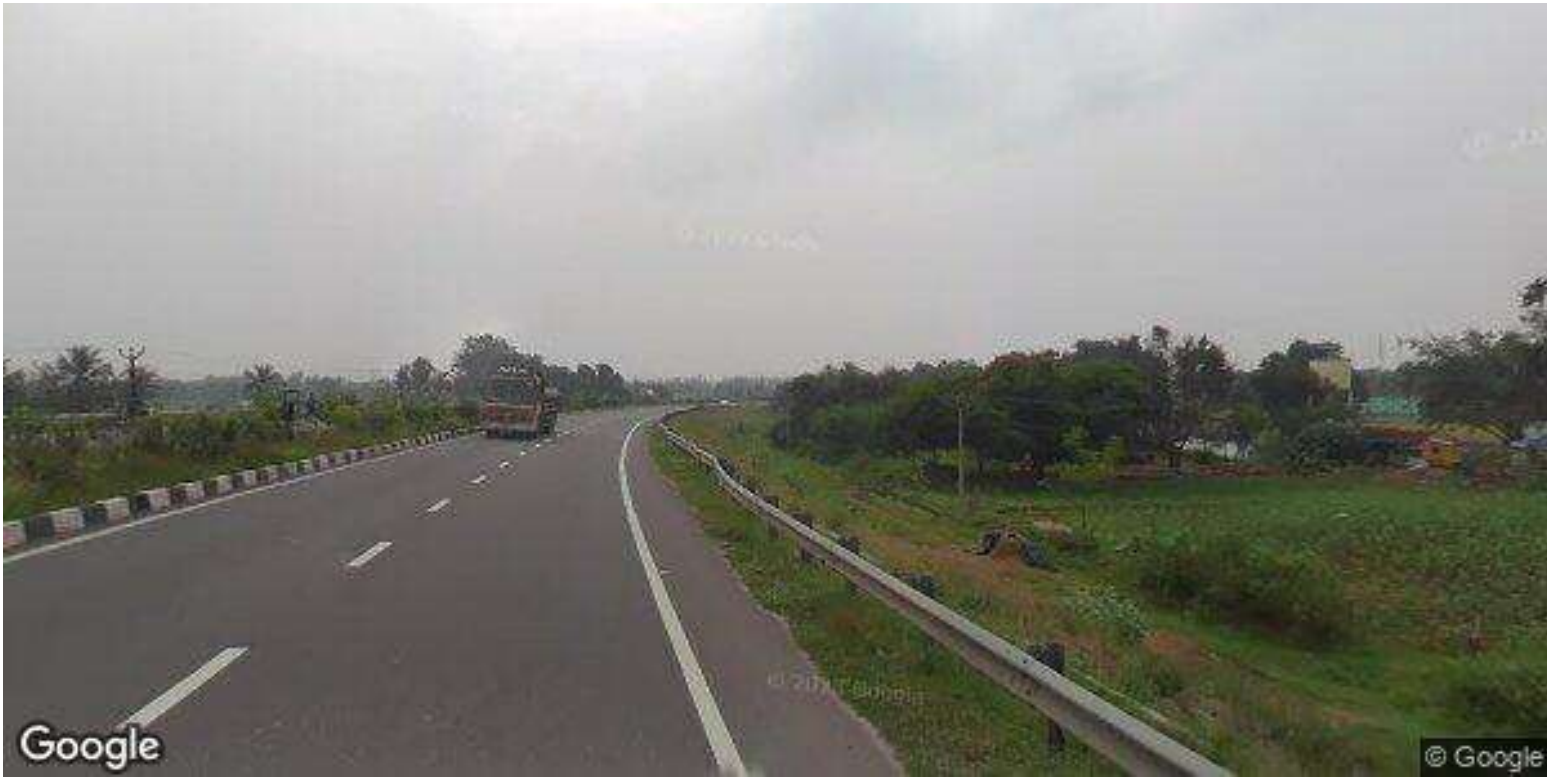
**Risk Type:** Turn  
**Risk Level:** Medium  
**Speed Limit:** 30 KM/Hr  
**Coordinates:** 12.25329, 78.20039

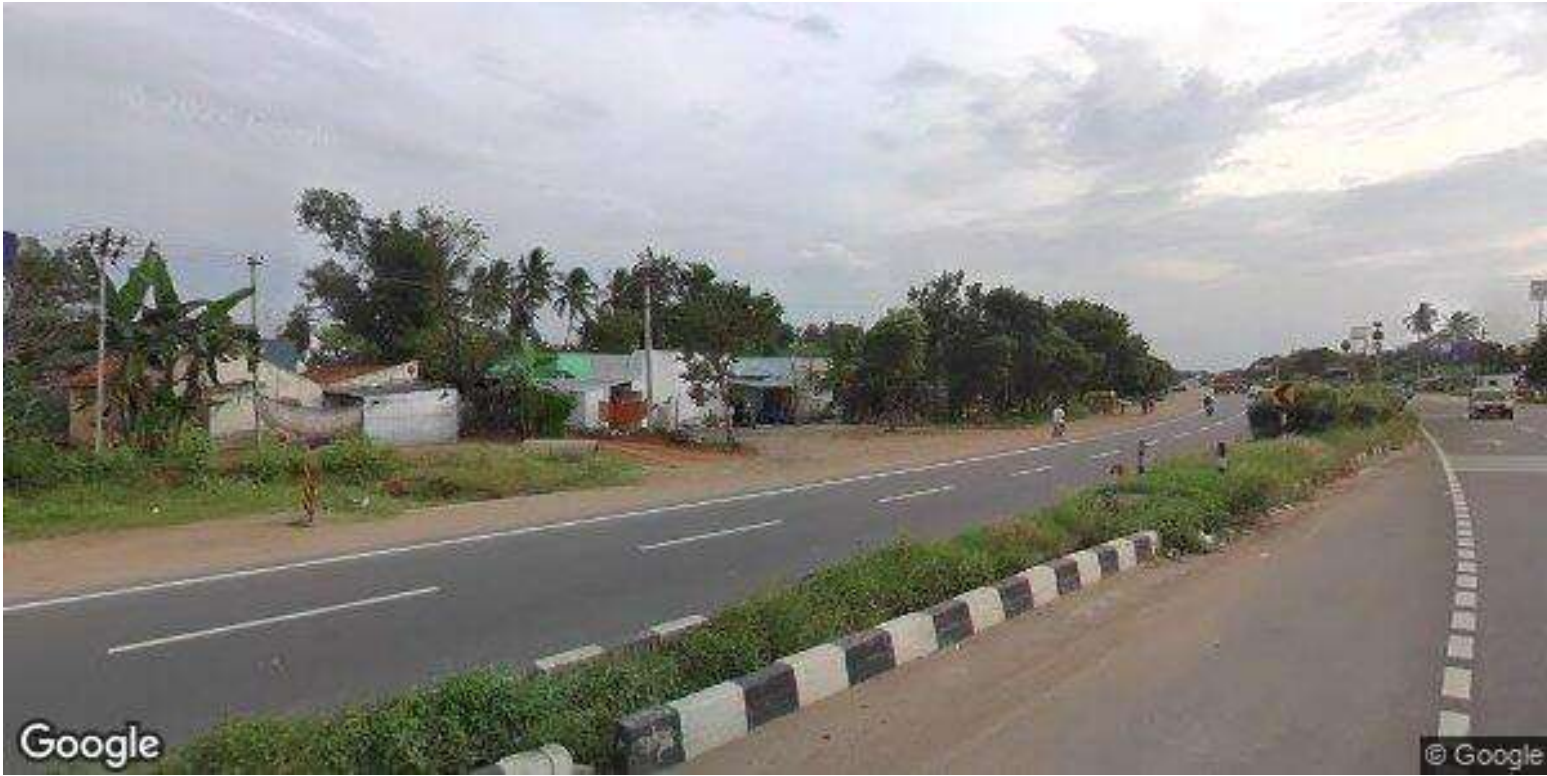
**Risk Type:** Turn  
**Risk Level:** Medium  
**Speed Limit:** 30 KM/Hr  
**Coordinates:** 12.29110, 78.19909

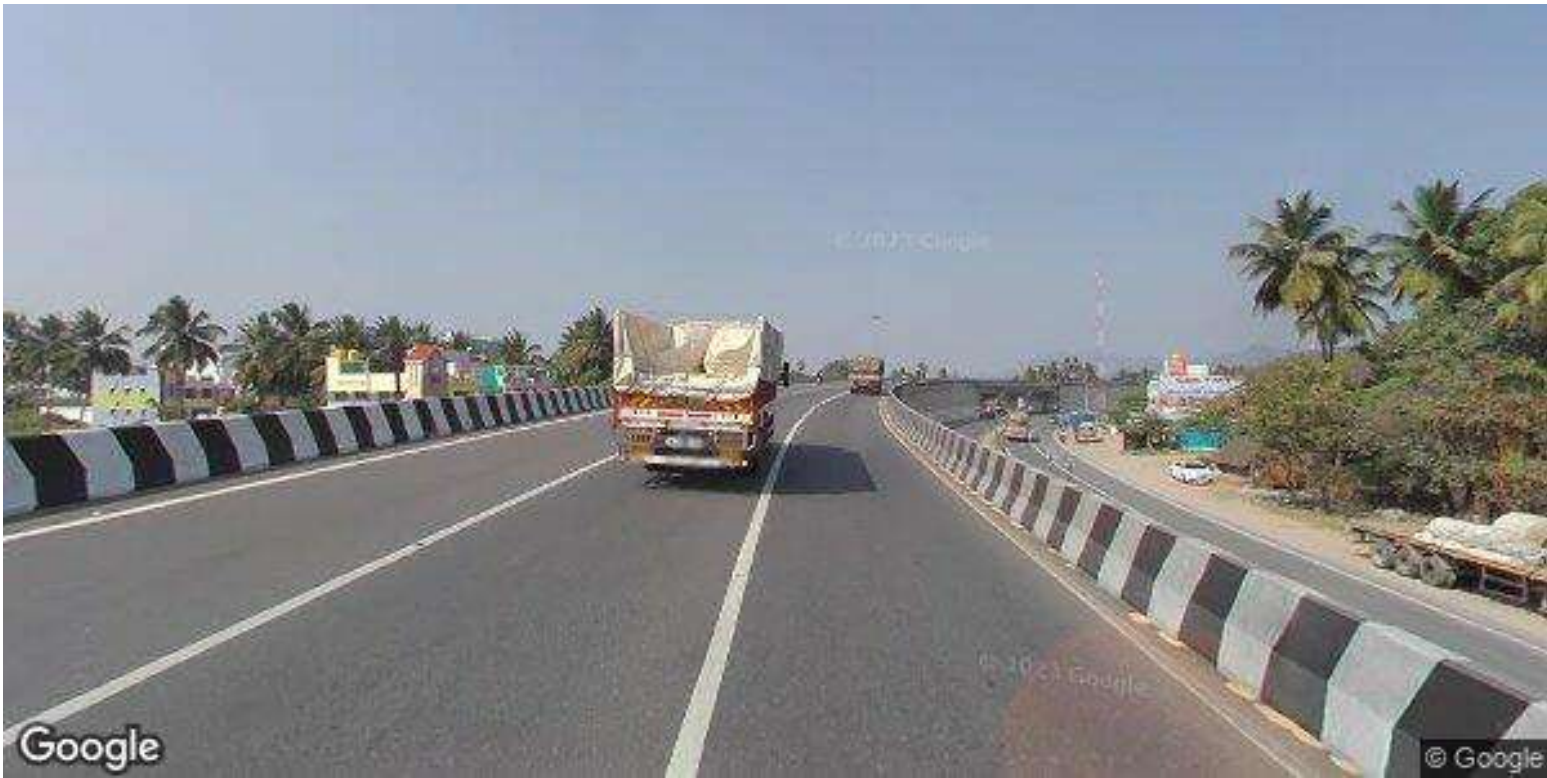
**Risk Type:** Turn  
**Risk Level:** Medium  
**Speed Limit:** 30 KM/Hr  
**Coordinates:** 12.39904, 78.21764

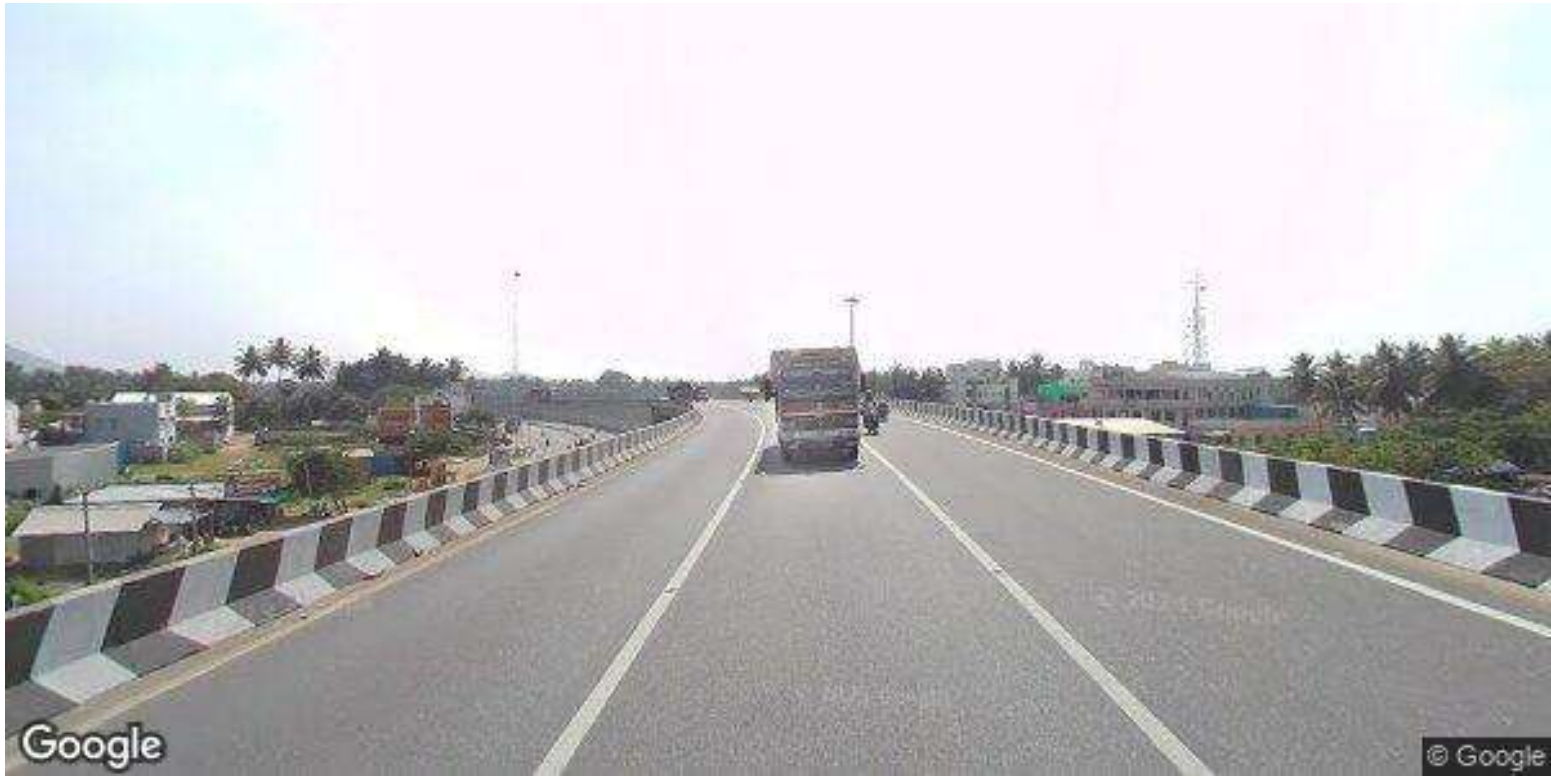
**Risk Type:** Turn  
**Risk Level:** Medium  
**Speed Limit:** 30 KM/Hr  
**Coordinates:** 12.40156, 78.21845

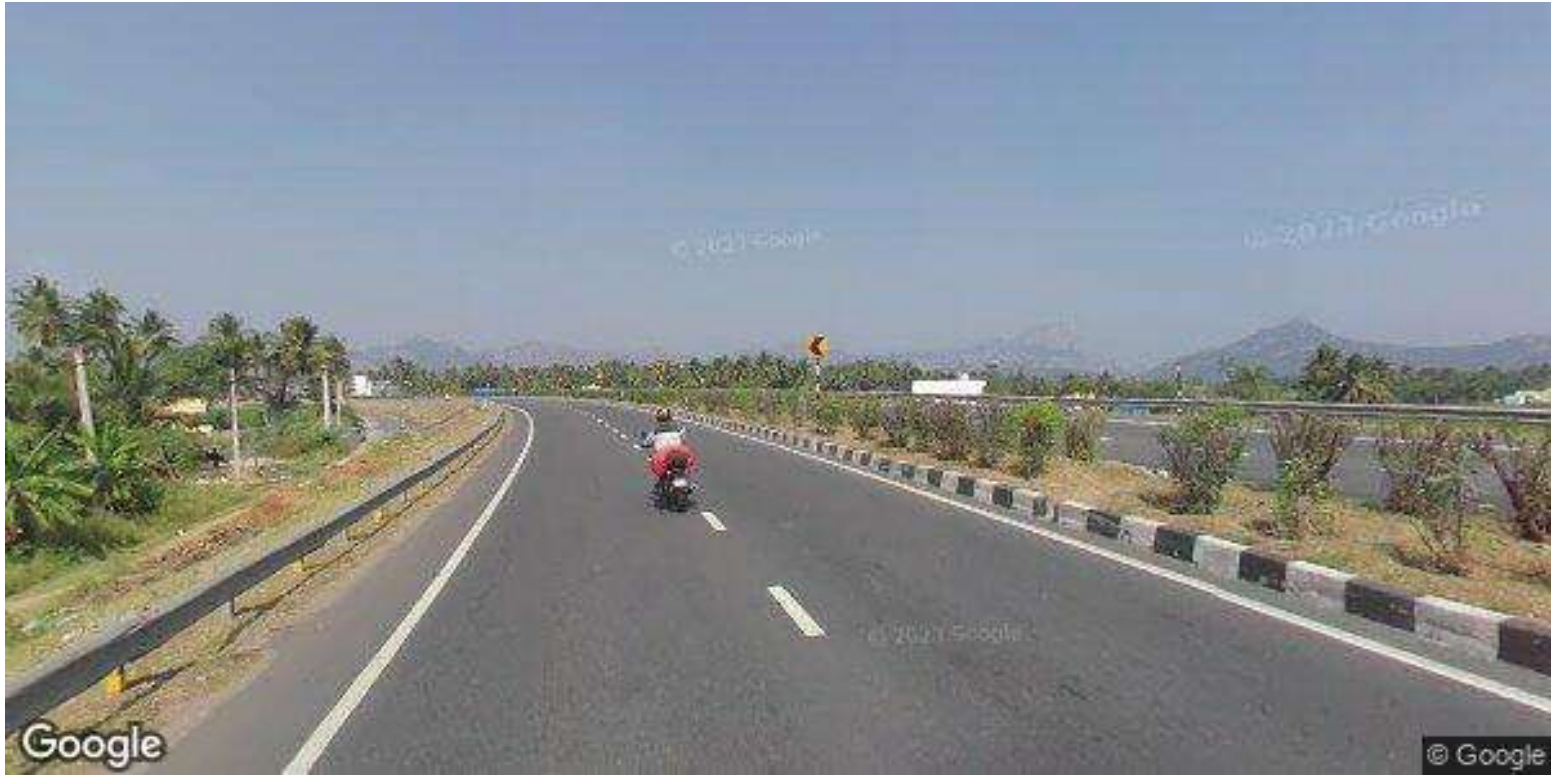
**Risk Type:** Turn  
**Risk Level:** Medium  
**Speed Limit:** 30 KM/Hr  
**Coordinates:** 12.40589, 78.22275

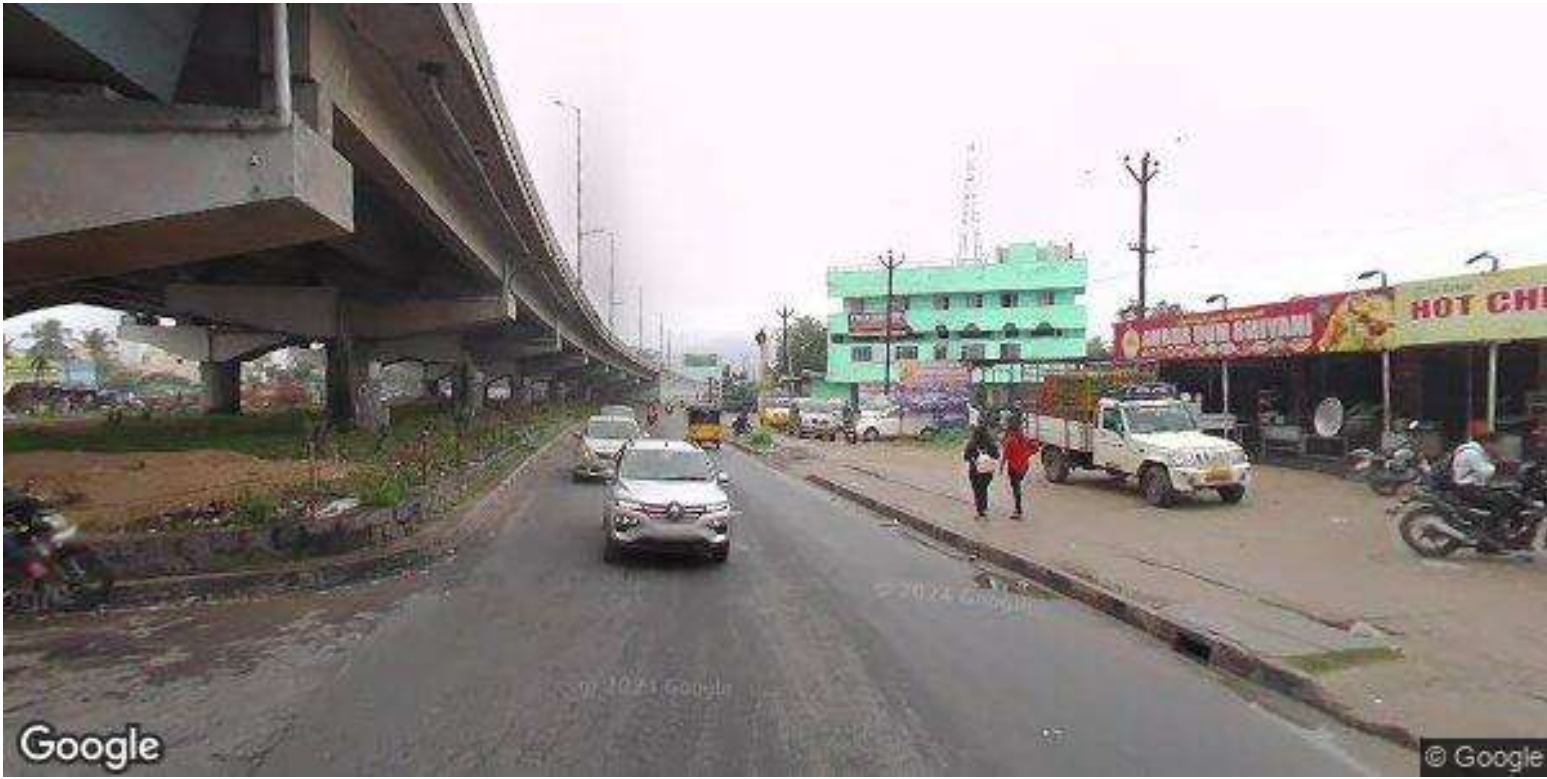
**Risk Type:** Turn

**Risk Level:** High

**Speed Limit:** 15 KM/Hr

**Coordinates:** 12.50709, 78.22230
