## JOURNEY RISK MANAGEMENT (JRM) STUDY

### Salem Terminal TO SRI MURUGAN AGENCIES UNIT II

**Route Safety Analysis from Sangagiri to Vennamalaipatty  
Railway Bridge, Karur**

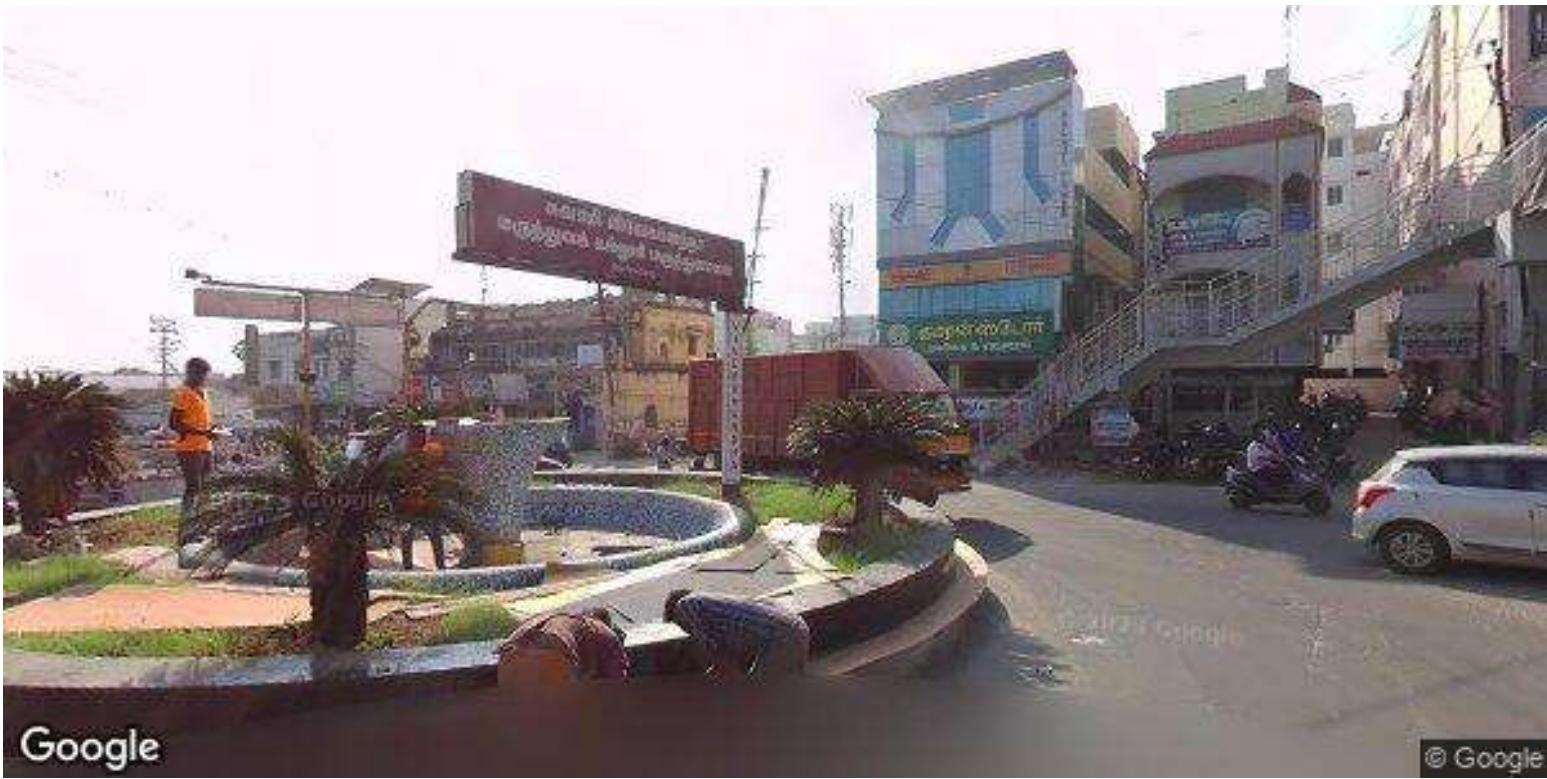
Coordinates: 11.38395, 77.89480

Risk Type: Roundabout

Risk Level: High

Speed Limit: 15 KM/Hr

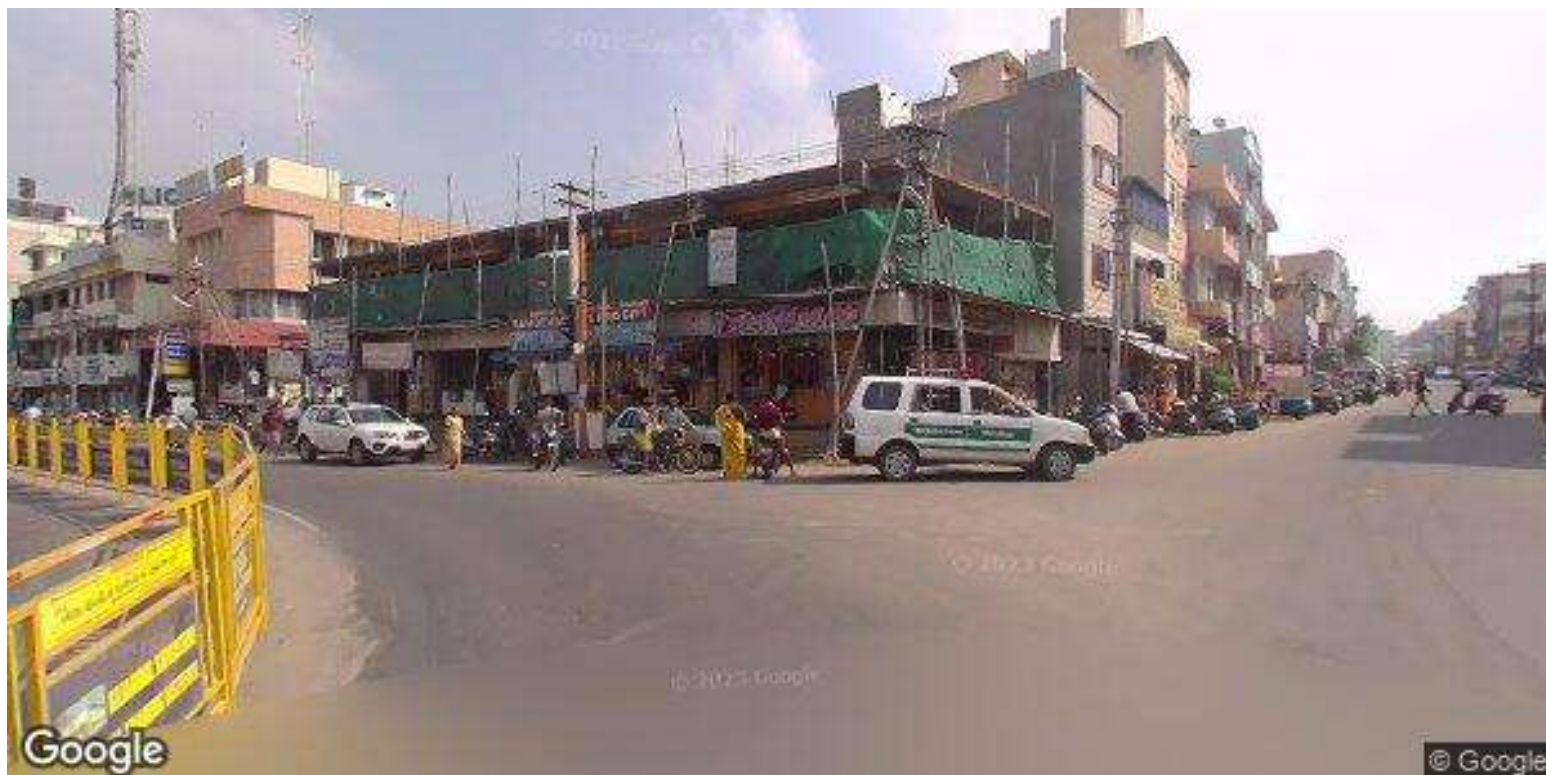
**Coordinates:** 11.37868, 77.89498

**Risk Type:** Turn

**Risk Level:** High

**Speed Limit:** 15 KM/Hr

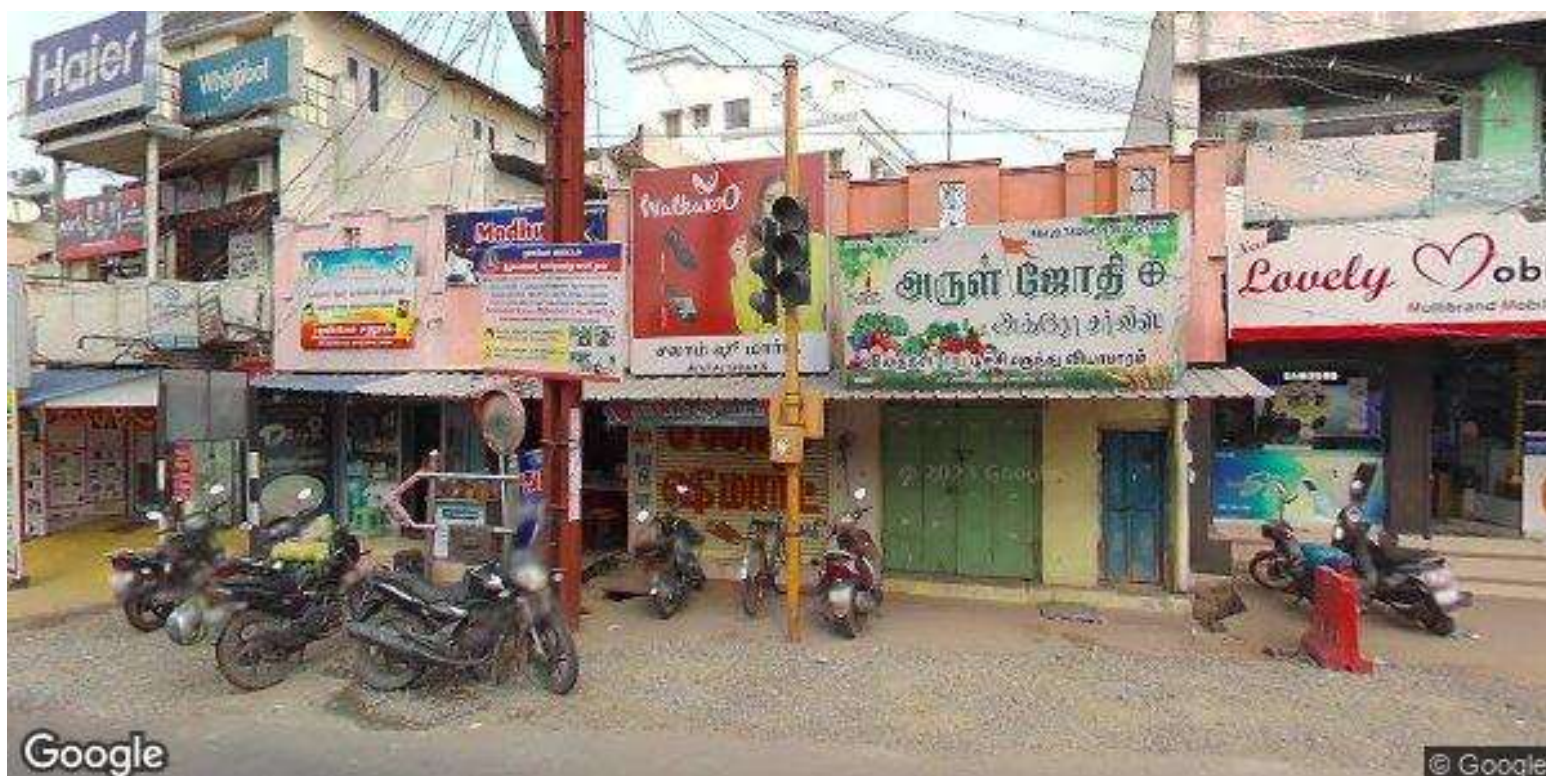
**Risk Type:** Turn  
**Risk Level:** High  
**Speed Limit:** 15 KM/Hr  
**Coordinates:** 11.37850, 77.89453

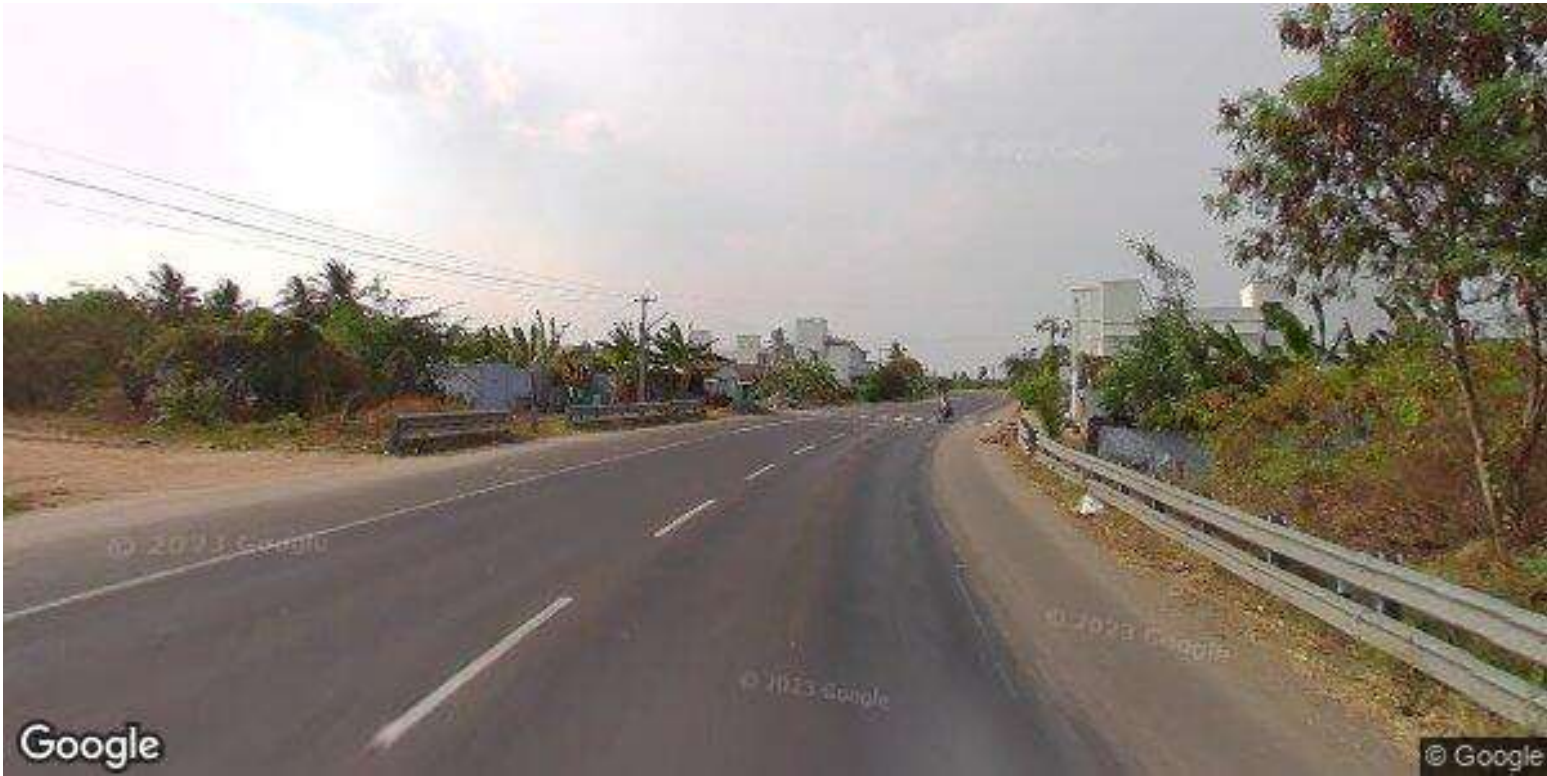
**Risk Type:** Turn  
**Risk Level:** Medium  
**Speed Limit:** 30 KM/Hr  
**Coordinates:** 11.16764, 78.01565

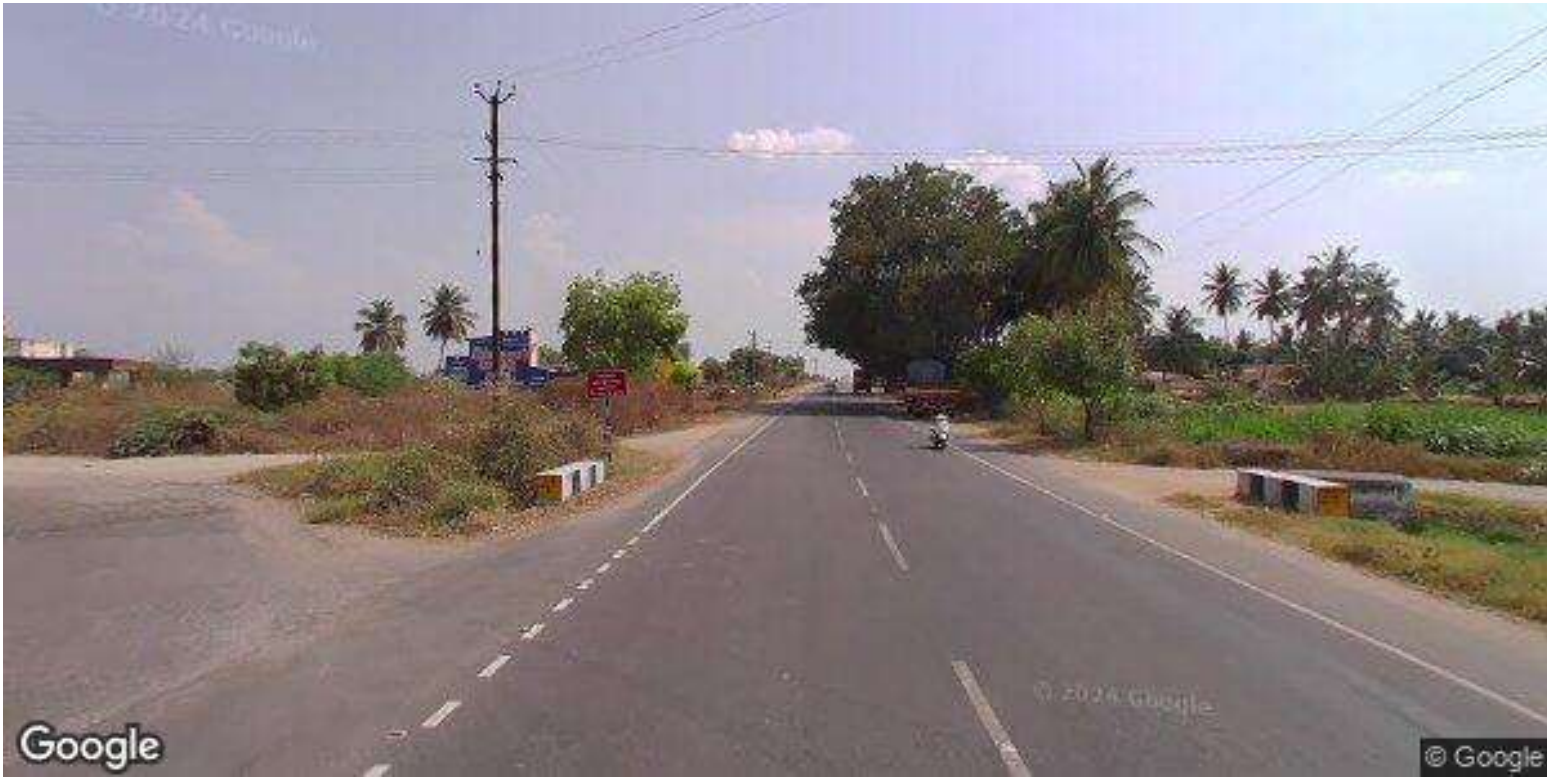
**Risk Type:** Turn  
**Risk Level:** High  
**Speed Limit:** 15 KM/Hr  
**Coordinates:** 11.14545, 78.02208

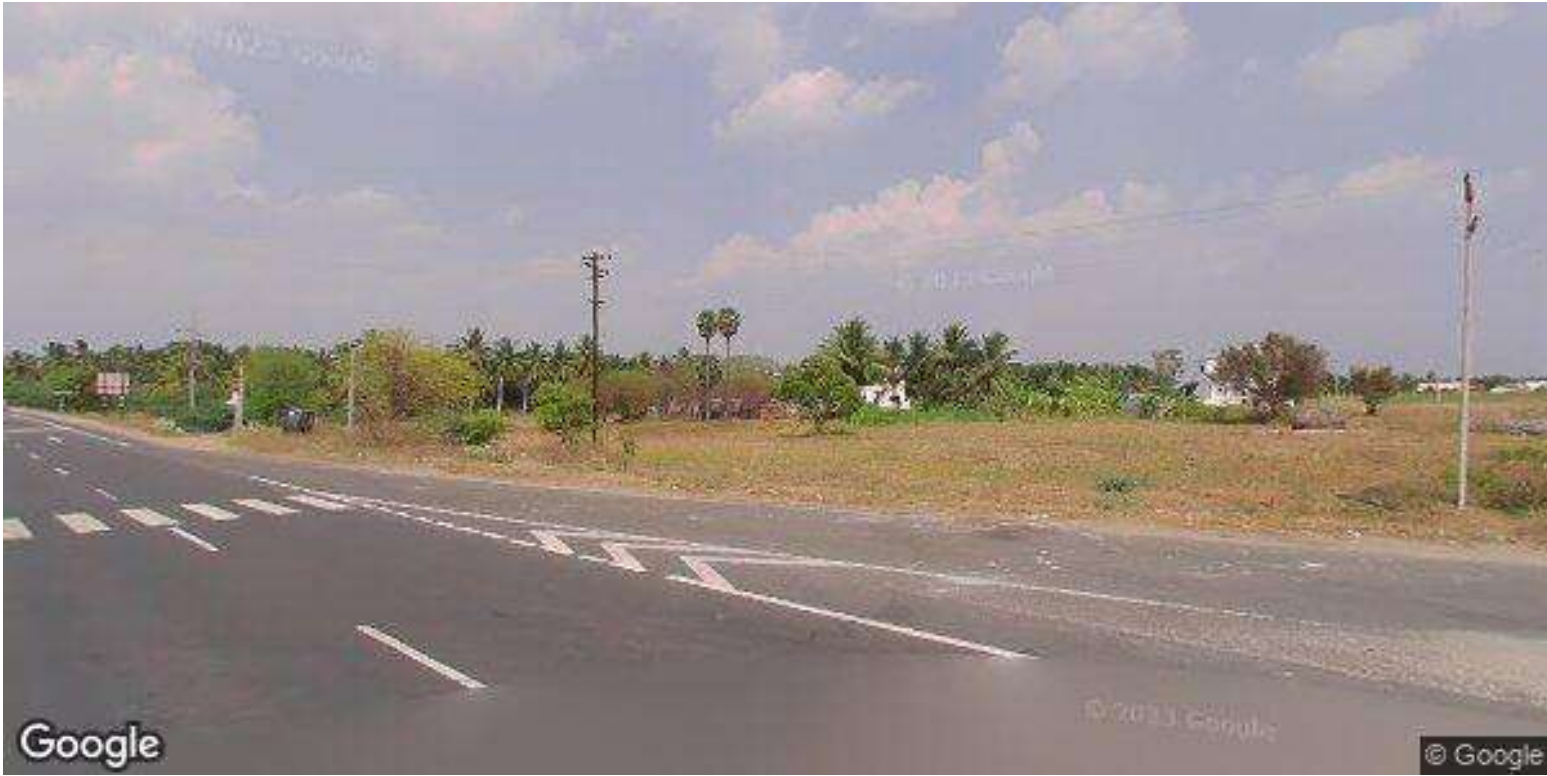
**Risk Type:** Turn  
**Risk Level:** High  
**Speed Limit:** 15 KM/Hr  
**Coordinates:** 11.14480, 78.02291
