# IndianOil

## JOURNEY RISK MANAGEMENT (JRM) STUDY

### Salem Terminal TO K P MARKETING

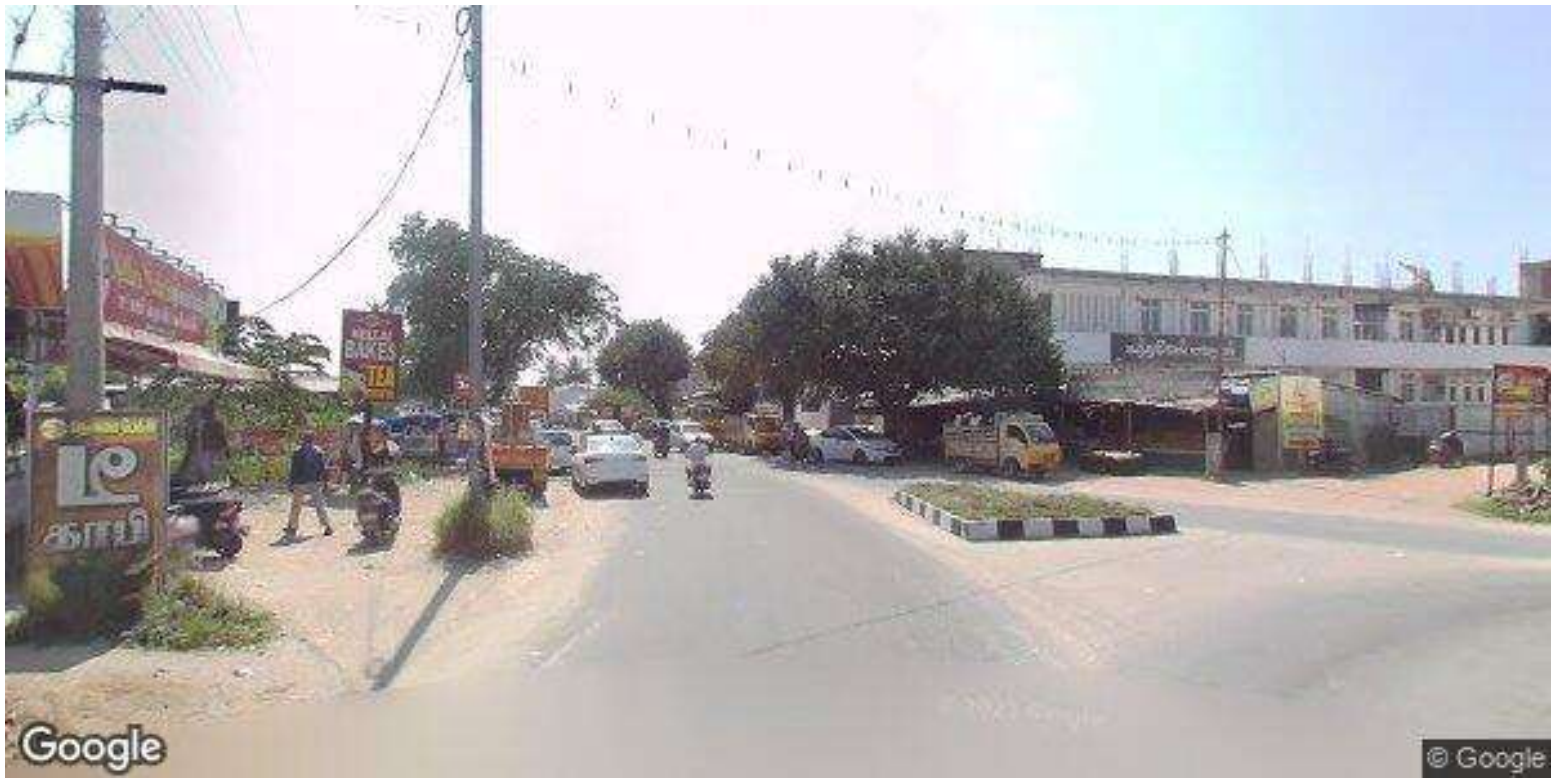
| | Risk Type | Risk Level | Coordinates | Speed Limit |
|---|---|---|---|---|
| 0 | Roundabout | High | 11.17250, 77.26863 | 15 KM/Hr |

Risk Type: Roundabout  
Risk Level: High  
Speed Limit: 15 KM/Hr  
Coordinates: 11.17250, 77.26863

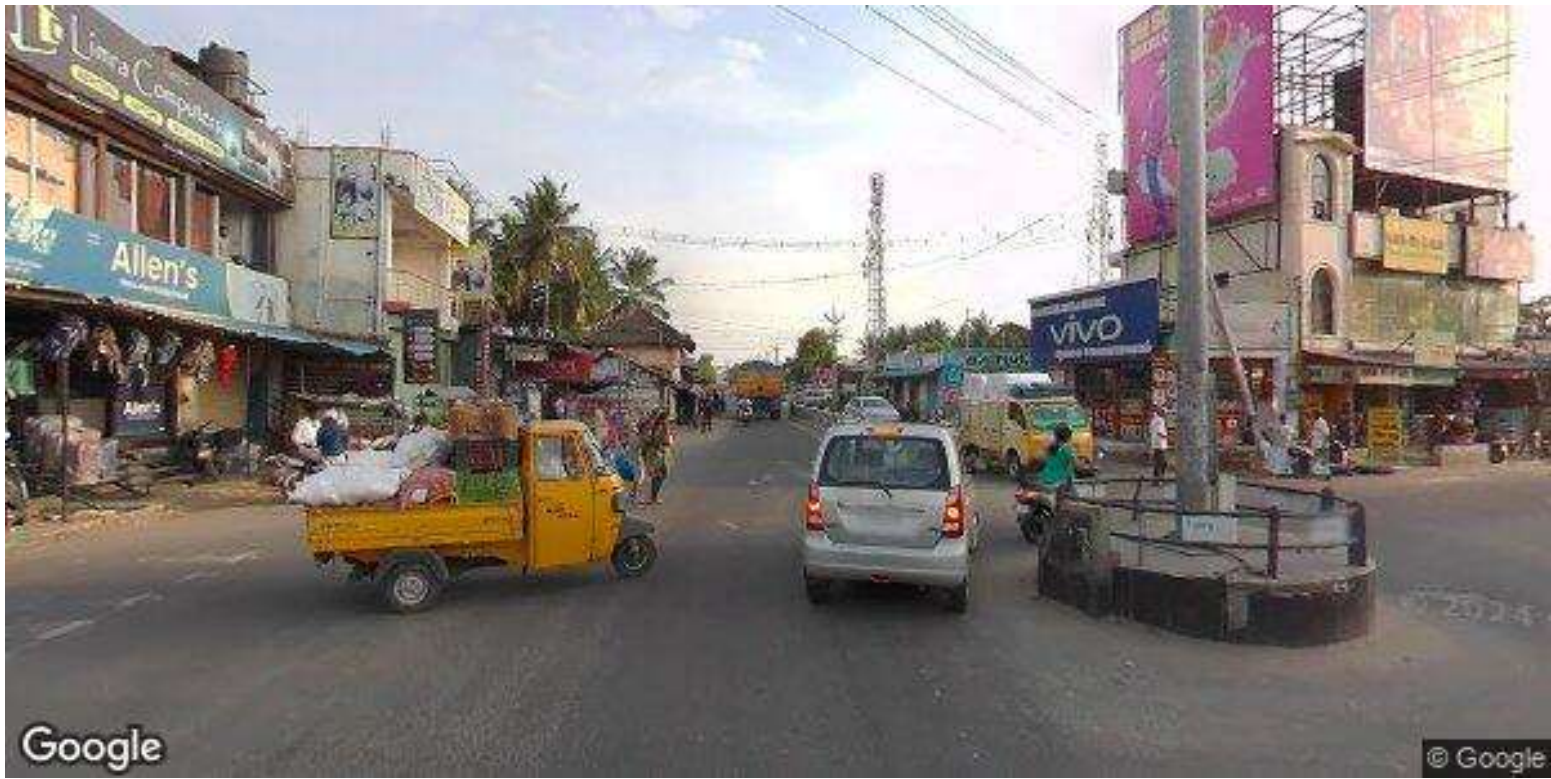
| | Risk Type | Risk Level | Coordinates | Speed Limit |
|---|---|---|---|---|
| 1 | Roundabout | High | 11.10249, 77.27146 | 15 KM/Hr |

Risk Type: Roundabout  
Risk Level: High

**Speed Limit: 15 KM/Hr**  
**Coordinates: 11.10249, 77.27146**

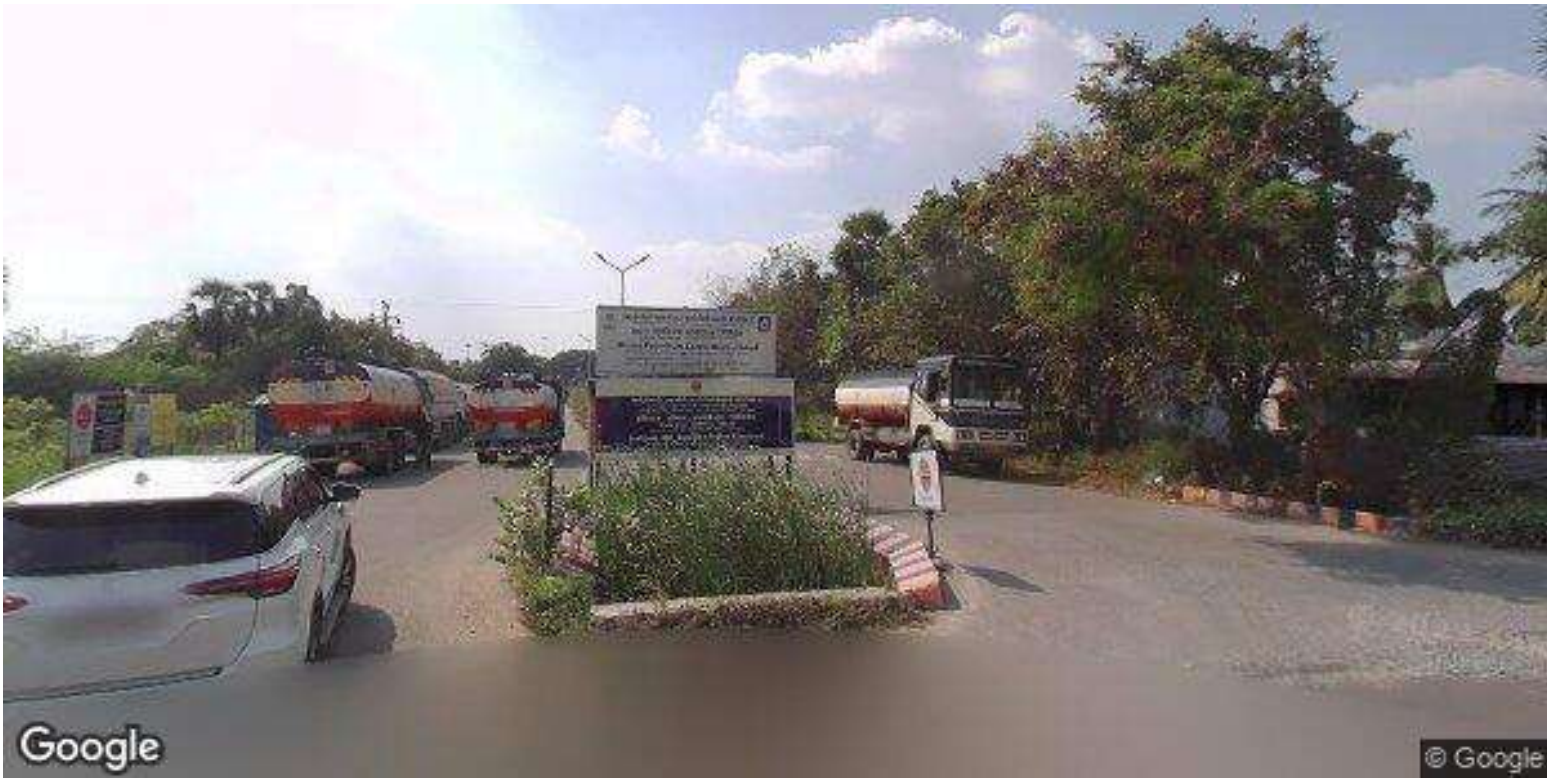
| | Risk Type | Risk Level | Coordinates | Speed Limit |
|---|---|---|---|---|
| 3 | Turn | High | 11.44024, 77.87528 | 15 KM/Hr |

**Risk Type: Turn**  
**Risk Level: High**  
**Speed Limit: 15 KM/Hr**  
**Coordinates: 11.44024, 77.87528**

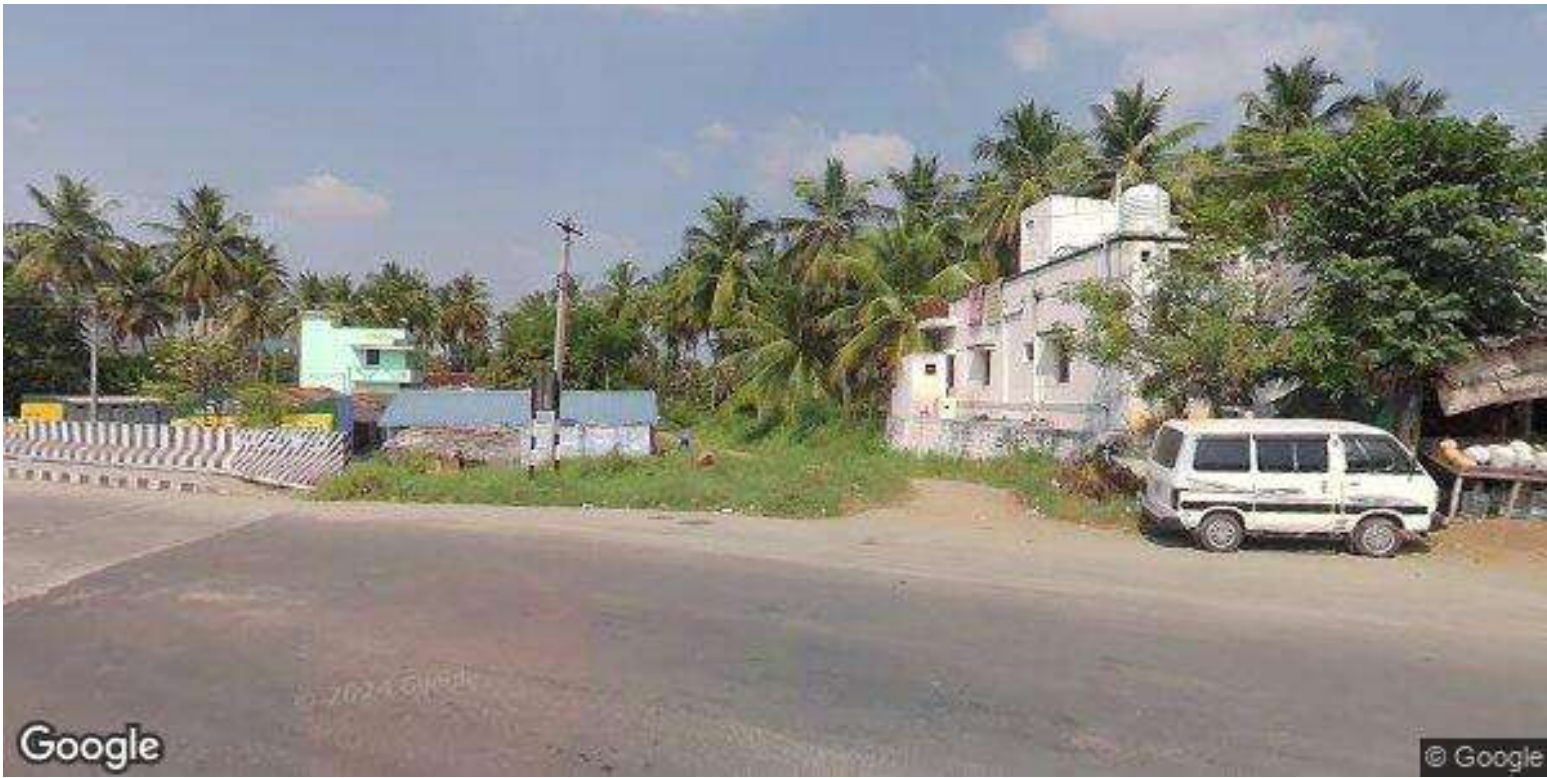
| | Risk Type | Risk Level | Coordinates | Speed Limit |
|---|---|---|---|---|
| 4 | Turn | High | 11.44898, 77.87410 | 15 KM/Hr |

**Risk Type: Turn**  
**Risk Level: High**  
**Speed Limit: 15 KM/Hr**  
**Coordinates: 11.44898, 77.87410**

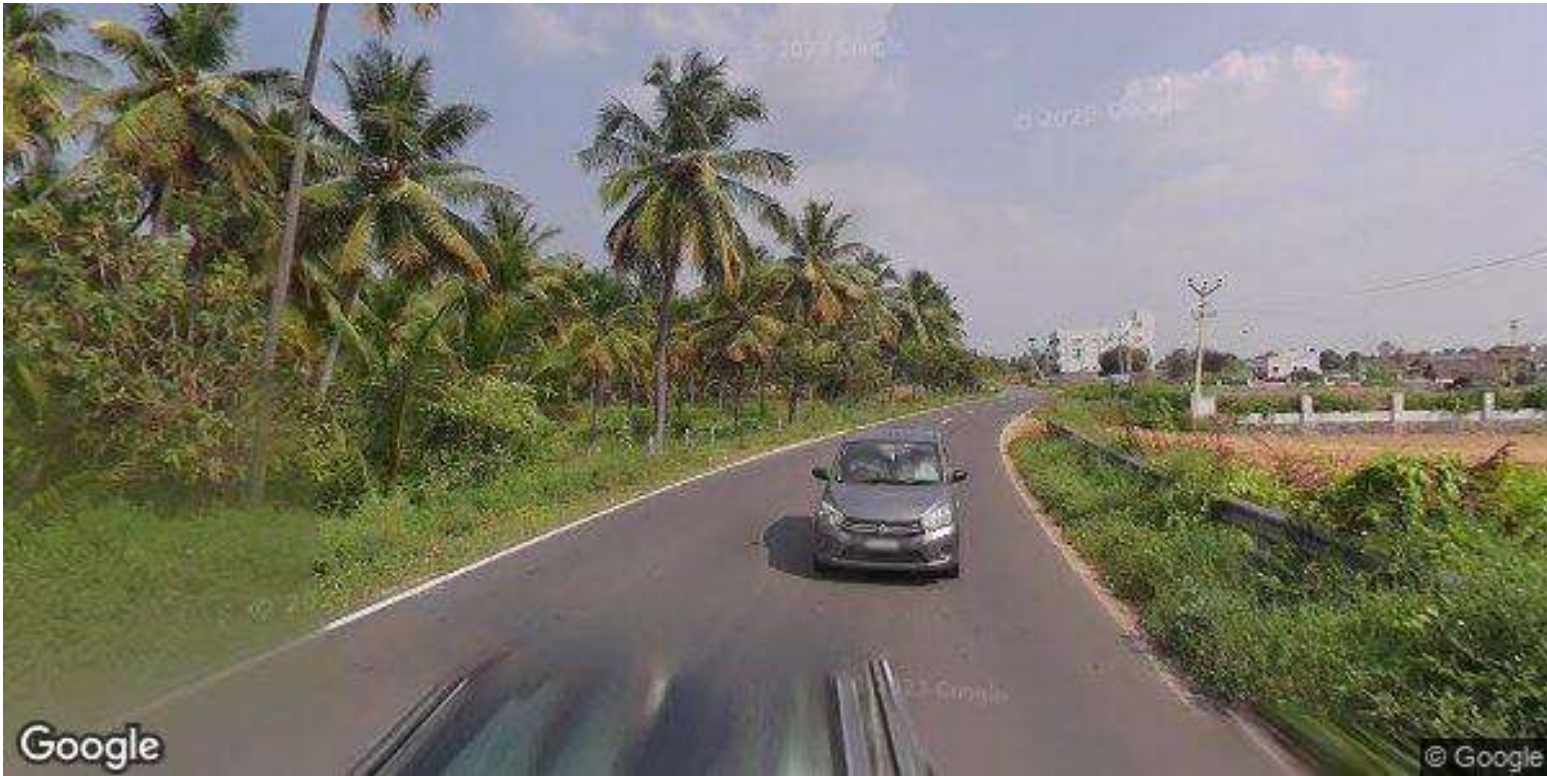
| | Risk Type | Risk Level | Coordinates | Speed Limit |
|---|---|---|---|---|
| 5 | Turn | Medium | 11.45357, 77.85789 | 30 KM/Hr |

**Risk Type:** Turn  
**Risk Level:** Medium  
**Speed Limit:** 30 KM/Hr  
**Coordinates:** 11.45357, 77.85789

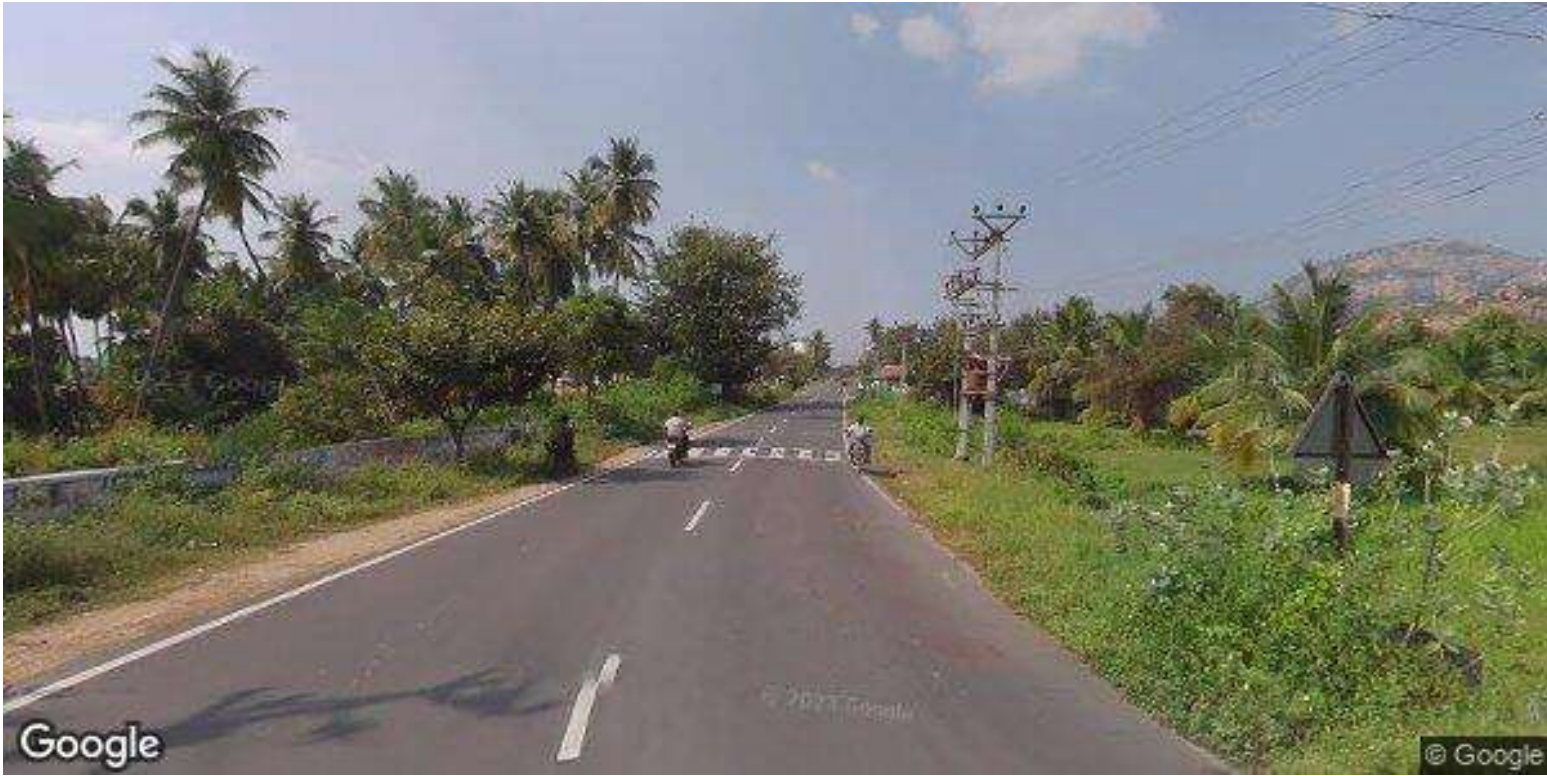
| | Risk Type | Risk Level | Coordinates | Speed Limit |
|---|---|---|---|---|
| 6 | Turn | High | 11.45352, 77.85698 | 15 KM/Hr |

**Risk Type:** Turn  
**Risk Level:** High  
**Speed Limit:** 15 KM/Hr  
**Coordinates:** 11.45352, 77.85698

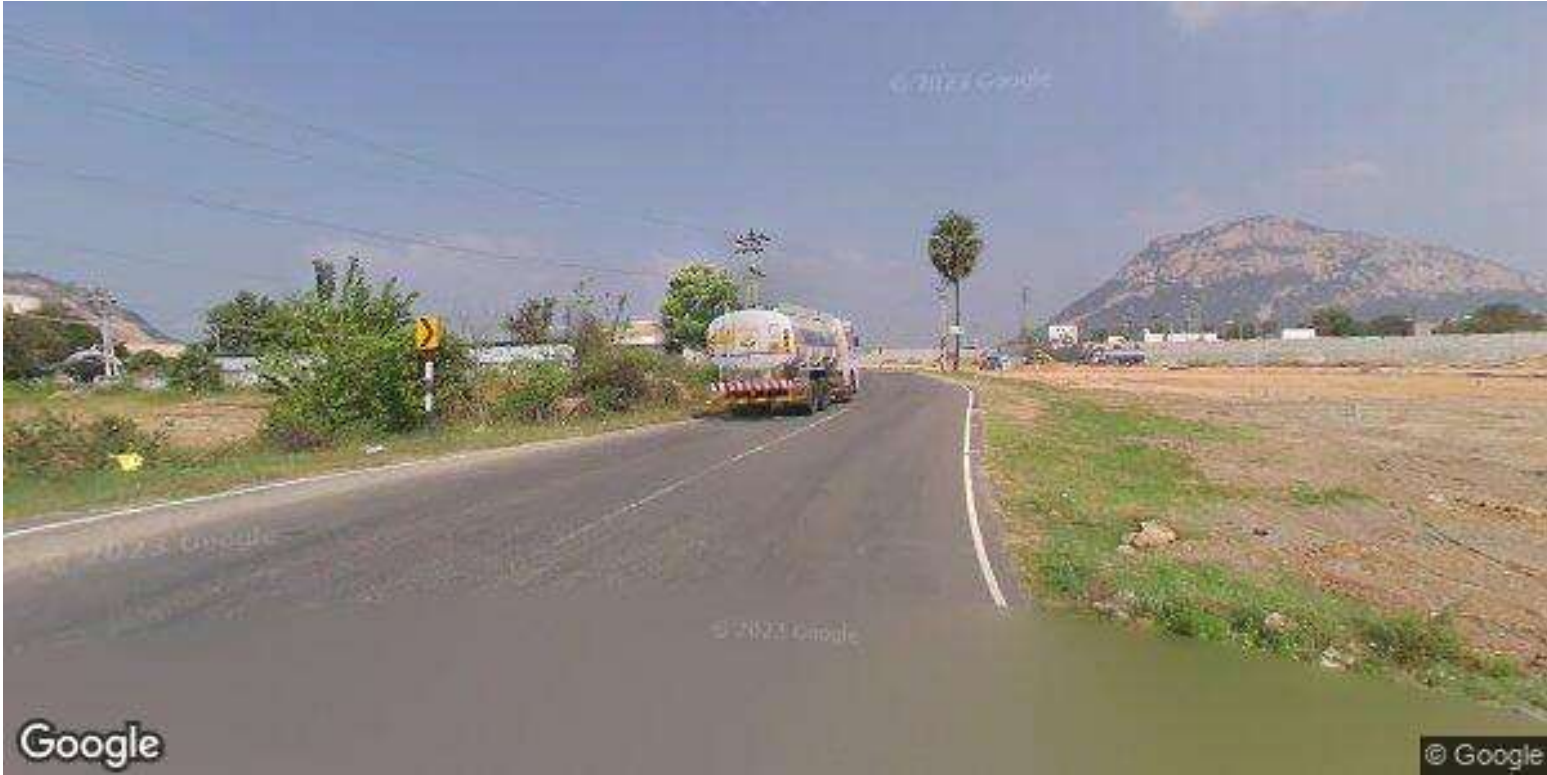
| | Risk Type | Risk Level | Coordinates | Speed Limit |
|---|---|---|---|---|
| 7 | Turn | Medium | 11.45847, 77.85140 | 30 KM/Hr |

**Risk Type:** Turn  
**Risk Level:** Medium  
**Speed Limit:** 30 KM/Hr  
**Coordinates:** 11.45847, 77.85140

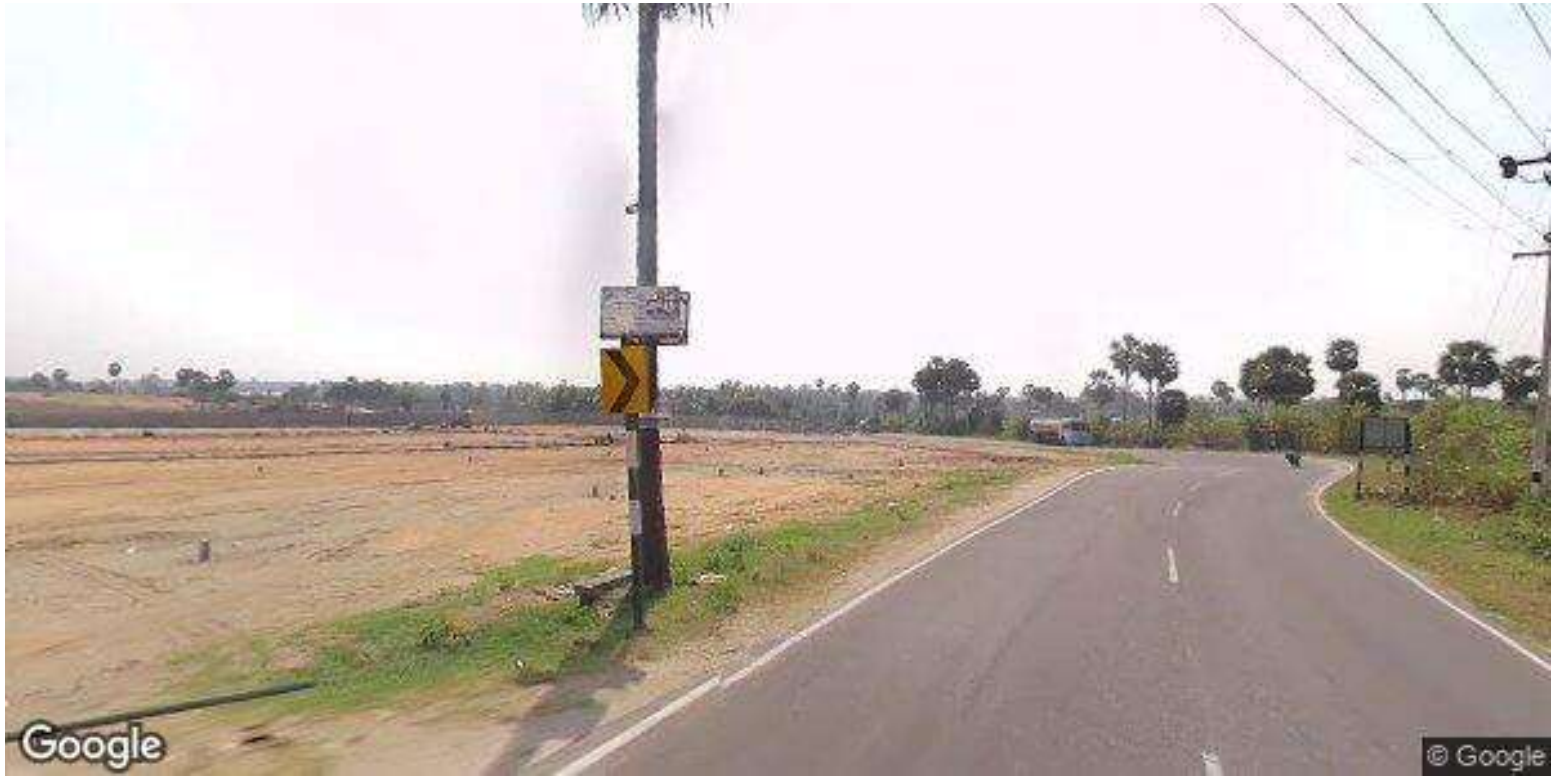
| | Risk Type | Risk Level | Coordinates | Speed Limit |
|---|---|---|---|---|
| 8 | Turn | Medium | 11.45898, 77.85135 | 30 KM/Hr |

**Risk Type:** Turn  
**Risk Level:** Medium  
**Speed Limit:** 30 KM/Hr  
**Coordinates:** 11.45898, 77.85135

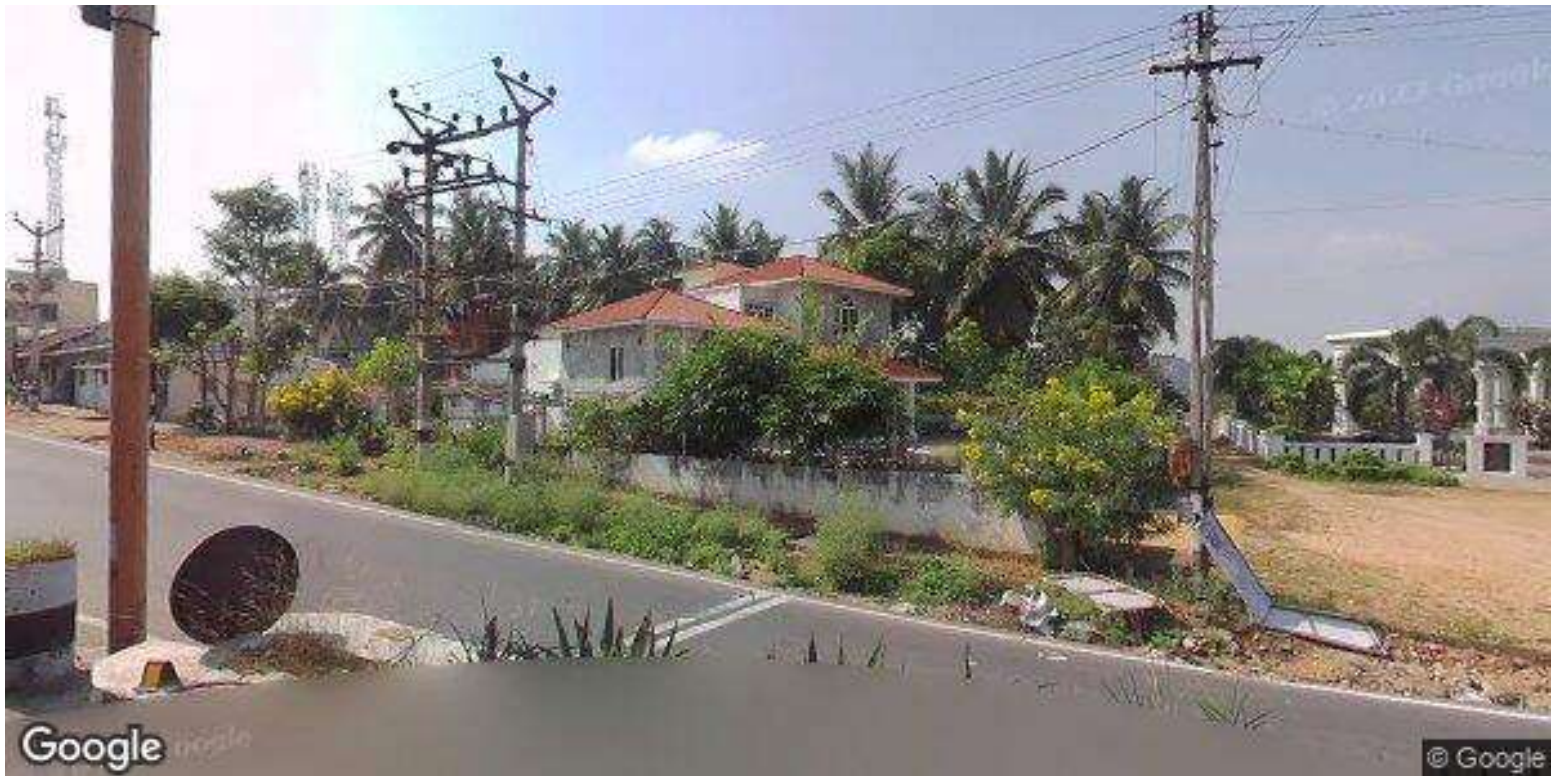
| | Risk Type | Risk Level | Coordinates | Speed Limit |
|---|---|---|---|---|
| 9 | Turn | High | 11.46303, 77.84945 | 15 KM/Hr |

**Risk Type:** Turn  
**Risk Level:** High  
**Speed Limit:** 15 KM/Hr  
**Coordinates:** 11.46303, 77.84945

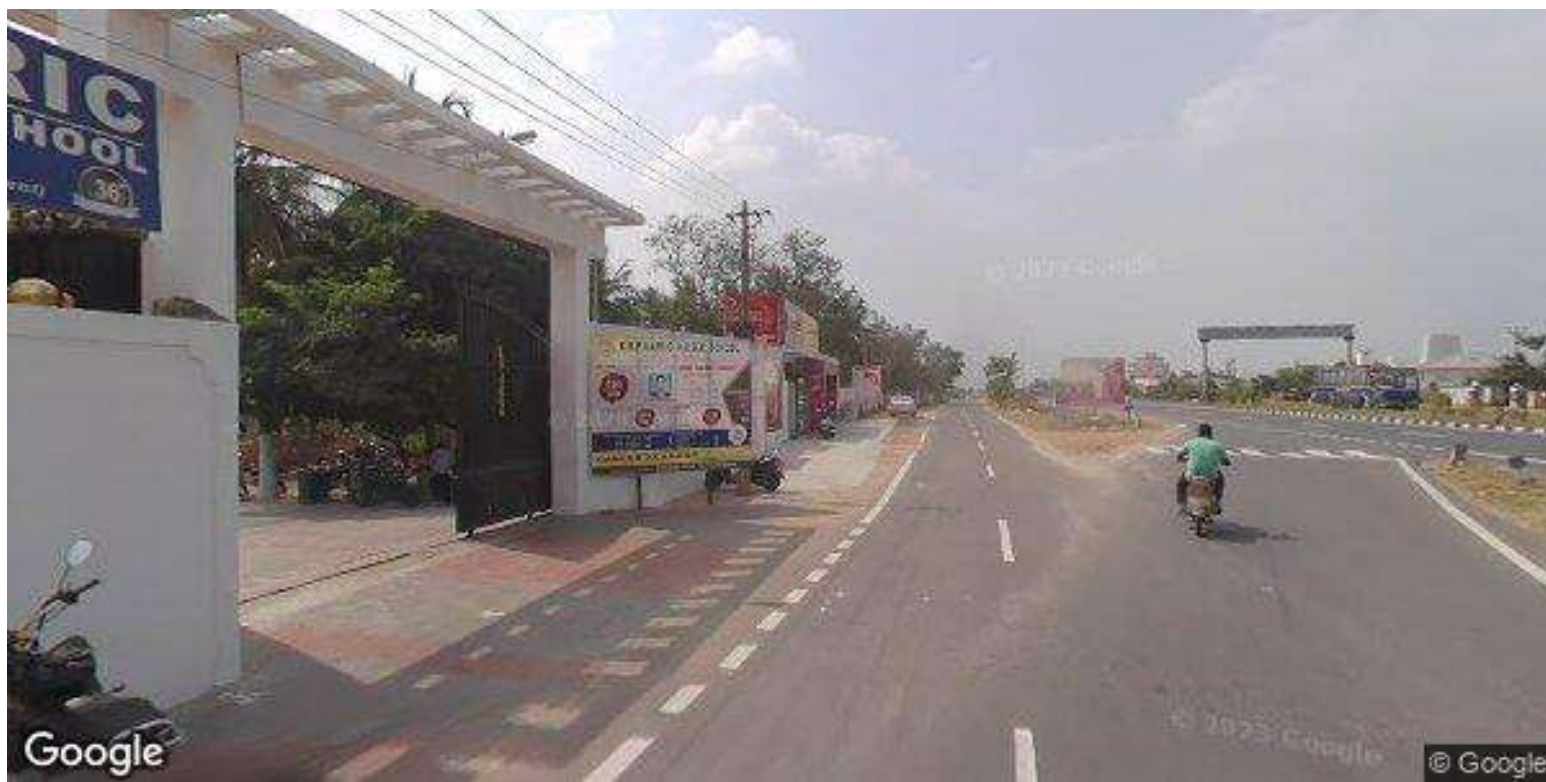
| | Risk Type | Risk Level | Coordinates | Speed Limit |
|---|---|---|---|---|
| 10 | Turn | Medium | 11.45509, 77.81383 | 30 KM/Hr |

**Risk Type:** Turn

**Risk Level:** Medium

**Speed Limit:** 30 KM/Hr

**Coordinates:** 11.45509, 77.81383

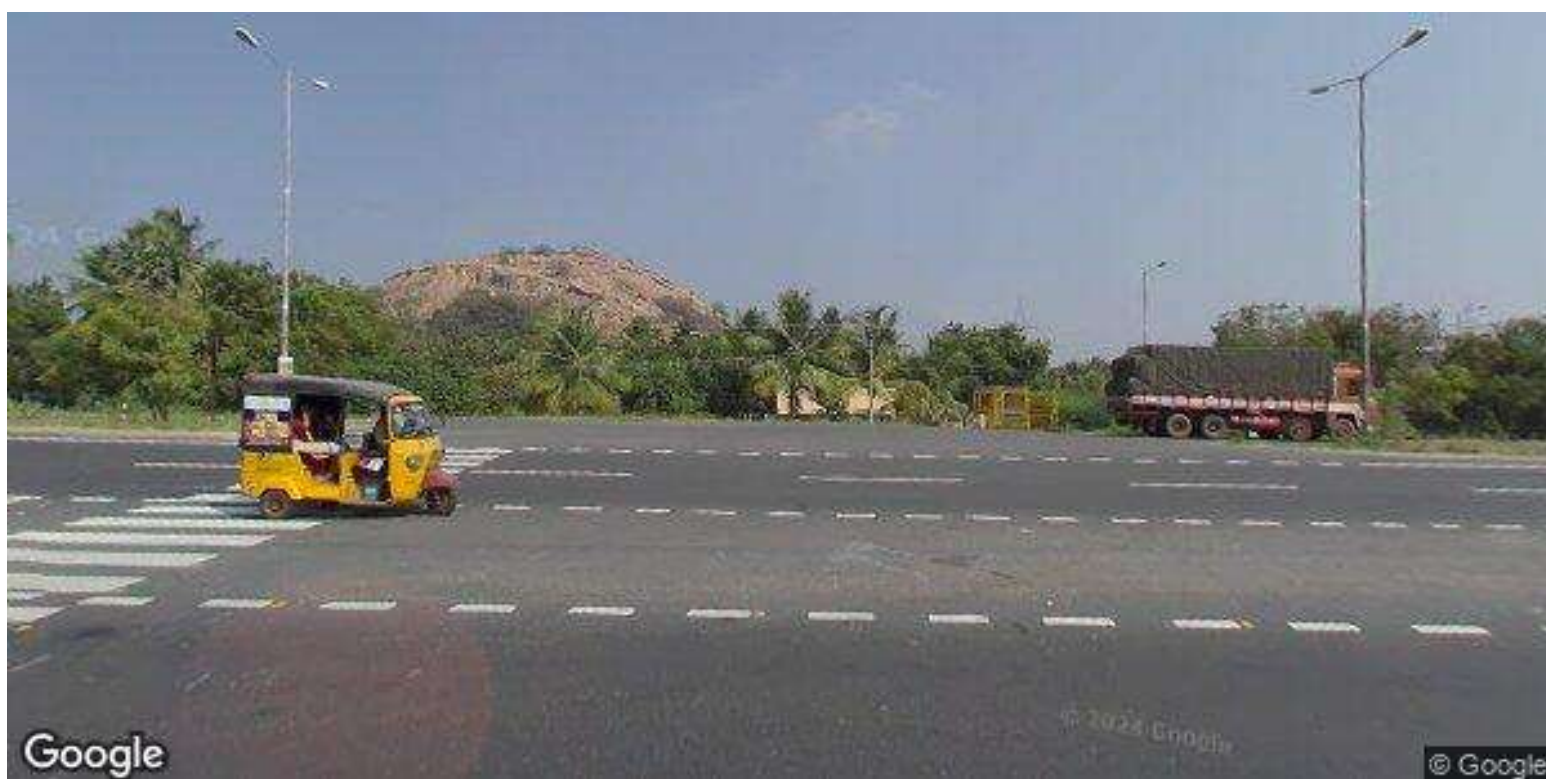
| | Risk Type | Risk Level | Coordinates | Speed Limit |
|---|---|---|---|---|
| 11 | Turn | Medium | 11.45085, 77.77020 | 30 KM/Hr |

**Risk Type:** Turn

**Risk Level:** Medium

**Speed Limit:** 30 KM/Hr

**Coordinates:** 11.45085, 77.77020

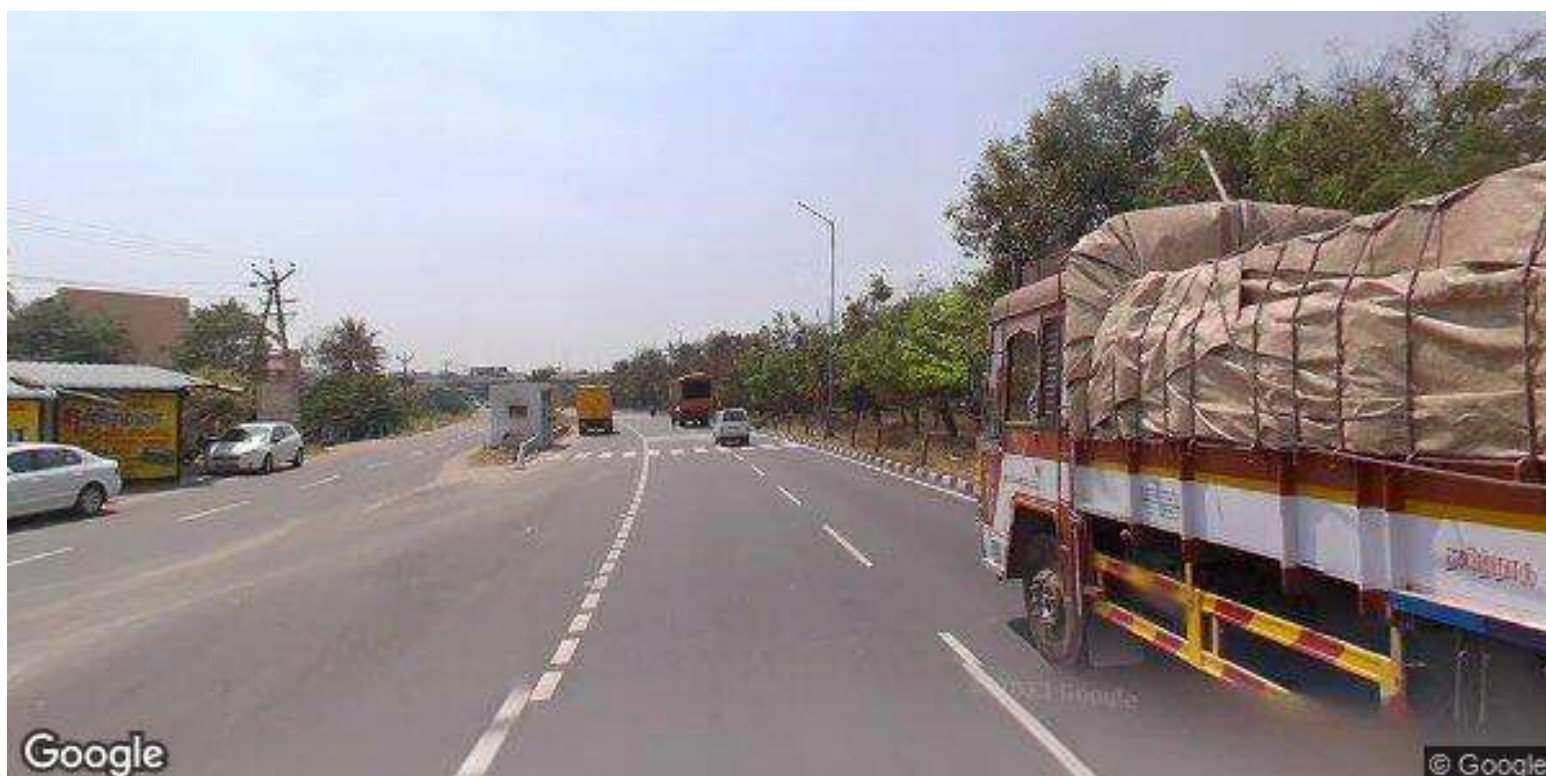
| | Risk Type | Risk Level | Coordinates | Speed Limit |
|---|---|---|---|---|
| 12 | Turn | Medium | 11.43165, 77.67734 | 30 KM/Hr |

**Risk Type:** Turn  
**Risk Level:** Medium  
**Speed Limit:** 30 KM/Hr  
**Coordinates:** 11.43165, 77.67734

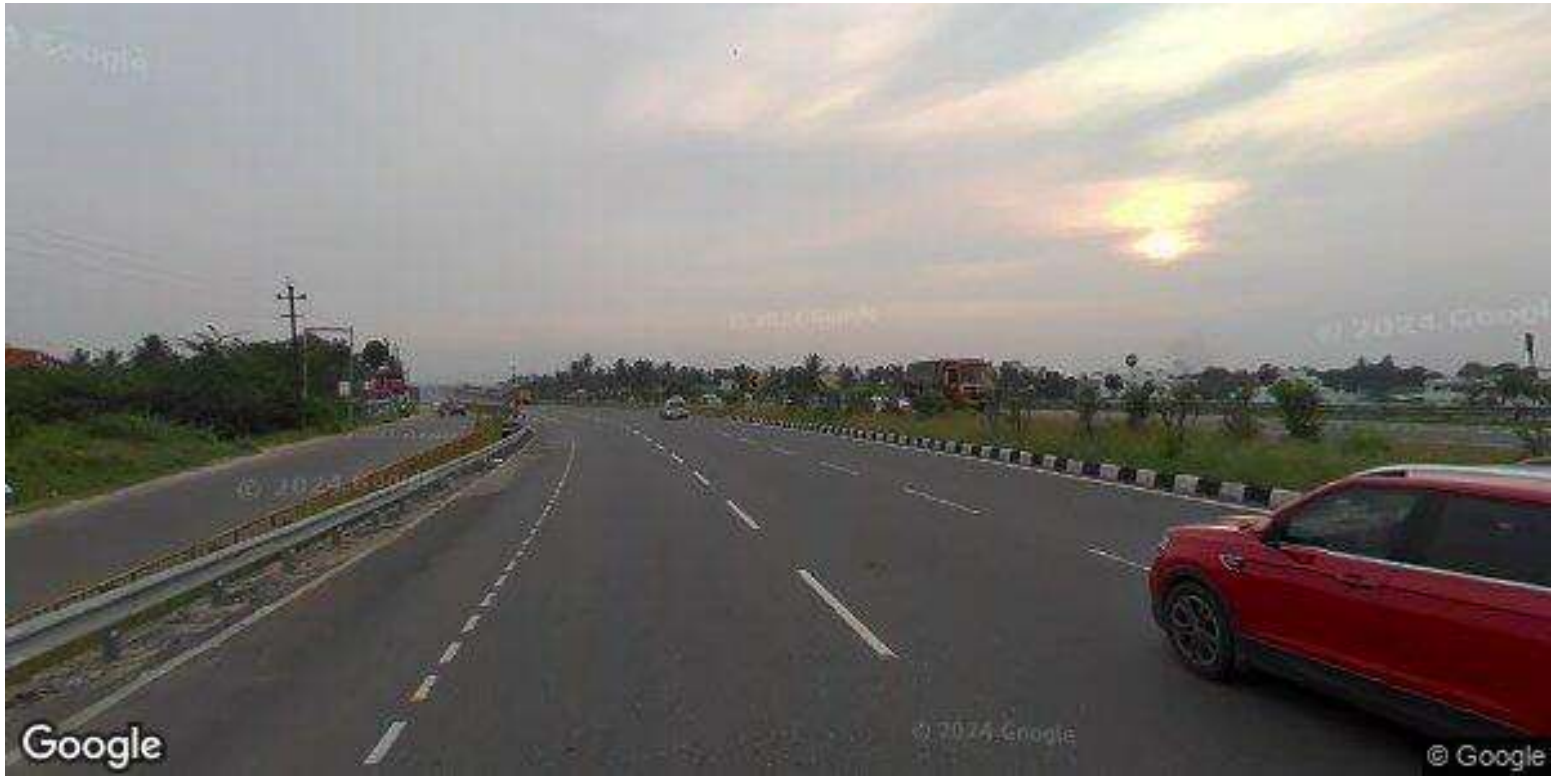
| | Risk Type | Risk Level | Coordinates | Speed Limit |
|---|---|---|---|---|
| 13 | Turn | Medium | 11.18808, 77.28672 | 30 KM/Hr |

**Risk Type:** Turn  
**Risk Level:** Medium  
**Speed Limit:** 30 KM/Hr  
**Coordinates:** 11.18808, 77.28672

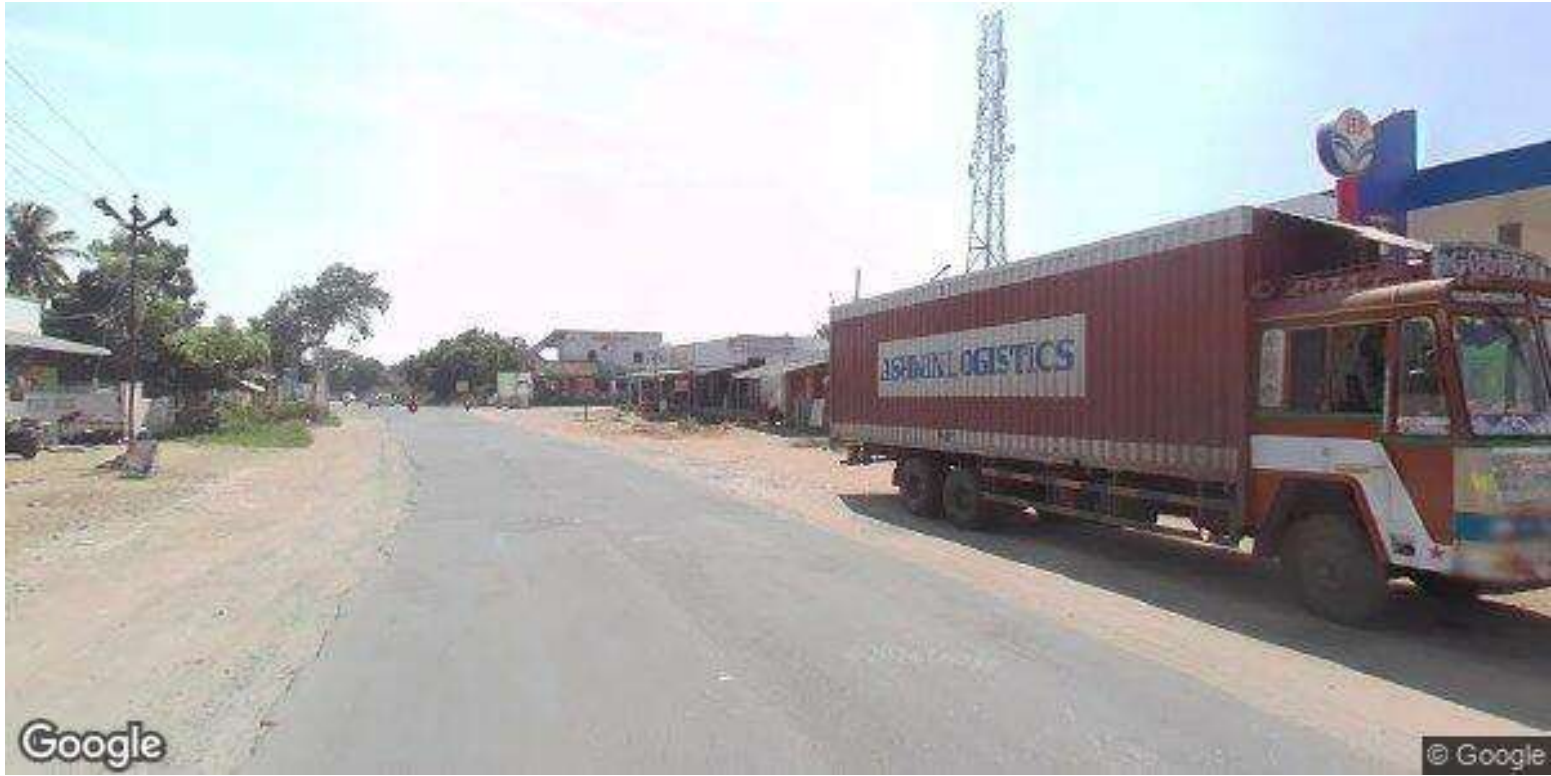
| | Risk Type | Risk Level | Coordinates | Speed Limit |
|---|---|---|---|---|
| 14 | Turn | Medium | 11.16848, 77.26757 | 30 KM/Hr |

**Risk Type:** Turn  
**Risk Level:** Medium  
**Speed Limit:** 30 KM/Hr  
**Coordinates:** 11.16848, 77.26757

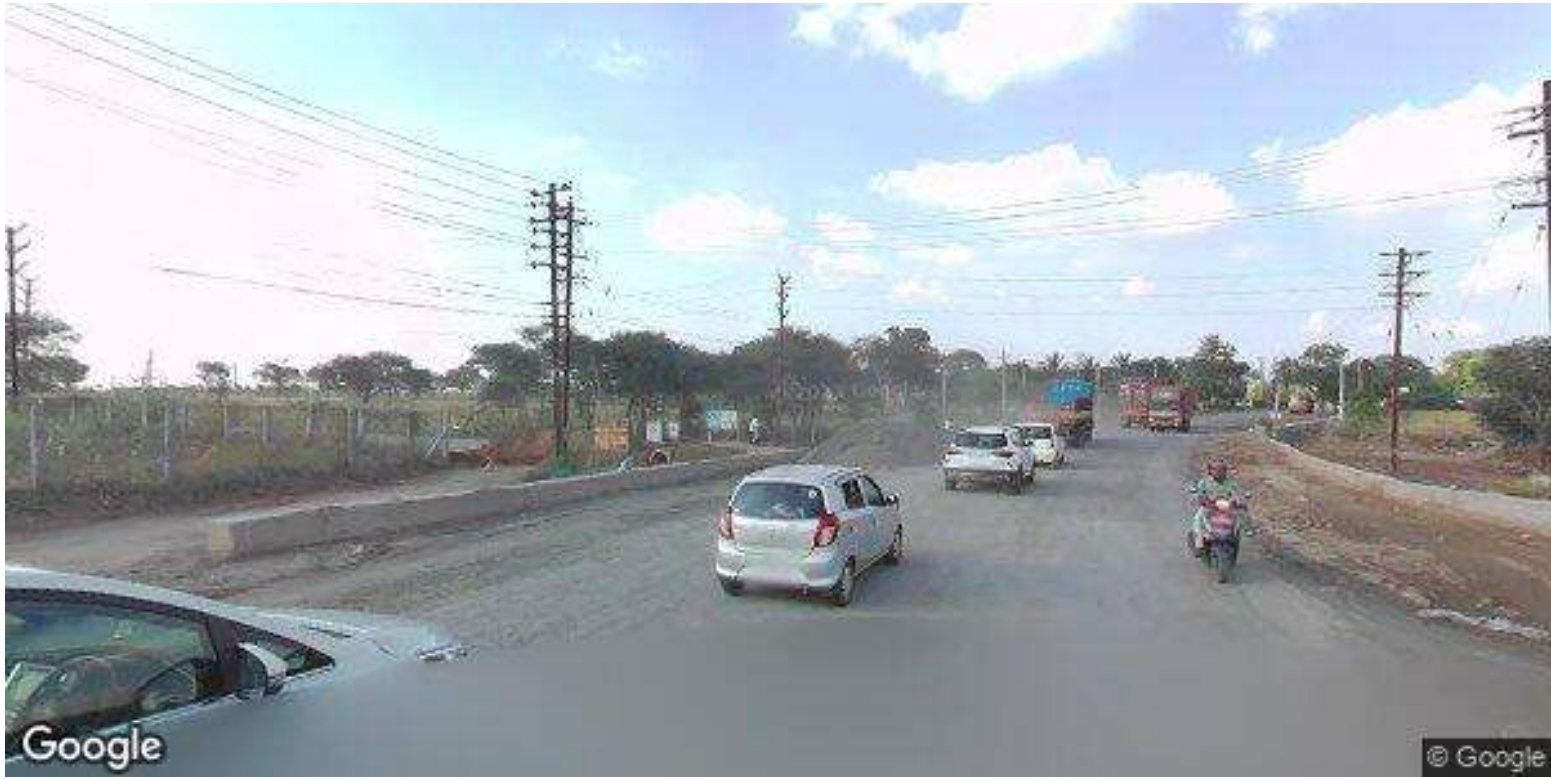
| | Risk Type | Risk Level | Coordinates | Speed Limit |
|---|---|---|---|---|
| 15 | Turn | Medium | 11.14580, 77.26363 | 30 KM/Hr |

**Risk Type:** Turn  
**Risk Level:** Medium  
**Speed Limit:** 30 KM/Hr  
**Coordinates:** 11.14580, 77.26363

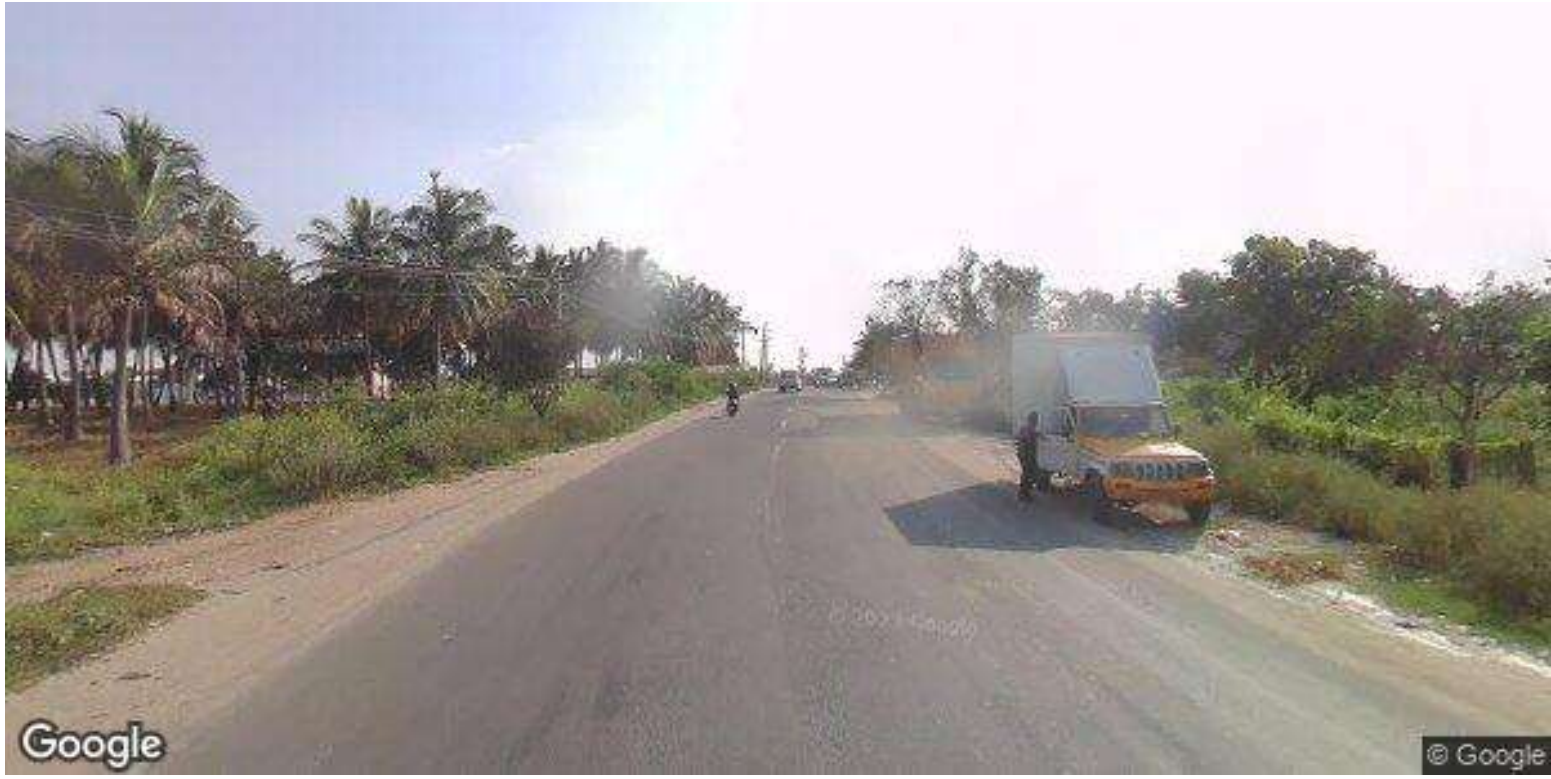
| | Risk Type | Risk Level | Coordinates | Speed Limit |
|---|---|---|---|---|
| 16 | Turn | Medium | 11.10890, 77.27134 | 30 KM/Hr |

**Risk Type:** Turn  
**Risk Level:** Medium  
**Speed Limit:** 30 KM/Hr  
**Coordinates:** 11.10890, 77.27134

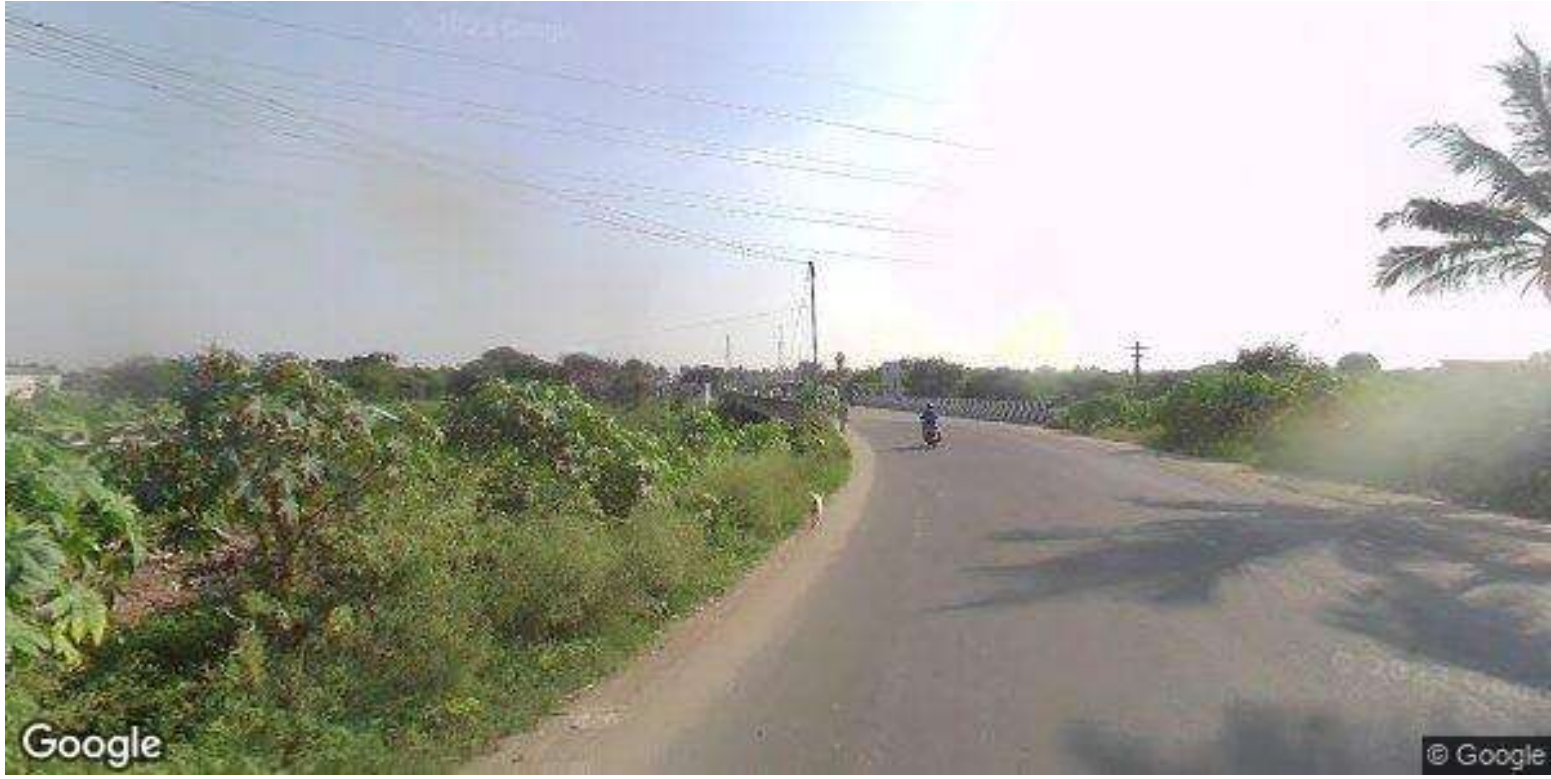
| | Risk Type | Risk Level | Coordinates | Speed Limit |
|---|---|---|---|---|
| 17 | Turn | Medium | 11.10680, 77.27043 | 30 KM/Hr |

**Risk Type:** Turn  
**Risk Level:** Medium  
**Speed Limit:** 30 KM/Hr  
**Coordinates:** 11.10680, 77.27043

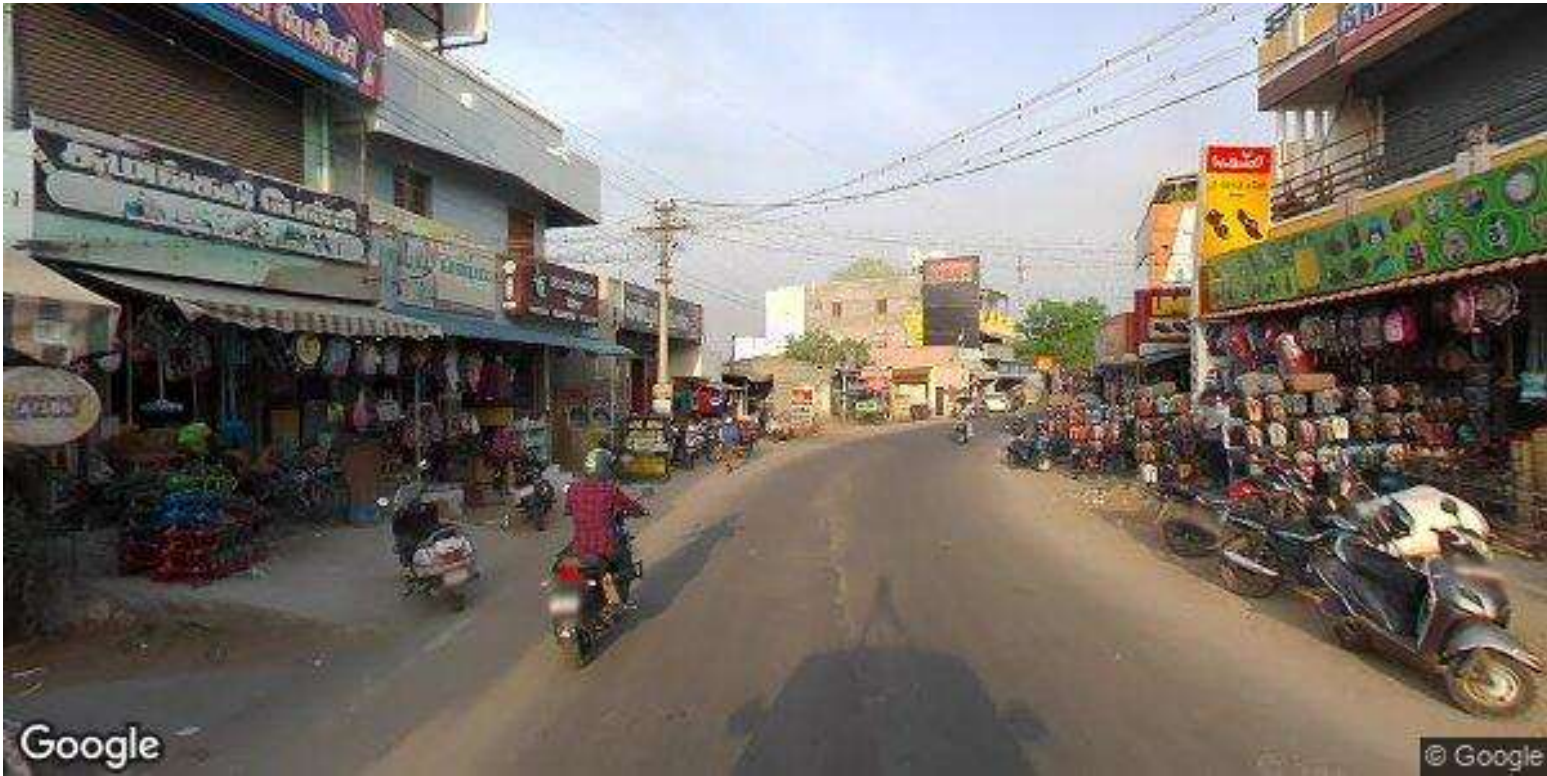
| | Risk Type | Risk Level | Coordinates | Speed Limit |
|---|---|---|---|---|
| 18 | Turn | Medium | 11.10256, 77.27210 | 30 KM/Hr |

**Risk Type:** Turn  
**Risk Level:** Medium  
**Speed Limit:** 30 KM/Hr  
**Coordinates:** 11.10256, 77.27210
