# IndianOil

## JOURNEY RISK MANAGEMENT (JRM) STUDY

### Salem Terminal TO K P MARKETING

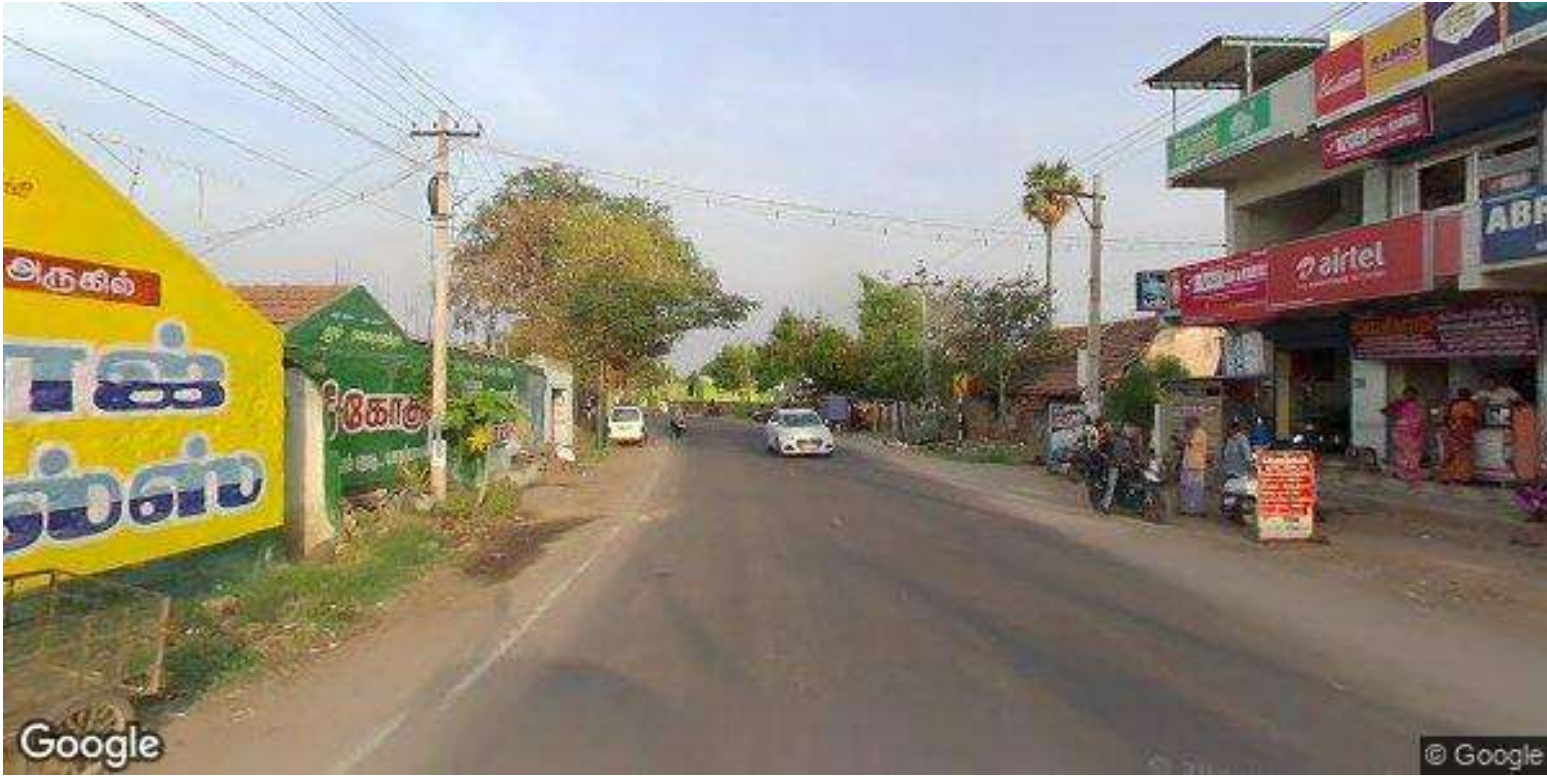
| | Risk Type | Risk Level | Coordinates | Speed Limit |
|---|---|---|---|---|
| 19 | Turn | Medium | 11.10162, 77.27443 | 30 KM/Hr |

**Risk Type:** Turn  
**Risk Level:** Medium  
**Speed Limit:** 30 KM/Hr  
**Coordinates:** 11.10162, 77.27443

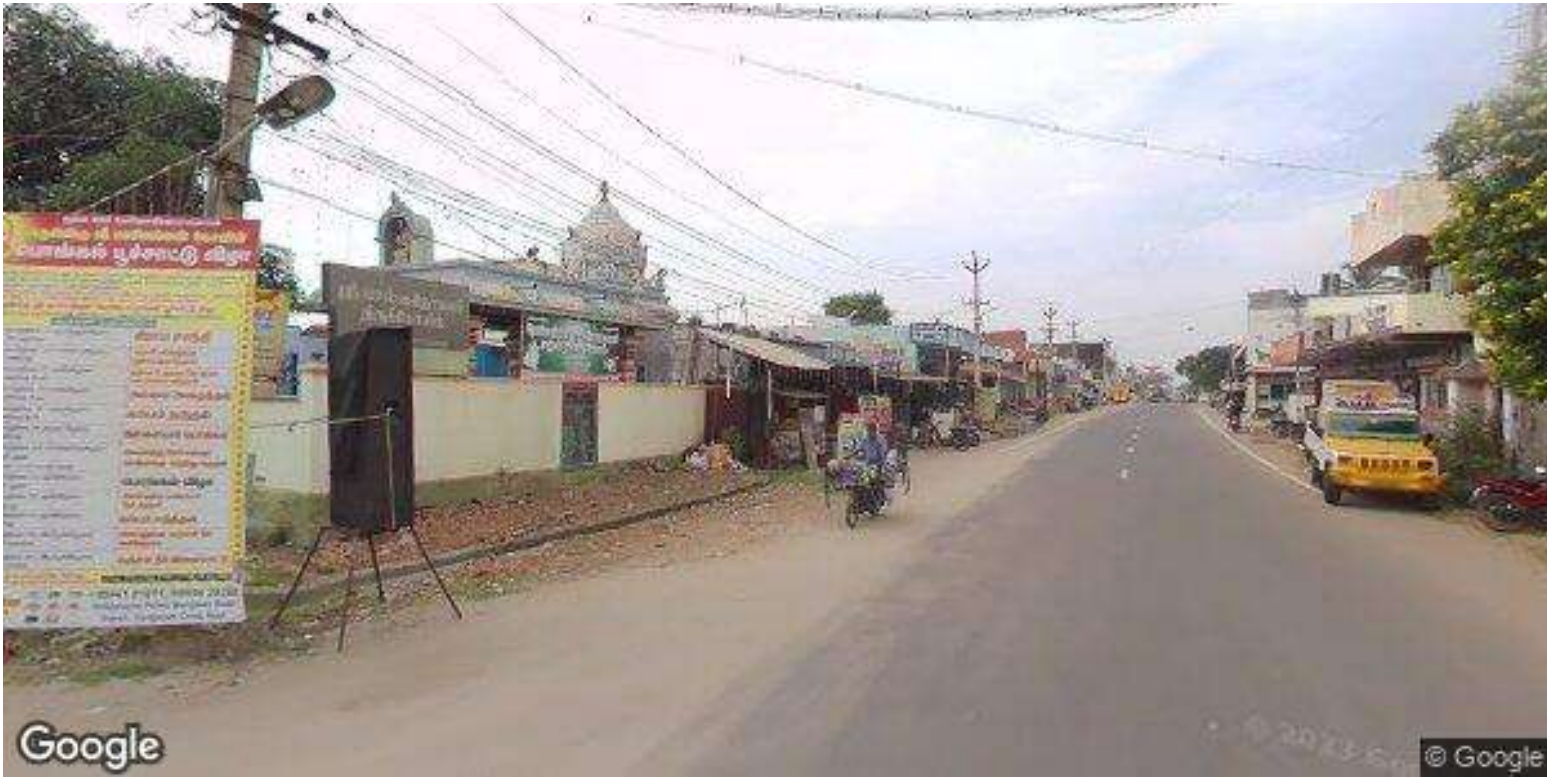
| | Risk Type | Risk Level | Coordinates | Speed Limit |
|---|---|---|---|---|
| 20 | Turn | Medium | 11.10164, 77.29834 | 30 KM/Hr |

**Risk Type:** Turn  
**Risk Level:** Medium  
**Speed Limit:** 30 KM/Hr  
**Coordinates:** 11.10164, 77.29834

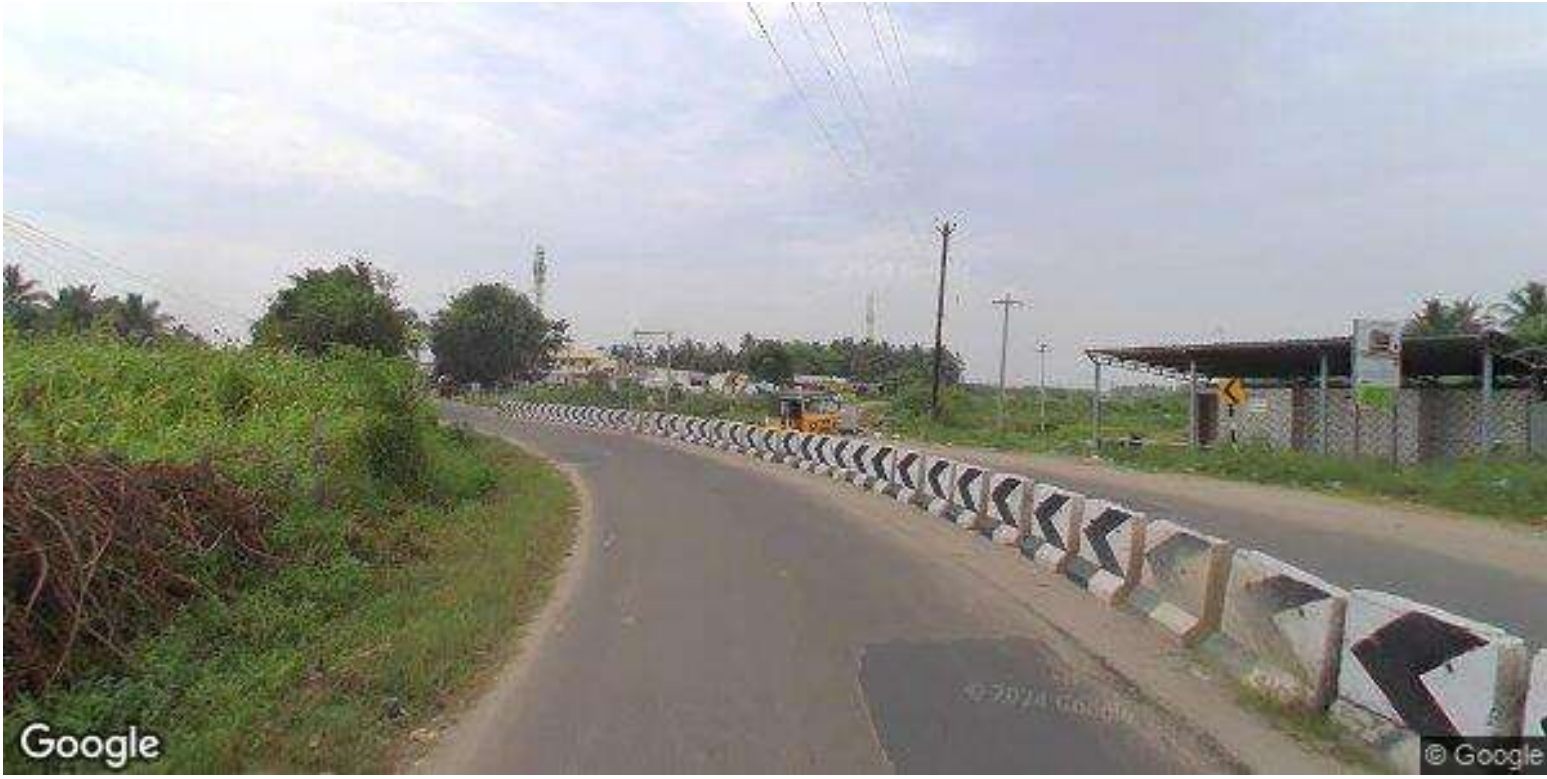
| | Risk Type | Risk Level | Coordinates | Speed Limit |
|---|---|---|---|---|
| 21 | Turn | High | 11.10238, 77.29955 | 15 KM/Hr |

**Risk Type:** Turn  
**Risk Level:** High  
**Speed Limit:** 15 KM/Hr  
**Coordinates:** 11.10238, 77.29955
