## JOURNEY RISK MANAGEMENT (JRM) STUDY

### Salem Terminal TO SAMY FUEL STATION

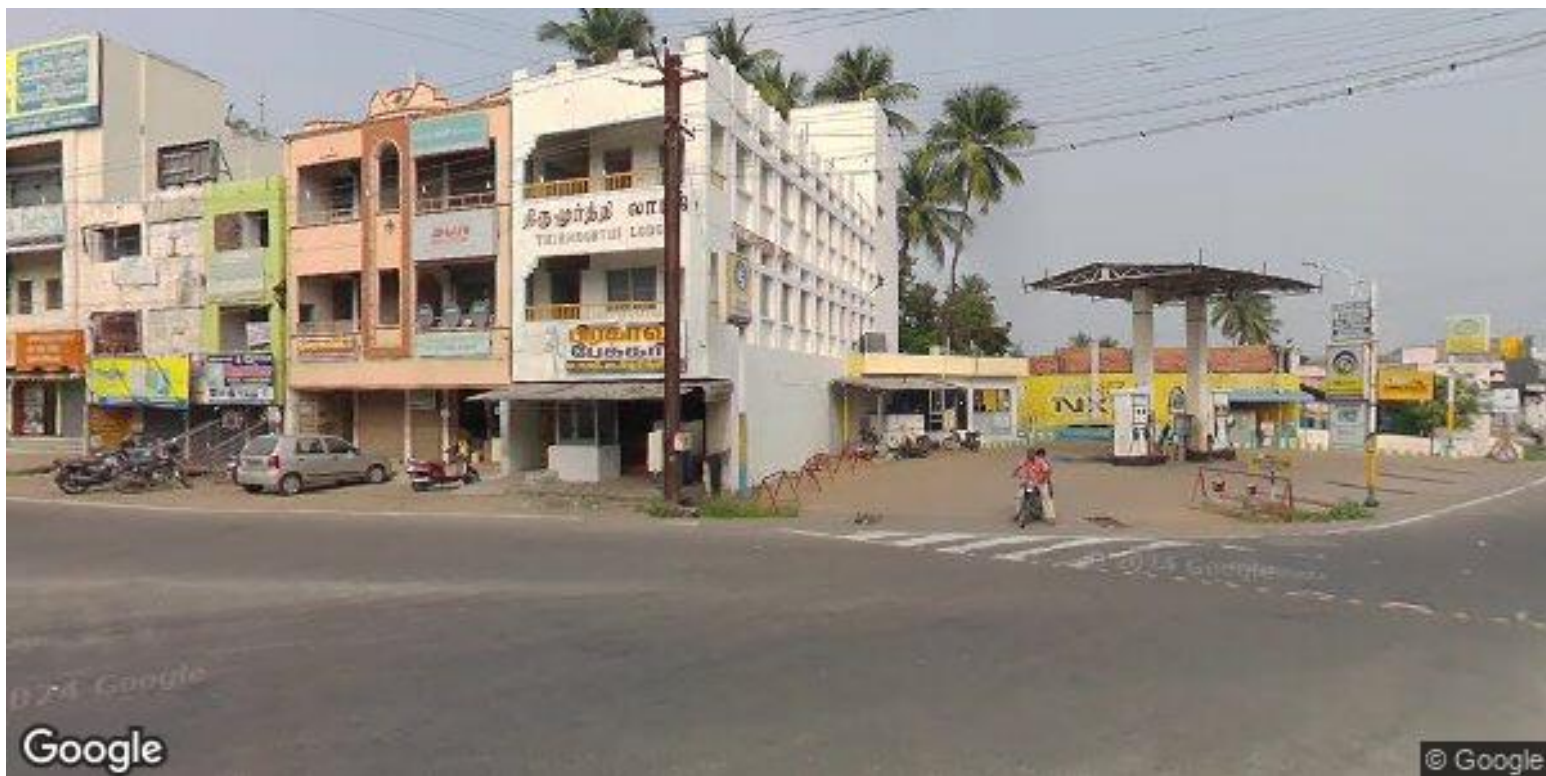
**Coordinates:** 11.00172, 77.56268

**Risk Type:** Roundabout

**Risk Level:** High

**Speed Limit:** 15 KM/Hr

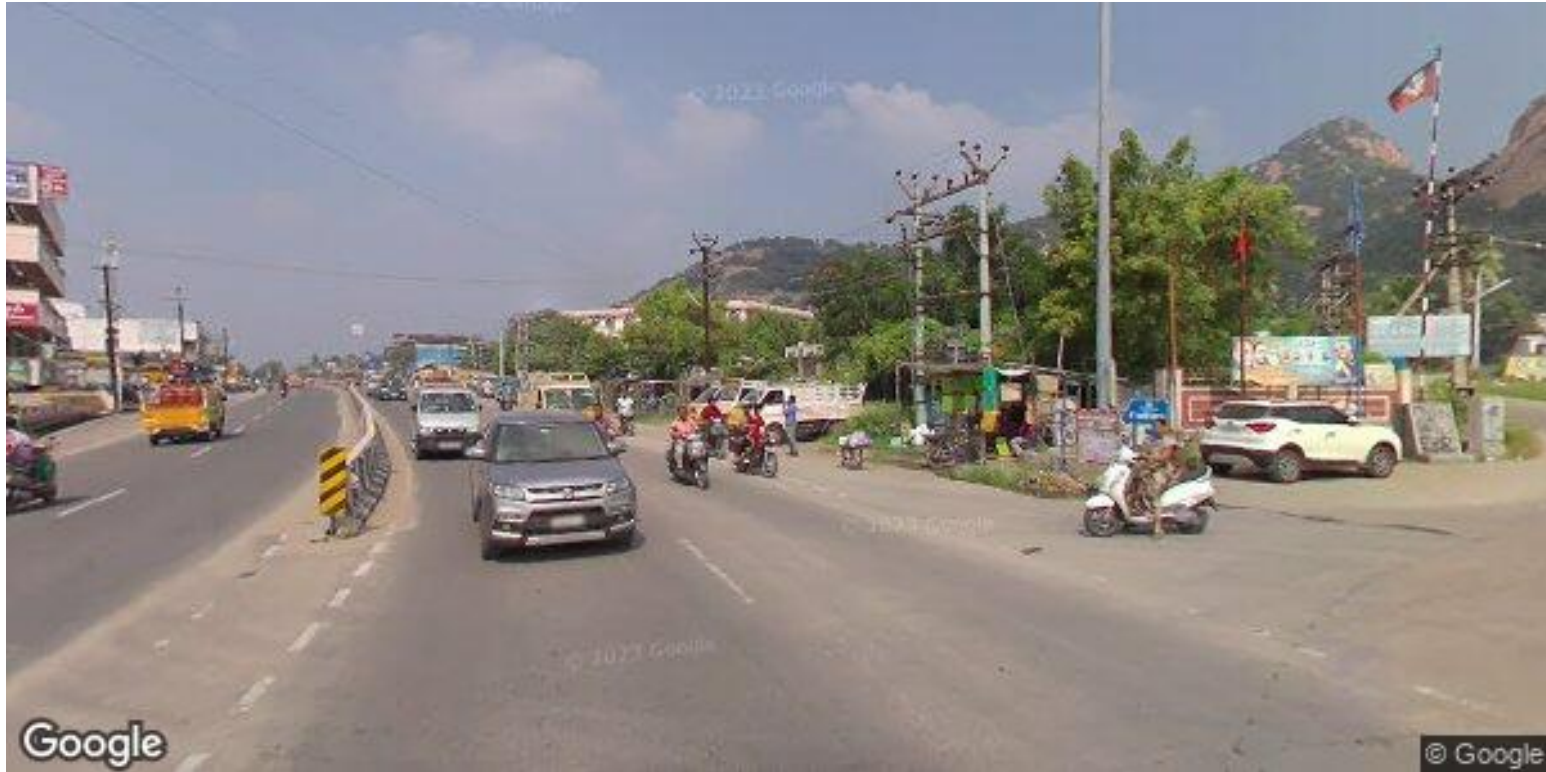
**Risk Type:** Turn  
**Risk Level:** Medium  
**Speed Limit:** 30 KM/Hr  
**Coordinates:** 11.39671, 77.88878

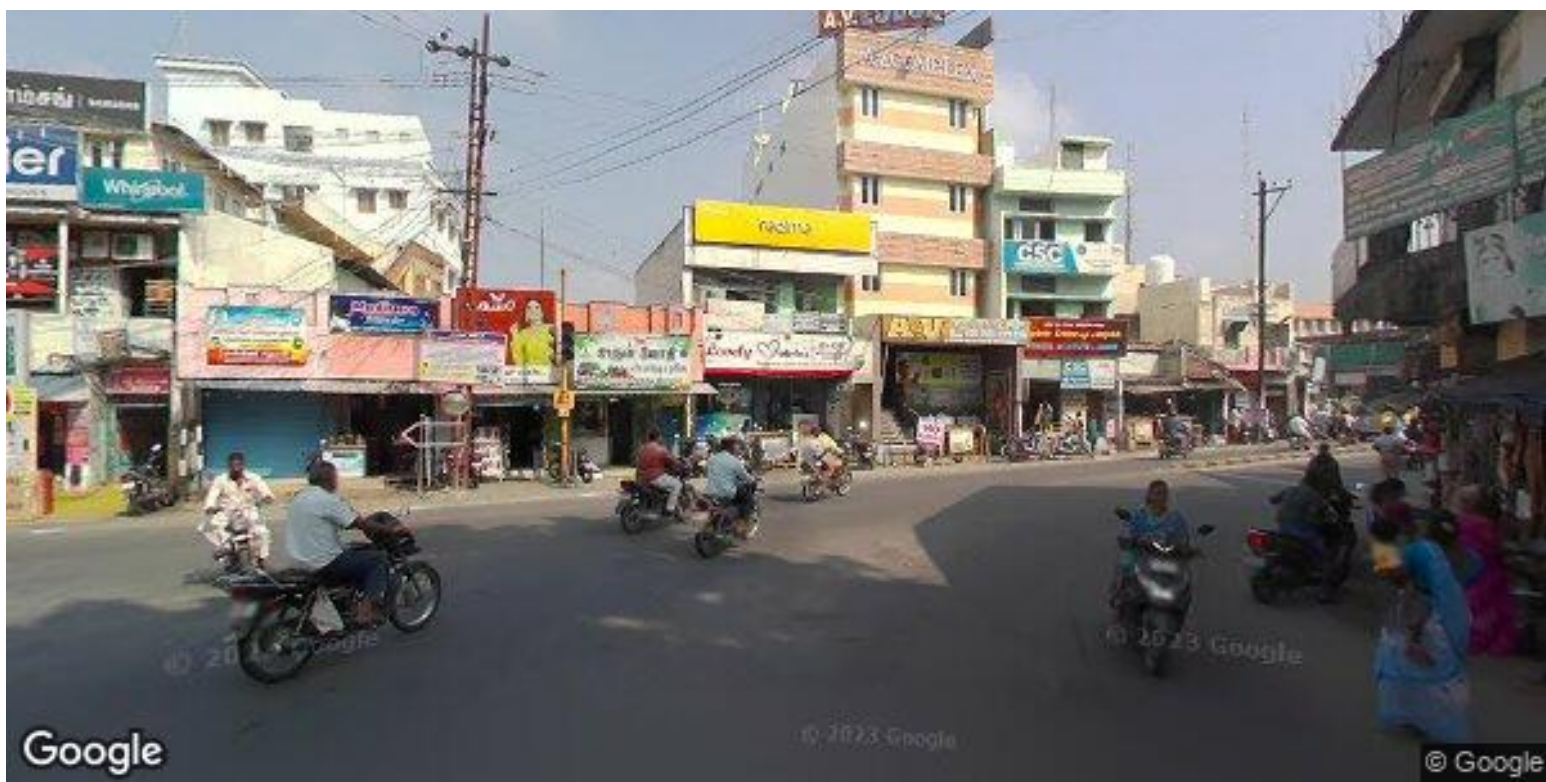
**Coordinates:** 11.37842, 77.89452

**Risk Type:** Turn

**Risk Level:** High

**Speed Limit:** 15 KM/Hr

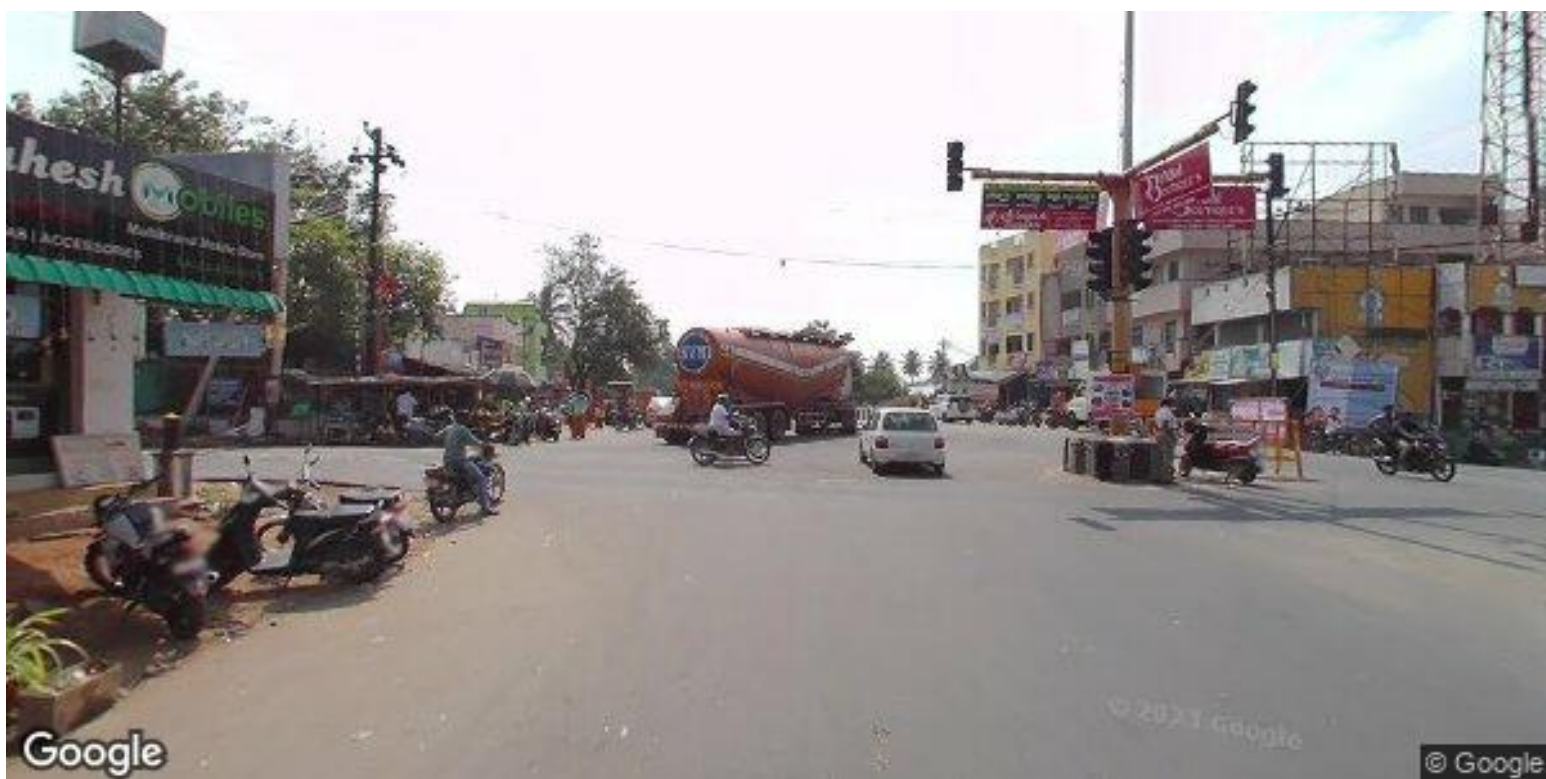
**Coordinates:** 11.36616, 77.88885

**Risk Type:** Turn

**Risk Level:** Medium

**Speed Limit:** 30 KM/Hr

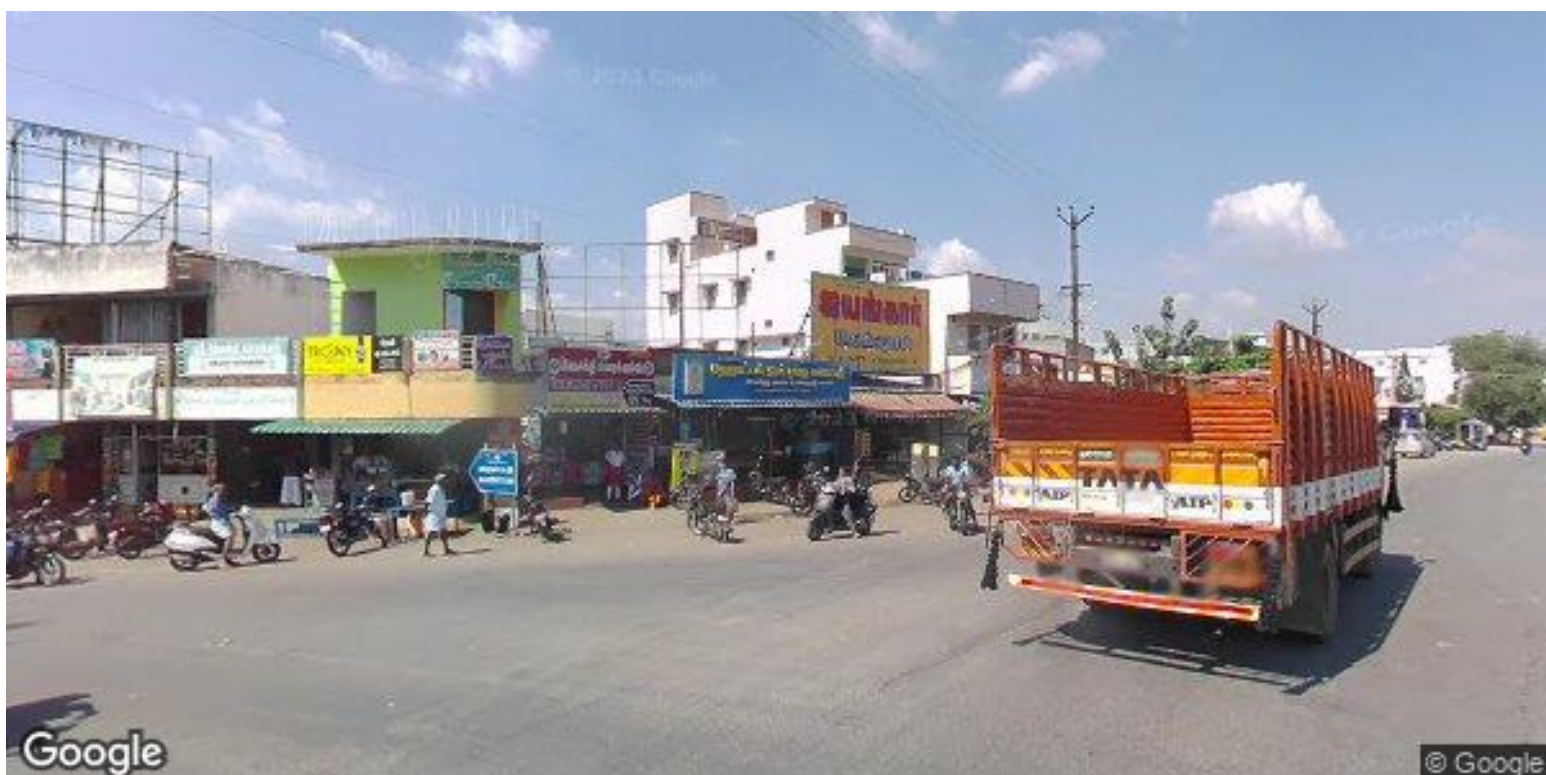
**Risk Type:** Turn  
**Risk Level:** Medium  
**Speed Limit:** 30 KM/Hr  
**Coordinates:** 11.36602, 77.88875

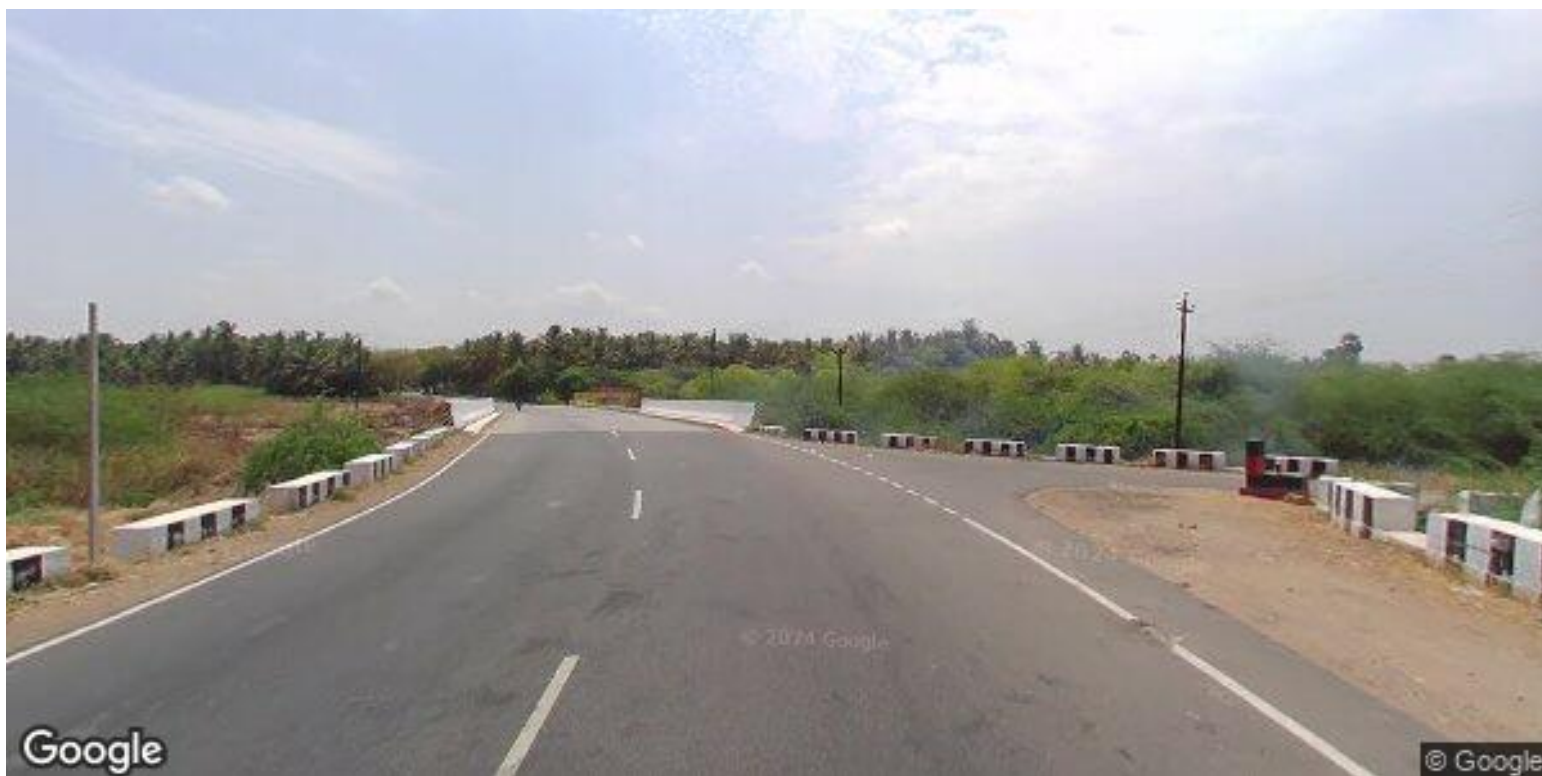
**Risk Type:** Turn  
**Risk Level:** Medium  
**Speed Limit:** 30 KM/Hr  
**Coordinates:** 11.31747, 77.84240

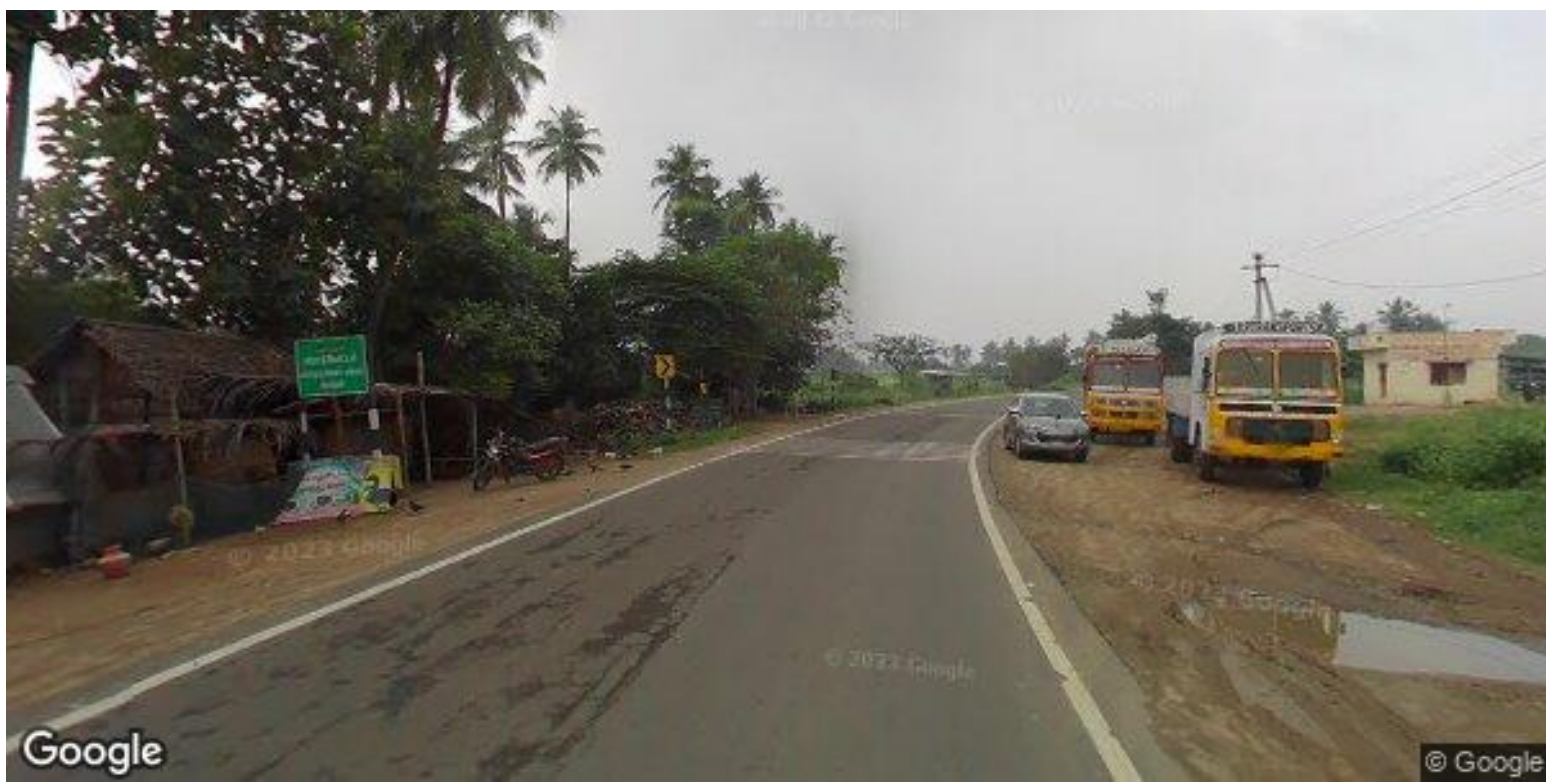
**Coordinates:** 11.30951, 77.77608

**Risk Type:** Turn

**Risk Level:** Medium

**Speed Limit:** 30 KM/Hr

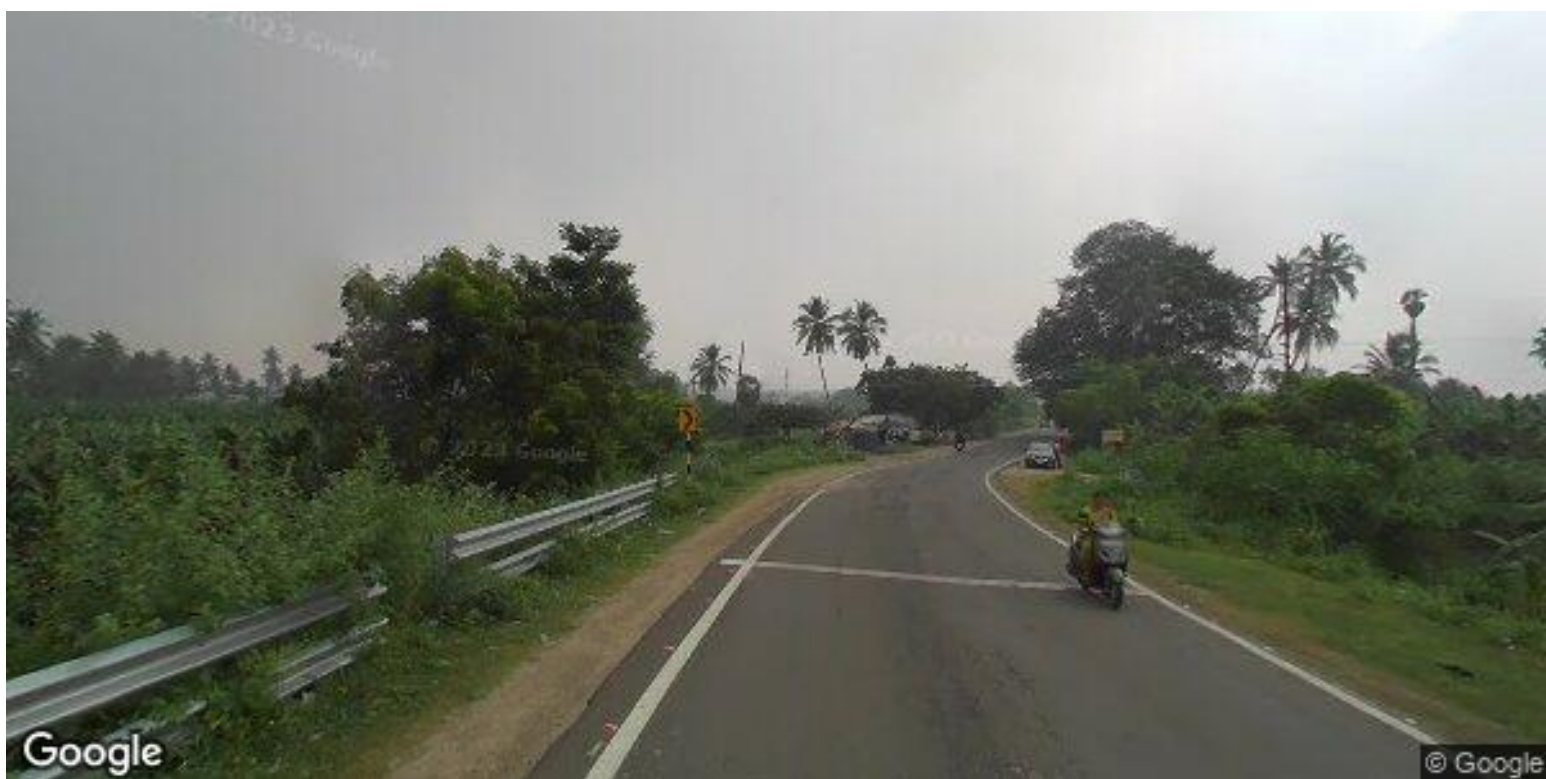
**Coordinates:** 11.31118, 77.77139

**Risk Type:** Turn

**Risk Level:** Medium

**Speed Limit:** 30 KM/Hr

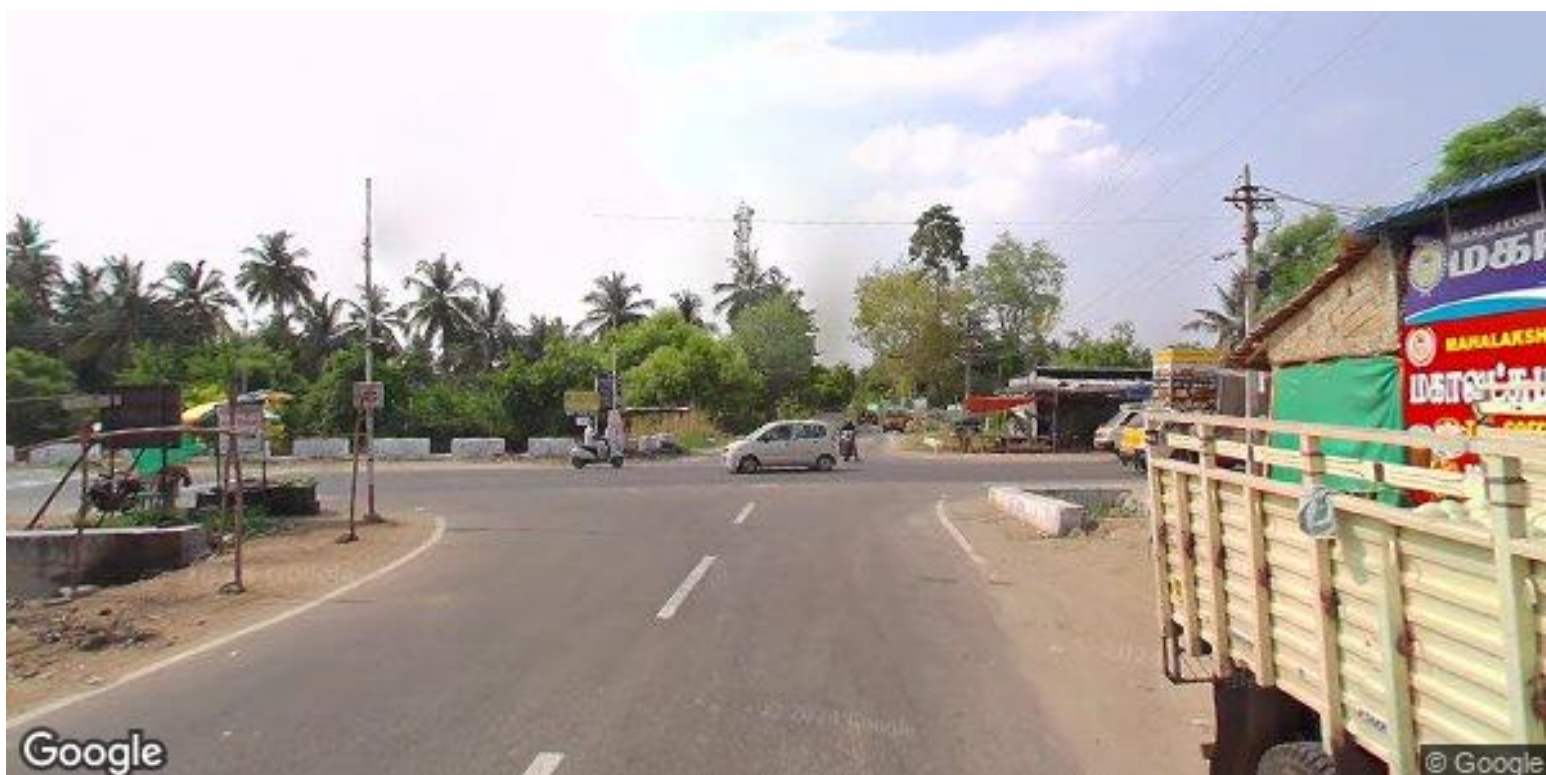
**Risk Type:** Turn  
**Risk Level:** High  
**Speed Limit:** 15 KM/Hr  
**Coordinates:** 11.29473, 77.74685

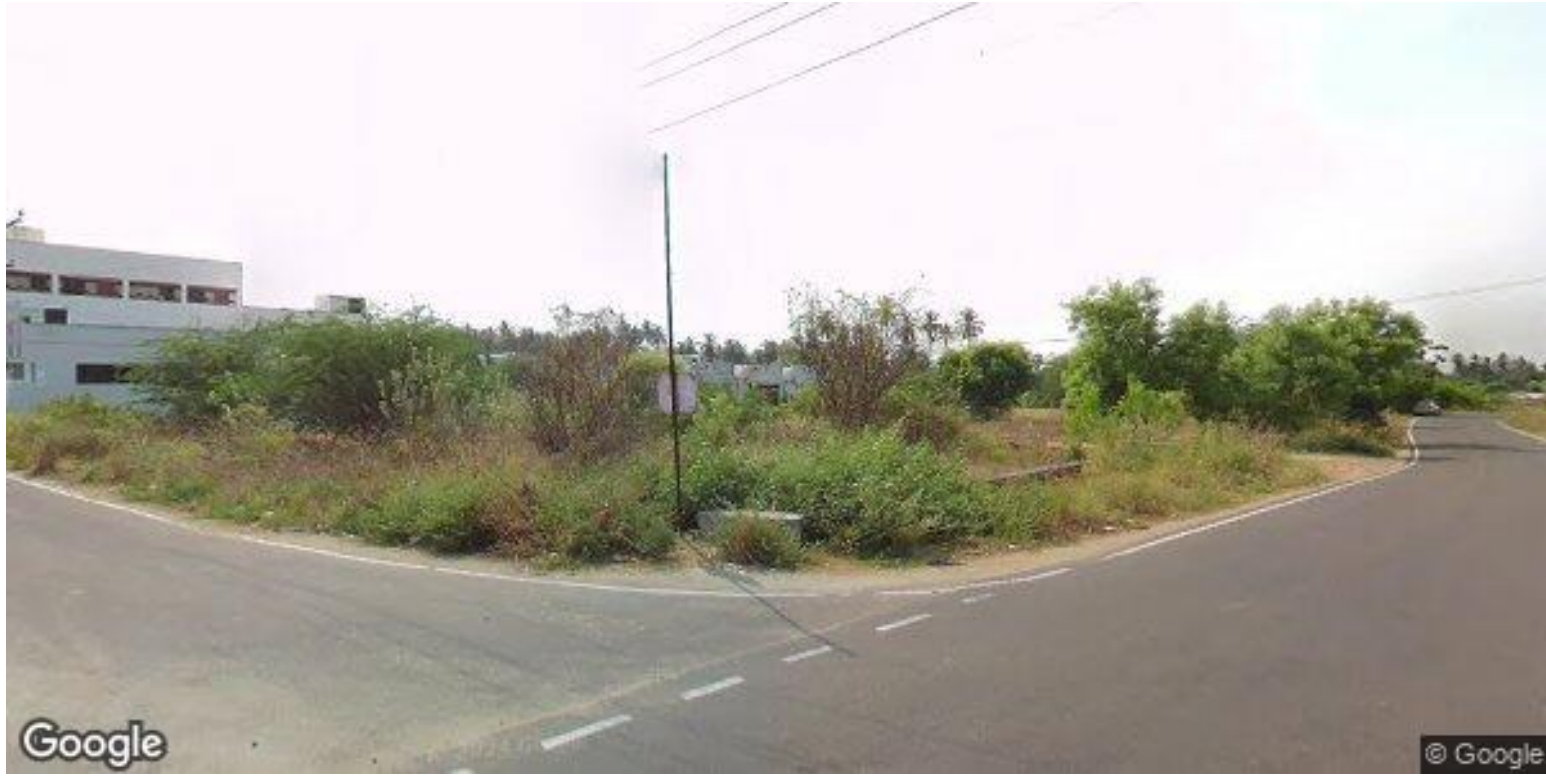
**Risk Type:** Turn  
**Risk Level:** High  
**Speed Limit:** 15 KM/Hr  
**Coordinates:** 11.29133, 77.74660

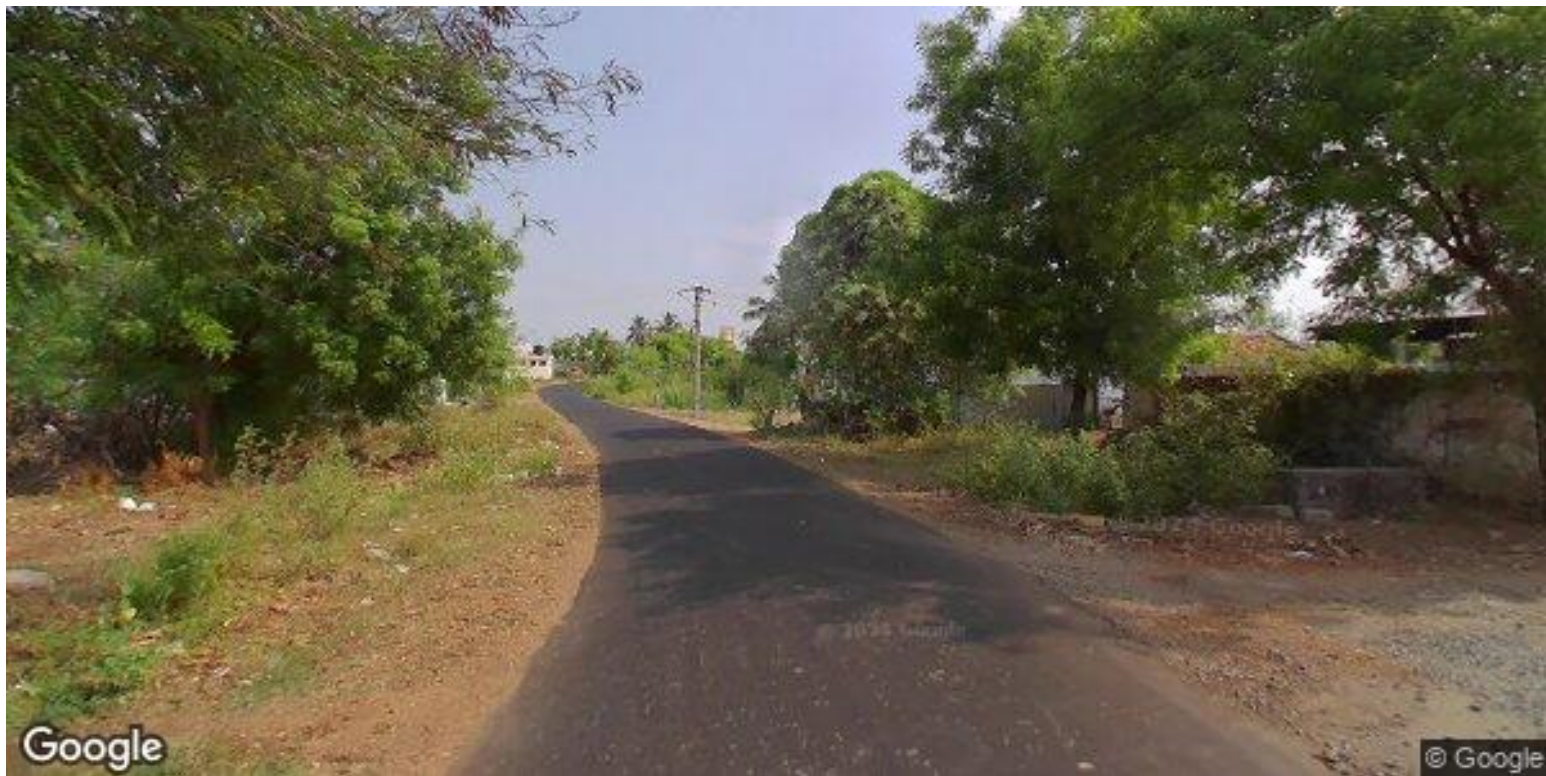
**Risk Type:** Turn  
**Risk Level:** Medium  
**Speed Limit:** 30 KM/Hr  
**Coordinates:** 11.28844, 77.74319

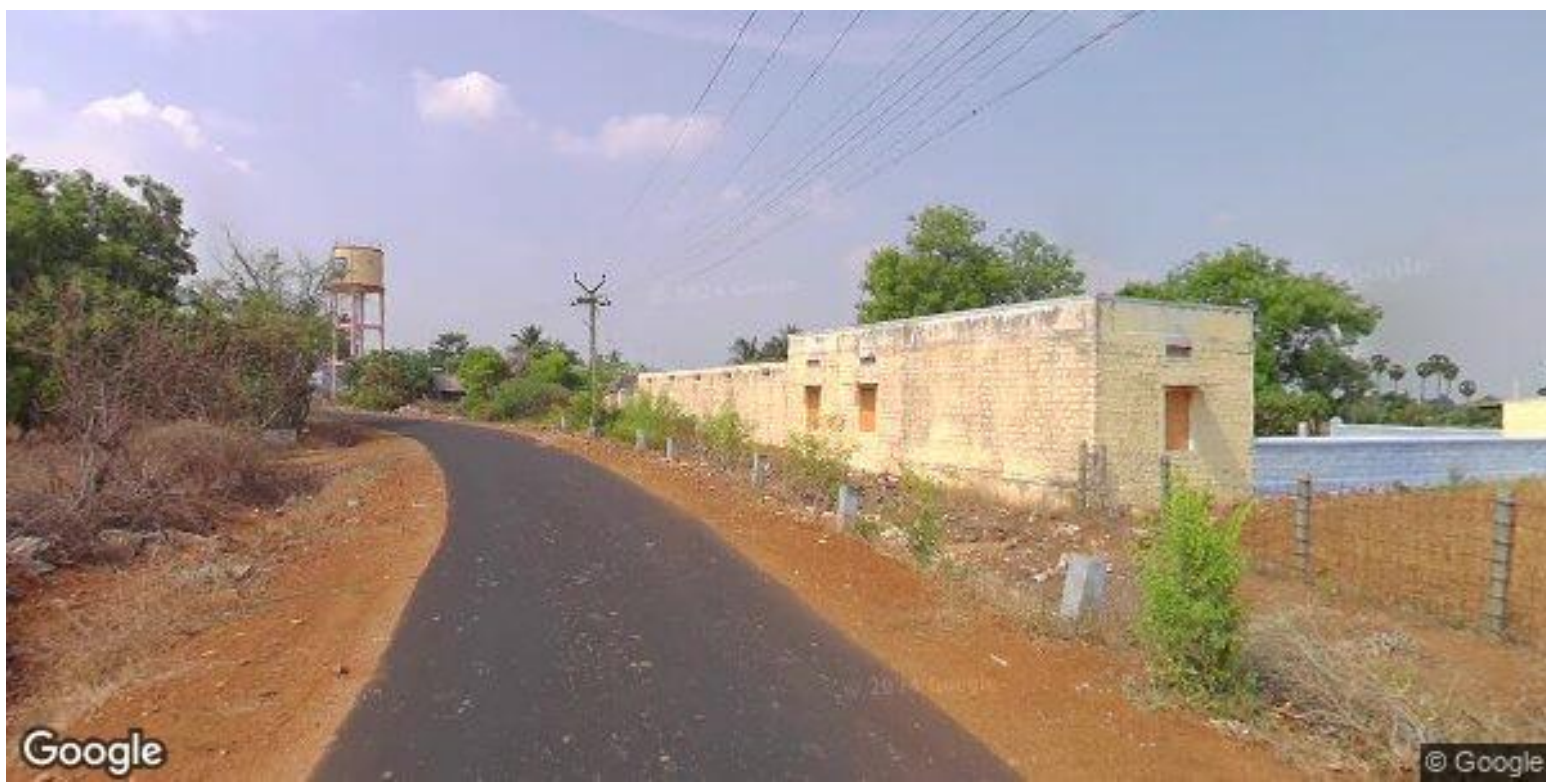
**Coordinates:** 11.28558, 77.74271

**Risk Type:** Turn

**Risk Level:** Medium

**Speed Limit:** 30 KM/Hr

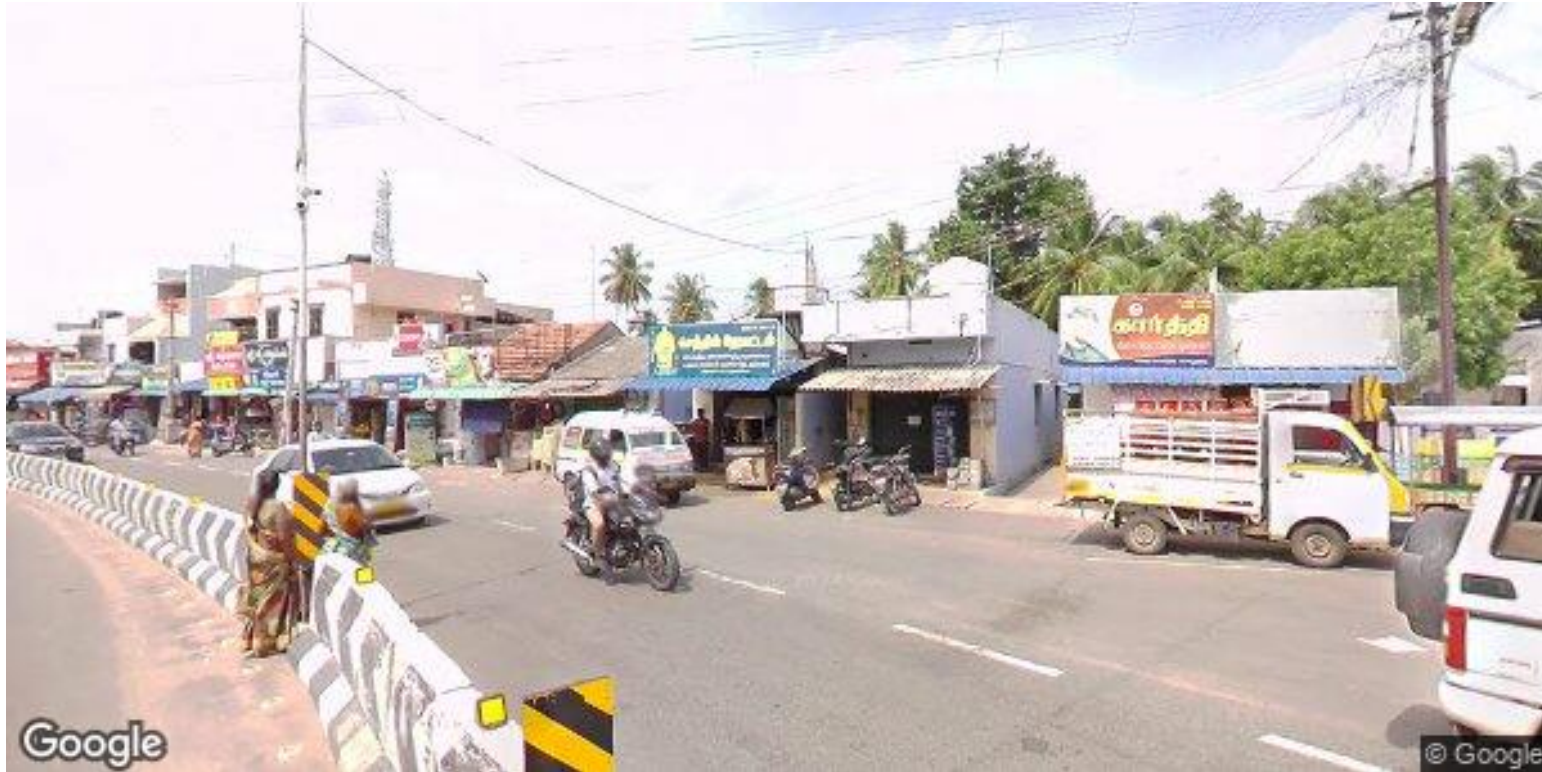
**Risk Type:** Turn  
**Risk Level:** Medium  
**Speed Limit:** 30 KM/Hr  
**Coordinates:** 11.23047, 77.71792

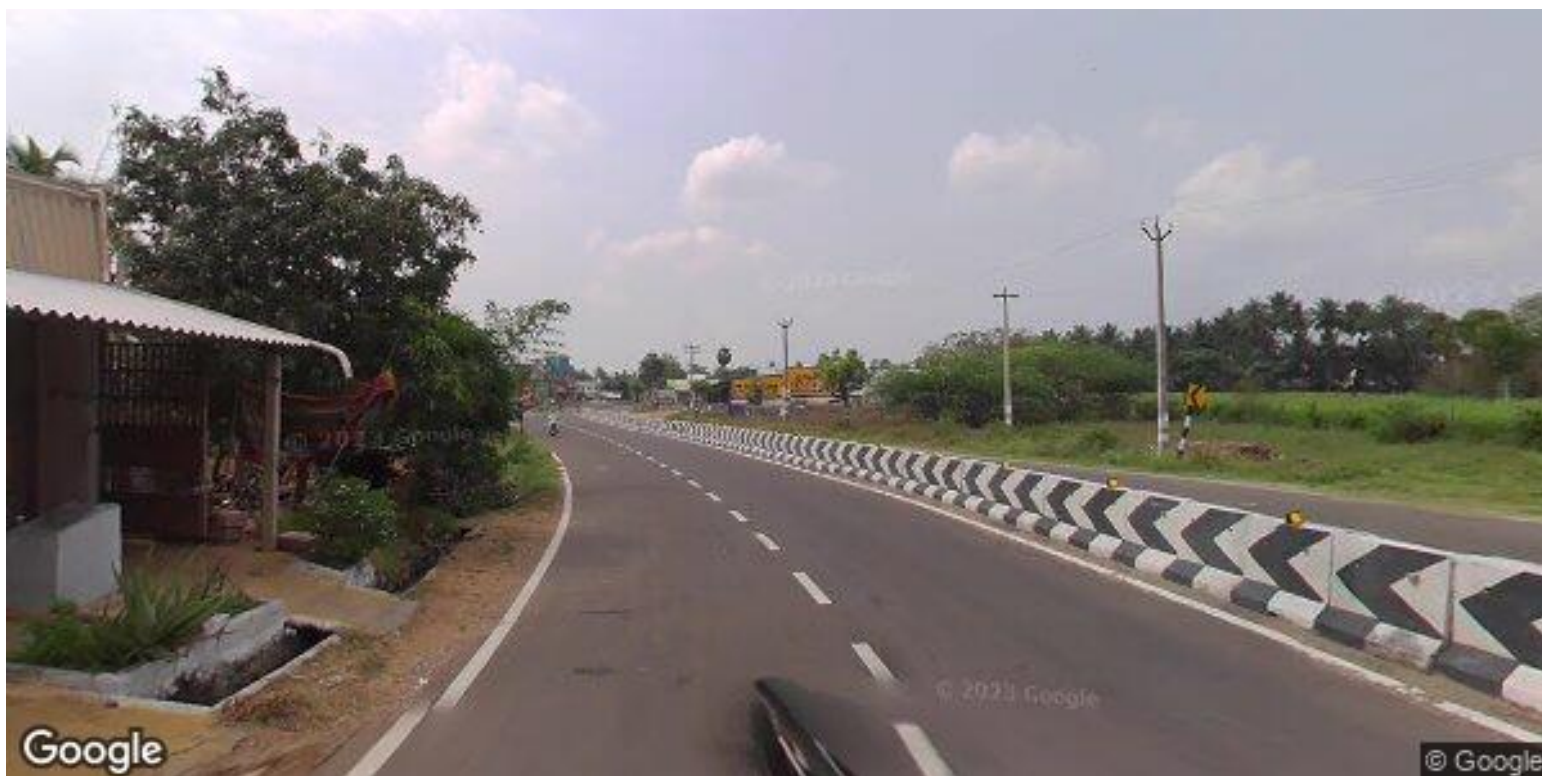
**Risk Type:** Turn  
**Risk Level:** Medium  
**Speed Limit:** 30 KM/Hr  
**Coordinates:** 11.22378, 77.71384

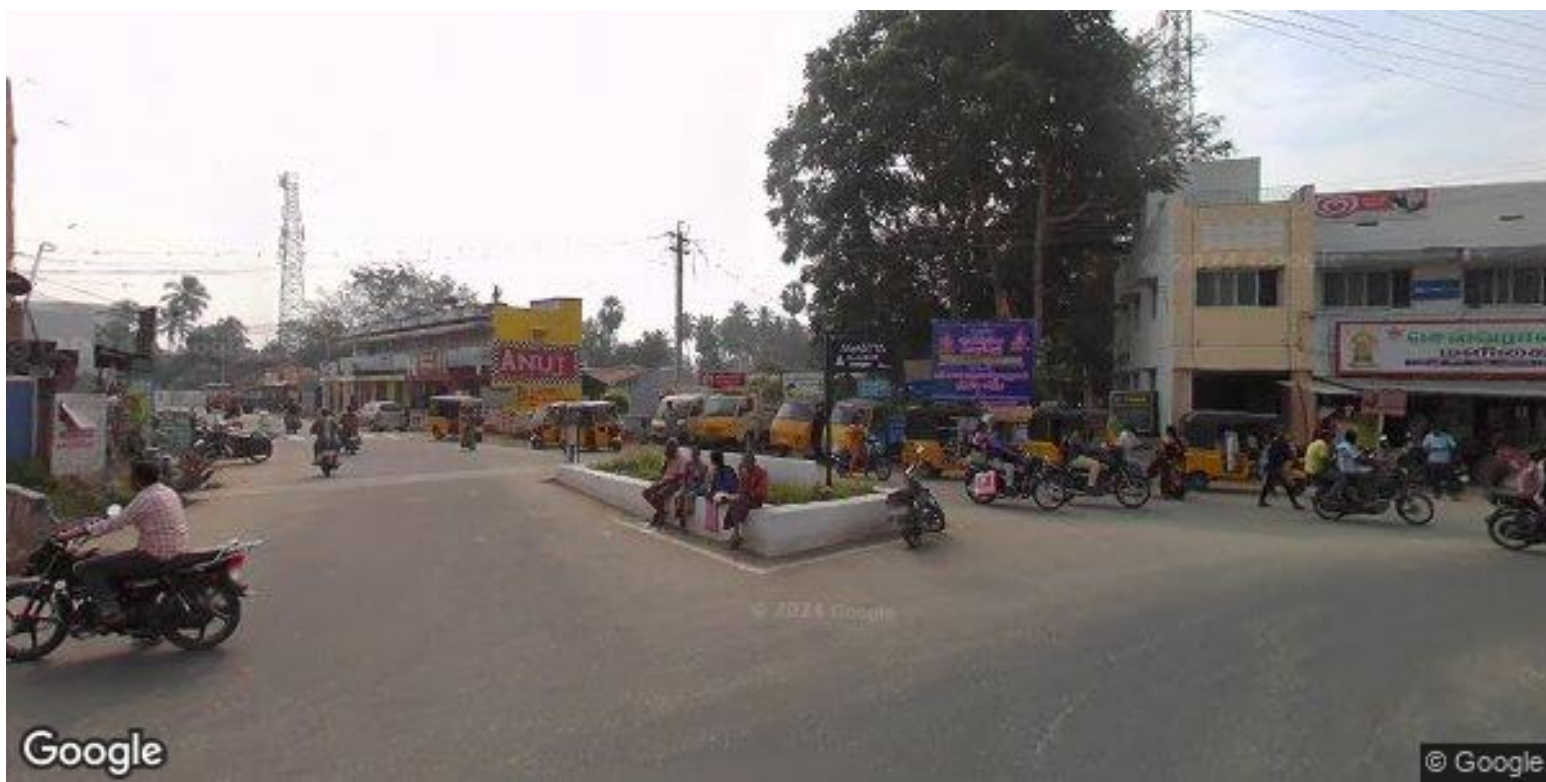
**Coordinates:** 11.15952, 77.70067

**Risk Type:** Turn

**Risk Level:** Medium

**Speed Limit:** 30 KM/Hr

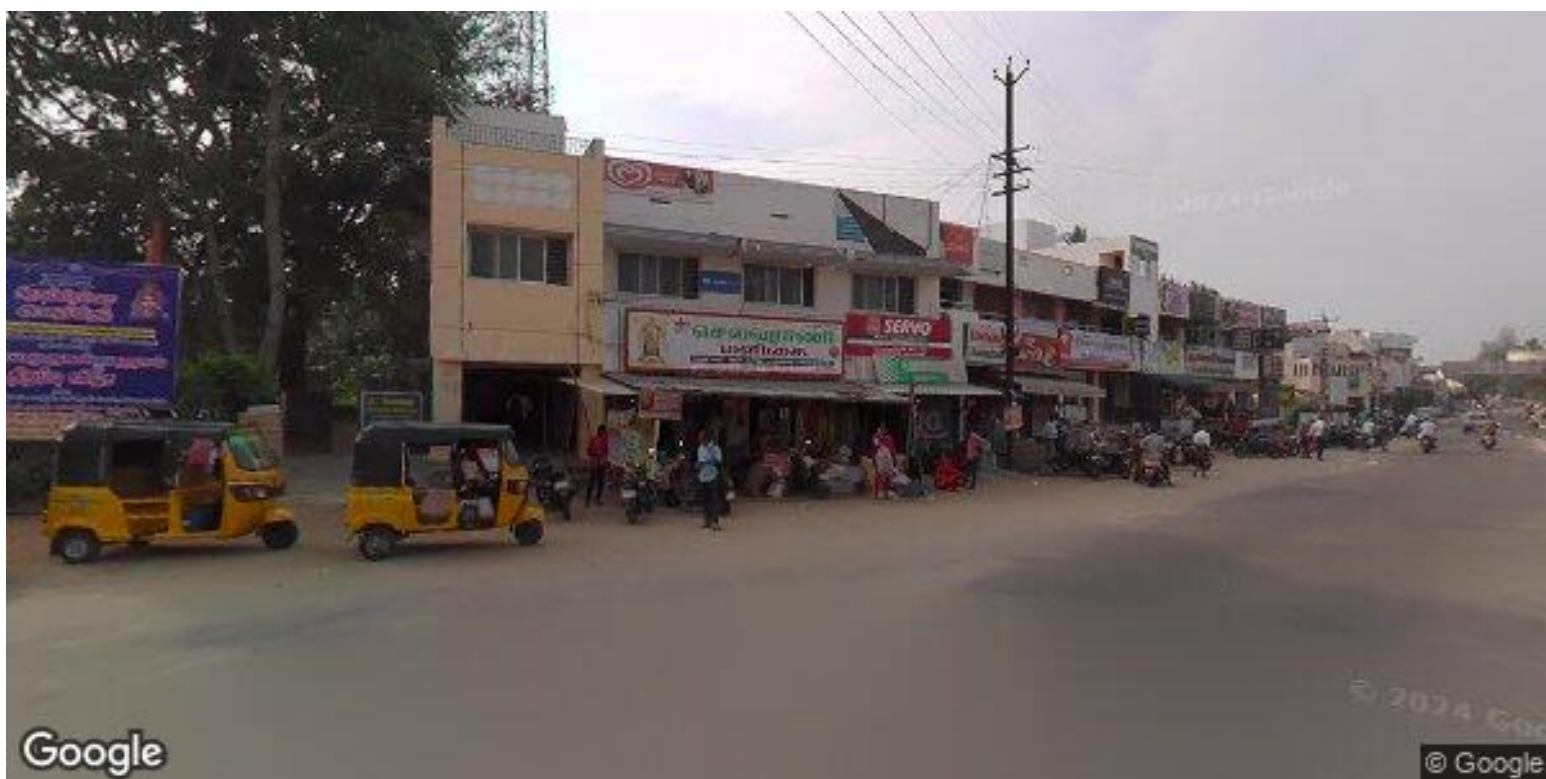
**Coordinates:** 11.15943, 77.70068

**Risk Type:** Turn

**Risk Level:** High

**Speed Limit:** 15 KM/Hr

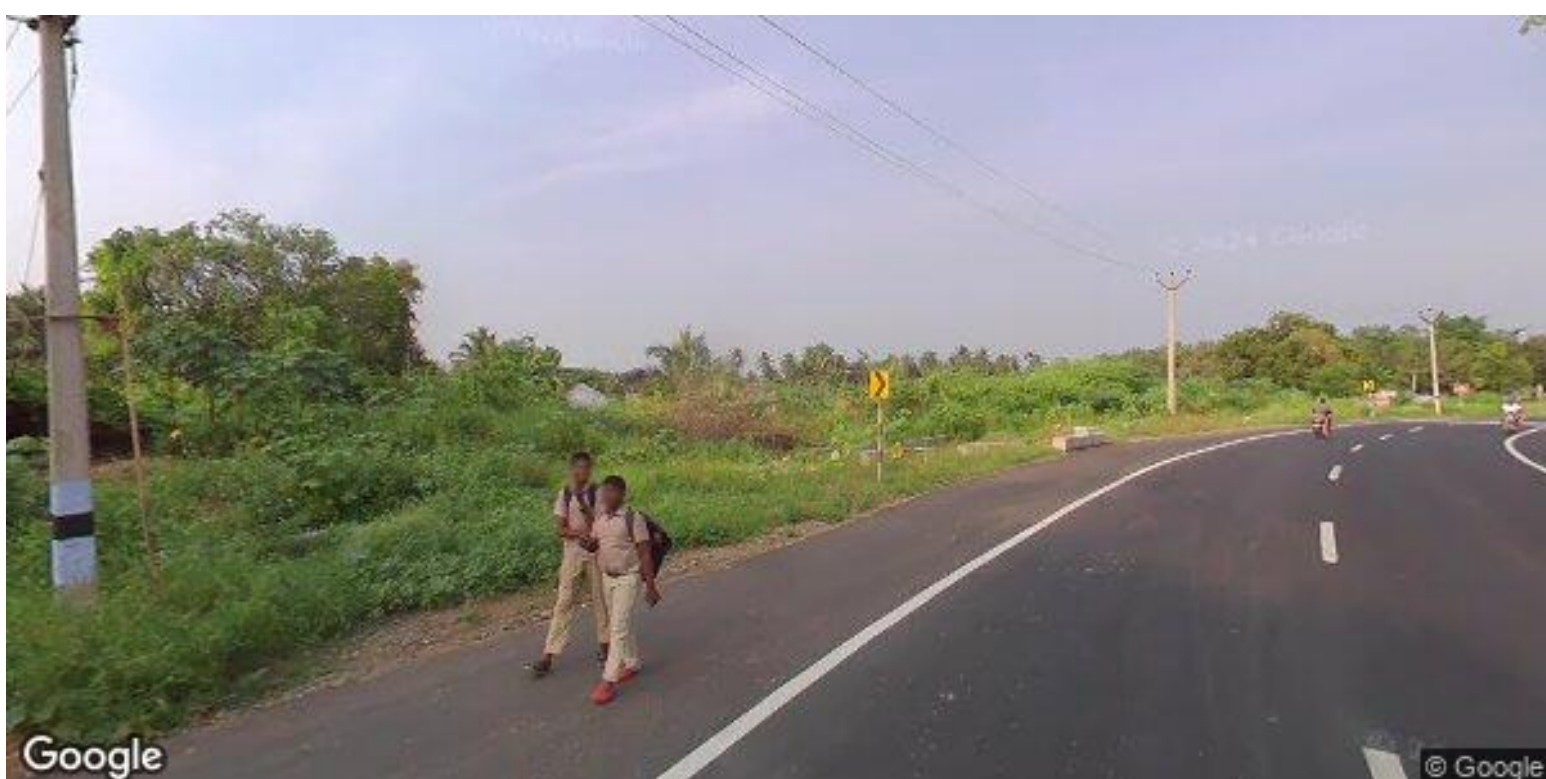
**Risk Type:** Turn  
**Risk Level:** Medium  
**Speed Limit:** 30 KM/Hr  
**Coordinates:** 11.11733, 77.67191

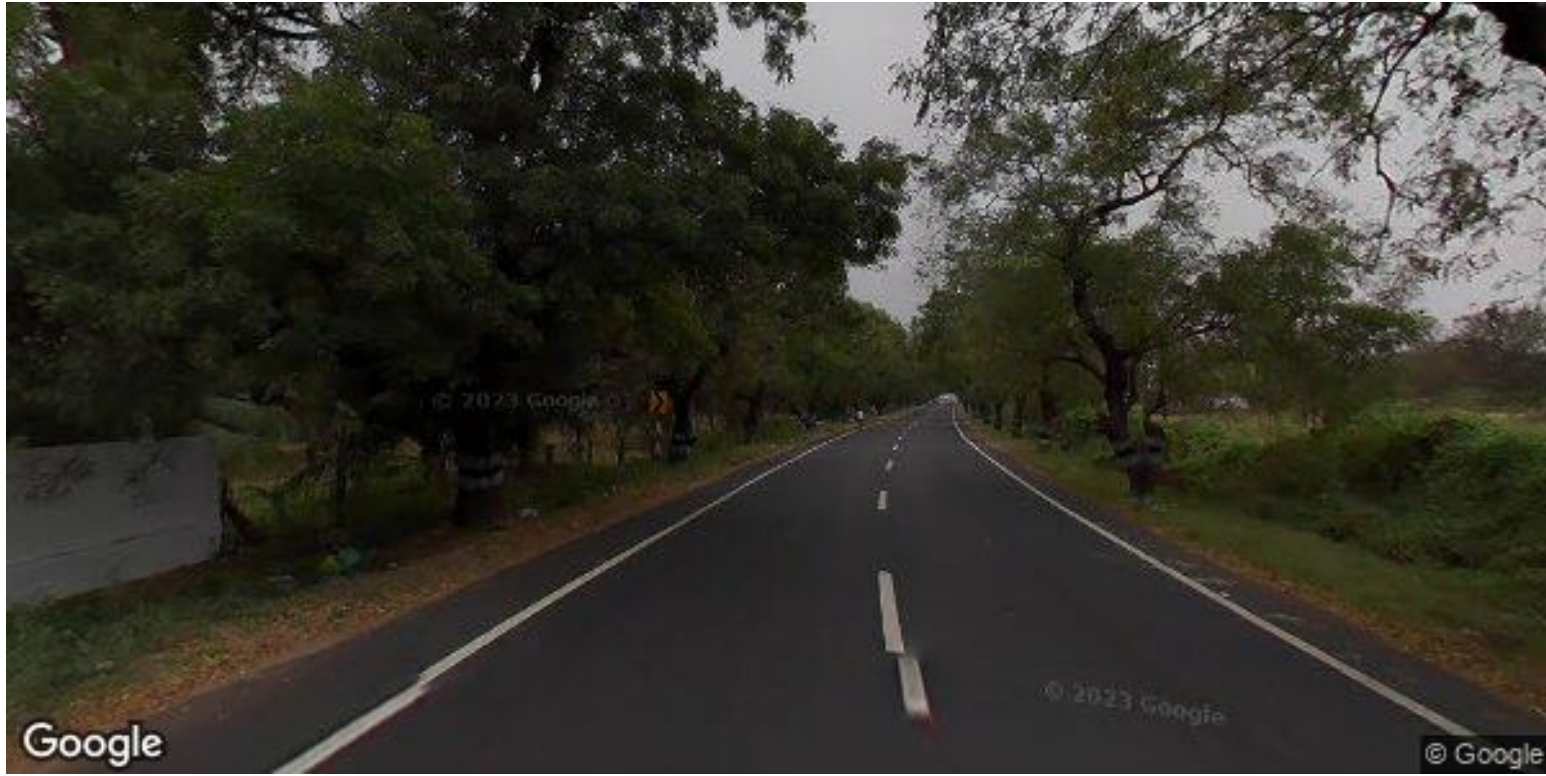
**Risk Type:** Turn  
**Risk Level:** Medium  
**Speed Limit:** 30 KM/Hr  
**Coordinates:** 11.10471, 77.67058

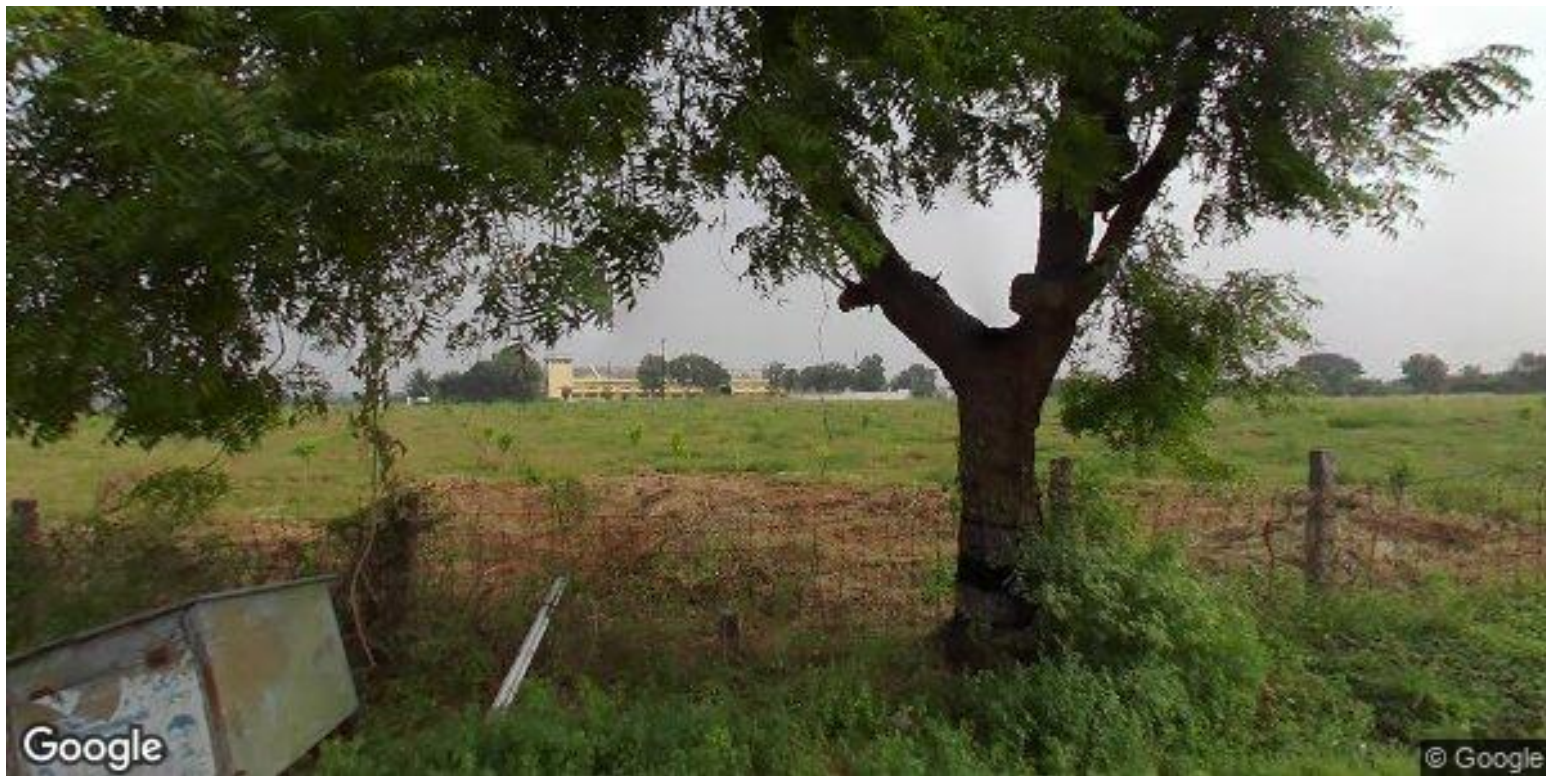
**Risk Type:** Turn  
**Risk Level:** Medium  
**Speed Limit:** 30 KM/Hr  
**Coordinates:** 11.09508, 77.66612
