## JOURNEY RISK MANAGEMENT (JRM) STUDY

### Salem Terminal TO SAMY FUEL STATION

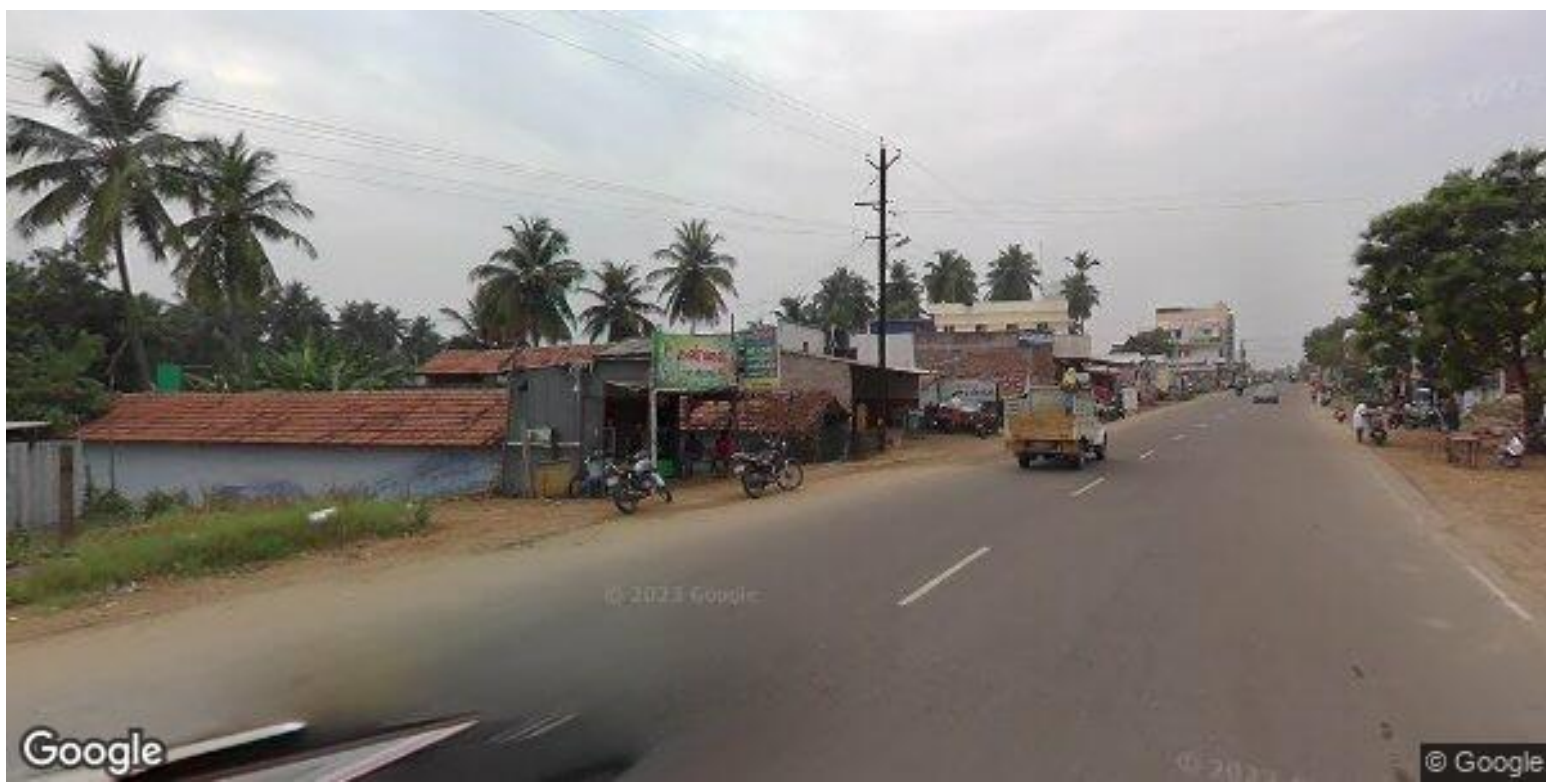
**Coordinates:** 11.08722, 77.66431

**Risk Type:** Turn

**Risk Level:** Medium

**Speed Limit:** 30 KM/Hr

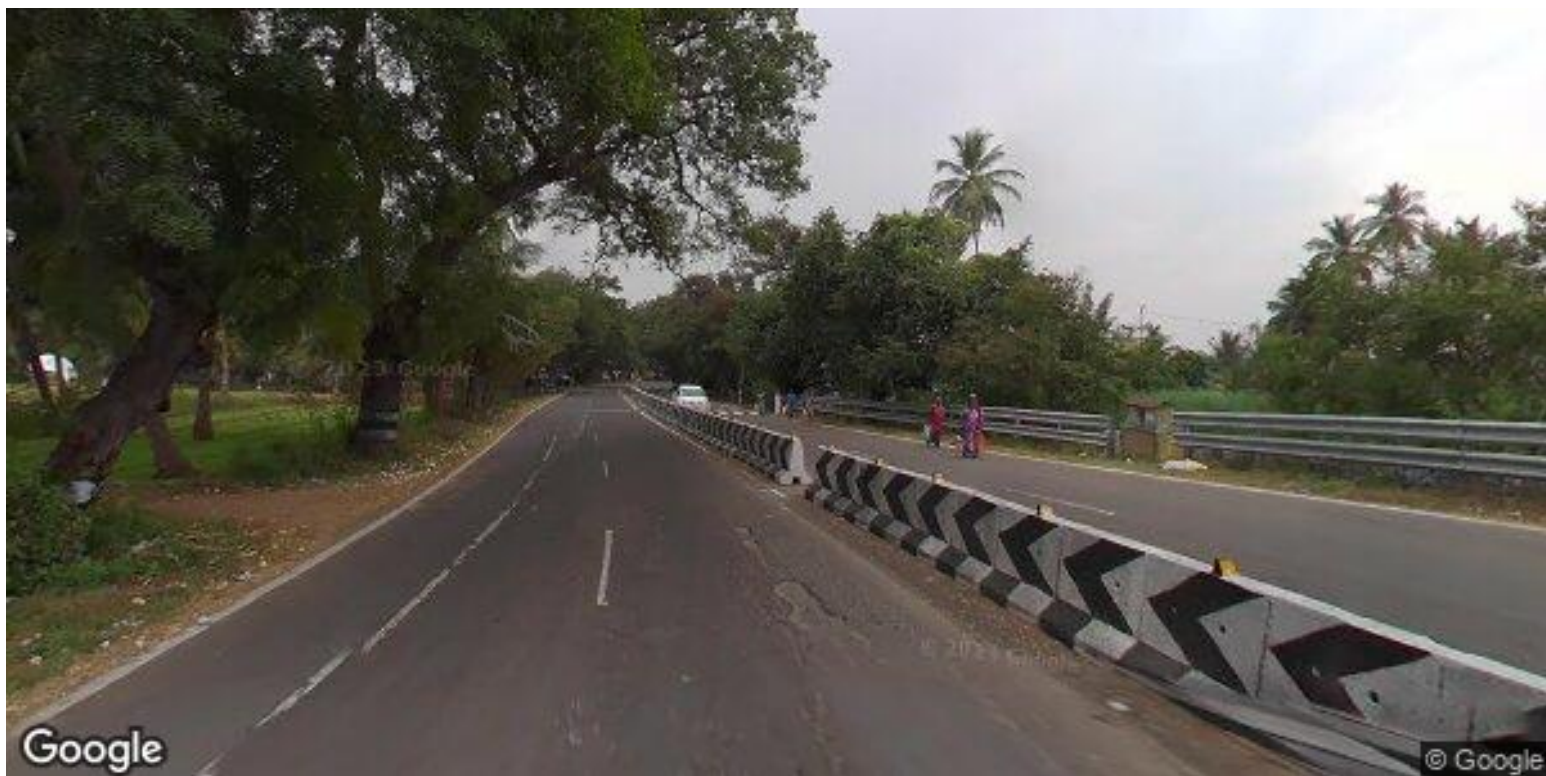
**Coordinates:** 11.08274, 77.65832

**Risk Type:** Turn

**Risk Level:** Medium

**Speed Limit:** 30 KM/Hr

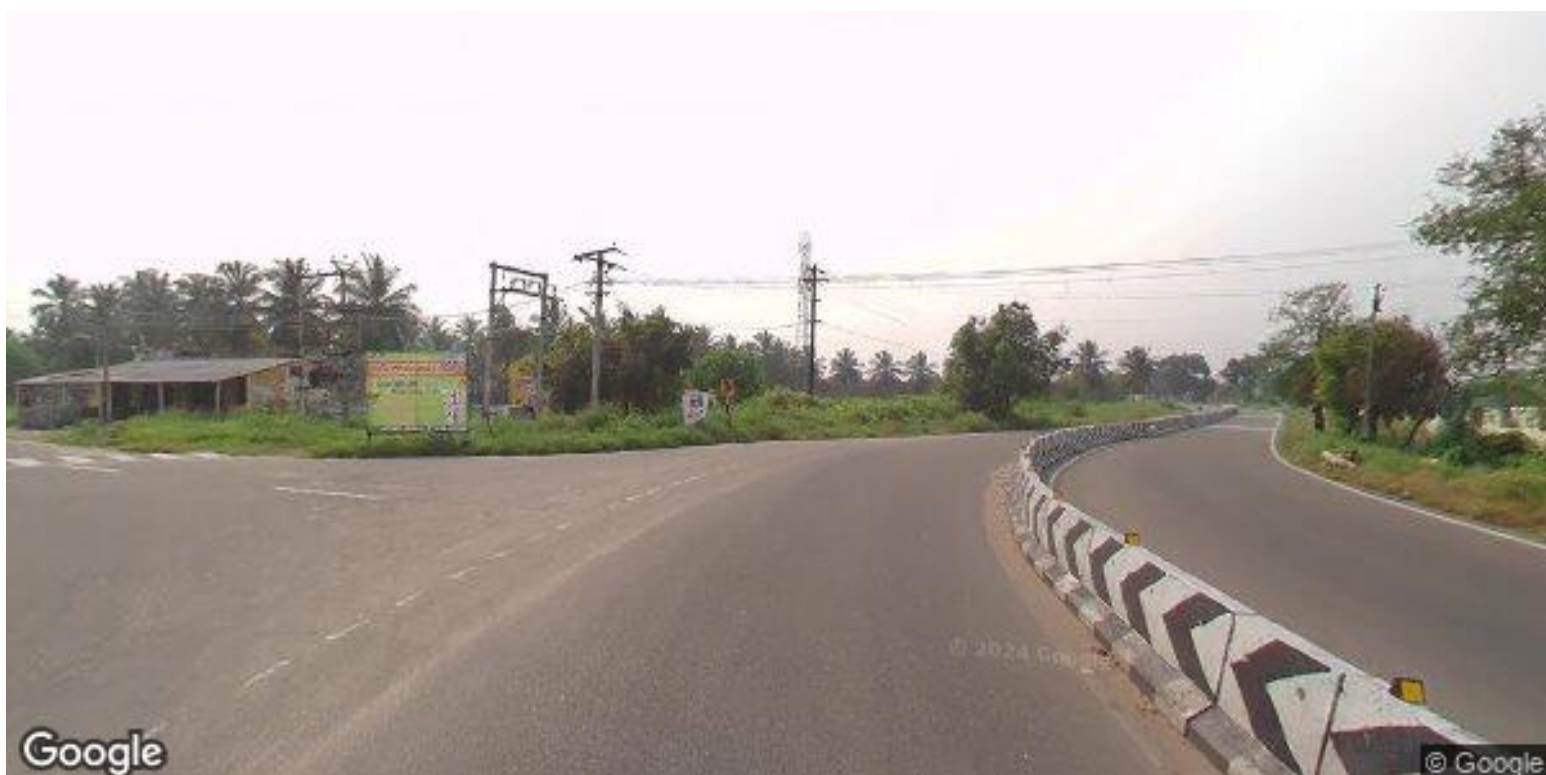
**Risk Type:** Turn  
**Risk Level:** High  
**Speed Limit:** 15 KM/Hr  
**Coordinates:** 11.06187, 77.63939
