## JOURNEY RISK MANAGEMENT (JRM) STUDY

### Salem Terminal TO TVR FUELS STATION

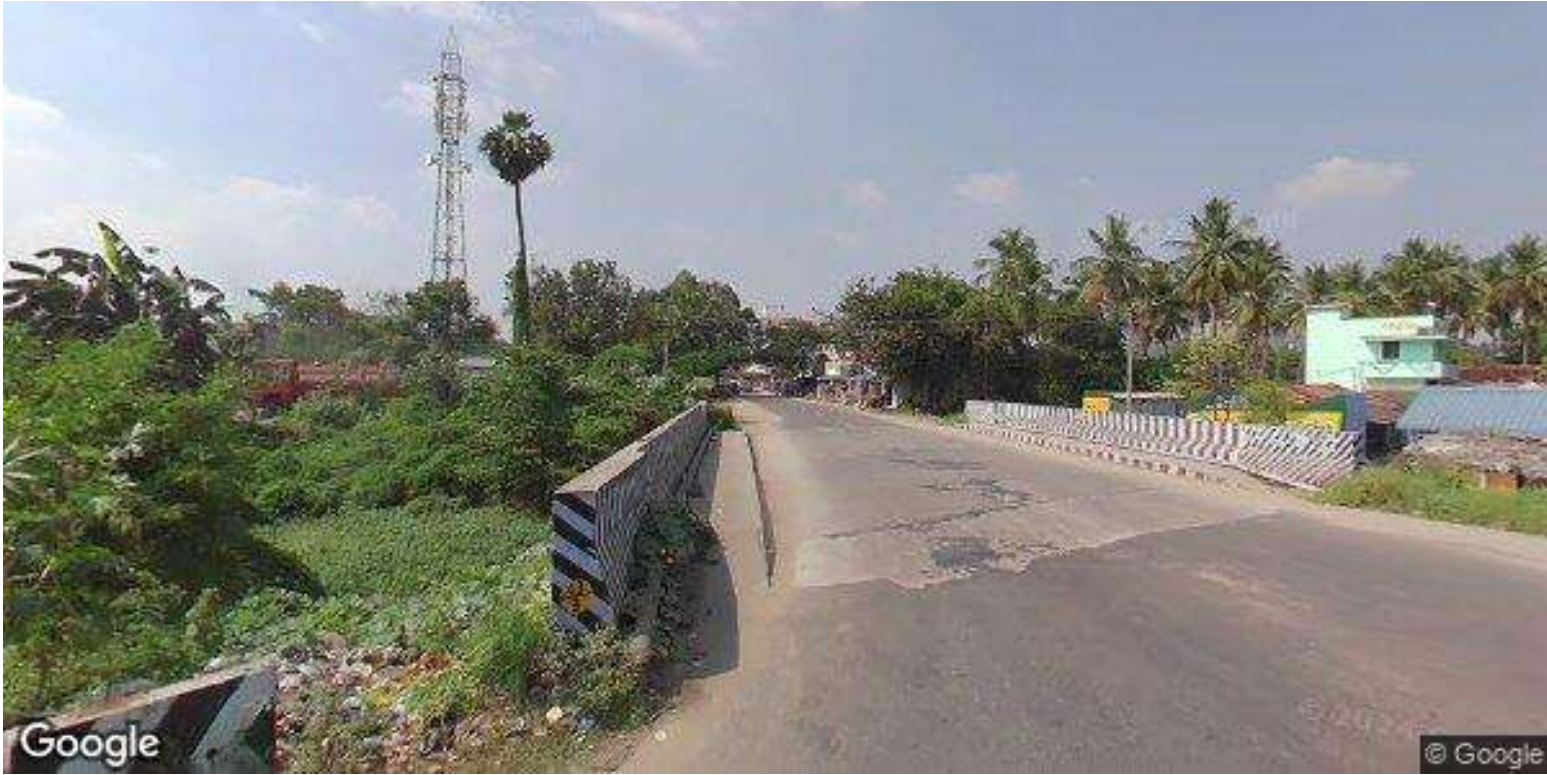
Risk Type: Turn

Risk Level: High

**Speed Limit: 15 KM/Hr**  
**Coordinates: 11.44900, 77.87406**

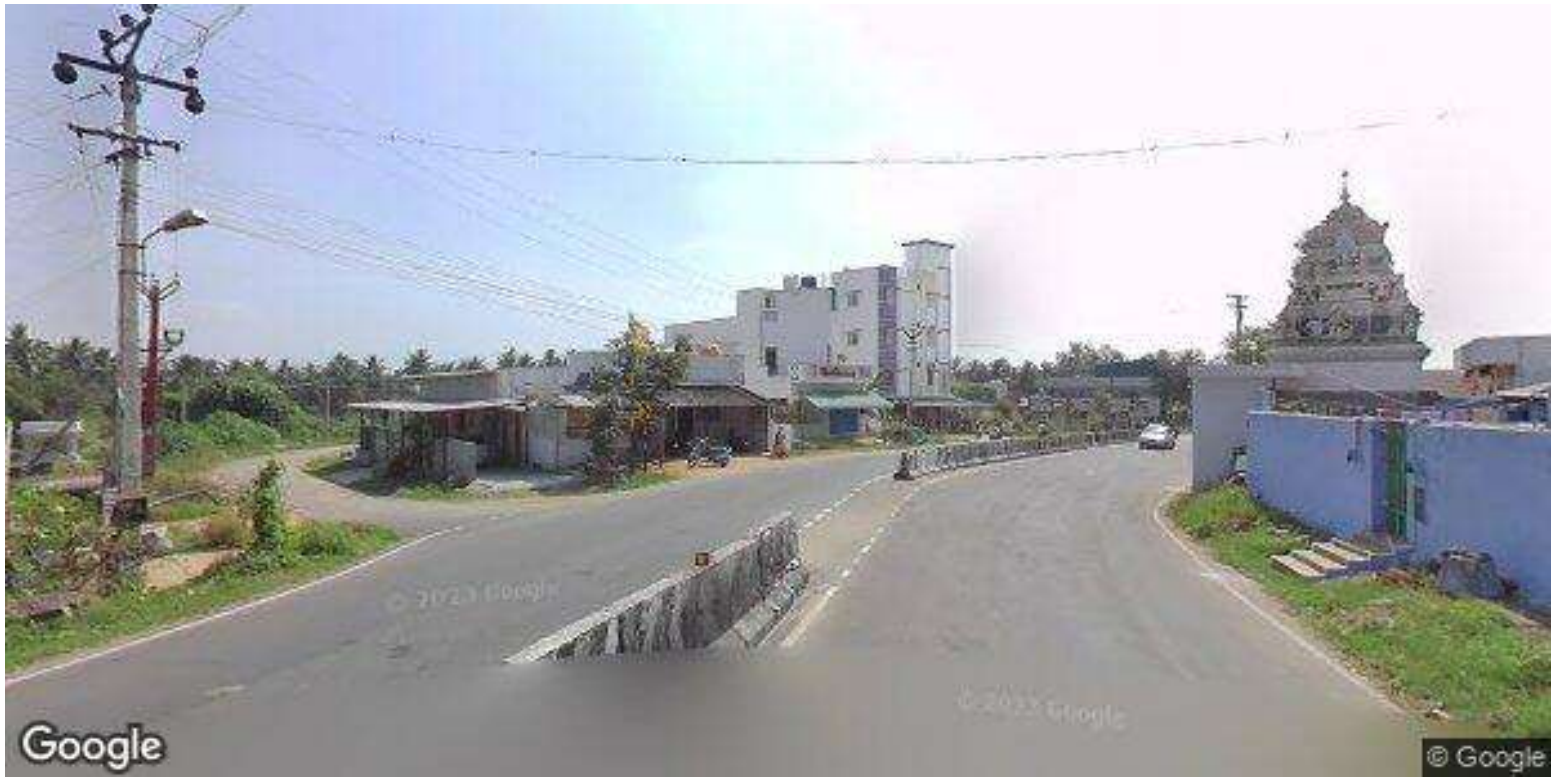
**Risk Type: Turn**  
**Risk Level: Medium**  
**Speed Limit: 30 KM/Hr**  
**Coordinates: 11.46400, 77.87323**

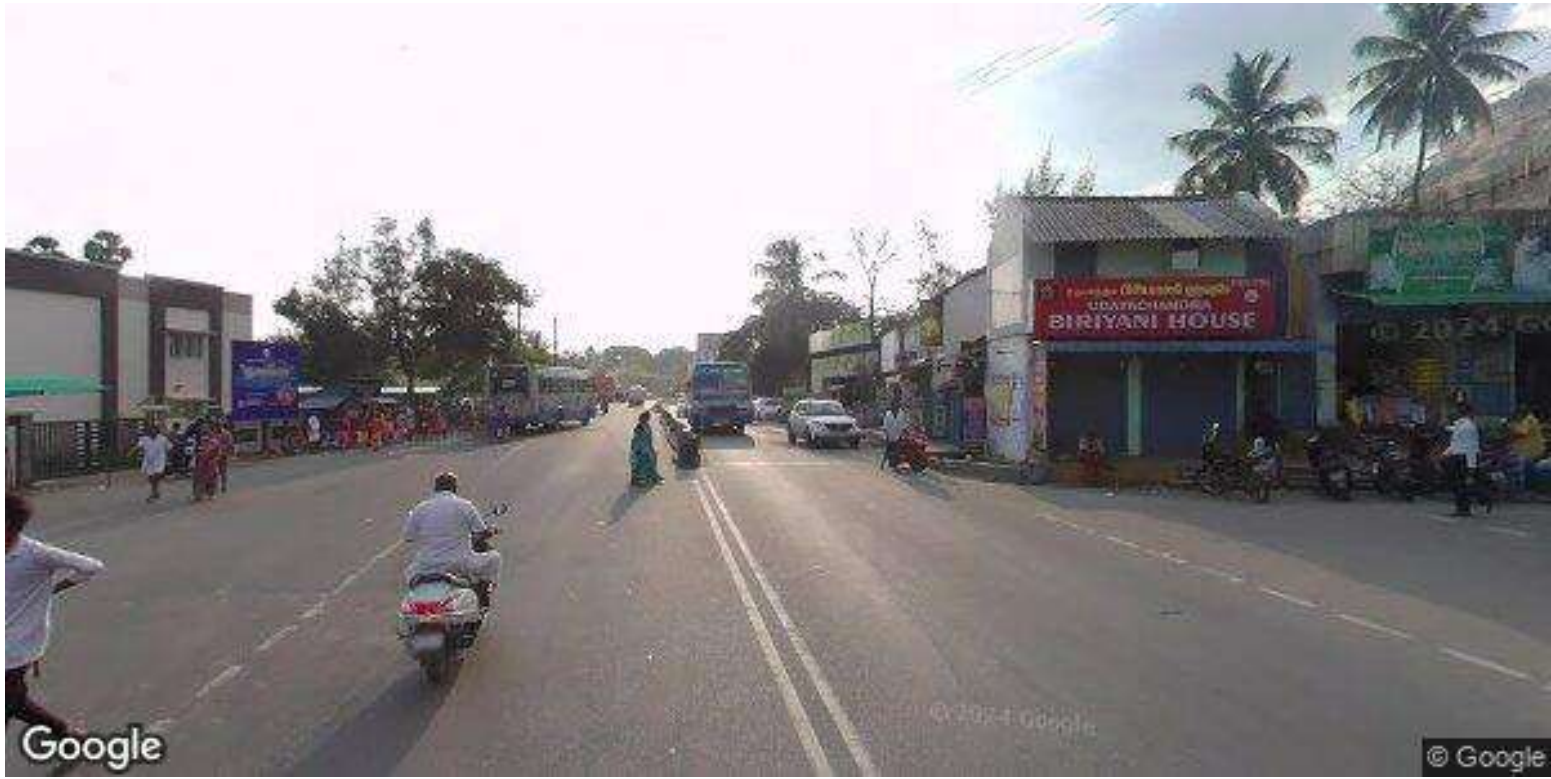
Risk Type: Turn  
Risk Level: High  
Speed Limit: 15 KM/Hr  
Coordinates: 11.47403, 77.86841

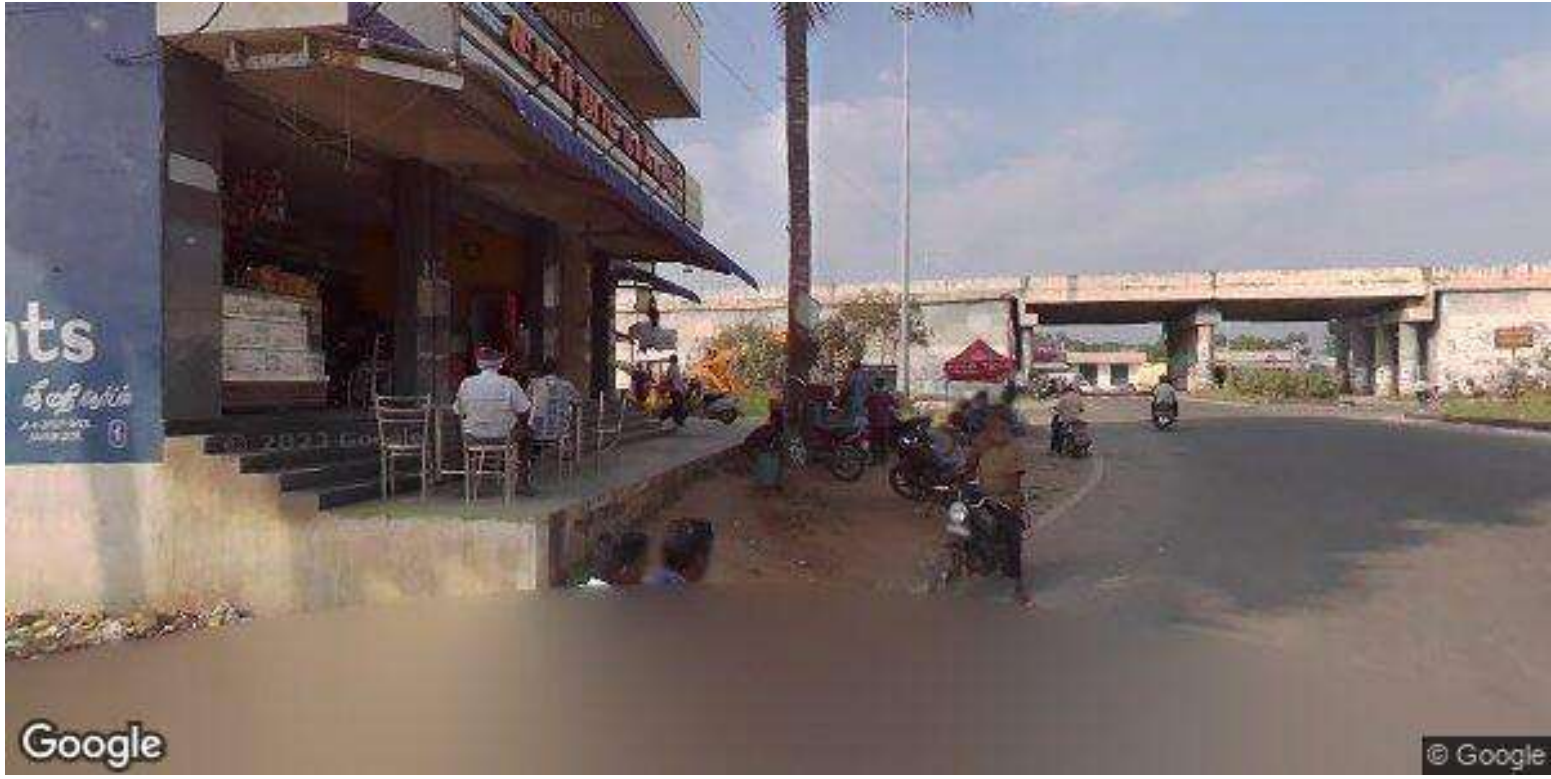
Risk Type: Turn  
Risk Level: High  
Speed Limit: 15 KM/Hr  
Coordinates: 11.49149, 77.89601

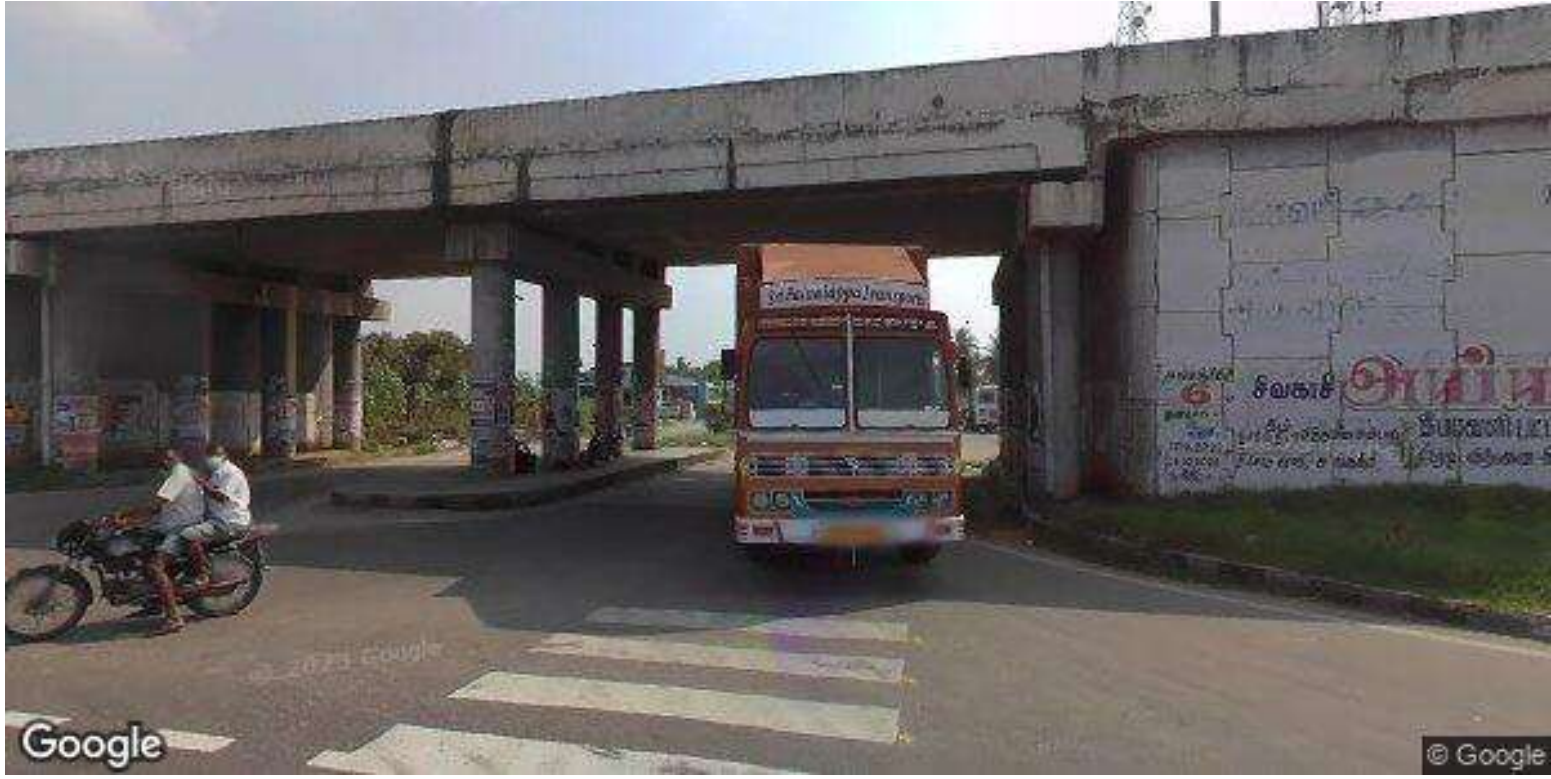
**Risk Type:** Turn  
**Risk Level:** High  
**Speed Limit:** 15 KM/Hr  
**Coordinates:** 11.49224, 77.89601

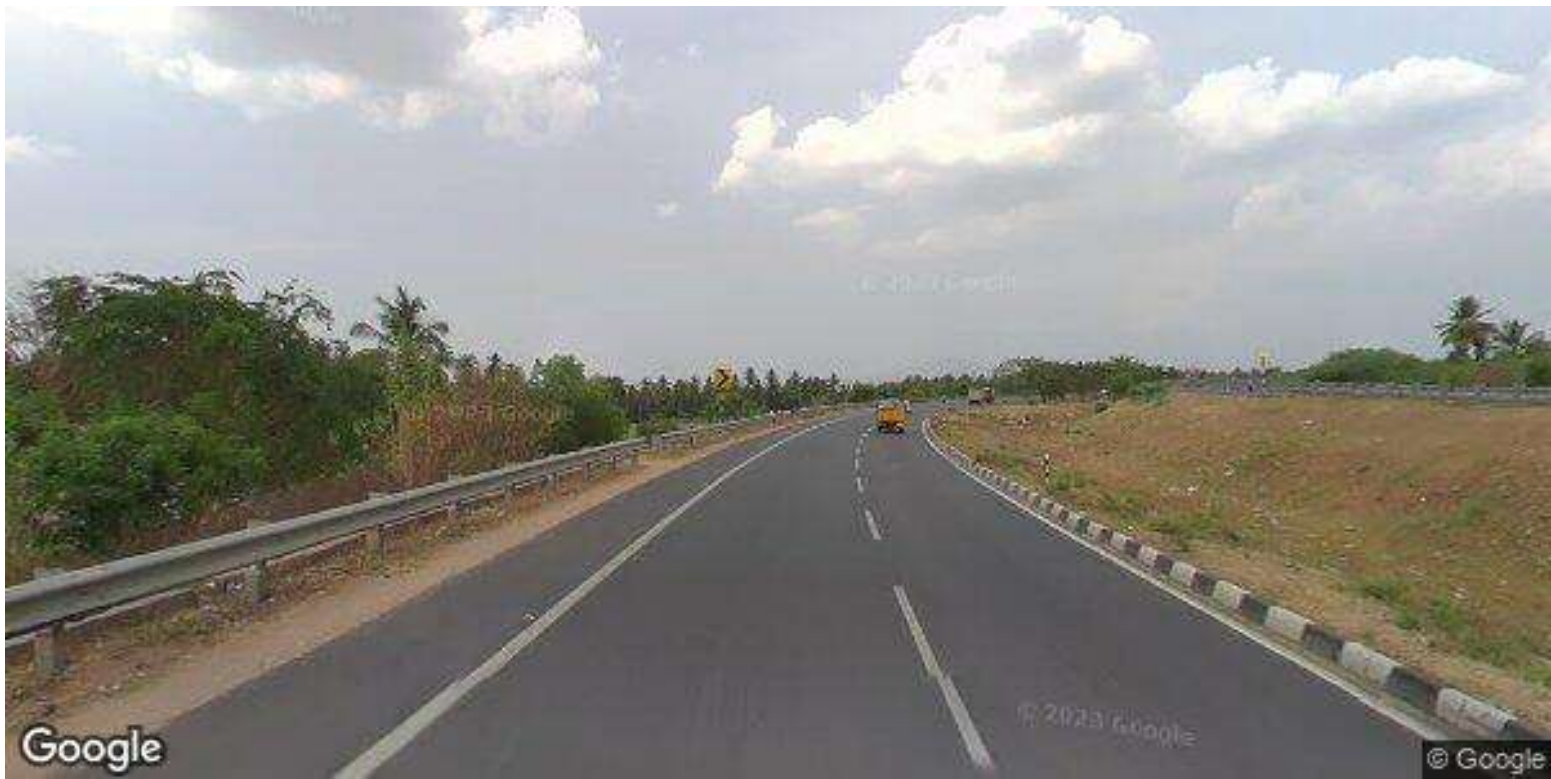
**Risk Type:** Turn  
**Risk Level:** Medium  
**Speed Limit:** 30 KM/Hr  
**Coordinates:** 11.53501, 77.95707

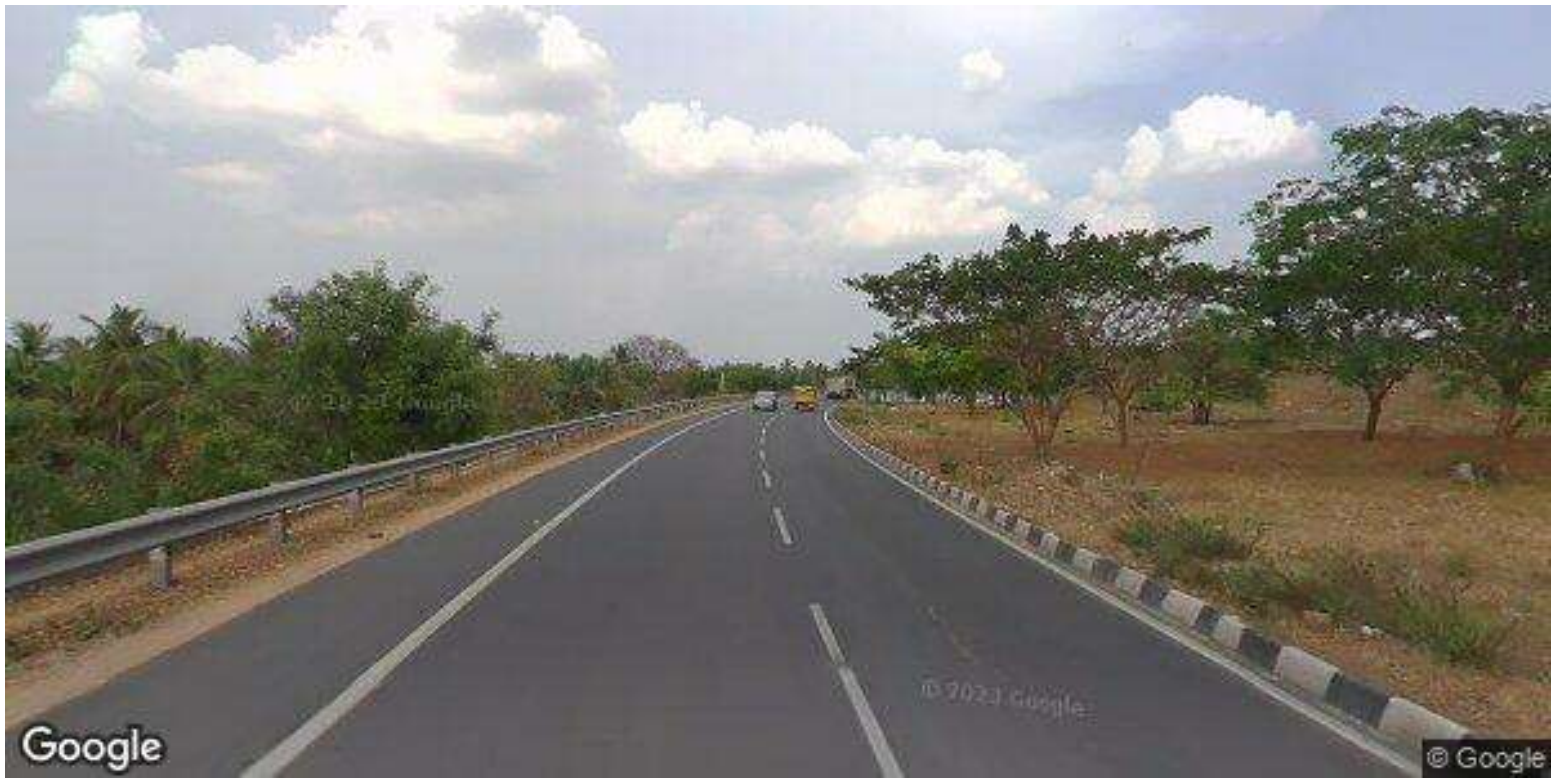
**Risk Type:** Turn  
**Risk Level:** Medium  
**Speed Limit:** 30 KM/Hr  
**Coordinates:** 11.53601, 77.95856

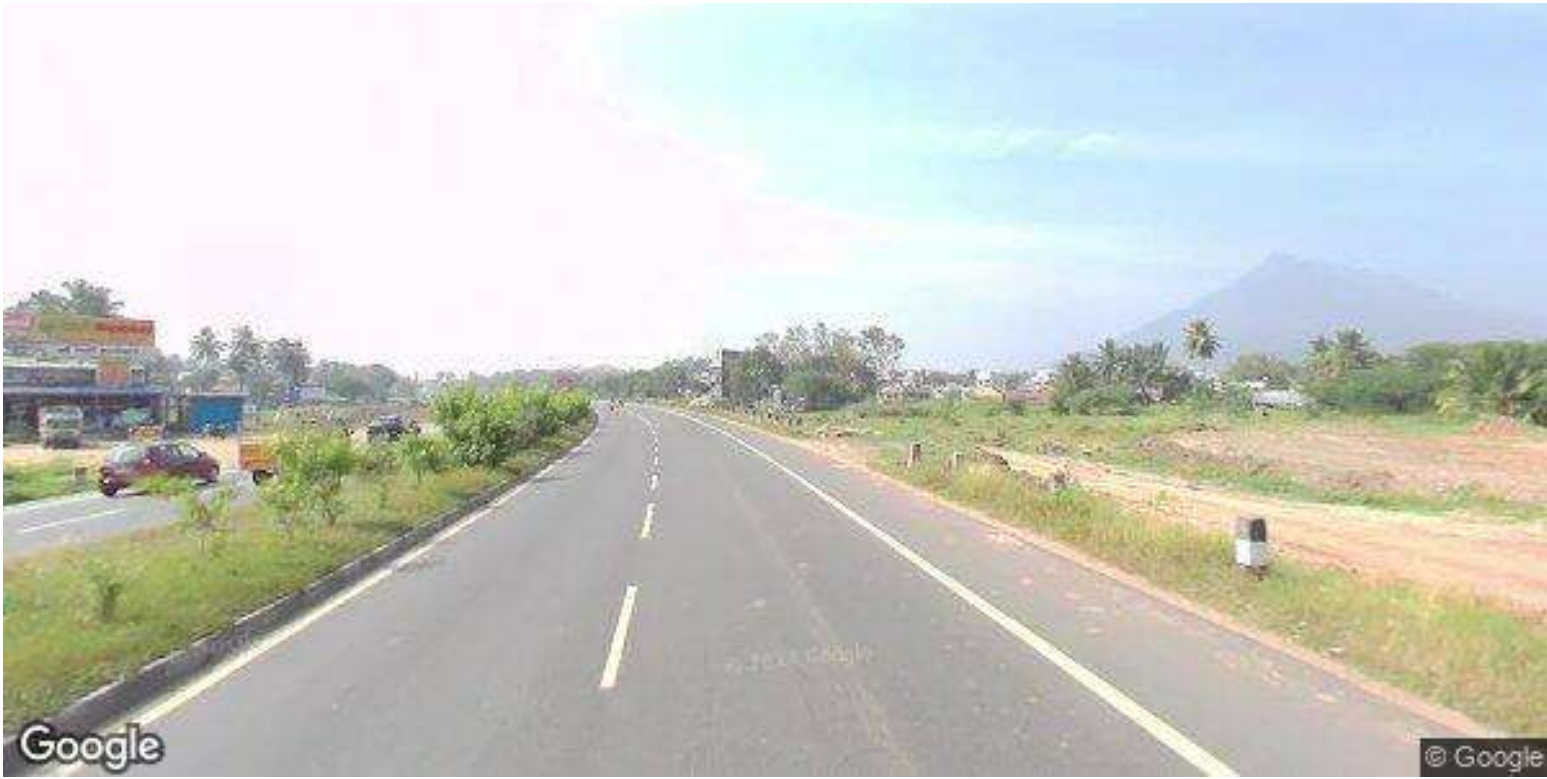
**Risk Type:** Turn  
**Risk Level:** Medium  
**Speed Limit:** 30 KM/Hr  
**Coordinates:** 11.62403, 78.10893

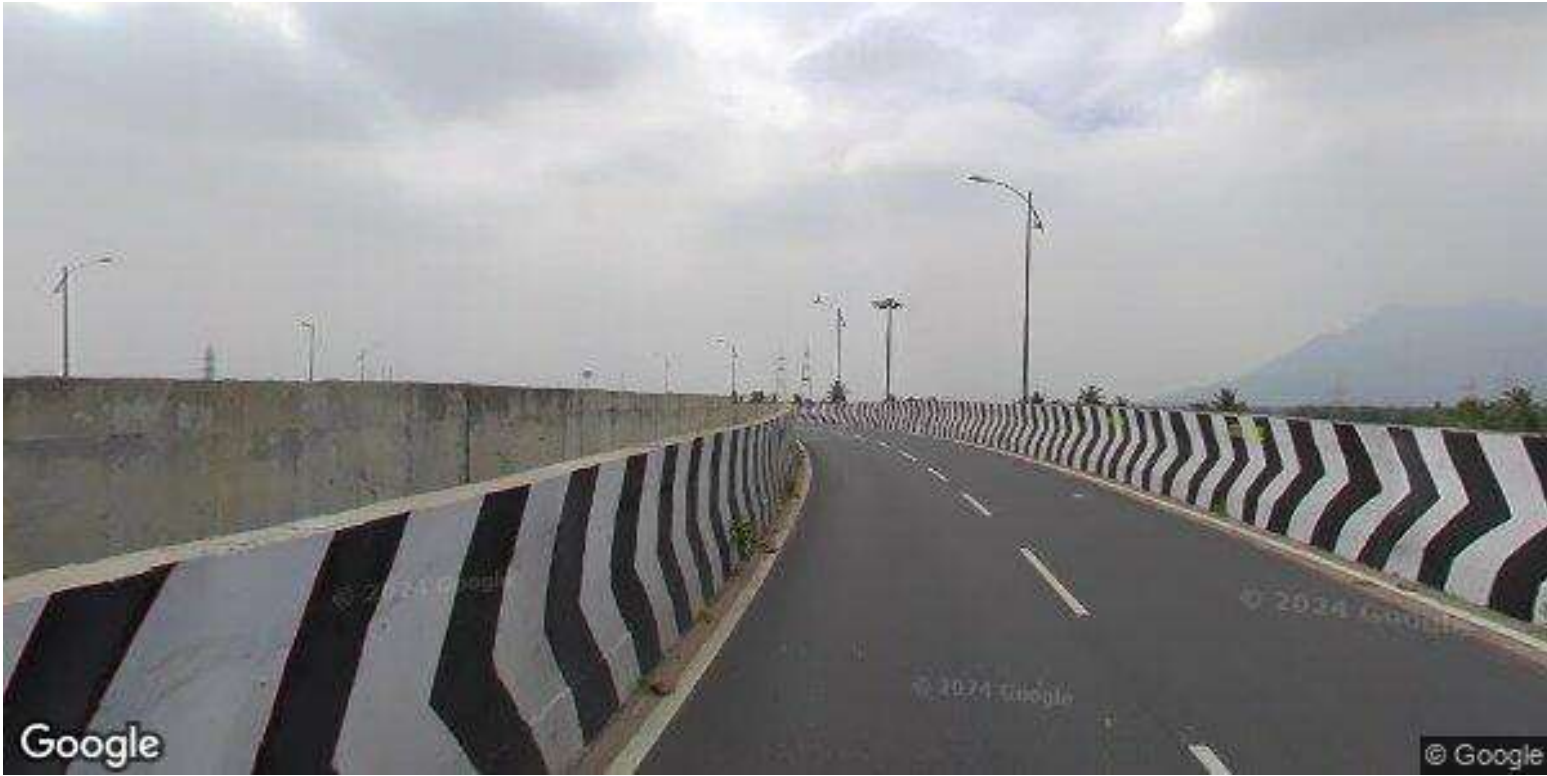
**Risk Type:** Turn  
**Risk Level:** High  
**Speed Limit:** 15 KM/Hr  
**Coordinates:** 11.64180, 78.11808

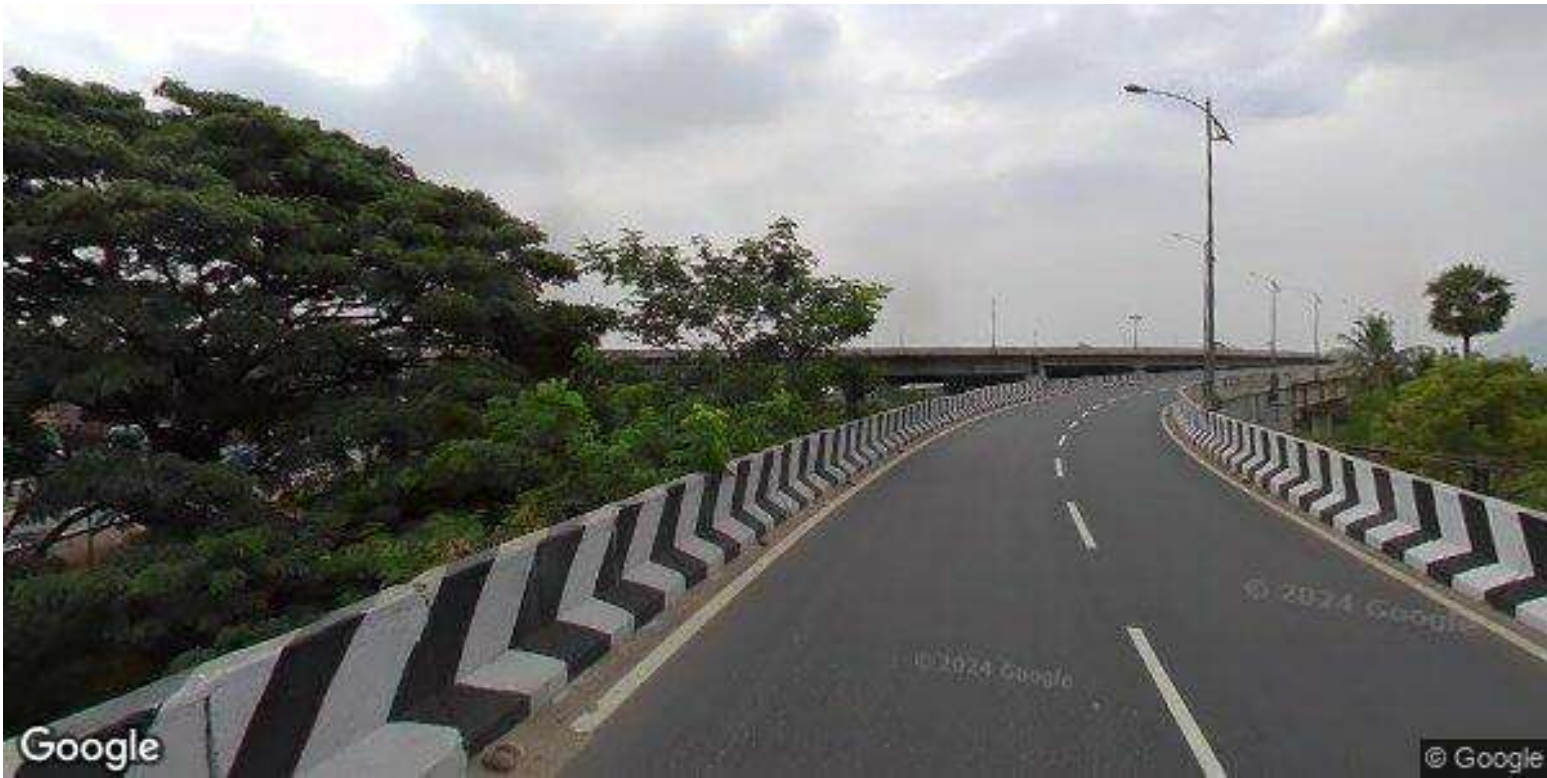
**Coordinates: 11.64325, 78.11993**

**Risk Type: Turn**

**Risk Level: High**

**Speed Limit: 15 KM/Hr**

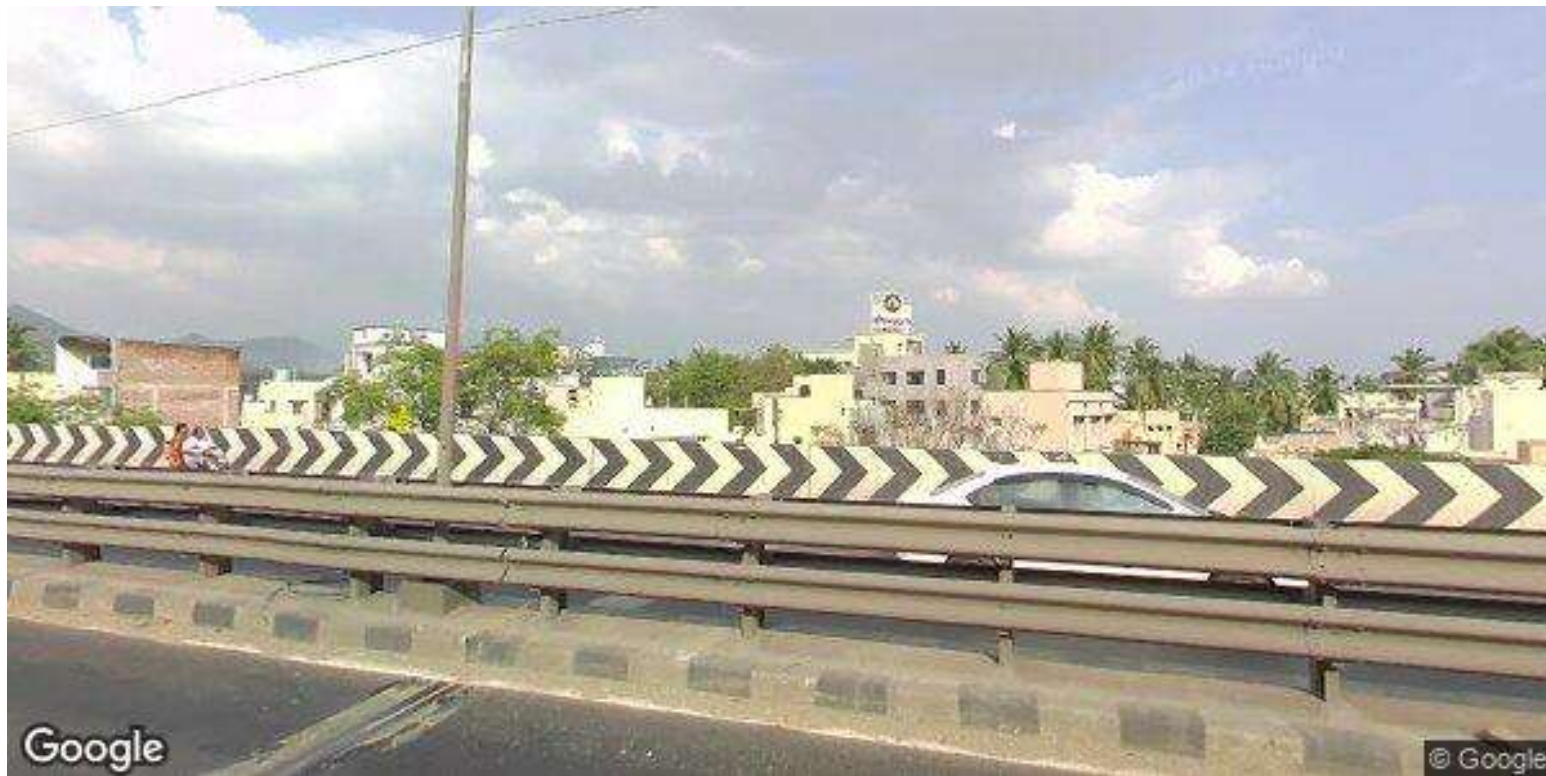
**Coordinates: 11.67865, 78.12803**

**Risk Type: Turn**

**Risk Level: Medium**

**Speed Limit: 30 KM/Hr**

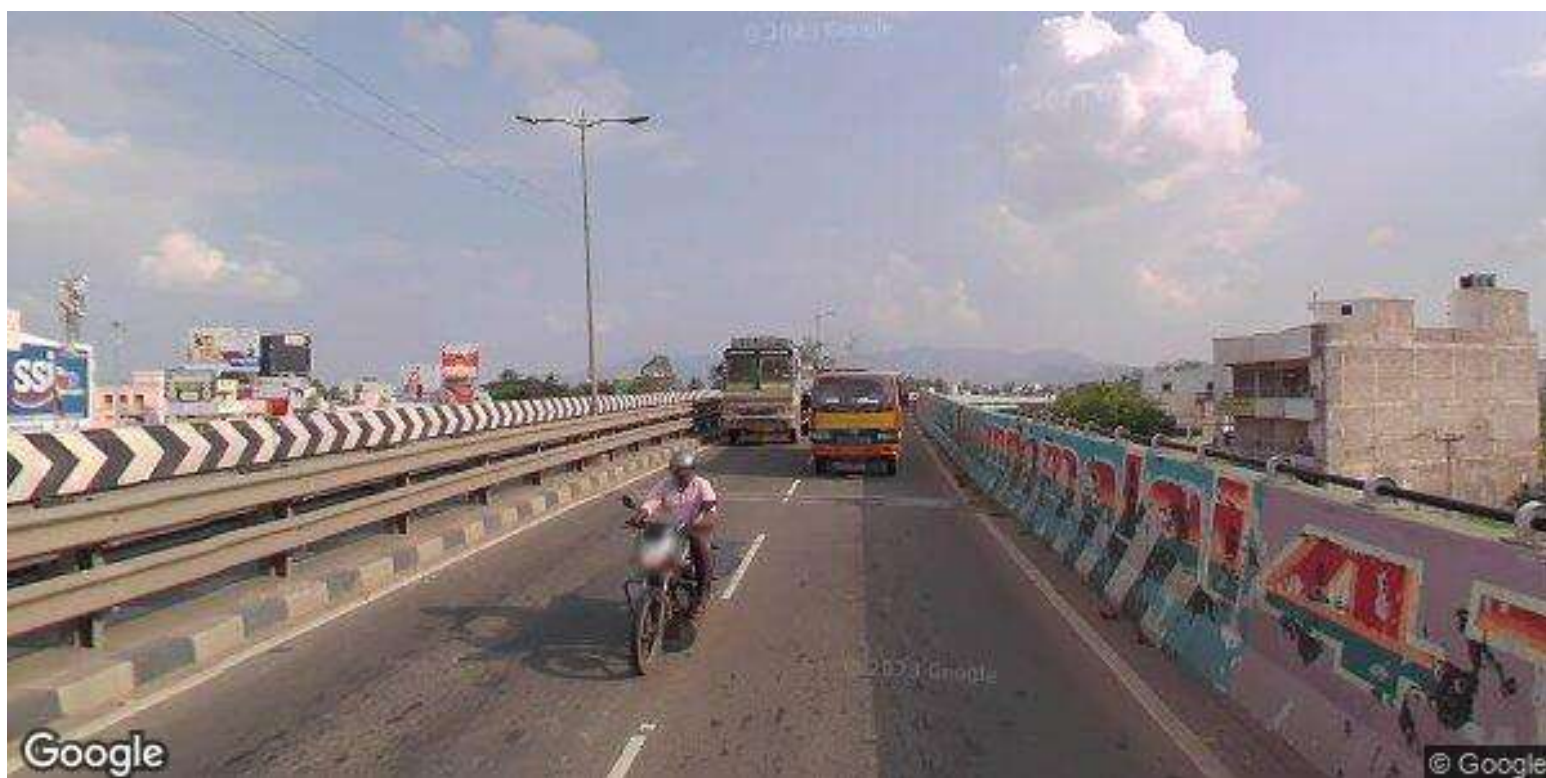
**Coordinates: 11.68201, 78.12639**

**Risk Type: Turn**

**Risk Level: Medium**

**Speed Limit: 30 KM/Hr**

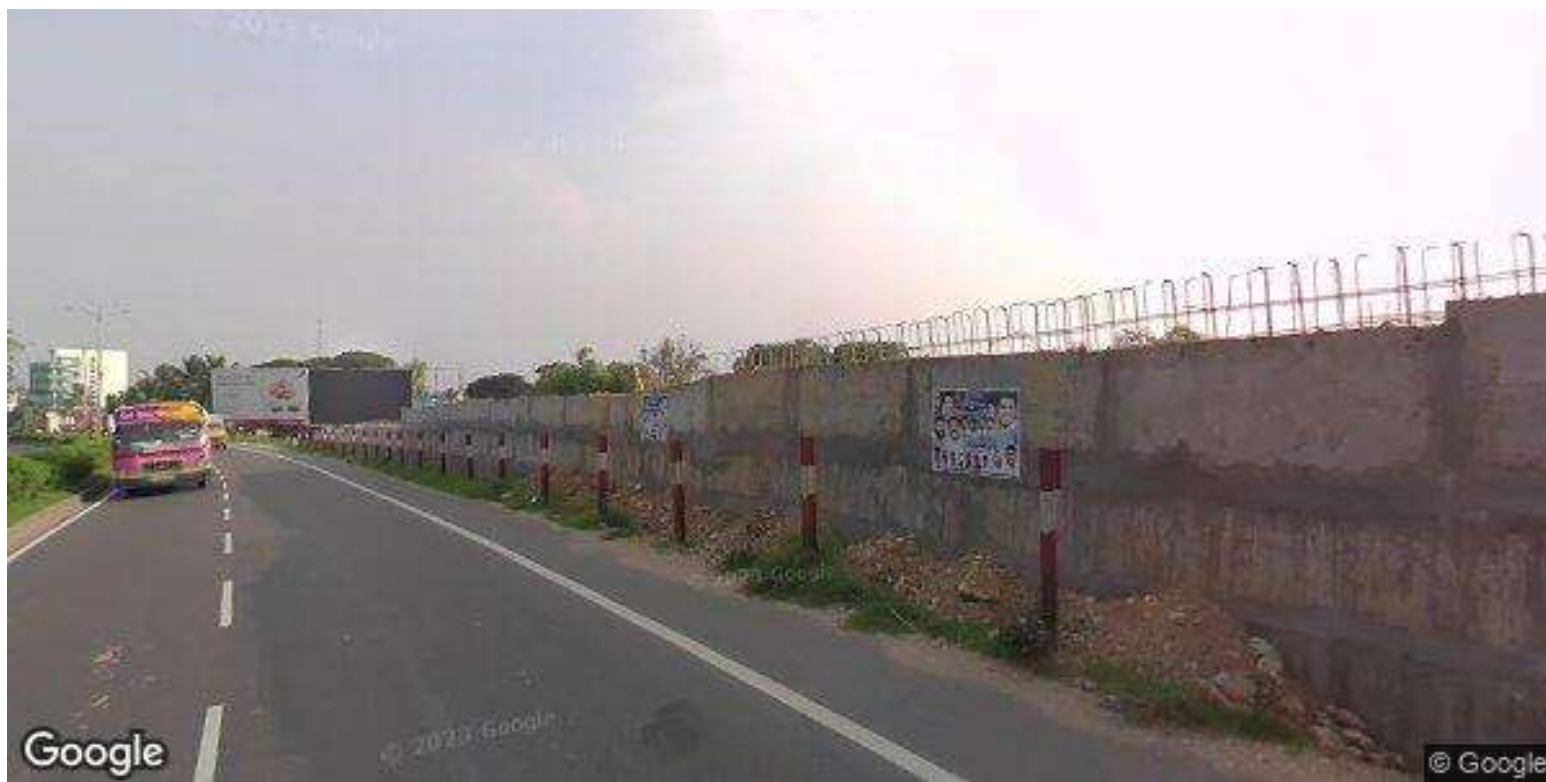
**Coordinates:** 11.69519, 78.10775

**Risk Type:** Turn

**Risk Level:** Medium

**Speed Limit:** 30 KM/Hr

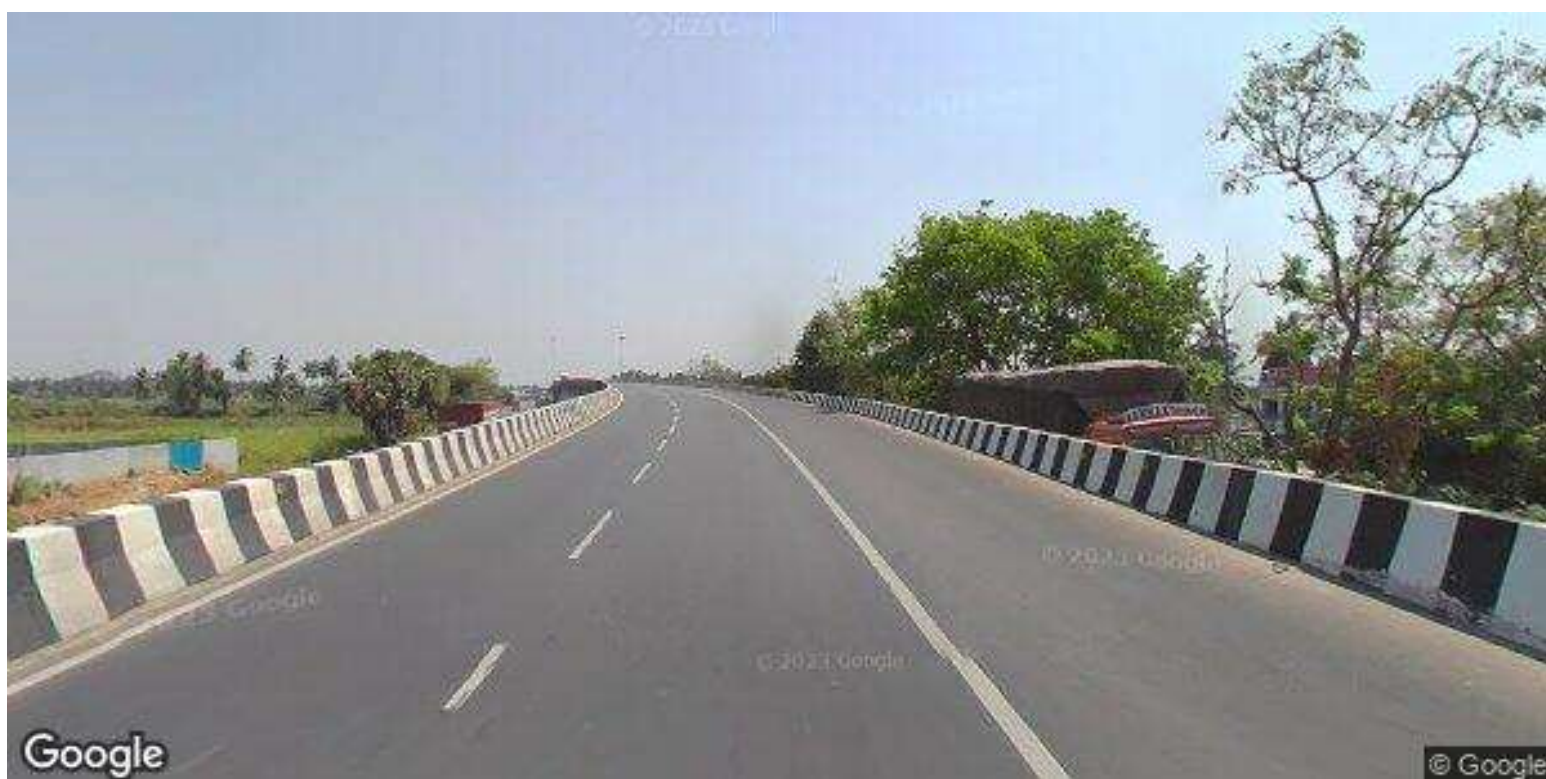
**Coordinates:** 11.73958, 78.05105

**Risk Type:** Turn

**Risk Level:** Medium

**Speed Limit:** 30 KM/Hr

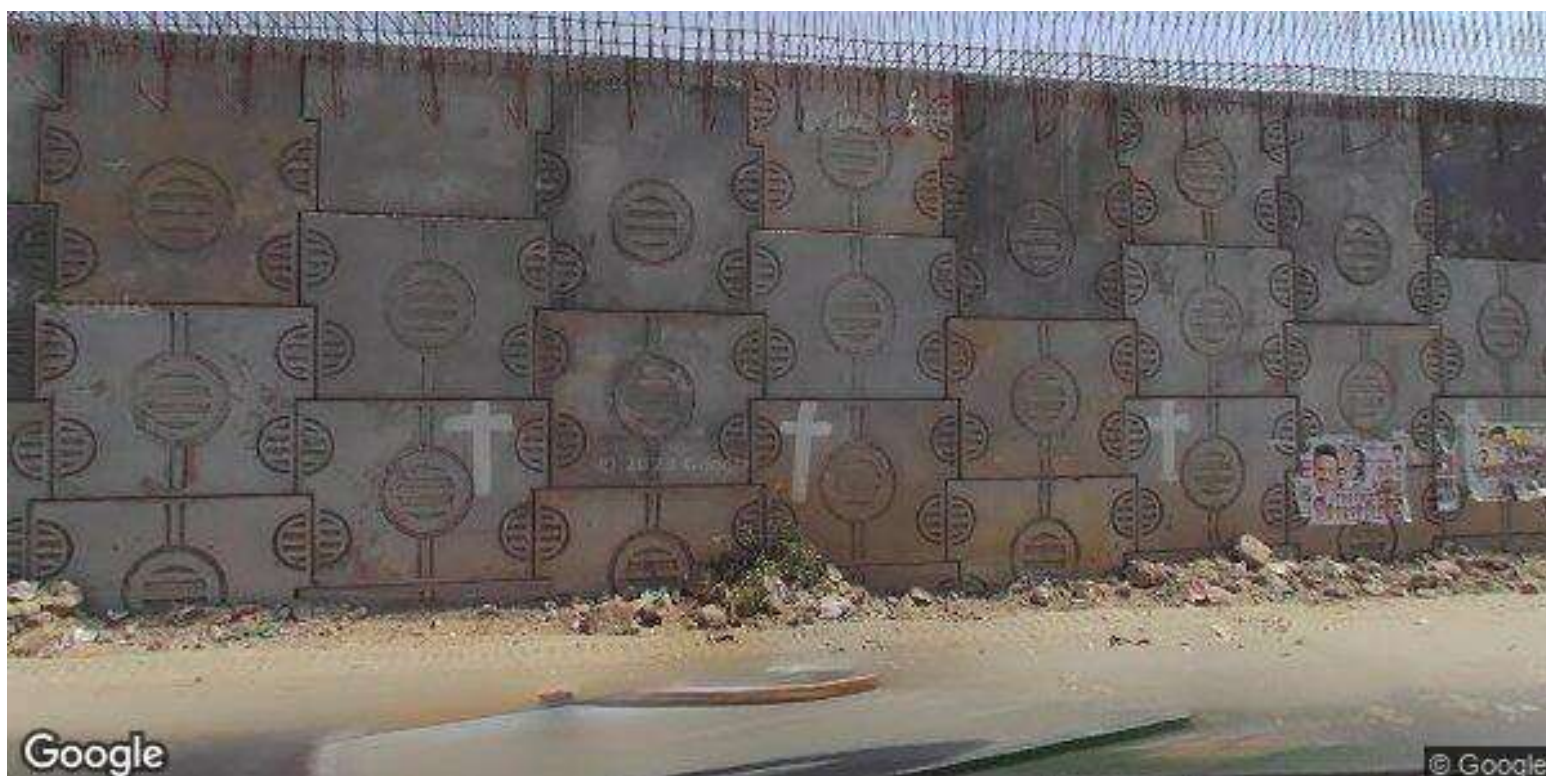
**Risk Type:** Turn  
**Risk Level:** Medium  
**Speed Limit:** 30 KM/Hr  
**Coordinates:** 11.75835, 78.05016

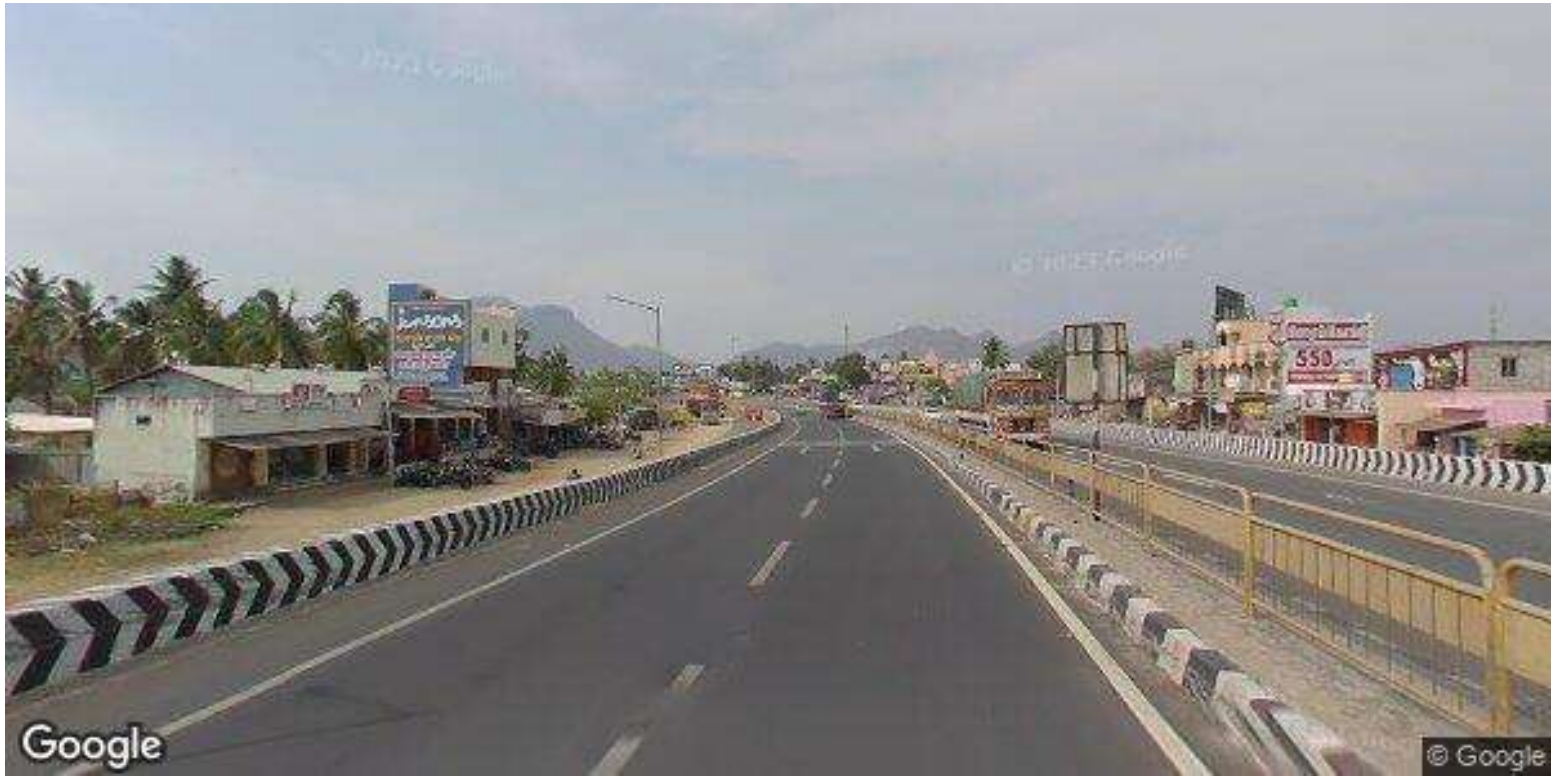
**Risk Type:** Turn  
**Risk Level:** Medium  
**Speed Limit:** 30 KM/Hr  
**Coordinates:** 11.86847, 78.08367

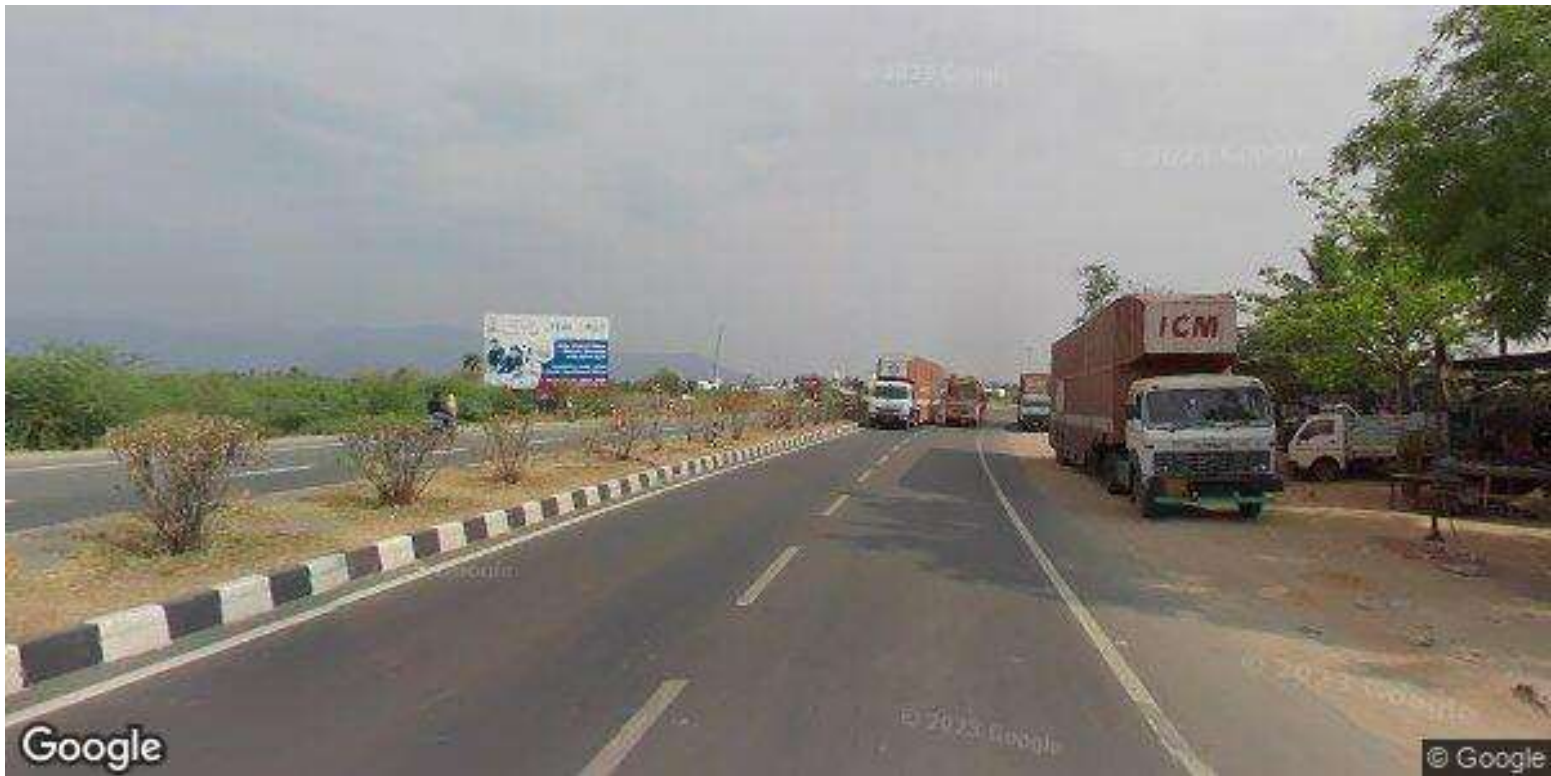
**Risk Type:** Turn  
**Risk Level:** Medium  
**Speed Limit:** 30 KM/Hr  
**Coordinates:** 11.87942, 78.08197

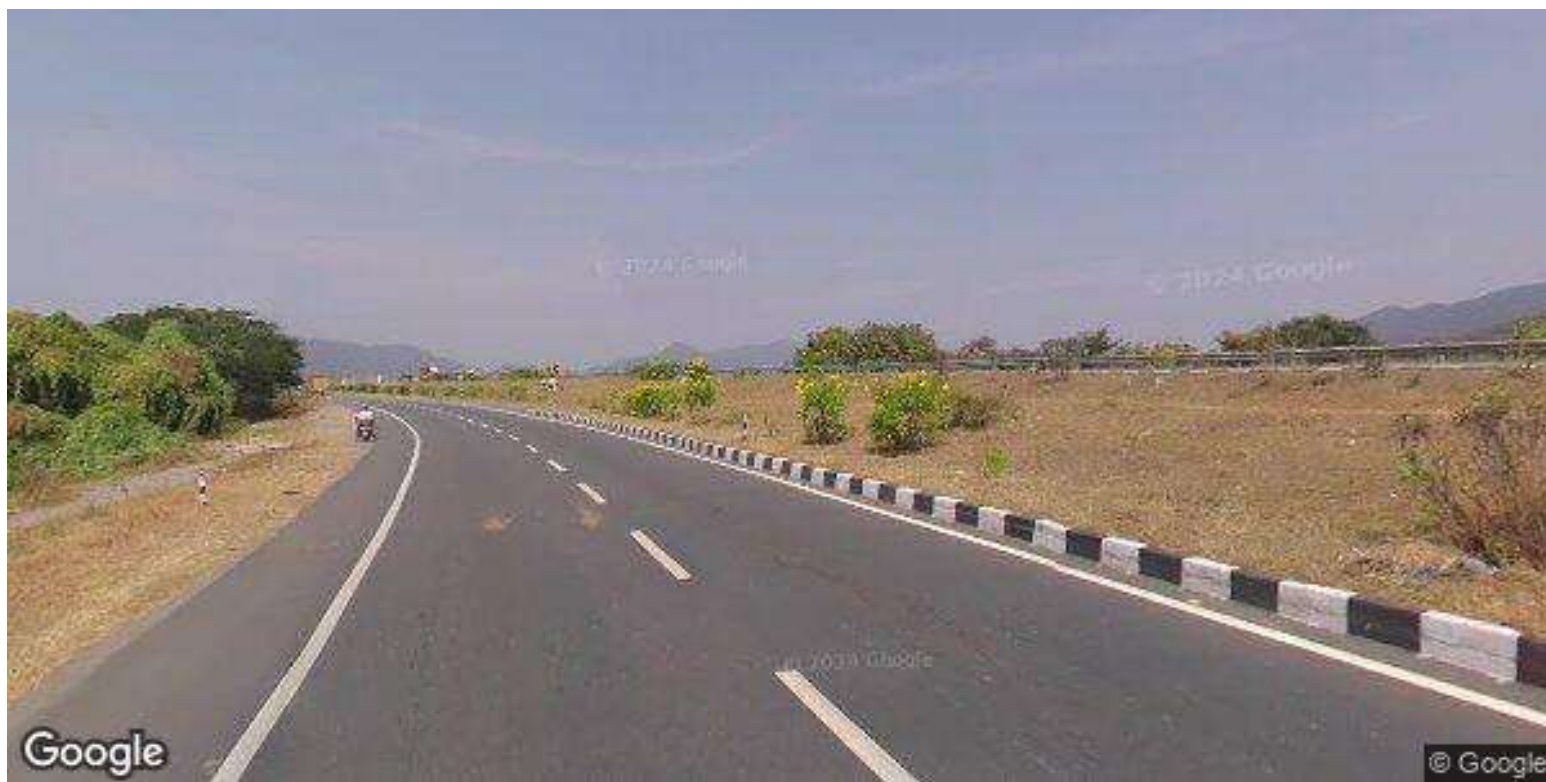
**Coordinates:** 11.92585, 78.06507

**Risk Type:** Turn

**Risk Level:** Medium

**Speed Limit:** 30 KM/Hr
