## JOURNEY RISK MANAGEMENT (JRM) STUDY

### Salem Terminal TO TVR FUELS STATION

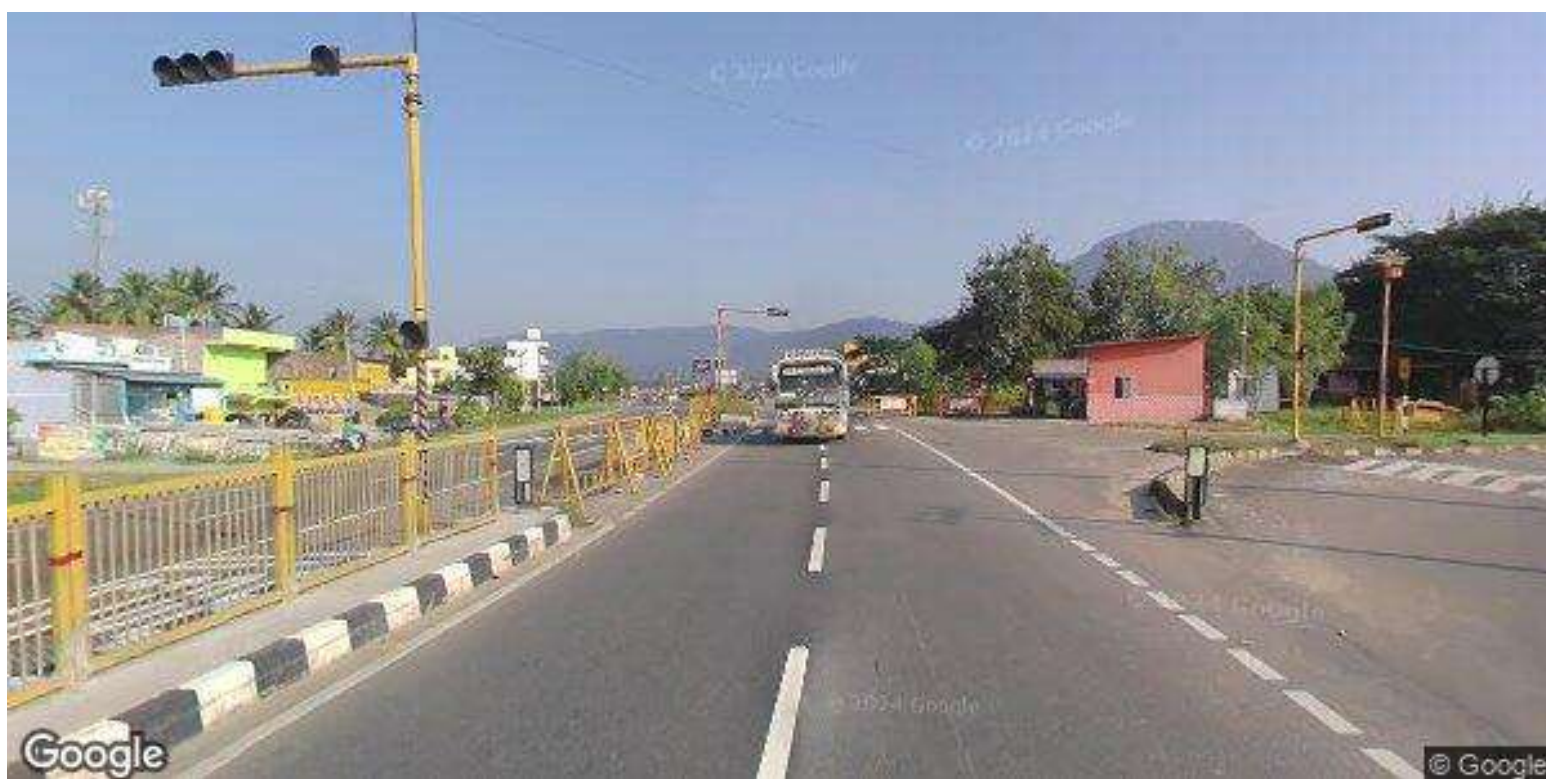
**Coordinates:** 11.93704, 78.05402

**Risk Type:** Turn

**Risk Level:** Medium

**Speed Limit:** 30 KM/Hr

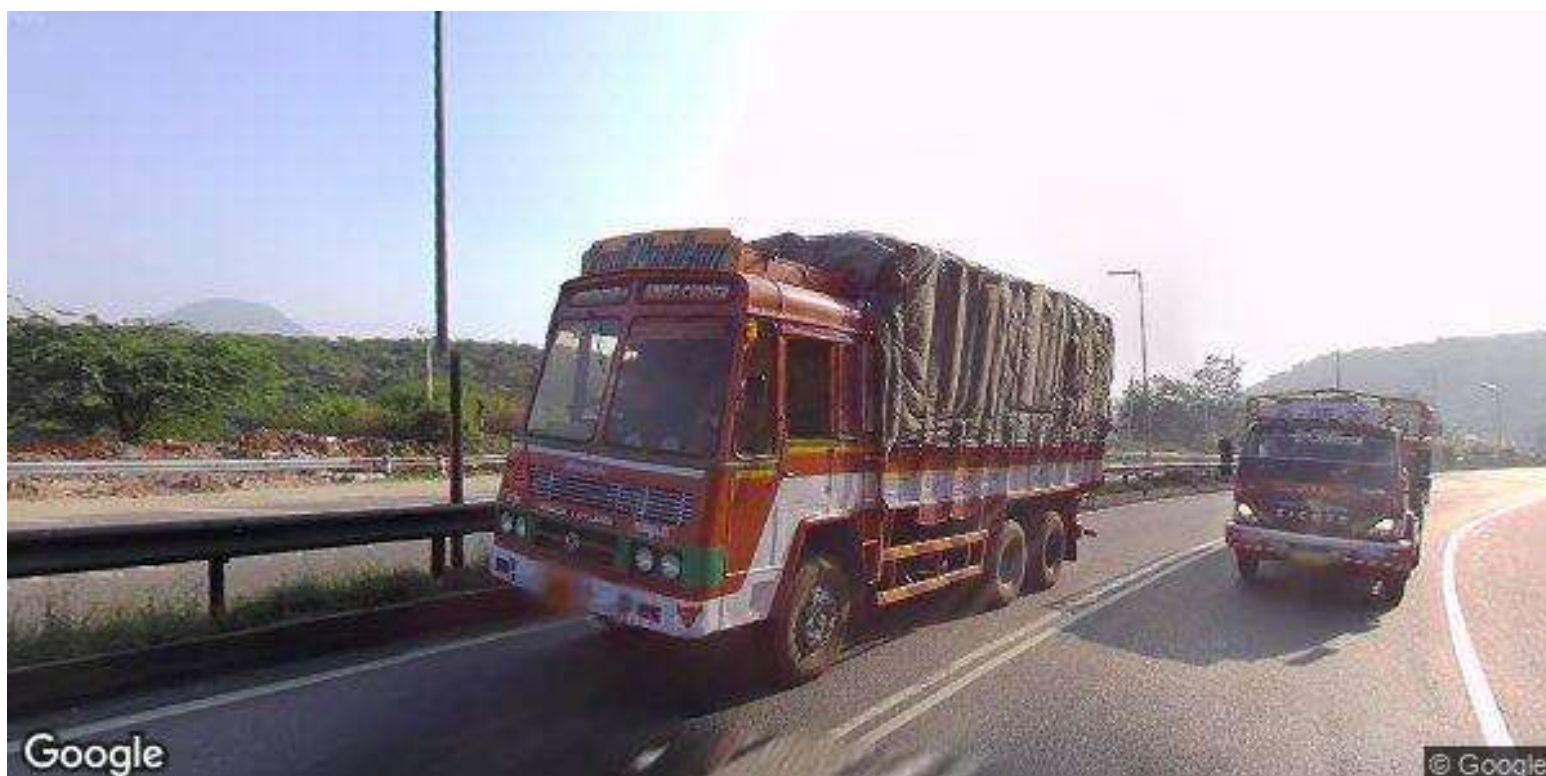
**Risk Type:** Turn  
**Risk Level:** High  
**Speed Limit:** 15 KM/Hr  
**Coordinates:** 11.95818, 78.04978

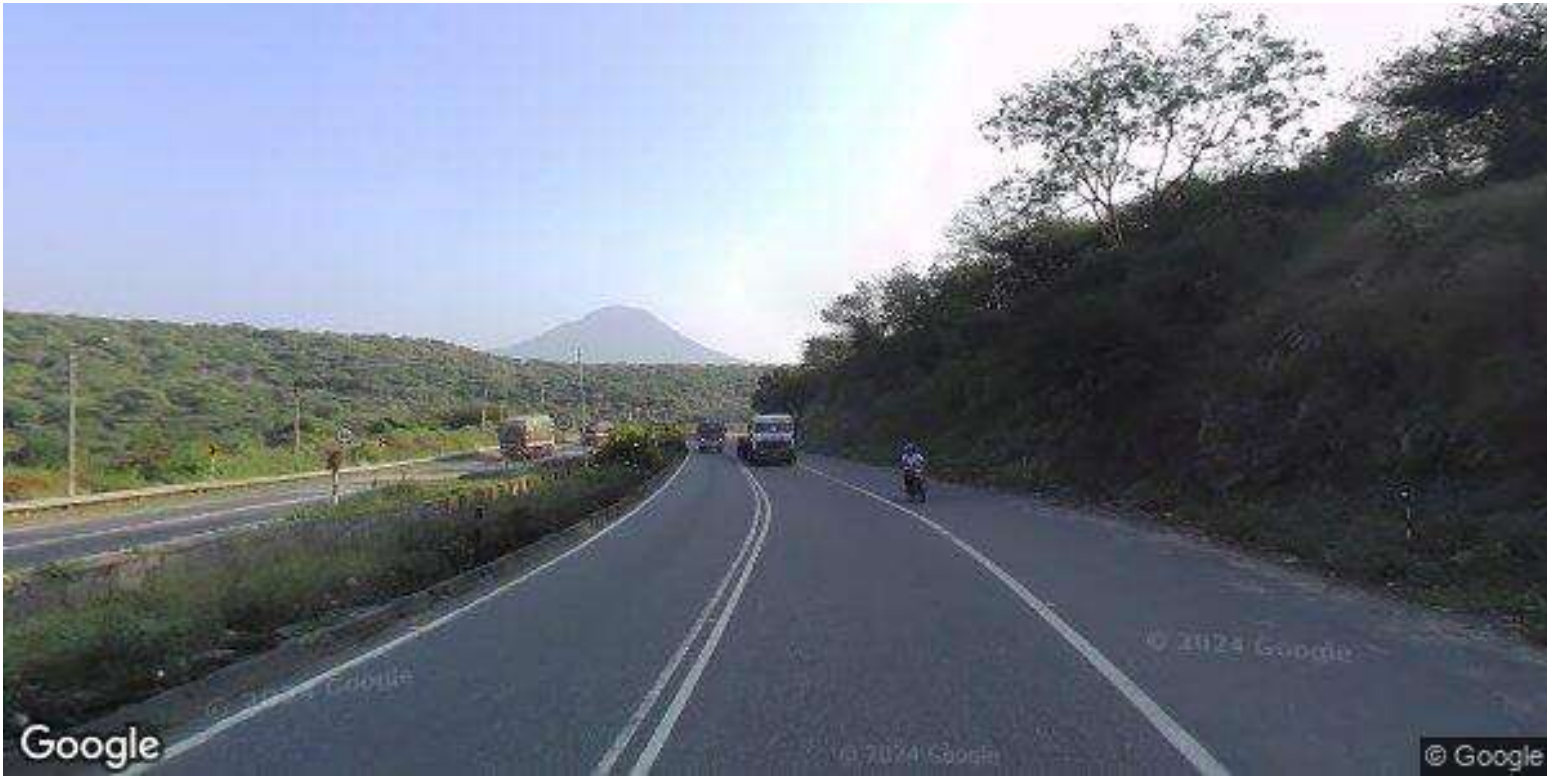
**Risk Type:** Turn  
**Risk Level:** Medium  
**Speed Limit:** 30 KM/Hr  
**Coordinates:** 11.95988, 78.04948

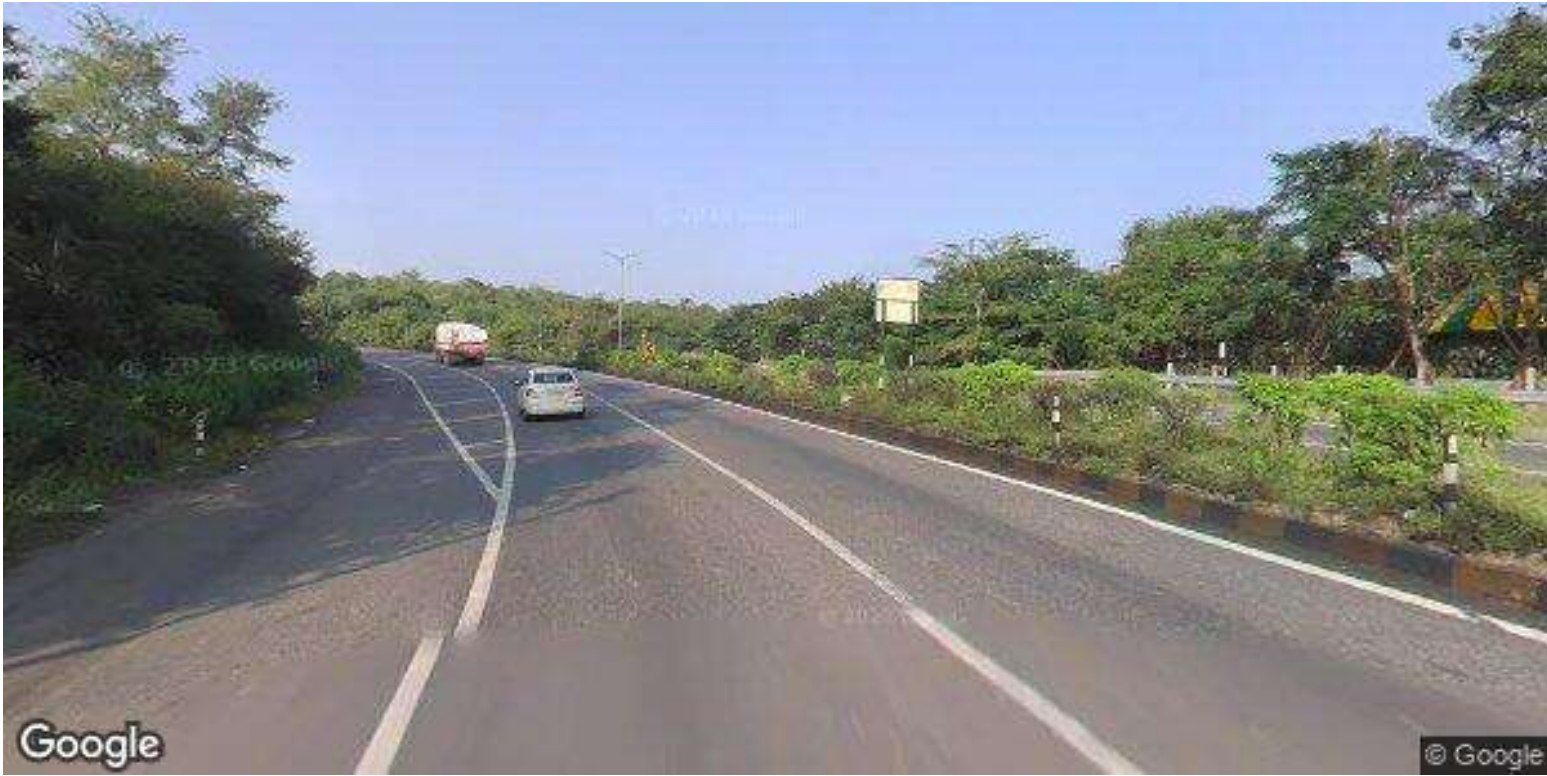
**Risk Type:** Turn  
**Risk Level:** Medium  
**Speed Limit:** 30 KM/Hr  
**Coordinates:** 11.96304, 78.05136

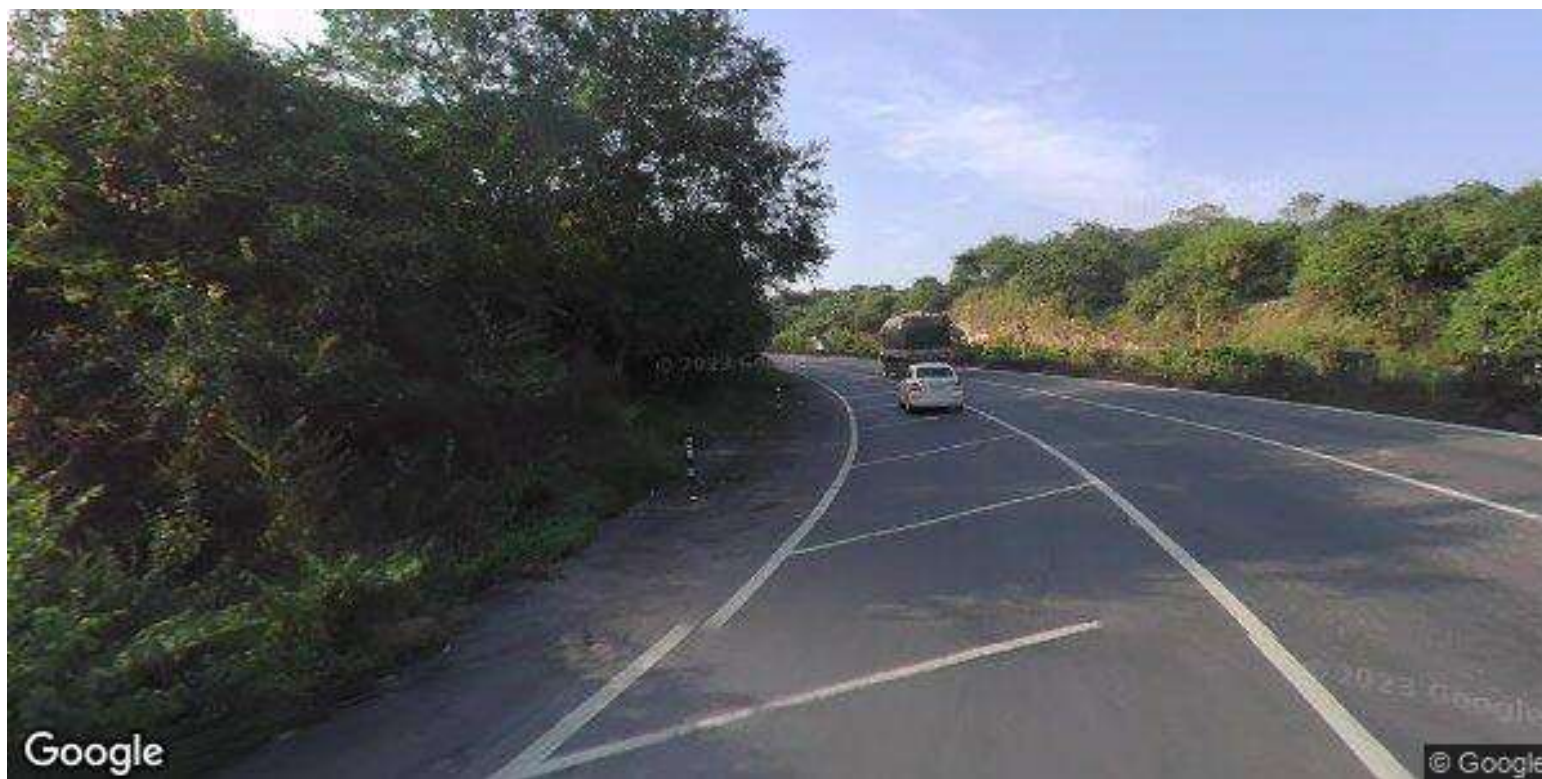
**Coordinates: 11.96399, 78.05135**

**Risk Type: Turn**

**Risk Level: High**

**Speed Limit: 15 KM/Hr**

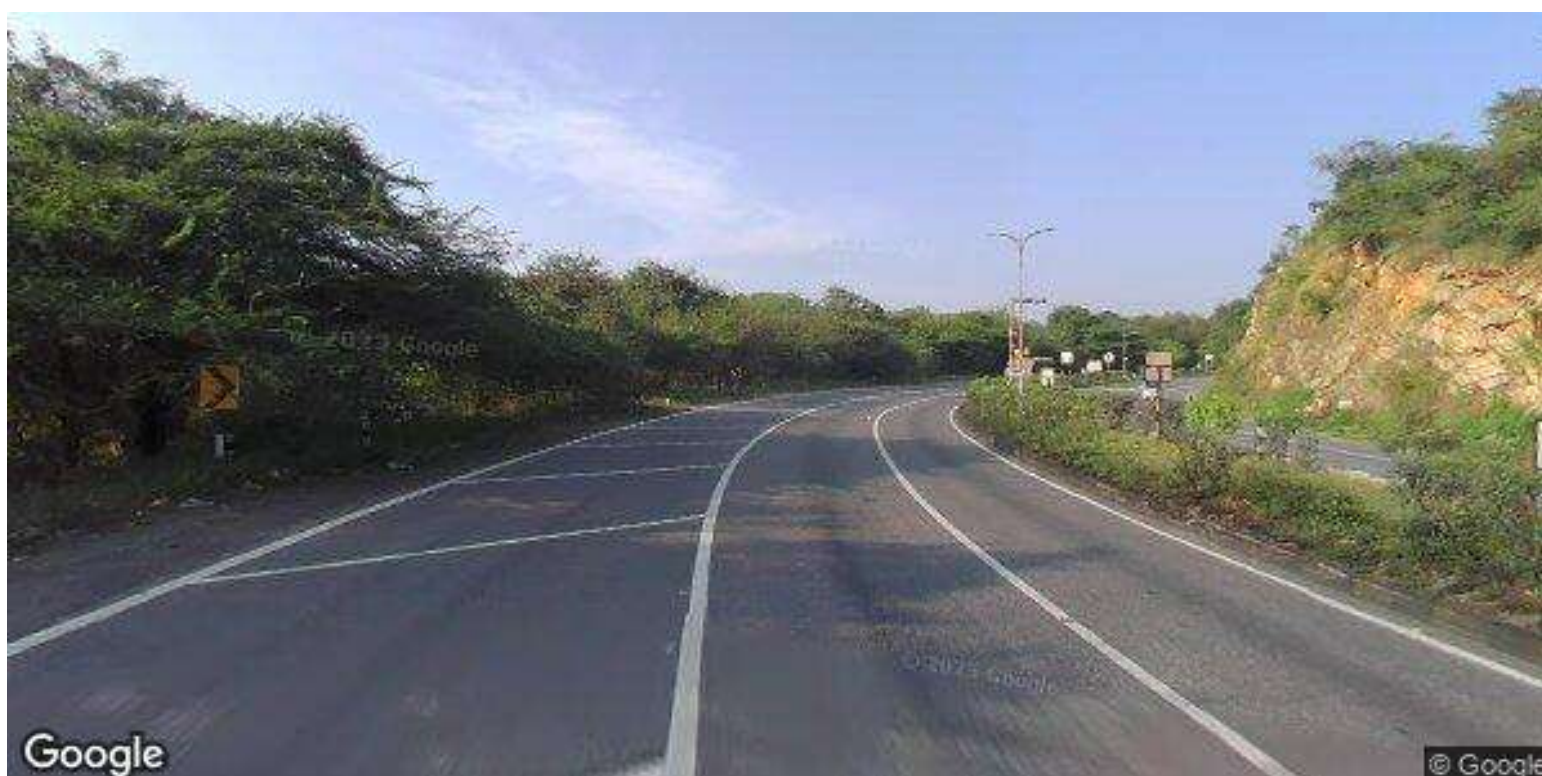
**Coordinates: 11.96580, 78.04923**

**Risk Type: Turn**

**Risk Level: High**

**Speed Limit: 15 KM/Hr**

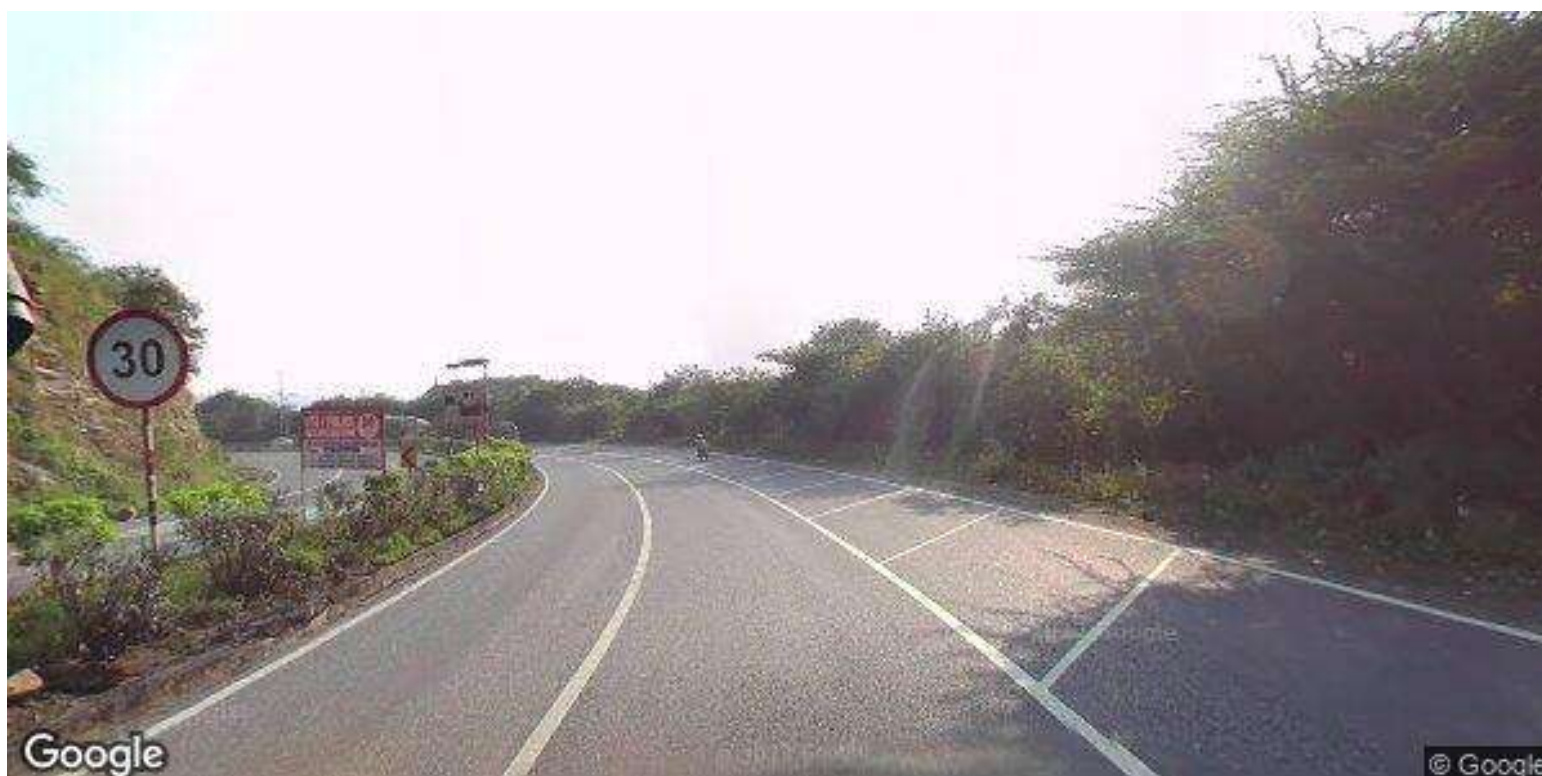
**Risk Type:** Turn  
**Risk Level:** Medium  
**Speed Limit:** 30 KM/Hr  
**Coordinates:** 11.96675, 78.04939

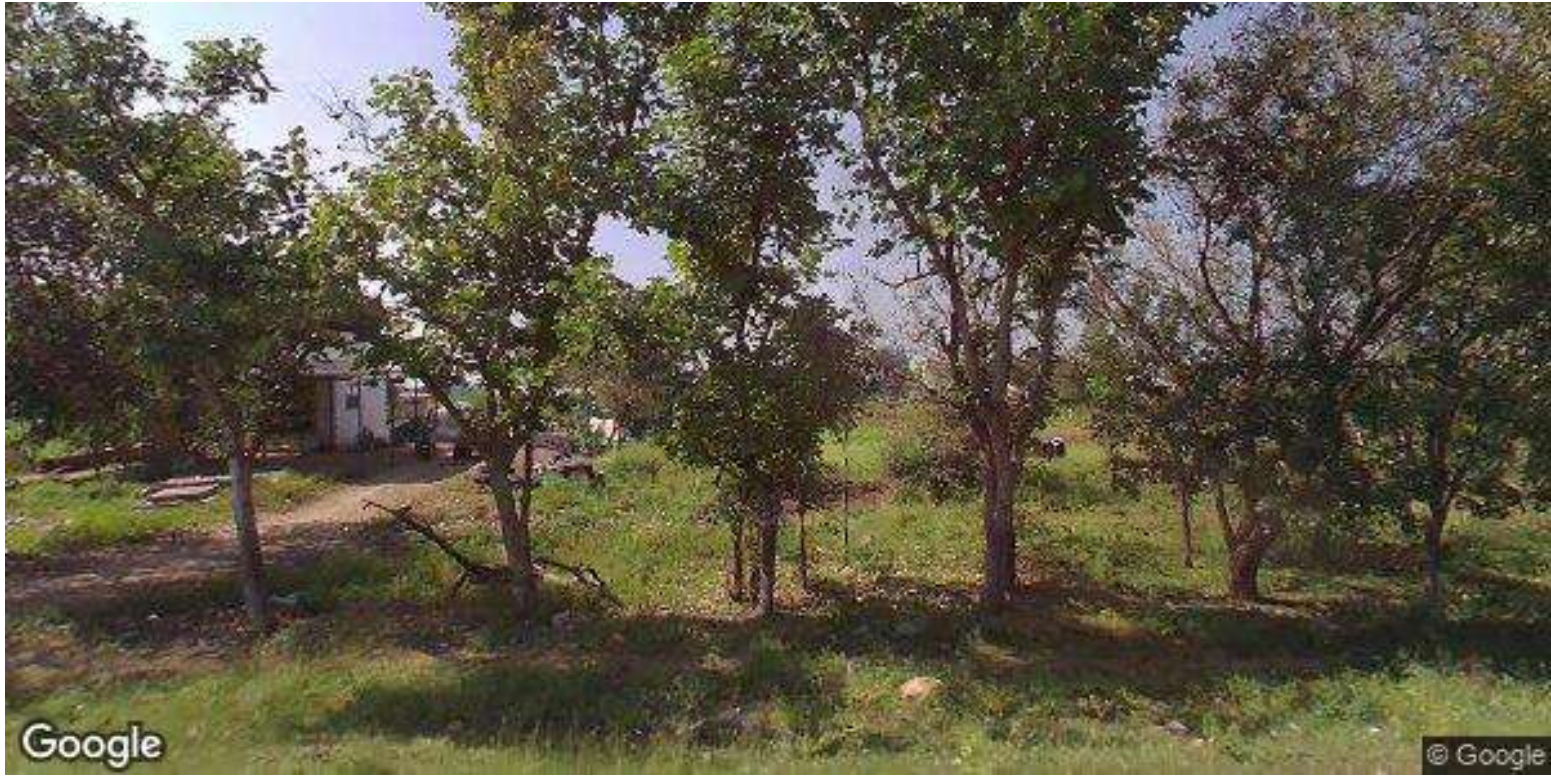
**Risk Type:** Turn  
**Risk Level:** Medium  
**Speed Limit:** 30 KM/Hr  
**Coordinates:** 12.11983, 78.13276

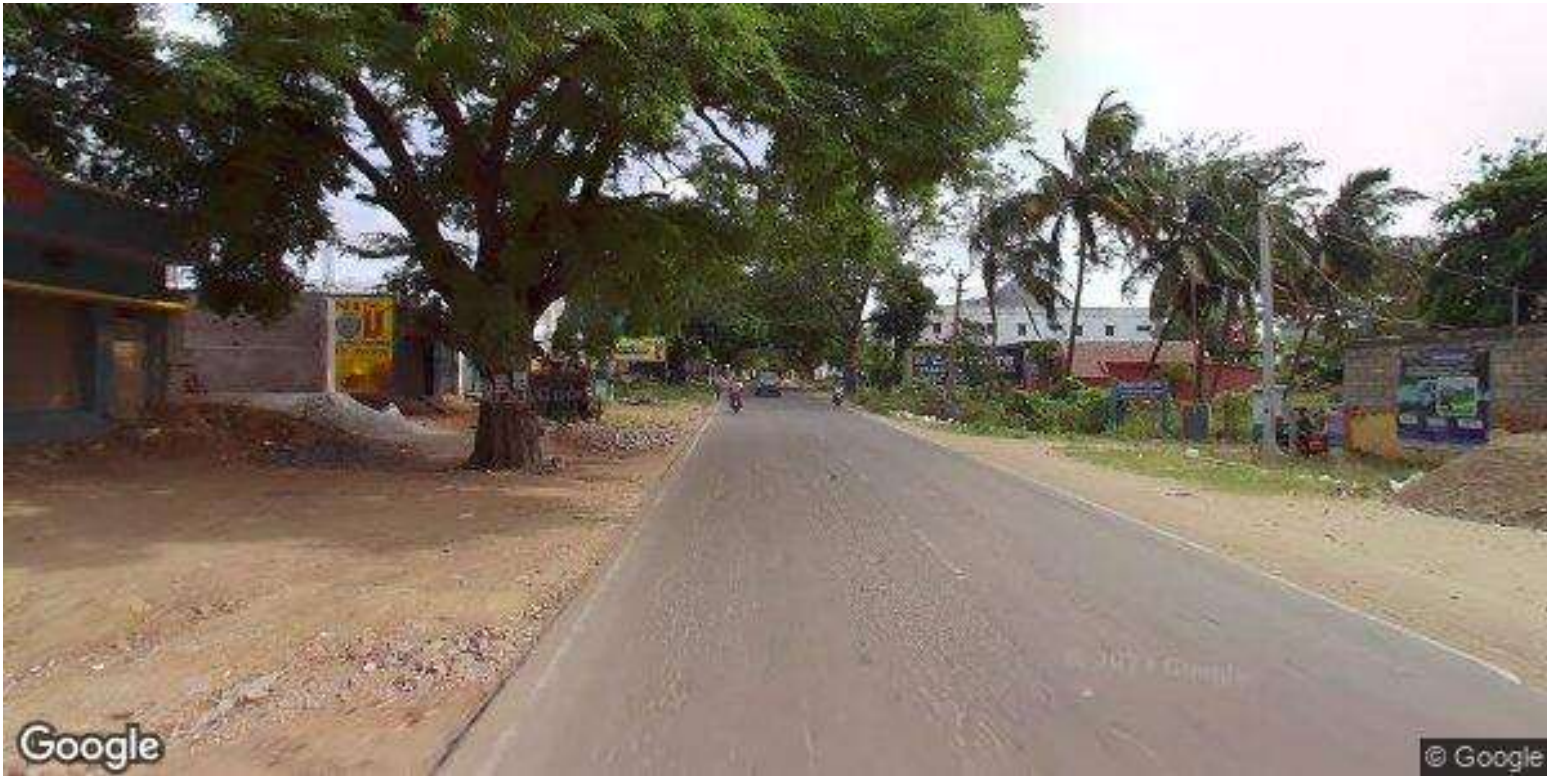
**Risk Type:** Turn  
**Risk Level:** Medium  
**Speed Limit:** 30 KM/Hr  
**Coordinates:** 12.50505, 78.03133

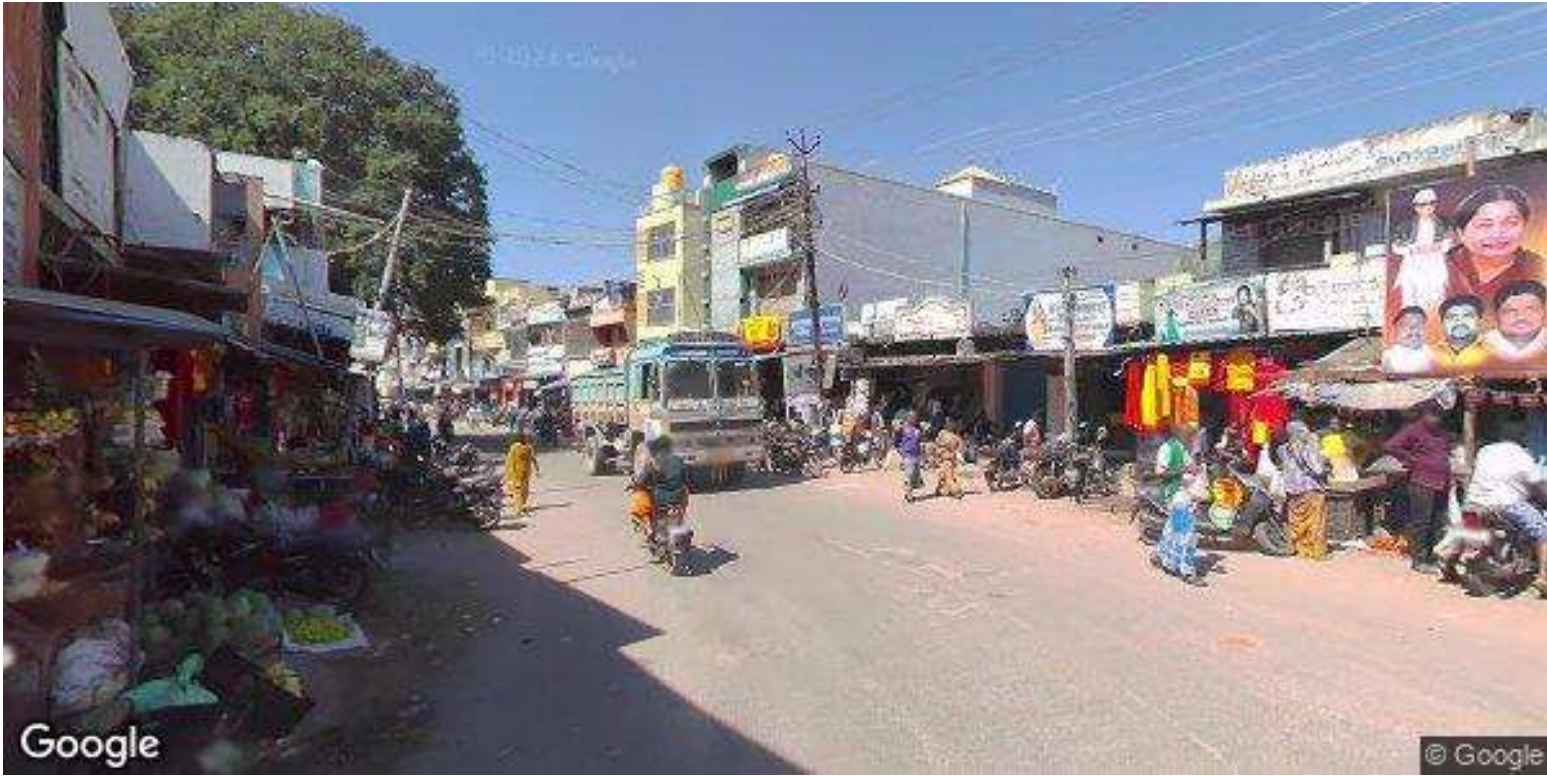
**Risk Type:** Blind Spot  
**Risk Level:** Blind Spot  
**Speed Limit:** 10 KM/Hr  
**Coordinates:** 12.51384, 78.03205

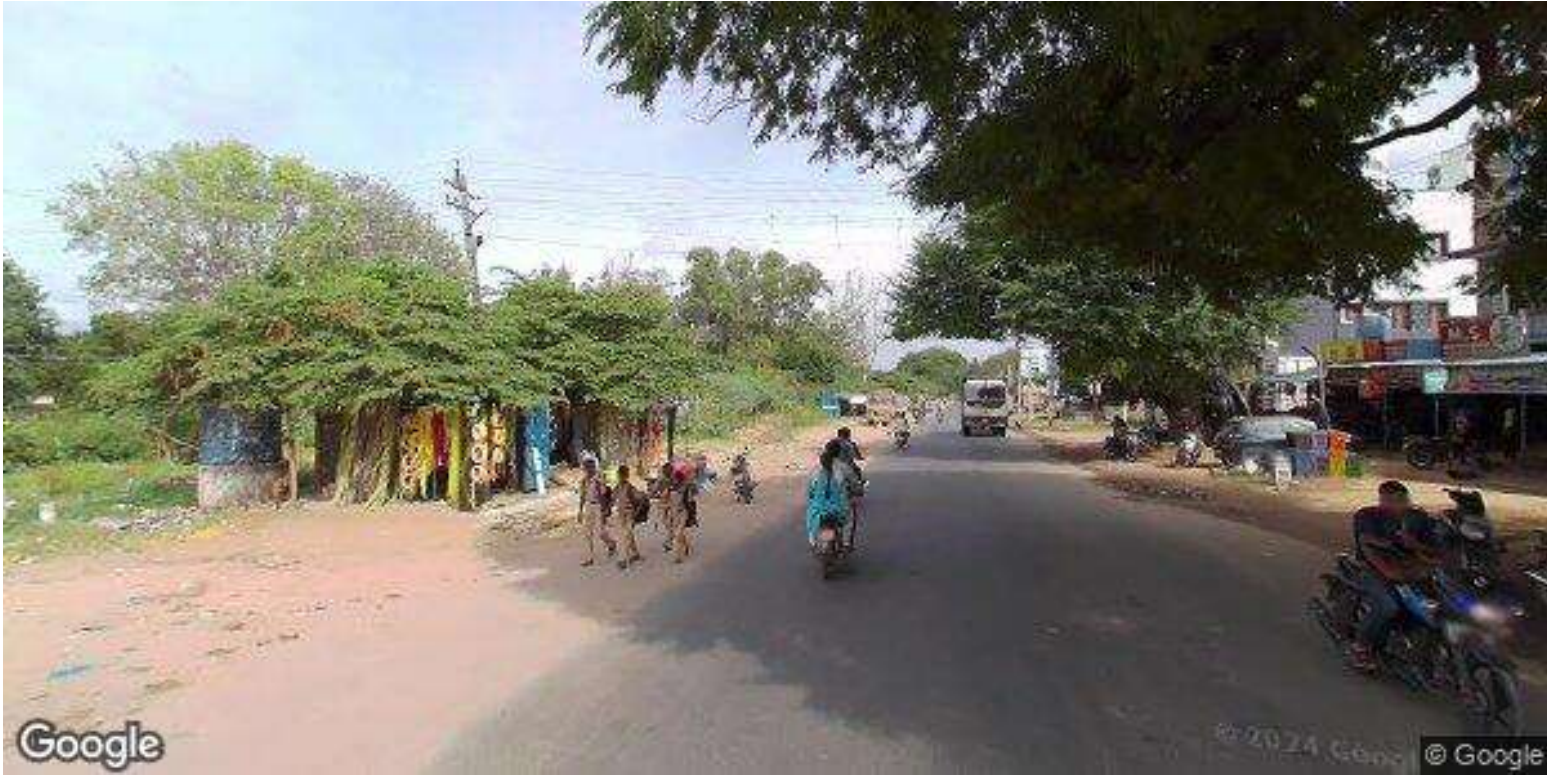
**Risk Type:** Turn  
**Risk Level:** Medium  
**Speed Limit:** 30 KM/Hr  
**Coordinates:** 12.51395, 78.02896

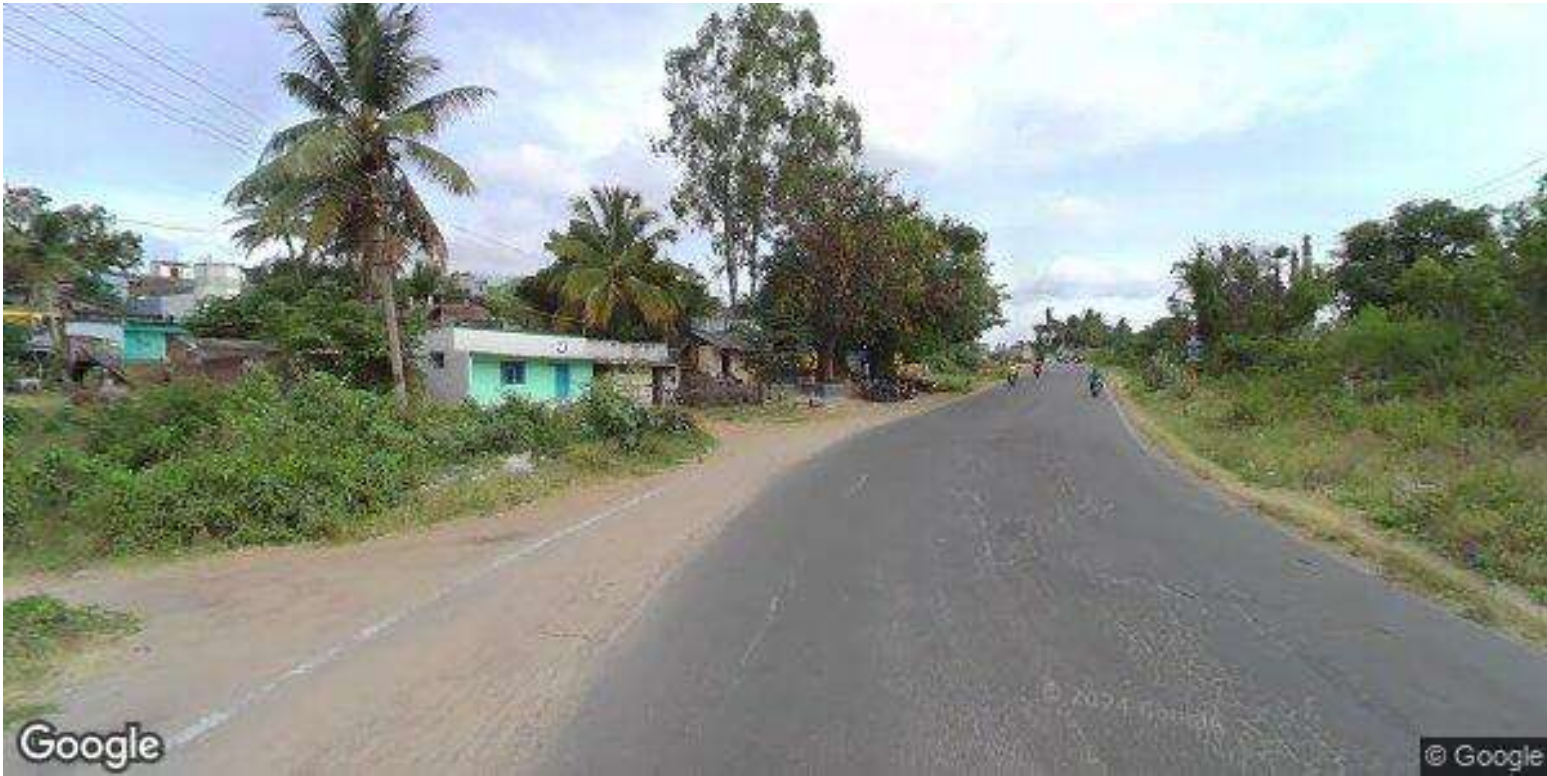
**Risk Type:** Turn  
**Risk Level:** Medium  
**Speed Limit:** 30 KM/Hr  
**Coordinates:** 12.51637, 78.02568

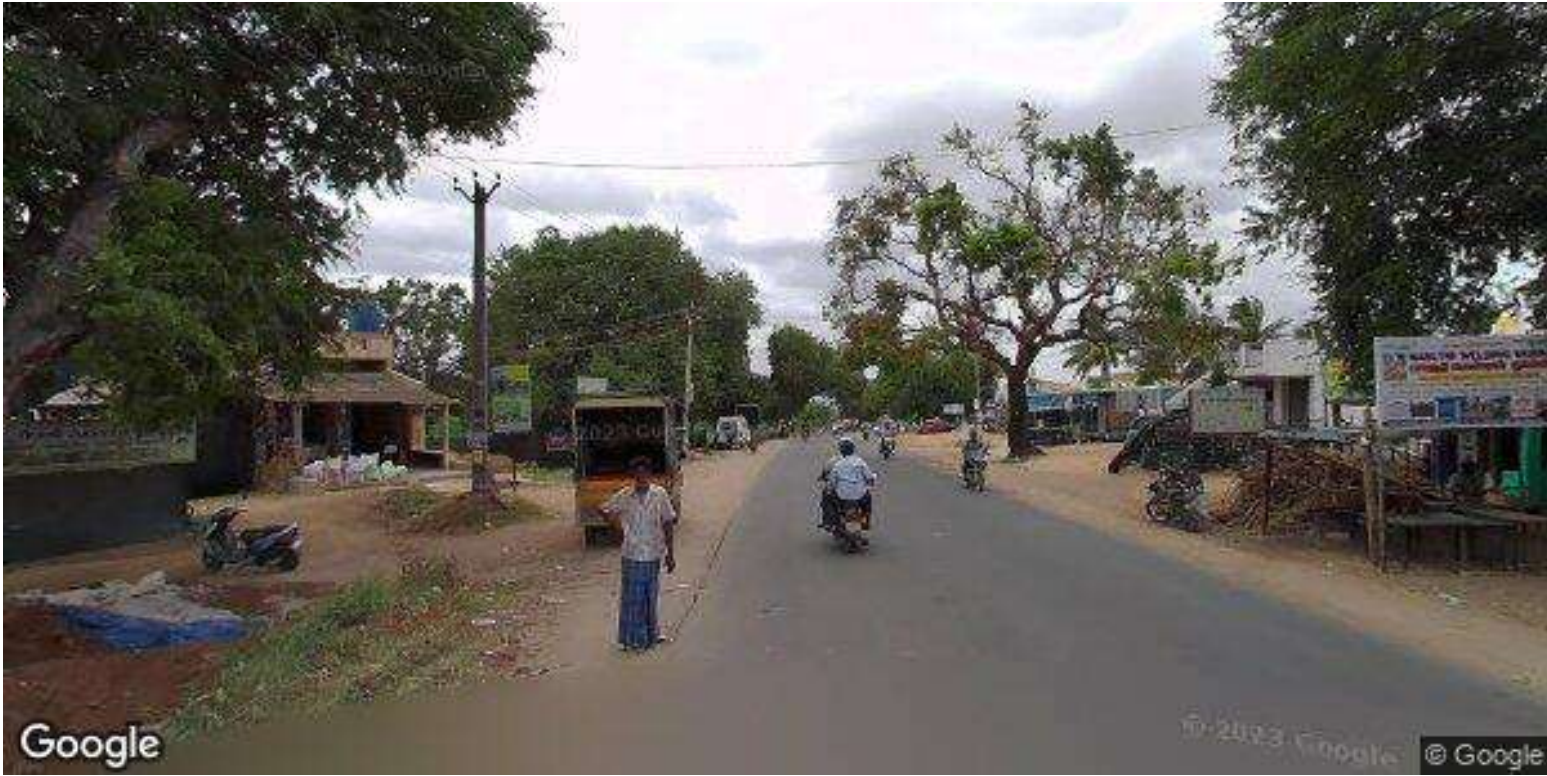
**Risk Type:** Turn  
**Risk Level:** Medium  
**Speed Limit:** 30 KM/Hr  
**Coordinates:** 12.52171, 78.02417

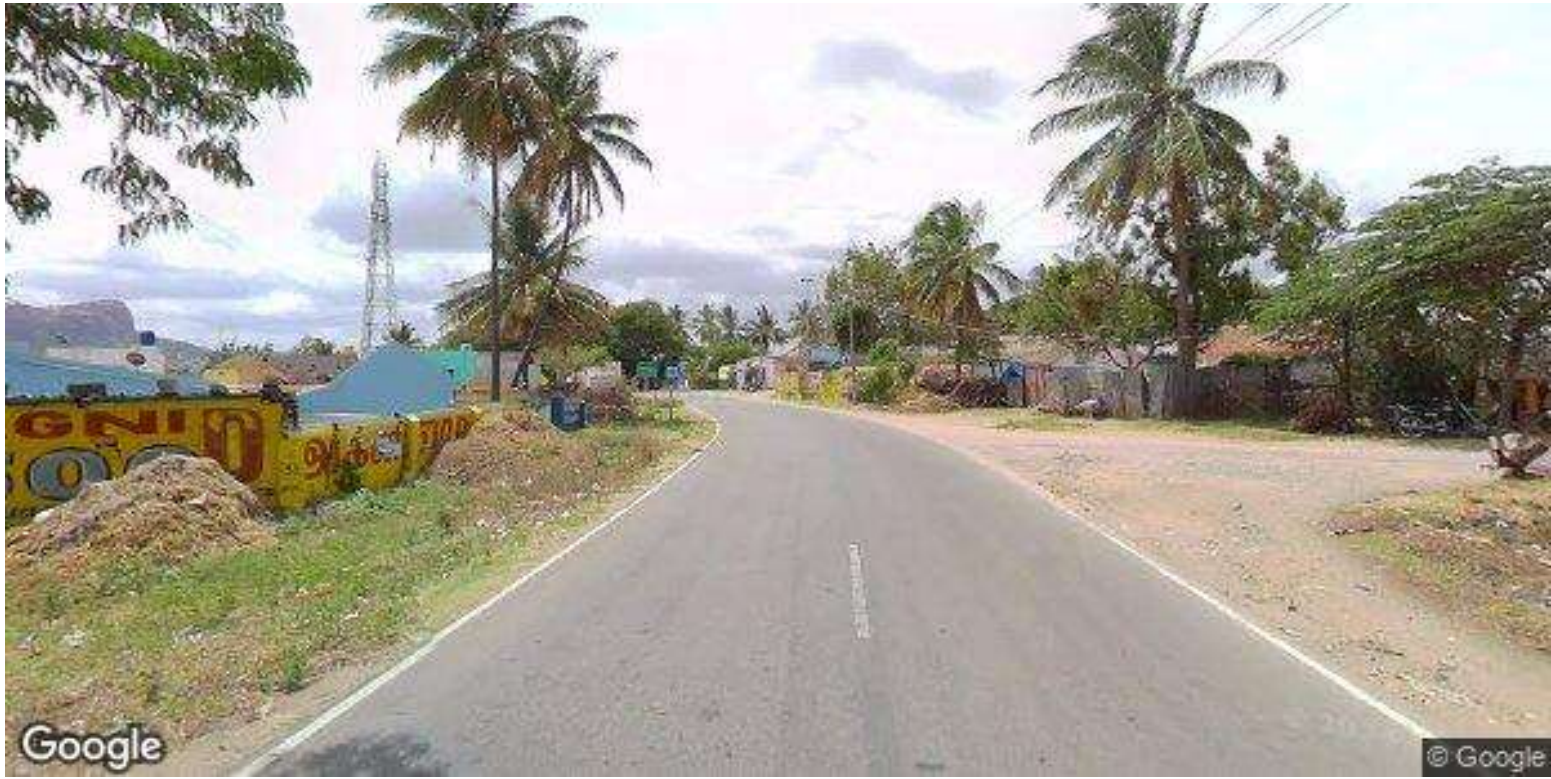
**Risk Type:** Turn  
**Risk Level:** Medium  
**Speed Limit:** 30 KM/Hr  
**Coordinates:** 12.52712, 78.00951

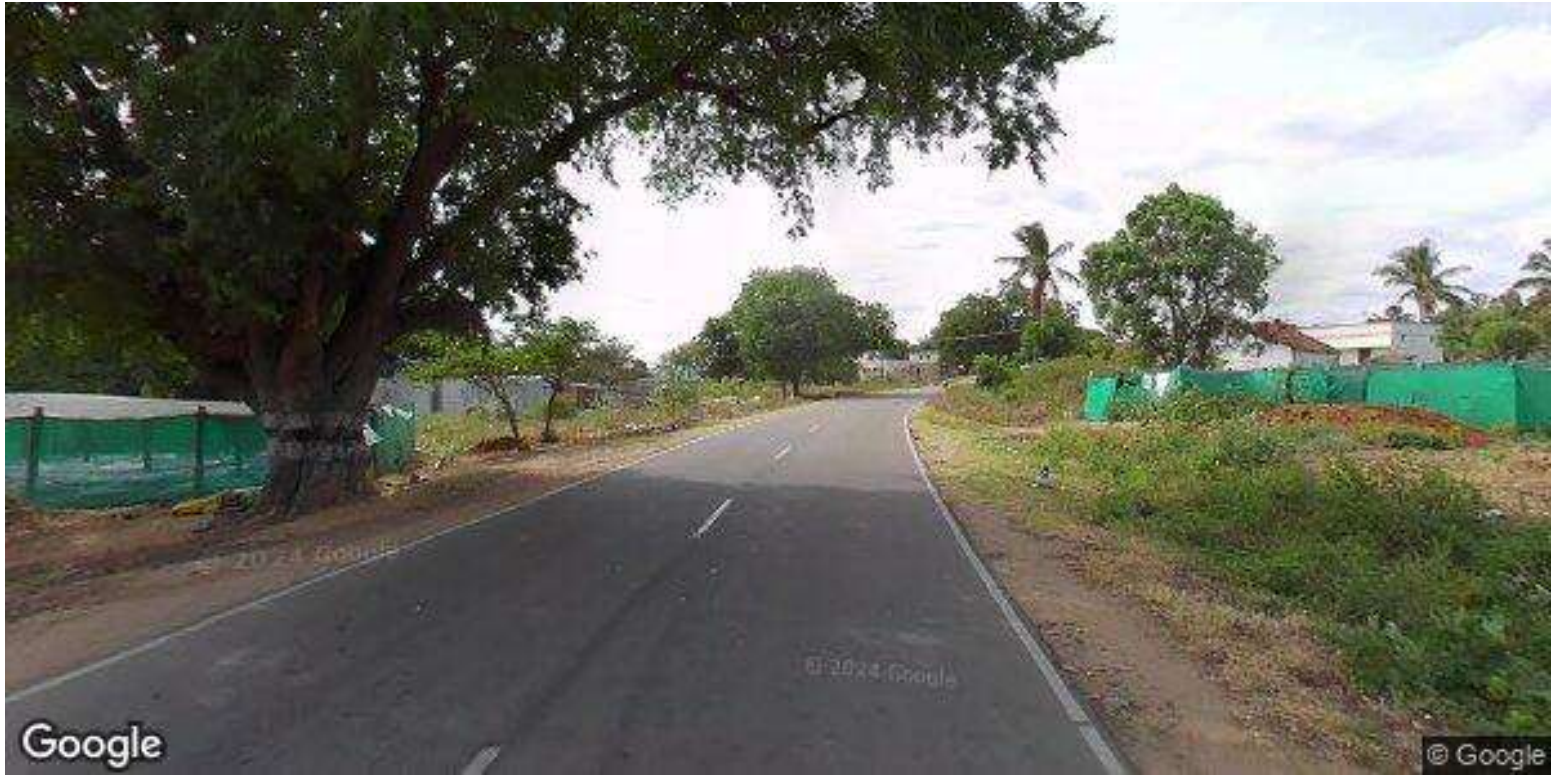
**Risk Type:** Turn  
**Risk Level:** Medium  
**Speed Limit:** 30 KM/Hr  
**Coordinates:** 12.52900, 78.00856

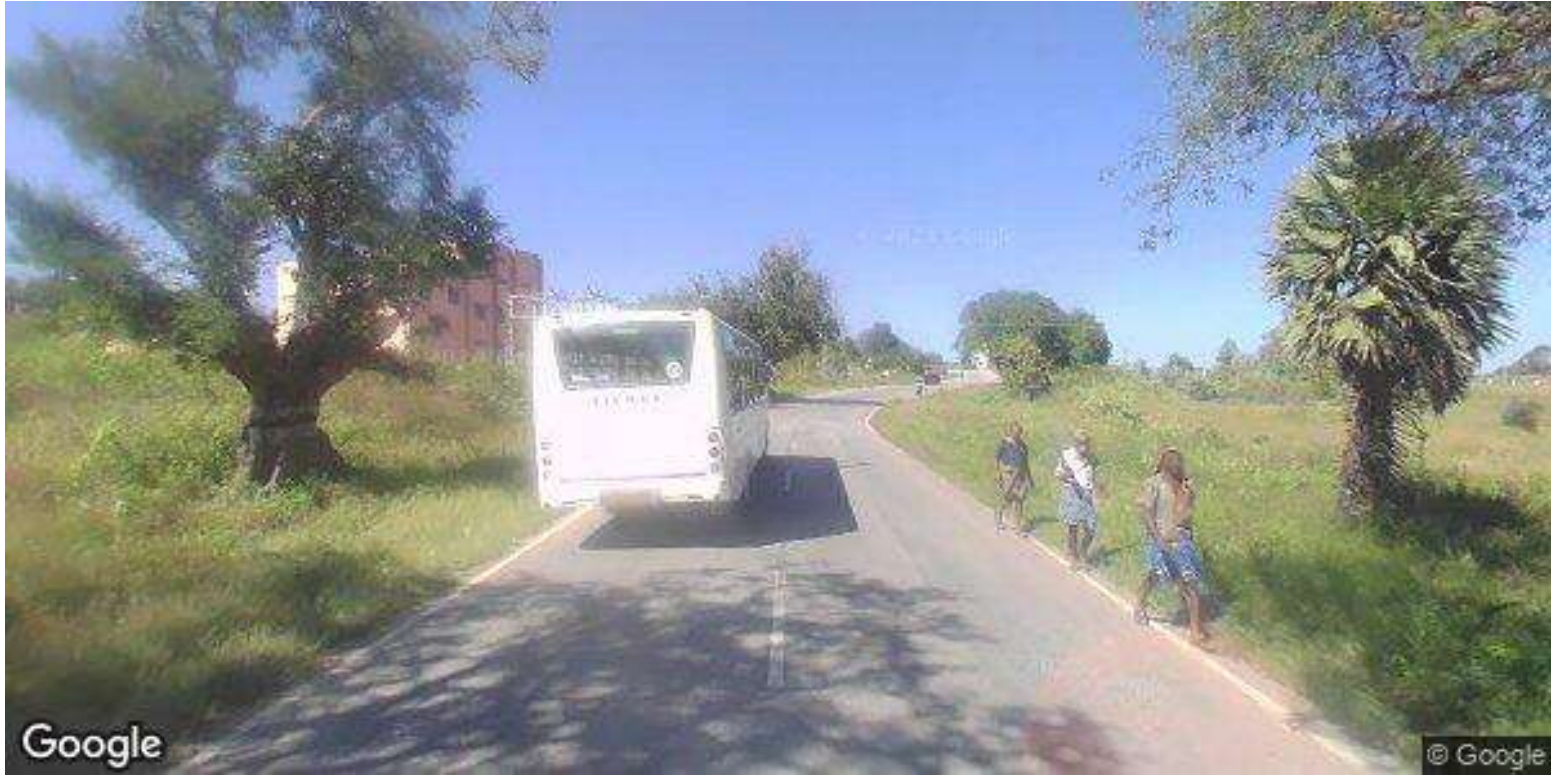
**Risk Type:** Turn  
**Risk Level:** Medium  
**Speed Limit:** 30 KM/Hr  
**Coordinates:** 12.54948, 77.97277

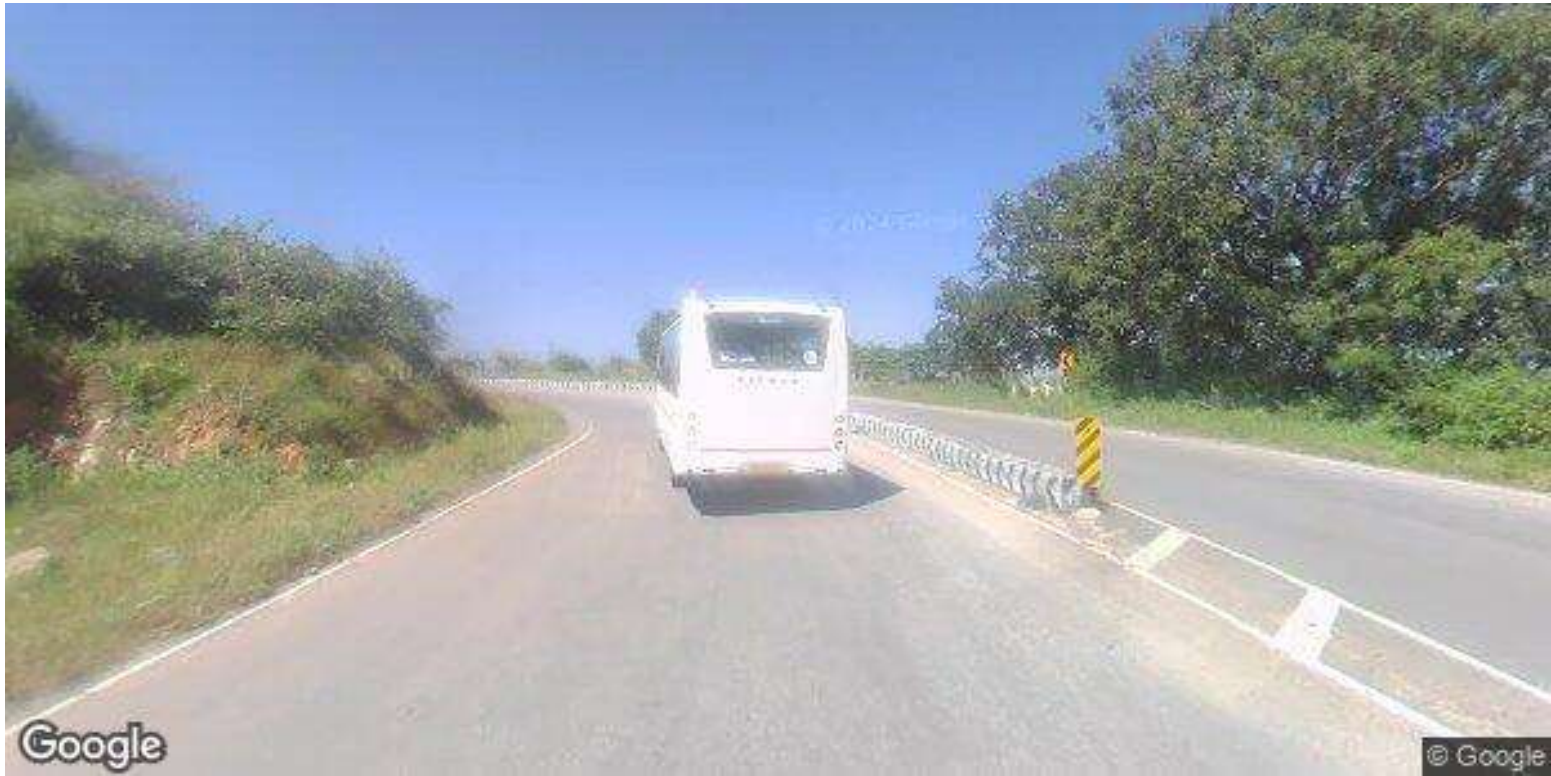
**Risk Type:** Turn  
**Risk Level:** Medium  
**Speed Limit:** 30 KM/Hr  
**Coordinates:** 12.55078, 77.97257

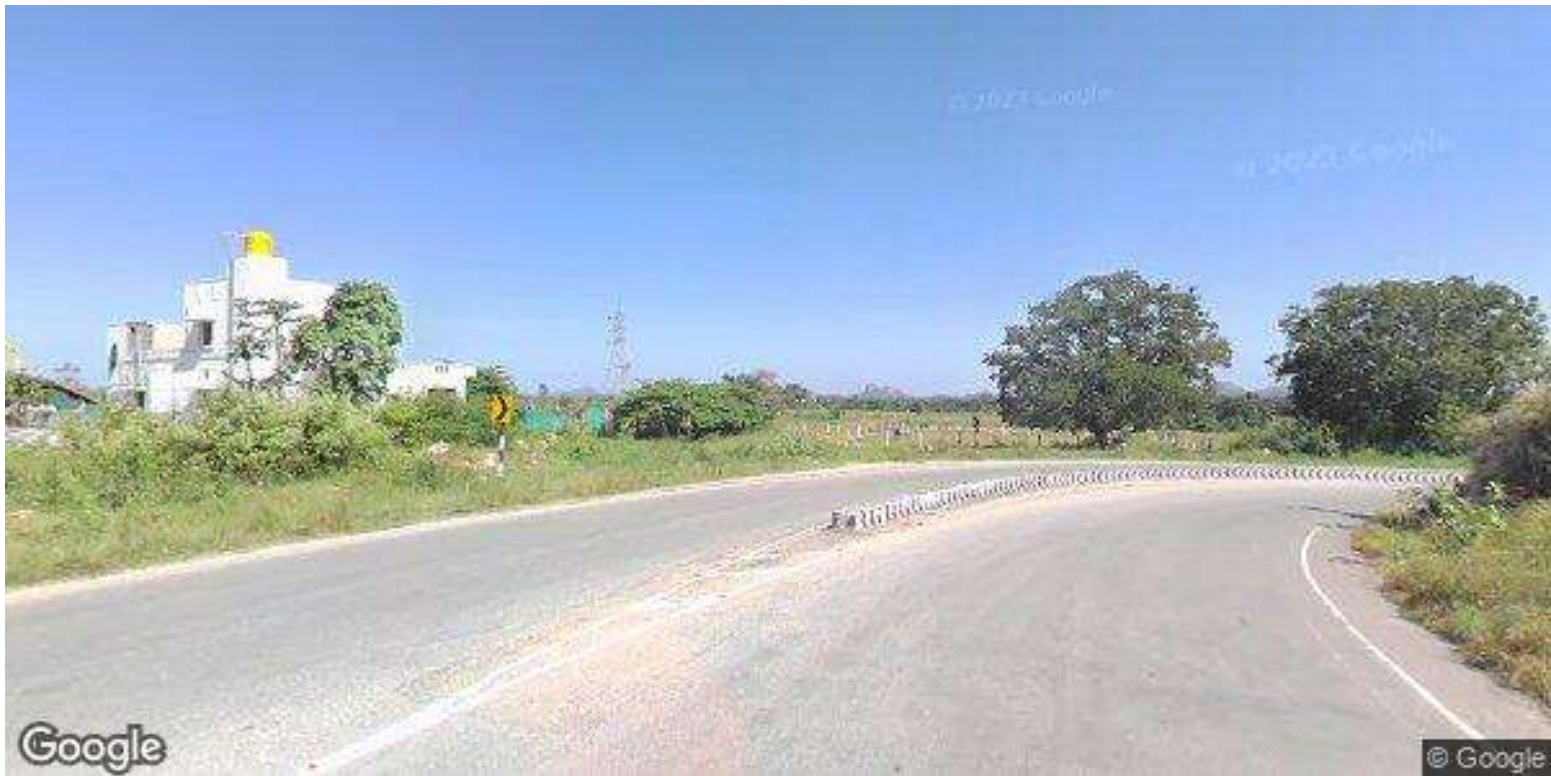
**Risk Type:** Turn  
**Risk Level:** Medium  
**Speed Limit:** 30 KM/Hr  
**Coordinates:** 12.55126, 77.97216
