## JOURNEY RISK MANAGEMENT (JRM) STUDY

### Salem Terminal TO TVR FUELS STATION

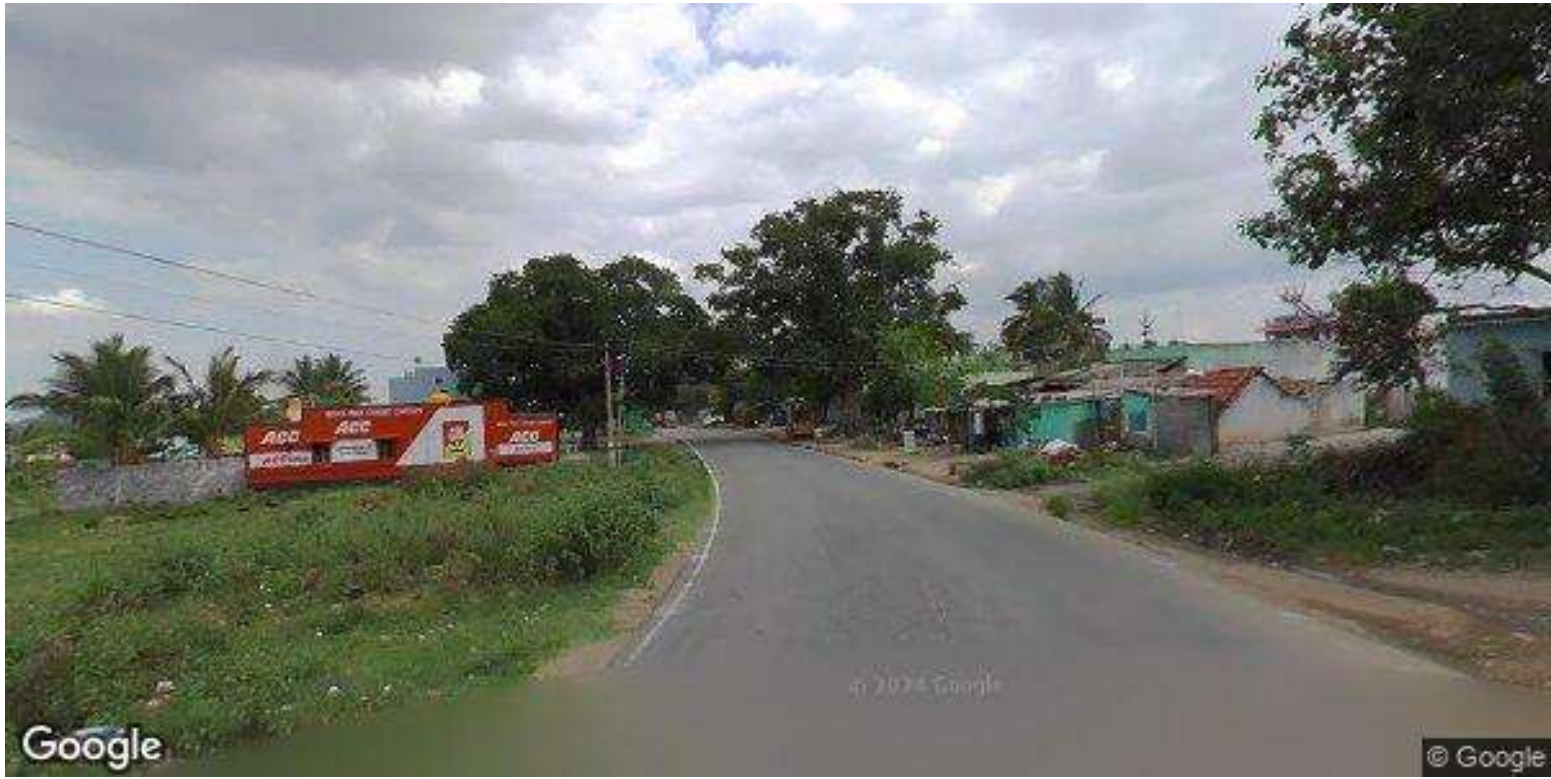
**Coordinates:** 12.55317, 77.96530

**Risk Type:** Turn

**Risk Level:** Medium

**Speed Limit:** 30 KM/Hr

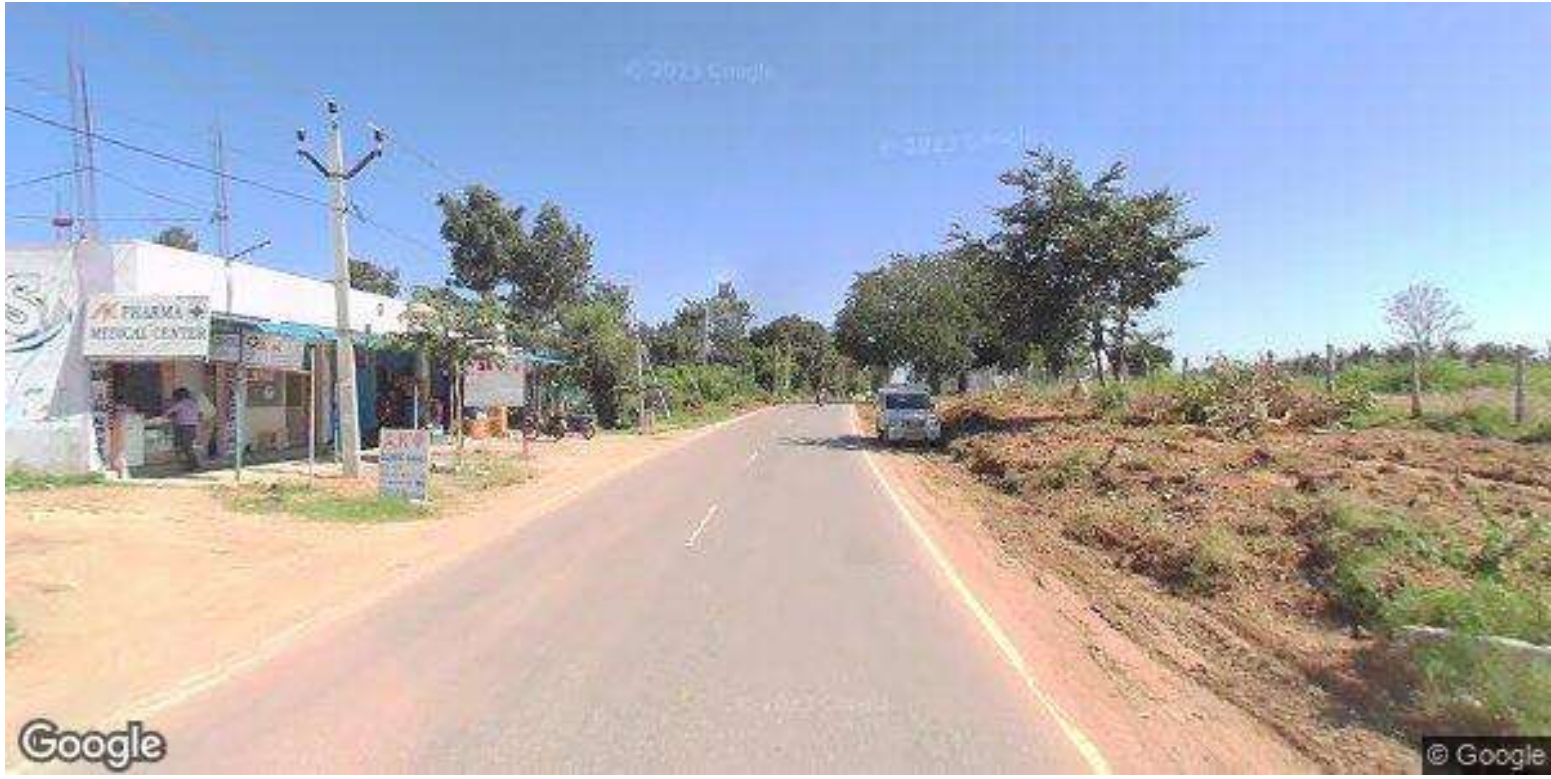
**Coordinates:** 12.56517, 77.95315

**Risk Type:** Turn

**Risk Level:** Medium

**Speed Limit:** 30 KM/Hr
