## **JOURNEY RISK MANAGEMENT (JRM) STUDY**

### **Salem Terminal TO SRI VETRI VELAN AGENCY**

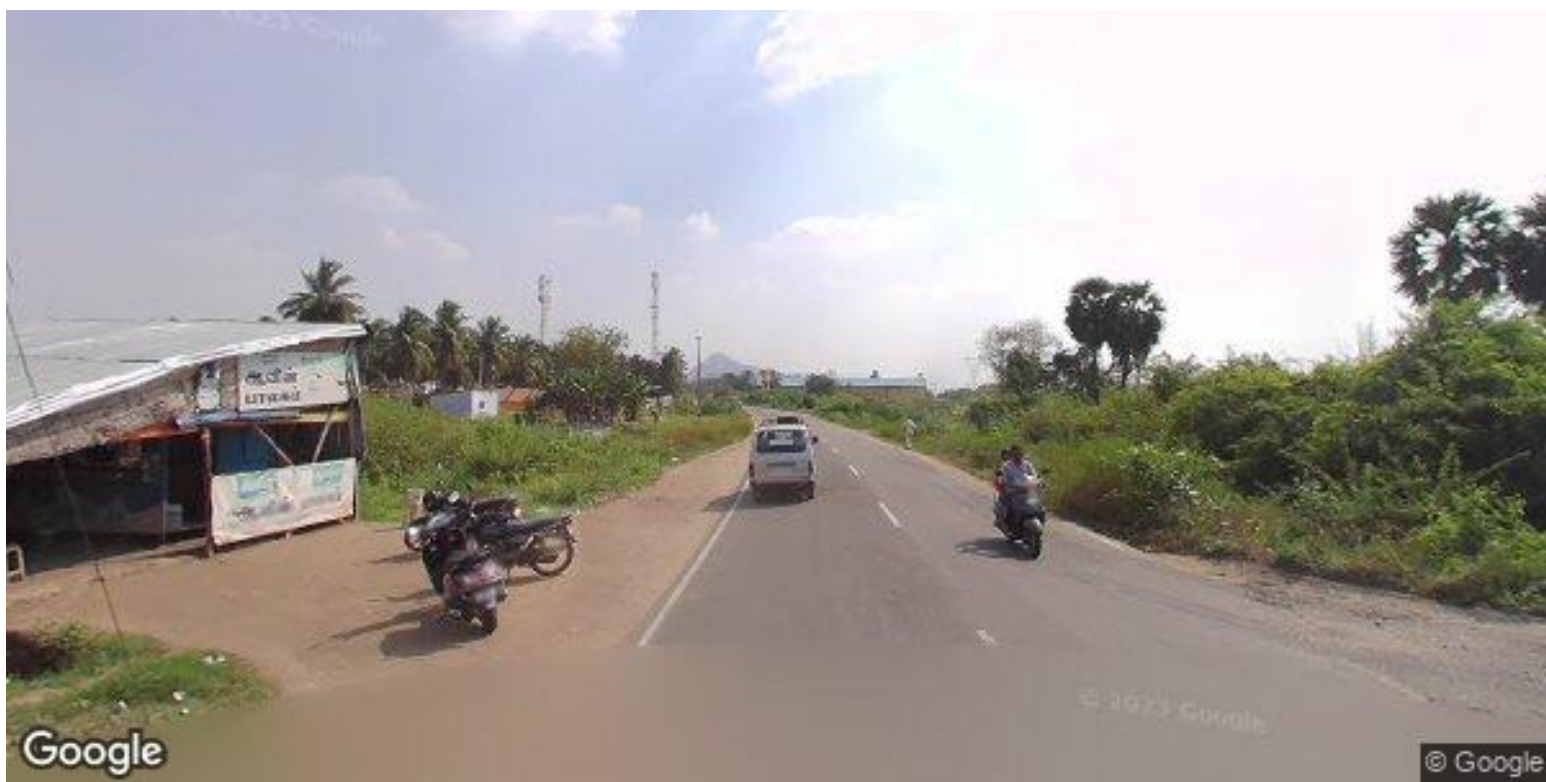
**Coordinates:** 11.44022, 77.87546

**Risk Type:** Turn

**Risk Level:** High

**Speed Limit:** 15 KM/Hr

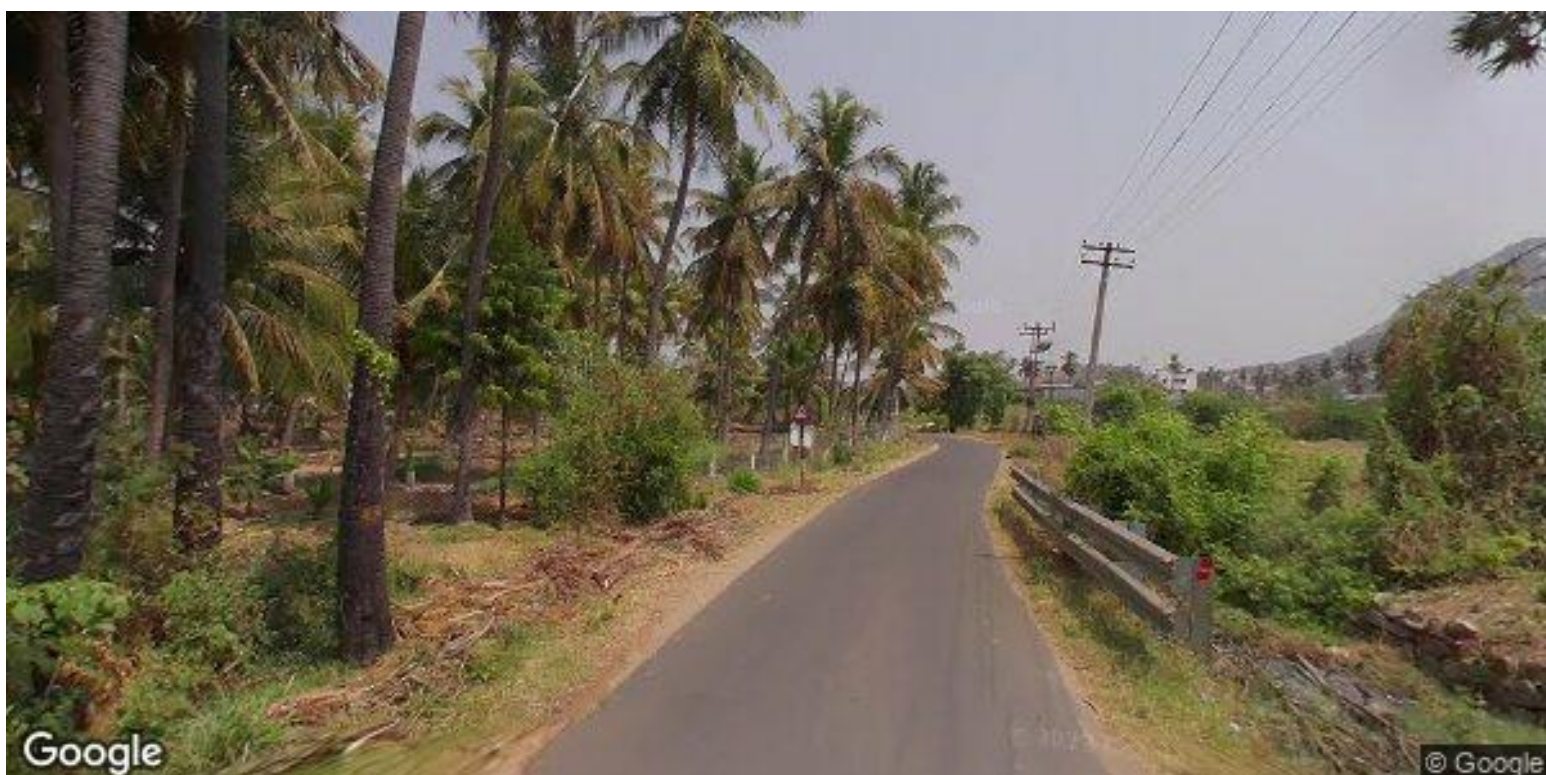
**Coordinates:** 11.41876, 77.88487

**Risk Type:** Turn

**Risk Level:** Medium

**Speed Limit:** 30 KM/Hr

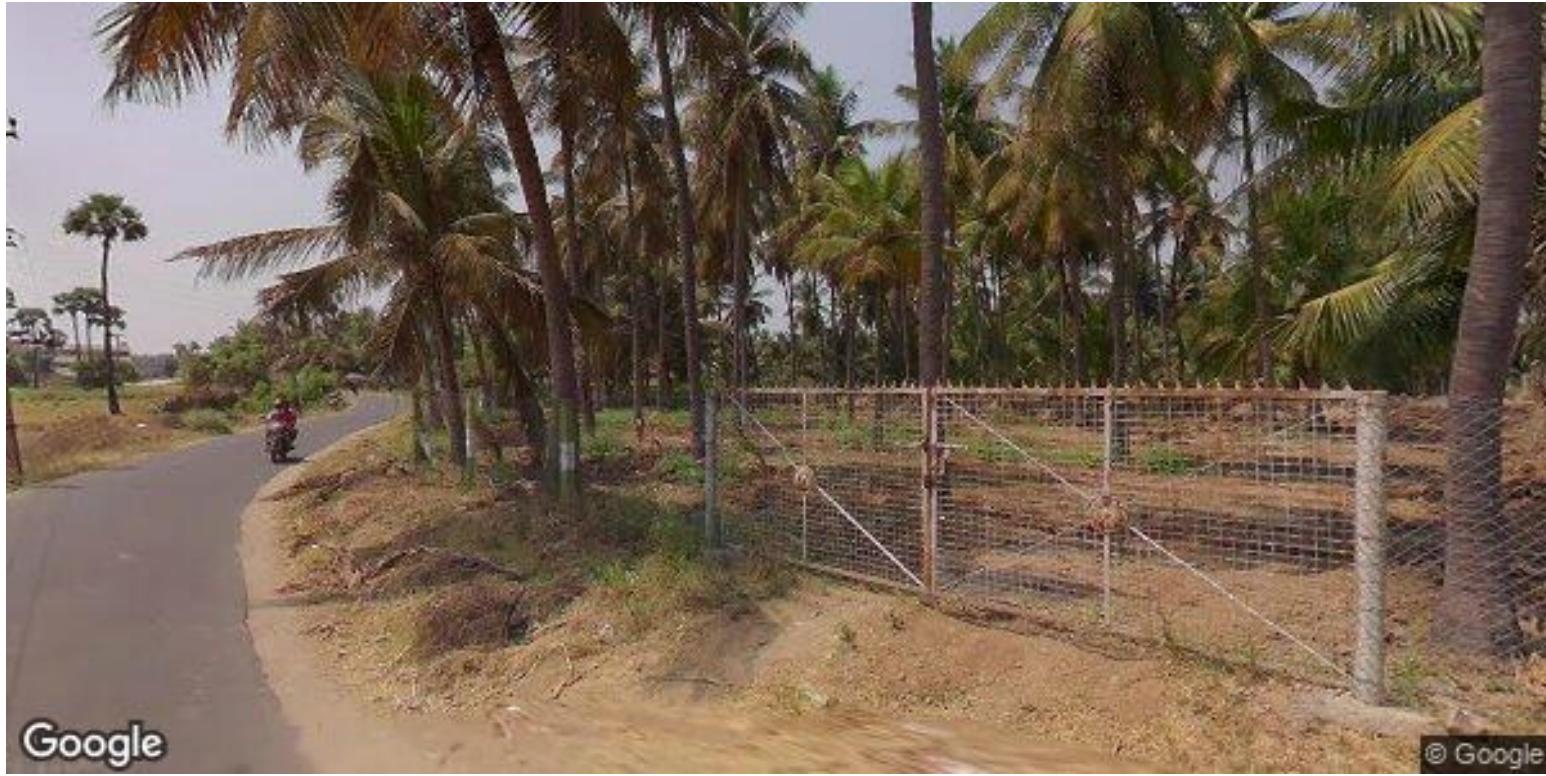
**Coordinates:** 11.41836, 77.88540

**Risk Type:** Turn

**Risk Level:** Medium

**Speed Limit:** 30 KM/Hr

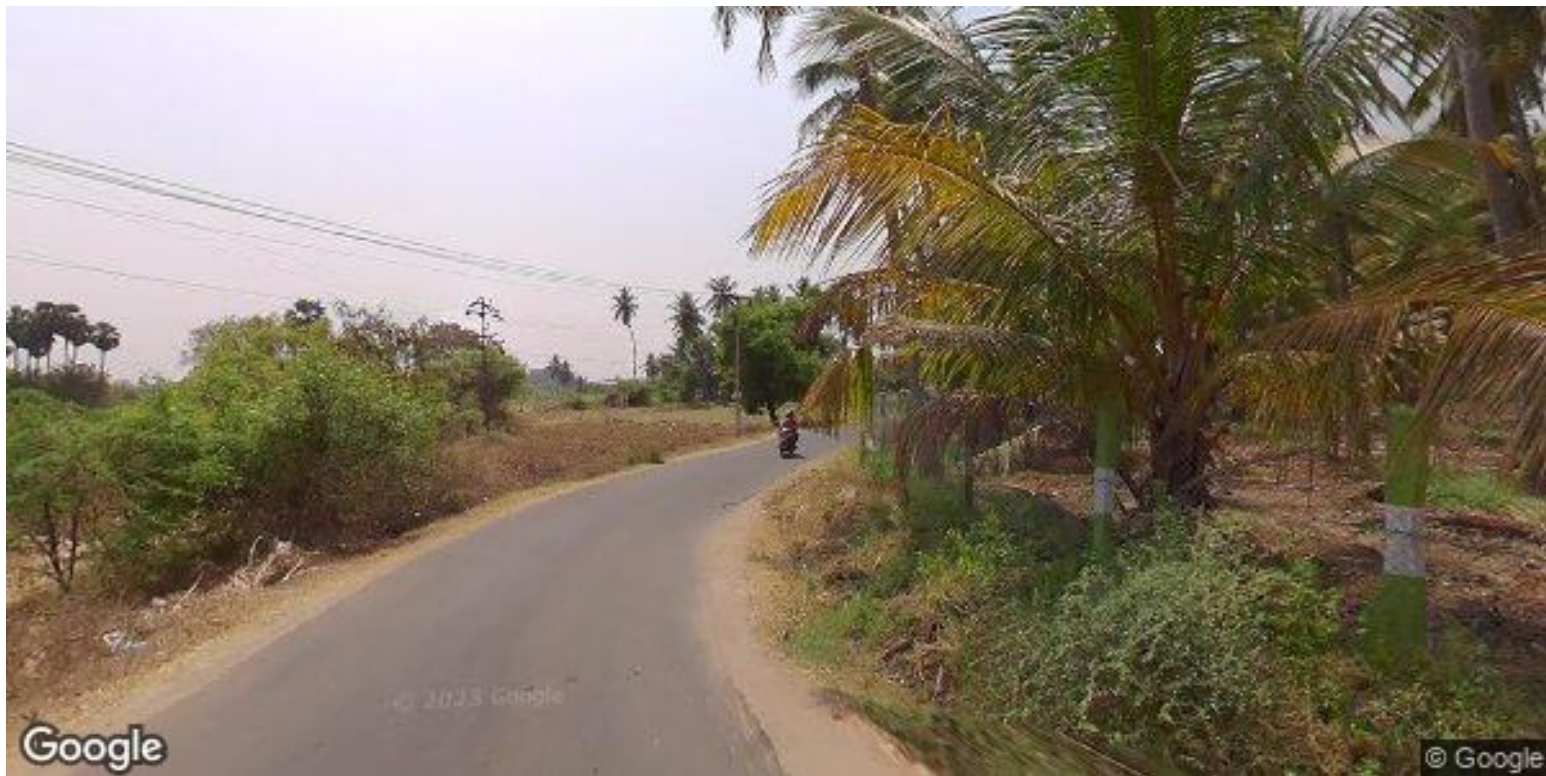
**Coordinates:** 11.41834, 77.88585

**Risk Type:** Turn

**Risk Level:** Medium

**Speed Limit:** 30 KM/Hr

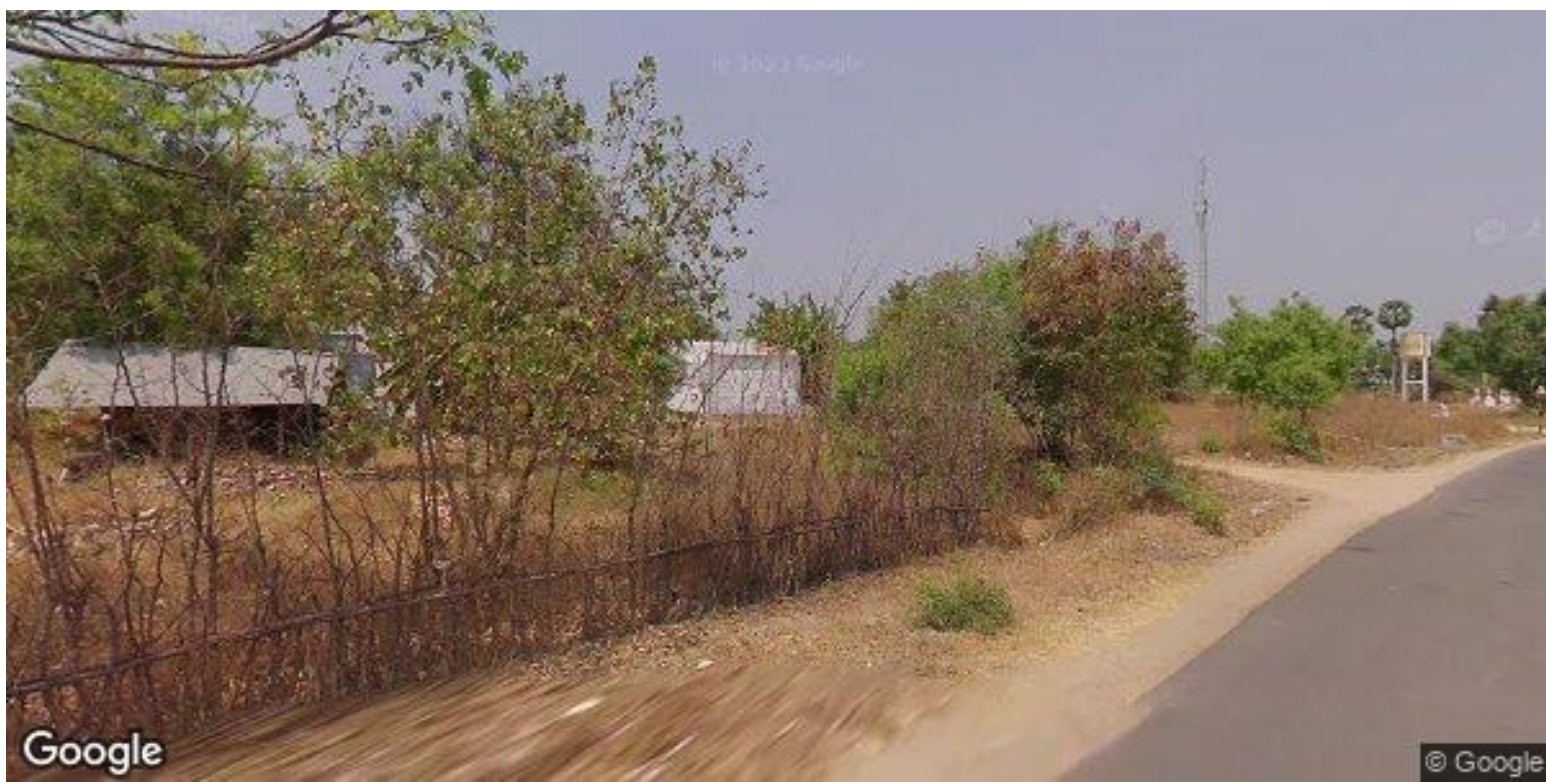
**Coordinates:** 11.41849, 77.88613

**Risk Type:** Turn

**Risk Level:** Medium

**Speed Limit:** 30 KM/Hr

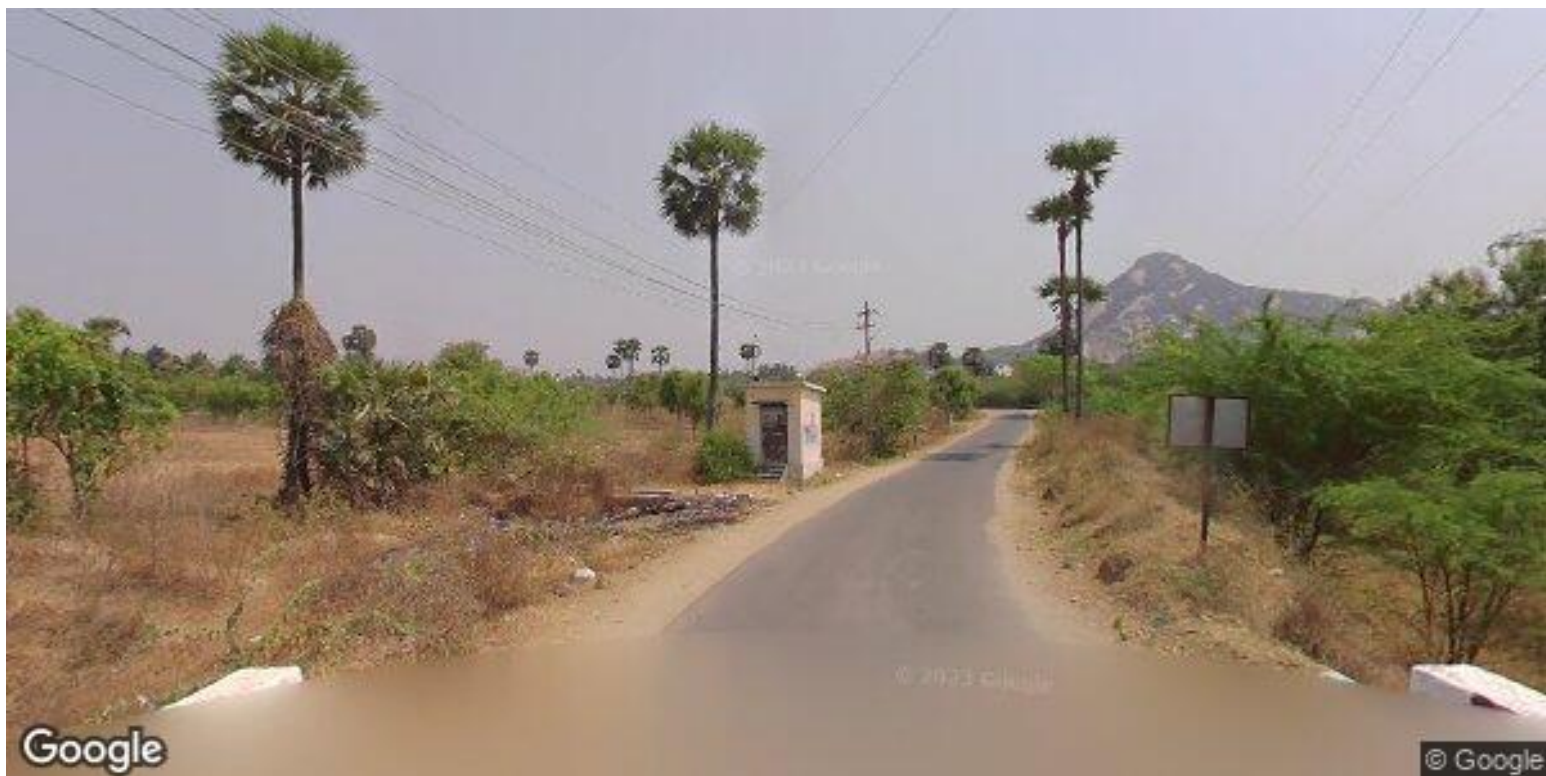
**Coordinates:** 11.41852, 77.88700

**Risk Type:** Turn

**Risk Level:** High

**Speed Limit:** 15 KM/Hr

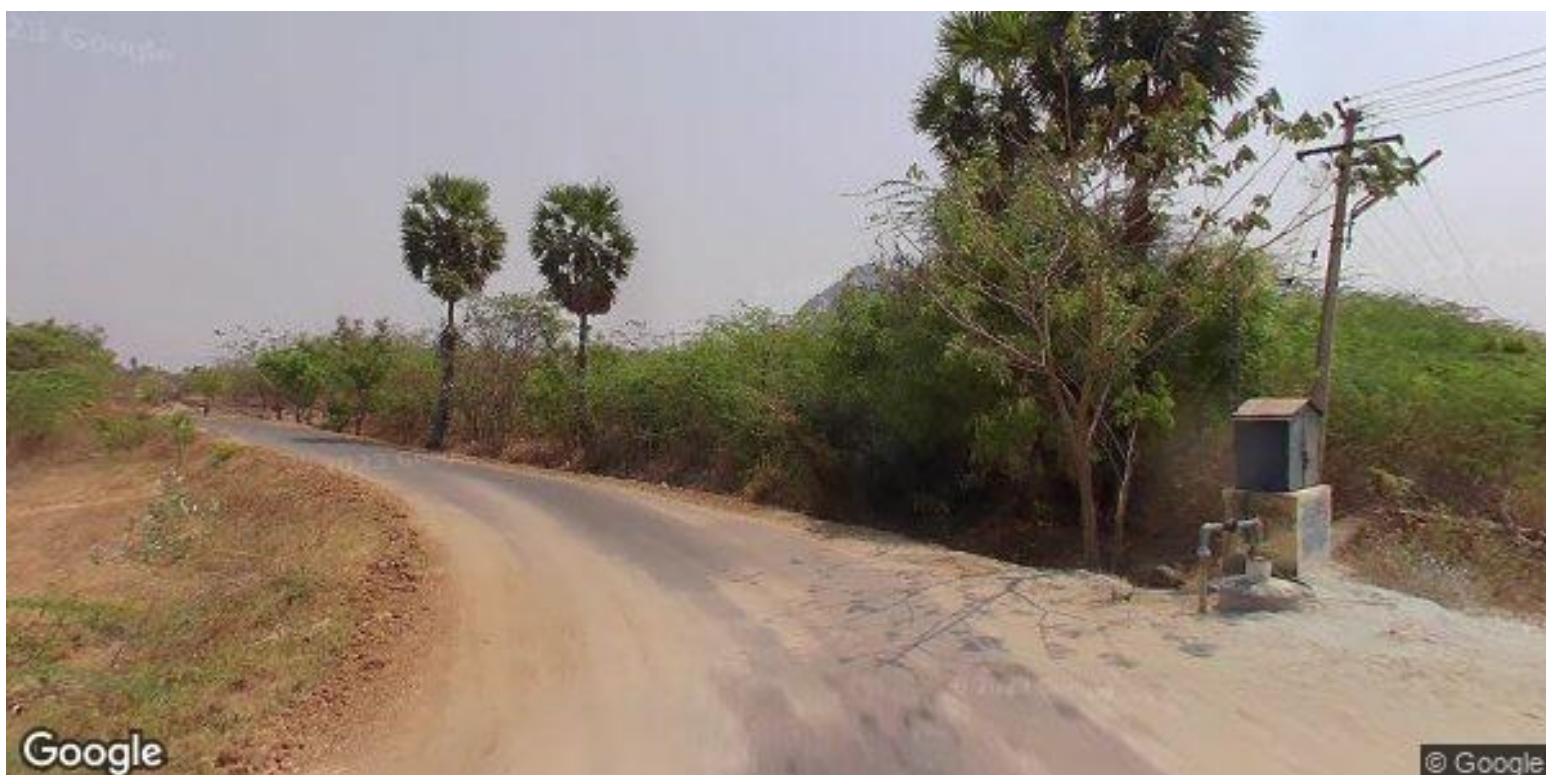
**Coordinates:** 11.41769, 77.88730

**Risk Type:** Turn

**Risk Level:** Medium

**Speed Limit:** 30 KM/Hr

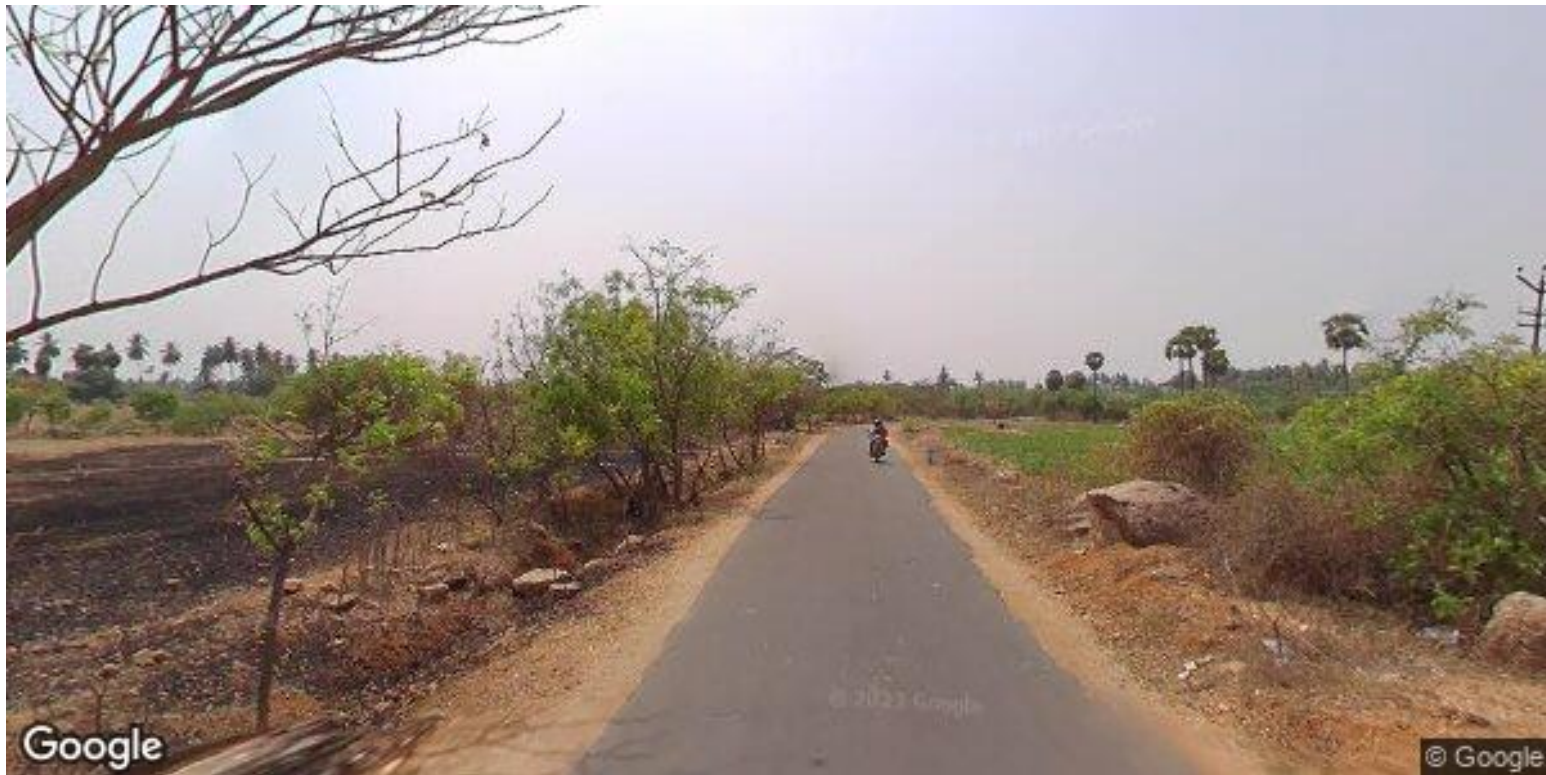
**Coordinates:** 11.41721, 77.88912

**Risk Type:** Turn

**Risk Level:** Medium

**Speed Limit:** 30 KM/Hr

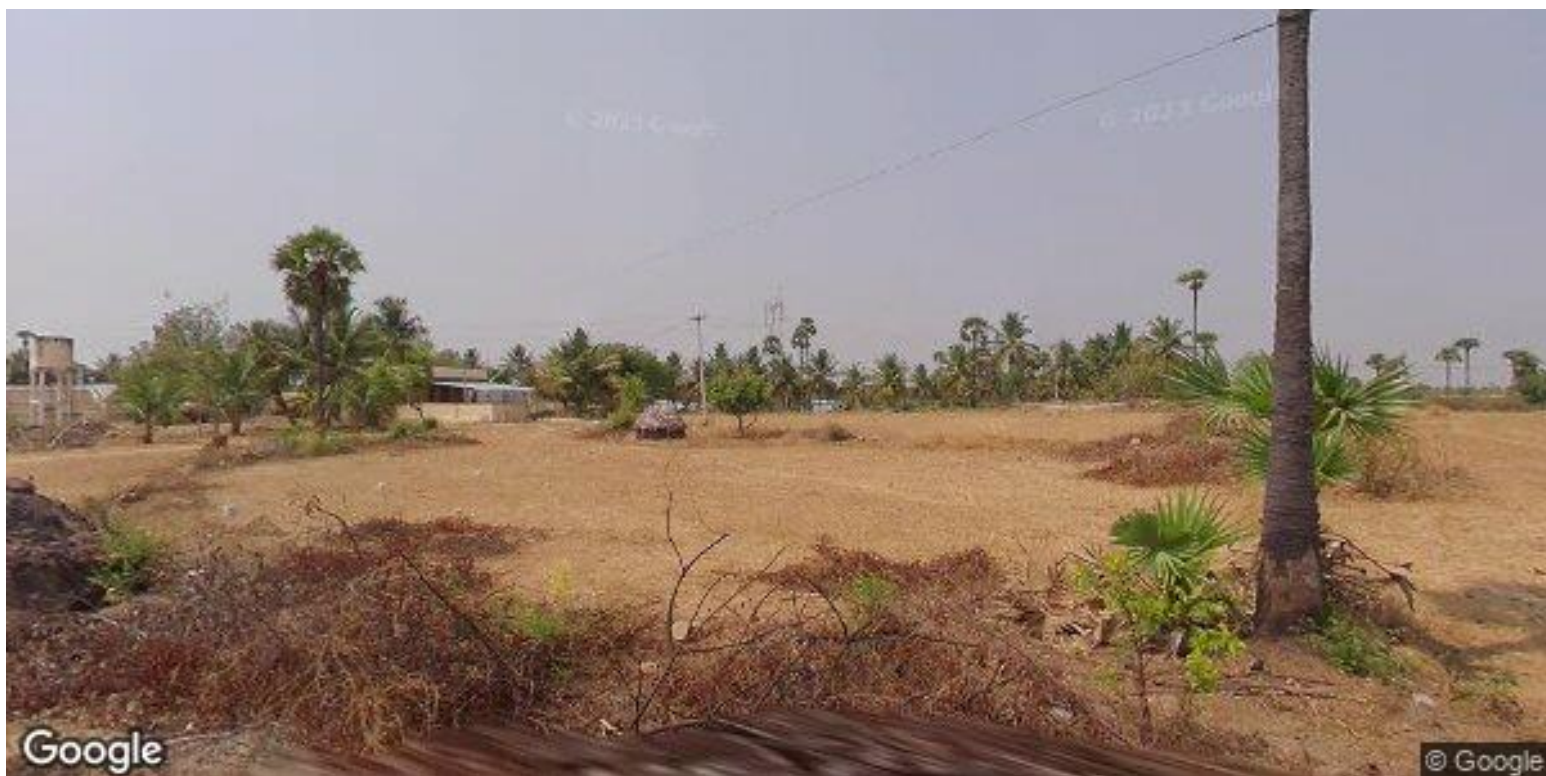
**Coordinates:** 11.41606, 77.89452

**Risk Type:** Turn

**Risk Level:** Medium

**Speed Limit:** 30 KM/Hr

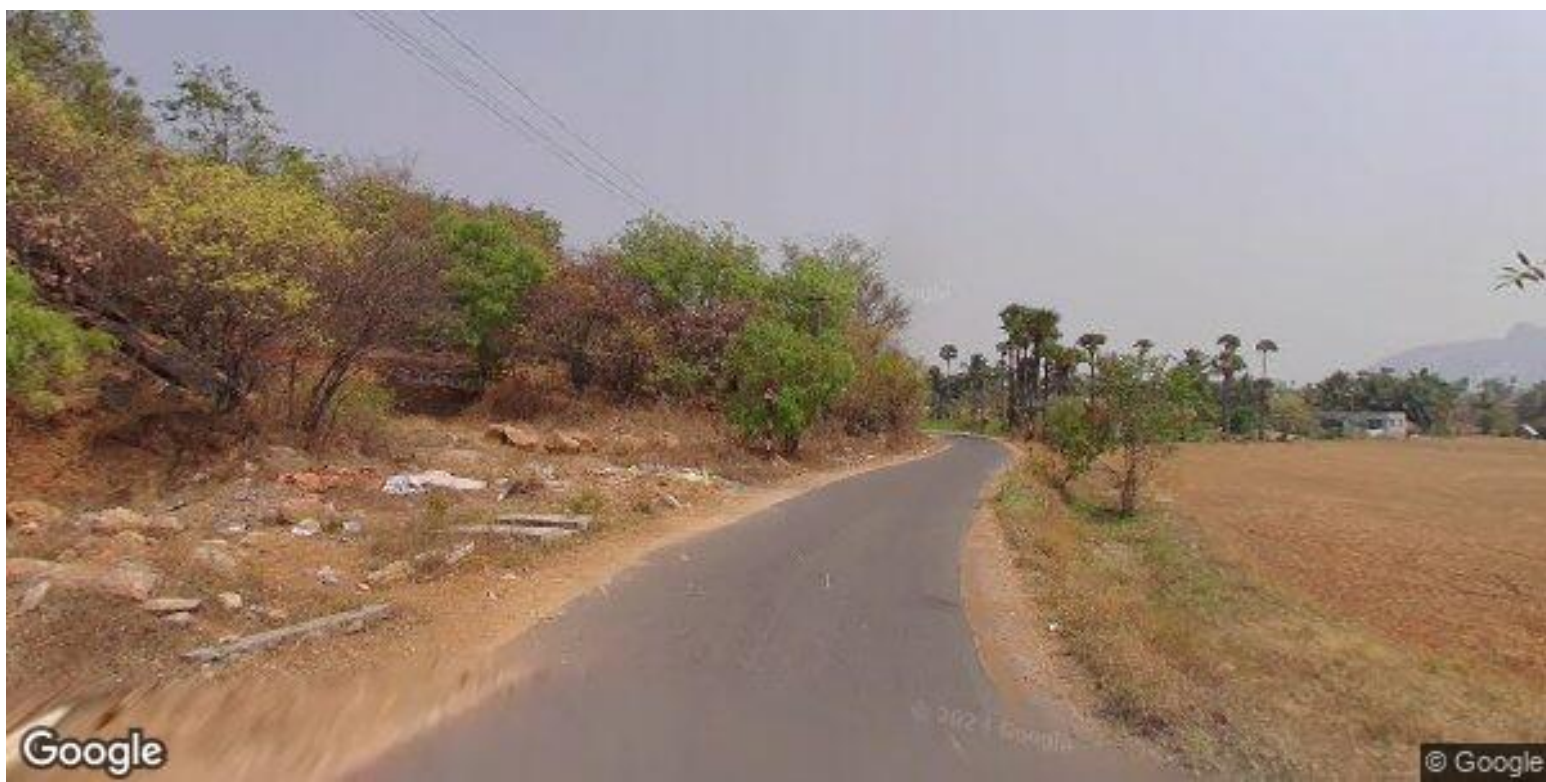
**Coordinates:** 11.41430, 77.90034

**Risk Type:** Turn

**Risk Level:** Medium

**Speed Limit:** 30 KM/Hr

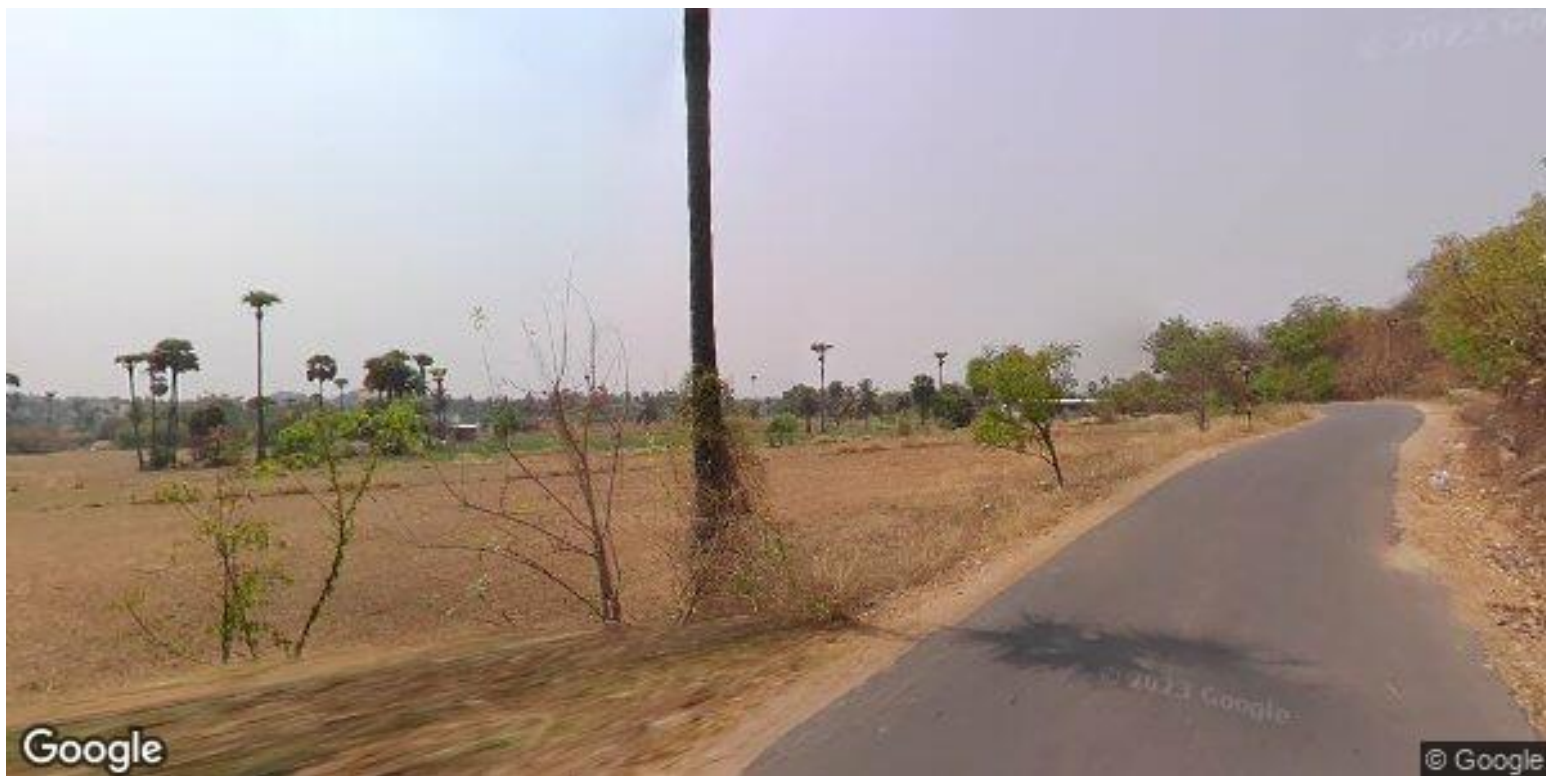
**Coordinates:** 11.41385, 77.90064

**Risk Type:** Turn

**Risk Level:** Medium

**Speed Limit:** 30 KM/Hr

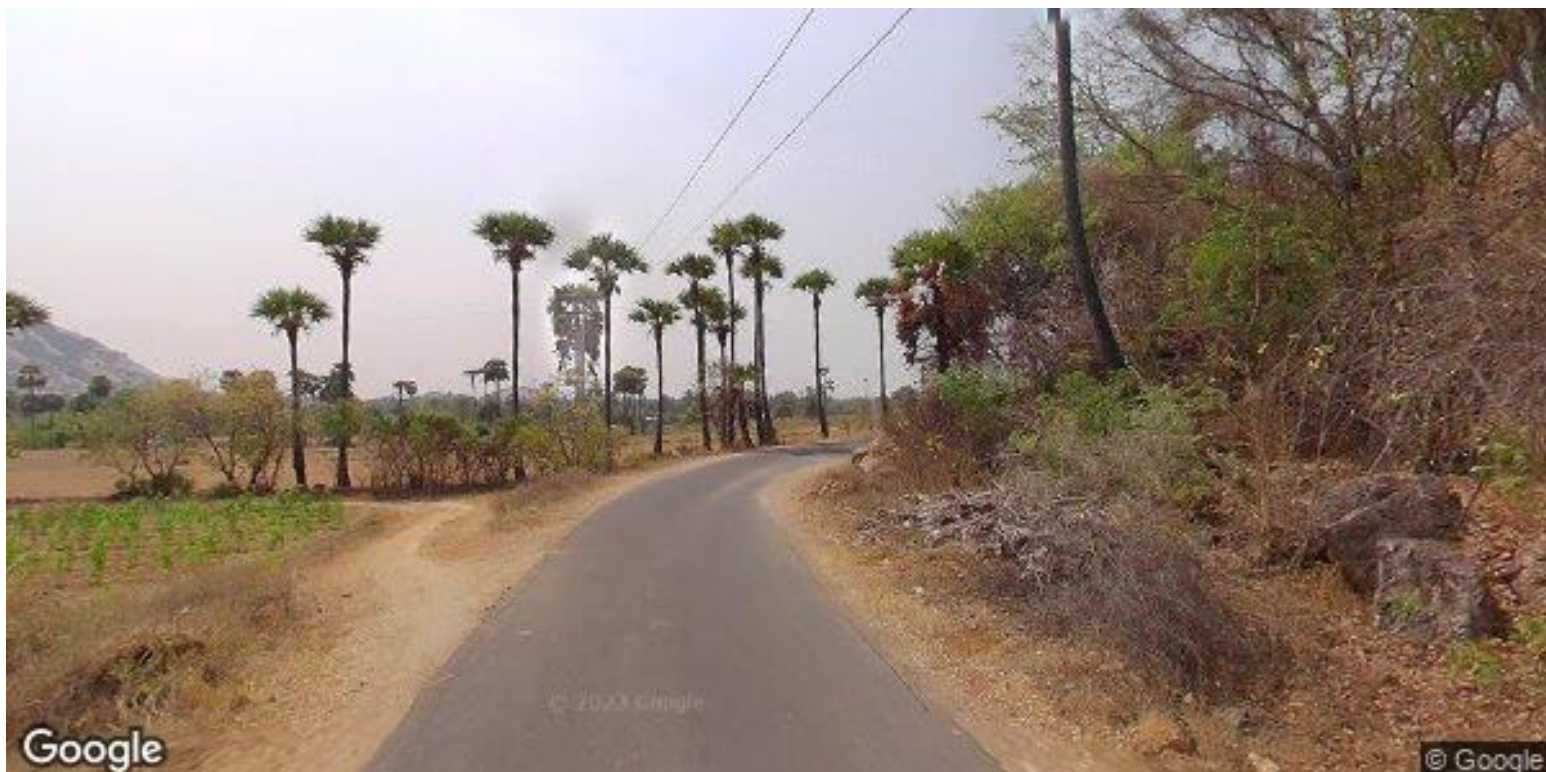
**Risk Type:** Turn  
**Risk Level:** Medium  
**Speed Limit:** 30 KM/Hr  
**Coordinates:** 11.41374, 77.90097

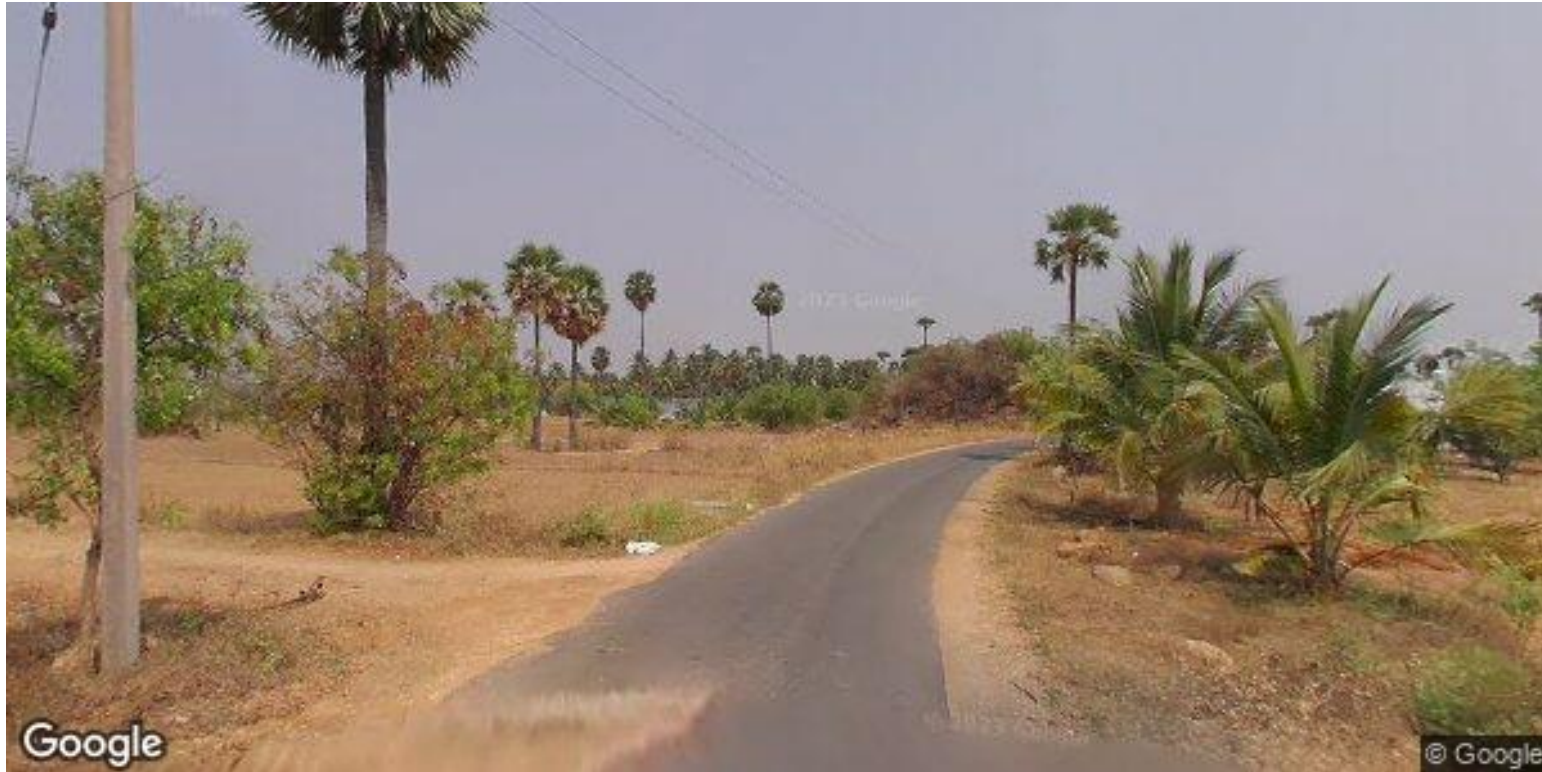
**Risk Type:** Turn  
**Risk Level:** Medium  
**Speed Limit:** 30 KM/Hr  
**Coordinates:** 11.41388, 77.90175

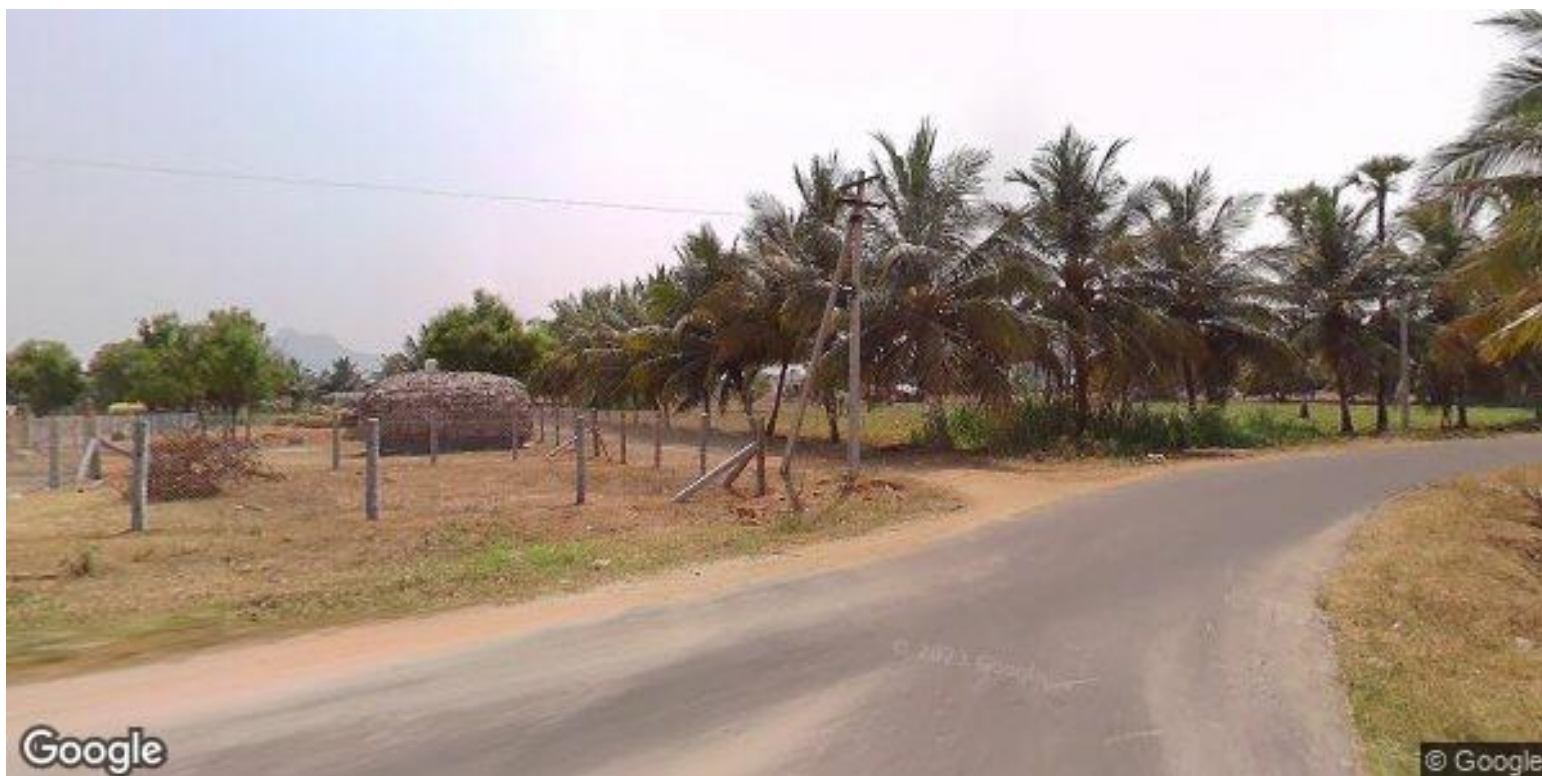
**Risk Type:** Turn  
**Risk Level:** High  
**Speed Limit:** 15 KM/Hr  
**Coordinates:** 11.41235, 77.90492

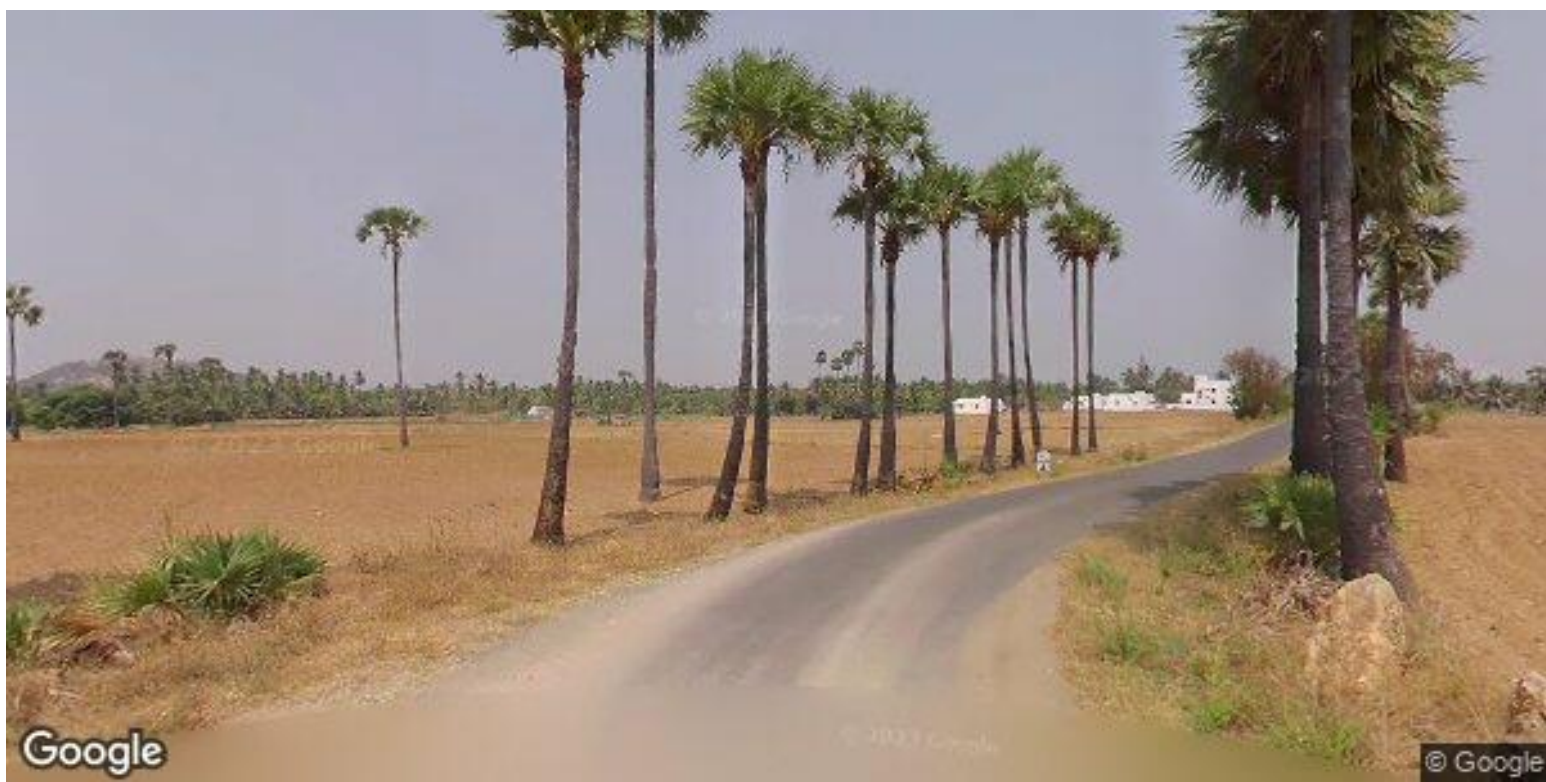
**Coordinates:** 11.41271, 77.90516

**Risk Type:** Turn

**Risk Level:** High

**Speed Limit:** 15 KM/Hr

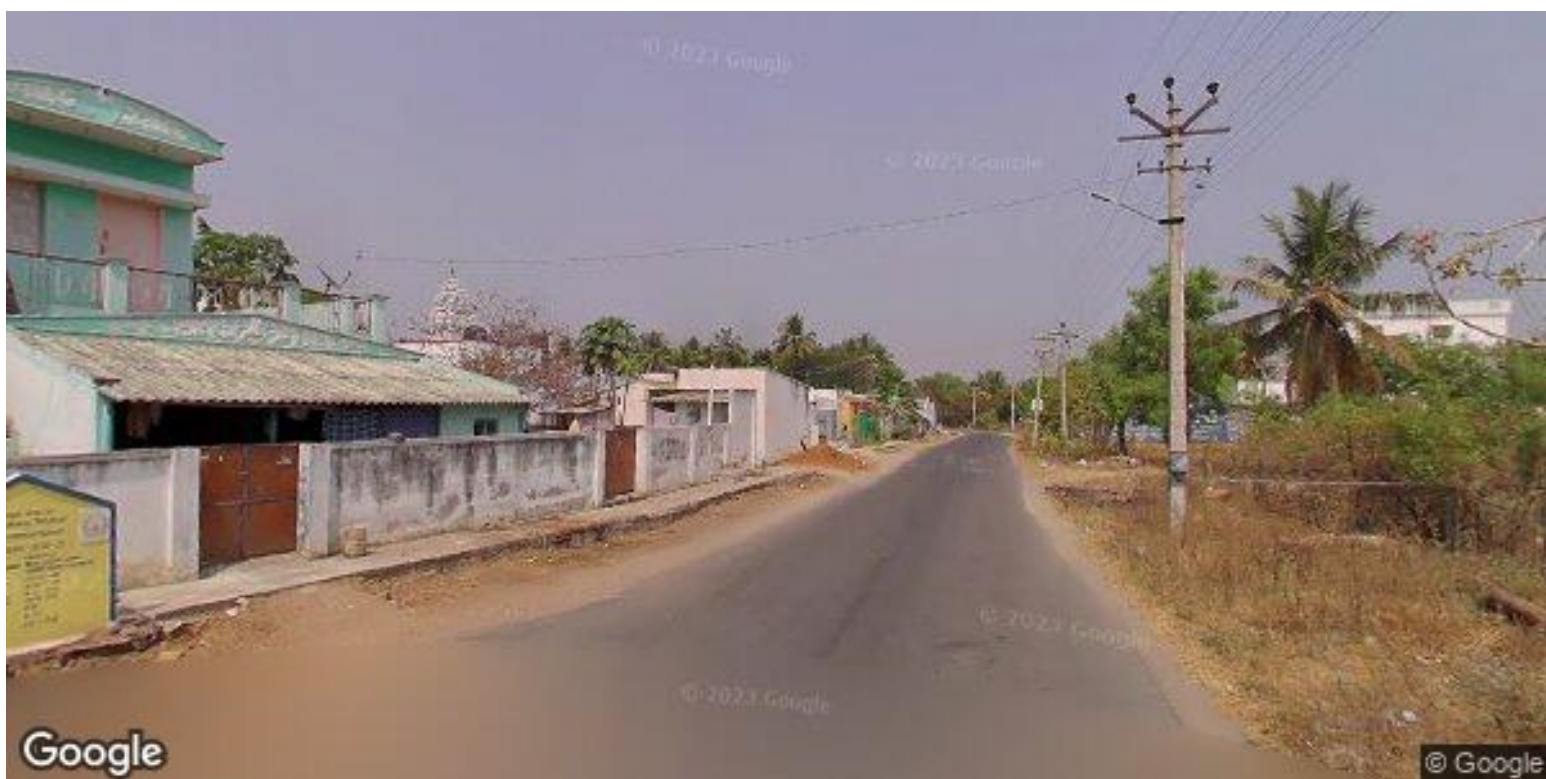
**Coordinates:** 11.41292, 77.91162

**Risk Type:** Turn

**Risk Level:** Medium

**Speed Limit:** 30 KM/Hr

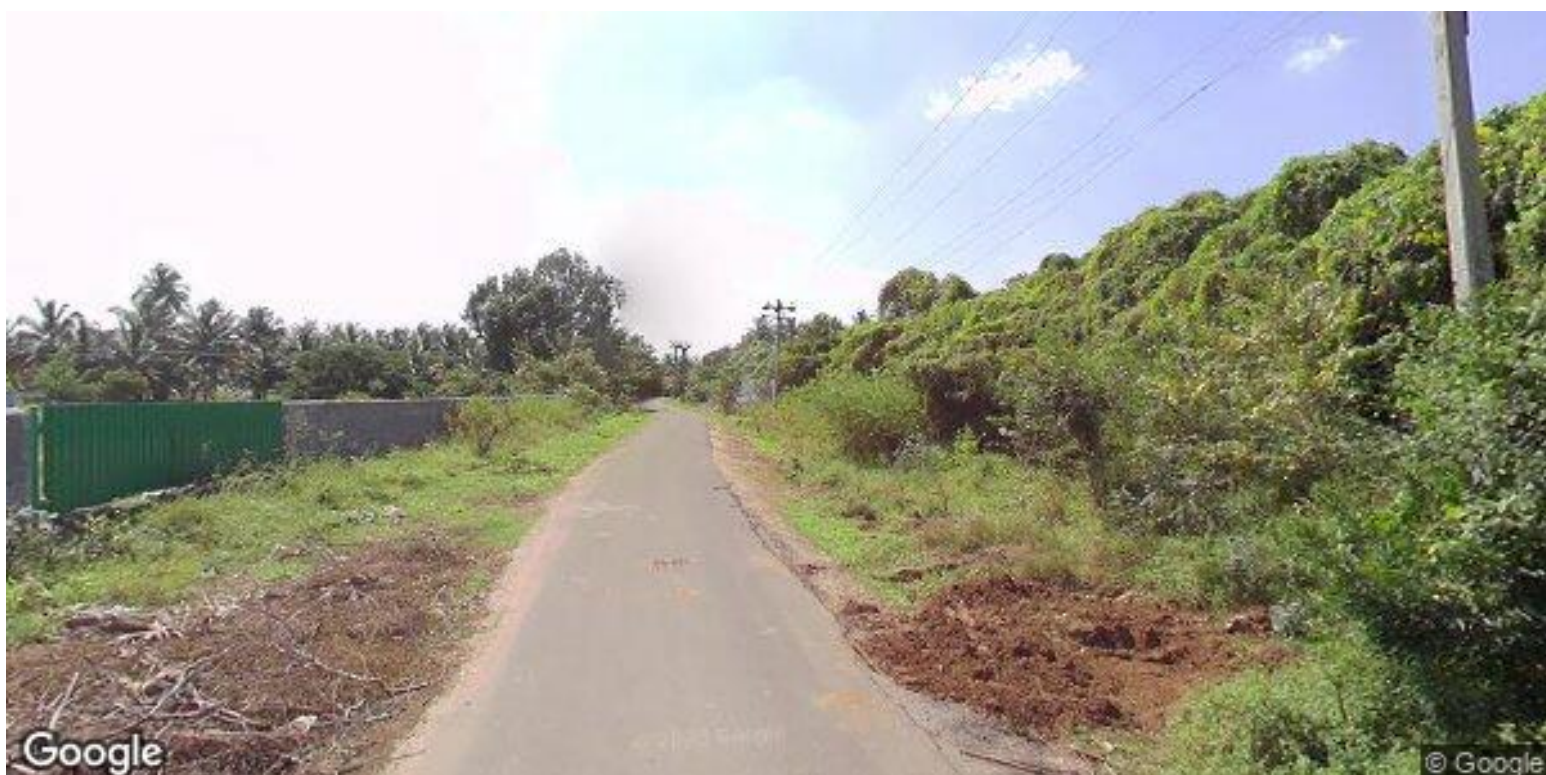
**Risk Type:** Turn  
**Risk Level:** High  
**Speed Limit:** 15 KM/Hr  
**Coordinates:** 11.41418, 77.91421

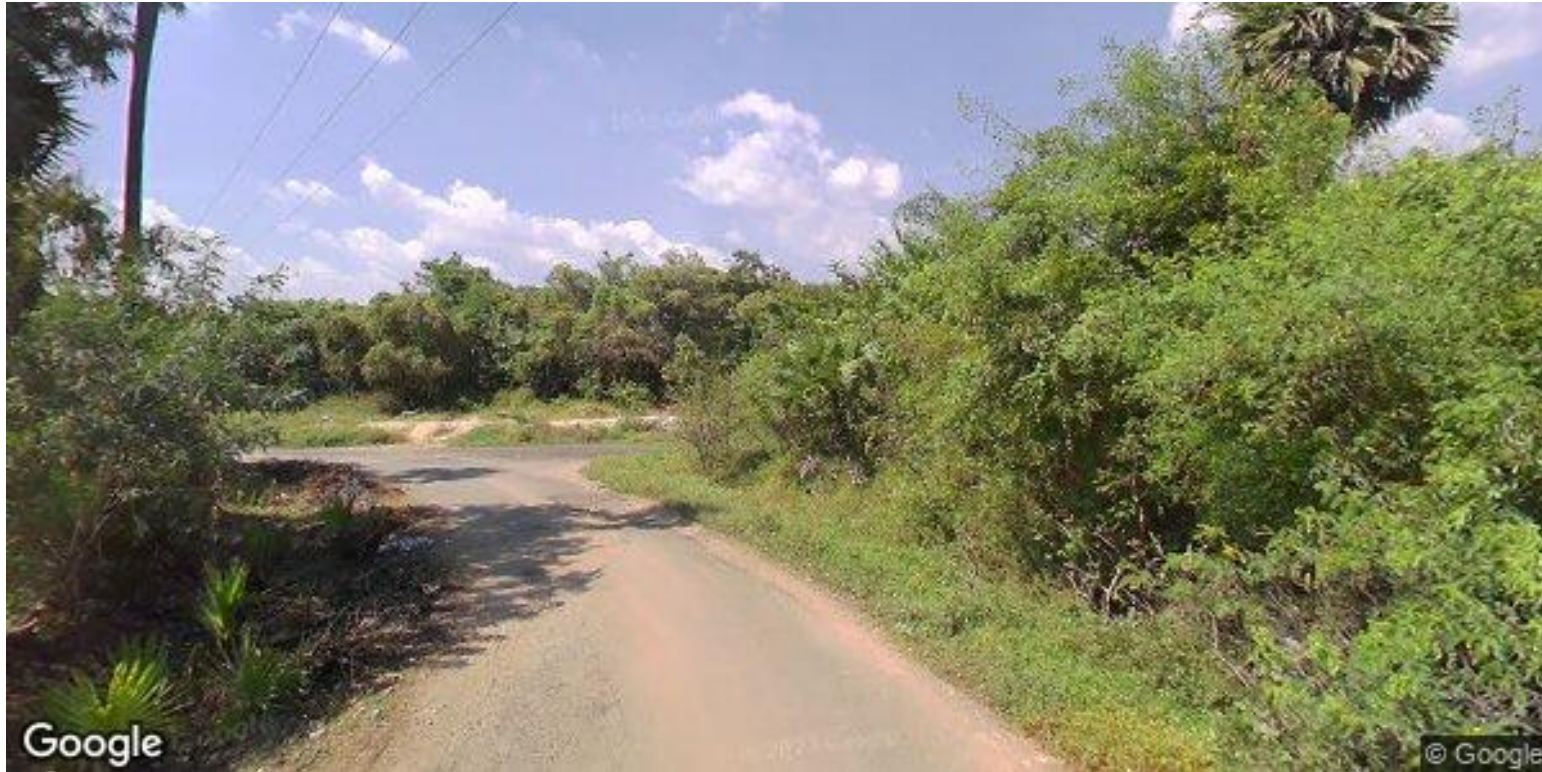
**Risk Type:** Turn  
**Risk Level:** High  
**Speed Limit:** 15 KM/Hr  
**Coordinates:** 11.41409, 77.91458

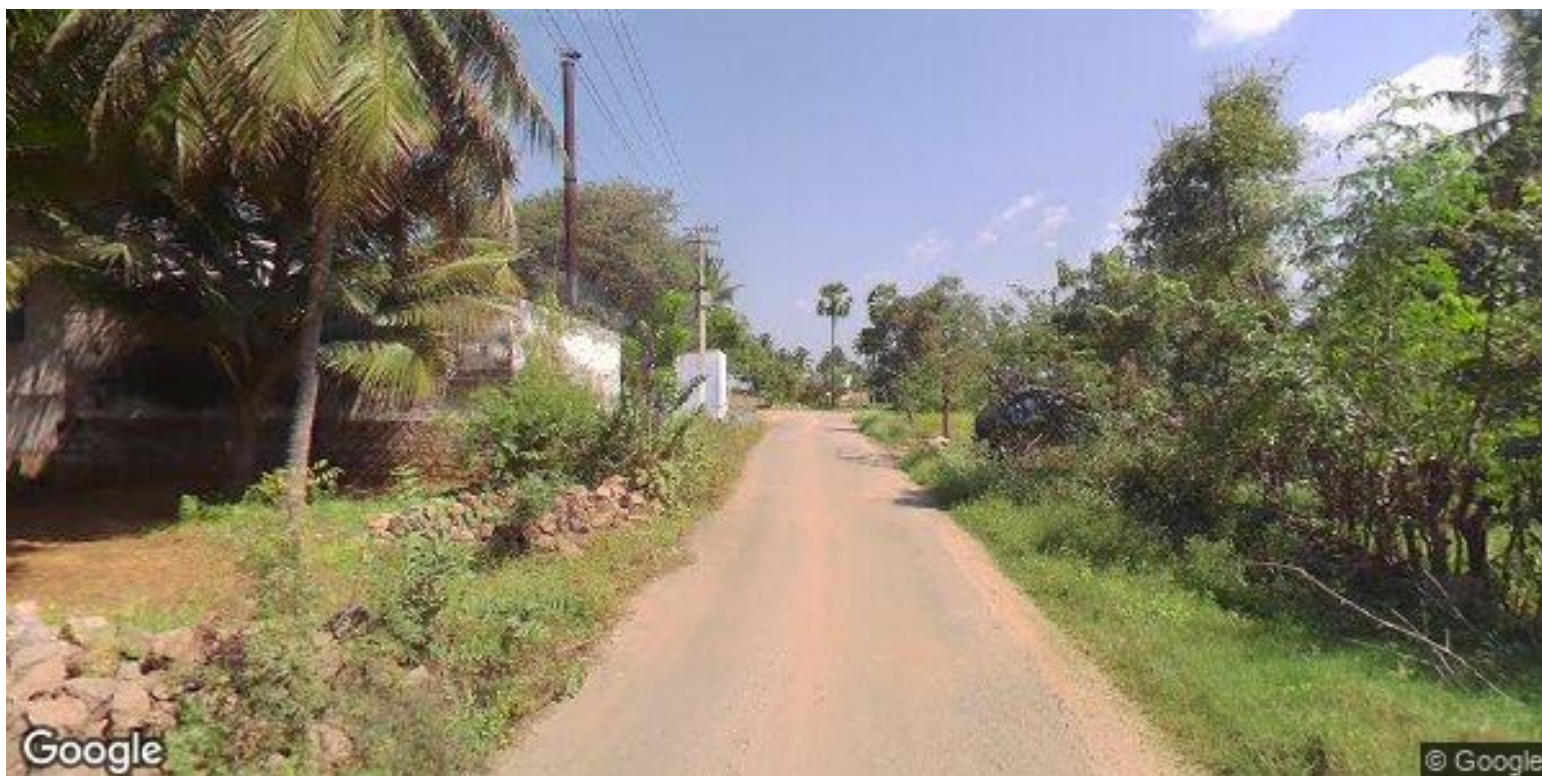
**Risk Type:** Turn  
**Risk Level:** High  
**Speed Limit:** 15 KM/Hr  
**Coordinates:** 11.41205, 77.91566
