## **JOURNEY RISK MANAGEMENT (JRM) STUDY**

### **Salem Terminal TO SRI VETRI VELAN AGENCY**

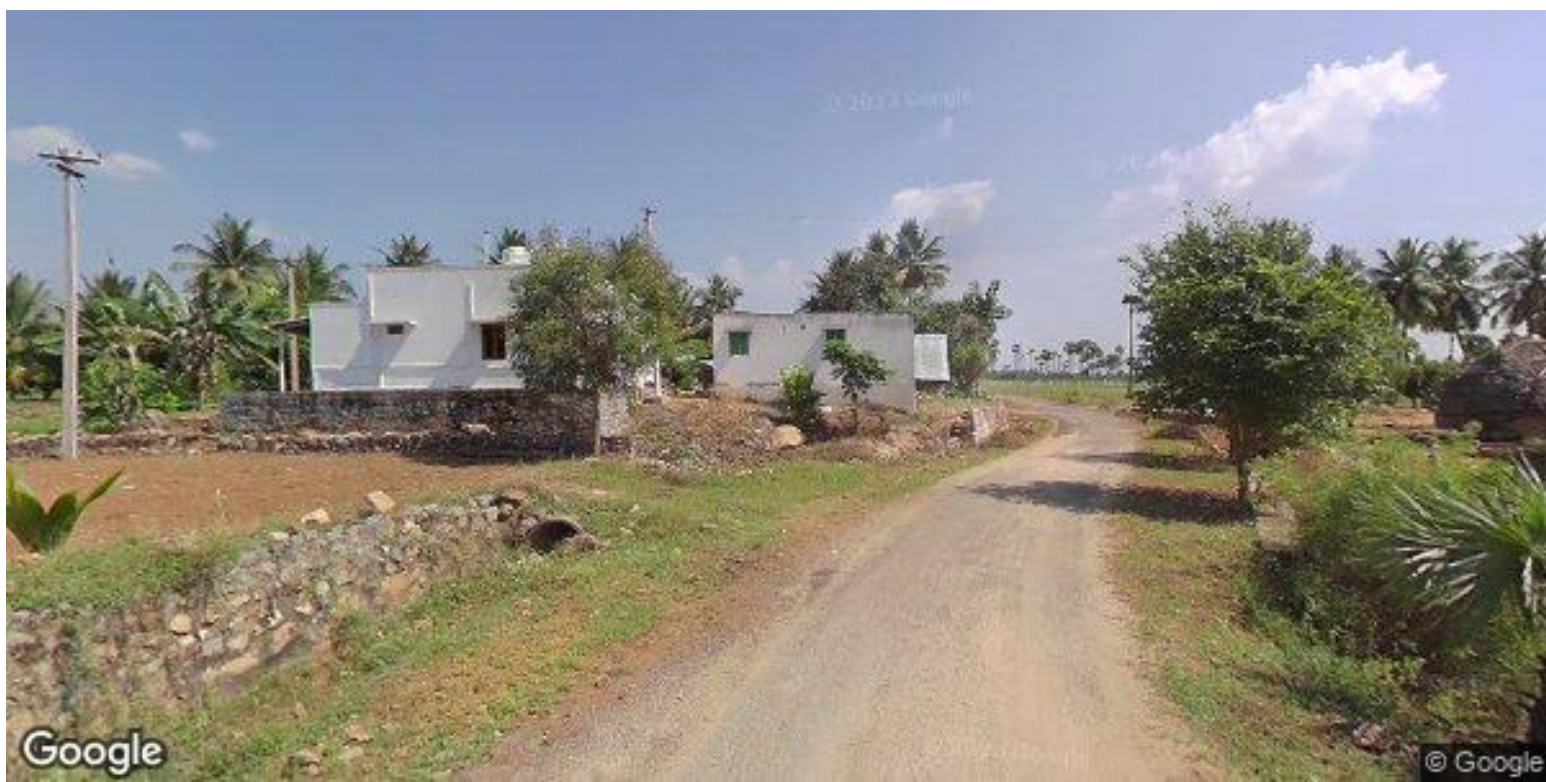
**Coordinates:** 11.41216, 77.91668

**Risk Type:** Turn

**Risk Level:** Medium

**Speed Limit:** 30 KM/Hr

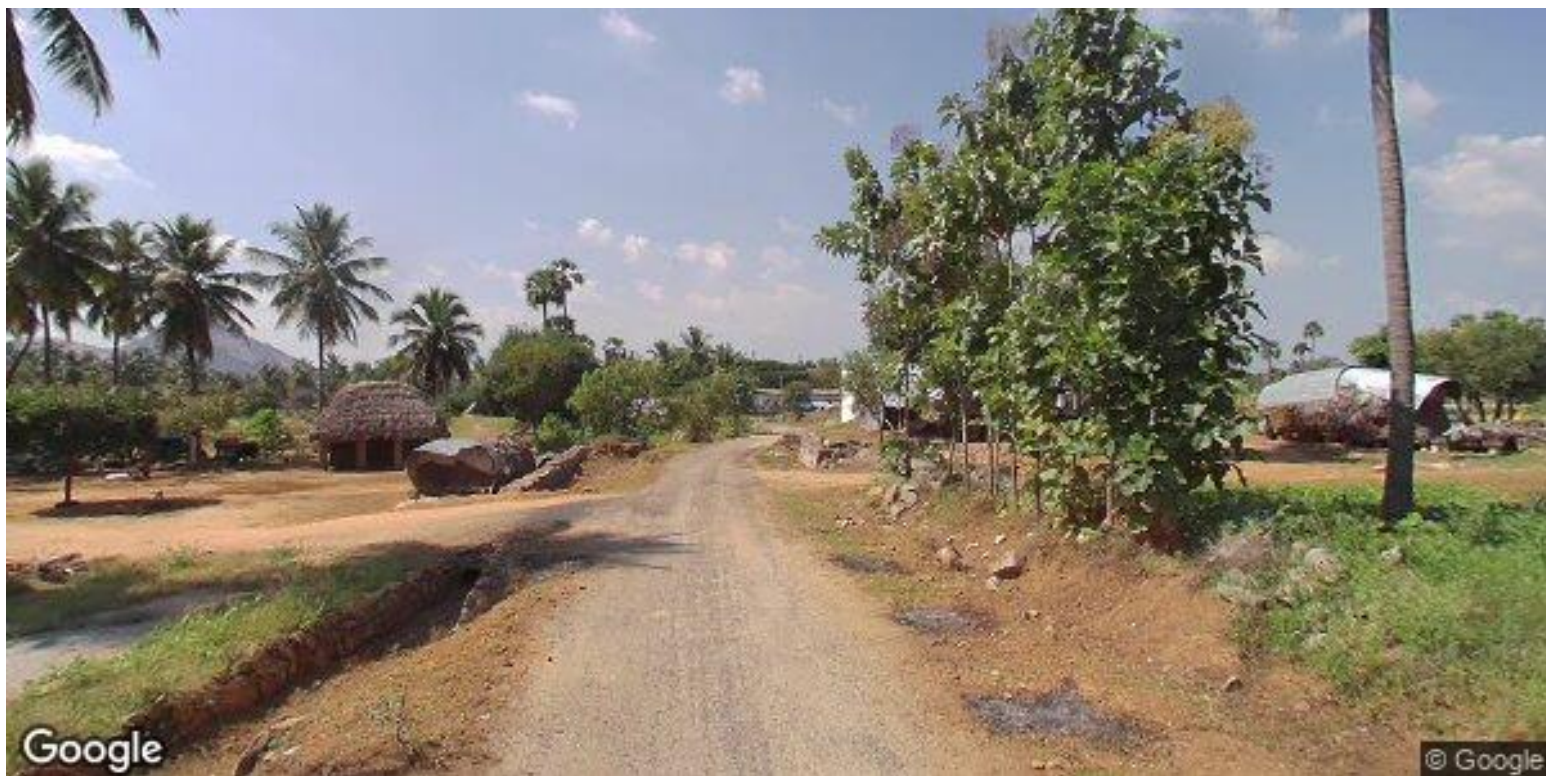
**Coordinates:** 11.41188, 77.91733

**Risk Type:** Turn

**Risk Level:** Medium

**Speed Limit:** 30 KM/Hr

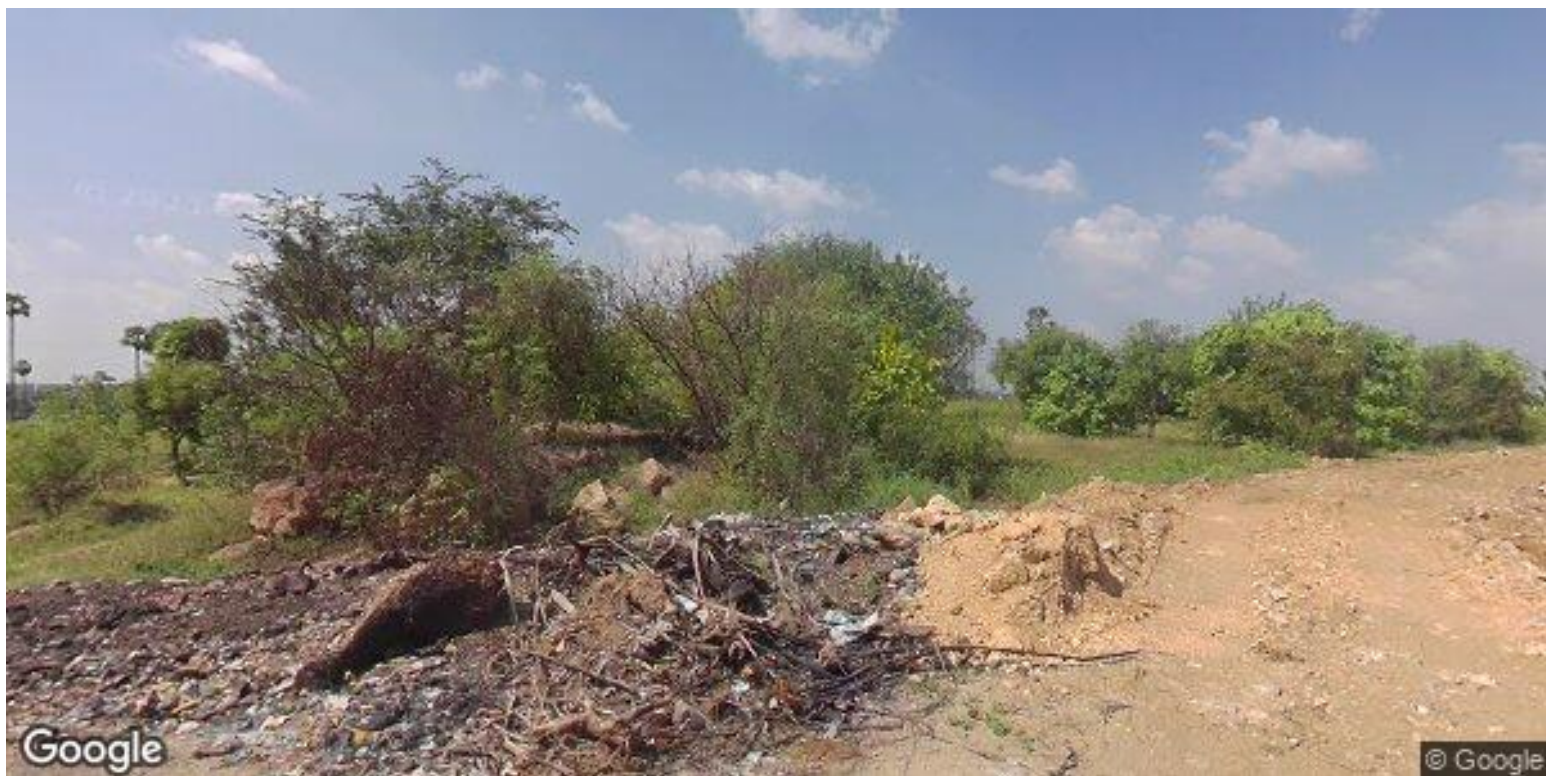
**Risk Type:** Turn  
**Risk Level:** Medium  
**Speed Limit:** 30 KM/Hr  
**Coordinates:** 11.41347, 77.92096

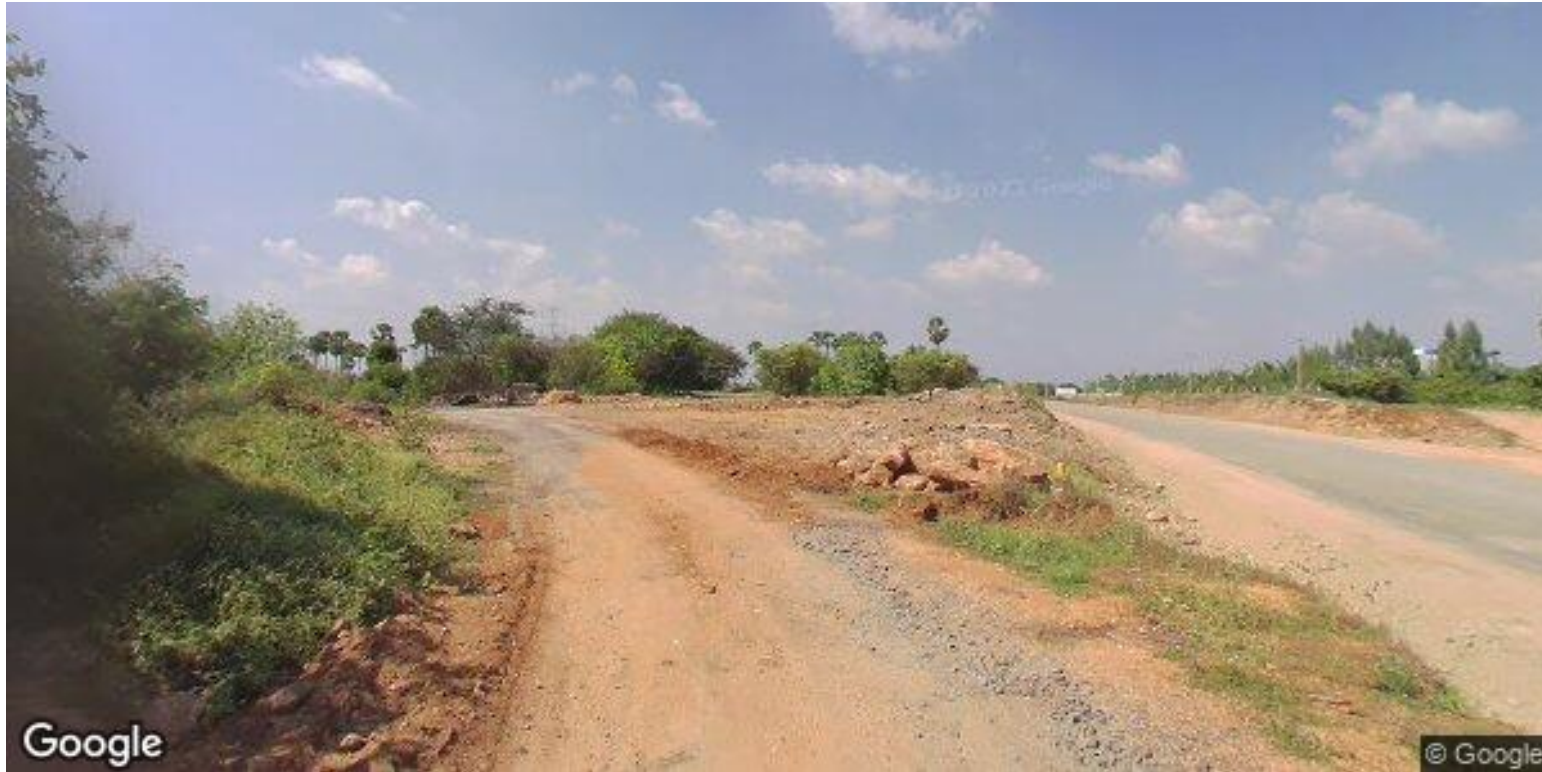
**Risk Type:** Turn  
**Risk Level:** Medium  
**Speed Limit:** 30 KM/Hr  
**Coordinates:** 11.41336, 77.92130

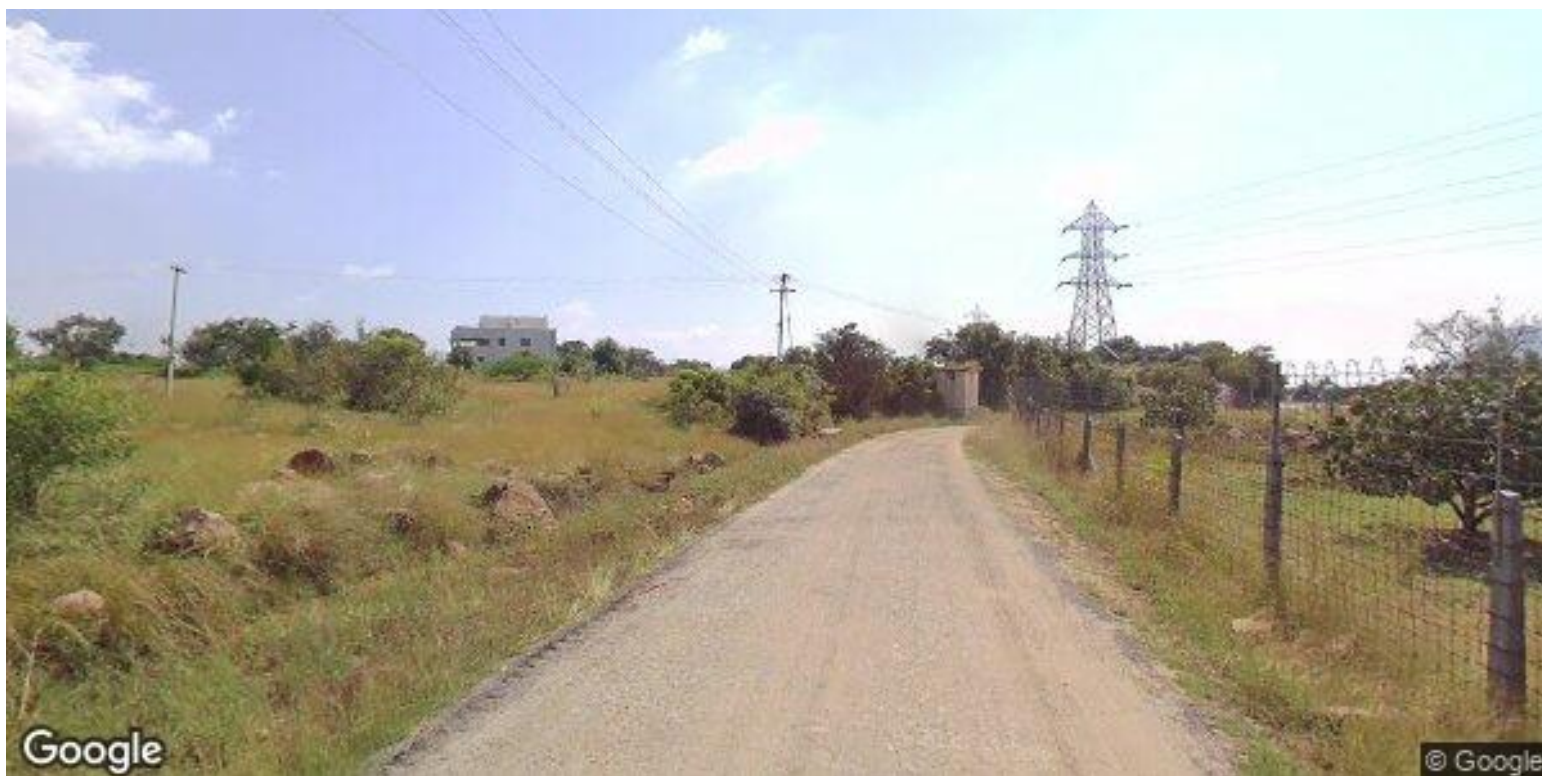
**Risk Type:** Turn  
**Risk Level:** Medium  
**Speed Limit:** 30 KM/Hr  
**Coordinates:** 11.40862, 77.92362

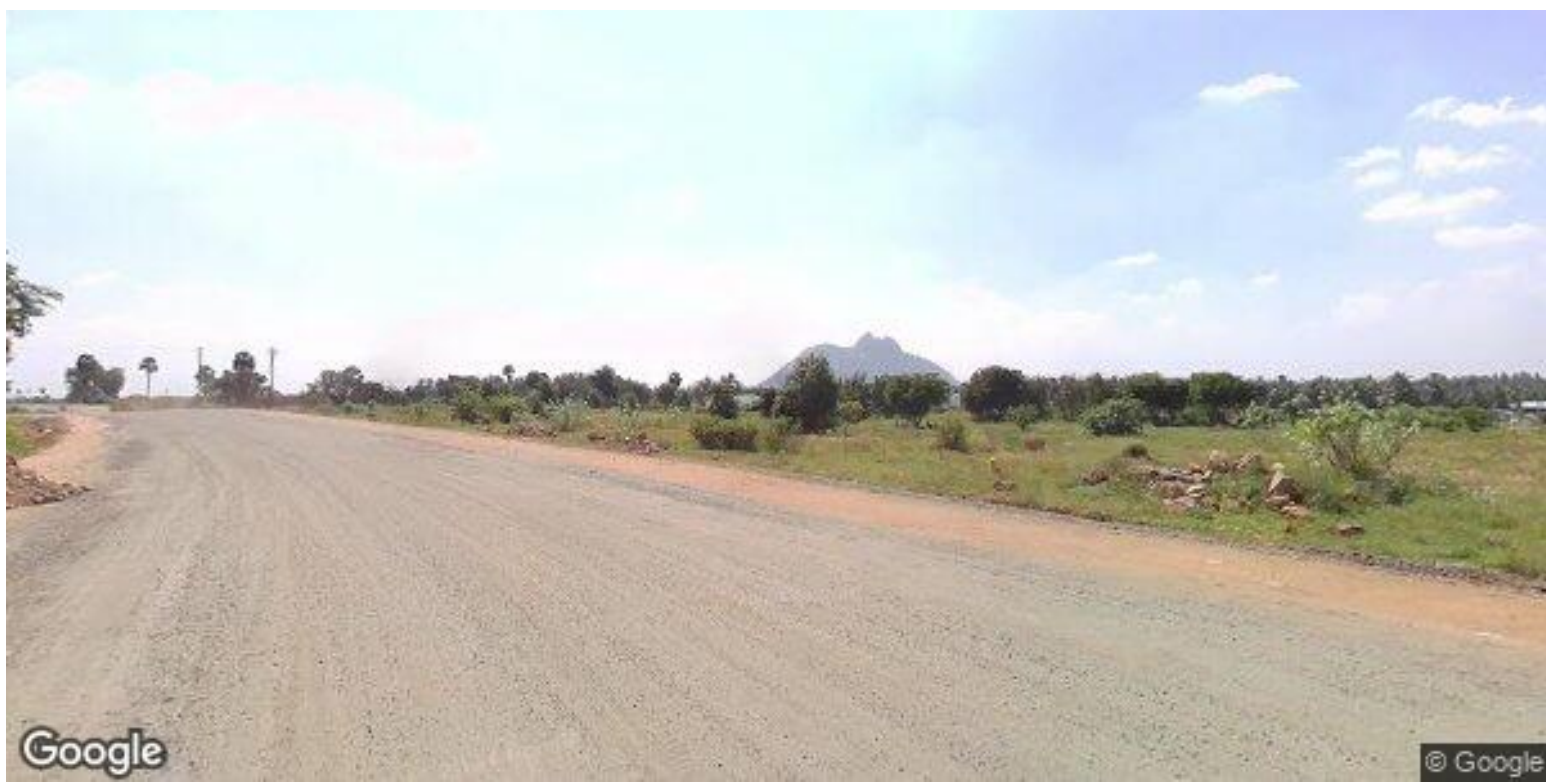
**Coordinates:** 11.40681, 77.92309

**Risk Type:** Turn

**Risk Level:** Medium

**Speed Limit:** 30 KM/Hr

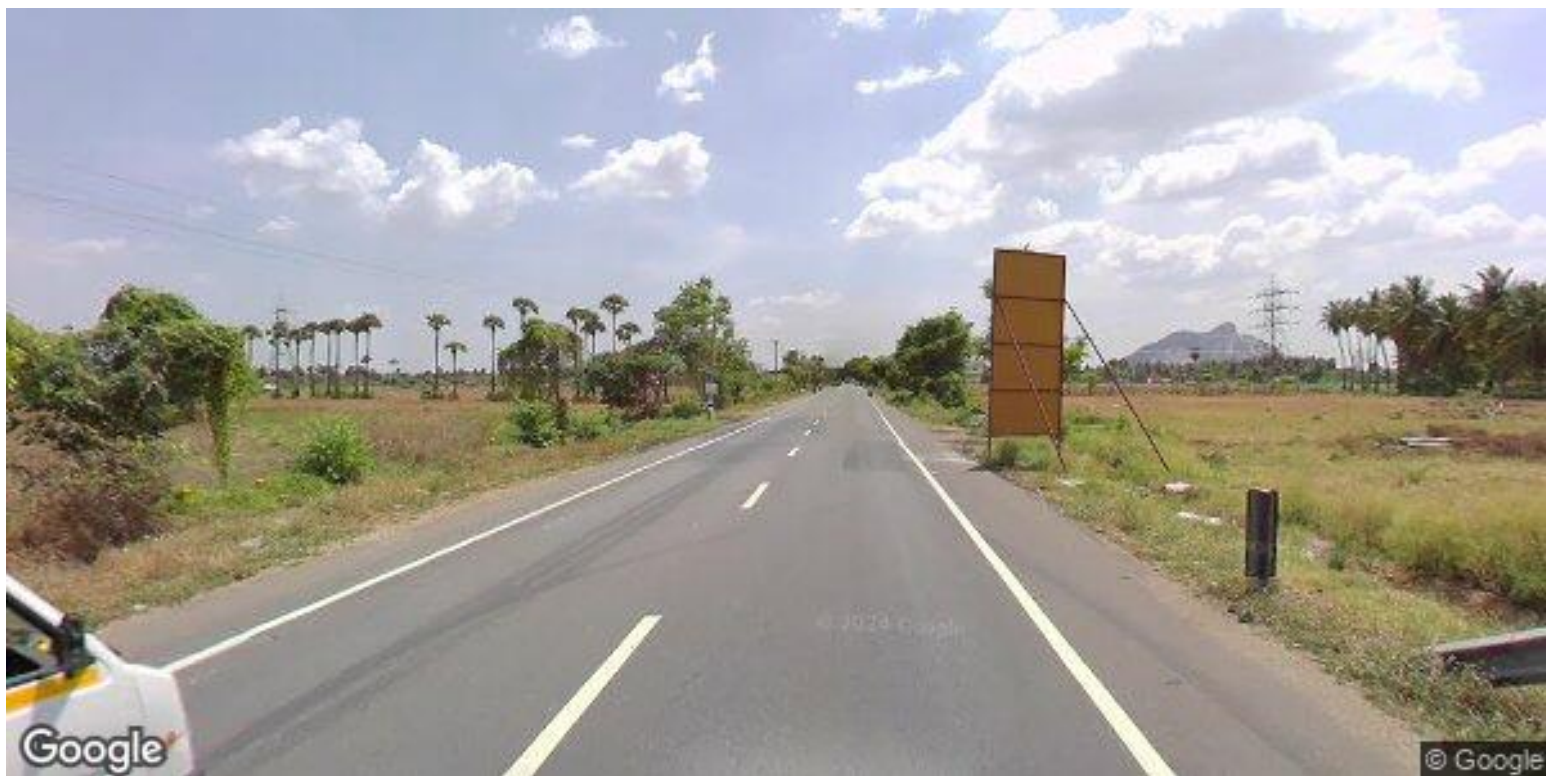
**Coordinates:** 11.36920, 77.94568

**Risk Type:** Blind Spot

**Risk Level:** Blind Spot

**Speed Limit:** 10 KM/Hr

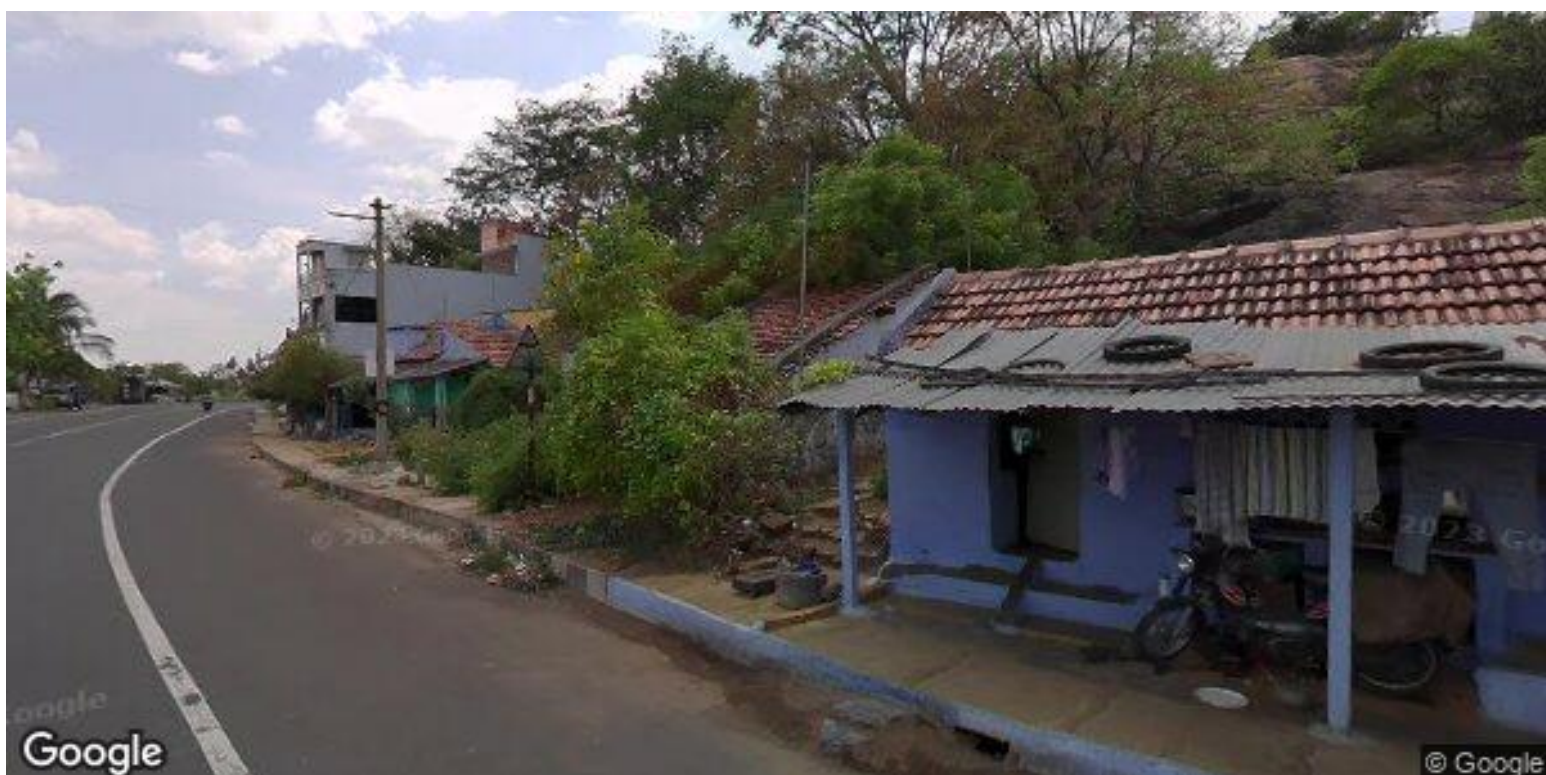
**Risk Type:** Turn  
**Risk Level:** Medium  
**Speed Limit:** 30 KM/Hr  
**Coordinates:** 11.41321, 78.08067

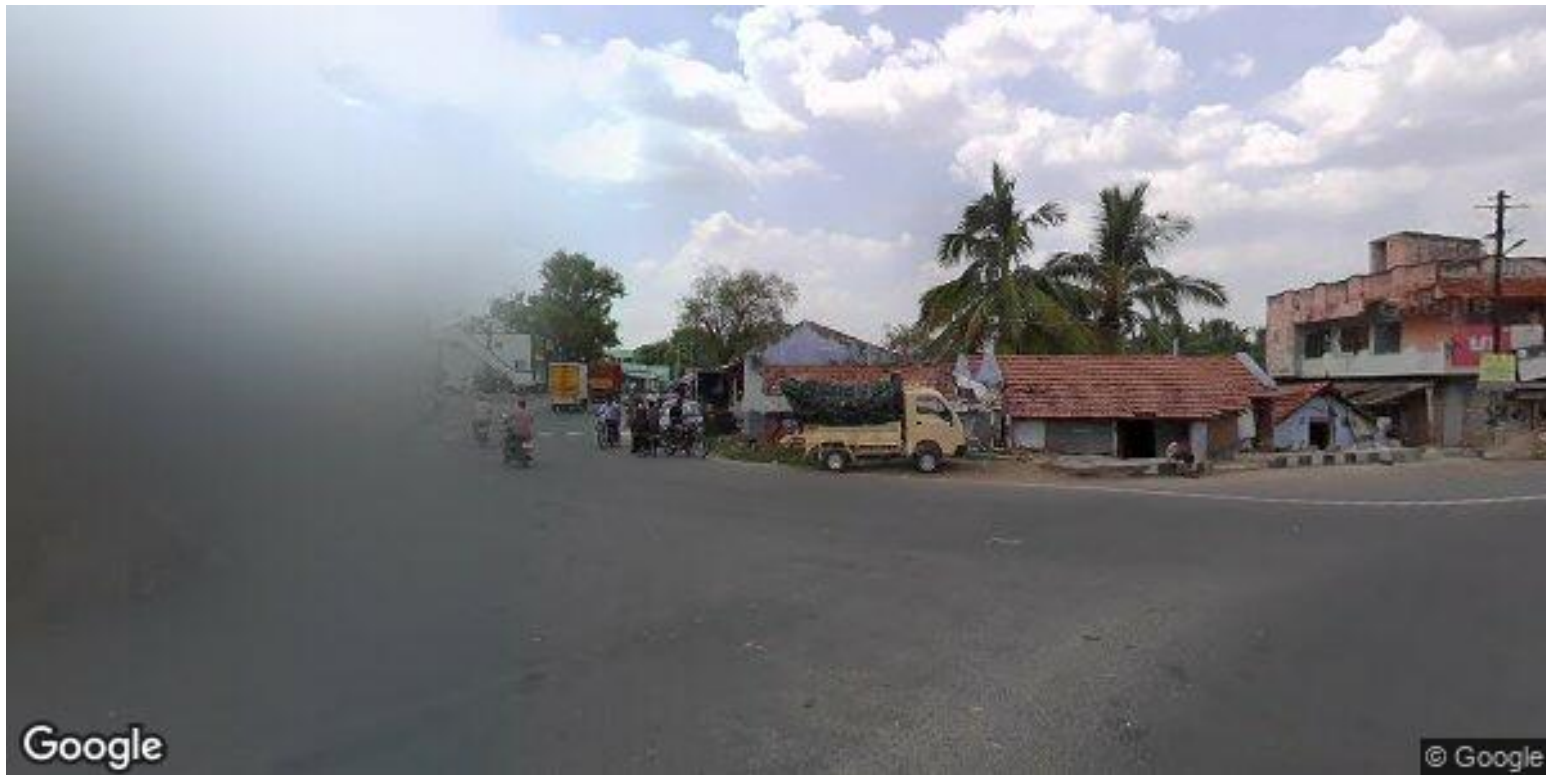
**Risk Type:** Turn  
**Risk Level:** High  
**Speed Limit:** 15 KM/Hr  
**Coordinates:** 11.41453, 78.08062

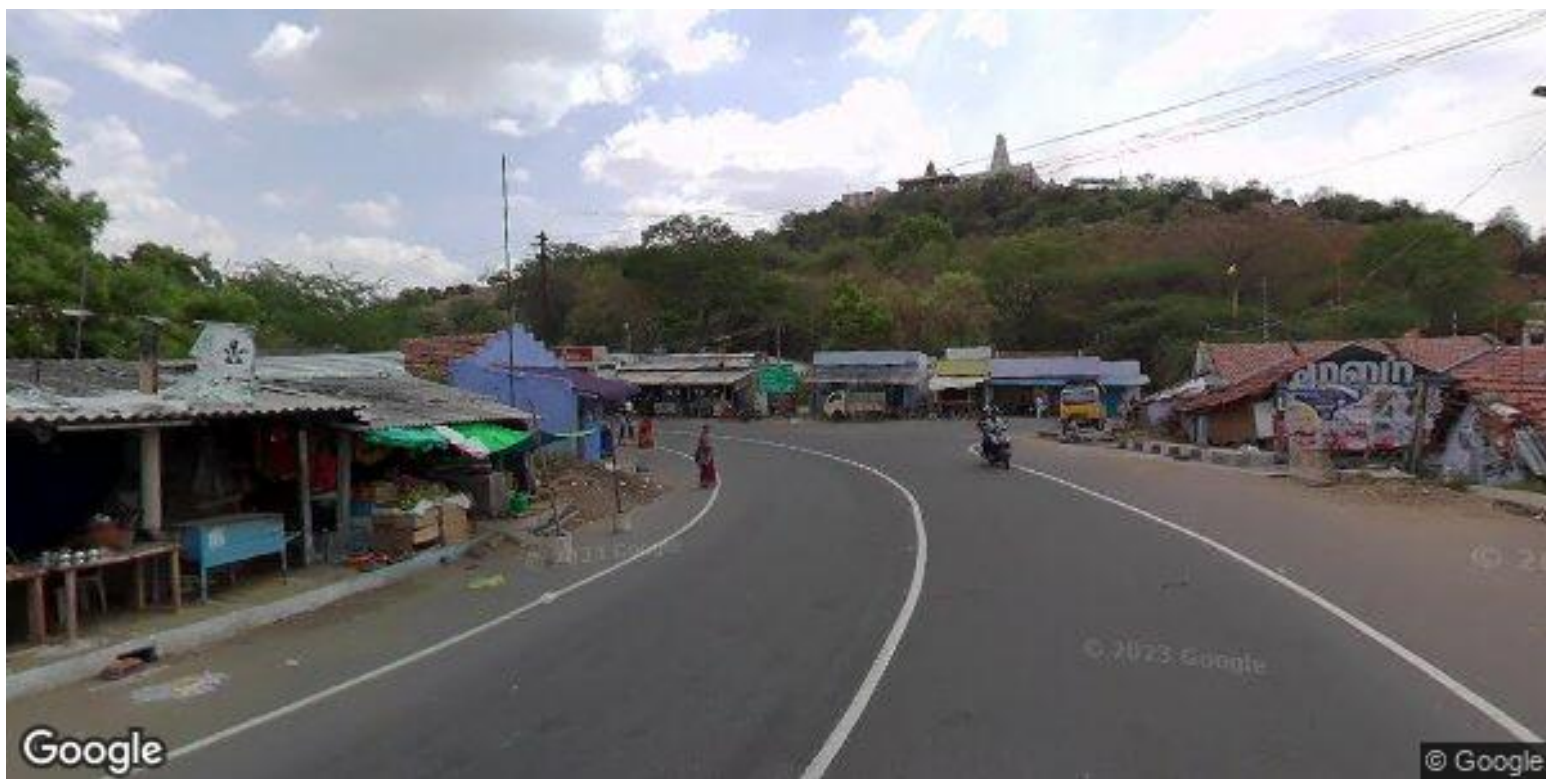
**Risk Type:** Turn  
**Risk Level:** Medium  
**Speed Limit:** 30 KM/Hr  
**Coordinates:** 11.41476, 78.08094

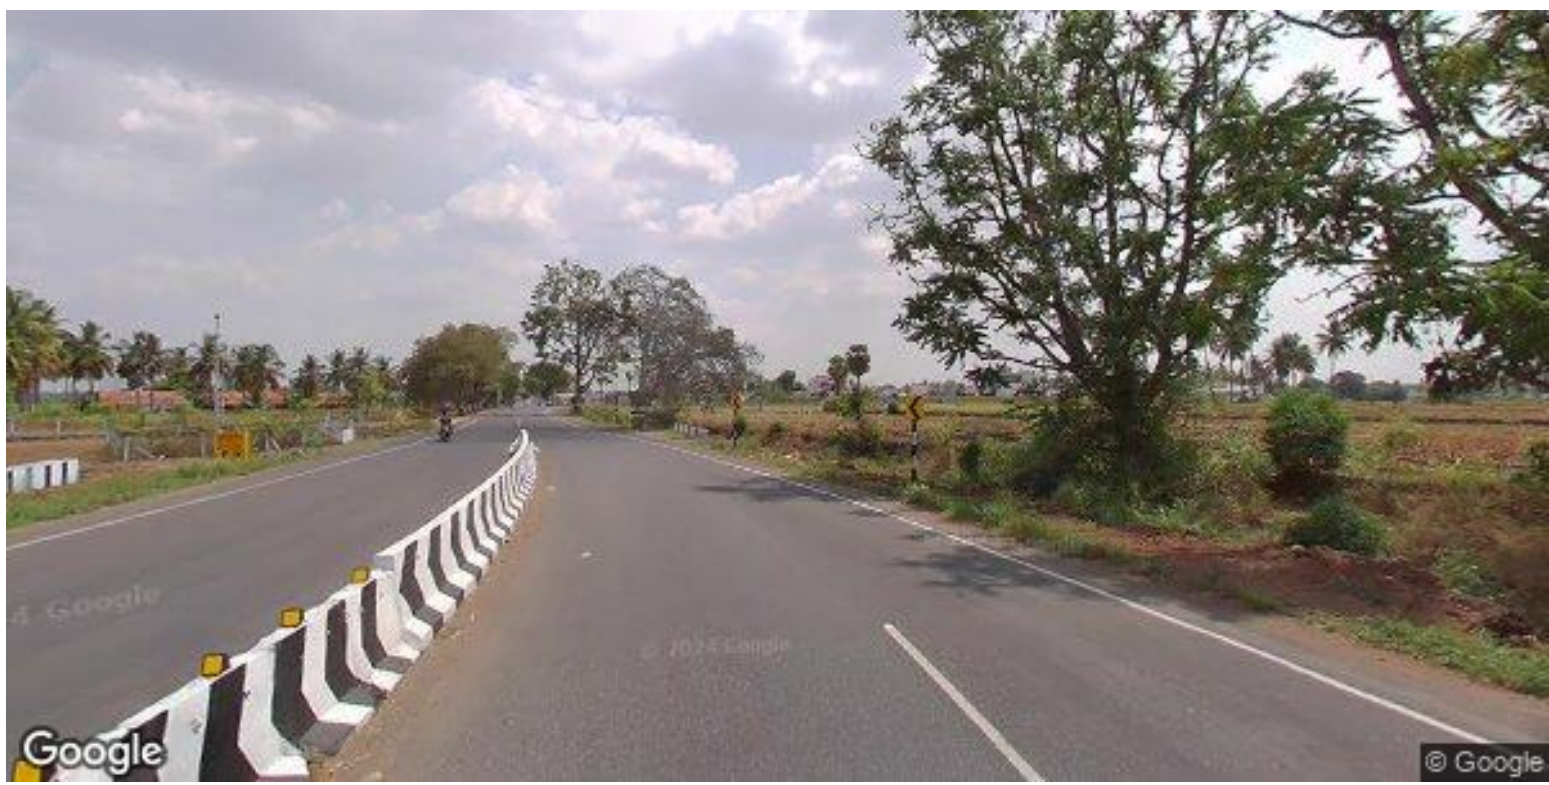
**Coordinates:** 11.43240, 78.12064

**Risk Type:** Turn

**Risk Level:** Medium

**Speed Limit:** 30 KM/Hr

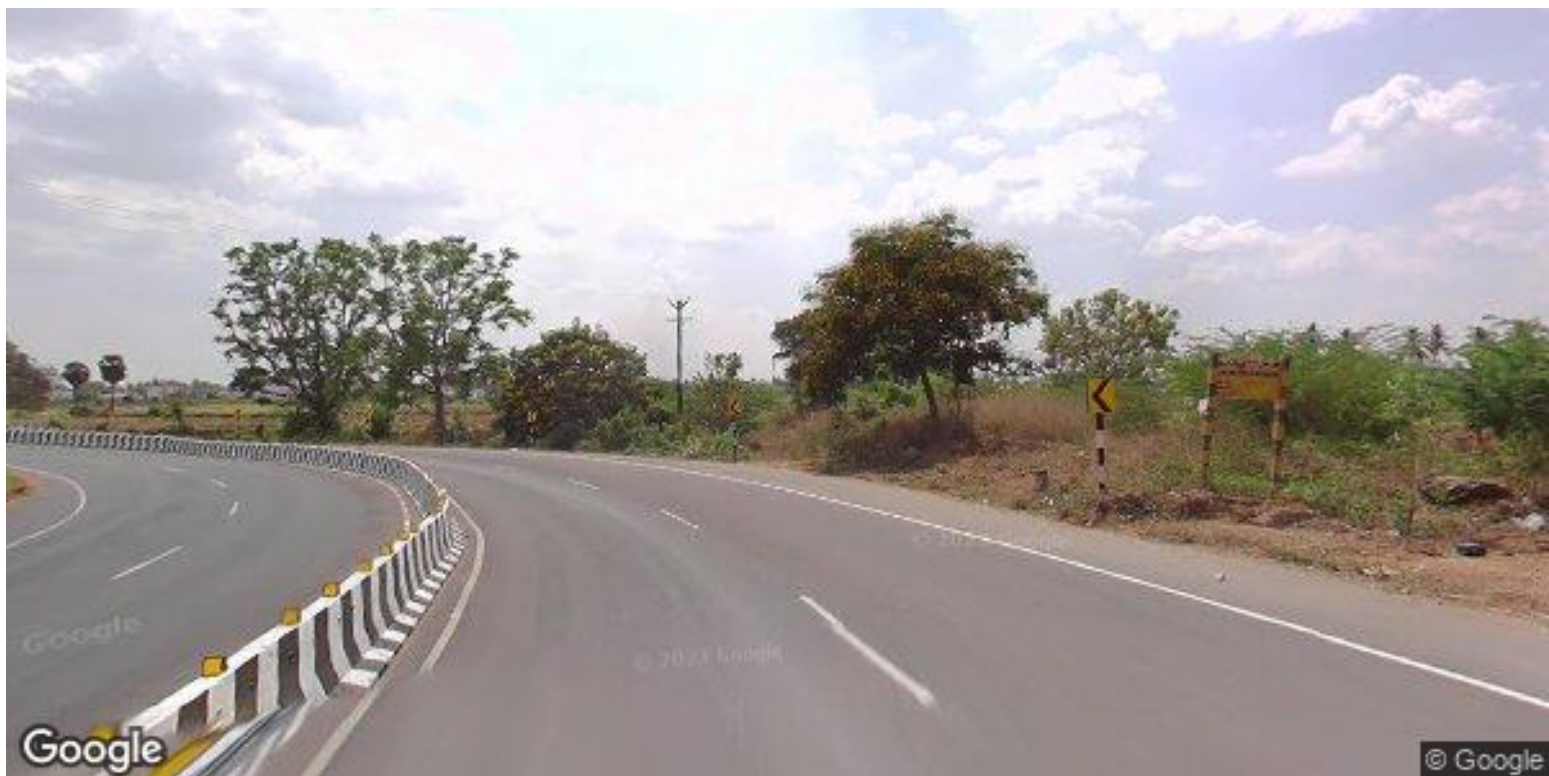
**Coordinates:** 11.43258, 78.12110

**Risk Type:** Turn

**Risk Level:** Medium

**Speed Limit:** 30 KM/Hr

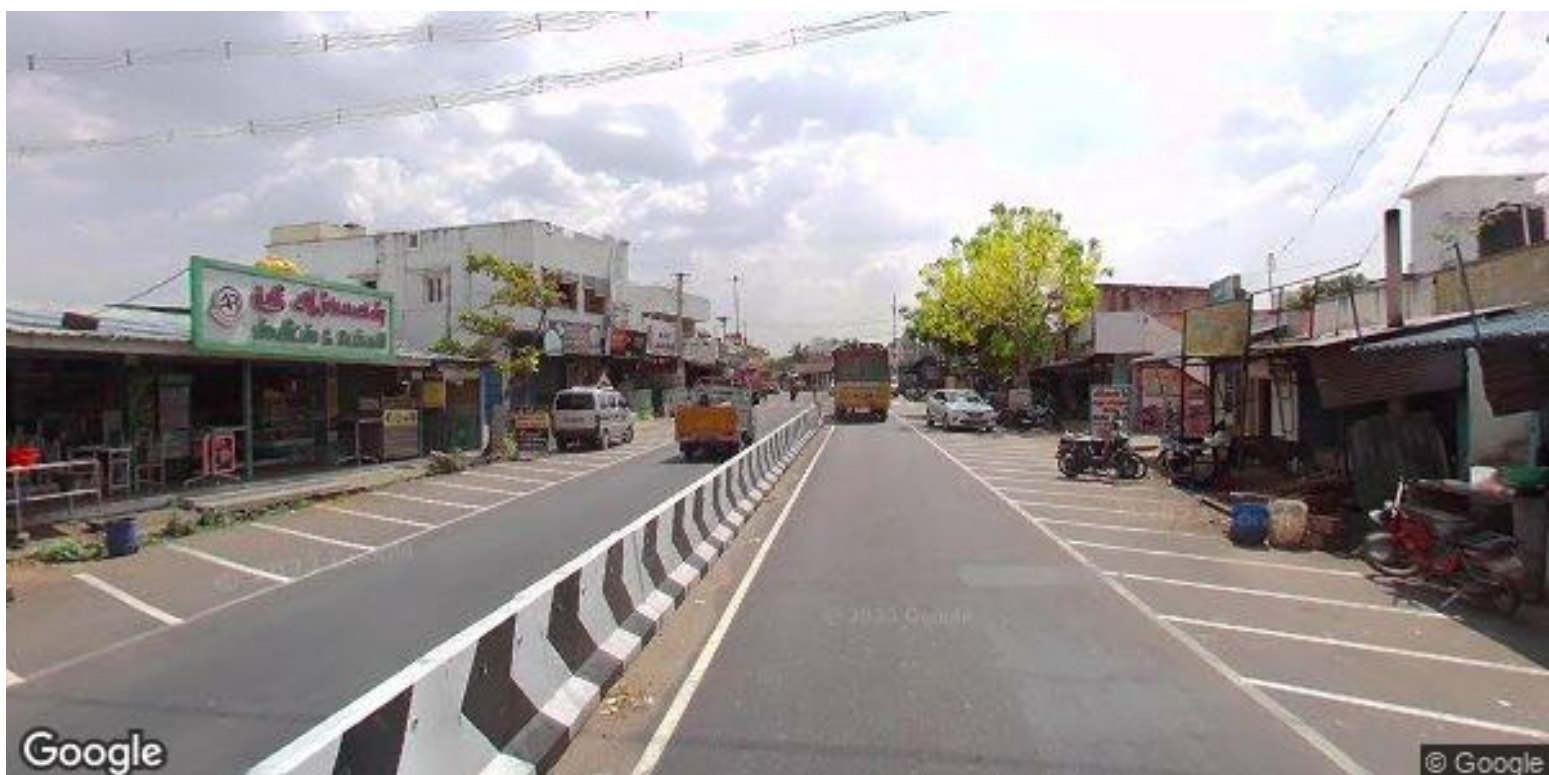
**Risk Type:** Blind Spot  
**Risk Level:** Blind Spot  
**Speed Limit:** 10 KM/Hr  
**Coordinates:** 11.43260, 78.13252

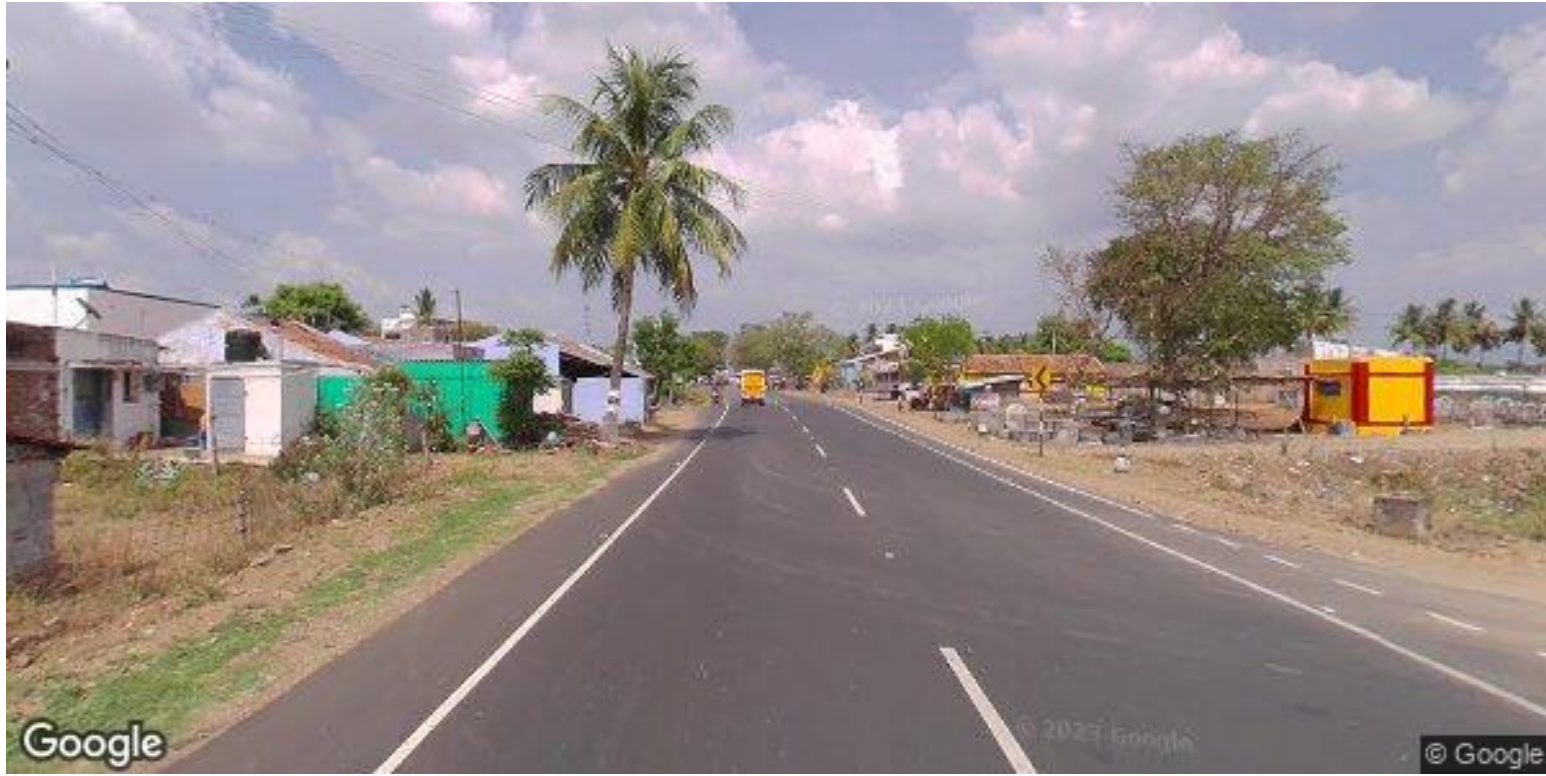
**Risk Type:** Turn  
**Risk Level:** High  
**Speed Limit:** 15 KM/Hr  
**Coordinates:** 11.43131, 78.12710

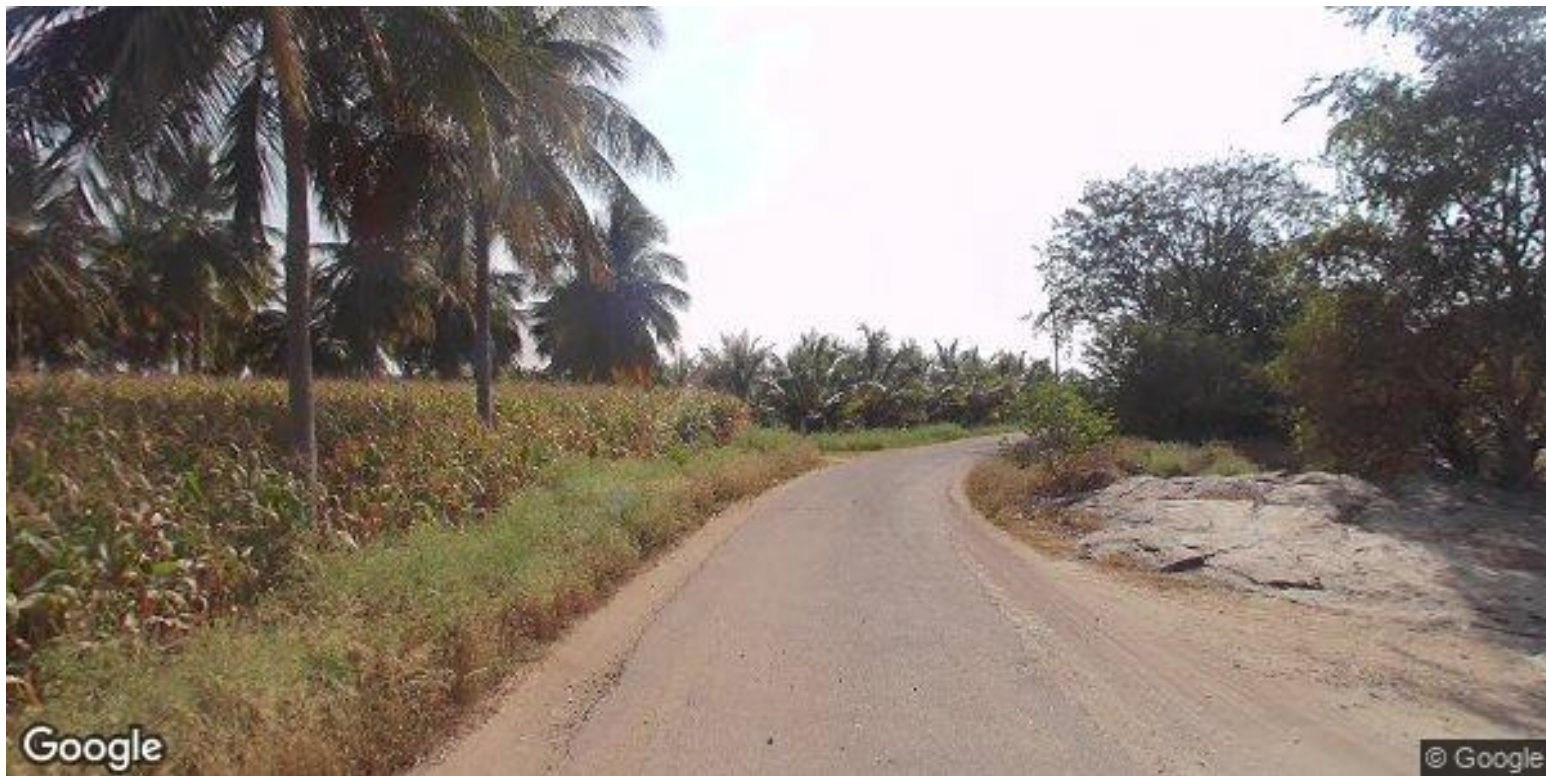
**Risk Type:** Turn  
**Risk Level:** Medium  
**Speed Limit:** 30 KM/Hr  
**Coordinates:** 11.42708, 78.12675

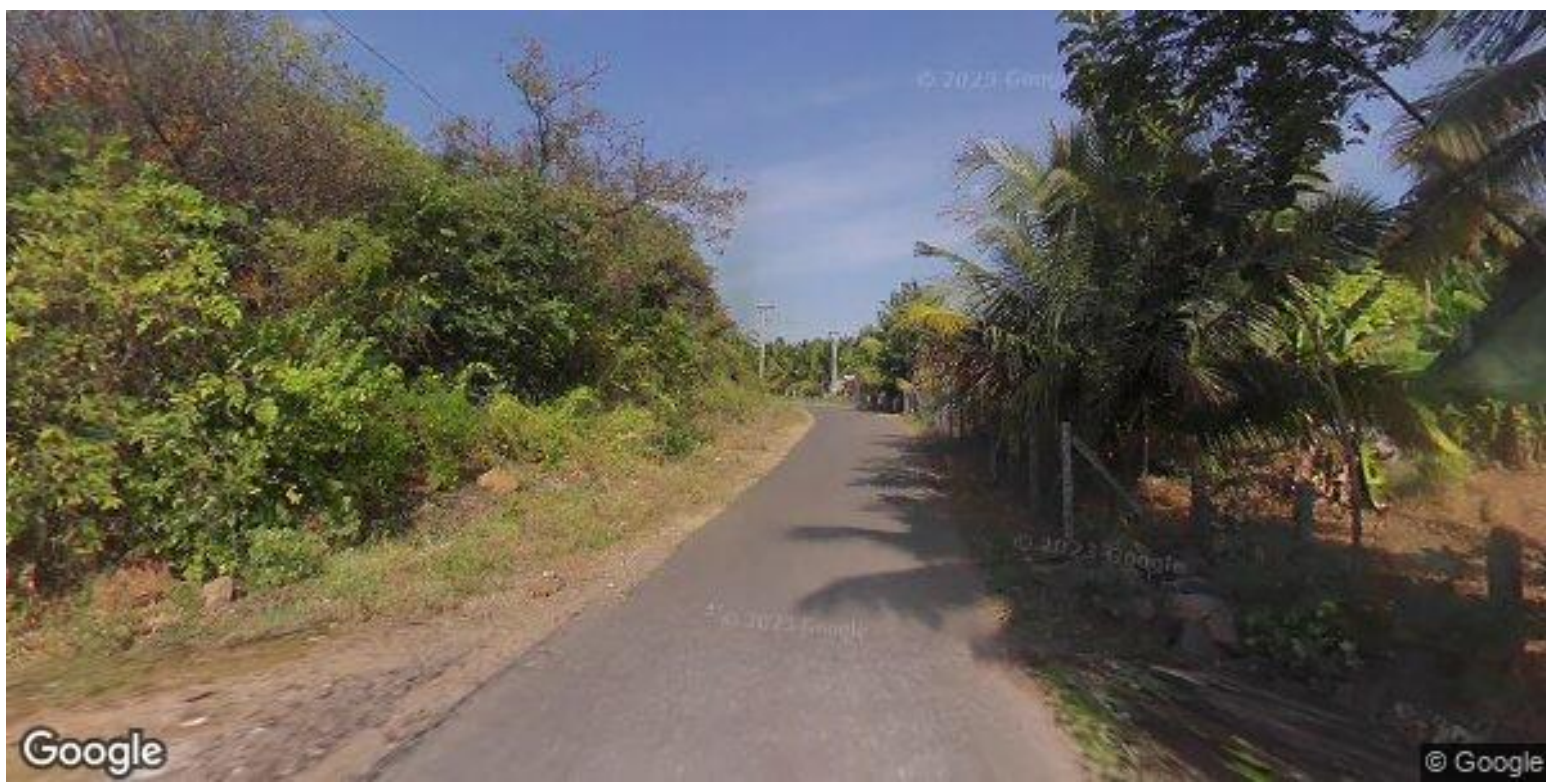
**Coordinates:** 11.42597, 78.12536

**Risk Type:** Turn

**Risk Level:** Medium

**Speed Limit:** 30 KM/Hr

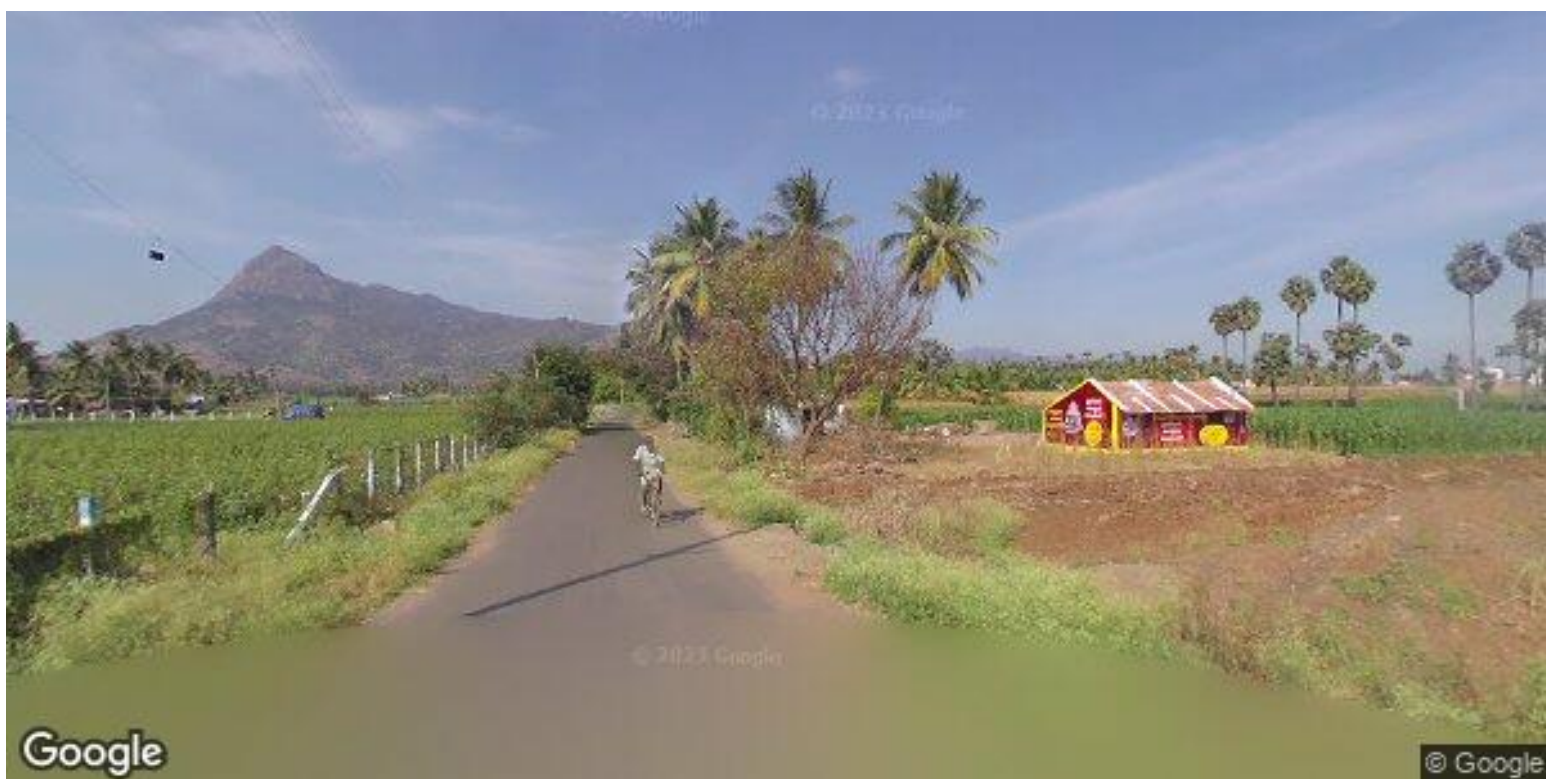
**Coordinates:** 11.42447, 78.12483

**Risk Type:** Turn

**Risk Level:** High

**Speed Limit:** 15 KM/Hr

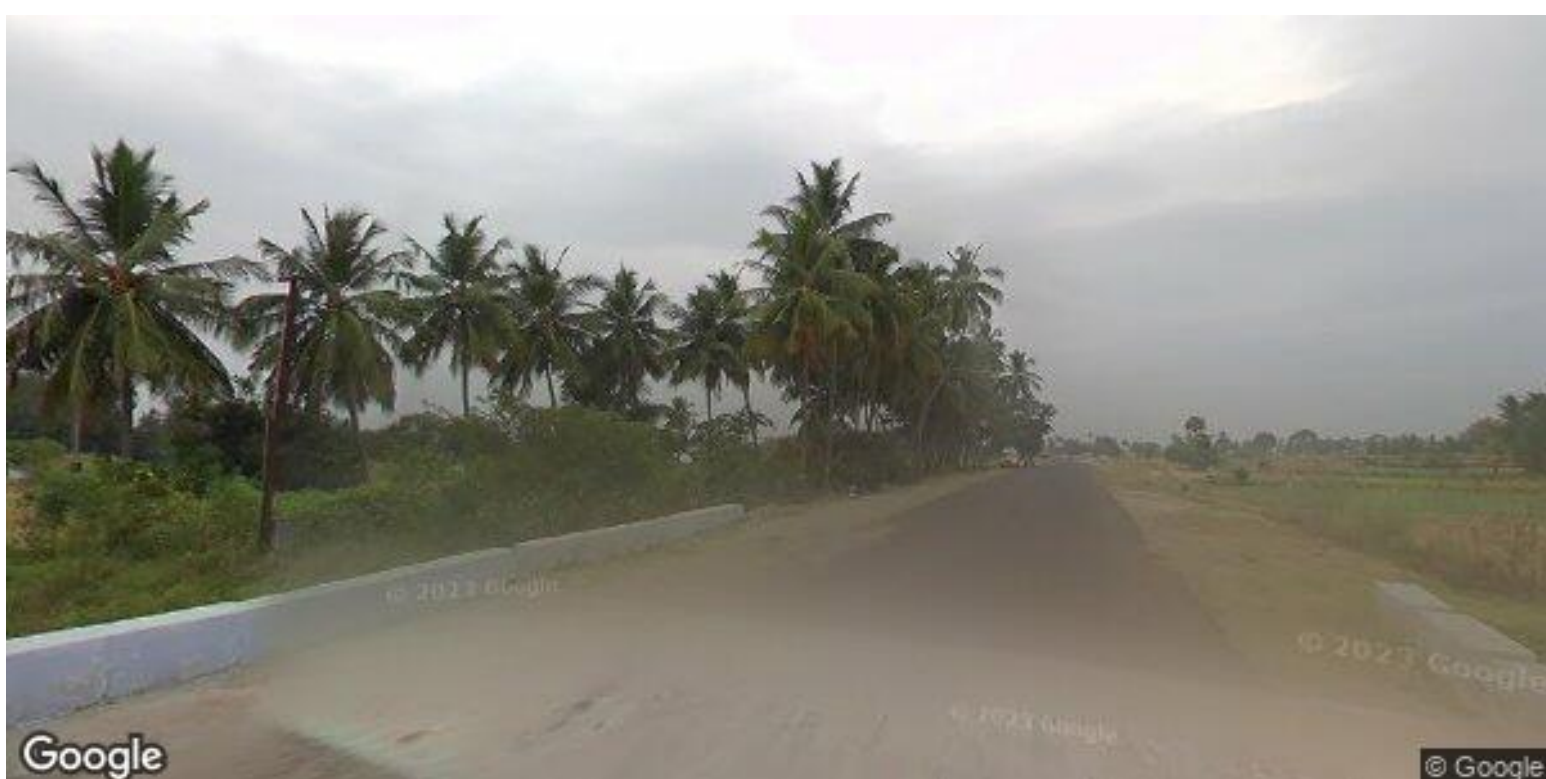
**Coordinates: 11.42450, 78.15278**

**Risk Type: Turn**

**Risk Level: Medium**

**Speed Limit: 30 KM/Hr**

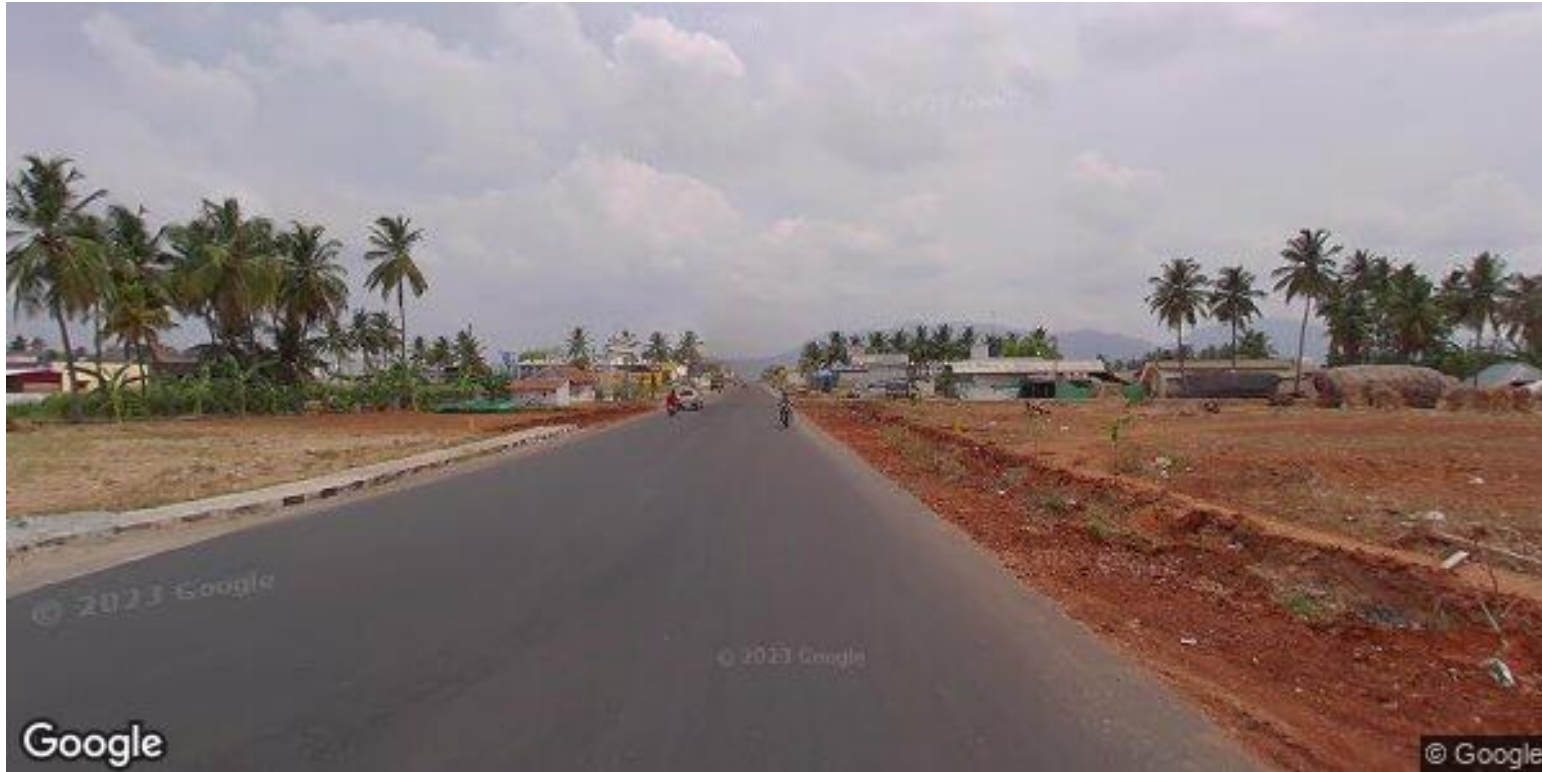
**Coordinates: 11.43542, 78.20754**

**Risk Type: Turn**

**Risk Level: High**

**Speed Limit: 15 KM/Hr**
