## **JOURNEY RISK MANAGEMENT (JRM) STUDY**

### **Salem Terminal TO SRI VETRI VELAN AGENCY**

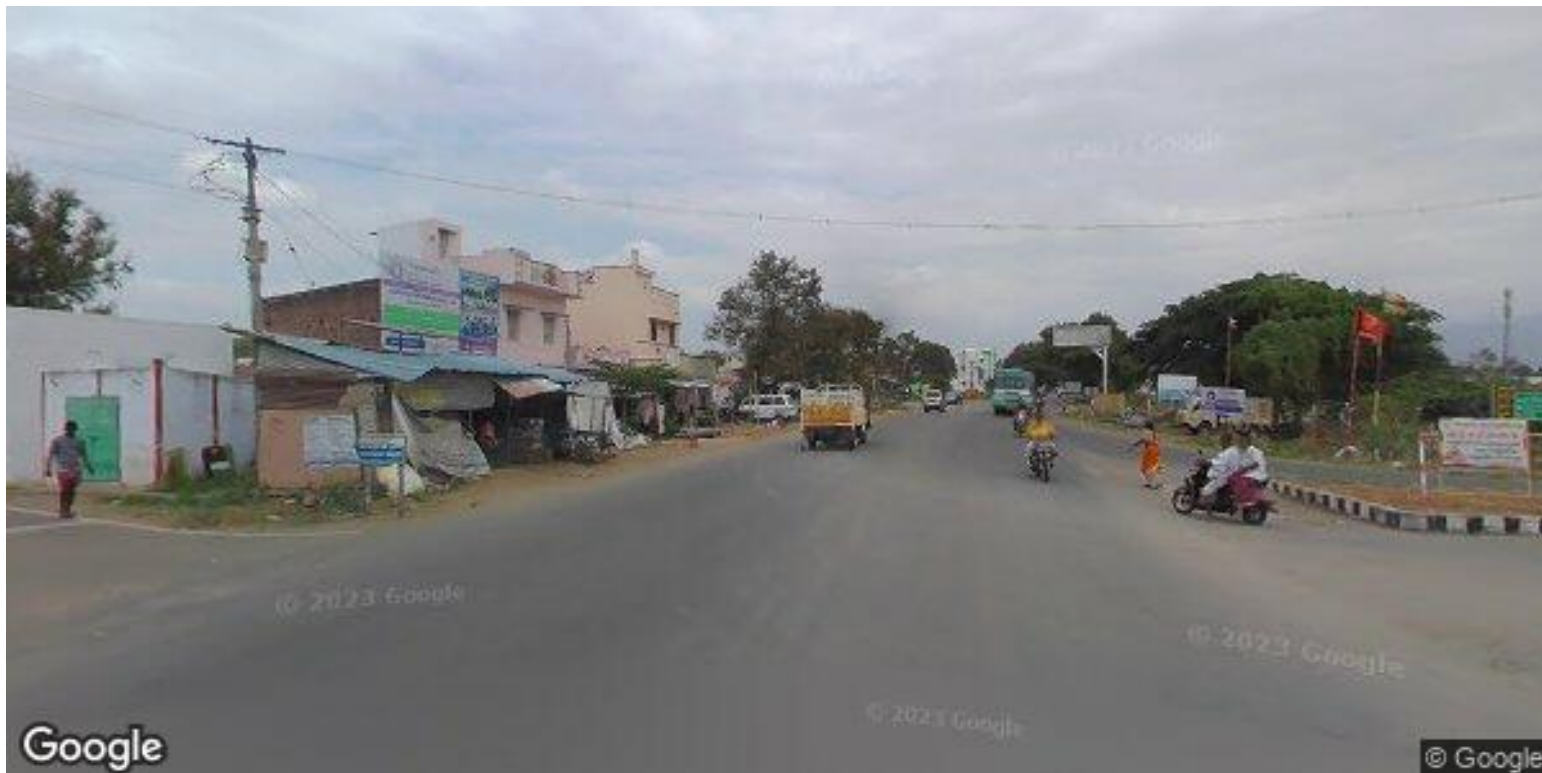
**Coordinates: 11.45100, 78.20385**

**Risk Type: Blind Spot**

**Risk Level: Blind Spot**

**Speed Limit: 10 KM/Hr**

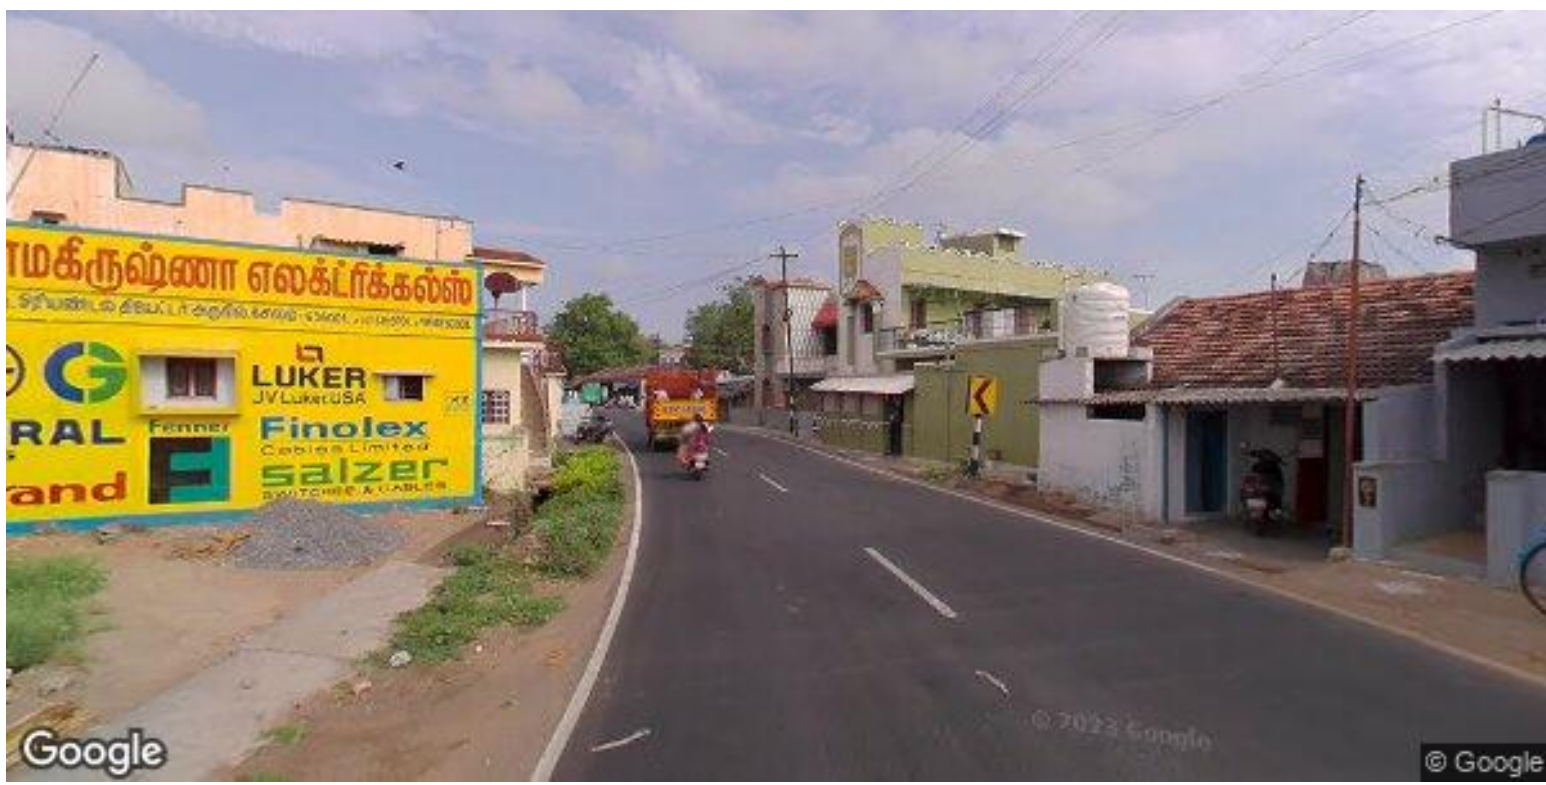
**Coordinates:** 11.44941, 78.22277

**Risk Type:** Turn

**Risk Level:** High

**Speed Limit:** 15 KM/Hr

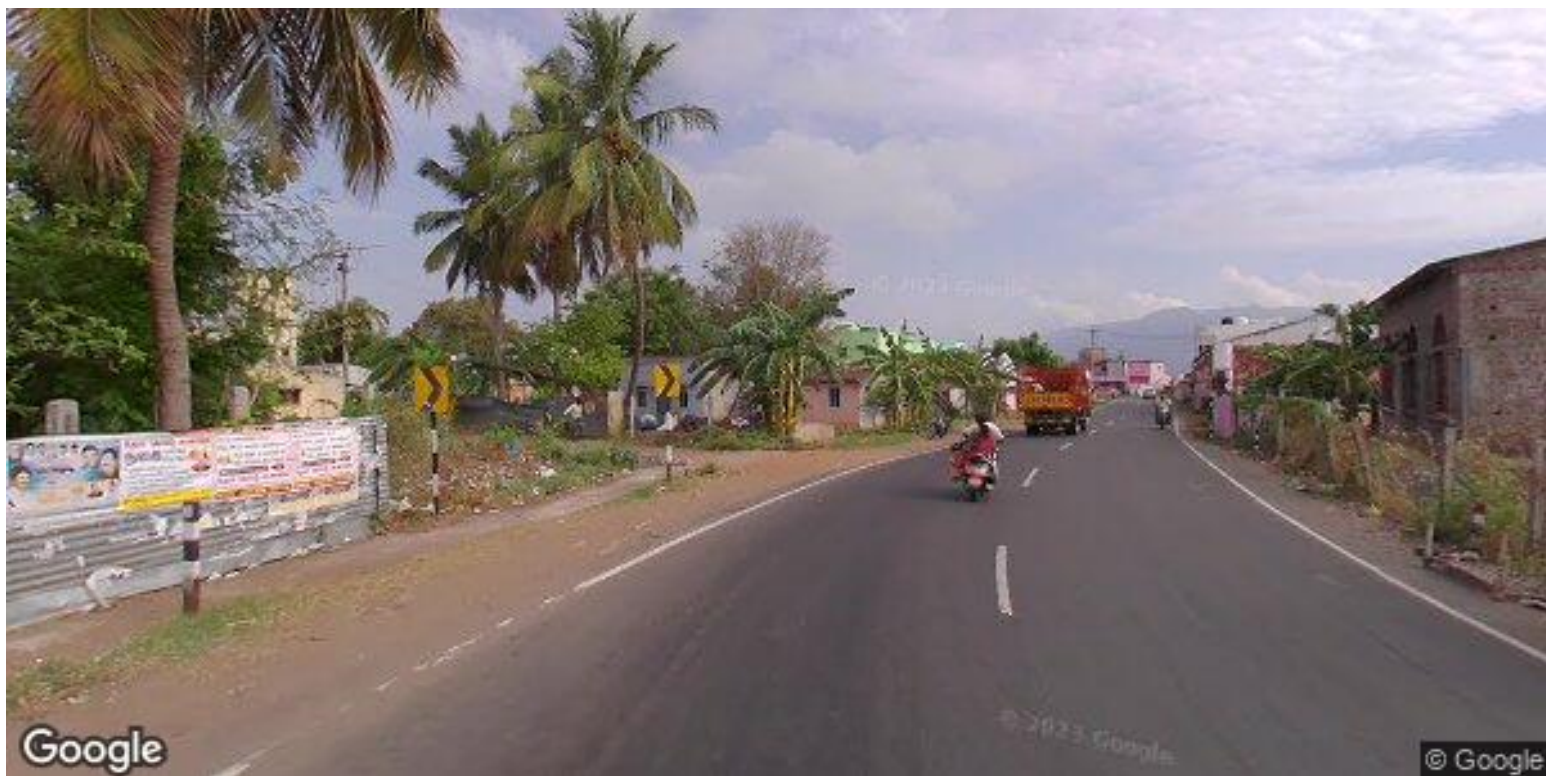
**Coordinates:** 11.44806, 78.22308

**Risk Type:** Turn

**Risk Level:** Medium

**Speed Limit:** 30 KM/Hr

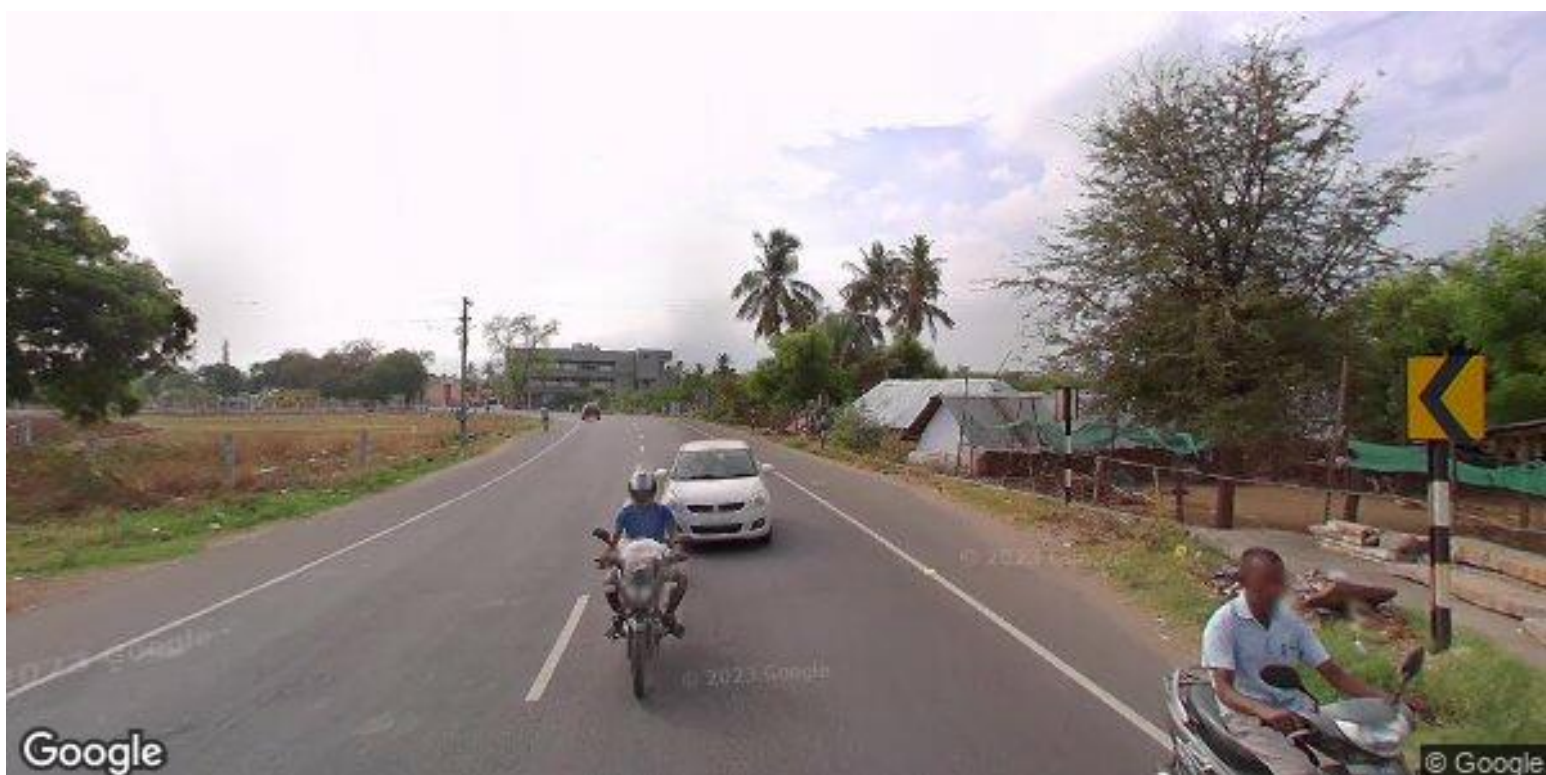
**Risk Type:** Turn  
**Risk Level:** Medium  
**Speed Limit:** 30 KM/Hr  
**Coordinates:** 11.44783, 78.22334

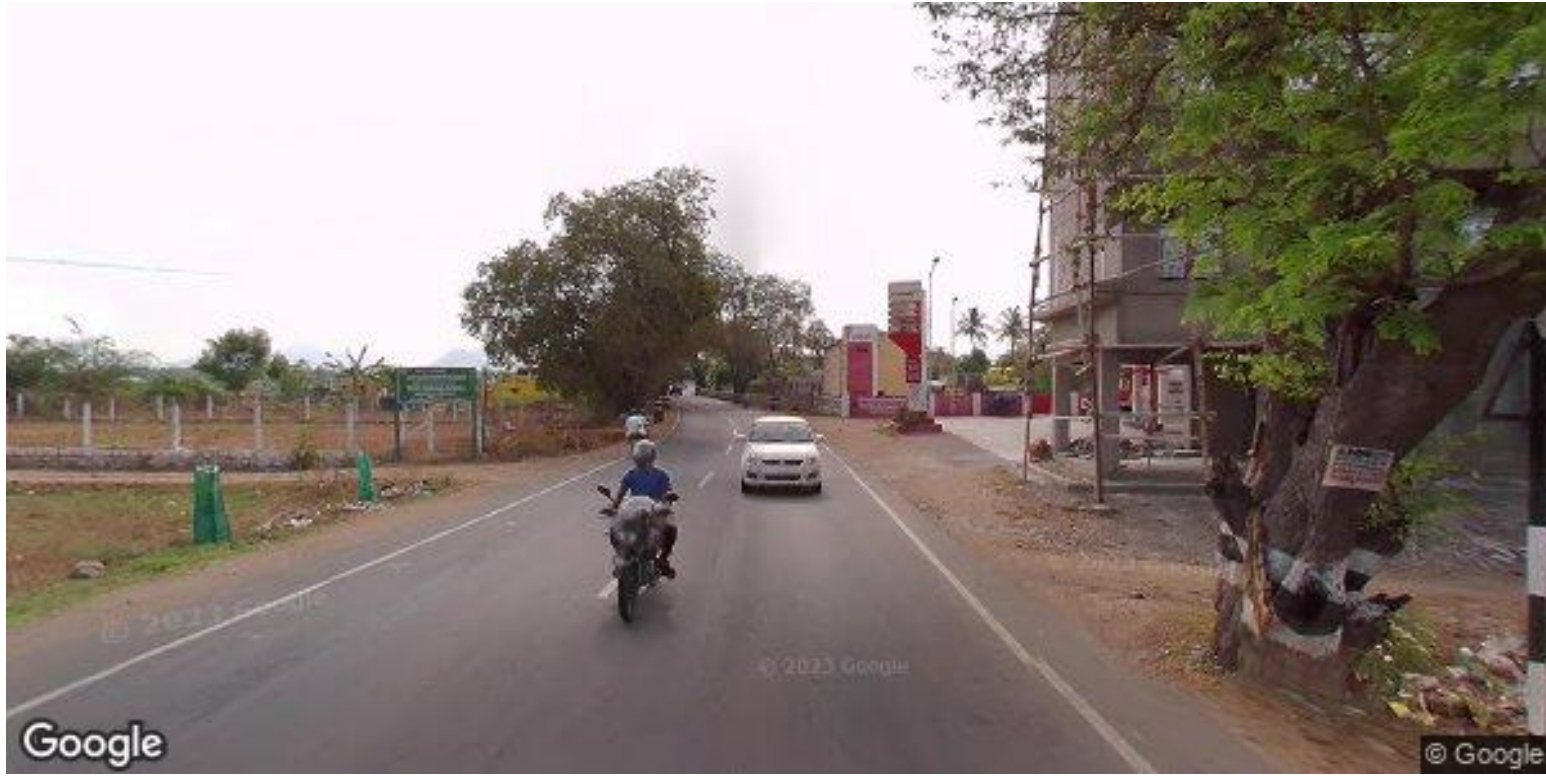
**Risk Type:** Turn  
**Risk Level:** Medium  
**Speed Limit:** 30 KM/Hr  
**Coordinates:** 11.44753, 78.22458

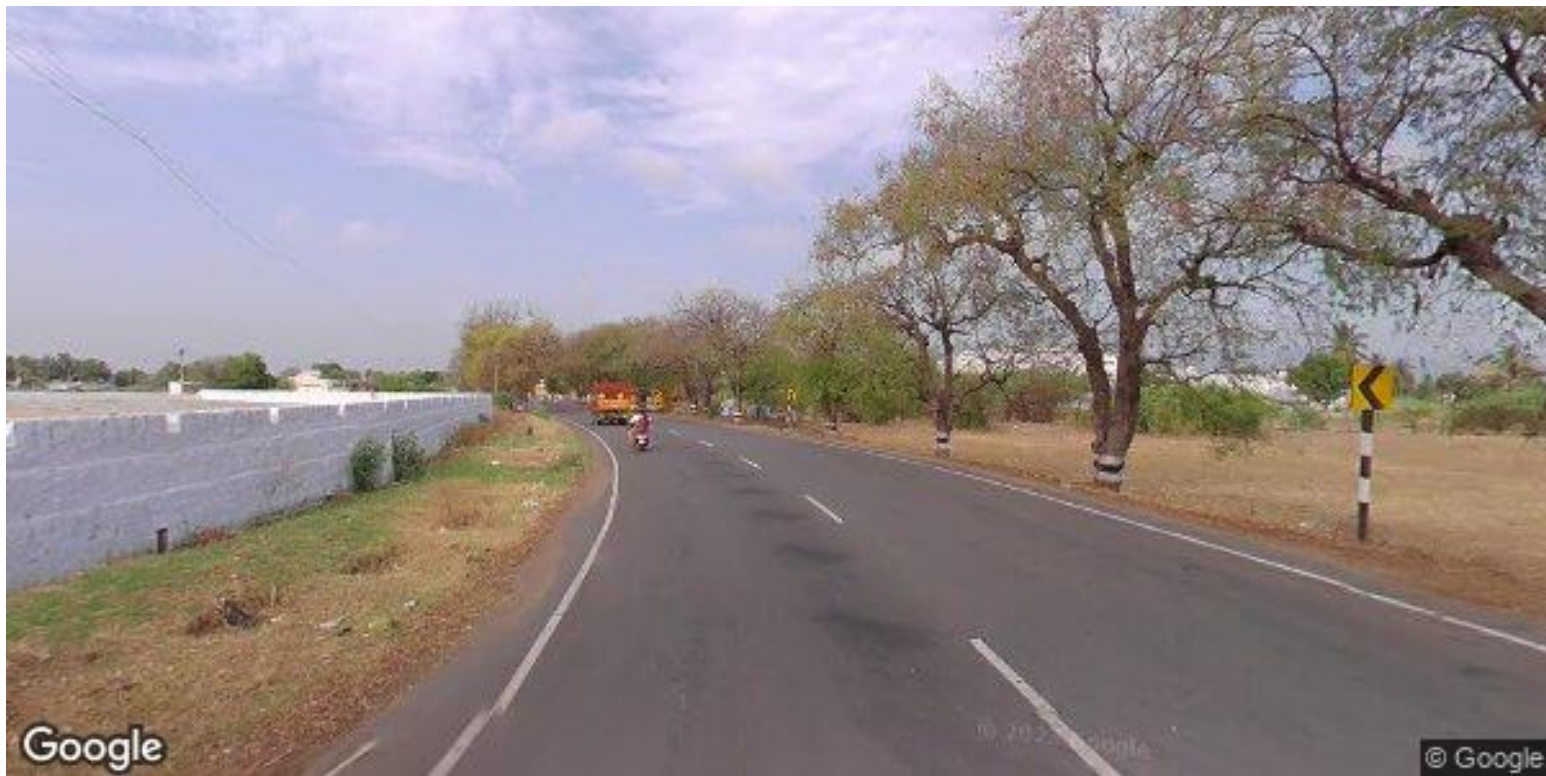
**Risk Type:** Turn  
**Risk Level:** Medium  
**Speed Limit:** 30 KM/Hr  
**Coordinates:** 11.45366, 78.23608

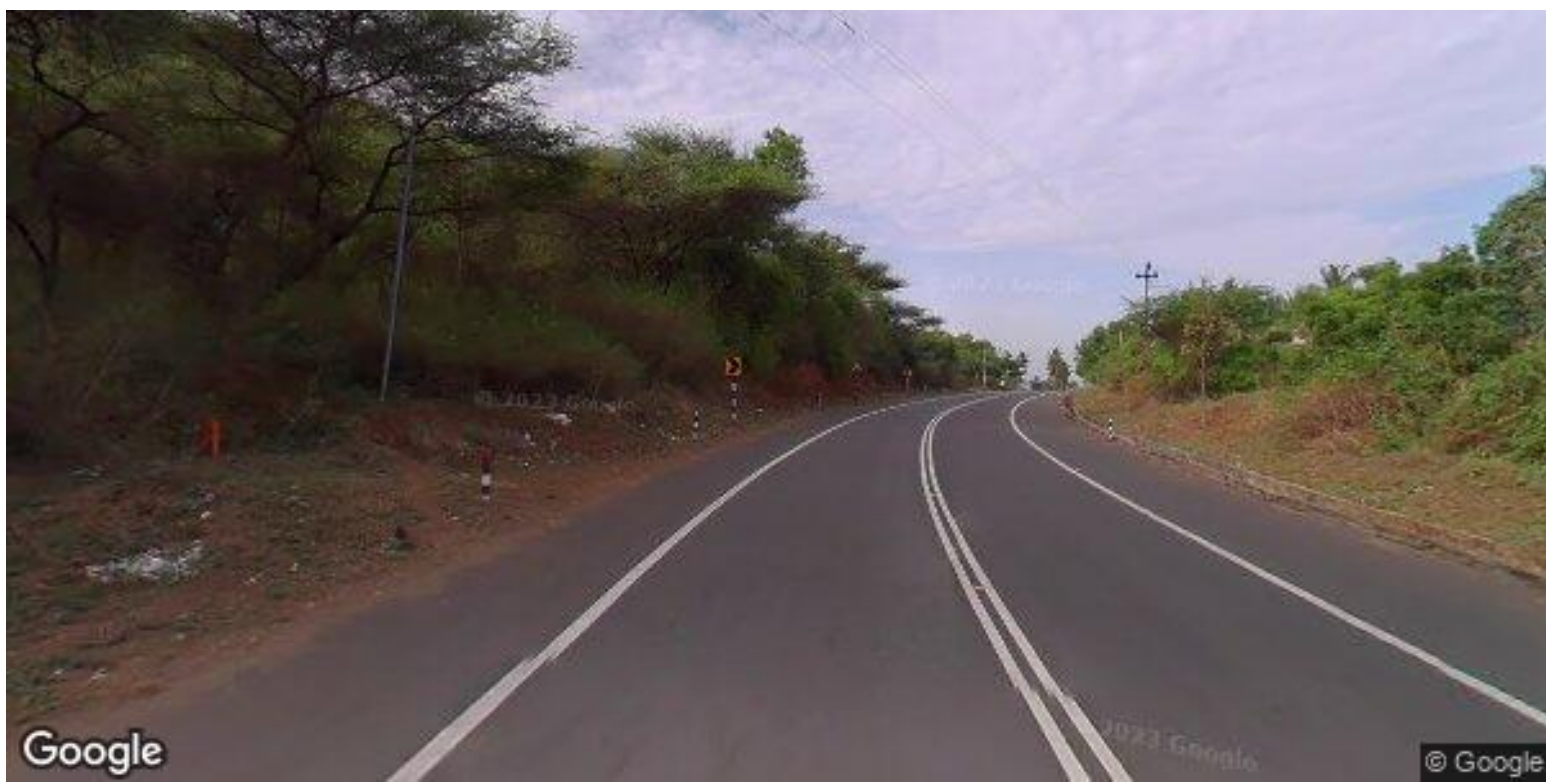
**Coordinates:** 11.49639, 78.32346

**Risk Type:** Turn

**Risk Level:** Medium

**Speed Limit:** 30 KM/Hr

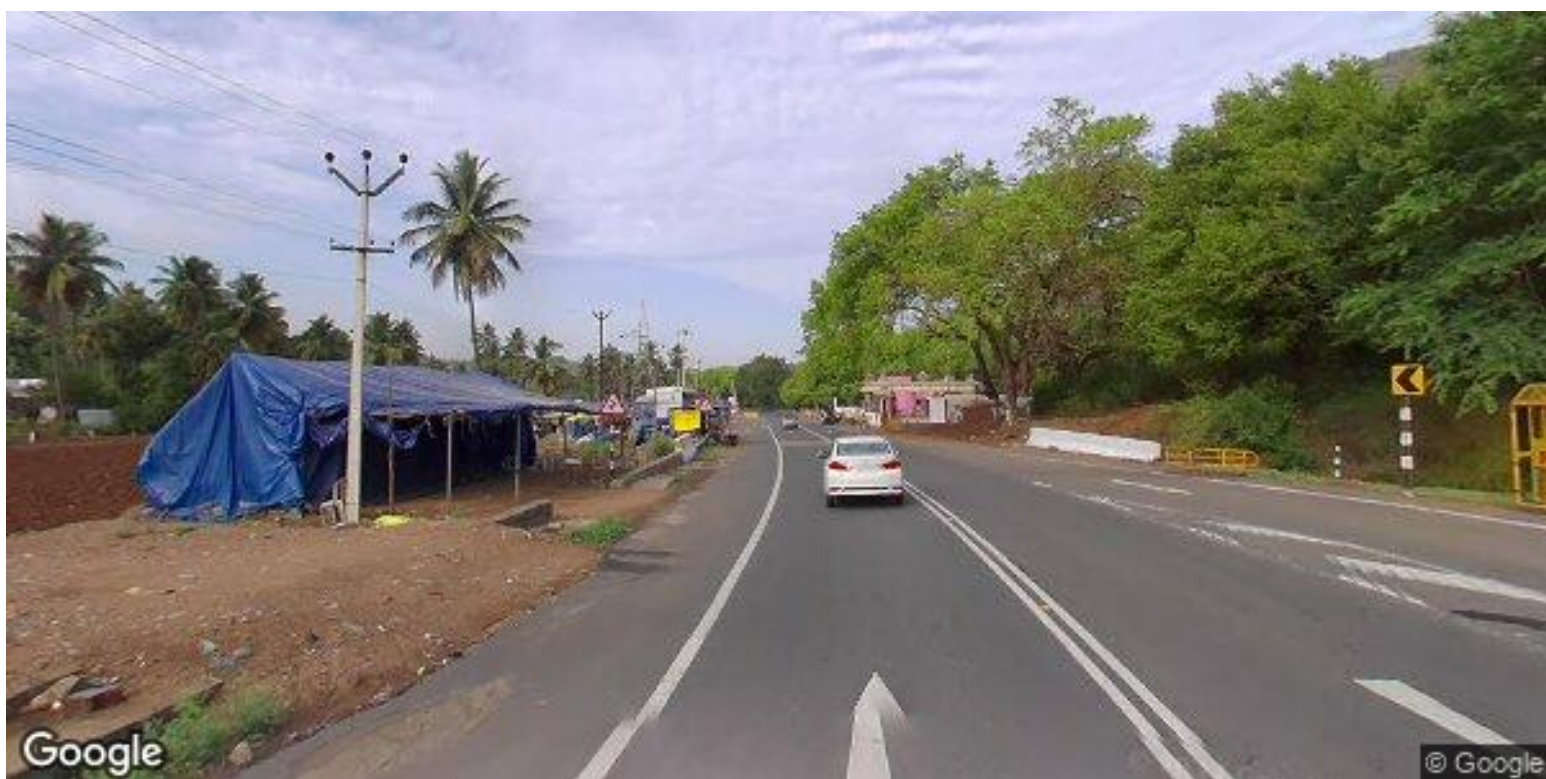
**Coordinates:** 11.50762, 78.33281

**Risk Type:** Turn

**Risk Level:** Medium

**Speed Limit:** 30 KM/Hr

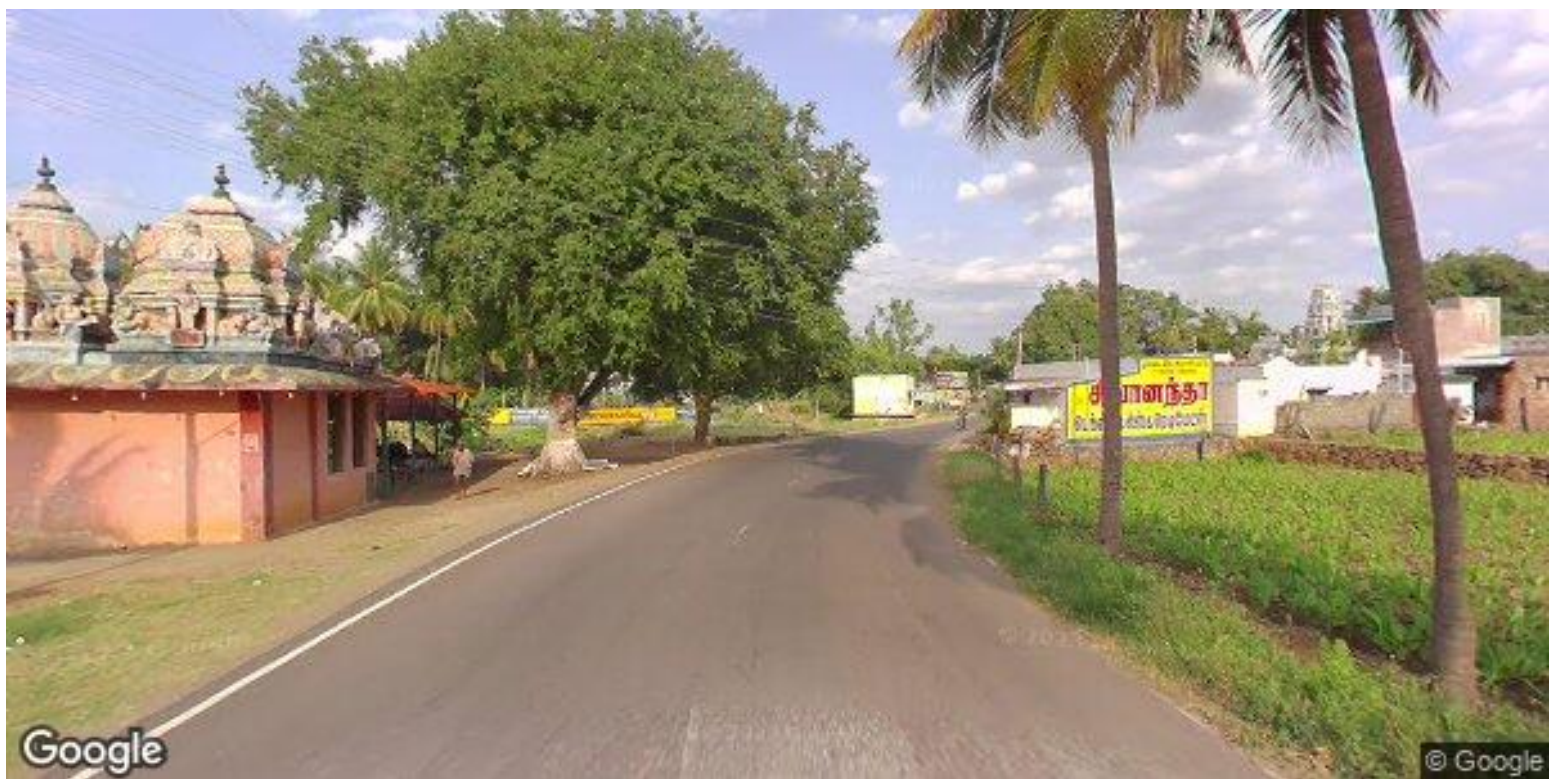
**Risk Type:** Turn  
**Risk Level:** Medium  
**Speed Limit:** 30 KM/Hr  
**Coordinates:** 11.51037, 78.34883

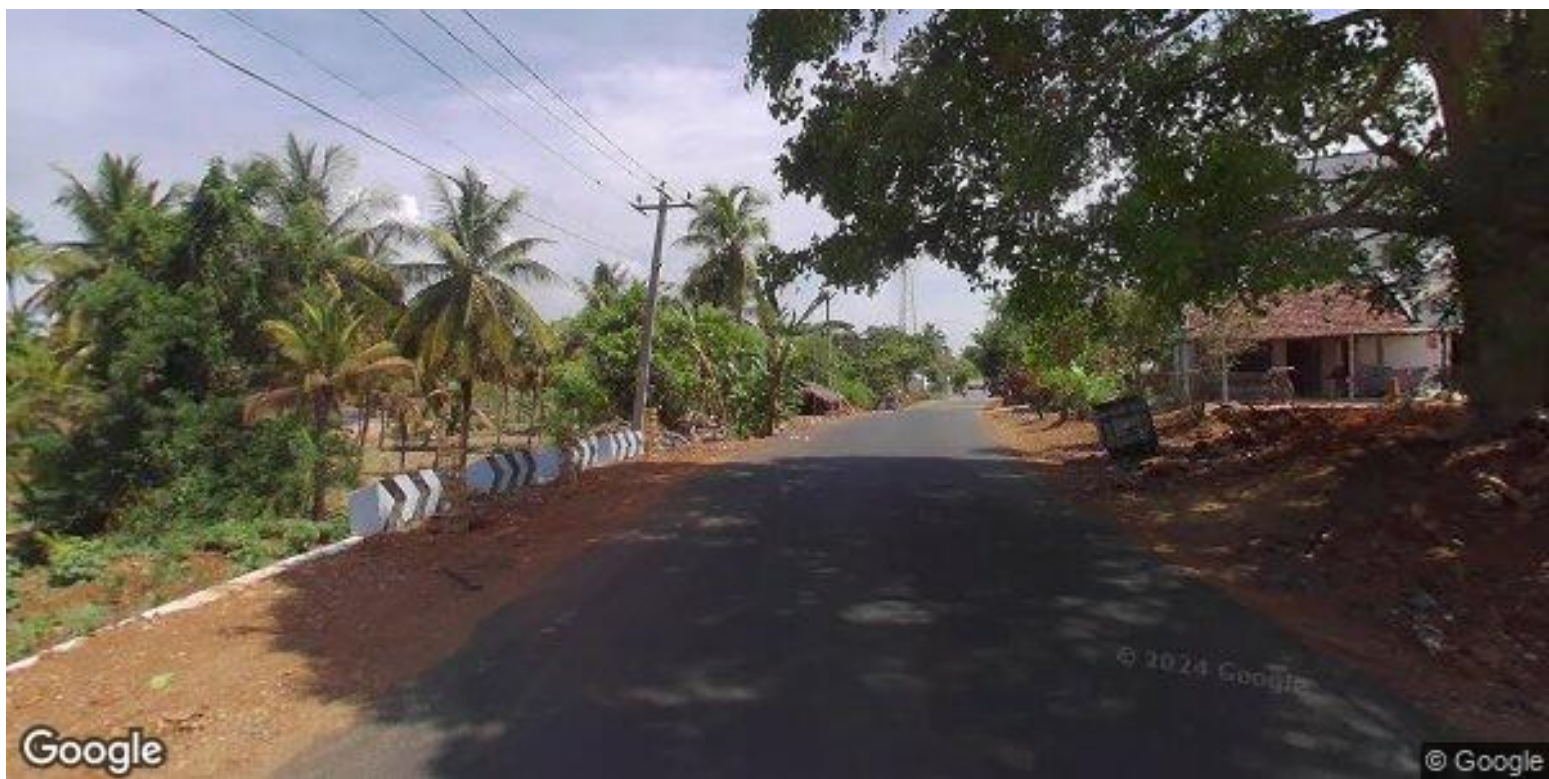
**Risk Type:** Turn  
**Risk Level:** Medium  
**Speed Limit:** 30 KM/Hr  
**Coordinates:** 11.47748, 78.38117
