# IndianOil

## JOURNEY RISK MANAGEMENT (JRM) STUDY

### Salem Terminal TO KPL FUELS

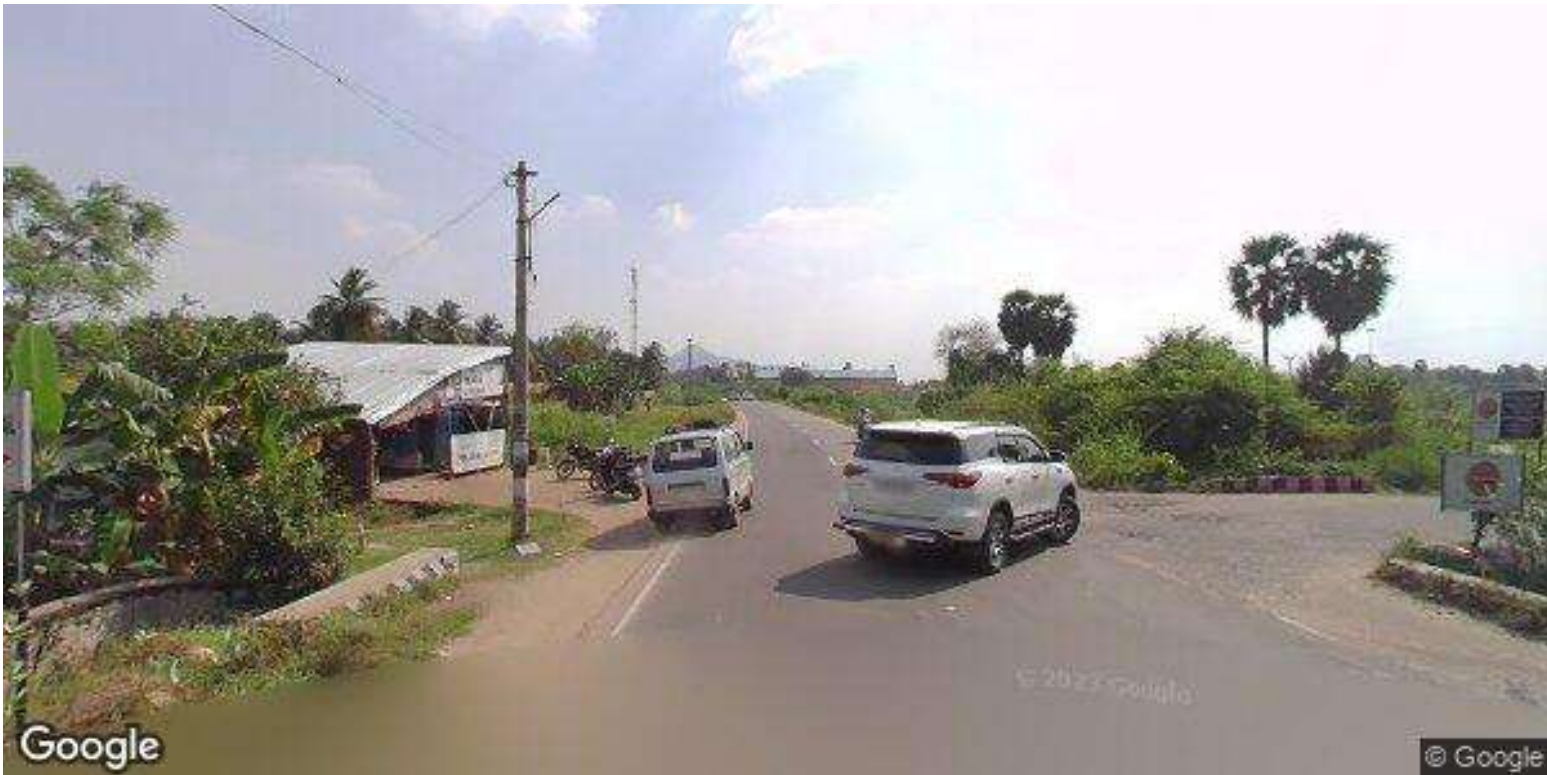
Coordinates: 11.44029, 77.87544

Risk Type: Turn

Risk Level: High

Speed Limit: 15 KM/Hr

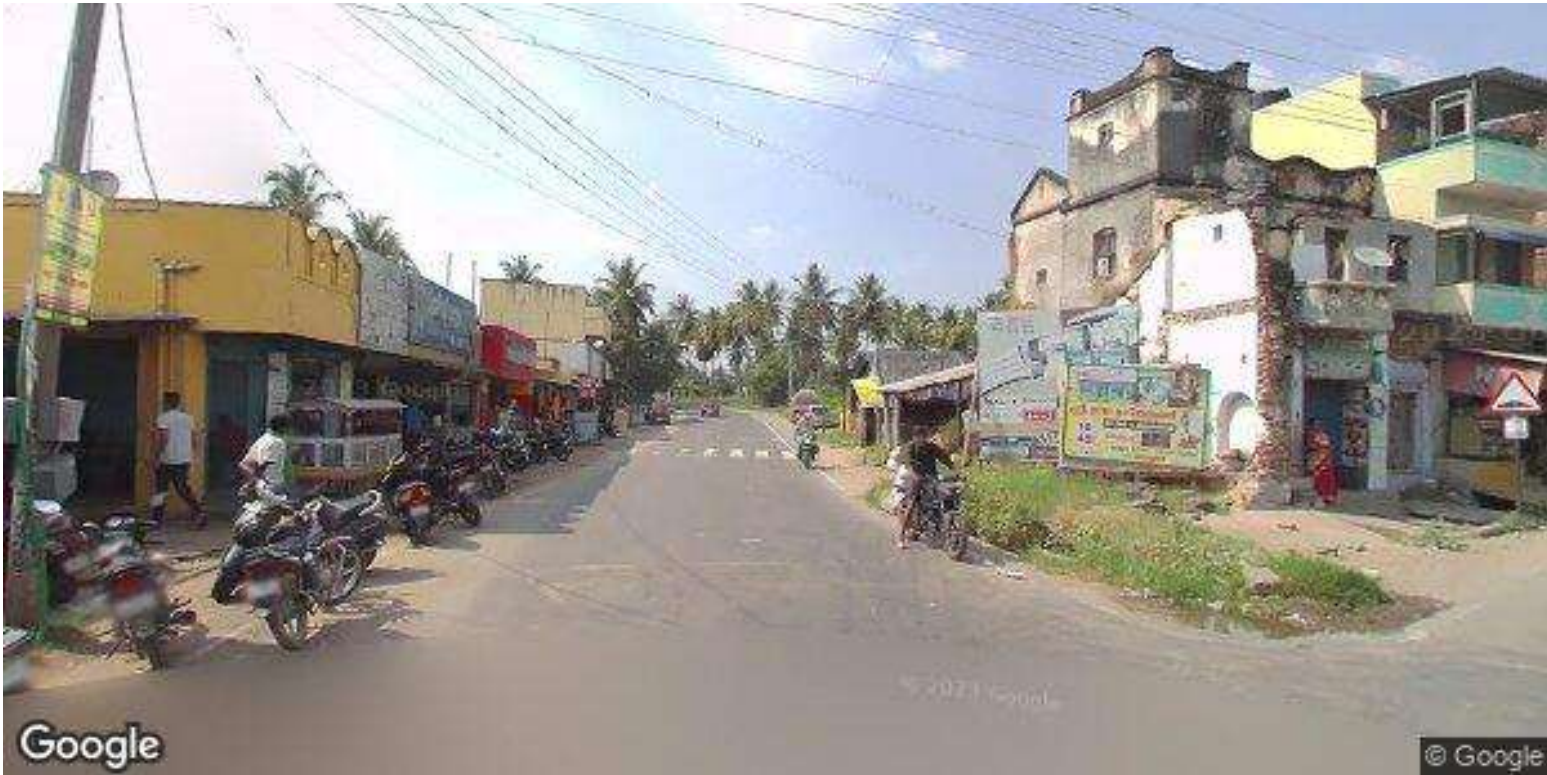
Coordinates: 11.45007, 77.87201

Risk Type: Turn

Risk Level: High

Speed Limit: 15 KM/Hr

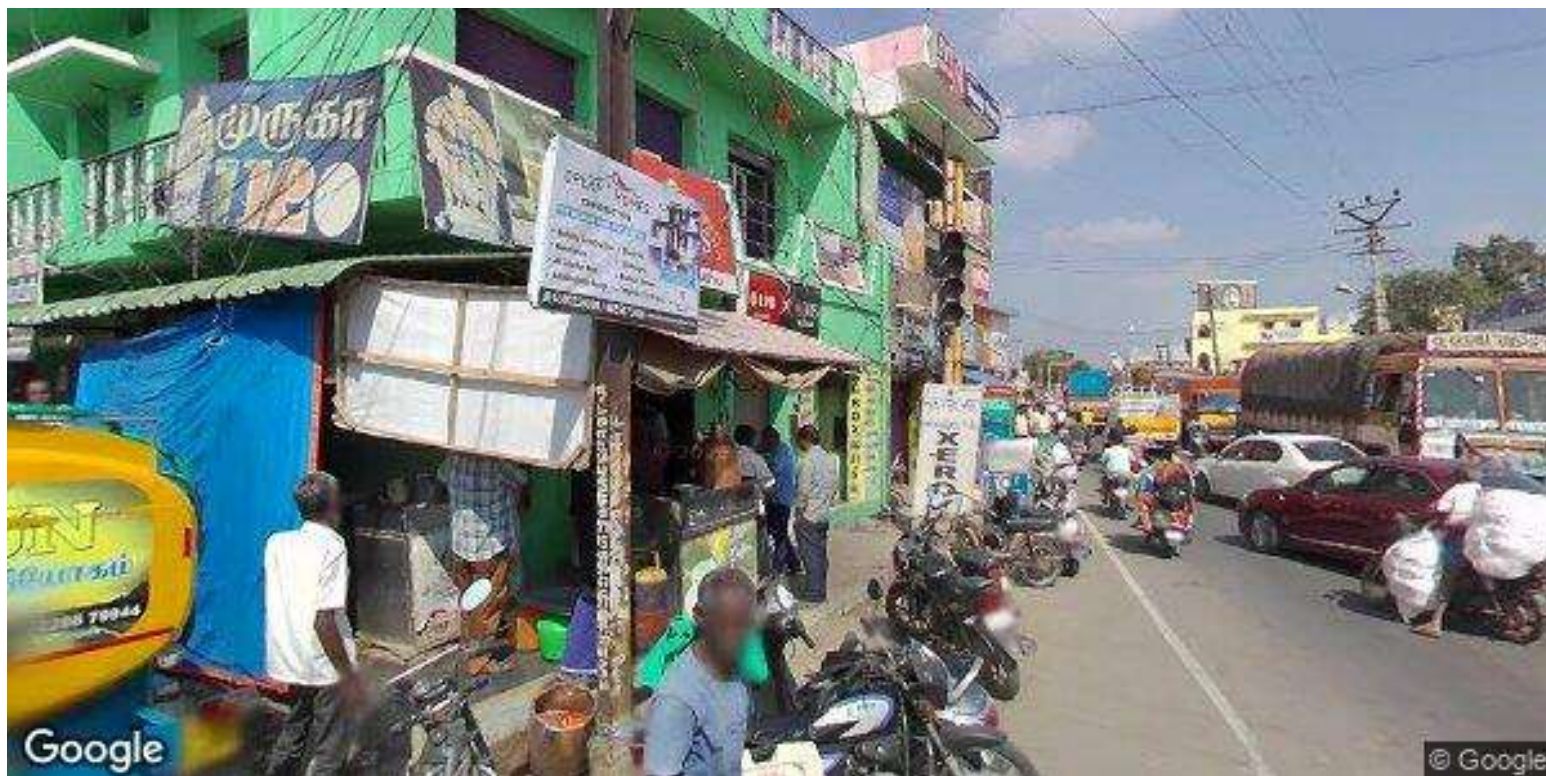
**Coordinates:** 11.47407, 77.86839

**Risk Type:** Turn

**Risk Level:** High

**Speed Limit:** 15 KM/Hr

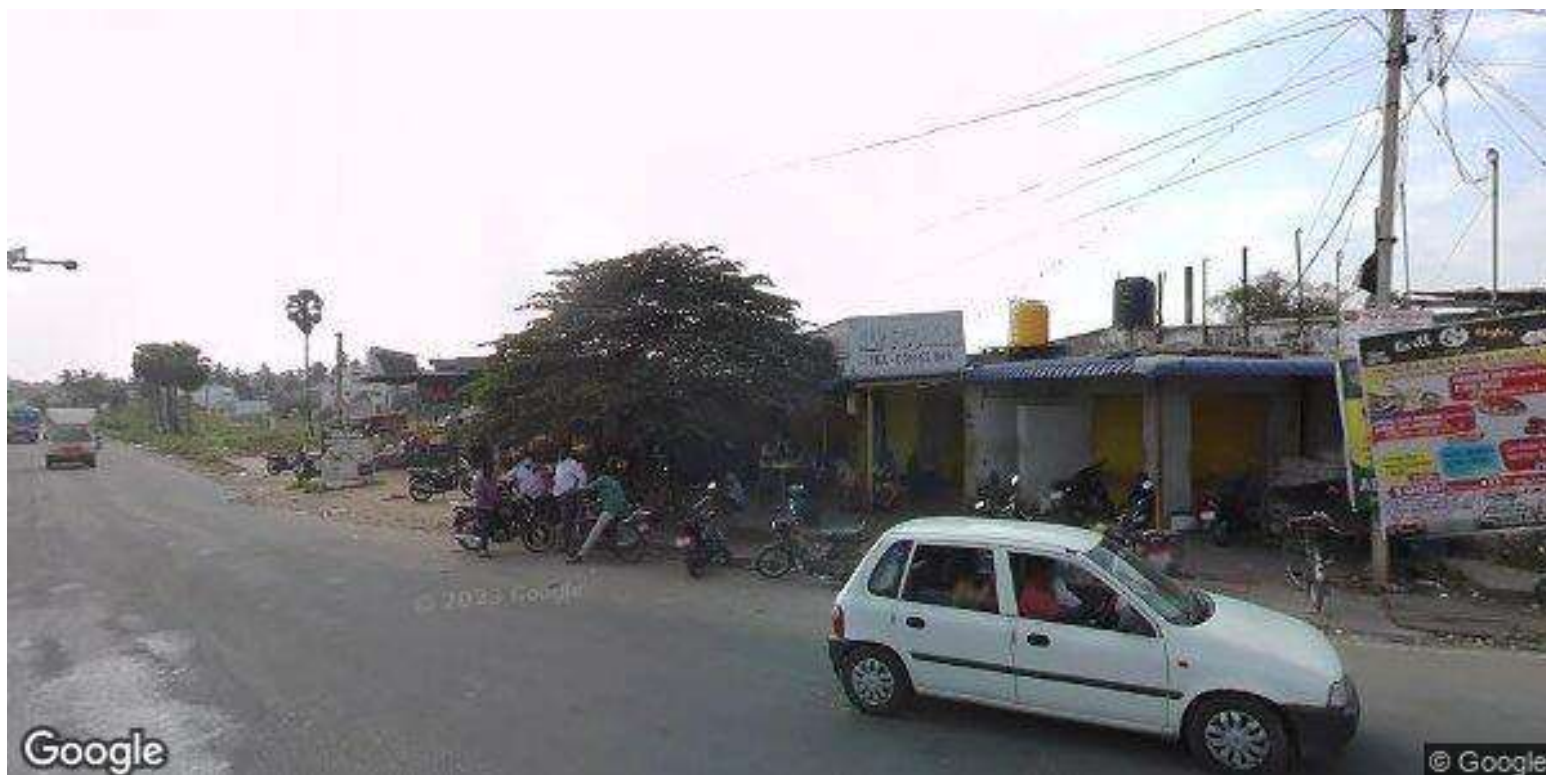
**Coordinates:** 11.48369, 77.88781

**Risk Type:** Turn

**Risk Level:** High

**Speed Limit:** 15 KM/Hr

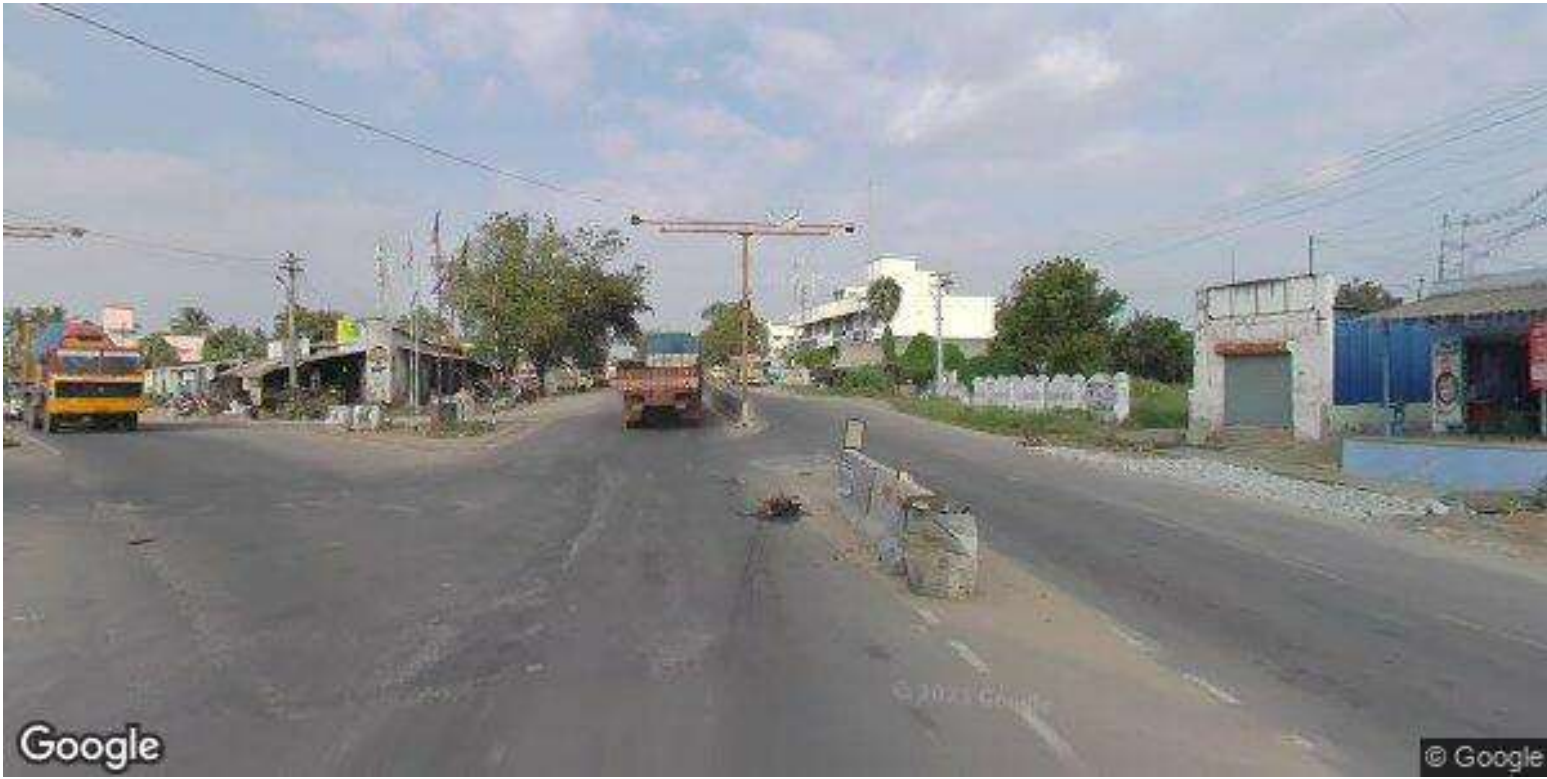
**Risk Type:** Turn  
**Risk Level:** Medium  
**Speed Limit:** 30 KM/Hr  
**Coordinates:** 11.48370, 77.88787

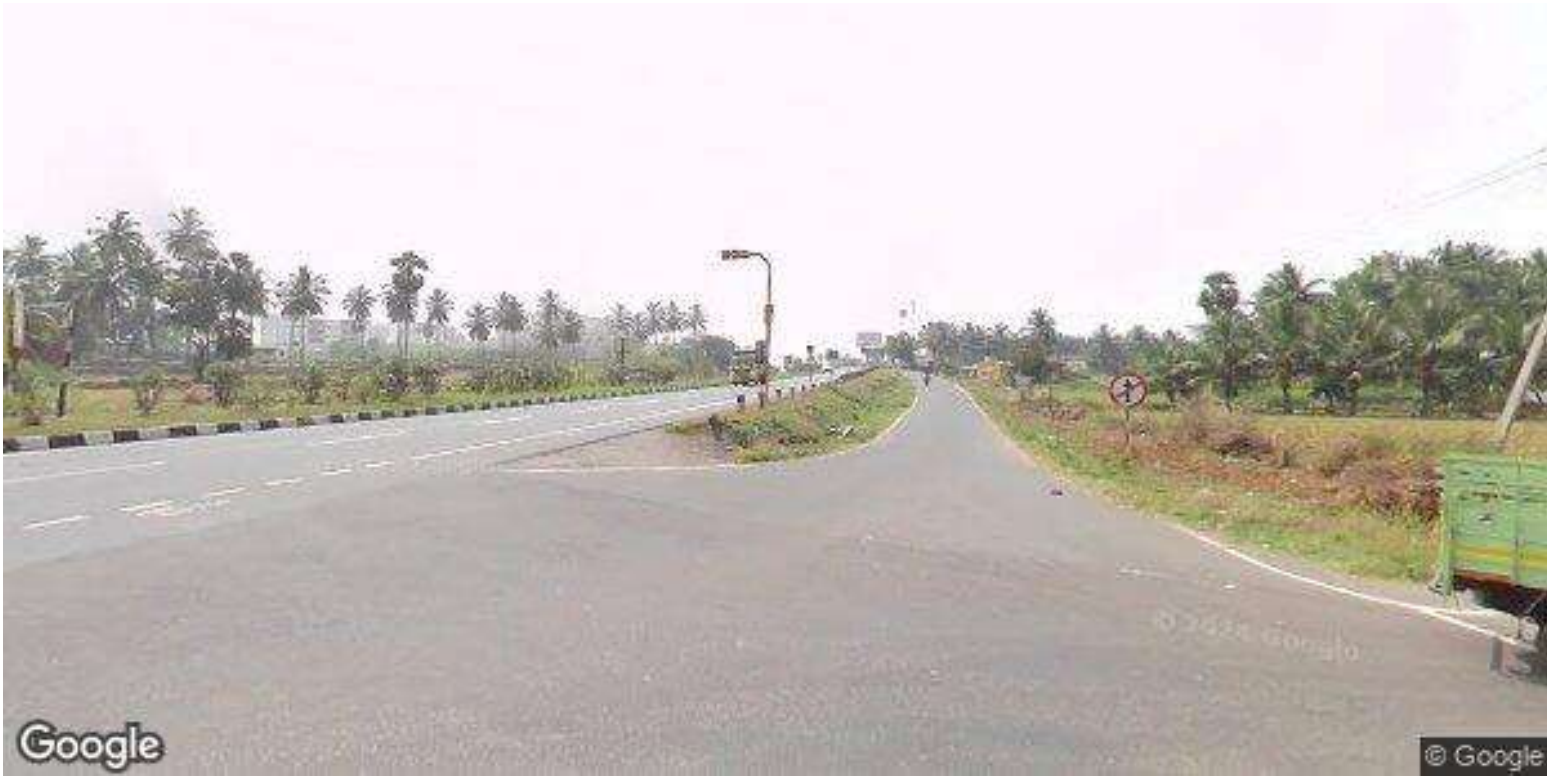
Coordinates: 11.57645, 78.04266

Risk Type: Blind Spot

Risk Level: Blind Spot

Speed Limit: 10 KM/Hr
