# IndianOil

## JOURNEY RISK MANAGEMENT (JRM) STUDY

### Salem Terminal TO BALAKRISHNA AGENCIES

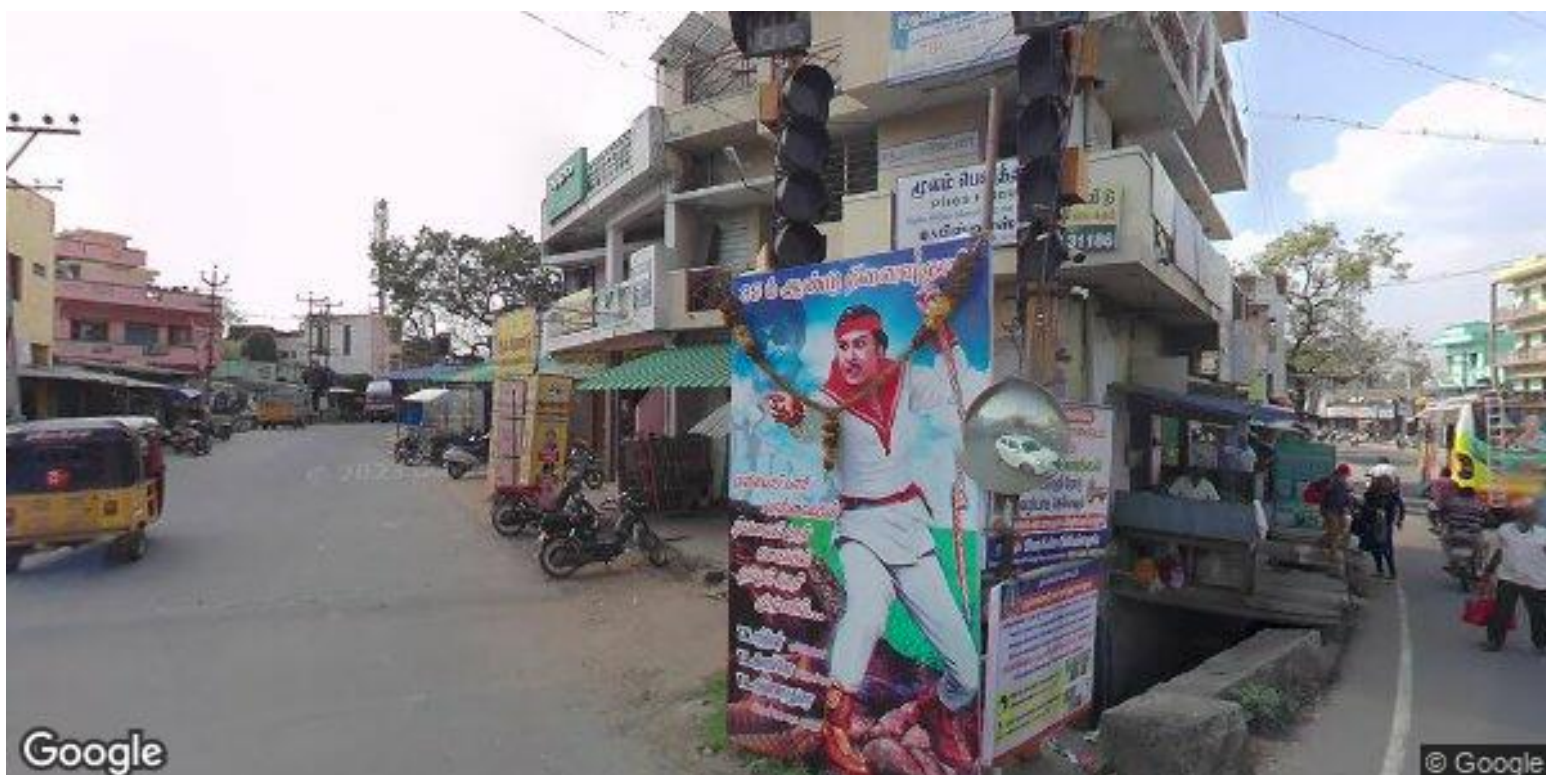
**Coordinates:** 11.38342, 77.89975

| | Risk Type | Risk Level | Coordinates | Speed Limit |
|---|---|---|---|---|
| 5 | Turn | Medium | 11.38342, 77.89975 | 30 KM/Hr |

**Risk Type:** Turn

**Risk Level:** Medium

**Speed Limit:** 30 KM/Hr

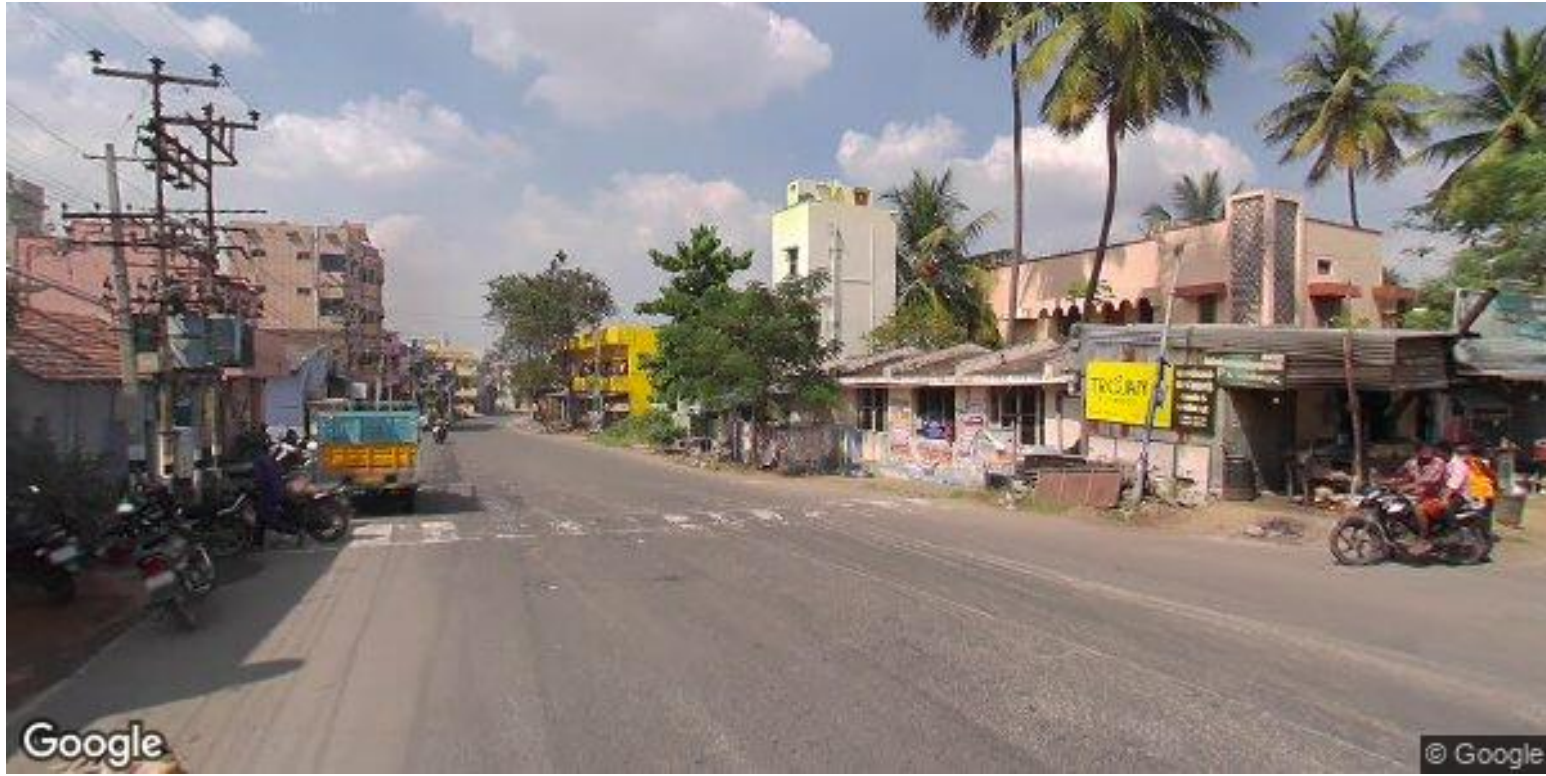
**Coordinates:** 11.38190, 77.90254

| | Risk Type | Risk Level | Coordinates | Speed Limit |
|---|---|---|---|---|
| 6 | Turn | Medium | 11.38190, 77.90254 | 30 KM/Hr |

**Risk Type:** Turn

**Risk Level:** Medium

**Speed Limit:** 30 KM/Hr

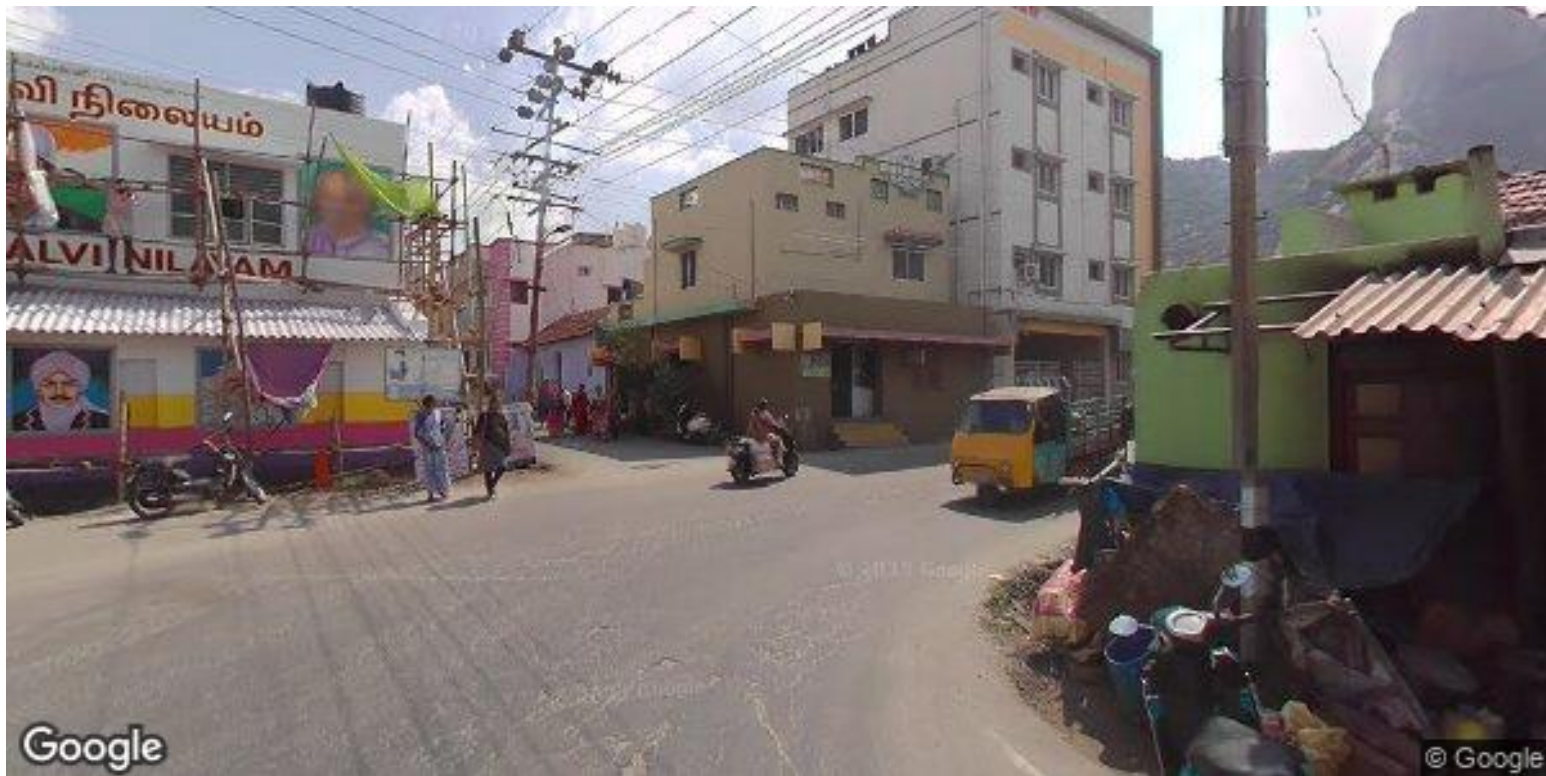
**Coordinates:** 11.38186, 77.90258

| | Risk Type | Risk Level | Coordinates | Speed Limit |
|---|---|---|---|---|
| 7 | Turn | High | 11.38186, 77.90258 | 15 KM/Hr |

**Risk Type:** Turn

**Risk Level:** High

**Speed Limit:** 15 KM/Hr

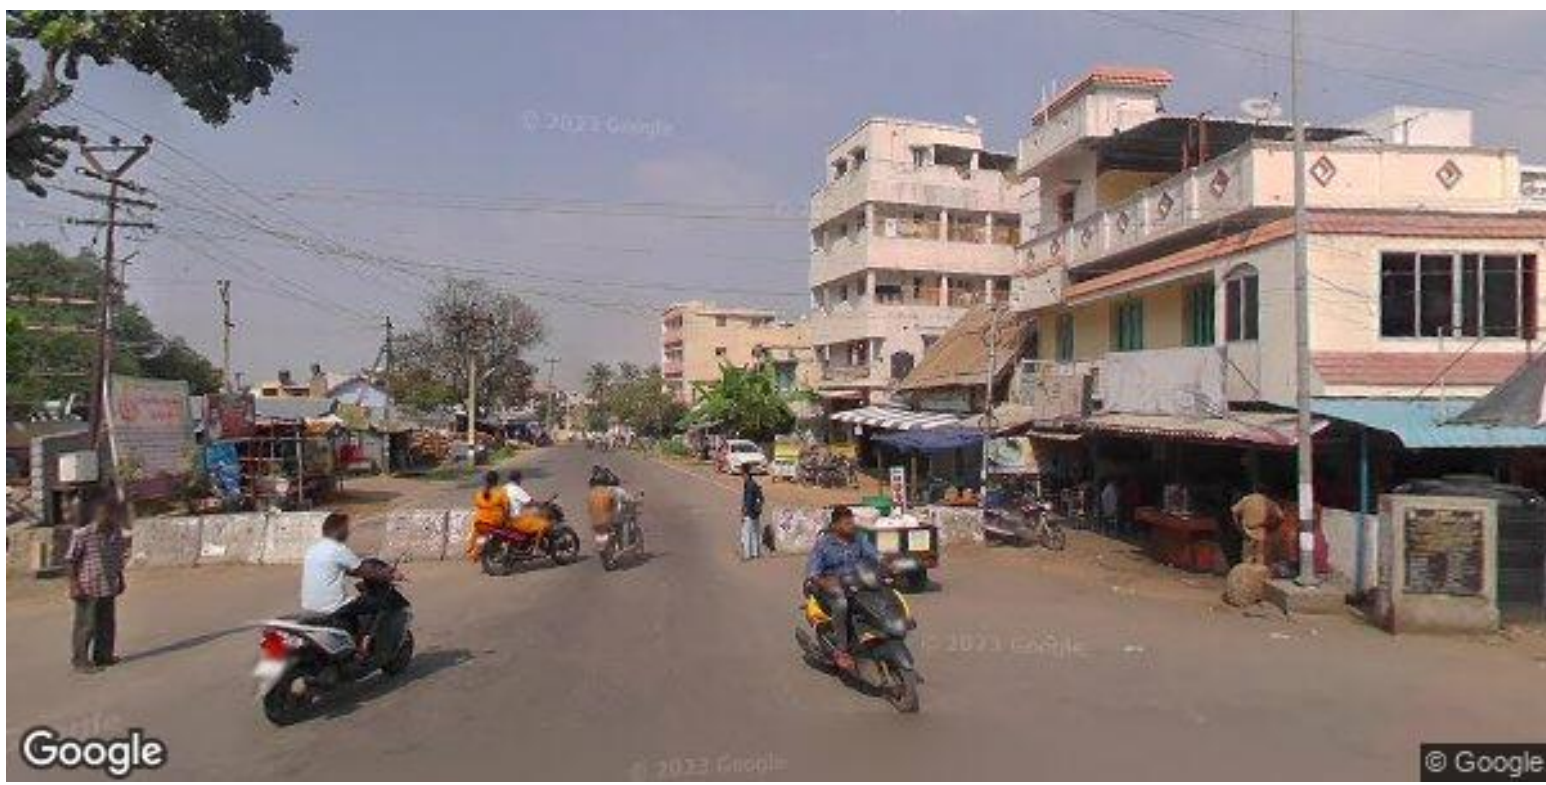
**Coordinates:** 11.37841, 77.90140

| | Risk Type | Risk Level | Coordinates | Speed Limit |
|---|---|---|---|---|
| 8 | Blind Spot | Blind Spot | 11.37841, 77.90140 | 10 KM/Hr |

**Risk Type:** Blind Spot

**Risk Level:** Blind Spot

**Speed Limit:** 10 KM/Hr

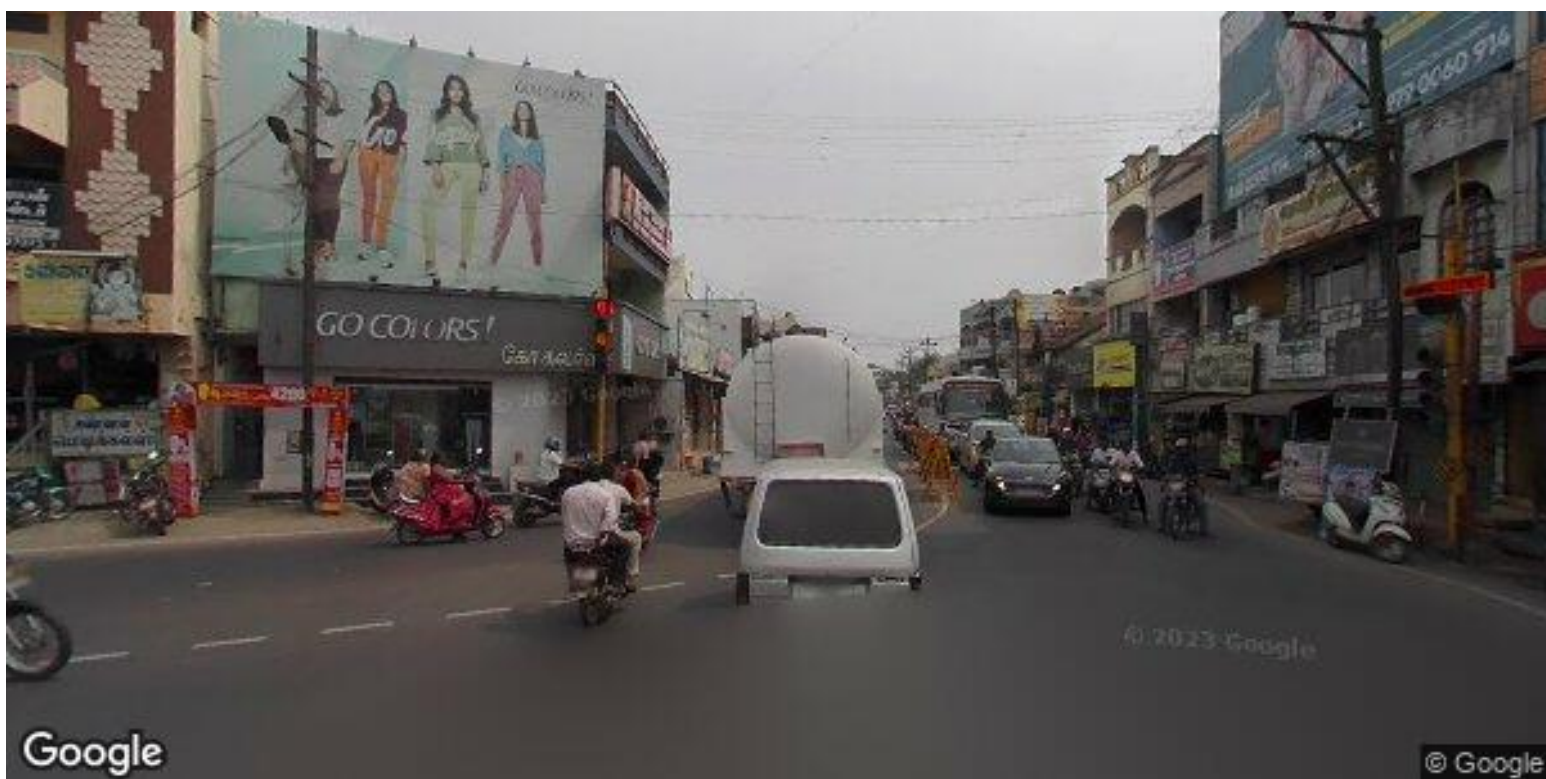
**Coordinates:** 11.22546, 78.16416

| | Risk Type | Risk Level | Coordinates | Speed Limit |
|---|---|---|---|---|
| 9 | Blind Spot | Blind Spot | 11.22546, 78.16416 | 10 KM/Hr |

**Risk Type:** Blind Spot

**Risk Level:** Blind Spot

**Speed Limit:** 10 KM/Hr
