# IndianOil

## JOURNEY RISK MANAGEMENT (JRM) STUDY

### Salem Terminal to SIVAMBIGA FUELS

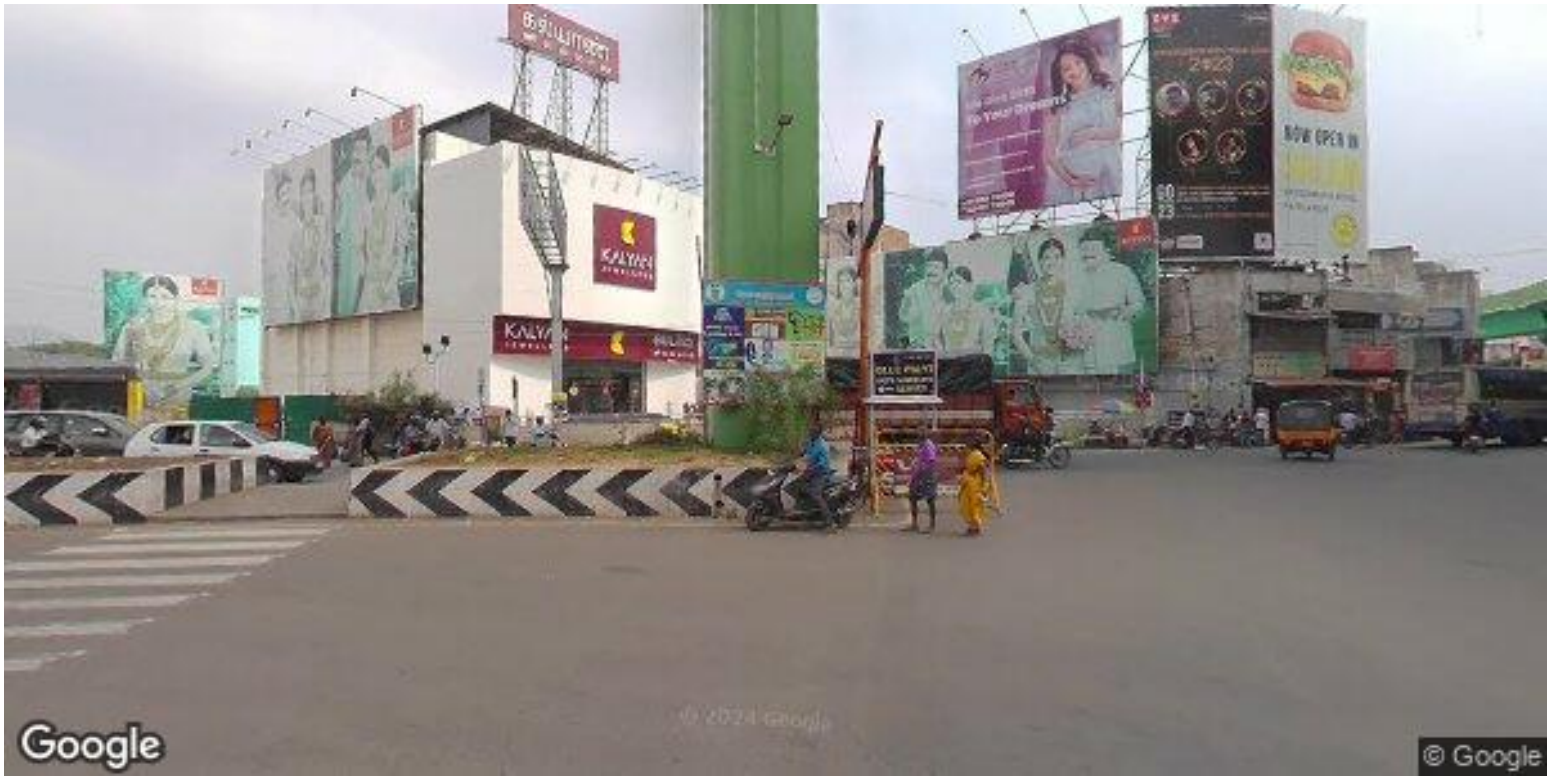
Risk Type: Roundabout  
Risk Level: High

**Speed Limit: 15 KM/Hr**  
**Coordinates: 11.67563, 78.13375**

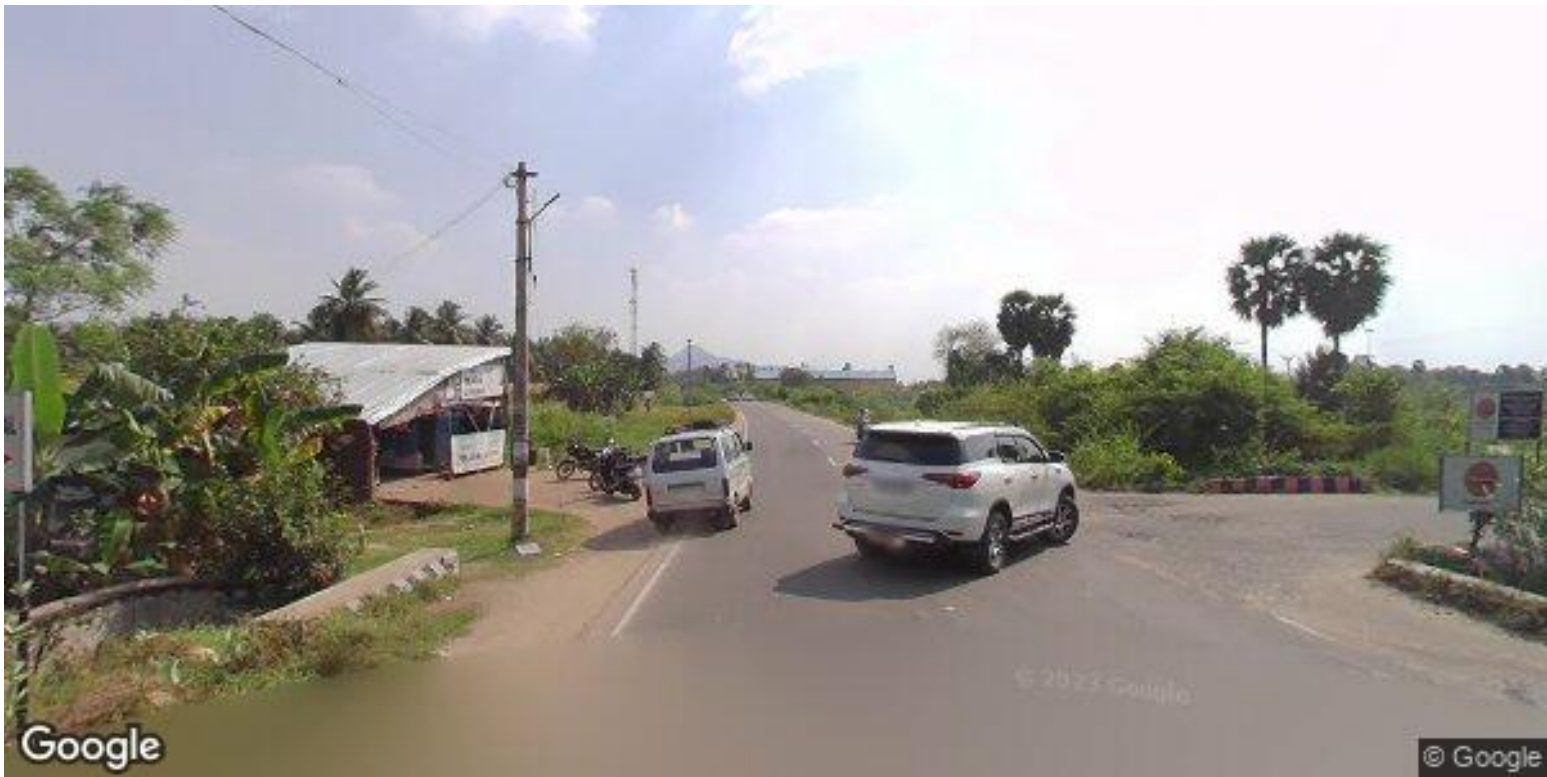
**Risk Type: Turn**  
**Risk Level: High**  
**Speed Limit: 15 KM/Hr**  
**Coordinates: 11.44029, 77.87544**

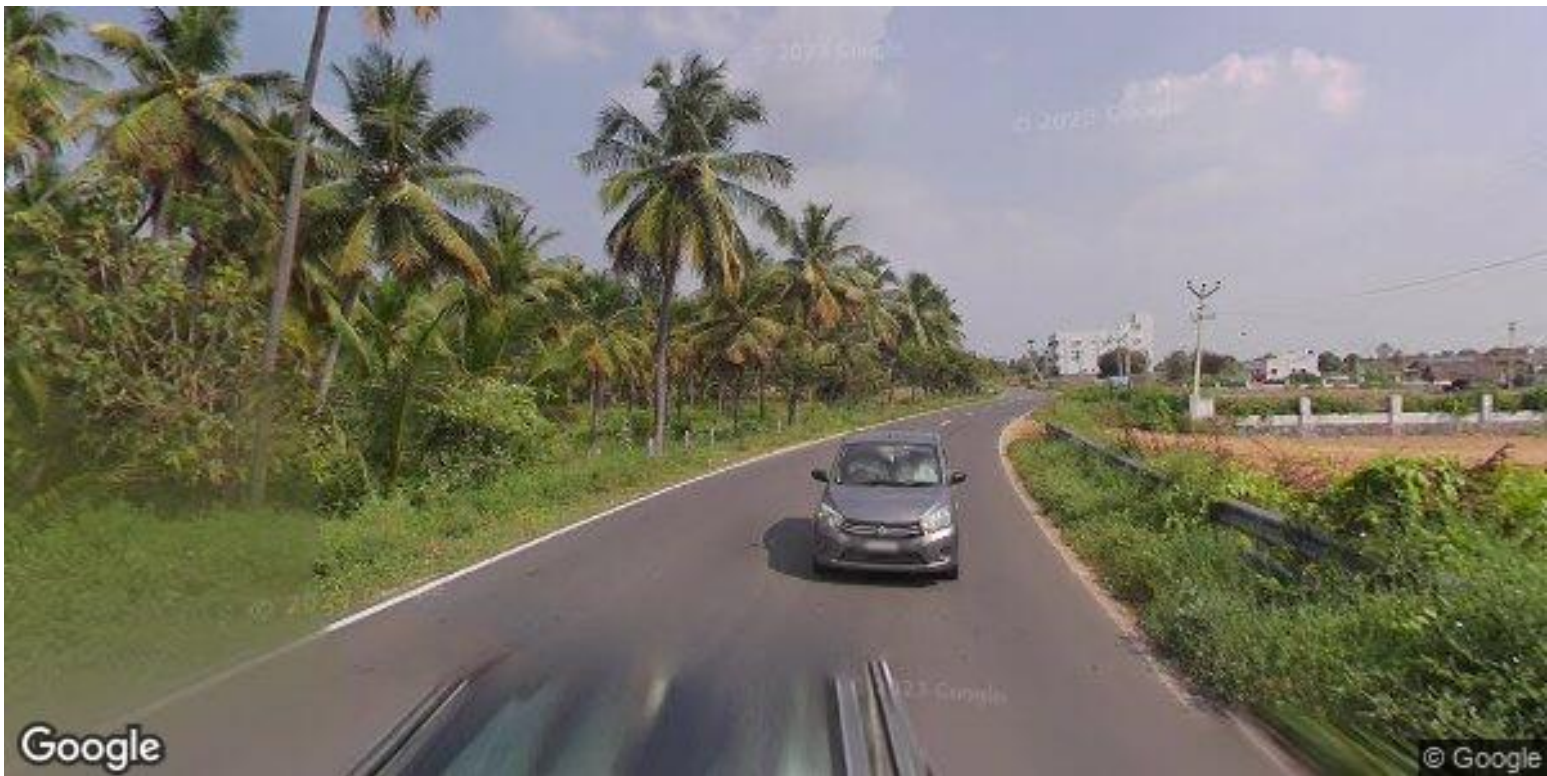
**Risk Type: Turn**  
**Risk Level: Medium**  
**Speed Limit: 30 KM/Hr**  
**Coordinates: 11.45357, 77.85789**

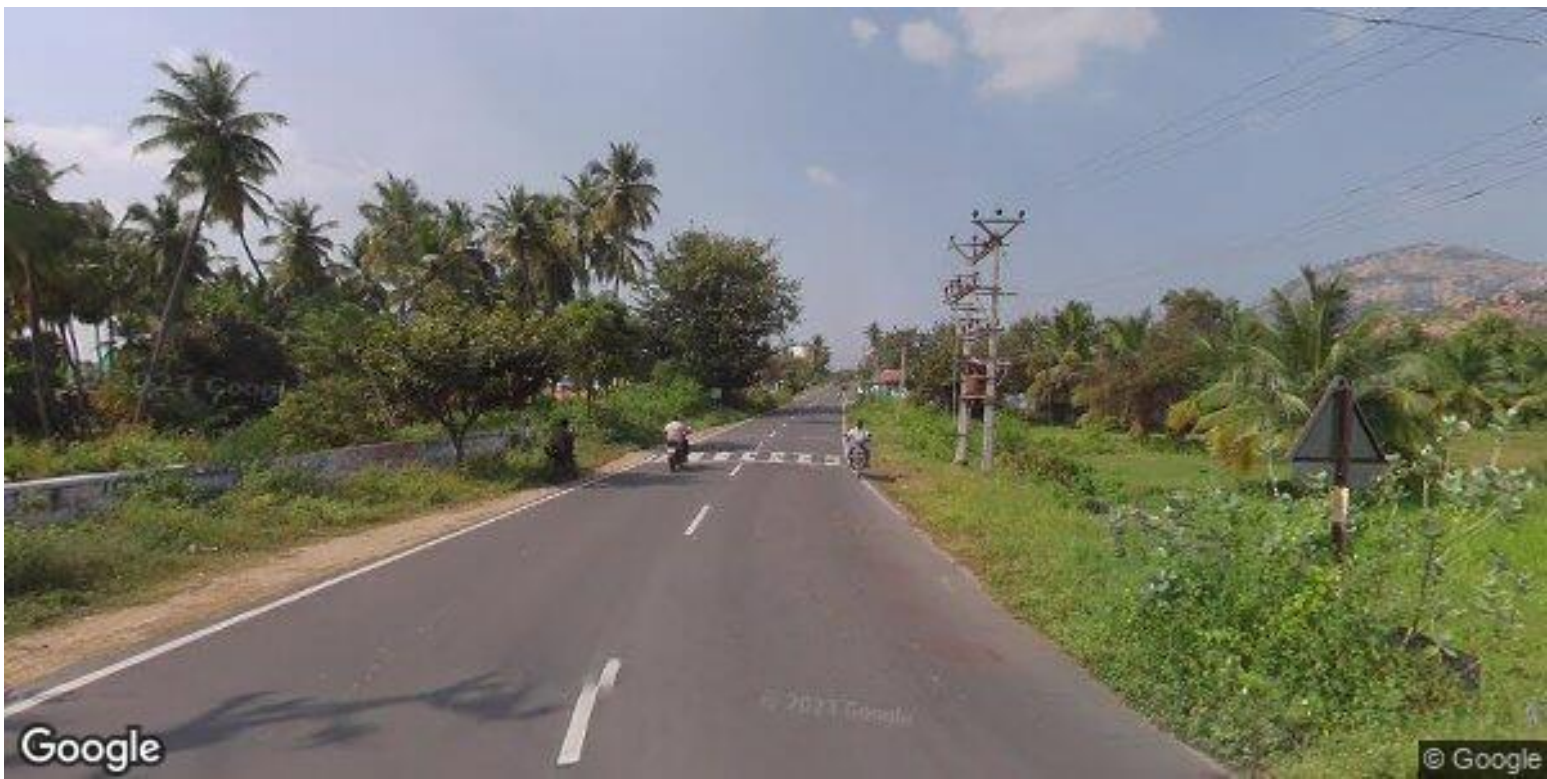
**Risk Type:** Turn  
**Risk Level:** Medium  
**Speed Limit:** 30 KM/Hr  
**Coordinates:** 11.45352, 77.85698

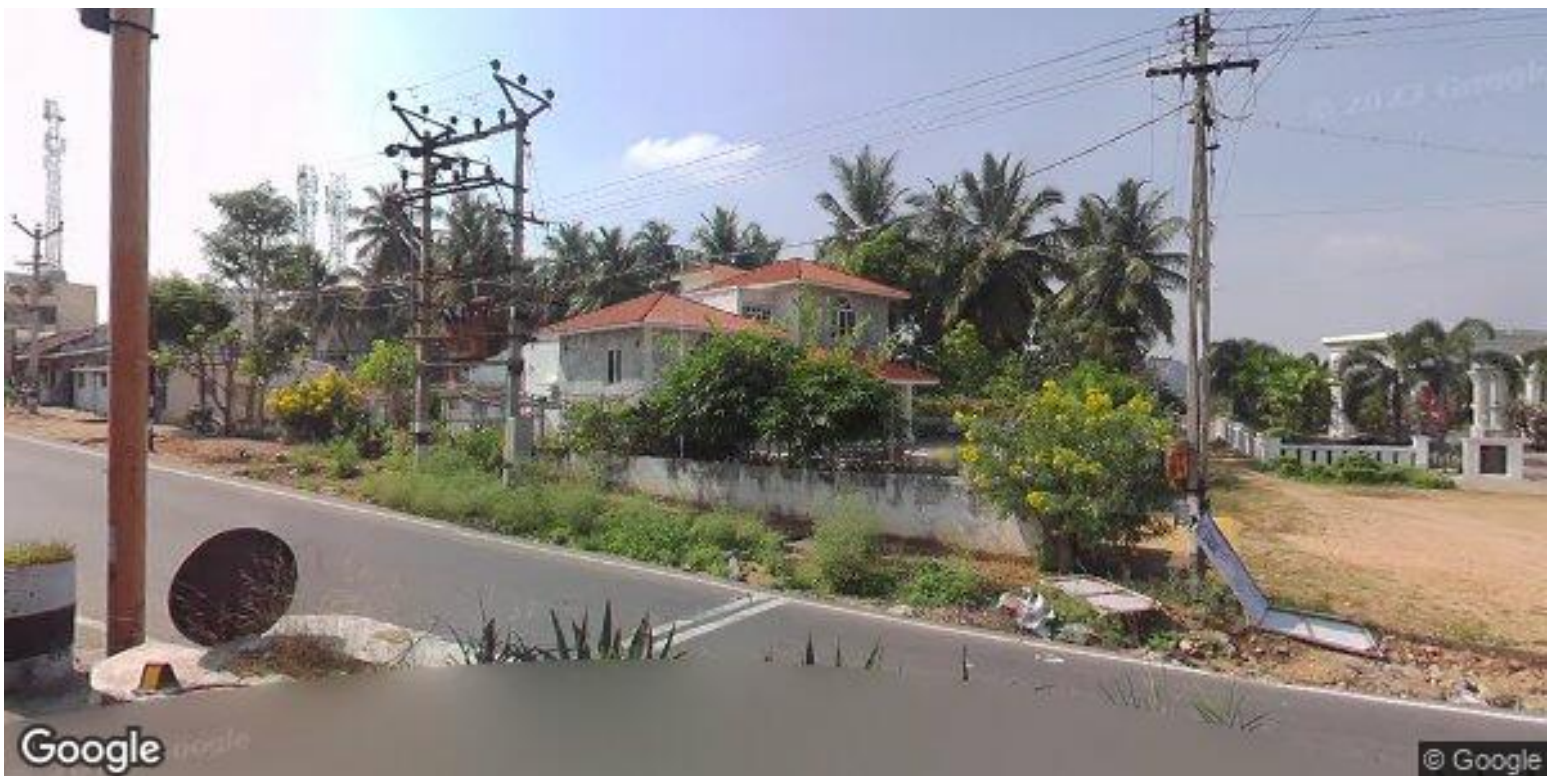
**Risk Type:** Turn  
**Risk Level:** Medium  
**Speed Limit:** 30 KM/Hr  
**Coordinates:** 11.46303, 77.84945

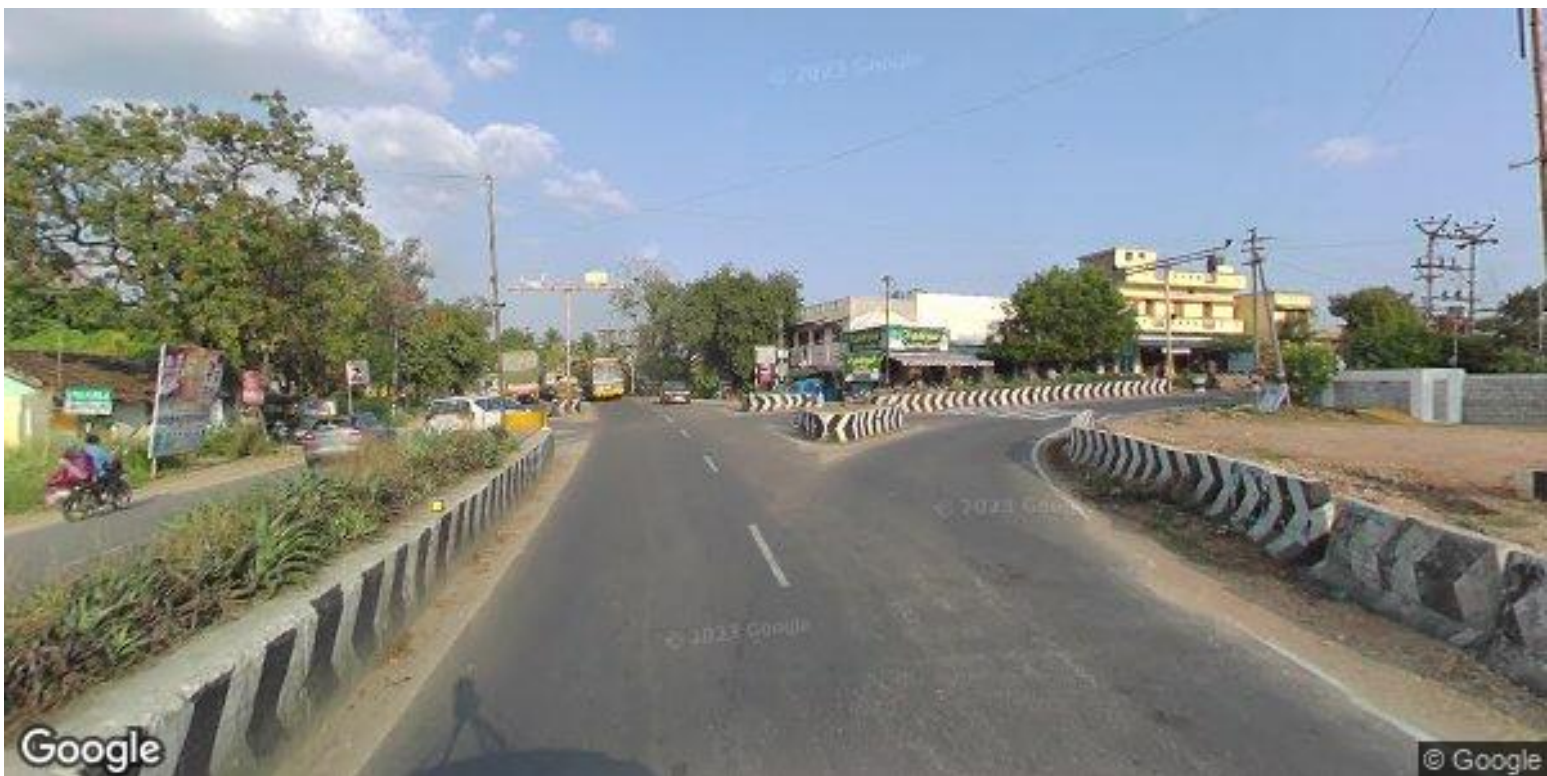
**Risk Type:** Turn  
**Risk Level:** Medium  
**Speed Limit:** 30 KM/Hr  
**Coordinates:** 11.46318, 77.84913

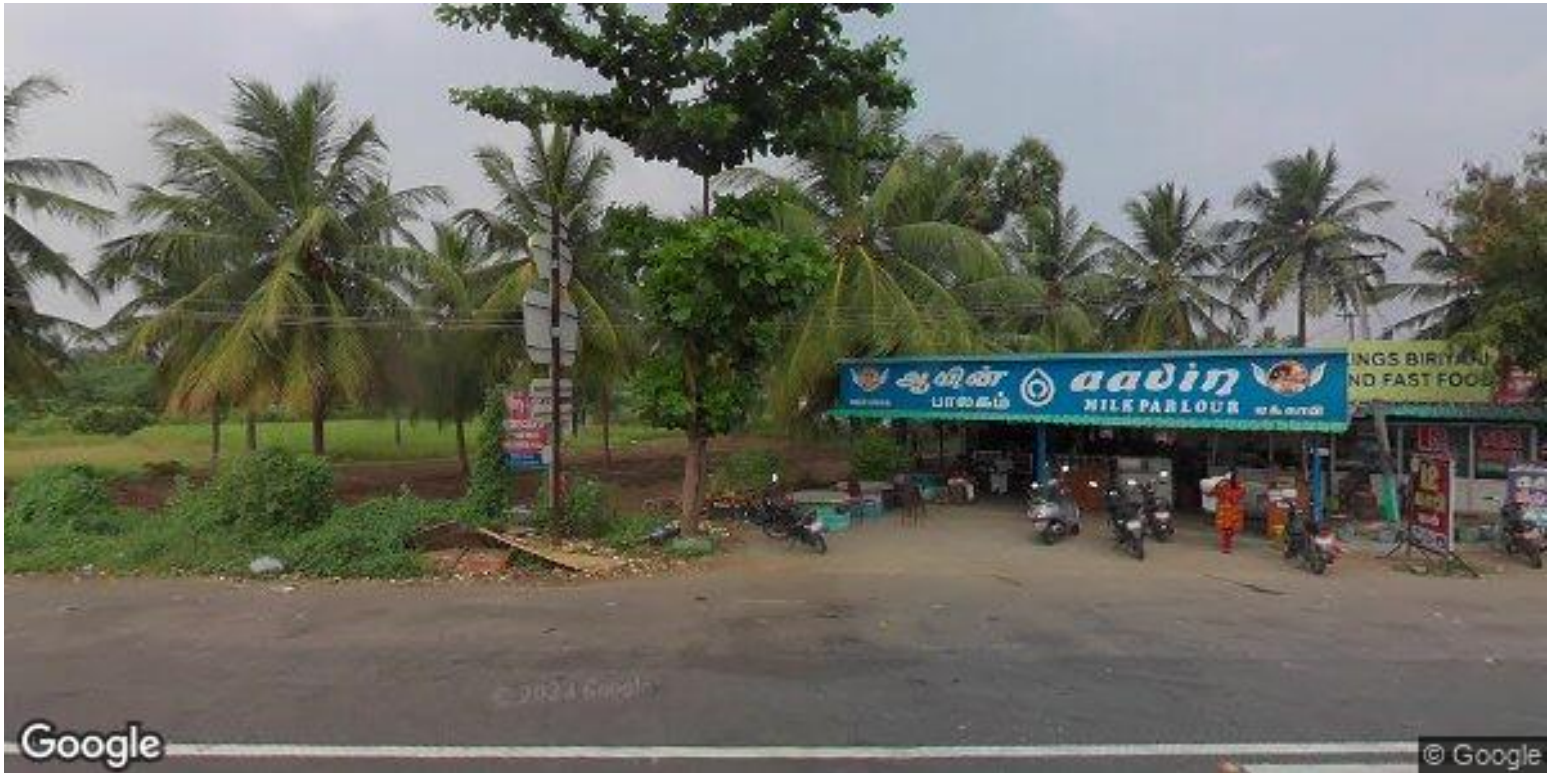
**Risk Type:** Turn  
**Risk Level:** High  
**Speed Limit:** 15 KM/Hr  
**Coordinates:** 11.45631, 77.81668

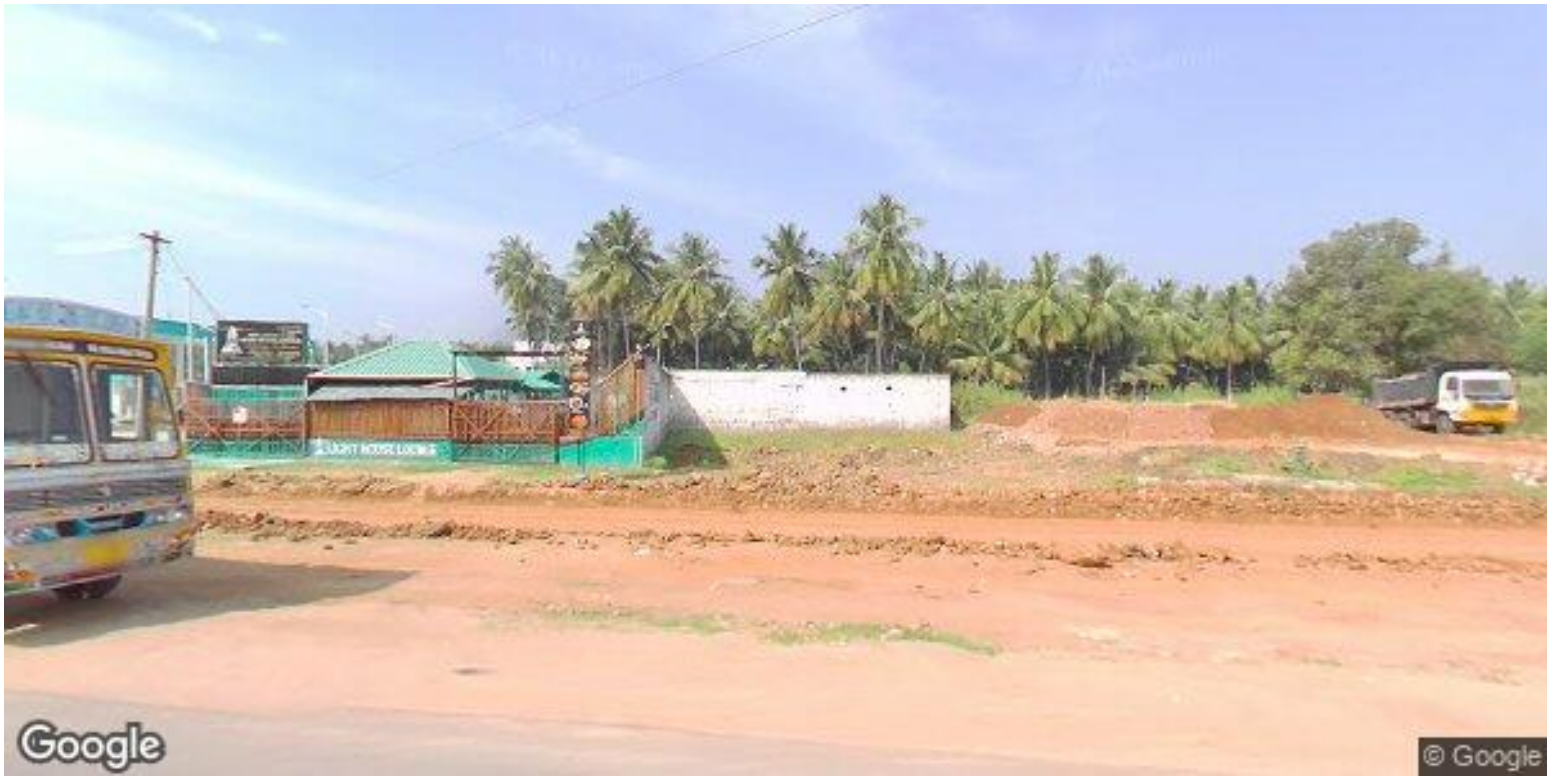
**Risk Type:** Turn  
**Risk Level:** Medium  
**Speed Limit:** 30 KM/Hr  
**Coordinates:** 11.61736, 78.10588

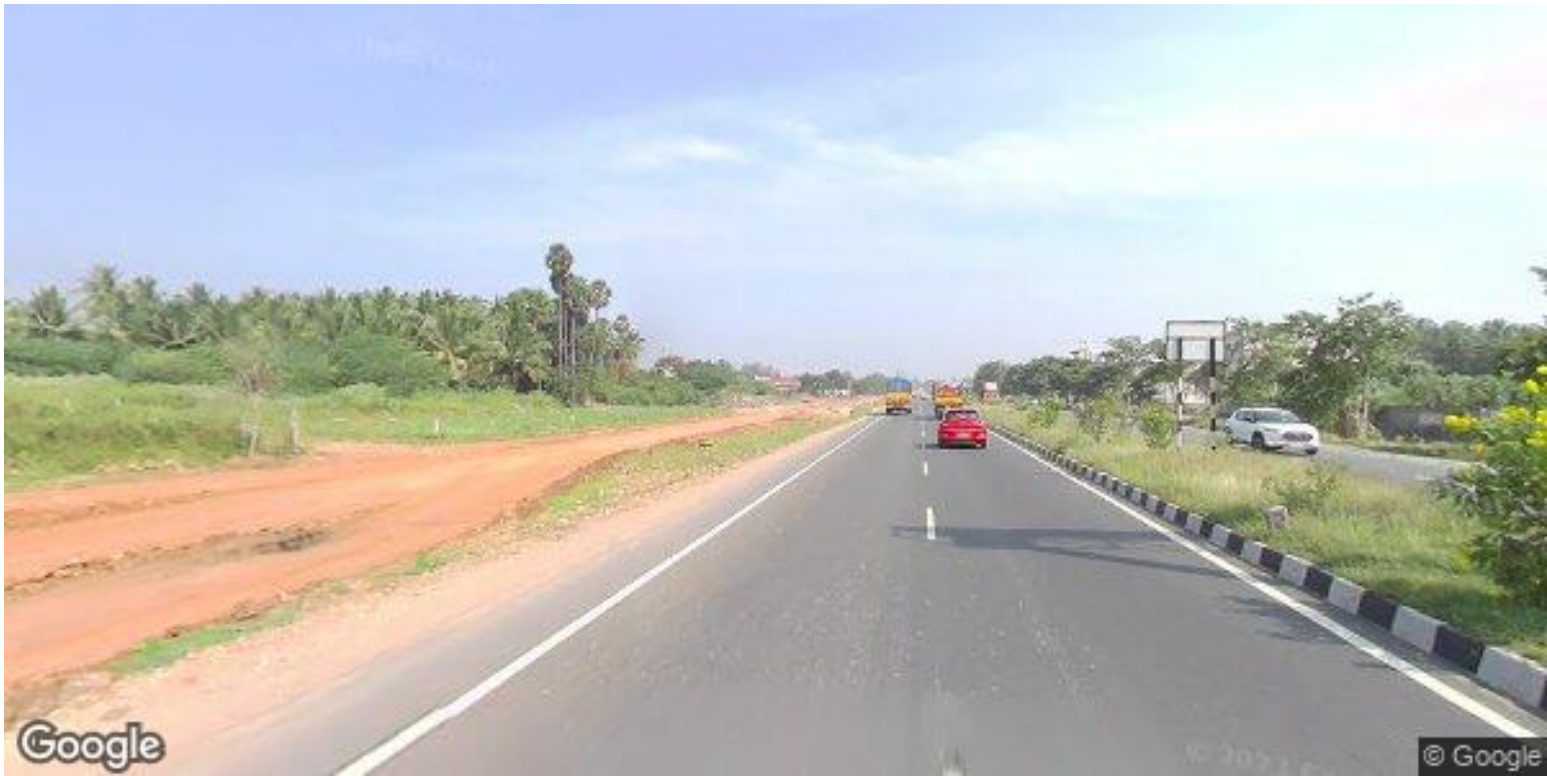
**Risk Type:** Turn  
**Risk Level:** Medium  
**Speed Limit:** 30 KM/Hr  
**Coordinates:** 11.61753, 78.10608

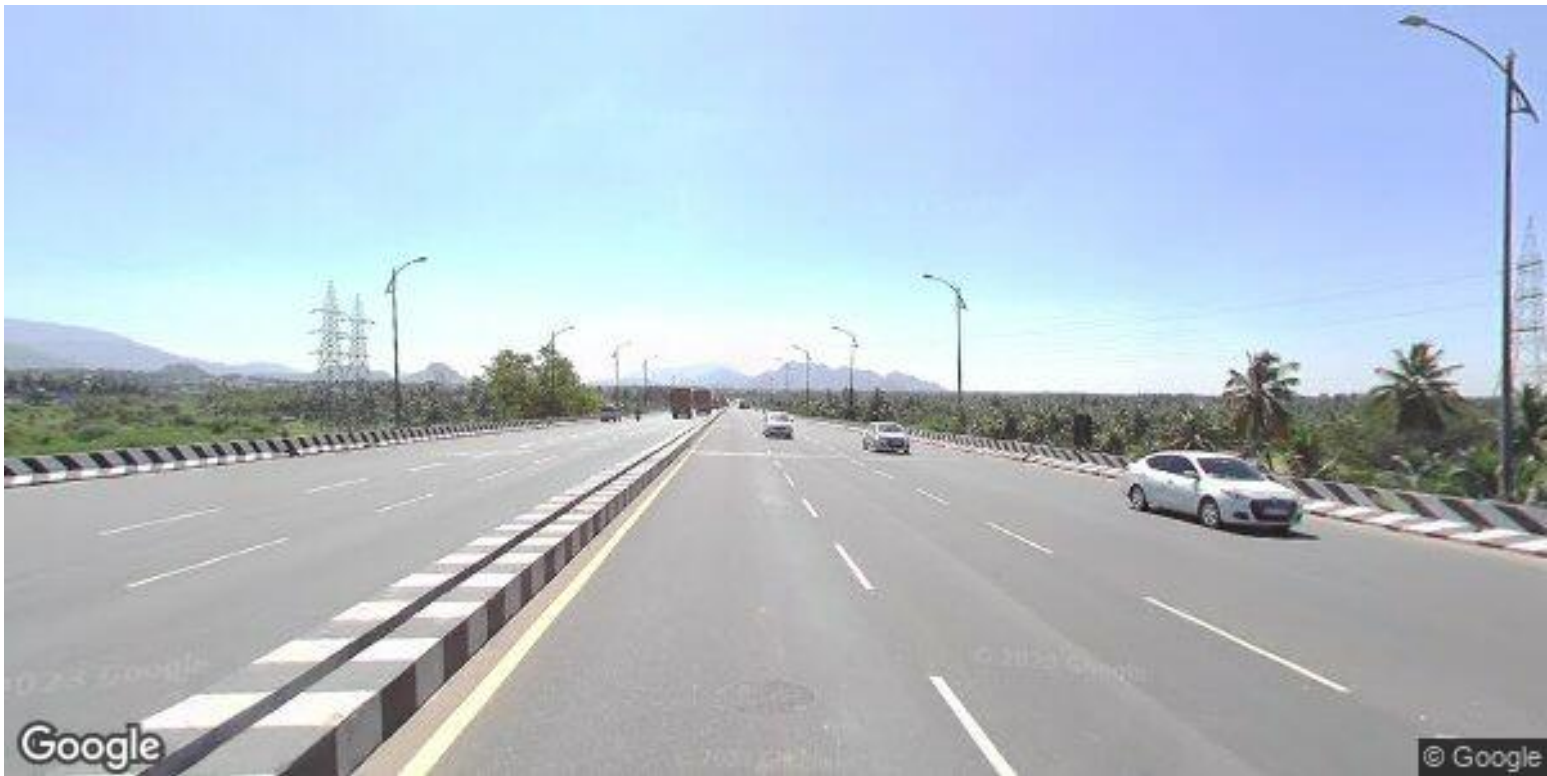
**Risk Type:** Turn  
**Risk Level:** Medium  
**Speed Limit:** 30 KM/Hr  
**Coordinates:** 11.64007, 78.11794

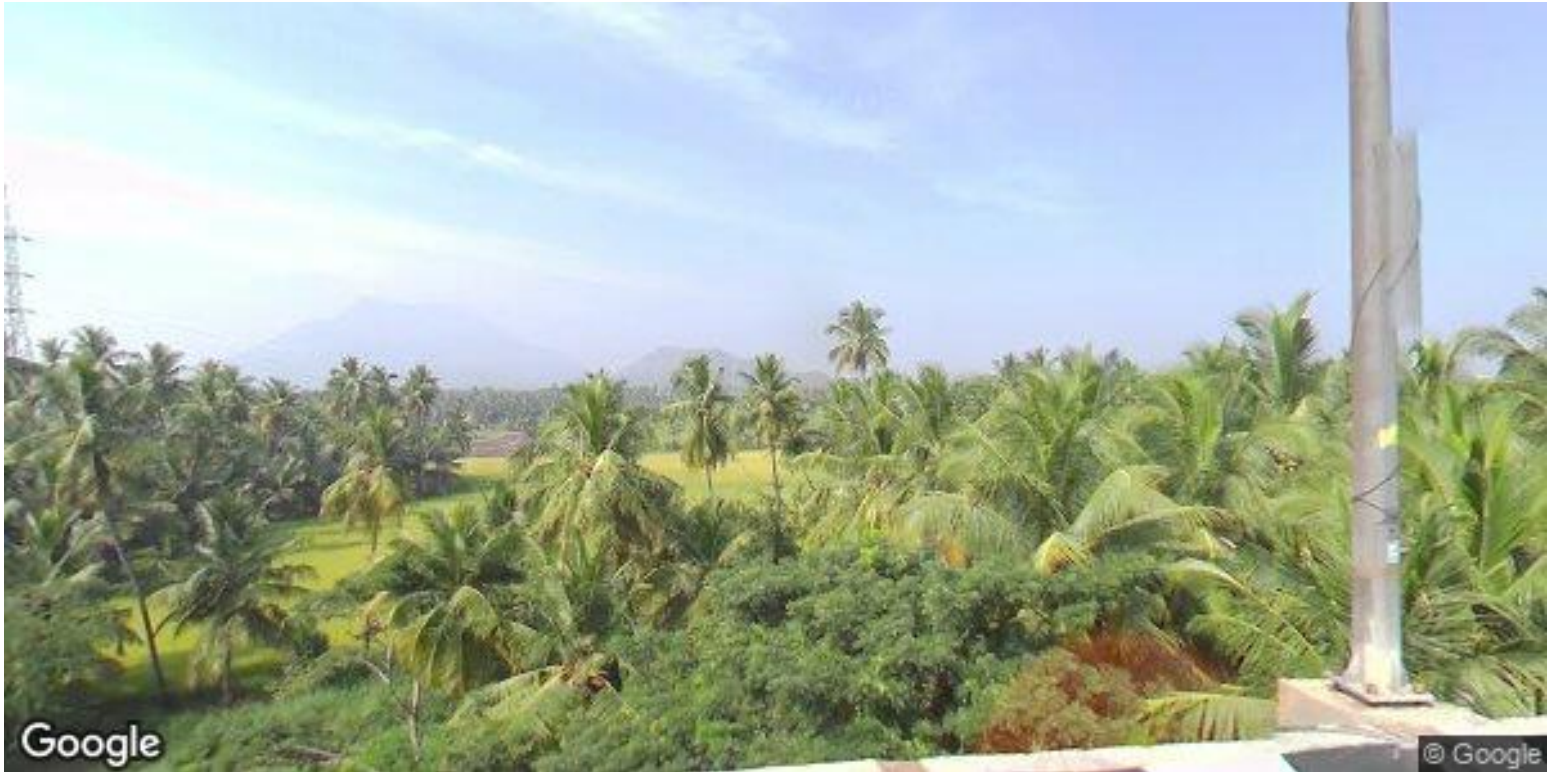
**Risk Type:** Turn  
**Risk Level:** Medium  
**Speed Limit:** 30 KM/Hr  
**Coordinates:** 11.64020, 78.11786

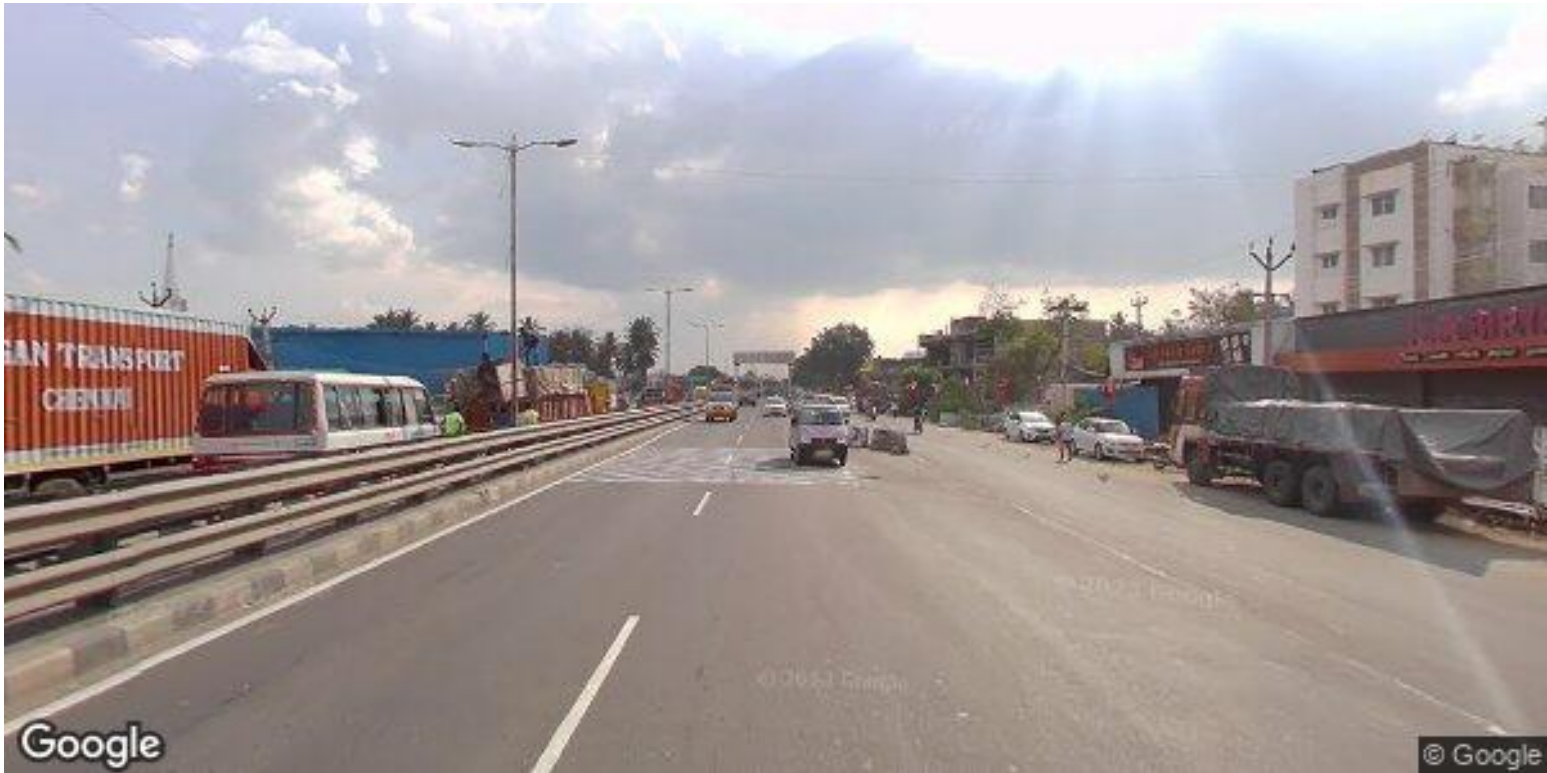
**Risk Type:** Turn  
**Risk Level:** High  
**Speed Limit:** 15 KM/Hr  
**Coordinates:** 11.67074, 78.12668

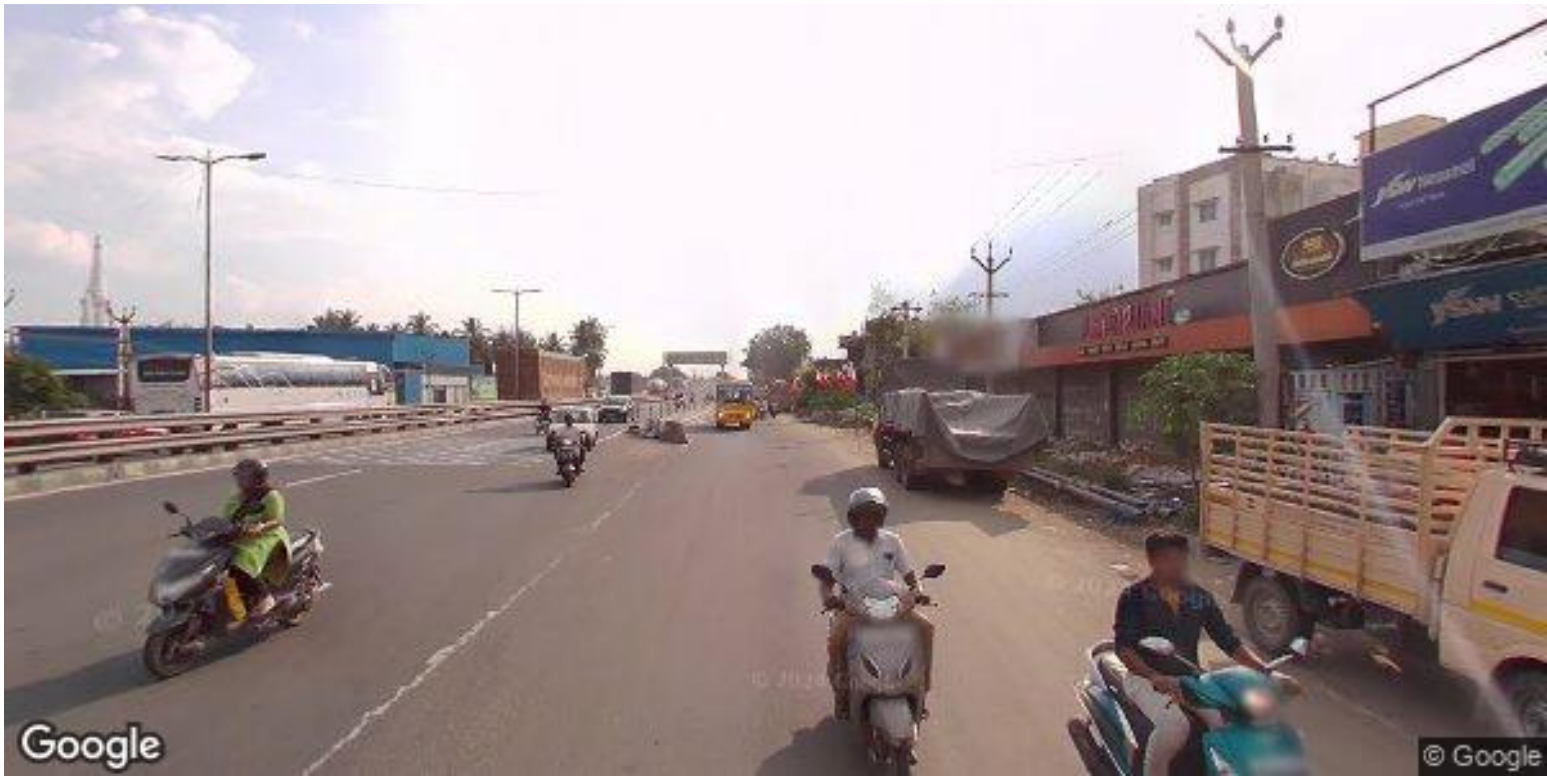
Coordinates: 11.67081, 78.12661

Risk Type: Turn

Risk Level: High

Speed Limit: 15 KM/Hr

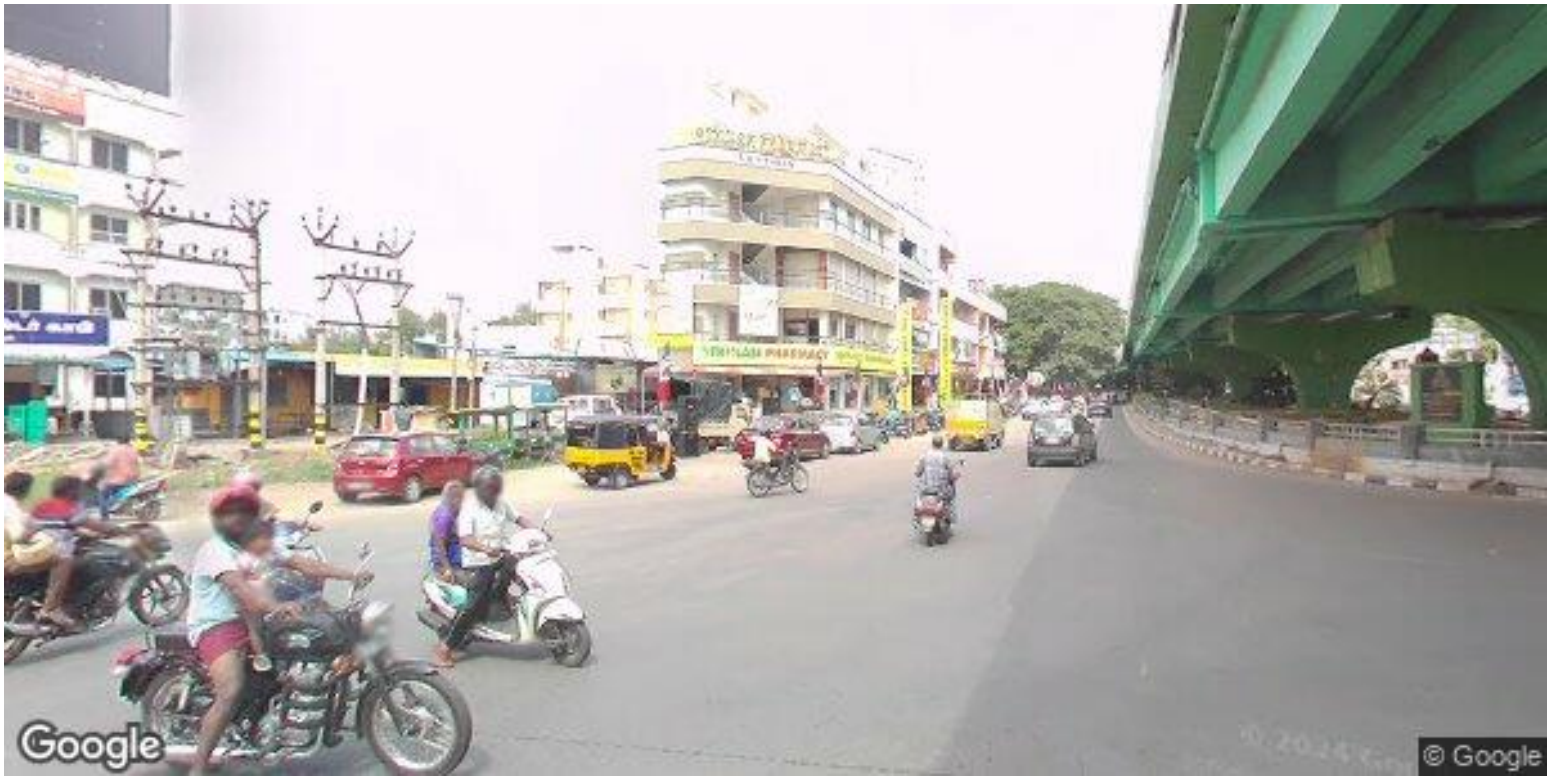
Coordinates: 11.67582, 78.12786

Risk Type: Turn

Risk Level: High

Speed Limit: 15 KM/Hr
