# IndianOil

## JOURNEY RISK MANAGEMENT (JRM) STUDY

### Salem Terminal to MODERN AGENCIES

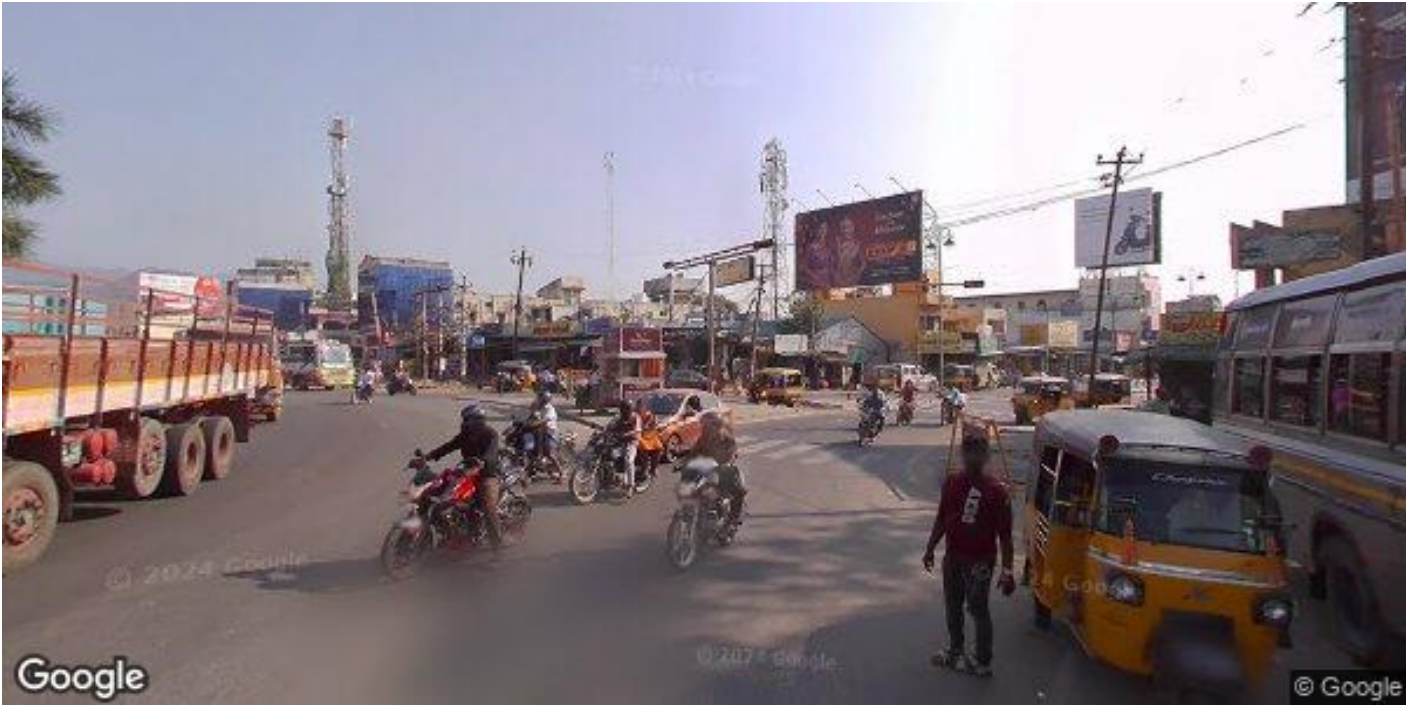
**Risk Type:** Roundabout  
**Risk Level:** High  
**Speed Limit:** 15 KM/Hr  
**Coordinates:** 11.63266, 78.12699

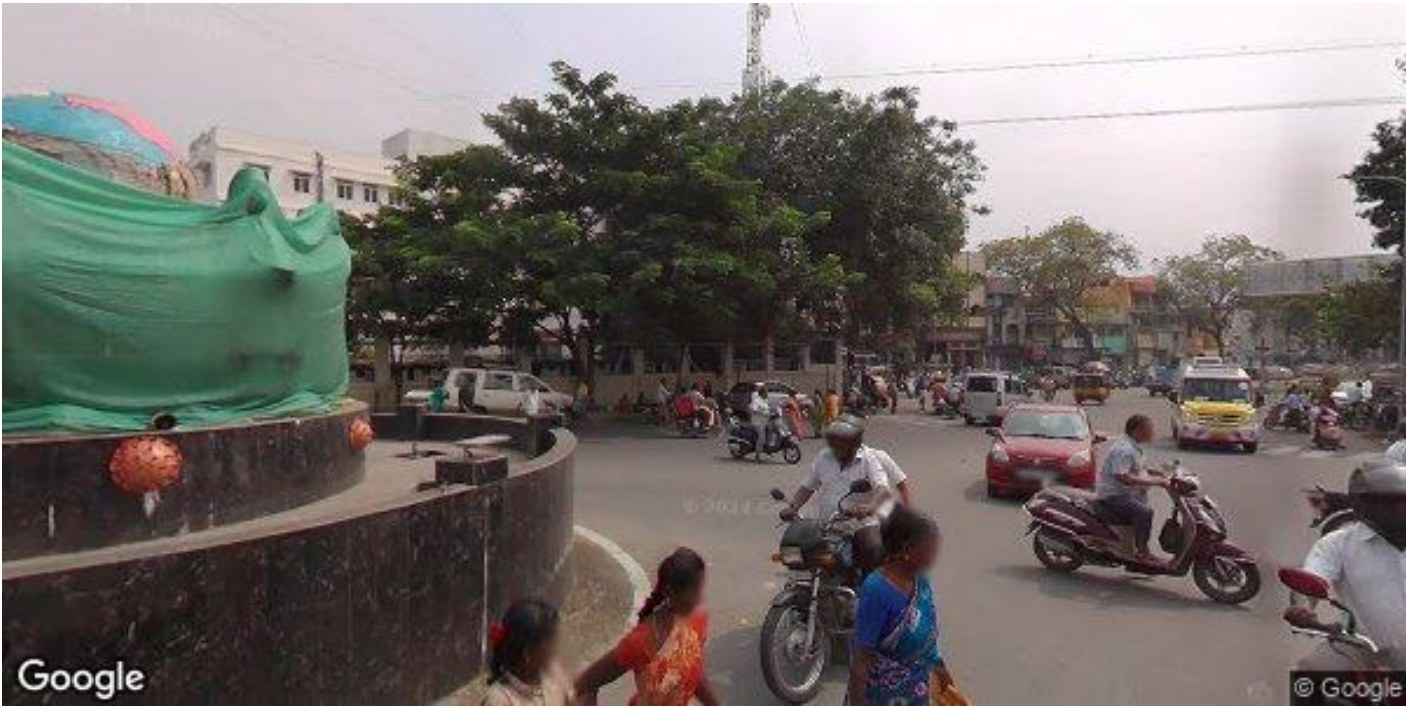
**Risk Type:** Roundabout  
**Risk Level:** High  
**Speed Limit:** 15 KM/Hr  
**Coordinates:** 11.65514, 78.15419

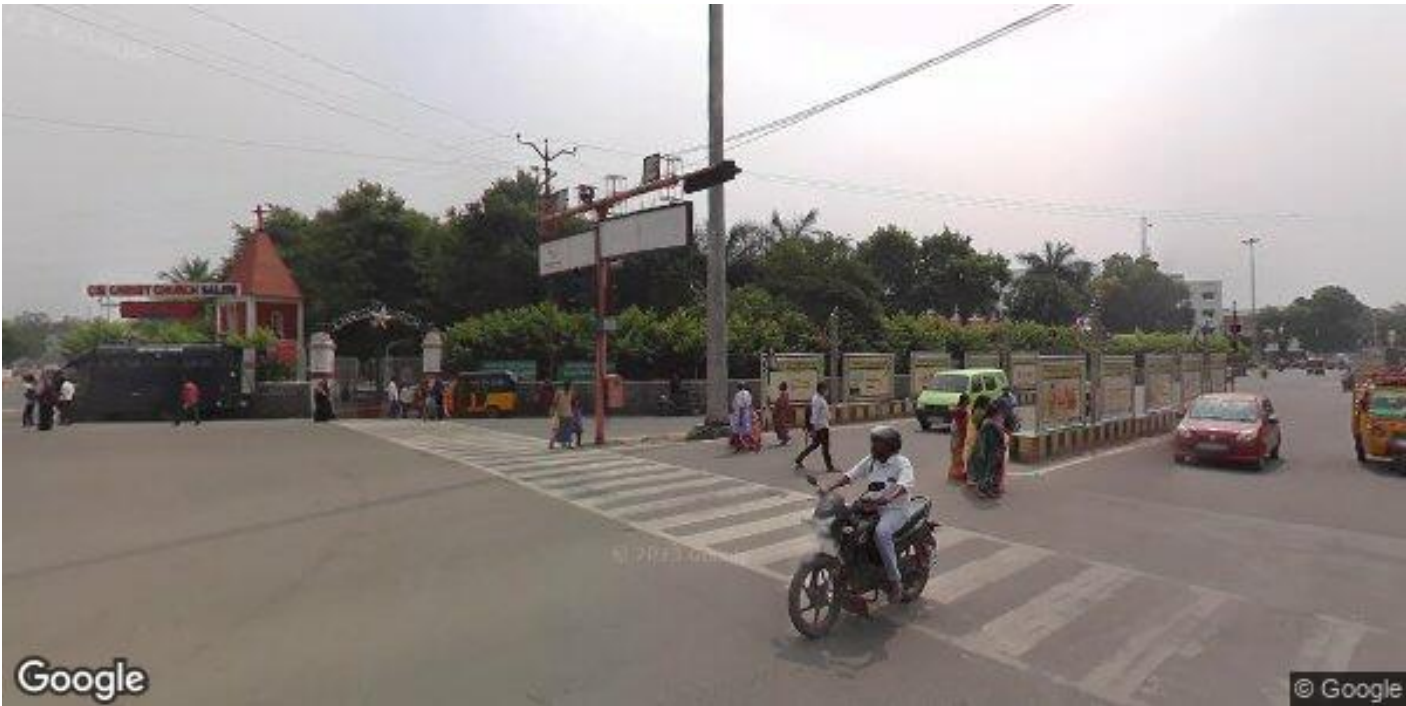
**Risk Type:** Roundabout  
**Risk Level:** High  
**Speed Limit:** 15 KM/Hr  
**Coordinates:** 11.65653, 78.15533

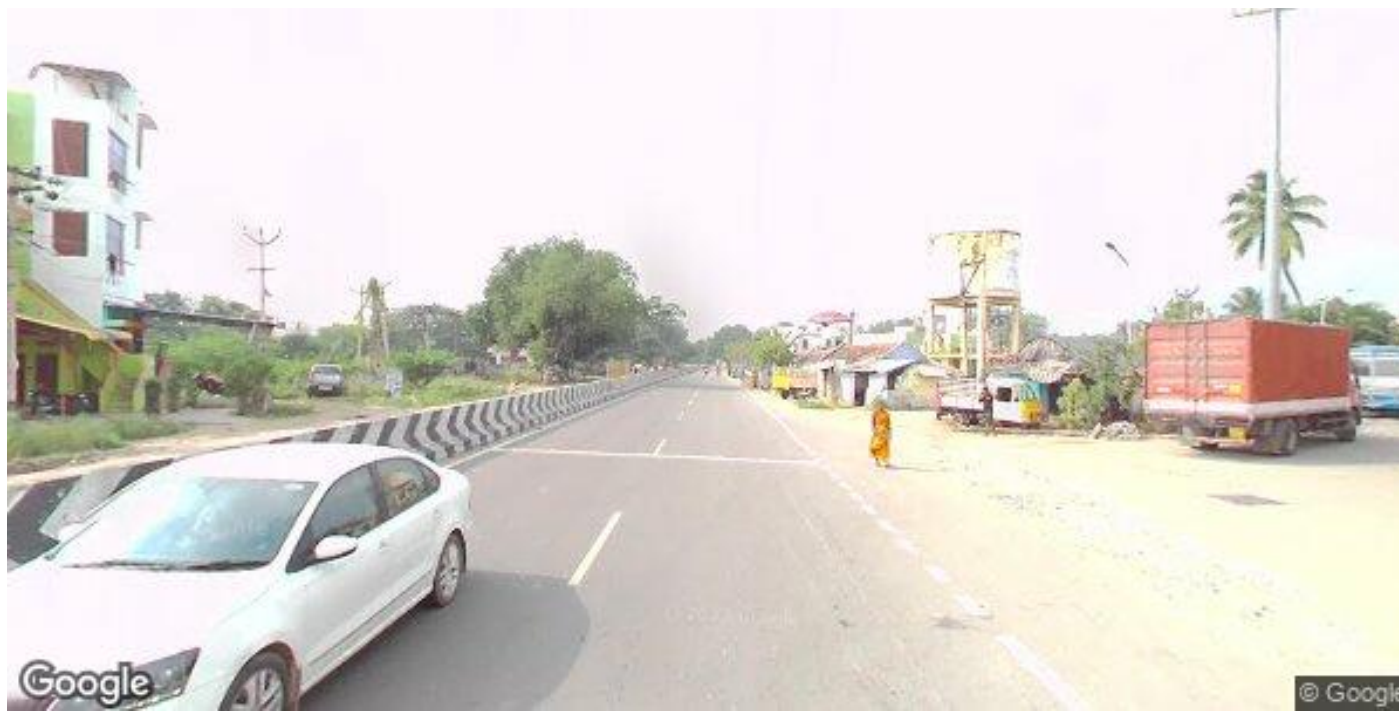
**Risk Type:** U-Turn  
**Risk Level:** High  
**Speed Limit:** 10 KM/Hr  
**Coordinates:** 11.6193714, 78.1124012

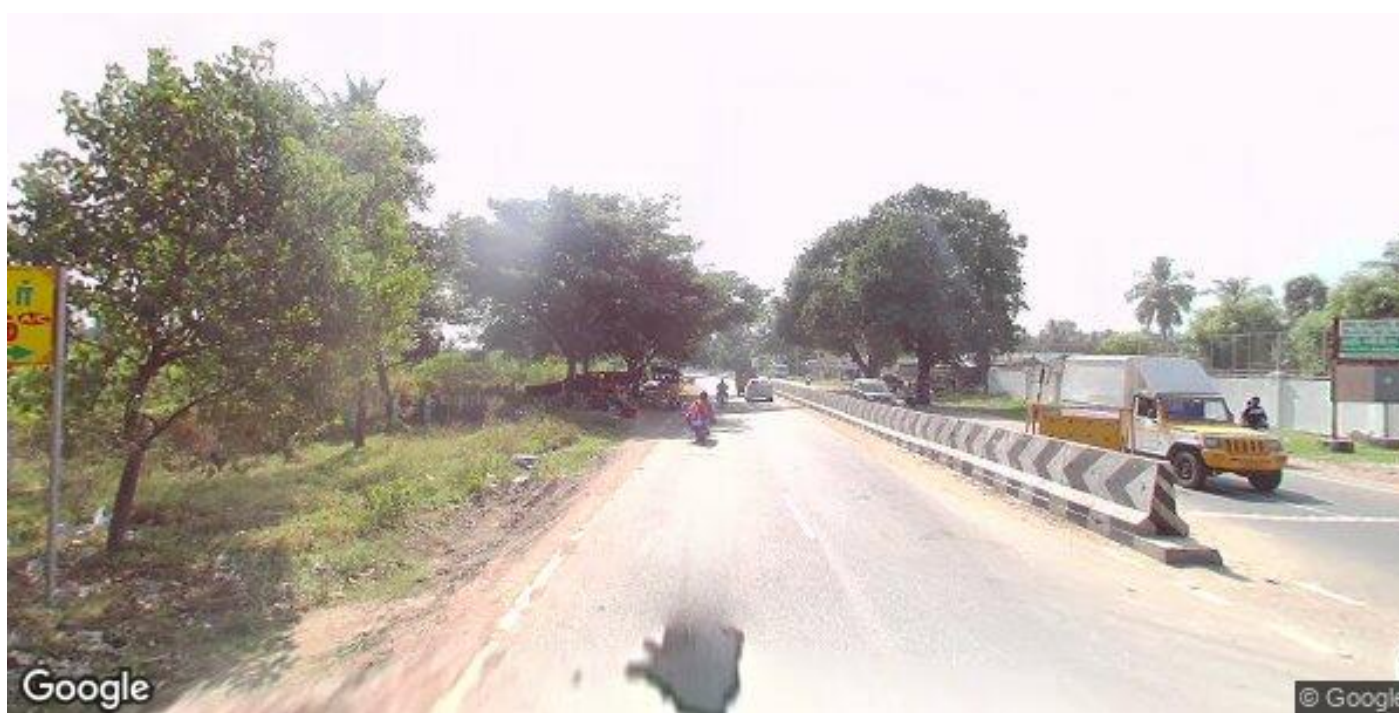
**Risk Type:** U-Turn  
**Risk Level:** High  
**Speed Limit:** 10 KM/Hr  
**Coordinates:** 11.618013, 78.1109532

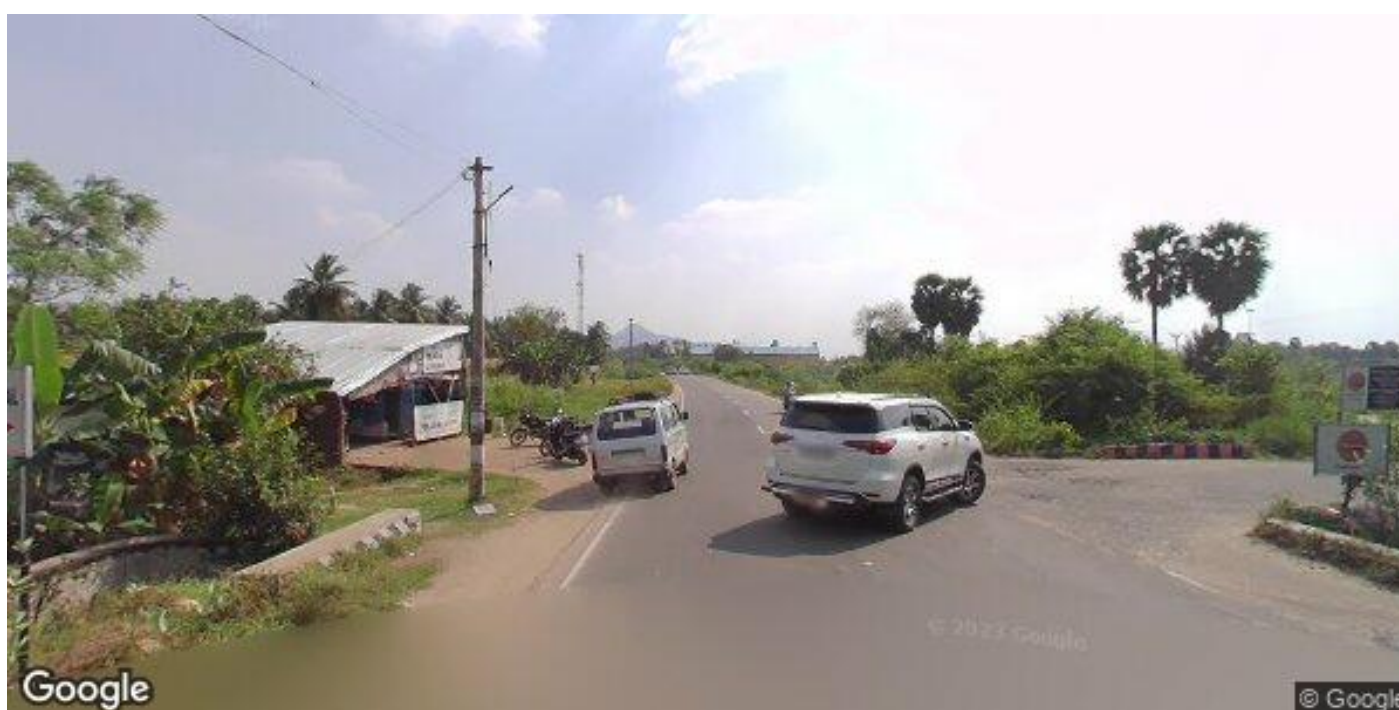
**Risk Type:** Turn  
**Risk Level:** High  
**Speed Limit:** 15 KM/Hr  
**Coordinates:** 11.44029, 77.87544

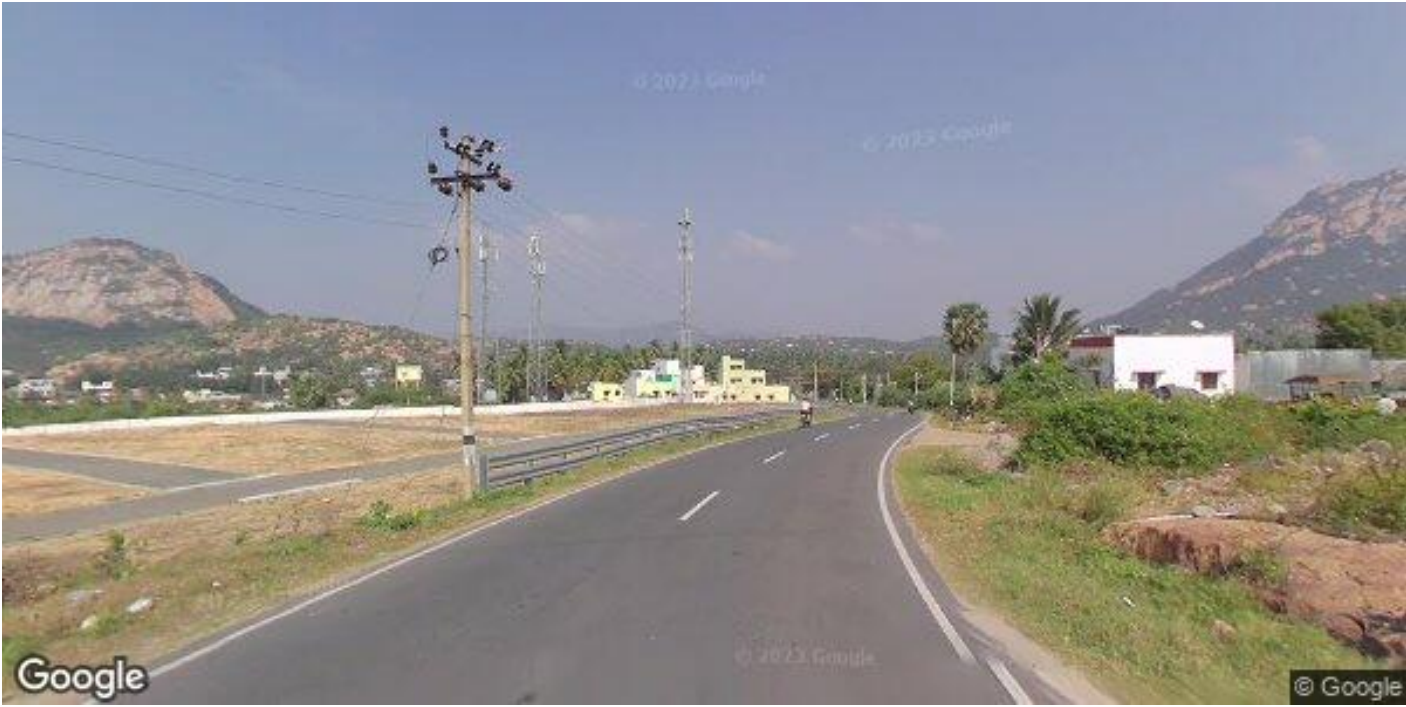
**Risk Type:** Turn  
**Risk Level:** Medium  
**Speed Limit:** 30 KM/Hr  
**Coordinates:** 11.46053, 77.85034

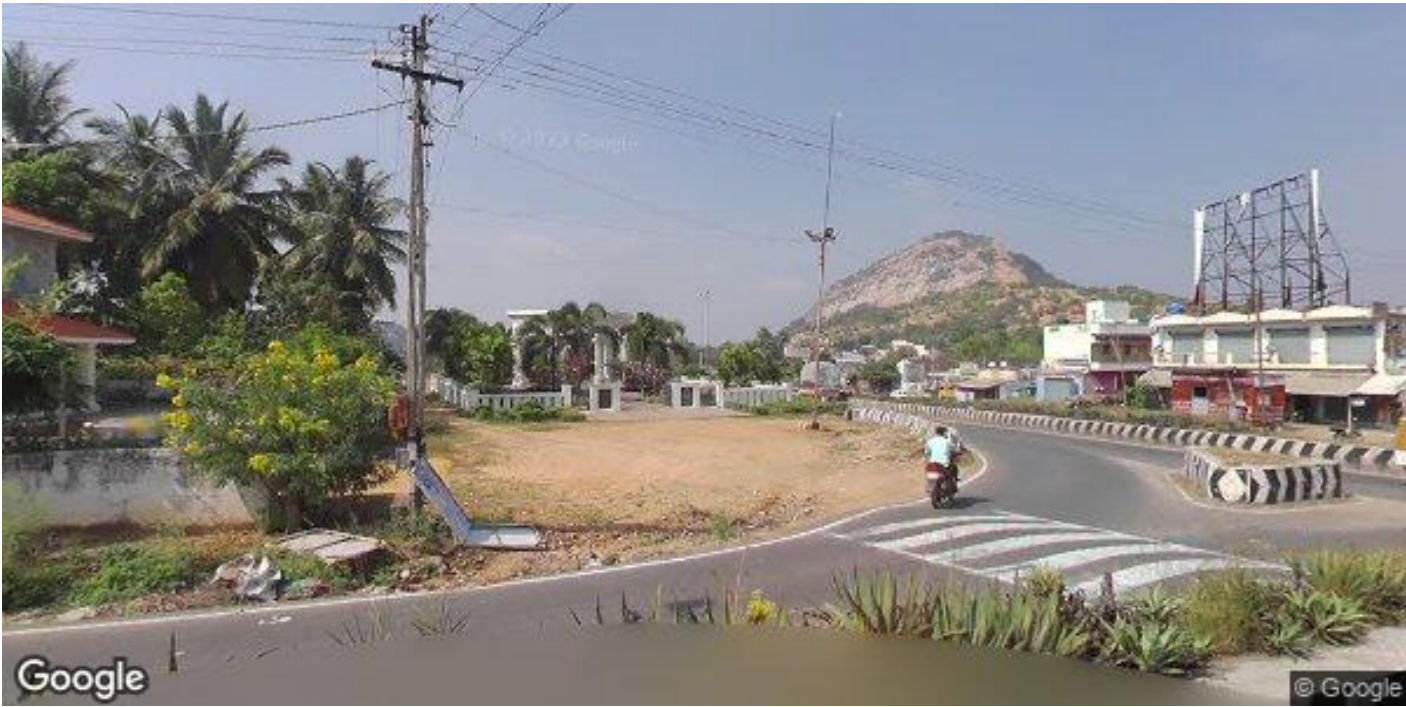
**Risk Type:** Turn  
**Risk Level:** Medium  
**Speed Limit:** 30 KM/Hr  
**Coordinates:** 11.46307, 77.84941

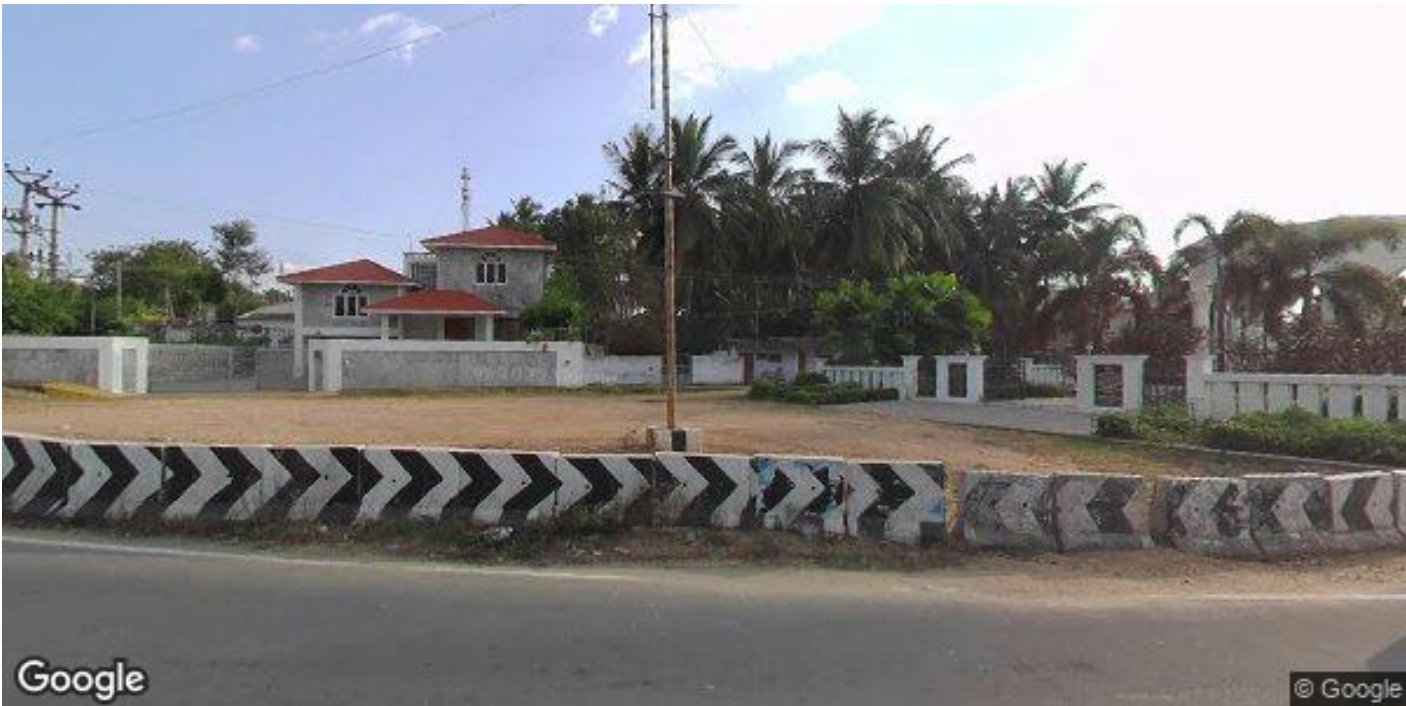
**Risk Type:** Turn  
**Risk Level:** Medium  
**Speed Limit:** 30 KM/Hr  
**Coordinates:** 11.46316, 77.84921

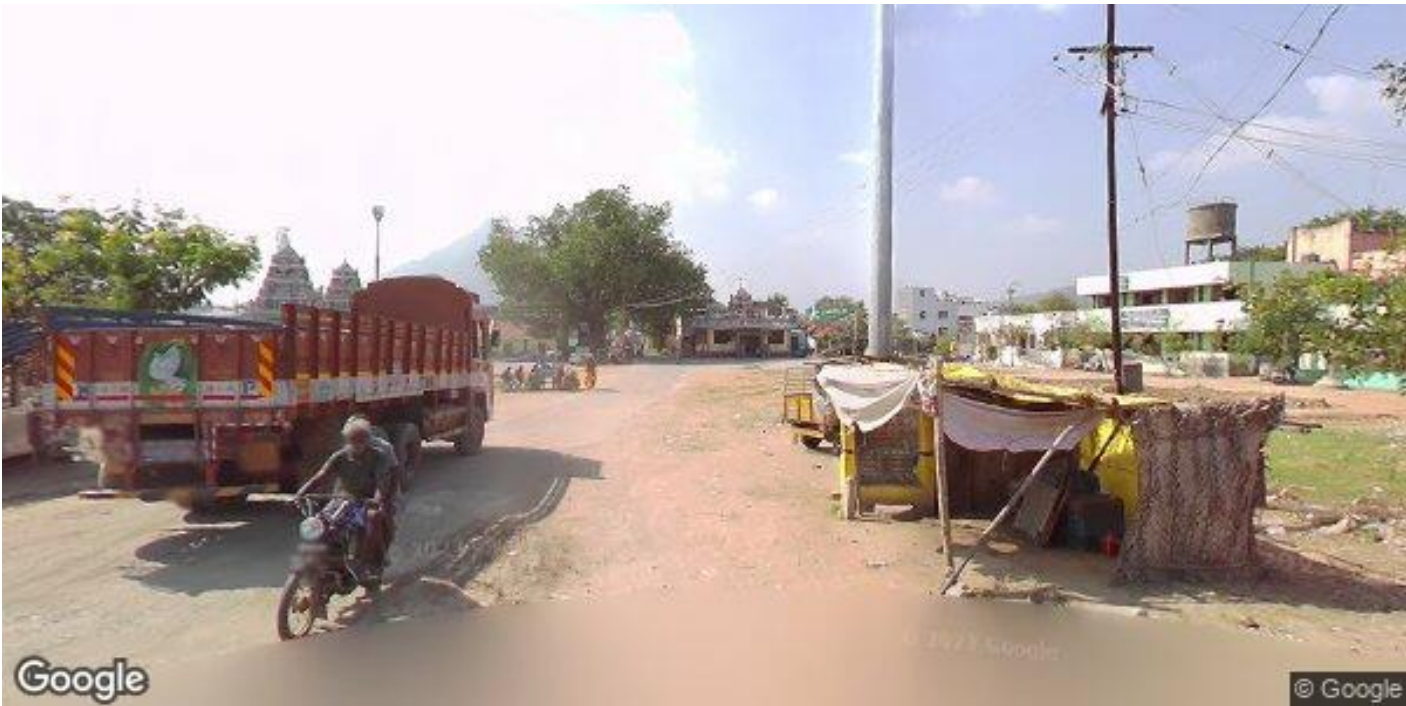
**Risk Type:** Blind Spot  
**Risk Level:** Blind Spot  
**Speed Limit:** 10 KM/Hr  
**Coordinates:** 11.62145, 78.10740

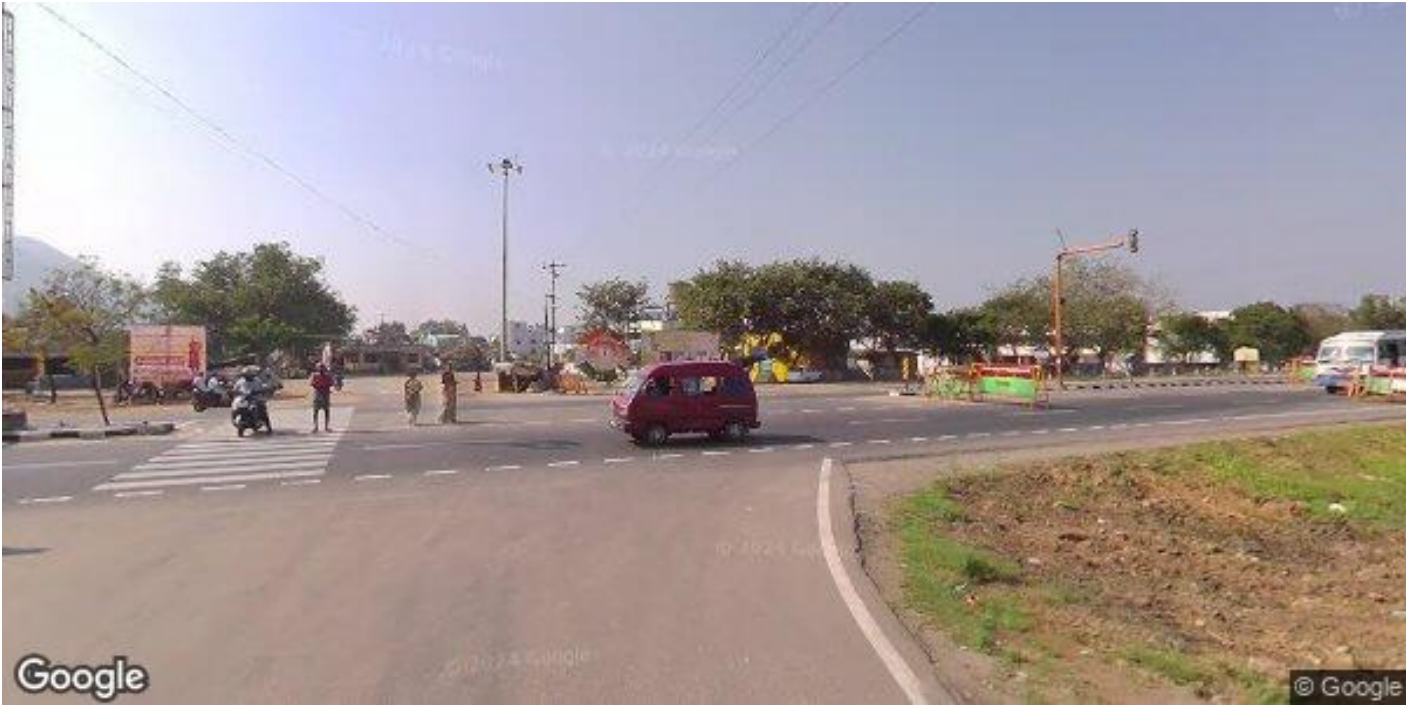
**Risk Type:** Turn  
**Risk Level:** High  
**Speed Limit:** 15 KM/Hr  
**Coordinates:** 11.62130, 78.10776

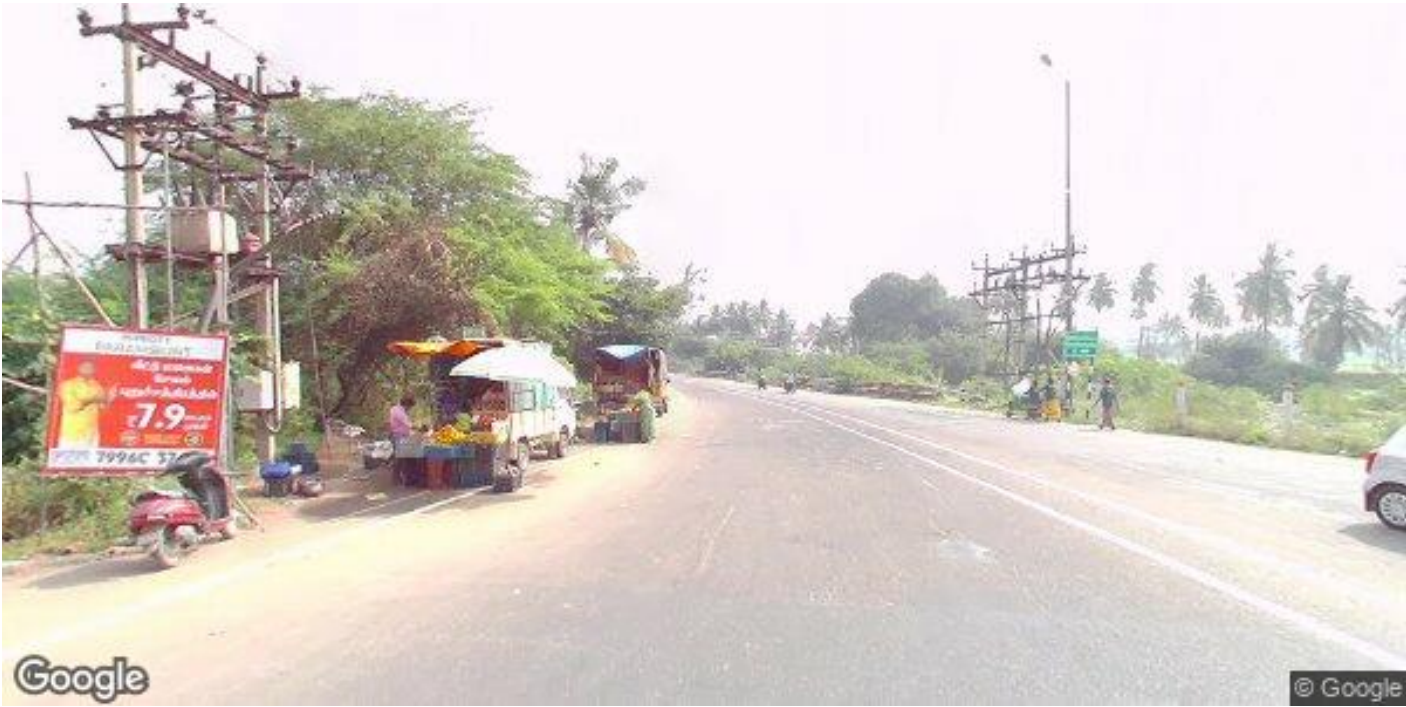
**Risk Type:** Blind Spot  
**Risk Level:** Blind Spot  
**Speed Limit:** 10 KM/Hr  
**Coordinates:** 11.61217, 78.10439

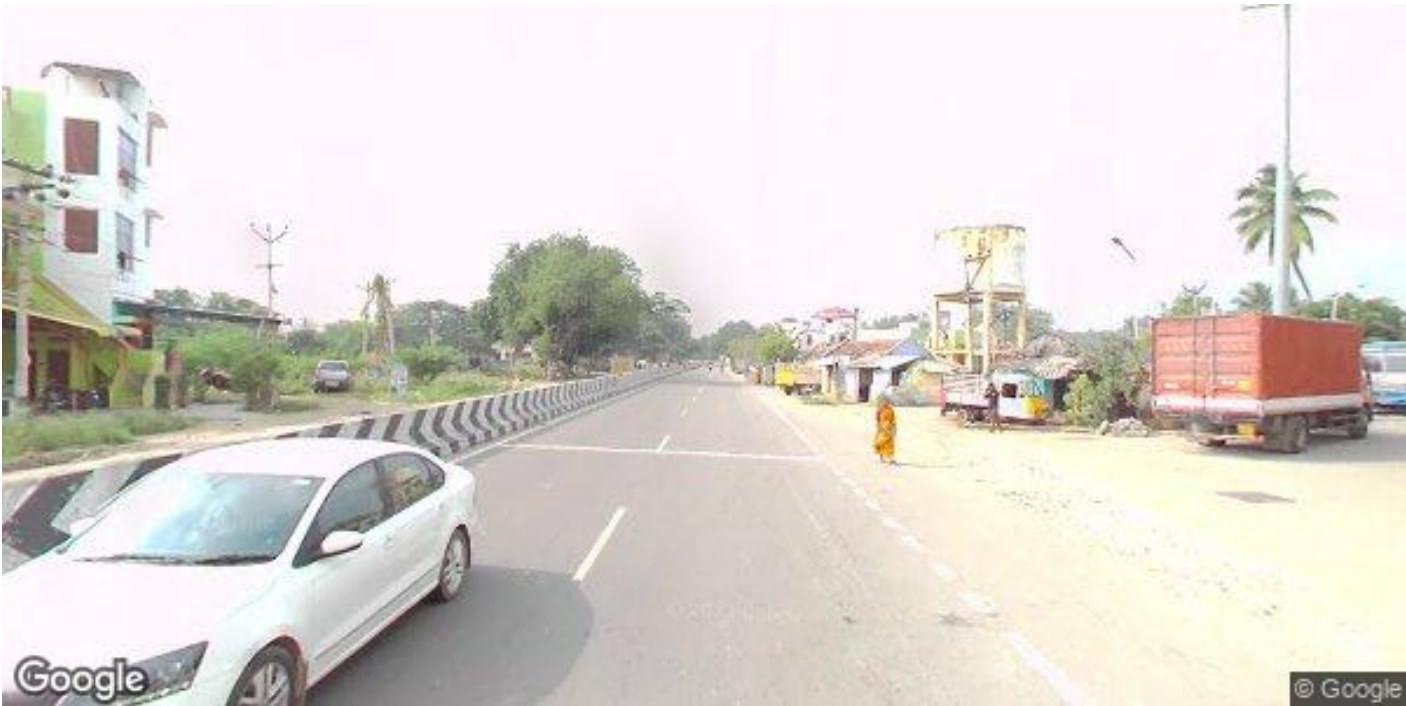
**Risk Type:** Blind Spot  
**Risk Level:** Blind Spot  
**Speed Limit:** 10 KM/Hr  
**Coordinates:** 11.61937, 78.11240

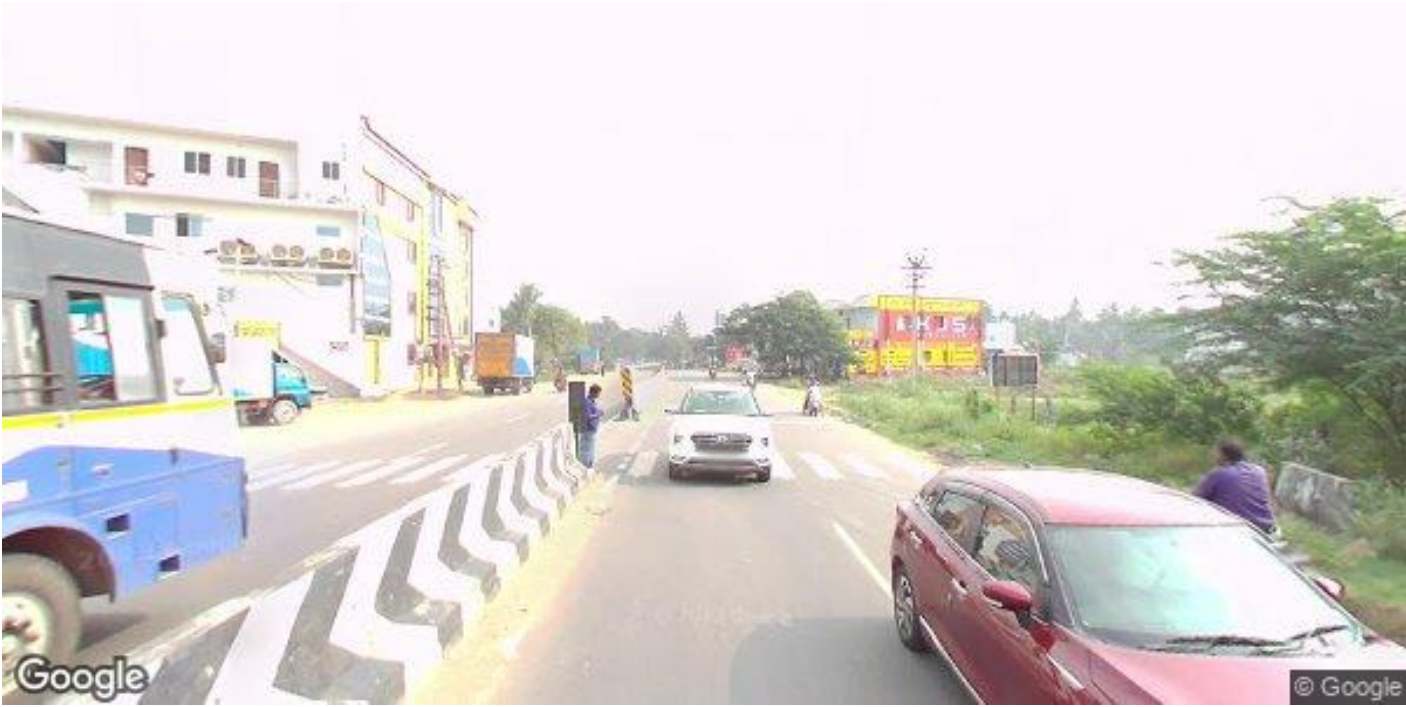
**Risk Type:** Turn  
**Risk Level:** Medium  
**Speed Limit:** 30 KM/Hr  
**Coordinates:** 11.61924, 78.11237

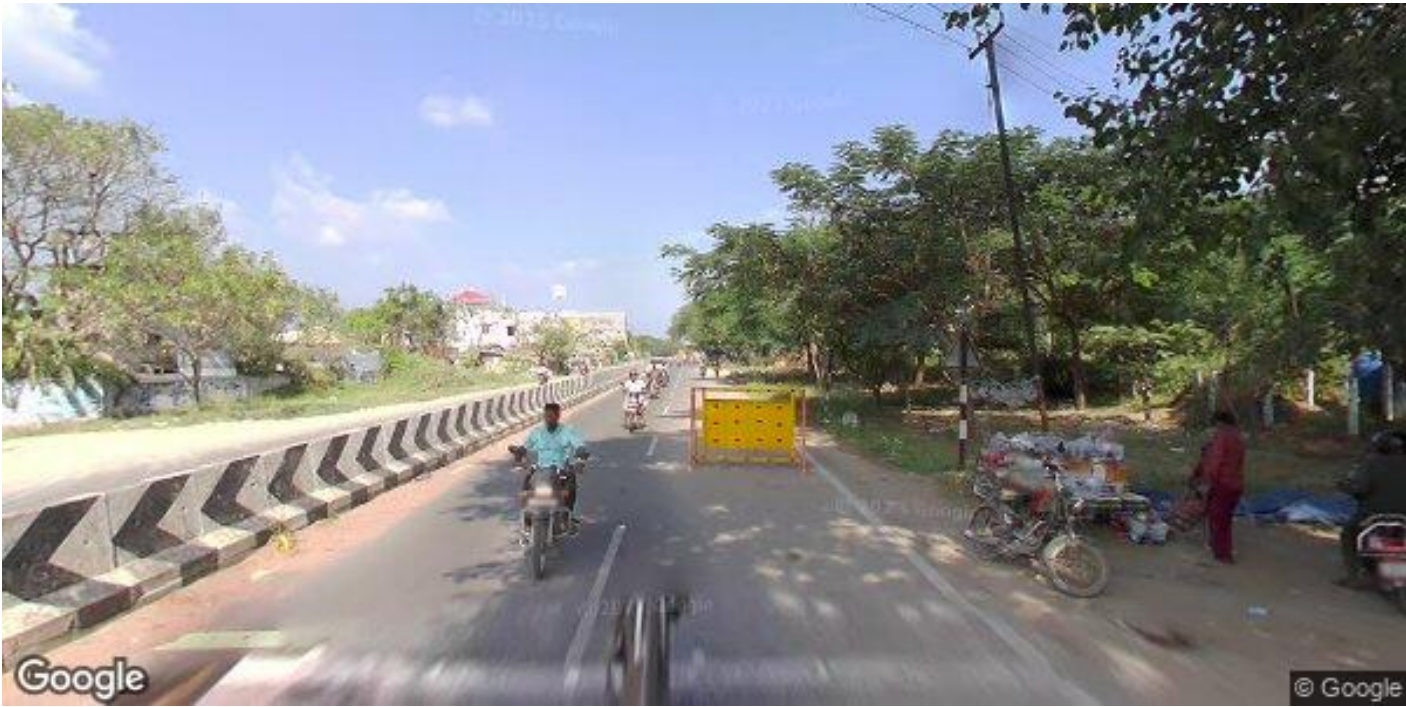
**Risk Type:** Turn  
**Risk Level:** Medium  
**Speed Limit:** 30 KM/Hr  
**Coordinates:** 11.61812, 78.11108

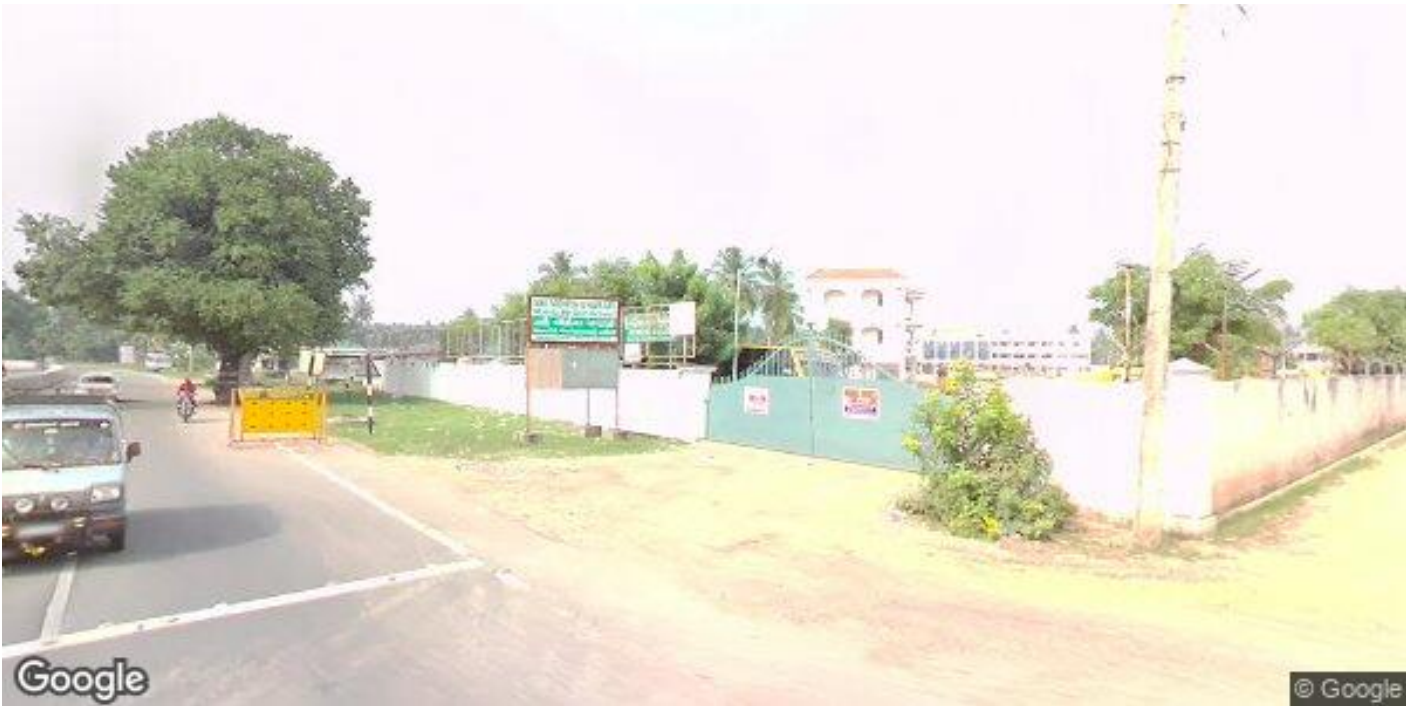
**Risk Type:** Blind Spot  
**Risk Level:** Blind Spot  
**Speed Limit:** 10 KM/Hr  
**Coordinates:** 11.61807, 78.11090

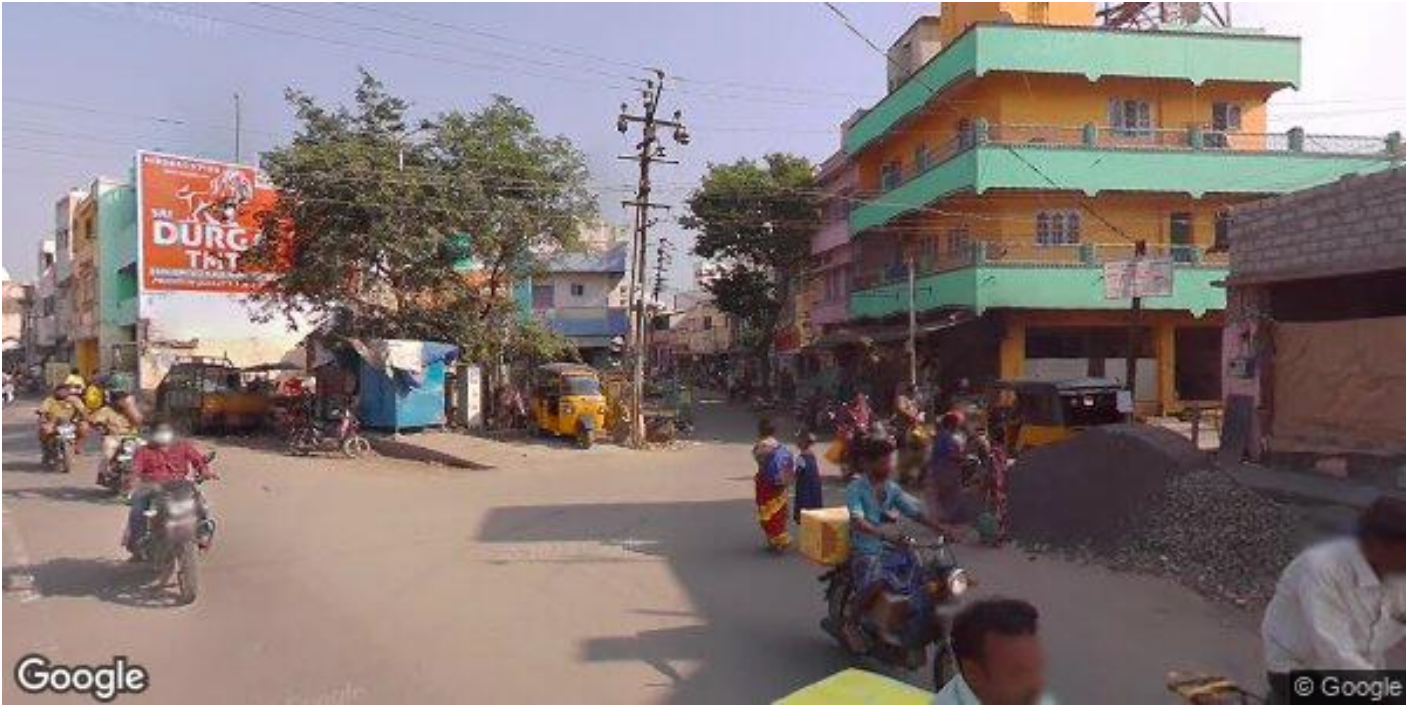
**Risk Type:** Turn  
**Risk Level:** Medium  
**Speed Limit:** 30 KM/Hr  
**Coordinates:** 11.64844, 78.14338

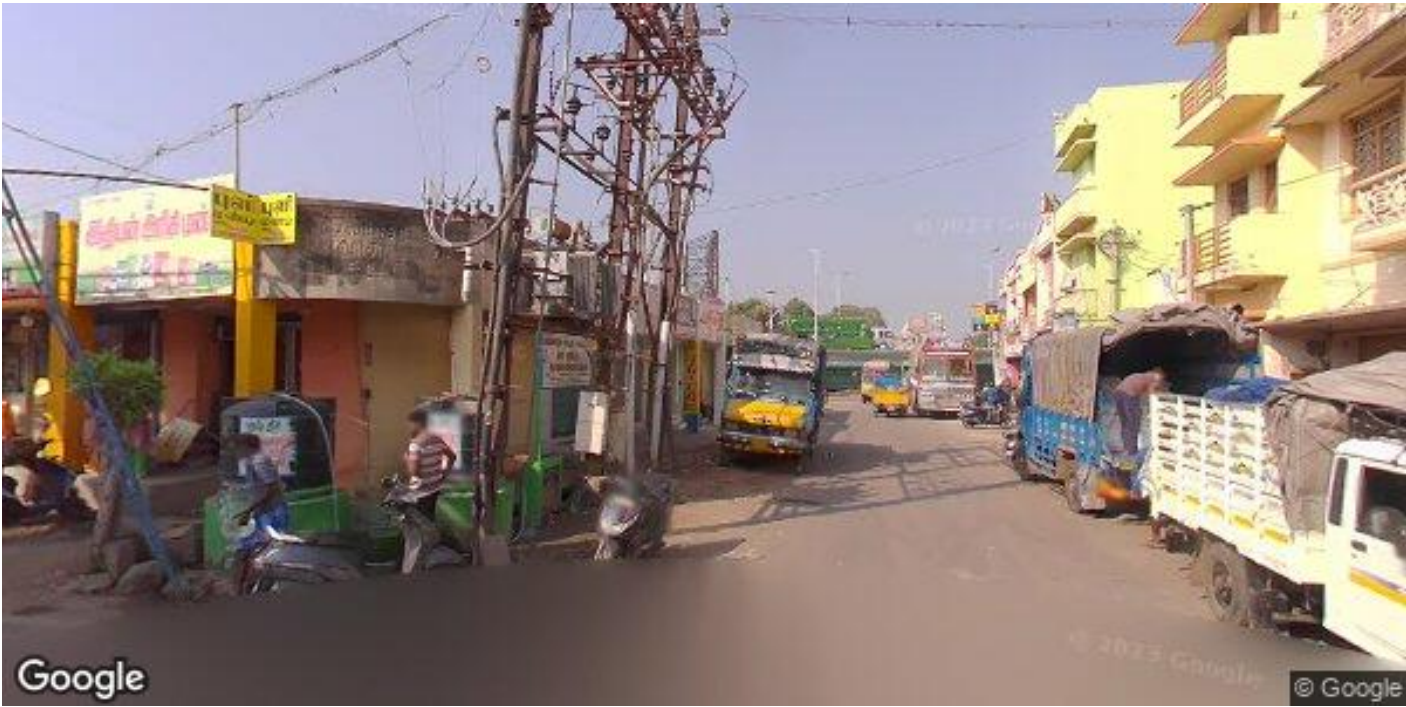
**Risk Type:** Turn  
**Risk Level:** High  
**Speed Limit:** 15 KM/Hr  
**Coordinates:** 11.65197, 78.14241

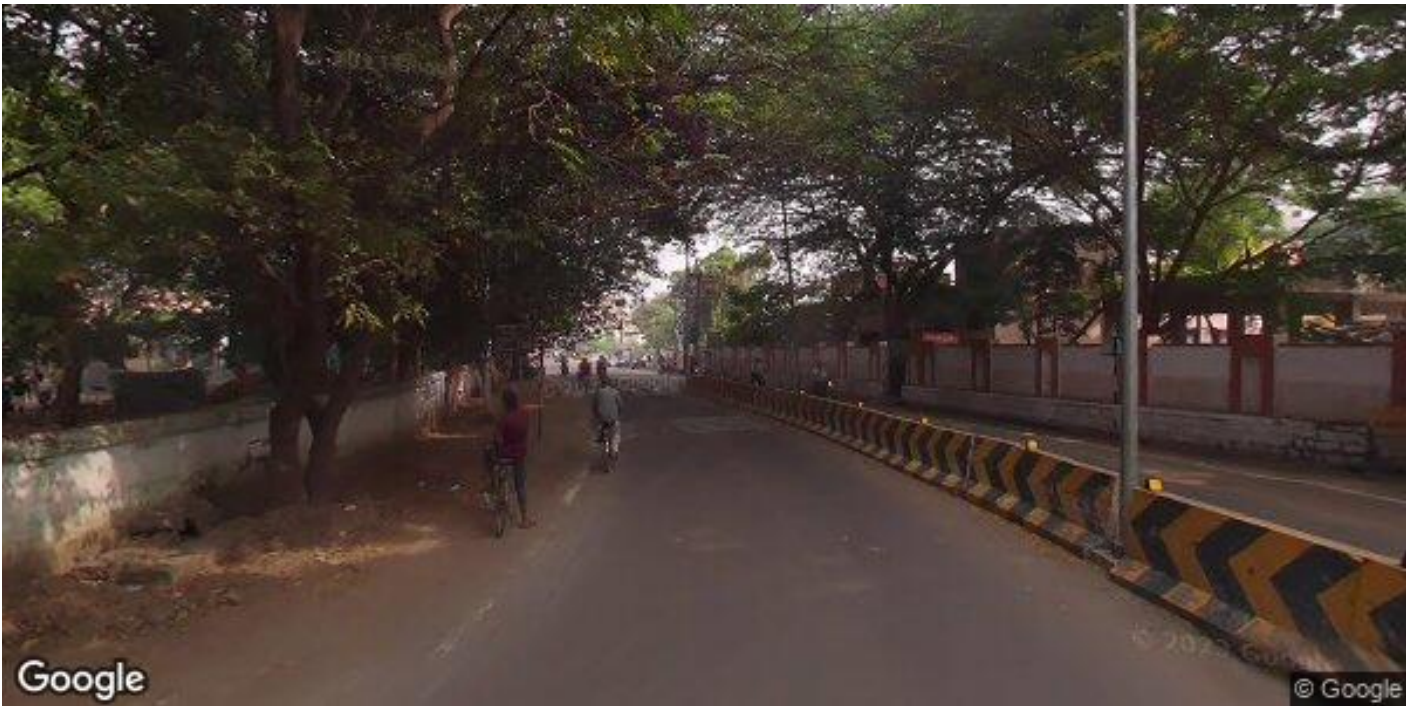
**Risk Type:** Turn  
**Risk Level:** Medium  
**Speed Limit:** 30 KM/Hr  
**Coordinates:** 11.65752, 78.15667

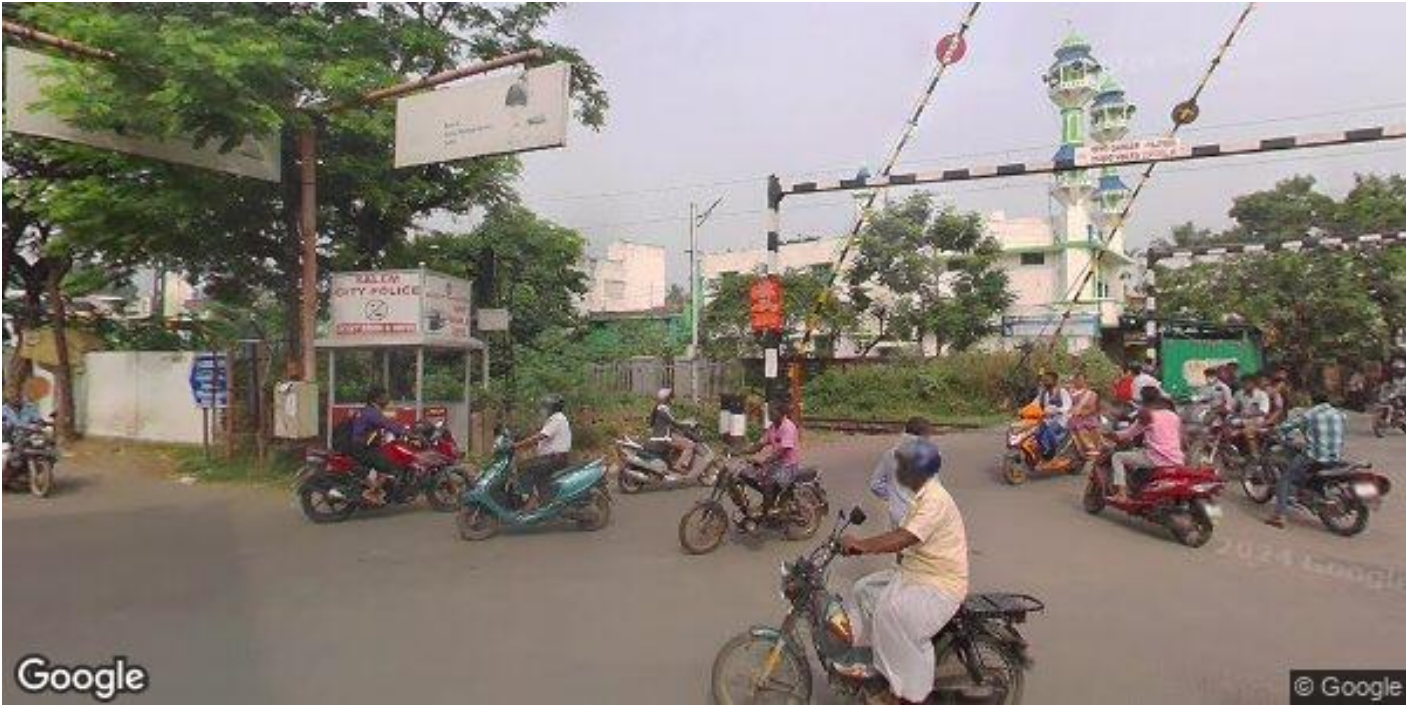
**Risk Type:** Turn  
**Risk Level:** High  
**Speed Limit:** 15 KM/Hr  
**Coordinates:** 11.65998, 78.15751
