# IndianOil

## JOURNEY RISK MANAGEMENT (JRM) STUDY

### Salem Terminal TO SRI VARALAKSHMI FUELS

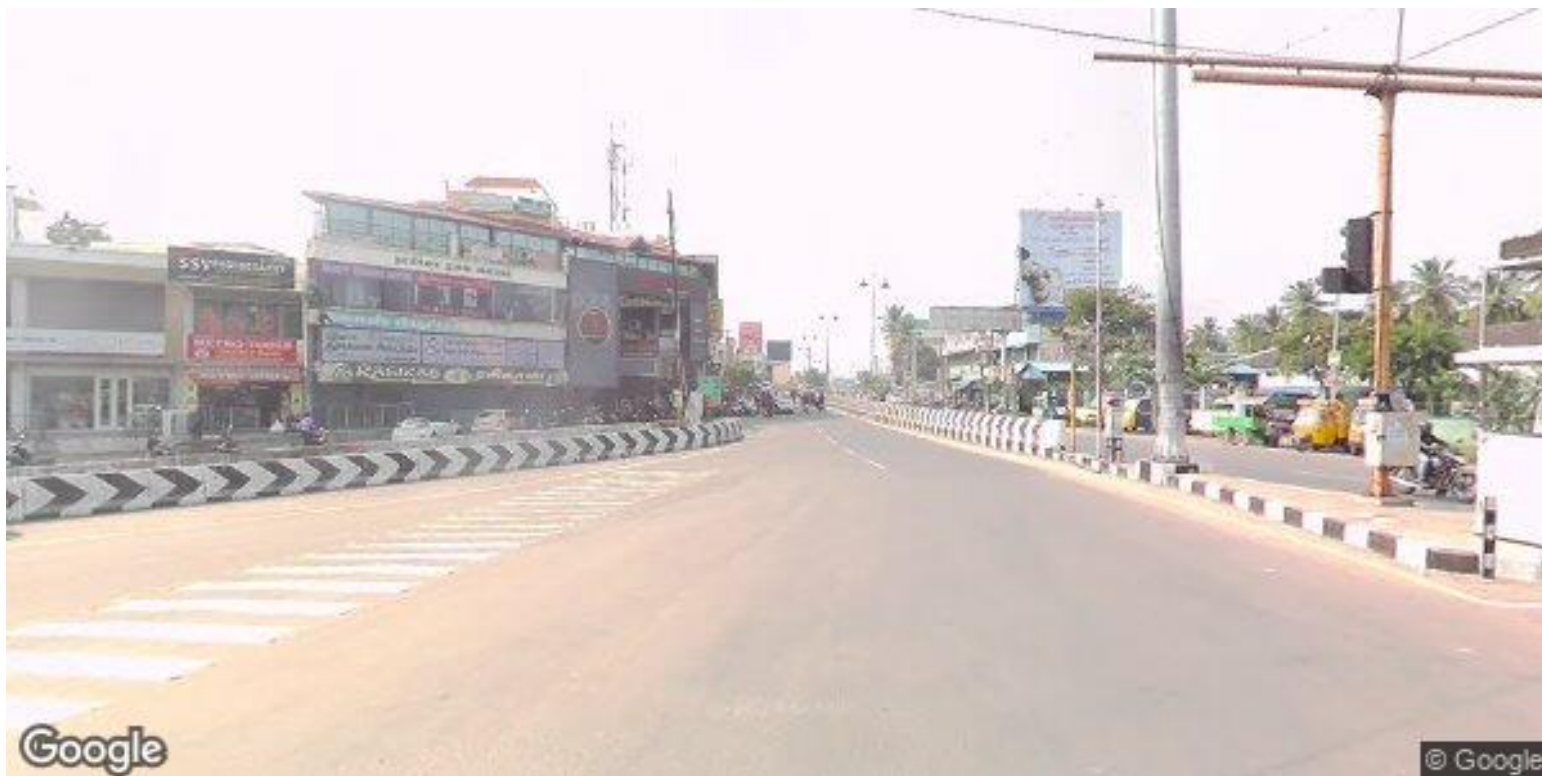
**Coordinates:** 11.6674963, 78.12460569999999

**Risk Type:** U-Turn

**Risk Level:** High

**Speed Limit:** 10 KM/Hr

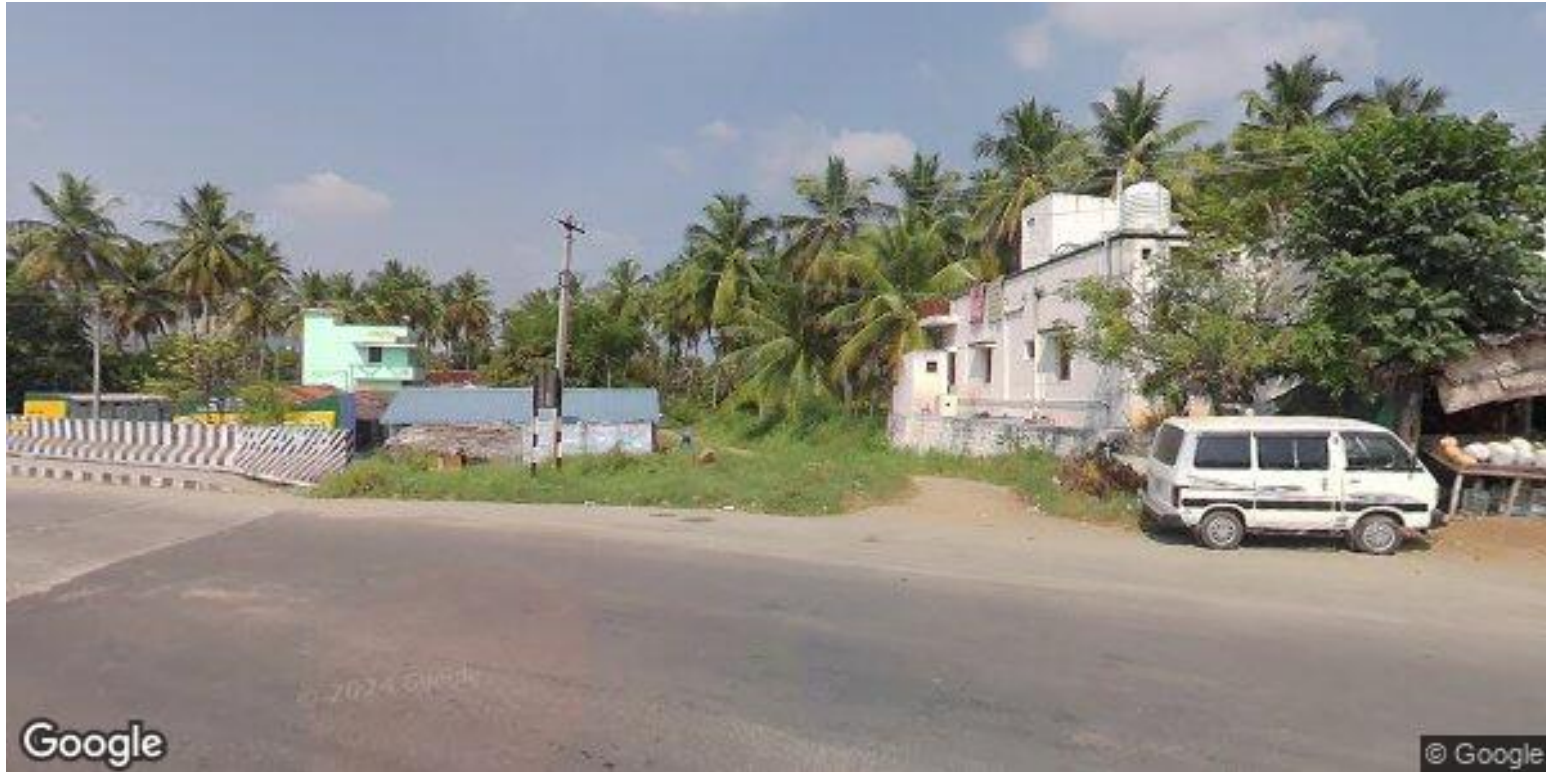
**Risk Type:** Turn  
**Risk Level:** Medium  
**Speed Limit:** 30 KM/Hr  
**Coordinates:** 11.44898, 77.87410

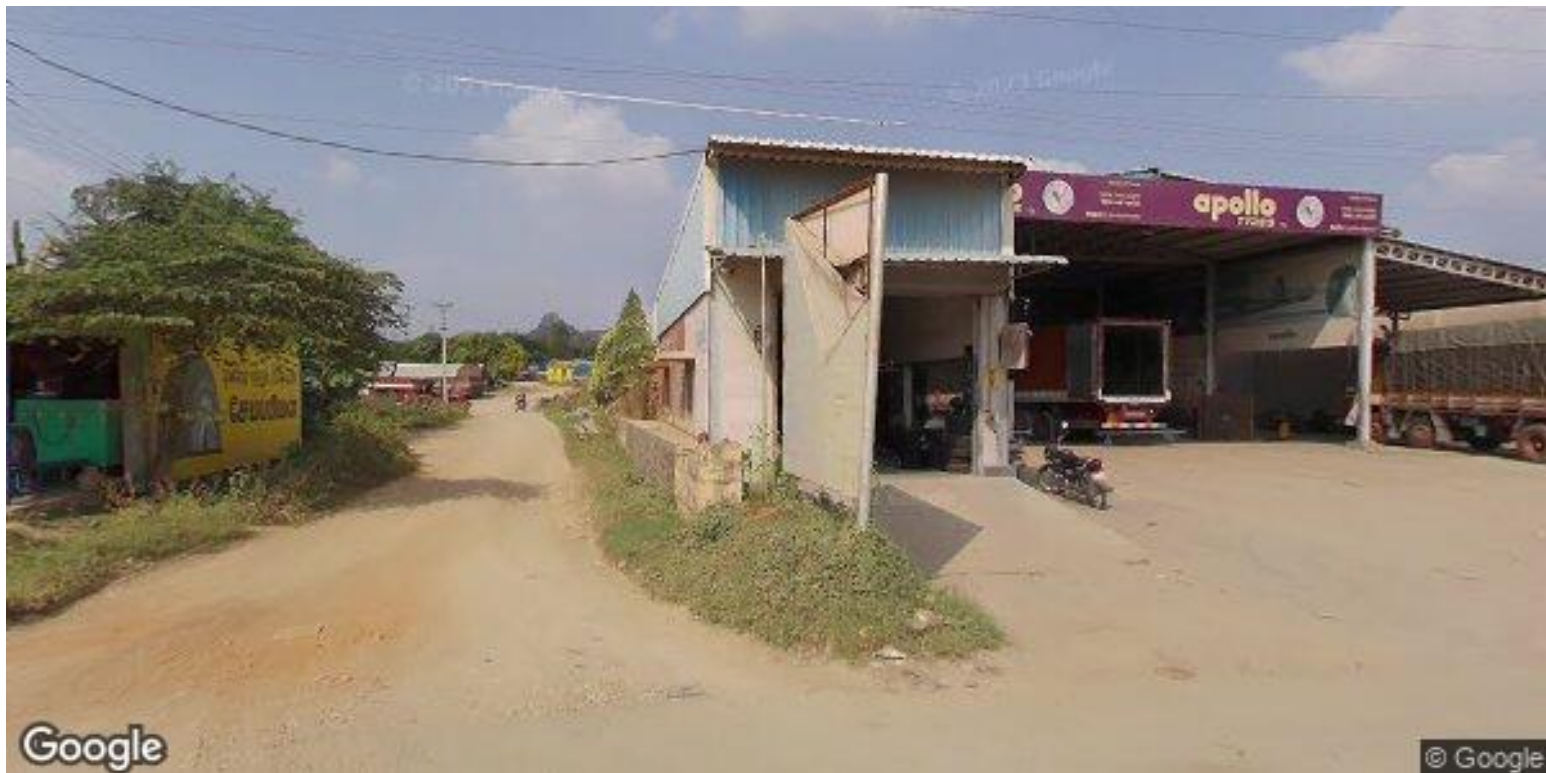
**Coordinates: 11.49235, 77.89561**

**Risk Type: Turn**

**Risk Level: High**

**Speed Limit: 15 KM/Hr**

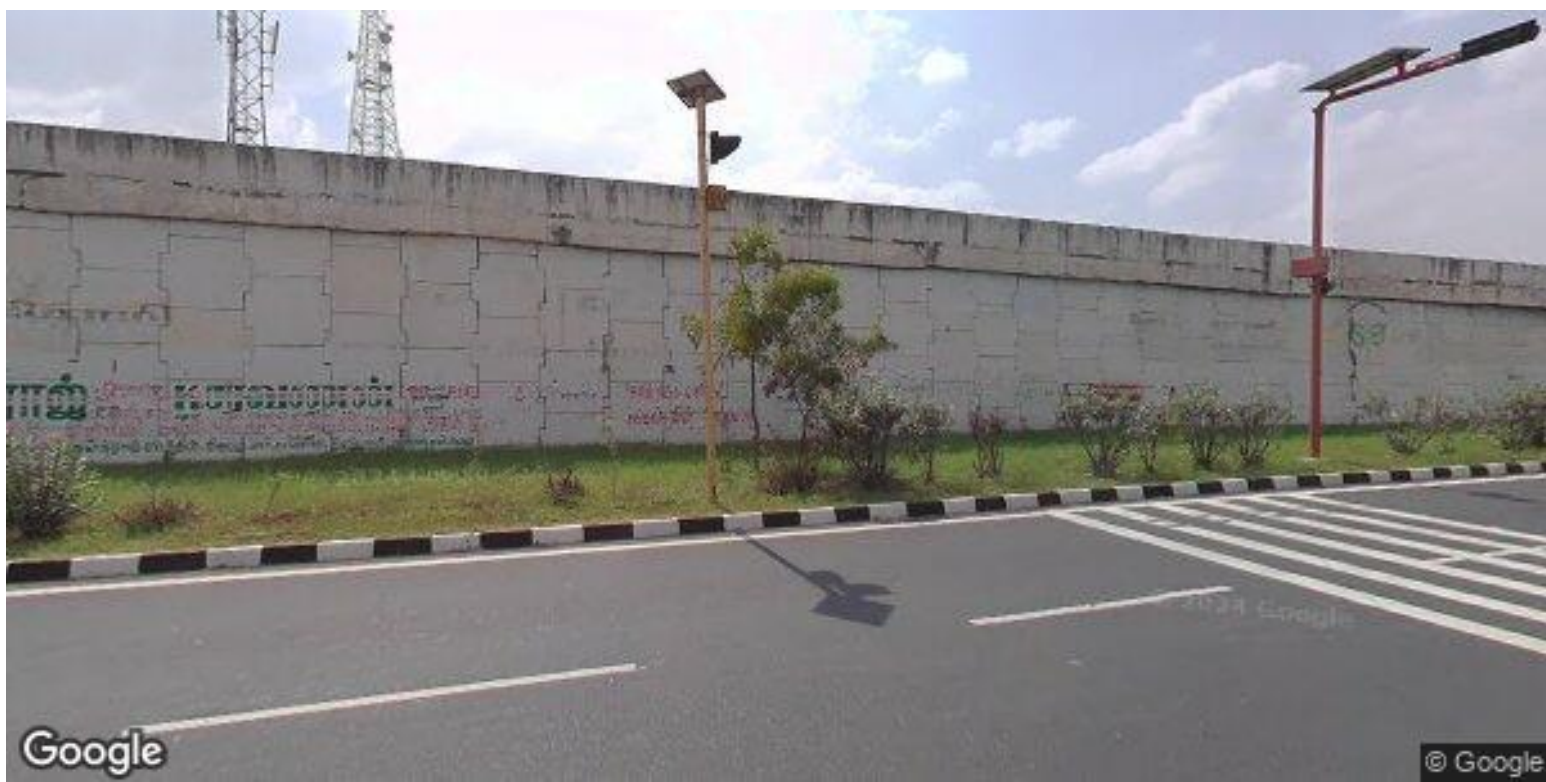
**Coordinates:** 11.49225, 77.89560

**Risk Type:** Blind Spot

**Risk Level:** Blind Spot

**Speed Limit:** 10 KM/Hr

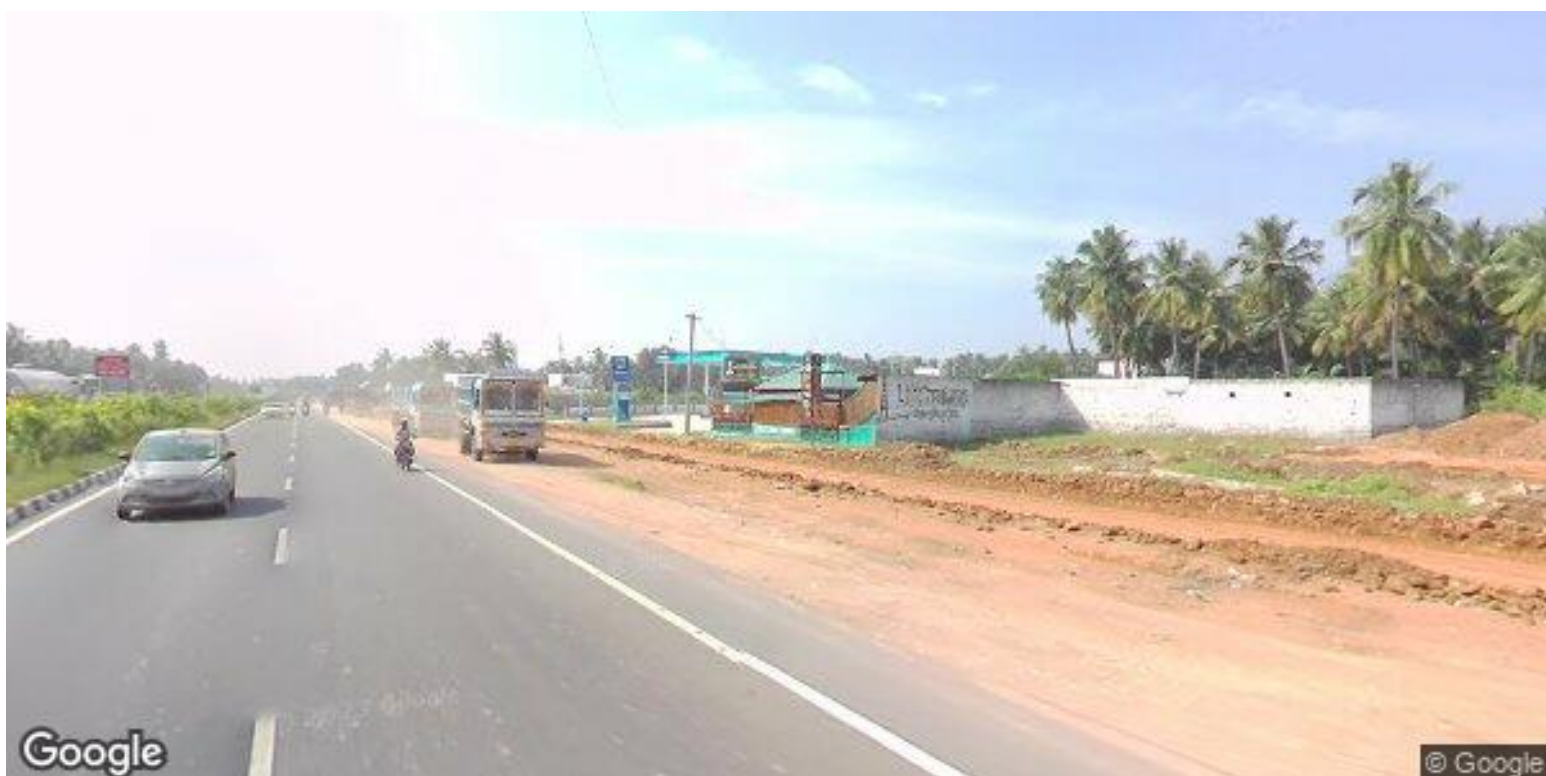
**Coordinates:** 11.61748, 78.10604

**Risk Type:** Turn

**Risk Level:** Medium

**Speed Limit:** 30 KM/Hr

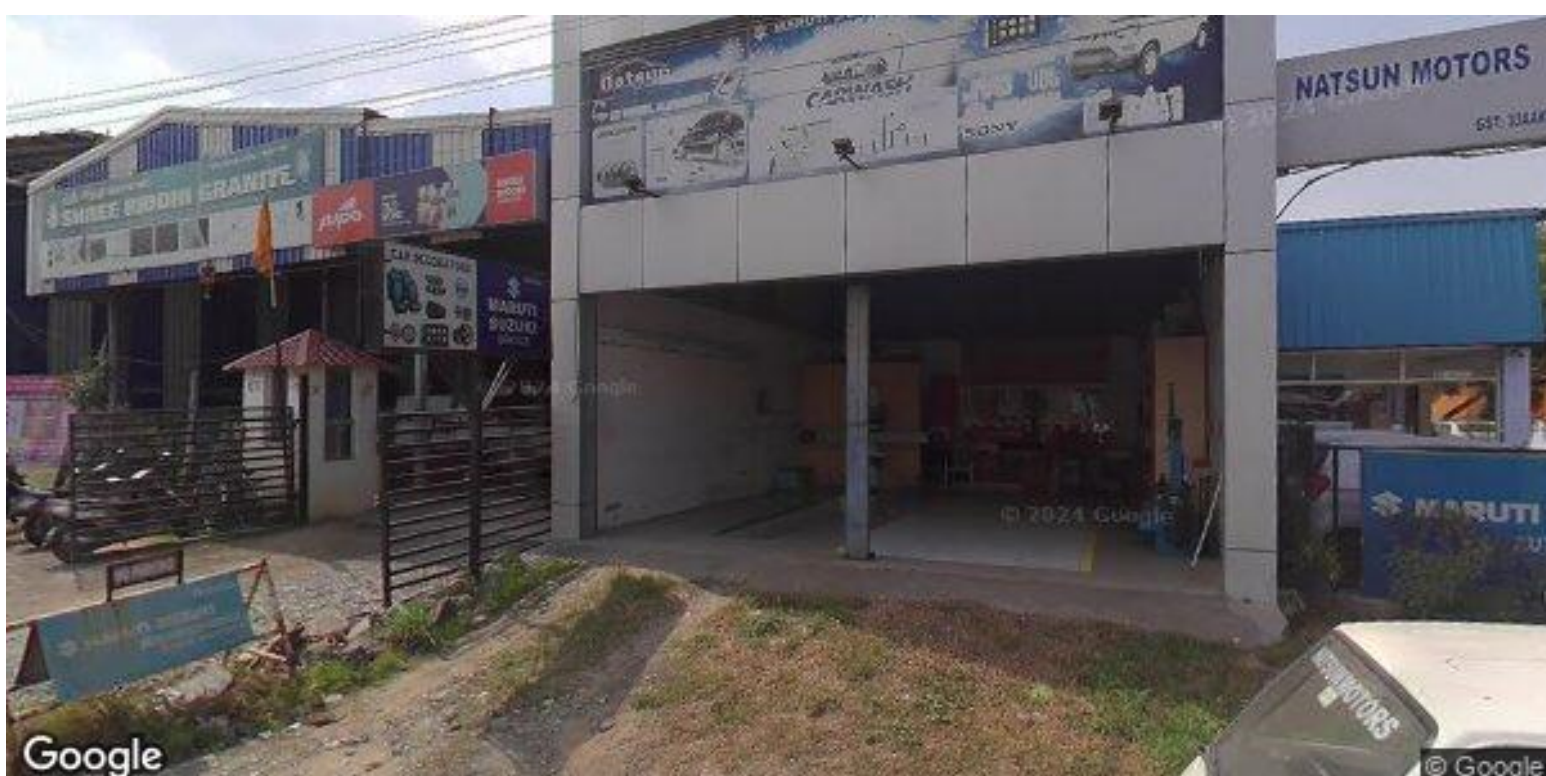
**Coordinates: 11.64490, 78.12024**

**Risk Type: Turn**

**Risk Level: Medium**

**Speed Limit: 30 KM/Hr**

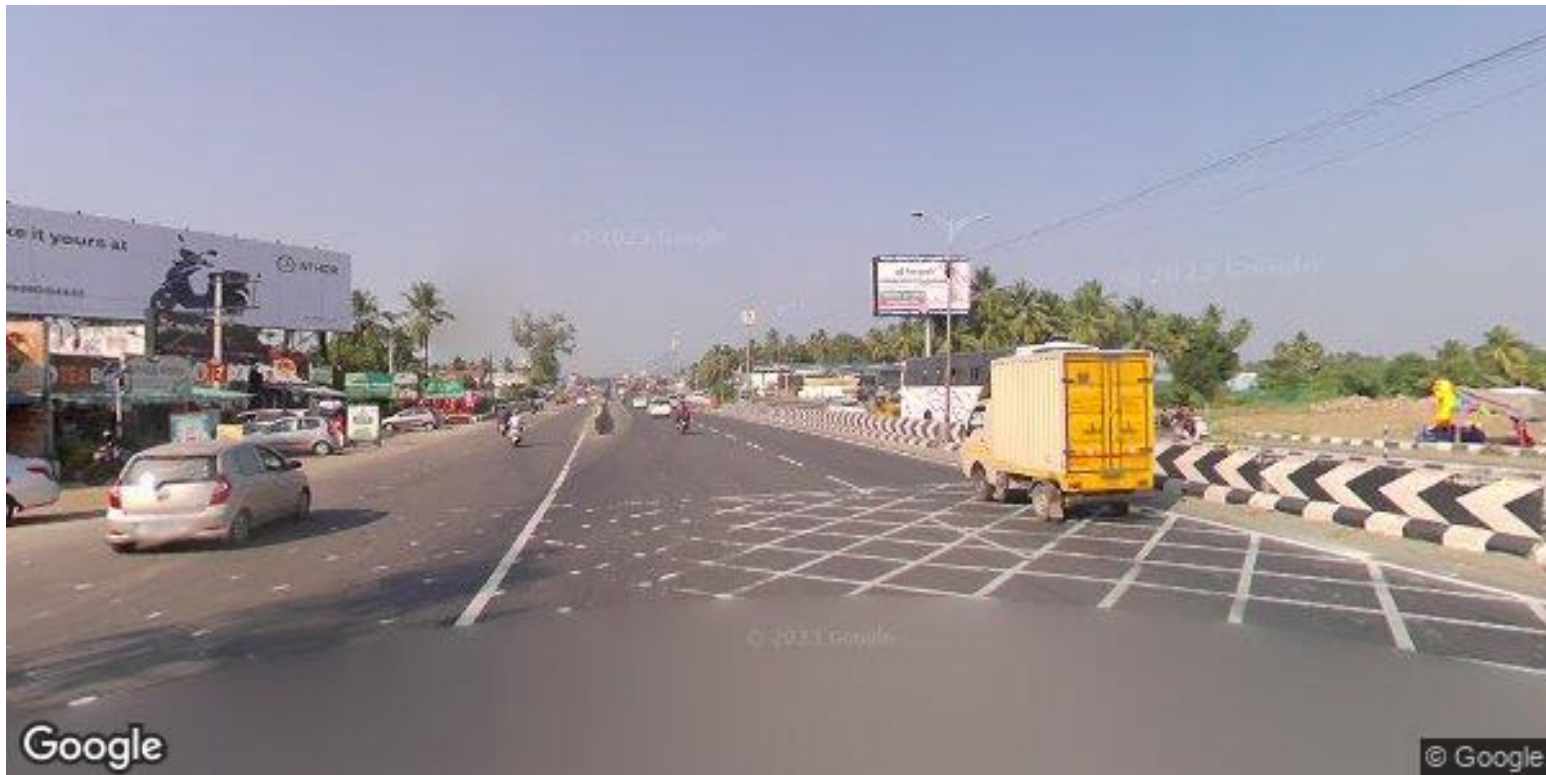
**Coordinates: 11.64503, 78.12034**

**Risk Type: Turn**

**Risk Level: Medium**

**Speed Limit: 30 KM/Hr**

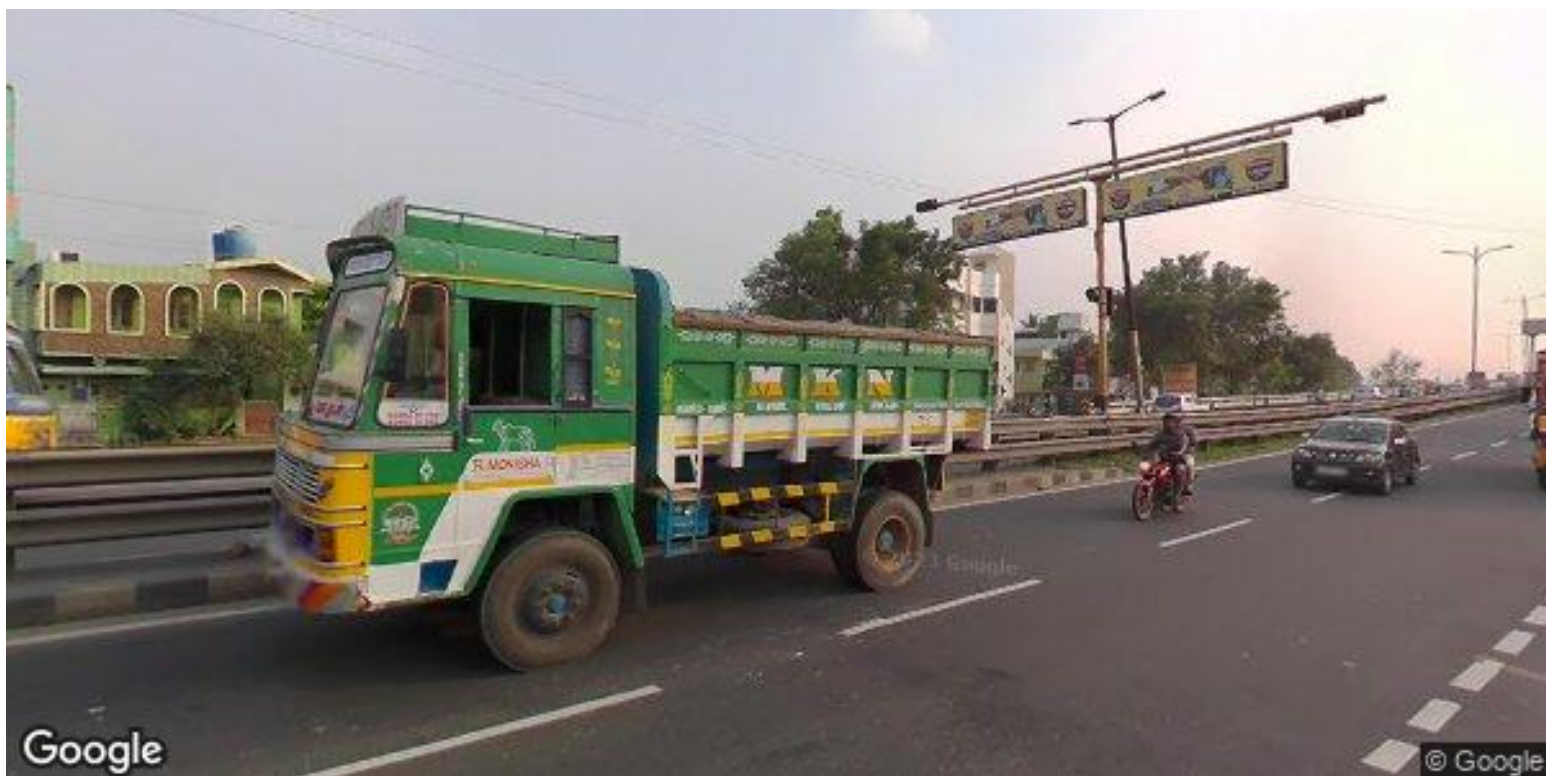
**Coordinates: 11.66458, 78.12303**

**Risk Type: Turn**

**Risk Level: High**

**Speed Limit: 15 KM/Hr**

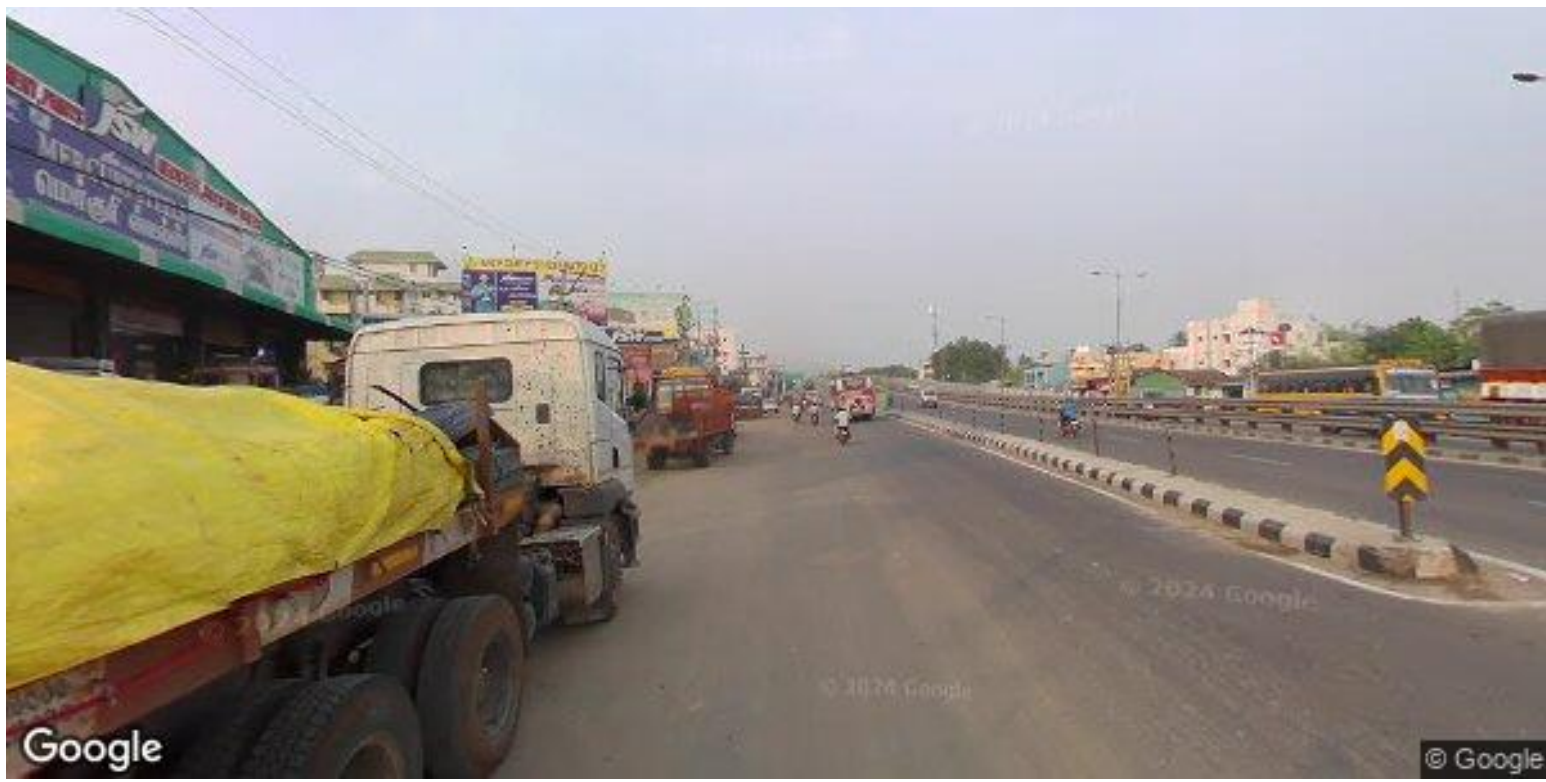
**Coordinates:** 11.66477, 78.12298

**Risk Type:** Turn

**Risk Level:** High

**Speed Limit:** 15 KM/Hr

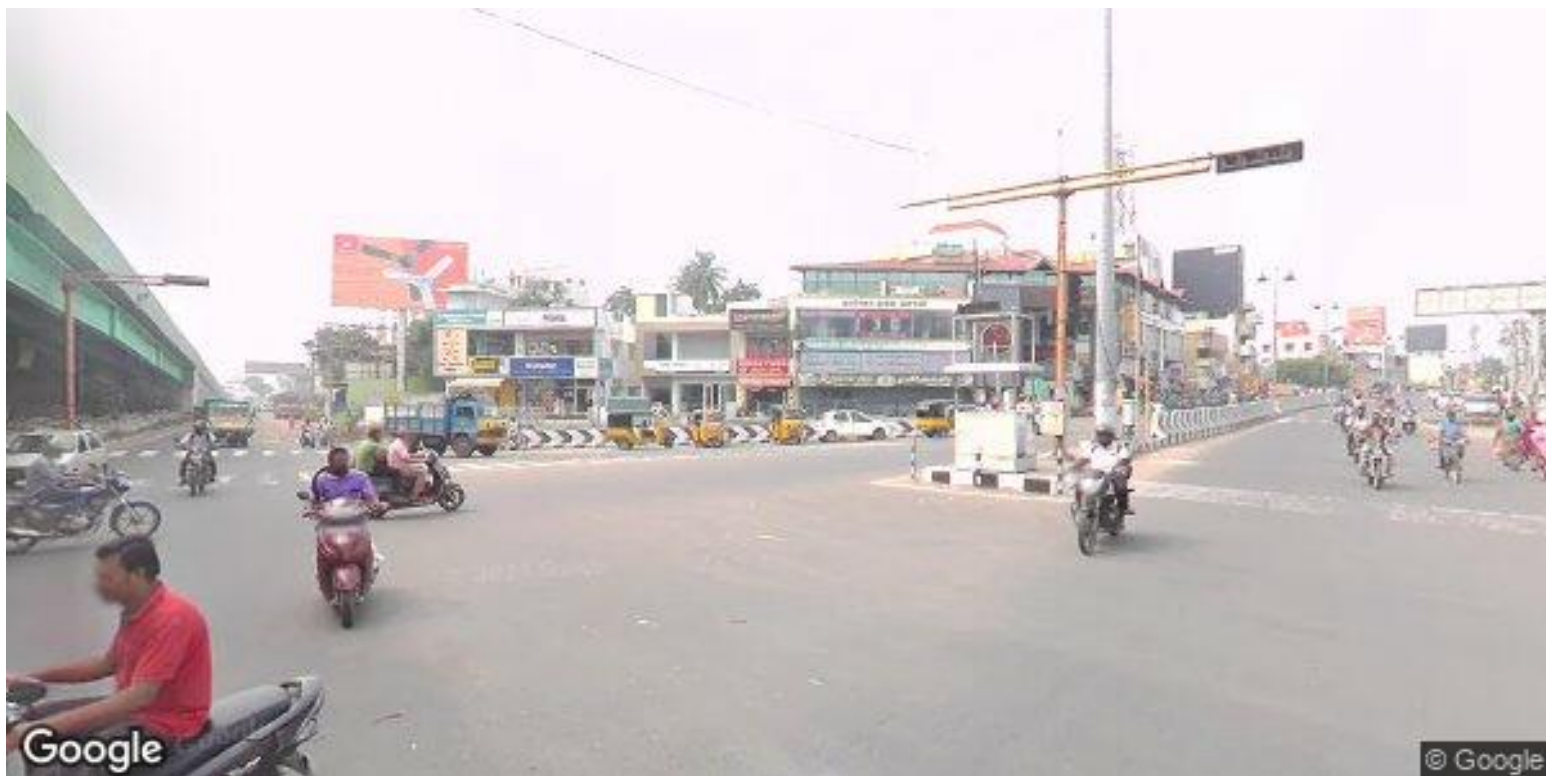
**Coordinates:** 11.66763, 78.12466

**Risk Type:** Turn

**Risk Level:** High

**Speed Limit:** 15 KM/Hr

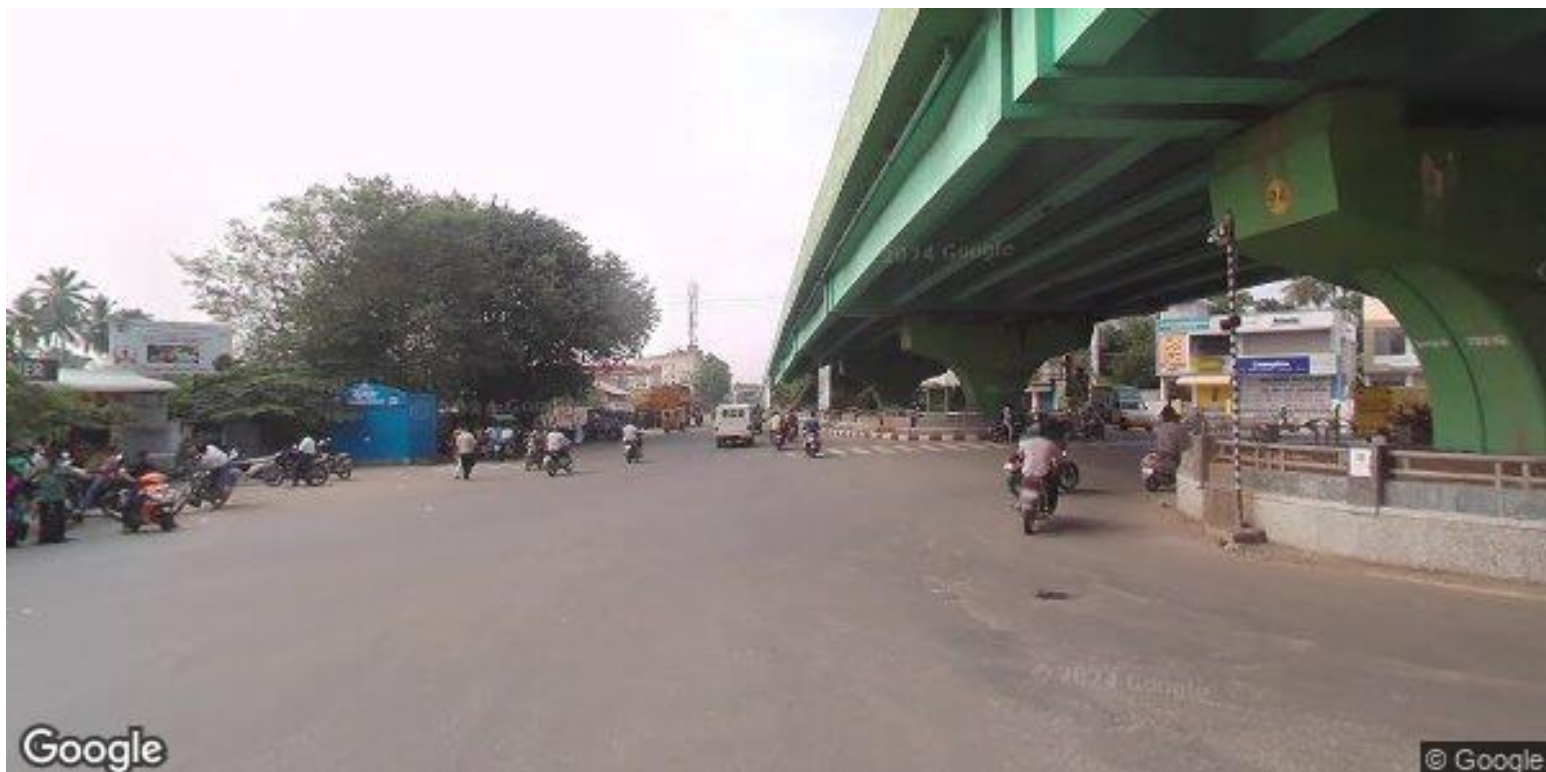
**Coordinates:** 11.66754, 78.12492

**Risk Type:** Turn

**Risk Level:** High

**Speed Limit:** 15 KM/Hr
