# IndianOil

## JOURNEY RISK MANAGEMENT (JRM) STUDY

### Salem Terminal TO SENGOTTAIYAN AGENCIES

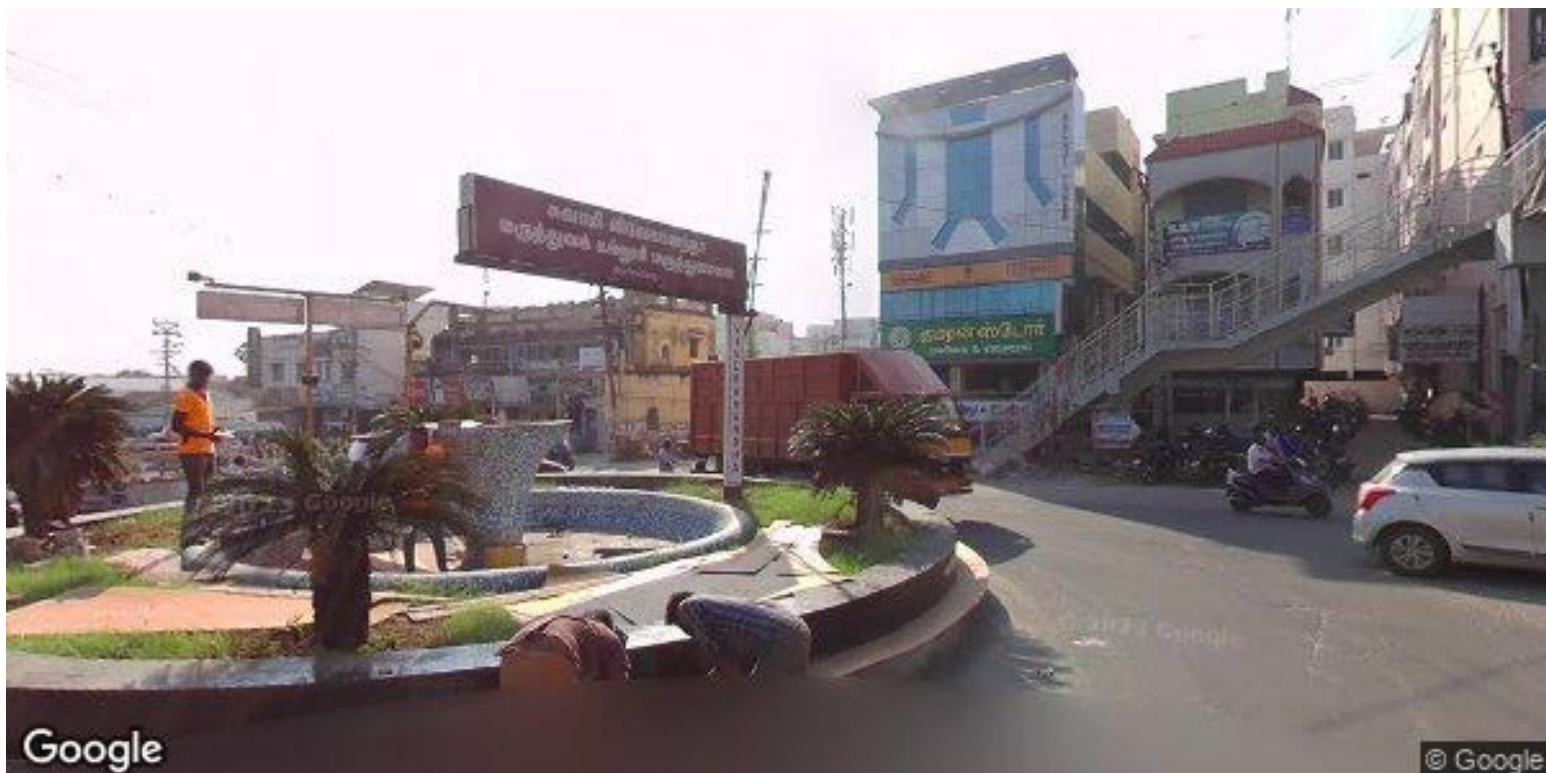
**Coordinates:** 11.38395, 77.89480

**Risk Type:** Roundabout

**Risk Level:** High

**Speed Limit:** 15 KM/Hr

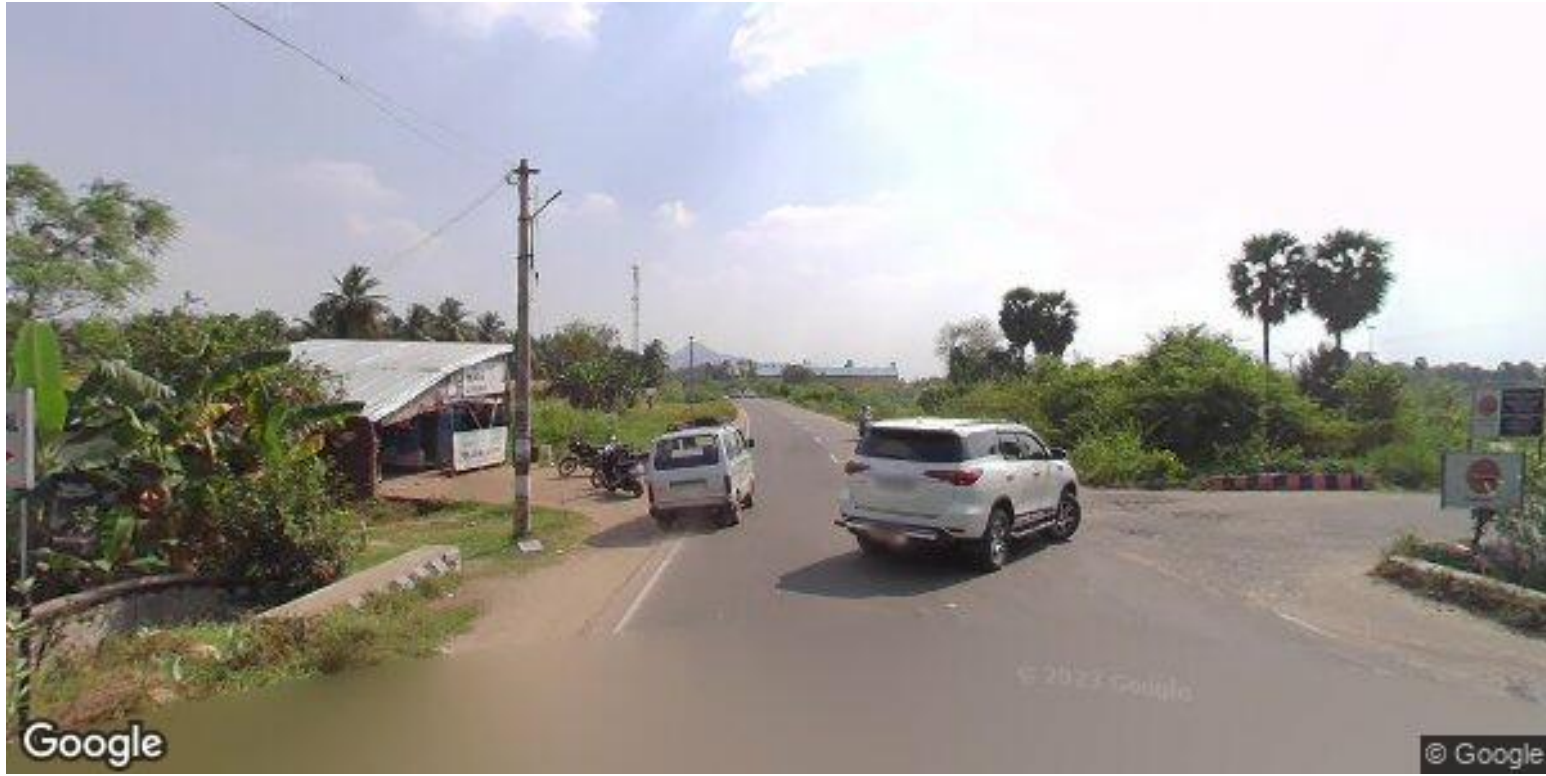
**Coordinates:** 11.44029, 77.87544

**Risk Type:** Blind Spot

**Risk Level:** Blind Spot

**Speed Limit:** 10 KM/Hr

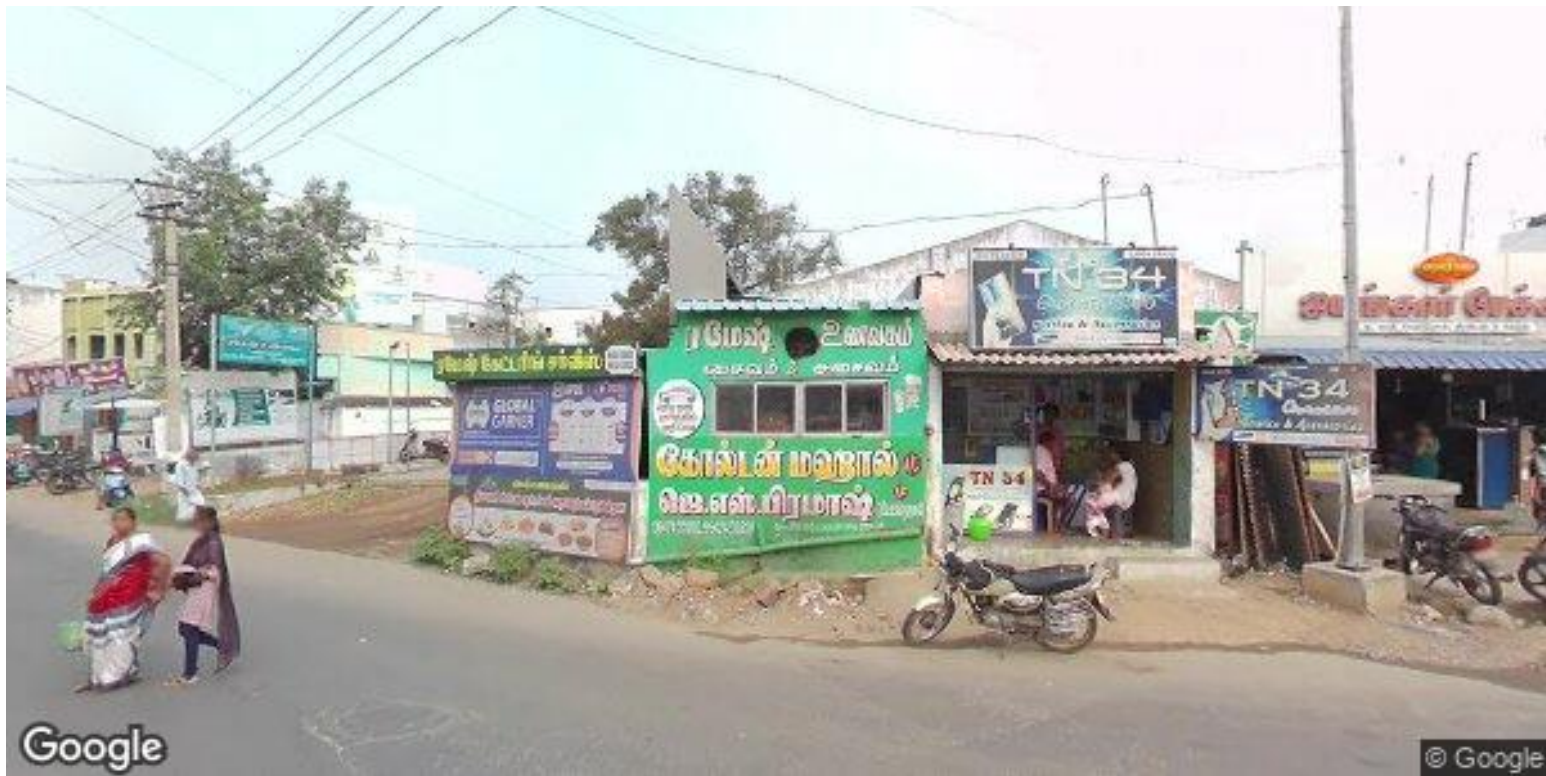
**Coordinates:** 11.38346, 77.89975

**Risk Type:** Turn

**Risk Level:** Medium

**Speed Limit:** 30 KM/Hr

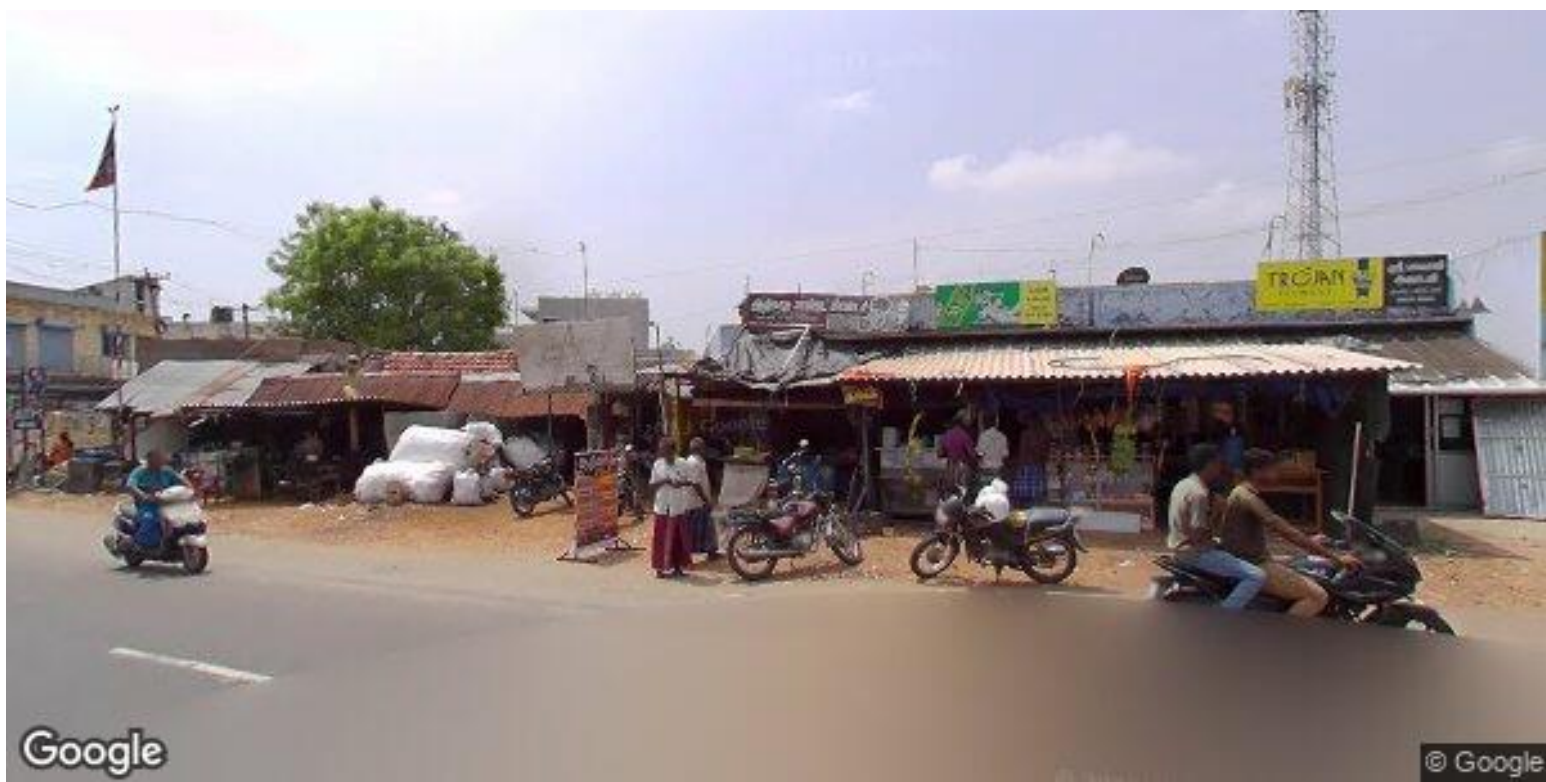
**Coordinates:** 11.44387, 77.96283

**Risk Type:** Blind Spot

**Risk Level:** Blind Spot

**Speed Limit:** 10 KM/Hr

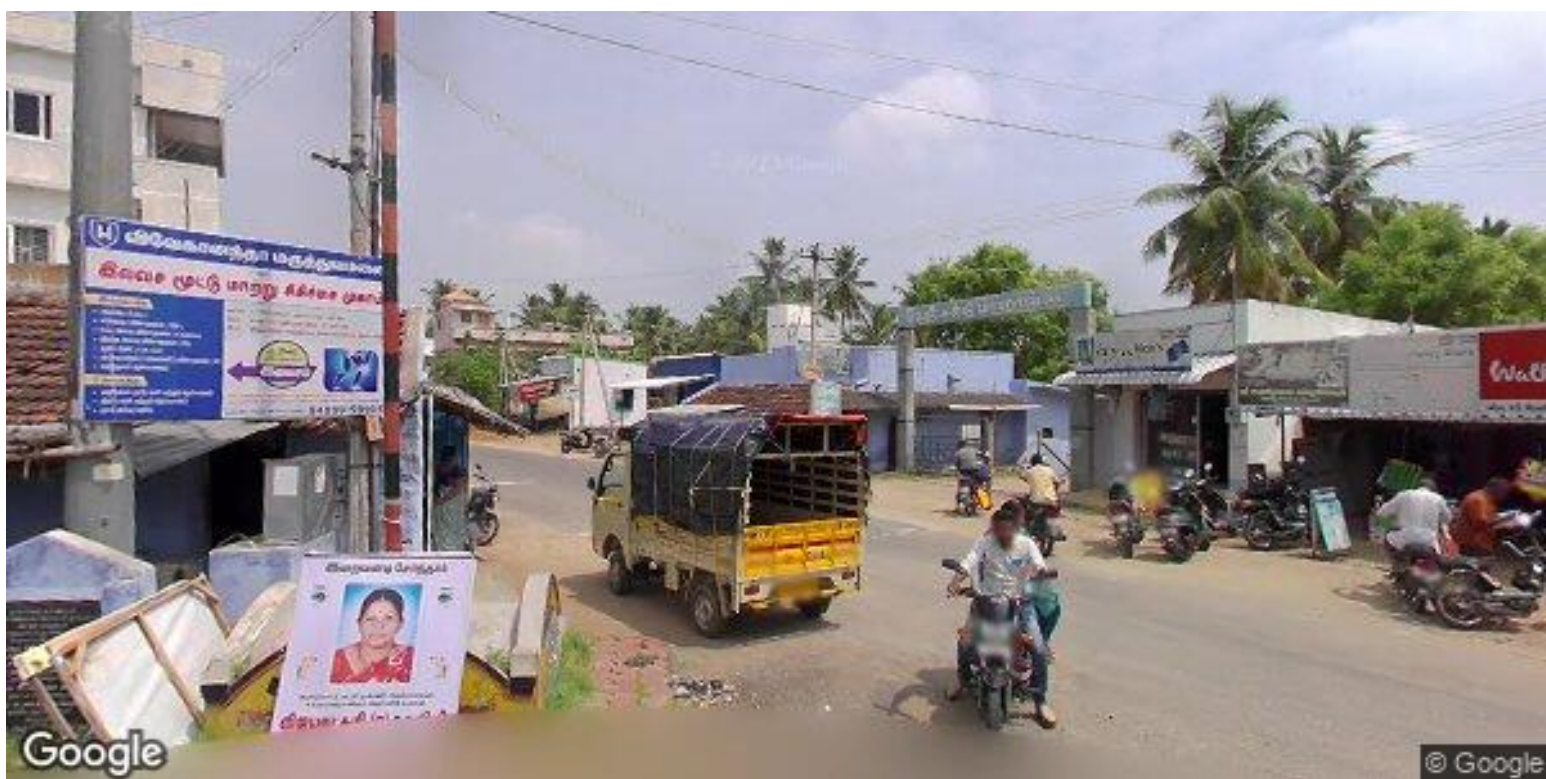
**Coordinates:** 11.44391, 77.96278

**Risk Type:** Blind Spot

**Risk Level:** Blind Spot

**Speed Limit:** 10 KM/Hr
