## JOURNEY RISK MANAGEMENT (JRM) STUDY

### Salem Terminal to PALANI VELAYUDAM TRADERS

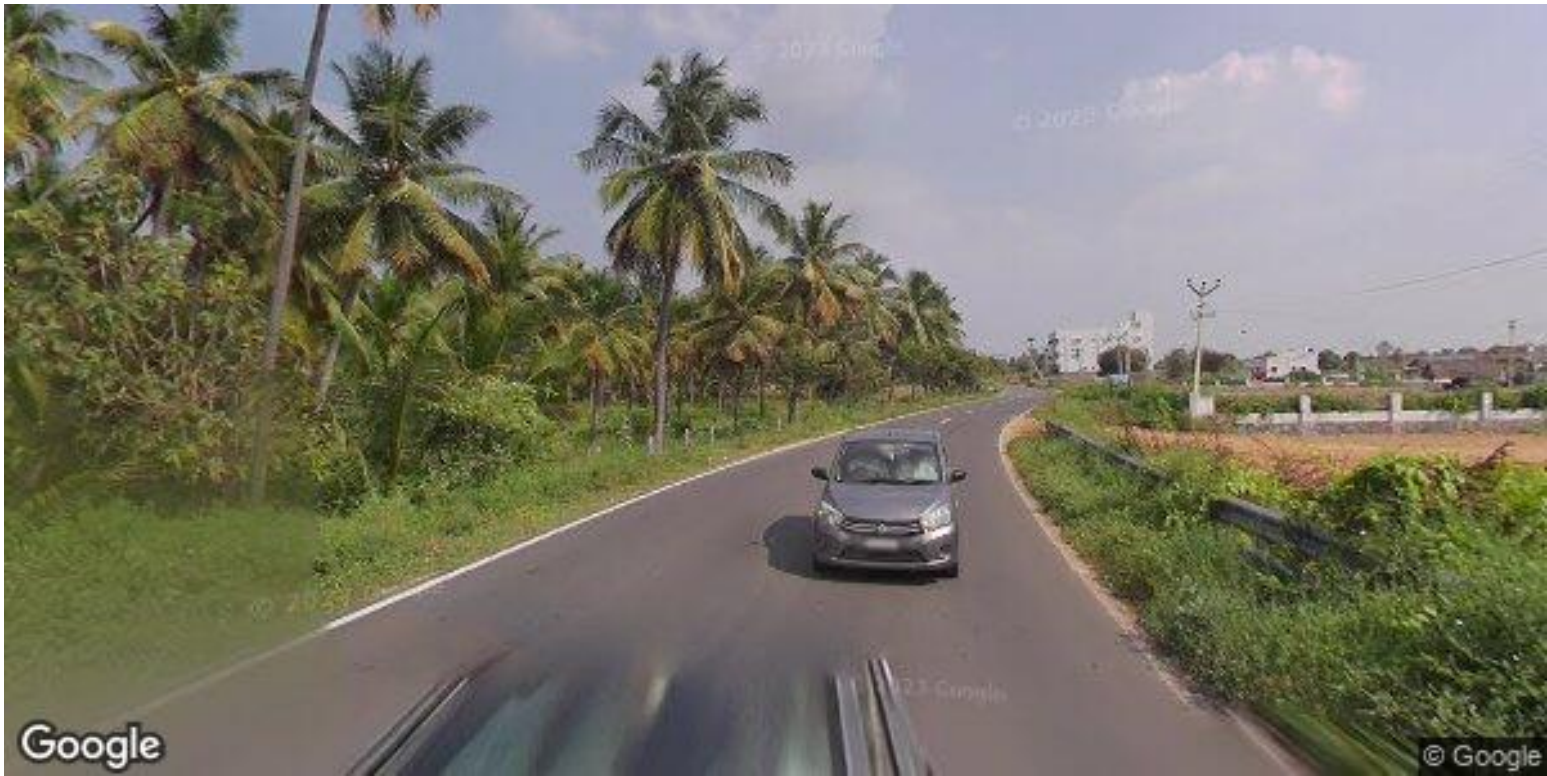
**Risk Type:** Turn  
**Risk Level:** Medium  
**Speed Limit:** 30 KM/Hr  
**Coordinates:** 11.45357, 77.85789

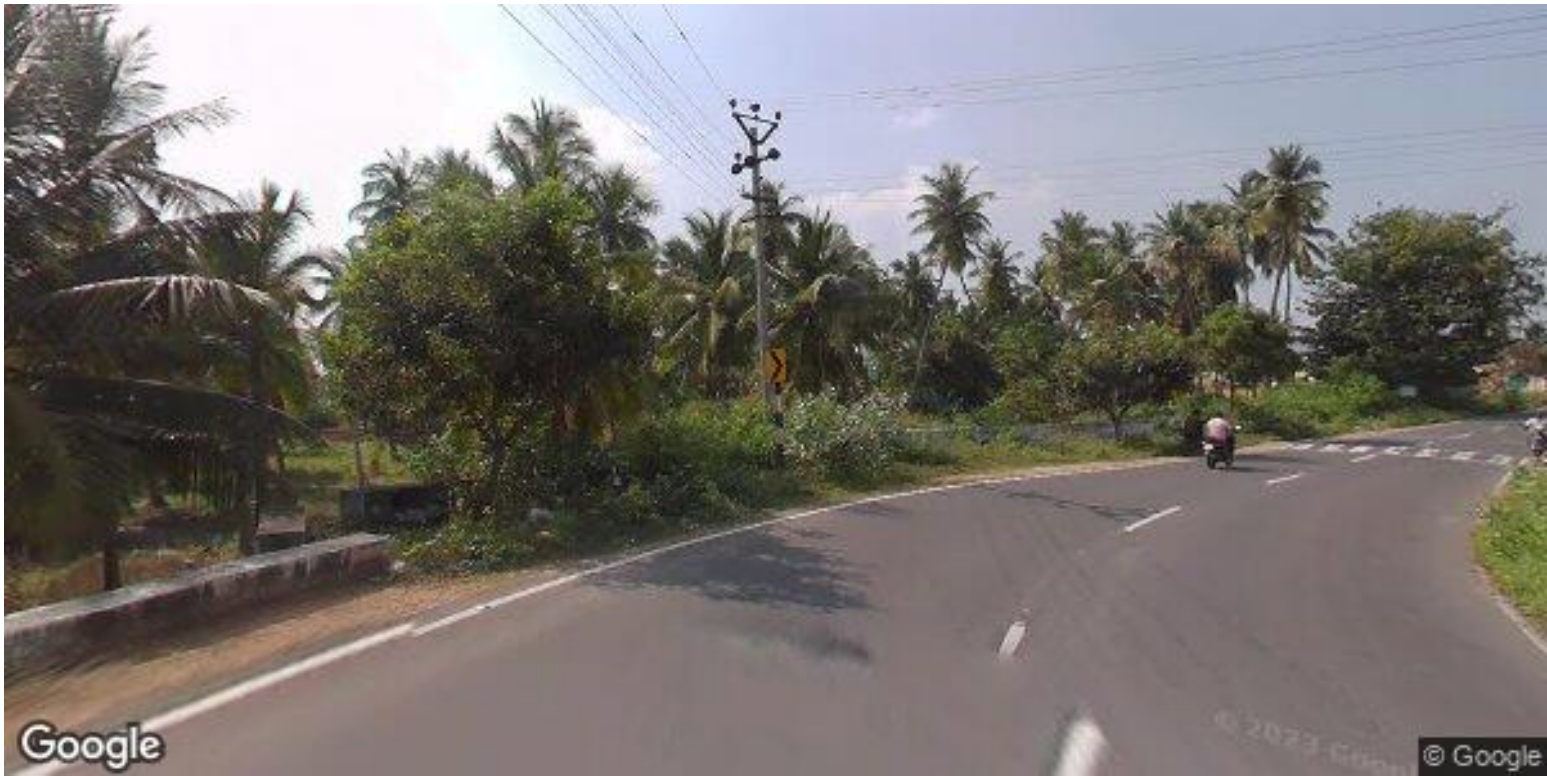
**Risk Type:** Turn  
**Risk Level:** Medium  
**Speed Limit:** 30 KM/Hr  
**Coordinates:** 11.45348, 77.85706

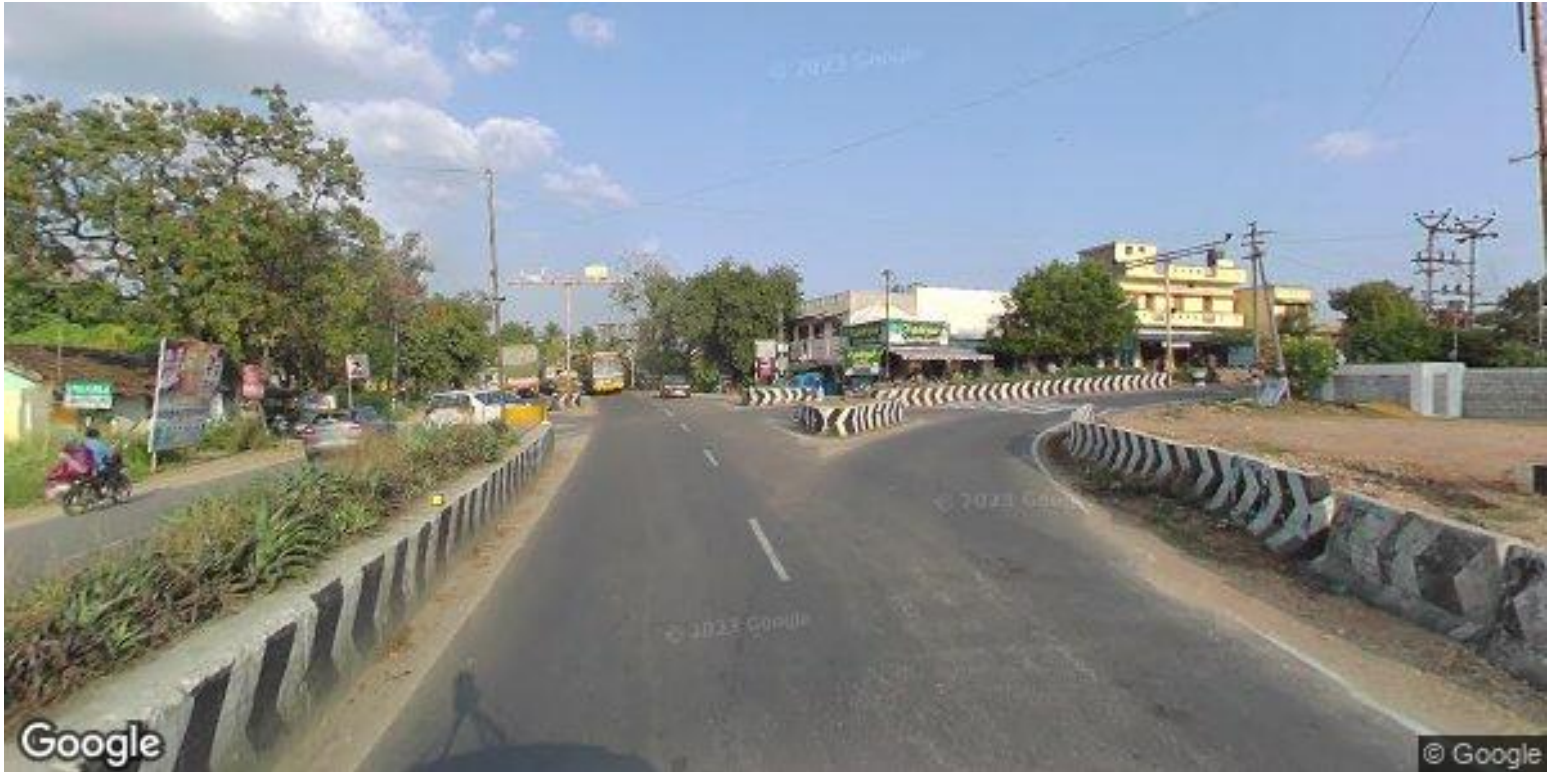
**Risk Type:** Turn  
**Risk Level:** Medium  
**Speed Limit:** 30 KM/Hr  
**Coordinates:** 11.46318, 77.84913

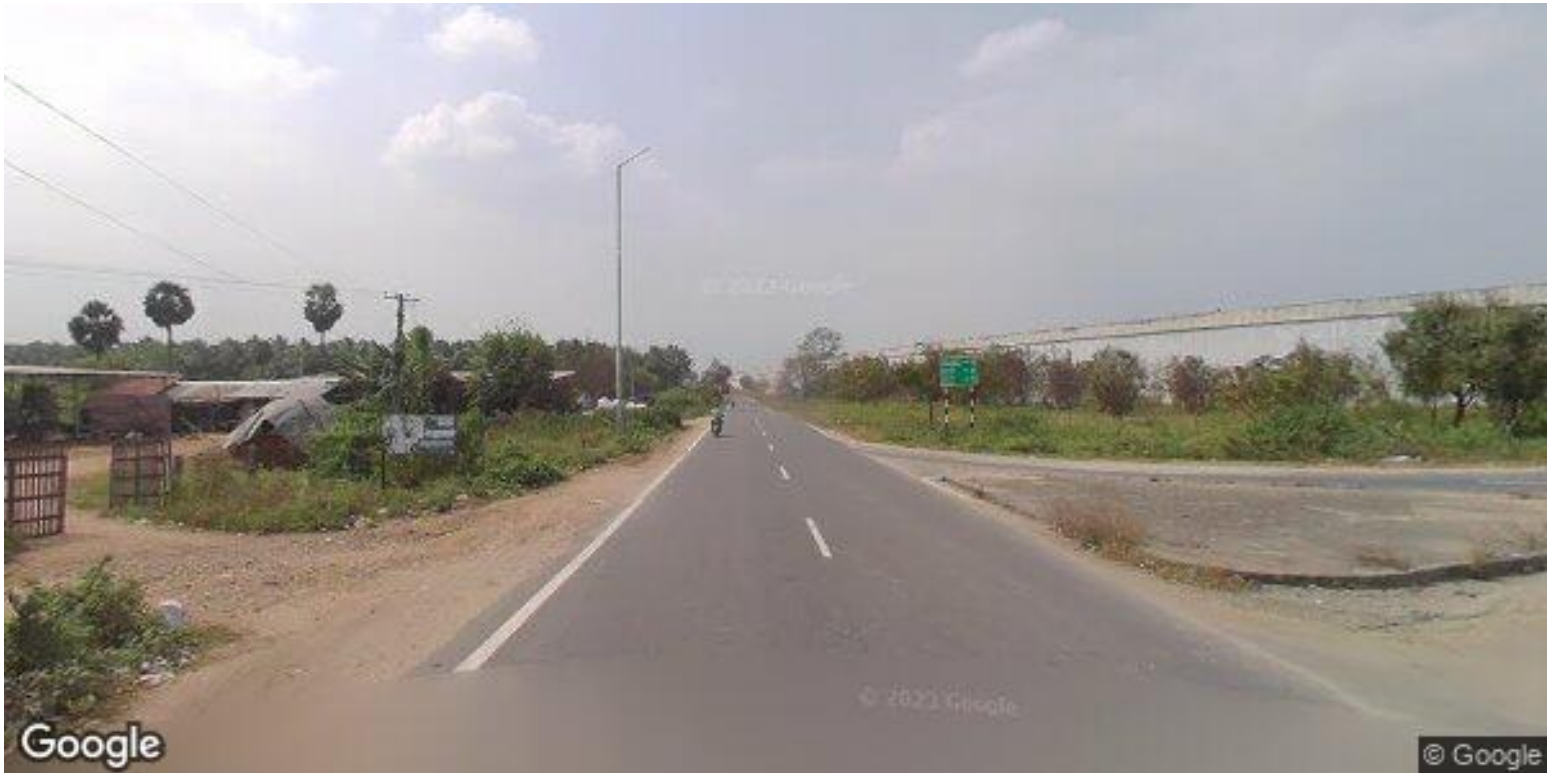
**Risk Type:** Turn  
**Risk Level:** High  
**Speed Limit:** 15 KM/Hr  
**Coordinates:** 11.45542, 77.81725

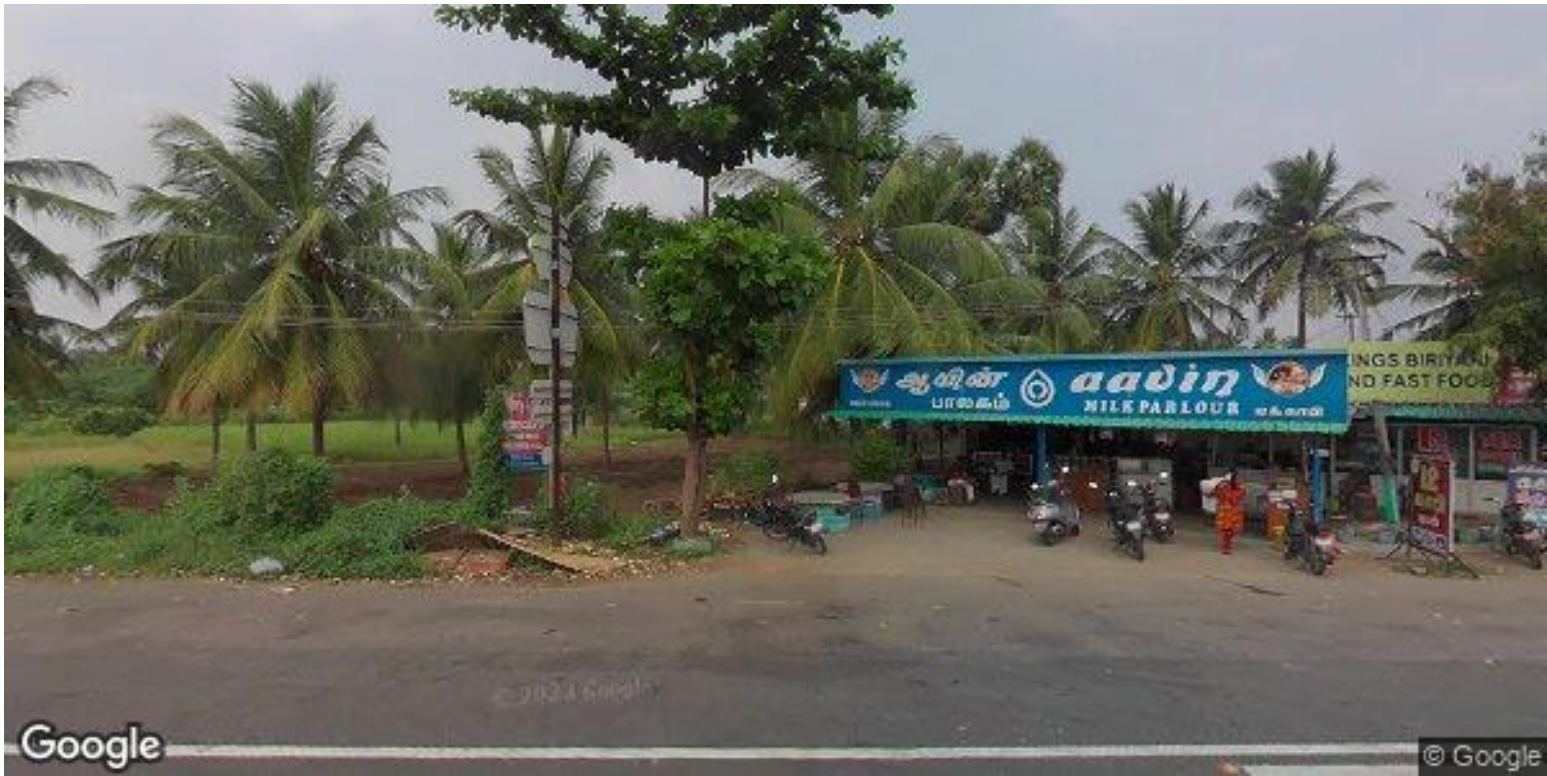
**Risk Type:** Turn  
**Risk Level:** High  
**Speed Limit:** 15 KM/Hr  
**Coordinates:** 11.45631, 77.81668

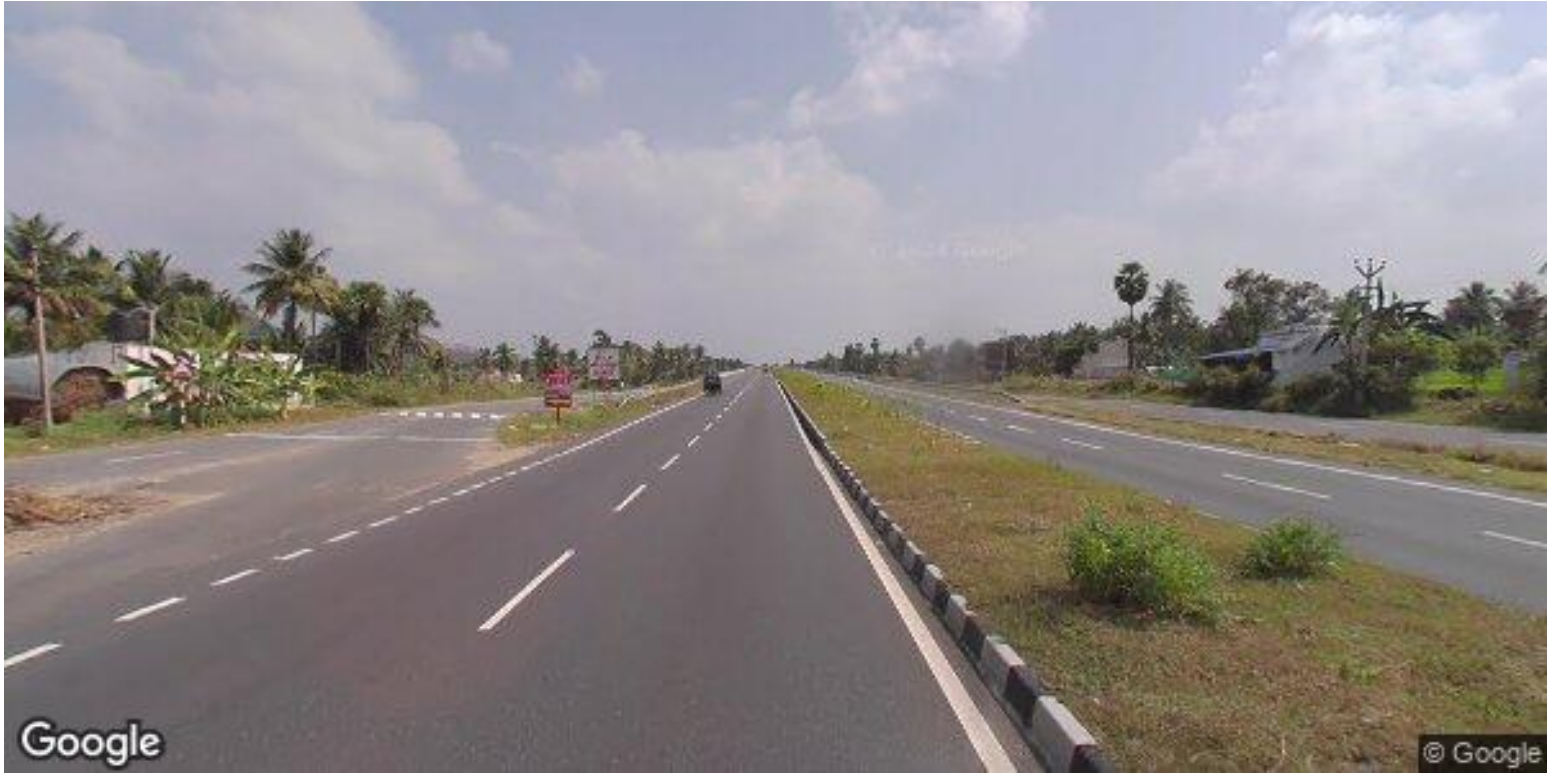
**Risk Type:** Turn  
**Risk Level:** Medium  
**Speed Limit:** 30 KM/Hr  
**Coordinates:** 11.49249, 77.85820

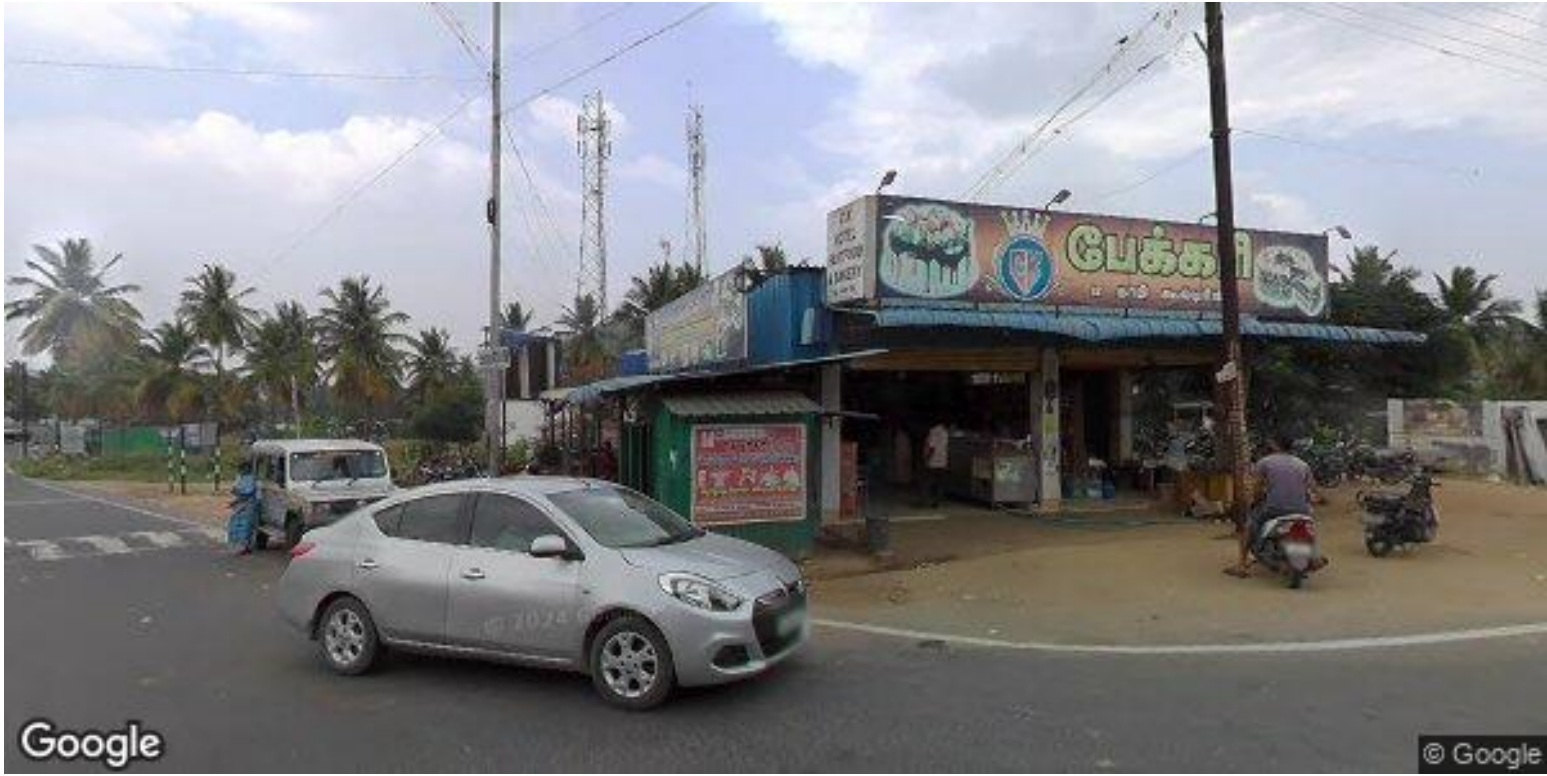
**Risk Type:** Blind Spot  
**Risk Level:** Blind Spot  
**Speed Limit:** 10 KM/Hr  
**Coordinates:** 11.49390, 77.86748

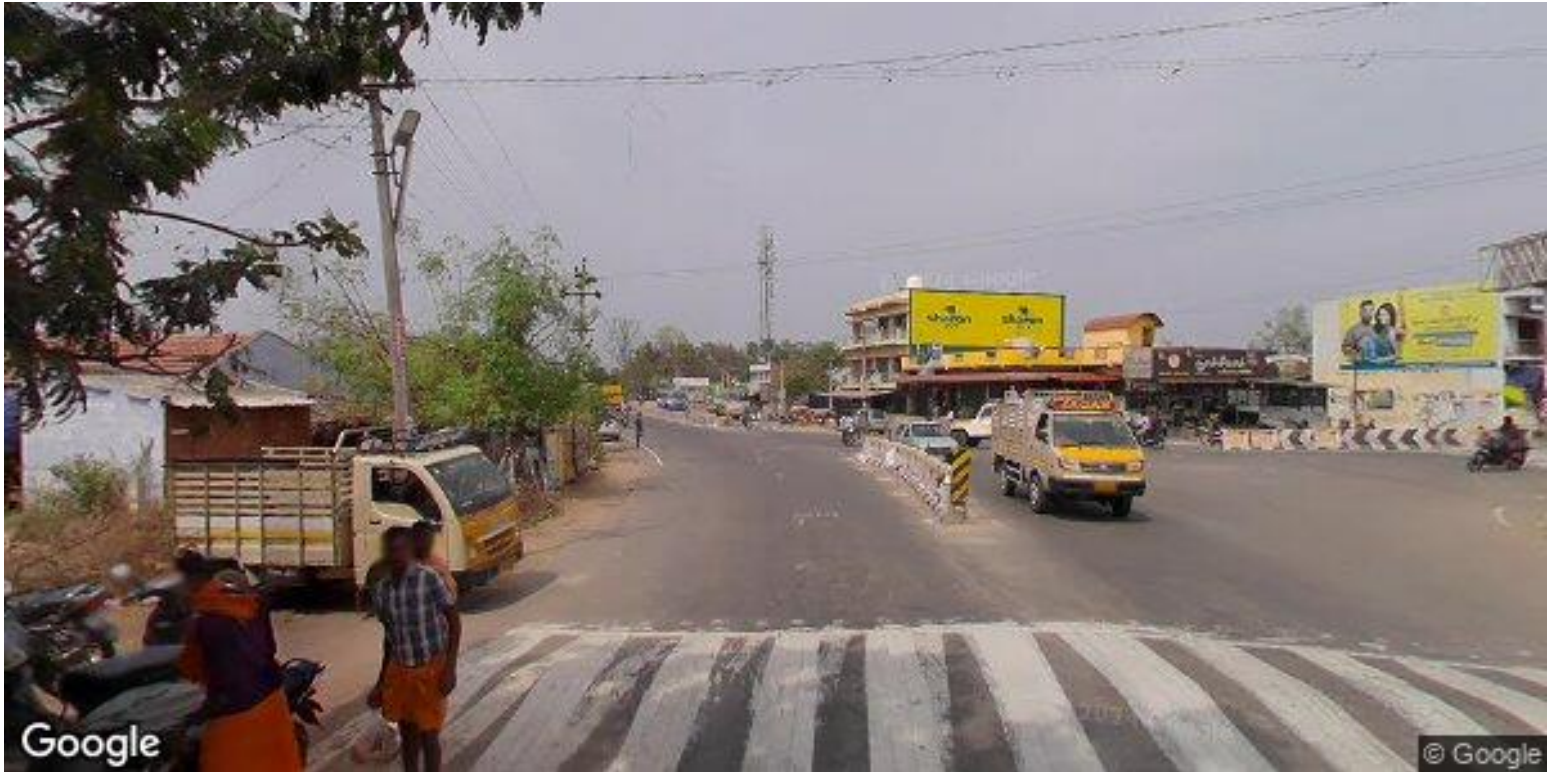
**Risk Type:** Turn  
**Risk Level:** Medium  
**Speed Limit:** 30 KM/Hr  
**Coordinates:** 11.58296, 77.85419

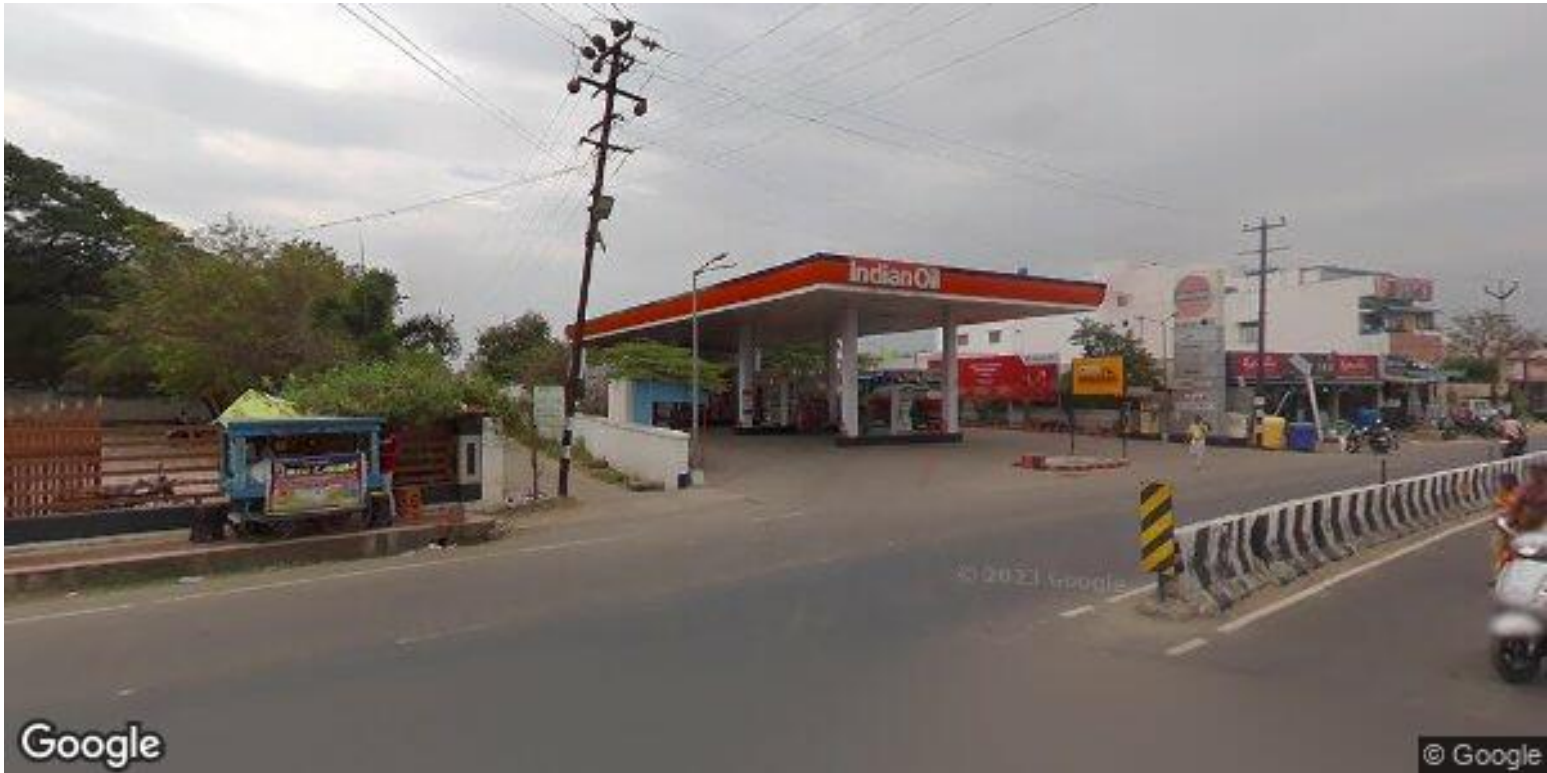
**Risk Type:** Turn  
**Risk Level:** High  
**Speed Limit:** 15 KM/Hr  
**Coordinates:** 11.58516, 77.84187
