# IndianOil

## JOURNEY RISK MANAGEMENT (JRM) STUDY

### Salem Terminal to SRI KANNIMARA AGENCY

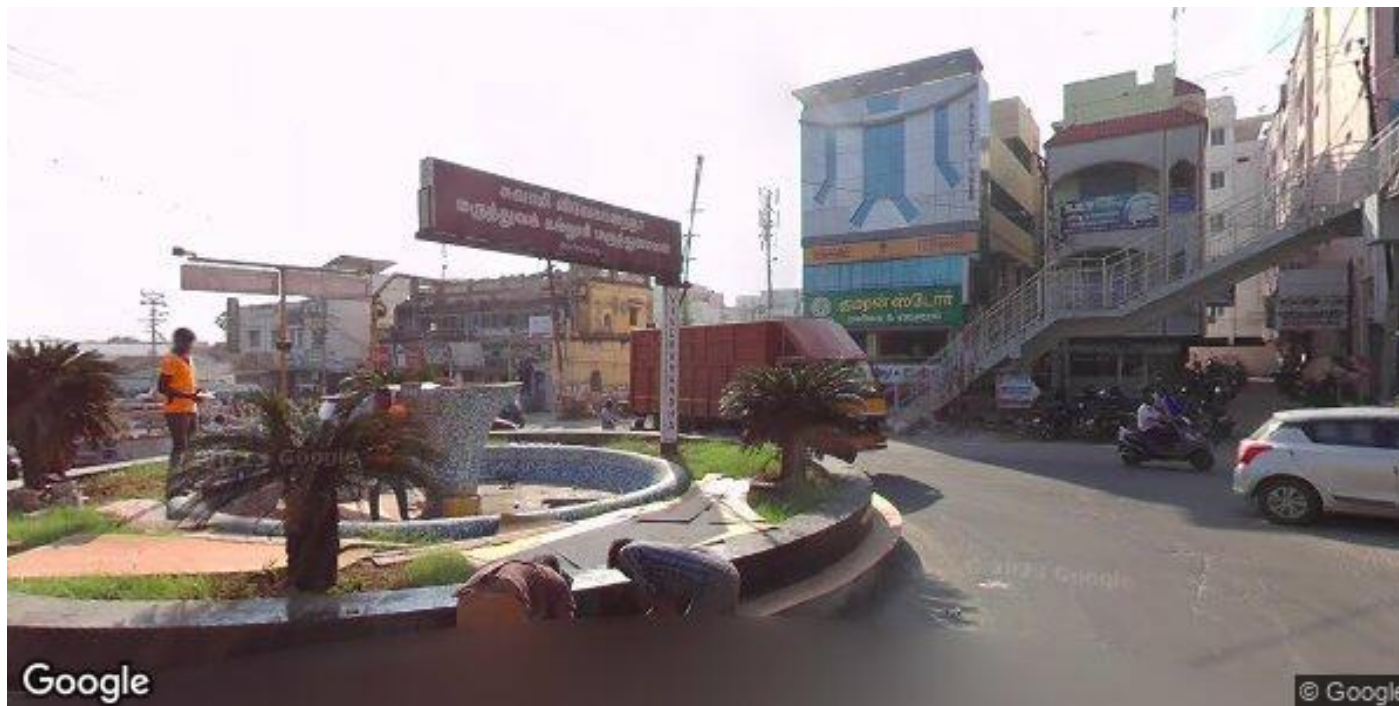
**Coordinates:** 11.38395, 77.89480

**Risk Type:** Roundabout

**Risk Level:** High

**Speed Limit:** 15 KM/Hr

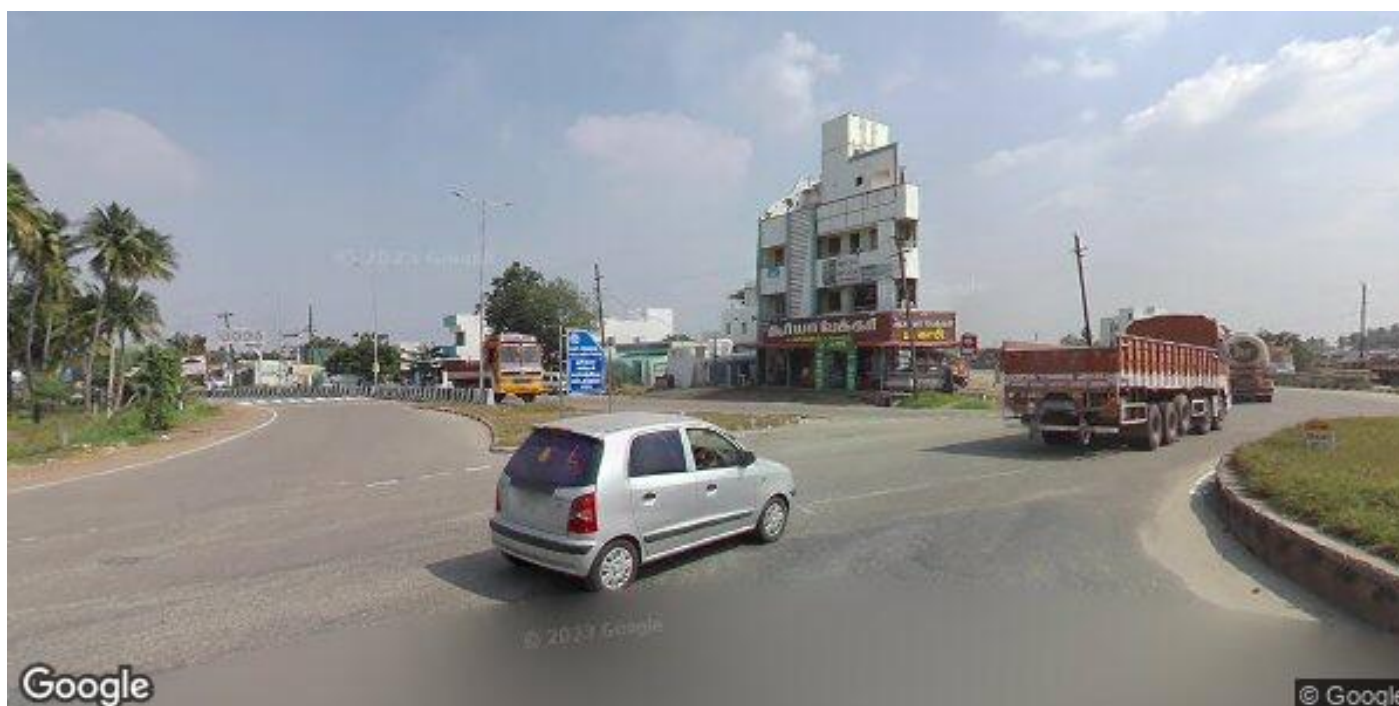
**Coordinates:** 10.92958, 78.05452

**Risk Type:** Roundabout

**Risk Level:** High

**Speed Limit:** 15 KM/Hr

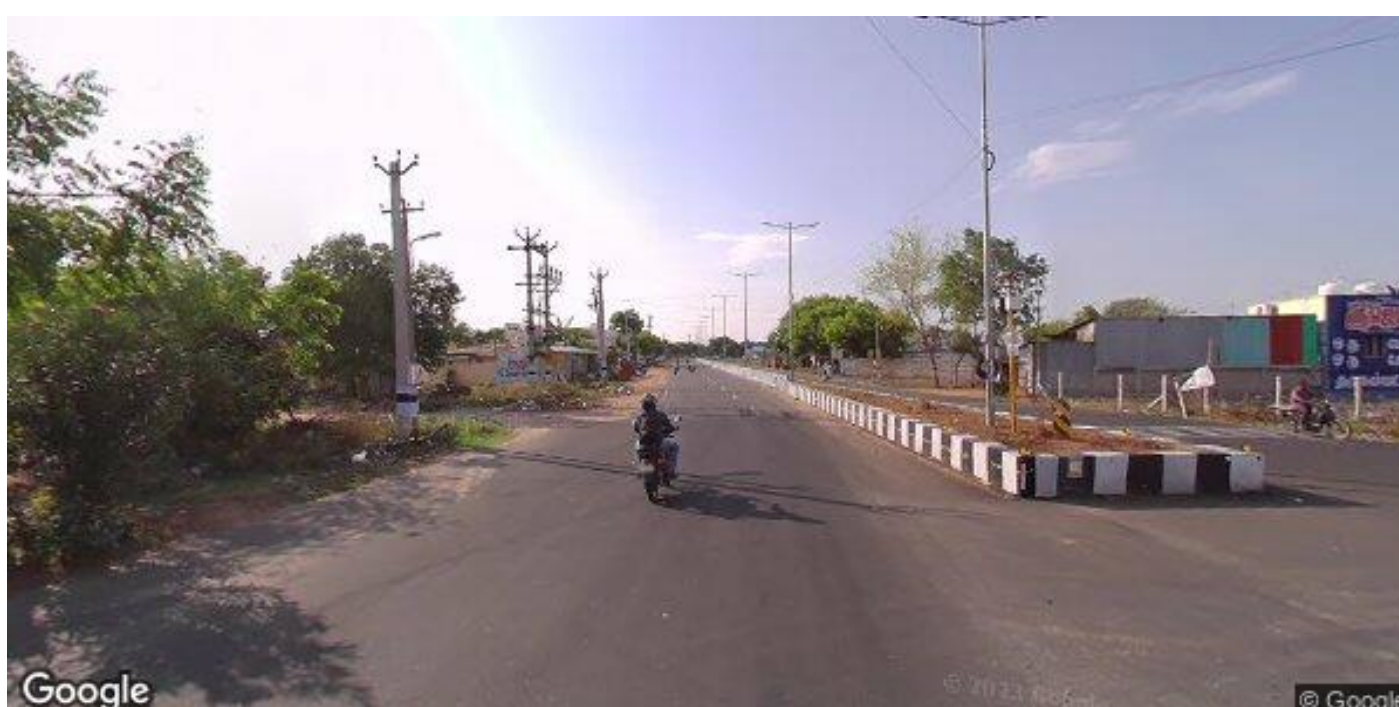
**Coordinates: 10.9110477, 78.09713769999999**

**Risk Type:** U-Turn

**Risk Level:** High

**Speed Limit: 10 KM/Hr**

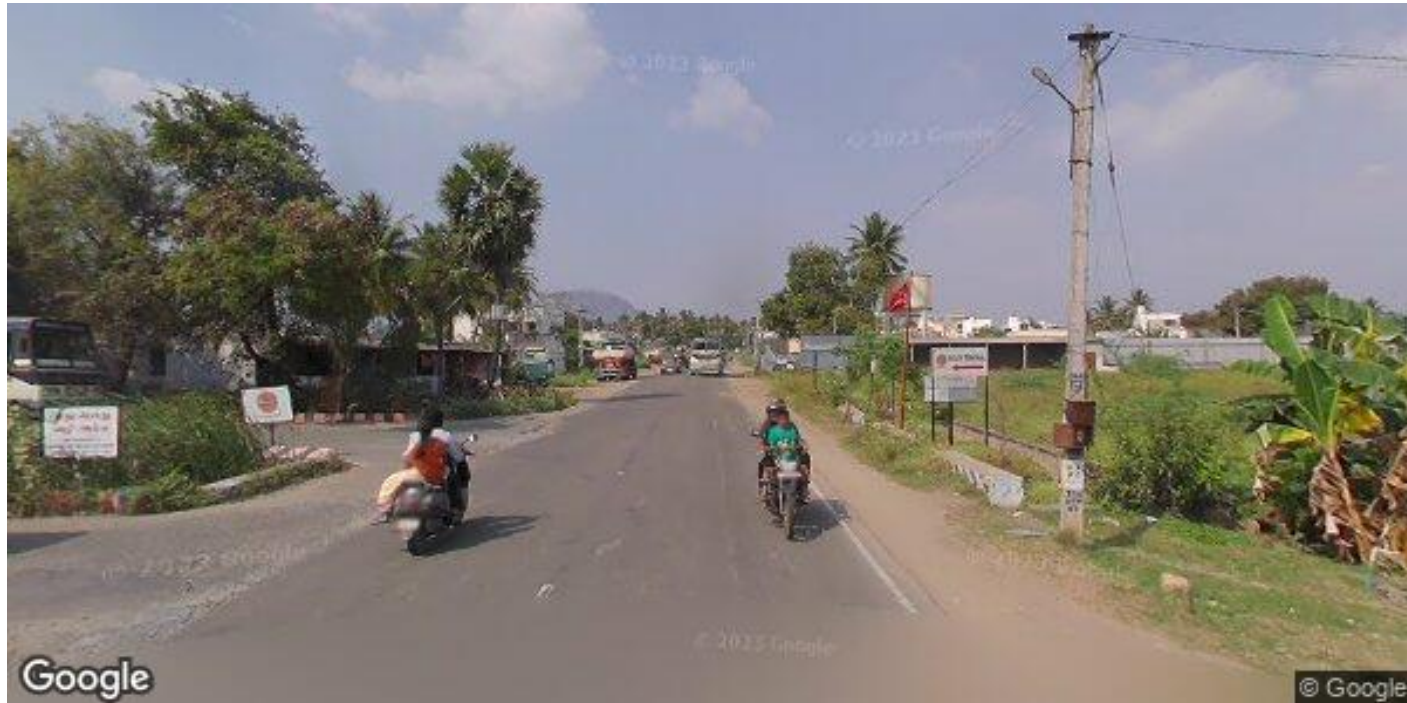
**Coordinates: 11.44019, 77.87547**

**Risk Type: Turn**

**Risk Level: High**

**Speed Limit: 15 KM/Hr**

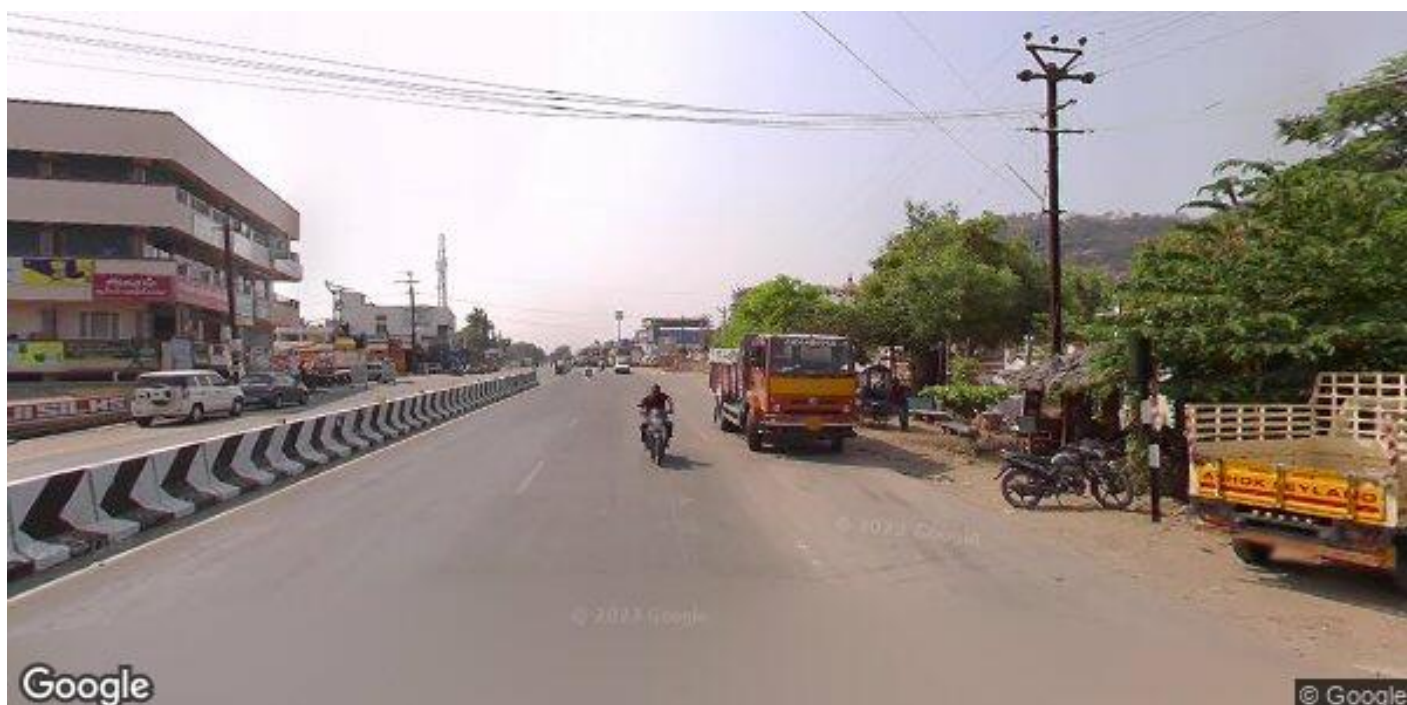
**Coordinates: 11.39685, 77.88861**

**Risk Type: Turn**

**Risk Level: Medium**

**Speed Limit: 30 KM/Hr**

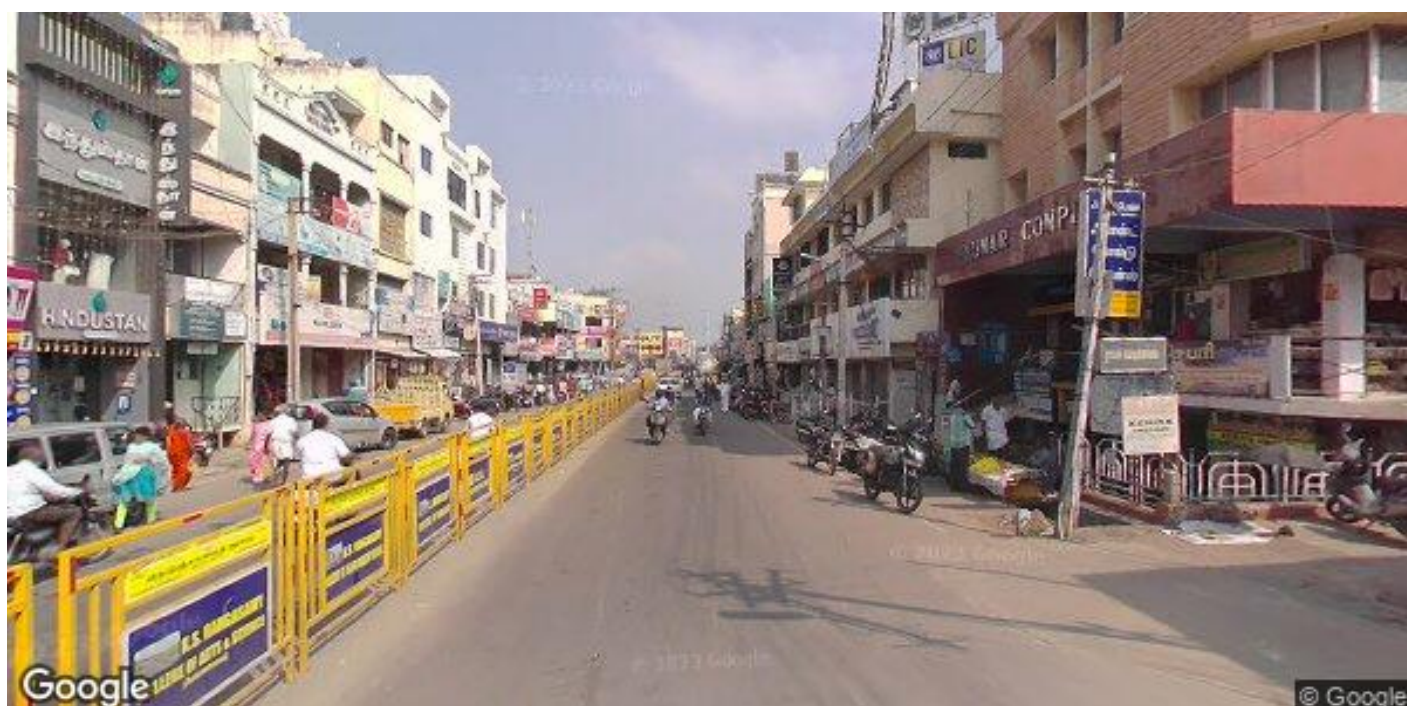
**Risk Type:** Turn  
**Risk Level:** Medium  
**Speed Limit:** 30 KM/Hr  
**Coordinates:** 11.37902, 77.89500

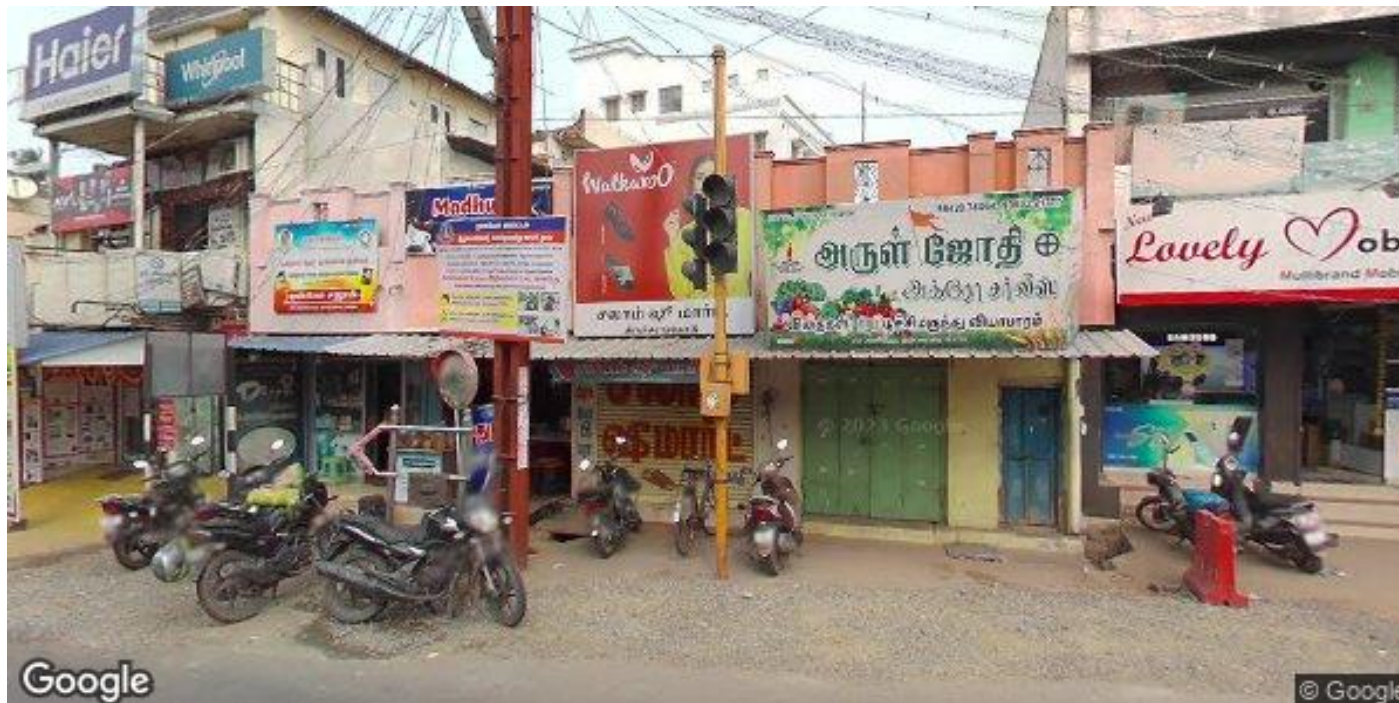
**Risk Type:** Turn  
**Risk Level:** Medium  
**Speed Limit:** 30 KM/Hr  
**Coordinates:** 11.37850, 77.89453

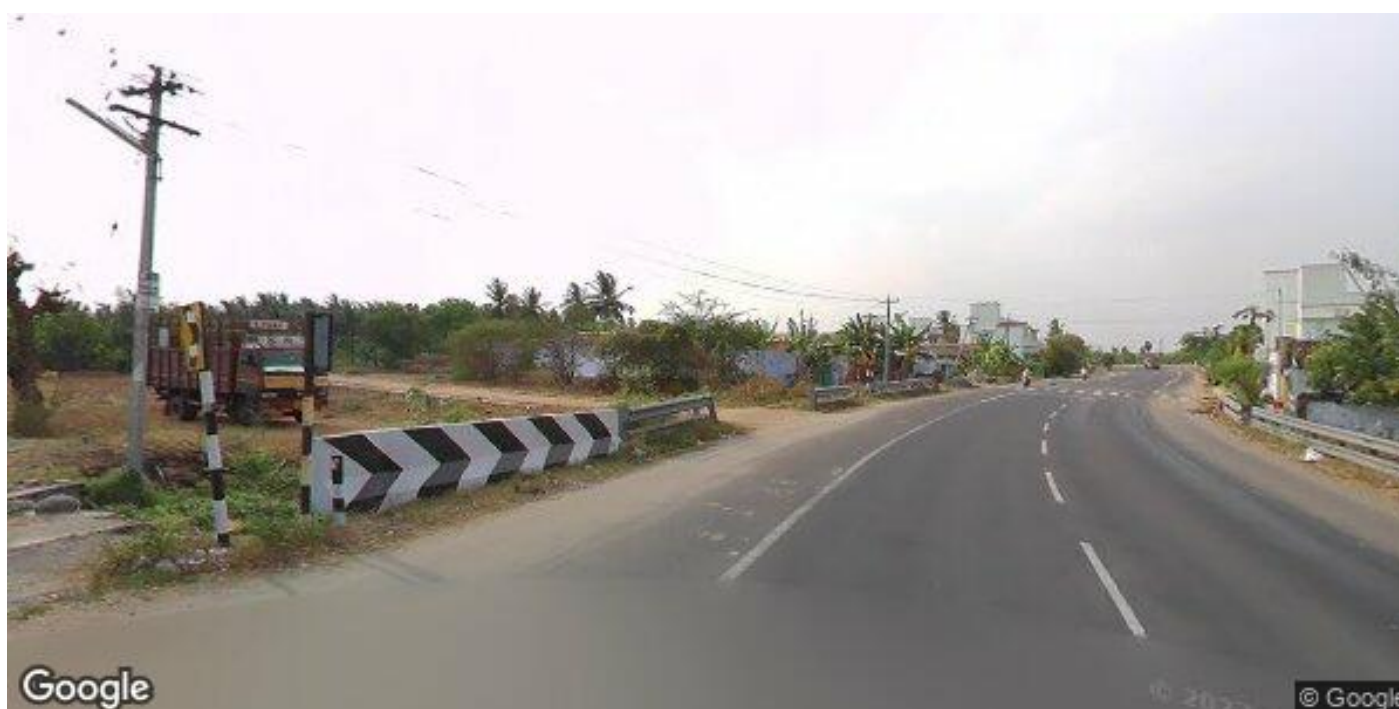
**Risk Type:** Turn  
**Risk Level:** Medium  
**Speed Limit:** 30 KM/Hr  
**Coordinates:** 11.16755, 78.01568

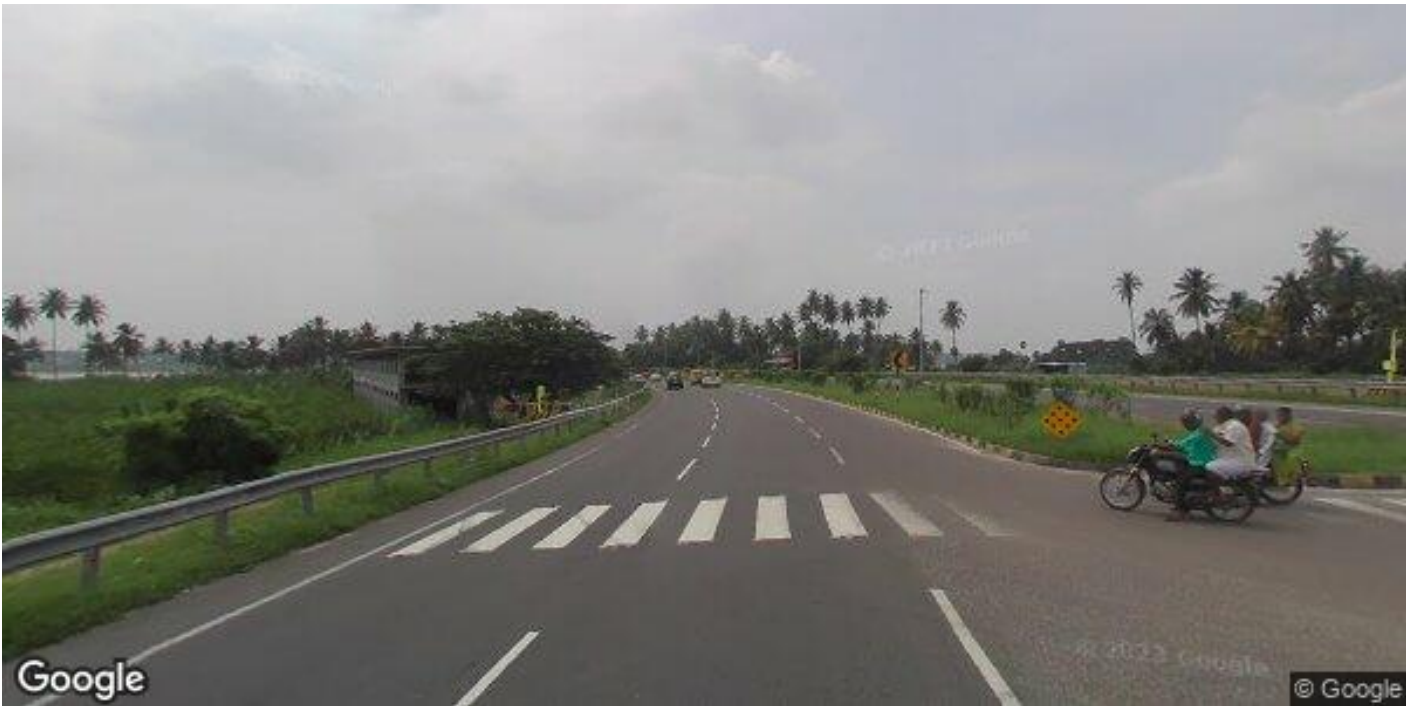
**Risk Type:** Turn  
**Risk Level:** Medium  
**Speed Limit:** 30 KM/Hr  
**Coordinates:** 11.10084, 78.00555

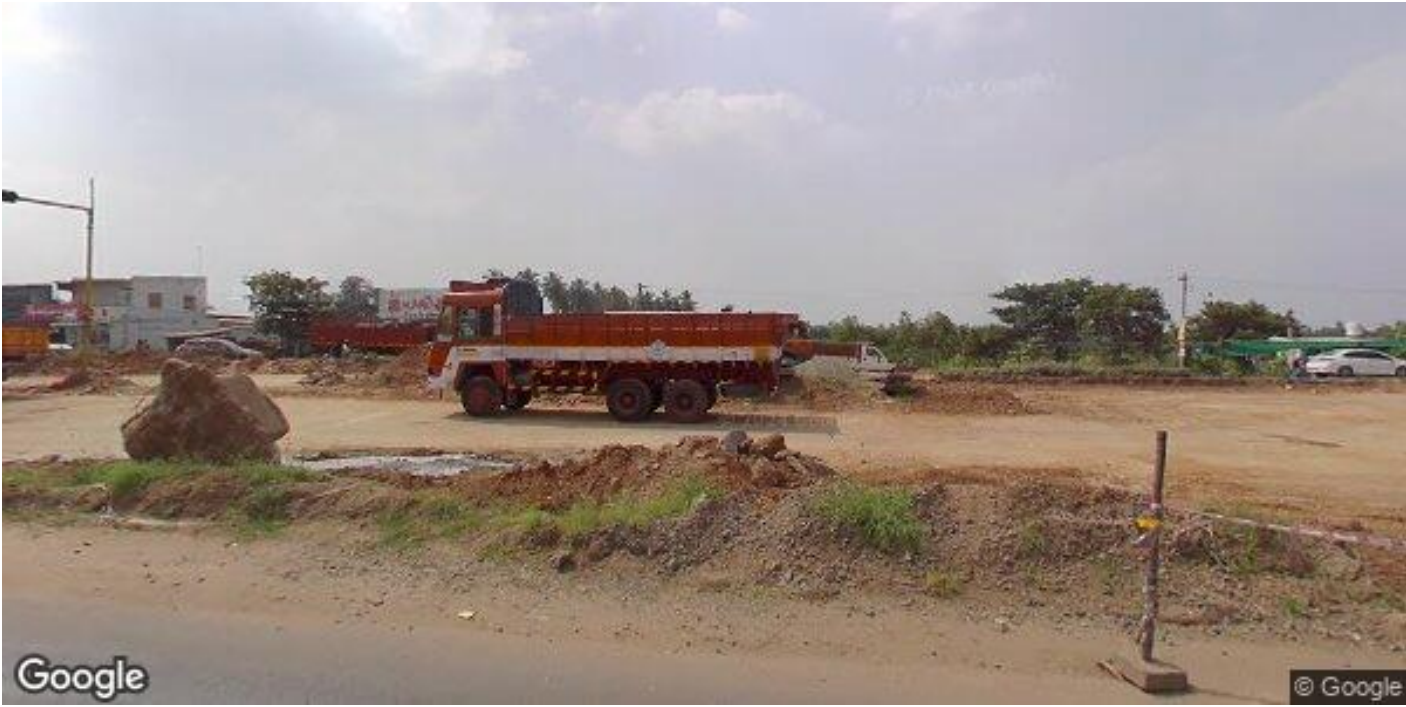
**Risk Type:** Turn  
**Risk Level:** Medium  
**Speed Limit:** 30 KM/Hr  
**Coordinates:** 11.08280, 78.00339

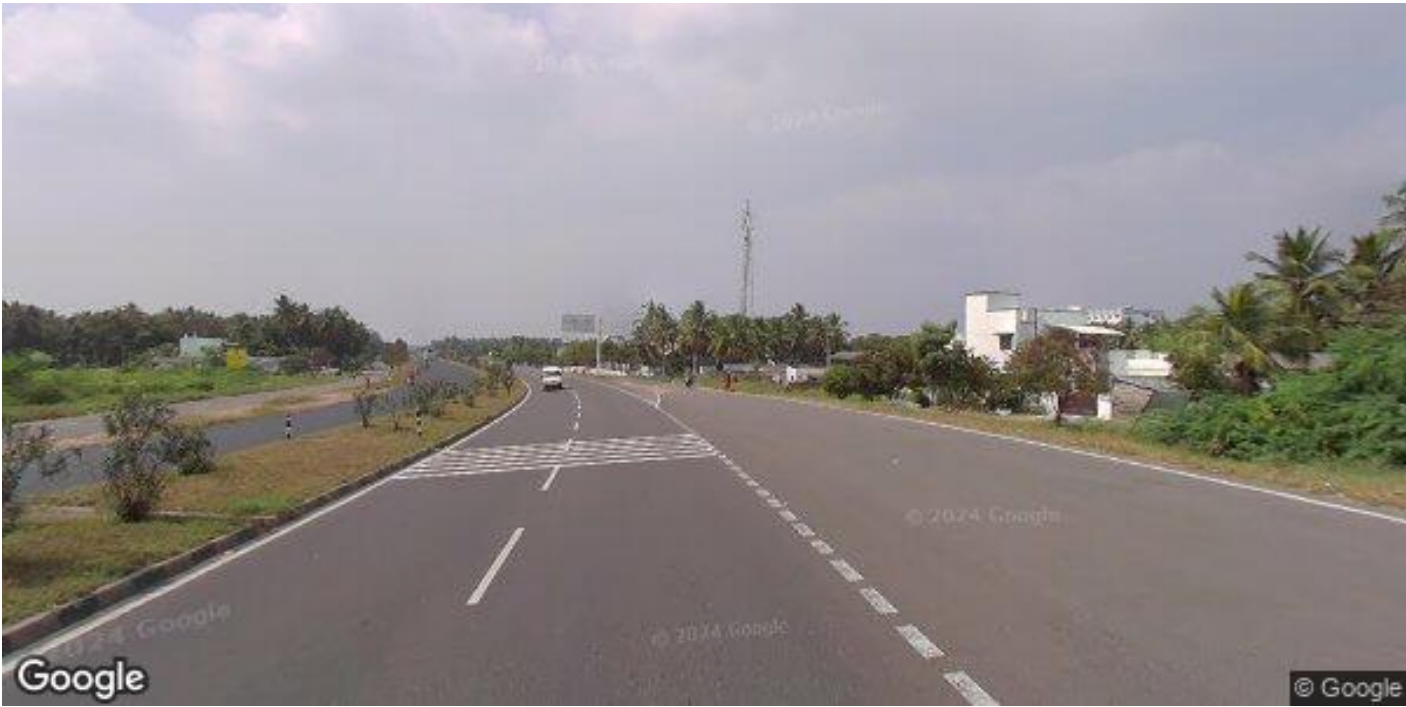
**Risk Type:** Turn  
**Risk Level:** Medium  
**Speed Limit:** 30 KM/Hr  
**Coordinates:** 11.05250, 78.05164

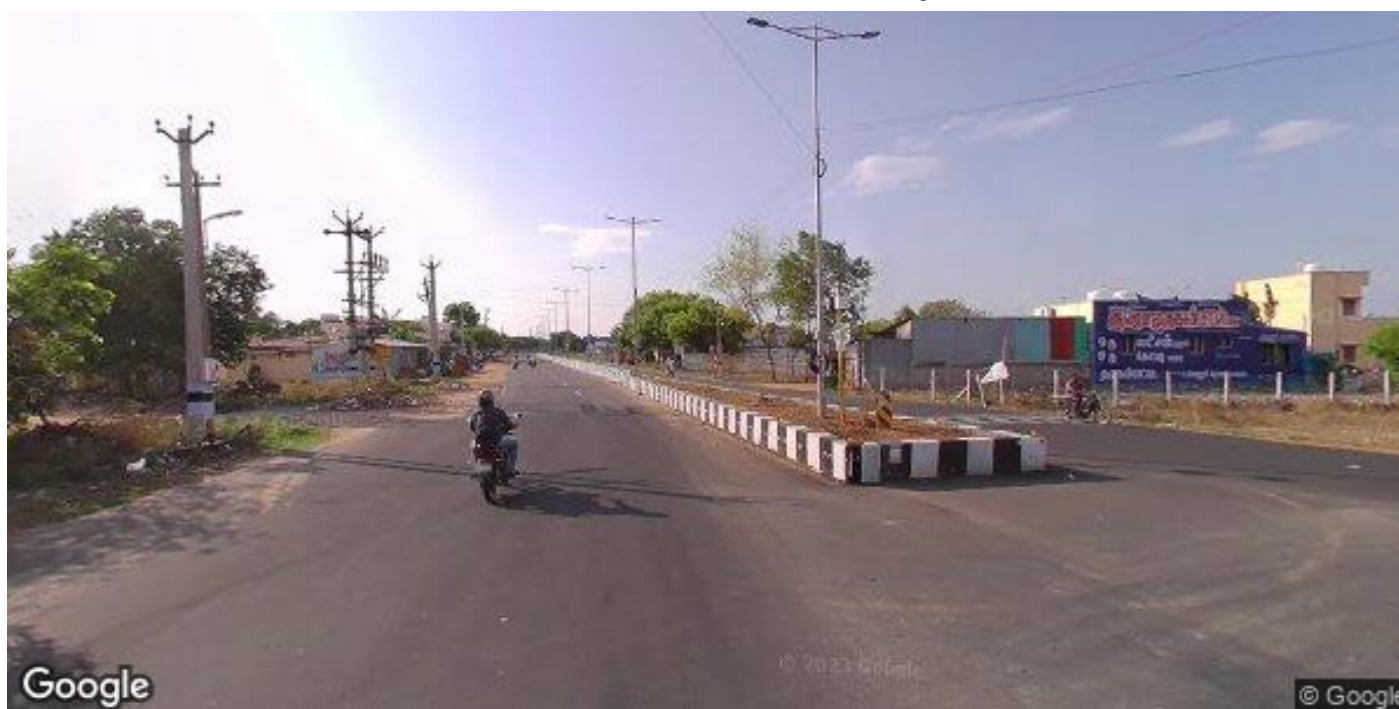
**Risk Type:** Blind Spot  
**Risk Level:** Blind Spot  
**Speed Limit:** 10 KM/Hr  
**Coordinates:** 10.91105, 78.09714

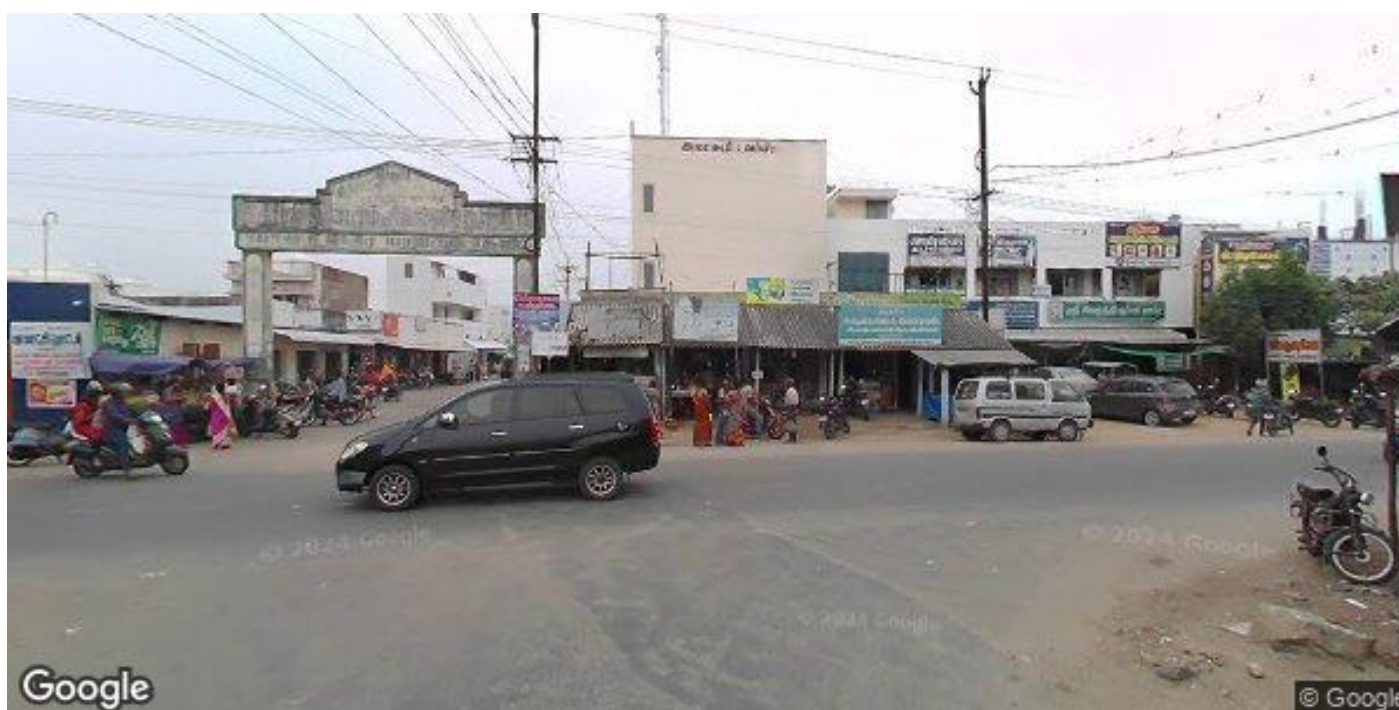
**Risk Type:** Turn  
**Risk Level:** High  
**Speed Limit:** 15 KM/Hr  
**Coordinates:** 10.84613, 78.12000

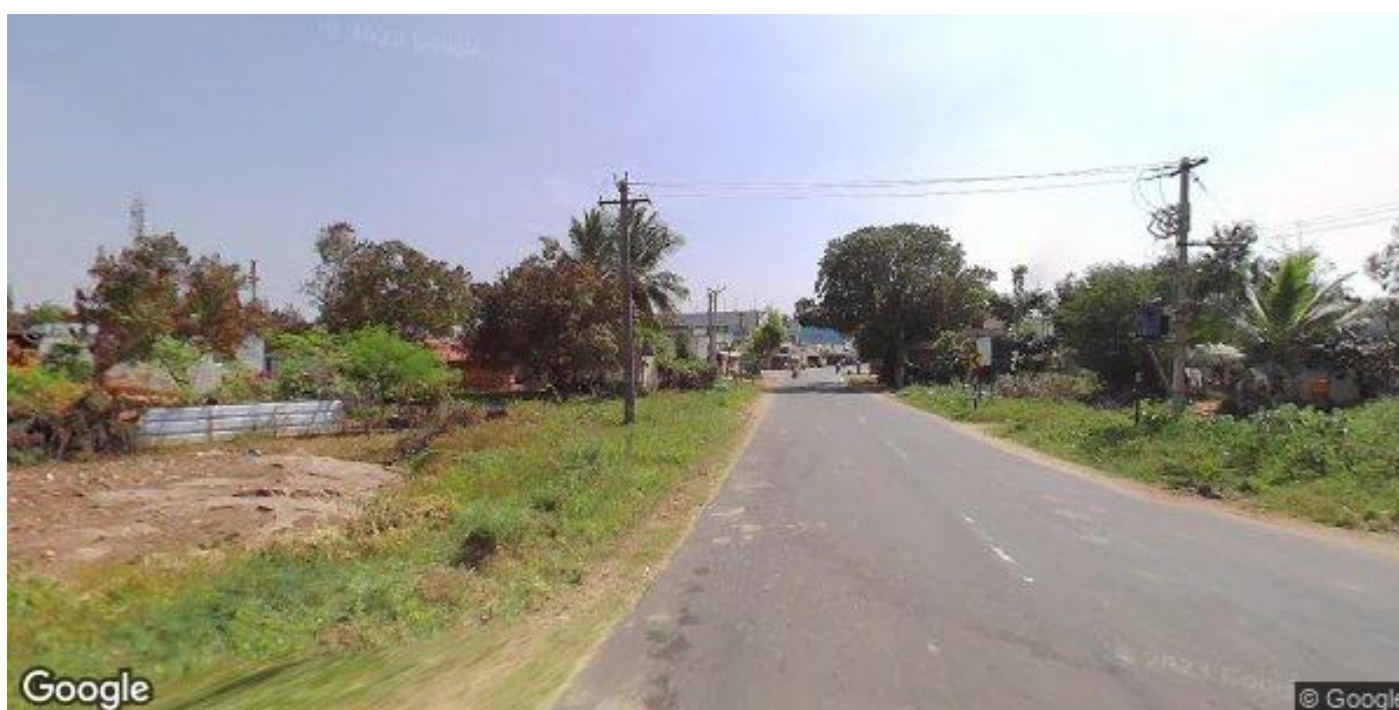
**Risk Type:** Turn  
**Risk Level:** Medium  
**Speed Limit:** 30 KM/Hr  
**Coordinates:** 10.84321, 78.16436

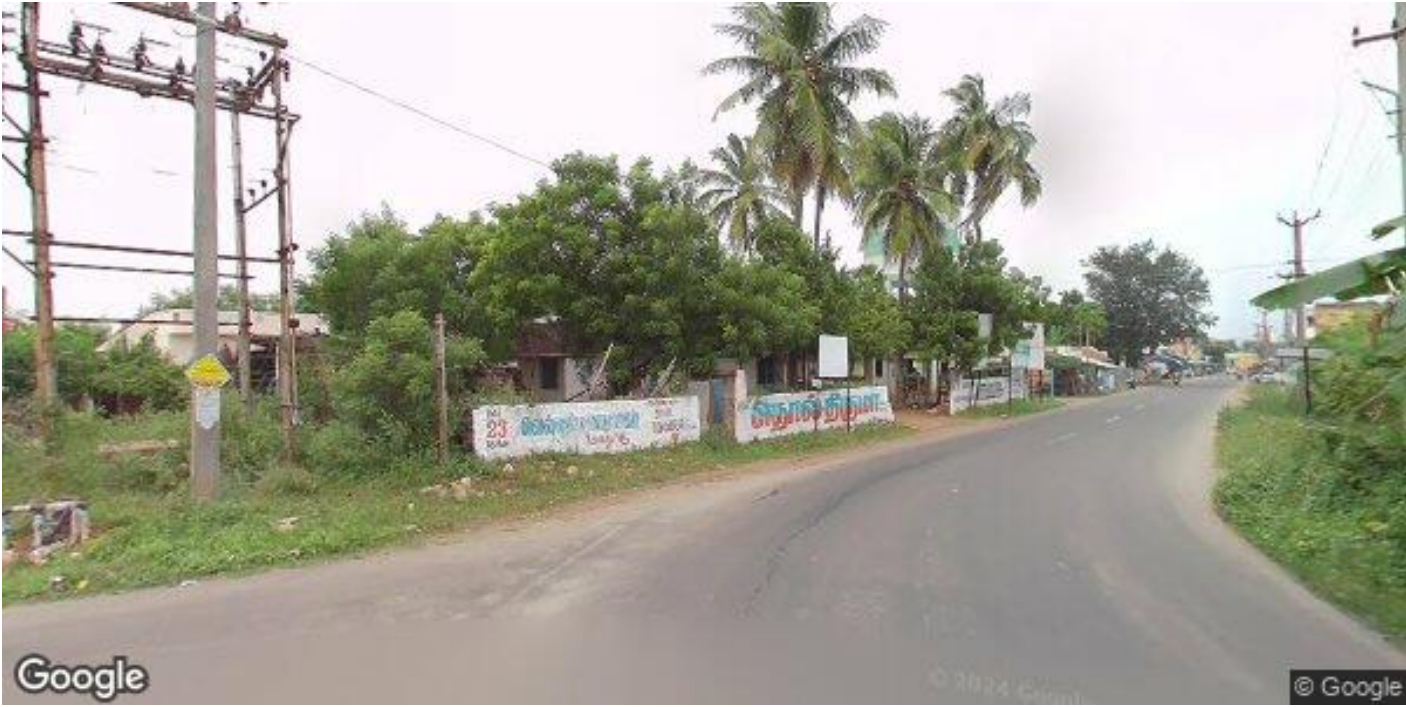
**Risk Type:** Turn  
**Risk Level:** High  
**Speed Limit:** 15 KM/Hr  
**Coordinates:** 10.84057, 78.16518

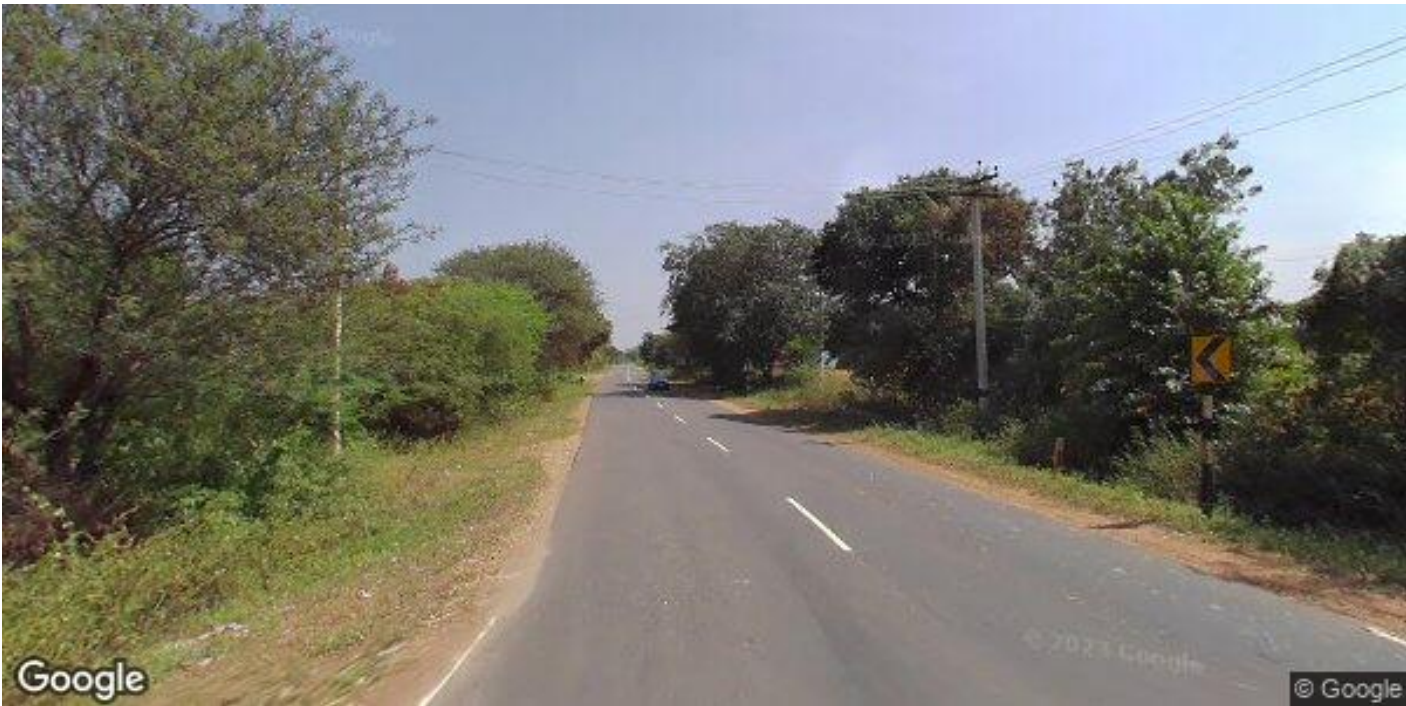
**Risk Type:** Turn  
**Risk Level:** Medium  
**Speed Limit:** 30 KM/Hr  
**Coordinates:** 10.83523, 78.18173

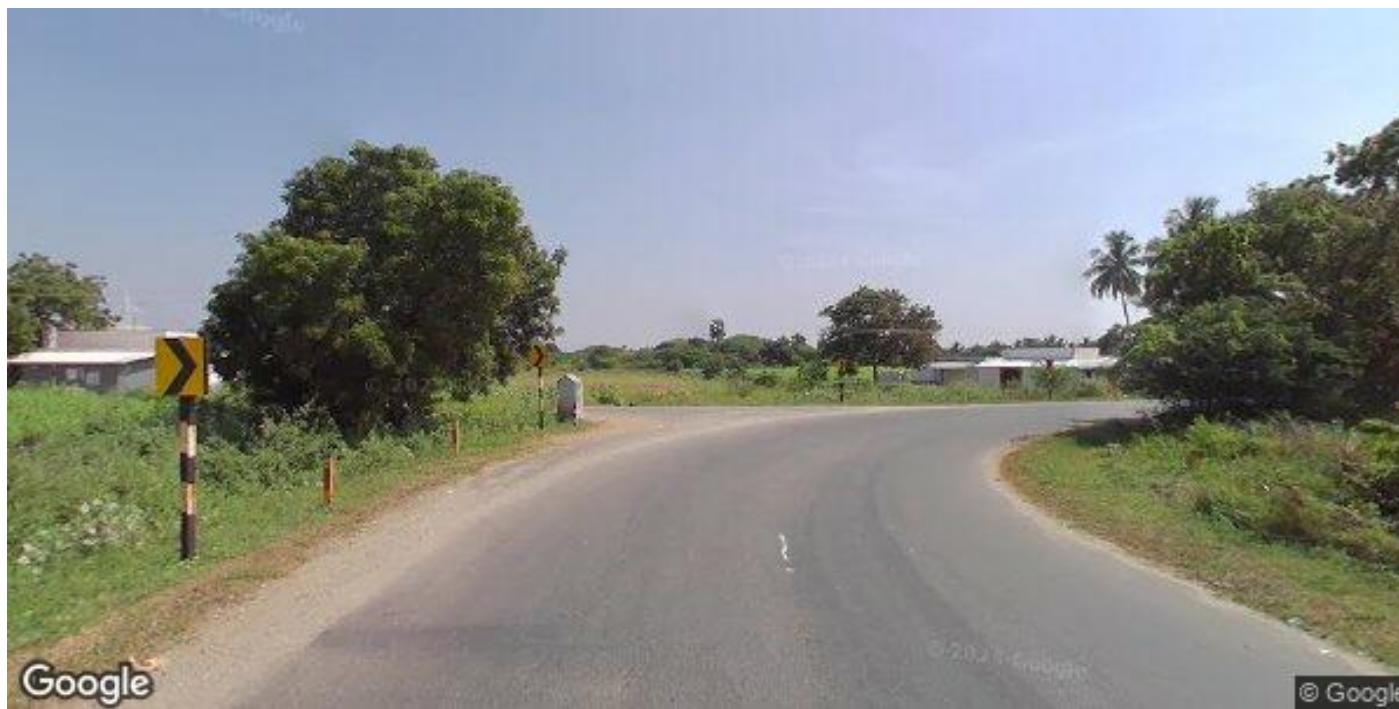
**Risk Type:** Turn  
**Risk Level:** Medium  
**Speed Limit:** 30 KM/Hr  
**Coordinates:** 10.82892, 78.20166

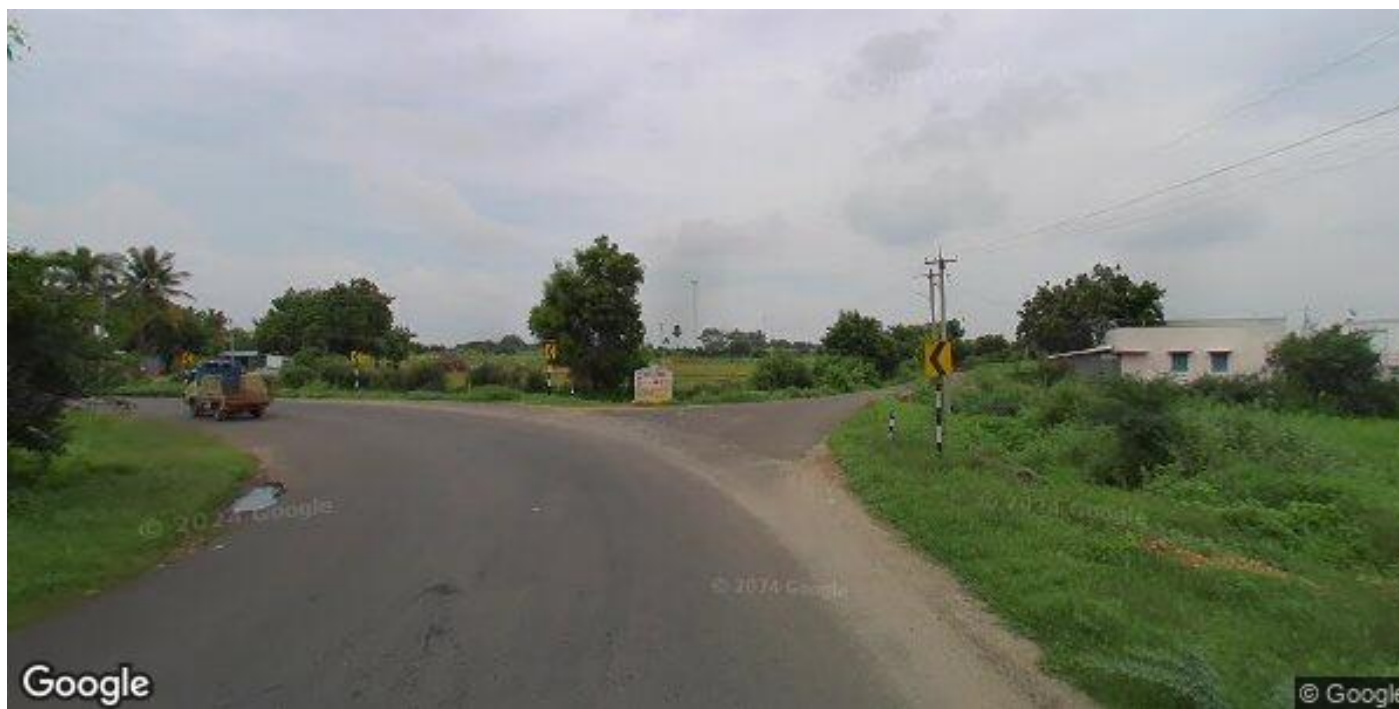
**Risk Type:** Turn  
**Risk Level:** Medium  
**Speed Limit:** 30 KM/Hr  
**Coordinates:** 10.82865, 78.20188

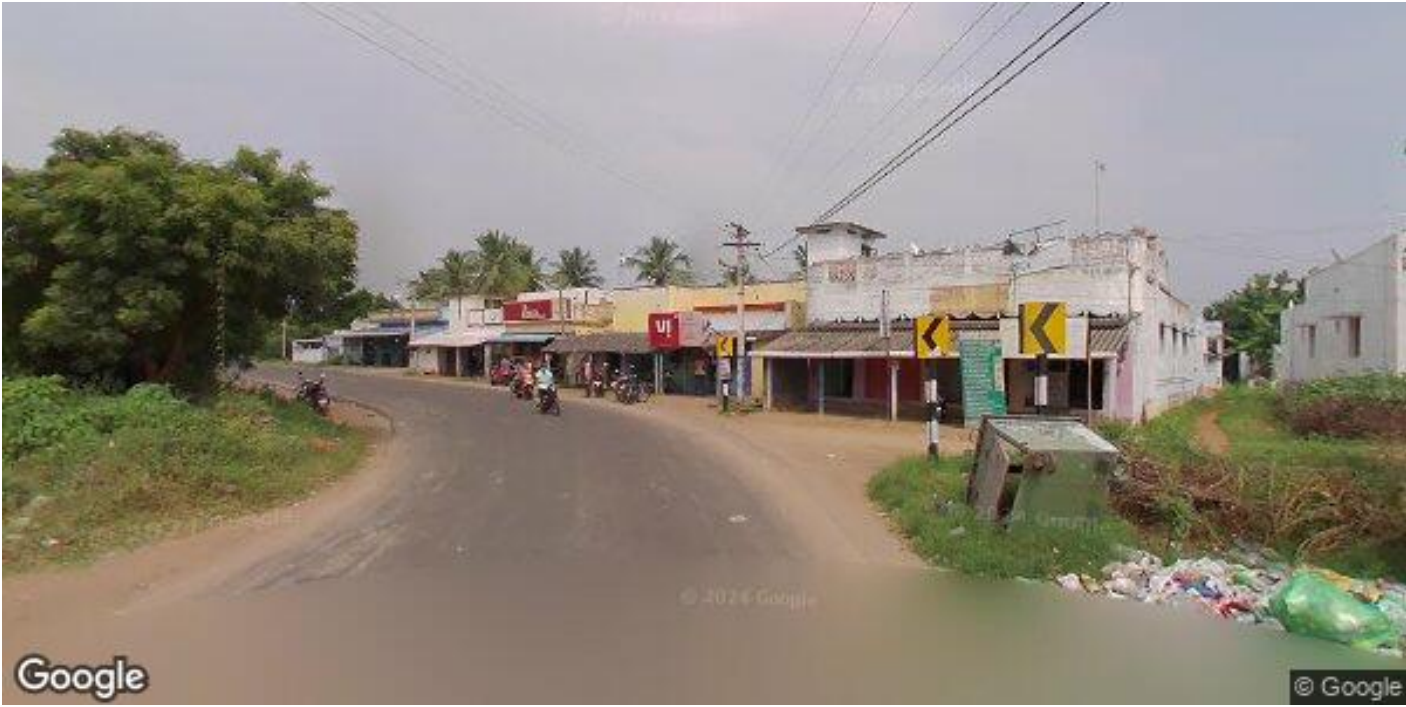
**Risk Type:** Turn  
**Risk Level:** Medium  
**Speed Limit:** 30 KM/Hr  
**Coordinates:** 10.79217, 78.20276

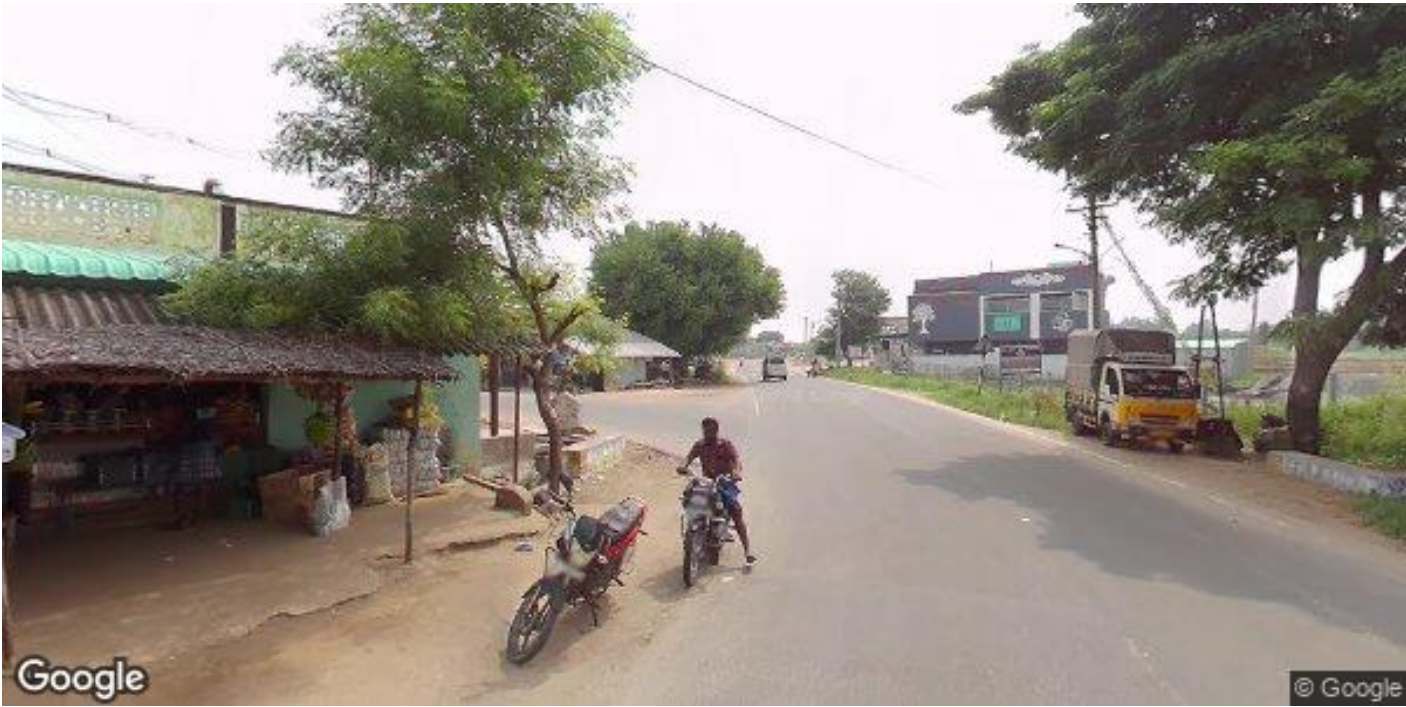
**Risk Type:** Turn  
**Risk Level:** Medium  
**Speed Limit:** 30 KM/Hr  
**Coordinates:** 10.79013, 78.20307

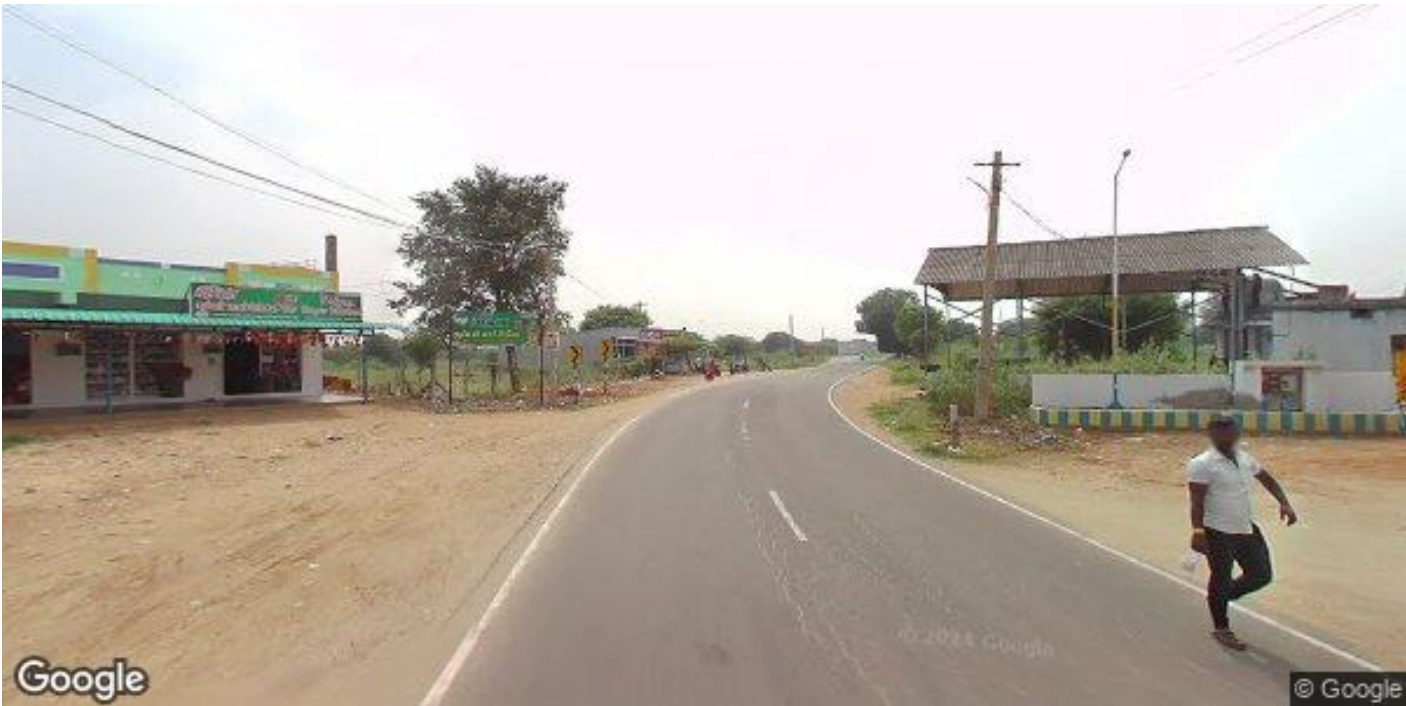
**Risk Type:** Turn  
**Risk Level:** Medium  
**Speed Limit:** 30 KM/Hr  
**Coordinates:** 10.78936, 78.20390

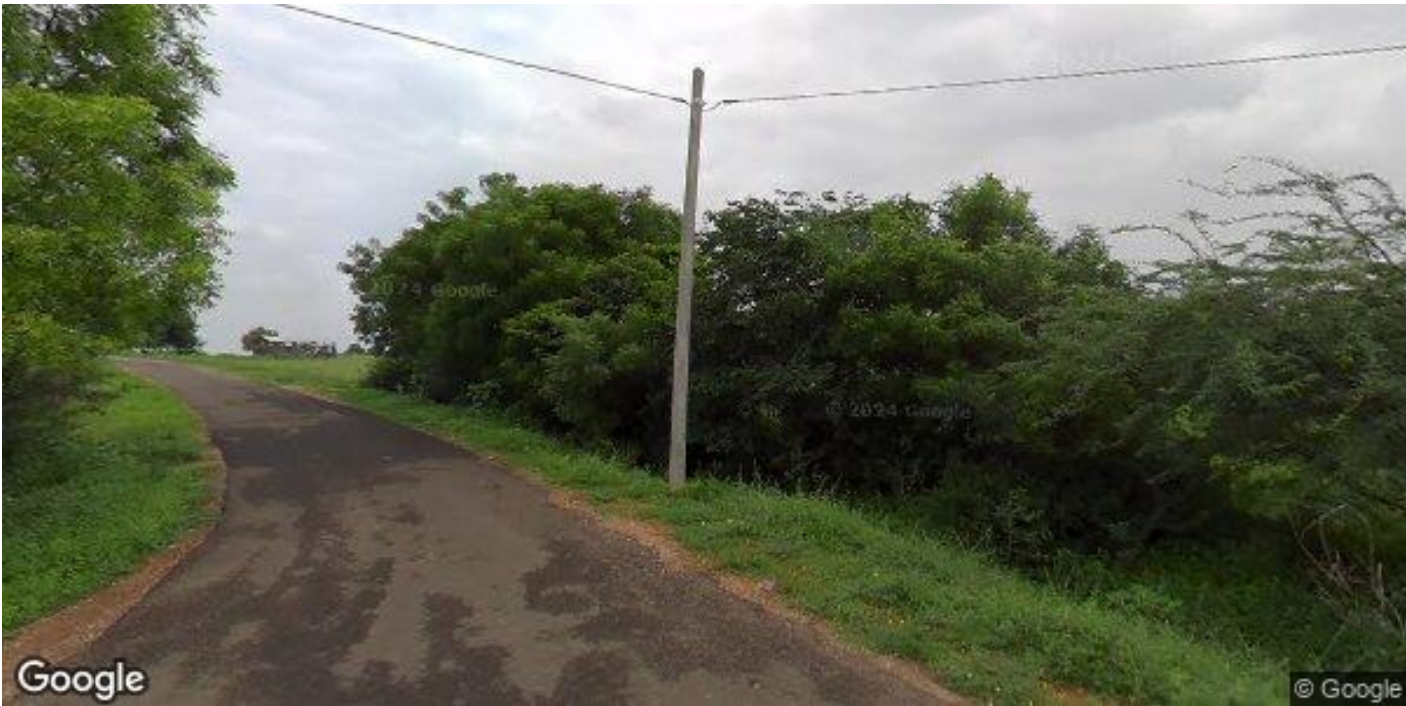
**Risk Type:** Turn  
**Risk Level:** High  
**Speed Limit:** 15 KM/Hr  
**Coordinates:** 10.77911, 78.21461
