# IndianOil

## JOURNEY RISK MANAGEMENT (JRM) STUDY

### Salem Terminal to SRI KANNIMARA AGENCY

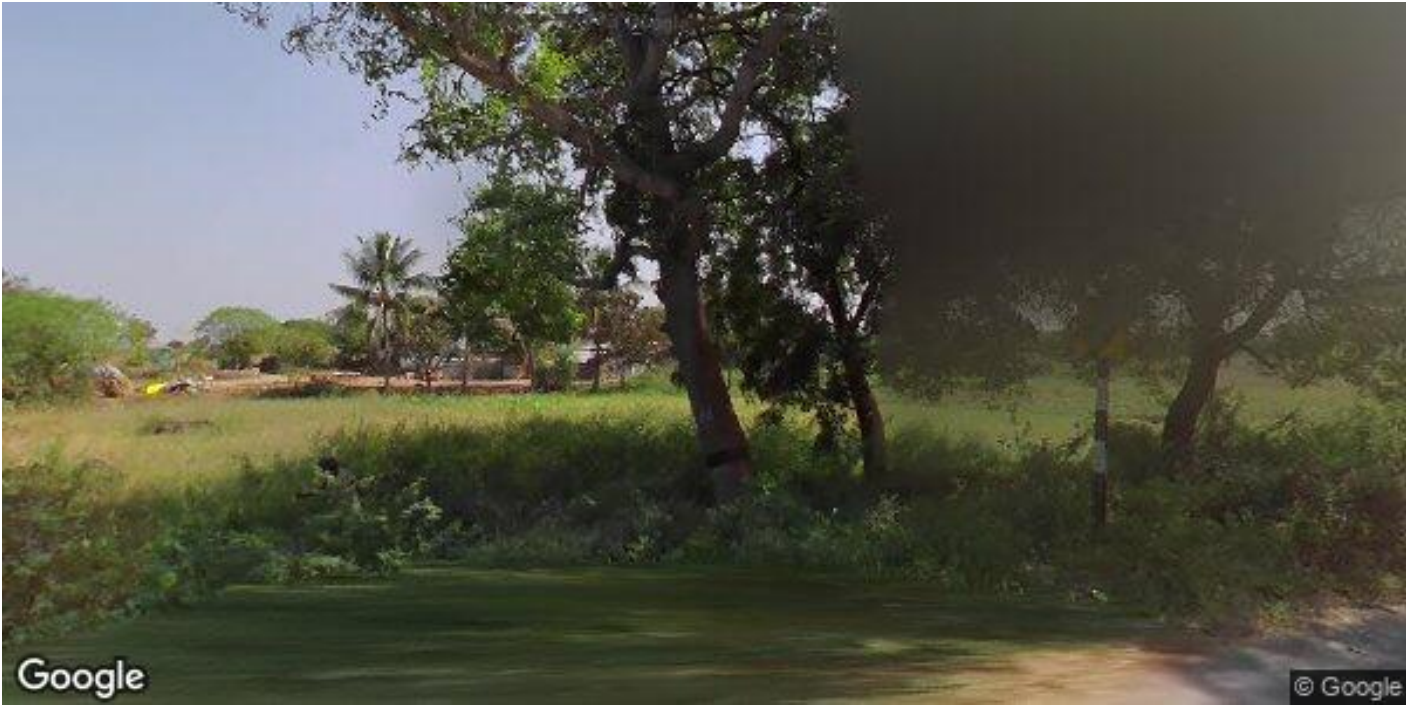
**Risk Type:** Turn  
**Risk Level:** Medium  
**Speed Limit:** 30 KM/Hr  
**Coordinates:** 10.77530, 78.21486

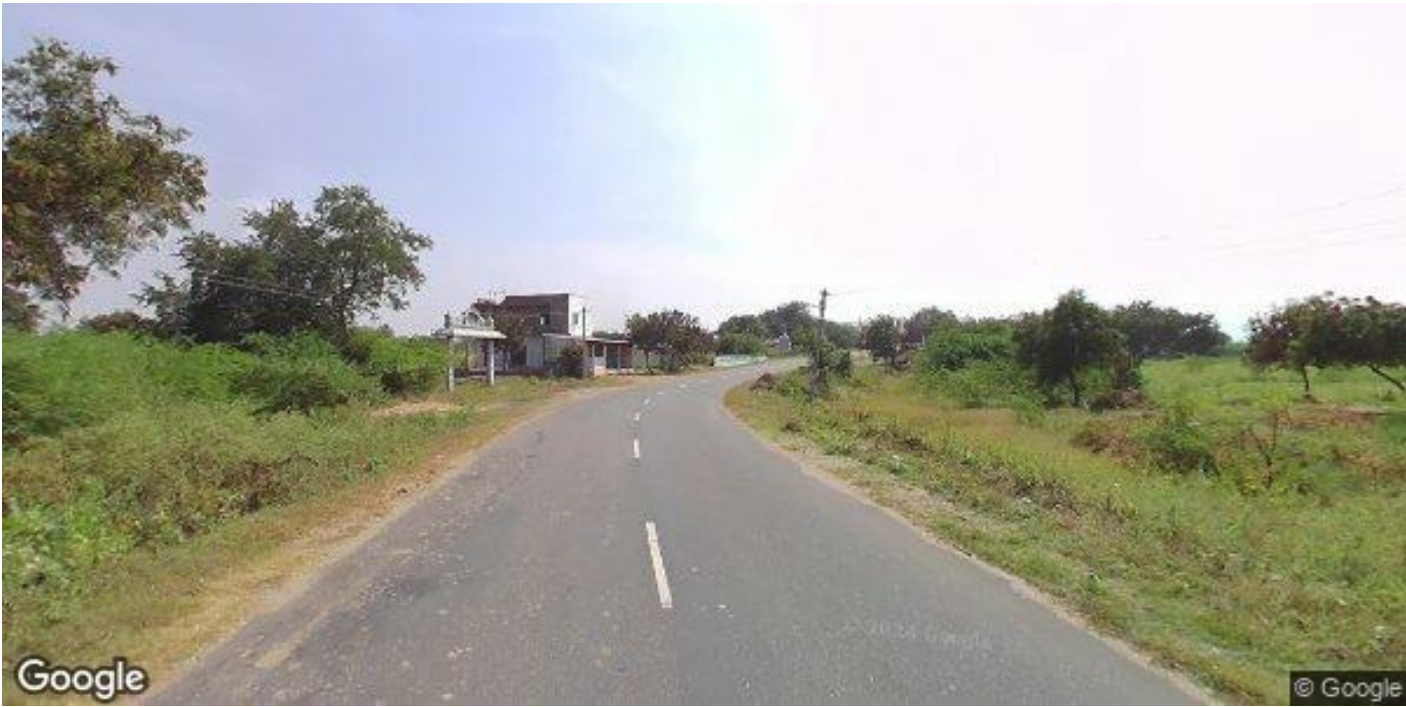
**Risk Type:** Turn  
**Risk Level:** Medium  
**Speed Limit:** 30 KM/Hr  
**Coordinates:** 10.74551, 78.22709

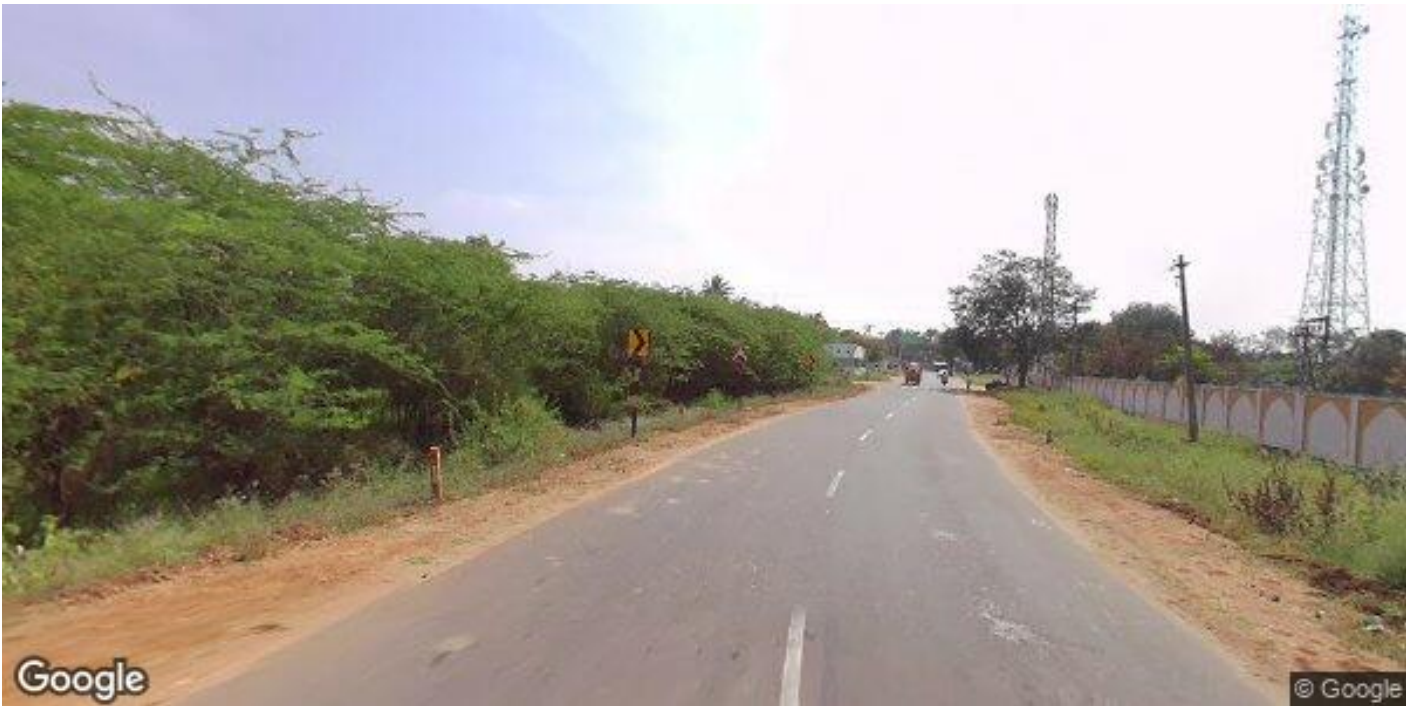
**Risk Type:** Turn  
**Risk Level:** Medium  
**Speed Limit:** 30 KM/Hr  
**Coordinates:** 10.73084, 78.23146

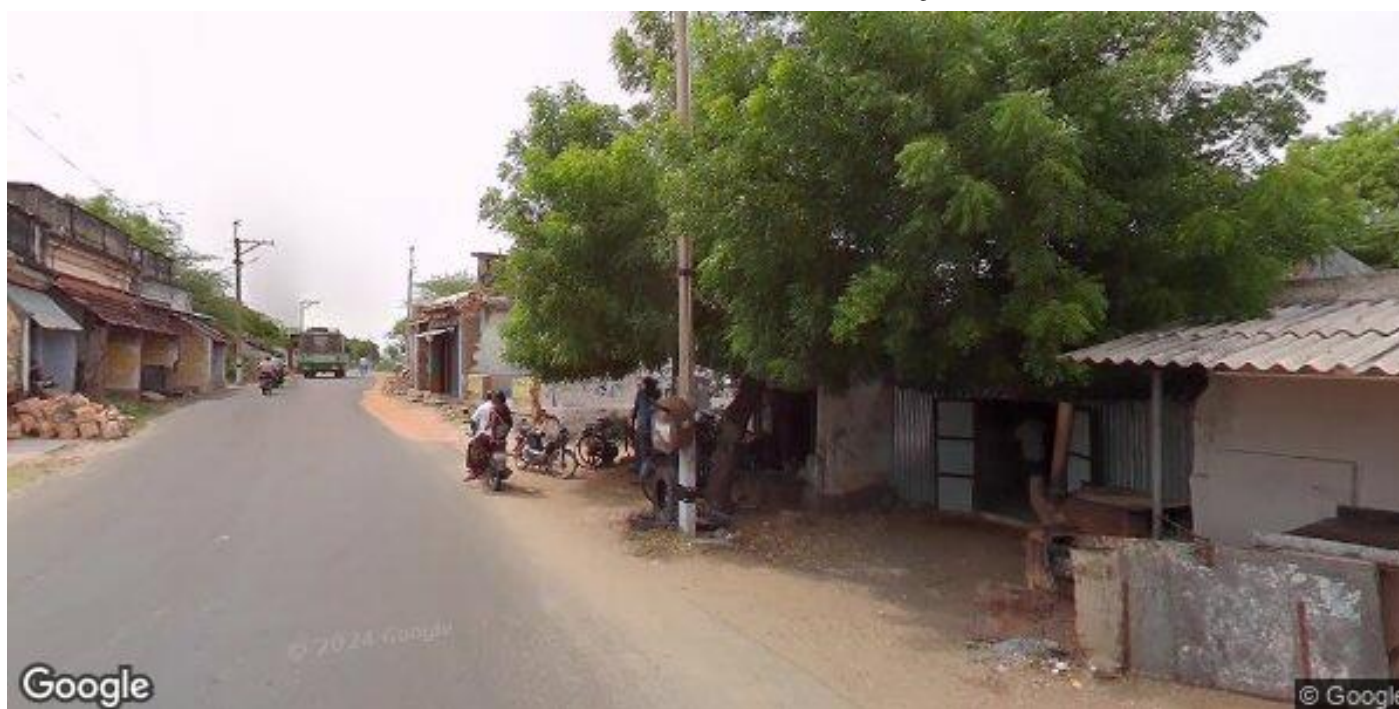
**Risk Type:** Turn  
**Risk Level:** High  
**Speed Limit:** 15 KM/Hr  
**Coordinates:** 10.72910, 78.23136

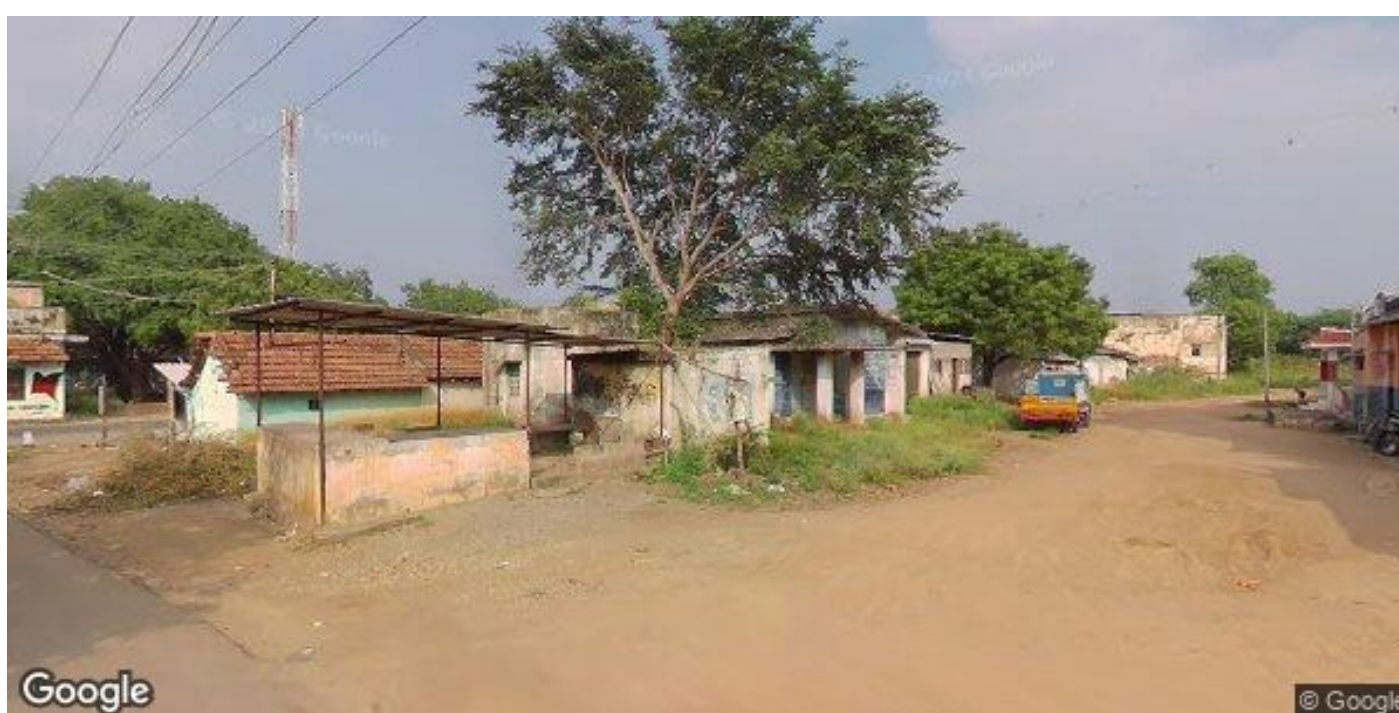
**Risk Type:** Turn  
**Risk Level:** High  
**Speed Limit:** 15 KM/Hr  
**Coordinates:** 10.72888, 78.23084

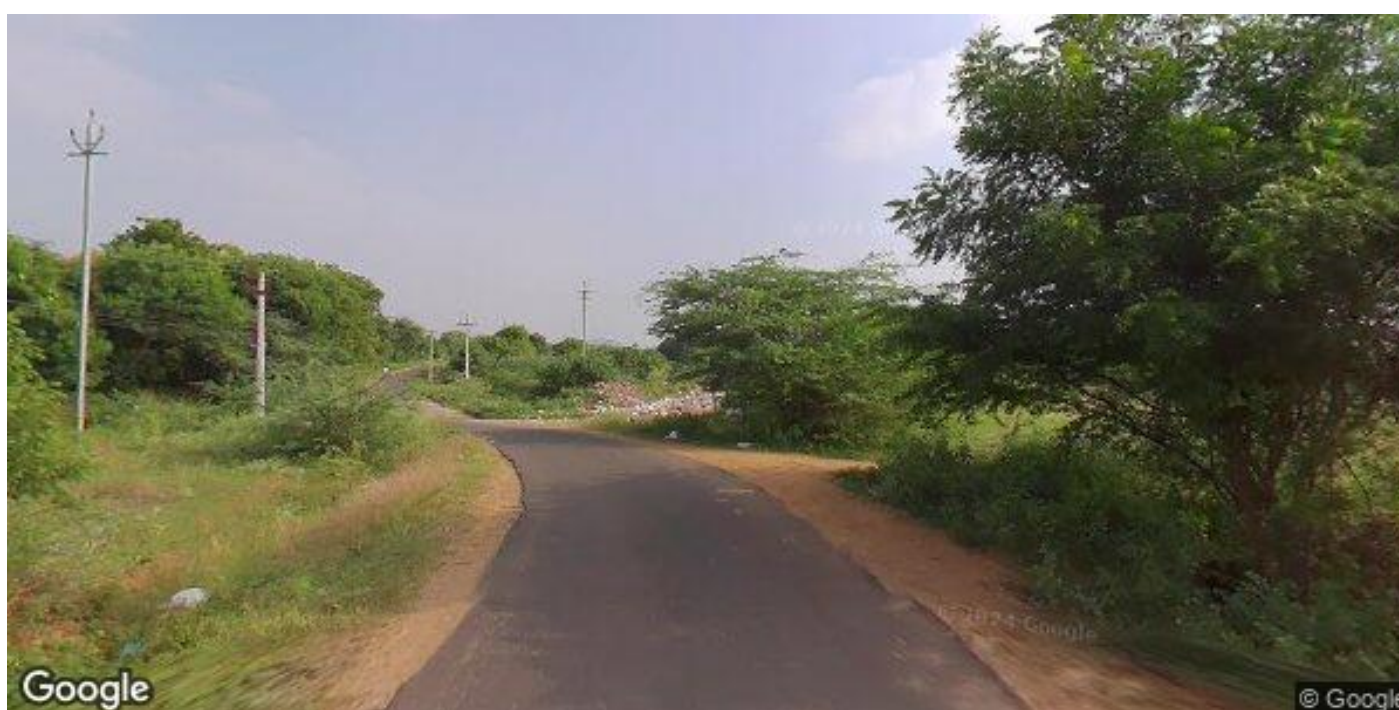
**Risk Type:** Turn  
**Risk Level:** Medium  
**Speed Limit:** 30 KM/Hr  
**Coordinates:** 10.71906, 78.23543

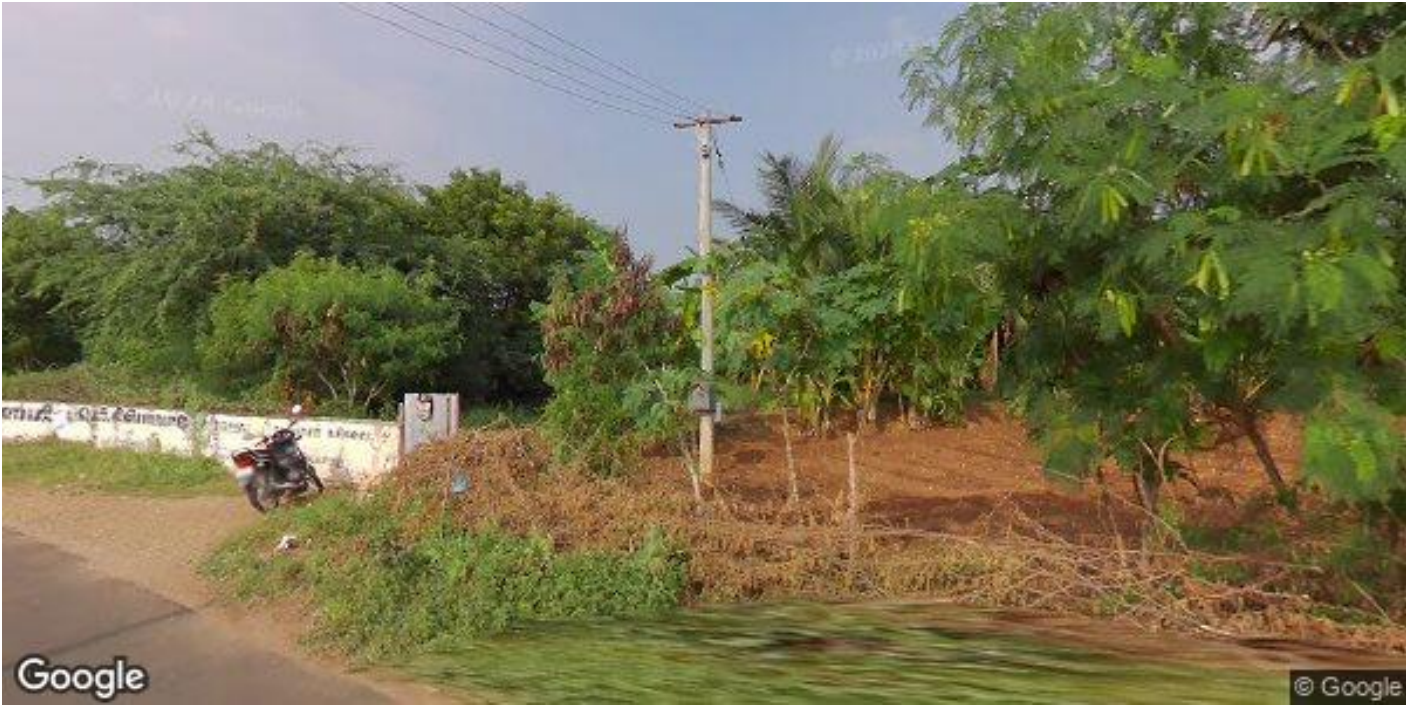
**Risk Type:** Turn  
**Risk Level:** High  
**Speed Limit:** 15 KM/Hr  
**Coordinates:** 10.71762, 78.23799

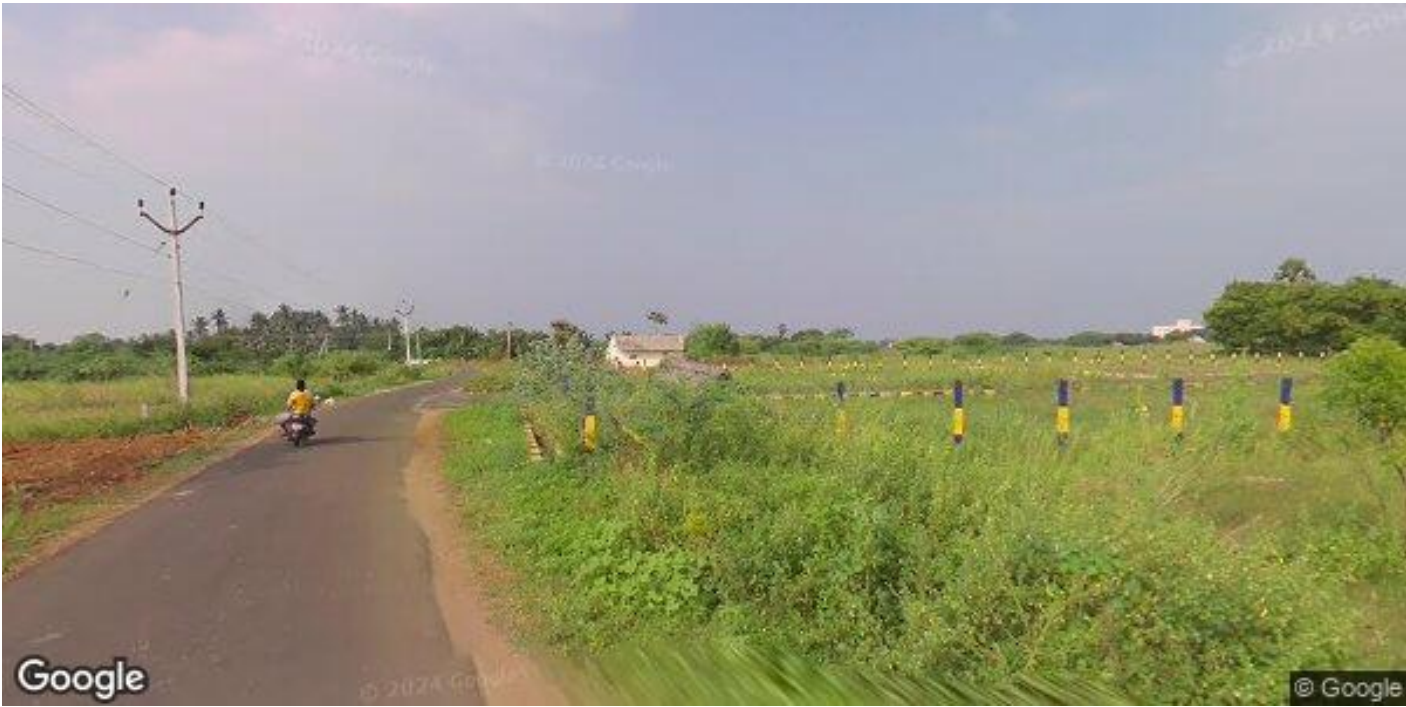
**Risk Type:** Turn  
**Risk Level:** Medium  
**Speed Limit:** 30 KM/Hr  
**Coordinates:** 10.71635, 78.23810

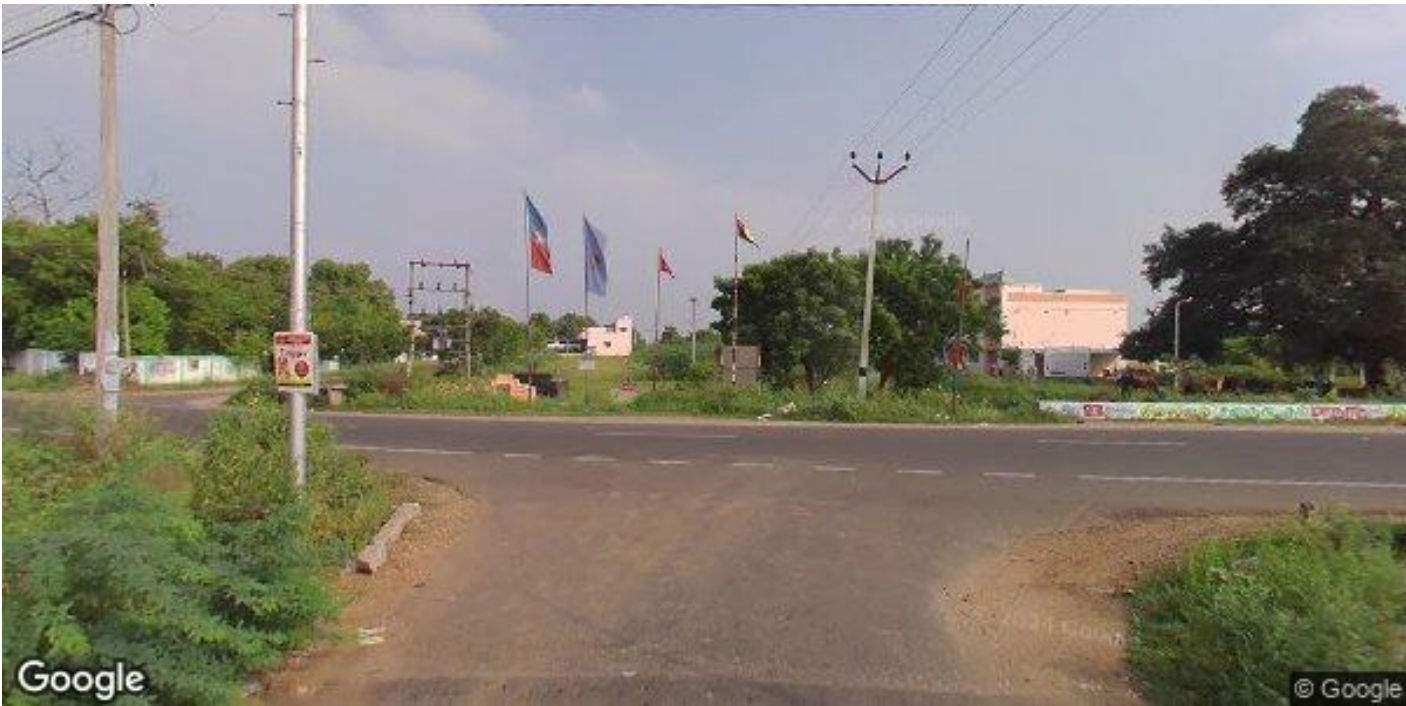
**Risk Type:** Turn  
**Risk Level:** High  
**Speed Limit:** 15 KM/Hr  
**Coordinates:** 10.71463, 78.23992

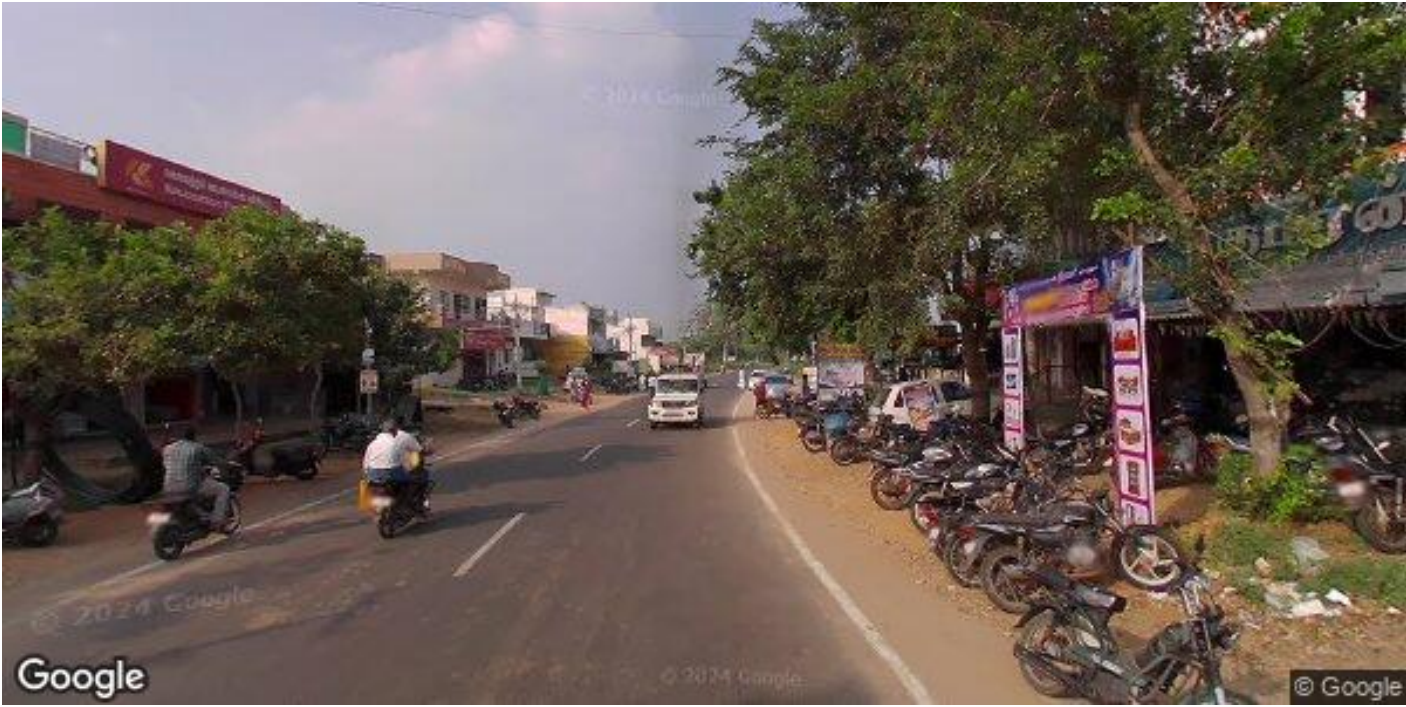
**Risk Type:** Turn  
**Risk Level:** Medium  
**Speed Limit:** 30 KM/Hr  
**Coordinates:** 10.71217, 78.23933

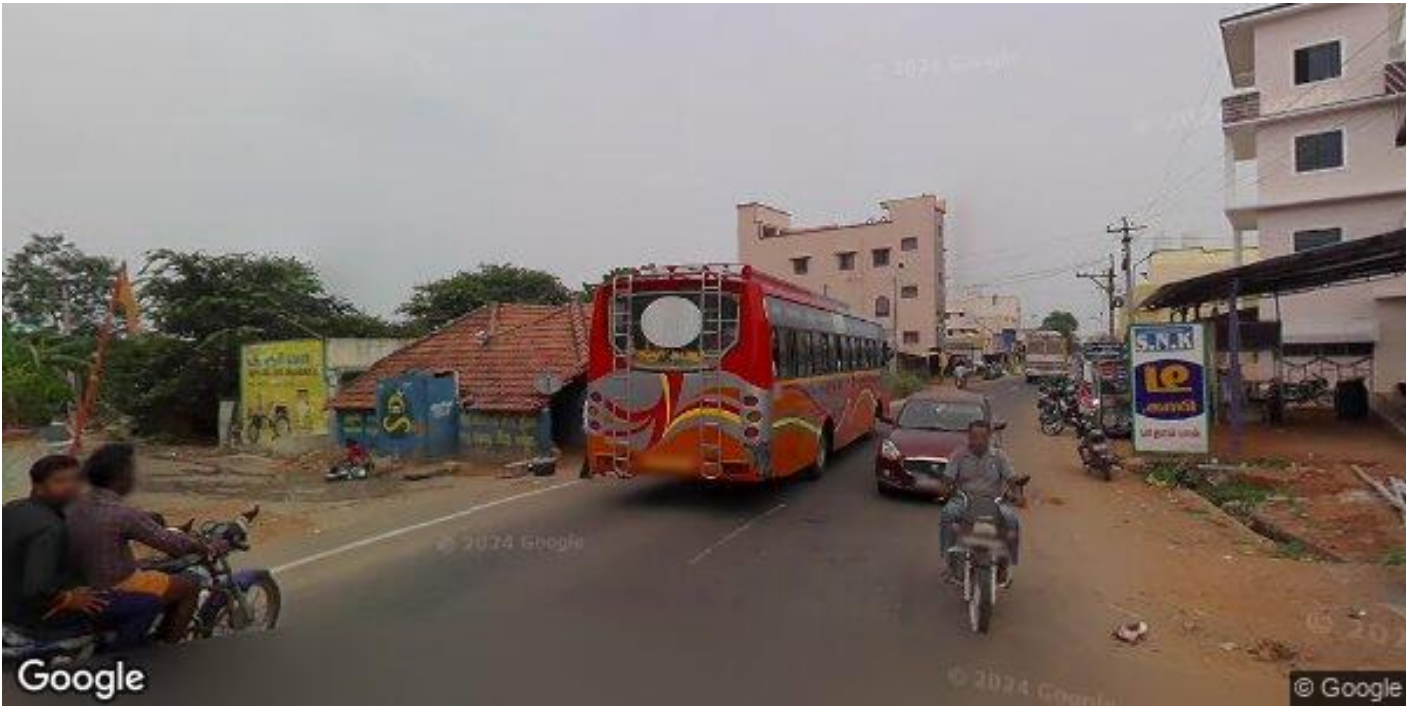
**Risk Type:** Turn  
**Risk Level:** Medium  
**Speed Limit:** 30 KM/Hr  
**Coordinates:** 10.70648, 78.24053
