## JOURNEY RISK MANAGEMENT (JRM) STUDY

### Salem Terminal TO HS FUELS

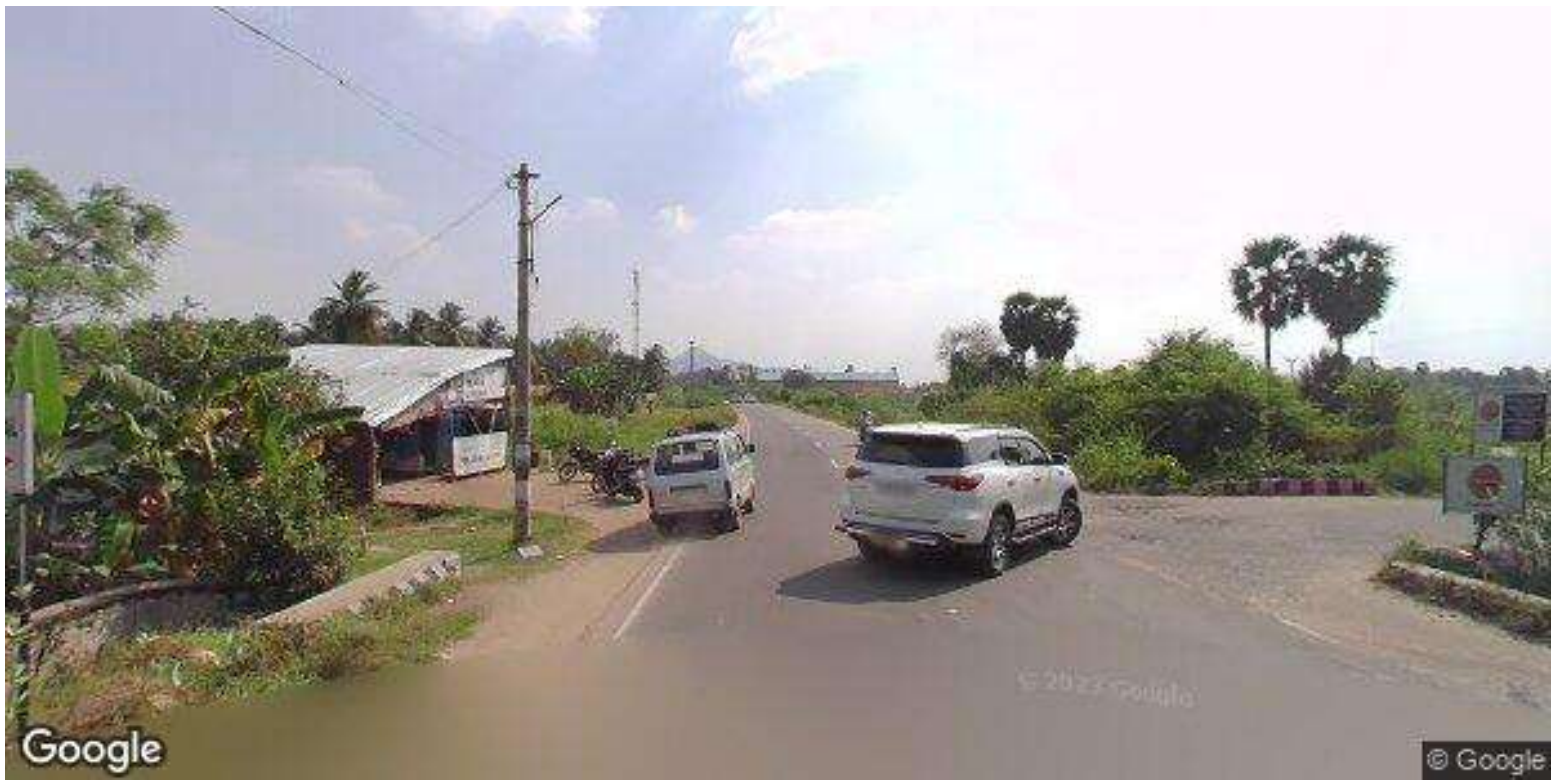
**Coordinates:** 11.44029, 77.87544

**Risk Type:** Turn

**Risk Level:** High

**Speed Limit:** 15 KM/Hr

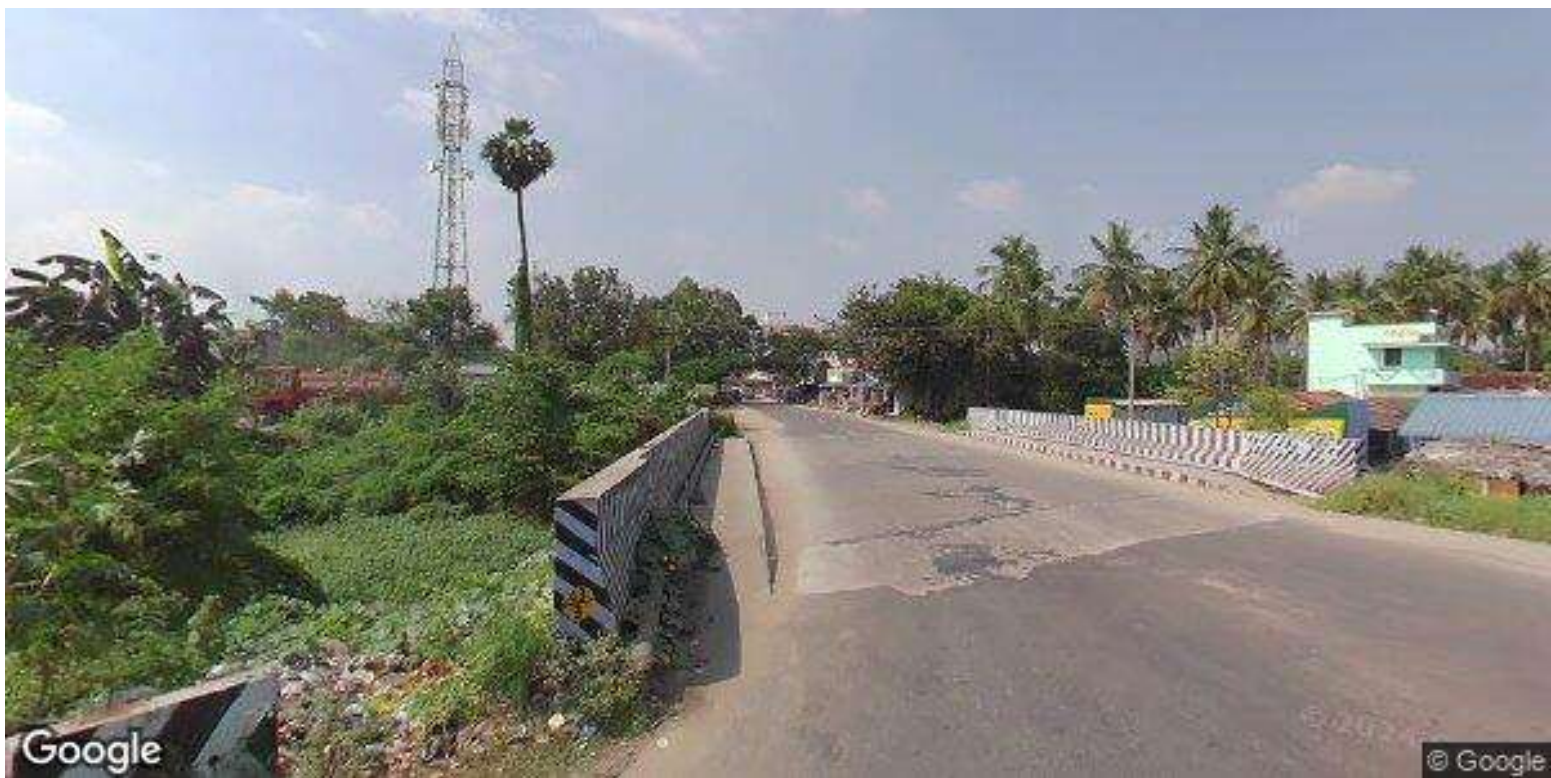
**Coordinates:** 11.44900, 77.87406

**Risk Type:** Turn

**Risk Level:** Medium

**Speed Limit:** 30 KM/Hr

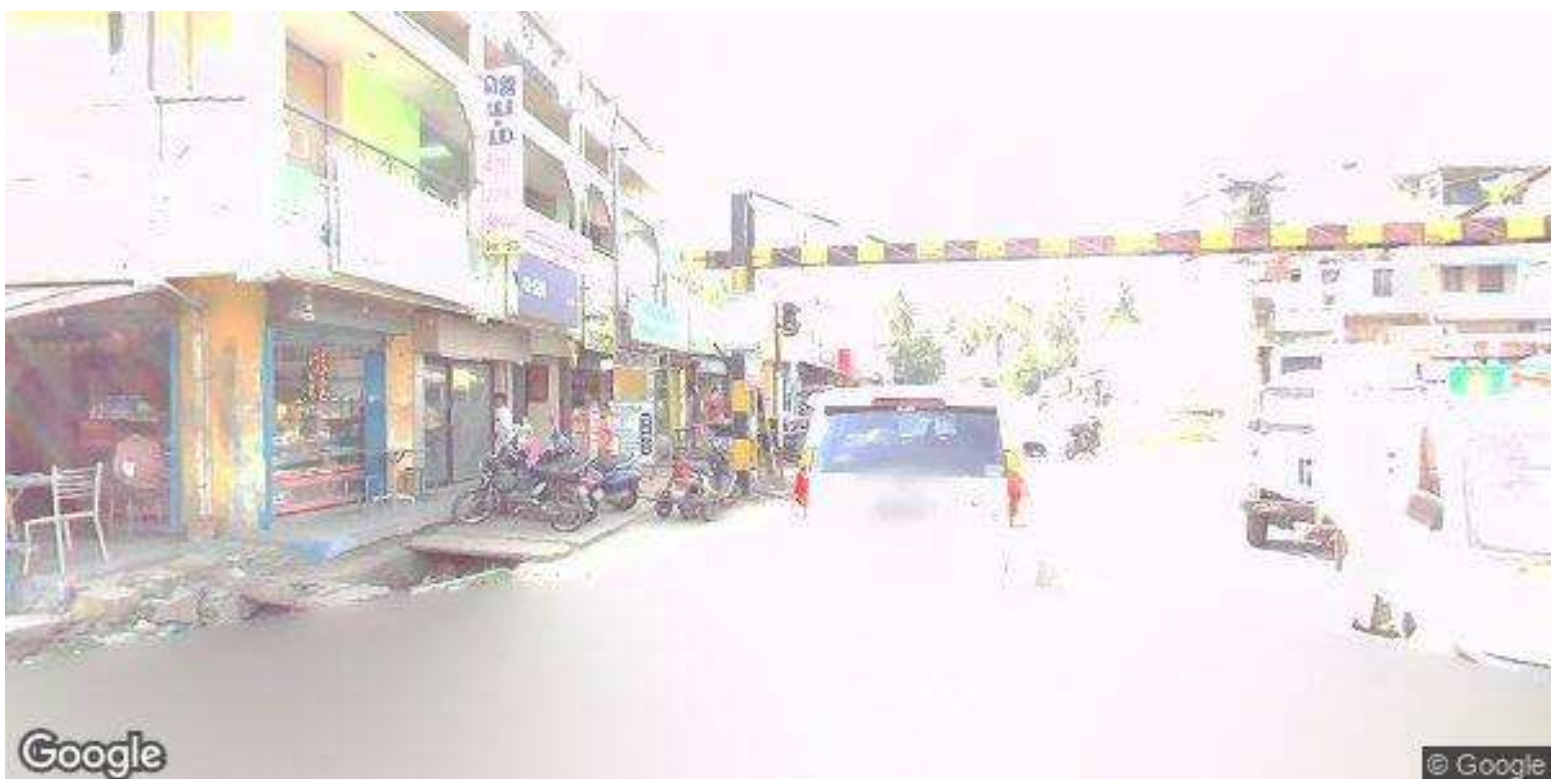
**Risk Type:** Turn  
**Risk Level:** Medium  
**Speed Limit:** 30 KM/Hr  
**Coordinates:** 11.45000, 77.87213

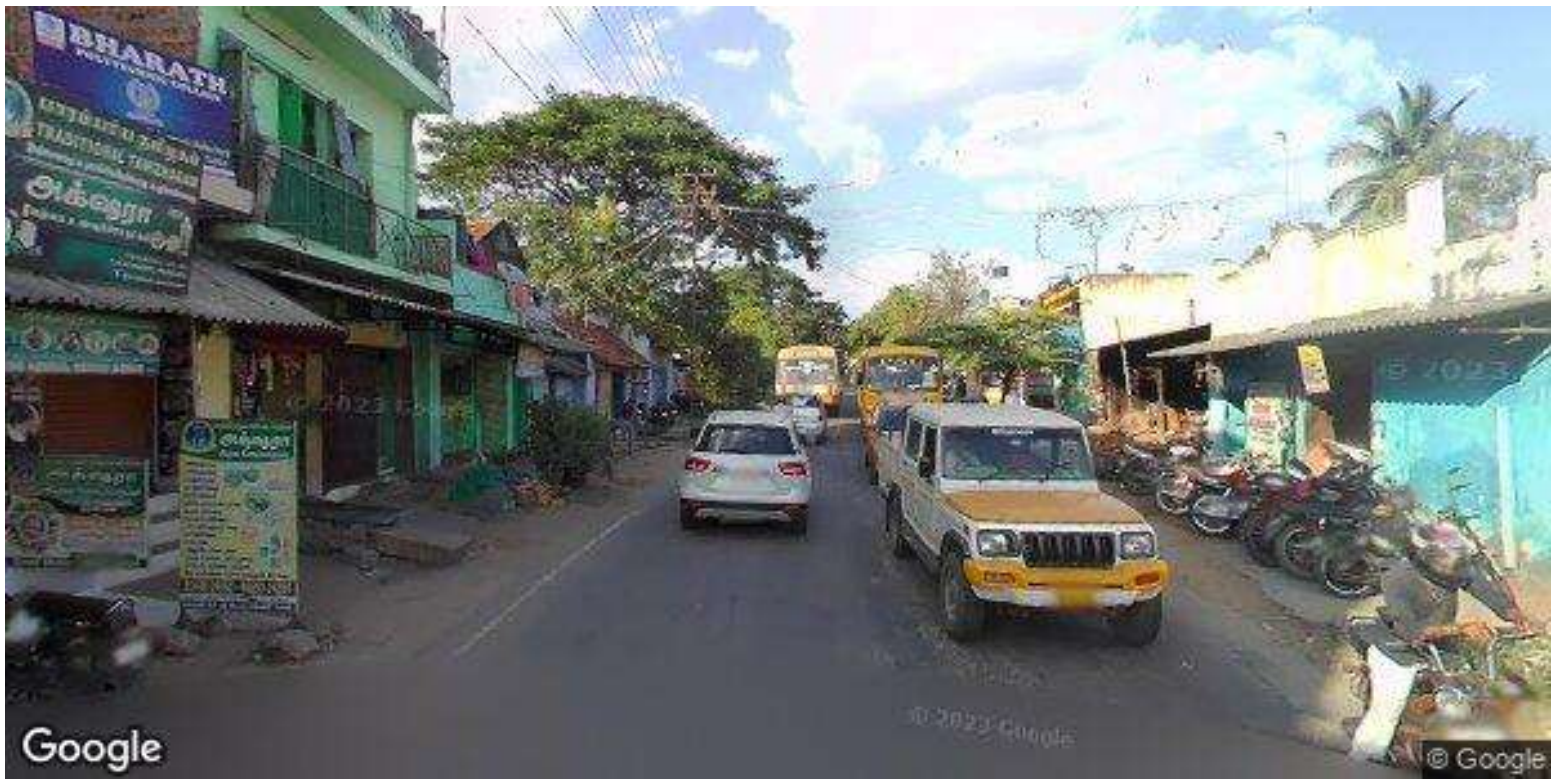
**Risk Type:** Turn  
**Risk Level:** High  
**Speed Limit:** 15 KM/Hr  
**Coordinates:** 11.45028, 77.87202

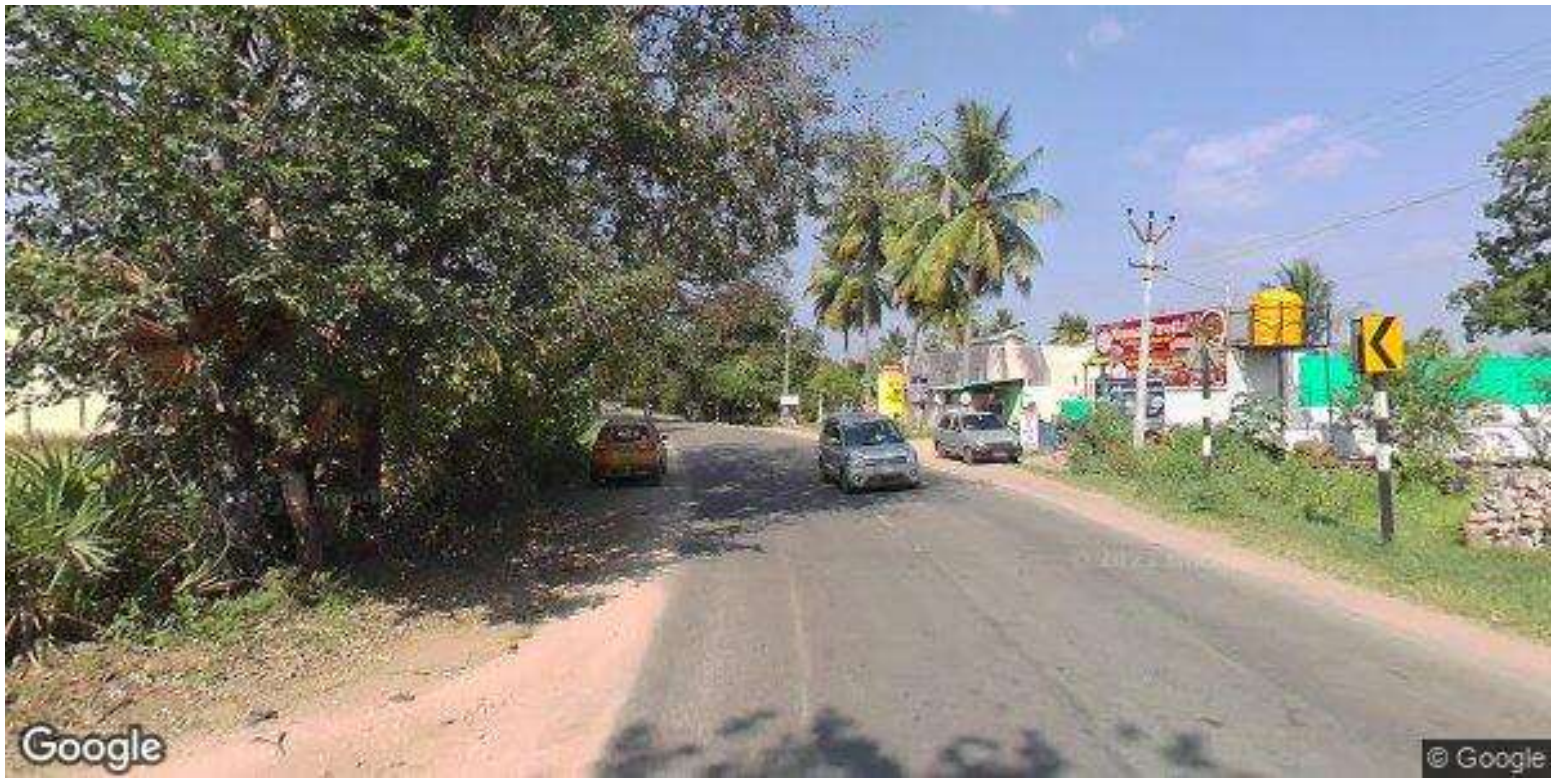
**Risk Type:** Turn  
**Risk Level:** Medium  
**Speed Limit:** 30 KM/Hr  
**Coordinates:** 11.45309, 77.87325

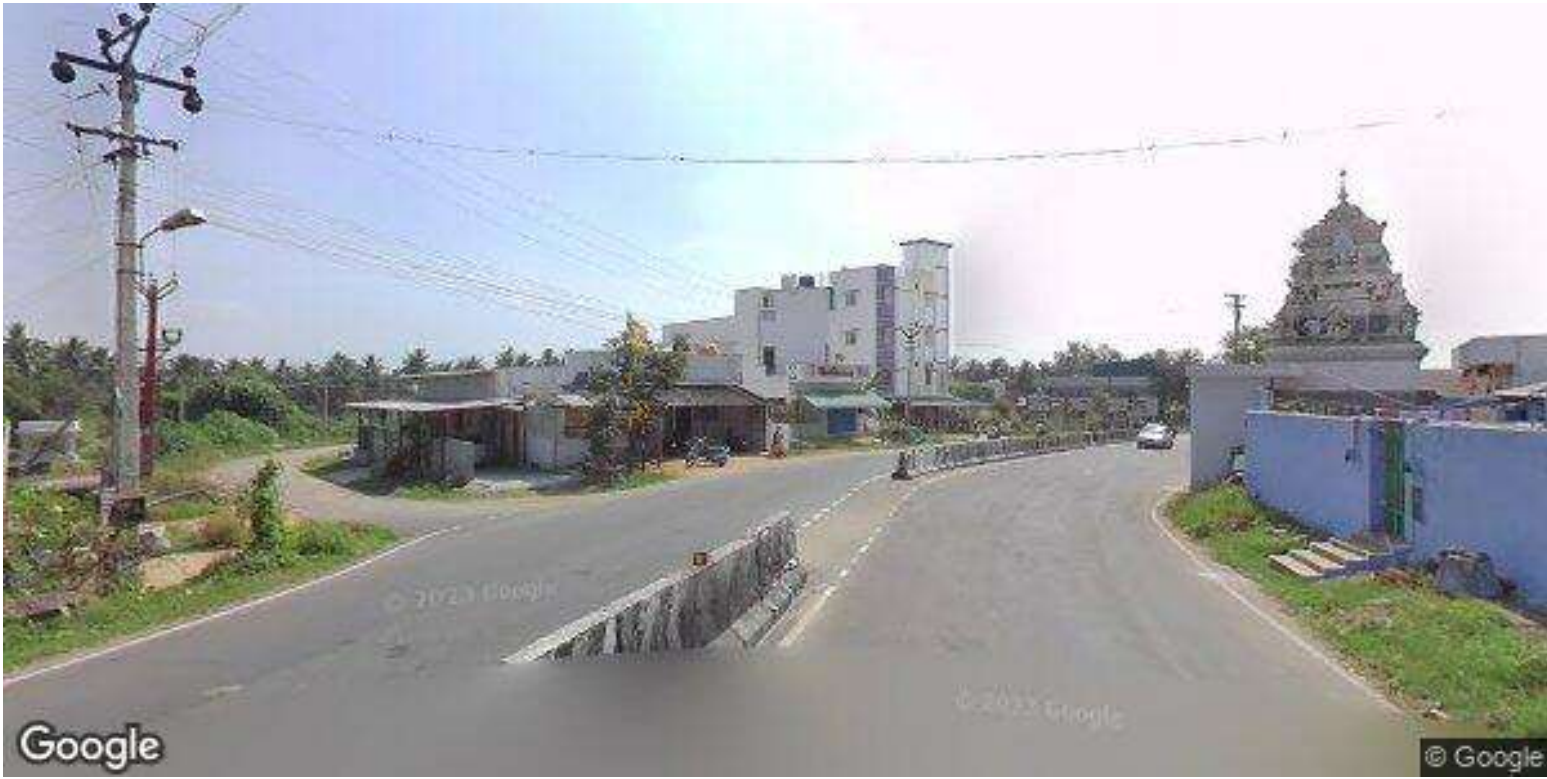
**Risk Type:** Turn  
**Risk Level:** Medium  
**Speed Limit:** 30 KM/Hr  
**Coordinates:** 11.46400, 77.87323

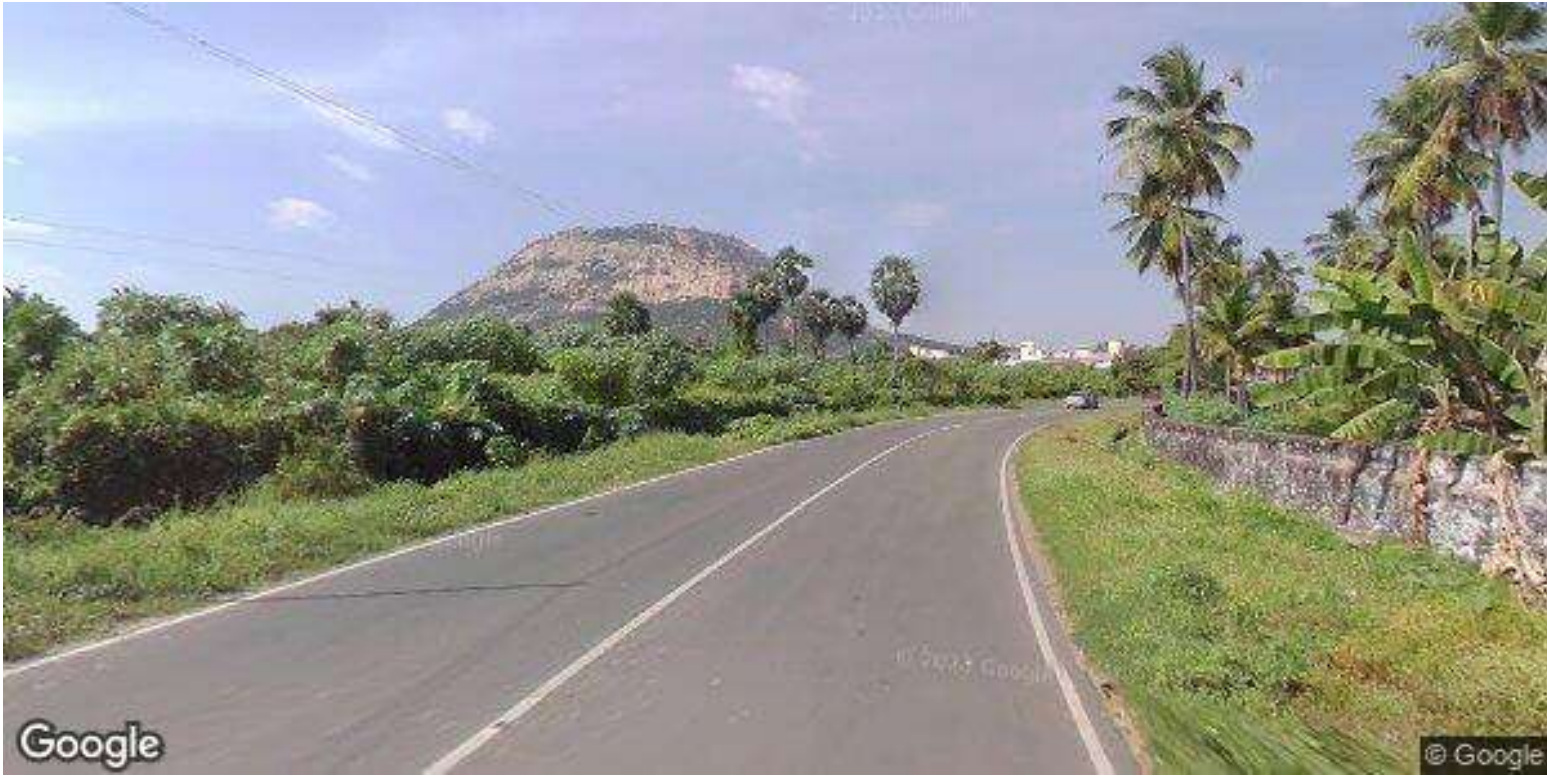
**Risk Type:** Turn  
**Risk Level:** Medium  
**Speed Limit:** 30 KM/Hr  
**Coordinates:** 11.46765, 77.87037

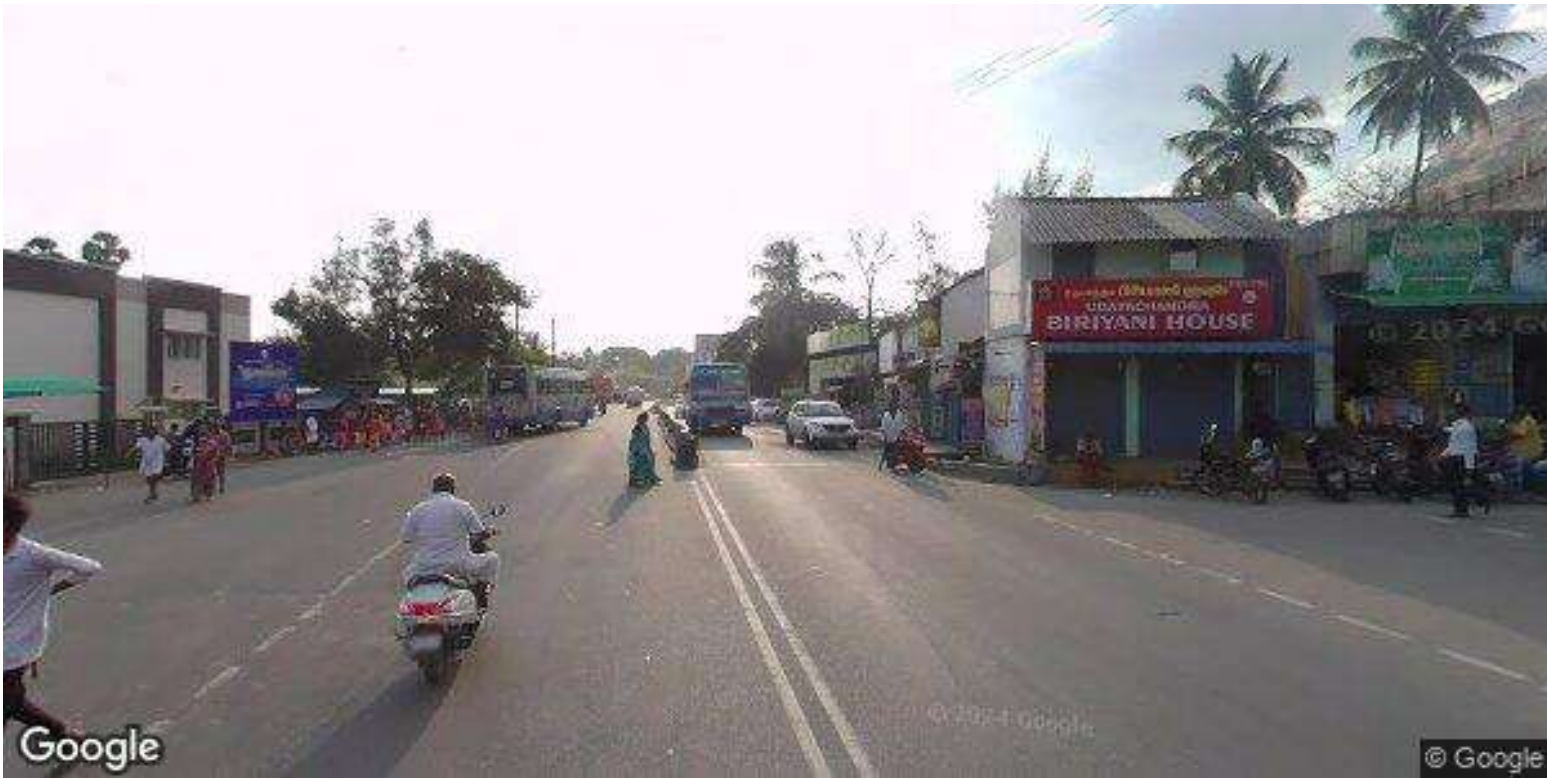
**Risk Type:** Turn  
**Risk Level:** High  
**Speed Limit:** 15 KM/Hr  
**Coordinates:** 11.47403, 77.86841

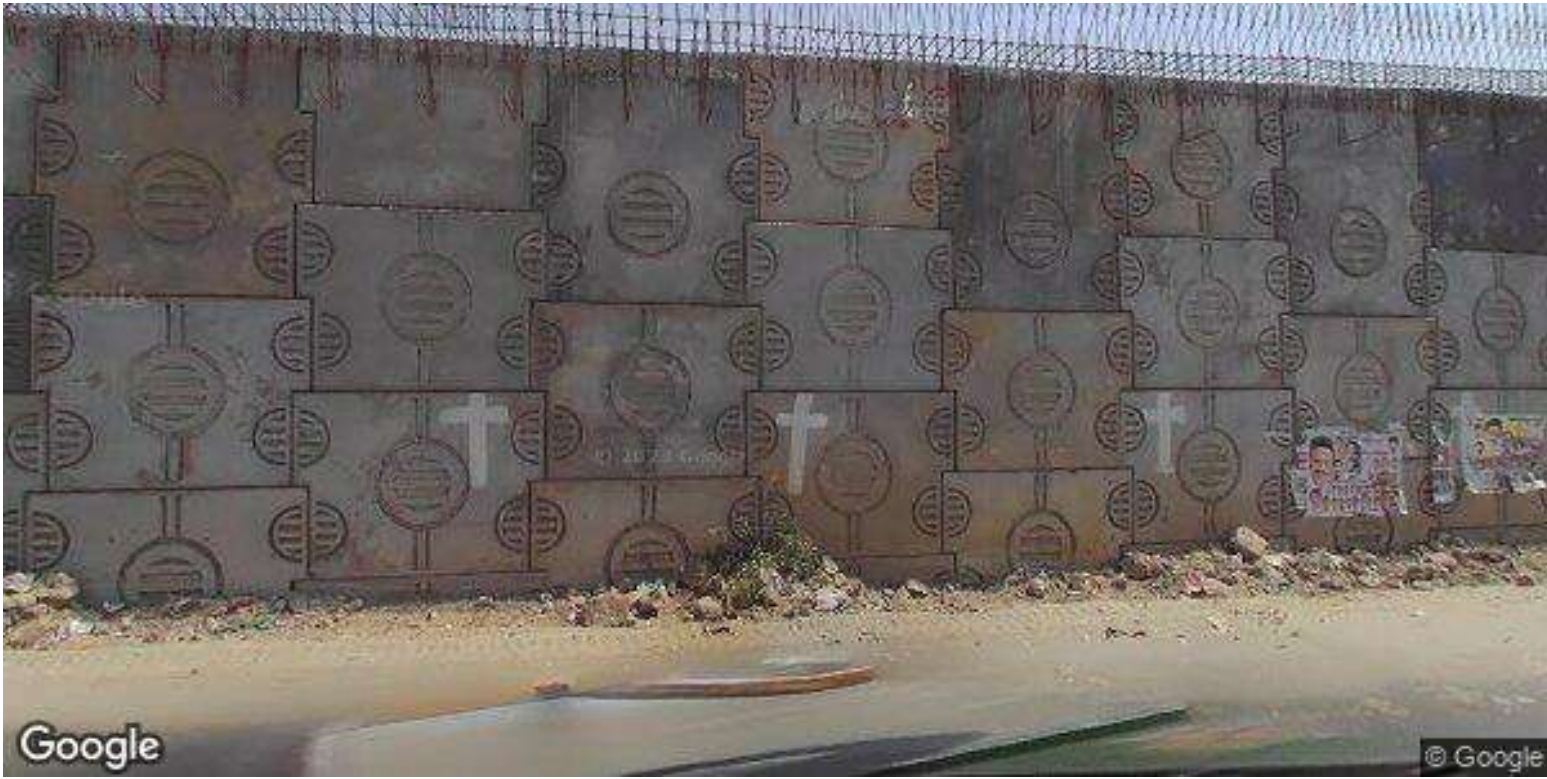
**Risk Type:** Turn  
**Risk Level:** Medium  
**Speed Limit:** 30 KM/Hr  
**Coordinates:** 11.75835, 78.05016

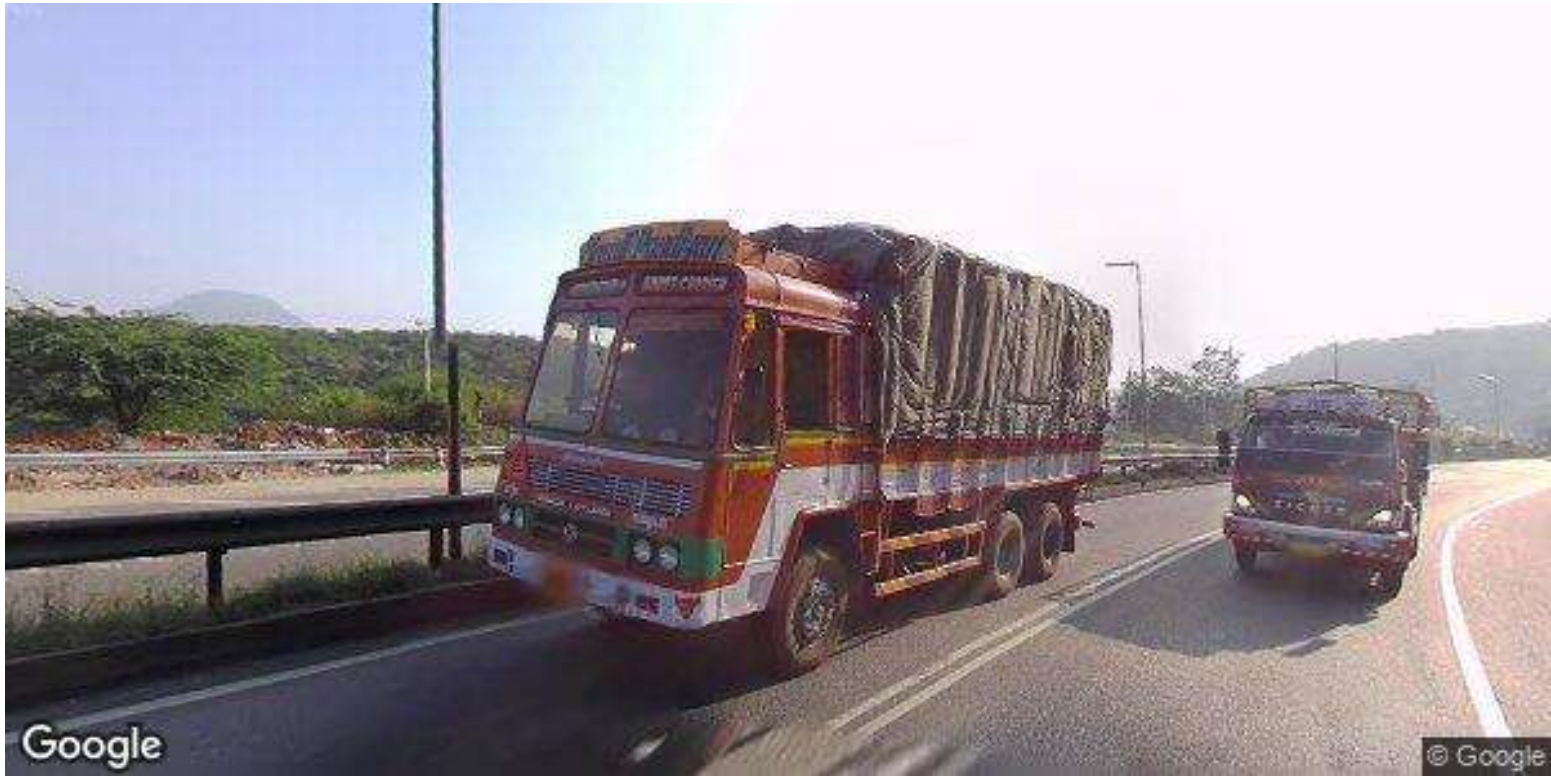
**Risk Type:** Turn  
**Risk Level:** Medium  
**Speed Limit:** 30 KM/Hr  
**Coordinates:** 11.95818, 78.04978

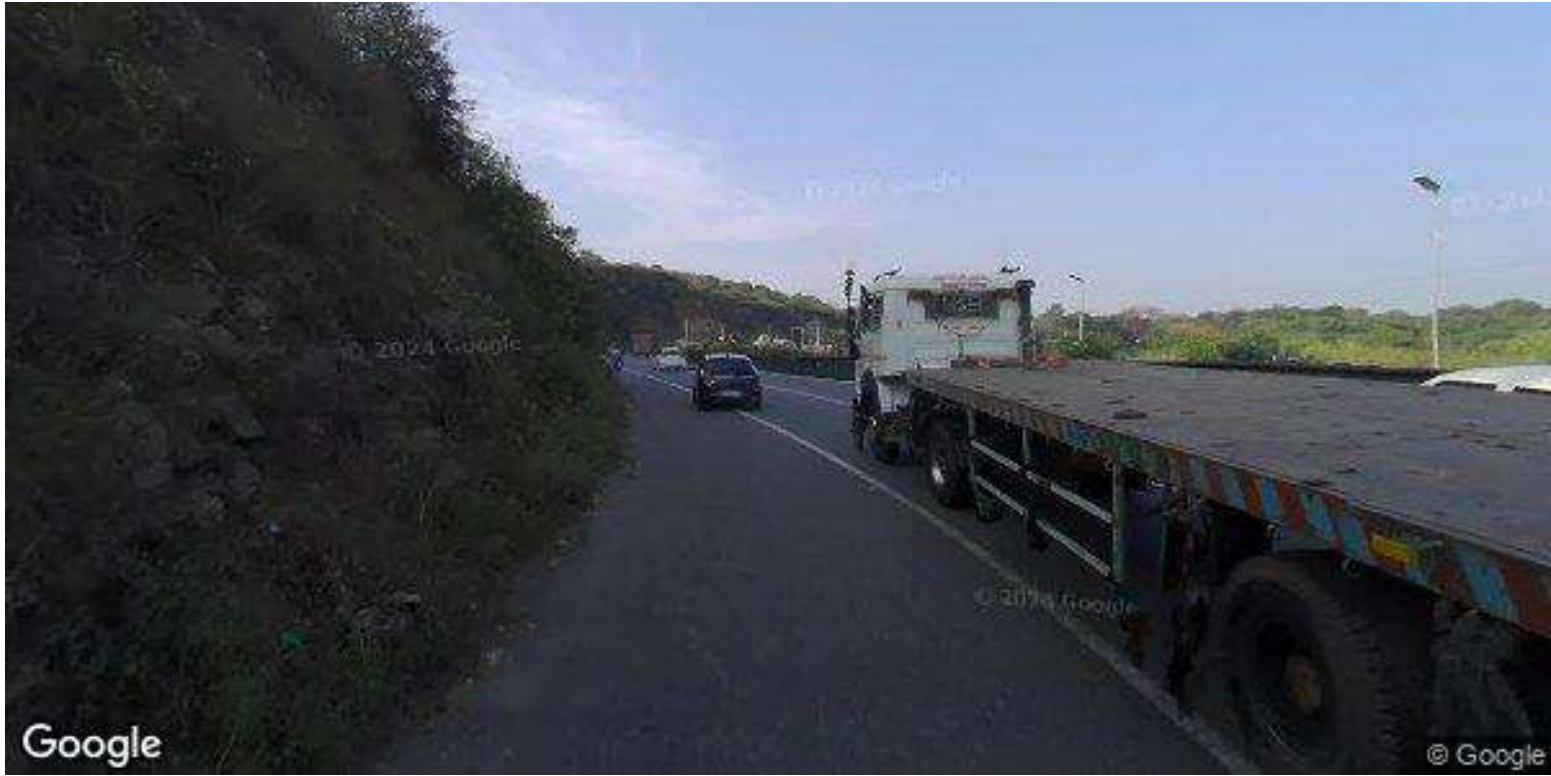
**Risk Type:** Turn  
**Risk Level:** Medium  
**Speed Limit:** 30 KM/Hr  
**Coordinates:** 11.95876, 78.04990

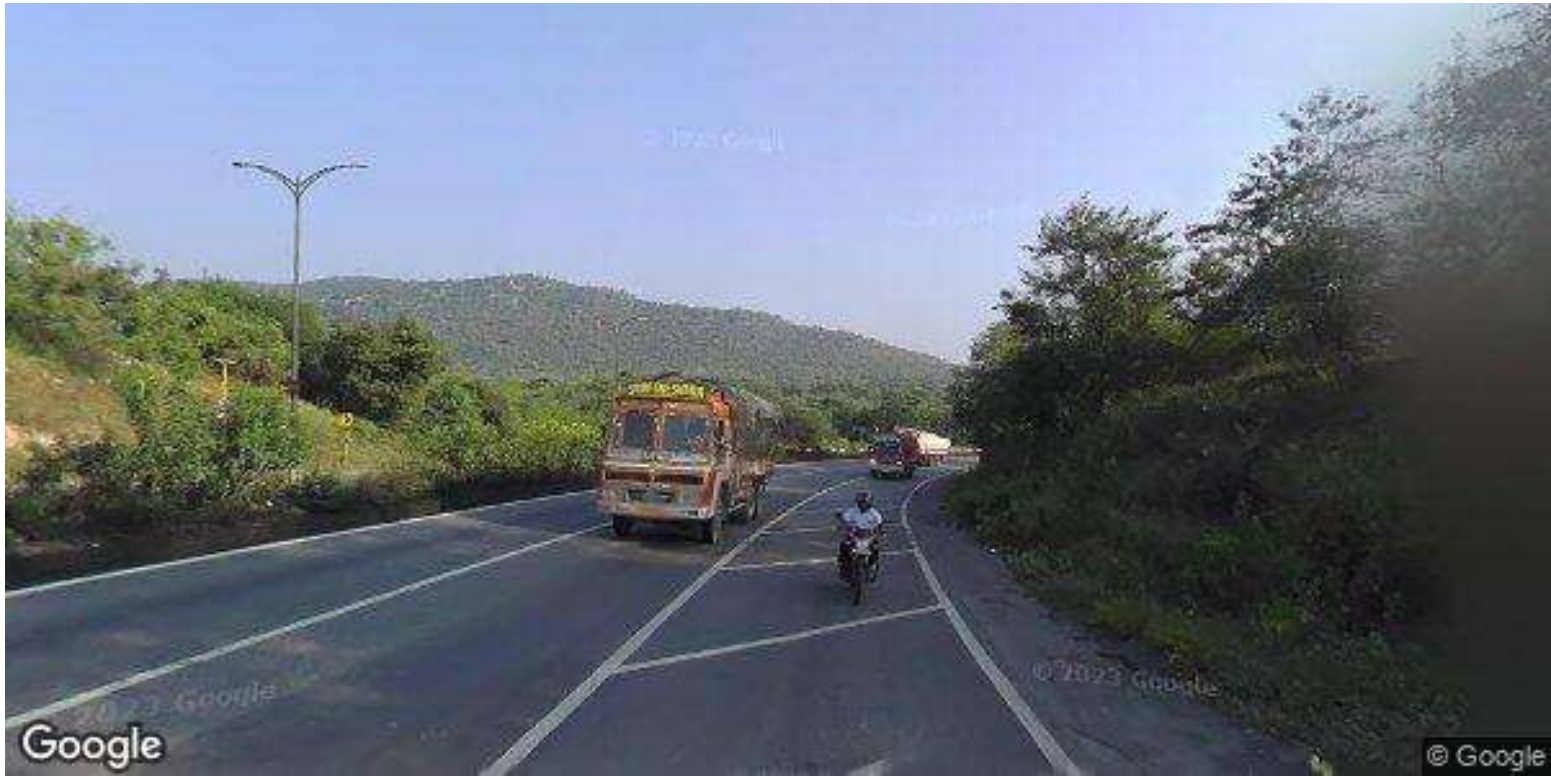
**Risk Type:** Turn  
**Risk Level:** Medium  
**Speed Limit:** 30 KM/Hr  
**Coordinates:** 11.96458, 78.05084

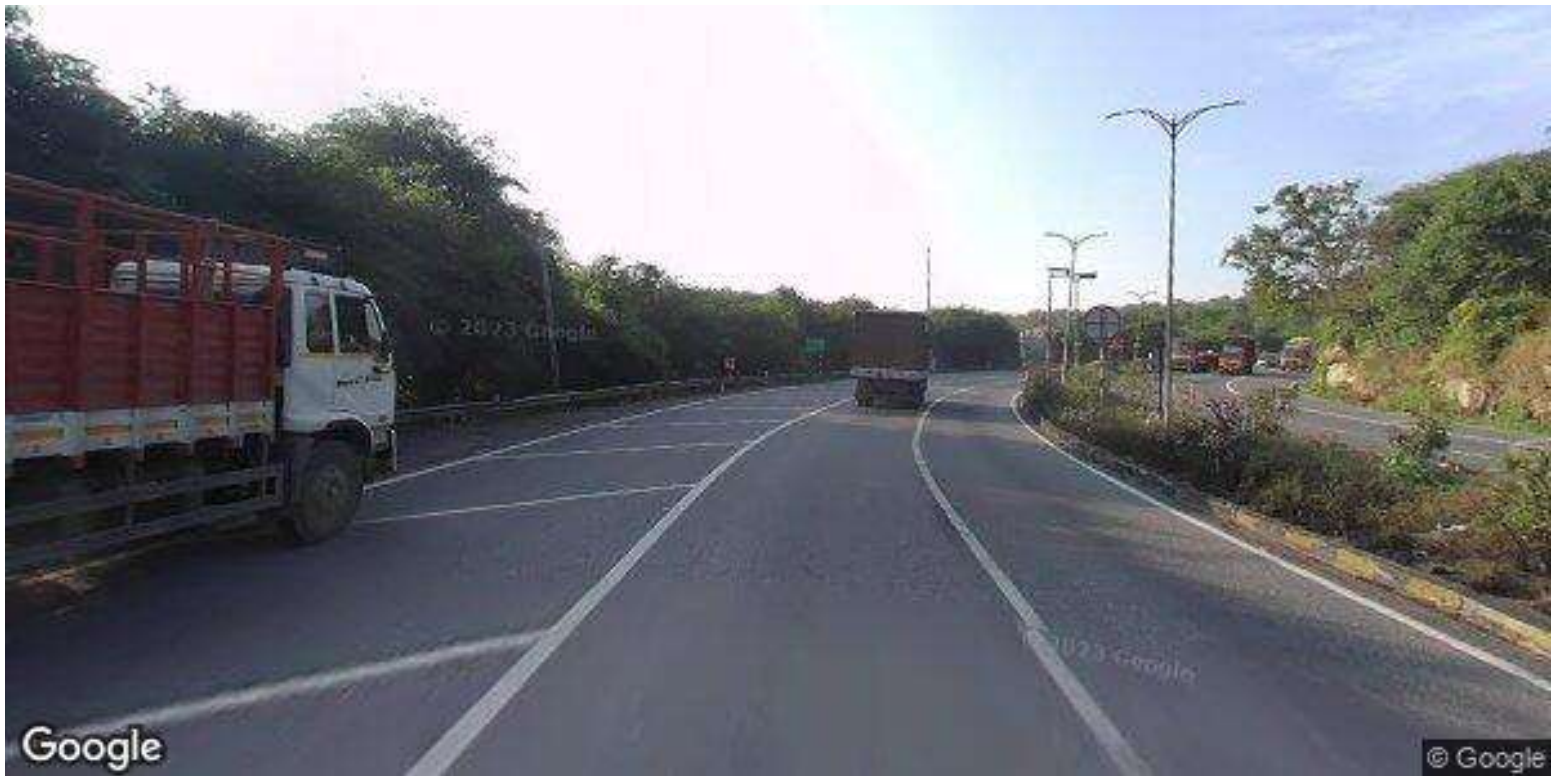
**Risk Type:** Turn  
**Risk Level:** Medium  
**Speed Limit:** 30 KM/Hr  
**Coordinates:** 11.96496, 78.04988

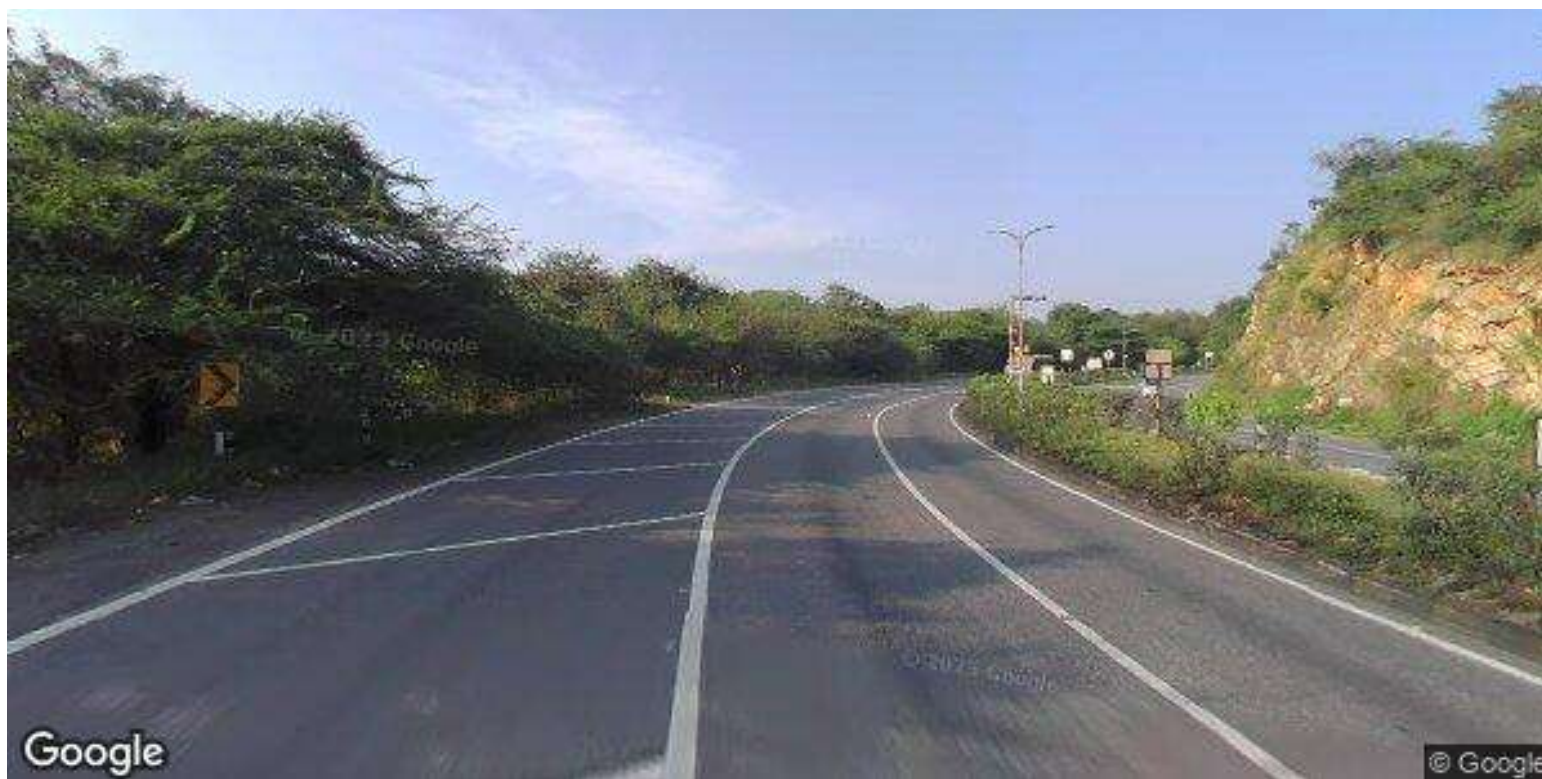
**Coordinates:** 11.96580, 78.04923

**Risk Type:** Turn

**Risk Level:** High

**Speed Limit:** 15 KM/Hr

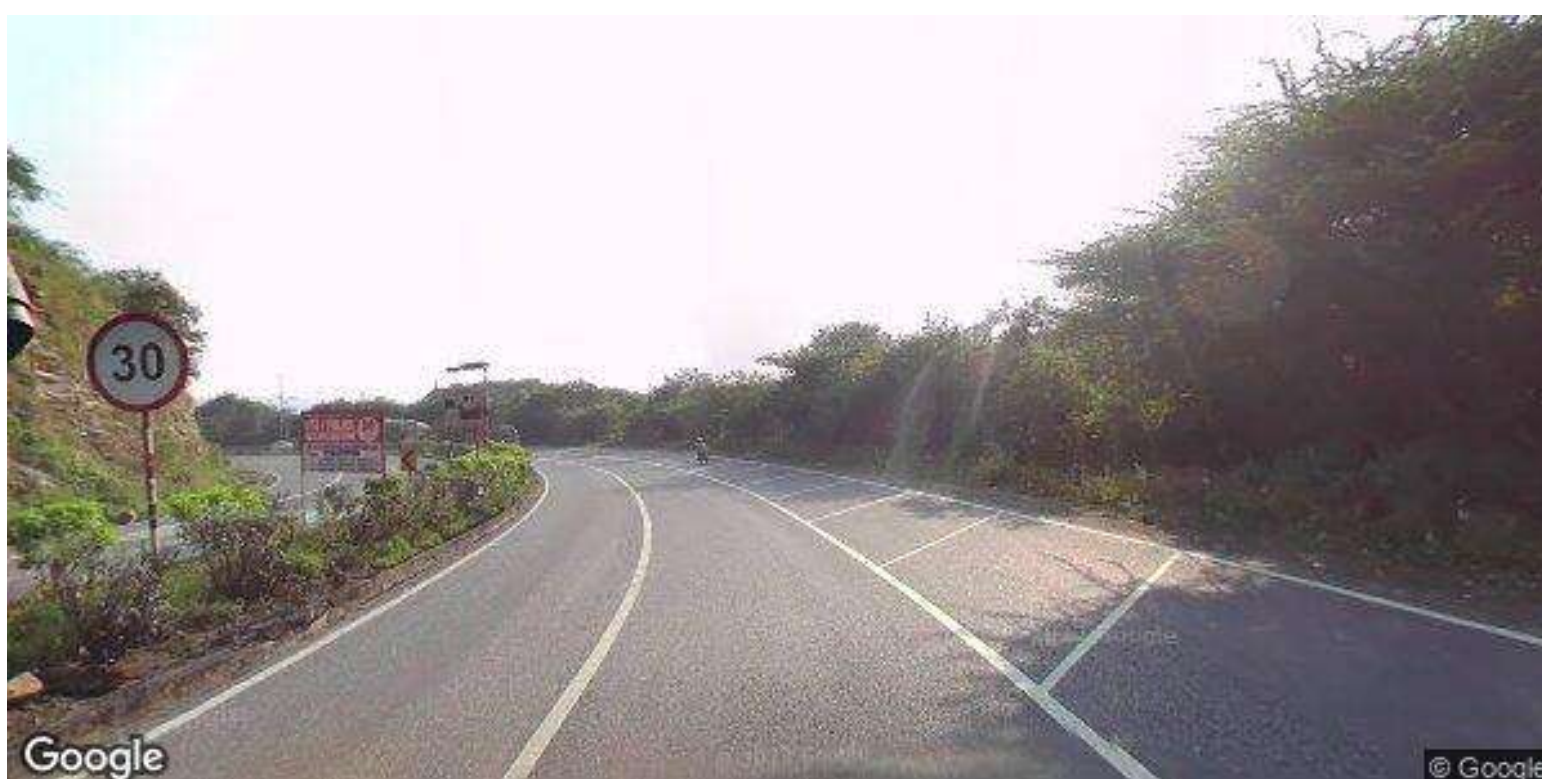
**Coordinates:** 11.96675, 78.04939

**Risk Type:** Turn

**Risk Level:** Medium

**Speed Limit:** 30 KM/Hr

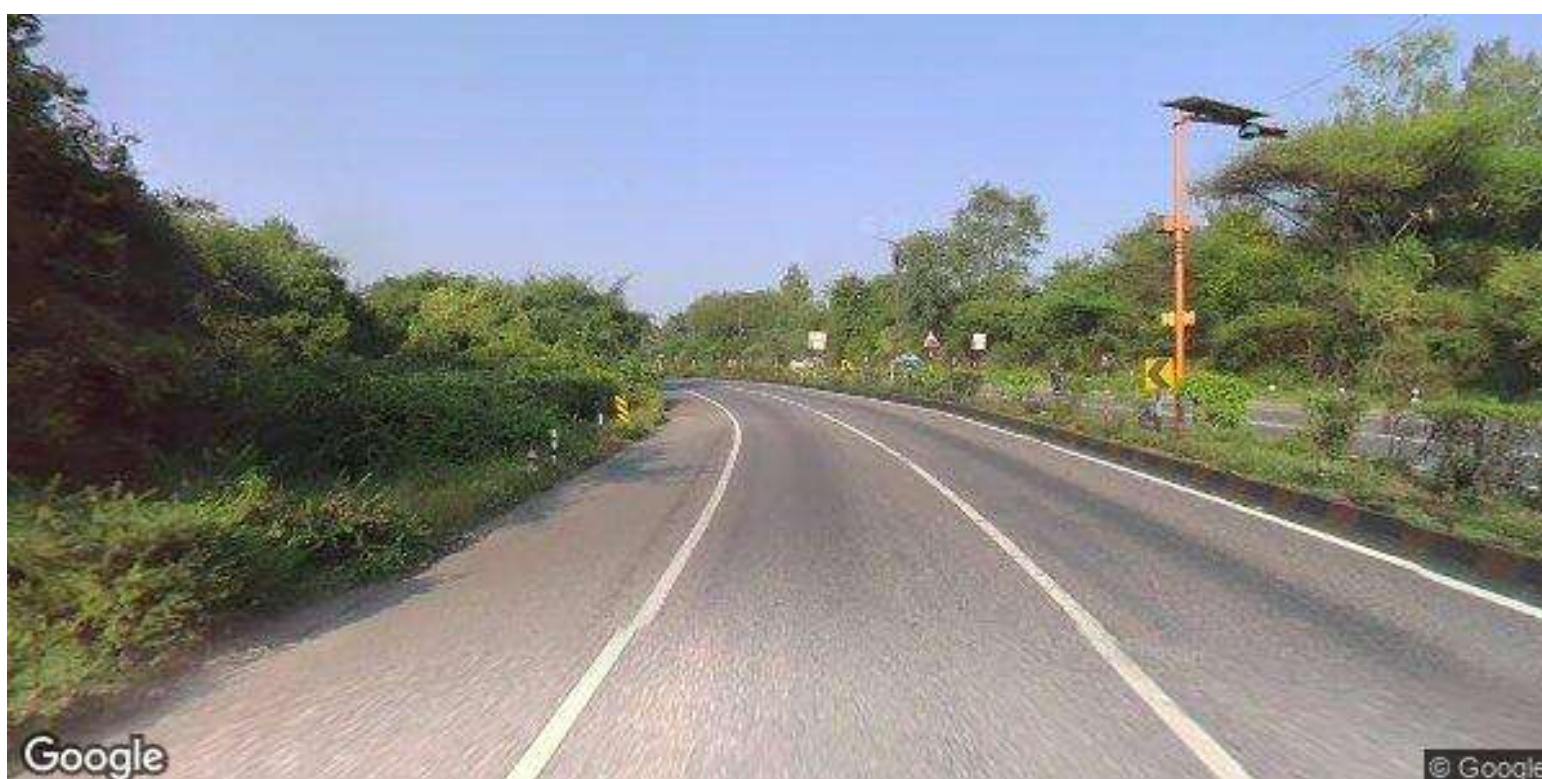
**Risk Type:** Turn  
**Risk Level:** Medium  
**Speed Limit:** 30 KM/Hr  
**Coordinates:** 11.96791, 78.05070

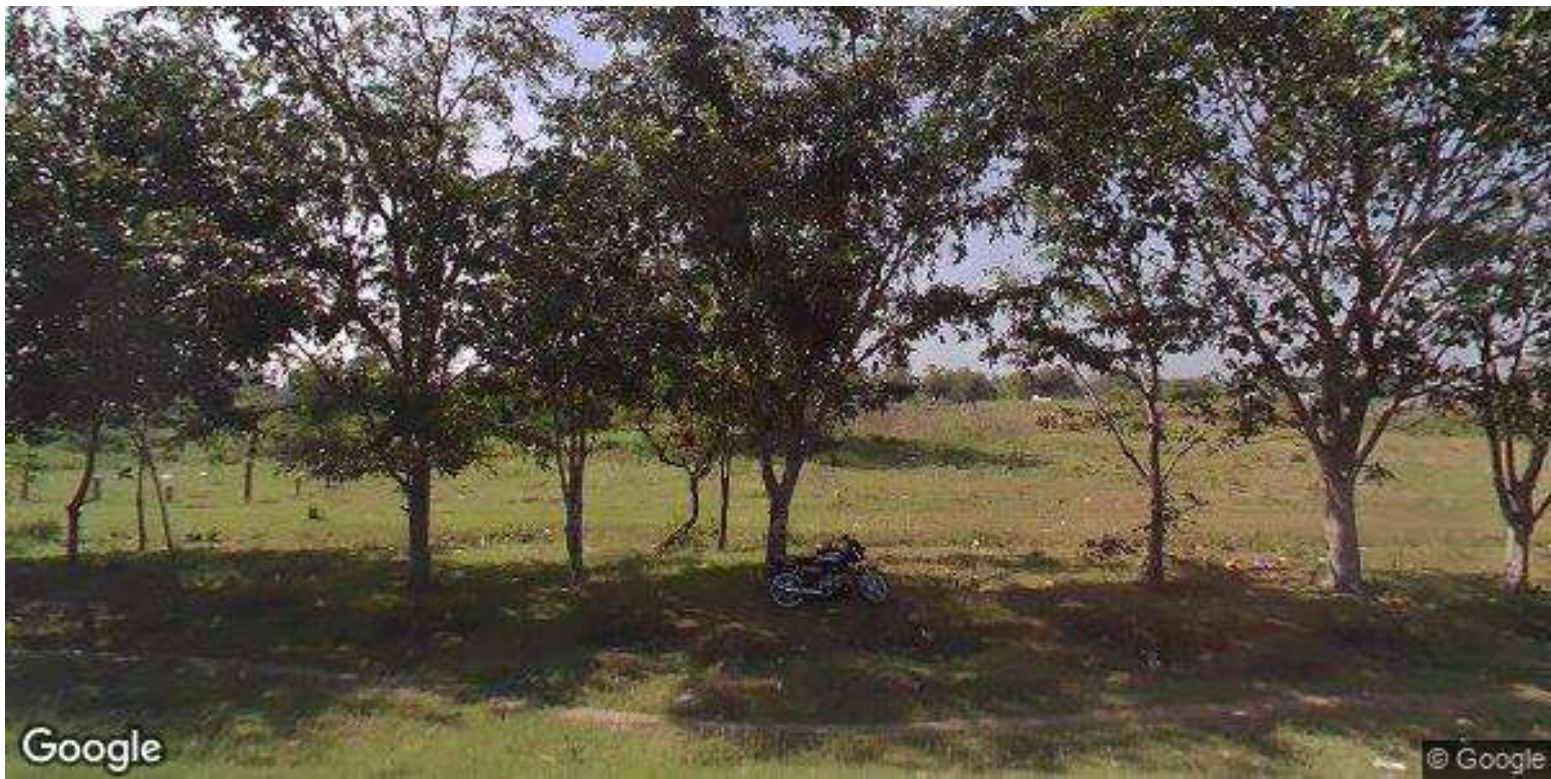
**Risk Type:** Turn  
**Risk Level:** Medium  
**Speed Limit:** 30 KM/Hr  
**Coordinates:** 12.12058, 78.13283

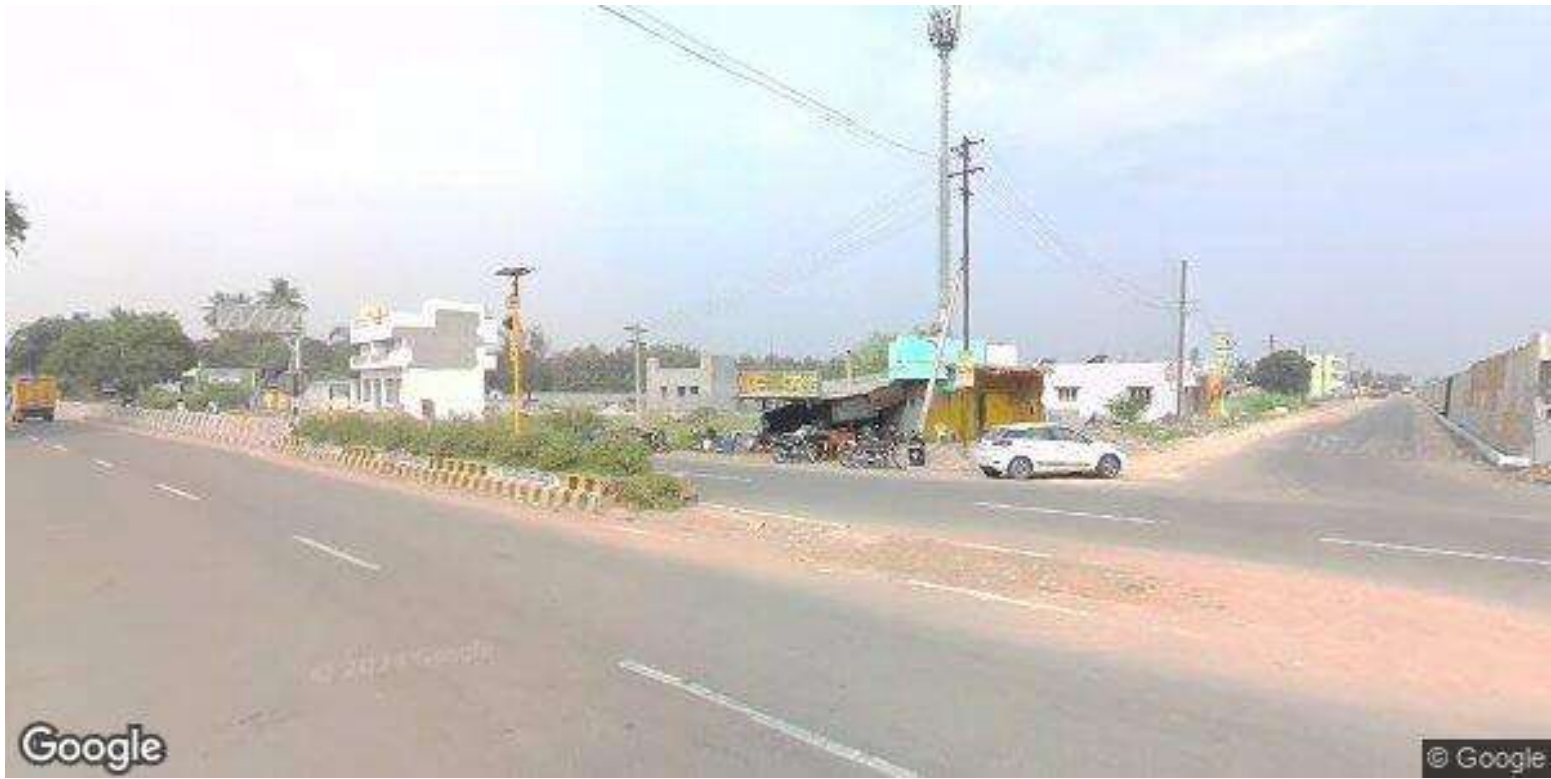
**Risk Type:** Turn  
**Risk Level:** High  
**Speed Limit:** 15 KM/Hr  
**Coordinates:** 12.14089, 78.12817
