## JOURNEY RISK MANAGEMENT (JRM) STUDY

### Salem Terminal TO HS FUELS

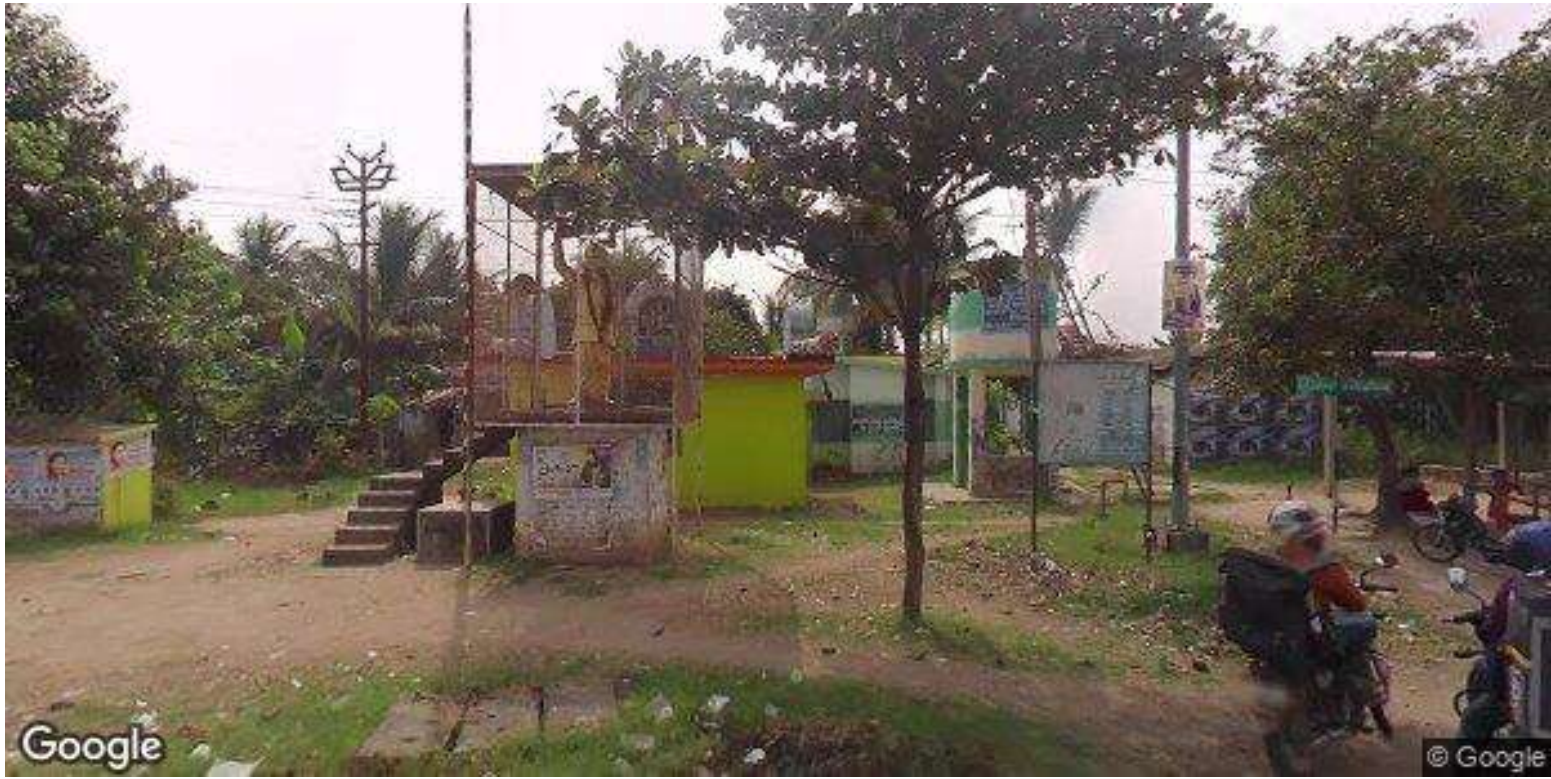
Coordinates: 12.14449, 78.09686

Risk Type: Turn

Risk Level: Medium

Speed Limit: 30 KM/Hr

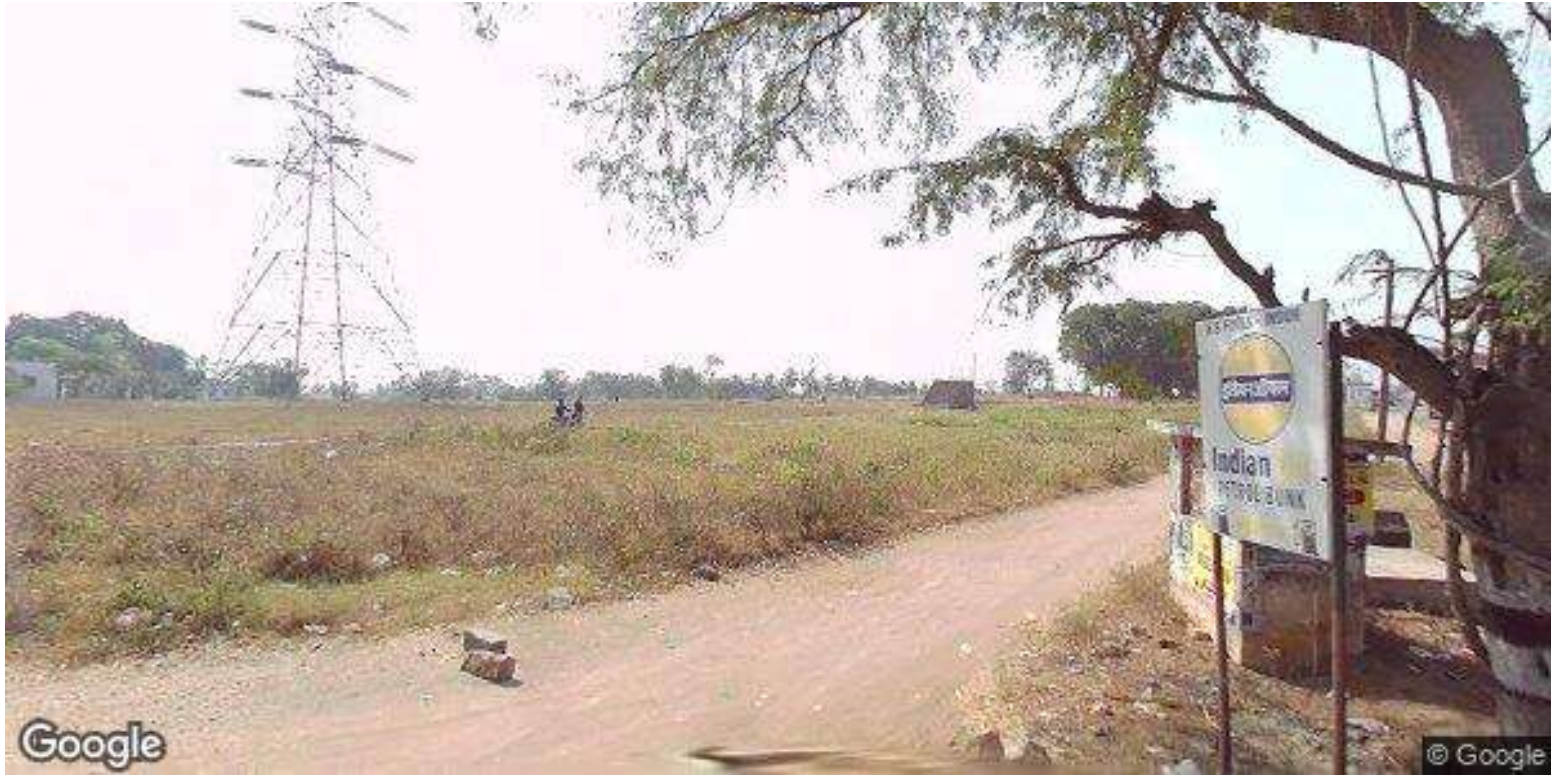
Coordinates: 12.13376, 78.06510

Risk Type: Turn

Risk Level: High

Speed Limit: 15 KM/Hr

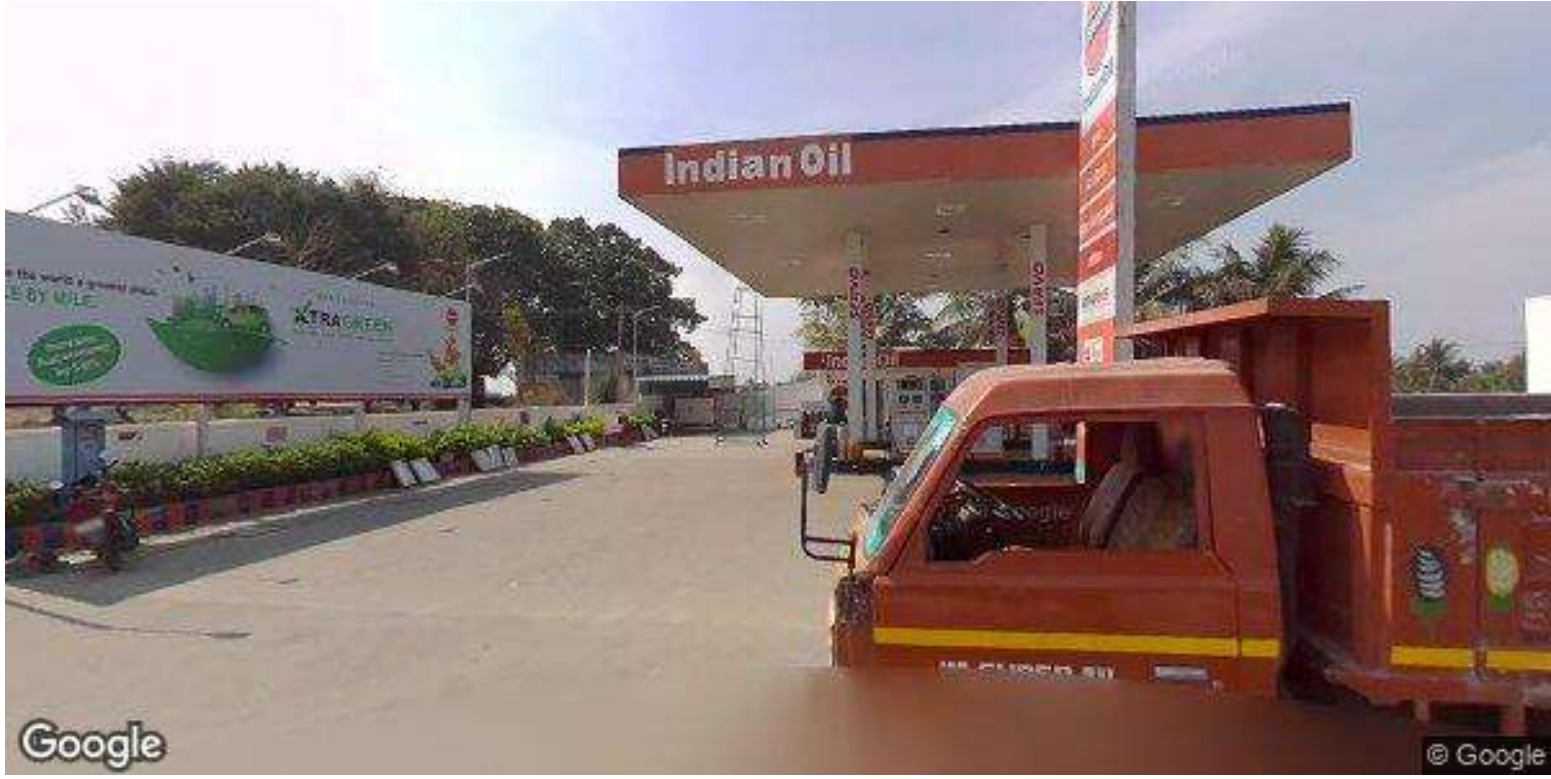
**Coordinates:** 12.13281, 78.06457

**Risk Type:** Turn

**Risk Level:** High

**Speed Limit:** 15 KM/Hr
