# IndianOil

## JOURNEY RISK MANAGEMENT (JRM) STUDY

### Salem Terminal TO MANICKAMALAYAN AGENCIES

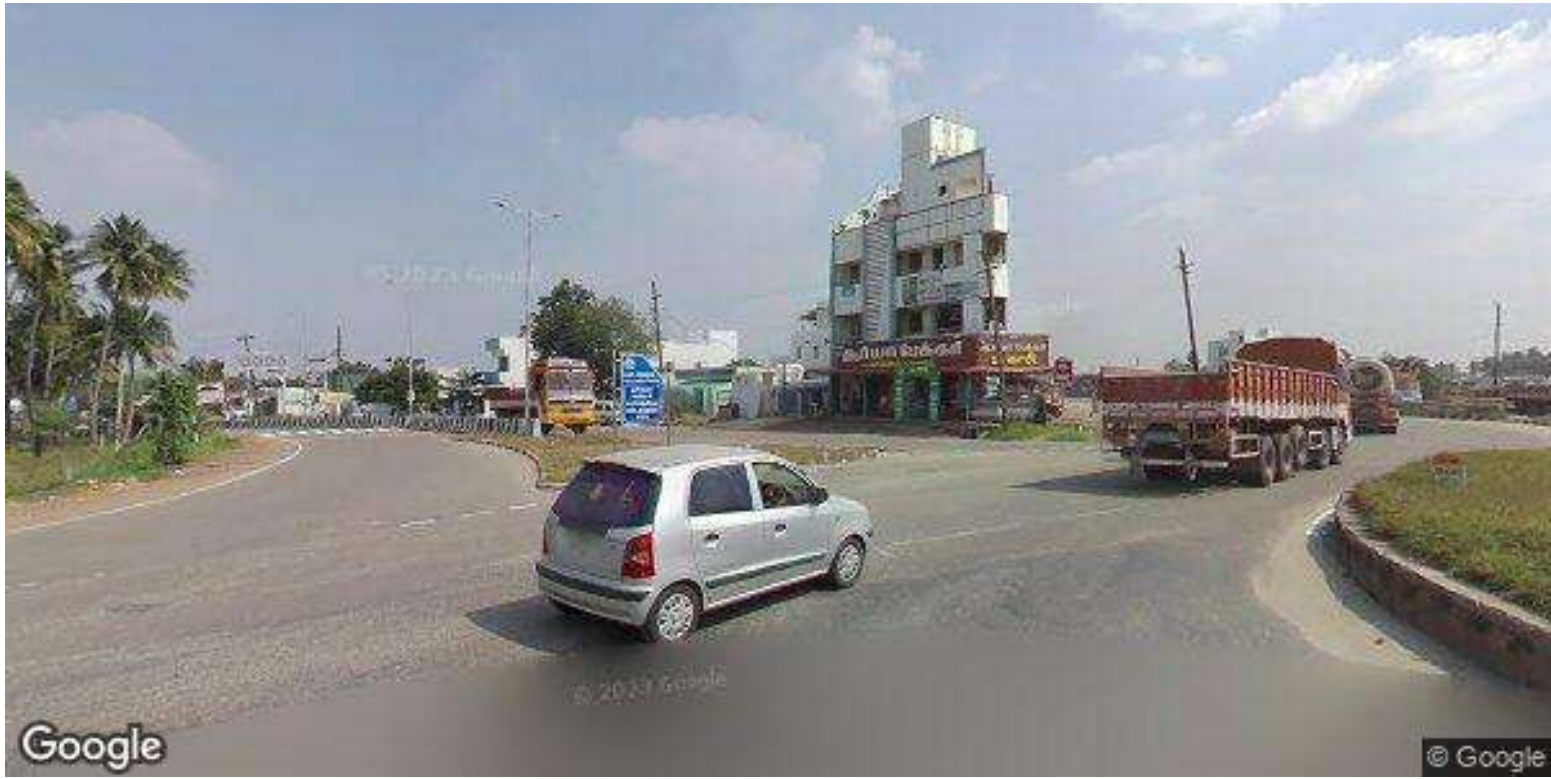
**Risk Type:** Roundabout  
**Risk Level:** High  
**Speed Limit:** 15 KM/Hr  
**Coordinates:** 10.92958, 78.05452

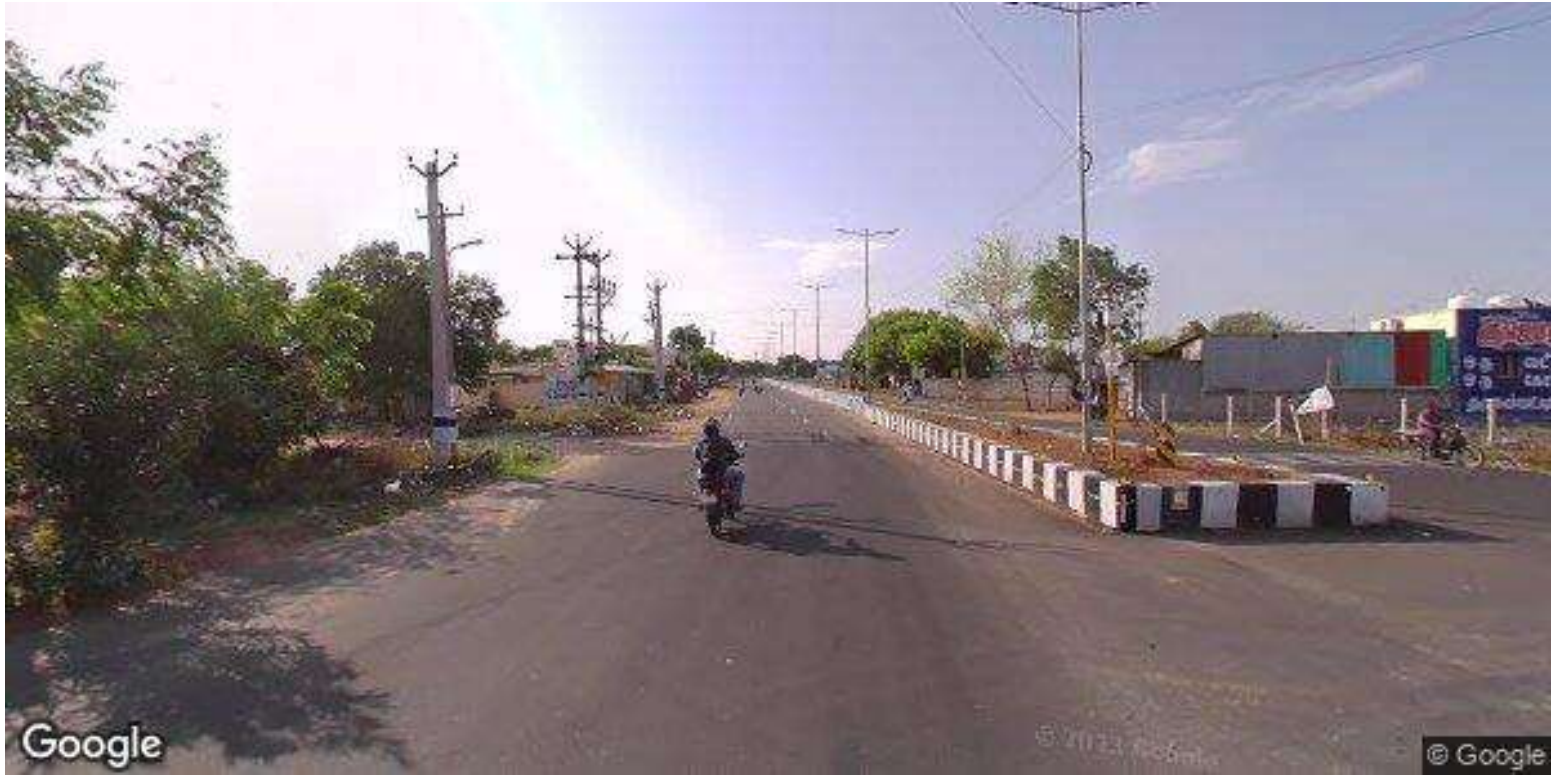
**Risk Type:** U-Turn  
**Risk Level:** High  
**Speed Limit:** 10 KM/Hr  
**Coordinates:** 10.9110477, 78.09713769999999

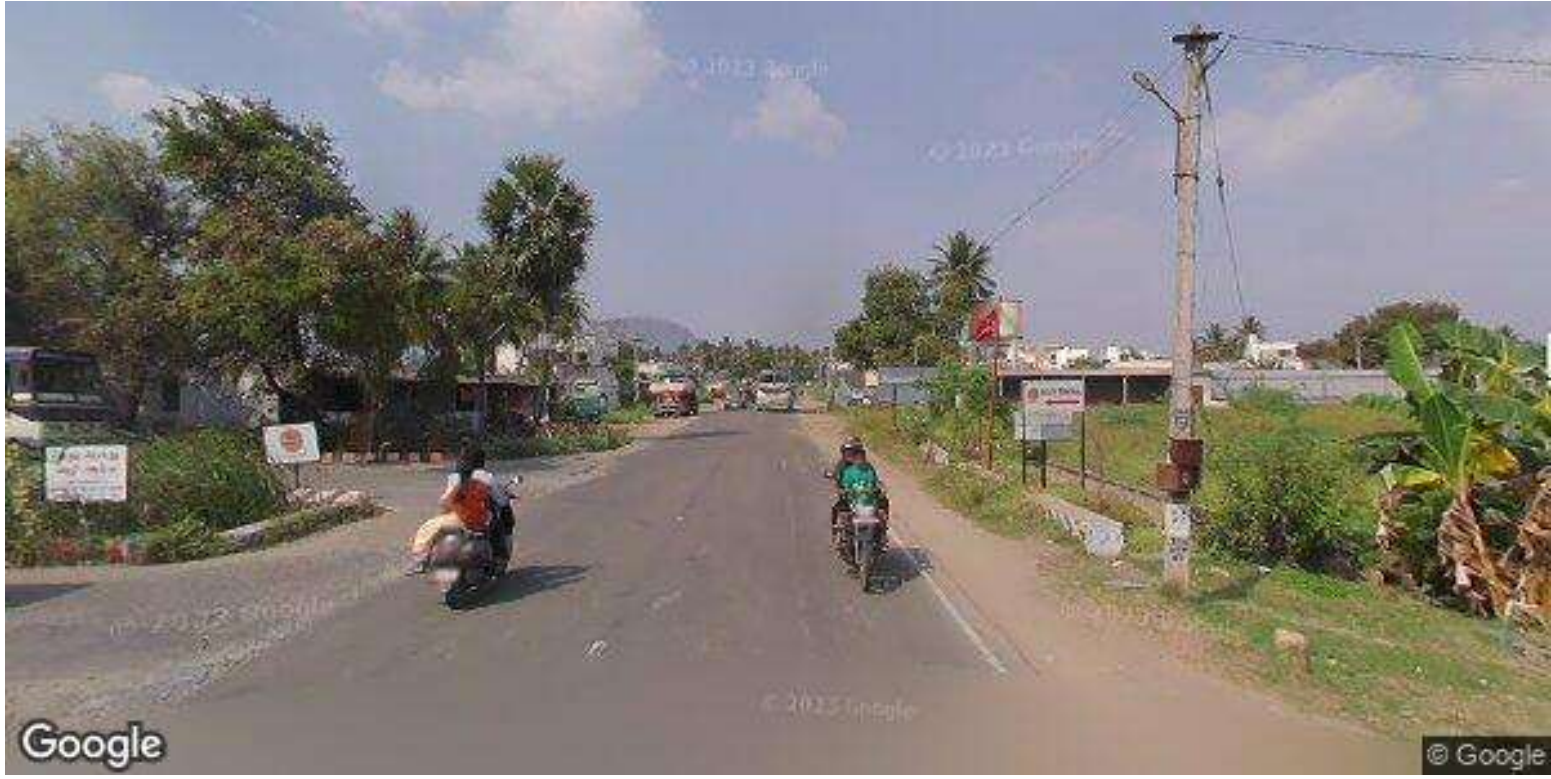
**Risk Type: Turn**

**Risk Level: High**

**Speed Limit: 15 KM/Hr**

**Coordinates: 11.44019, 77.87547**

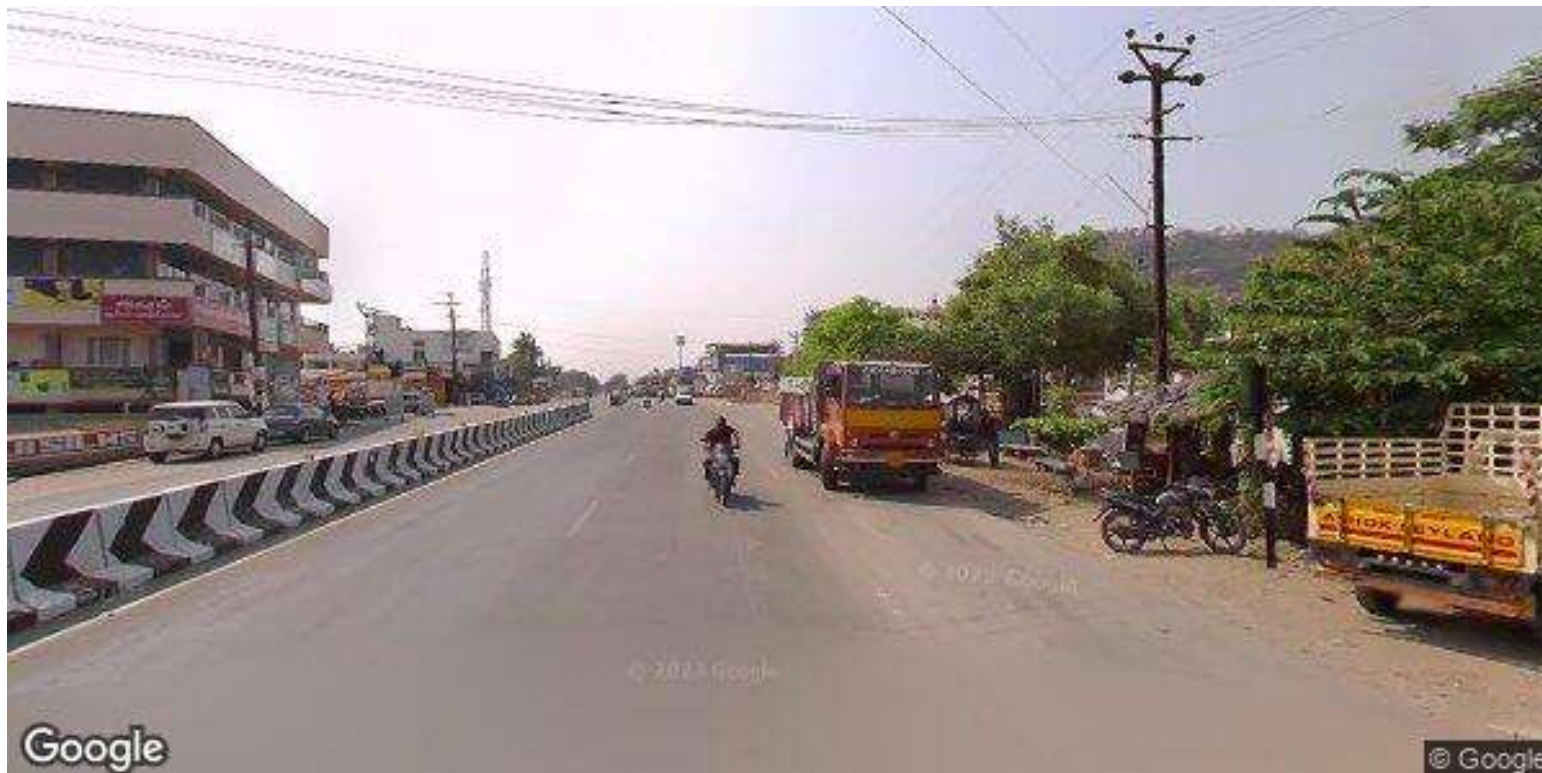
**Risk Type: Turn**

**Risk Level: Medium**

**Speed Limit: 30 KM/Hr**

**Coordinates: 11.39685, 77.88861**

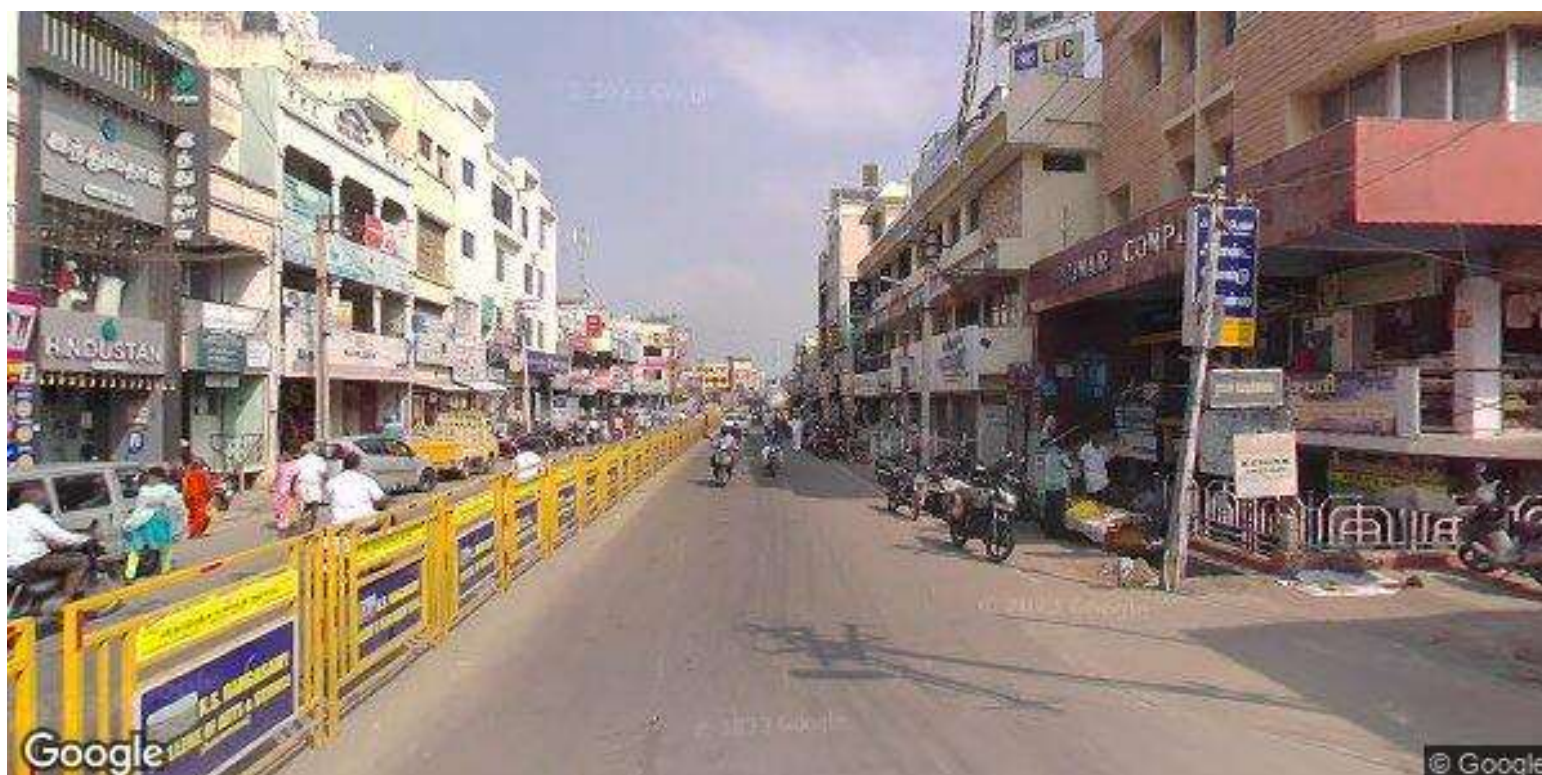
**Risk Type: Turn**

**Risk Level: Medium**

**Speed Limit: 30 KM/Hr**

**Coordinates: 11.37902, 77.89500**

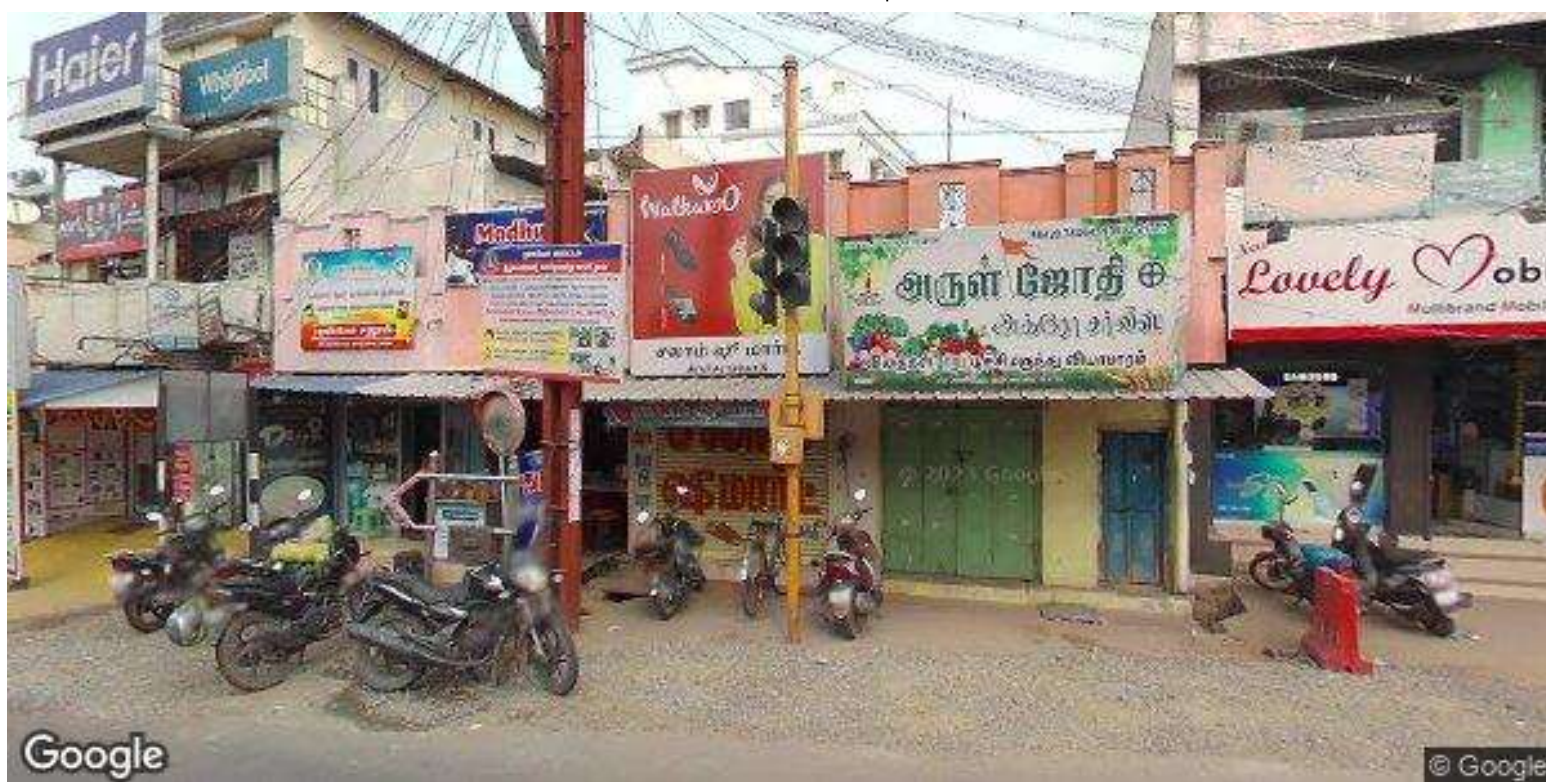
**Risk Type:** Turn

**Risk Level:** Medium

**Speed Limit:** 30 KM/Hr

**Coordinates:** 11.37850, 77.89453

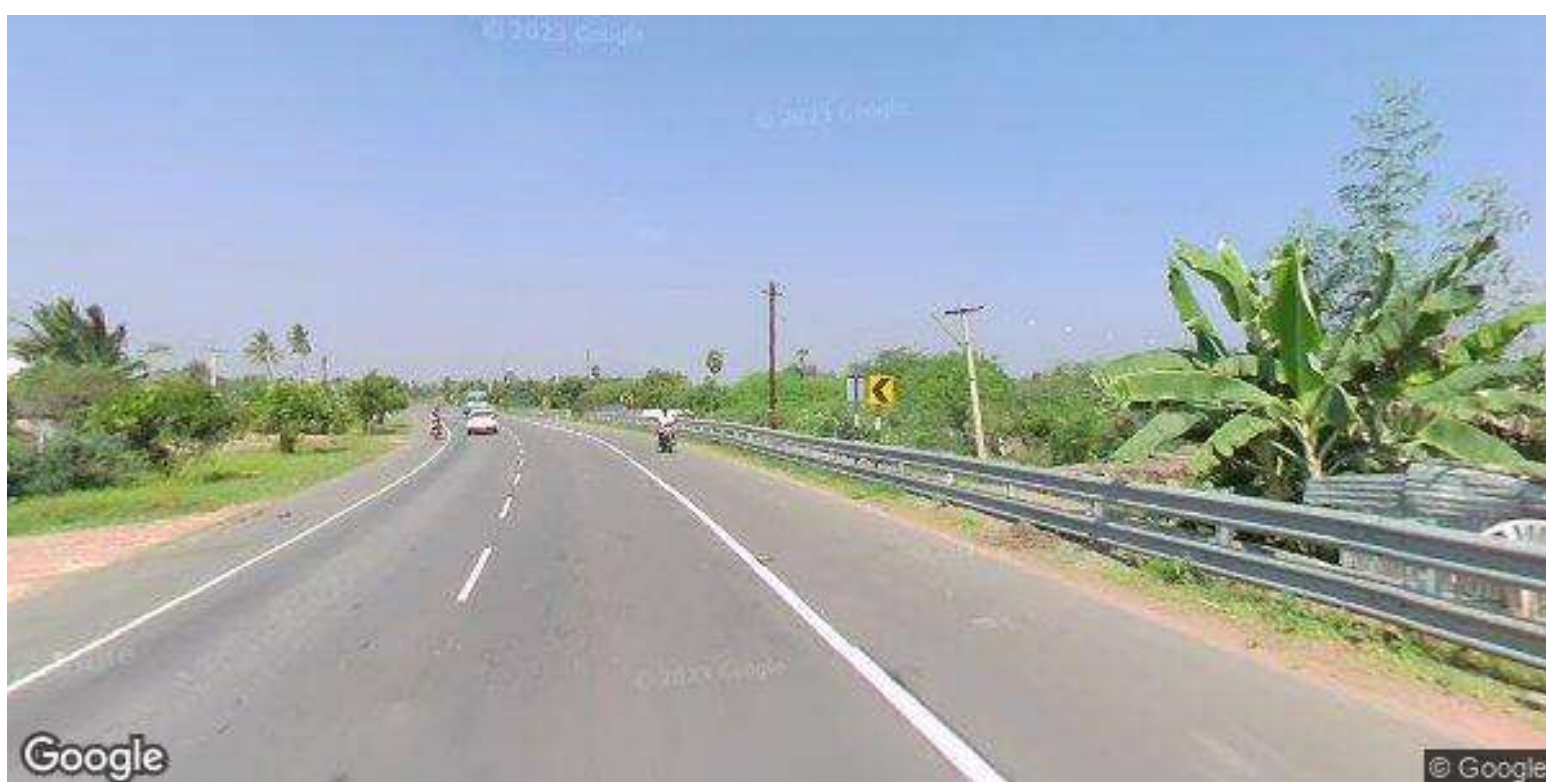
**Risk Type:** Turn

**Risk Level:** Medium

**Speed Limit:** 30 KM/Hr

**Coordinates:** 11.16950, 78.01544

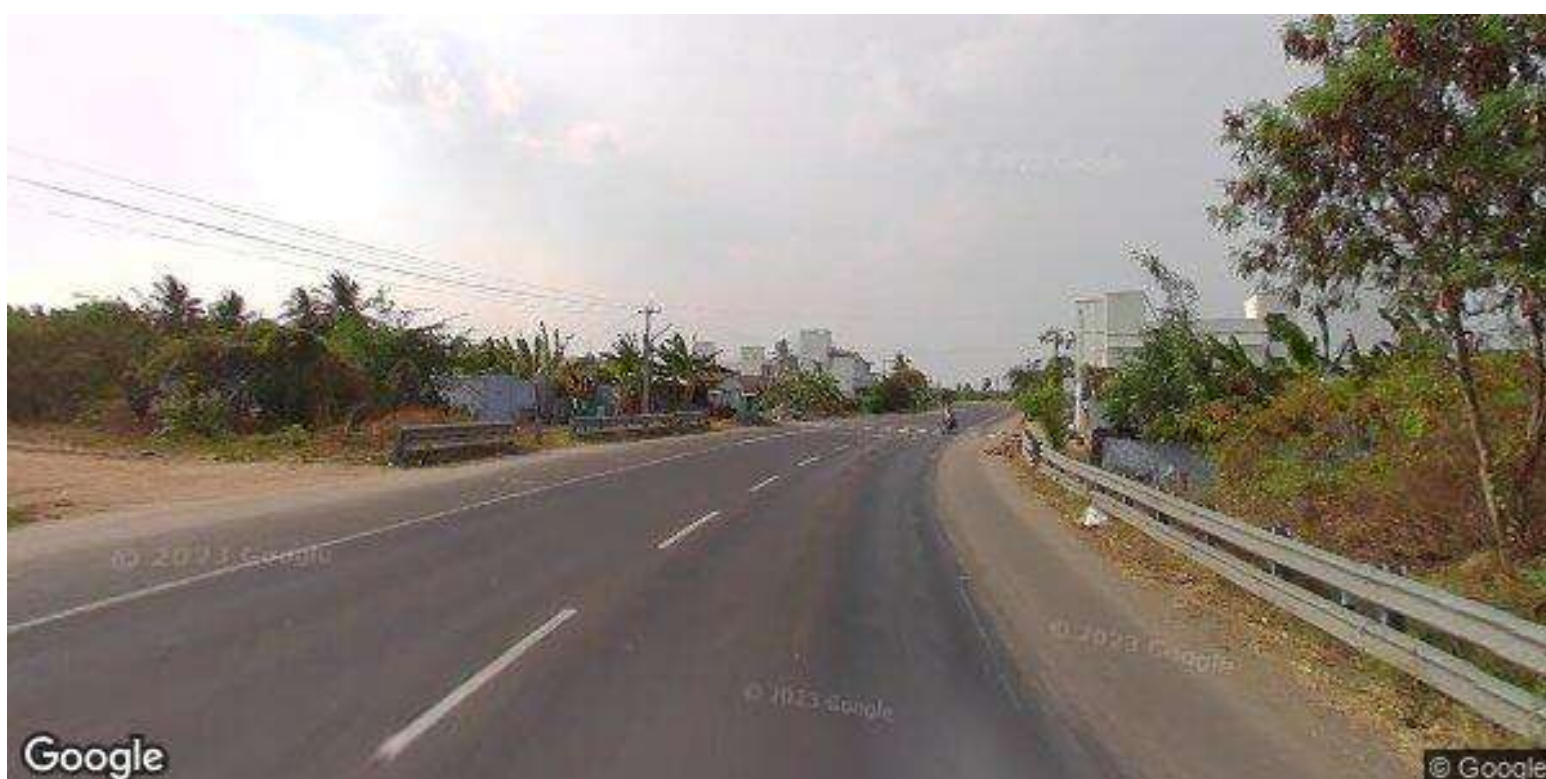
Risk Type: Turn

Risk Level: Medium

Speed Limit: 30 KM/Hr

Coordinates: 11.16764, 78.01565

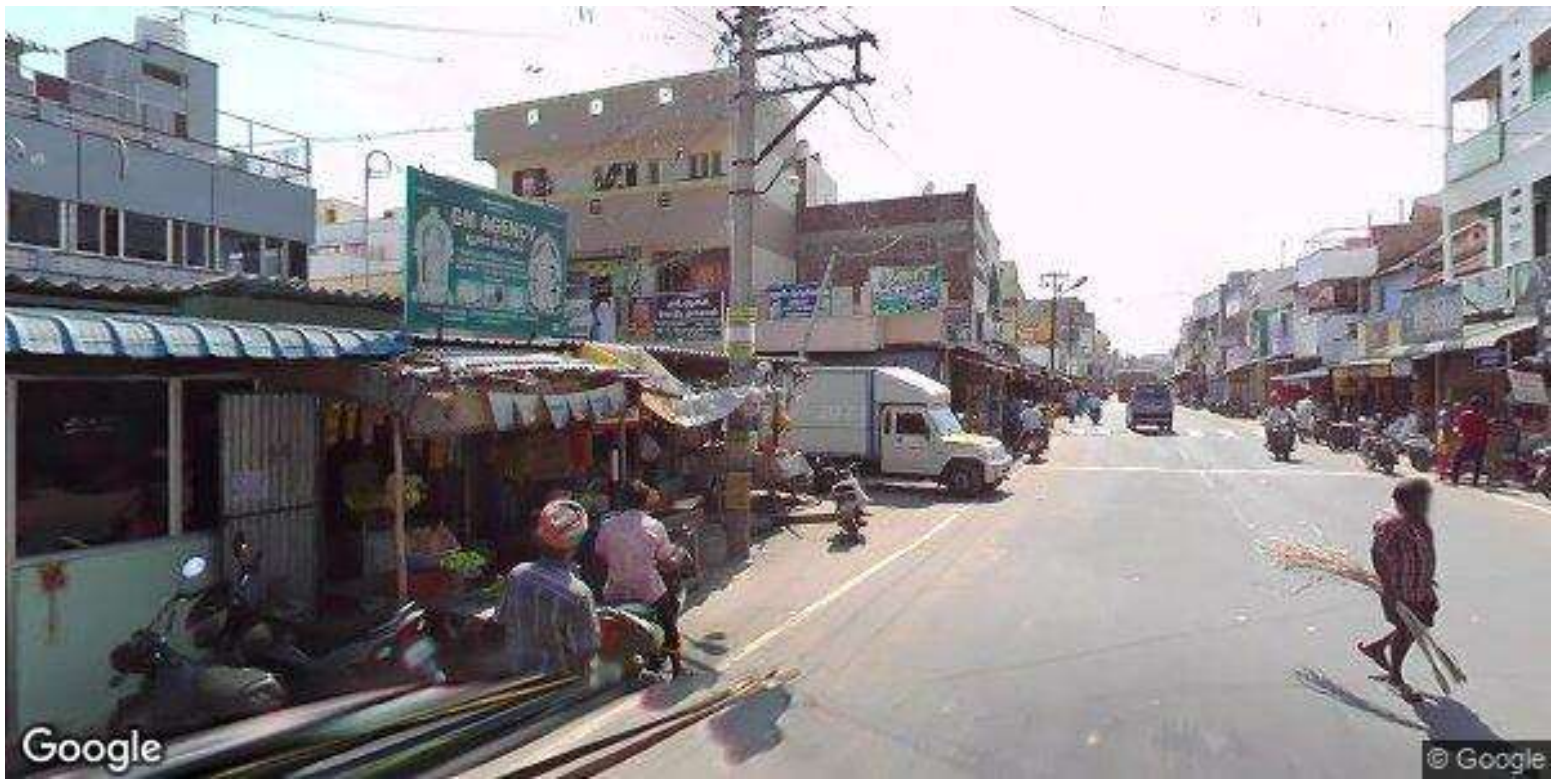
Risk Type: Turn

Risk Level: Medium

Speed Limit: 30 KM/Hr

Coordinates: 11.15546, 78.02170

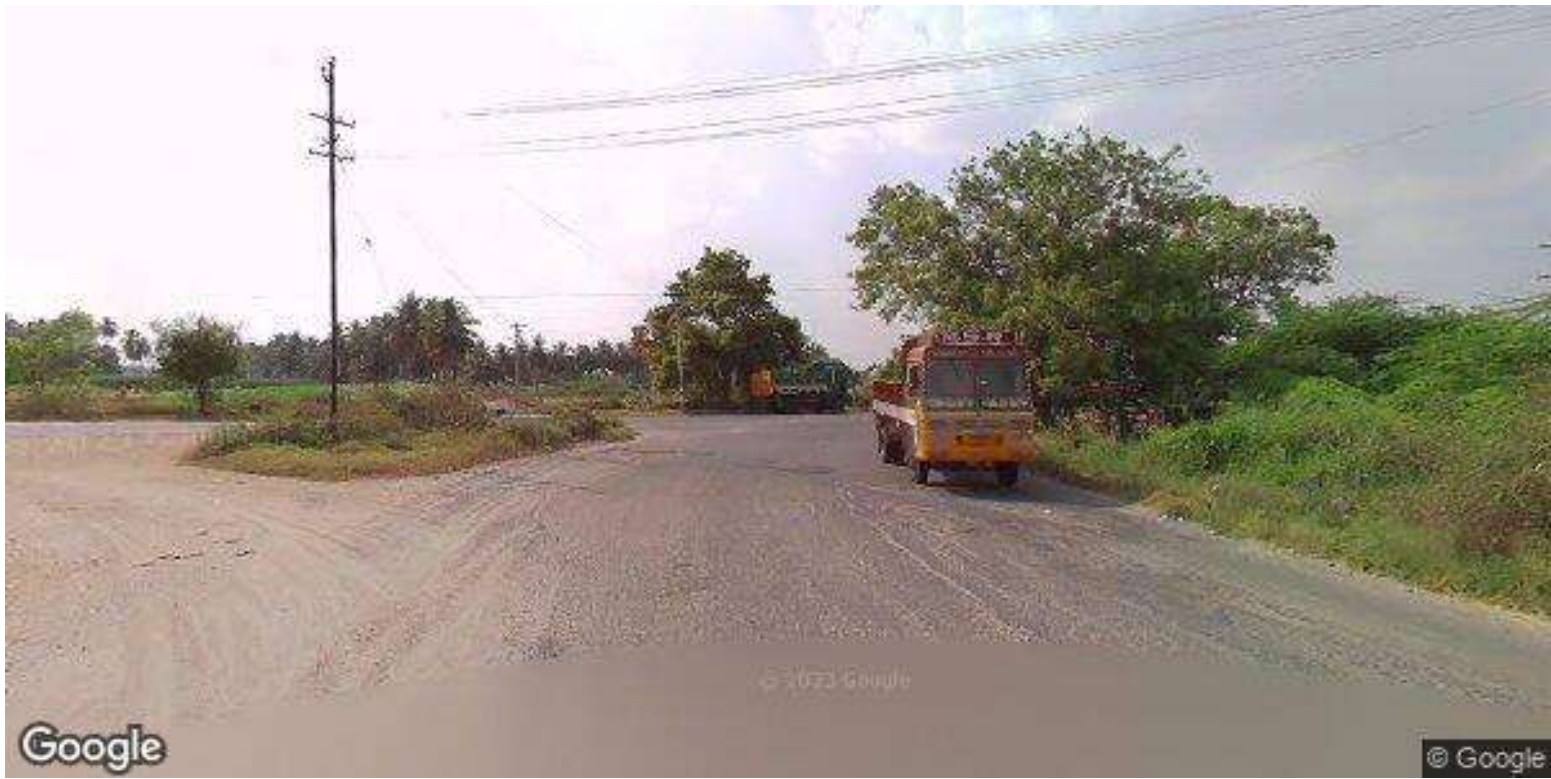
Risk Type: Turn

Risk Level: High

Speed Limit: 15 KM/Hr

Coordinates: 11.14521, 78.02239

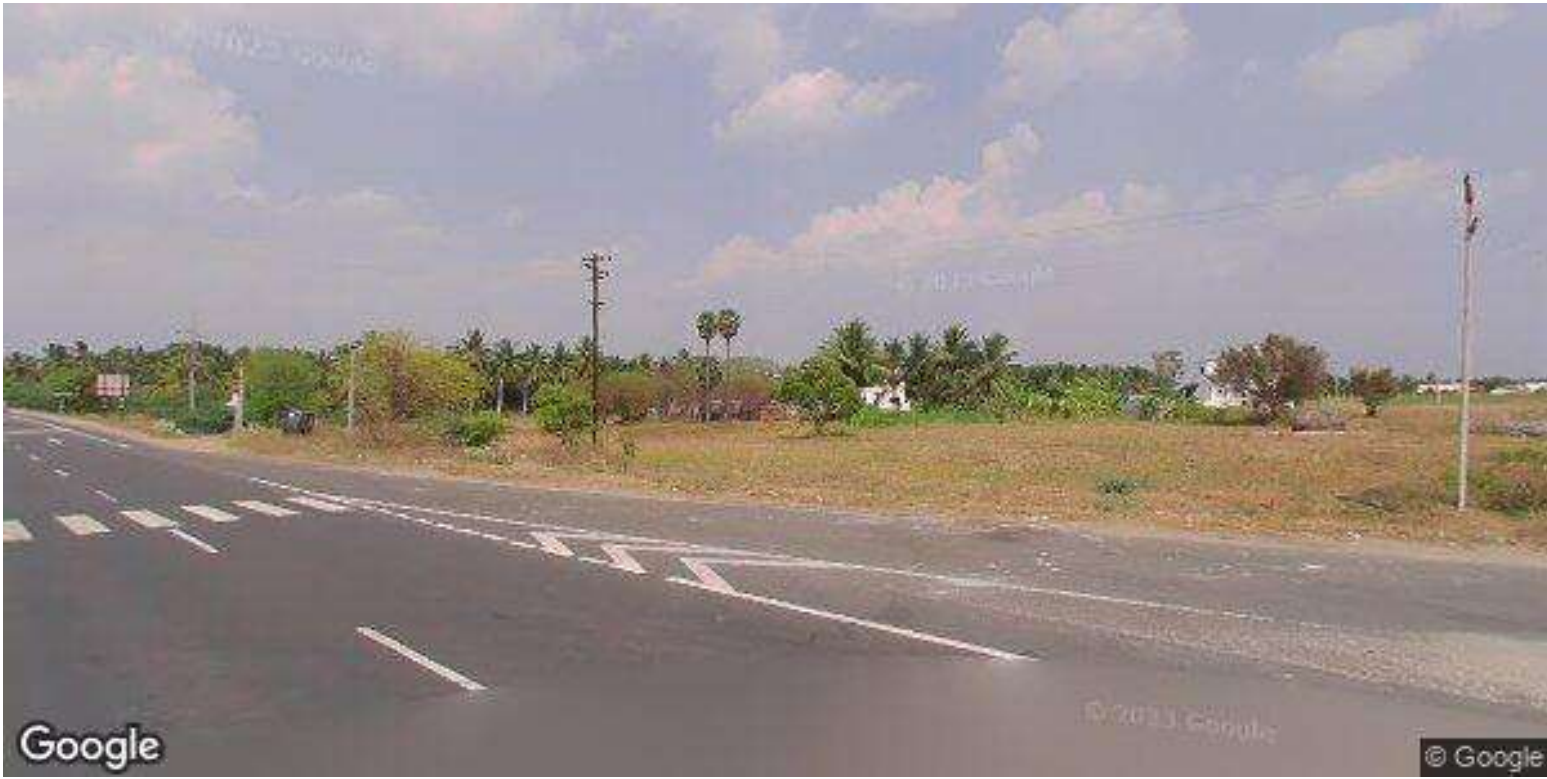
**Risk Type:** Turn  
**Risk Level:** High  
**Speed Limit:** 15 KM/Hr  
**Coordinates:** 11.14480, 78.02291

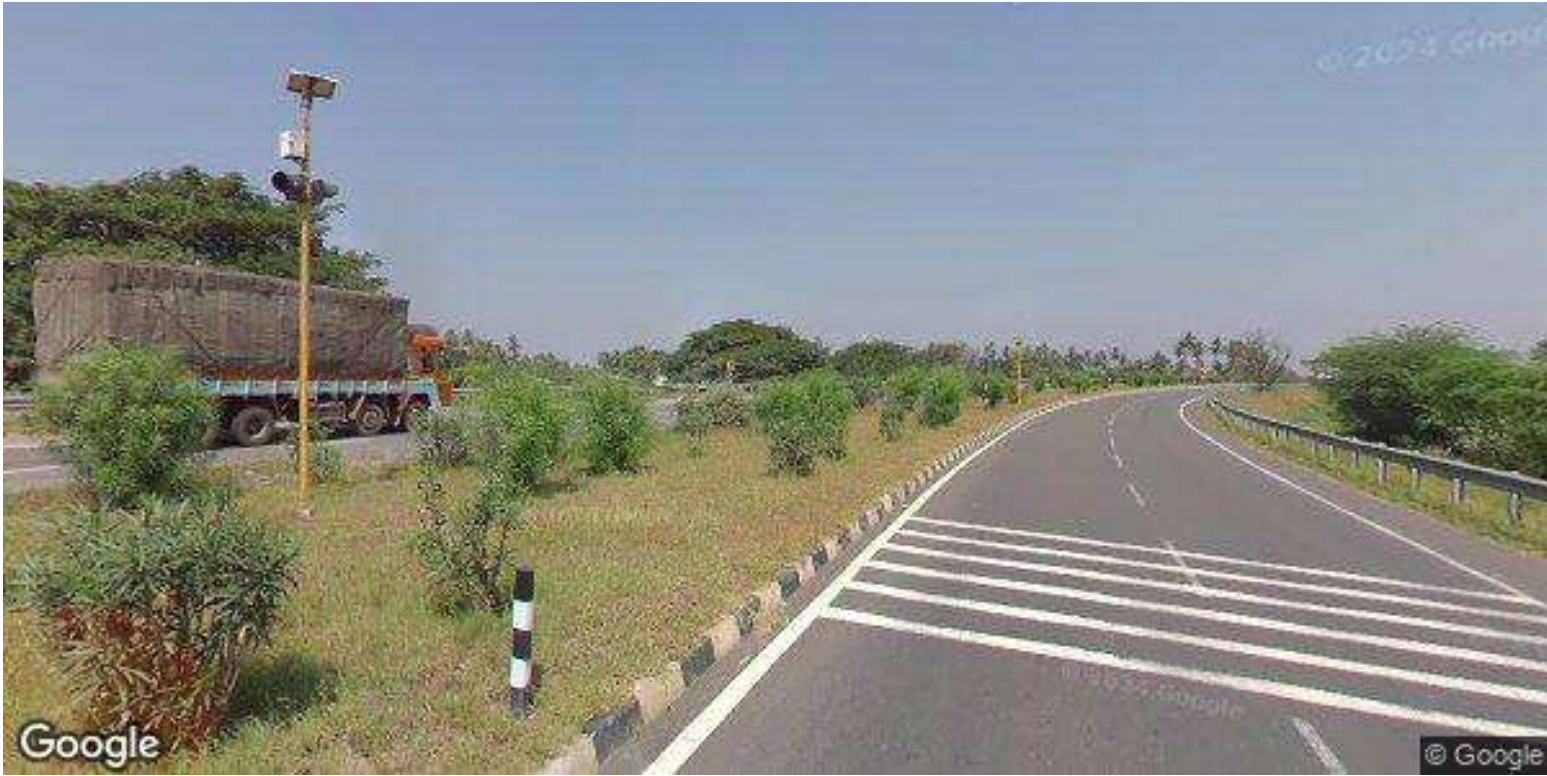
**Risk Type:** Turn  
**Risk Level:** Medium  
**Speed Limit:** 30 KM/Hr  
**Coordinates:** 11.10102, 78.00572

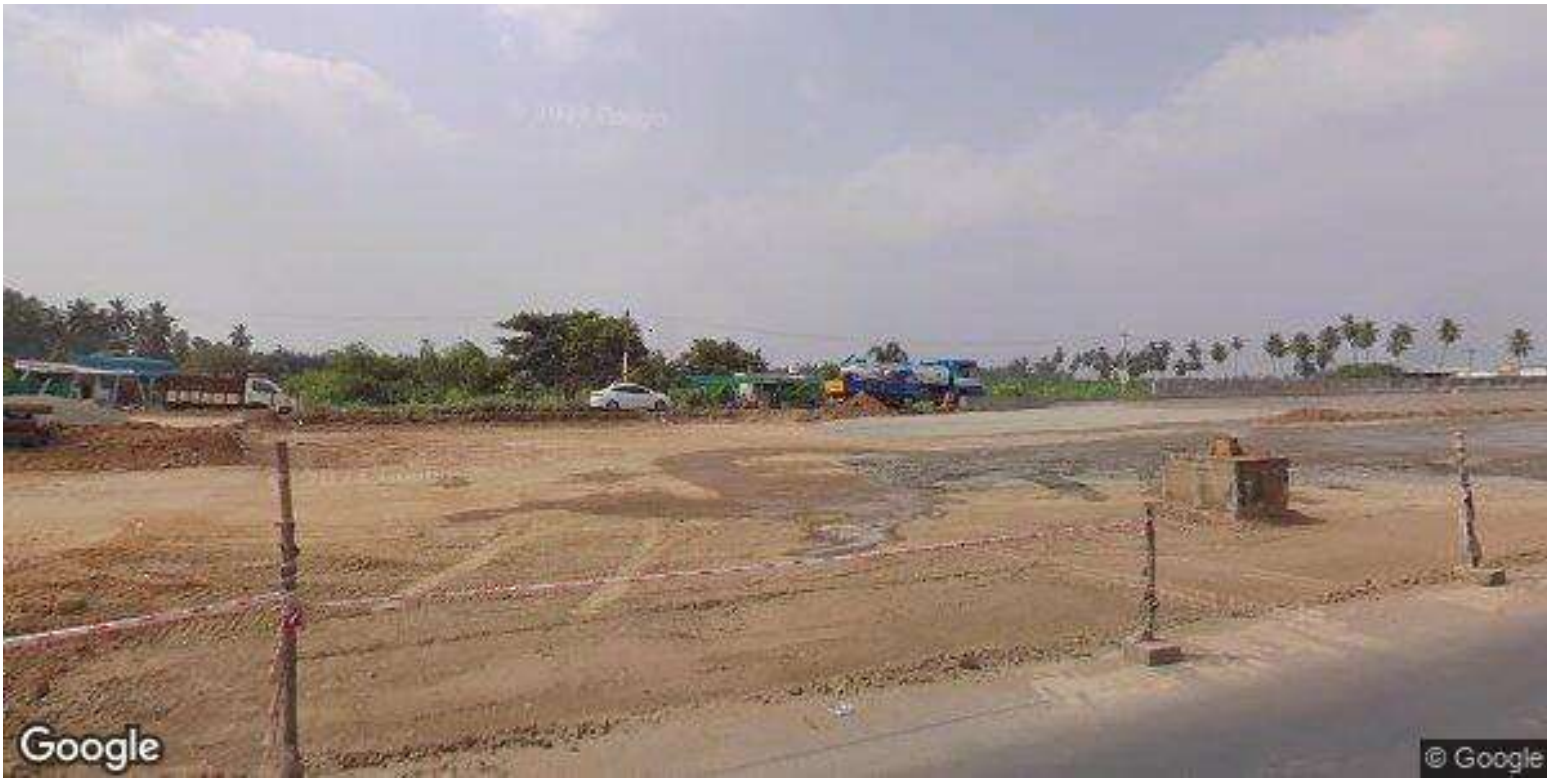
**Risk Type:** Turn  
**Risk Level:** Medium  
**Speed Limit:** 30 KM/Hr  
**Coordinates:** 11.08294, 78.00335

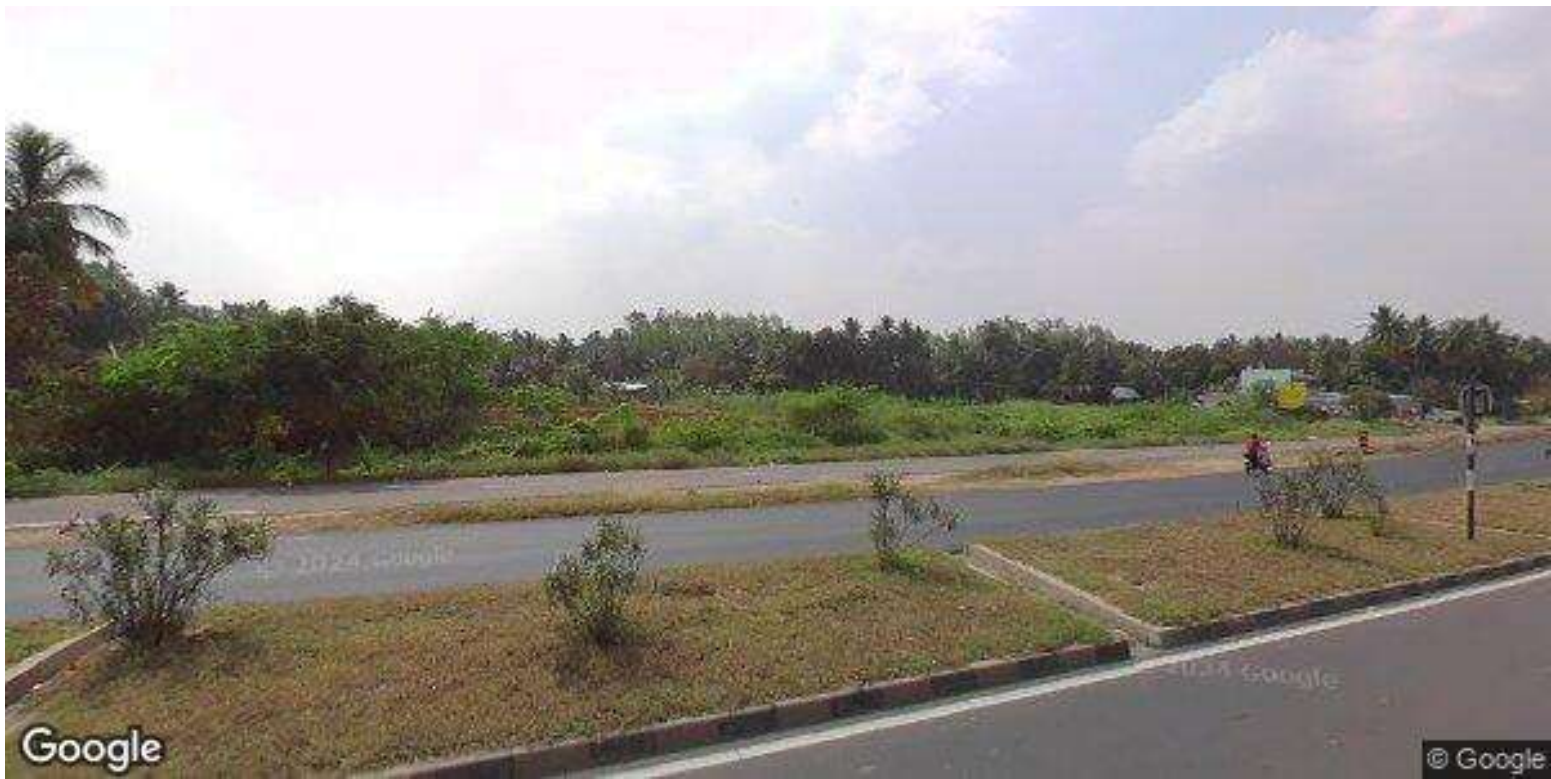
**Risk Type:** Turn  
**Risk Level:** Medium  
**Speed Limit:** 30 KM/Hr  
**Coordinates:** 11.05261, 78.05138

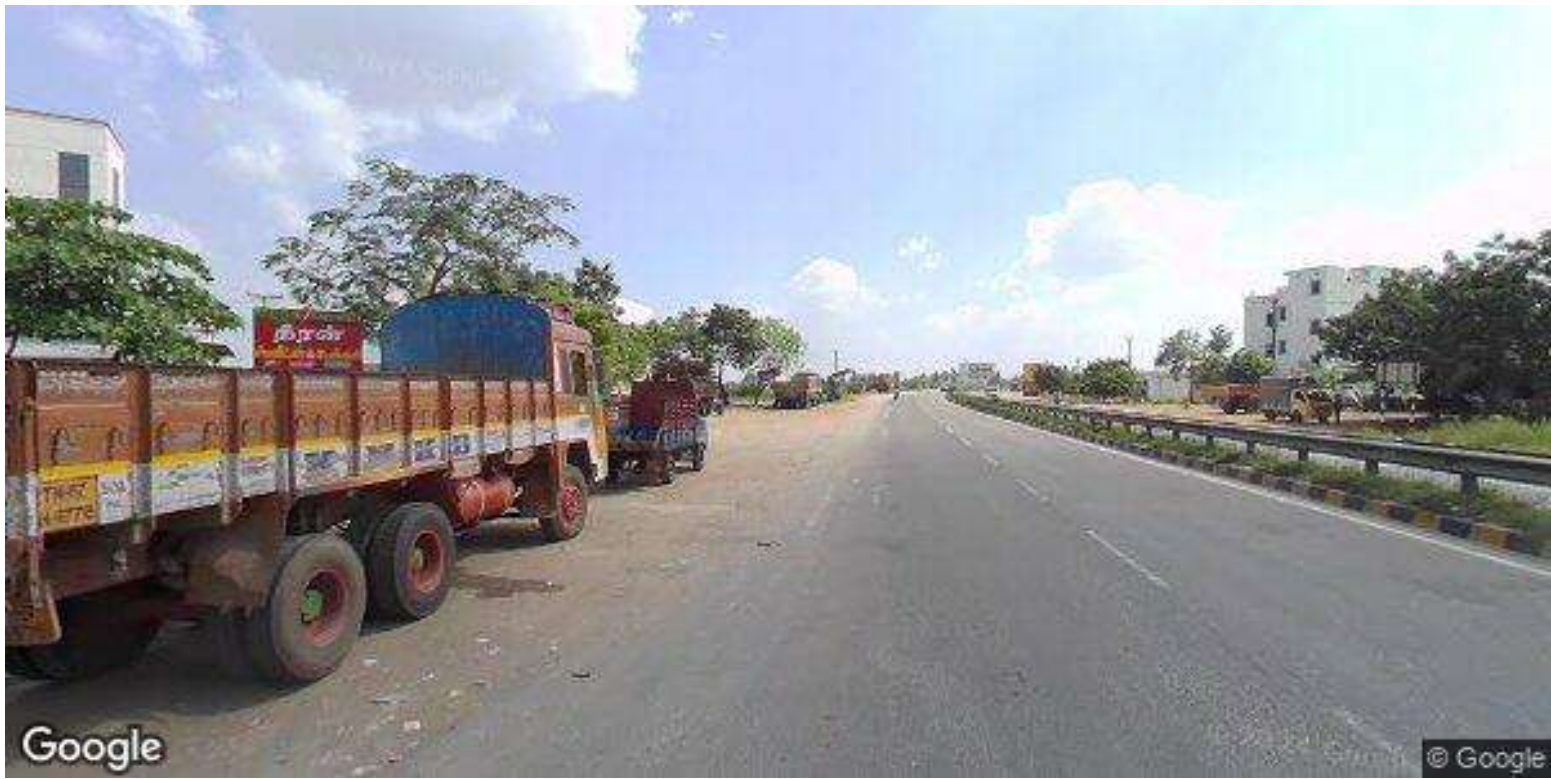
**Risk Type:** Turn  
**Risk Level:** Medium  
**Speed Limit:** 30 KM/Hr  
**Coordinates:** 10.92908, 78.05505

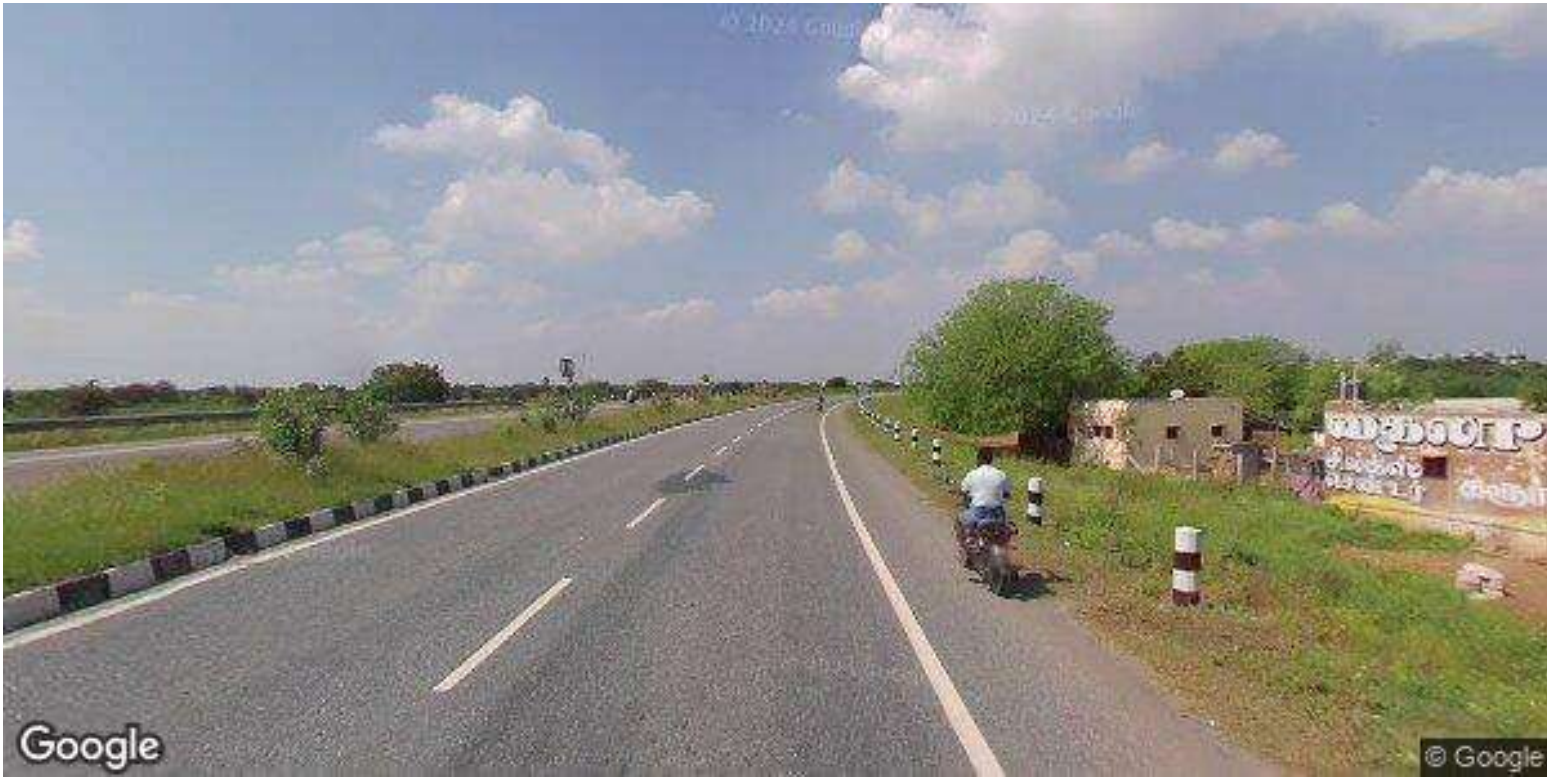
**Risk Type:** Turn  
**Risk Level:** Medium  
**Speed Limit:** 30 KM/Hr  
**Coordinates:** 10.90753, 78.09394

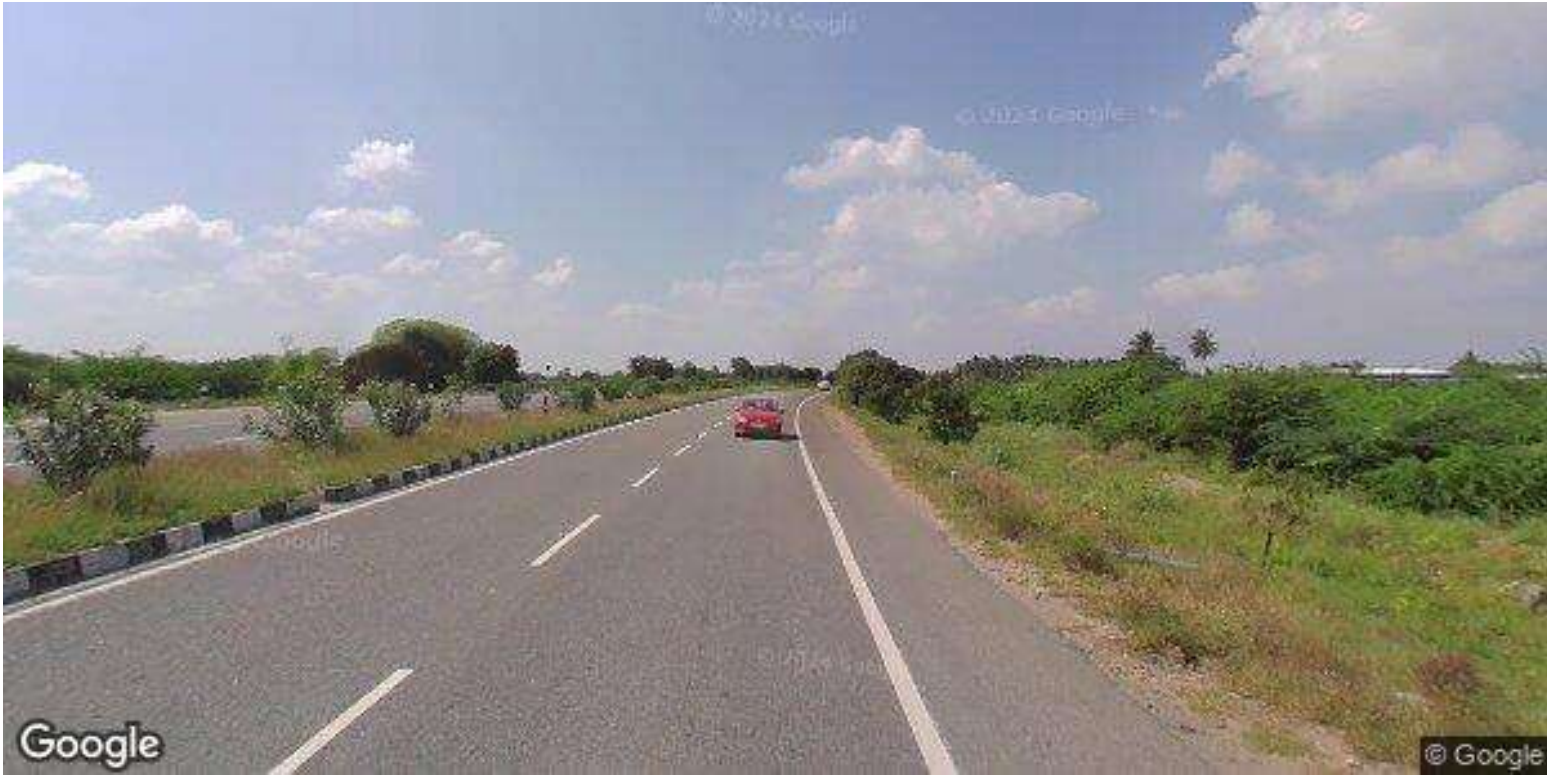
**Risk Type:** Turn  
**Risk Level:** Medium  
**Speed Limit:** 30 KM/Hr  
**Coordinates:** 10.90730, 78.09763

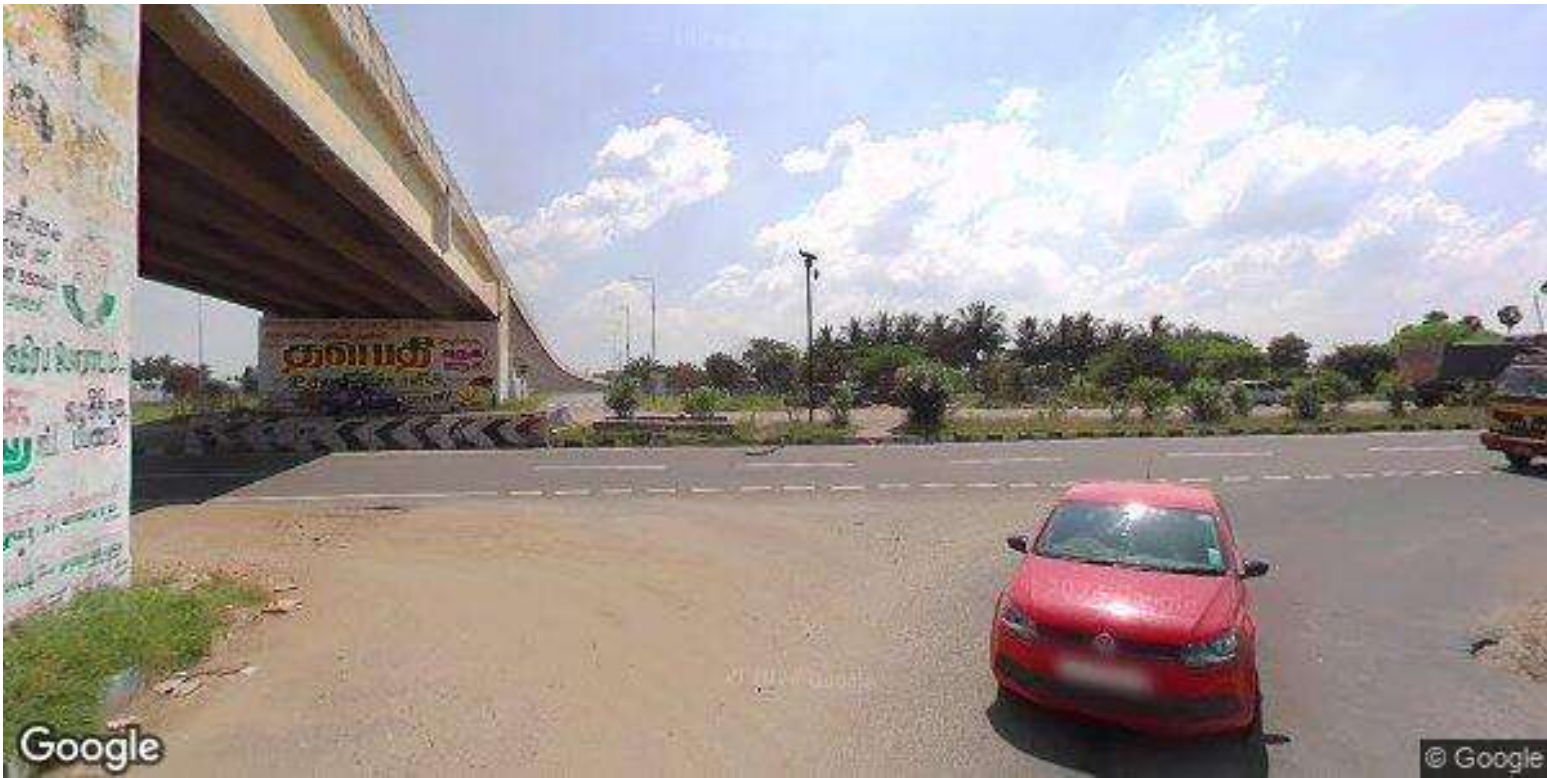
**Risk Type:** Blind Spot  
**Risk Level:** Blind Spot  
**Speed Limit:** 10 KM/Hr  
**Coordinates:** 10.90793, 78.09916
