# IndianOil

## JOURNEY RISK MANAGEMENT (JRM) STUDY

### Salem Terminal TO MANICKAMALAYAN AGENCIES

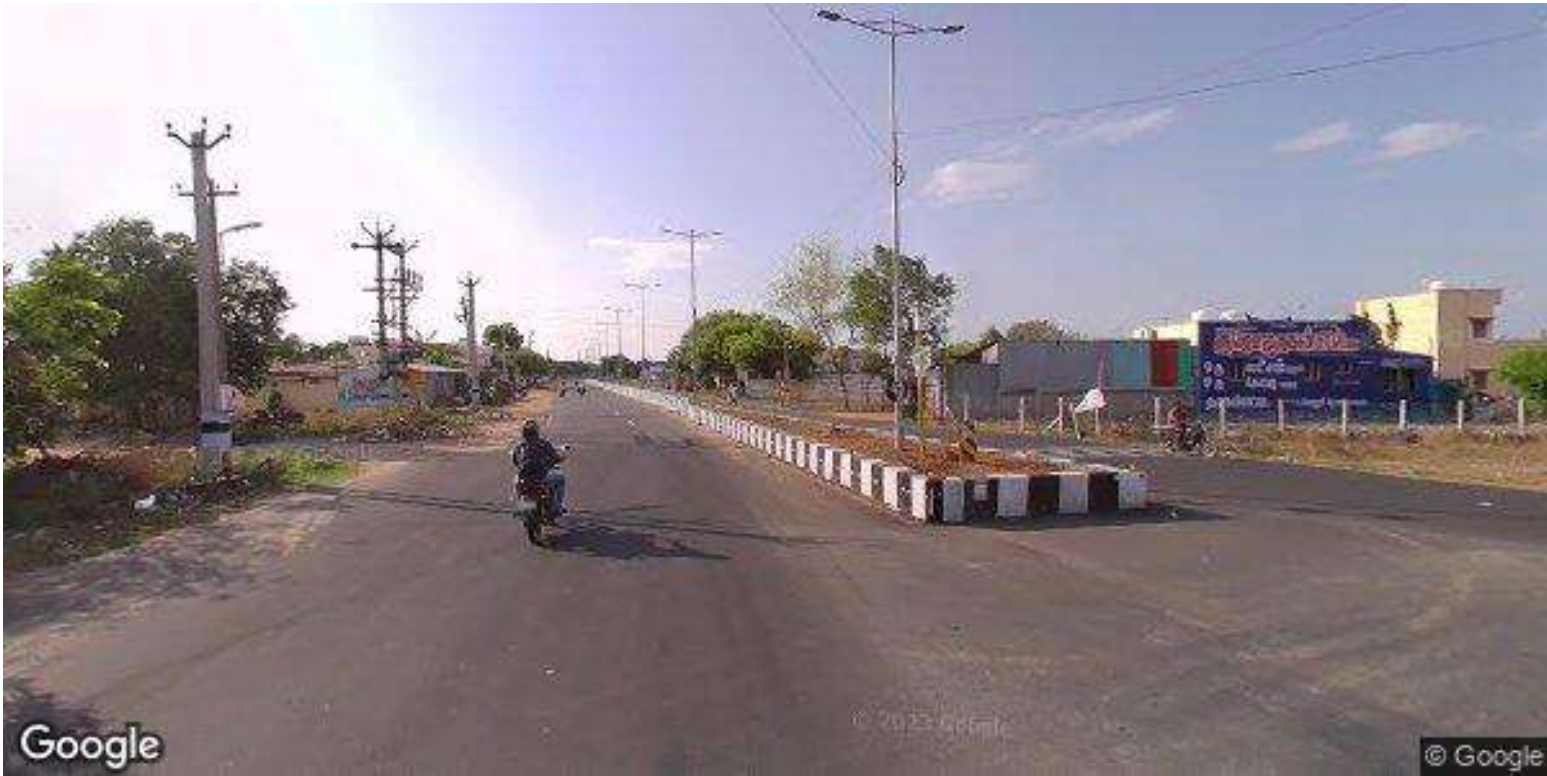
**Risk Type:** Blind Spot  
**Risk Level:** Blind Spot  
**Speed Limit:** 10 KM/Hr  
**Coordinates:** 10.91105, 78.09714

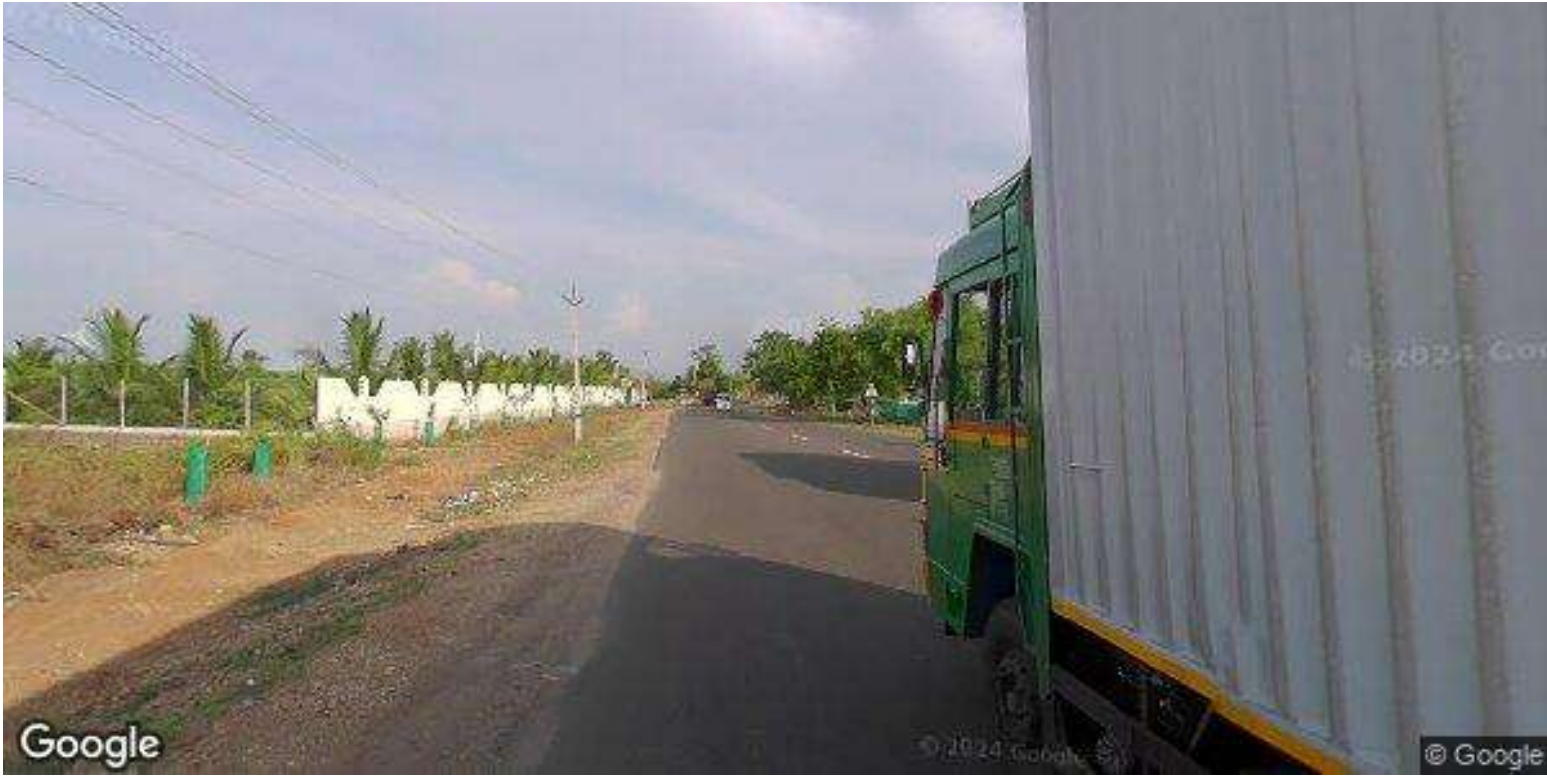
**Risk Type:** Turn  
**Risk Level:** Medium  
**Speed Limit:** 30 KM/Hr  
**Coordinates:** 10.81788, 78.12357

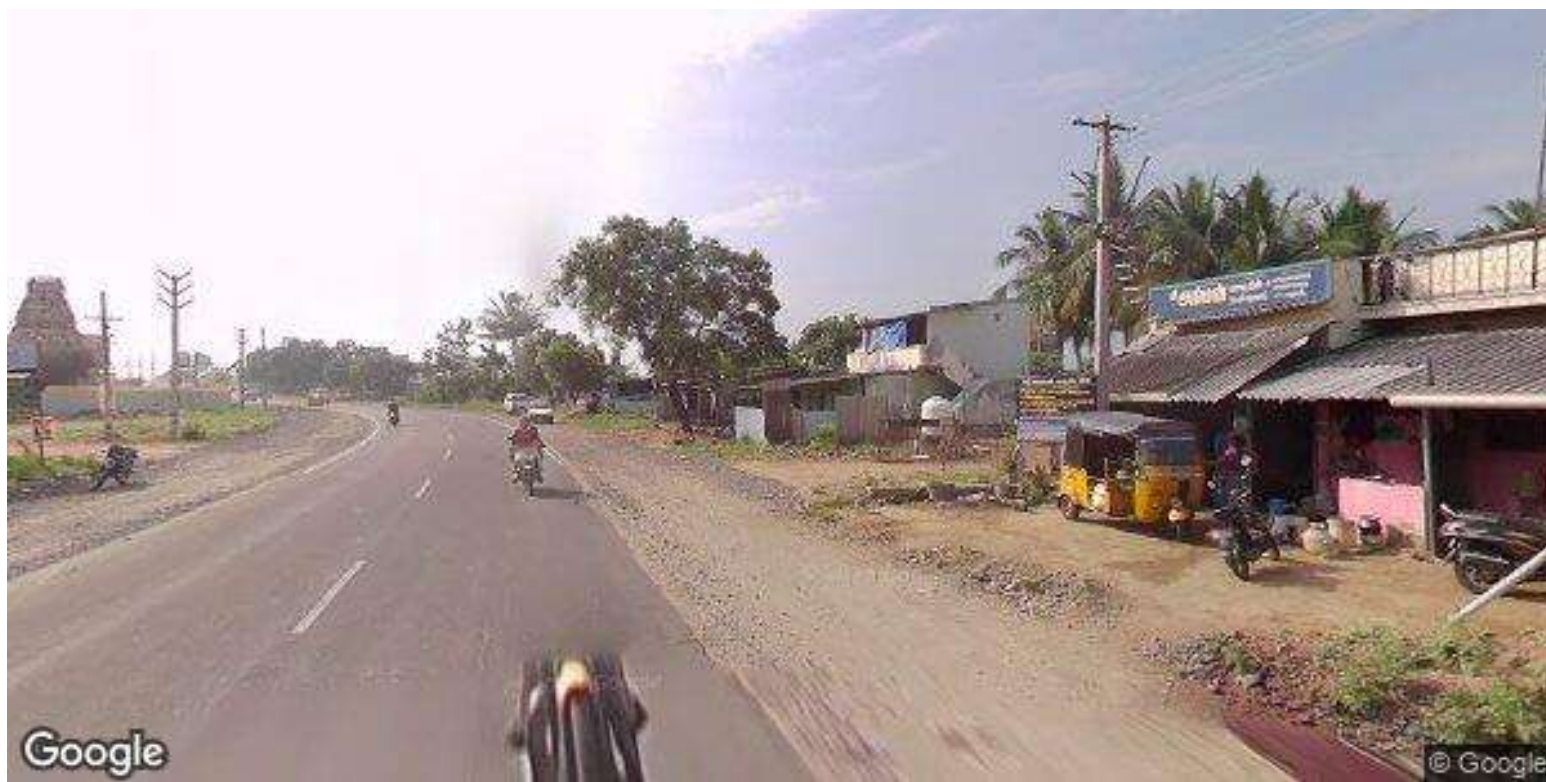
**Risk Type:** Turn

**Risk Level:** Medium

**Speed Limit:** 30 KM/Hr

**Coordinates:** 10.78879, 78.12489

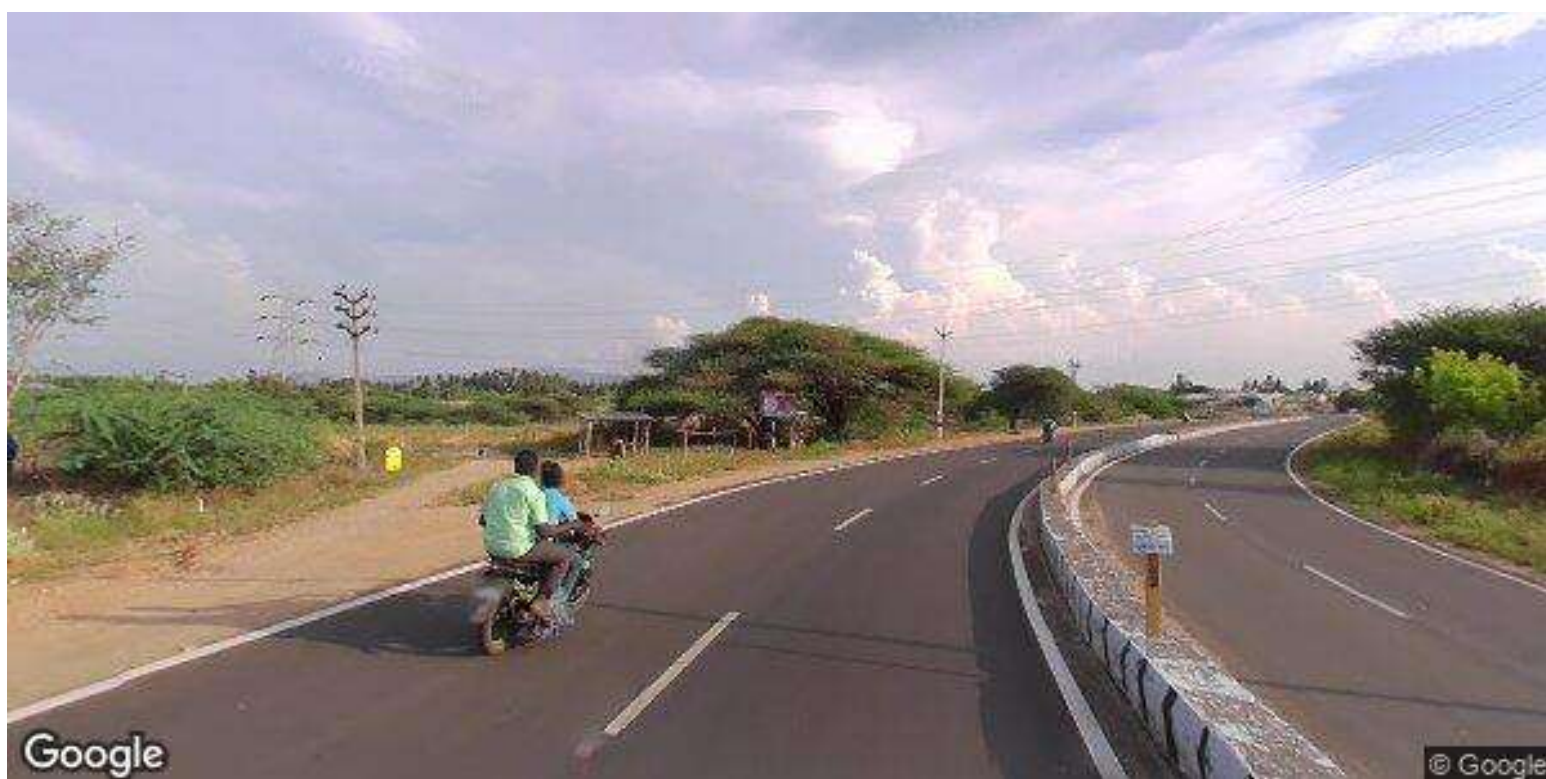
**Risk Type:** Turn

**Risk Level:** Medium

**Speed Limit:** 30 KM/Hr

**Coordinates:** 10.75989, 78.13139

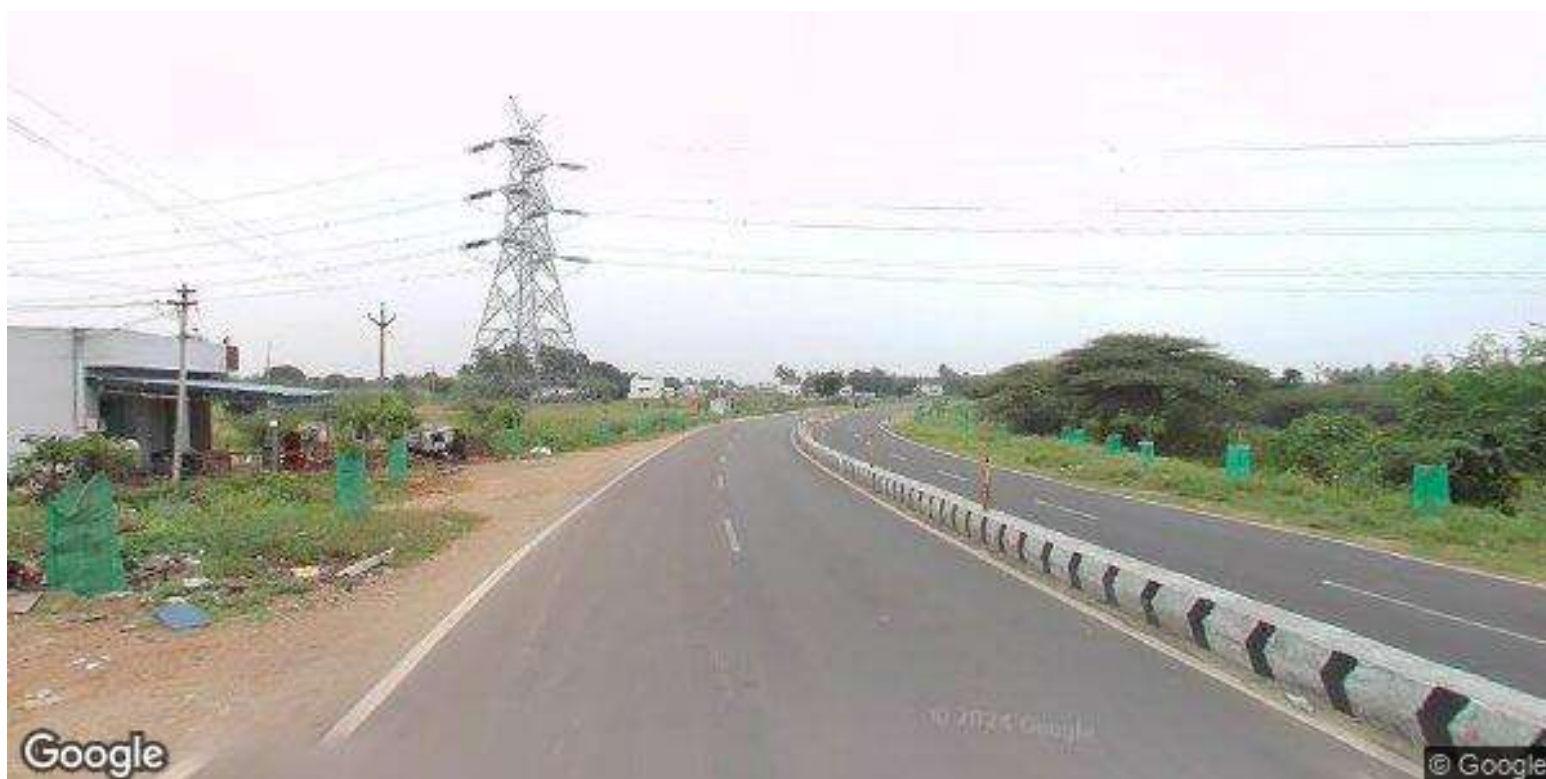
**Risk Type:** Turn  
**Risk Level:** Medium  
**Speed Limit:** 30 KM/Hr  
**Coordinates:** 10.75772, 78.13010

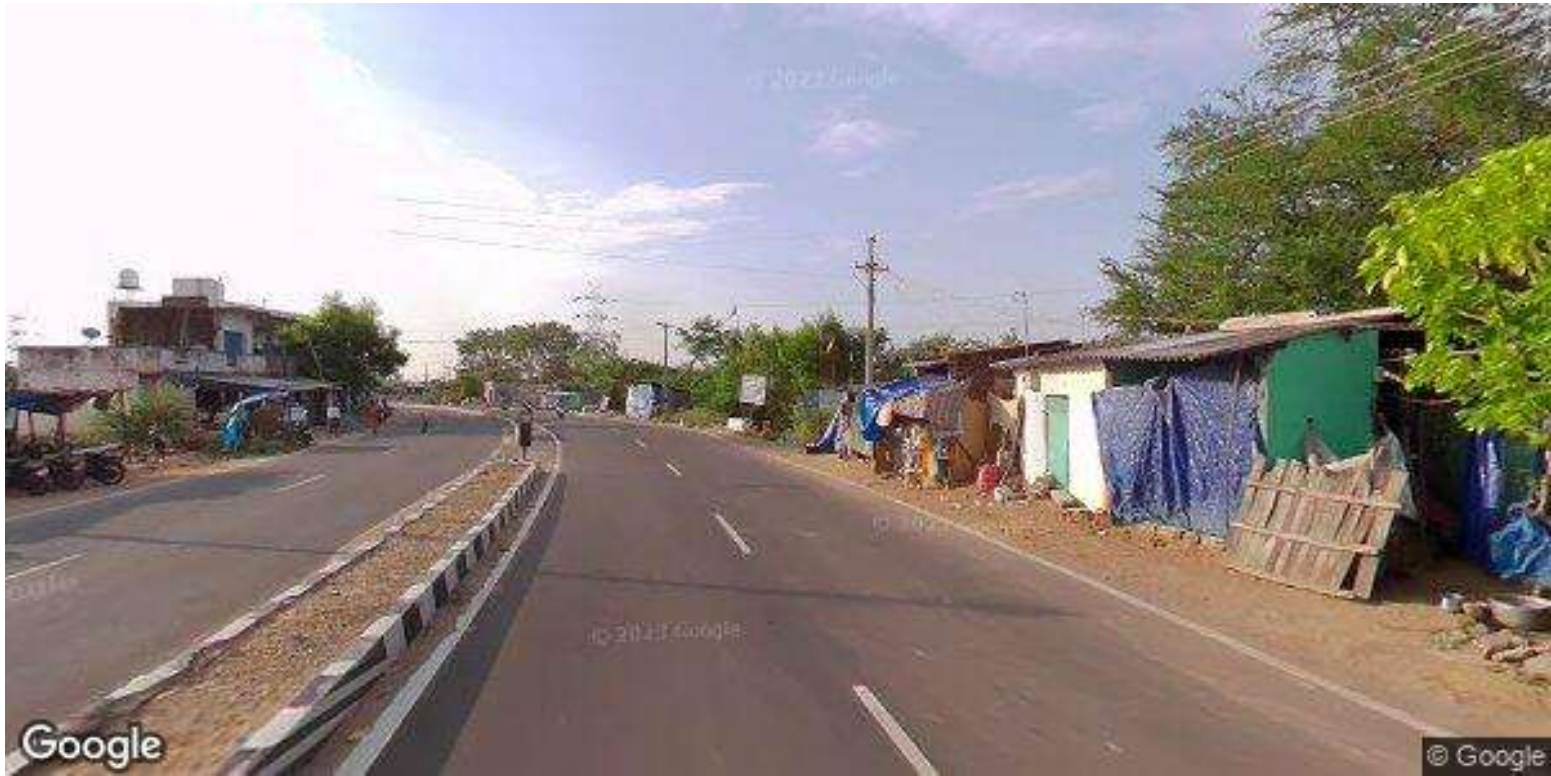
**Risk Type:** Turn  
**Risk Level:** Medium  
**Speed Limit:** 30 KM/Hr  
**Coordinates:** 10.75558, 78.13104

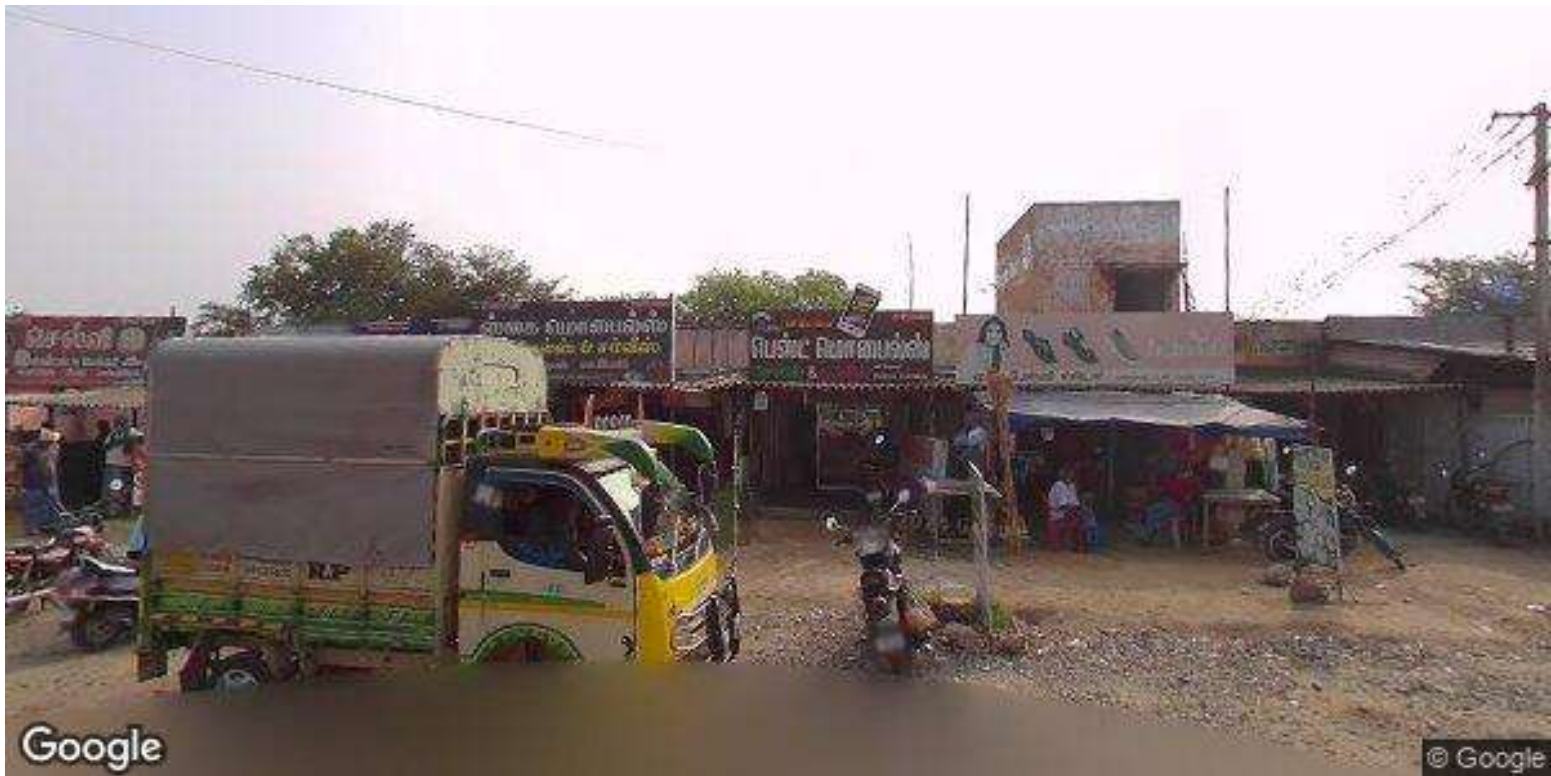
**Risk Type:** Turn  
**Risk Level:** Medium  
**Speed Limit:** 30 KM/Hr  
**Coordinates:** 10.72618, 78.13583

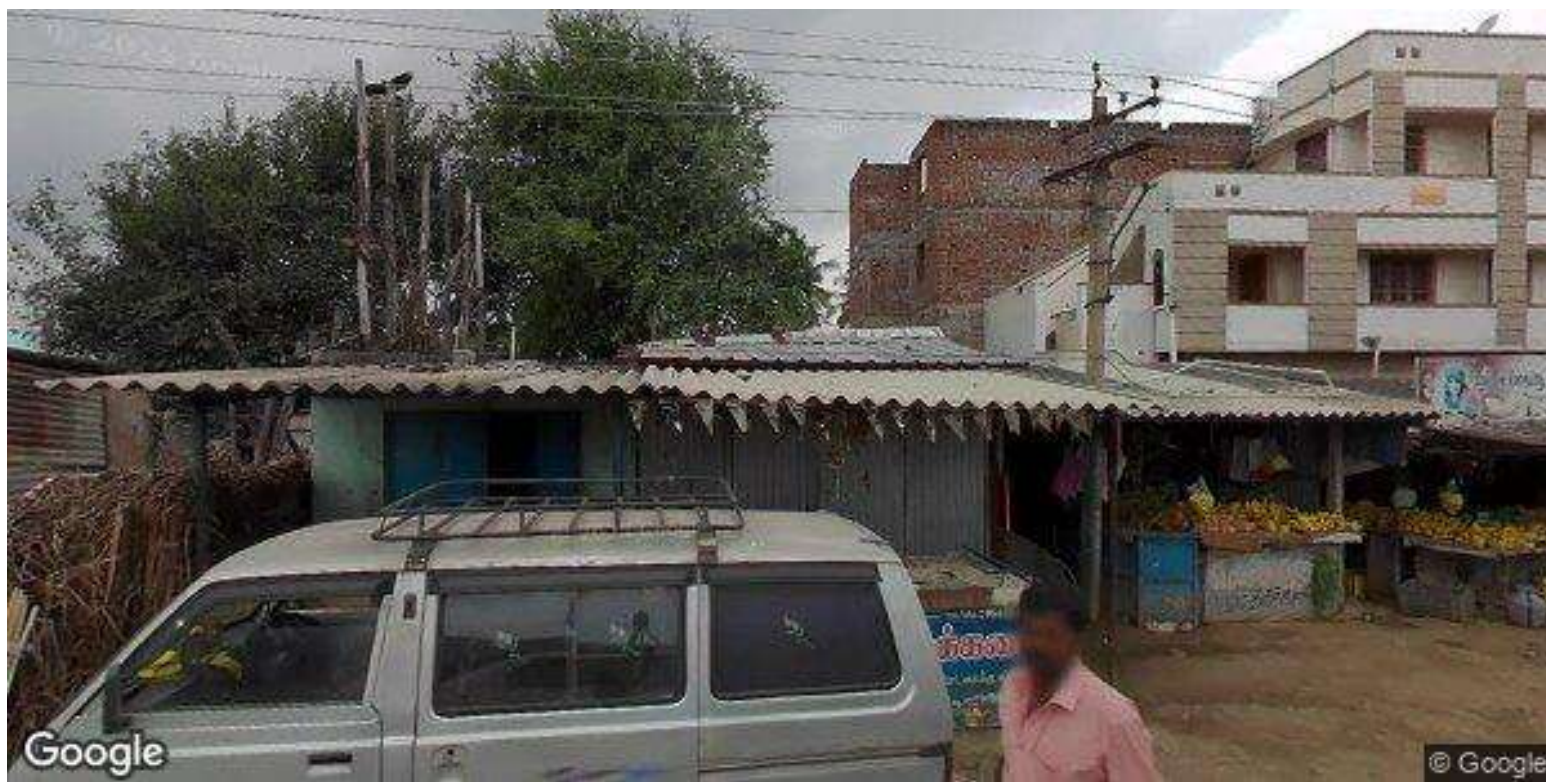
**Risk Type:** Turn

**Risk Level:** High

**Speed Limit:** 15 KM/Hr

**Coordinates:** 10.72580, 78.13601

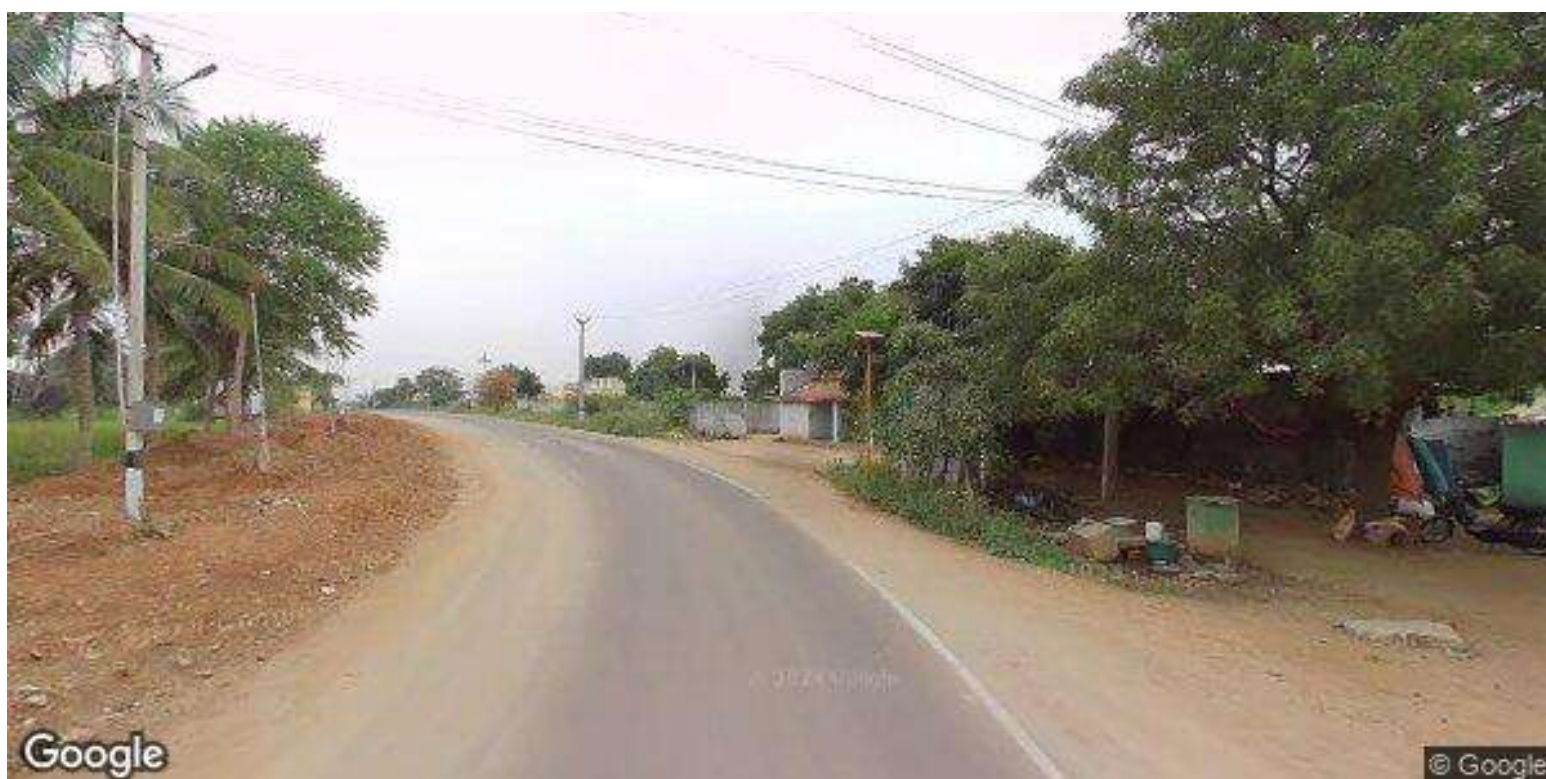
**Risk Type:** Turn

**Risk Level:** Medium

**Speed Limit:** 30 KM/Hr

**Coordinates:** 10.72241, 78.14604

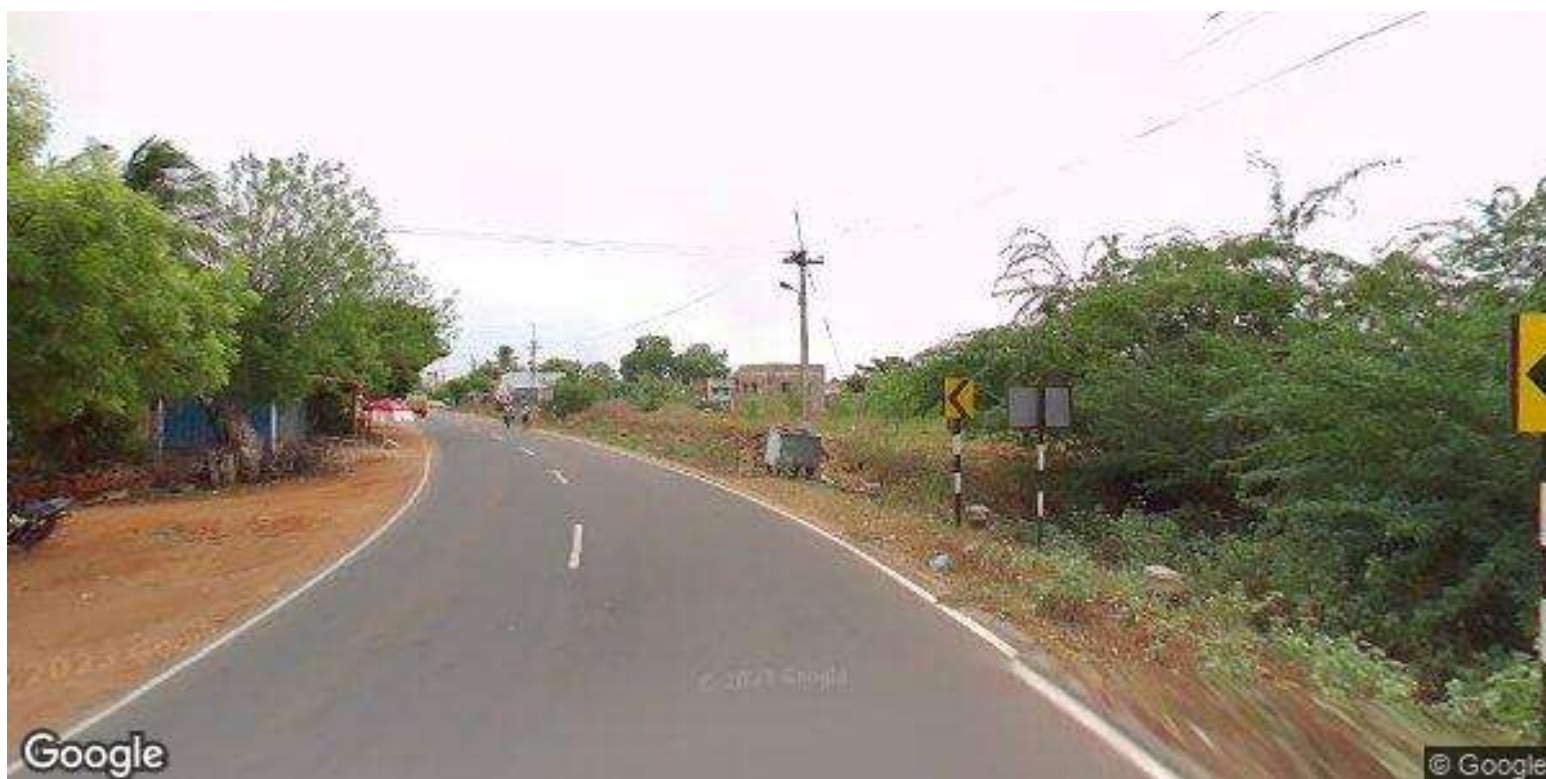
**Risk Type:** Turn  
**Risk Level:** High  
**Speed Limit:** 15 KM/Hr  
**Coordinates:** 10.72145, 78.16655

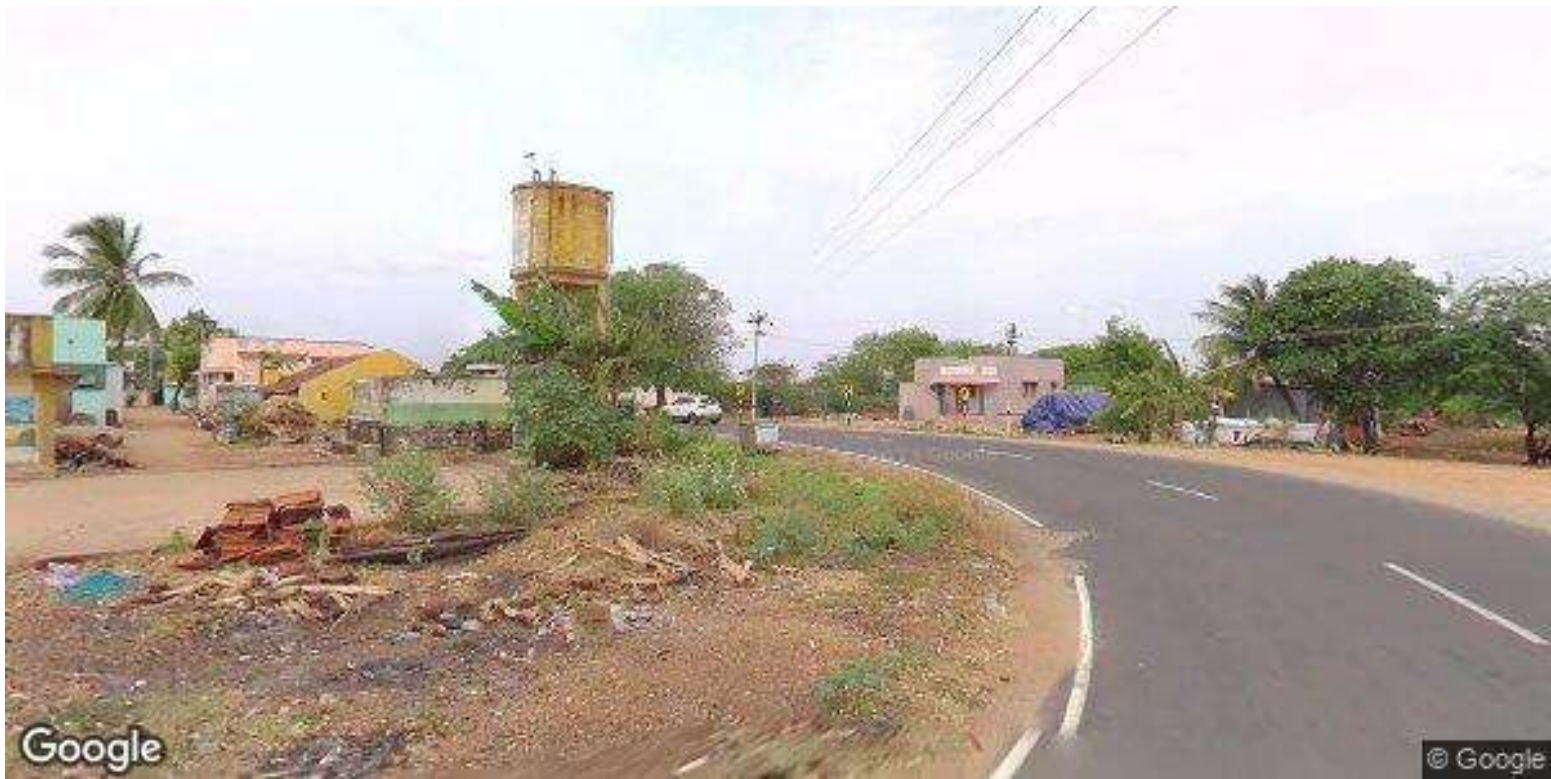
**Risk Type:** Turn  
**Risk Level:** High  
**Speed Limit:** 15 KM/Hr  
**Coordinates:** 10.72346, 78.16703

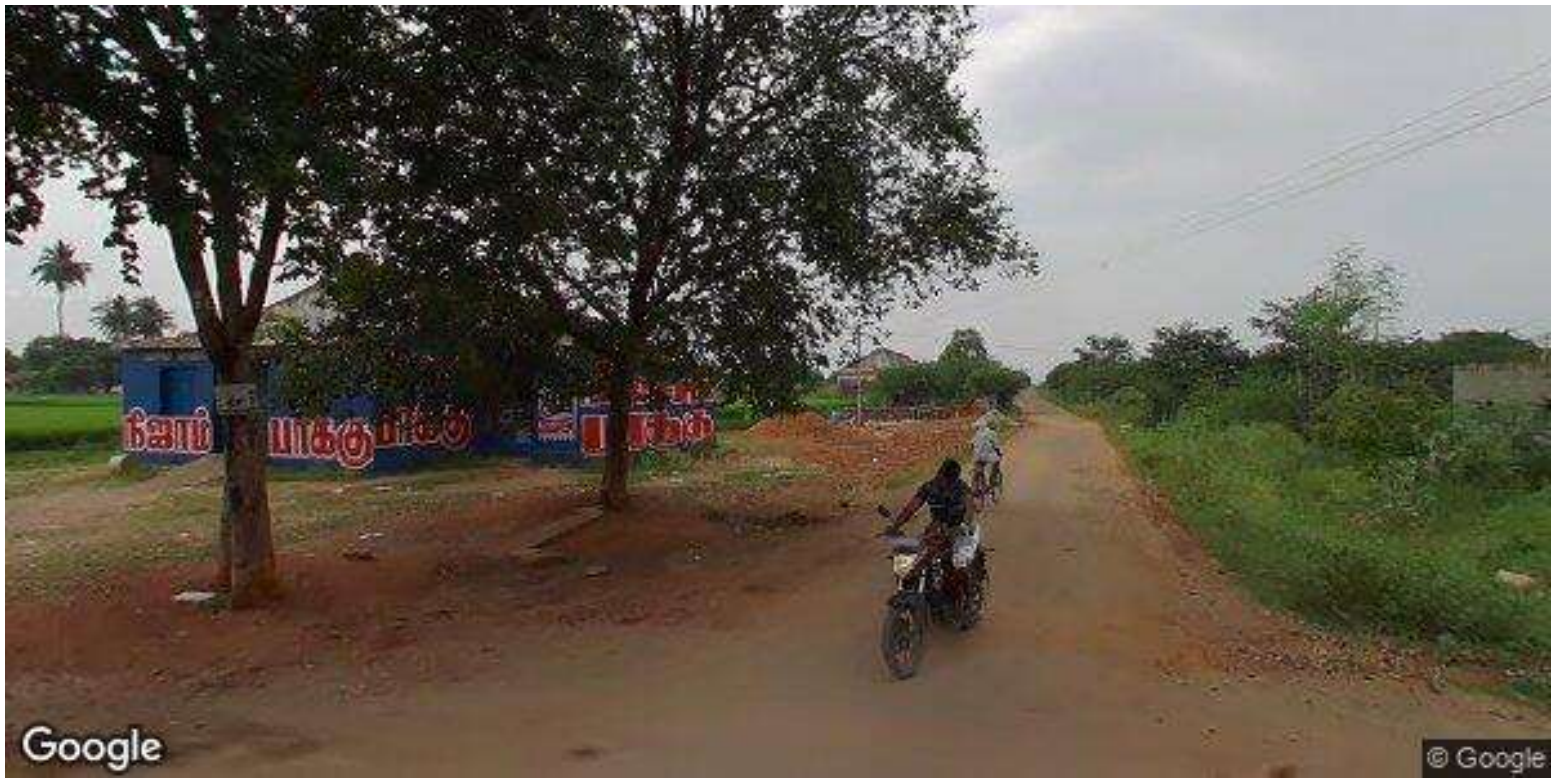
**Risk Type:** Turn  
**Risk Level:** High  
**Speed Limit:** 15 KM/Hr  
**Coordinates:** 10.72265, 78.17354

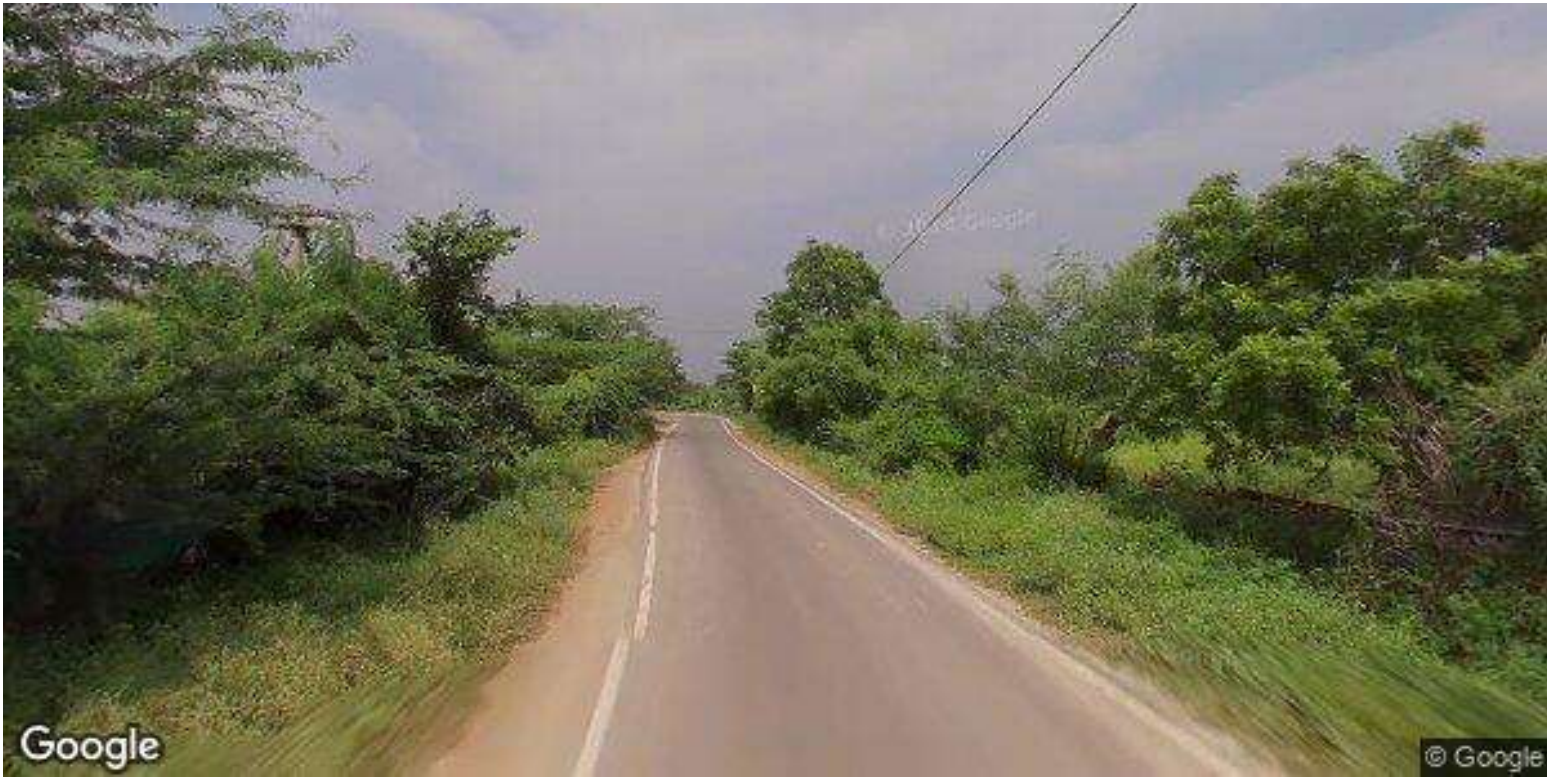
**Risk Type:** Turn  
**Risk Level:** Medium  
**Speed Limit:** 30 KM/Hr  
**Coordinates:** 10.71884, 78.17426

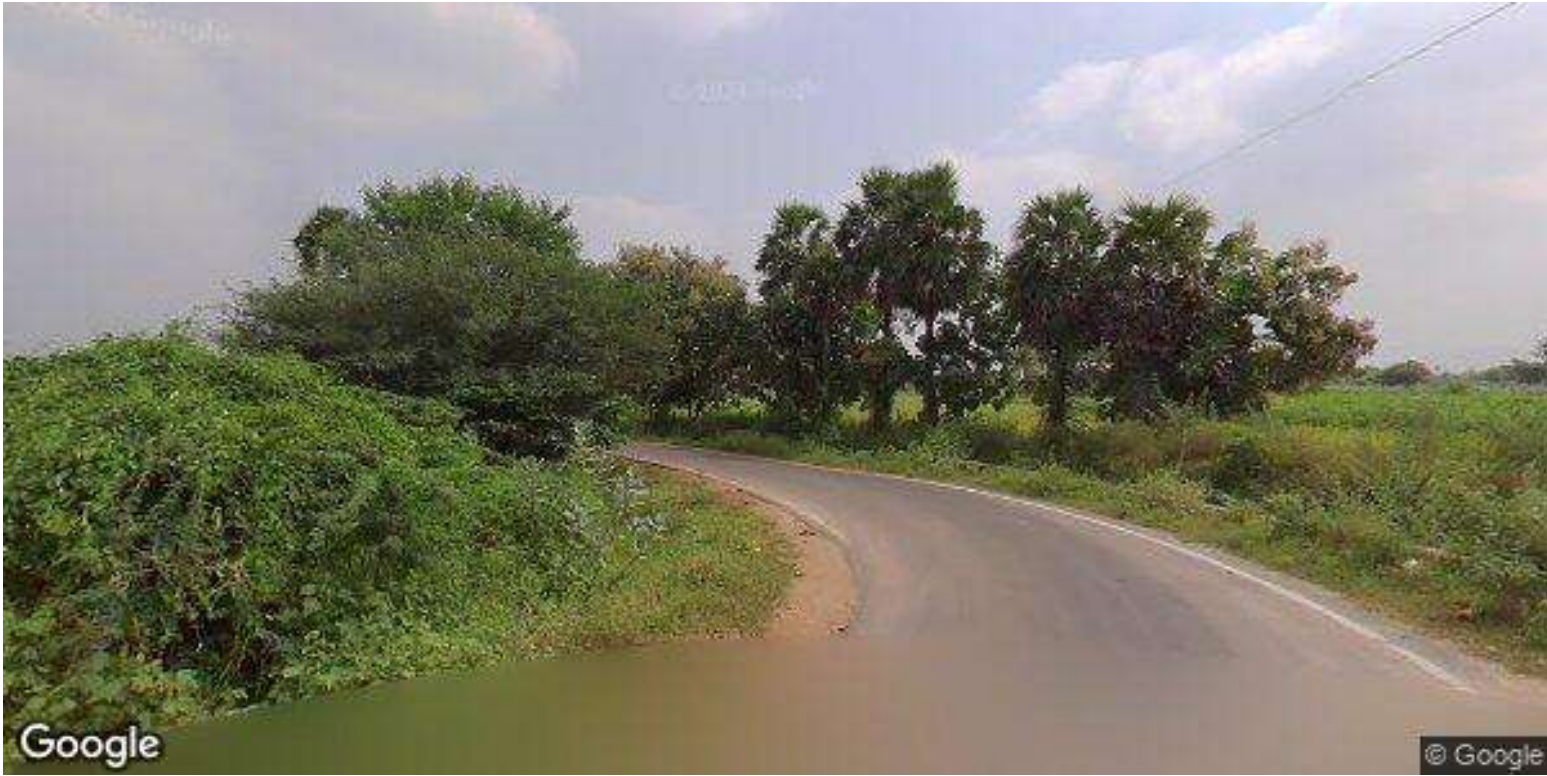
**Risk Type:** Blind Spot  
**Risk Level:** Blind Spot  
**Speed Limit:** 10 KM/Hr  
**Coordinates:** 10.71810, 78.17408

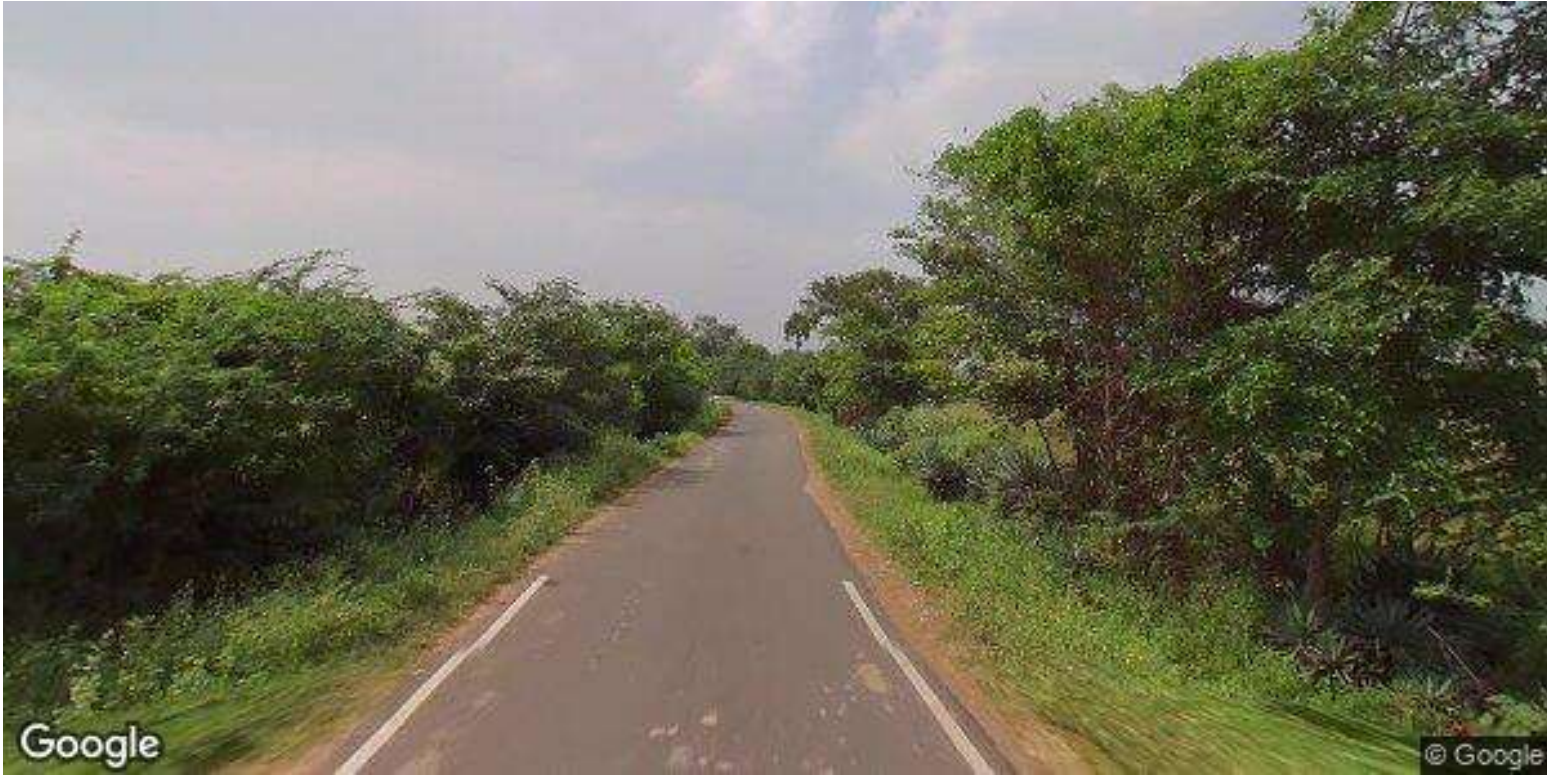
**Risk Type:** Turn  
**Risk Level:** Medium  
**Speed Limit:** 30 KM/Hr  
**Coordinates:** 10.71800, 78.17522

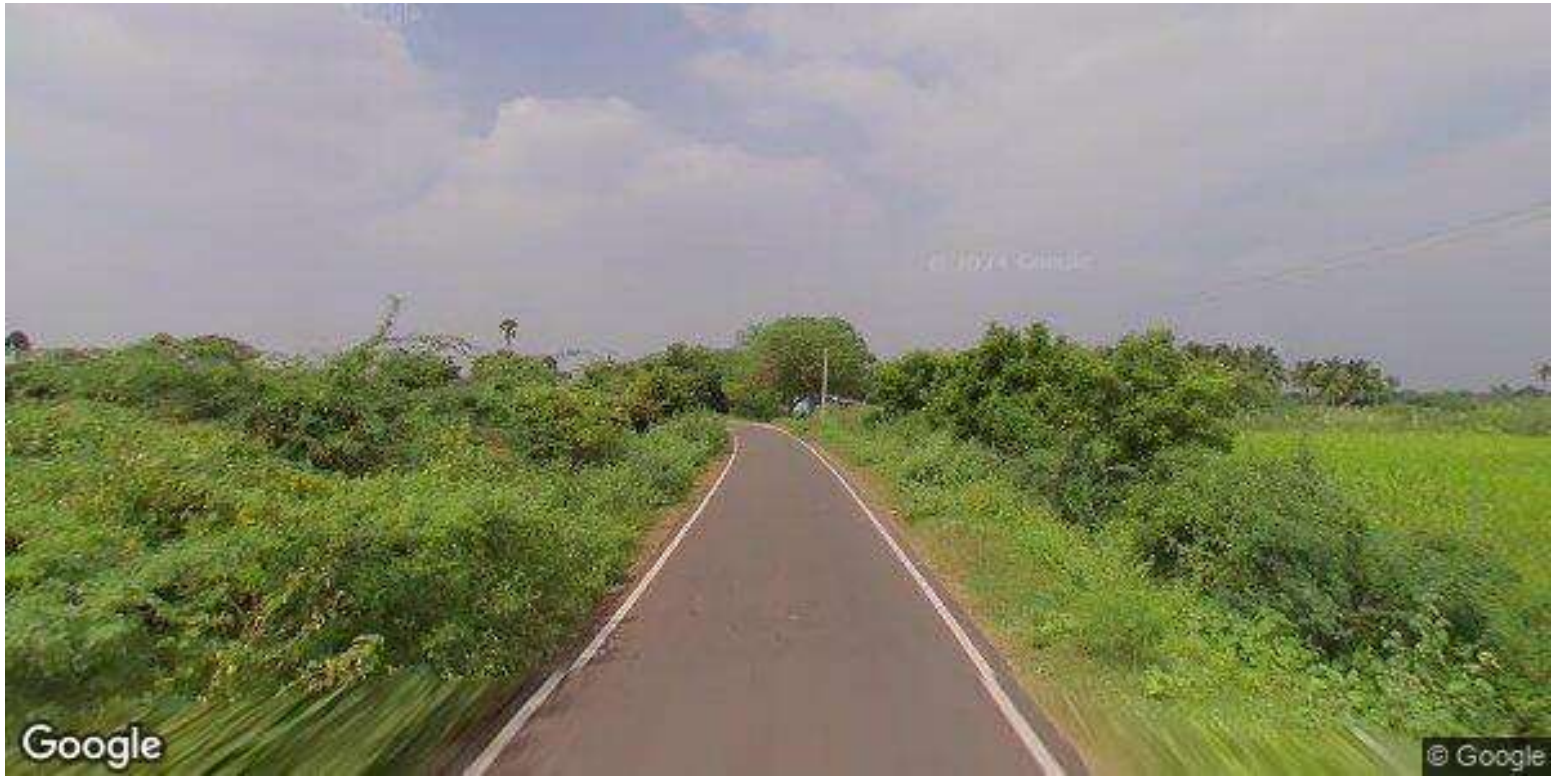
**Risk Type:** Turn  
**Risk Level:** Medium  
**Speed Limit:** 30 KM/Hr  
**Coordinates:** 10.71743, 78.17572

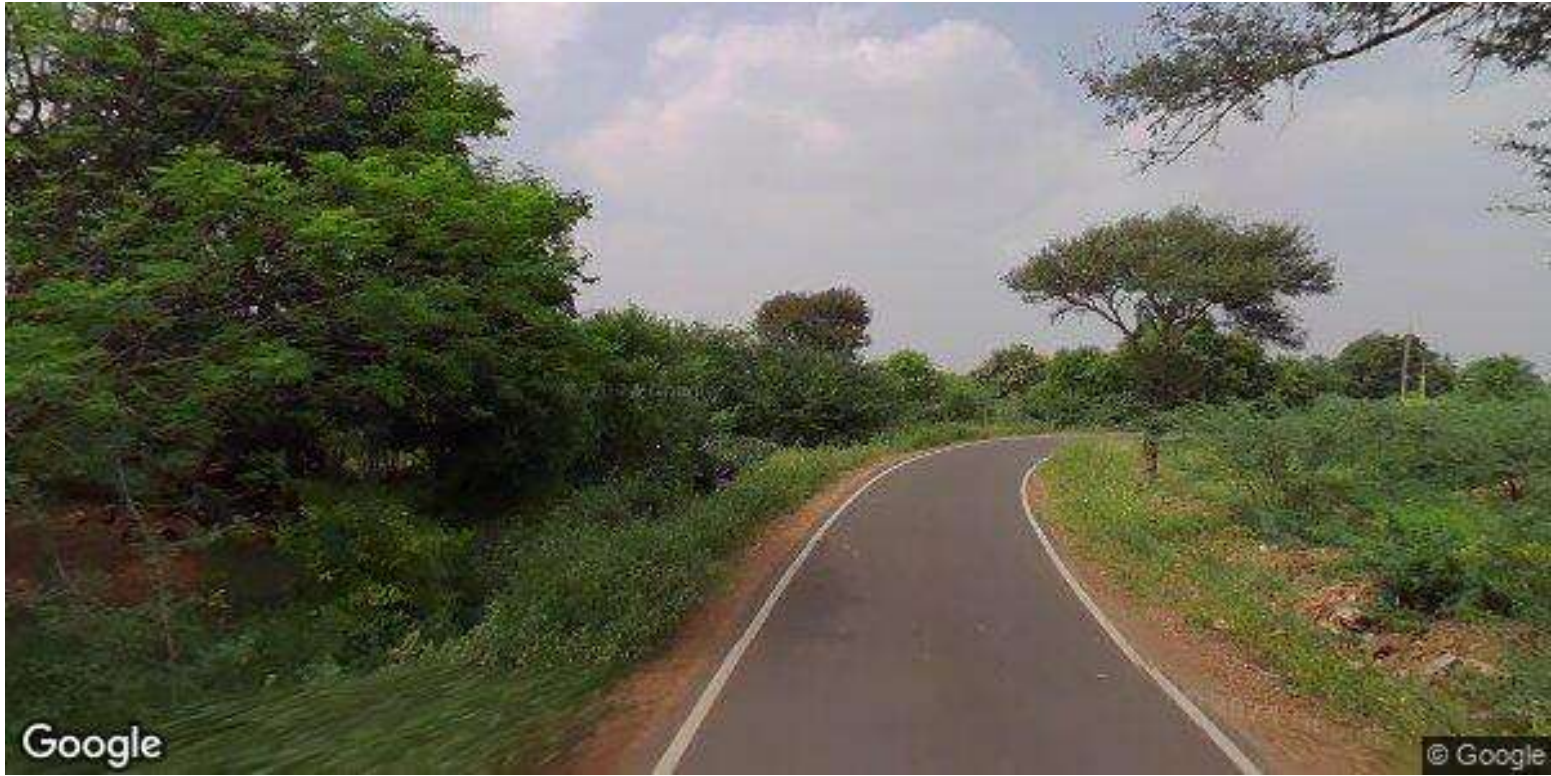
**Risk Type:** Turn  
**Risk Level:** Medium  
**Speed Limit:** 30 KM/Hr  
**Coordinates:** 10.71421, 78.17604

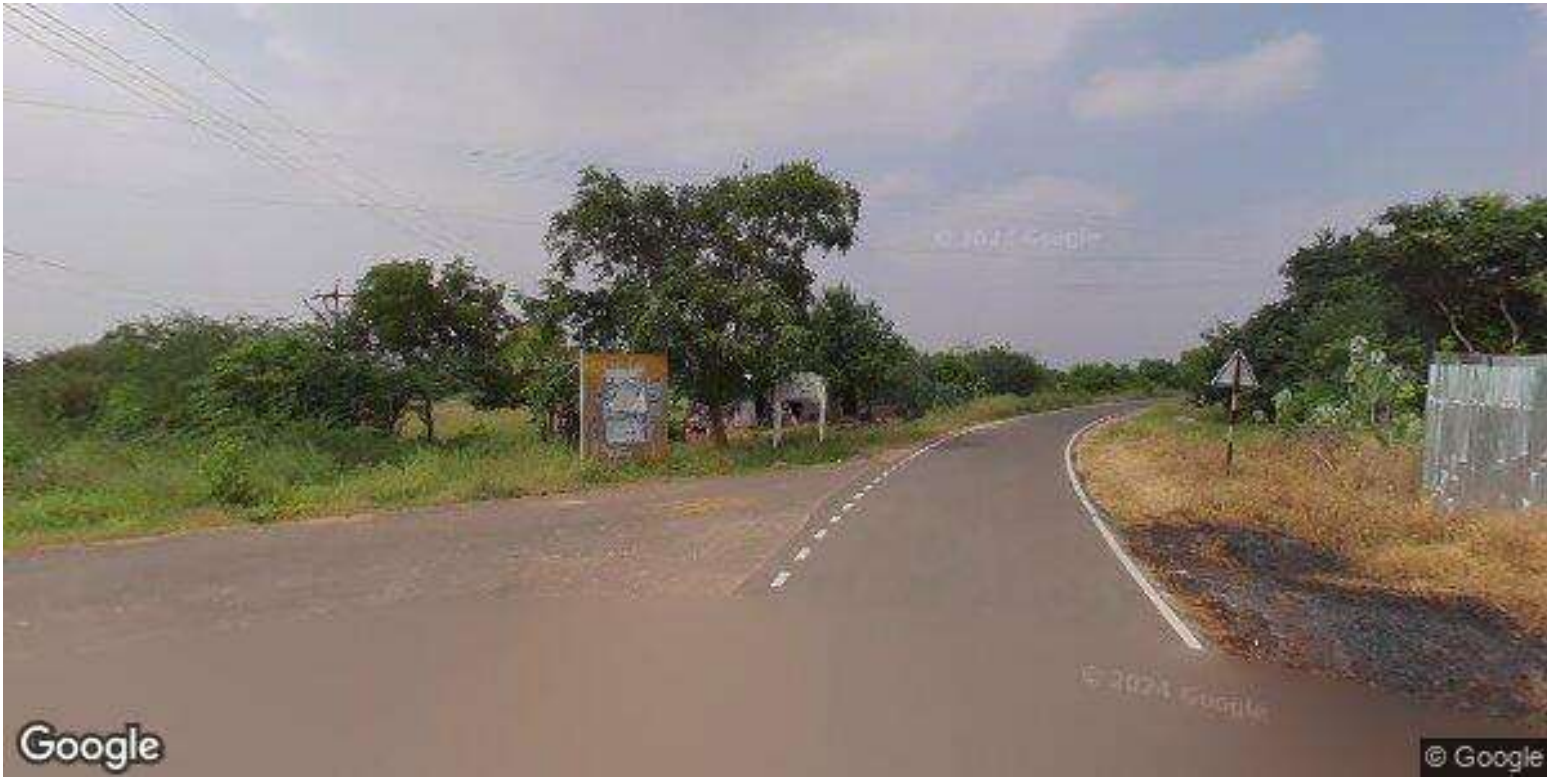
**Risk Type:** Turn  
**Risk Level:** Medium  
**Speed Limit:** 30 KM/Hr  
**Coordinates:** 10.70289, 78.18316
