# IndianOil

## JOURNEY RISK MANAGEMENT (JRM) STUDY

### Salem Terminal TO MANICKAMALAYAN AGENCIES

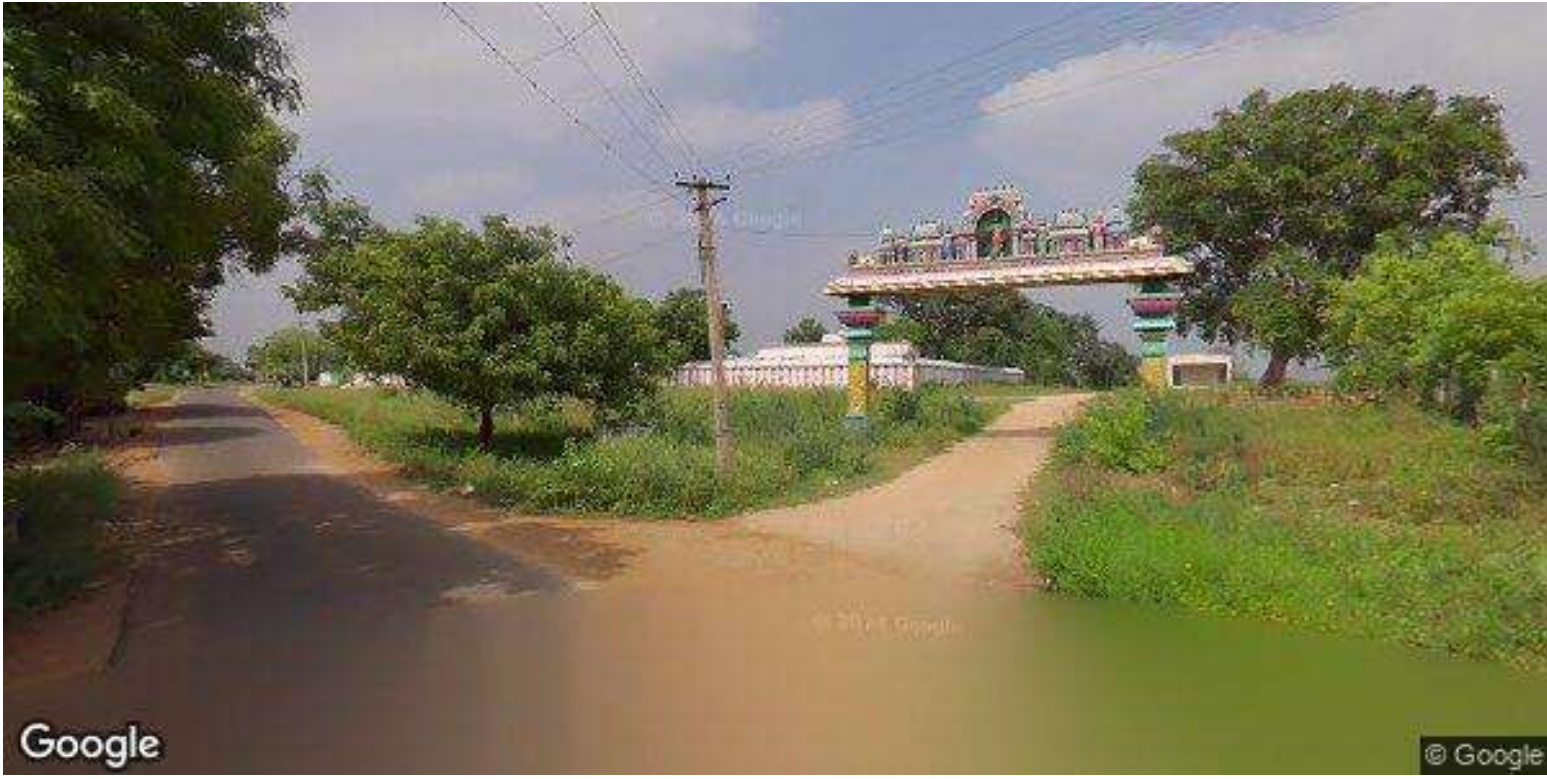
**Risk Type:** Turn  
**Risk Level:** Medium  
**Speed Limit:** 30 KM/Hr  
**Coordinates:** 10.70200, 78.18437

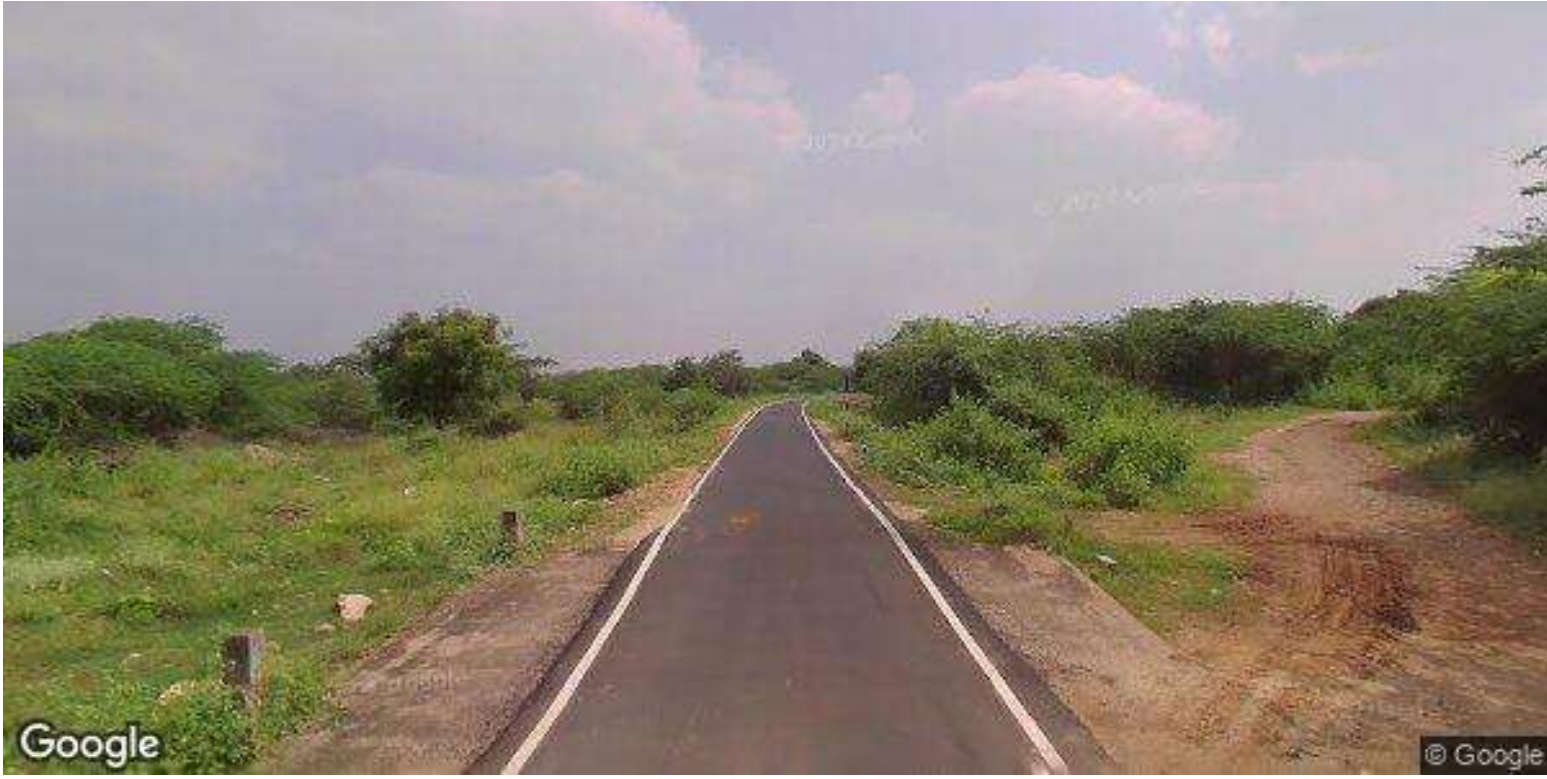
**Risk Type:** Turn  
**Risk Level:** High  
**Speed Limit:** 15 KM/Hr  
**Coordinates:** 10.69823, 78.18475

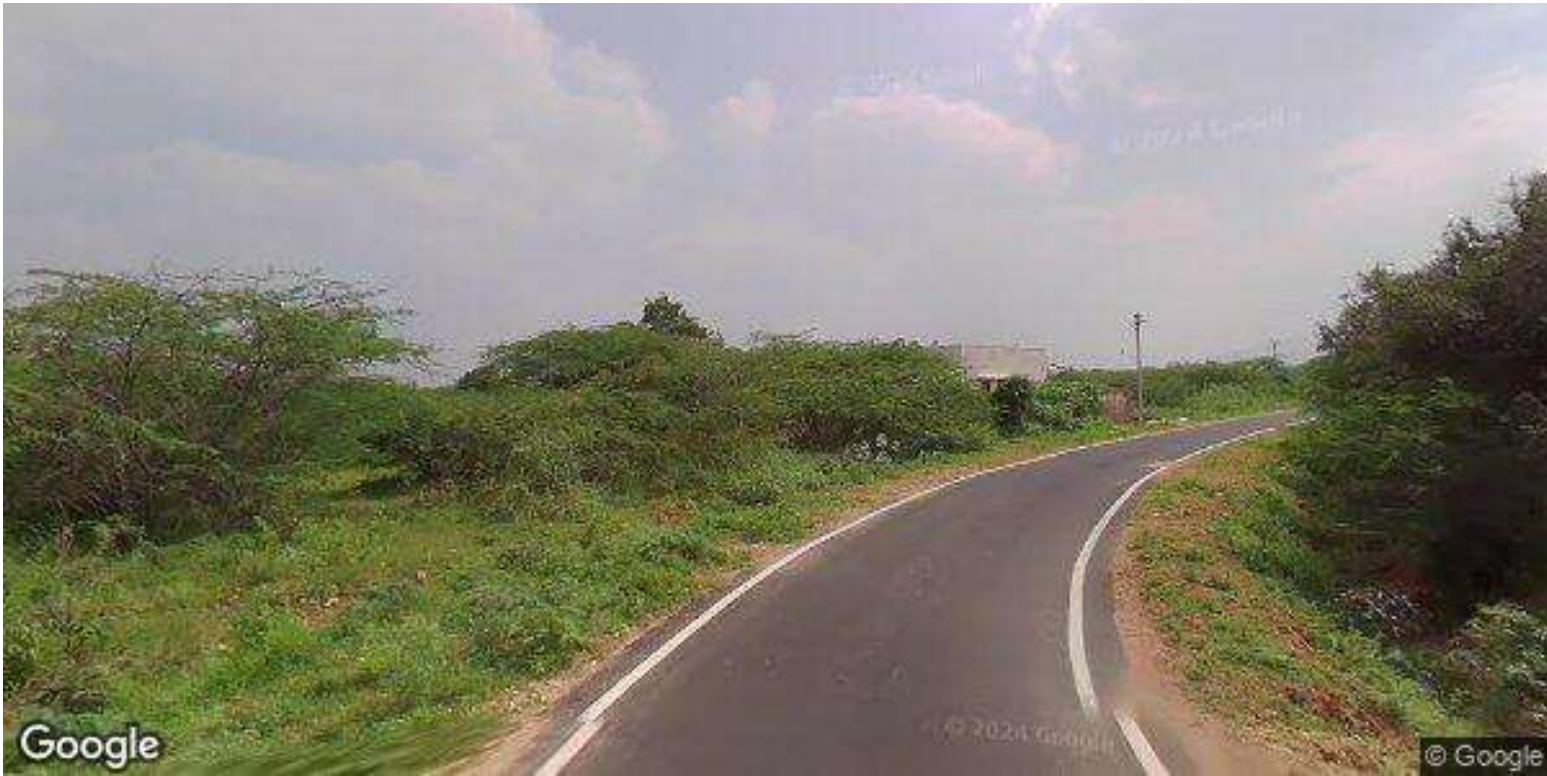
**Risk Type:** Turn  
**Risk Level:** High  
**Speed Limit:** 15 KM/Hr  
**Coordinates:** 10.69780, 78.18539

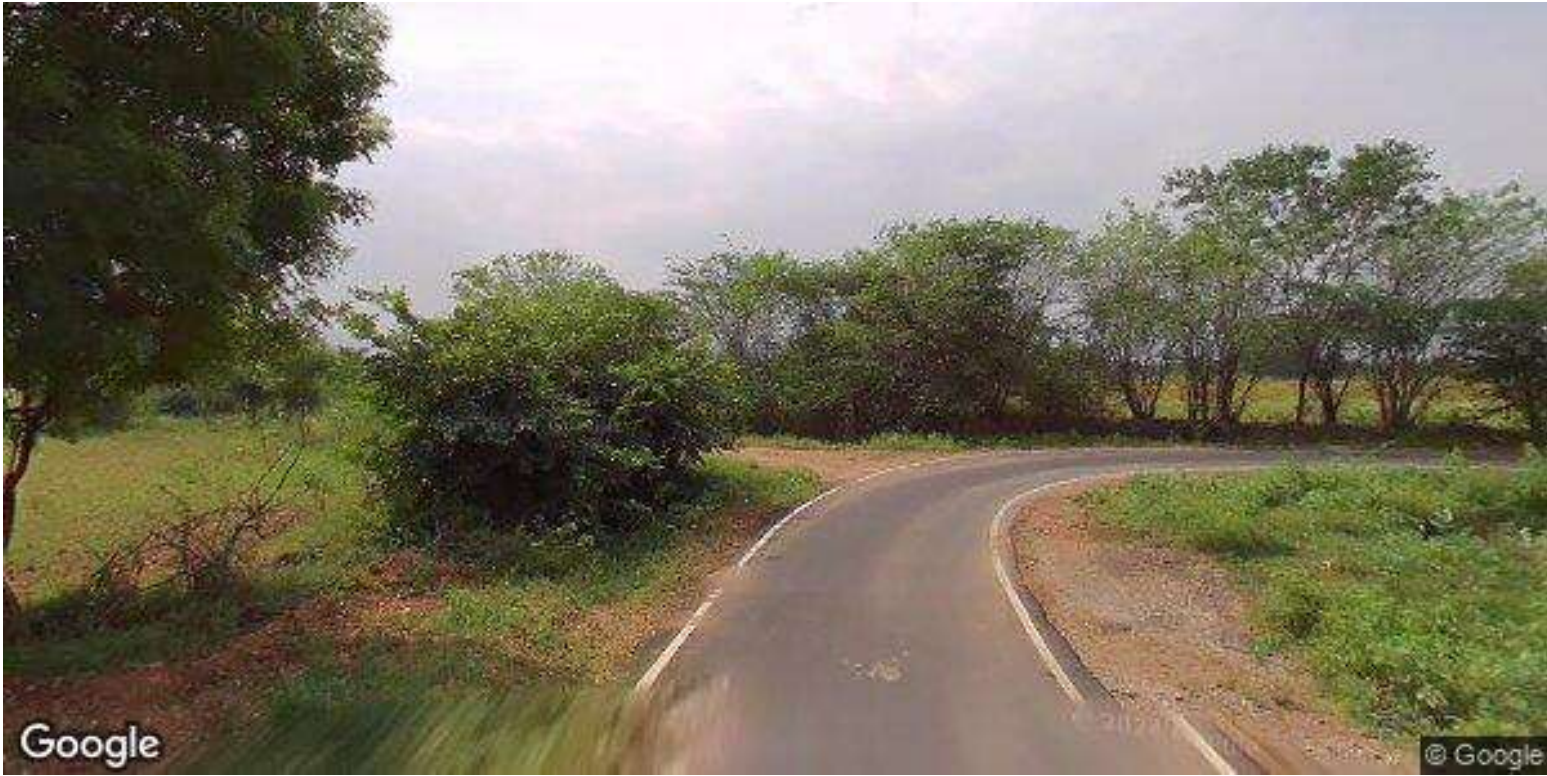
**Risk Type:** Turn  
**Risk Level:** High  
**Speed Limit:** 15 KM/Hr  
**Coordinates:** 10.69403, 78.18652

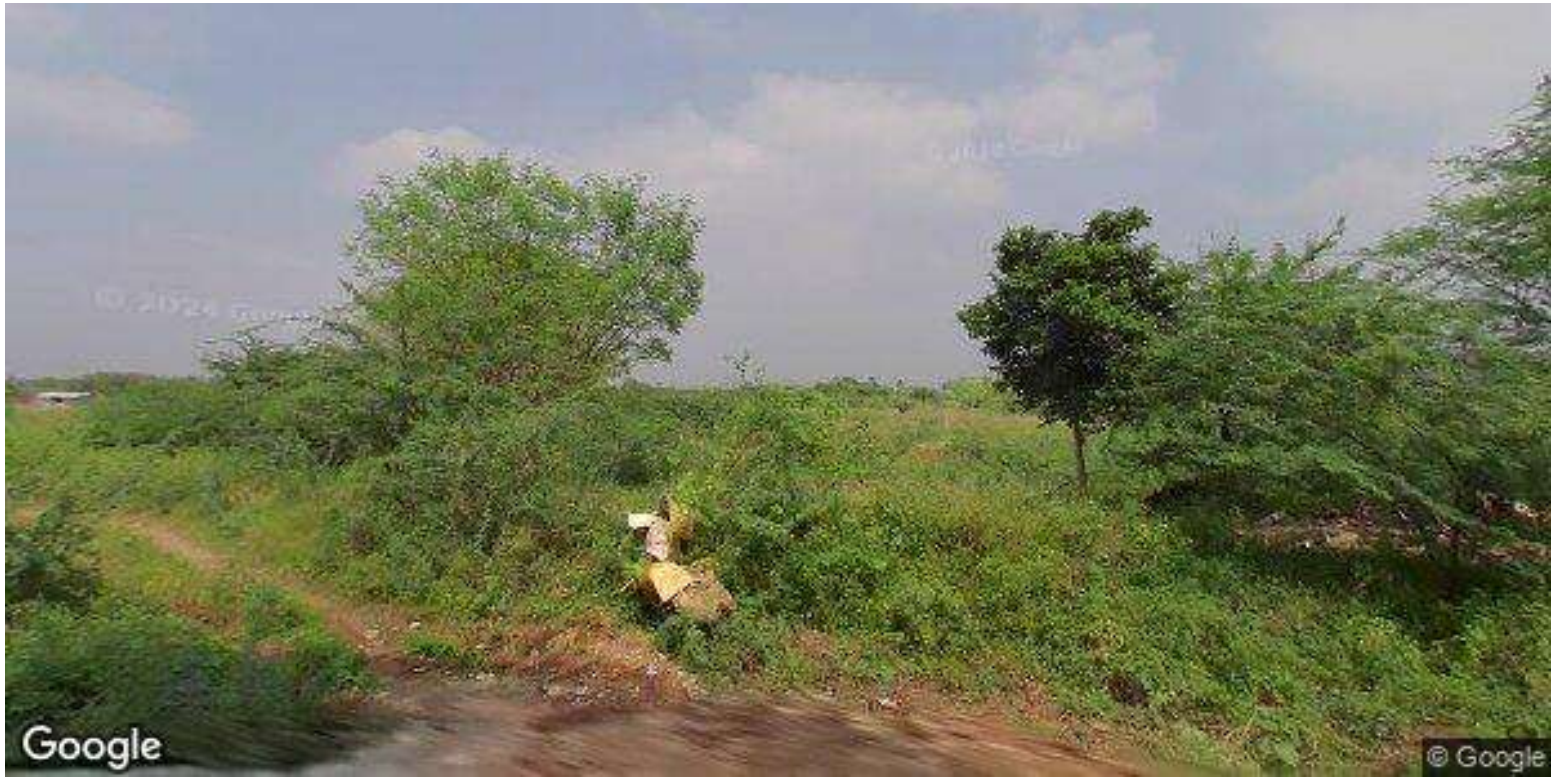
**Risk Type:** Turn  
**Risk Level:** High  
**Speed Limit:** 15 KM/Hr  
**Coordinates:** 10.69421, 78.18730

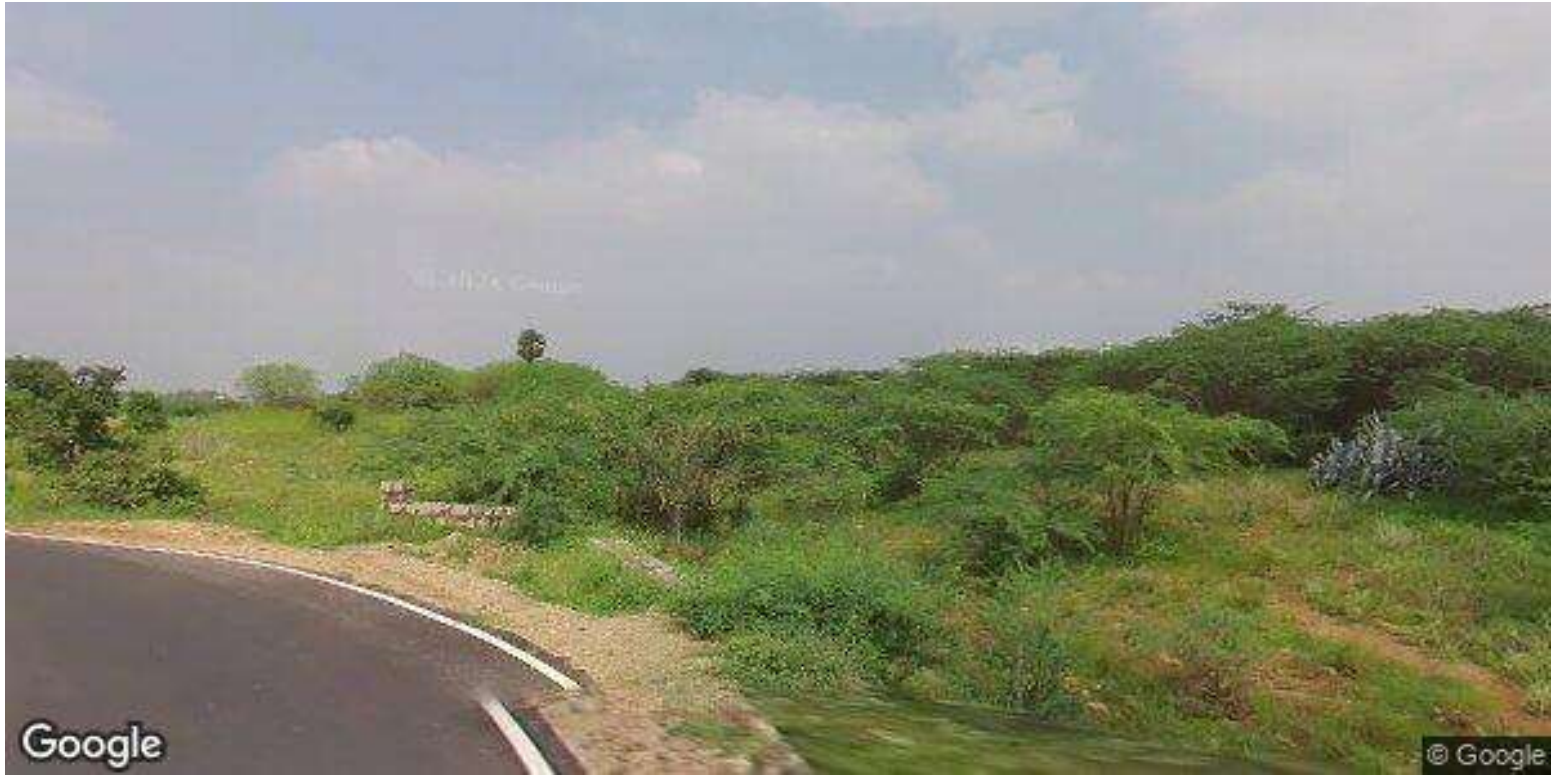
**Risk Type:** Turn  
**Risk Level:** Medium  
**Speed Limit:** 30 KM/Hr  
**Coordinates:** 10.69314, 78.18822

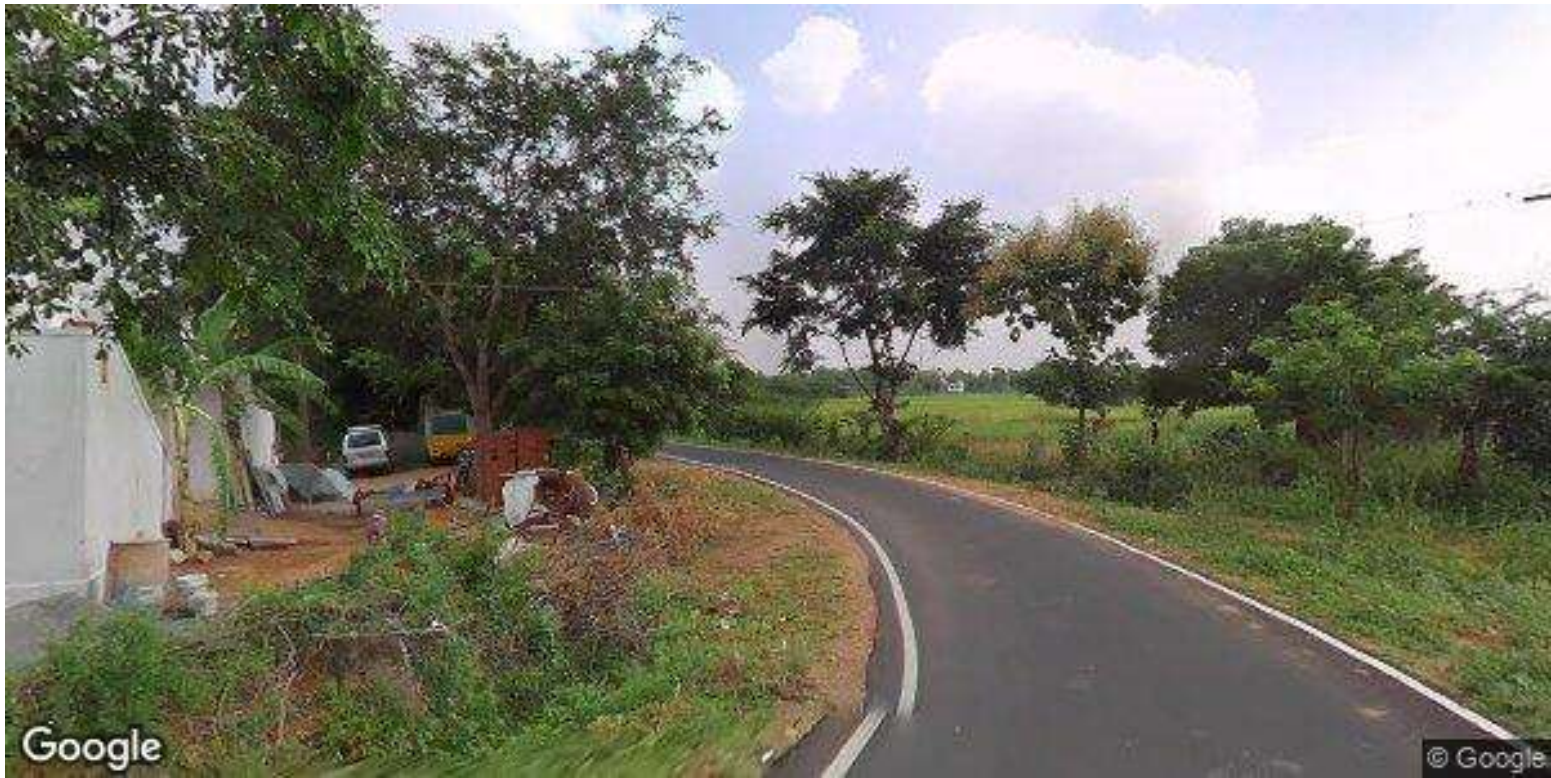
**Risk Type:** Turn  
**Risk Level:** High  
**Speed Limit:** 15 KM/Hr  
**Coordinates:** 10.69197, 78.18847

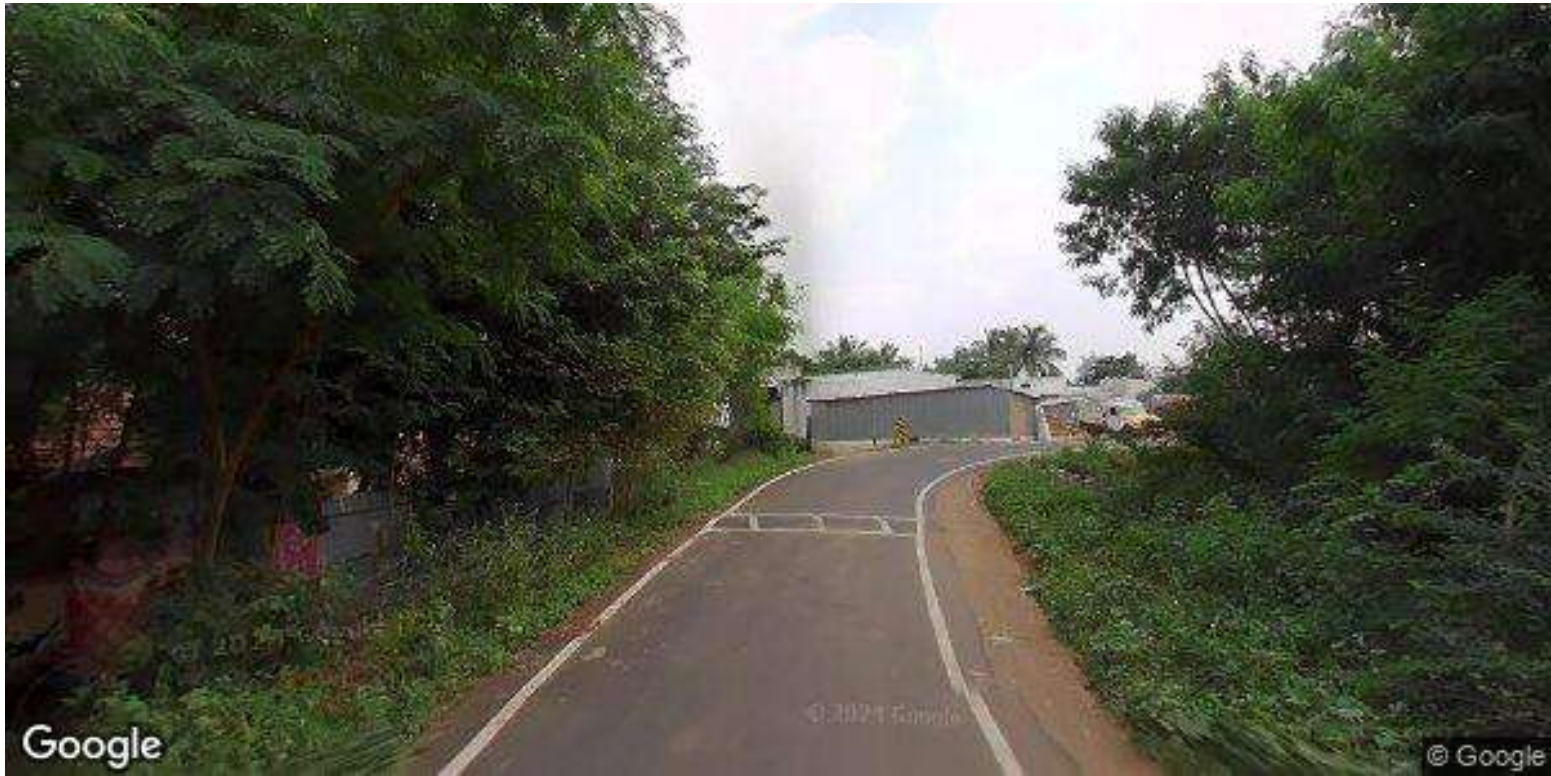
**Risk Type:** Turn  
**Risk Level:** High  
**Speed Limit:** 15 KM/Hr  
**Coordinates:** 10.69146, 78.19202

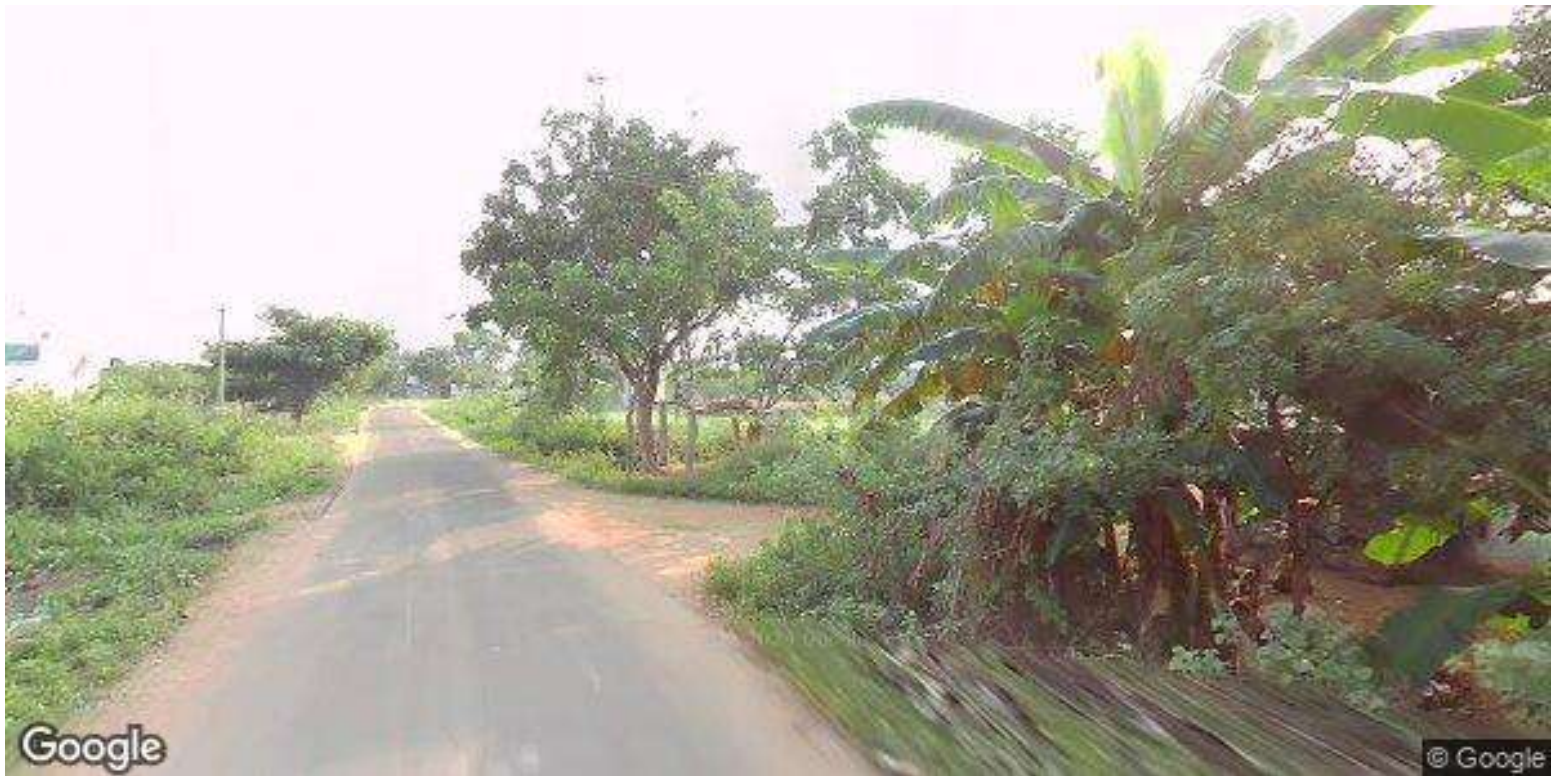
**Risk Type:** Turn  
**Risk Level:** Medium  
**Speed Limit:** 30 KM/Hr  
**Coordinates:** 10.69027, 78.19205

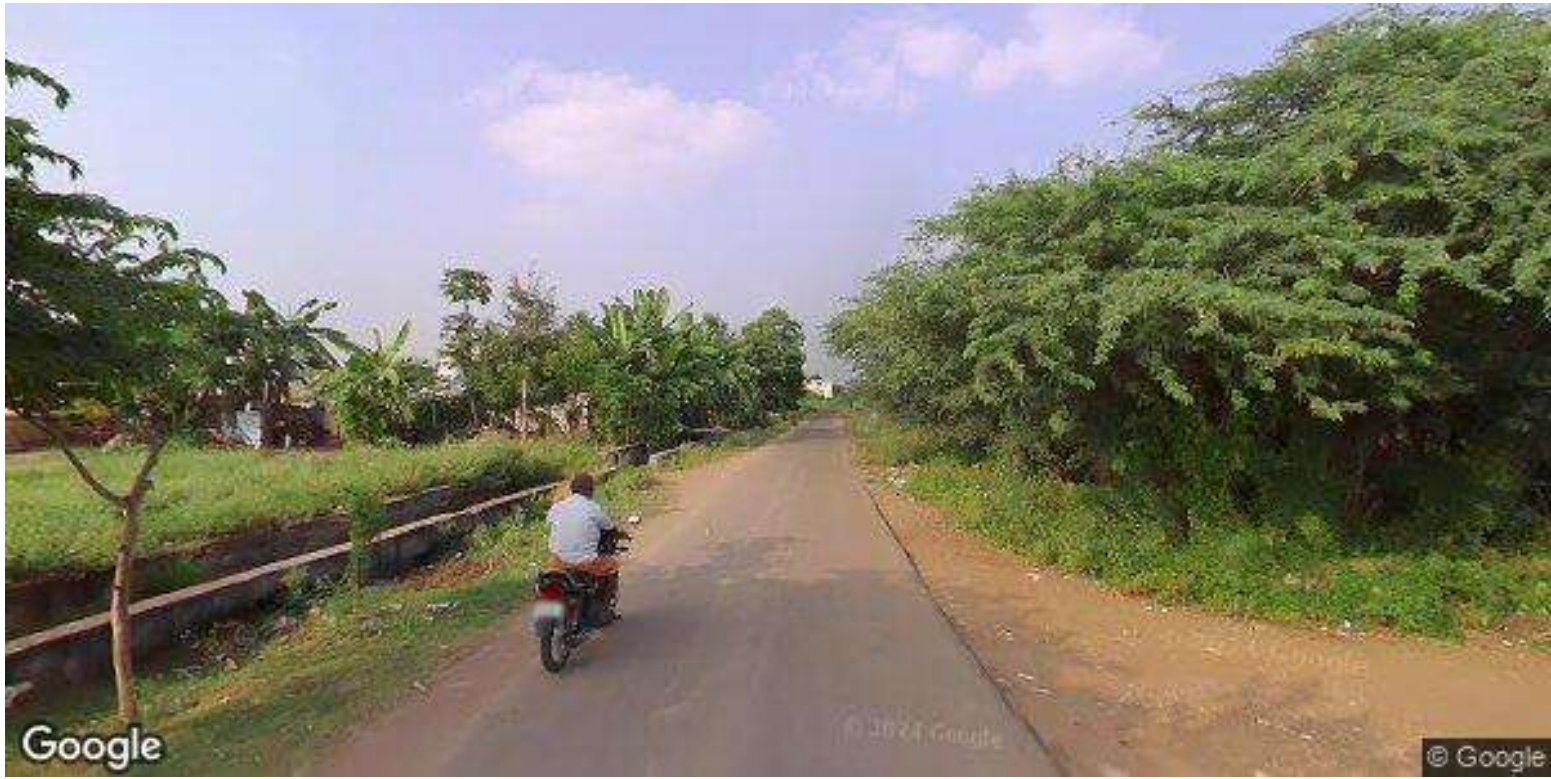
**Risk Type:** Turn  
**Risk Level:** Medium  
**Speed Limit:** 30 KM/Hr  
**Coordinates:** 10.68708, 78.19063

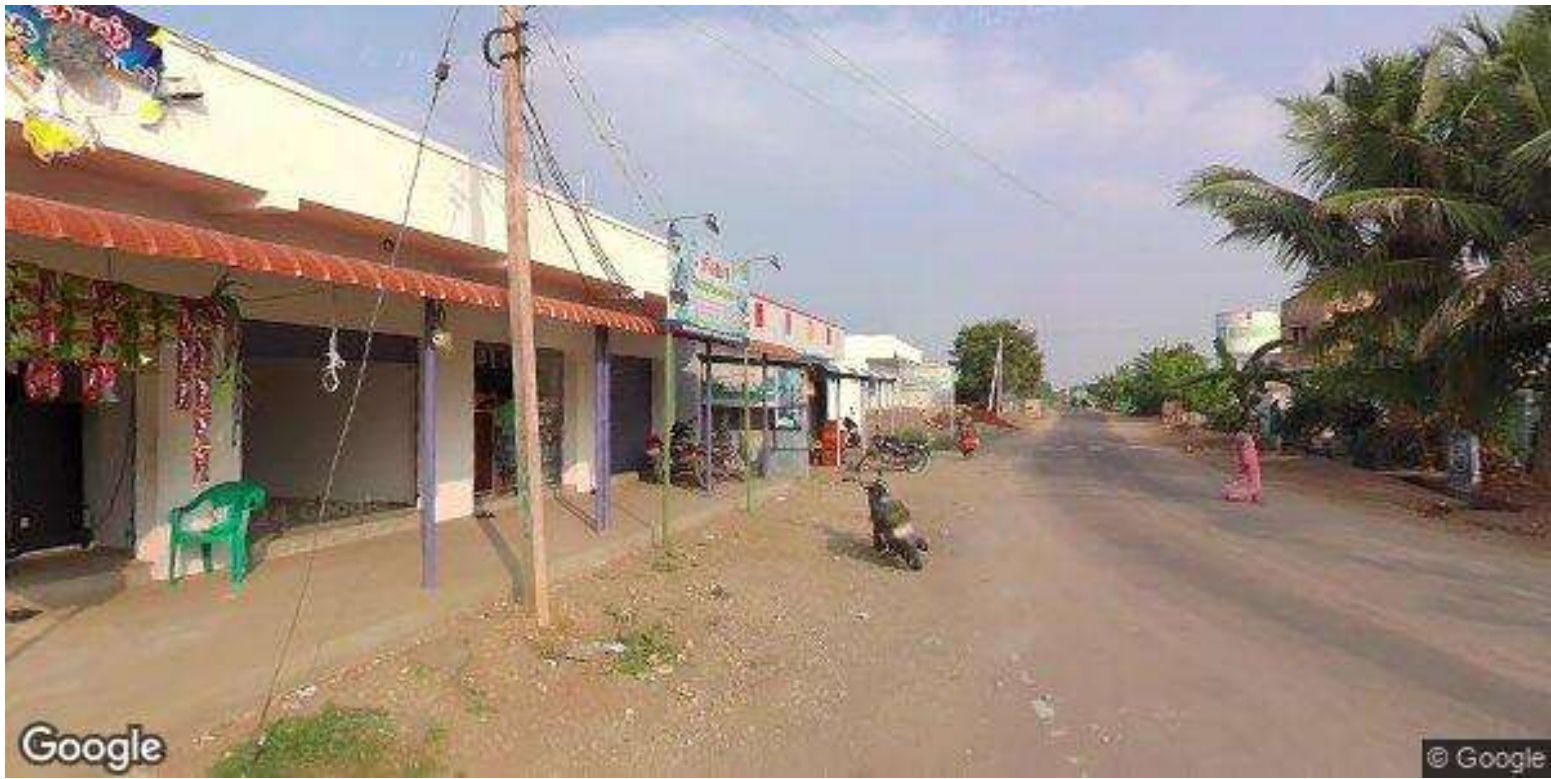
**Risk Type:** Turn  
**Risk Level:** High  
**Speed Limit:** 15 KM/Hr  
**Coordinates:** 10.68669, 78.19068

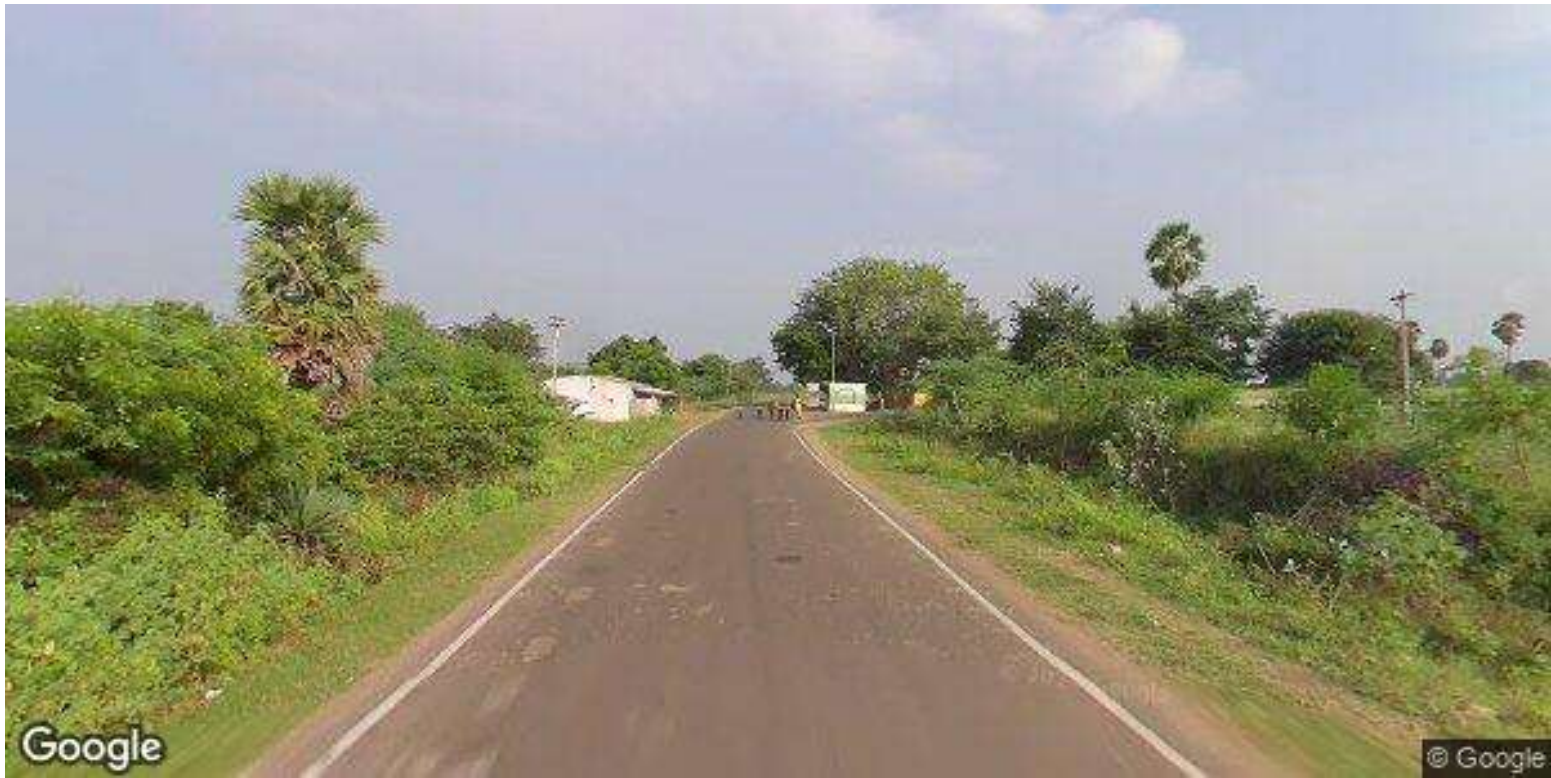
**Risk Type:** Turn  
**Risk Level:** Medium  
**Speed Limit:** 30 KM/Hr  
**Coordinates:** 10.68560, 78.19717

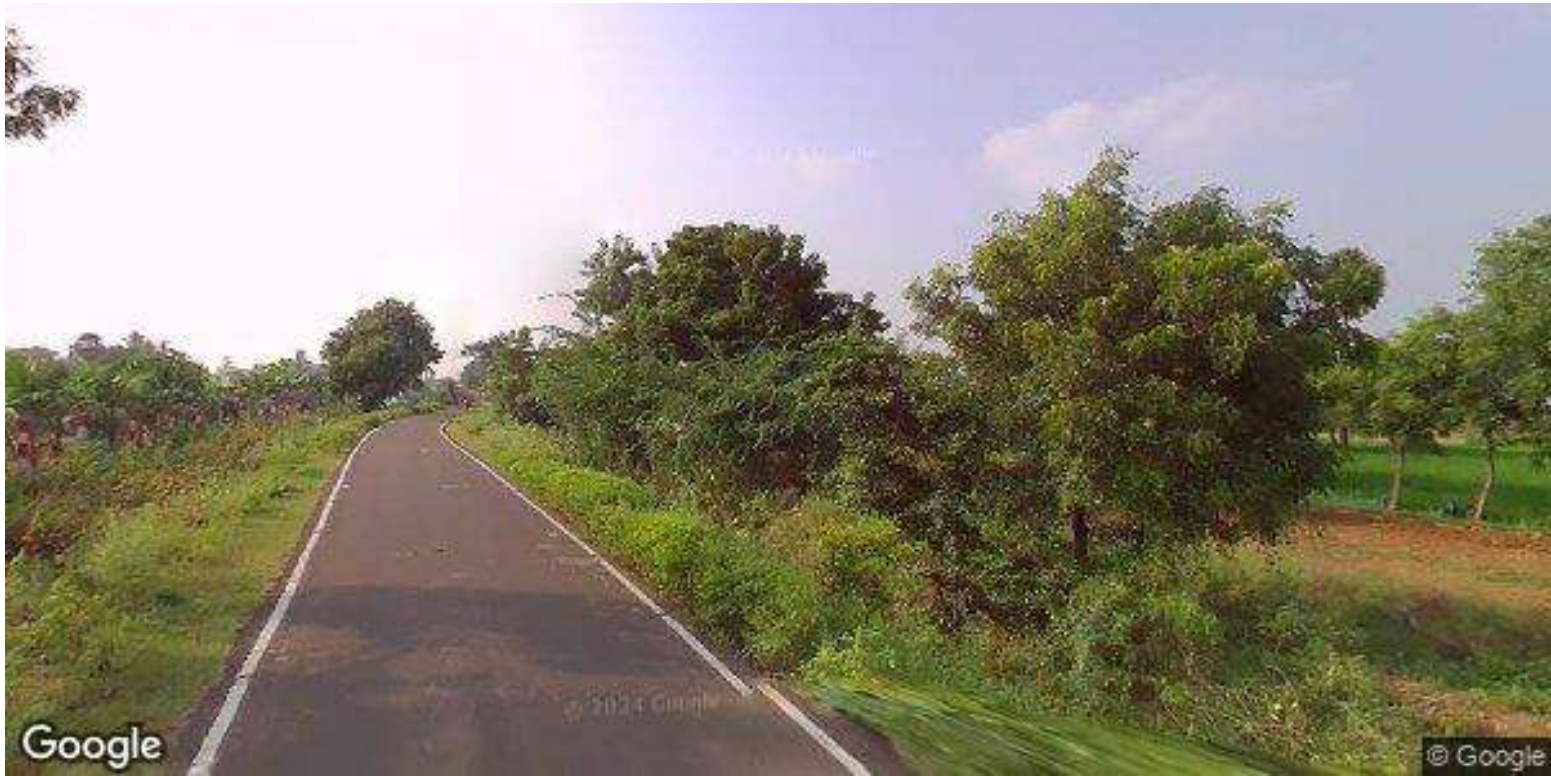
**Risk Type:** Turn  
**Risk Level:** High  
**Speed Limit:** 15 KM/Hr  
**Coordinates:** 10.68312, 78.20051

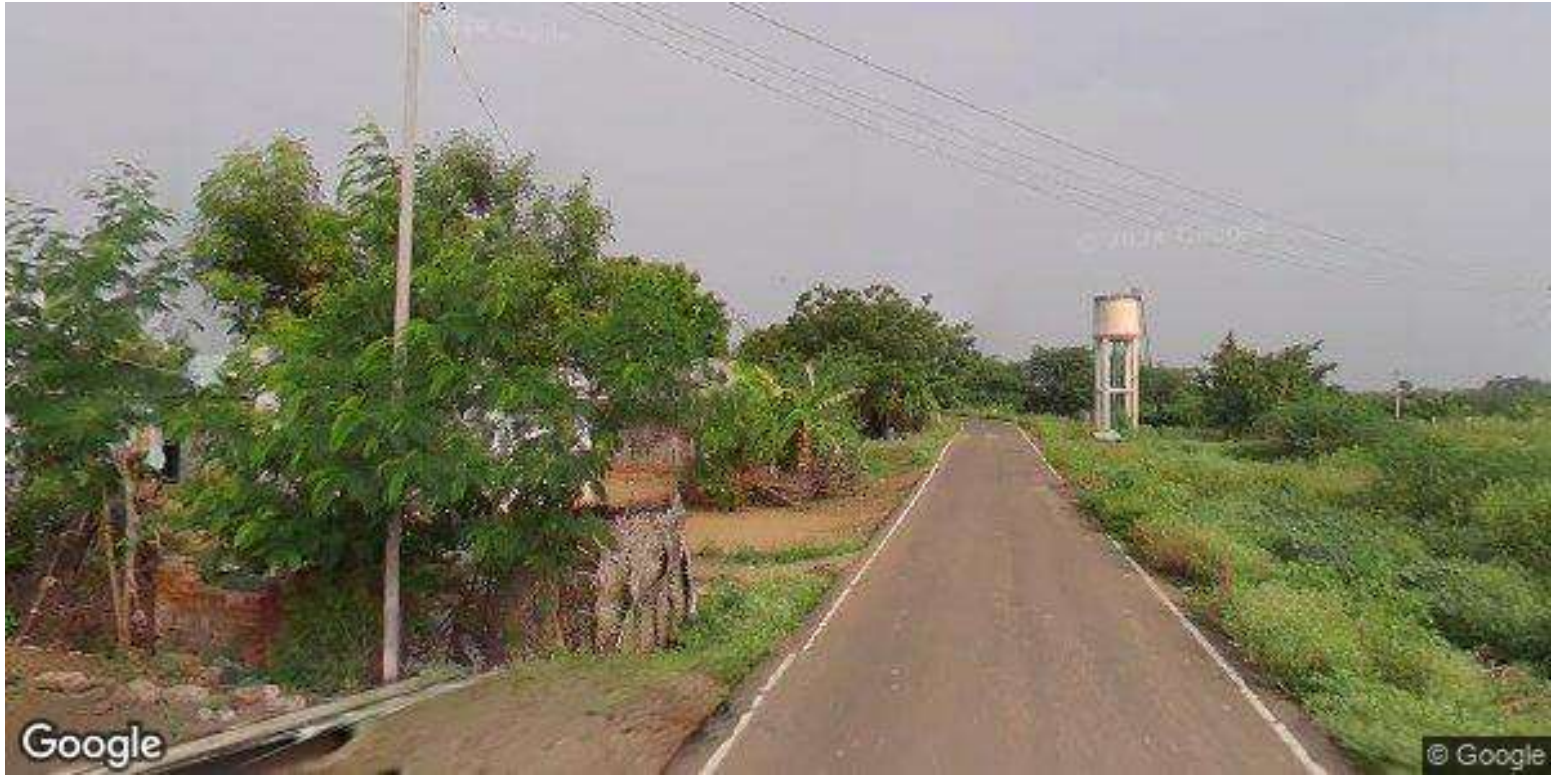
**Risk Type:** Turn  
**Risk Level:** High  
**Speed Limit:** 15 KM/Hr  
**Coordinates:** 10.68024, 78.20065

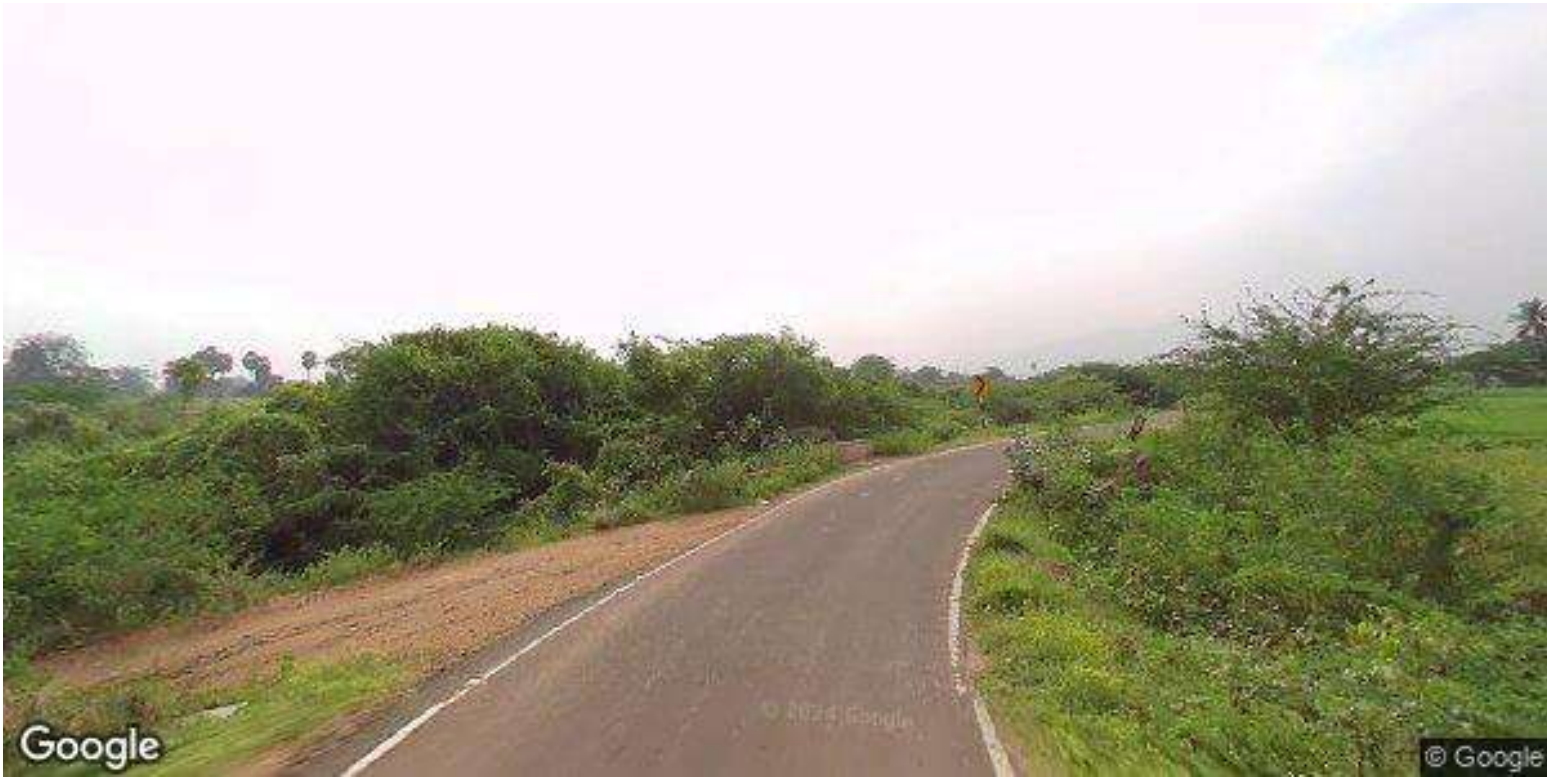
**Risk Type:** Turn  
**Risk Level:** High  
**Speed Limit:** 15 KM/Hr  
**Coordinates:** 10.67972, 78.20149

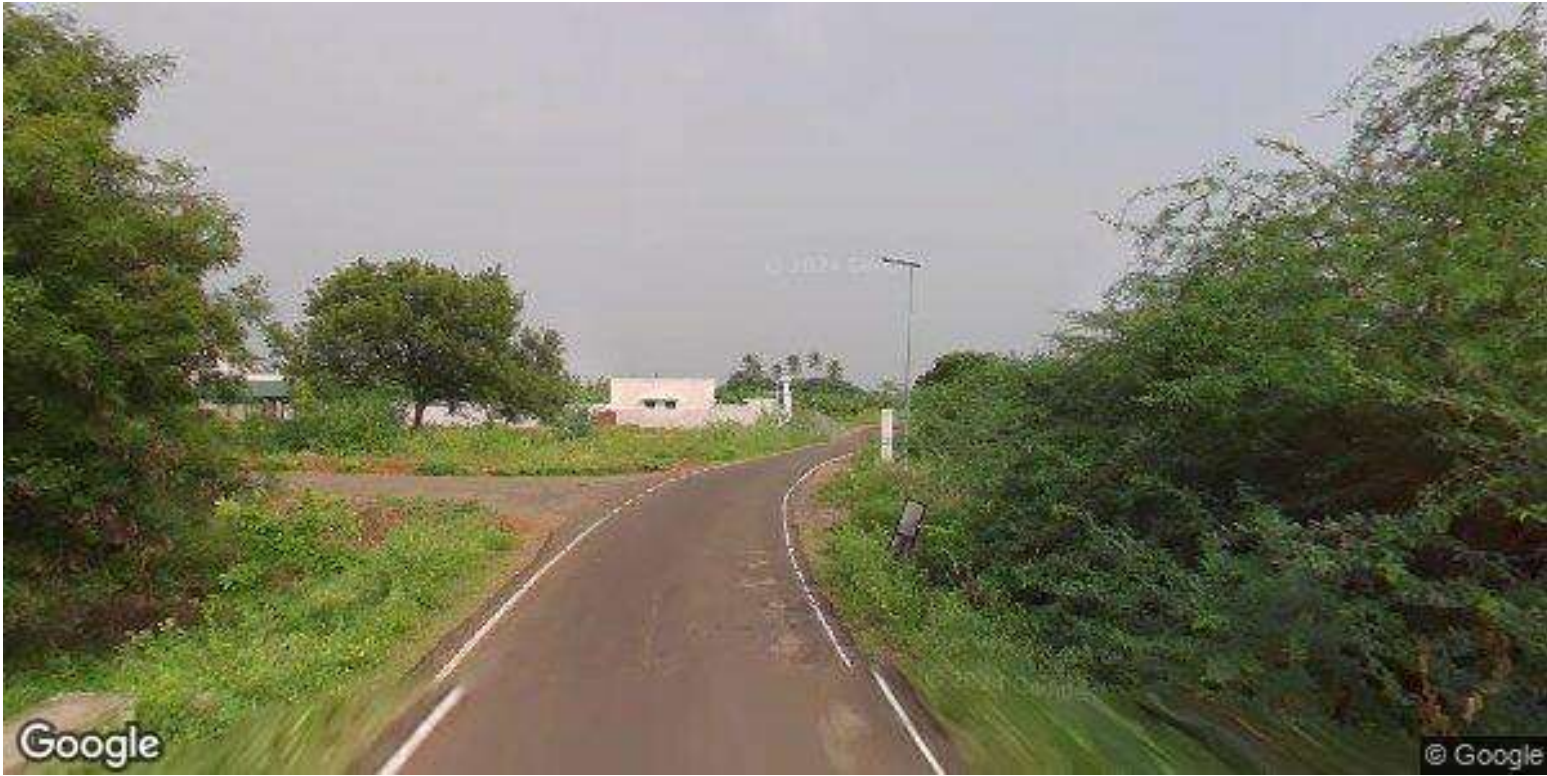
**Risk Type:** Turn  
**Risk Level:** Medium  
**Speed Limit:** 30 KM/Hr  
**Coordinates:** 10.67622, 78.20086

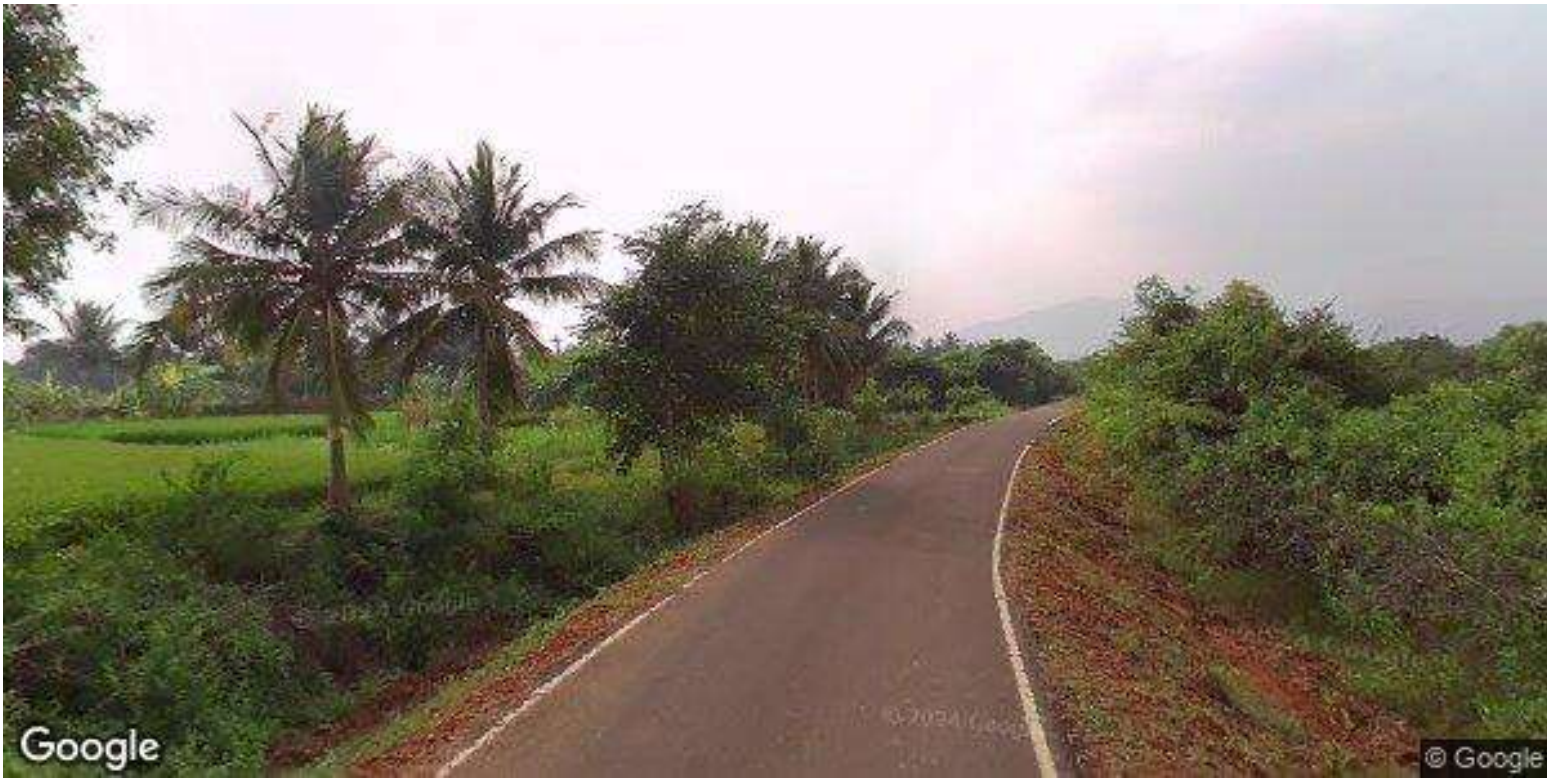
**Risk Type:** Turn  
**Risk Level:** High  
**Speed Limit:** 15 KM/Hr  
**Coordinates:** 10.66152, 78.21040

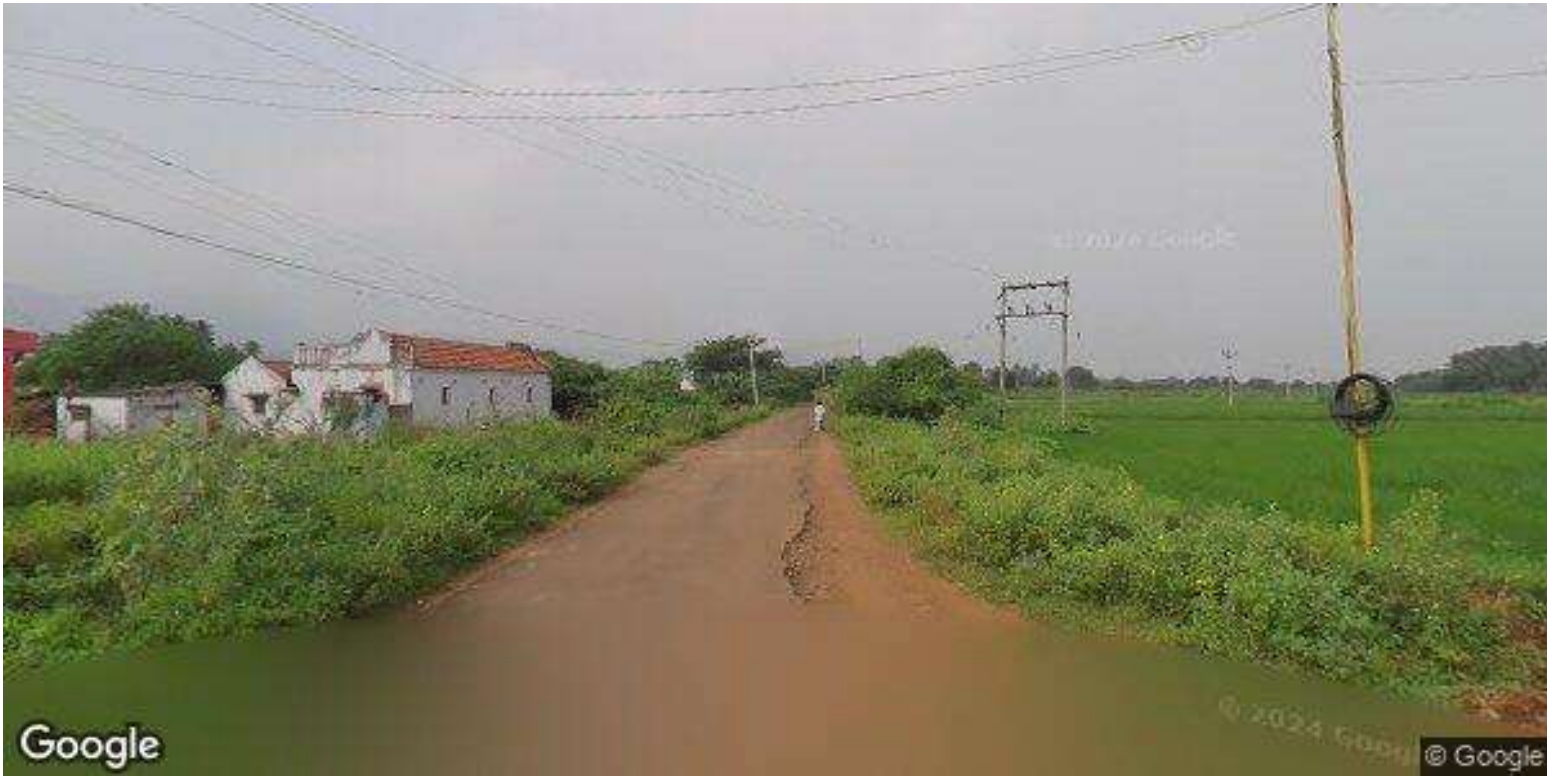
**Risk Type:** Turn  
**Risk Level:** High  
**Speed Limit:** 15 KM/Hr  
**Coordinates:** 10.65166, 78.20938
