# IndianOil

## JOURNEY RISK MANAGEMENT (JRM) STUDY

### Salem Terminal TO MANICKAMALAYAN AGENCIES

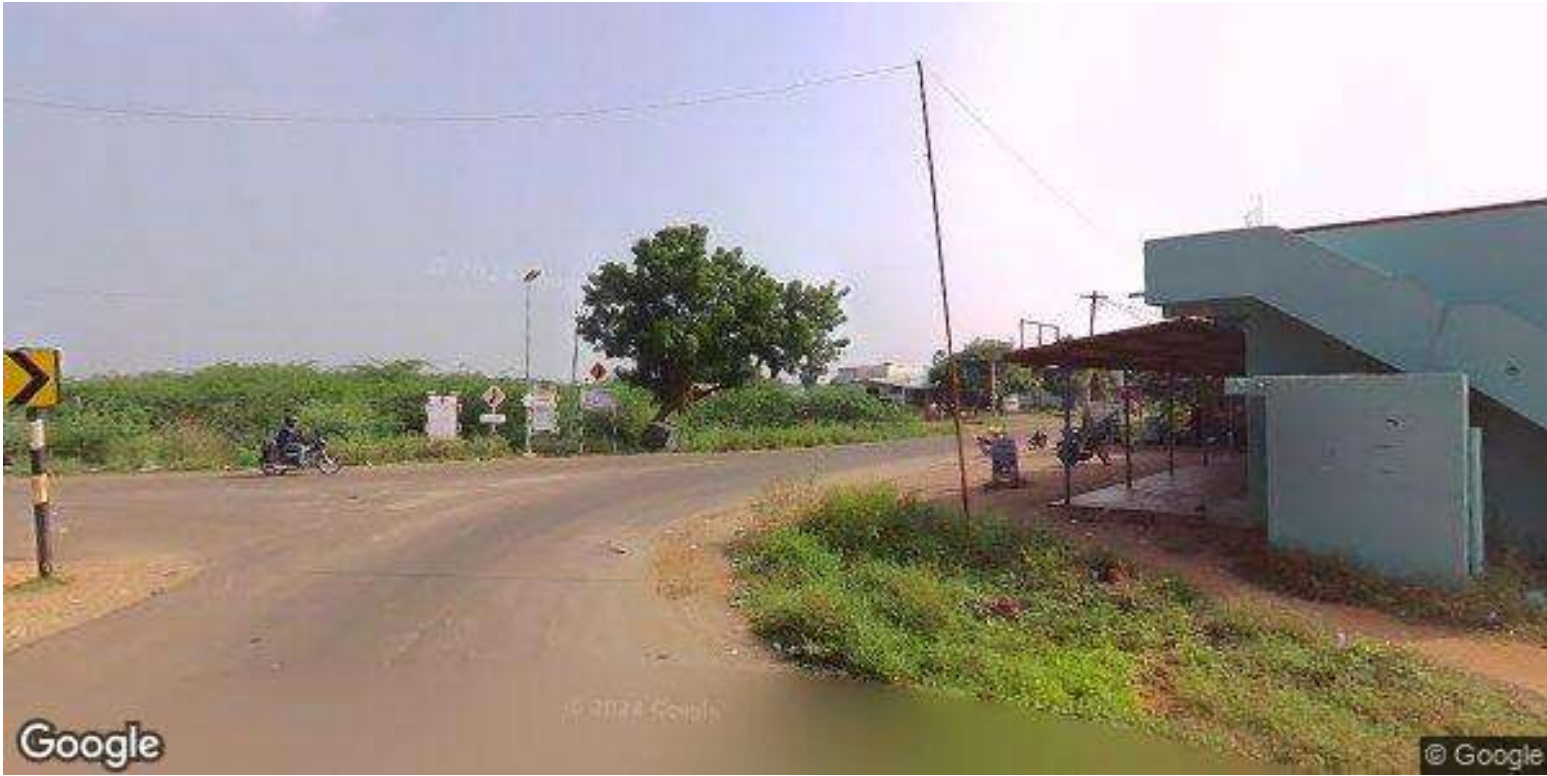
**Risk Type:** Turn  
**Risk Level:** High  
**Speed Limit:** 15 KM/Hr  
**Coordinates:** 10.64662, 78.23481

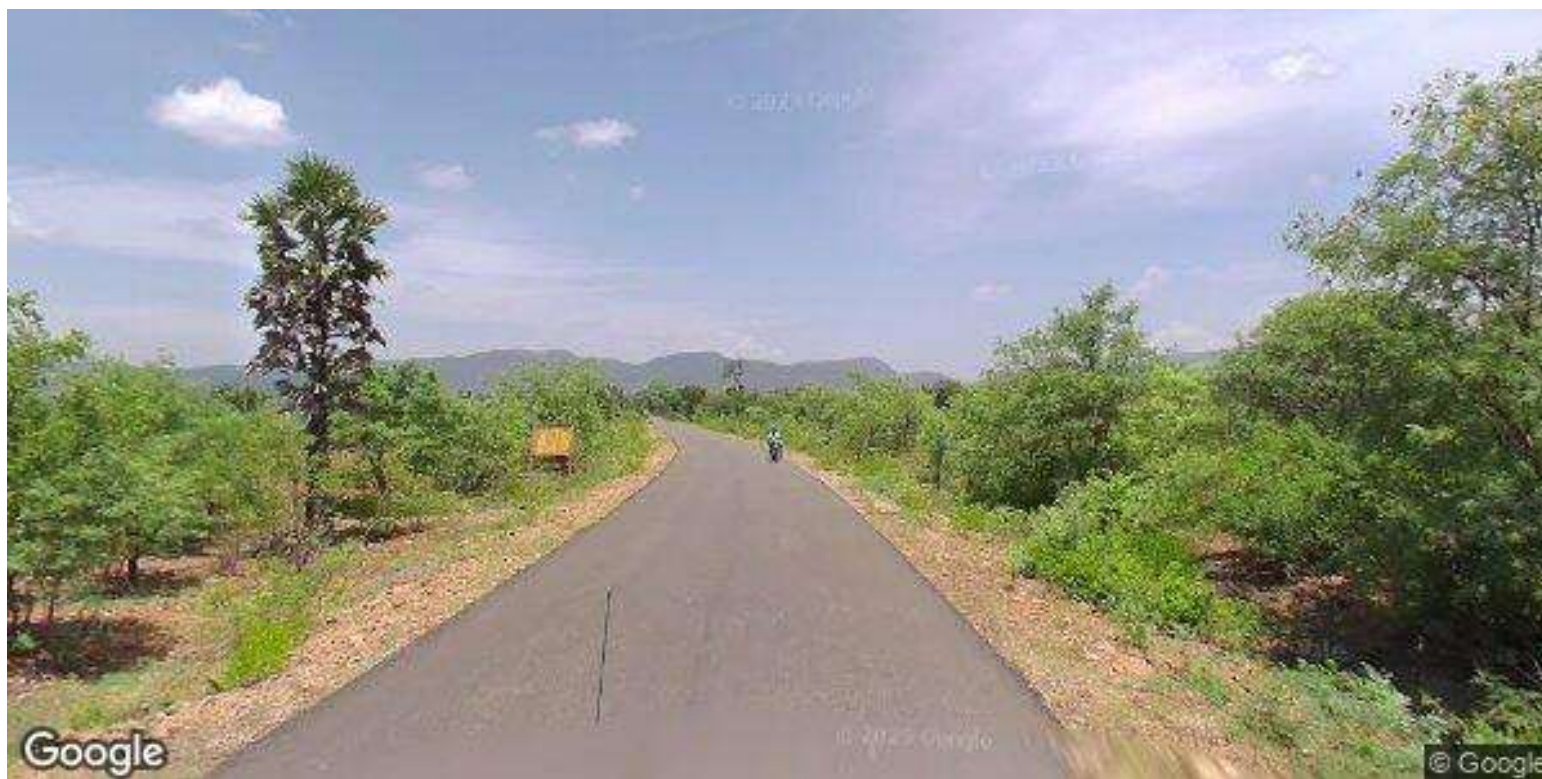
**Risk Type:** Turn

**Risk Level:** Medium

**Speed Limit:** 30 KM/Hr

**Coordinates:** 10.60662, 78.21679

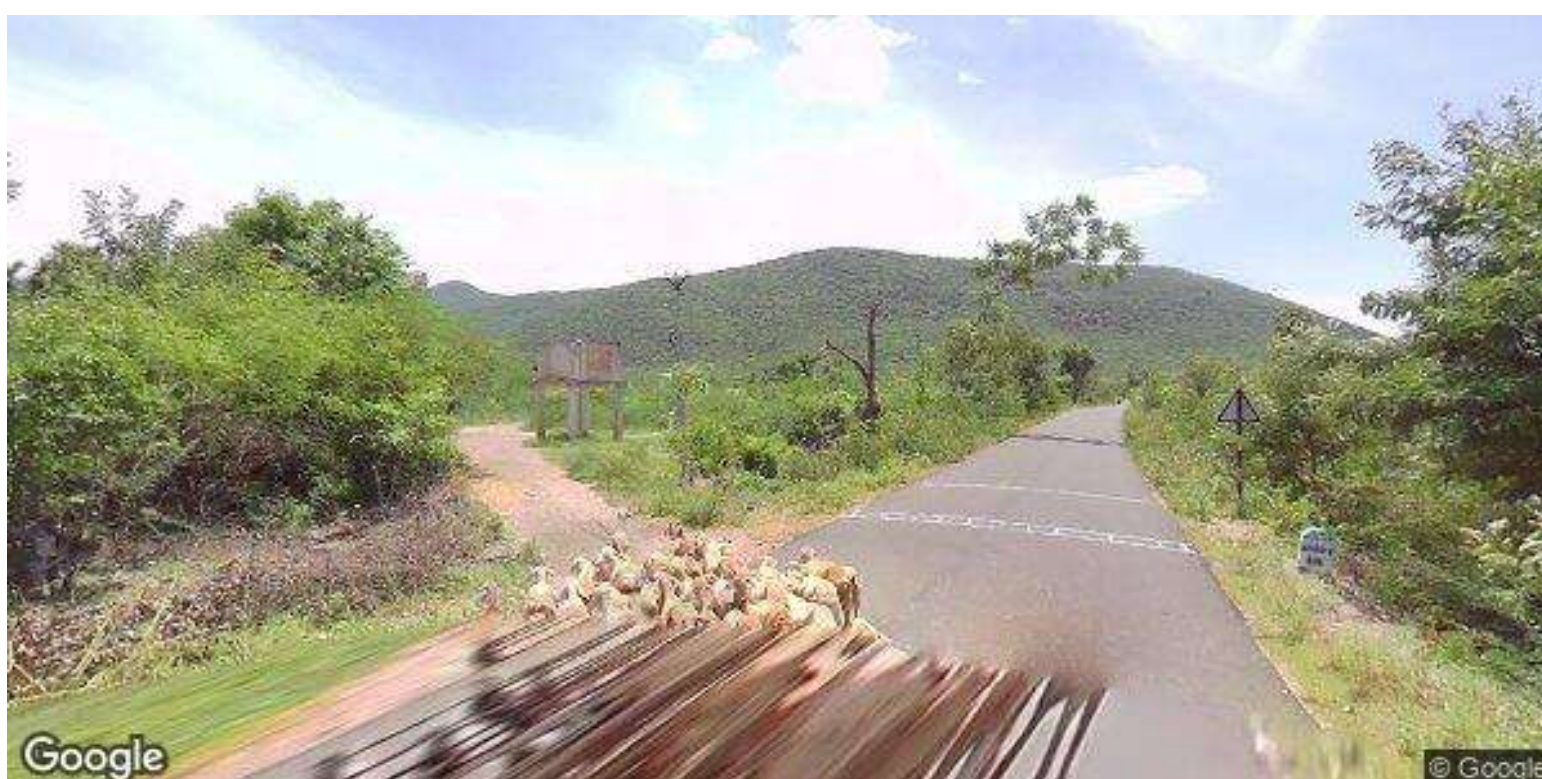
**Risk Type:** Turn

**Risk Level:** Medium

**Speed Limit:** 30 KM/Hr

**Coordinates:** 10.60270, 78.21527

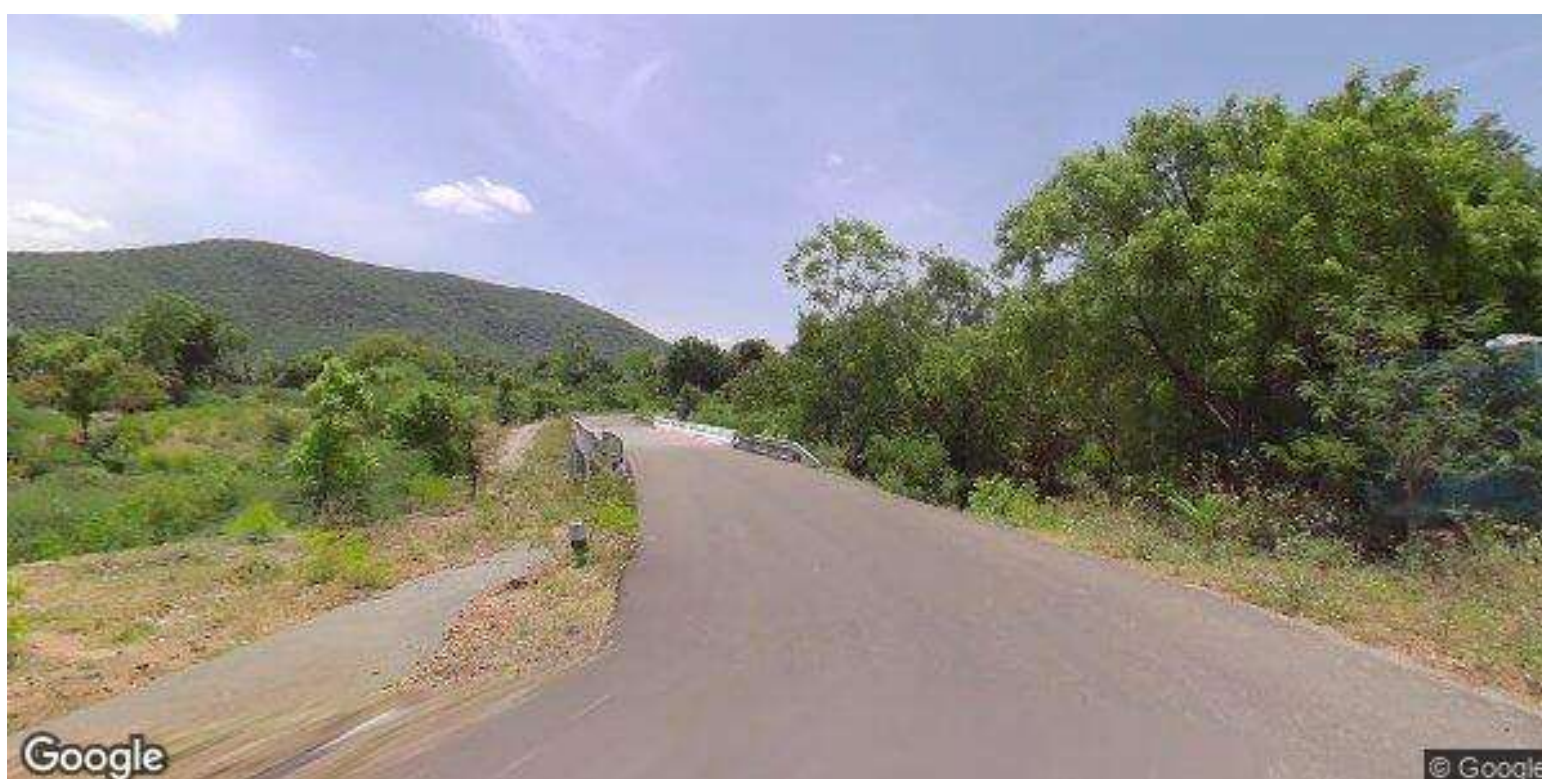
**Risk Type:** Turn  
**Risk Level:** High  
**Speed Limit:** 15 KM/Hr  
**Coordinates:** 10.60079, 78.21365

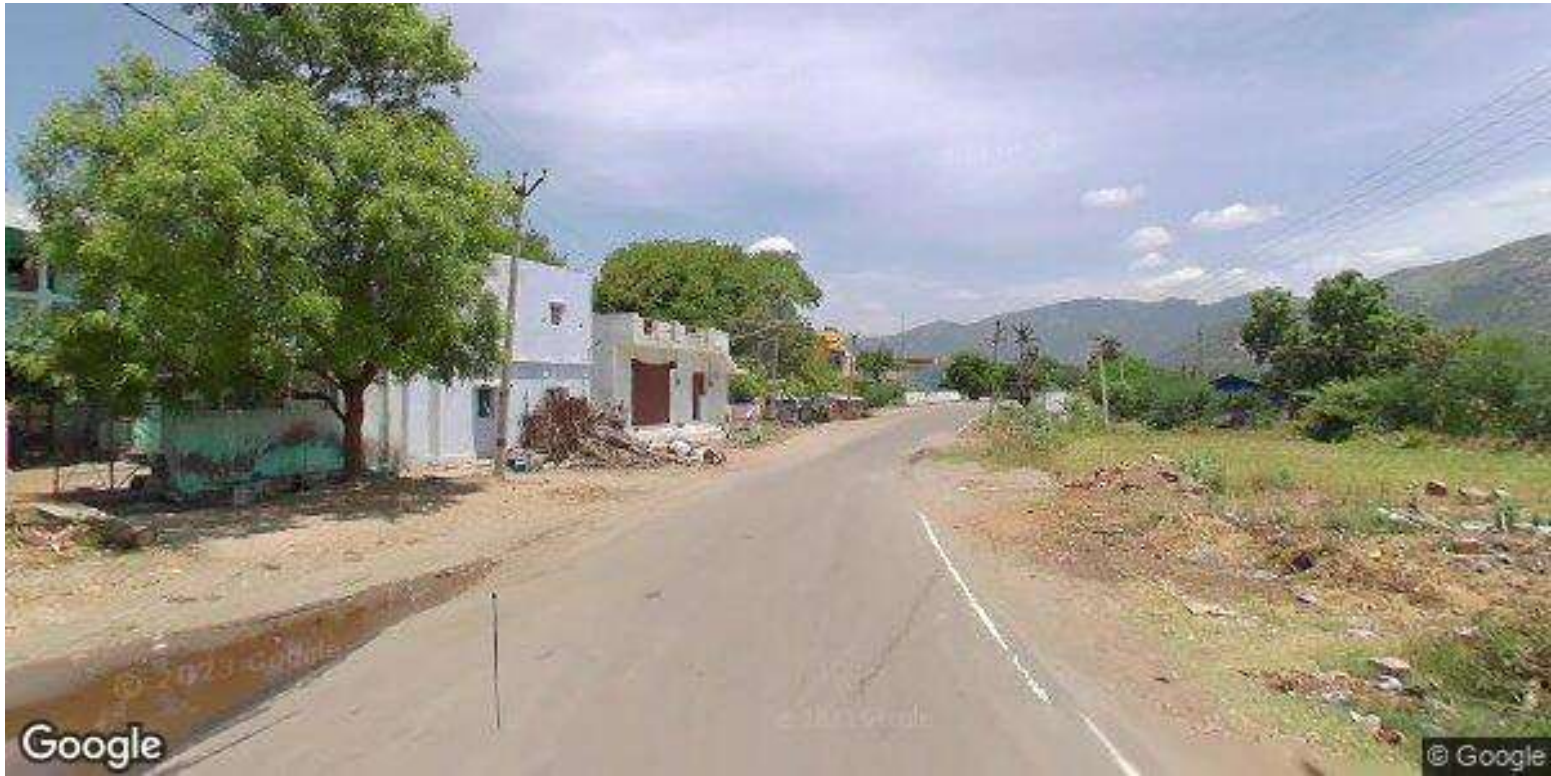
**Risk Type:** Blind Spot  
**Risk Level:** Blind Spot  
**Speed Limit:** 10 KM/Hr  
**Coordinates:** 10.59513, 78.19657
