# IndianOil

## JOURNEY RISK MANAGEMENT (JRM) STUDY

### Salem Terminal to KRISHNA AGENCY

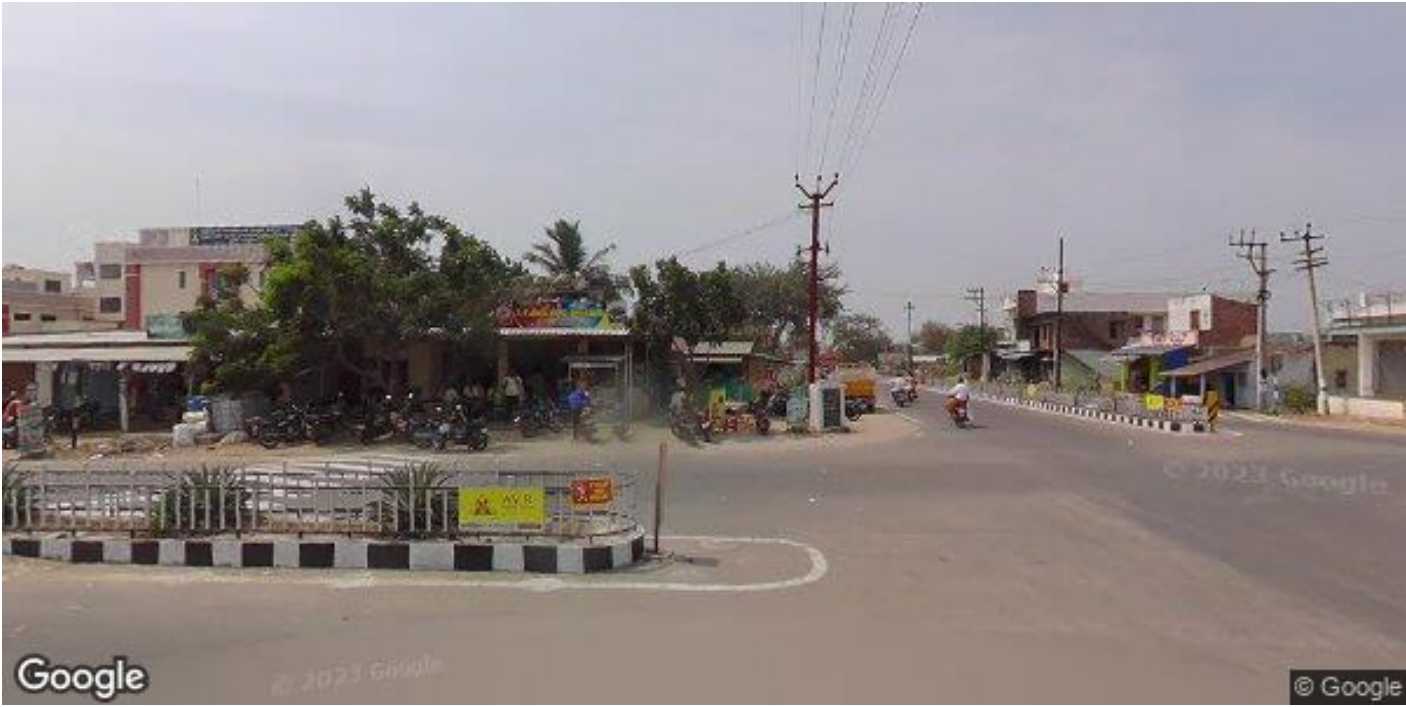
**Risk Type:** Roundabout  
**Risk Level:** High  
**Speed Limit:** 15 KM/Hr  
**Coordinates:** 11.58300, 77.85813

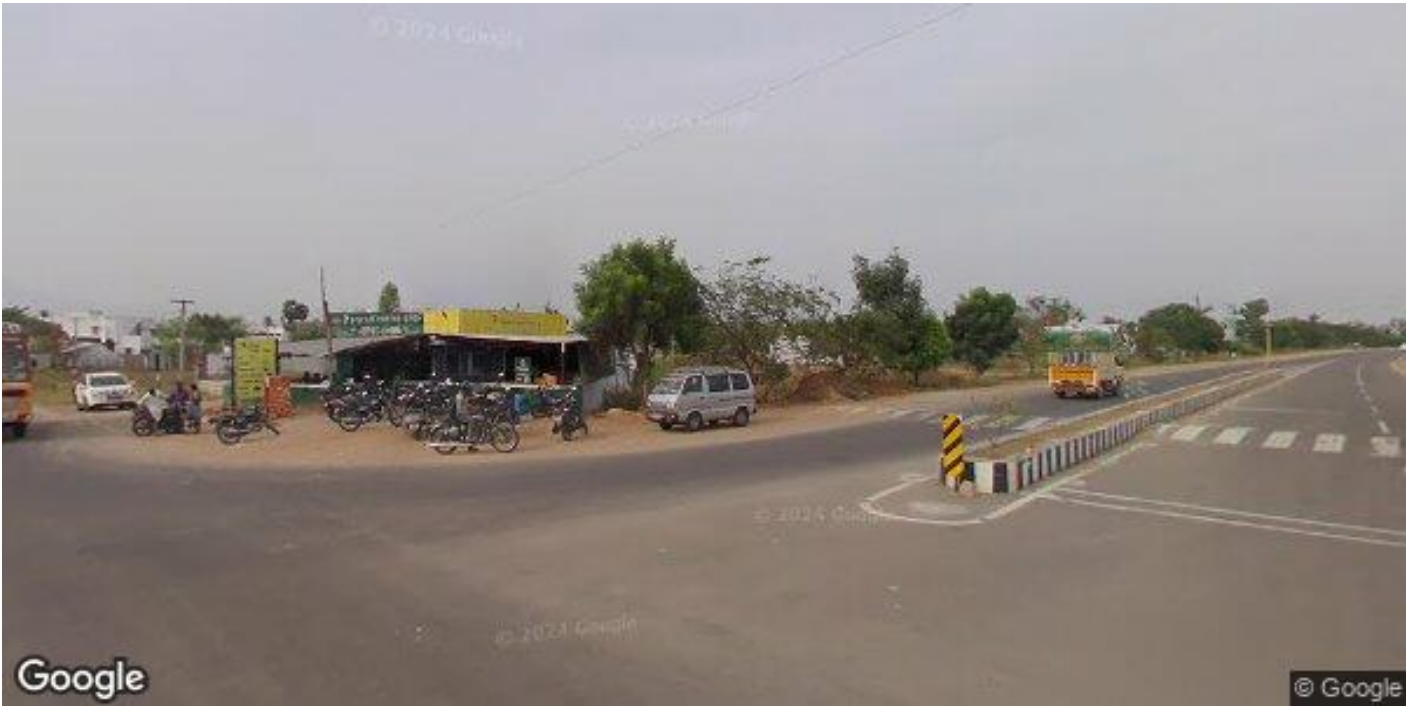
**Risk Type:** Roundabout  
**Risk Level:** High  
**Speed Limit:** 15 KM/Hr  
**Coordinates:** 11.60019, 77.81968

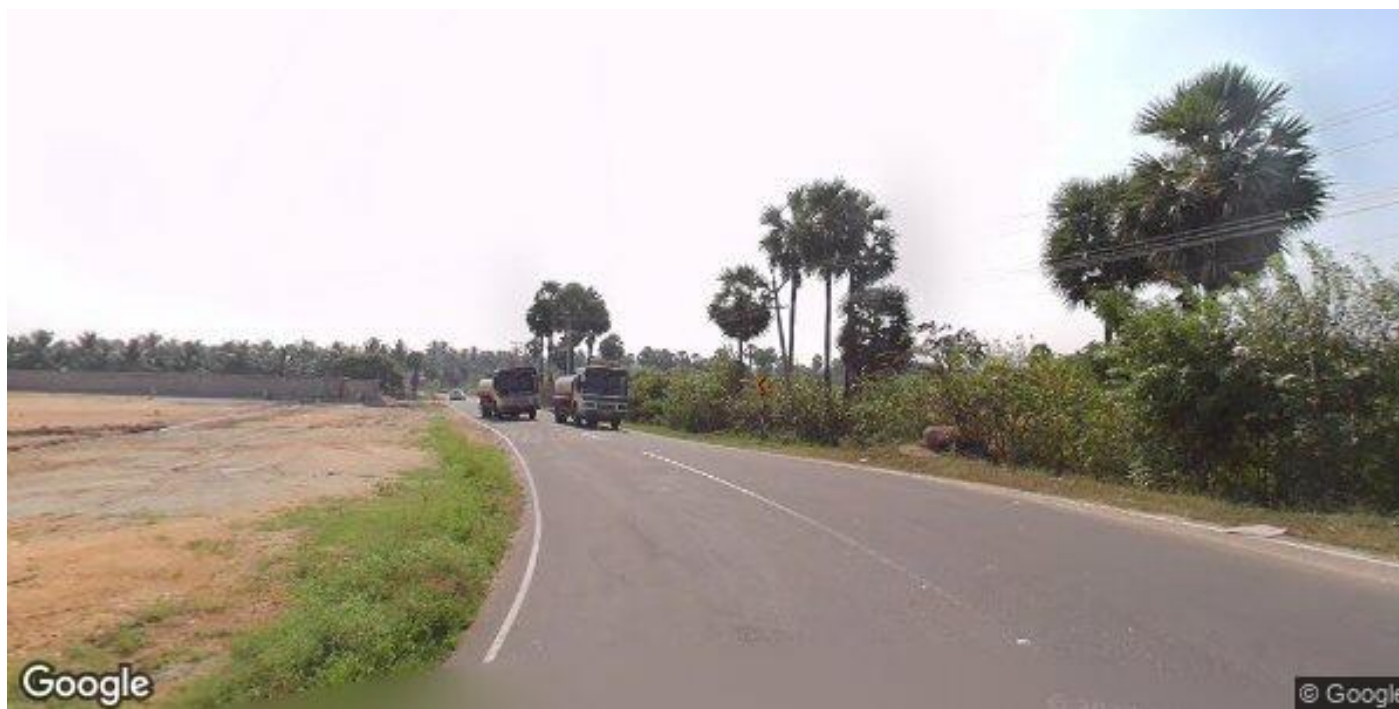
**Risk Type:** Turn  
**Risk Level:** Medium  
**Speed Limit:** 30 KM/Hr  
**Coordinates:** 11.45839, 77.85143

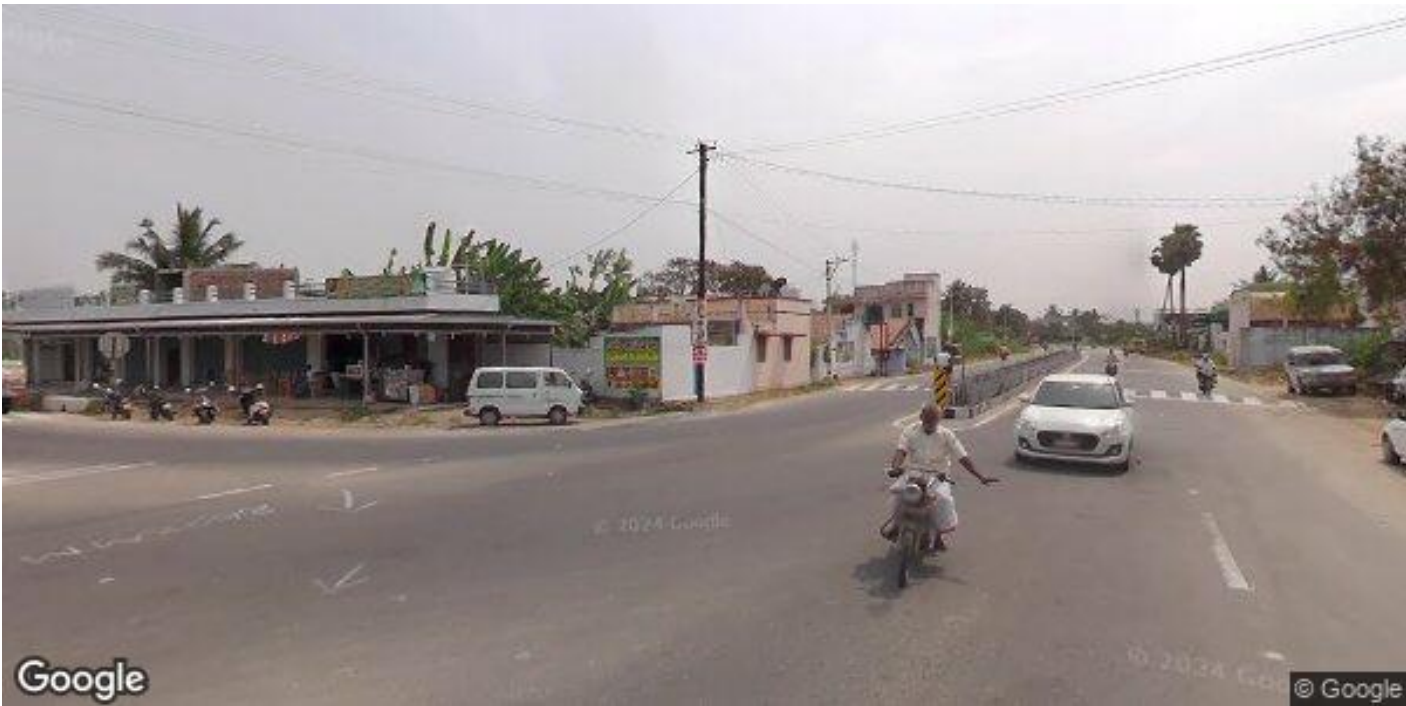
**Risk Type:** Turn  
**Risk Level:** High  
**Speed Limit:** 15 KM/Hr  
**Coordinates:** 11.57903, 77.85432

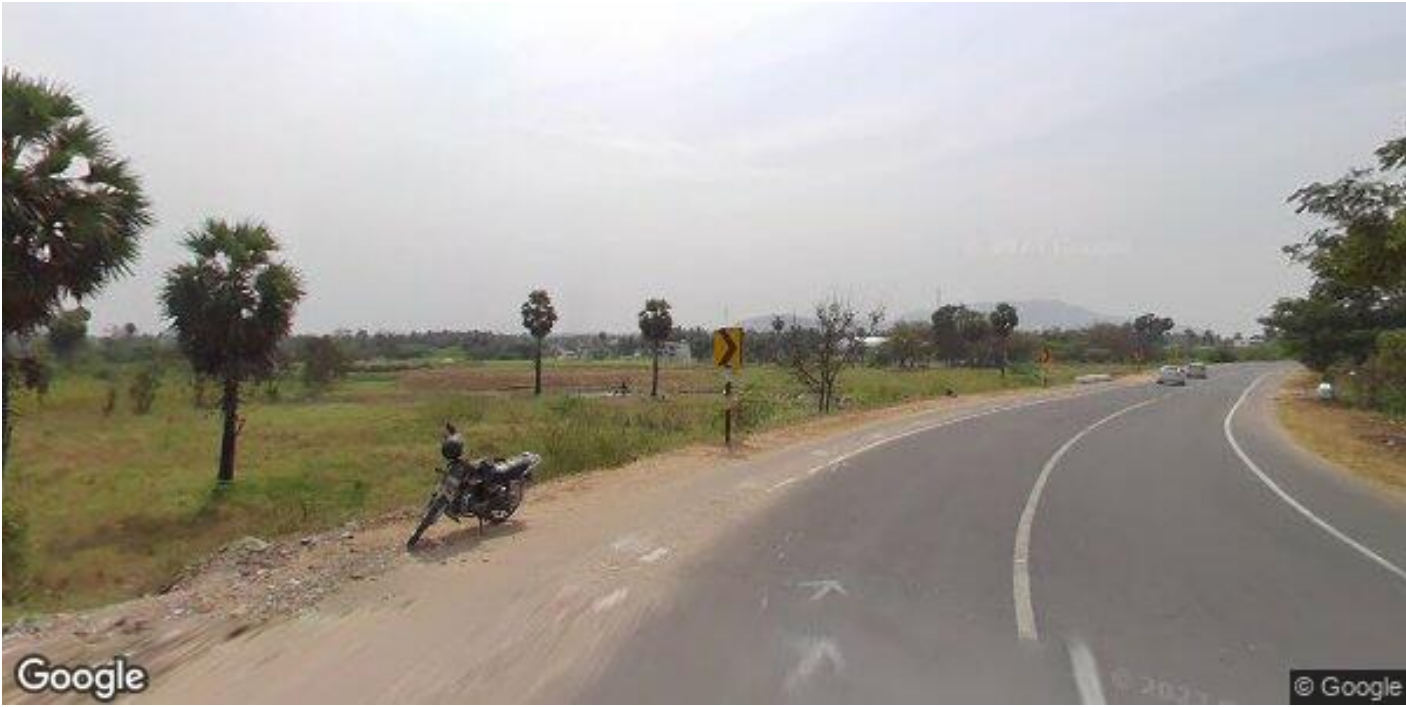
**Risk Type:** Turn  
**Risk Level:** Medium  
**Speed Limit:** 30 KM/Hr  
**Coordinates:** 11.58022, 77.85744

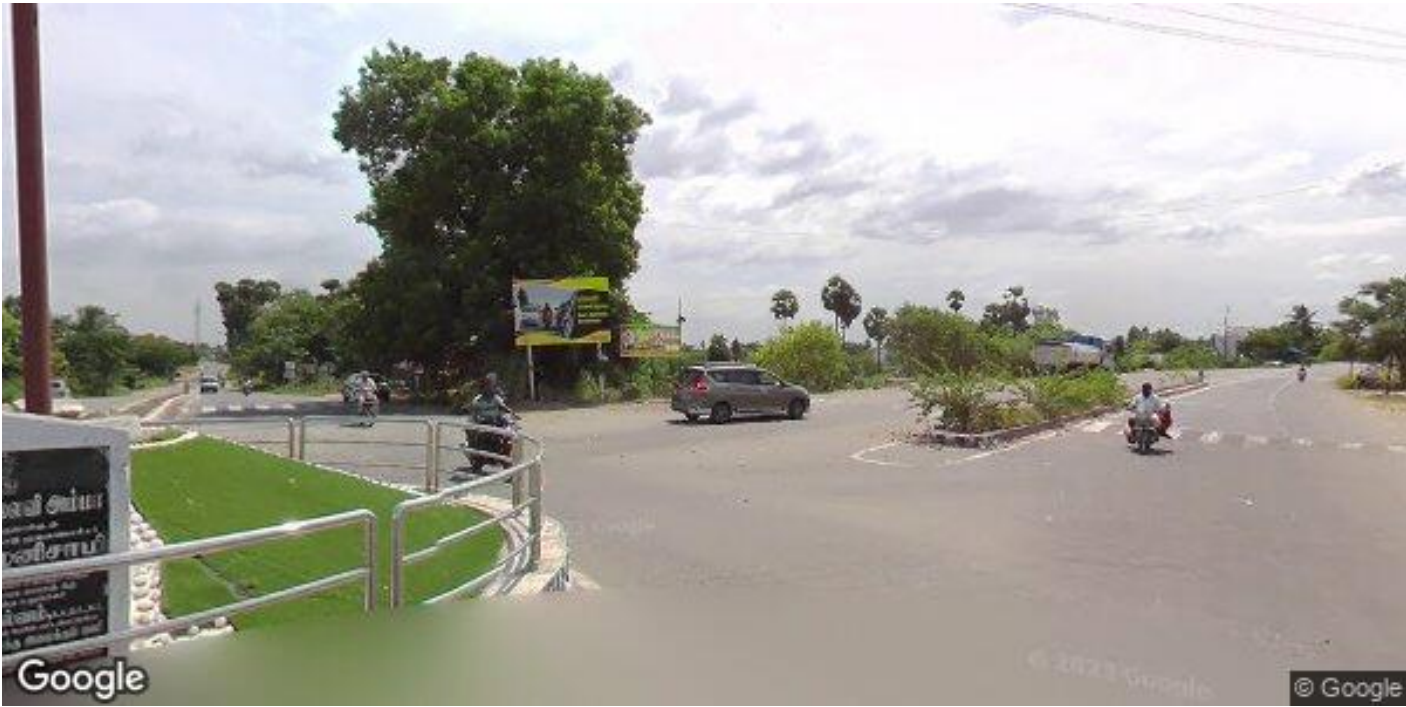
**Risk Type:** Turn  
**Risk Level:** Medium  
**Speed Limit:** 30 KM/Hr  
**Coordinates:** 11.60348, 77.83967

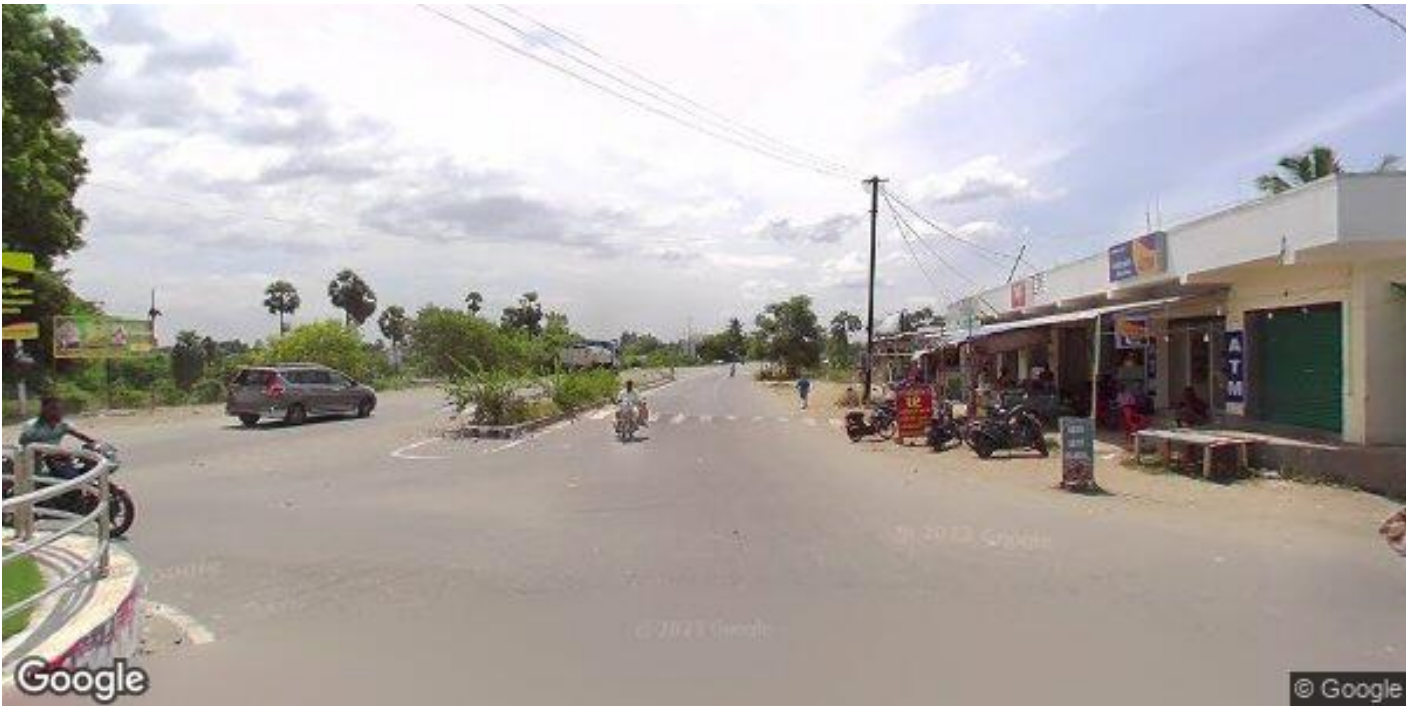
**Risk Type:** Turn  
**Risk Level:** Medium  
**Speed Limit:** 30 KM/Hr  
**Coordinates:** 11.60345, 77.83963

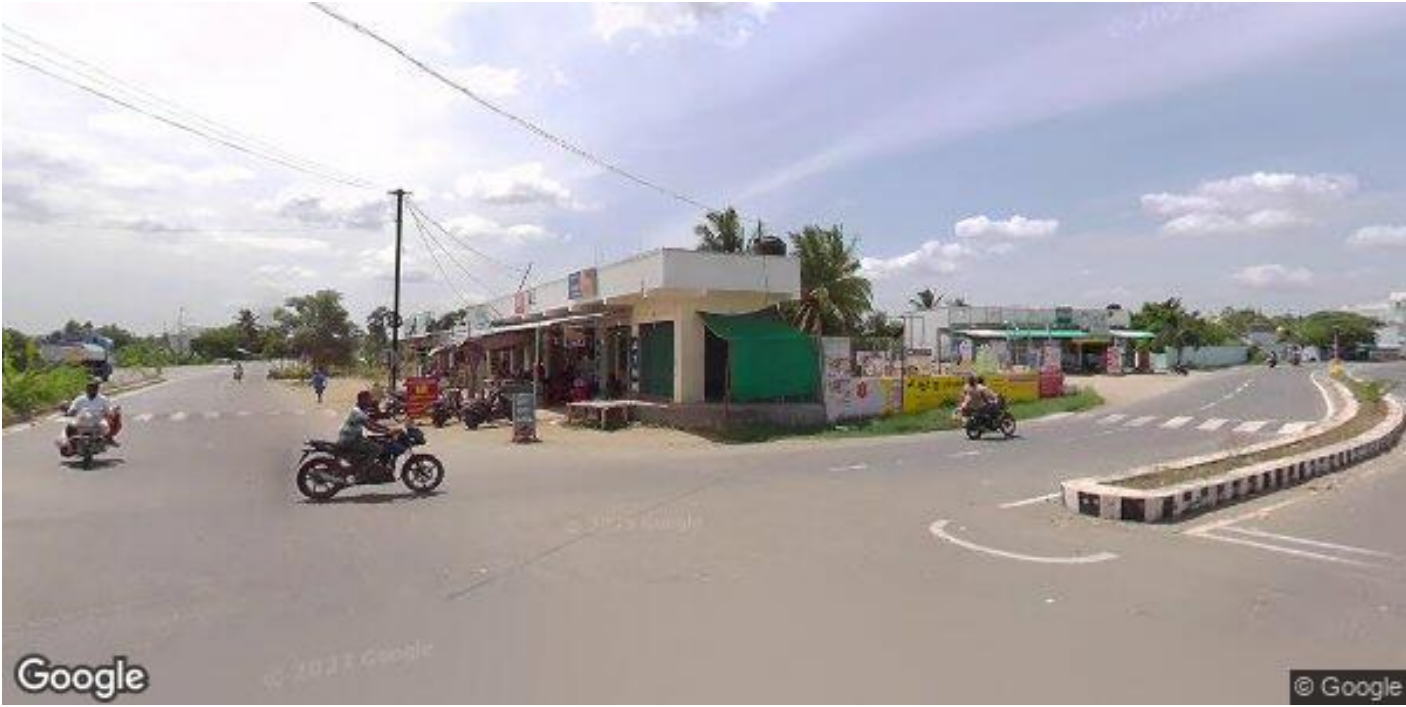
**Risk Type:** Turn  
**Risk Level:** Medium  
**Speed Limit:** 30 KM/Hr  
**Coordinates:** 11.60345, 77.83958

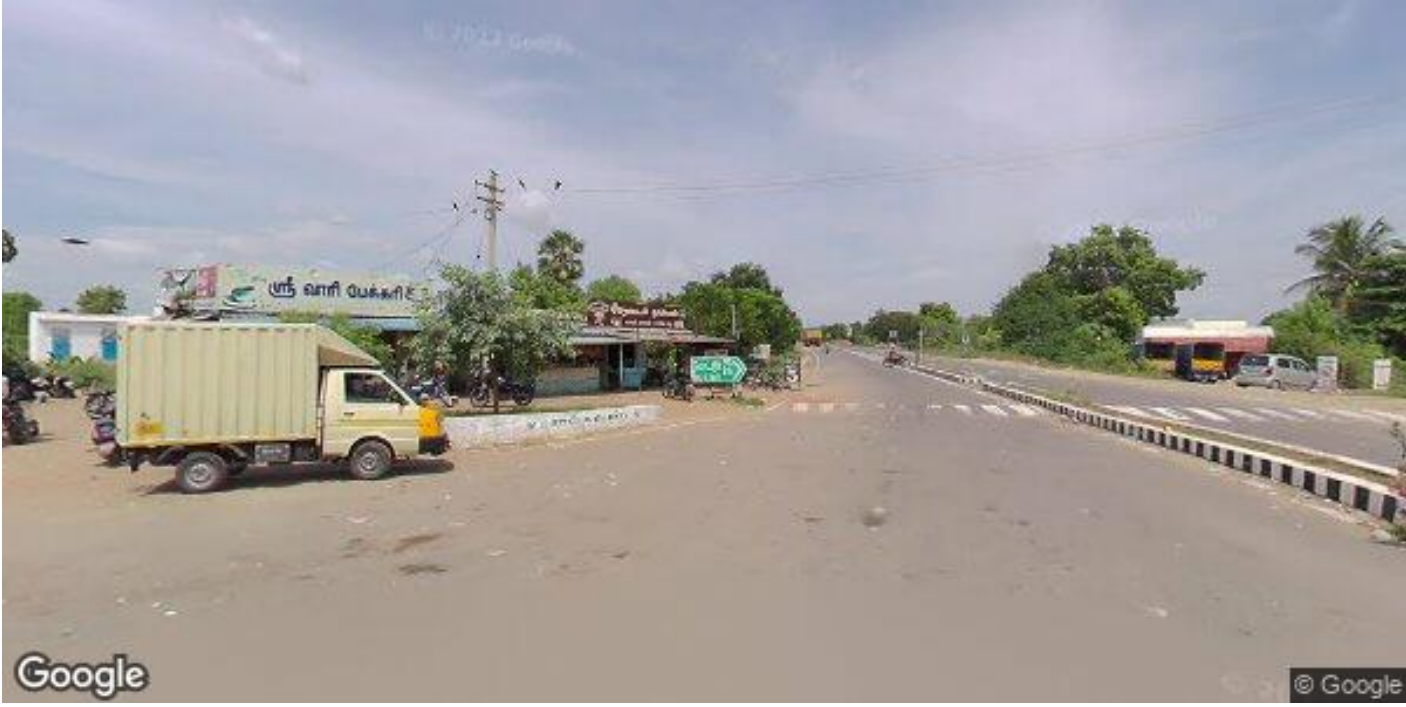
**Risk Type:** Turn  
**Risk Level:** Medium  
**Speed Limit:** 30 KM/Hr  
**Coordinates:** 11.60347, 77.83954

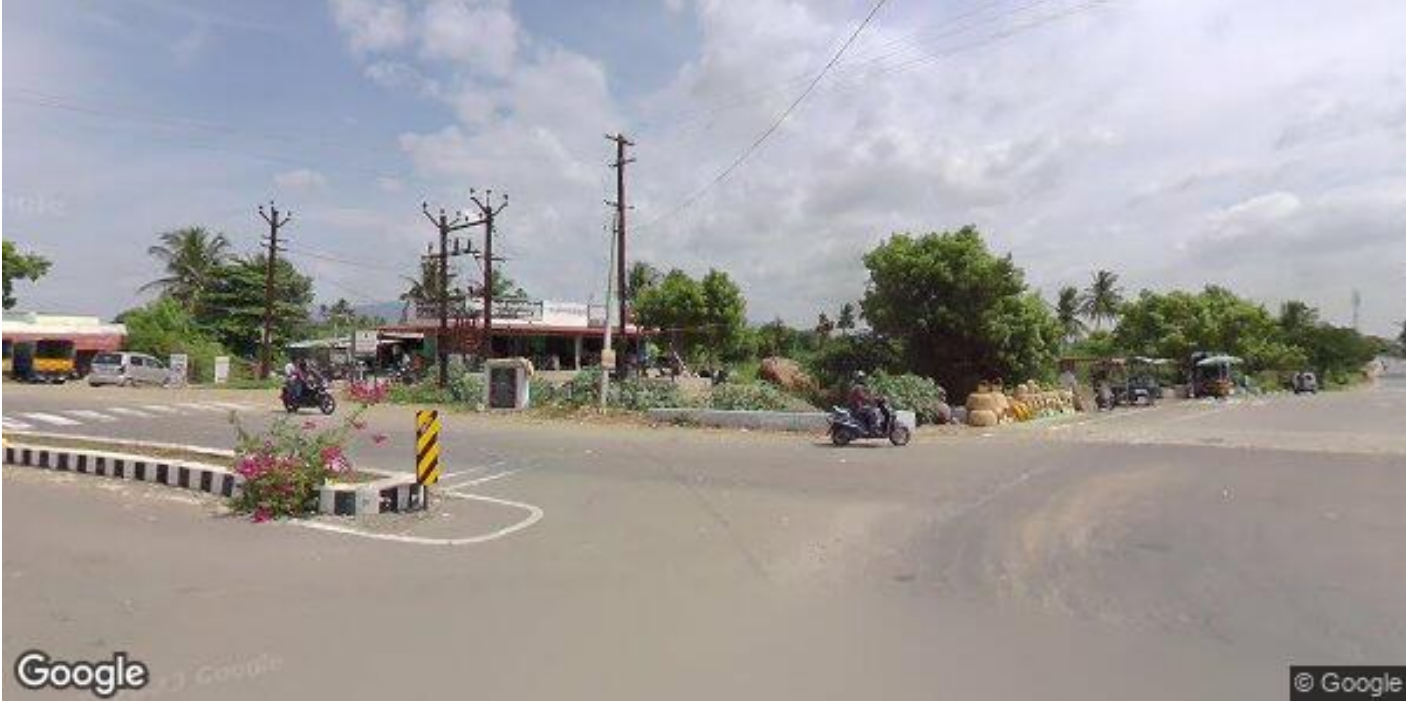
**Risk Type:** Turn  
**Risk Level:** High  
**Speed Limit:** 15 KM/Hr  
**Coordinates:** 11.60349, 77.83953
