## JOURNEY RISK MANAGEMENT (JRM) STUDY

### Salem Terminal TO M.S TAMILVAANI AGENCIES

Route Safety Analysis: Sangagiri to Ranganoor, Tamil Nadu

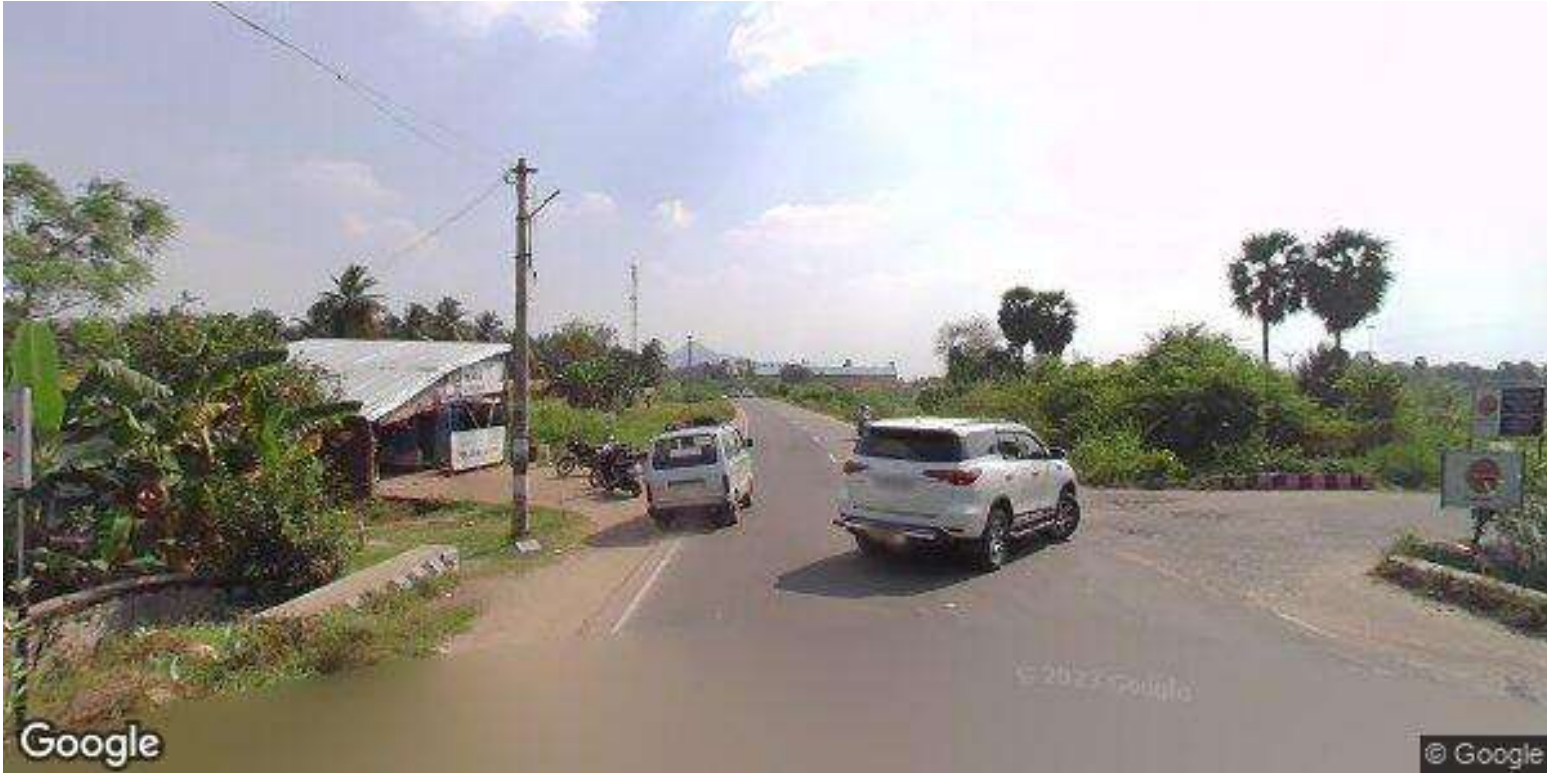
| | Risk Type | Risk Level | Coordinates | Speed Limit |
|---|---|---|---|---|
| 3 | Turn | High | 11.44029, 77.87544 | 15 KM/Hr |

Risk Type: Turn  
Risk Level: High  
Speed Limit: 15 KM/Hr  
Coordinates: 11.44029, 77.87544

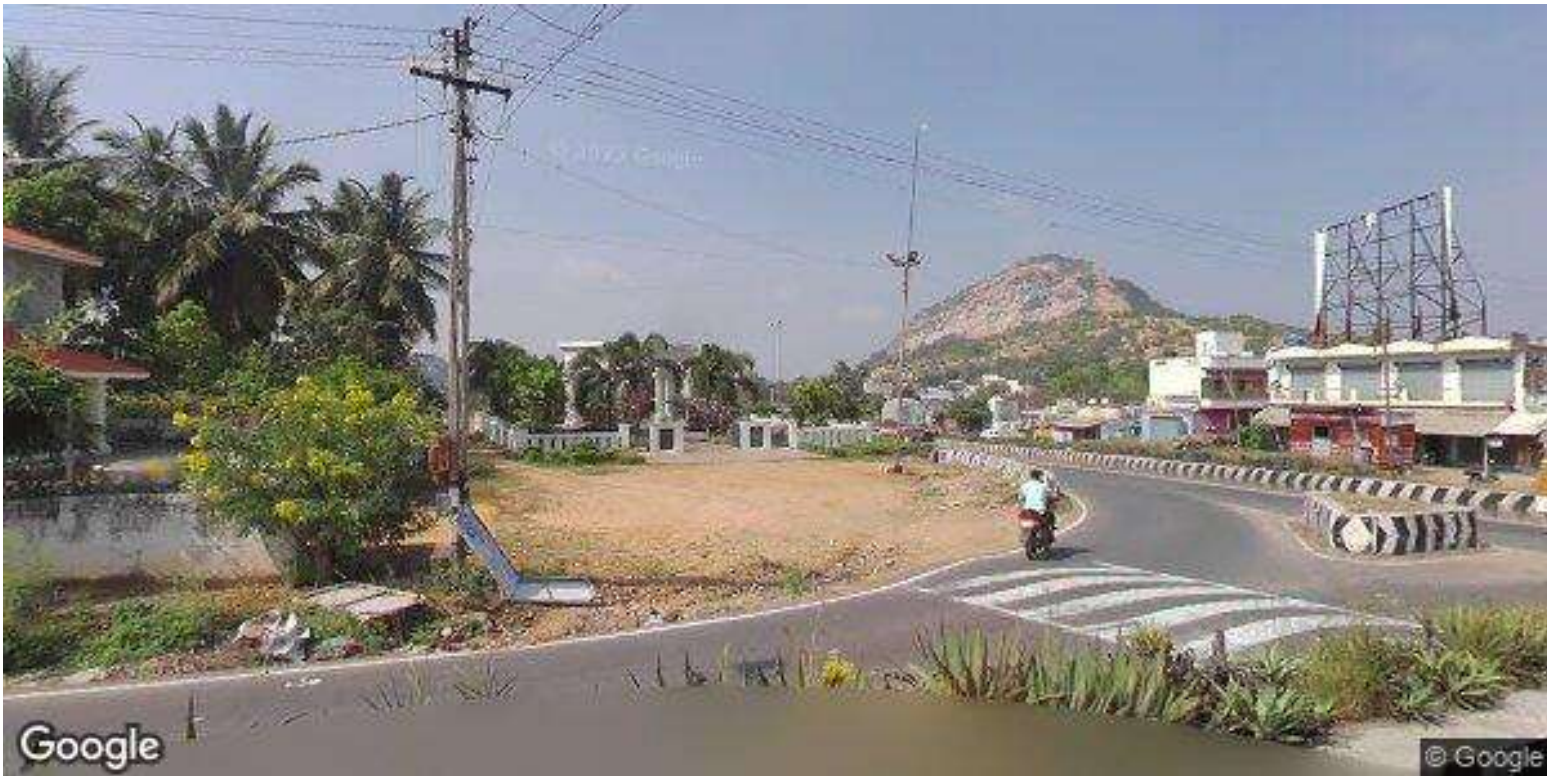
| | Risk Type | Risk Level | Coordinates | Speed Limit |
|---|---|---|---|---|
| 4 | Turn | Medium | 11.46307, 77.84941 | 30 KM/Hr |

Risk Type: Turn  
Risk Level: Medium  
Speed Limit: 30 KM/Hr  
Coordinates: 11.46307, 77.84941

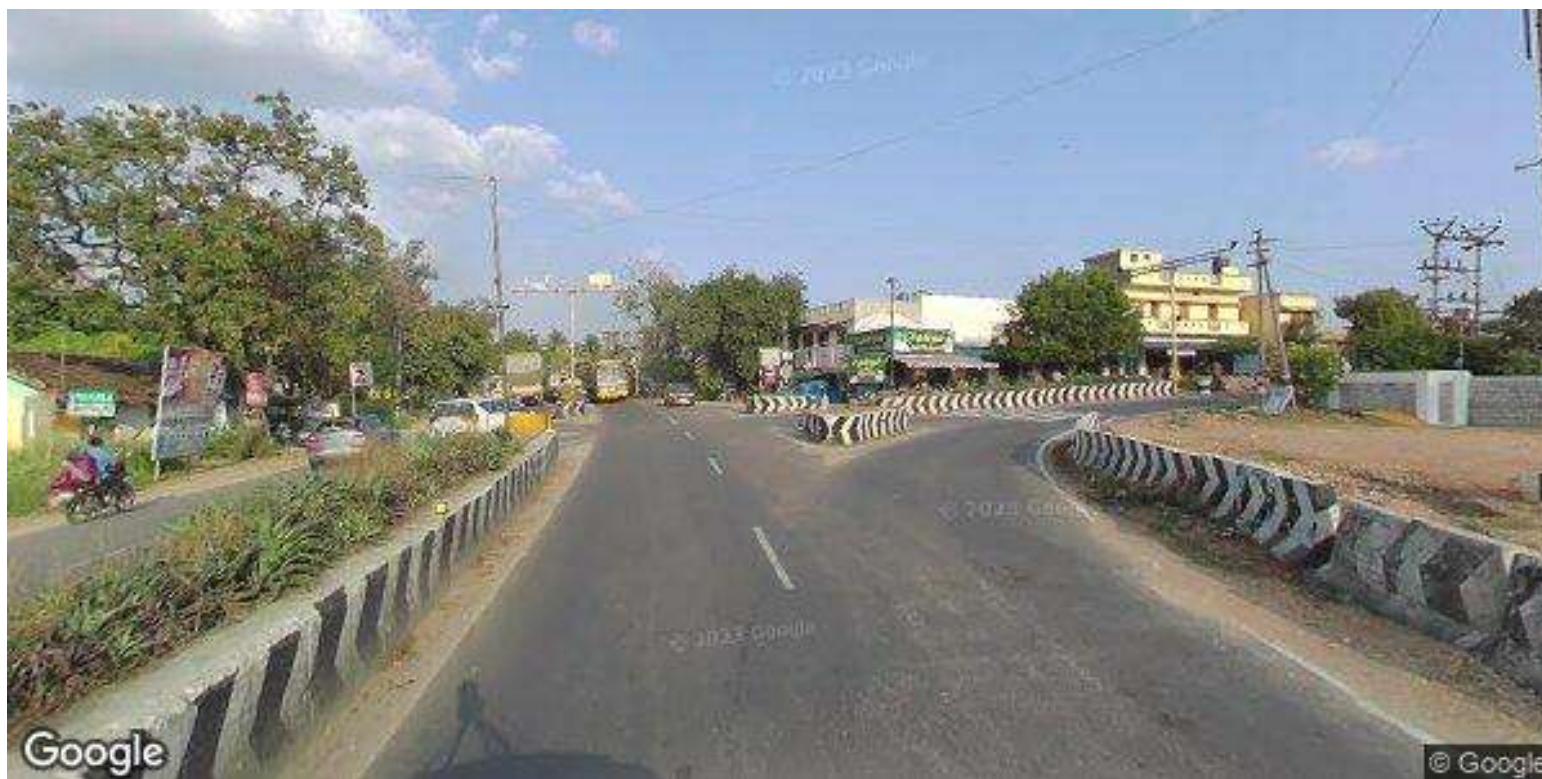
**Coordinates:** 11.46318, 77.84913

| | Risk Type | Risk Level | Coordinates | Speed Limit |
|---|---|---|---|---|
| 5 | Turn | Medium | 11.46318, 77.84913 | 30 KM/Hr |

**Risk Type:** Turn

**Risk Level:** Medium

**Speed Limit:** 30 KM/Hr

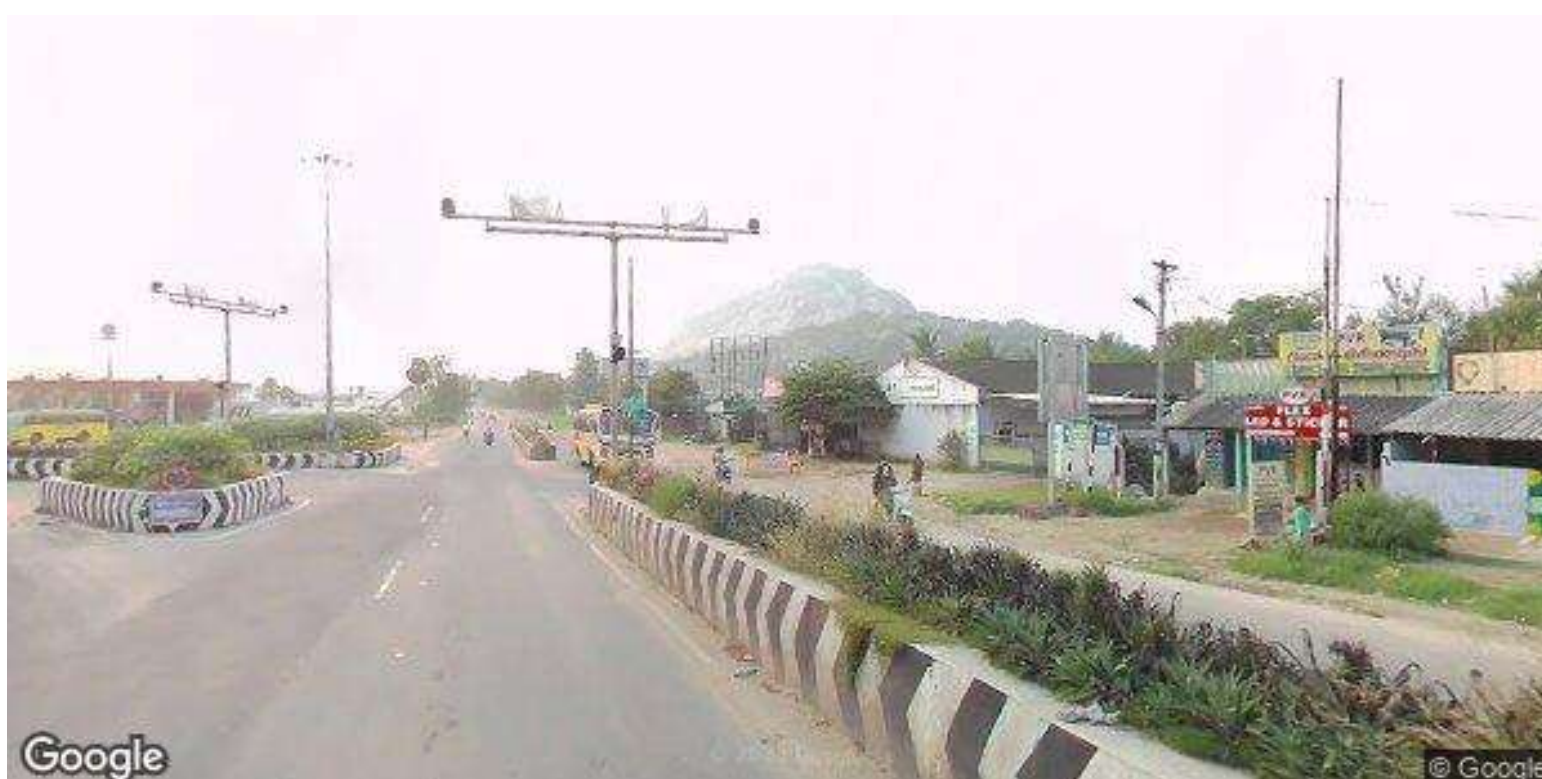
**Coordinates:** 11.46312, 77.84886

| | Risk Type | Risk Level | Coordinates | Speed Limit |
|---|---|---|---|---|
| 6 | Turn | Medium | 11.46312, 77.84886 | 30 KM/Hr |

**Risk Type:** Turn

**Risk Level:** Medium

**Speed Limit:** 30 KM/Hr

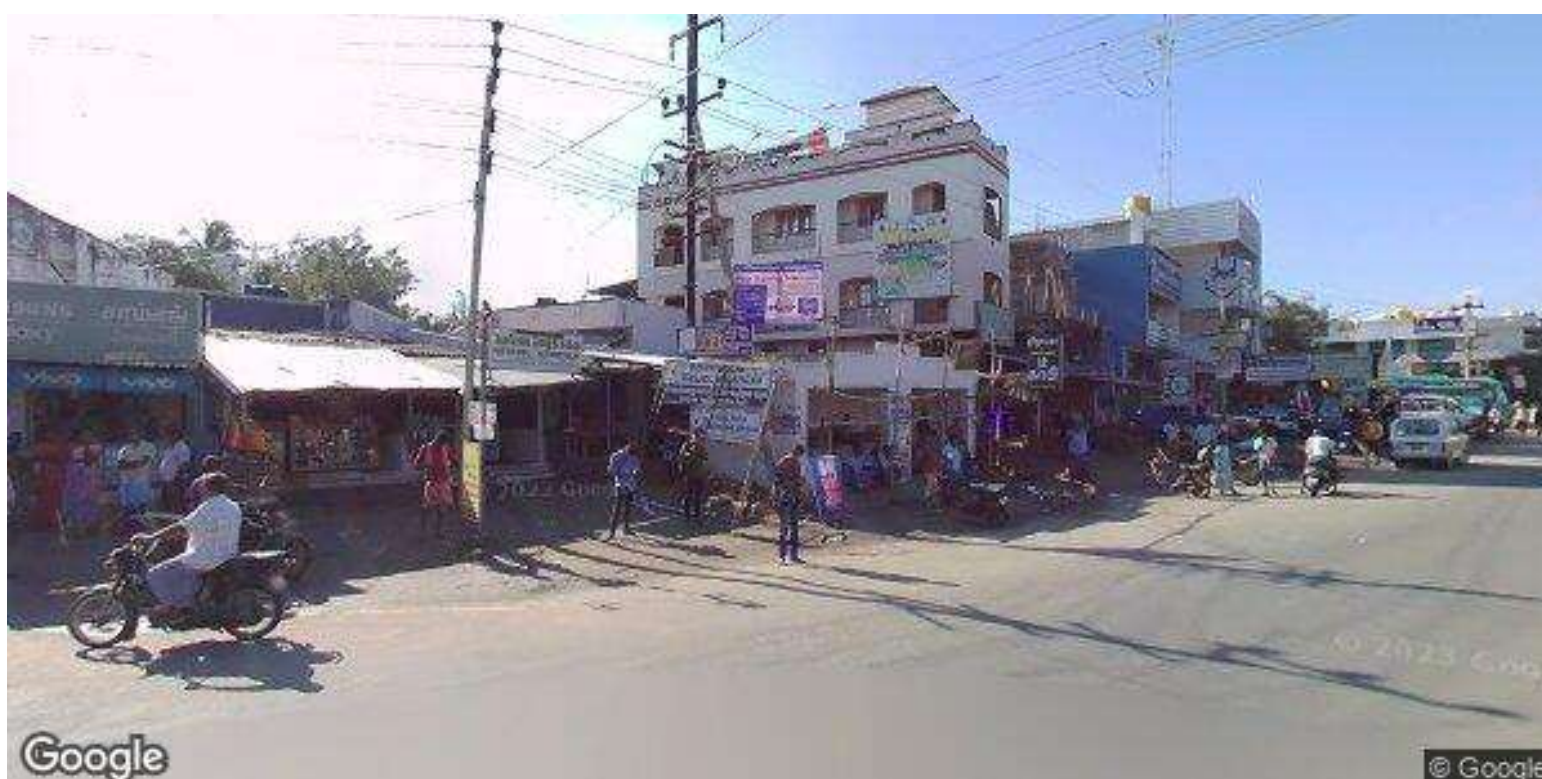
Coordinates: 11.40574, 77.78829

| | Risk Type | Risk Level | Coordinates | Speed Limit |
|---|---|---|---|---|
| 7 | Turn | High | 11.40574, 77.78829 | 15 KM/Hr |

Risk Type: Turn

Risk Level: High

Speed Limit: 15 KM/Hr

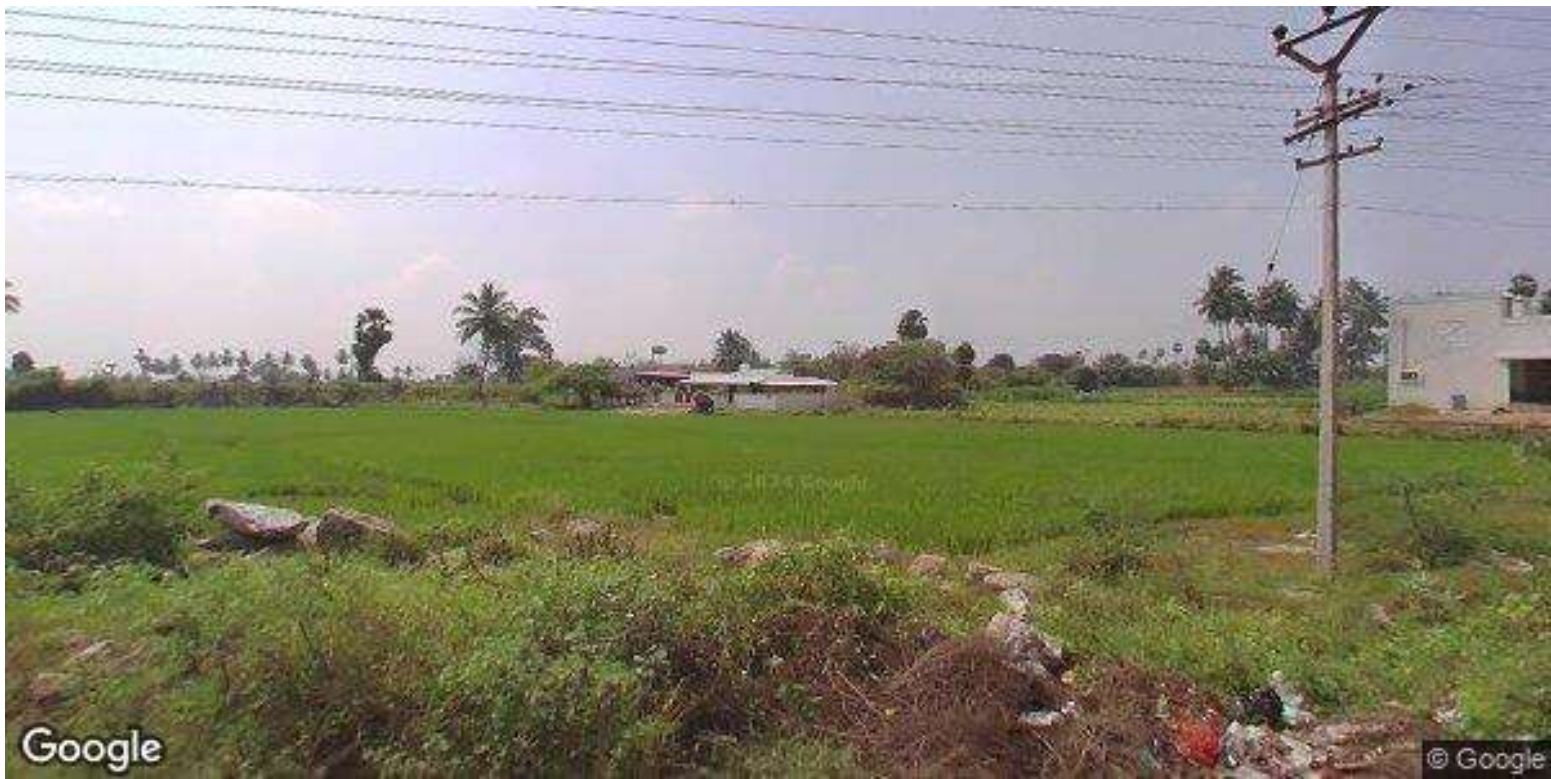
Coordinates: 11.41493, 77.76777

| | Risk Type | Risk Level | Coordinates | Speed Limit |
|---|---|---|---|---|
| 8 | Turn | High | 11.41493, 77.76777 | 15 KM/Hr |

Risk Type: Turn

Risk Level: High

Speed Limit: 15 KM/Hr
