# IndianOil

## **JOURNEY RISK MANAGEMENT (JRM) STUDY**

### **Salem Terminal TO SRI MURUGA AGENCIES**

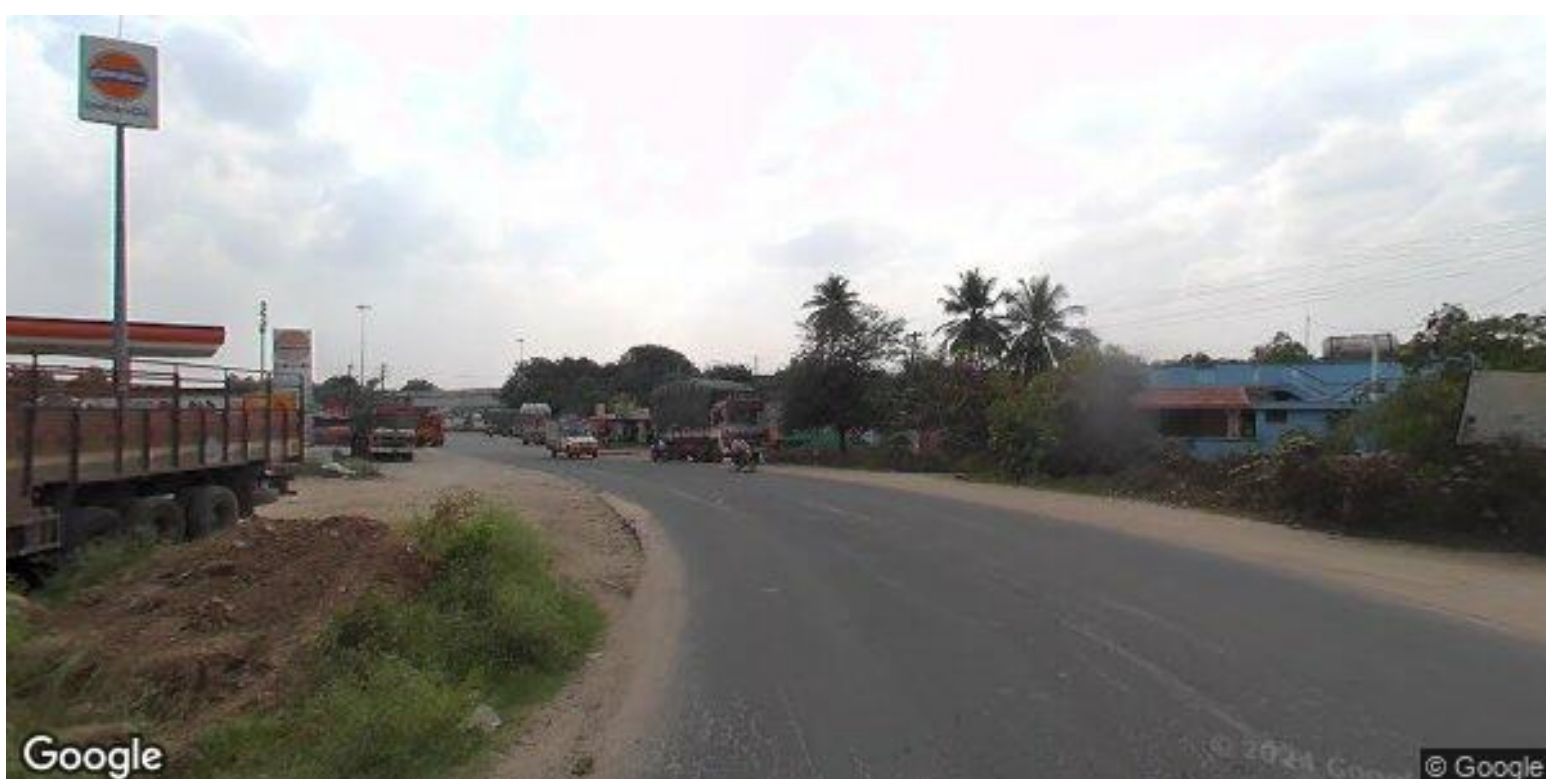
**Coordinates:** 11.49448, 77.88490

**Risk Type:** Turn

**Risk Level:** Medium

**Speed Limit:** 30 KM/Hr

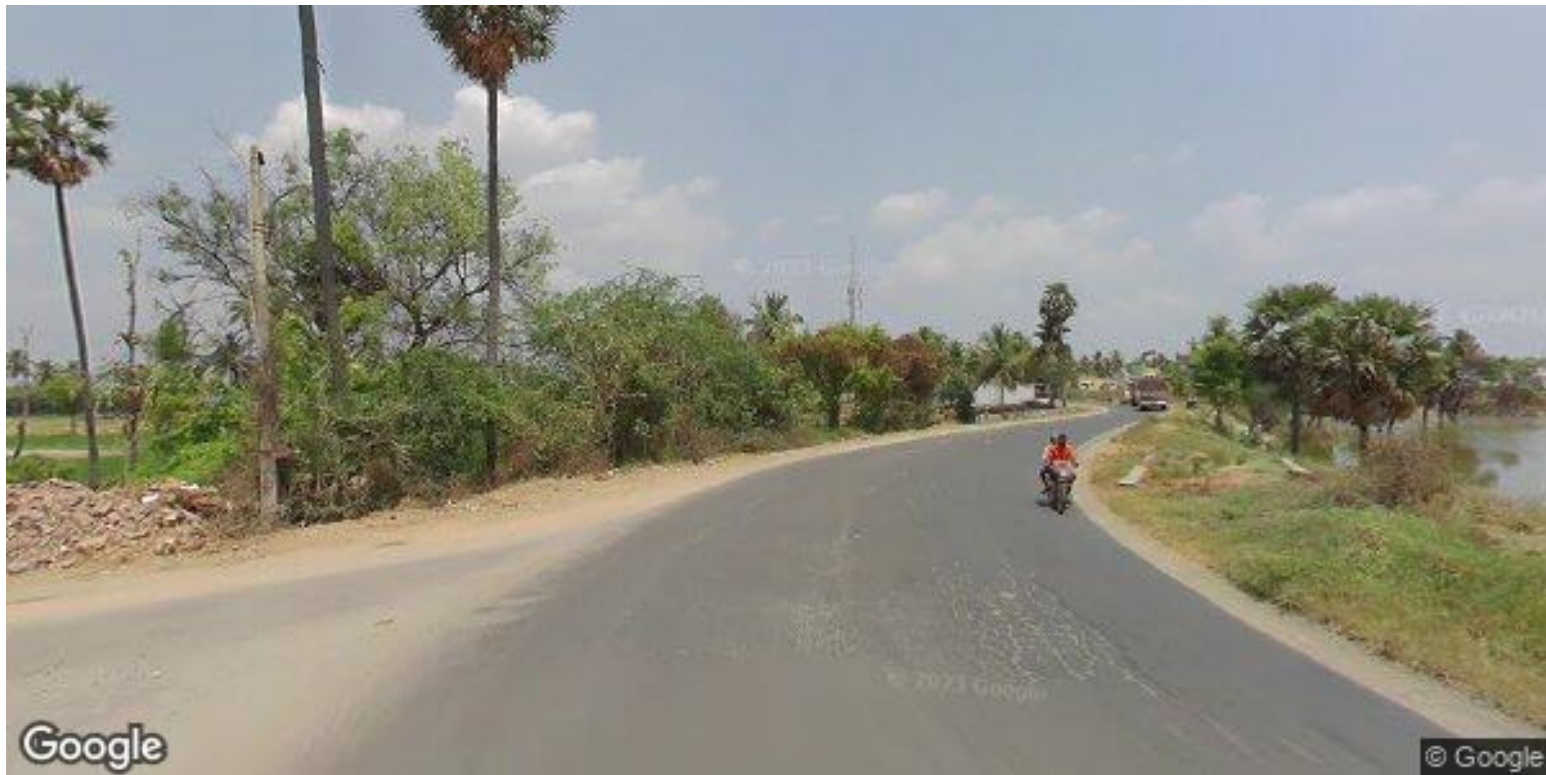
**Coordinates:** 11.56083, 77.89921

**Risk Type:** Turn

**Risk Level:** High

**Speed Limit:** 15 KM/Hr

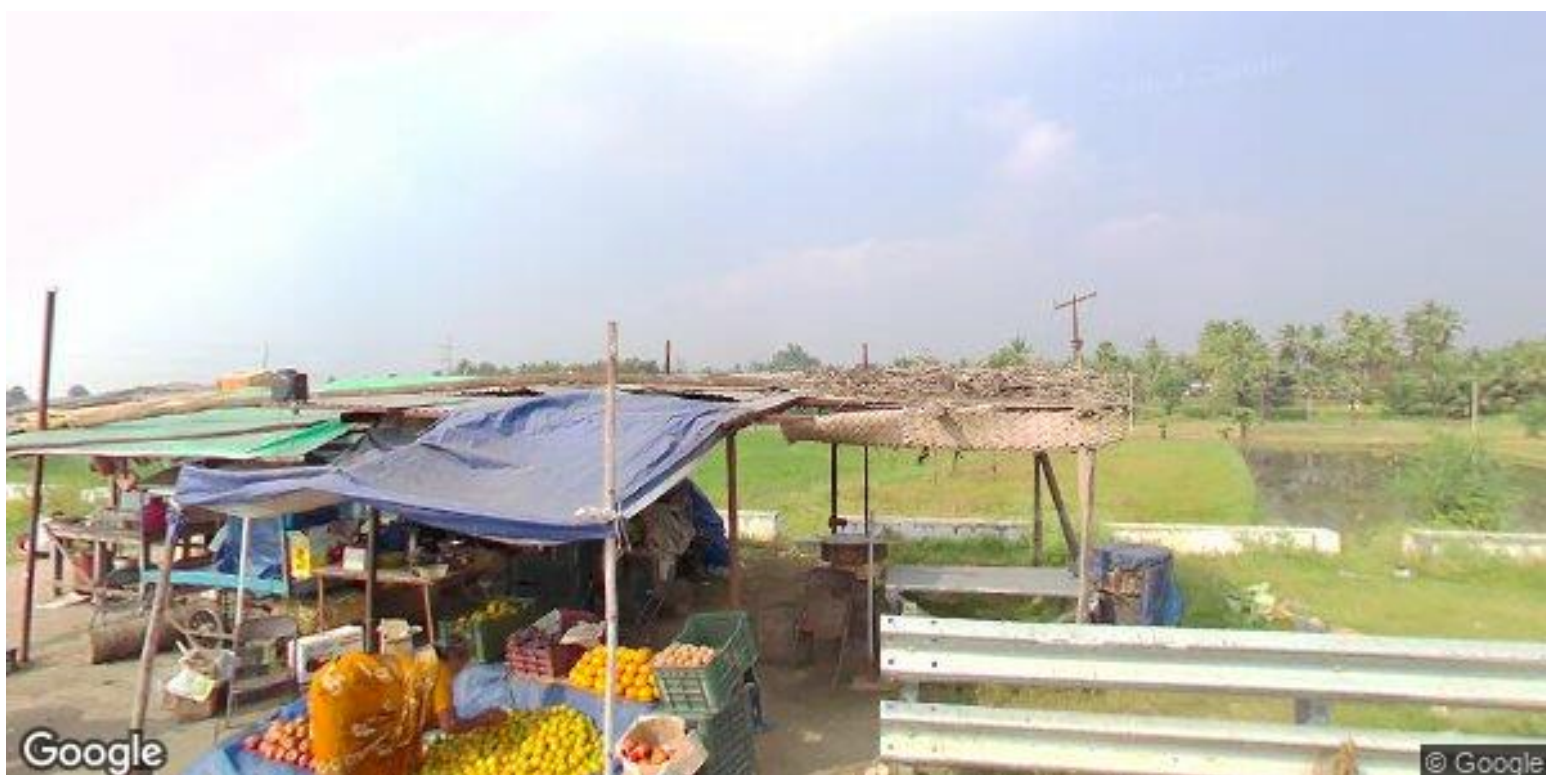
**Risk Type:** Turn  
**Risk Level:** Medium  
**Speed Limit:** 30 KM/Hr  
**Coordinates:** 11.67858, 77.96834

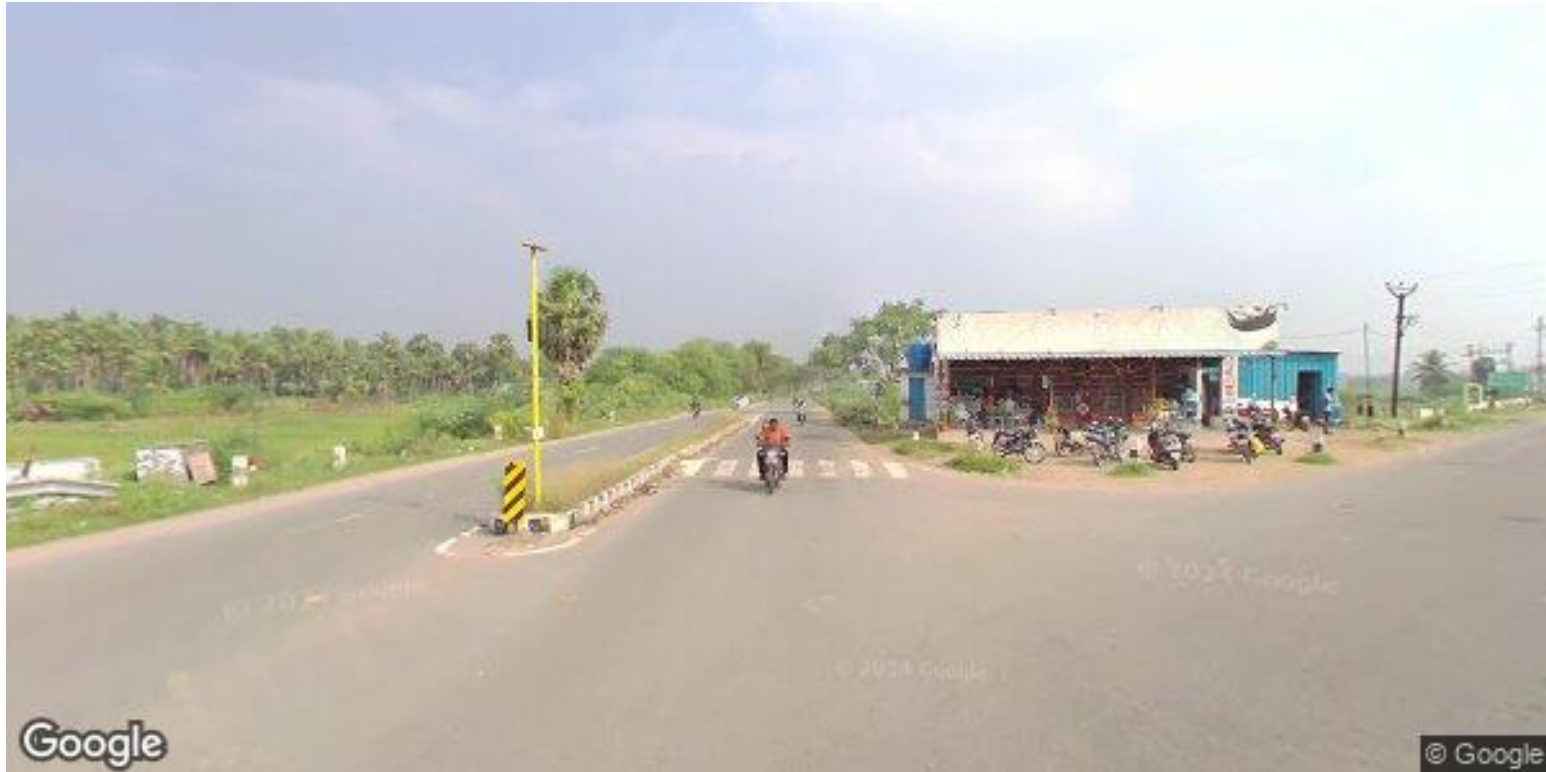
**Risk Type:** Turn  
**Risk Level:** Medium  
**Speed Limit:** 30 KM/Hr  
**Coordinates:** 11.67870, 77.96846

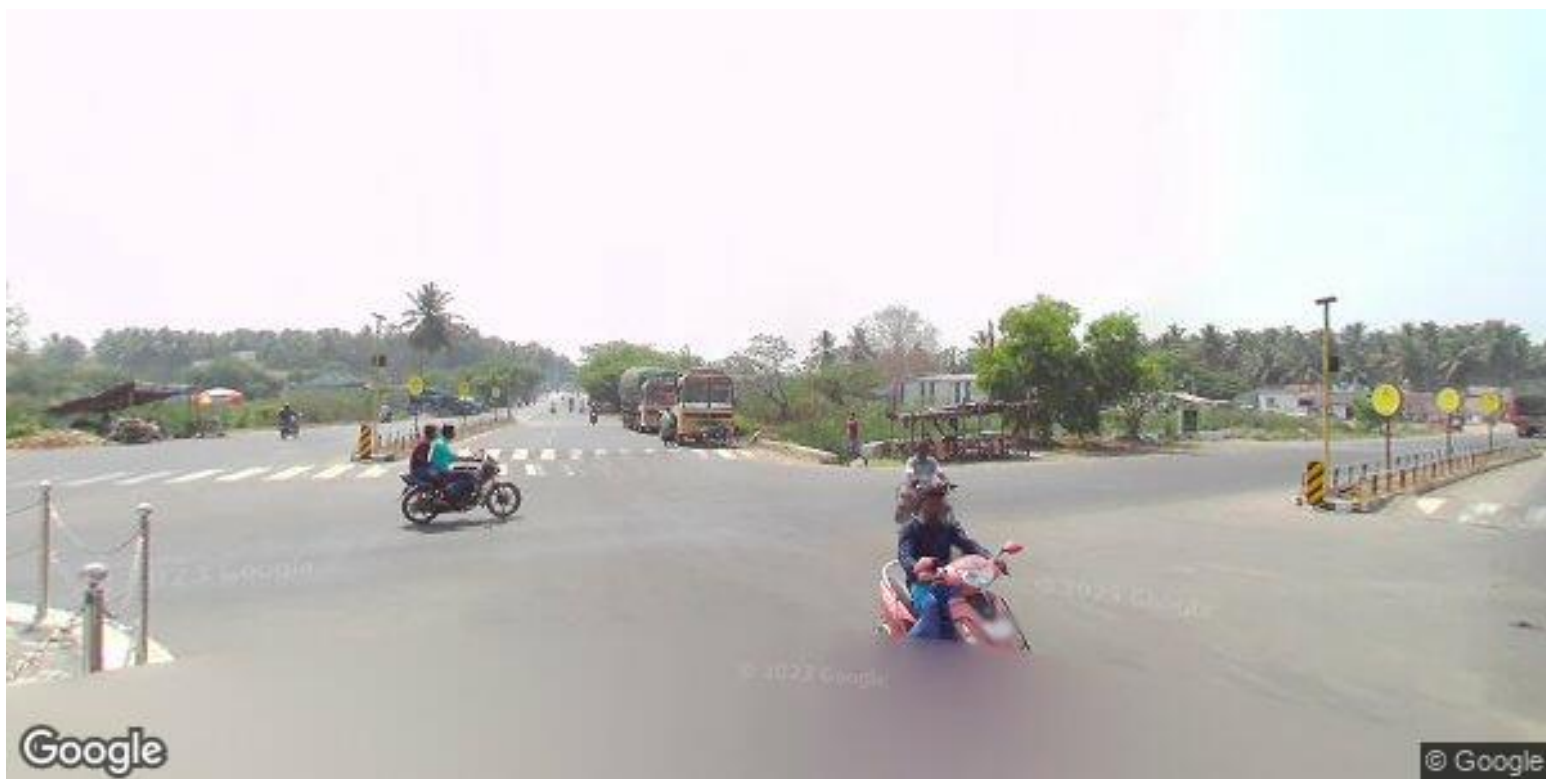
**Risk Type:** Turn  
**Risk Level:** Medium  
**Speed Limit:** 30 KM/Hr  
**Coordinates:** 11.68905, 77.97736

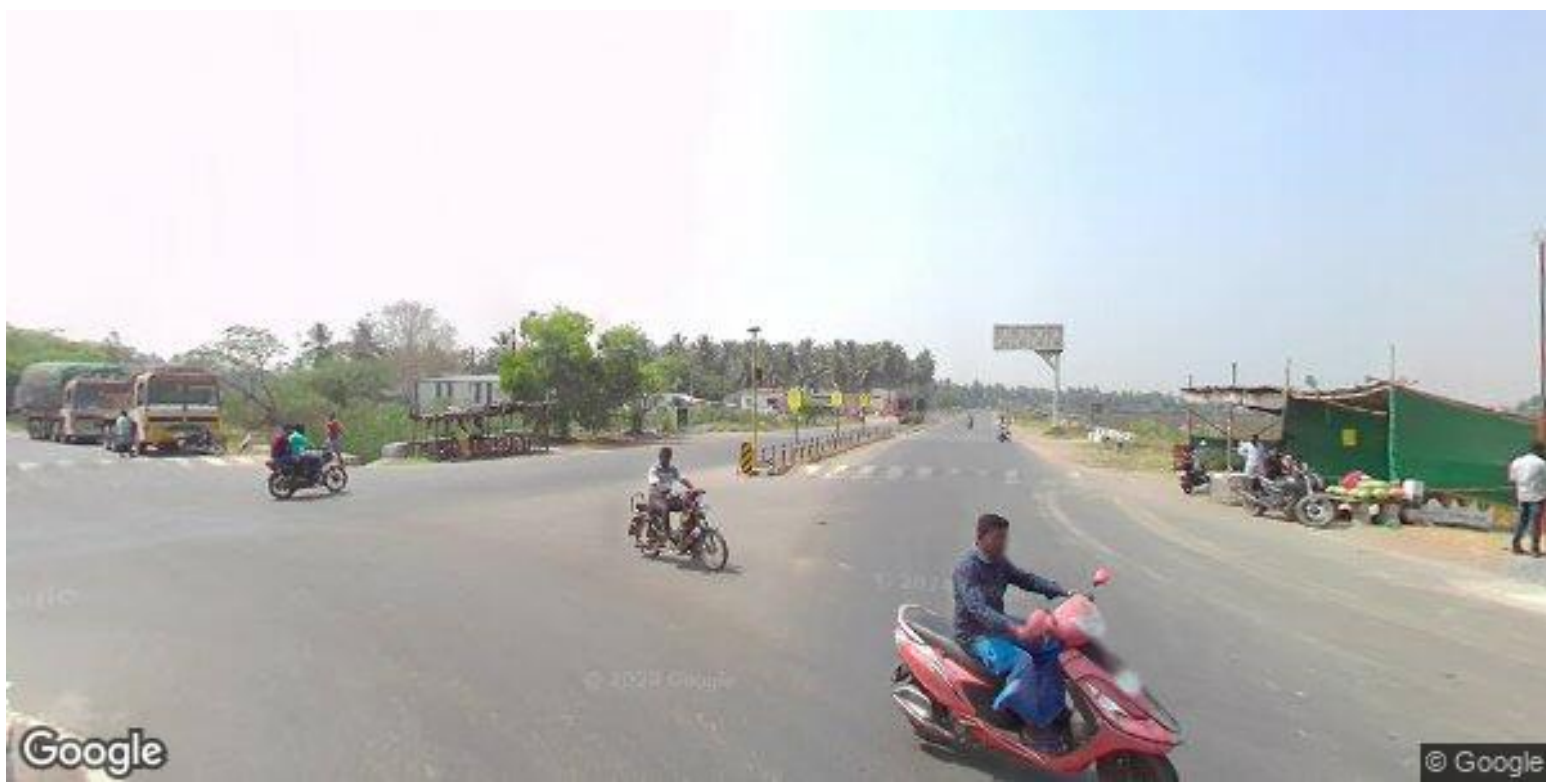
**Coordinates:** 11.68913, 77.97734

**Risk Type:** Turn

**Risk Level:** Medium

**Speed Limit:** 30 KM/Hr

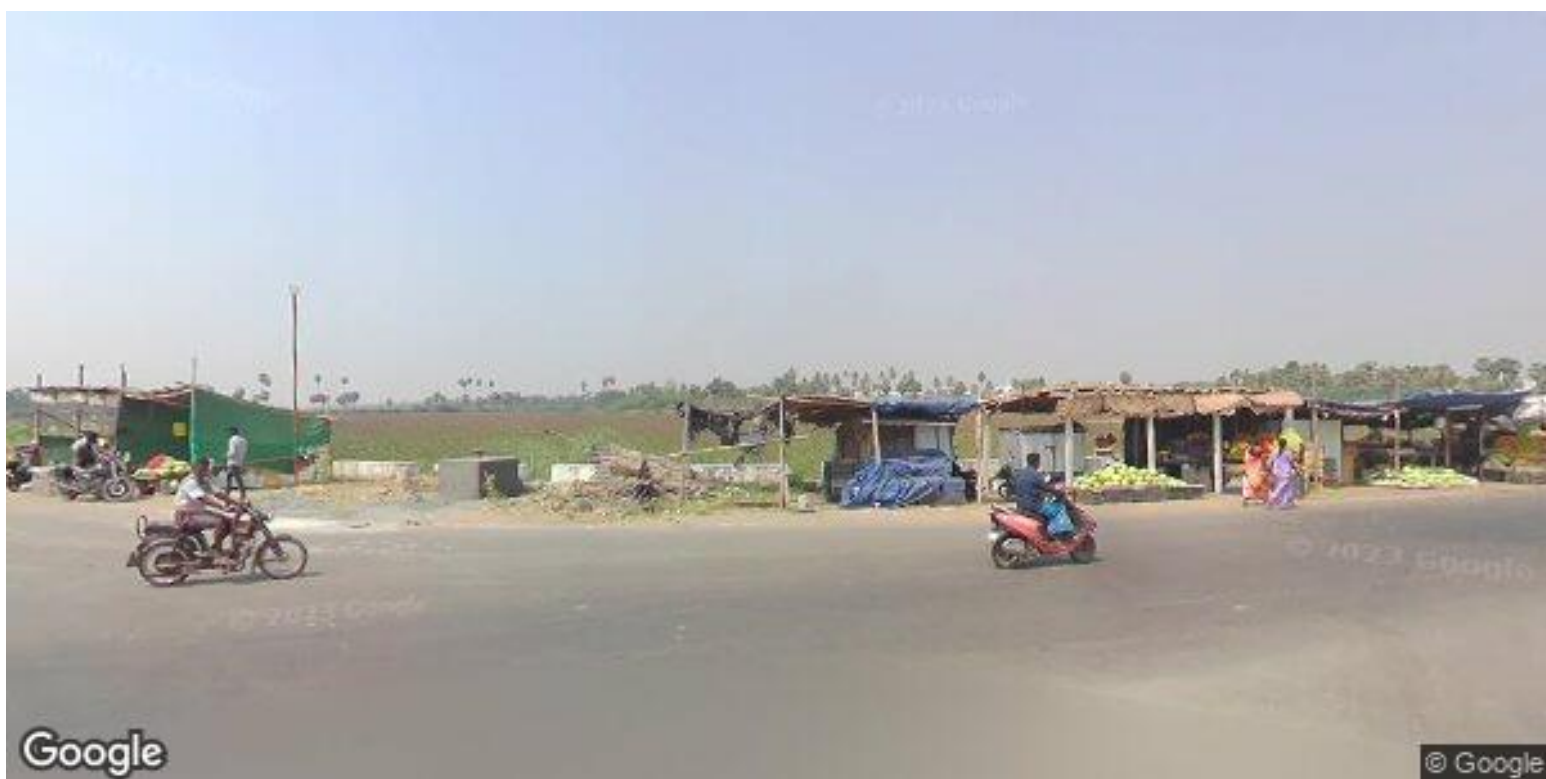
**Coordinates:** 11.68925, 77.97741

**Risk Type:** Turn

**Risk Level:** Medium

**Speed Limit:** 30 KM/Hr

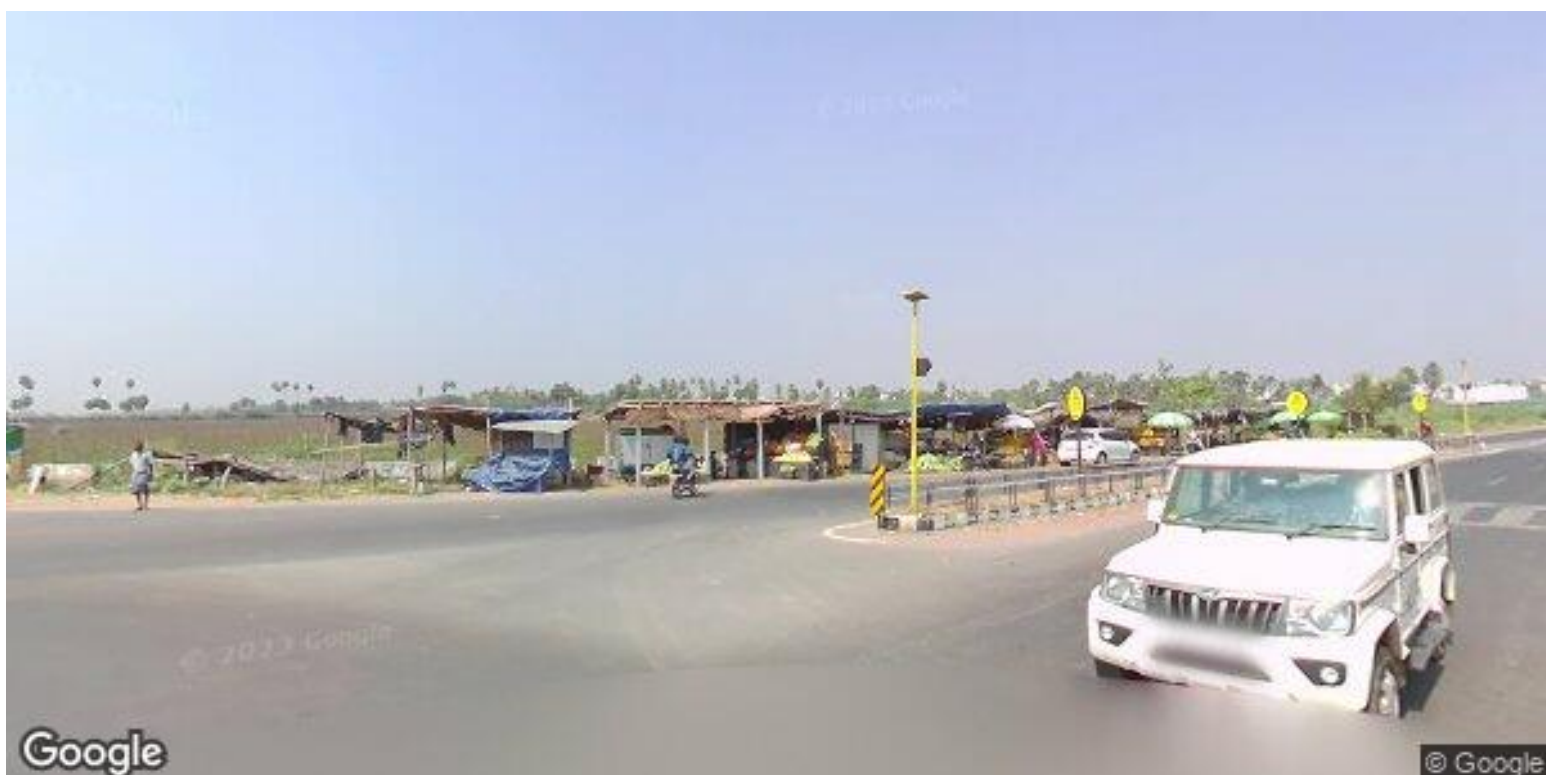
**Coordinates:** 11.68927, 77.97747

**Risk Type:** Turn

**Risk Level:** High

**Speed Limit:** 15 KM/Hr

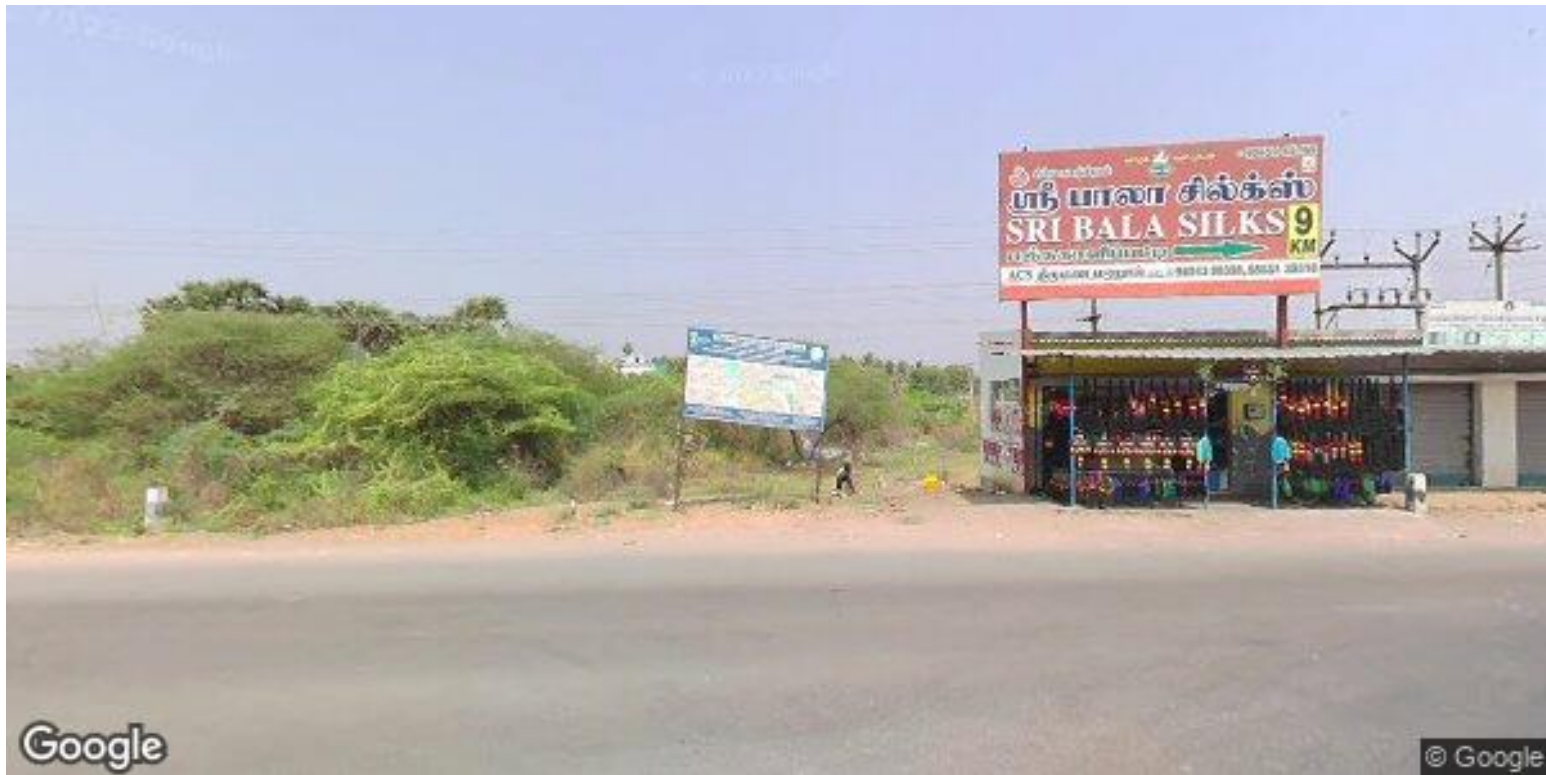
**Coordinates:** 11.70223, 77.97860

**Risk Type:** Turn

**Risk Level:** High

**Speed Limit:** 15 KM/Hr

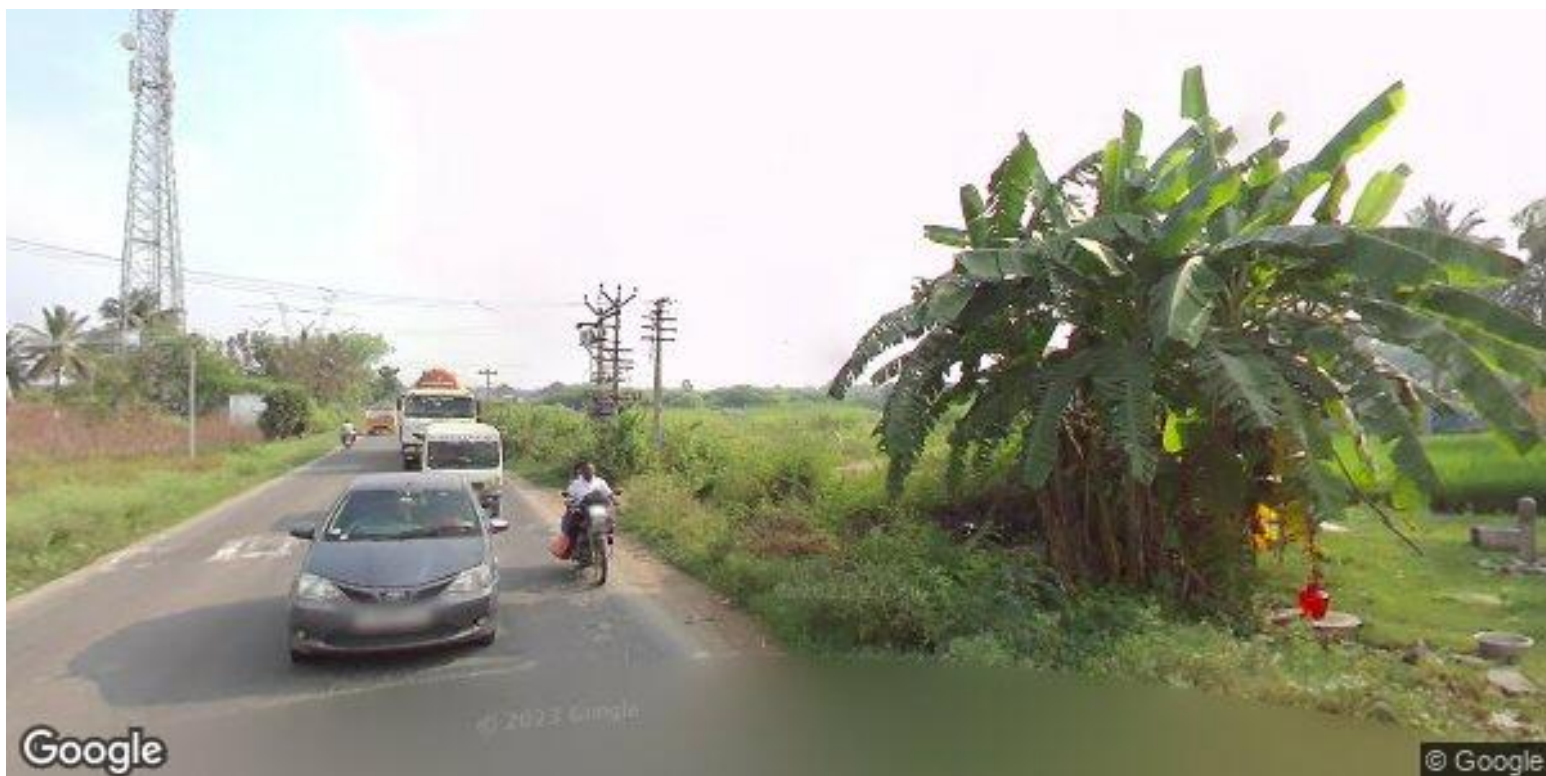
**Coordinates:** 11.71394, 77.99572

**Risk Type:** Turn

**Risk Level:** Medium

**Speed Limit:** 30 KM/Hr

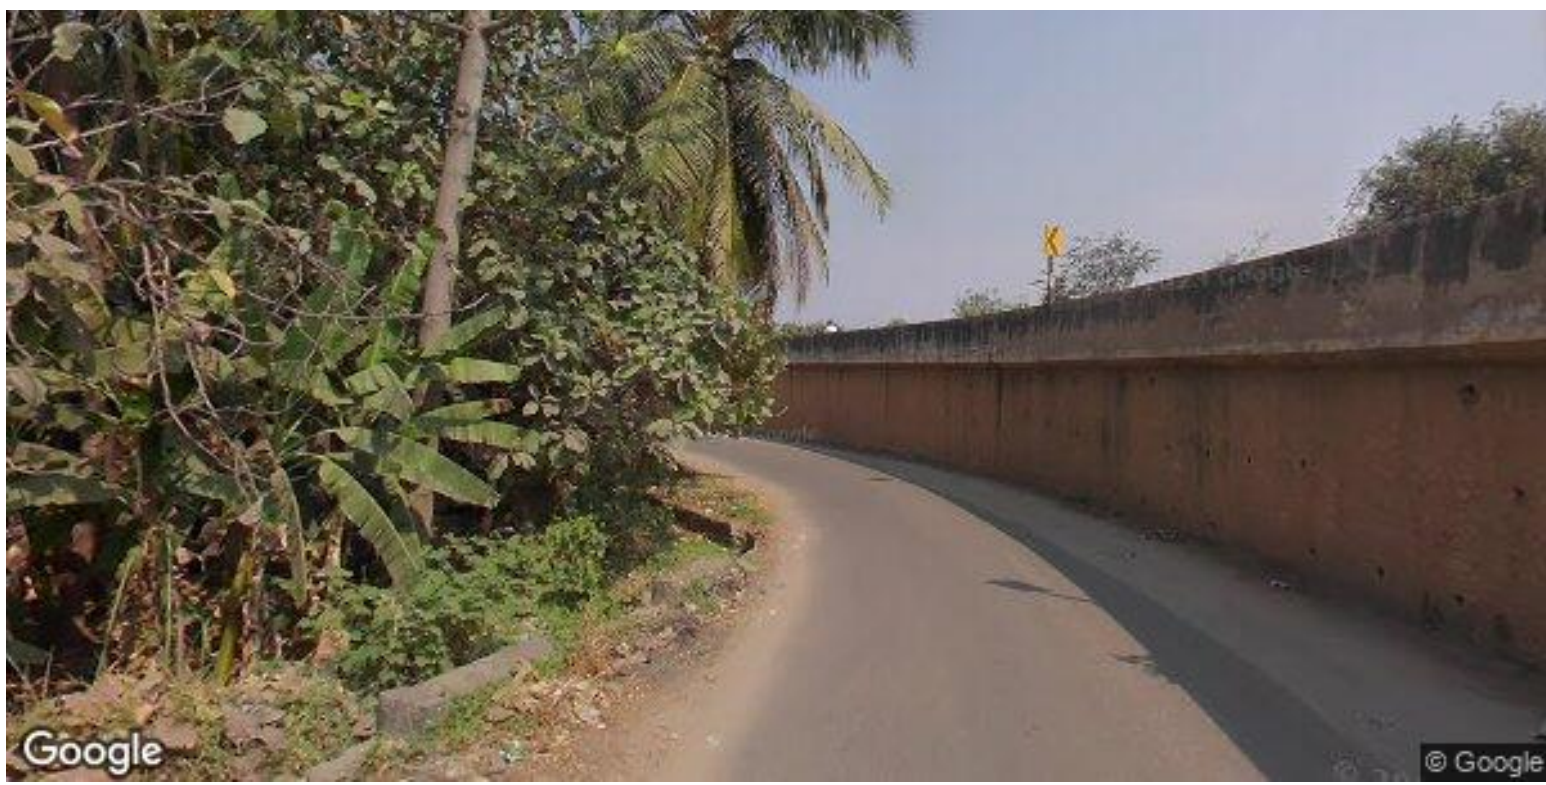
**Coordinates:** 11.73661, 78.03864

**Risk Type:** Turn

**Risk Level:** Medium

**Speed Limit:** 30 KM/Hr

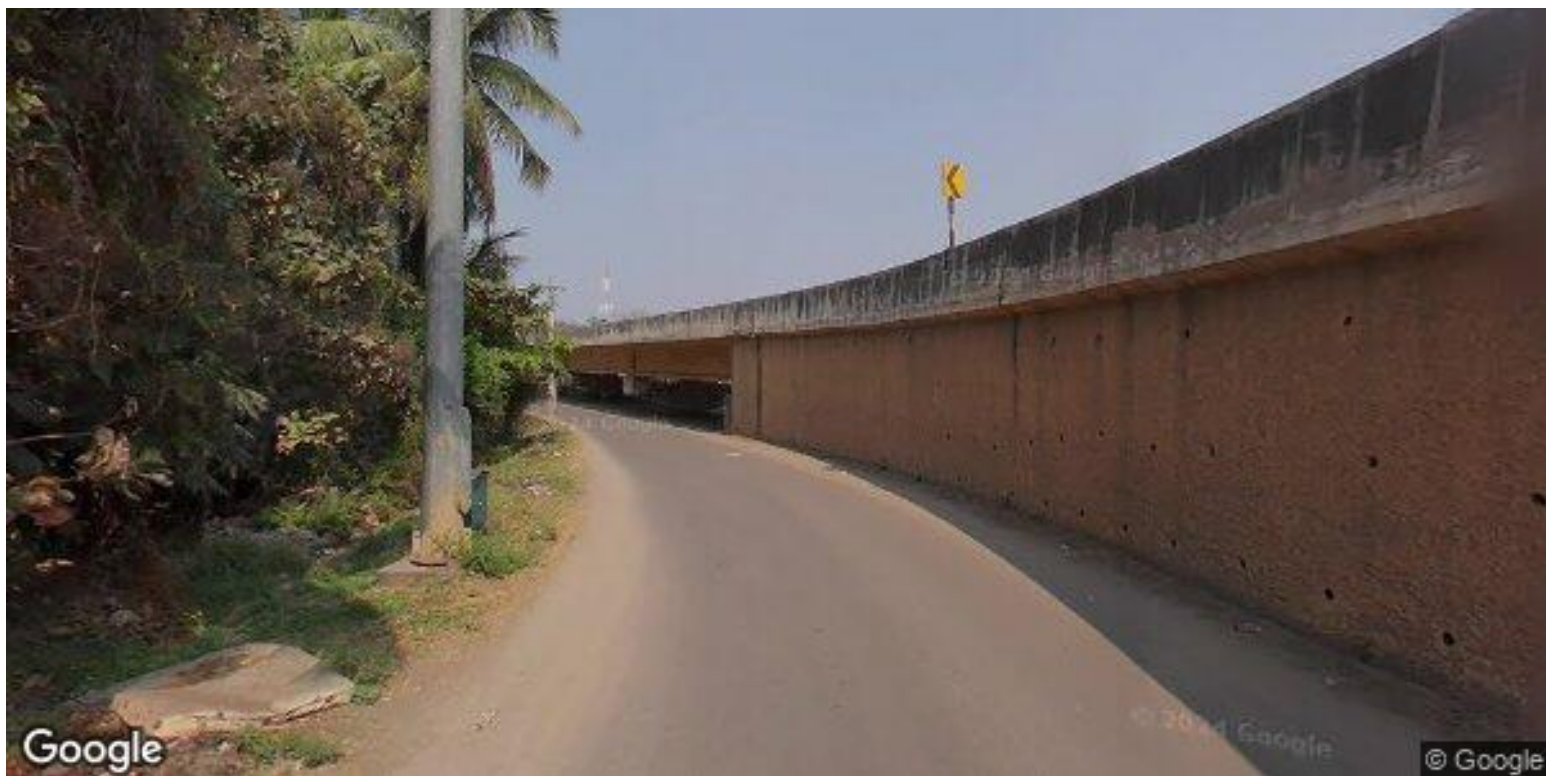
**Coordinates:** 11.73661, 78.03886

**Risk Type:** Turn

**Risk Level:** Medium

**Speed Limit:** 30 KM/Hr

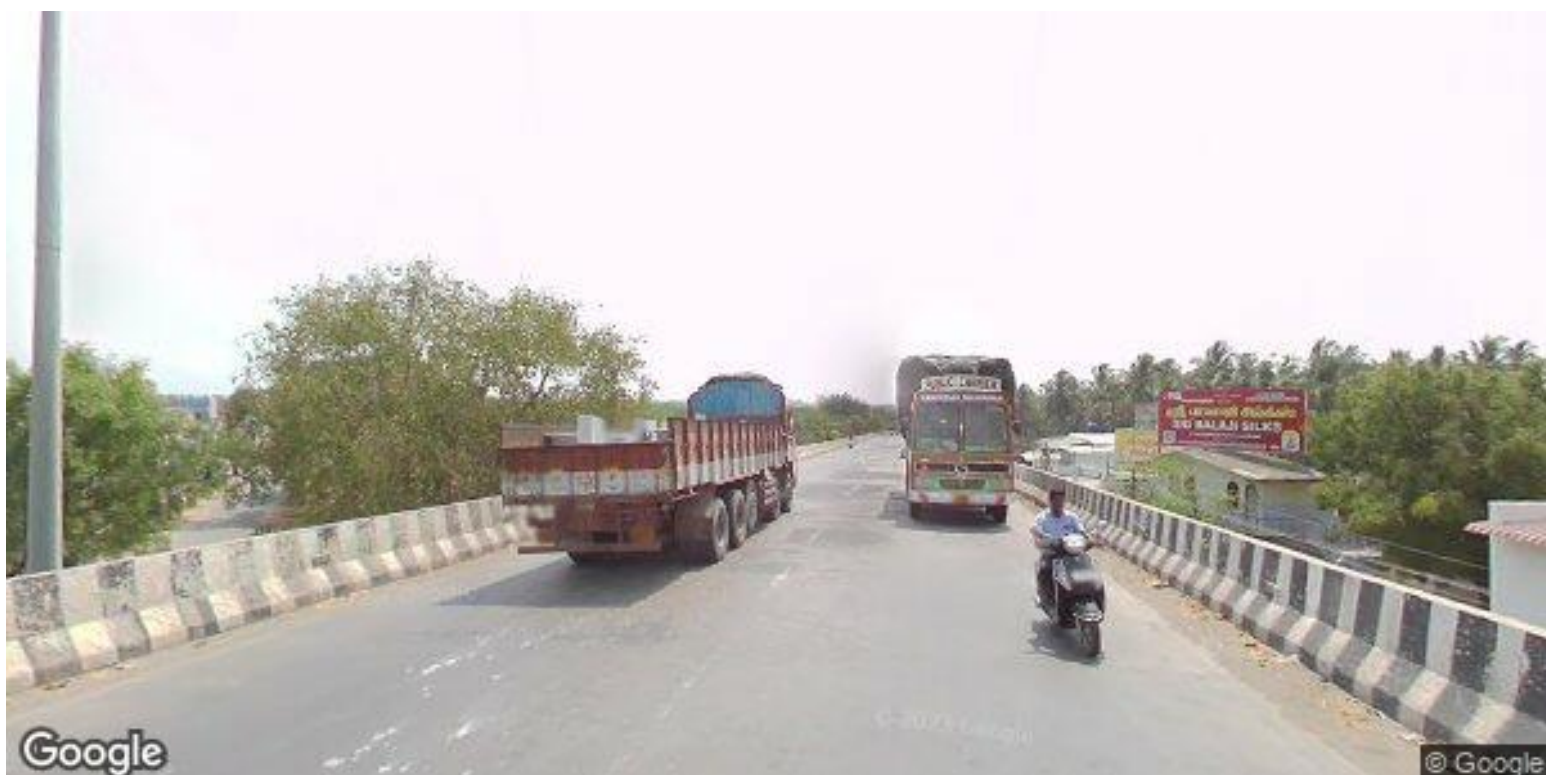
**Coordinates: 11.73772, 78.04016**

**Risk Type: Turn**

**Risk Level: High**

**Speed Limit: 15 KM/Hr**

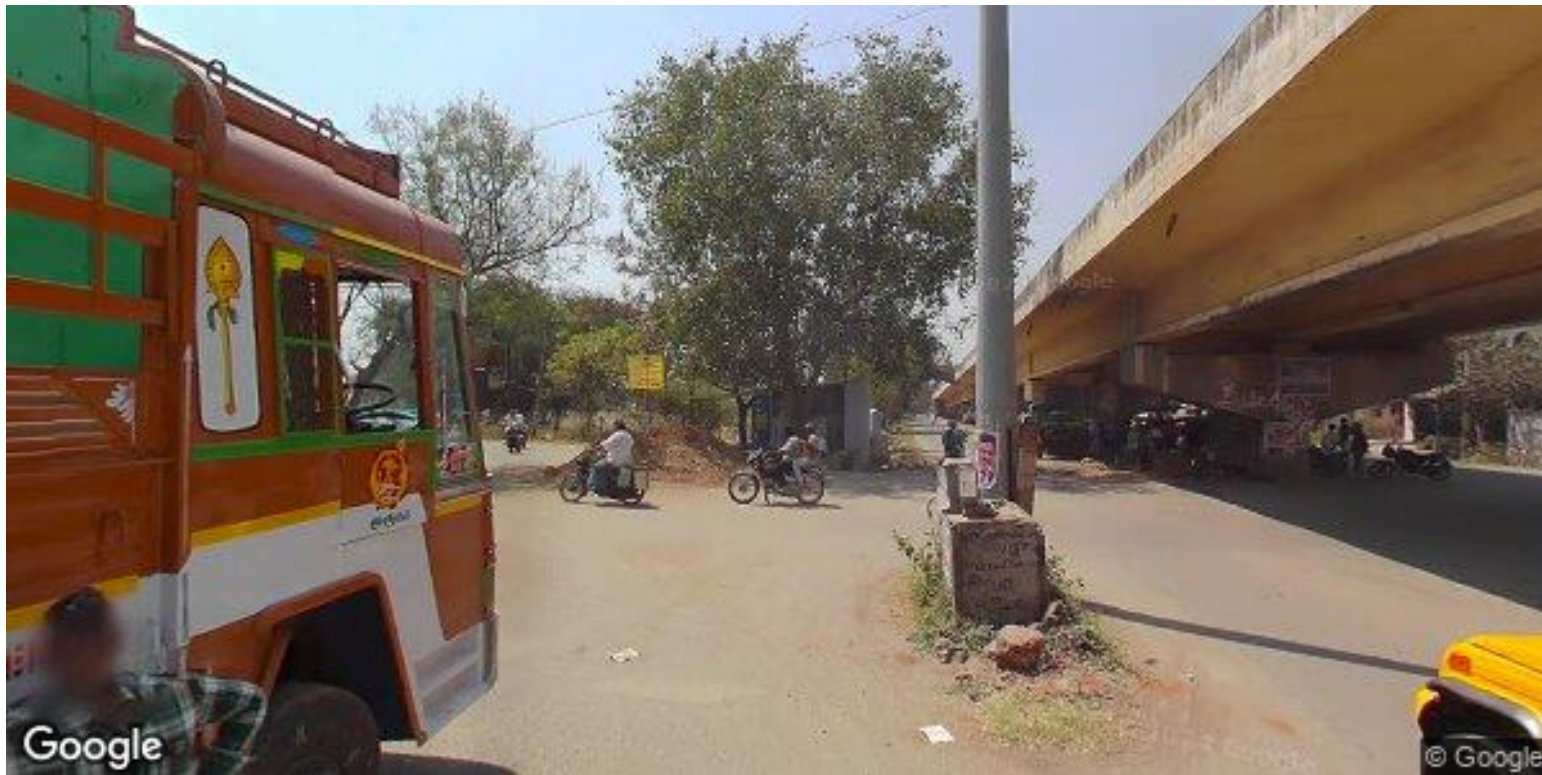
**Coordinates: 11.73763, 78.04027**

**Risk Type: Blind Spot**

**Risk Level: Blind Spot**

**Speed Limit: 10 KM/Hr**

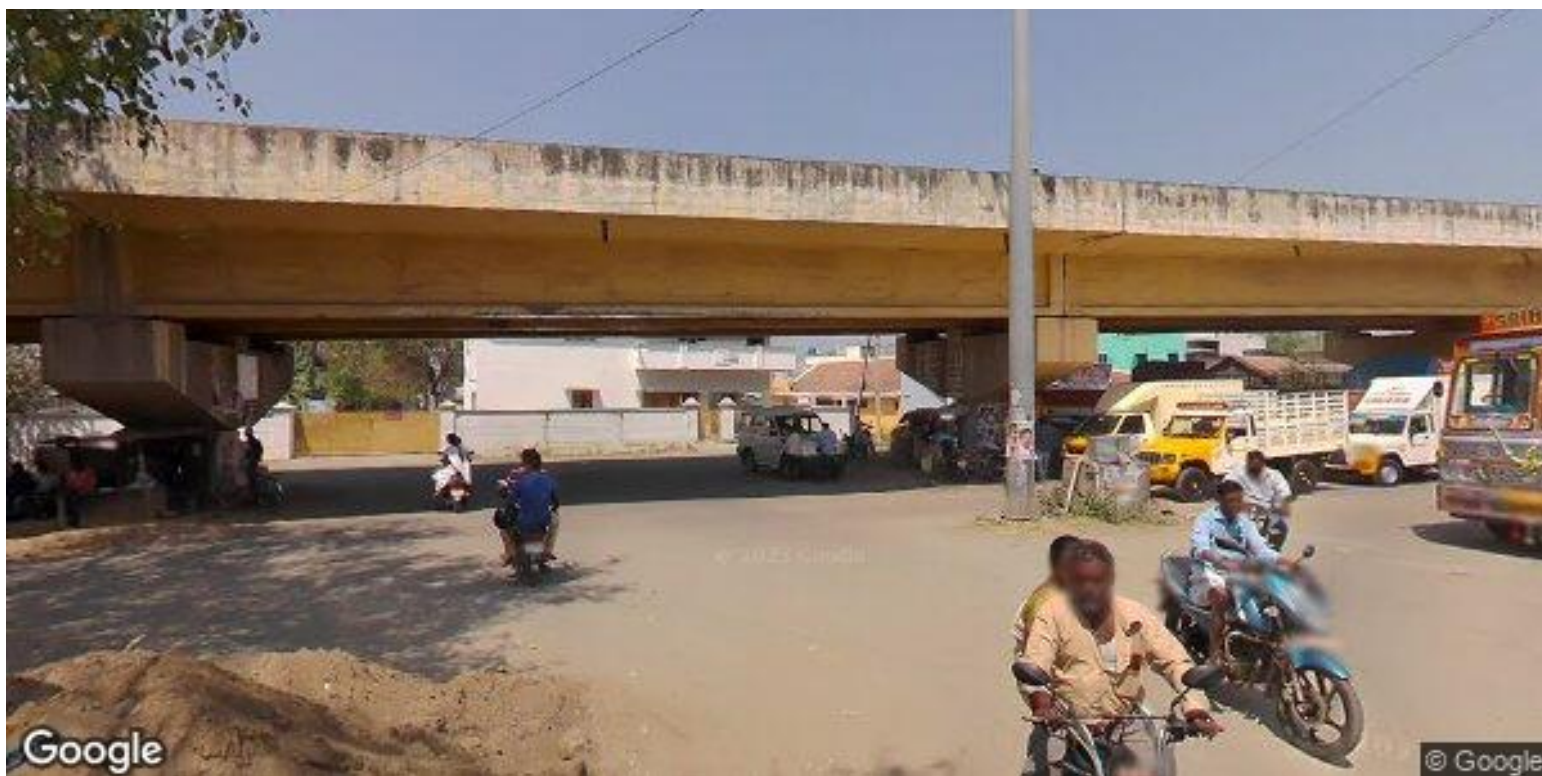
**Coordinates: 11.73751, 78.04016**

**Risk Type: Blind Spot**

**Risk Level: Blind Spot**

**Speed Limit: 10 KM/Hr**

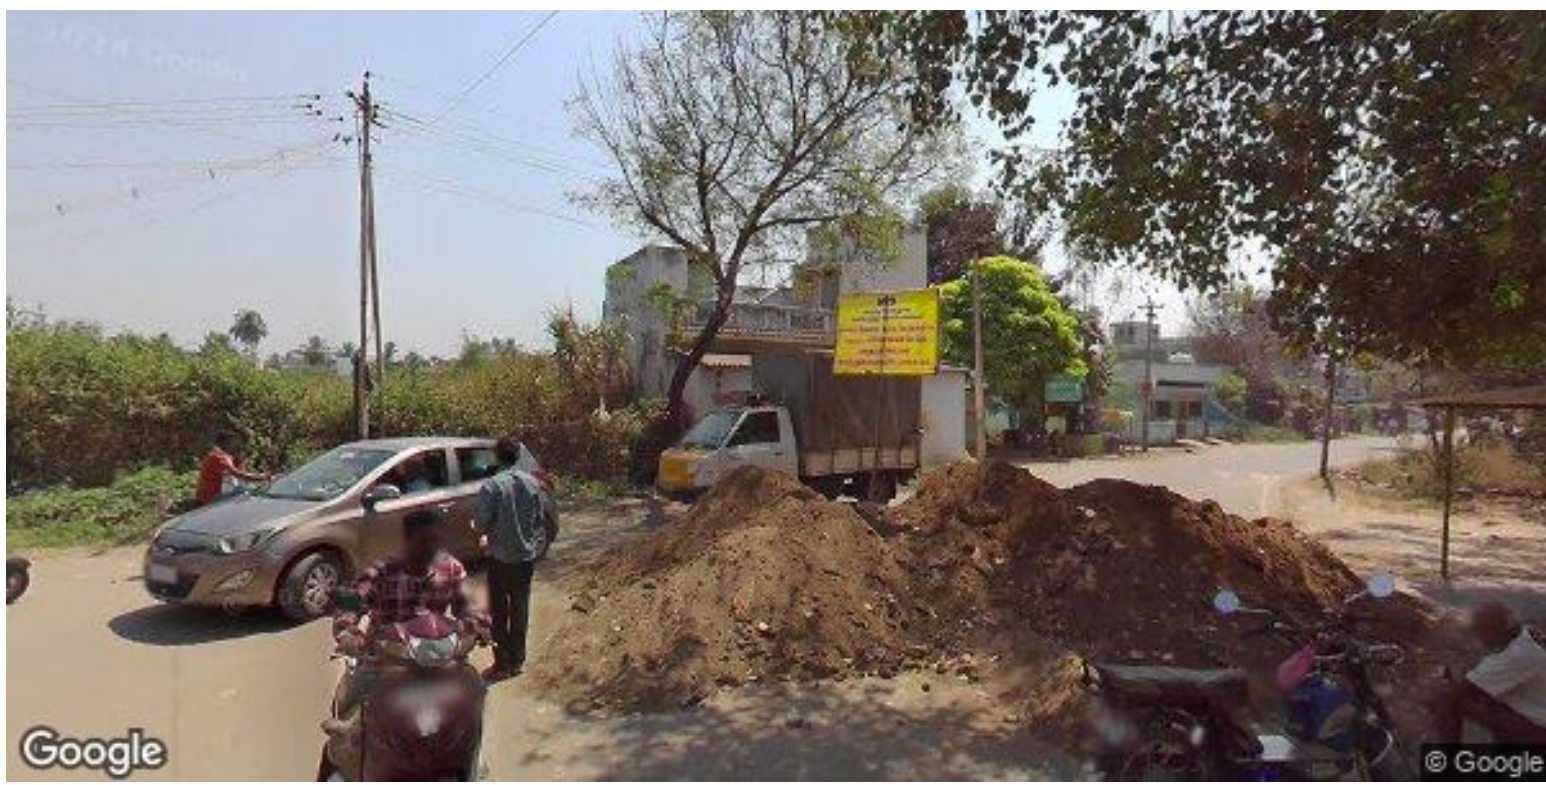
**Coordinates:** 11.73756, 78.04012

**Risk Type:** Blind Spot

**Risk Level:** Blind Spot

**Speed Limit:** 10 KM/Hr

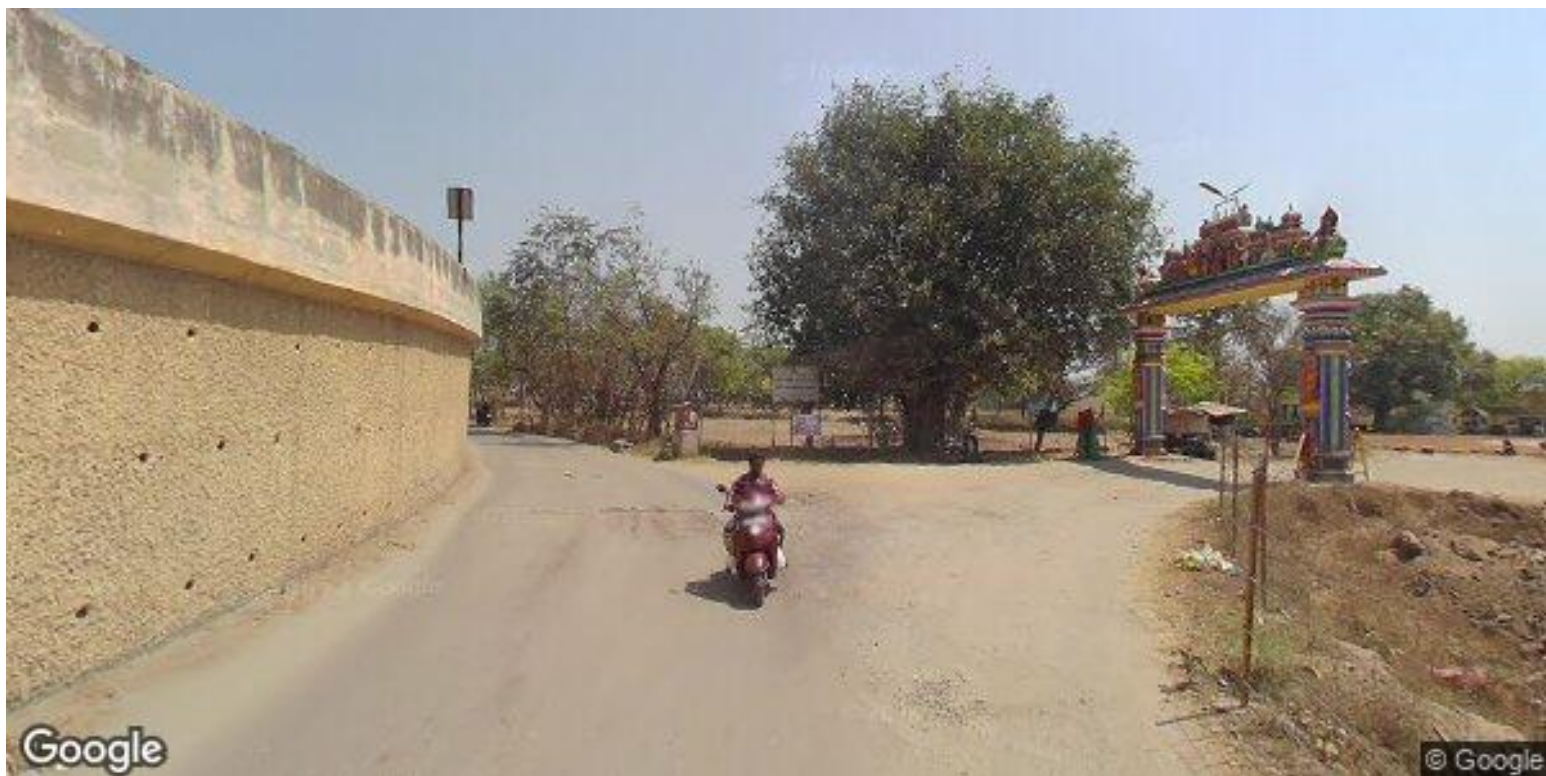
**Coordinates:** 11.73643, 78.03869

**Risk Type:** Turn

**Risk Level:** Medium

**Speed Limit:** 30 KM/Hr
