# IndianOil

## JOURNEY RISK MANAGEMENT (JRM) STUDY

### Salem Terminal to SHREE RENGGA AGENCY

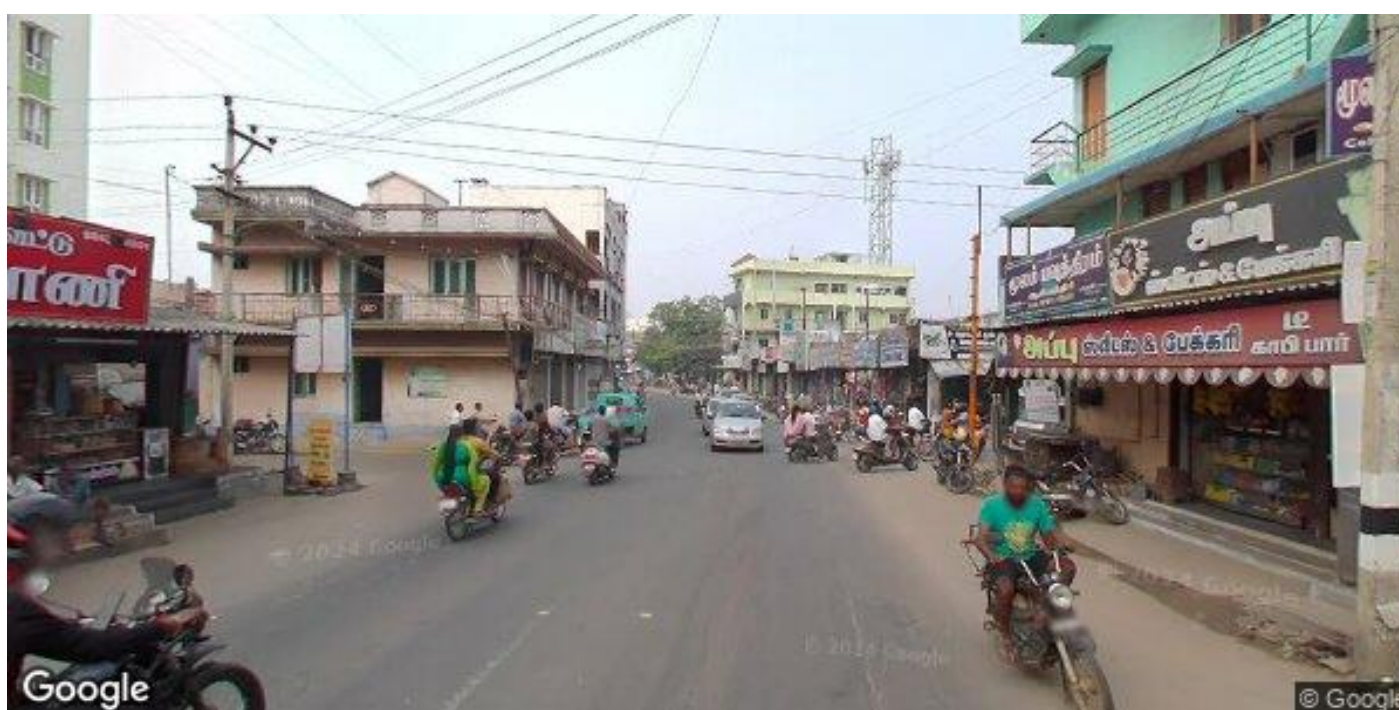
**Risk Type:** Turn  
**Risk Level:** Medium  
**Speed Limit:** 30 KM/Hr  
**Coordinates:** 11.38376, 77.89914

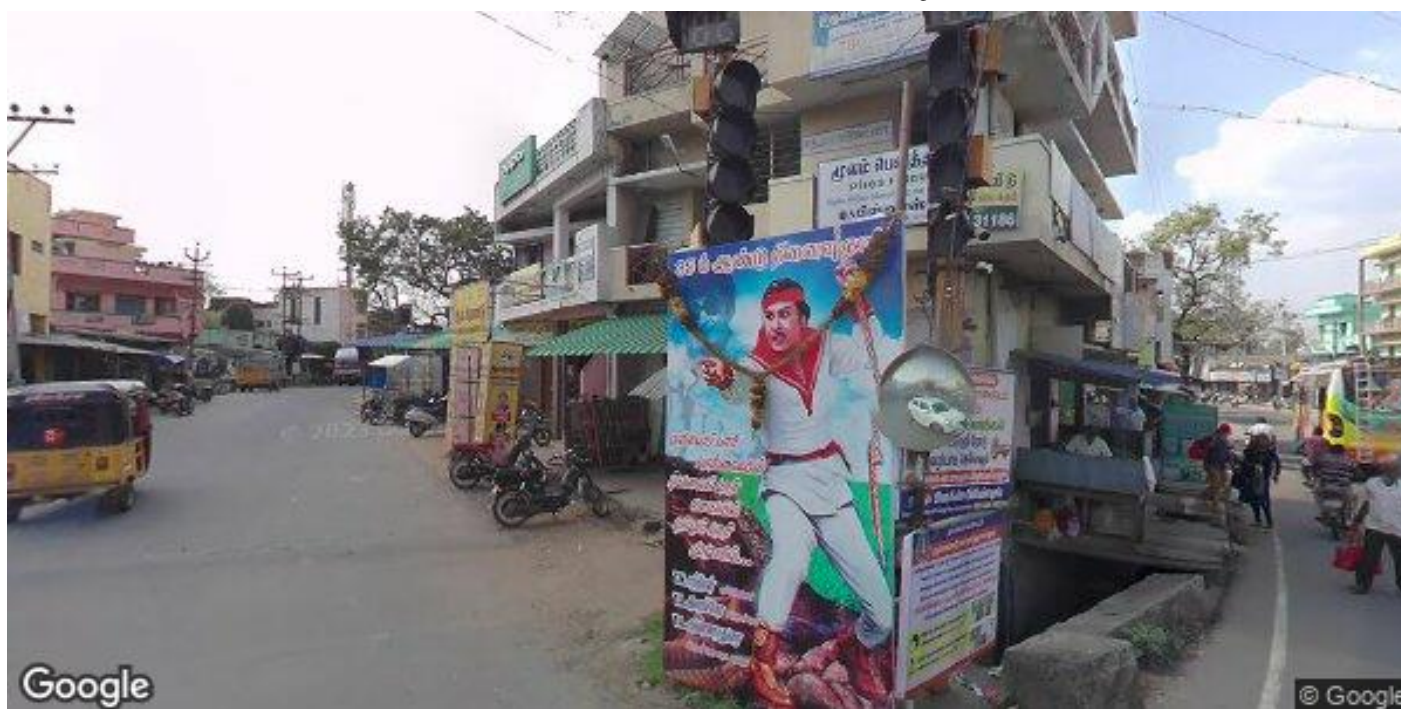
**Coordinates:** 11.38342, 77.89975

**Risk Type:** Turn

**Risk Level:** Medium

**Speed Limit:** 30 KM/Hr

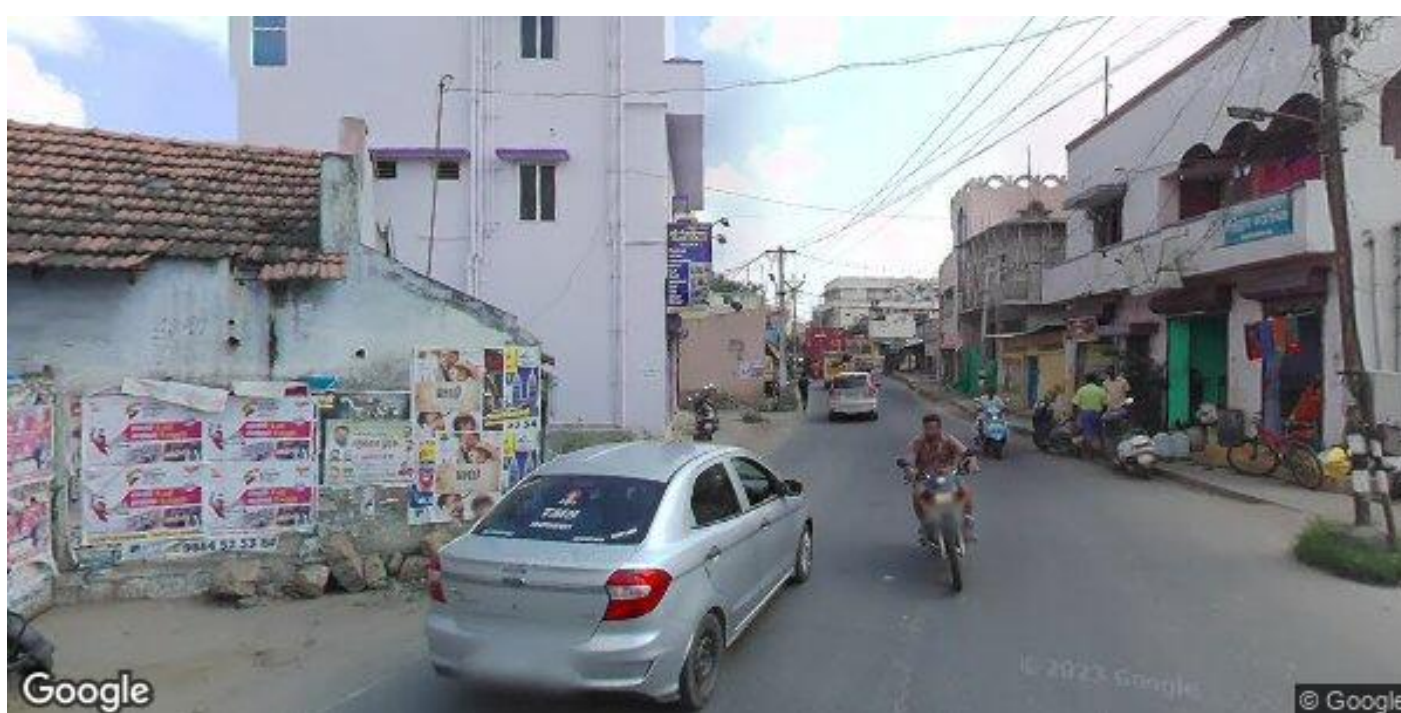
**Coordinates:** 11.38295, 77.90001

**Risk Type:** Turn

**Risk Level:** Medium

**Speed Limit:** 30 KM/Hr

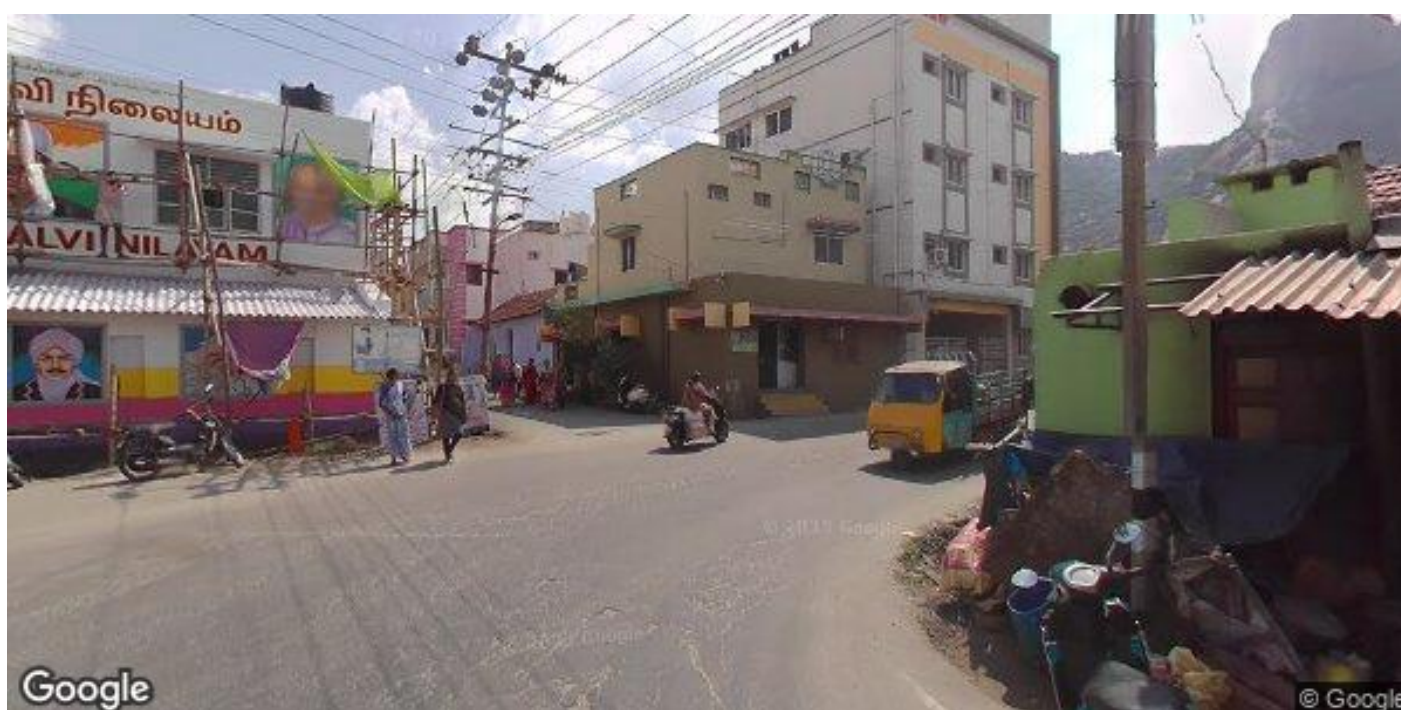
**Coordinates:** 11.38186, 77.90258

**Risk Type:** Turn

**Risk Level:** High

**Speed Limit:** 15 KM/Hr

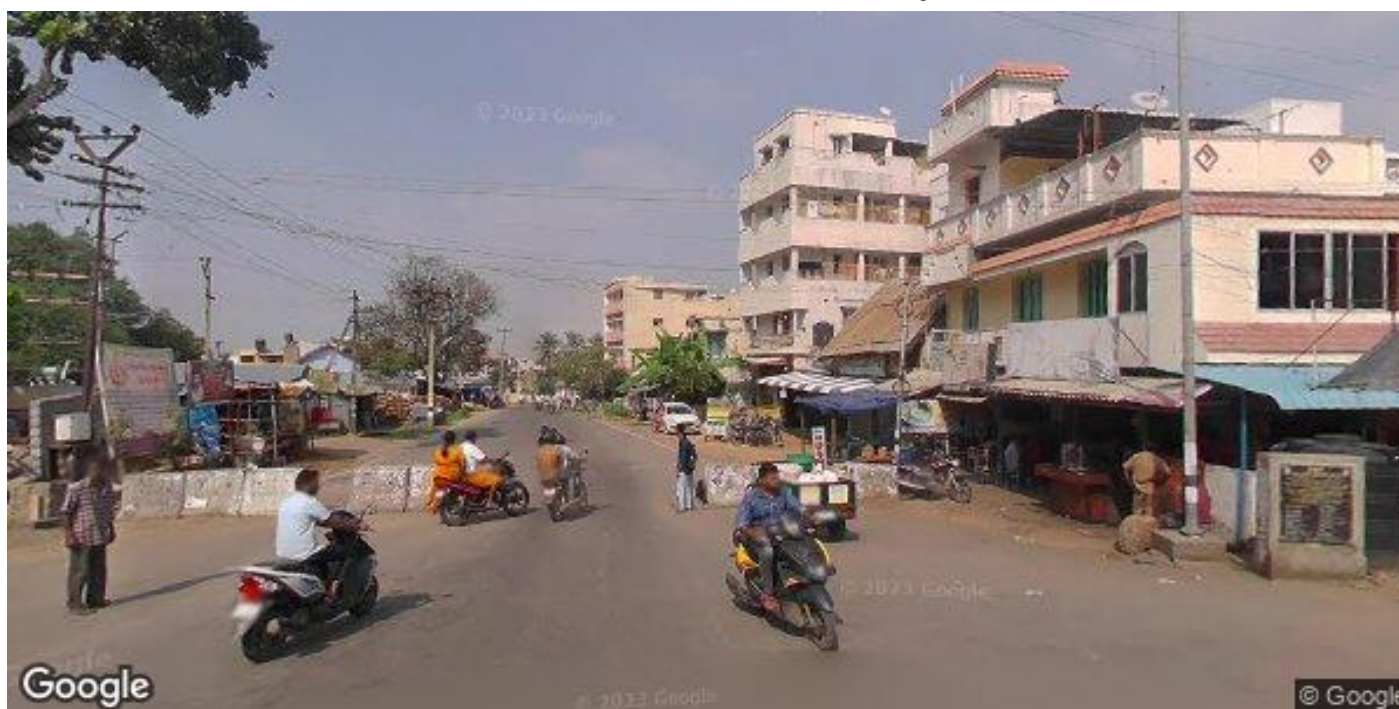
**Risk Type:** Blind Spot  
**Risk Level:** Blind Spot  
**Speed Limit:** 10 KM/Hr  
**Coordinates:** 11.37841, 77.90140

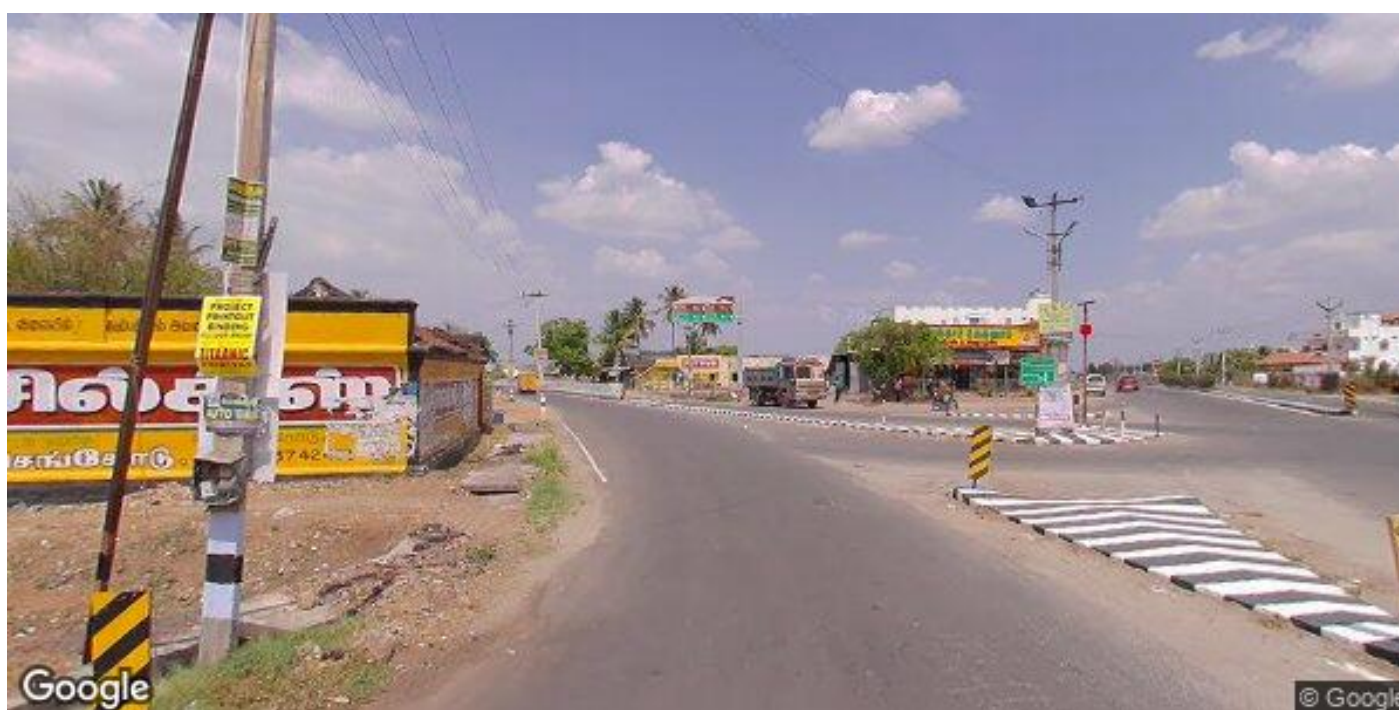
**Risk Type:** Turn  
**Risk Level:** Medium  
**Speed Limit:** 30 KM/Hr  
**Coordinates:** 11.36745, 77.93951

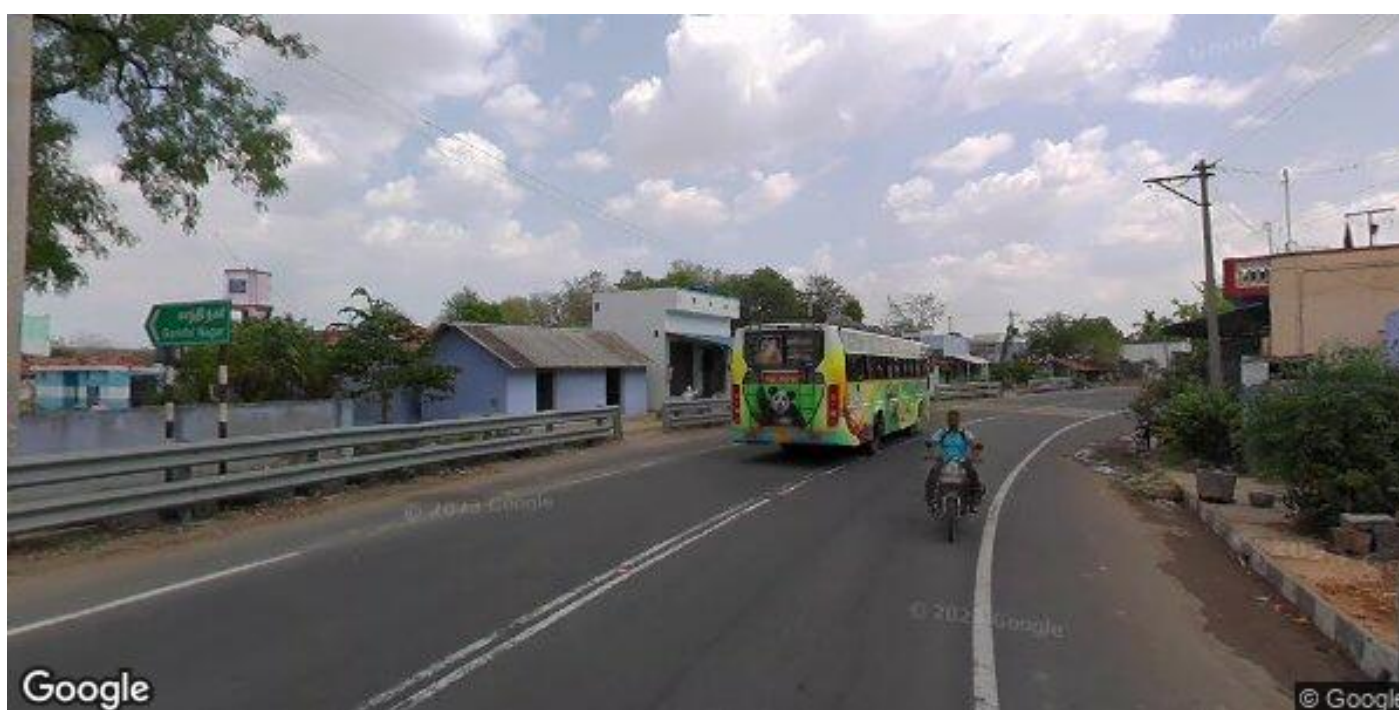
**Risk Type:** Turn  
**Risk Level:** Medium  
**Speed Limit:** 30 KM/Hr  
**Coordinates:** 11.41354, 78.08075

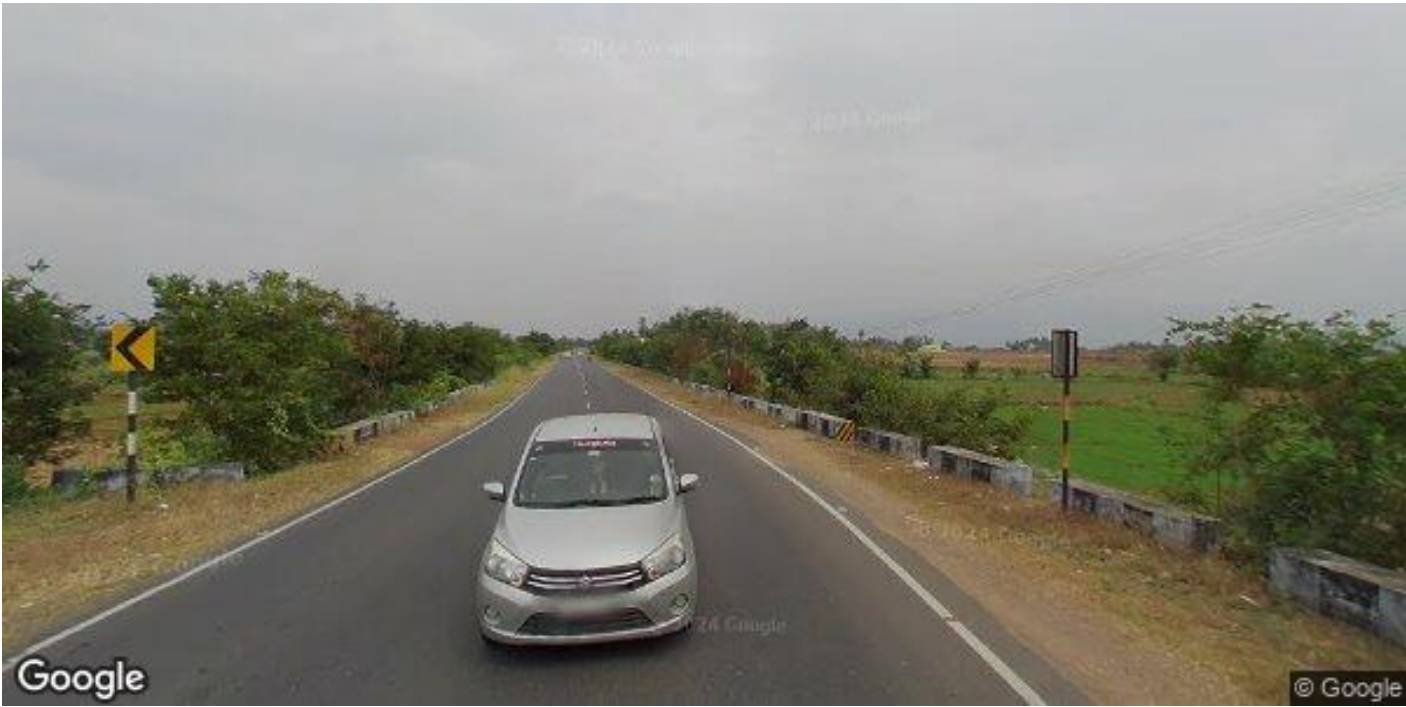
**Risk Type:** Turn  
**Risk Level:** Medium  
**Speed Limit:** 30 KM/Hr  
**Coordinates:** 11.43142, 78.18808

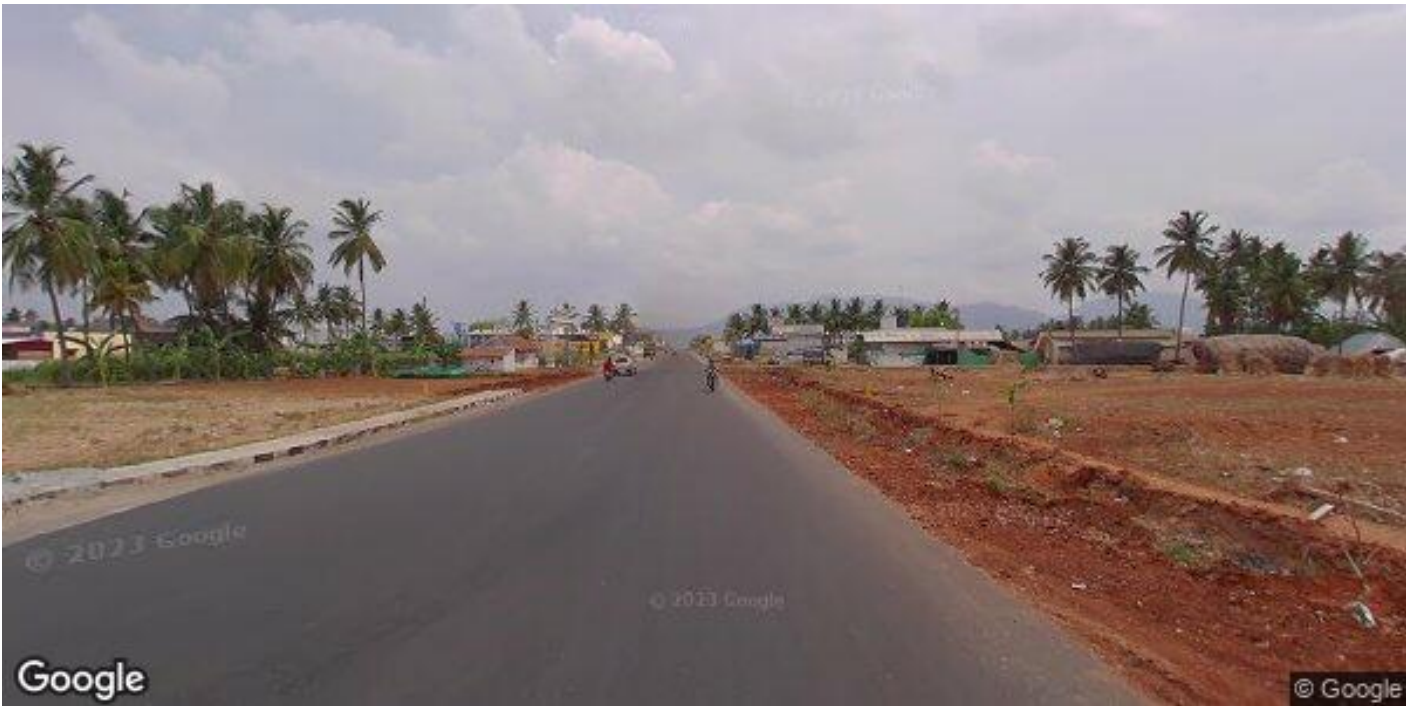
**Risk Type:** Turn  
**Risk Level:** High  
**Speed Limit:** 15 KM/Hr  
**Coordinates:** 11.43542, 78.20754

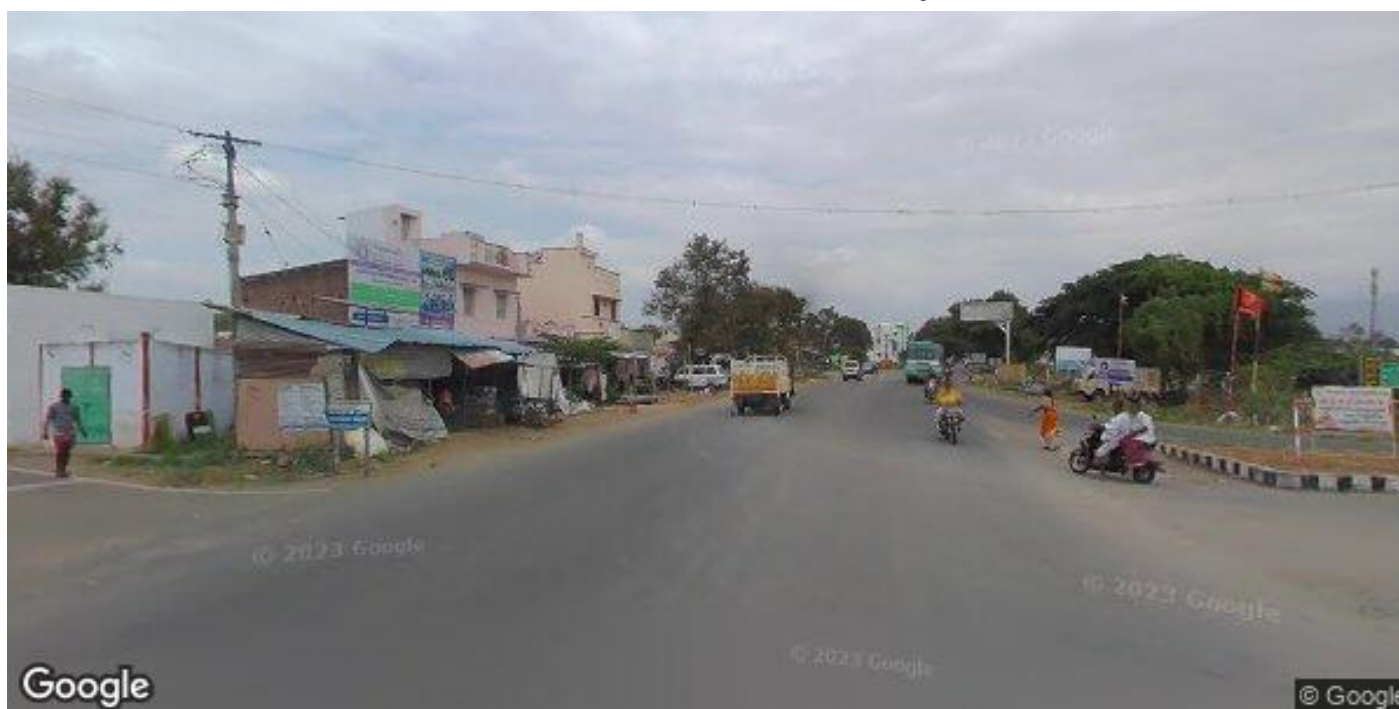
**Risk Type:** Blind Spot  
**Risk Level:** Blind Spot  
**Speed Limit:** 10 KM/Hr  
**Coordinates:** 11.45100, 78.20385

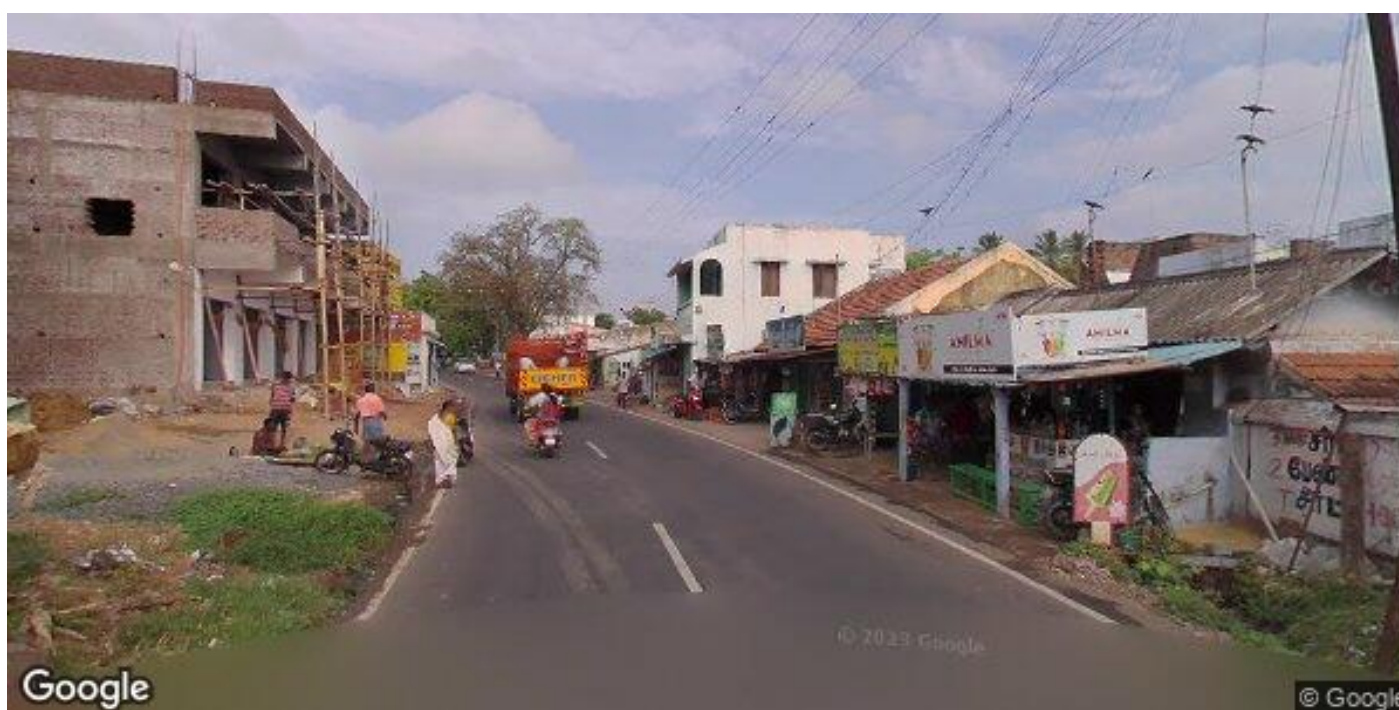
**Risk Type:** Turn  
**Risk Level:** Medium  
**Speed Limit:** 30 KM/Hr  
**Coordinates:** 11.44993, 78.22152

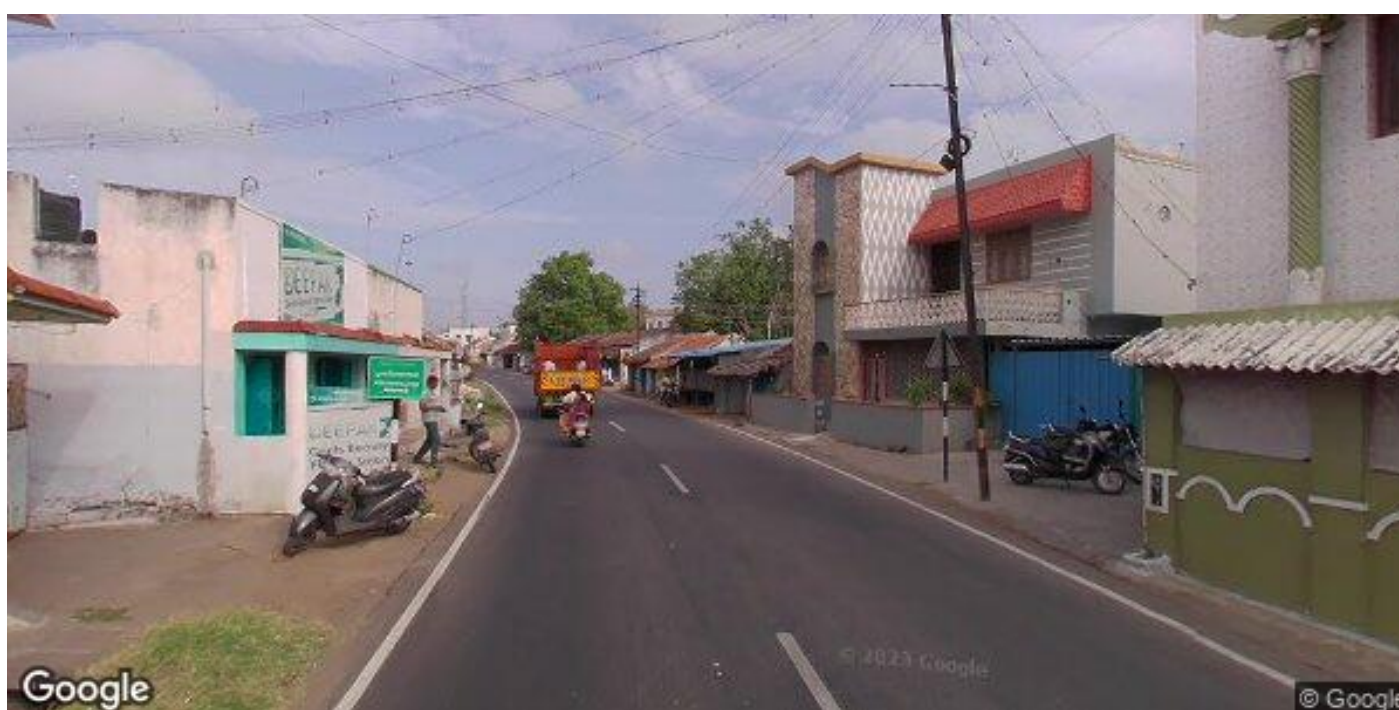
**Risk Type:** Turn  
**Risk Level:** Medium  
**Speed Limit:** 30 KM/Hr  
**Coordinates:** 11.44951, 78.22263

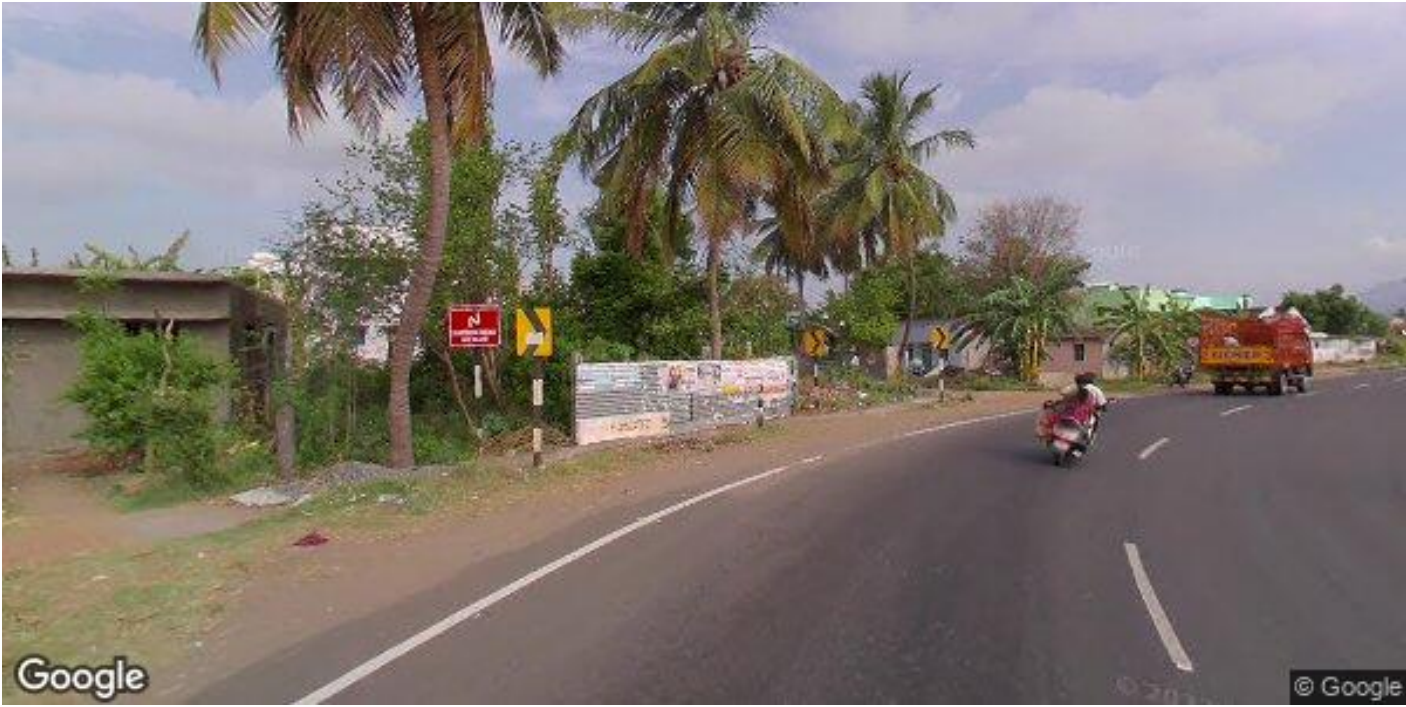
**Risk Type:** Turn  
**Risk Level:** High  
**Speed Limit:** 15 KM/Hr  
**Coordinates:** 11.44797, 78.22314

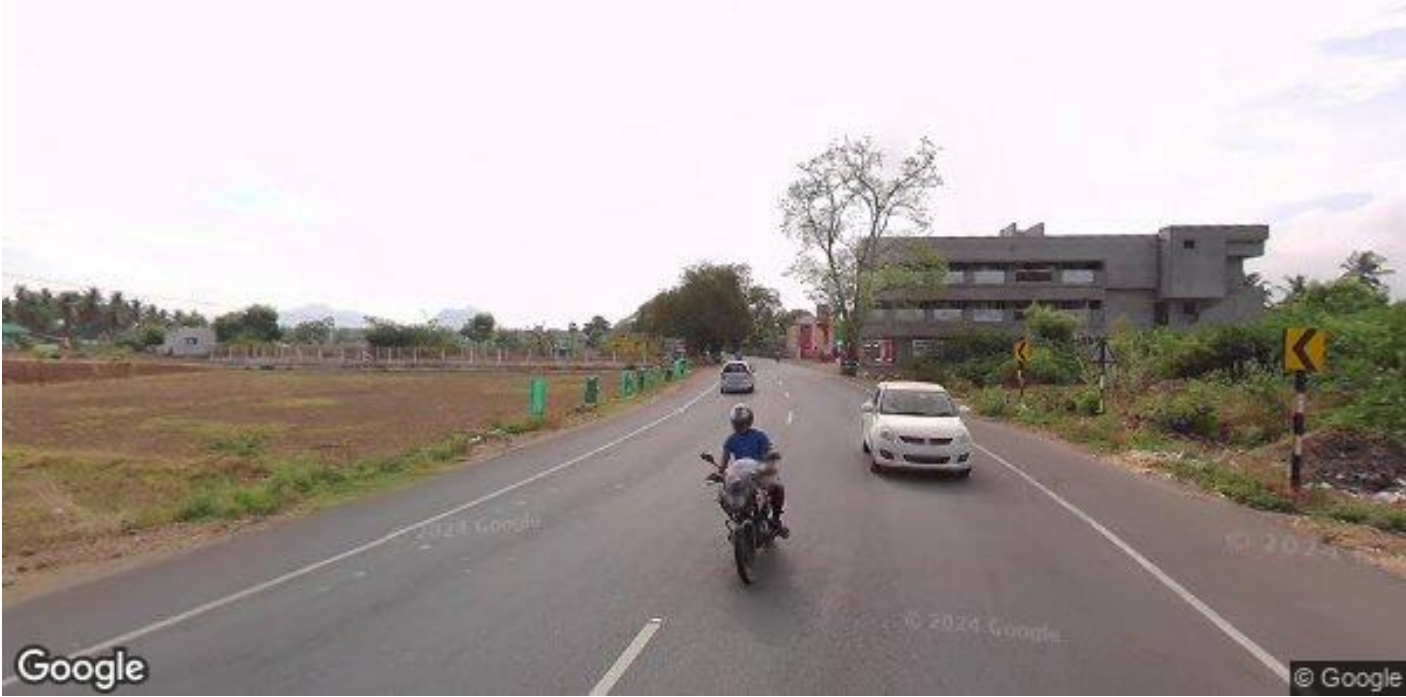
**Risk Type:** Turn  
**Risk Level:** Medium  
**Speed Limit:** 30 KM/Hr  
**Coordinates:** 11.44756, 78.22414

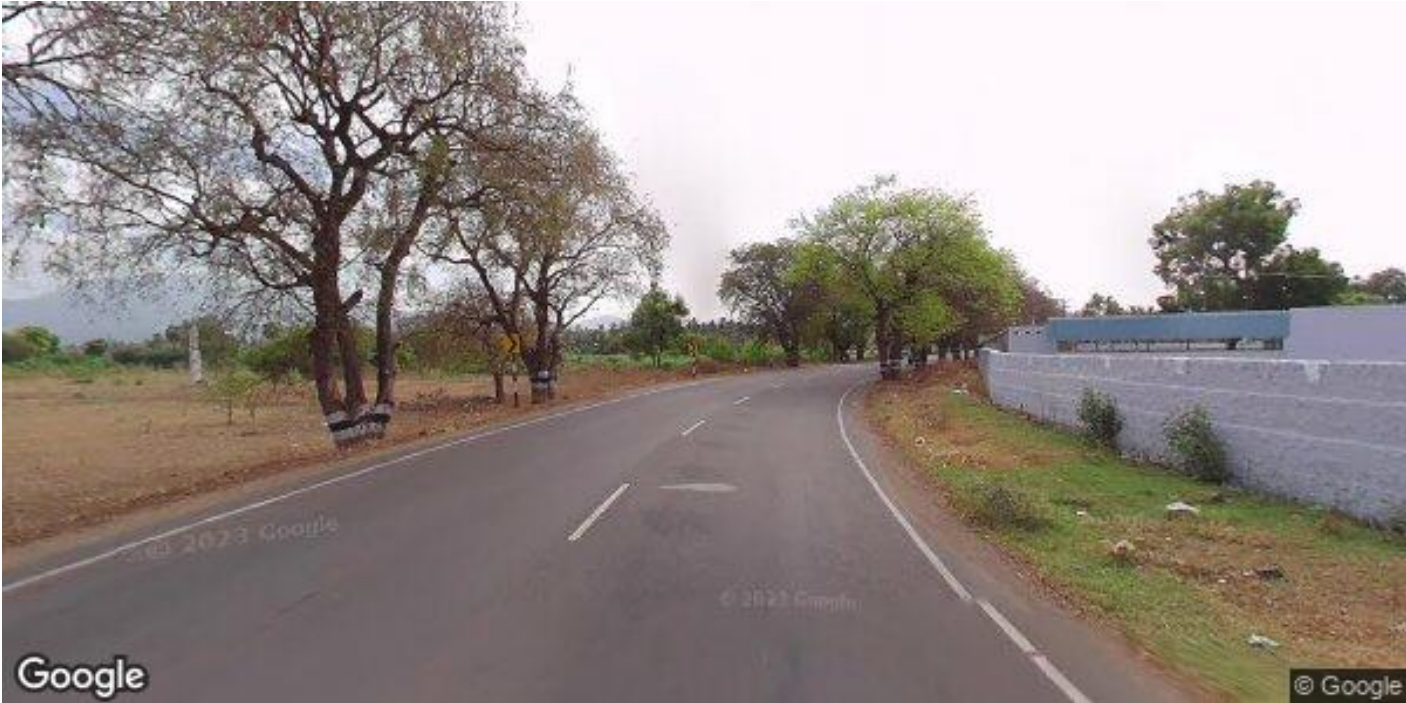
**Risk Type:** Turn  
**Risk Level:** Medium  
**Speed Limit:** 30 KM/Hr  
**Coordinates:** 11.45353, 78.23584

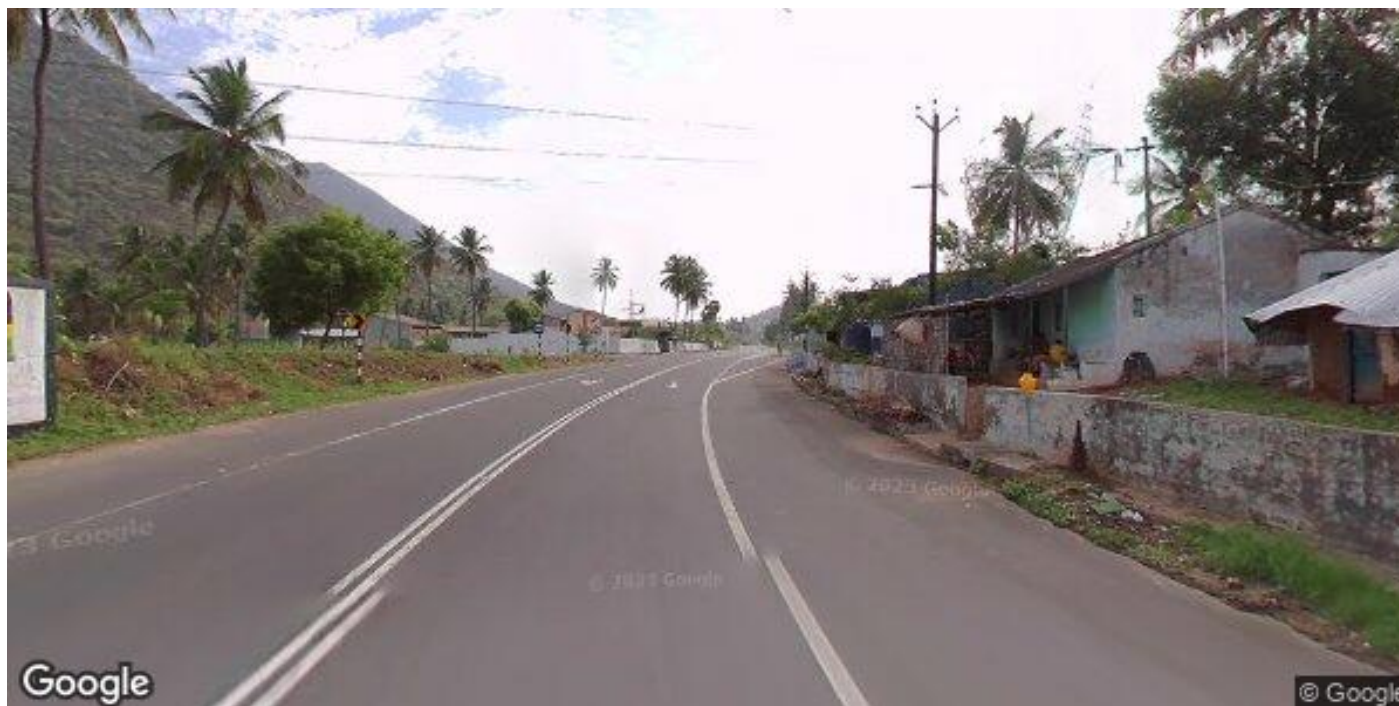
**Risk Type:** Turn  
**Risk Level:** Medium  
**Speed Limit:** 30 KM/Hr  
**Coordinates:** 11.49835, 78.32417

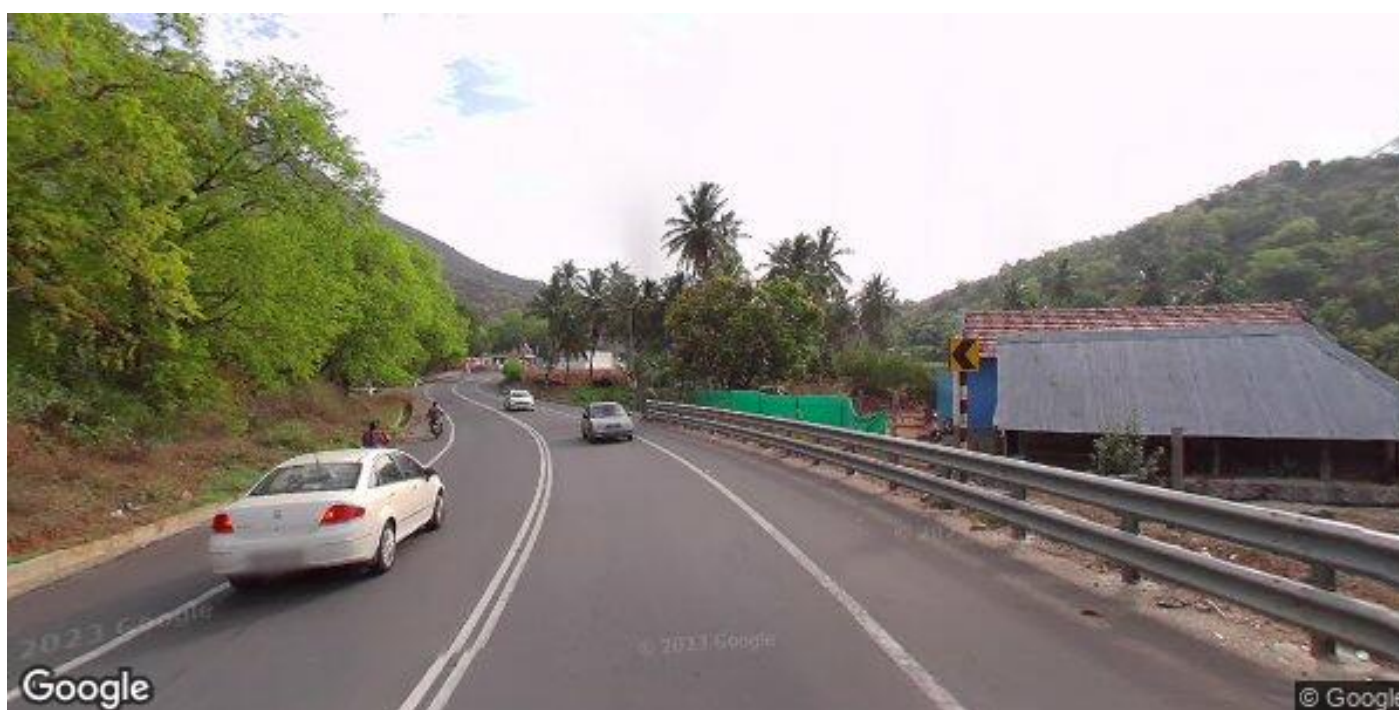
**Risk Type:** Turn  
**Risk Level:** Medium  
**Speed Limit:** 30 KM/Hr  
**Coordinates:** 11.50506, 78.33087

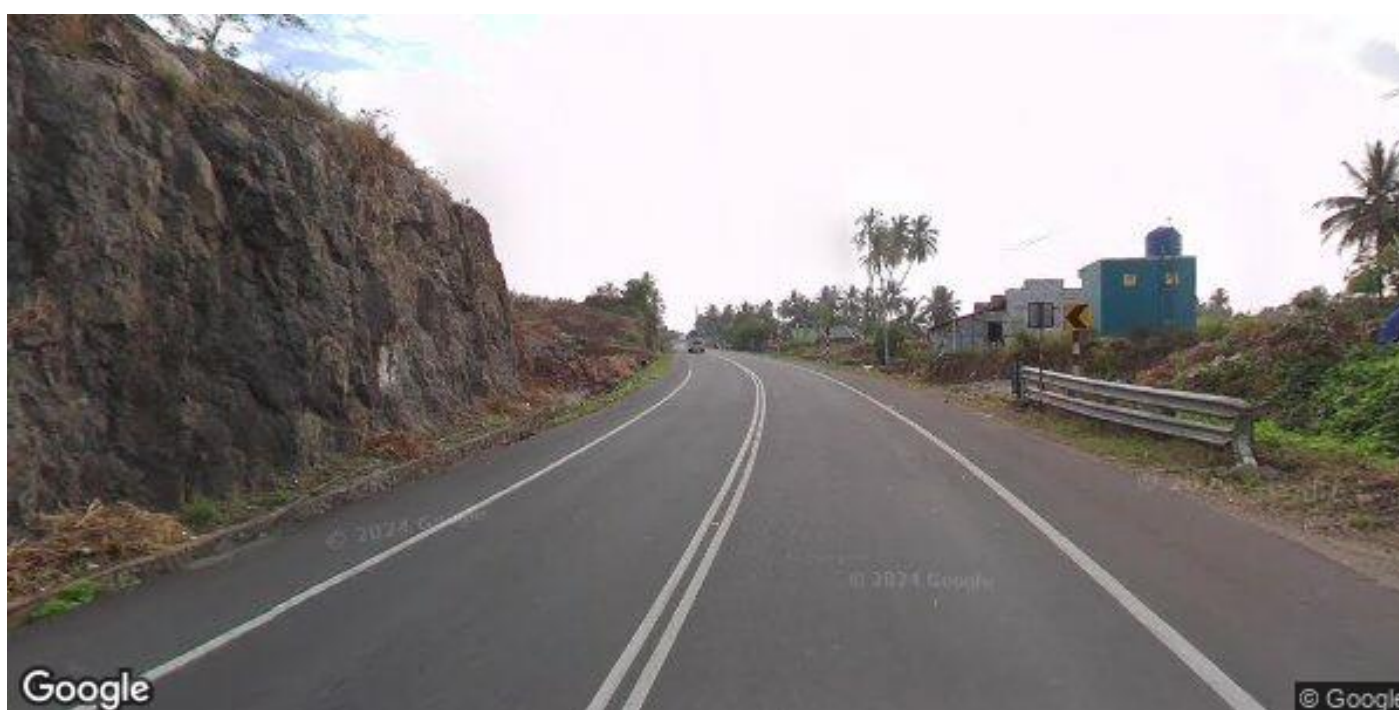
**Risk Type:** Turn  
**Risk Level:** Medium  
**Speed Limit:** 30 KM/Hr  
**Coordinates:** 11.50865, 78.33966

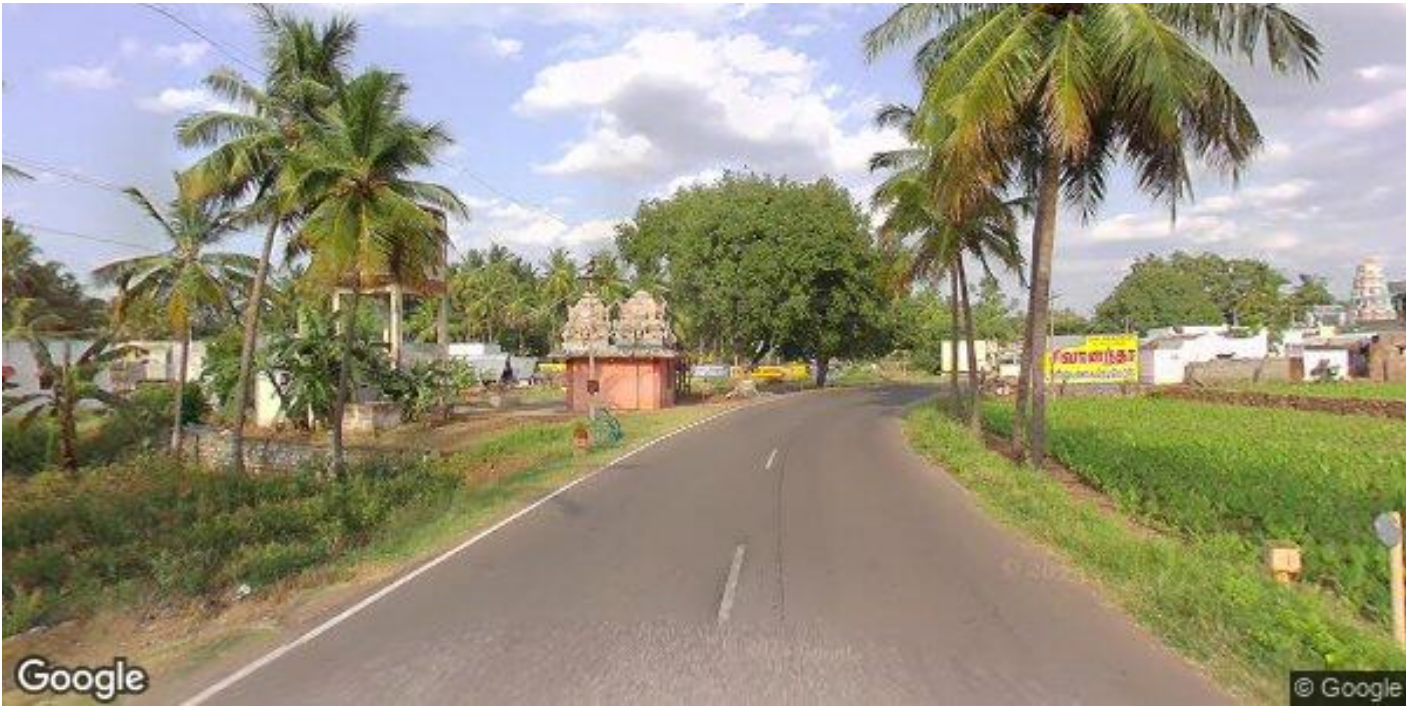
**Risk Type:** Turn  
**Risk Level:** Medium  
**Speed Limit:** 30 KM/Hr  
**Coordinates:** 11.51042, 78.34865

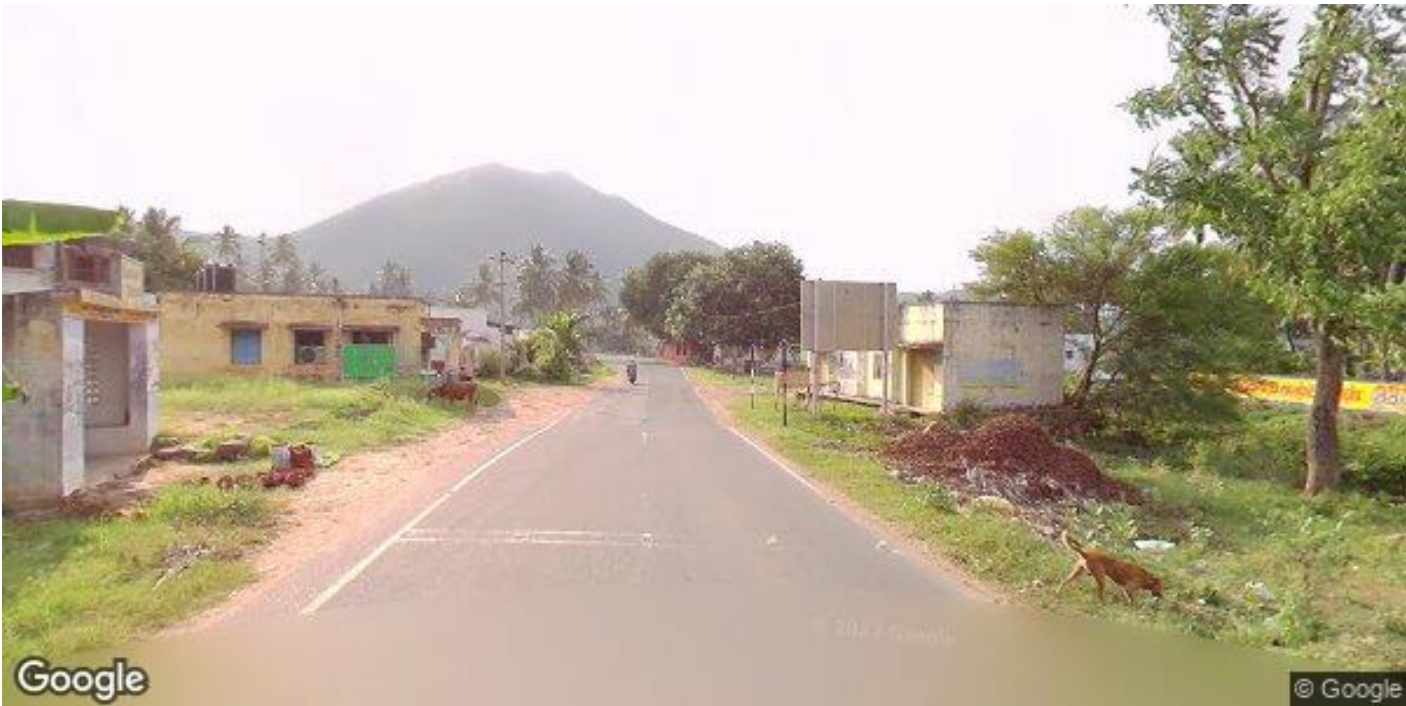
**Risk Type:** Turn  
**Risk Level:** Medium  
**Speed Limit:** 30 KM/Hr  
**Coordinates:** 11.50973, 78.34962

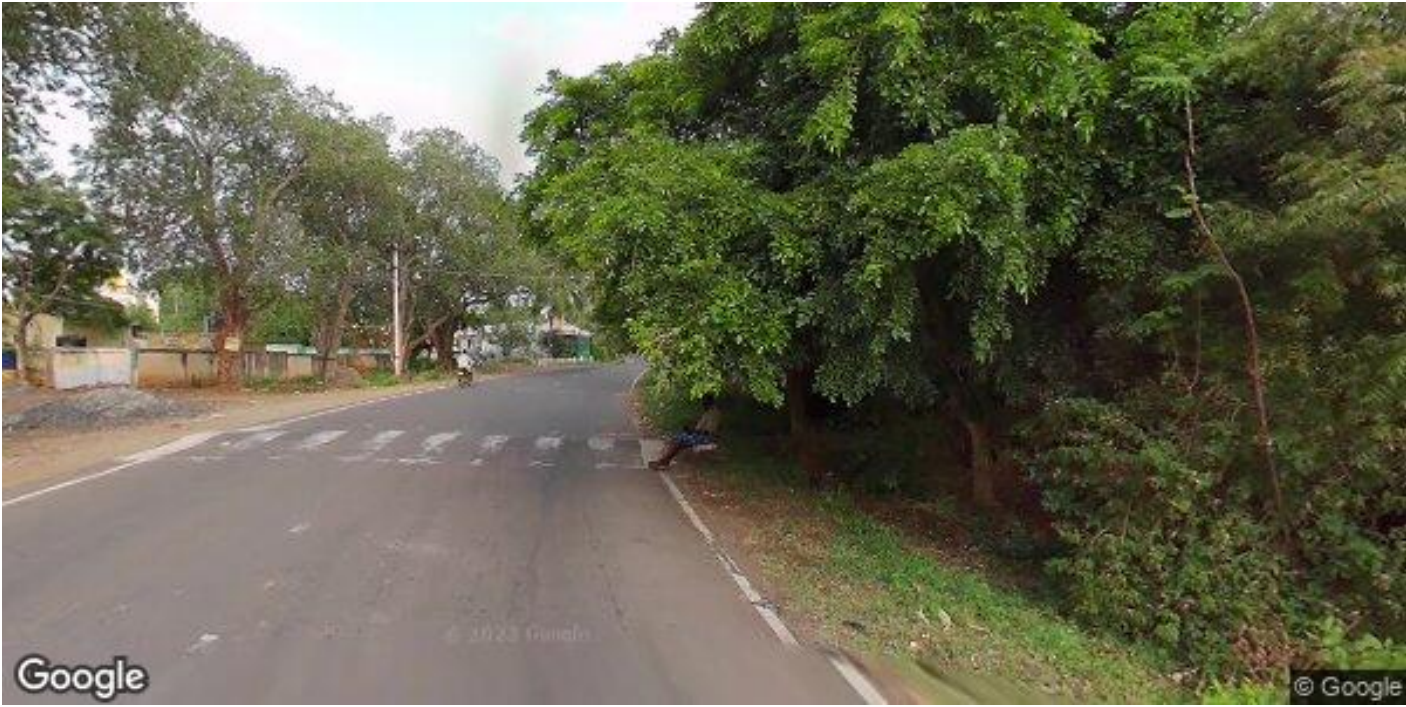
**Risk Type:** Turn  
**Risk Level:** Medium  
**Speed Limit:** 30 KM/Hr  
**Coordinates:** 11.50909, 78.35278

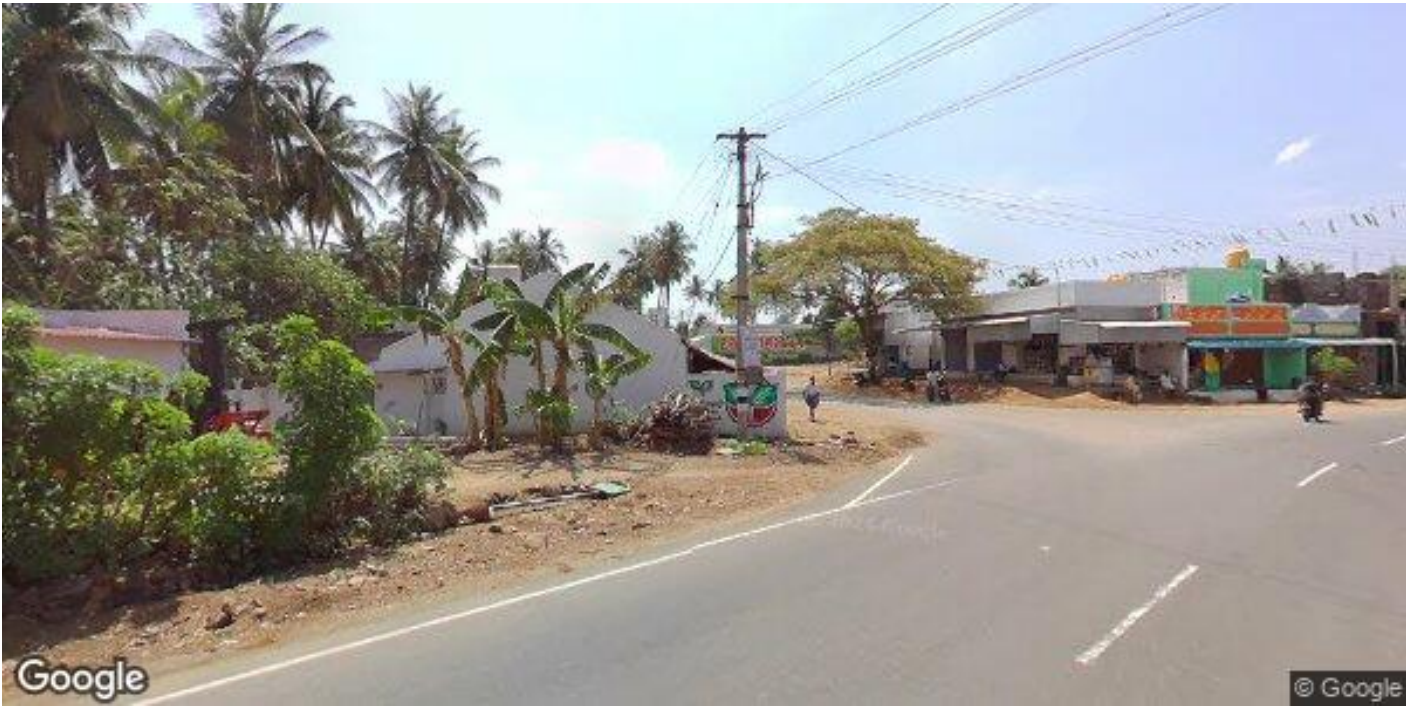
**Risk Type:** Turn  
**Risk Level:** Medium  
**Speed Limit:** 30 KM/Hr  
**Coordinates:** 11.47991, 78.38028
