# IndianOil

## JOURNEY RISK MANAGEMENT (JRM) STUDY

### Salem Terminal to SHREE RENGGA AGENCY

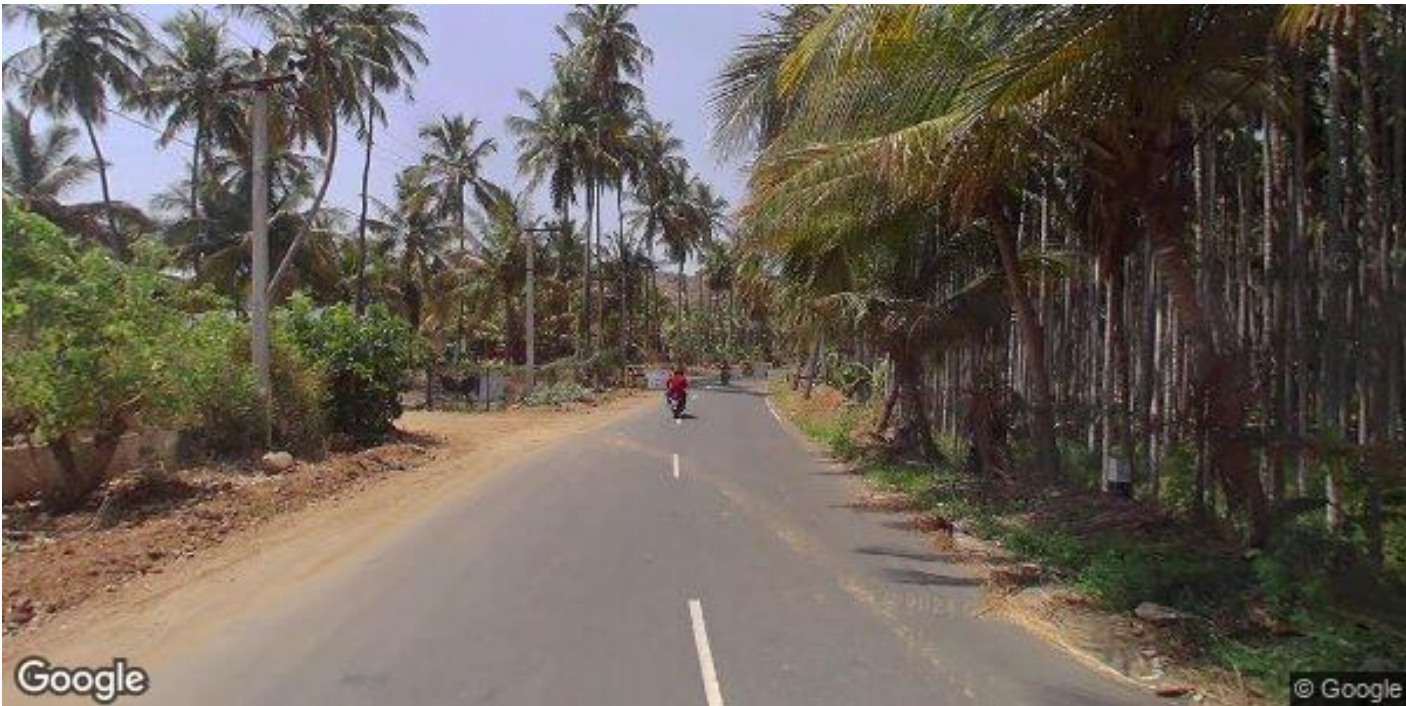
**Risk Type:** Turn  
**Risk Level:** Medium  
**Speed Limit:** 30 KM/Hr  
**Coordinates:** 11.46964, 78.39358

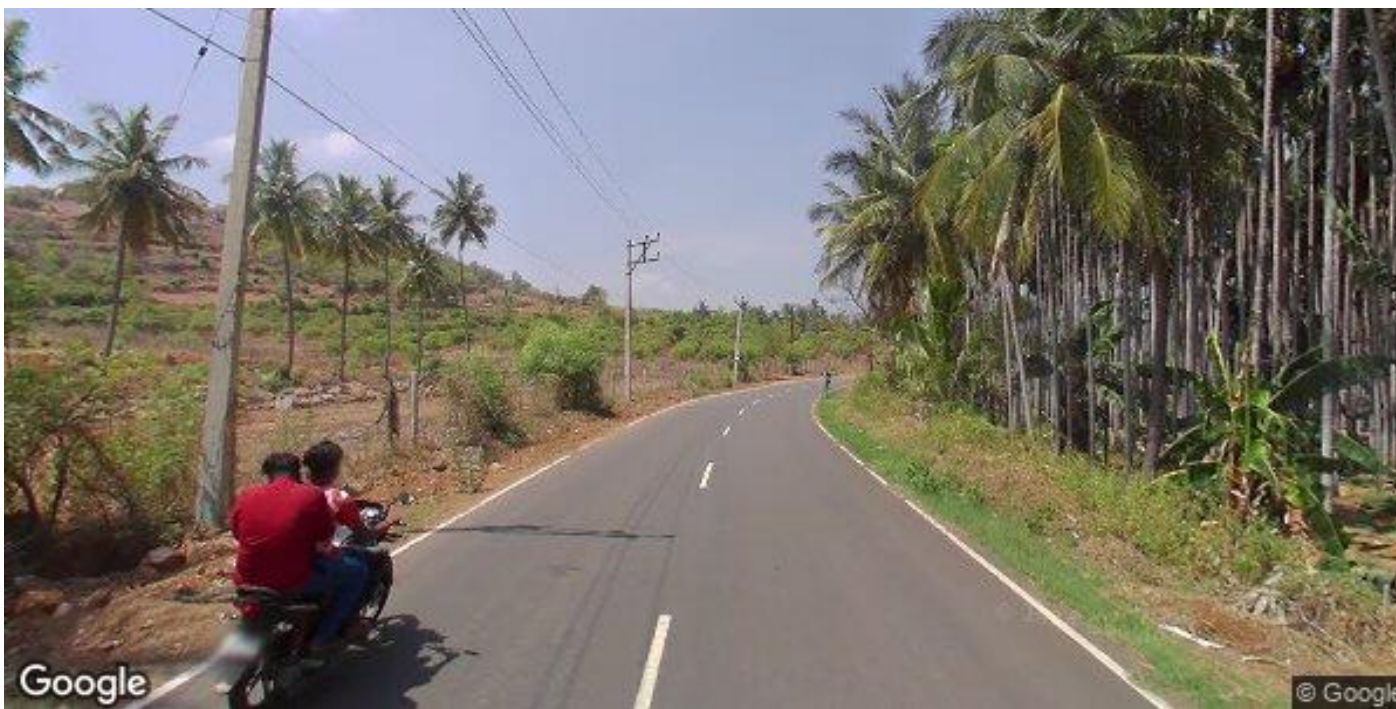
**Risk Type:** Turn  
**Risk Level:** Medium  
**Speed Limit:** 30 KM/Hr  
**Coordinates:** 11.46790, 78.39420

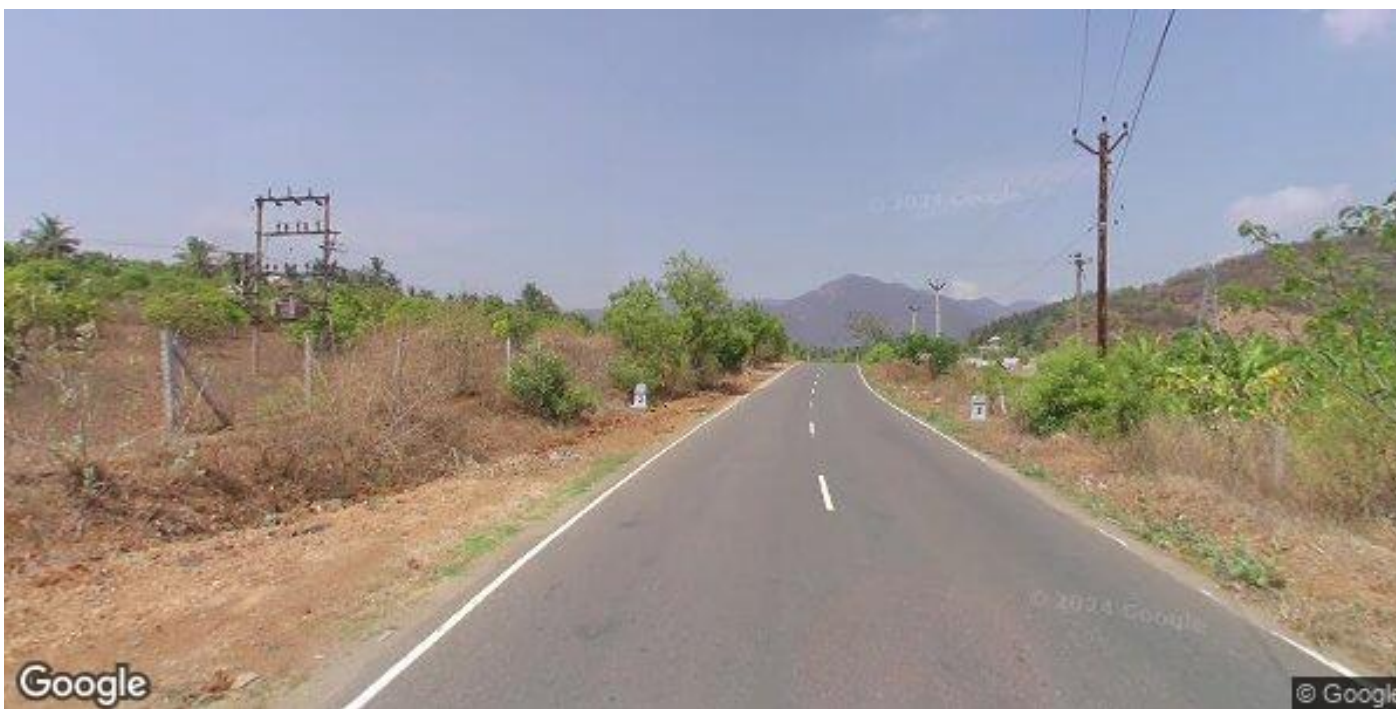
**Risk Type:** Turn  
**Risk Level:** Medium  
**Speed Limit:** 30 KM/Hr  
**Coordinates:** 11.46691, 78.39407

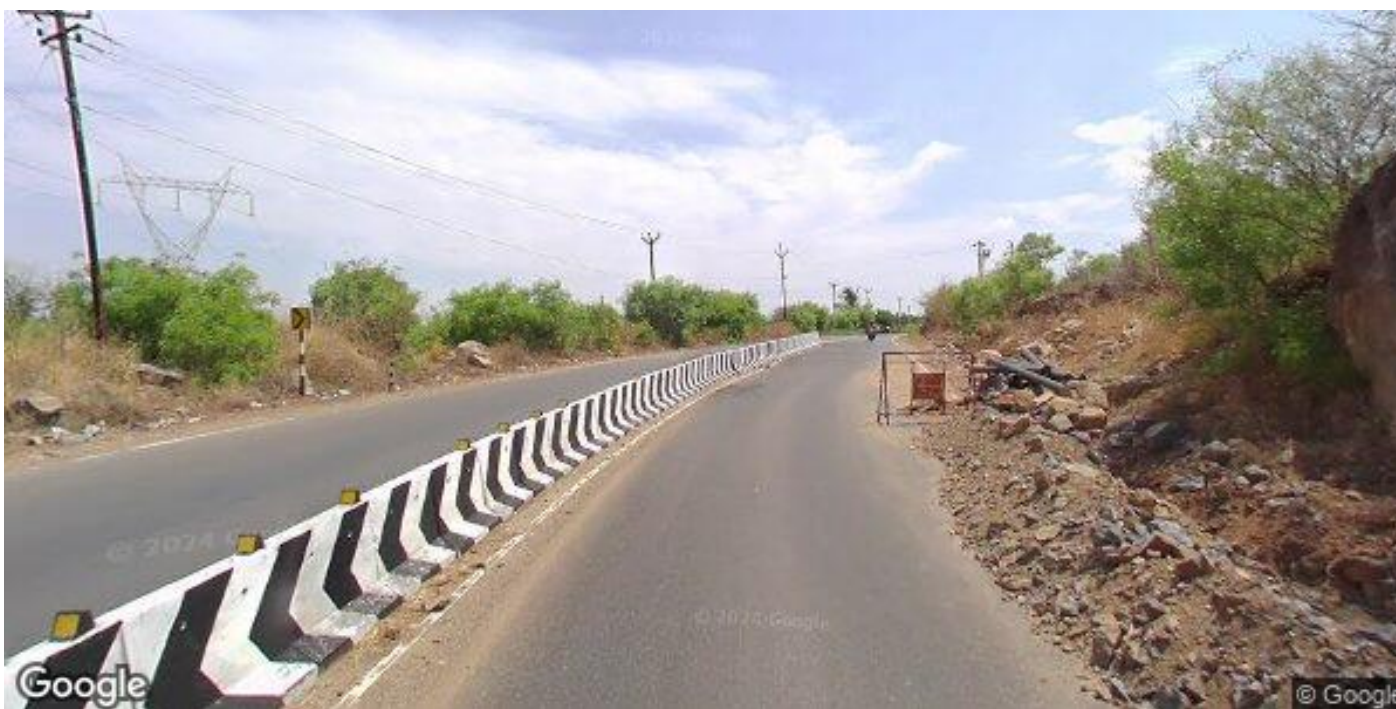
**Risk Type:** Turn  
**Risk Level:** Medium  
**Speed Limit:** 30 KM/Hr  
**Coordinates:** 11.46466, 78.39289

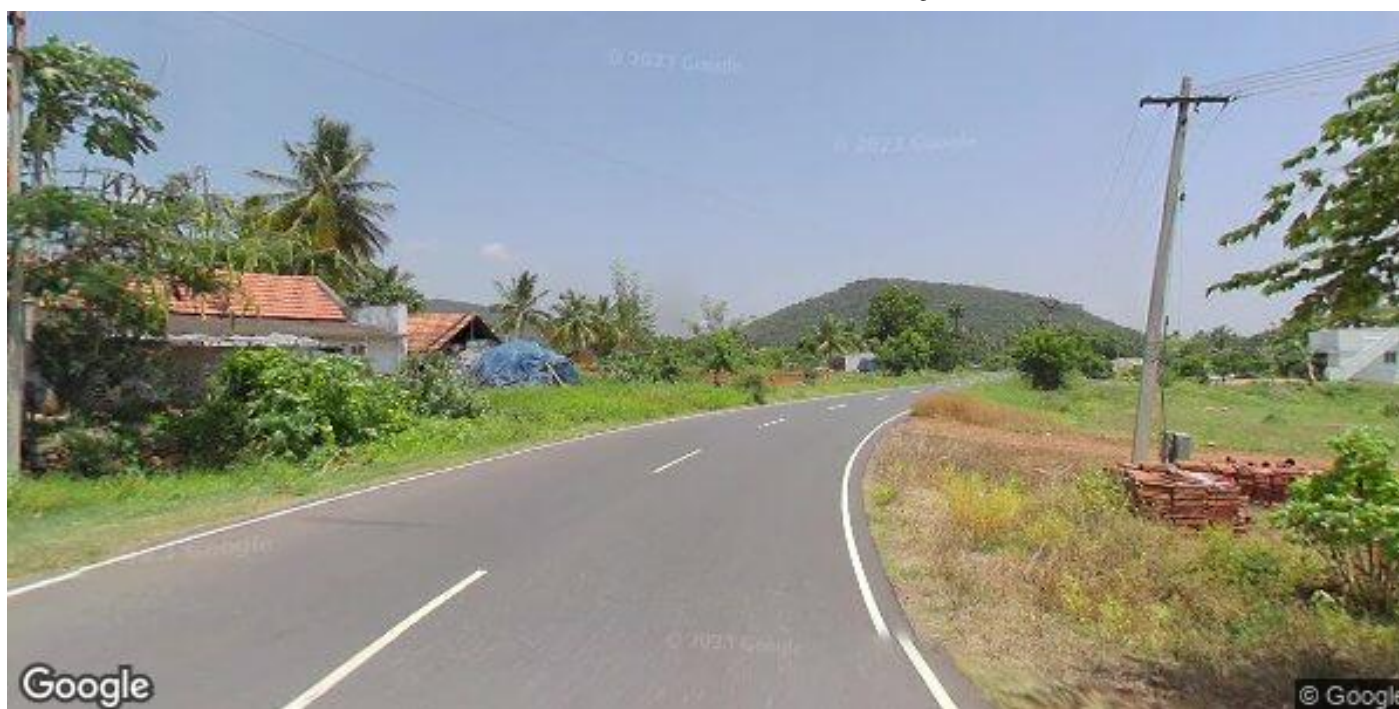
**Risk Type:** Turn  
**Risk Level:** Medium  
**Speed Limit:** 30 KM/Hr  
**Coordinates:** 11.45658, 78.40441

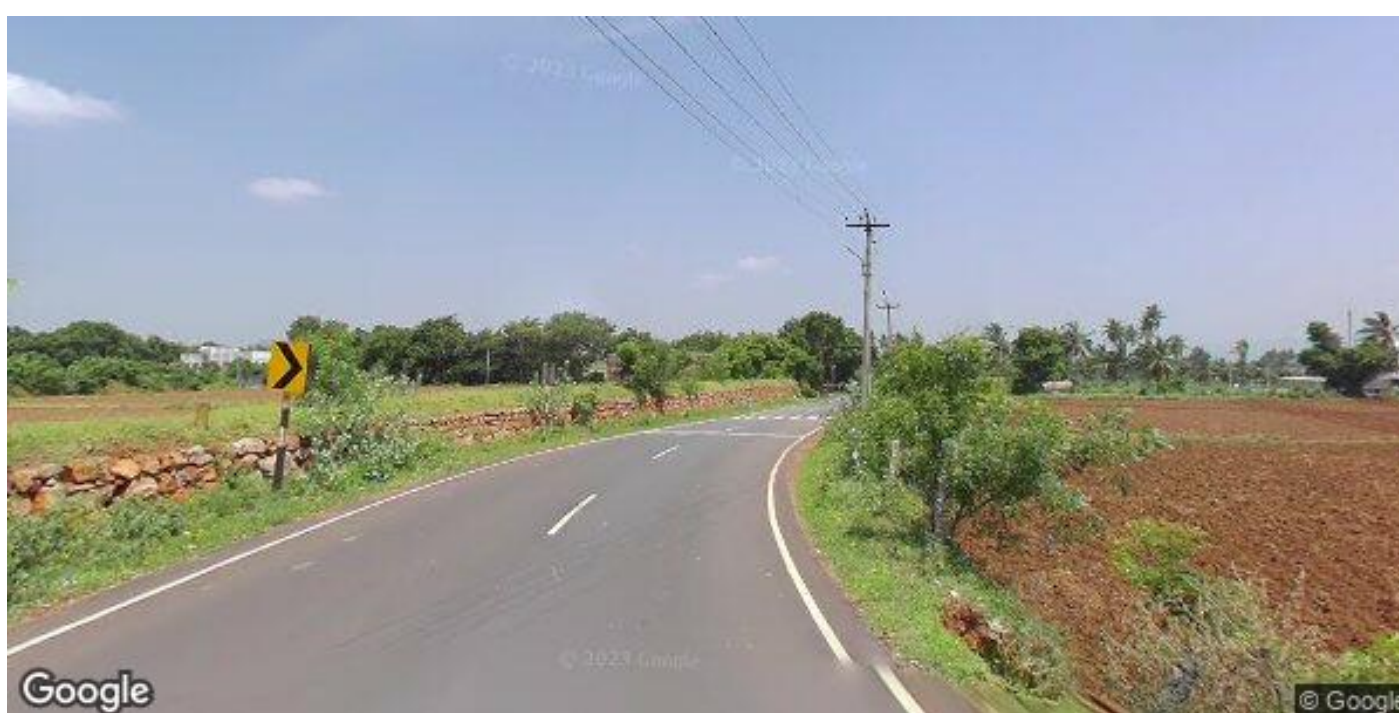
**Risk Type:** Turn  
**Risk Level:** Medium  
**Speed Limit:** 30 KM/Hr  
**Coordinates:** 11.46740, 78.45082

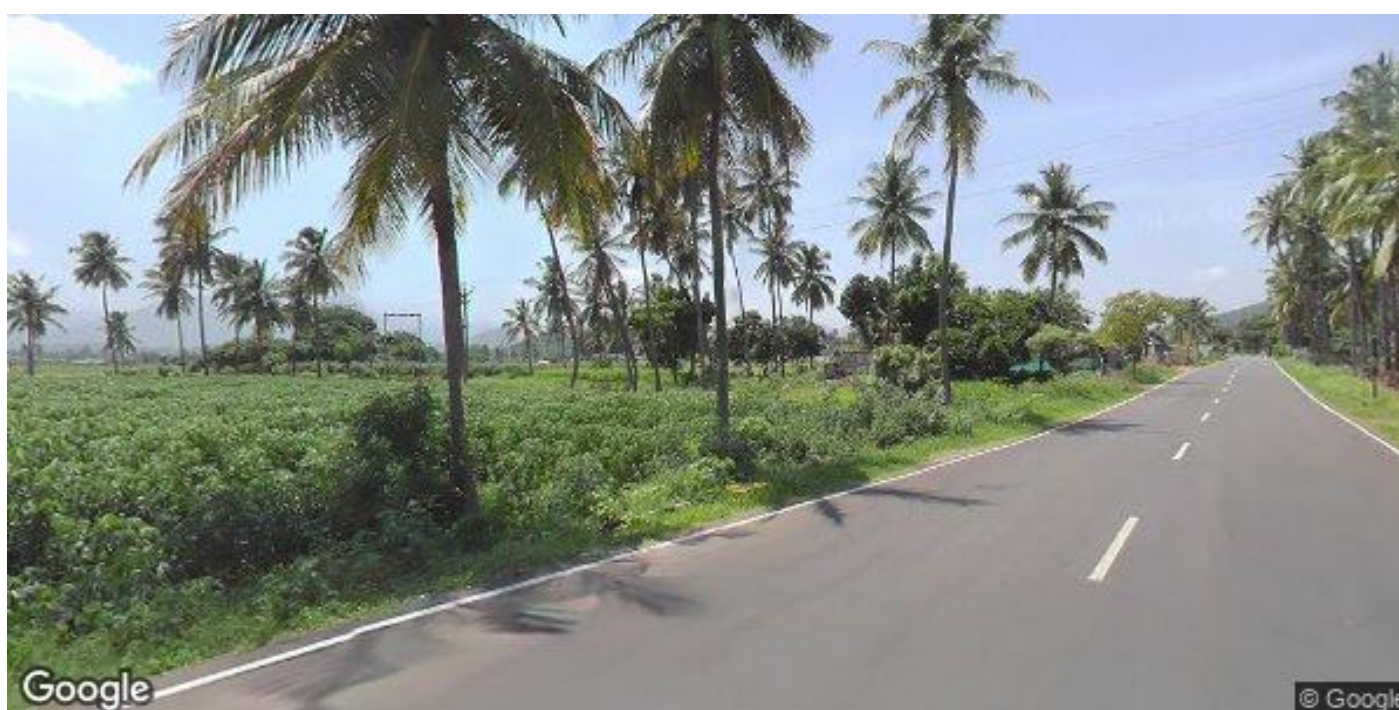
**Risk Type:** Turn  
**Risk Level:** Medium  
**Speed Limit:** 30 KM/Hr  
**Coordinates:** 11.46728, 78.45442

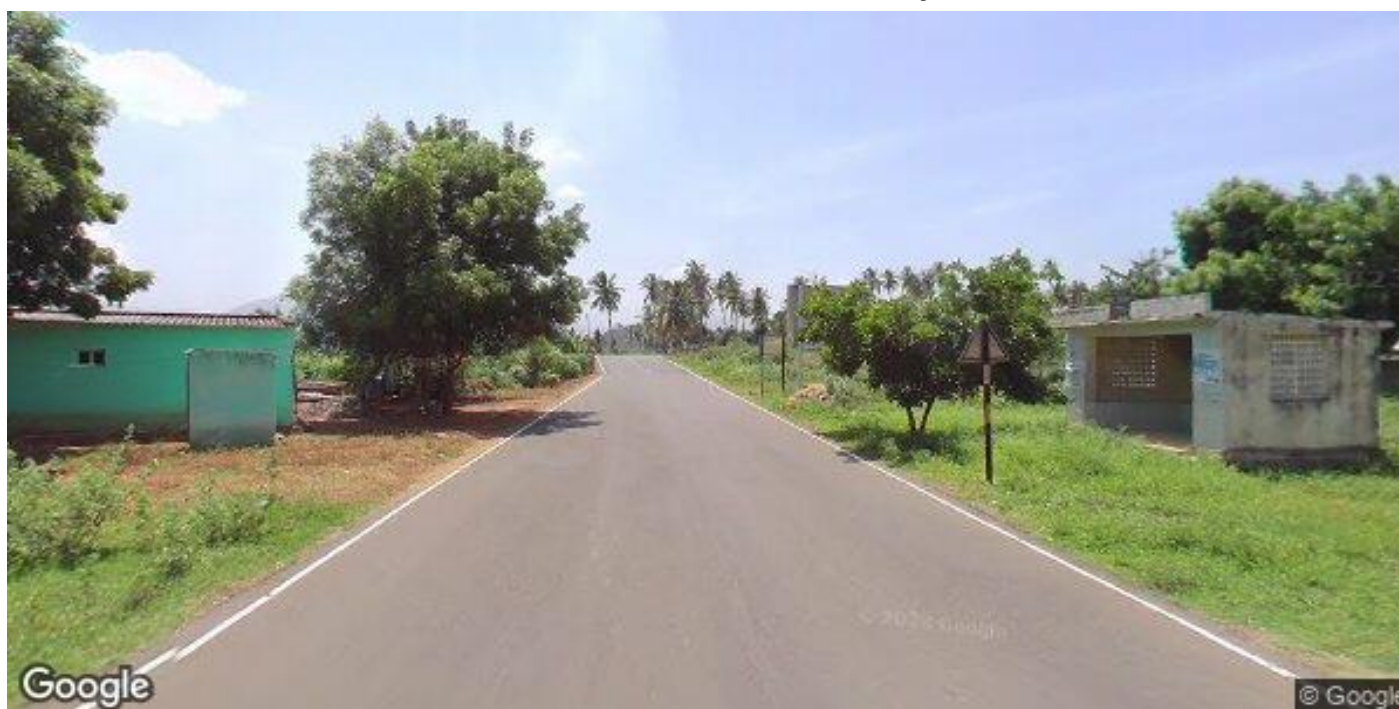
**Risk Type:** Turn  
**Risk Level:** Medium  
**Speed Limit:** 30 KM/Hr  
**Coordinates:** 11.46798, 78.45523

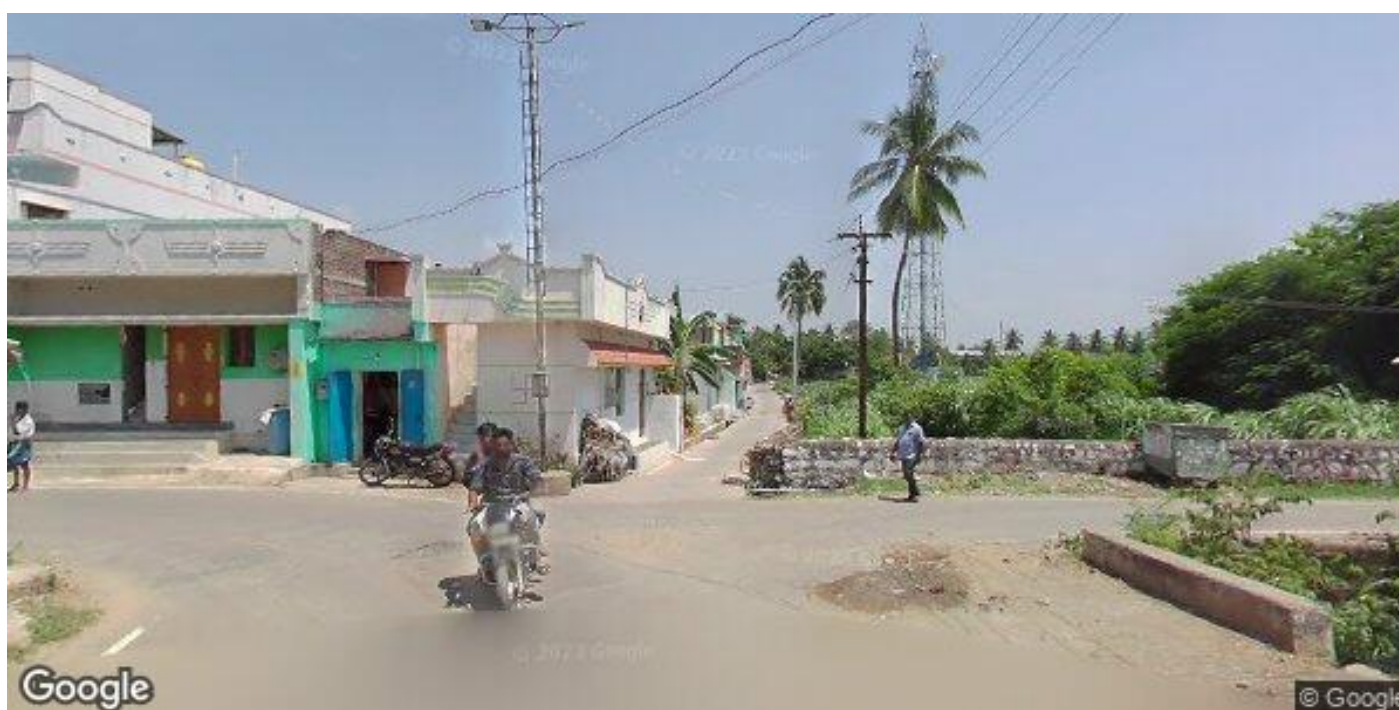
**Risk Type:** Blind Spot  
**Risk Level:** Blind Spot  
**Speed Limit:** 10 KM/Hr  
**Coordinates:** 11.46798, 78.45844

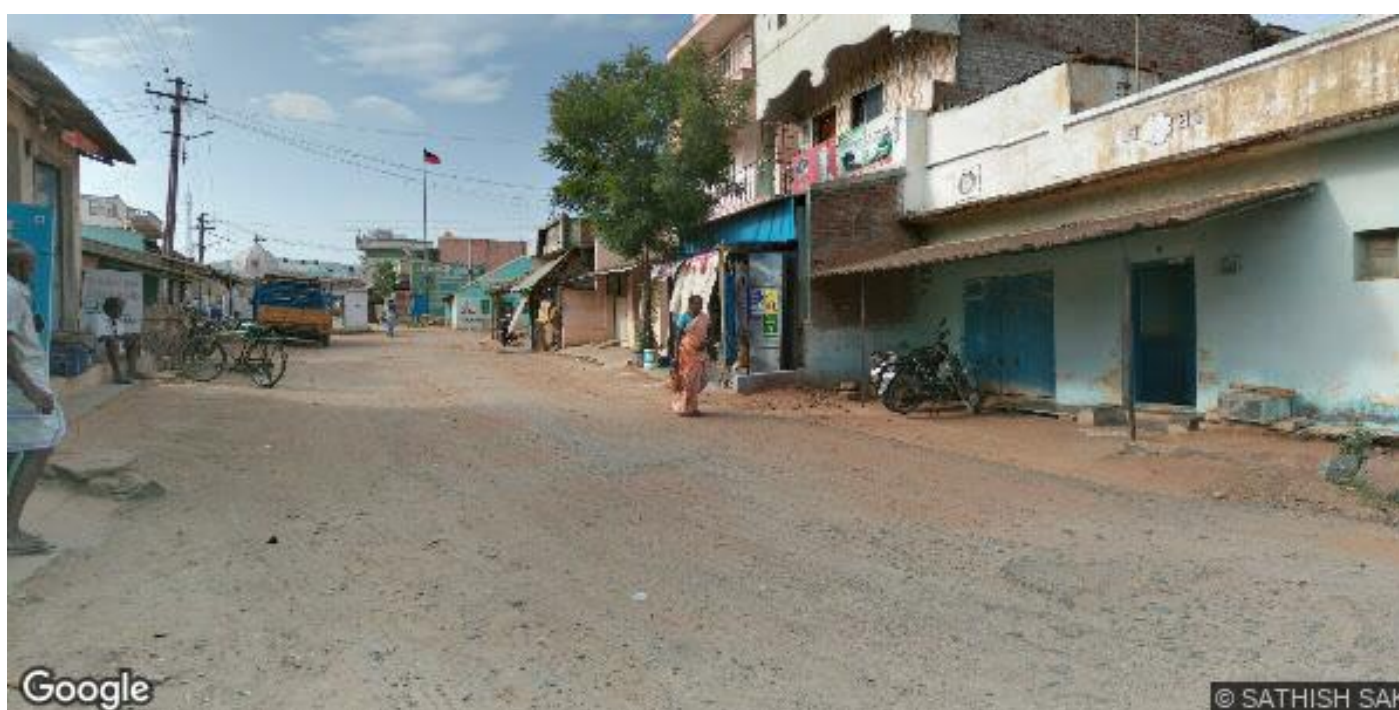
**Risk Type:** Blind Spot  
**Risk Level:** Blind Spot  
**Speed Limit:** 10 KM/Hr  
**Coordinates:** 11.46857, 78.45844

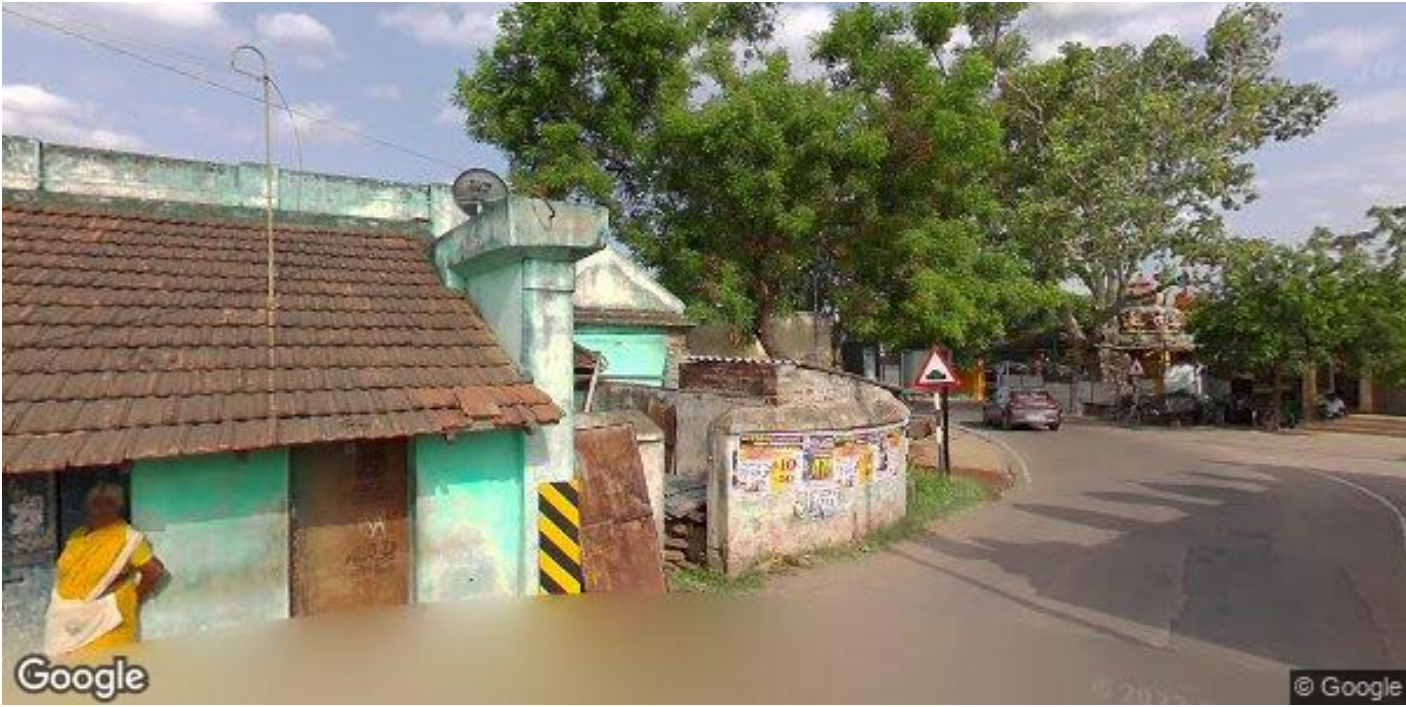
**Risk Type:** Turn  
**Risk Level:** Medium  
**Speed Limit:** 30 KM/Hr  
**Coordinates:** 11.46835, 78.45959

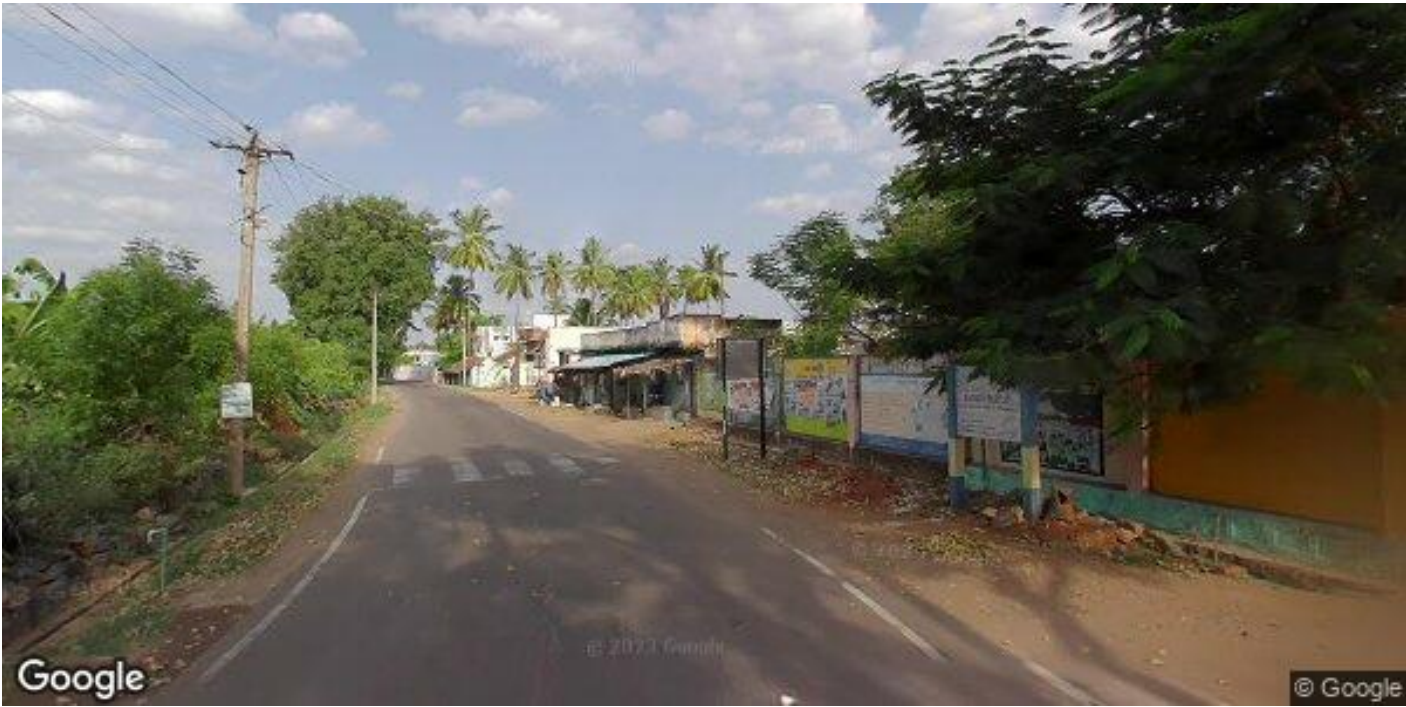
**Risk Type:** Turn  
**Risk Level:** Medium  
**Speed Limit:** 30 KM/Hr  
**Coordinates:** 11.46800, 78.45987

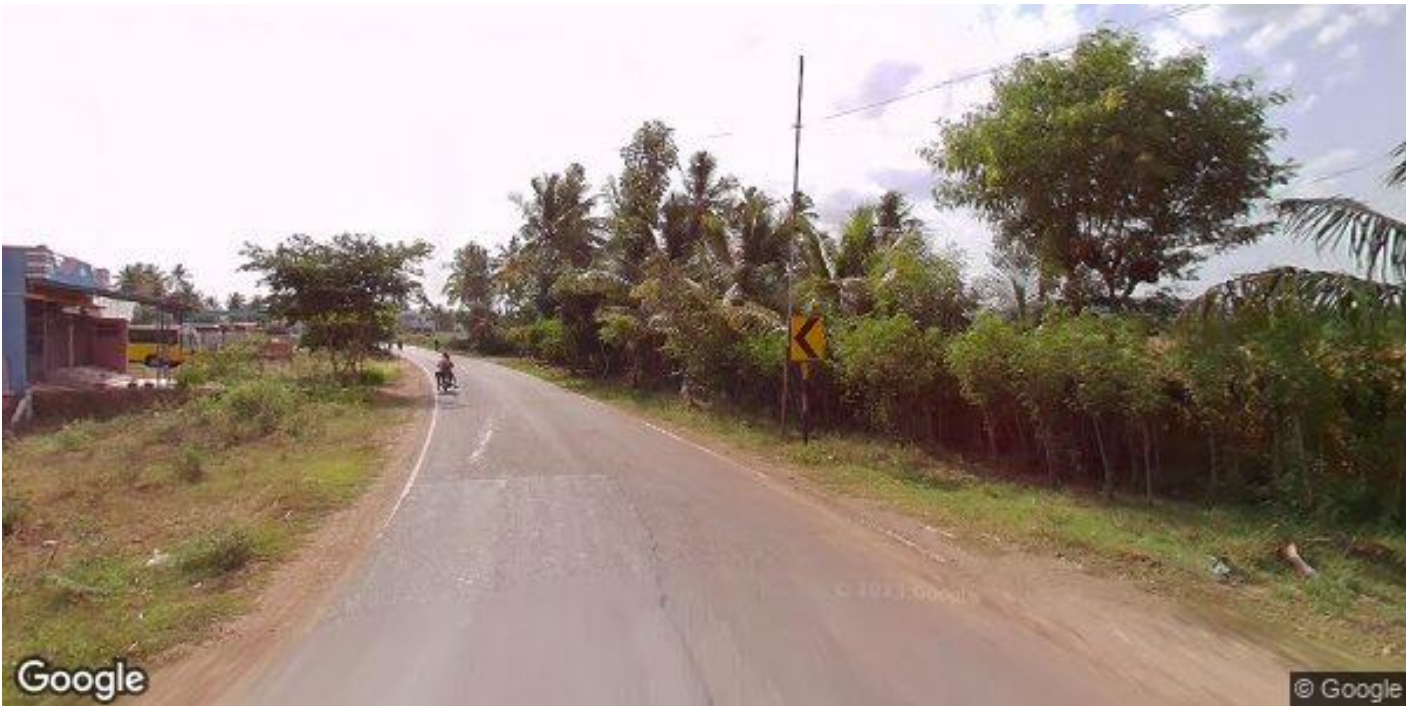
**Risk Type:** Turn  
**Risk Level:** Medium  
**Speed Limit:** 30 KM/Hr  
**Coordinates:** 11.46461, 78.47397

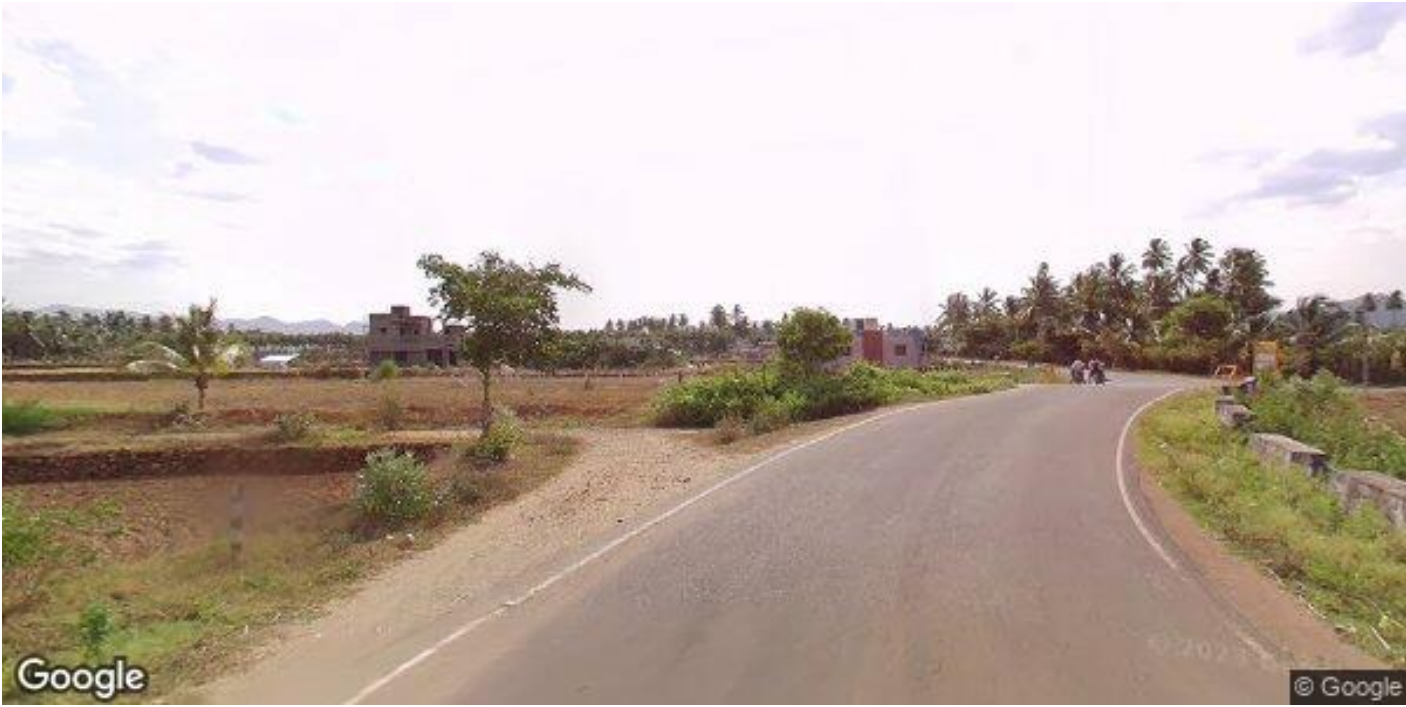
**Risk Type:** Turn  
**Risk Level:** Medium  
**Speed Limit:** 30 KM/Hr  
**Coordinates:** 11.46419, 78.47445

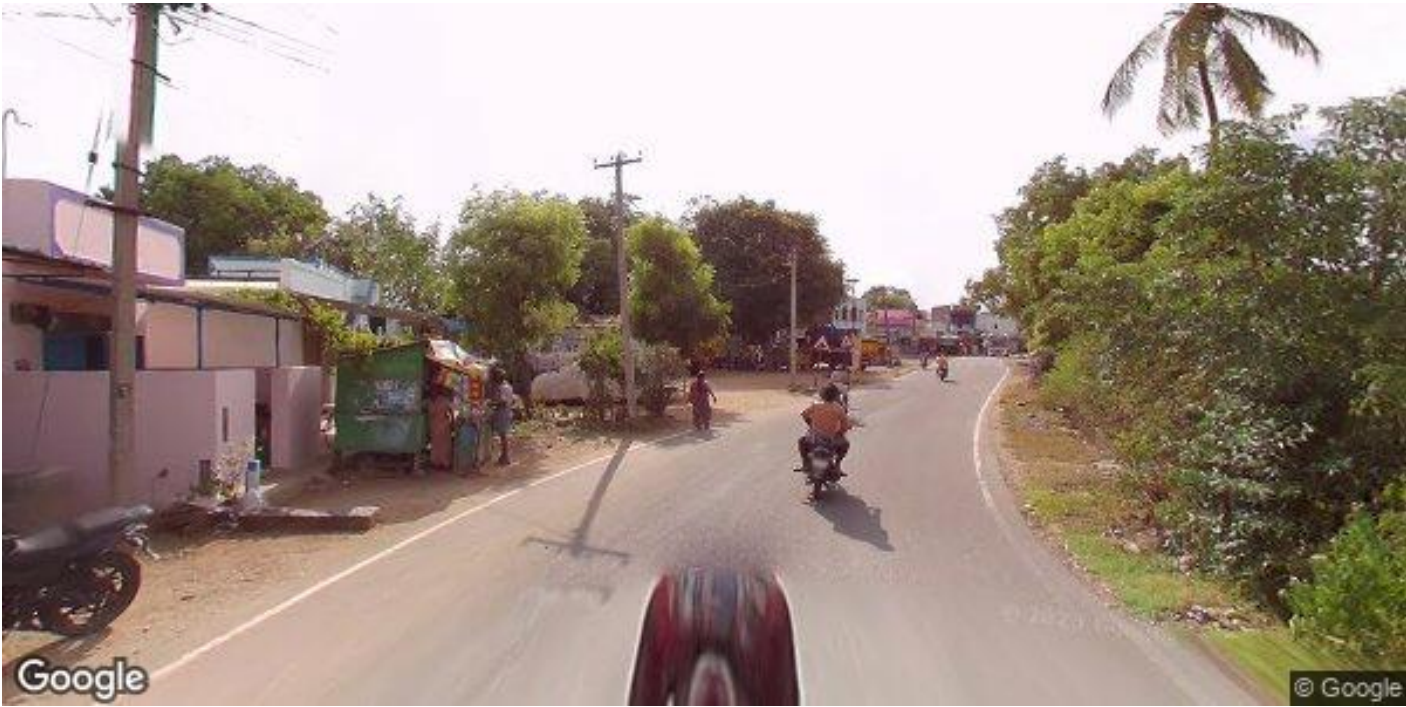
**Risk Type:** Turn  
**Risk Level:** Medium  
**Speed Limit:** 30 KM/Hr  
**Coordinates:** 11.46211, 78.48159

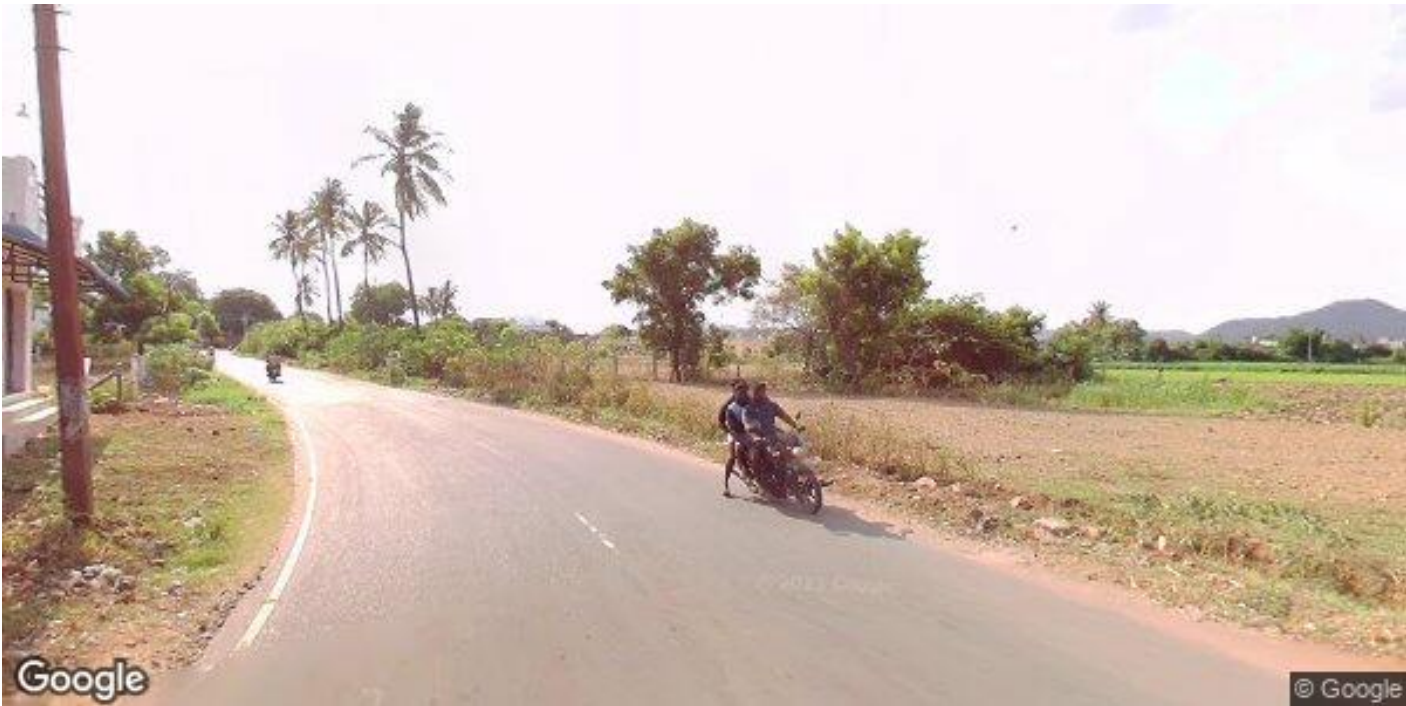
**Risk Type:** Turn  
**Risk Level:** Medium  
**Speed Limit:** 30 KM/Hr  
**Coordinates:** 11.46184, 78.48270

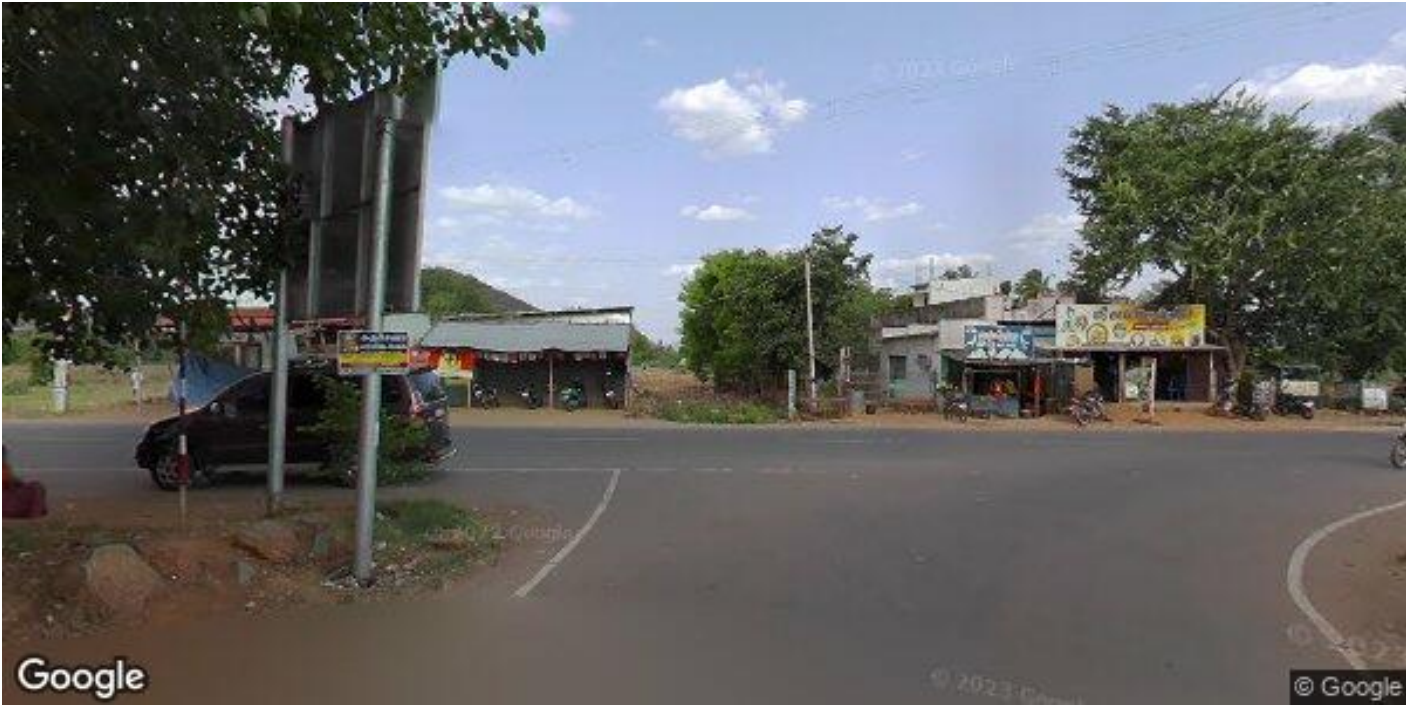
**Risk Type:** Turn  
**Risk Level:** High  
**Speed Limit:** 15 KM/Hr  
**Coordinates:** 11.46106, 78.48357
