# IndianOil

## JOURNEY RISK MANAGEMENT (JRM) STUDY

### Salem Terminal TO VIJAYALAKSHMI AGENCIES

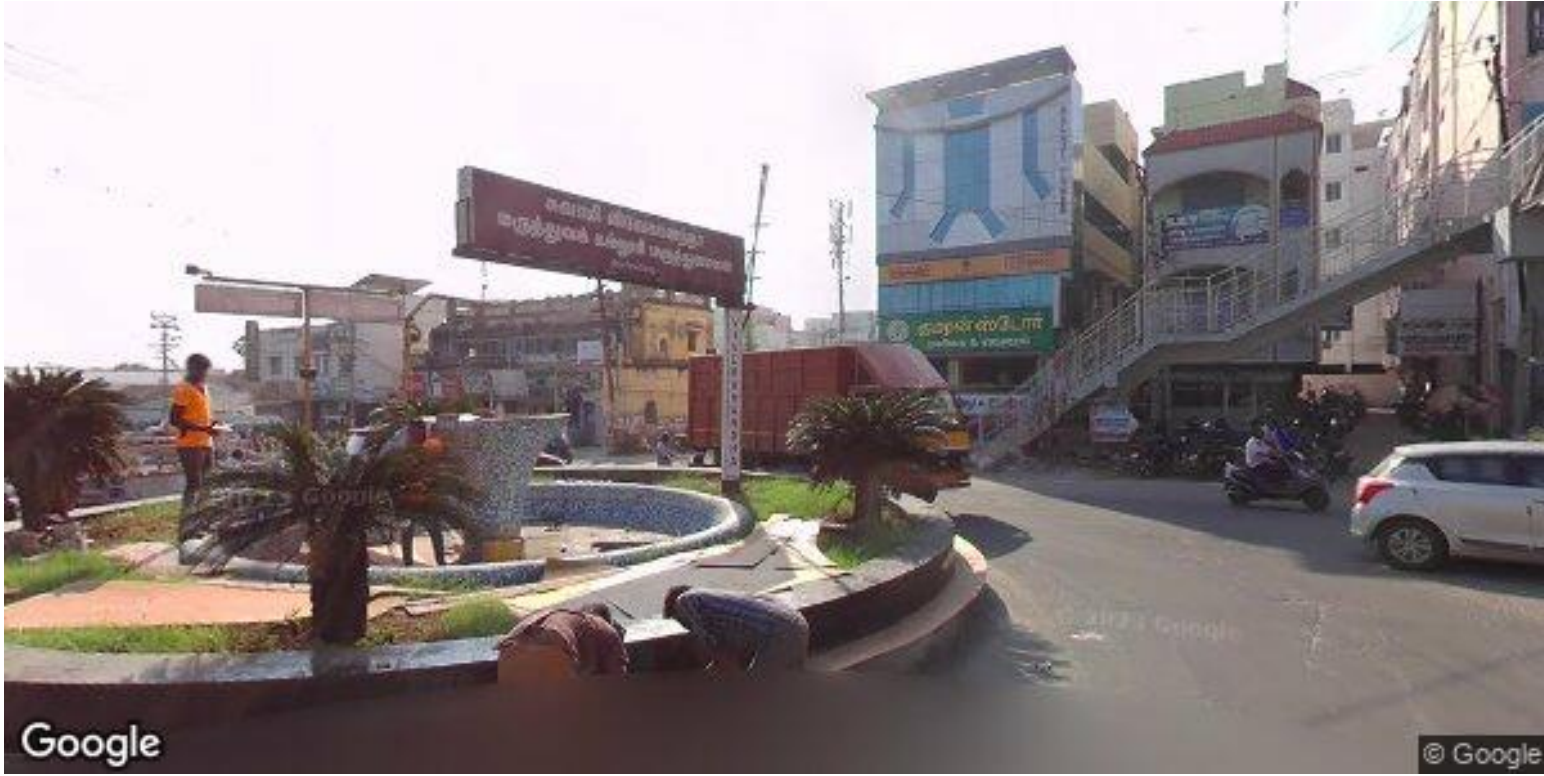
**Coordinates:** 11.38395, 77.89480

**Risk Type:** Roundabout

**Risk Level:** High

**Speed Limit:** 15 KM/Hr

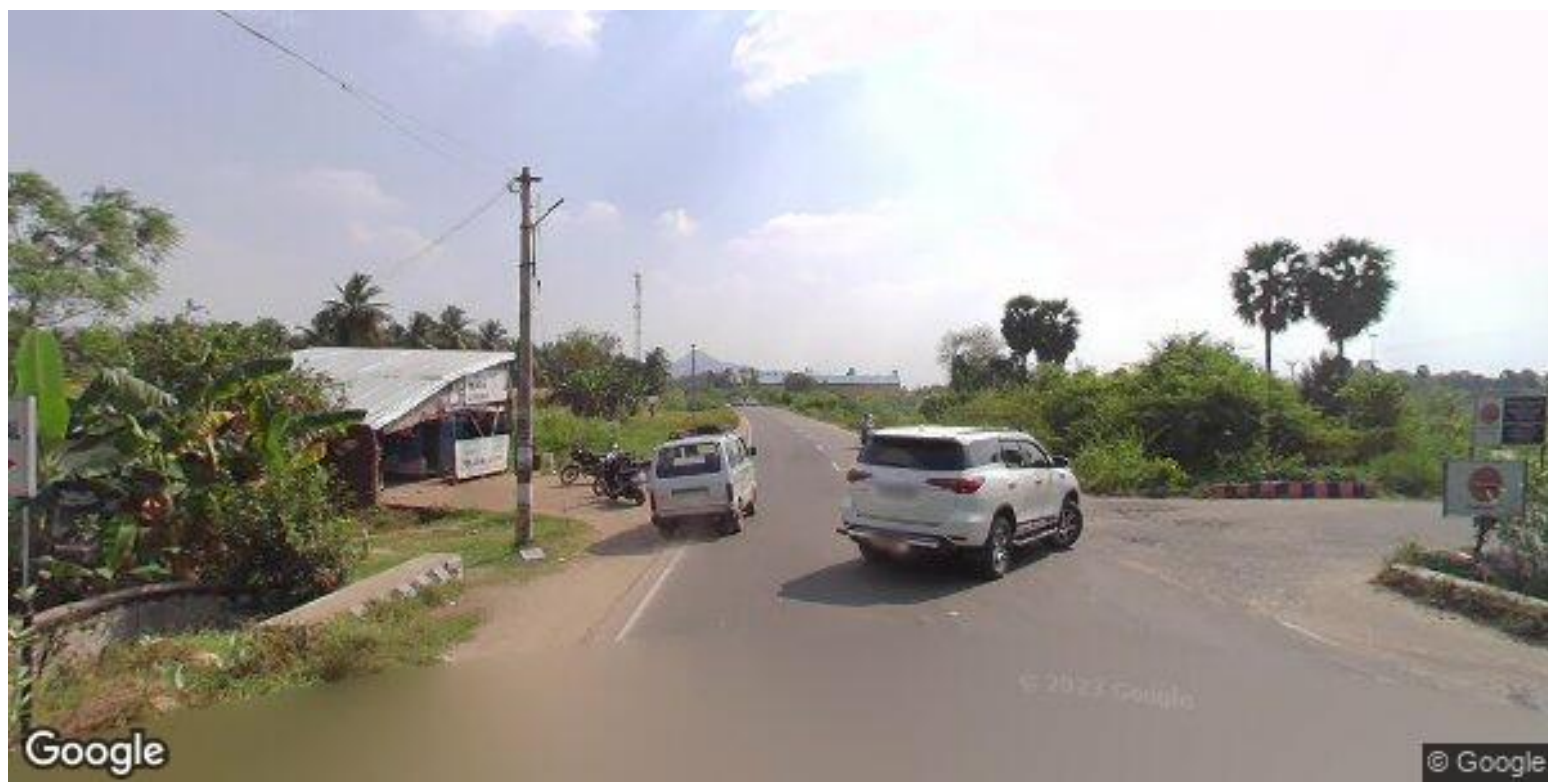
Coordinates: 11.44029, 77.87544

### Risk Type: Blind Spot

### Risk Level: Blind Spot

**Speed Limit: 10 KM/Hr**

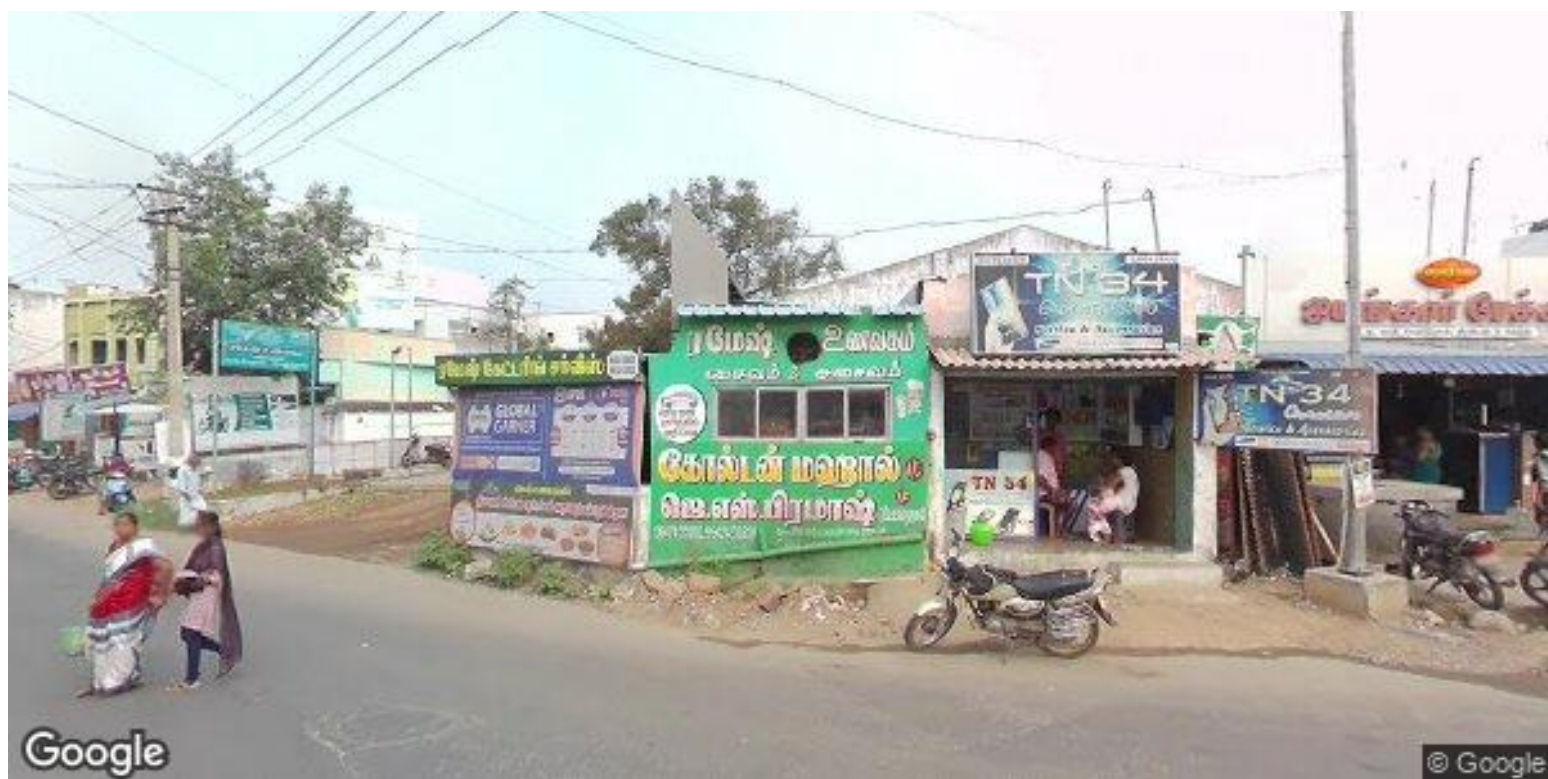
Coordinates: 11.38346, 77.89975

### Risk Type: Turn

**Risk Level: Medium**

**Speed Limit: 30 KM/Hr**

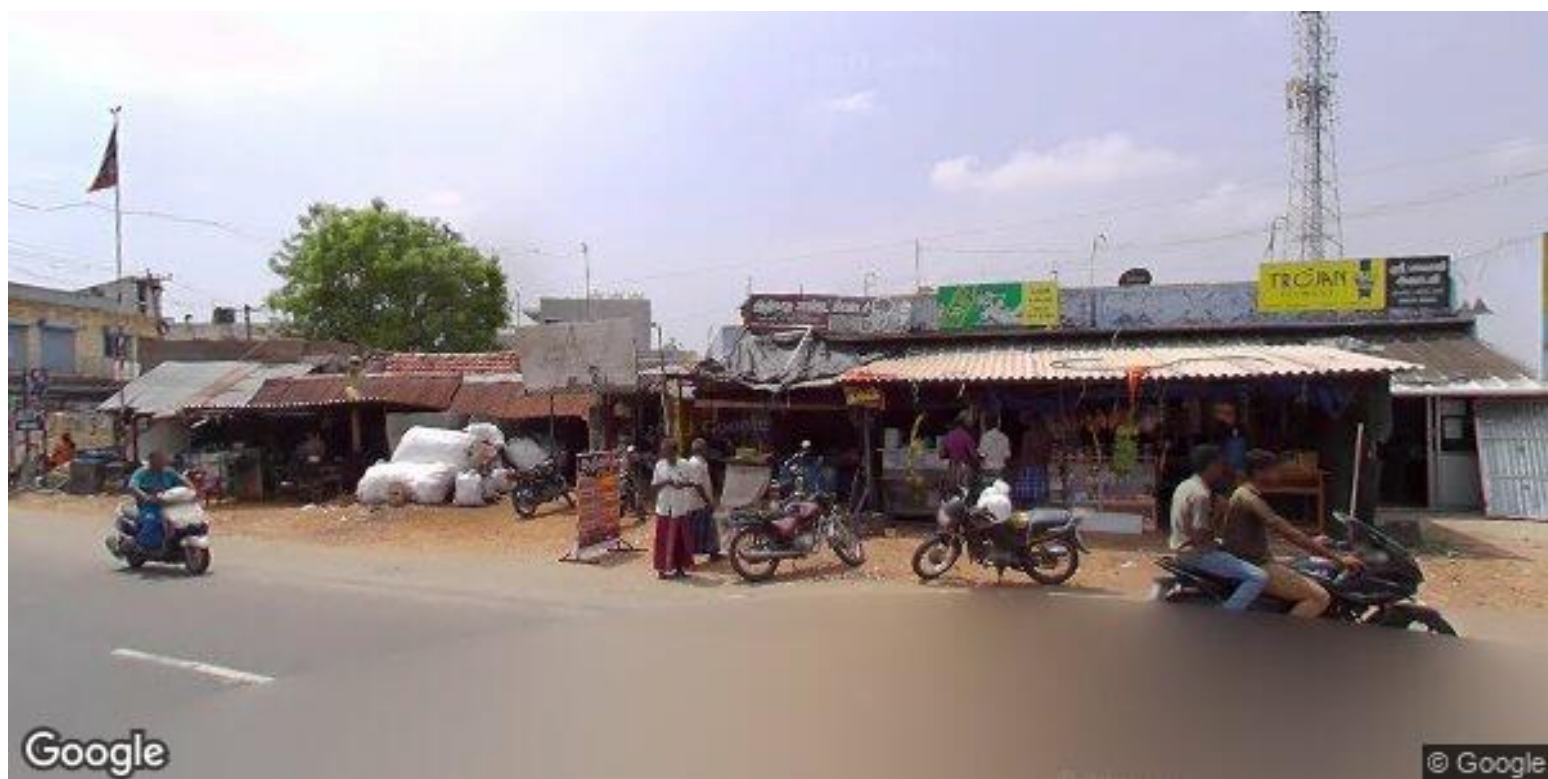
**Risk Type:** Blind Spot  
**Risk Level:** Blind Spot  
**Speed Limit:** 10 KM/Hr  
**Coordinates:** 11.44387, 77.96283

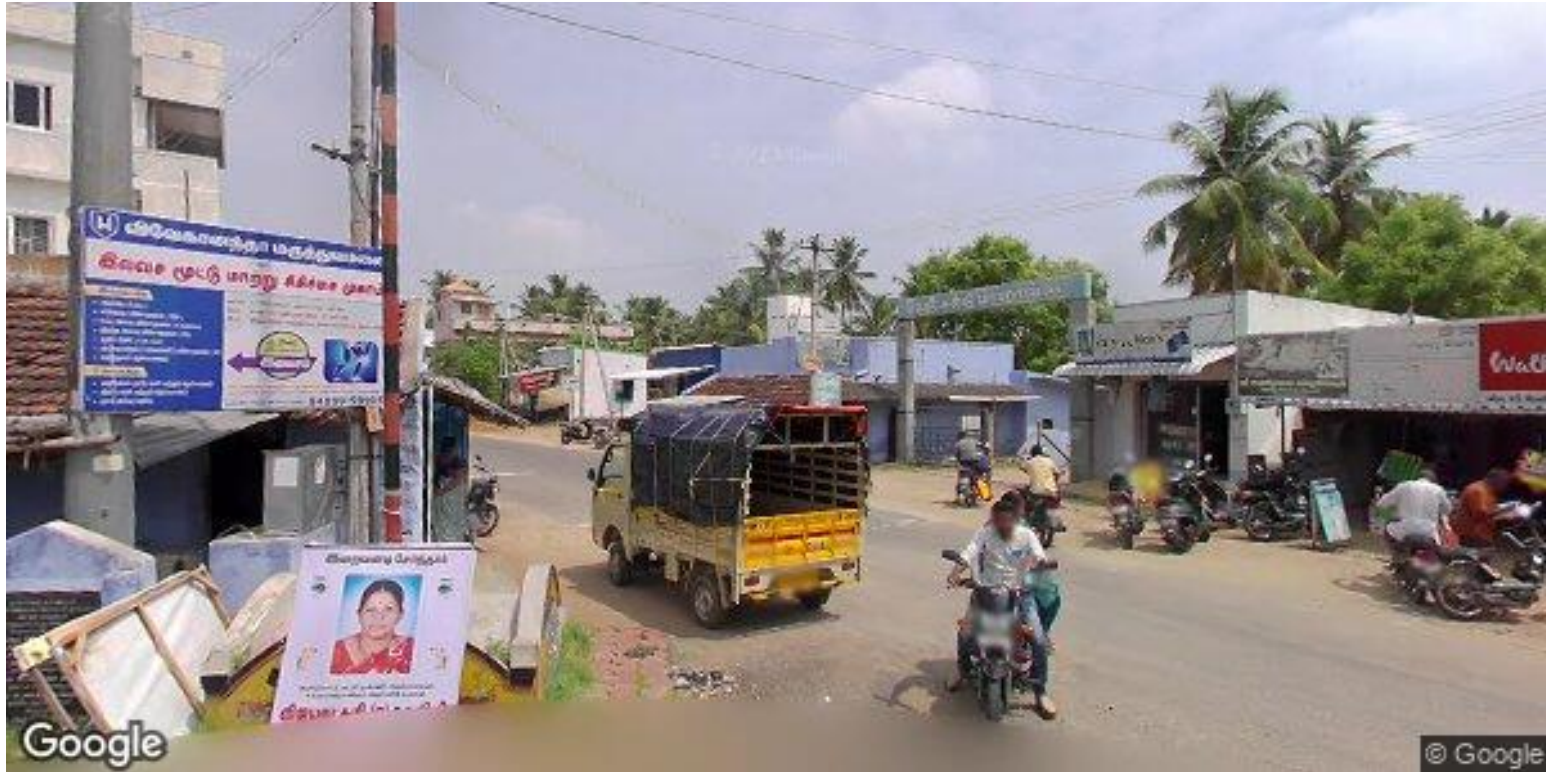
**Risk Type:** Blind Spot  
**Risk Level:** Blind Spot  
**Speed Limit:** 10 KM/Hr  
**Coordinates:** 11.44391, 77.96278

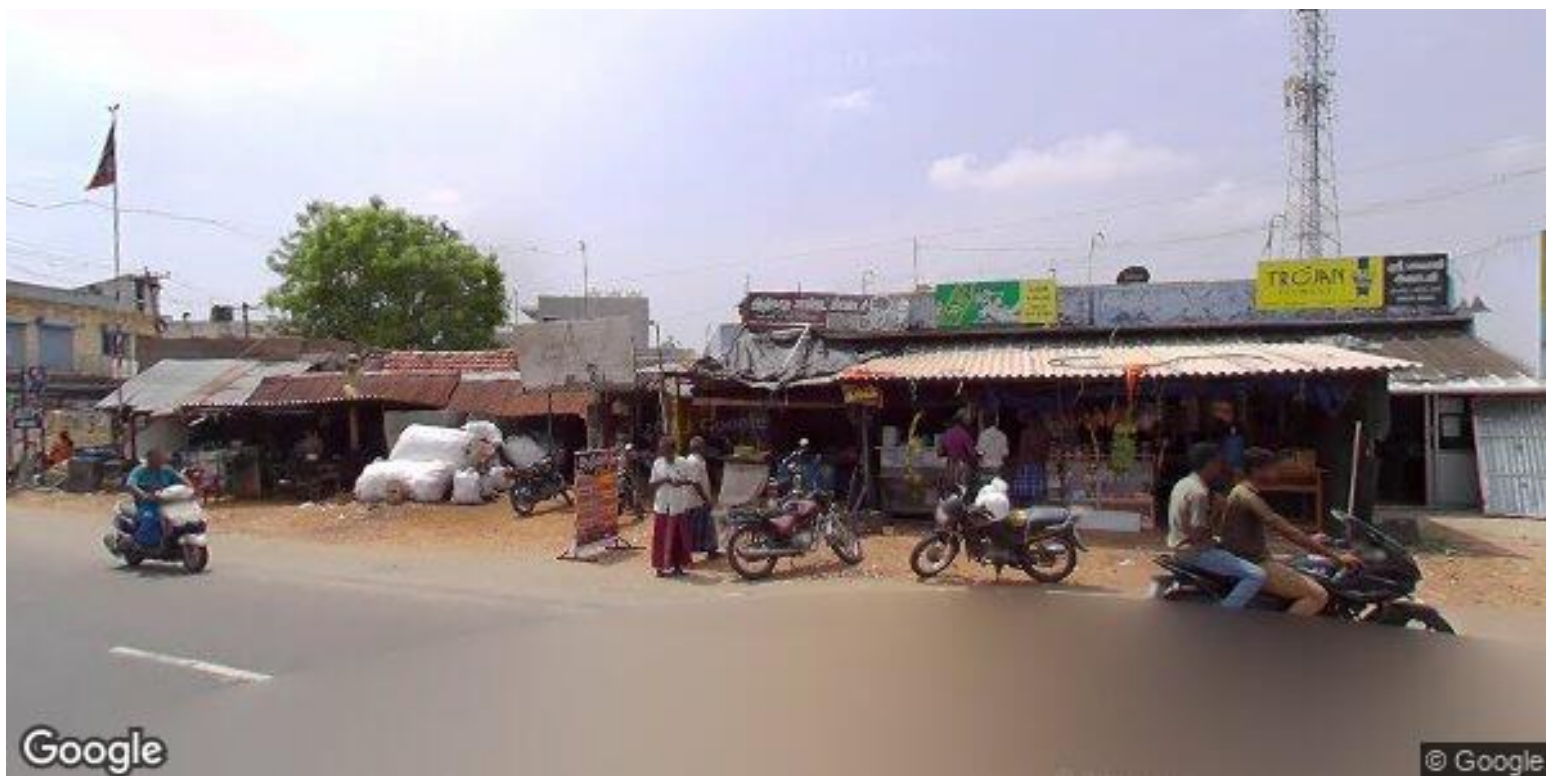
**Risk Type:** Turn  
**Risk Level:** High  
**Speed Limit:** 15 KM/Hr  
**Coordinates:** 11.44387, 77.96283

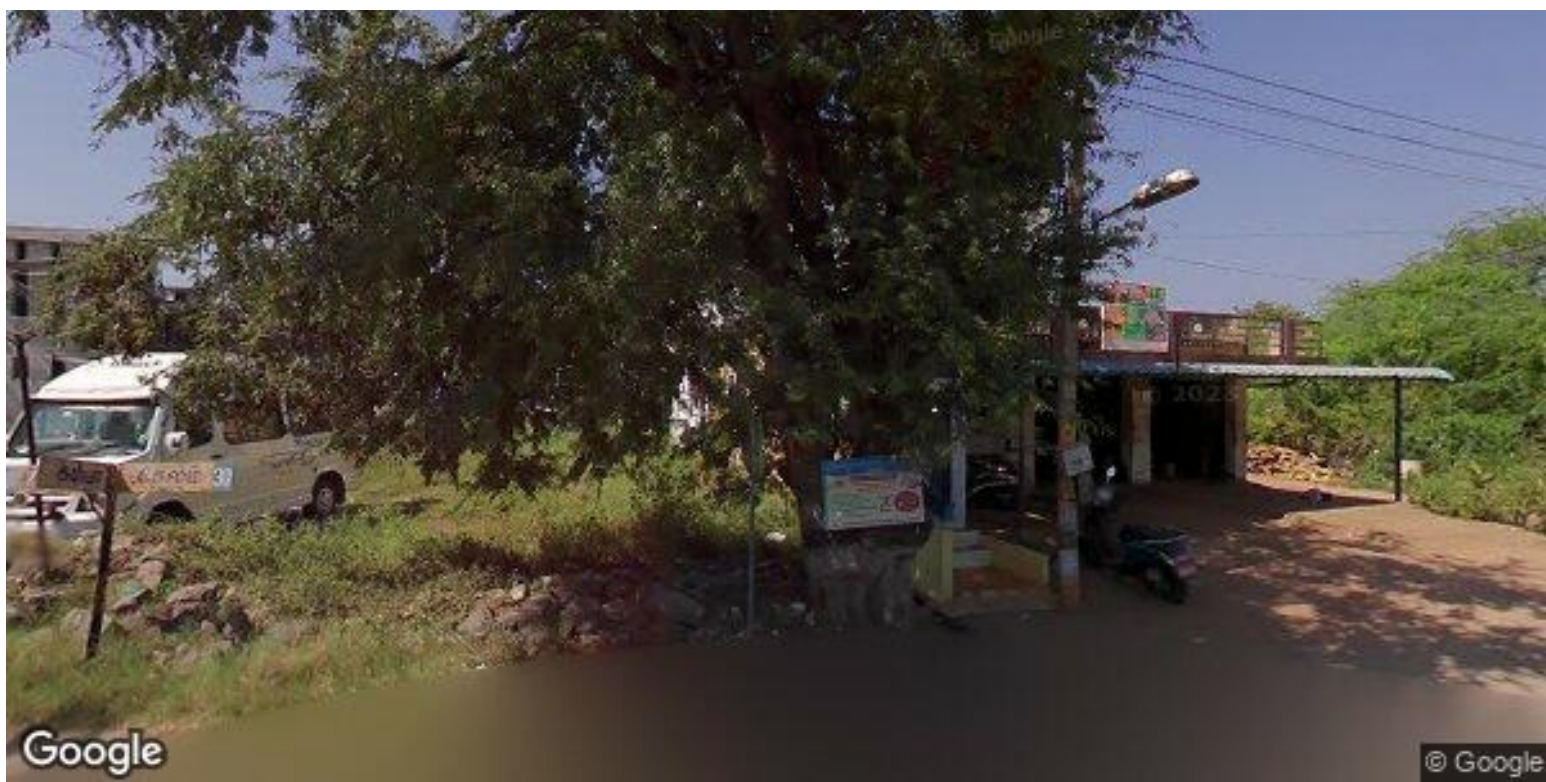
**Coordinates:** 11.49063, 78.02680

**Risk Type:** Turn

**Risk Level:** High

**Speed Limit:** 15 KM/Hr

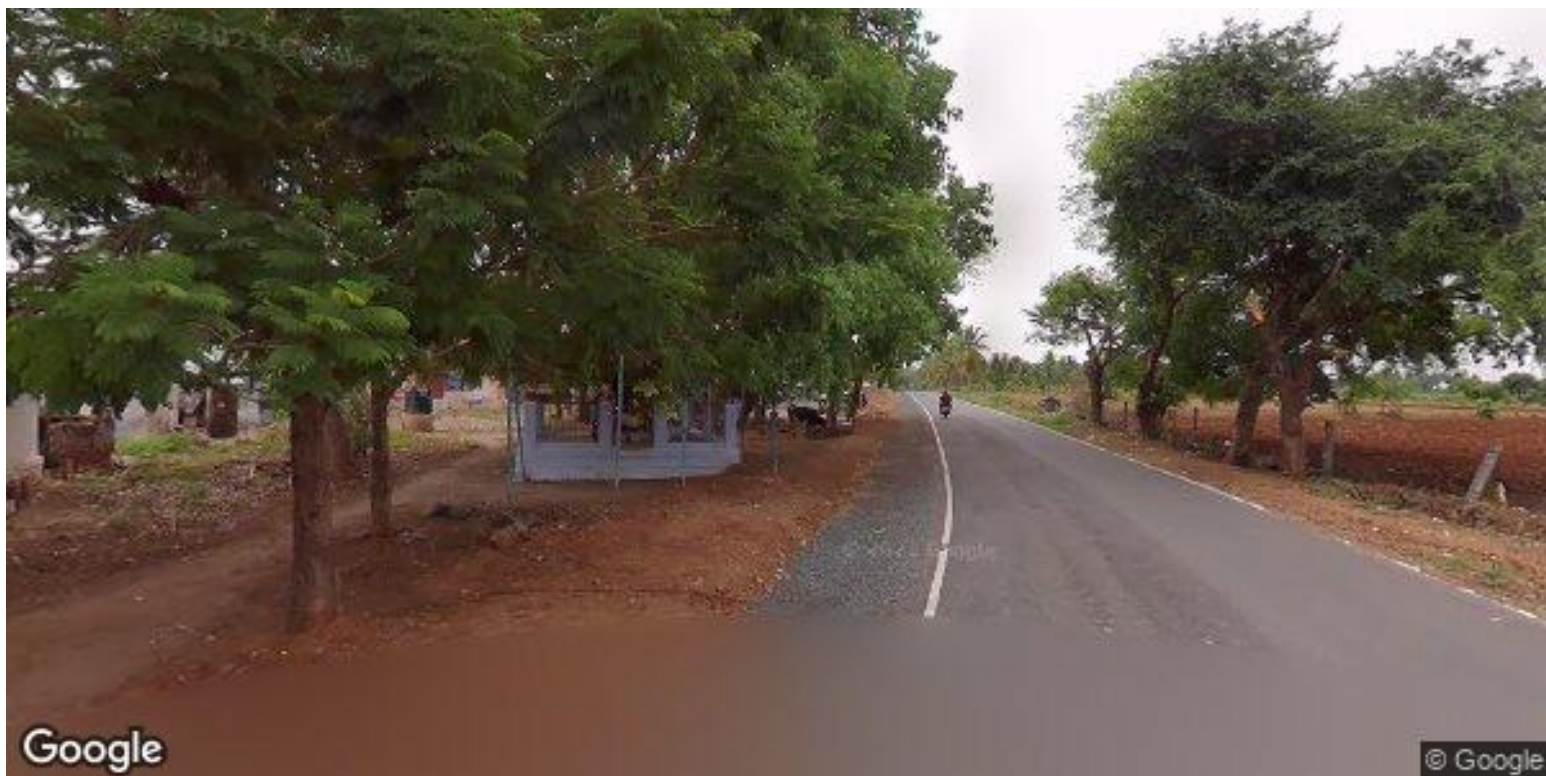
**Coordinates:** 11.46721, 78.04520

**Risk Type:** Turn

**Risk Level:** Medium

**Speed Limit:** 30 KM/Hr
