# IndianOil

## **JOURNEY RISK MANAGEMENT (JRM) STUDY**

### **Salem Terminal TO SRE AMMAN AGENCIES**

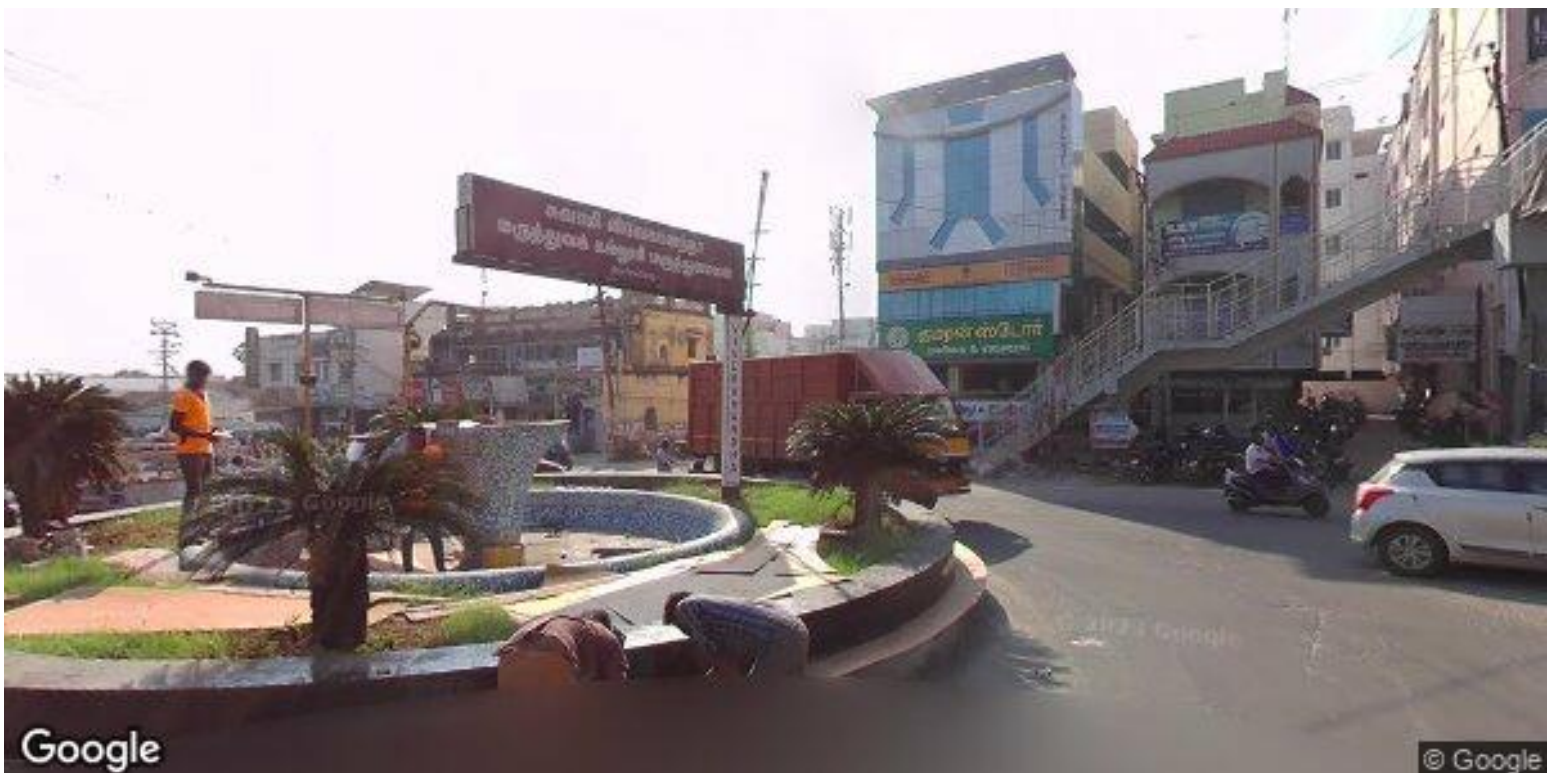
**Speed Limit: 15 KM/Hr**  
**Coordinates: 11.38395, 77.89480**

**Risk Type:** Roundabout

**Risk Level:** High

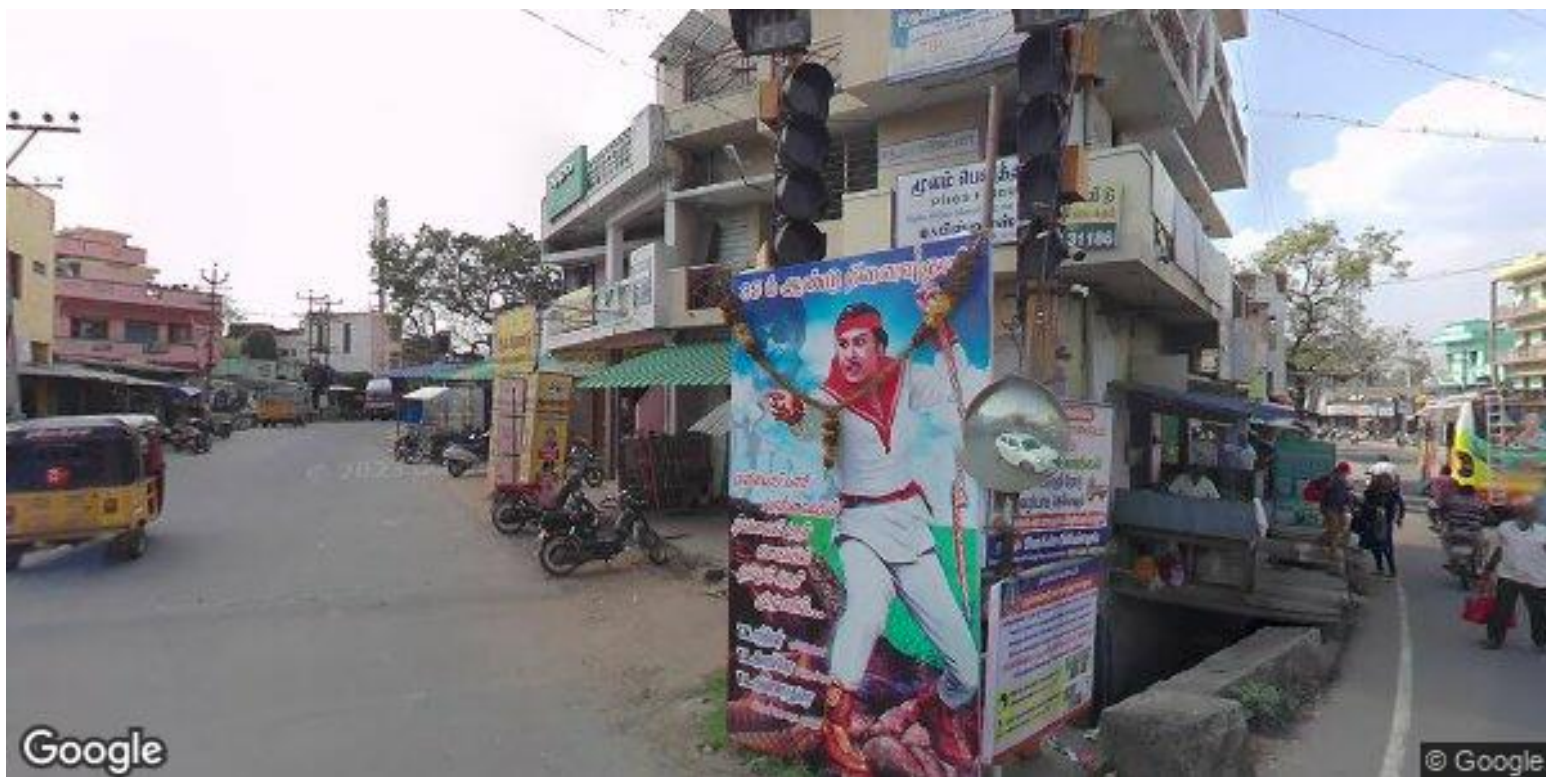
**Risk Type: Turn**  
**Risk Level: Medium**  
**Speed Limit: 30 KM/Hr**  
**Coordinates: 11.38342, 77.89975**

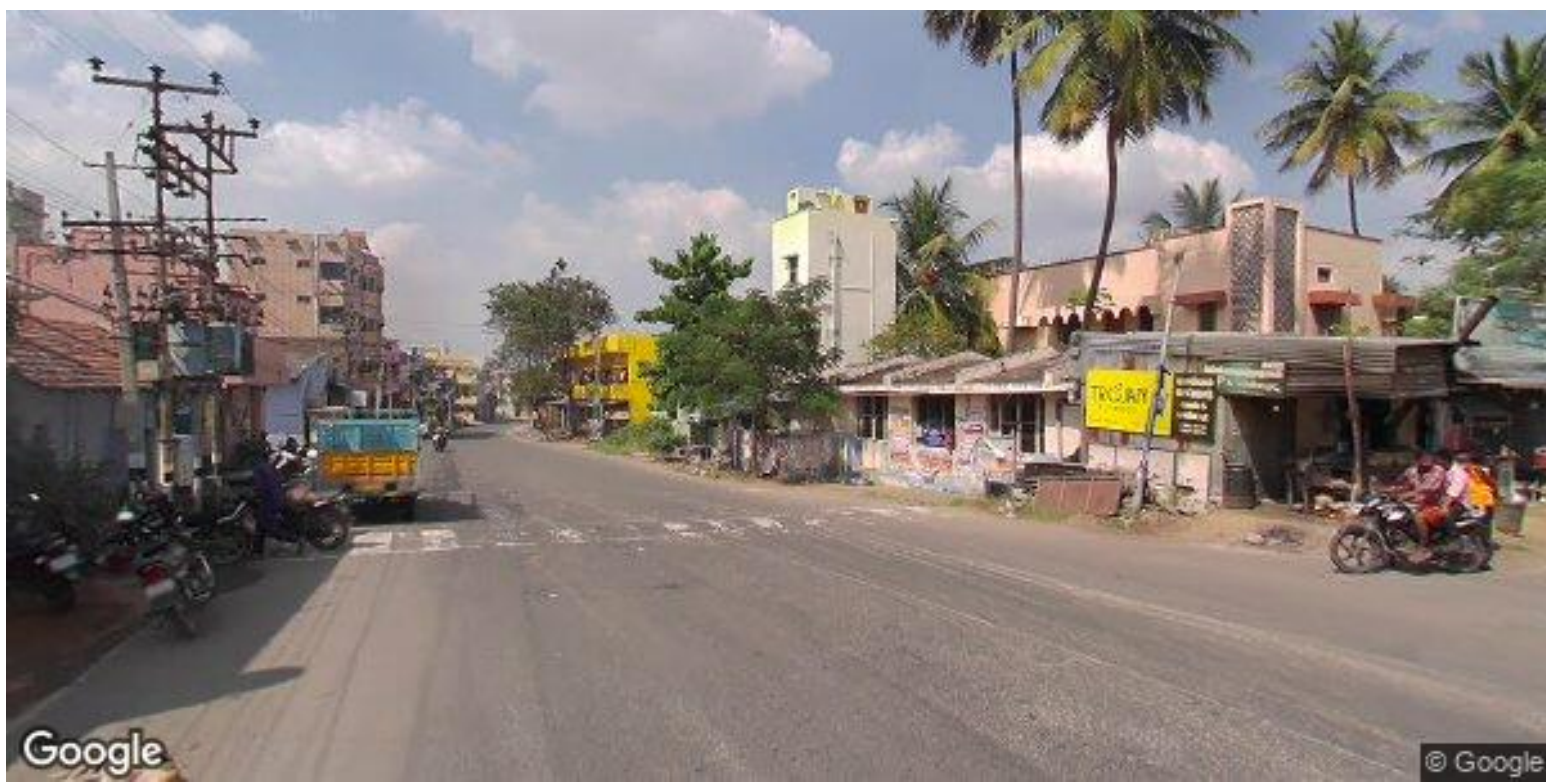
**Coordinates:** 11.38190, 77.90254

**Risk Type:** Turn

**Risk Level:** High

**Speed Limit:** 15 KM/Hr

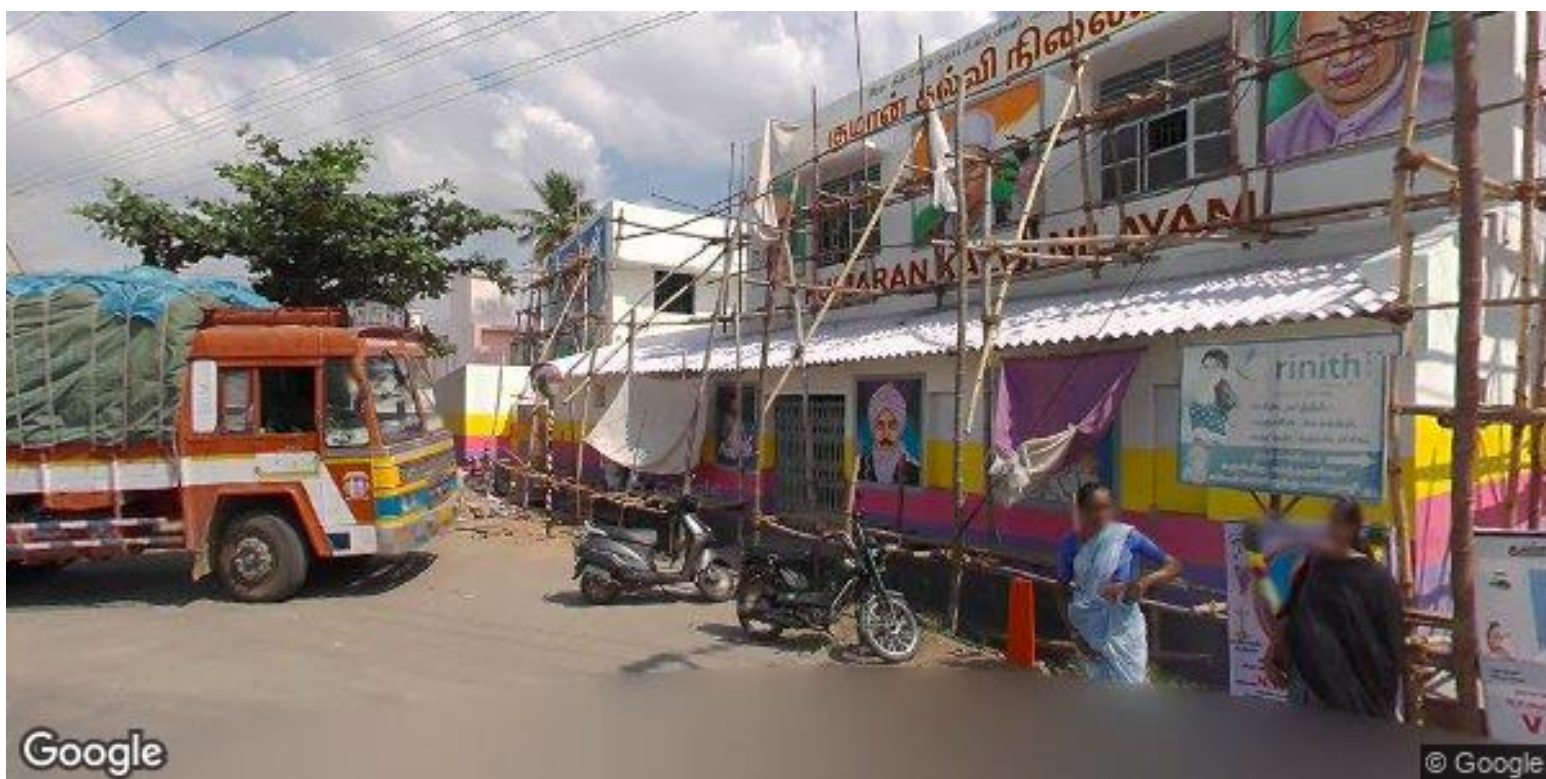
**Coordinates:** 11.38182, 77.90259

**Risk Type:** Turn

**Risk Level:** Medium

**Speed Limit:** 30 KM/Hr

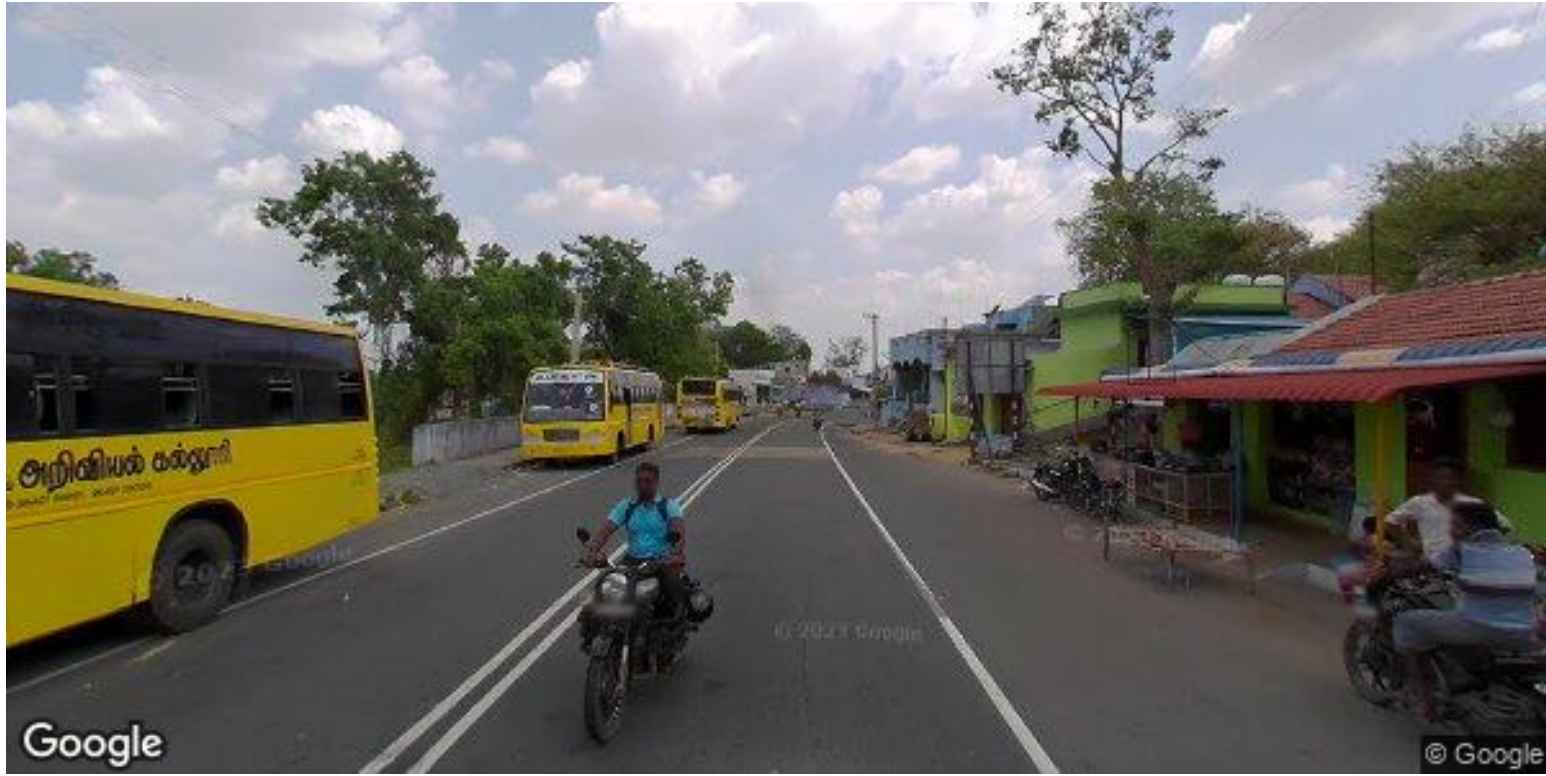
**Risk Type:** Blind Spot  
**Risk Level:** Blind Spot  
**Speed Limit:** 10 KM/Hr  
**Coordinates:** 11.41410, 78.08065

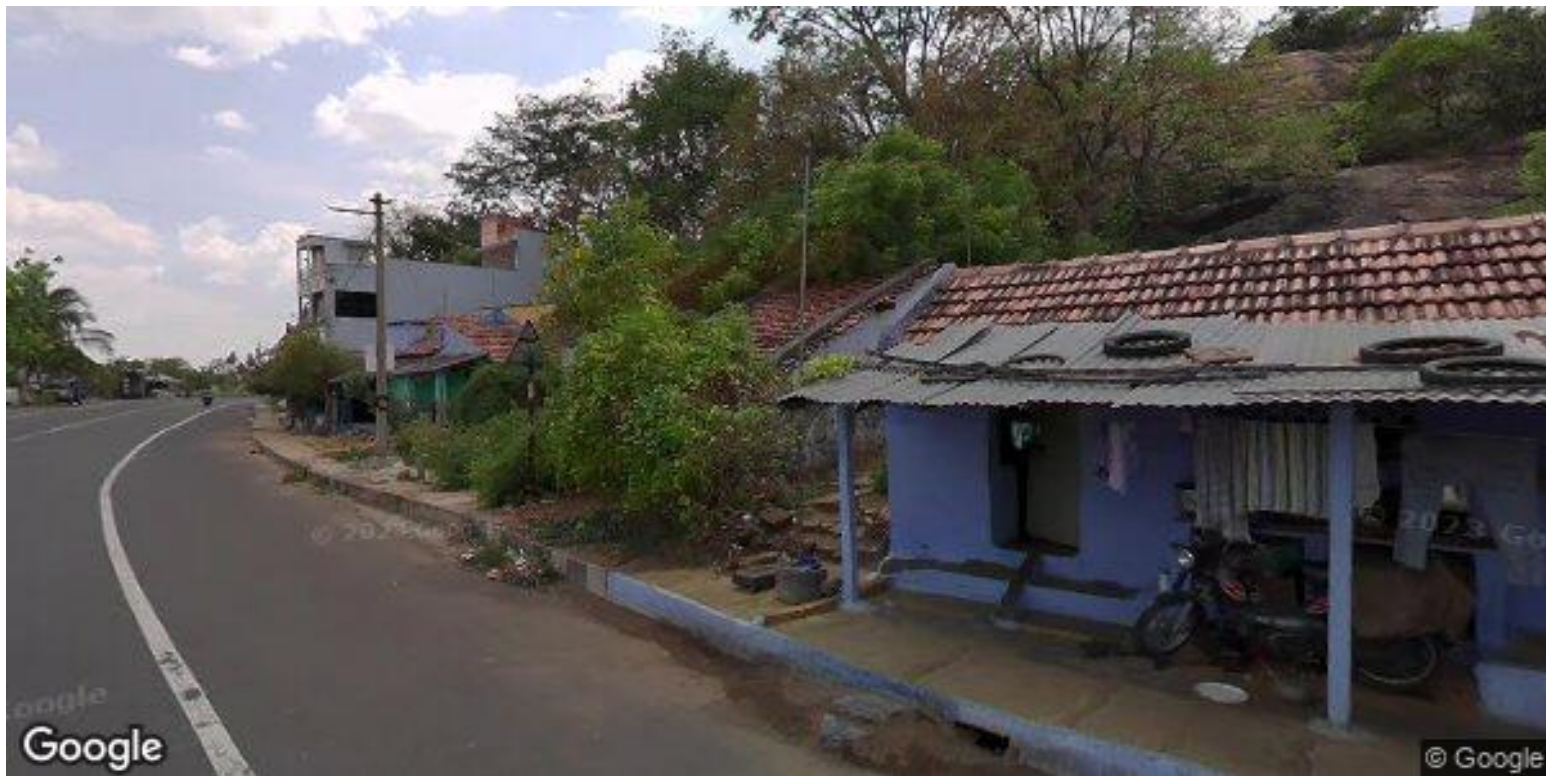
**Risk Type:** Turn  
**Risk Level:** Medium  
**Speed Limit:** 30 KM/Hr  
**Coordinates:** 11.41321, 78.08067

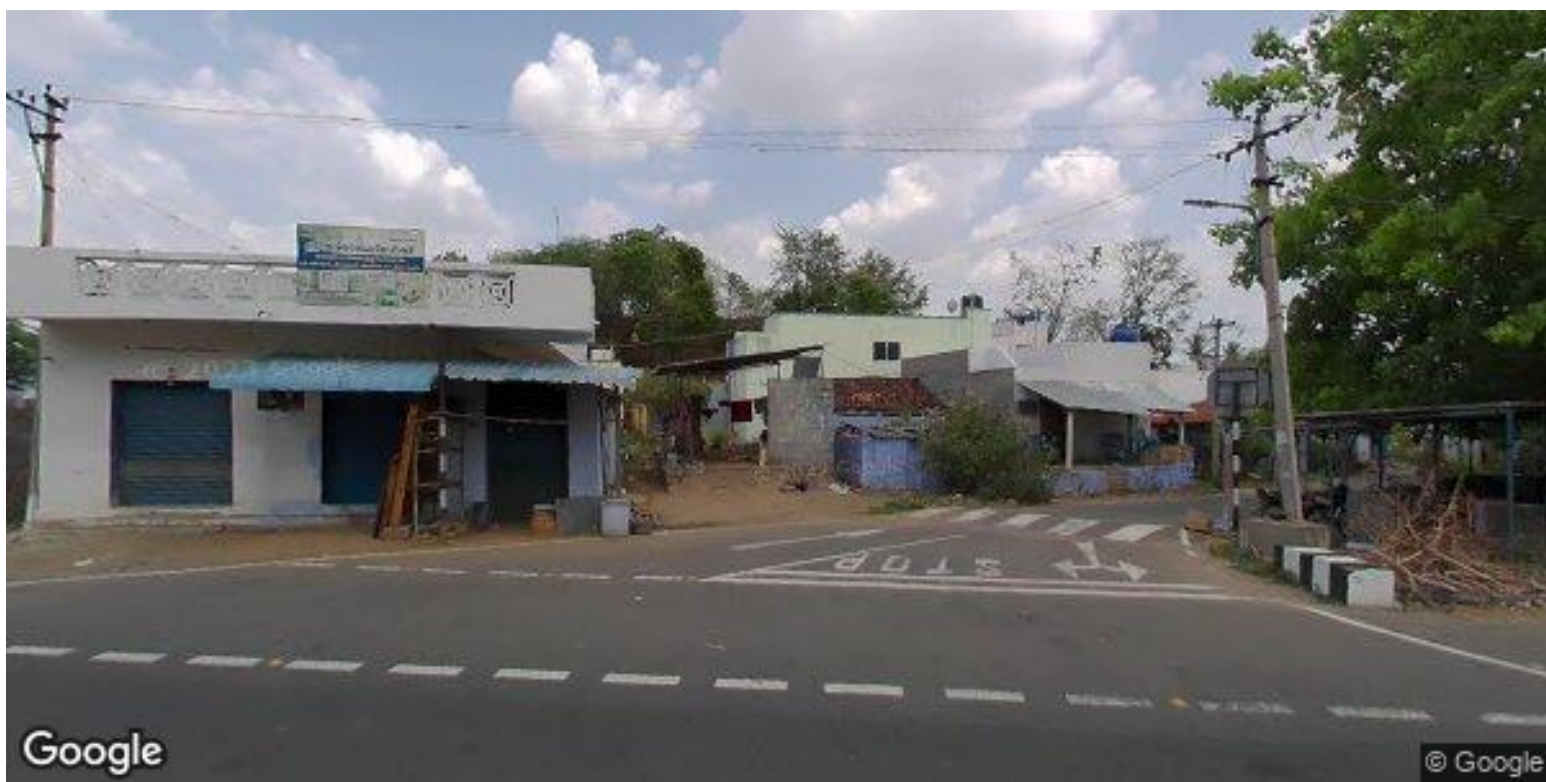
**Coordinates:** 11.41276, 78.08042

**Risk Type:** Turn

**Risk Level:** Medium

**Speed Limit:** 30 KM/Hr

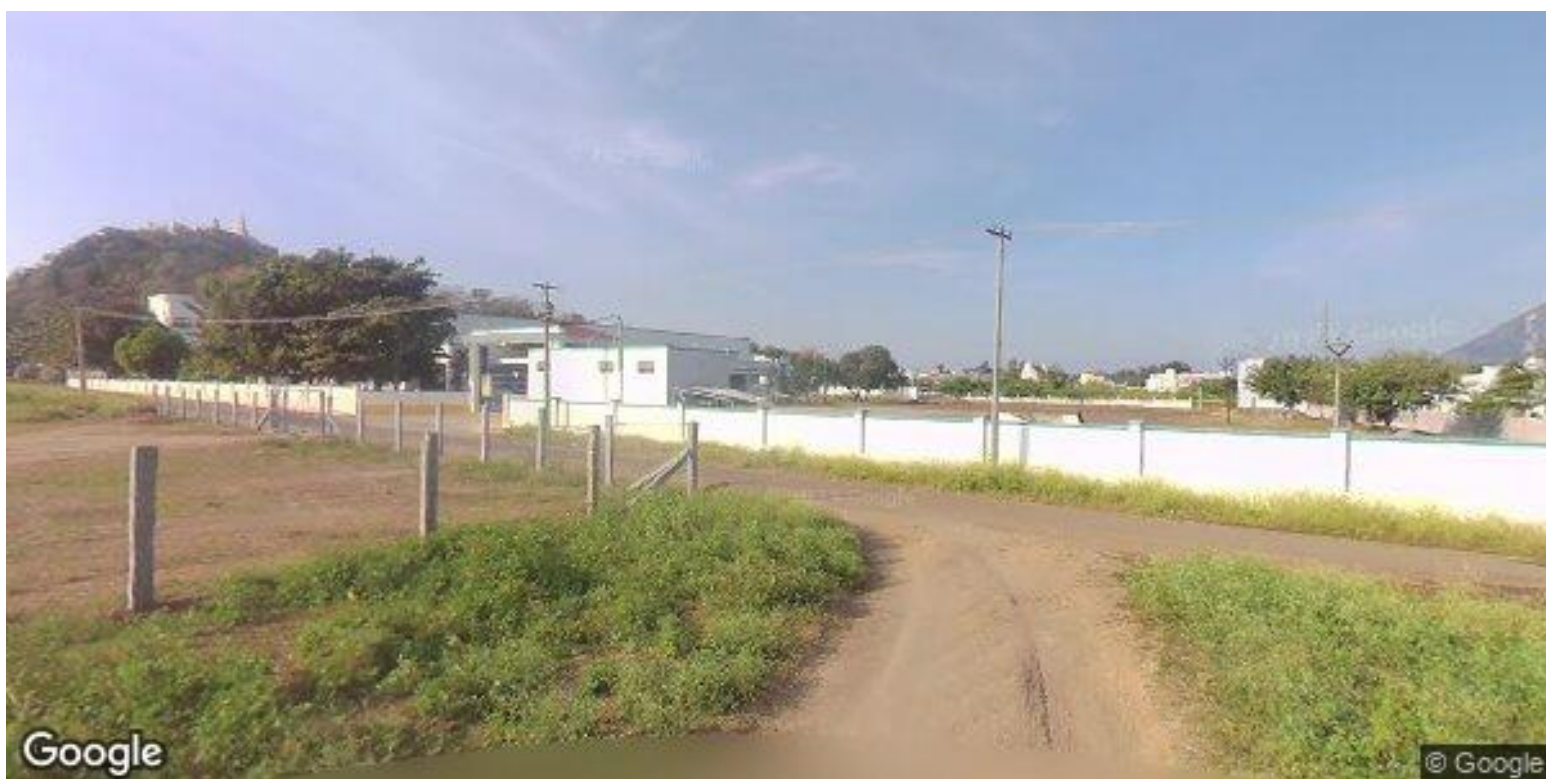
**Coordinates:** 11.41113, 78.08228

**Risk Type:** Turn

**Risk Level:** High

**Speed Limit:** 15 KM/Hr

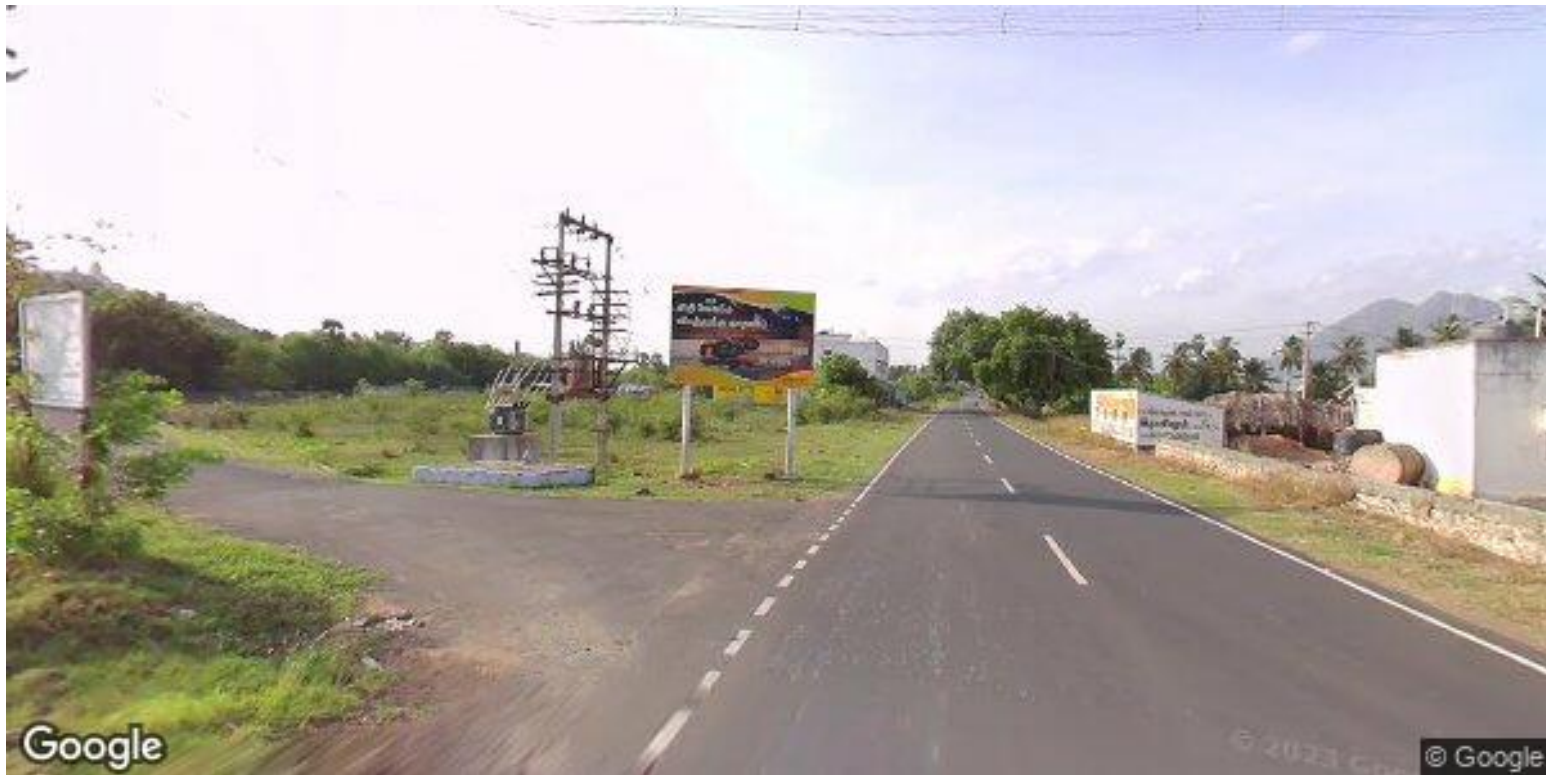
**Risk Type:** Turn  
**Risk Level:** High  
**Speed Limit:** 15 KM/Hr  
**Coordinates:** 11.40979, 78.08384

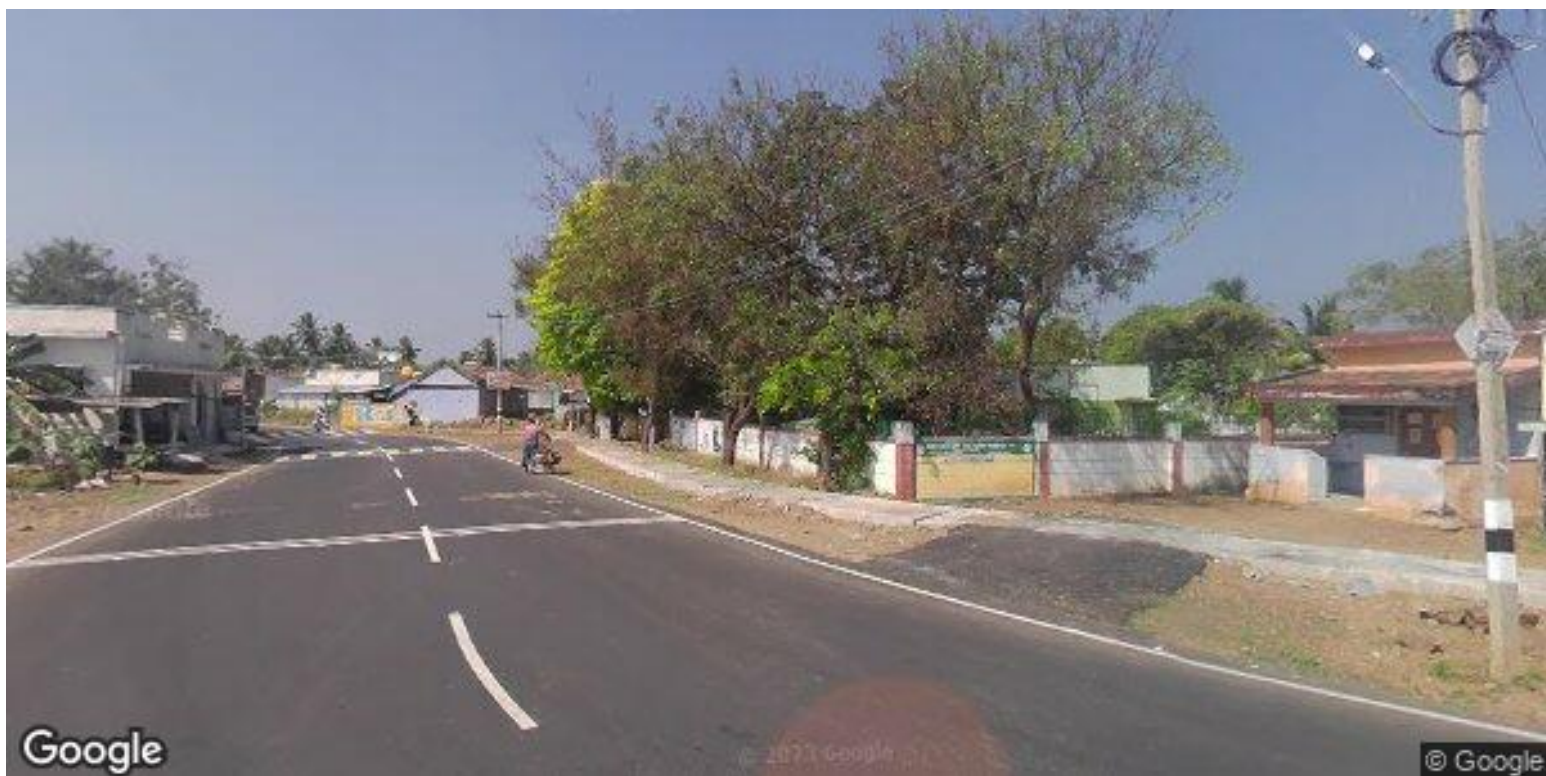
**Risk Type:** Turn  
**Risk Level:** High  
**Speed Limit:** 15 KM/Hr  
**Coordinates:** 11.39425, 78.08455

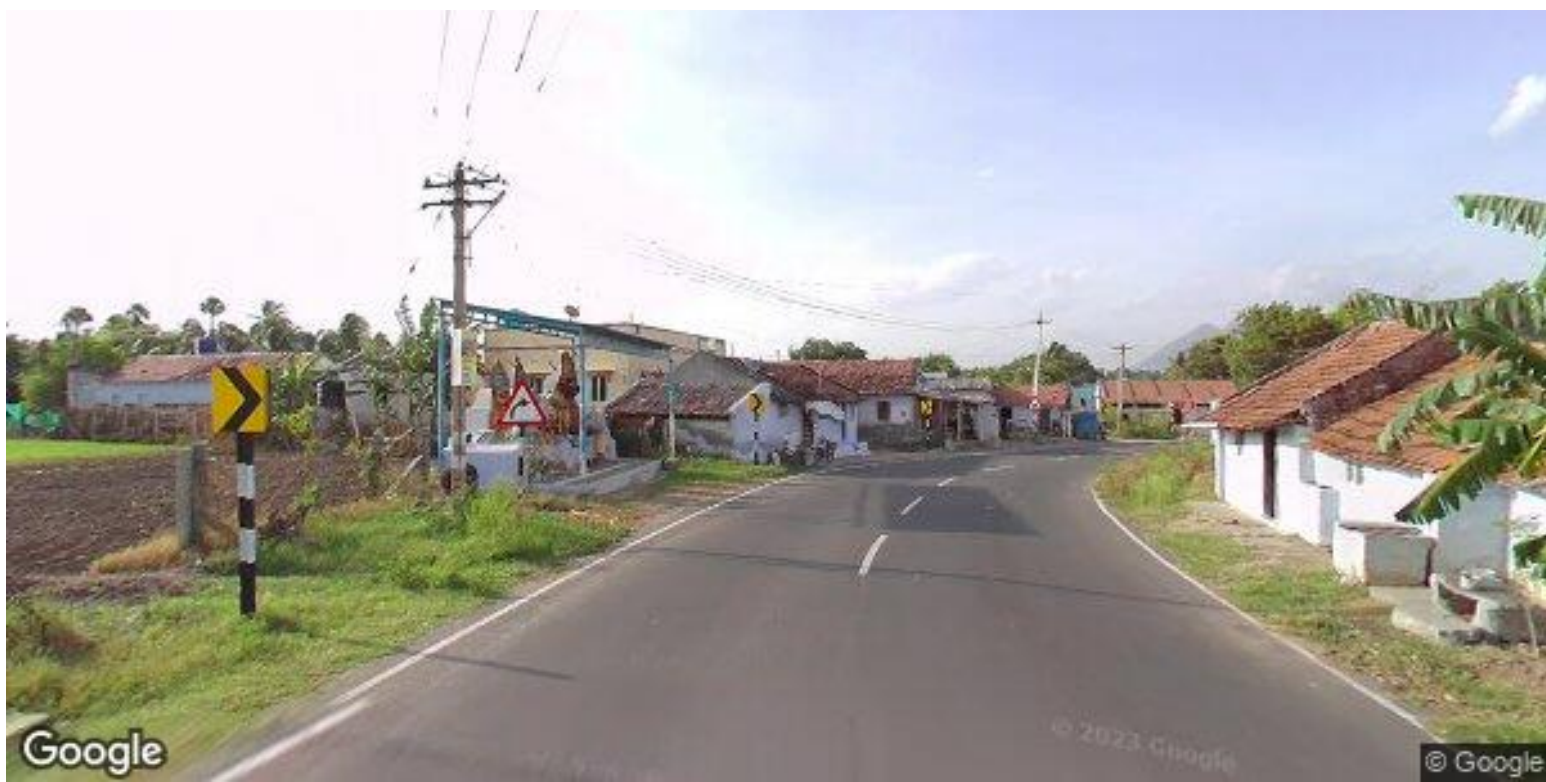
**Coordinates:** 11.39350, 78.08368

**Risk Type:** Turn

**Risk Level:** Medium

**Speed Limit:** 30 KM/Hr

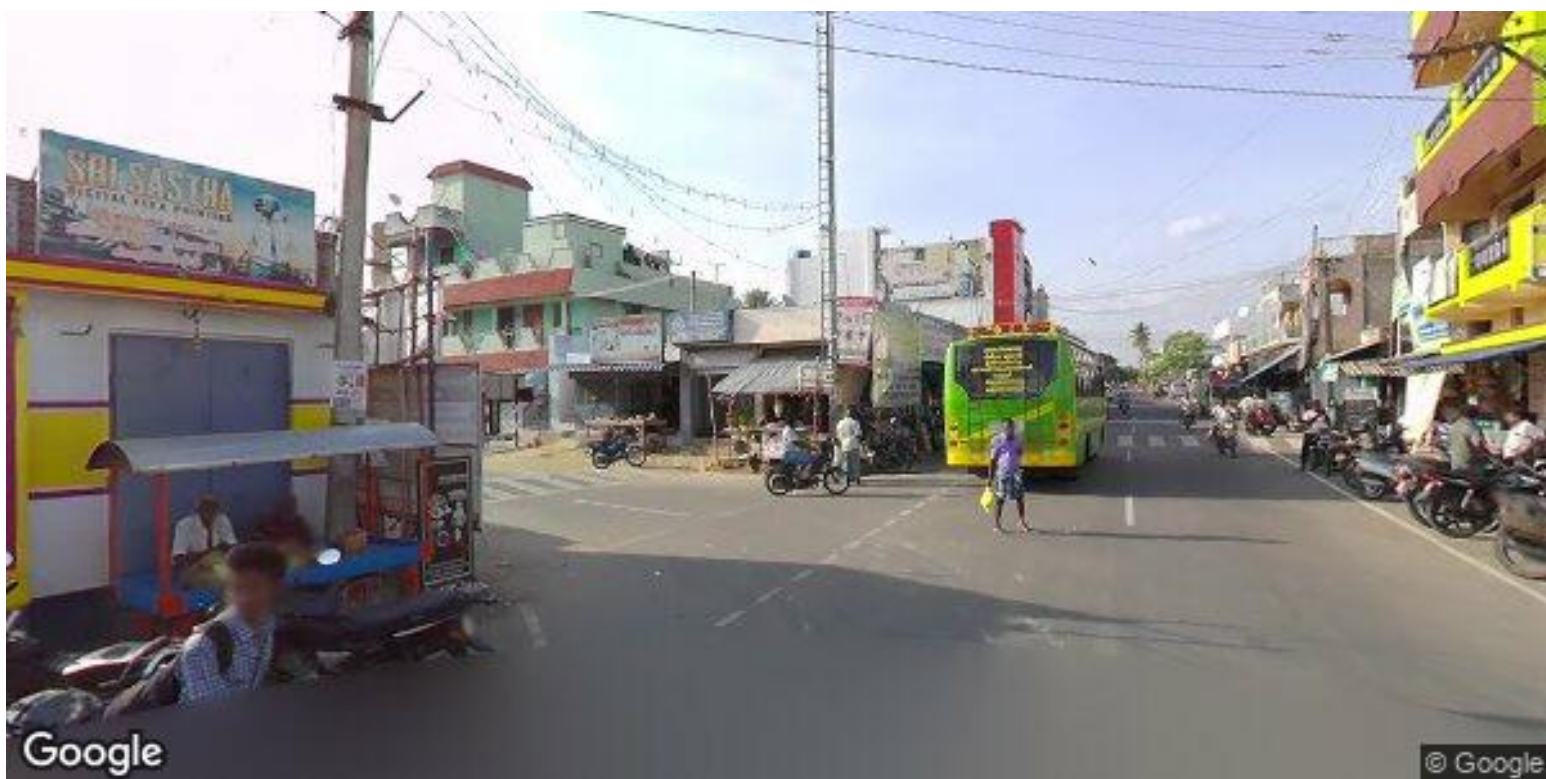
**Coordinates:** 11.37119, 78.07401

**Risk Type:** Turn

**Risk Level:** High

**Speed Limit:** 15 KM/Hr

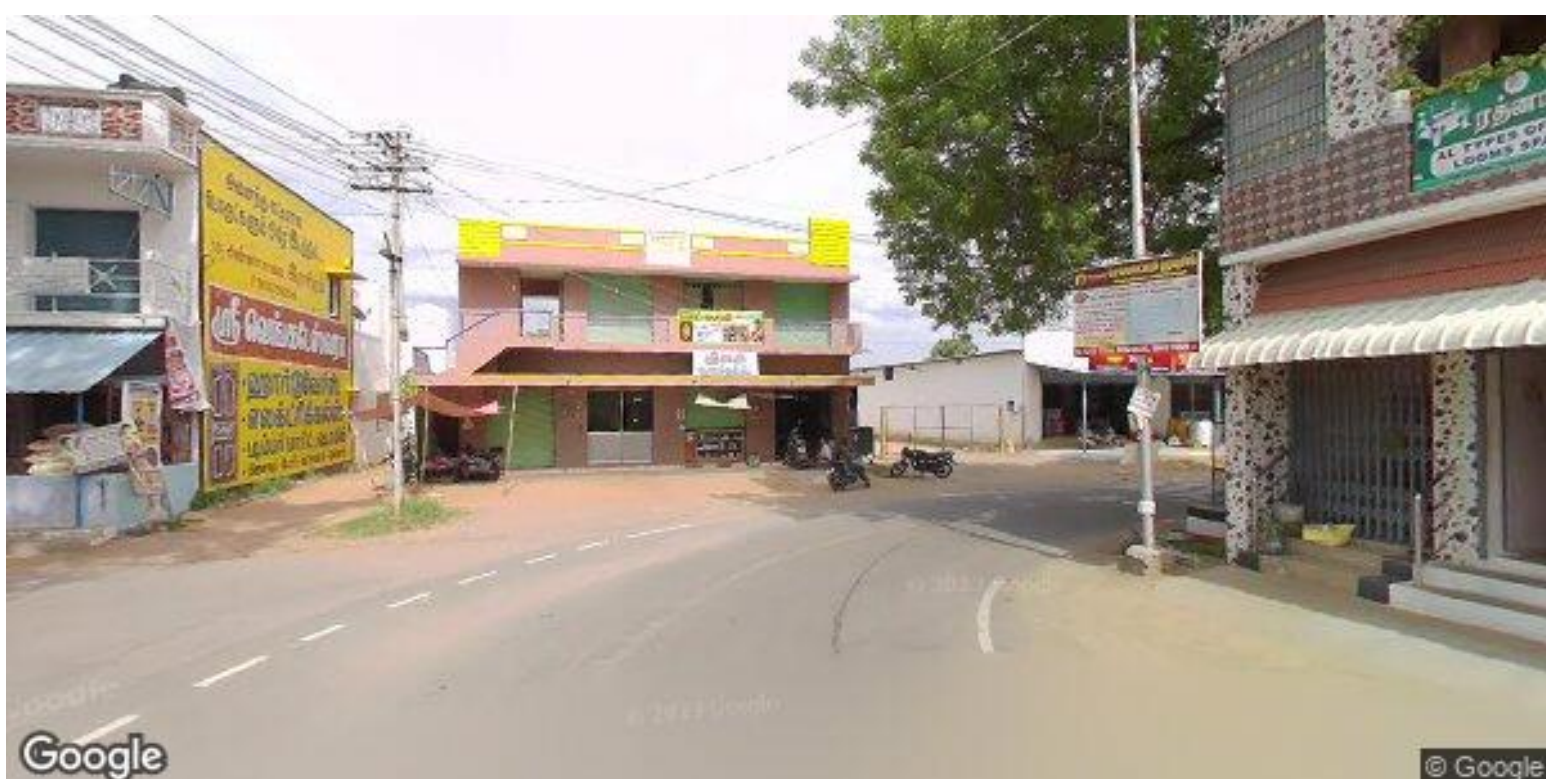
**Coordinates: 11.36691, 78.08320**

**Risk Type: Turn**

**Risk Level: High**

**Speed Limit: 15 KM/Hr**

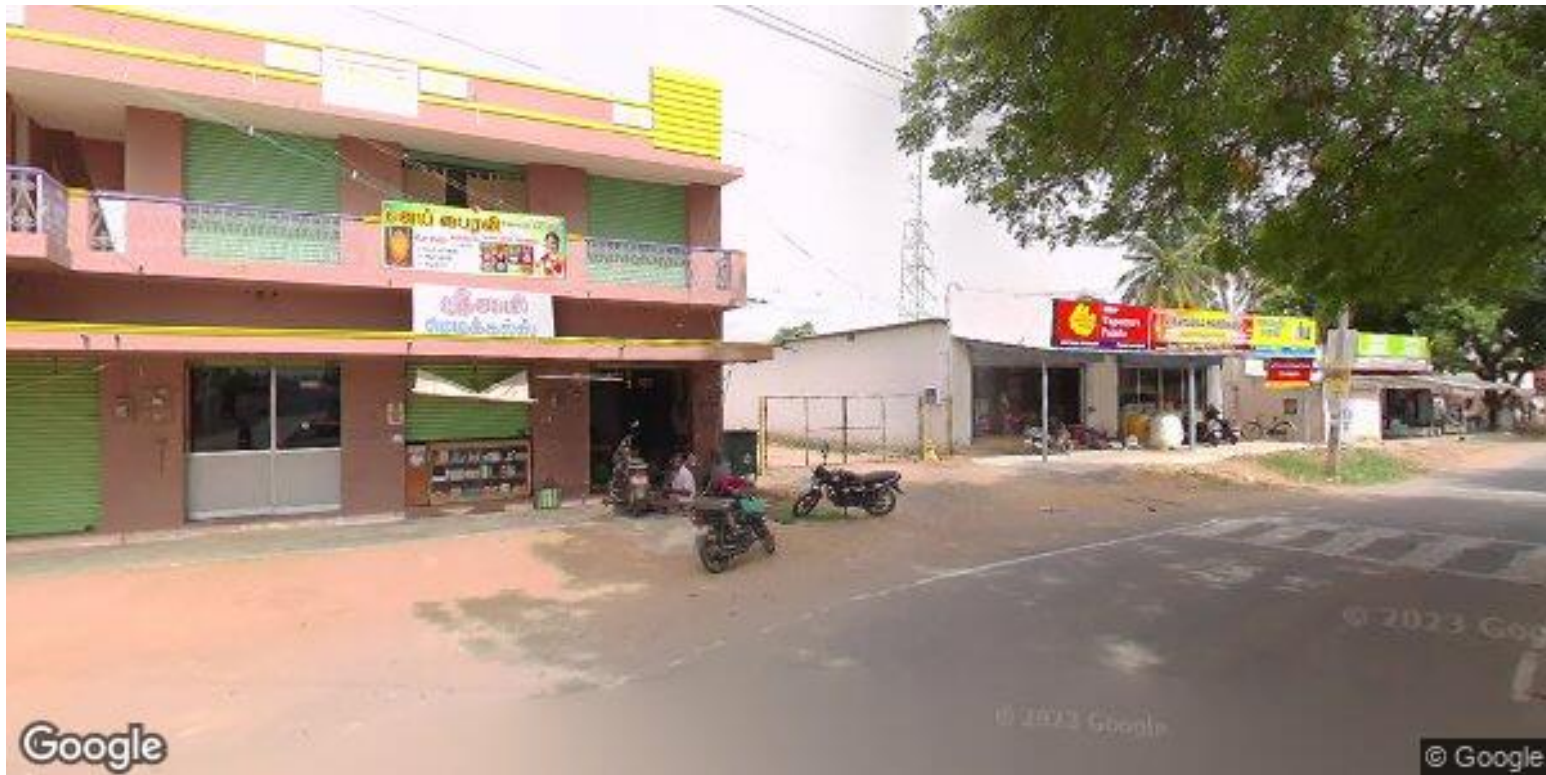
**Coordinates: 11.36684, 78.08323**

**Risk Type: Turn**

**Risk Level: Medium**

**Speed Limit: 30 KM/Hr**

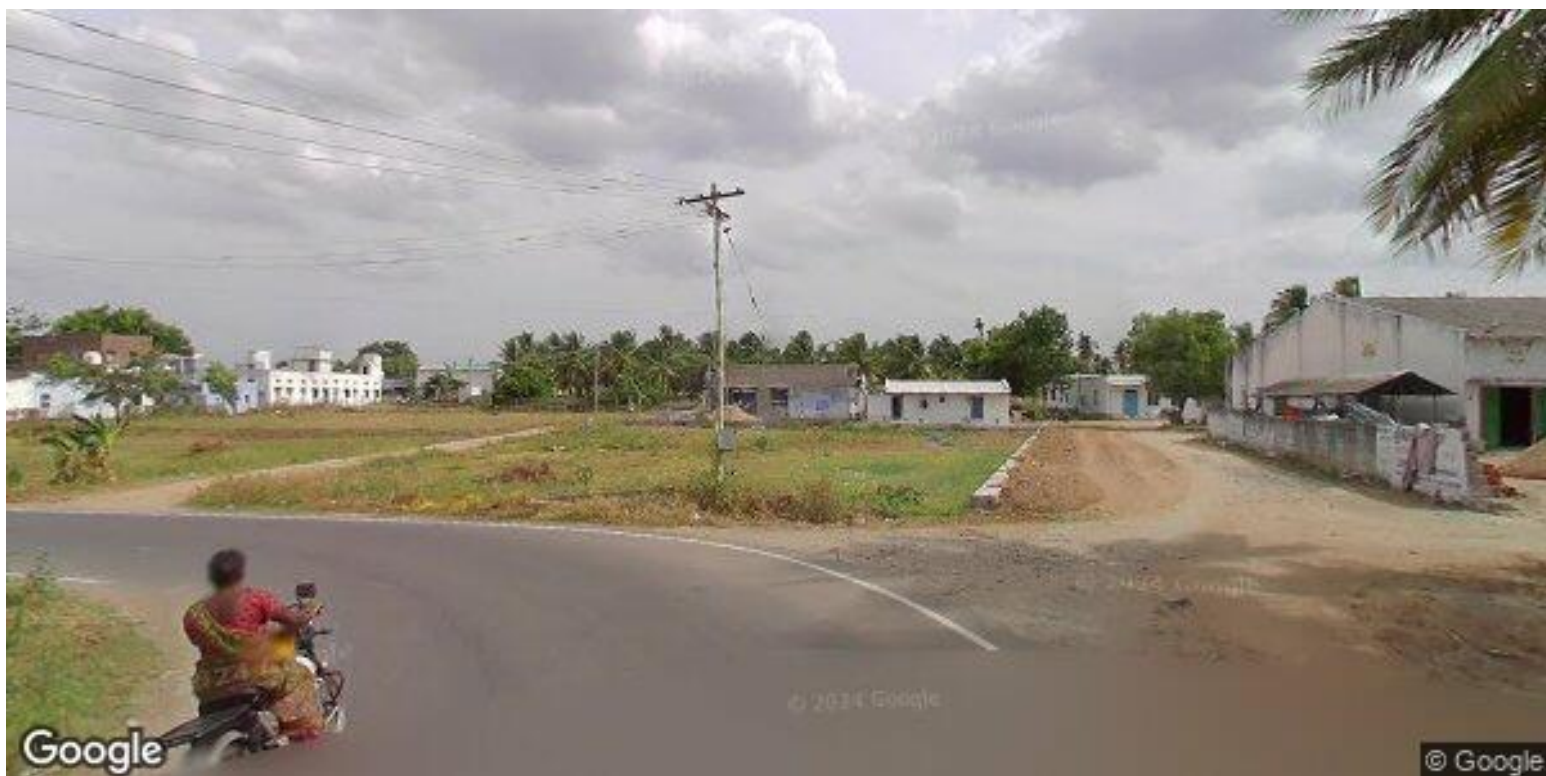
**Coordinates: 11.36525, 78.08282**

**Risk Type: Turn**

**Risk Level: High**

**Speed Limit: 15 KM/Hr**

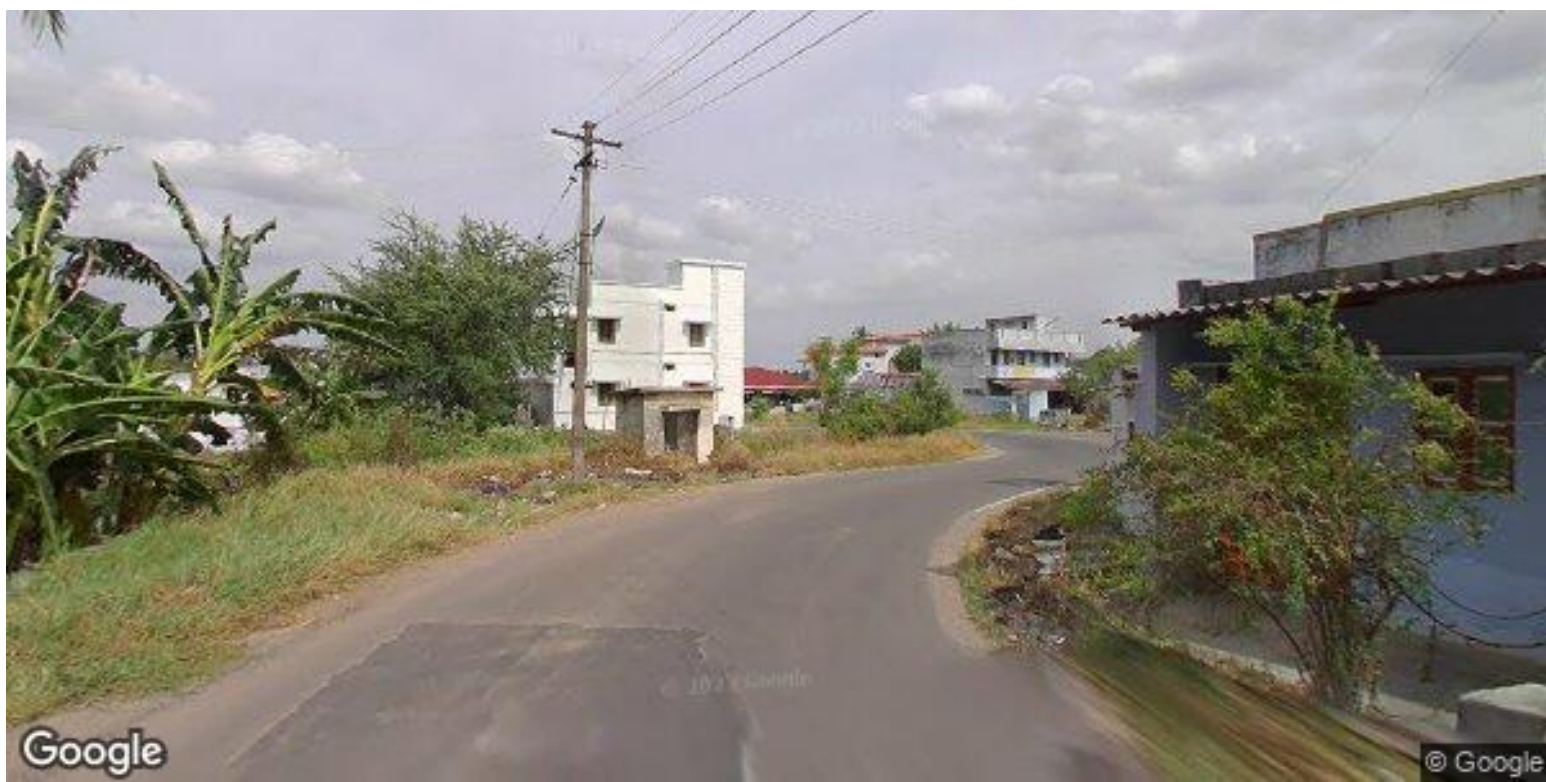
**Coordinates:** 11.36462, 78.08383

**Risk Type:** Turn

**Risk Level:** High

**Speed Limit:** 15 KM/Hr

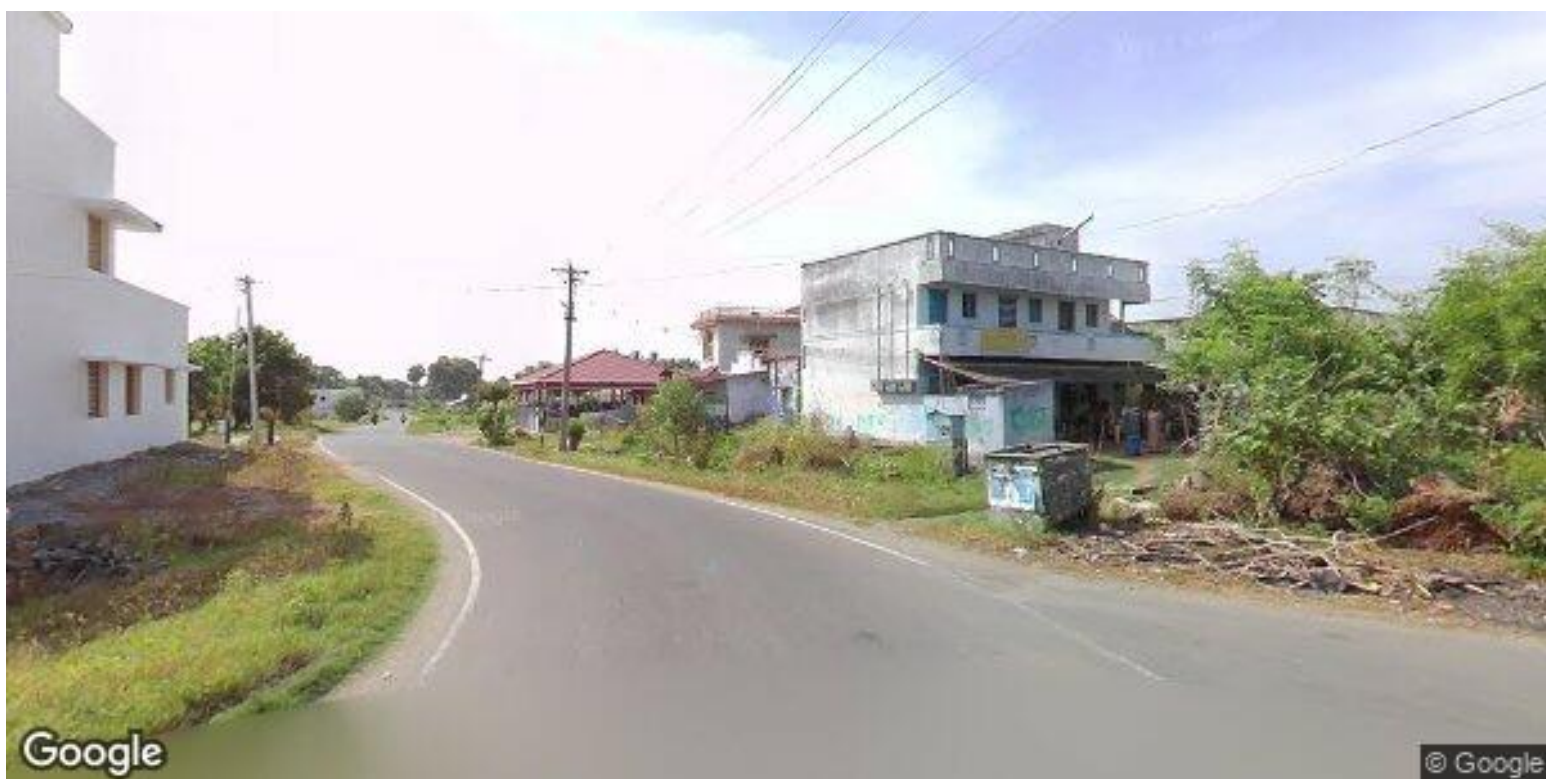
**Coordinates:** 11.36435, 78.08389

**Risk Type:** Turn

**Risk Level:** High

**Speed Limit:** 15 KM/Hr

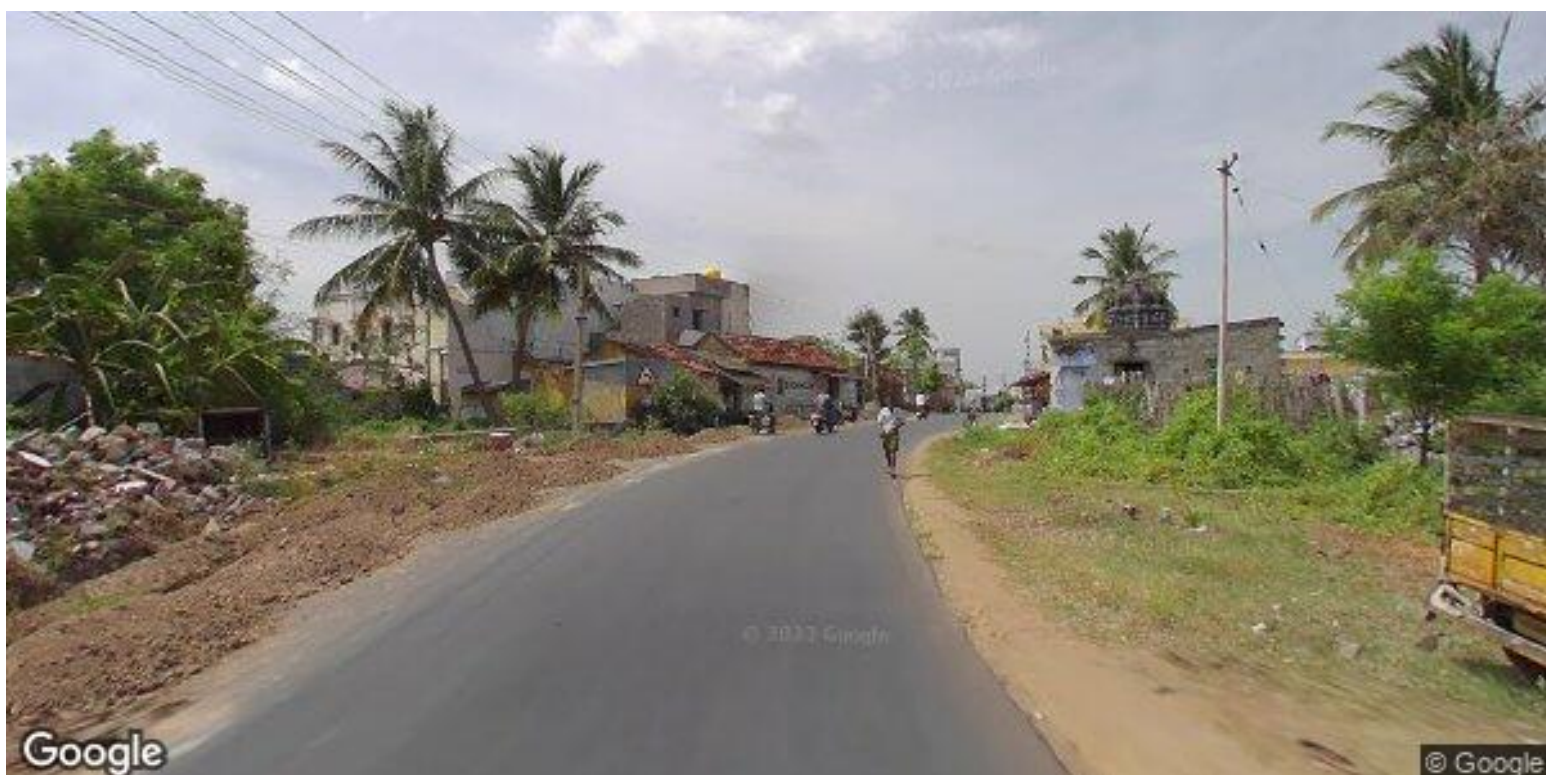
**Coordinates:** 11.35168, 78.10819

**Risk Type:** Turn

**Risk Level:** Medium

**Speed Limit:** 30 KM/Hr

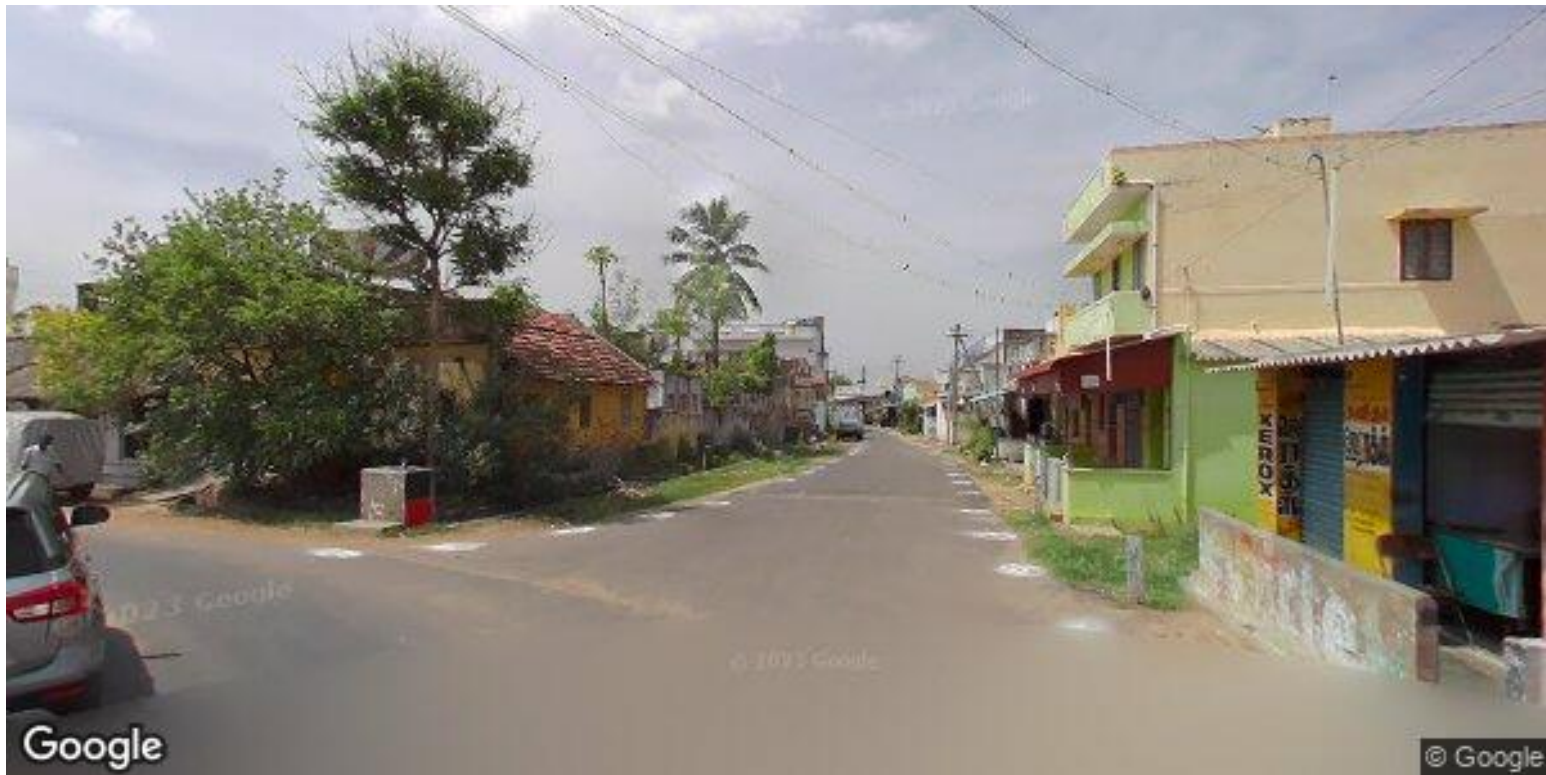
**Coordinates:** 11.35121, 78.10818

**Risk Type:** Turn

**Risk Level:** High

**Speed Limit:** 15 KM/Hr
