# IndianOil

## JOURNEY RISK MANAGEMENT (JRM) STUDY

### Salem Terminal to SHRI GURU SAI AND COMPANY

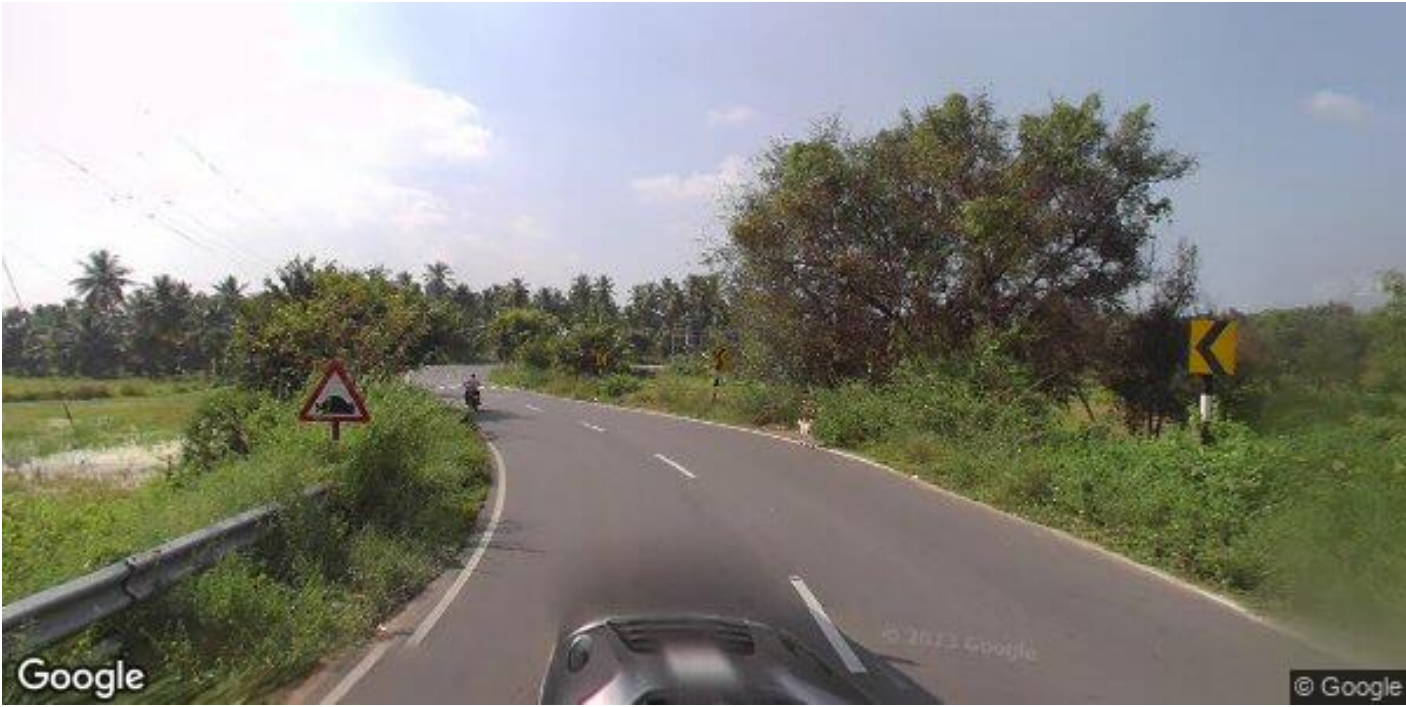
| | Risk Type | Risk Level | Coordinates | Speed Limit |
|---|---|---|---|---|
| 3 | Turn | Medium | 11.45358, 77.85781 | 30 KM/Hr |

**Risk Type:** Turn  
**Risk Level:** Medium  
**Speed Limit:** 30 KM/Hr  
**Coordinates:** 11.45358, 77.85781

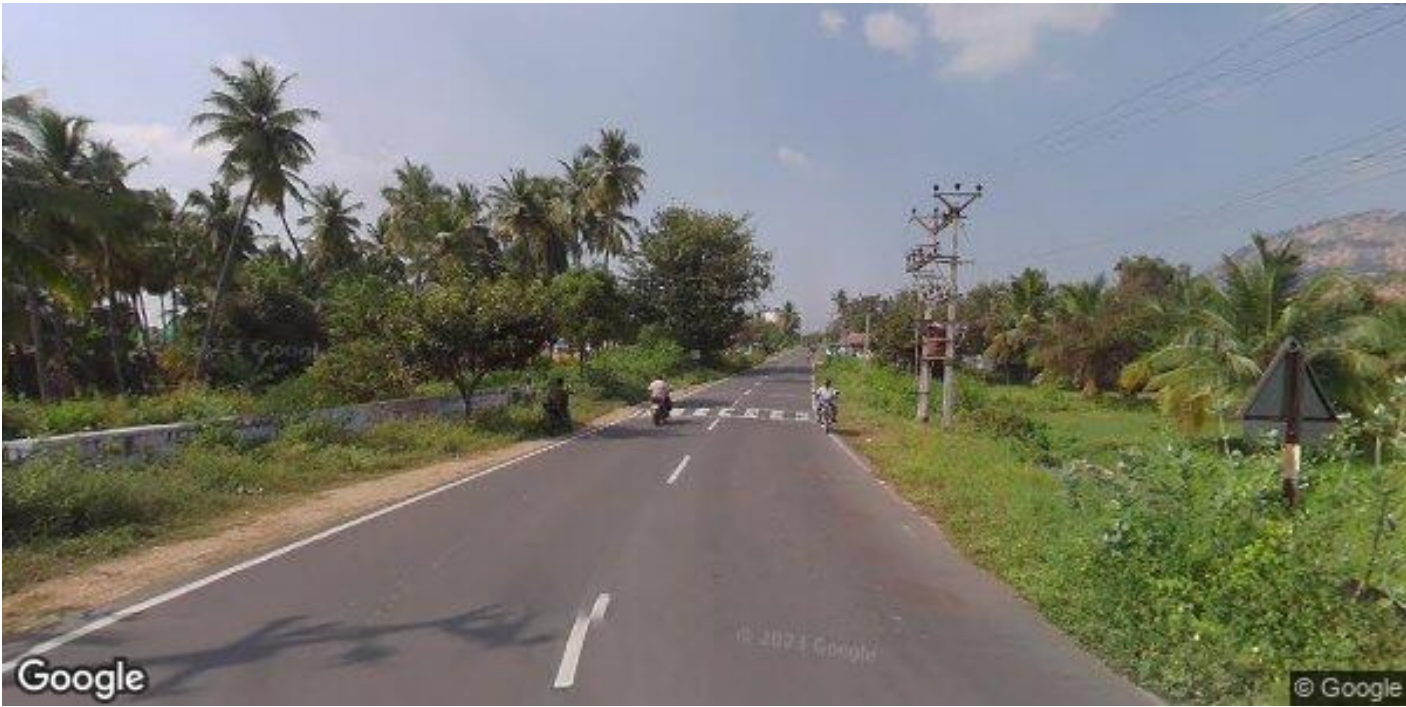
| | Risk Type | Risk Level | Coordinates | Speed Limit |
|---|---|---|---|---|
| 4 | Turn | Medium | 11.45353, 77.85697 | 30 KM/Hr |

**Risk Type:** Turn  
**Risk Level:** Medium  
**Speed Limit:** 30 KM/Hr  
**Coordinates:** 11.45353, 77.85697

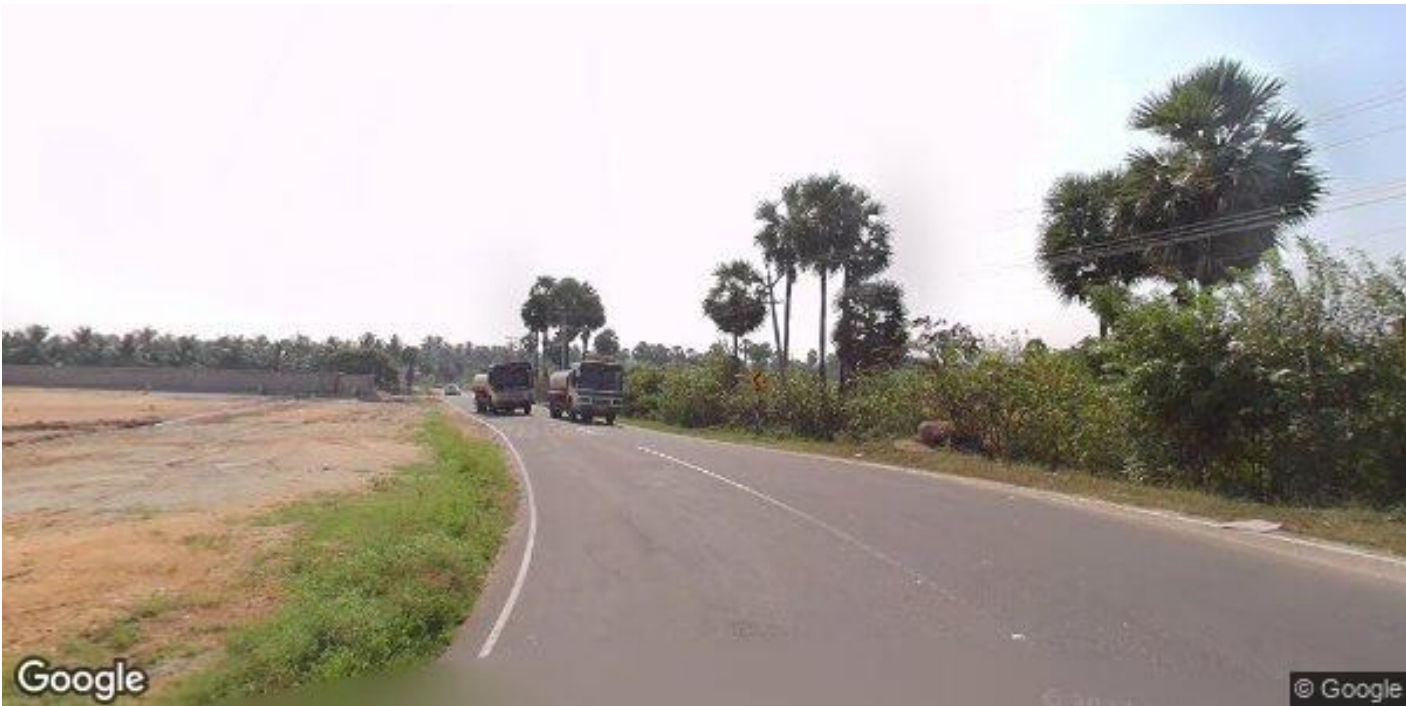
| | Risk Type | Risk Level | Coordinates | Speed Limit |
|---|---|---|---|---|
| 5 | Turn | Medium | 11.45839, 77.85143 | 30 KM/Hr |

**Risk Type:** Turn  
**Risk Level:** Medium  
**Speed Limit:** 30 KM/Hr  
**Coordinates:** 11.45839, 77.85143

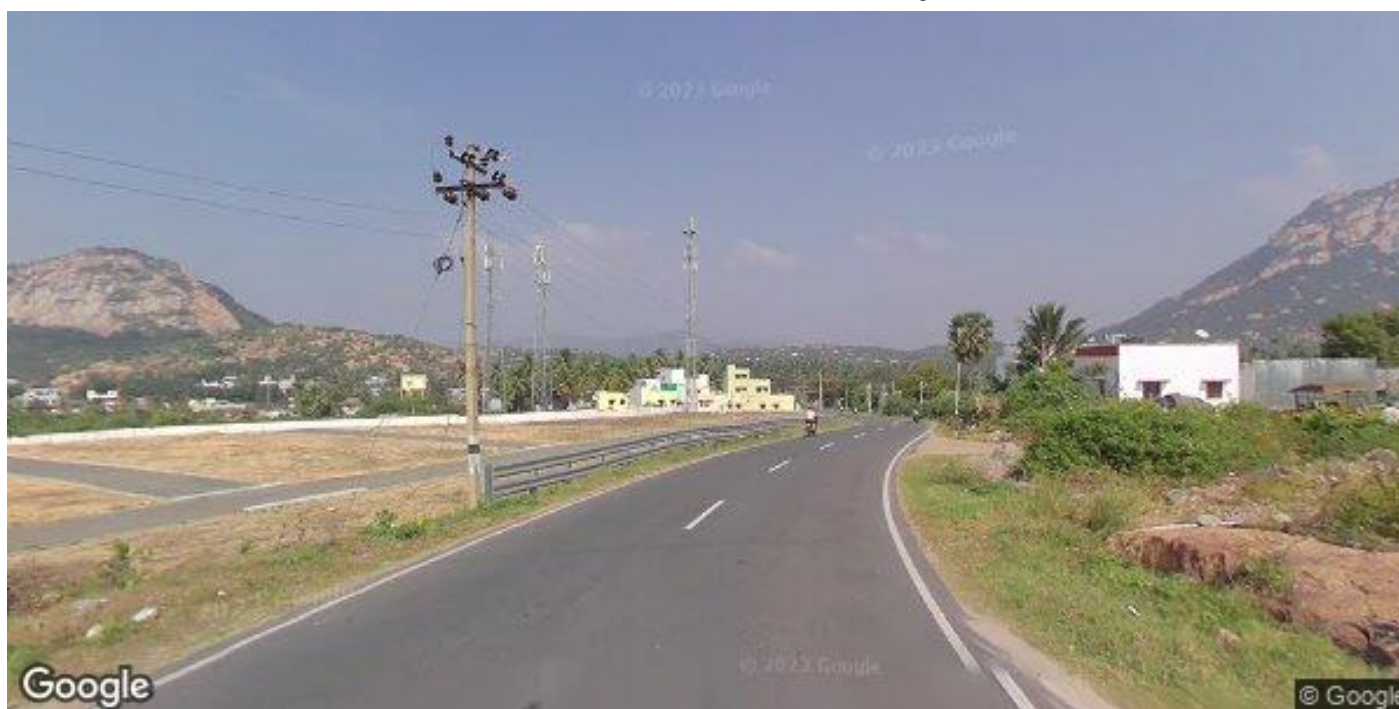
| | Risk Type | Risk Level | Coordinates | Speed Limit |
|---|---|---|---|---|
| 6 | Turn | Medium | 11.46053, 77.85034 | 30 KM/Hr |

**Risk Type:** Turn  
**Risk Level:** Medium  
**Speed Limit:** 30 KM/Hr  
**Coordinates:** 11.46053, 77.85034

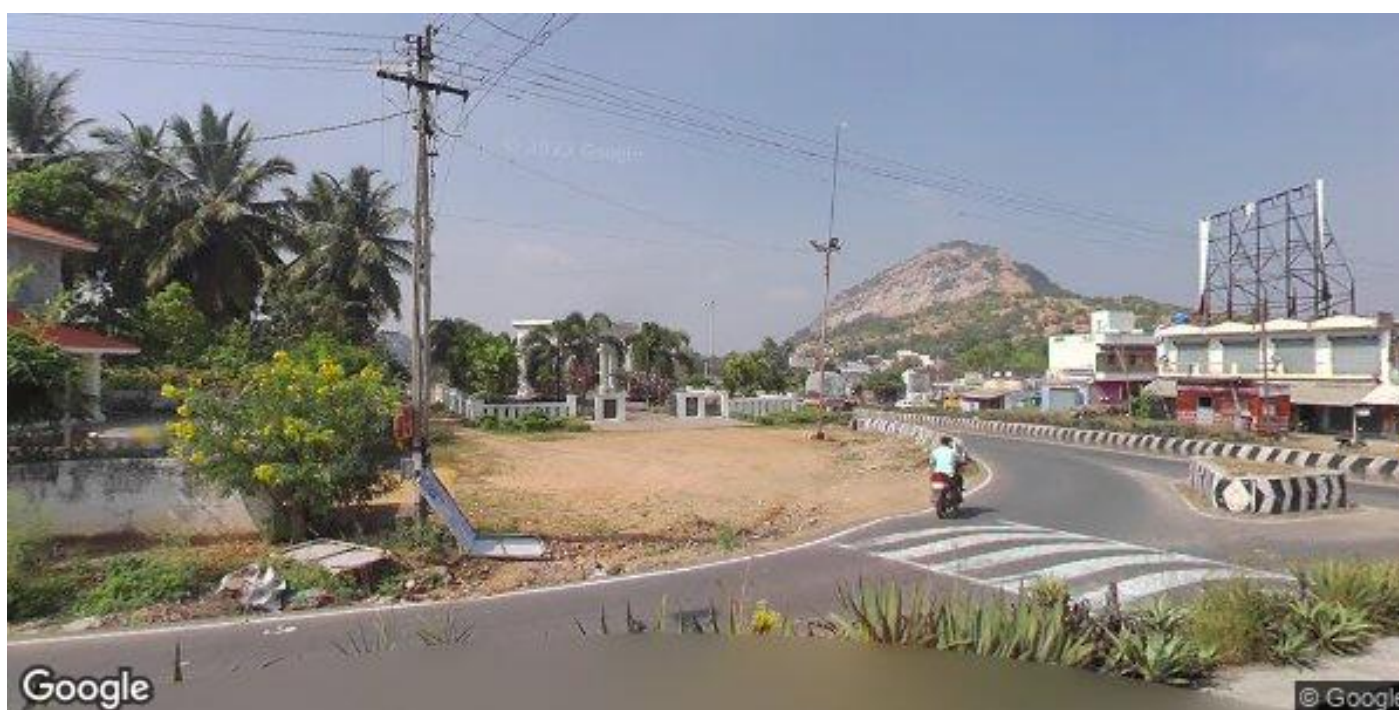
| | Risk Type | Risk Level | Coordinates | Speed Limit |
|---|---|---|---|---|
| 7 | Turn | Medium | 11.46307, 77.84941 | 30 KM/Hr |

**Risk Type:** Turn  
**Risk Level:** Medium  
**Speed Limit:** 30 KM/Hr  
**Coordinates:** 11.46307, 77.84941

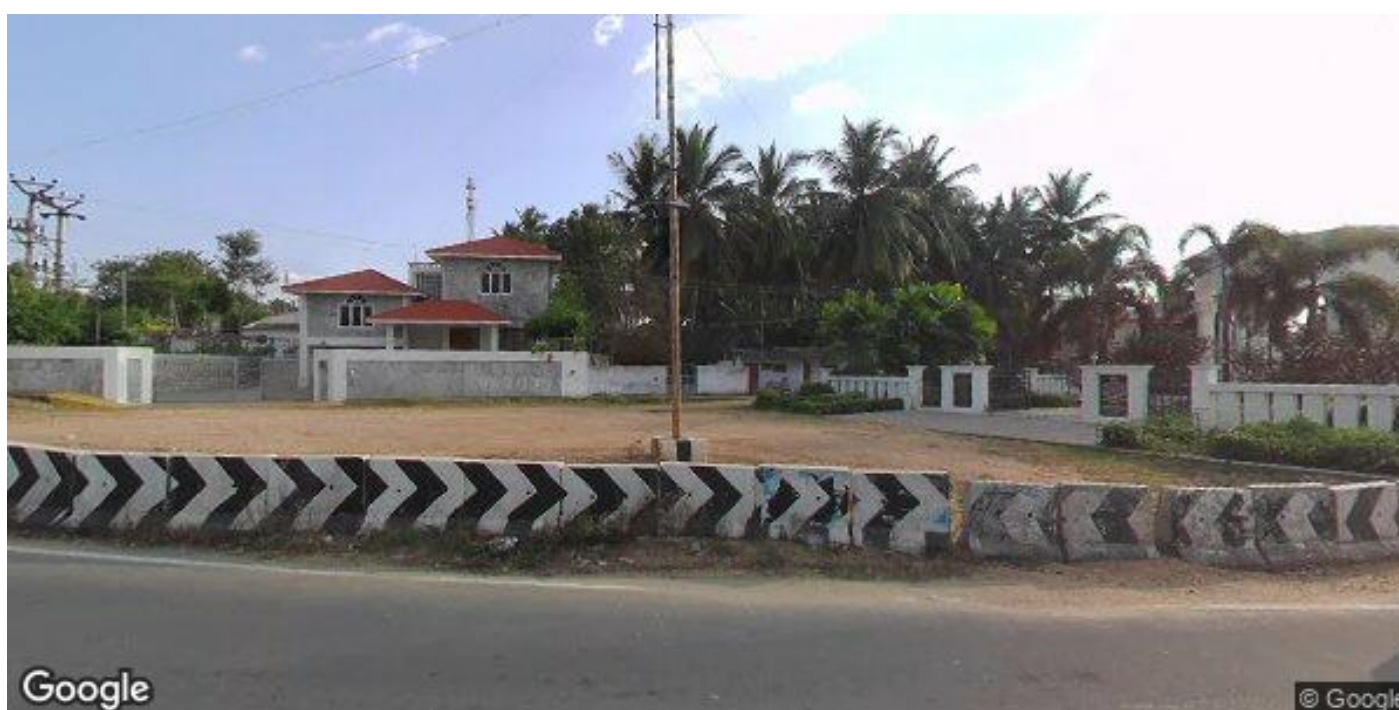
| | Risk Type | Risk Level | Coordinates | Speed Limit |
|---|---|---|---|---|
| 8 | Turn | Medium | 11.46316, 77.84921 | 30 KM/Hr |

**Risk Type:** Turn  
**Risk Level:** Medium  
**Speed Limit:** 30 KM/Hr  
**Coordinates:** 11.46316, 77.84921

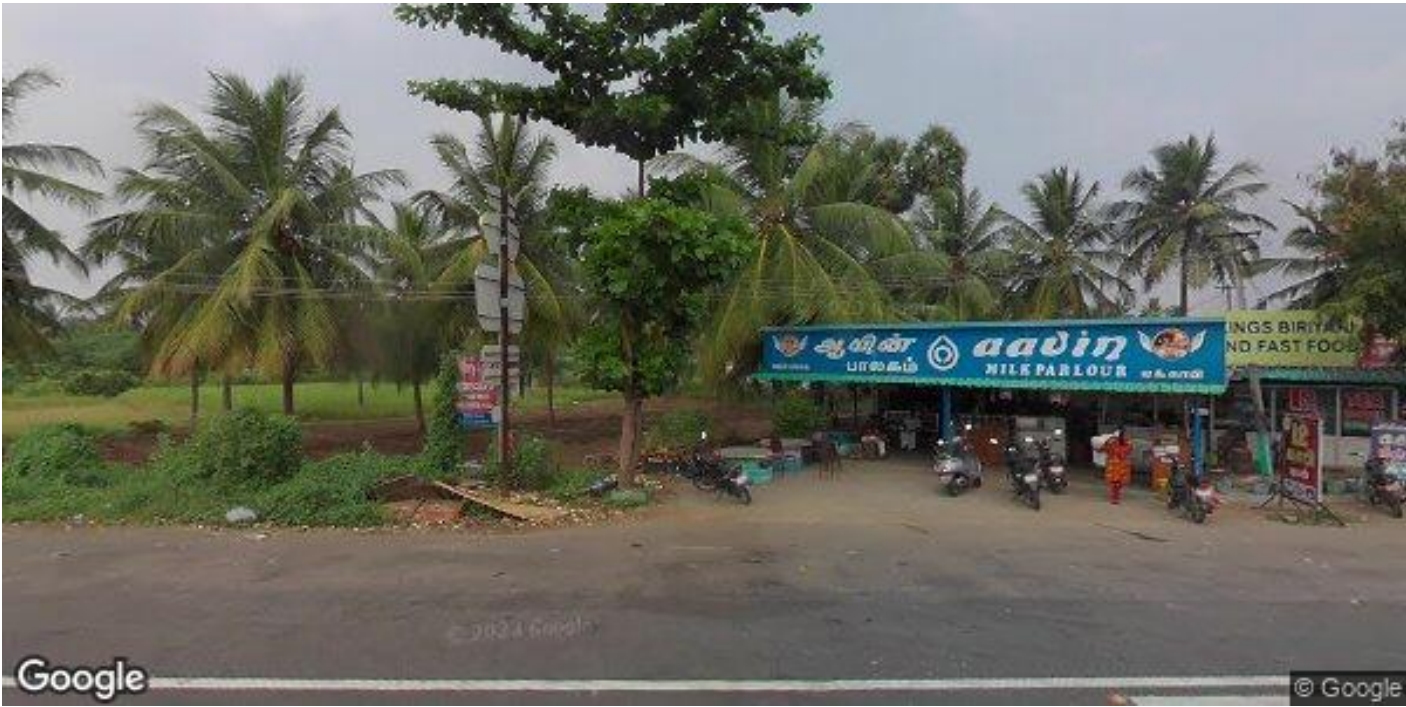
| | Risk Type | Risk Level | Coordinates | Speed Limit |
|---|---|---|---|---|
| 10 | Blind Spot | Blind Spot | 11.45631, 77.81668 | 10 KM/Hr |

**Risk Type:** Blind Spot  
**Risk Level:** Blind Spot  
**Speed Limit:** 10 KM/Hr  
**Coordinates:** 11.45631, 77.81668

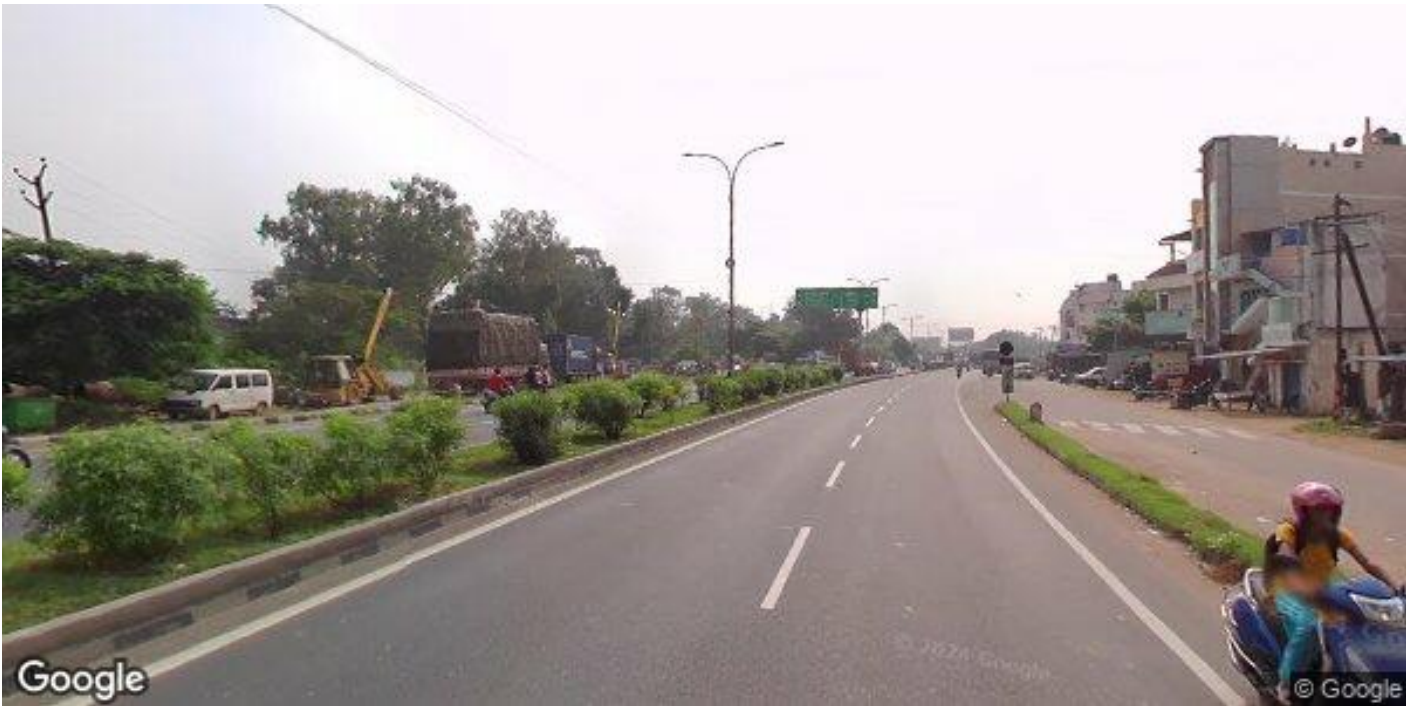
| | Risk Type | Risk Level | Coordinates | Speed Limit |
|---|---|---|---|---|
| 12 | Turn | Medium | 11.68920, 78.11799 | 30 KM/Hr |

**Risk Type:** Turn  
**Risk Level:** Medium  
**Speed Limit:** 30 KM/Hr  
**Coordinates:** 11.68920, 78.11799

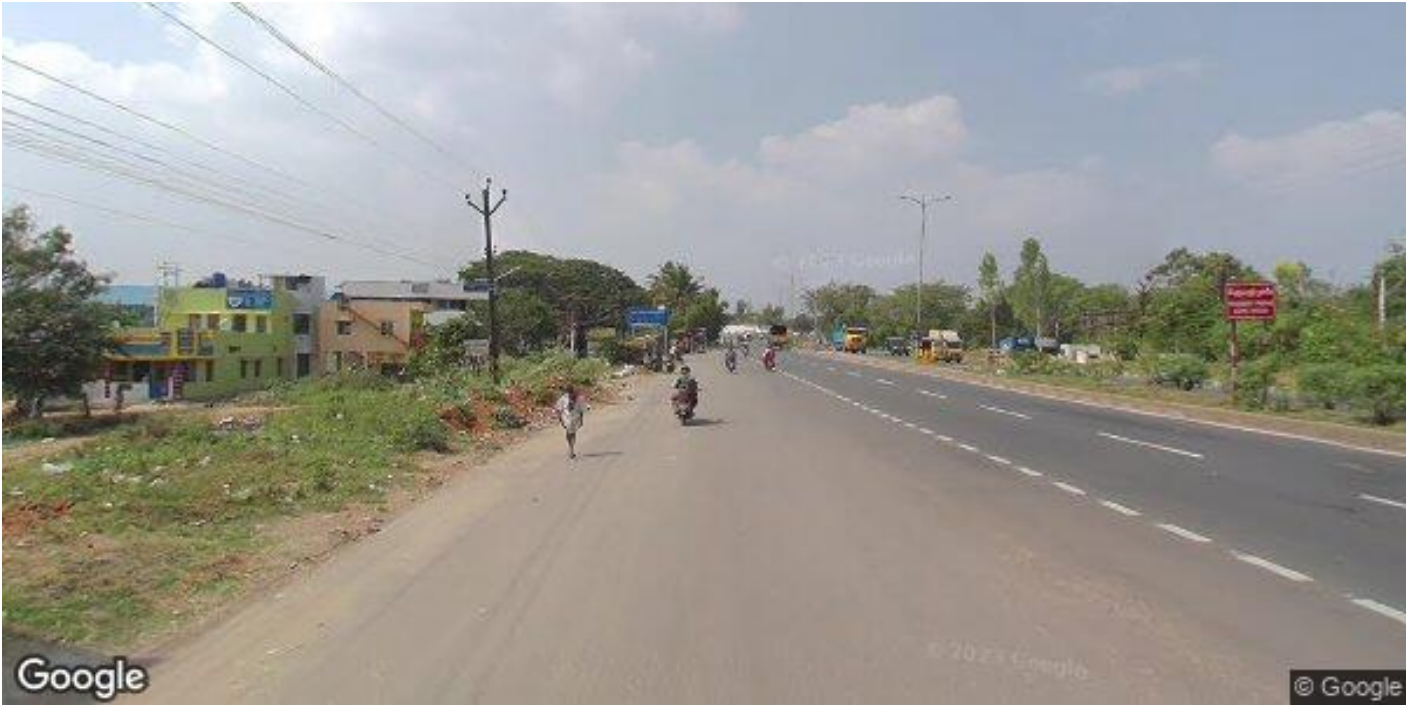
| | Risk Type | Risk Level | Coordinates | Speed Limit |
|---|---|---|---|---|
| 13 | Turn | Medium | 11.69386, 78.10968 | 30 KM/Hr |

**Risk Type:** Turn  
**Risk Level:** Medium  
**Speed Limit:** 30 KM/Hr  
**Coordinates:** 11.69386, 78.10968

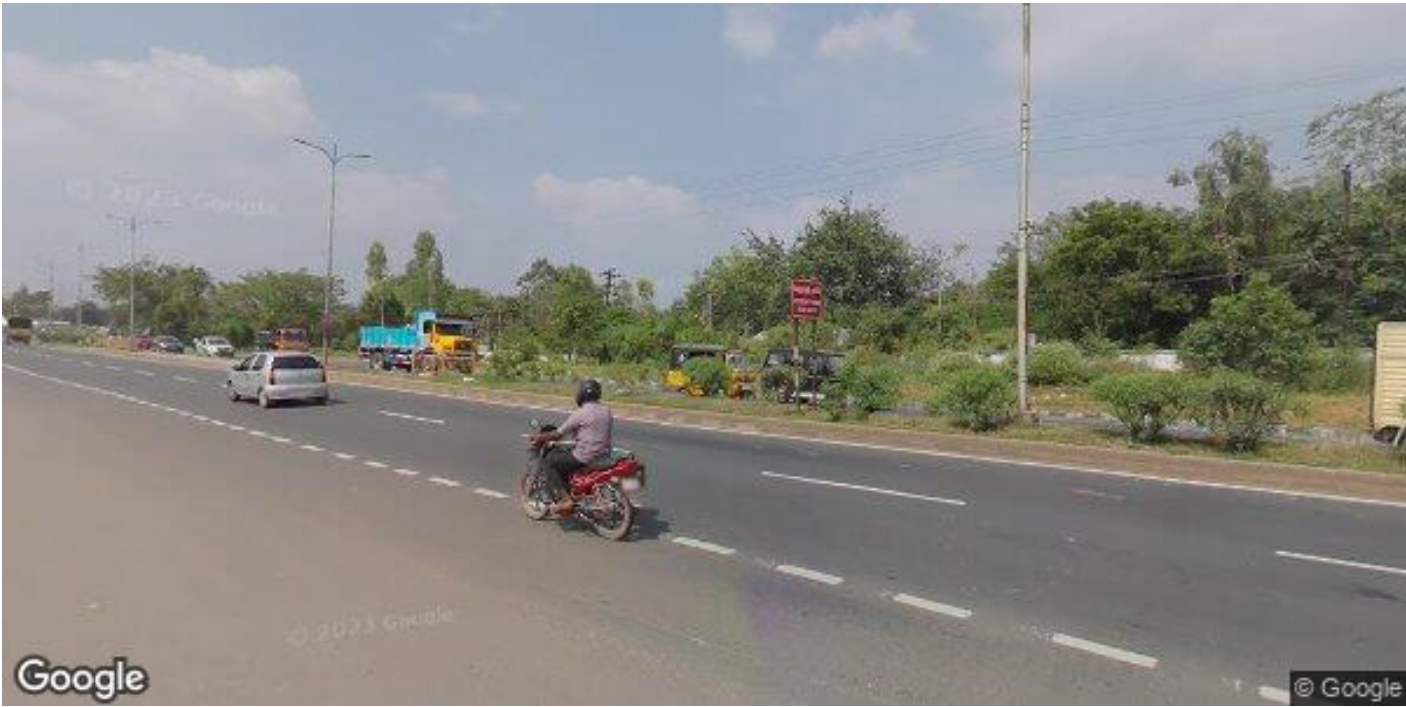
| | Risk Type | Risk Level | Coordinates | Speed Limit |
|---|---|---|---|---|
| 14 | Turn | Medium | 11.69392, 78.10964 | 30 KM/Hr |

**Risk Type:** Turn  
**Risk Level:** Medium  
**Speed Limit:** 30 KM/Hr  
**Coordinates:** 11.69392, 78.10964

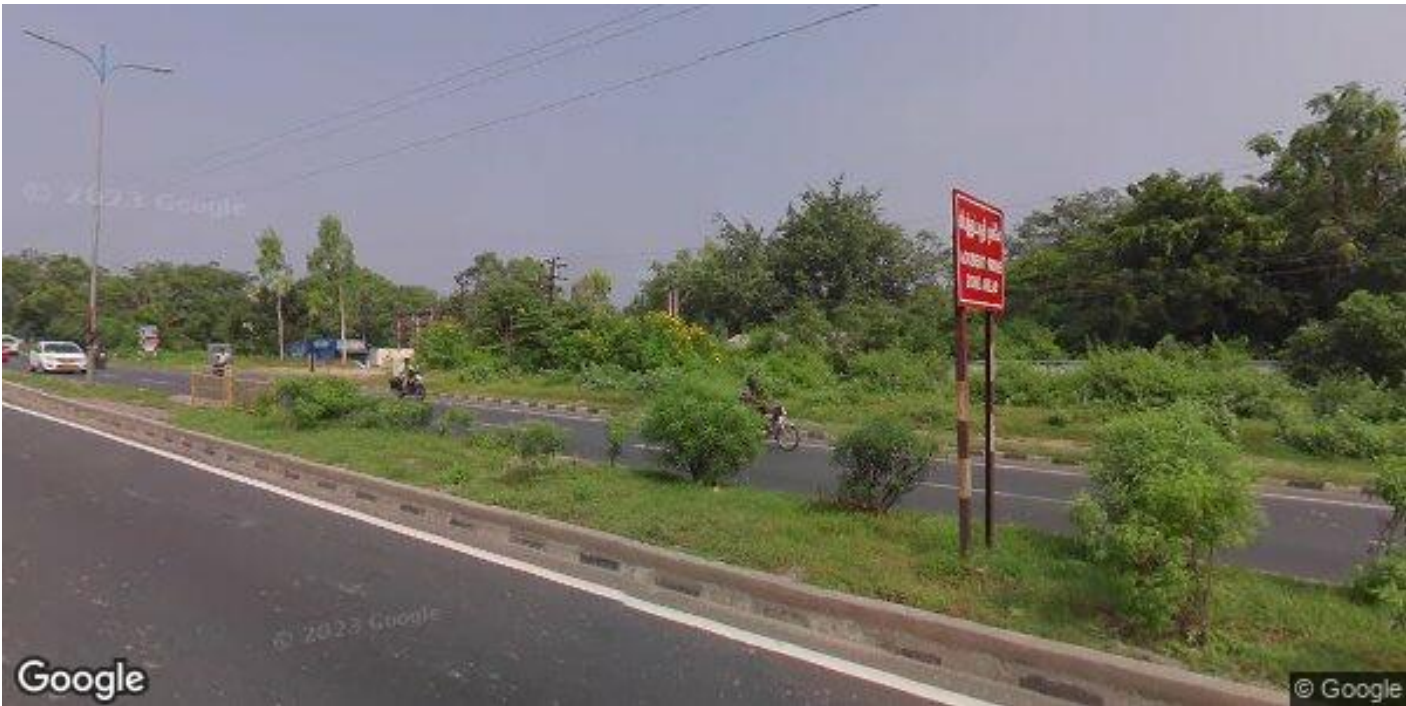
| | Risk Type | Risk Level | Coordinates | Speed Limit |
|---|---|---|---|---|
| 15 | Turn | High | 11.69400, 78.10963 | 15 KM/Hr |

**Risk Type:** Turn  
**Risk Level:** High  
**Speed Limit:** 15 KM/Hr  
**Coordinates:** 11.69400, 78.10963

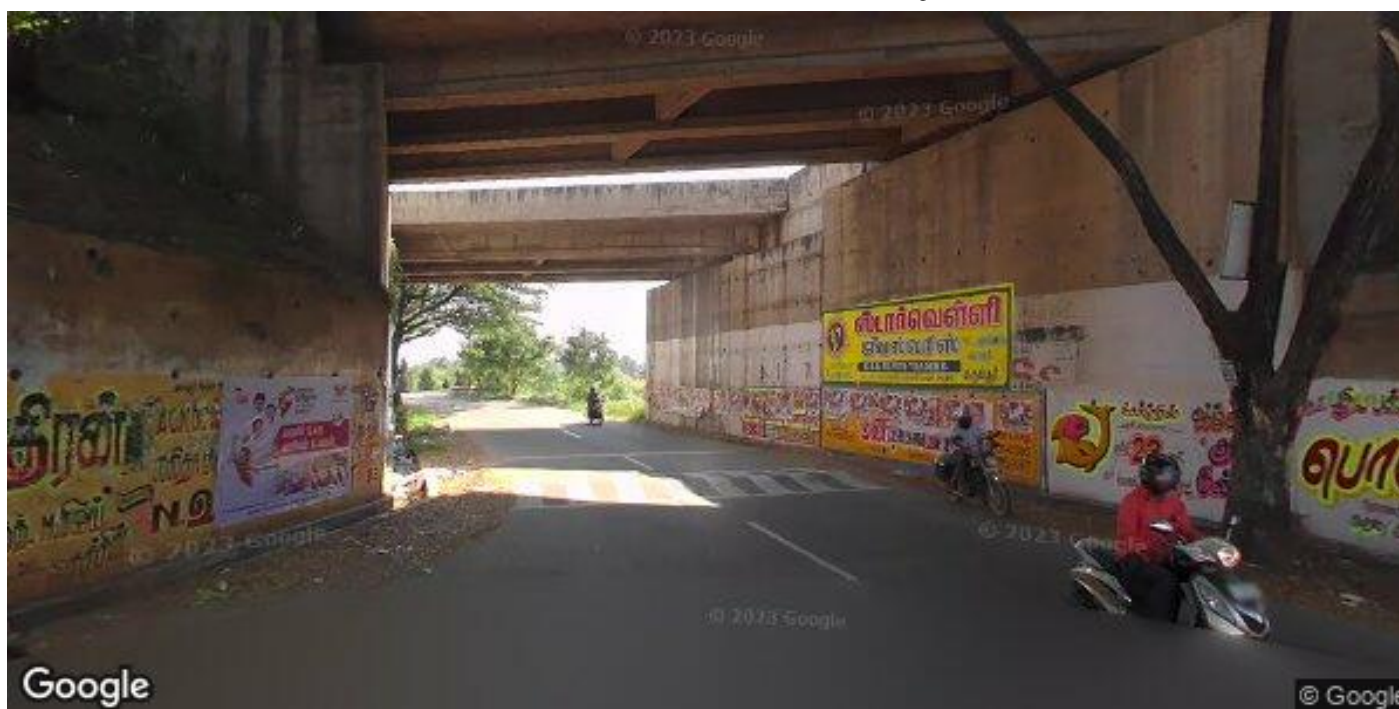
| | Risk Type | Risk Level | Coordinates | Speed Limit |
|---|---|---|---|---|
| 16 | Turn | Medium | 11.70817, 78.09316 | 30 KM/Hr |

**Risk Type:** Turn  
**Risk Level:** Medium  
**Speed Limit:** 30 KM/Hr  
**Coordinates:** 11.70817, 78.09316

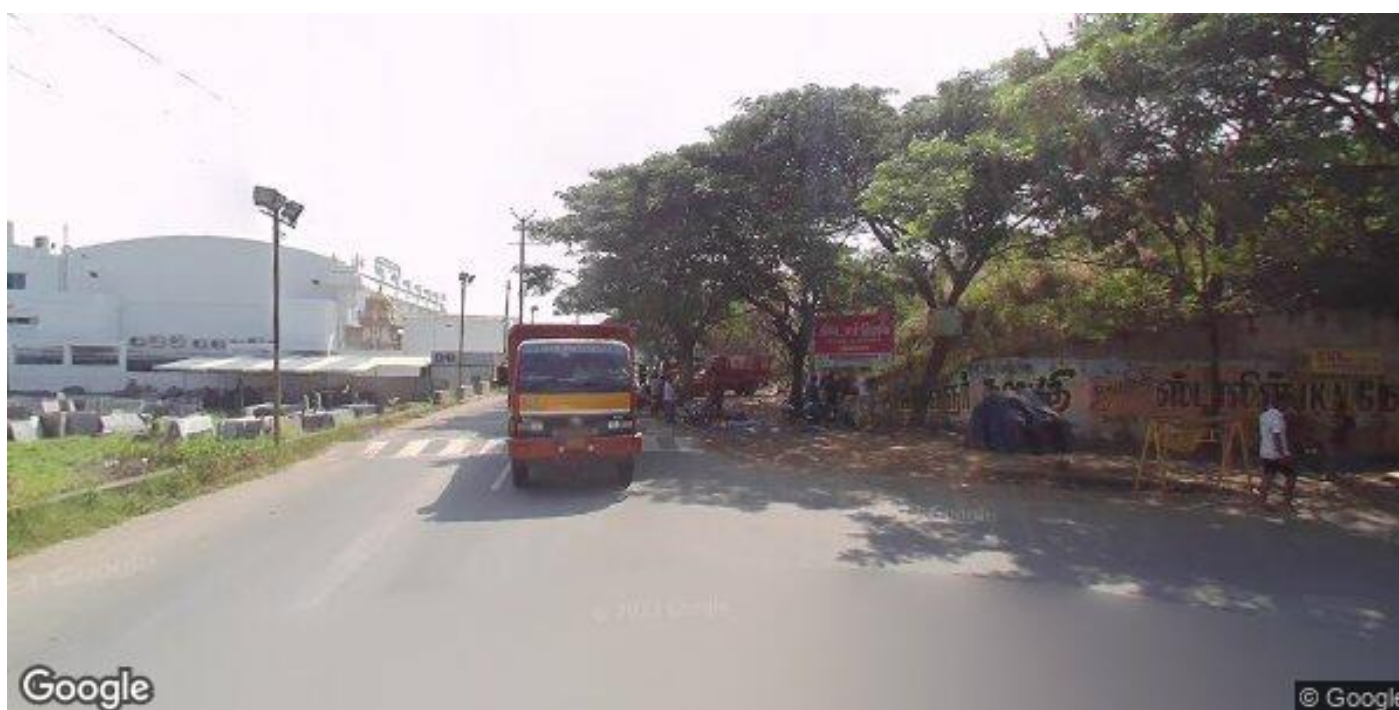
| | Risk Type | Risk Level | Coordinates | Speed Limit |
|---|---|---|---|---|
| 17 | Turn | High | 11.70831, 78.09326 | 15 KM/Hr |

**Risk Type:** Turn  
**Risk Level:** High  
**Speed Limit:** 15 KM/Hr  
**Coordinates:** 11.70831, 78.09326

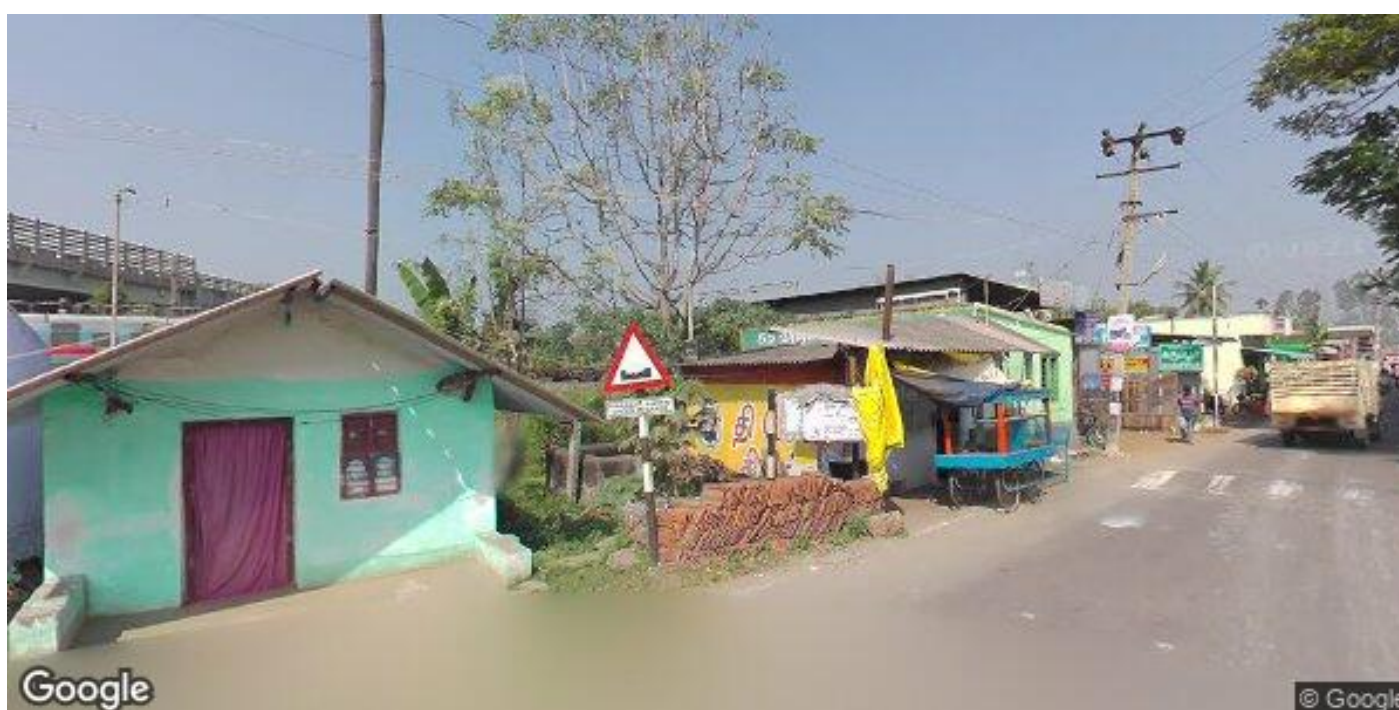
| | Risk Type | Risk Level | Coordinates | Speed Limit |
|---|---|---|---|---|
| 18 | Turn | Medium | 11.70850, 78.09305 | 30 KM/Hr |

**Risk Type:** Turn  
**Risk Level:** Medium  
**Speed Limit:** 30 KM/Hr  
**Coordinates:** 11.70850, 78.09305

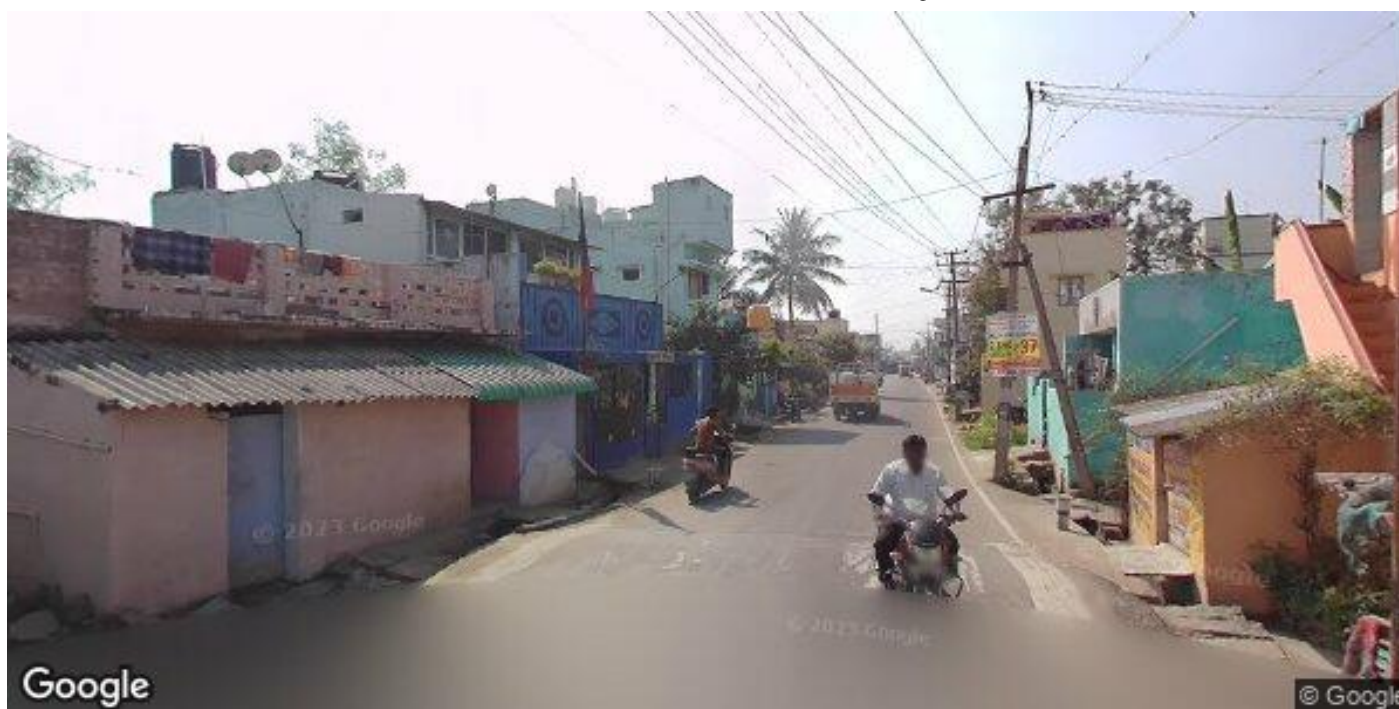
| | Risk Type | Risk Level | Coordinates | Speed Limit |
|---|---|---|---|---|
| 19 | Turn | Medium | 11.71612, 78.09288 | 30 KM/Hr |

**Risk Type:** Turn  
**Risk Level:** Medium  
**Speed Limit:** 30 KM/Hr  
**Coordinates:** 11.71612, 78.09288

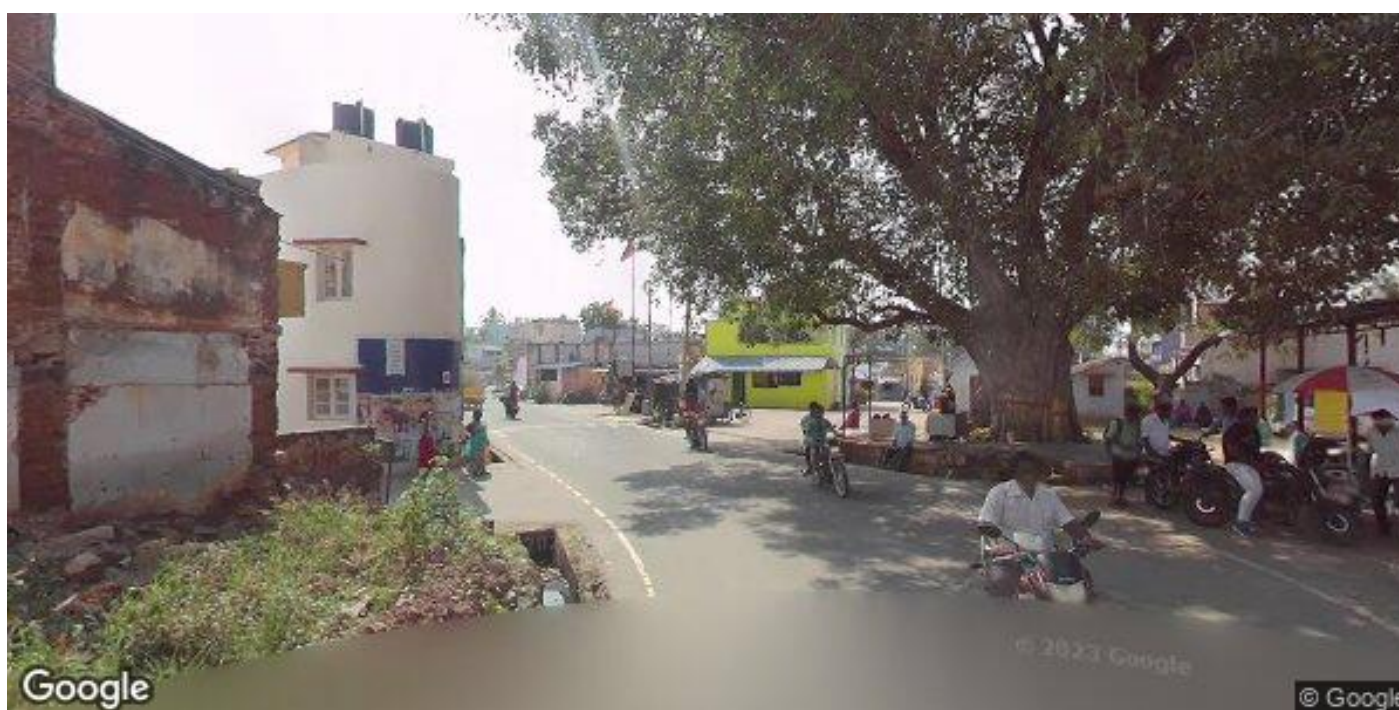
| | Risk Type | Risk Level | Coordinates | Speed Limit |
|---|---|---|---|---|
| 20 | Turn | High | 11.71689, 78.09240 | 15 KM/Hr |

**Risk Type:** Turn  
**Risk Level:** High  
**Speed Limit:** 15 KM/Hr  
**Coordinates:** 11.71689, 78.09240

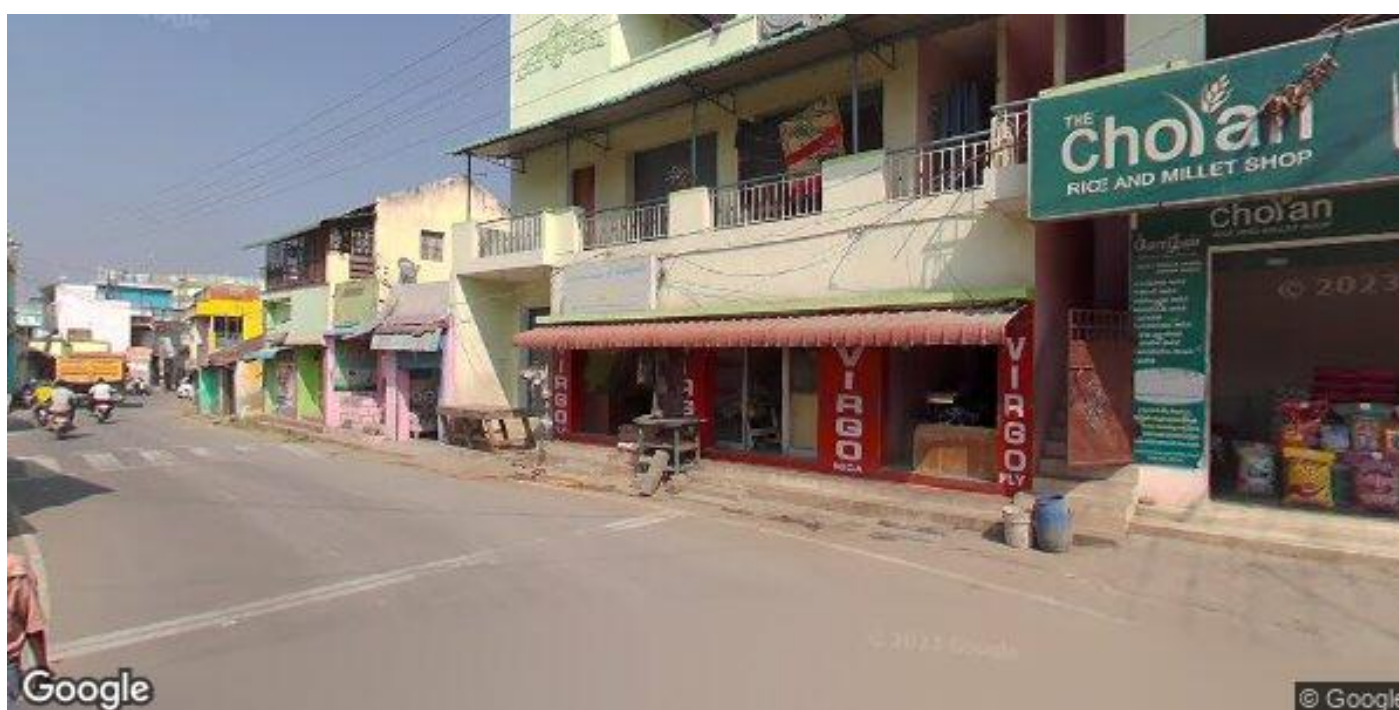
| | Risk Type | Risk Level | Coordinates | Speed Limit |
|---|---|---|---|---|
| 21 | Turn | High | 11.71764, 78.09254 | 15 KM/Hr |

**Risk Type:** Turn  
**Risk Level:** High  
**Speed Limit:** 15 KM/Hr  
**Coordinates:** 11.71764, 78.09254

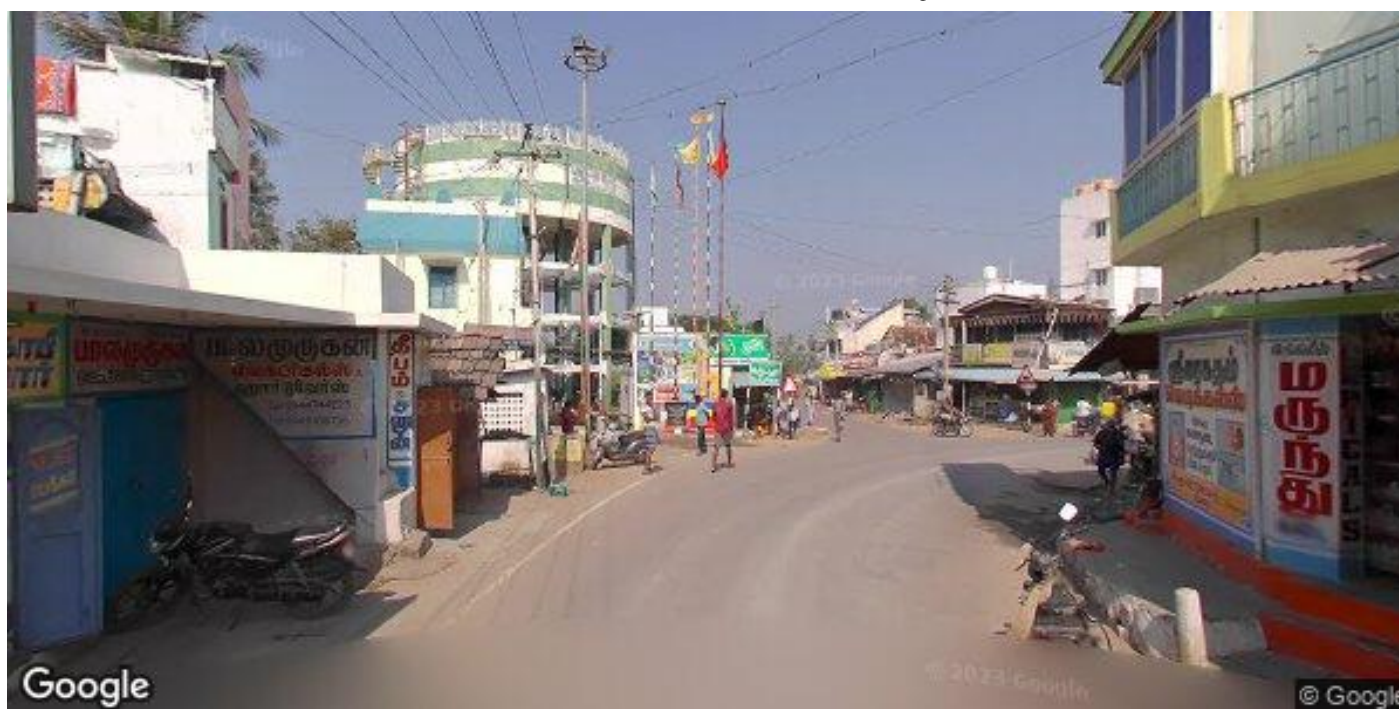
| | Risk Type | Risk Level | Coordinates | Speed Limit |
|---|---|---|---|---|
| 22 | Turn | Medium | 11.71813, 78.09187 | 30 KM/Hr |

**Risk Type:** Turn  
**Risk Level:** Medium  
**Speed Limit:** 30 KM/Hr  
**Coordinates:** 11.71813, 78.09187

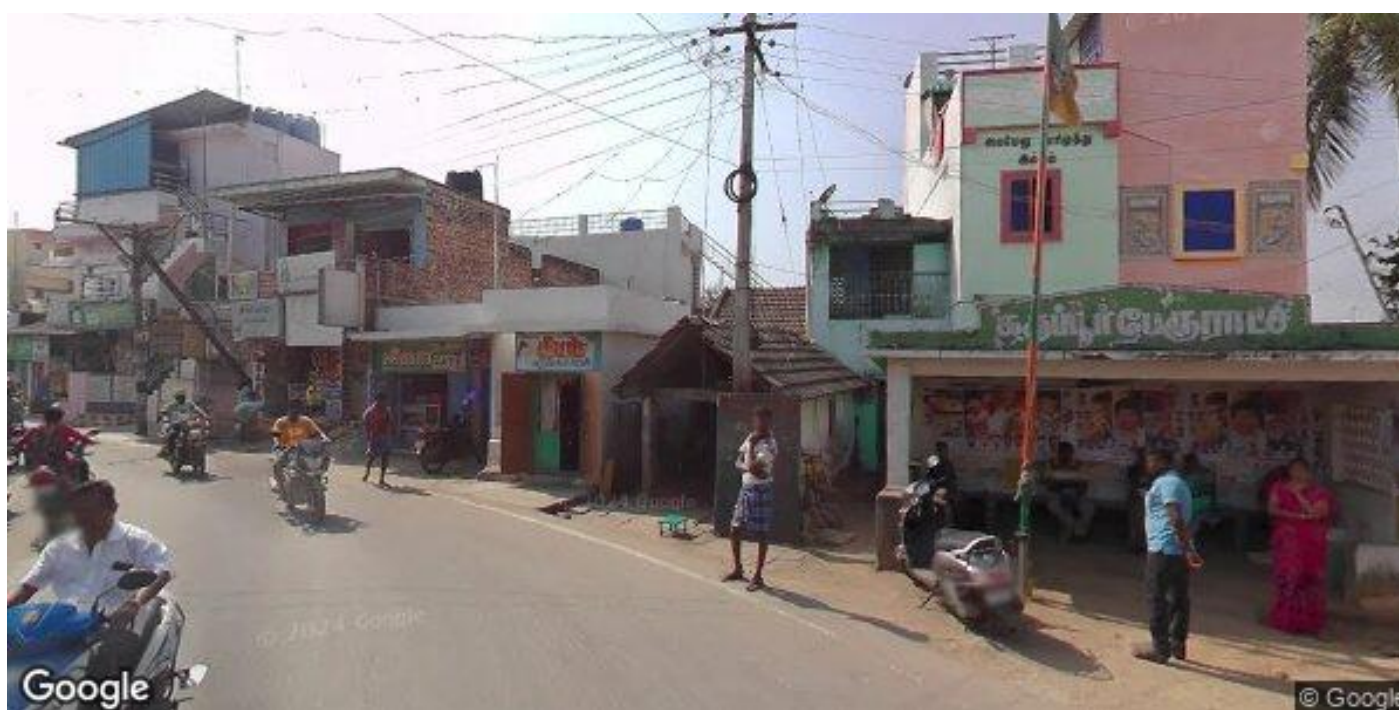
| | Risk Type | Risk Level | Coordinates | Speed Limit |
|---|---|---|---|---|
| 23 | Turn | High | 11.71825, 78.09182 | 15 KM/Hr |

**Risk Type:** Turn  
**Risk Level:** High  
**Speed Limit:** 15 KM/Hr  
**Coordinates:** 11.71825, 78.09182

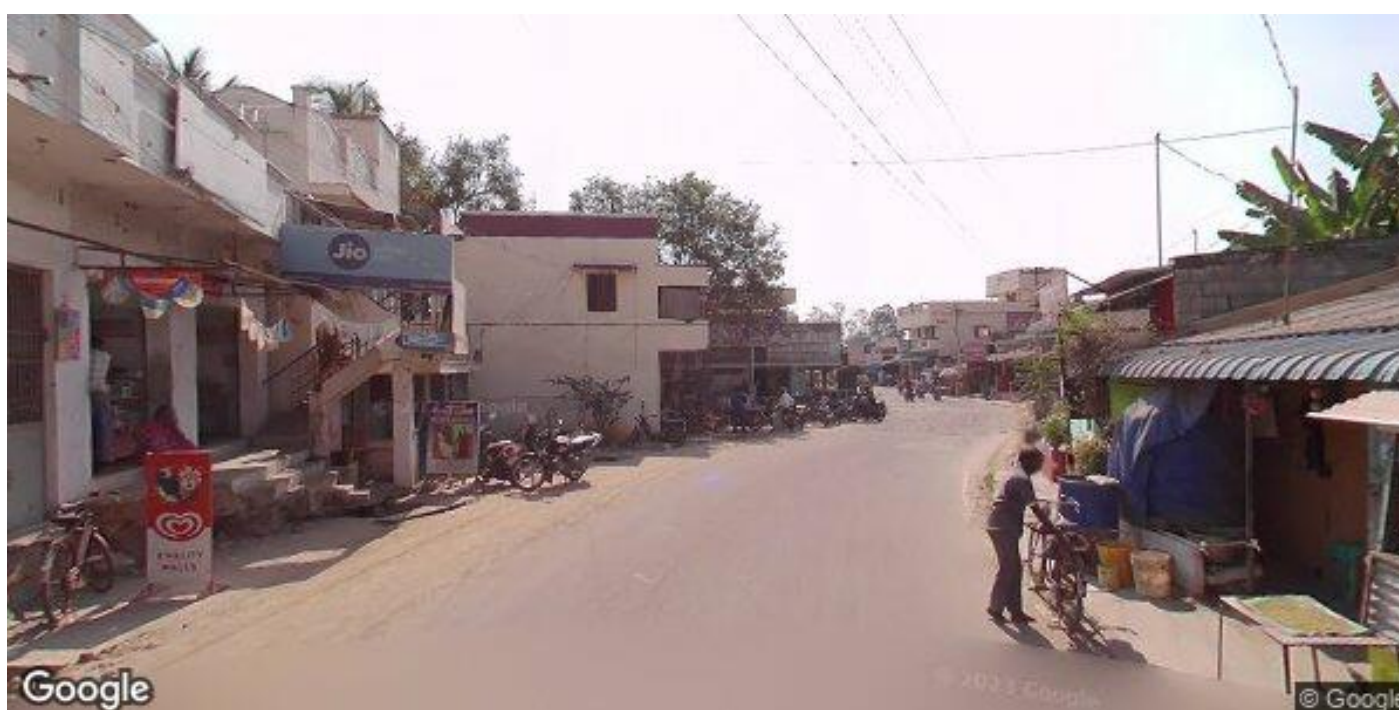
| | Risk Type | Risk Level | Coordinates | Speed Limit |
|---|---|---|---|---|
| 24 | Turn | Medium | 11.72096, 78.09476 | 30 KM/Hr |

**Risk Type:** Turn  
**Risk Level:** Medium  
**Speed Limit:** 30 KM/Hr  
**Coordinates:** 11.72096, 78.09476
