# IndianOil

## JOURNEY RISK MANAGEMENT (JRM) STUDY

### Salem Terminal to K.M.B. FUELS AND OILS

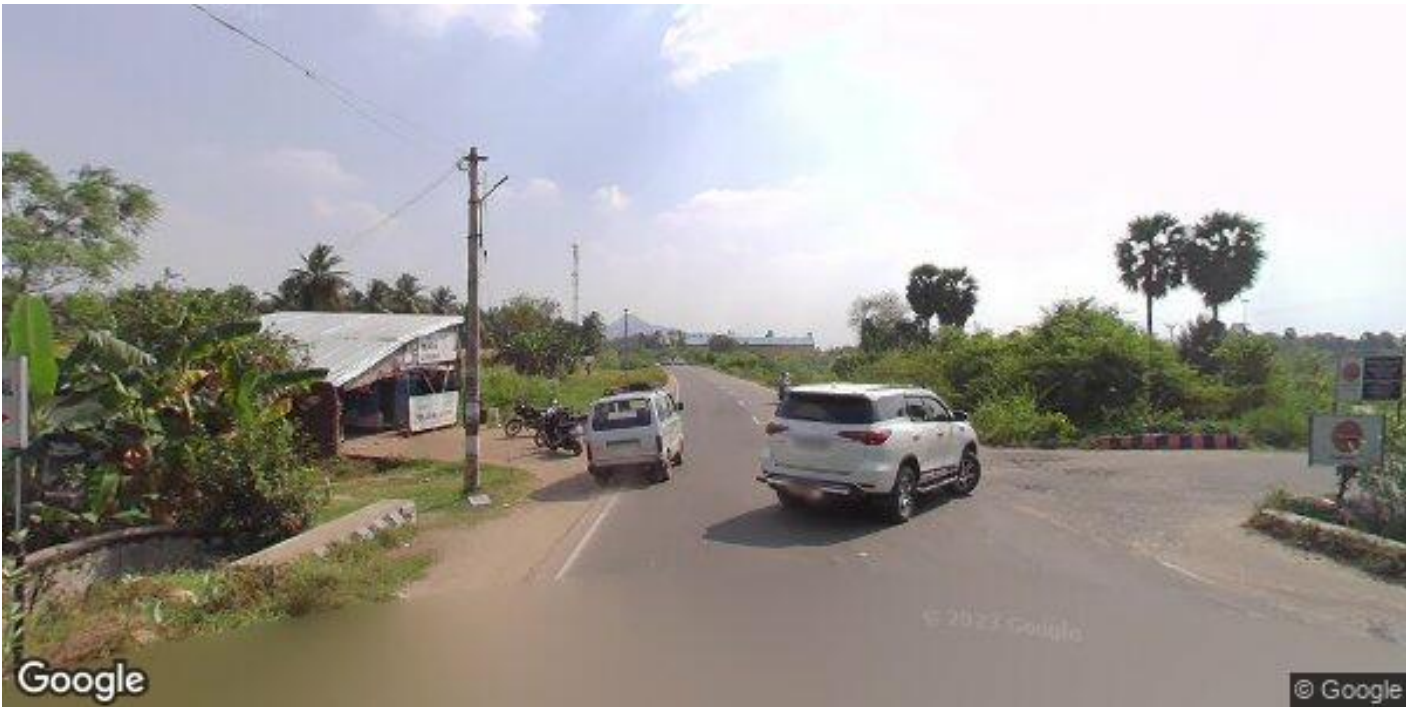
| | Risk Type | Risk Level | Coordinates | Speed Limit |
|---|---|---|---|---|
| 3 | Turn | High | 11.44029, 77.87544 | 15 KM/Hr |

**Risk Type:** Turn  
**Risk Level:** High  
**Speed Limit:** 15 KM/Hr  
**Coordinates:** 11.44029, 77.87544

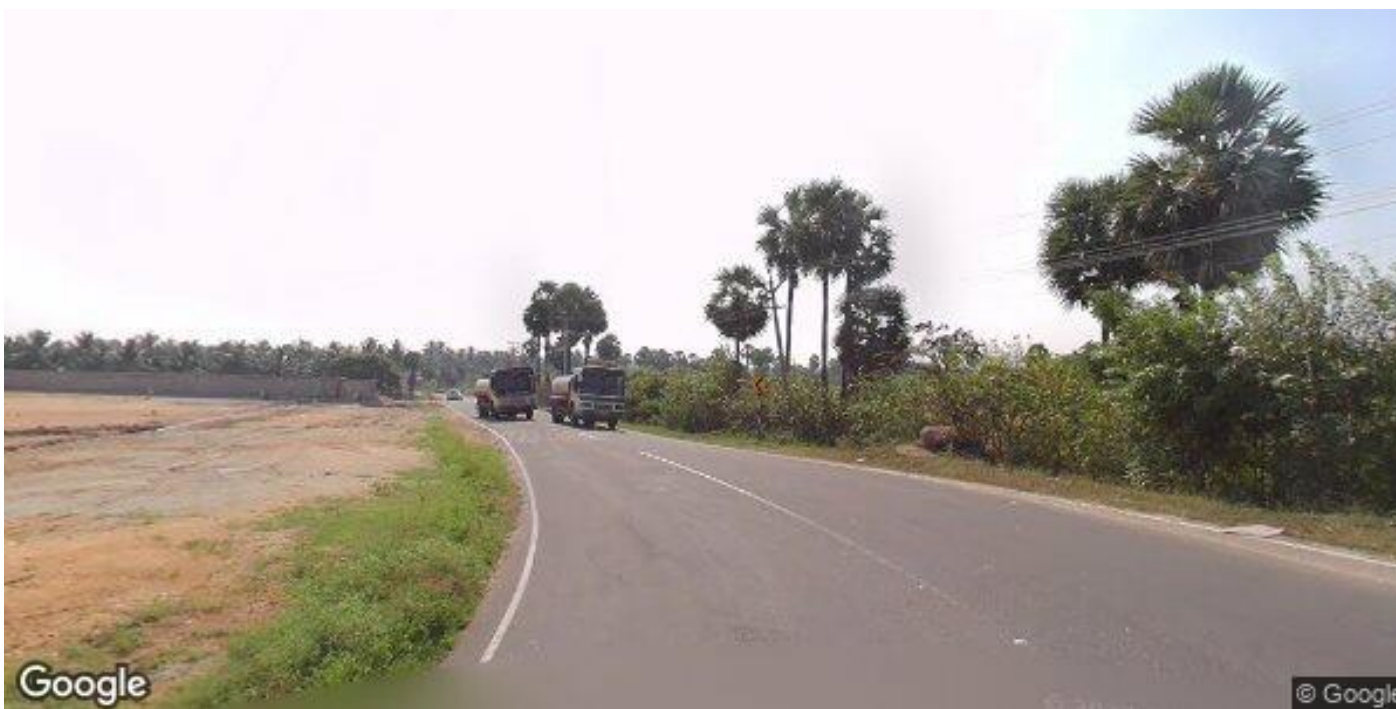
| | Risk Type | Risk Level | Coordinates | Speed Limit |
|---|---|---|---|---|
| 5 | Turn | Medium | 11.45839, 77.85143 | 30 KM/Hr |

**Risk Type:** Turn  
**Risk Level:** Medium  
**Speed Limit:** 30 KM/Hr  
**Coordinates:** 11.45839, 77.85143

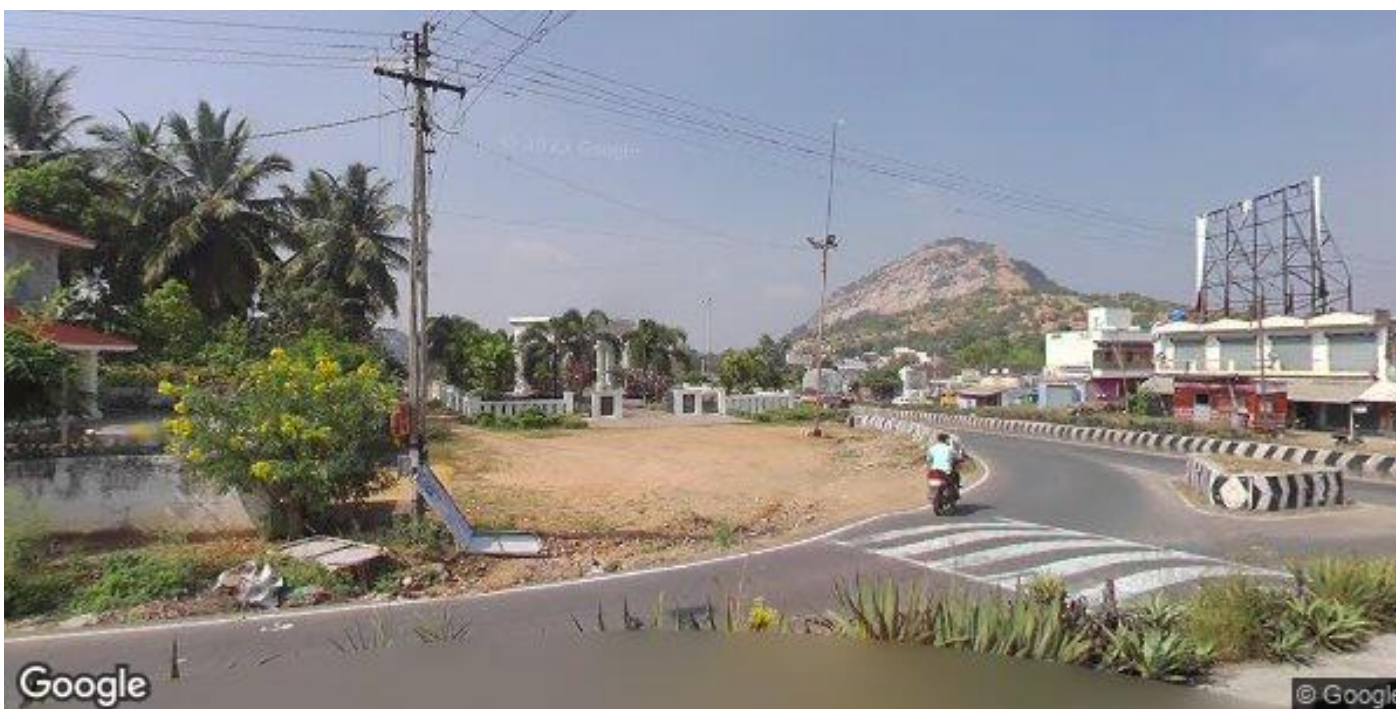
| | Risk Type | Risk Level | Coordinates | Speed Limit |
|---|---|---|---|---|
| 6 | Turn | Medium | 11.46307, 77.84941 | 30 KM/Hr |

**Risk Type:** Turn  
**Risk Level:** Medium  
**Speed Limit:** 30 KM/Hr  
**Coordinates:** 11.46307, 77.84941

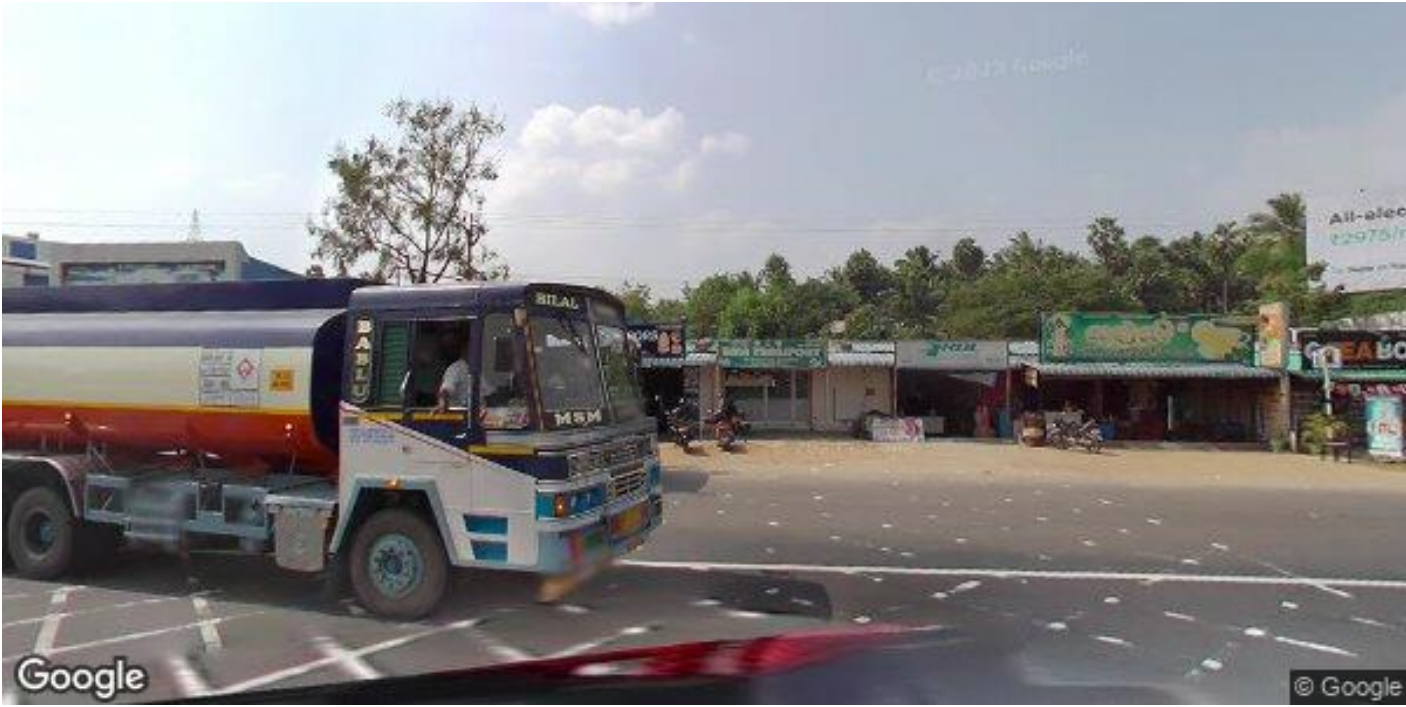
| | Risk Type | Risk Level | Coordinates | Speed Limit |
|---|---|---|---|---|
| 10 | Turn | Medium | 11.64510, 78.12033 | 30 KM/Hr |

**Risk Type:** Turn  
**Risk Level:** Medium  
**Speed Limit:** 30 KM/Hr  
**Coordinates:** 11.64510, 78.12033

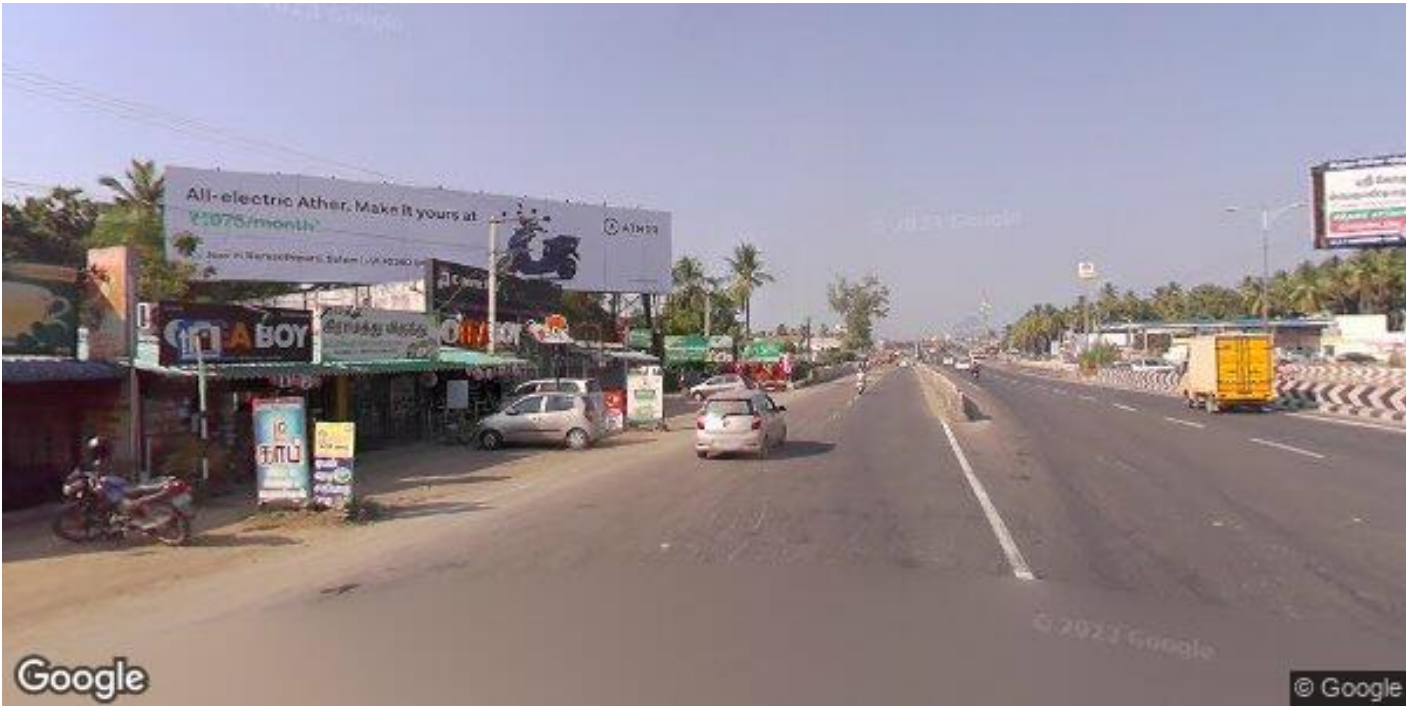
| | Risk Type | Risk Level | Coordinates | Speed Limit |
|---|---|---|---|---|
| 11 | Turn | Medium | 11.64518, 78.12029 | 30 KM/Hr |

**Risk Type:** Turn  
**Risk Level:** Medium  
**Speed Limit:** 30 KM/Hr  
**Coordinates:** 11.64518, 78.12029

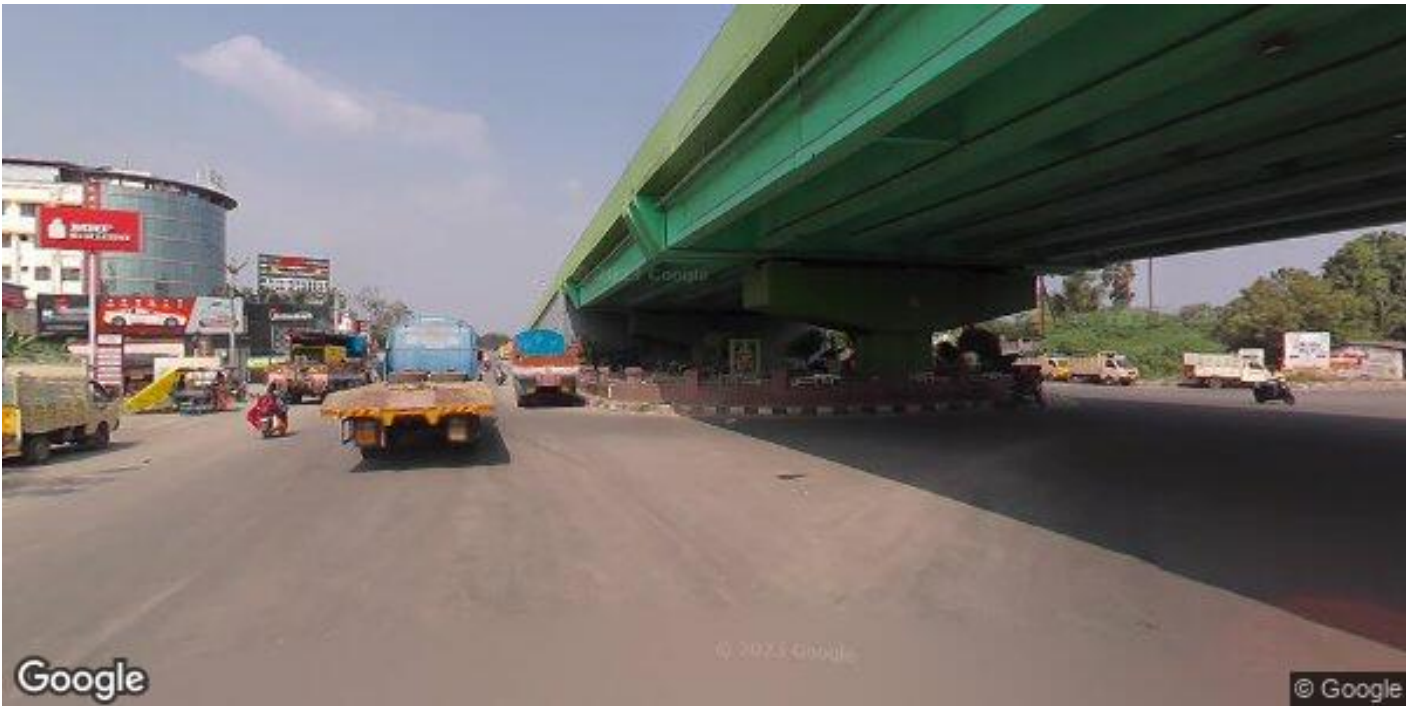
| | Risk Type | Risk Level | Coordinates | Speed Limit |
|---|---|---|---|---|
| 12 | Turn | High | 11.64970, 78.12064 | 15 KM/Hr |

**Risk Type:** Turn  
**Risk Level:** High  
**Speed Limit:** 15 KM/Hr  
**Coordinates:** 11.64970, 78.12064

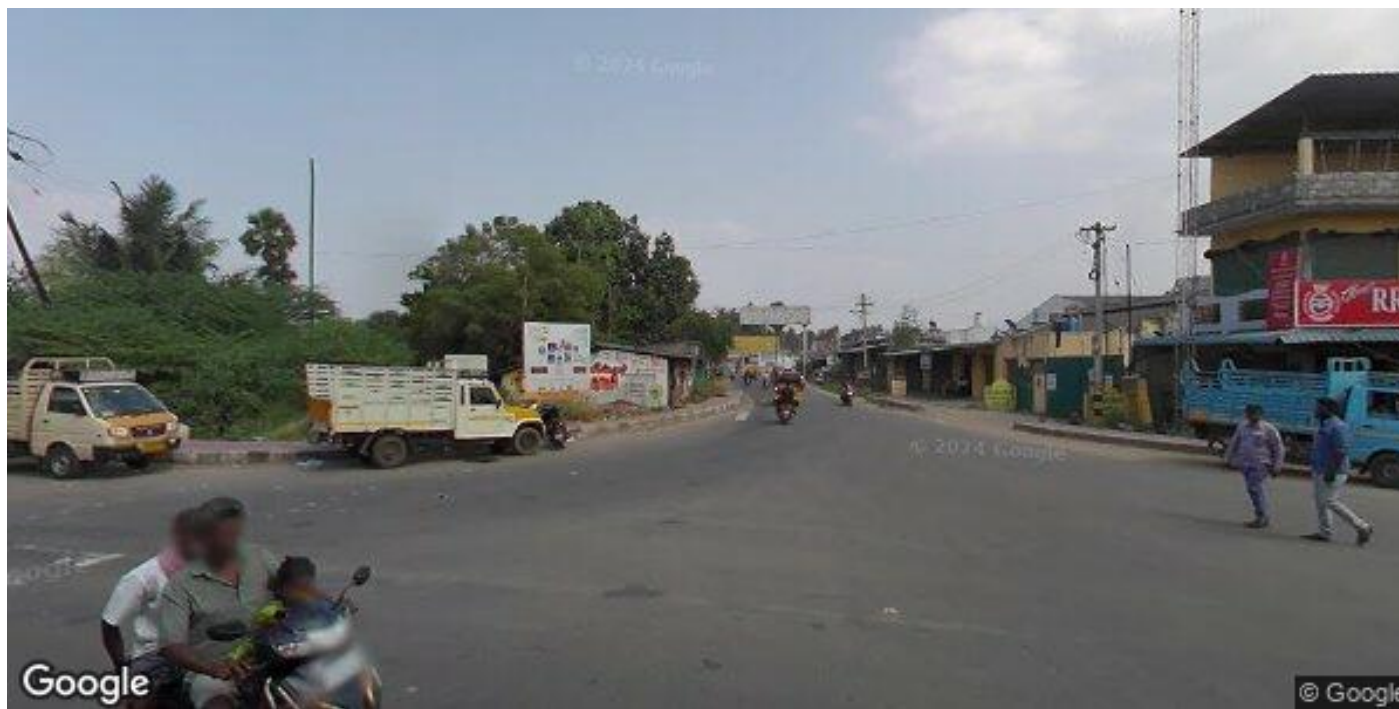
| | Risk Type | Risk Level | Coordinates | Speed Limit |
|---|---|---|---|---|
| 13 | Turn | Medium | 11.64986, 78.12096 | 30 KM/Hr |

**Risk Type:** Turn  
**Risk Level:** Medium  
**Speed Limit:** 30 KM/Hr  
**Coordinates:** 11.64986, 78.12096

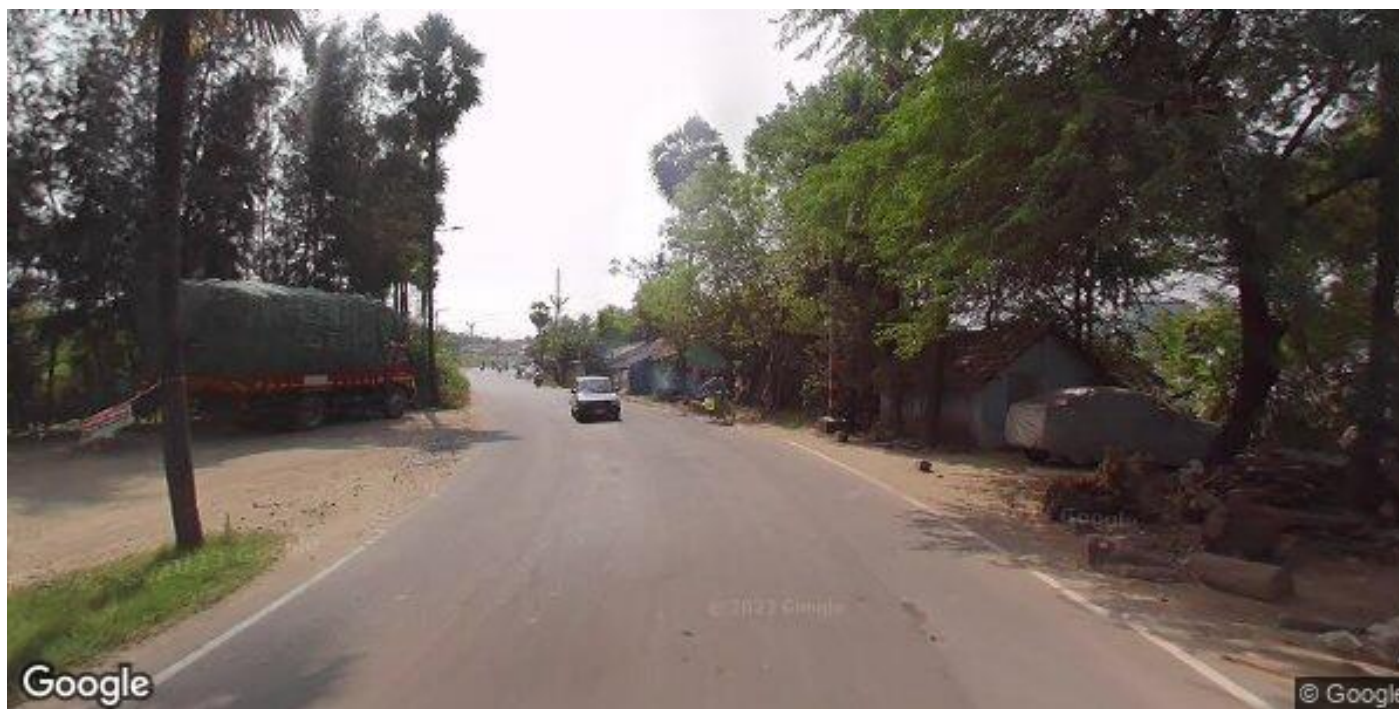
| | Risk Type | Risk Level | Coordinates | Speed Limit |
|---|---|---|---|---|
| 14 | Turn | Medium | 11.65102, 78.12280 | 30 KM/Hr |

**Risk Type:** Turn  
**Risk Level:** Medium  
**Speed Limit:** 30 KM/Hr  
**Coordinates:** 11.65102, 78.12280

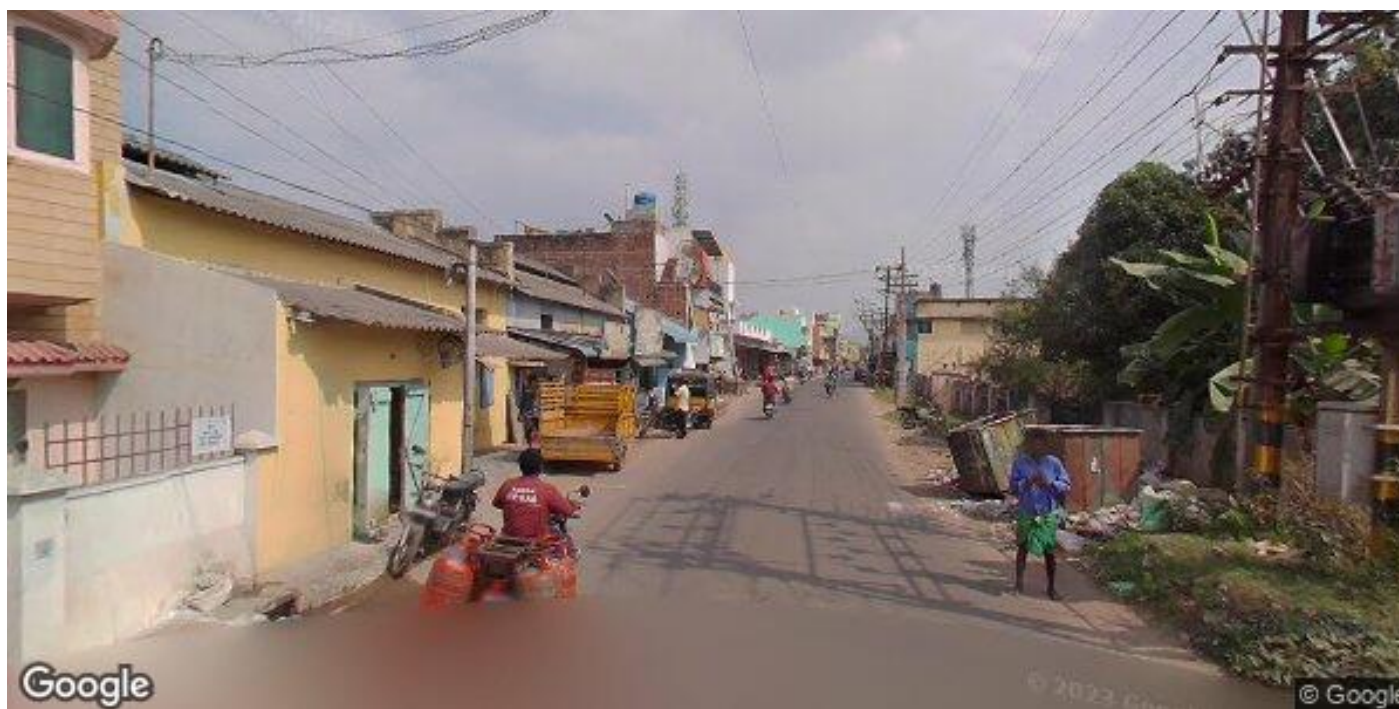
| | Risk Type | Risk Level | Coordinates | Speed Limit |
|---|---|---|---|---|
| 15 | Blind Spot | Blind Spot | 11.65293, 78.13182 | 10 KM/Hr |

**Risk Type:** Blind Spot  
**Risk Level:** Blind Spot  
**Speed Limit:** 10 KM/Hr  
**Coordinates:** 11.65293, 78.13182
