# IndianOil

## JOURNEY RISK MANAGEMENT (JRM) STUDY

### Salem Terminal to SRI VENKATESHWARA AGENCIES

### Route Safety Analysis Report

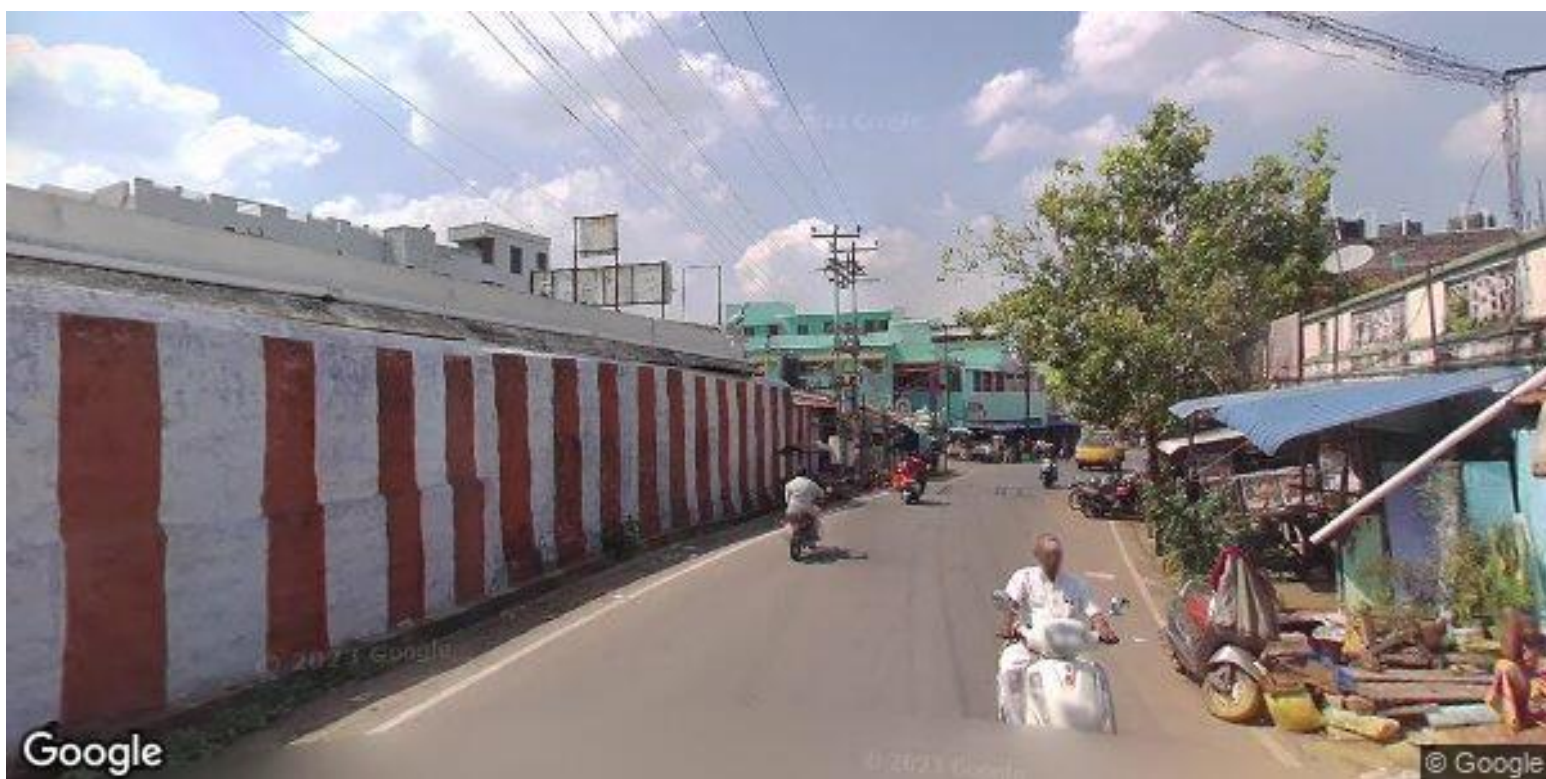
**Coordinates:** 11.37809, 77.89834

**Risk Type:** Turn

**Risk Level:** Medium

**Speed Limit:** 30 KM/Hr

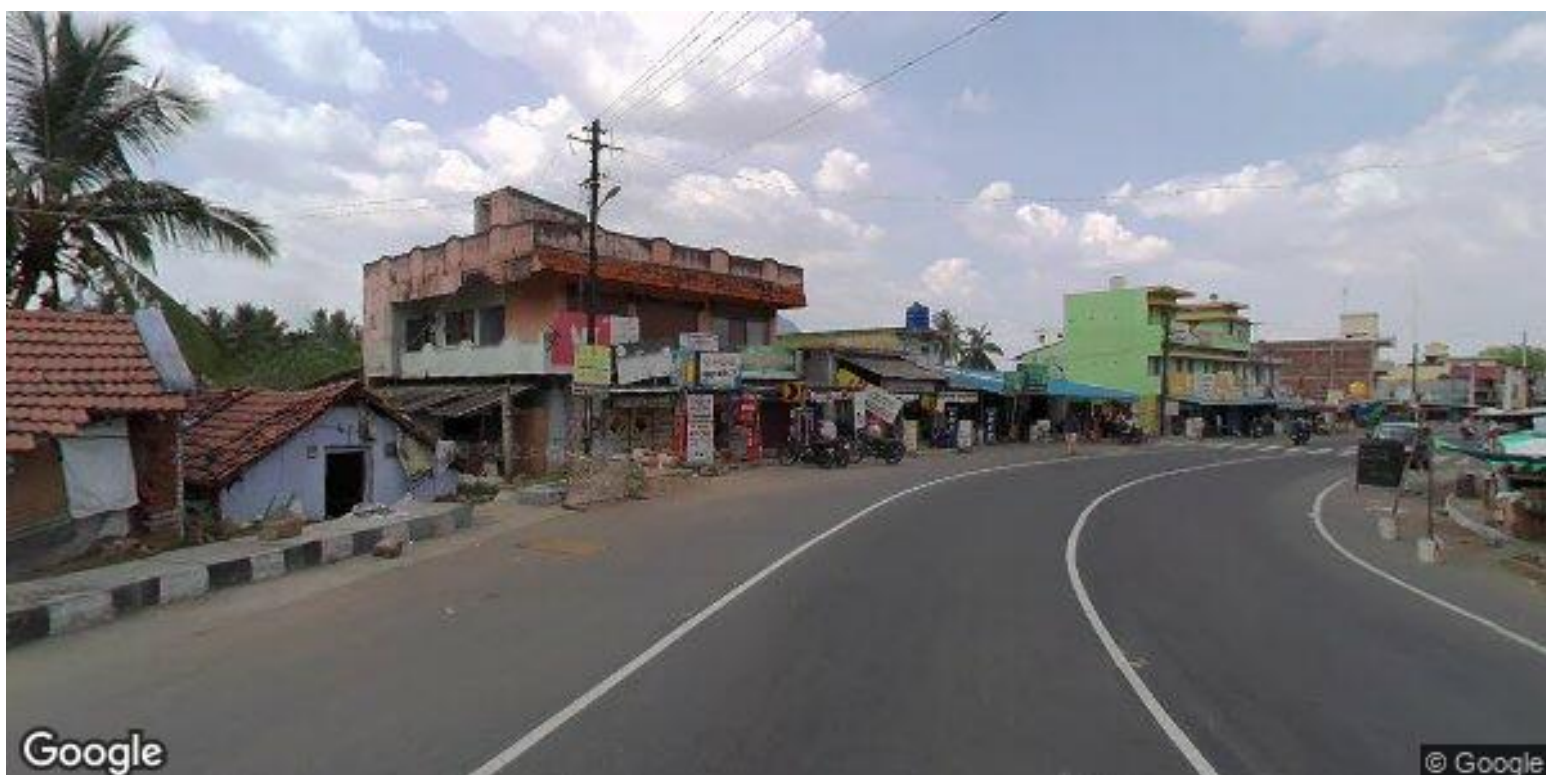
**Risk Type:** Turn  
**Risk Level:** High  
**Speed Limit:** 15 KM/Hr  
**Coordinates:** 11.41466, 78.08070

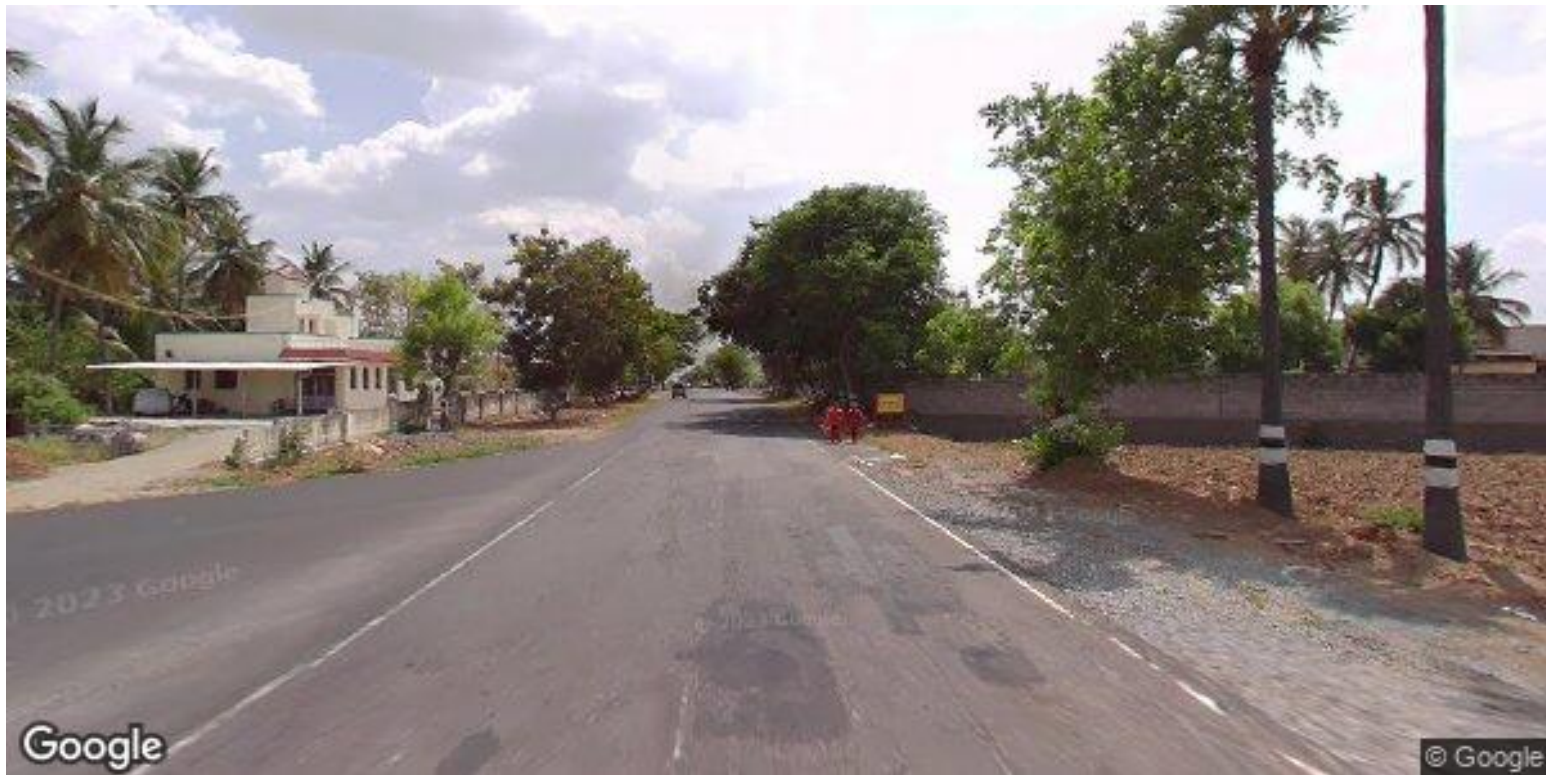
**Risk Type:** Turn  
**Risk Level:** High  
**Speed Limit:** 15 KM/Hr  
**Coordinates:** 11.42962, 78.11578

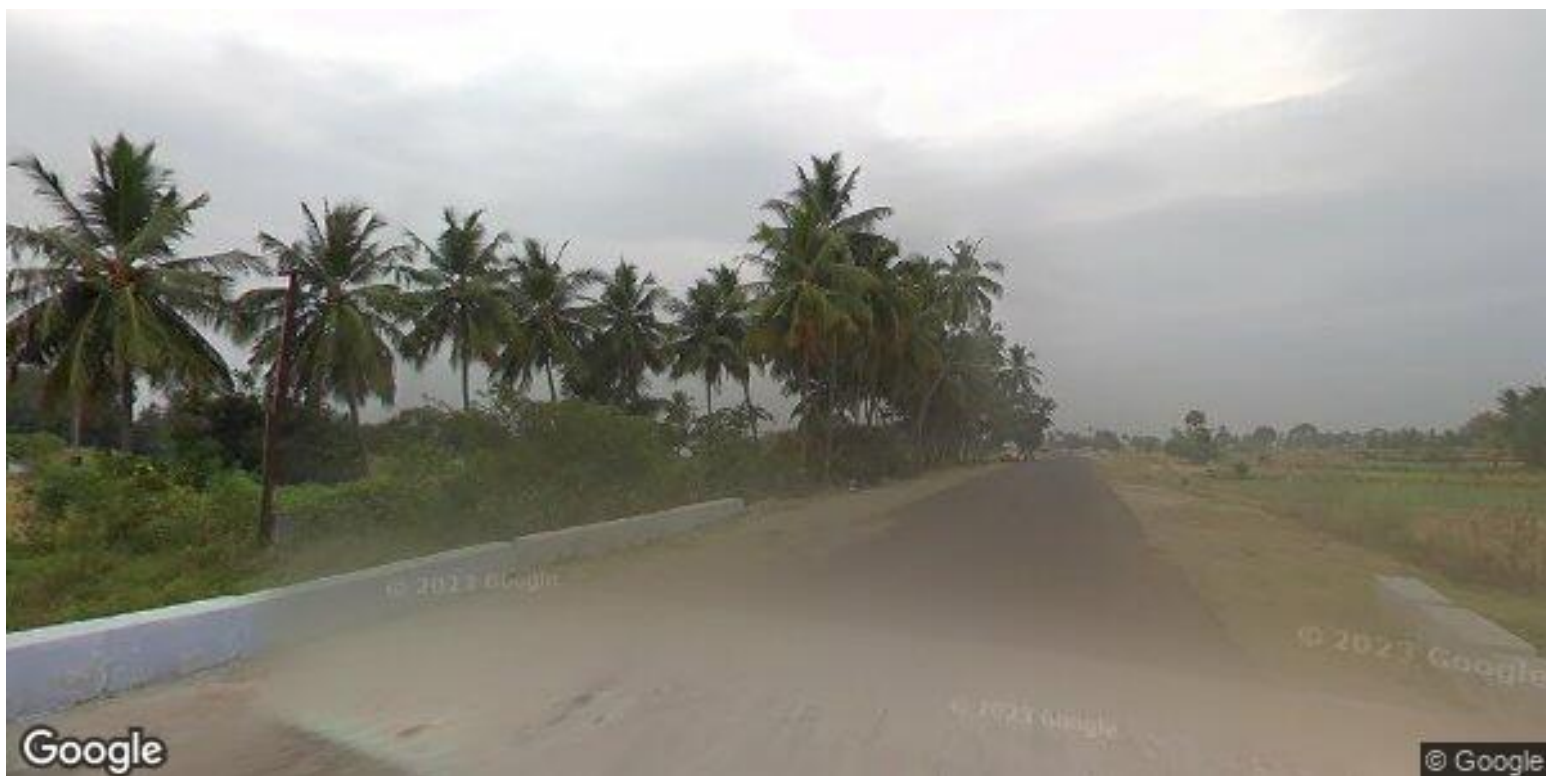
**Risk Type:** Turn  
**Risk Level:** Medium  
**Speed Limit:** 30 KM/Hr  
**Coordinates:** 11.42450, 78.15278

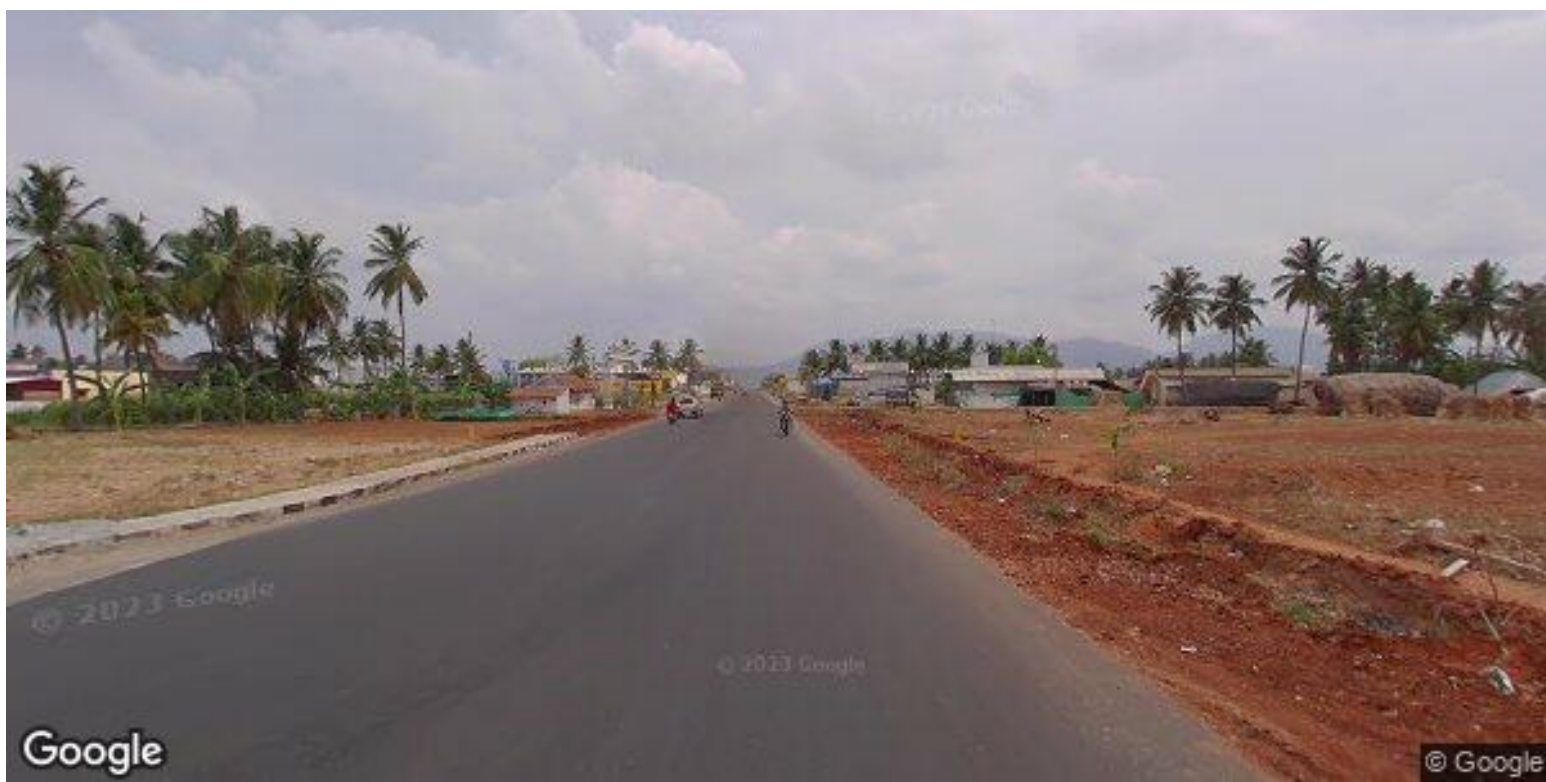
**Risk Type:** Blind Spot  
**Risk Level:** Blind Spot  
**Speed Limit:** 10 KM/Hr  
**Coordinates:** 11.43542, 78.20754

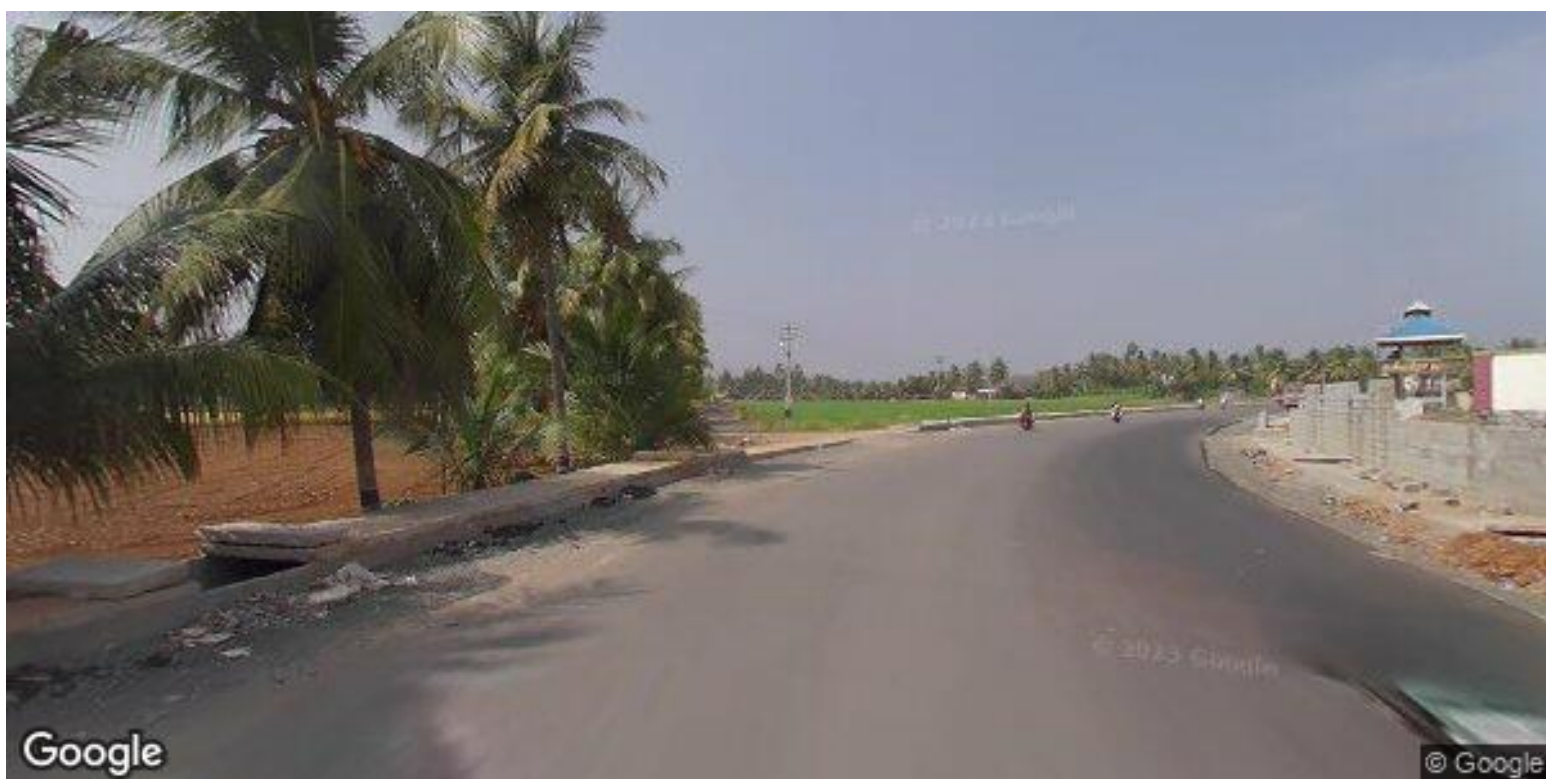
**Risk Type:** Turn  
**Risk Level:** Medium  
**Speed Limit:** 30 KM/Hr  
**Coordinates:** 11.43035, 78.20865

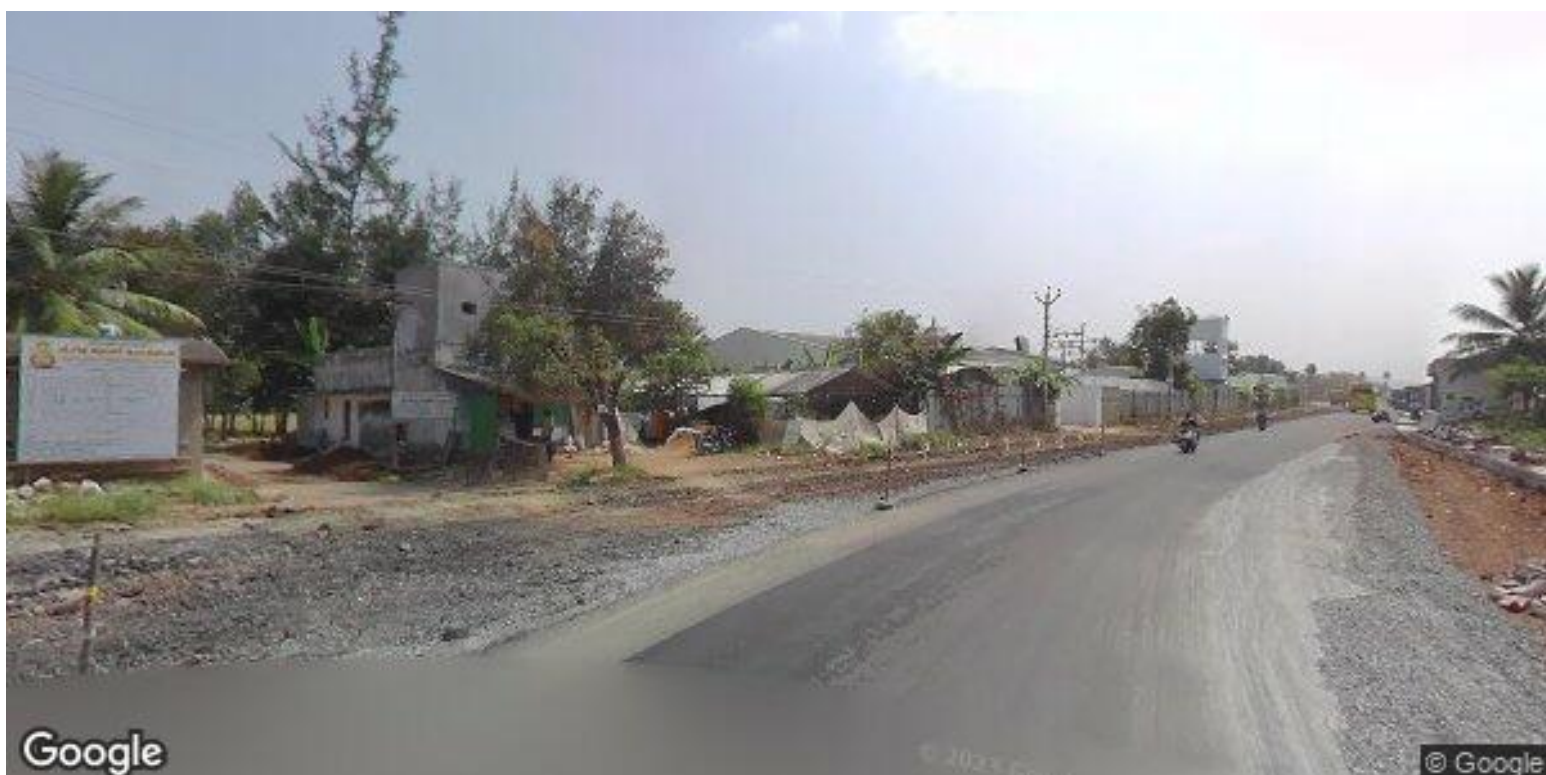
**Risk Type:** Turn  
**Risk Level:** Medium  
**Speed Limit:** 30 KM/Hr  
**Coordinates:** 11.42167, 78.21705

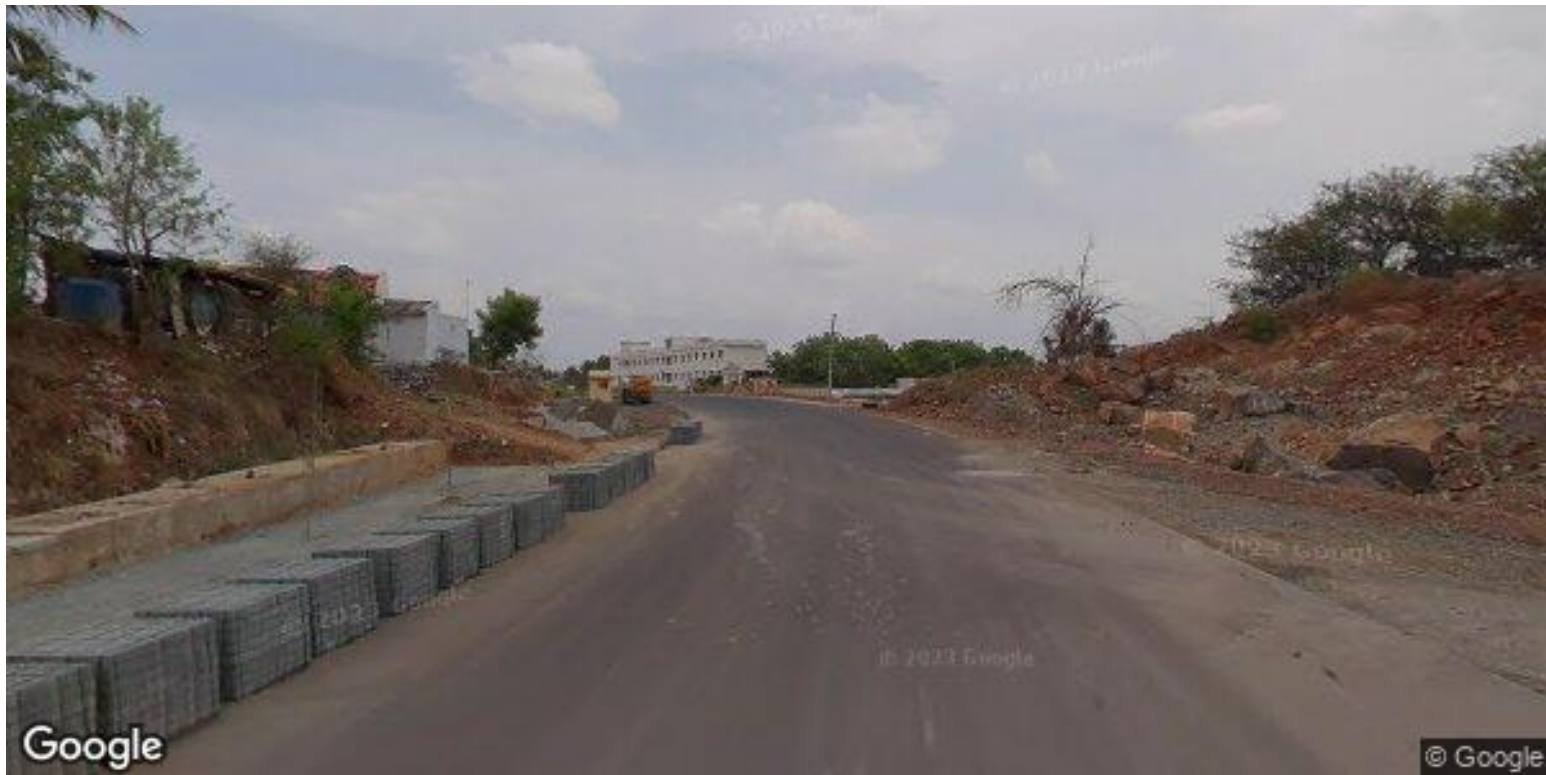
**Risk Type:** Turn  
**Risk Level:** Medium  
**Speed Limit:** 30 KM/Hr  
**Coordinates:** 11.39642, 78.25111

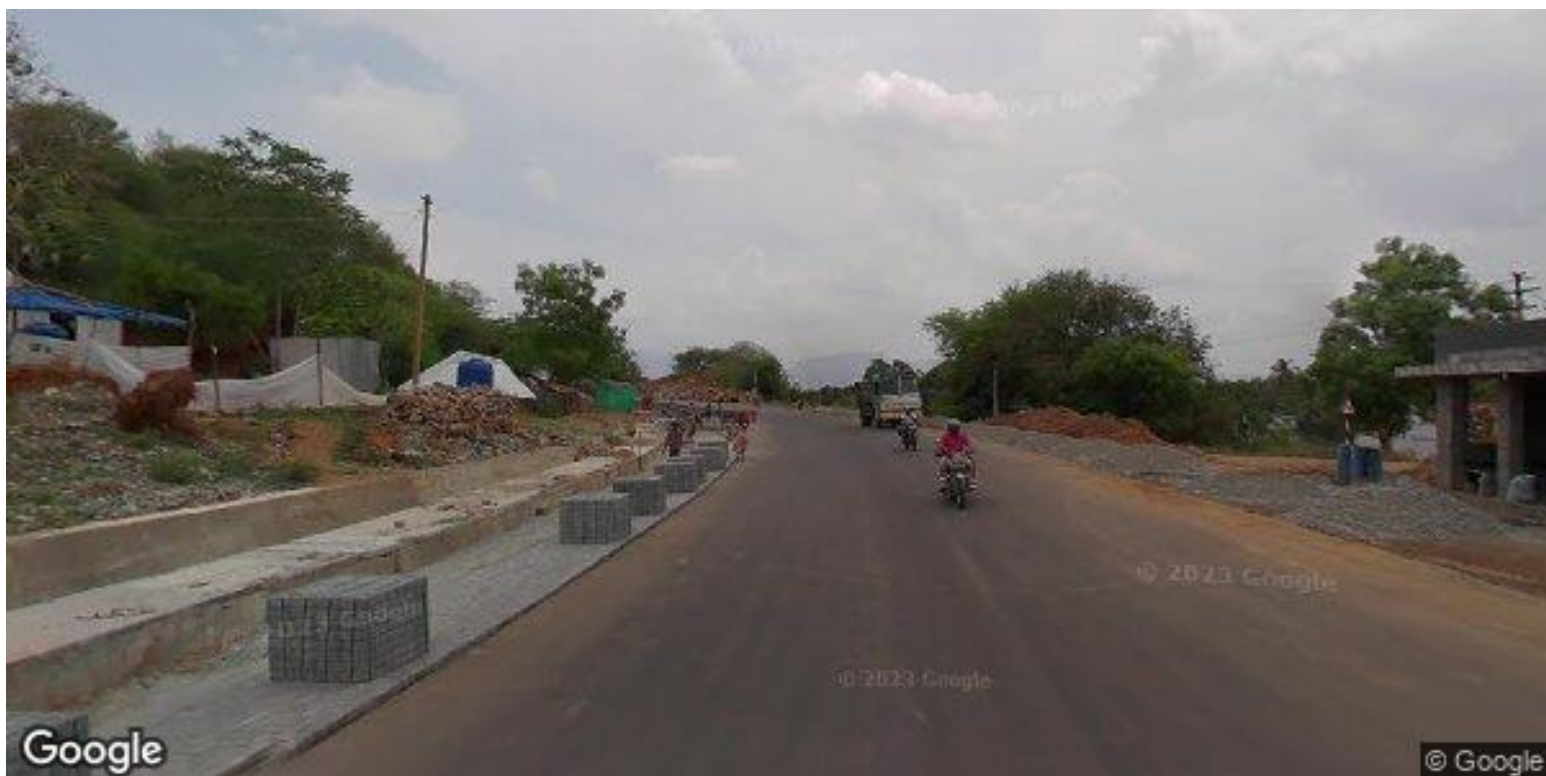
**Risk Type:** Turn  
**Risk Level:** Medium  
**Speed Limit:** 30 KM/Hr  
**Coordinates:** 11.39536, 78.25156

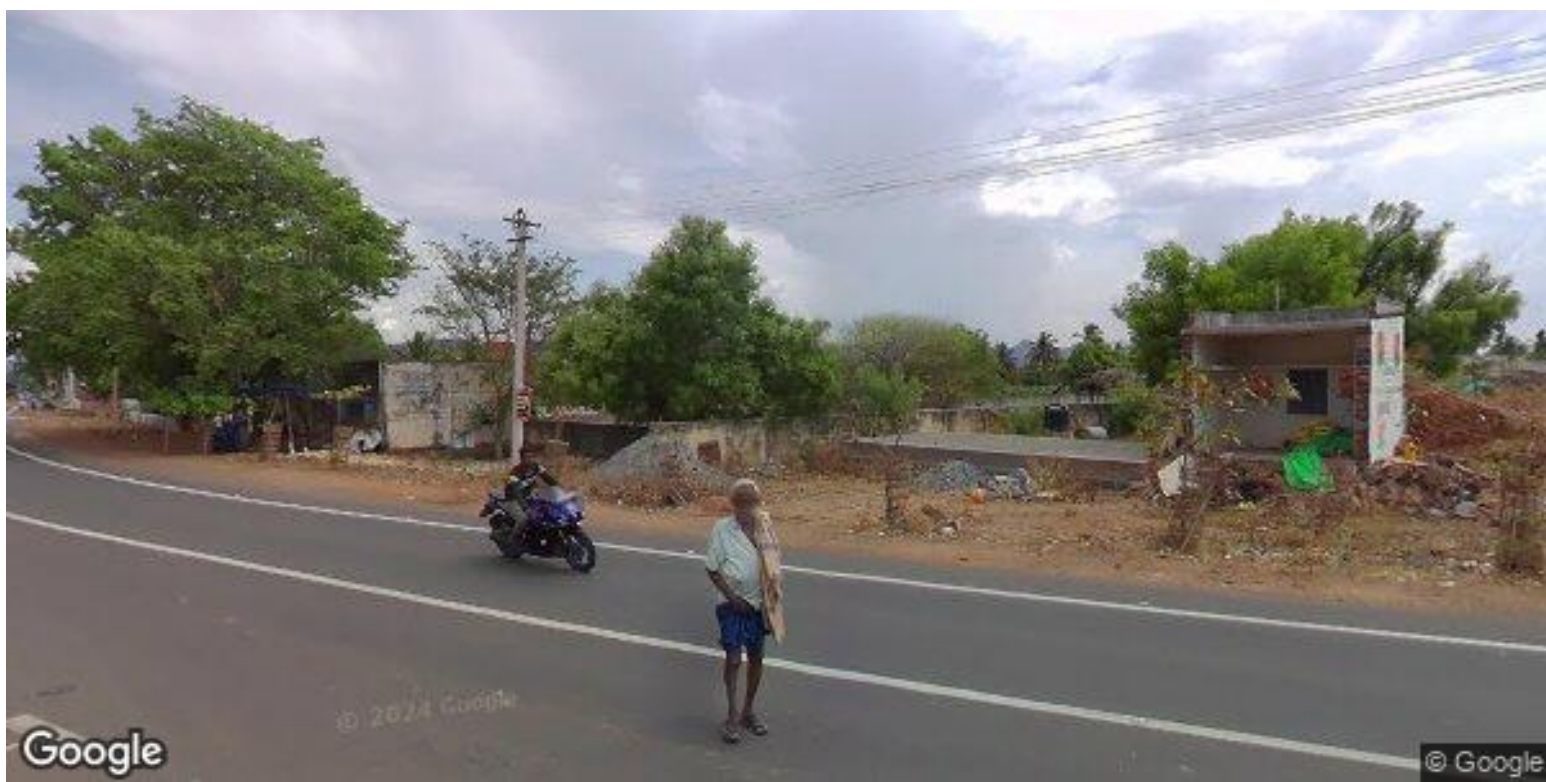
**Coordinates:** 11.38226, 78.25407

**Risk Type:** Turn

**Risk Level:** Medium

**Speed Limit:** 30 KM/Hr

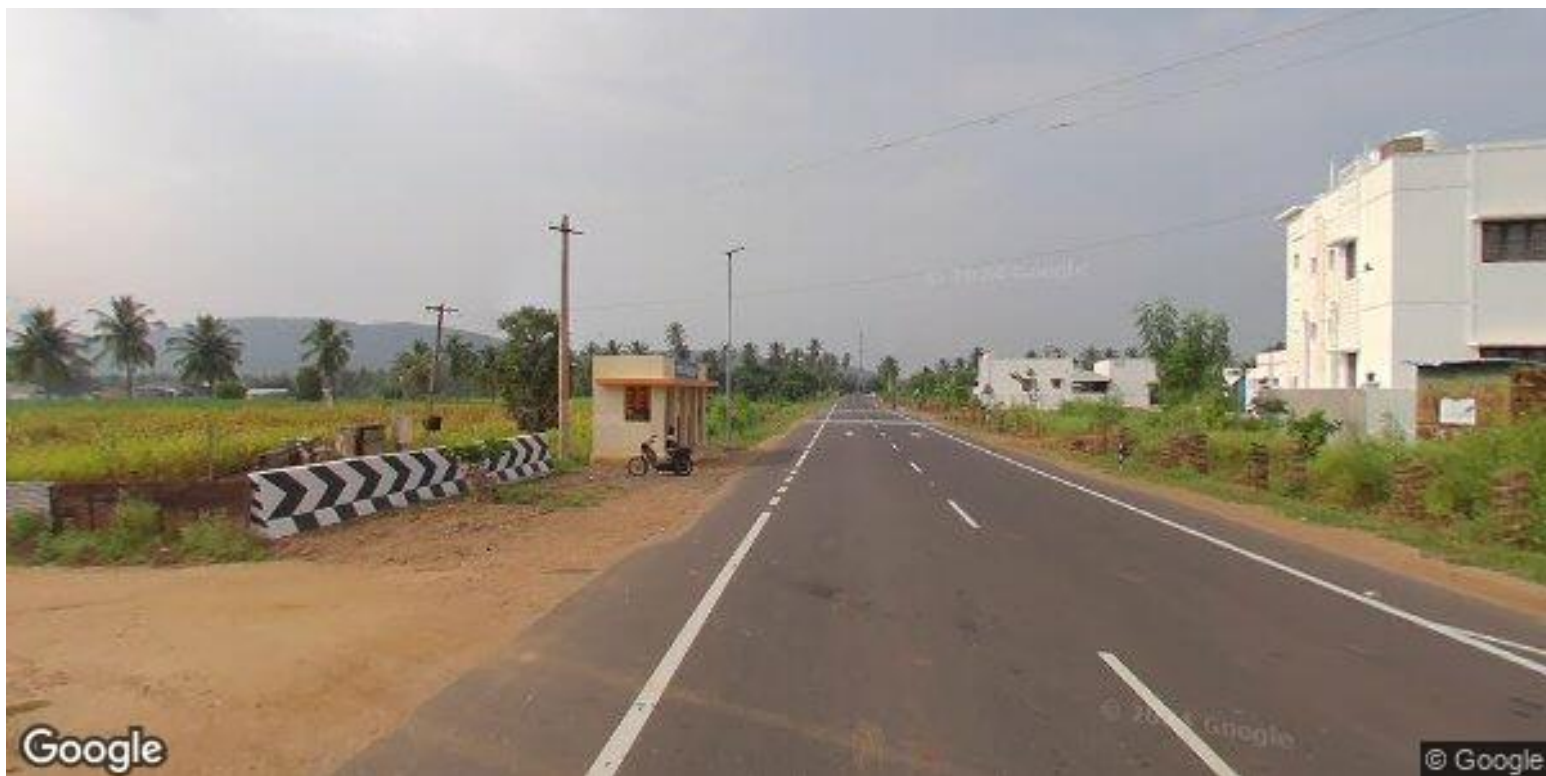
**Coordinates:** 11.37644, 78.25558

**Risk Type:** Turn

**Risk Level:** High

**Speed Limit:** 15 KM/Hr
