# IndianOil

## **JOURNEY RISK MANAGEMENT (JRM) STUDY**

### **Salem Terminal to BHAVANI KOMARAPALAYAM LORRY**

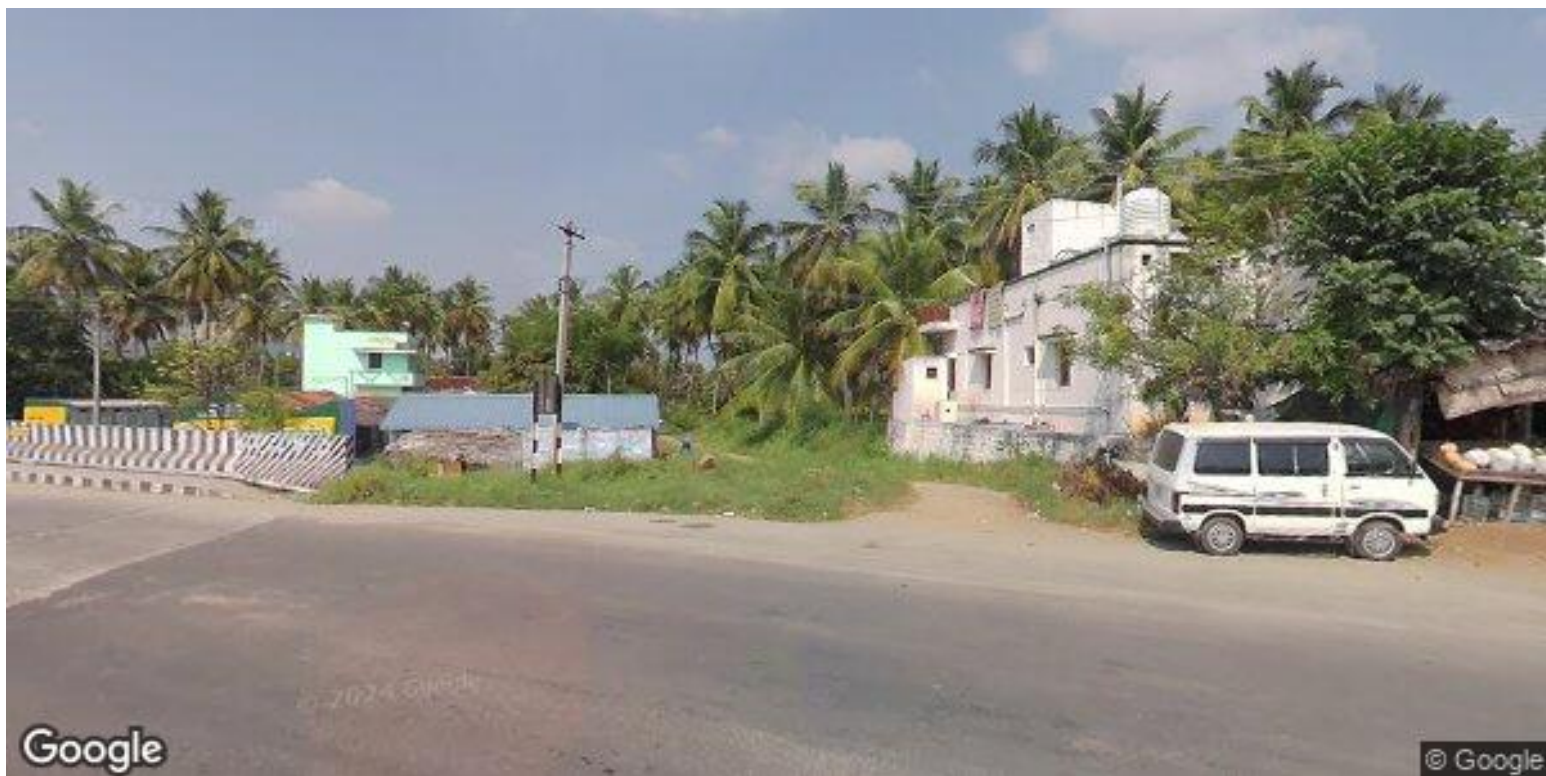
**Coordinates:** 11.44898, 77.87410

**Risk Type:** Turn

**Risk Level:** Medium

**Speed Limit:** 30 KM/Hr

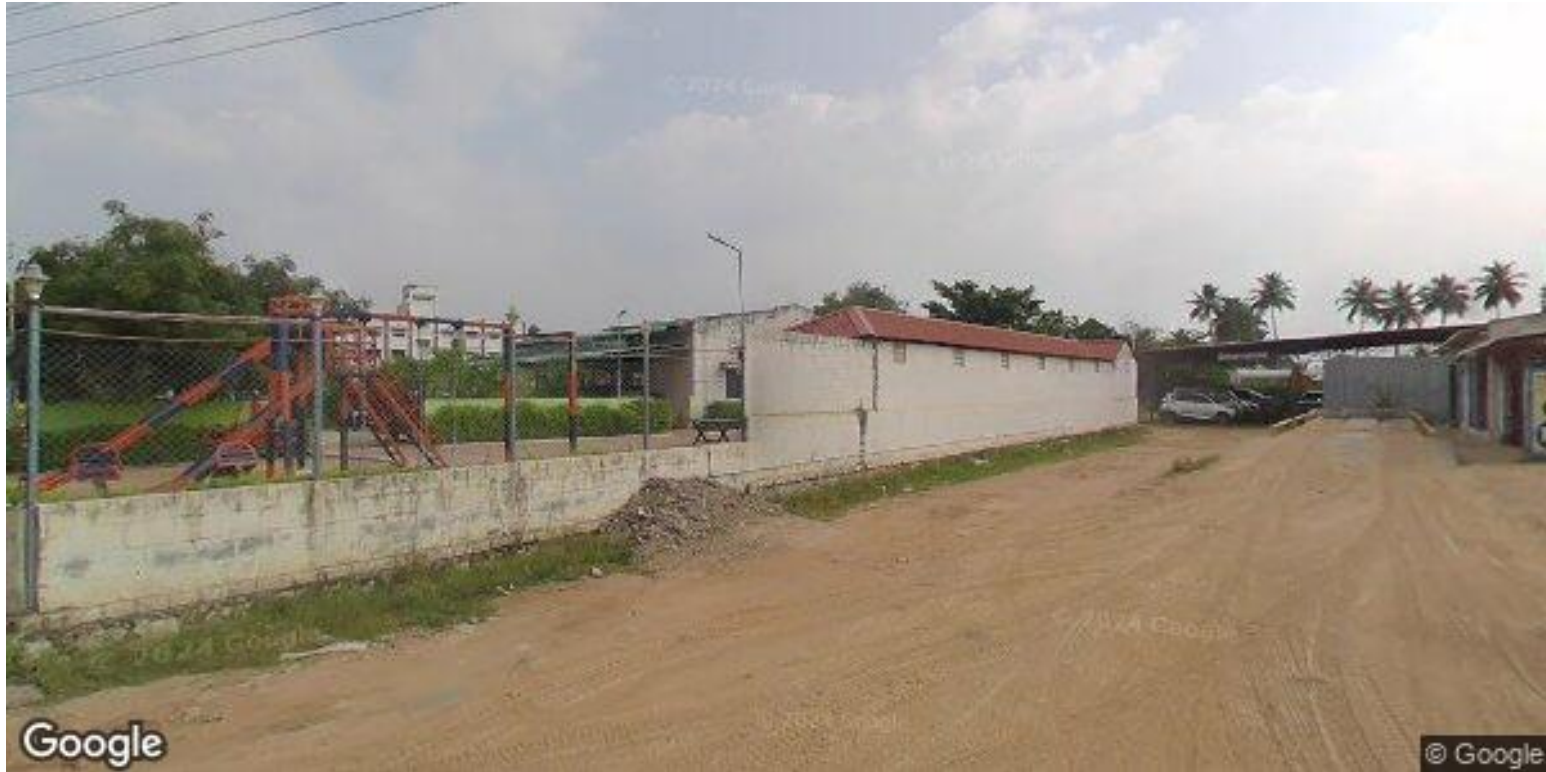
**Risk Type:** Turn  
**Risk Level:** High  
**Speed Limit:** 15 KM/Hr  
**Coordinates:** 11.44377, 77.71562

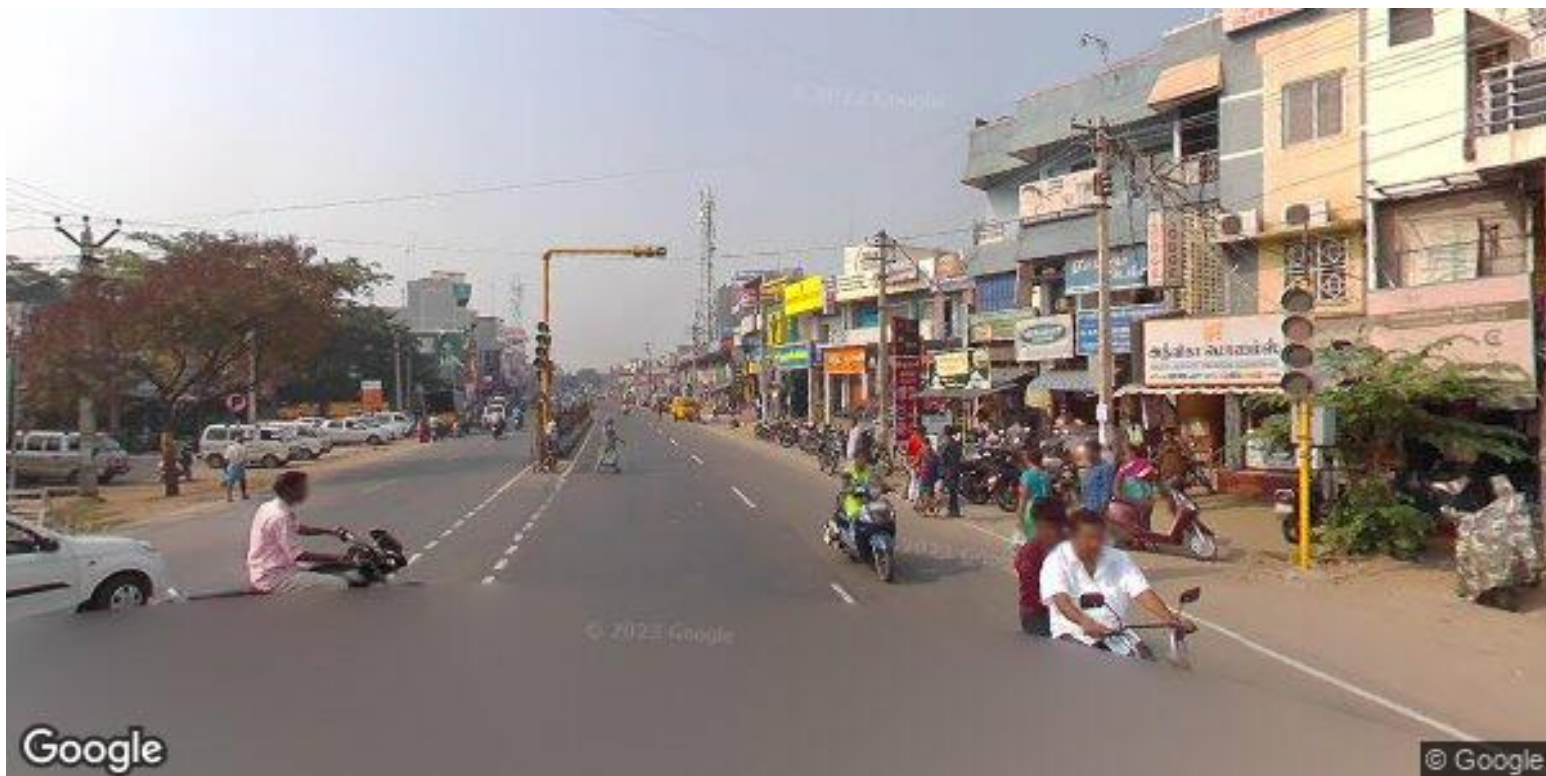
**Coordinates:** 11.45331, 77.68803

**Risk Type:** Turn

**Risk Level:** High

**Speed Limit:** 15 KM/Hr

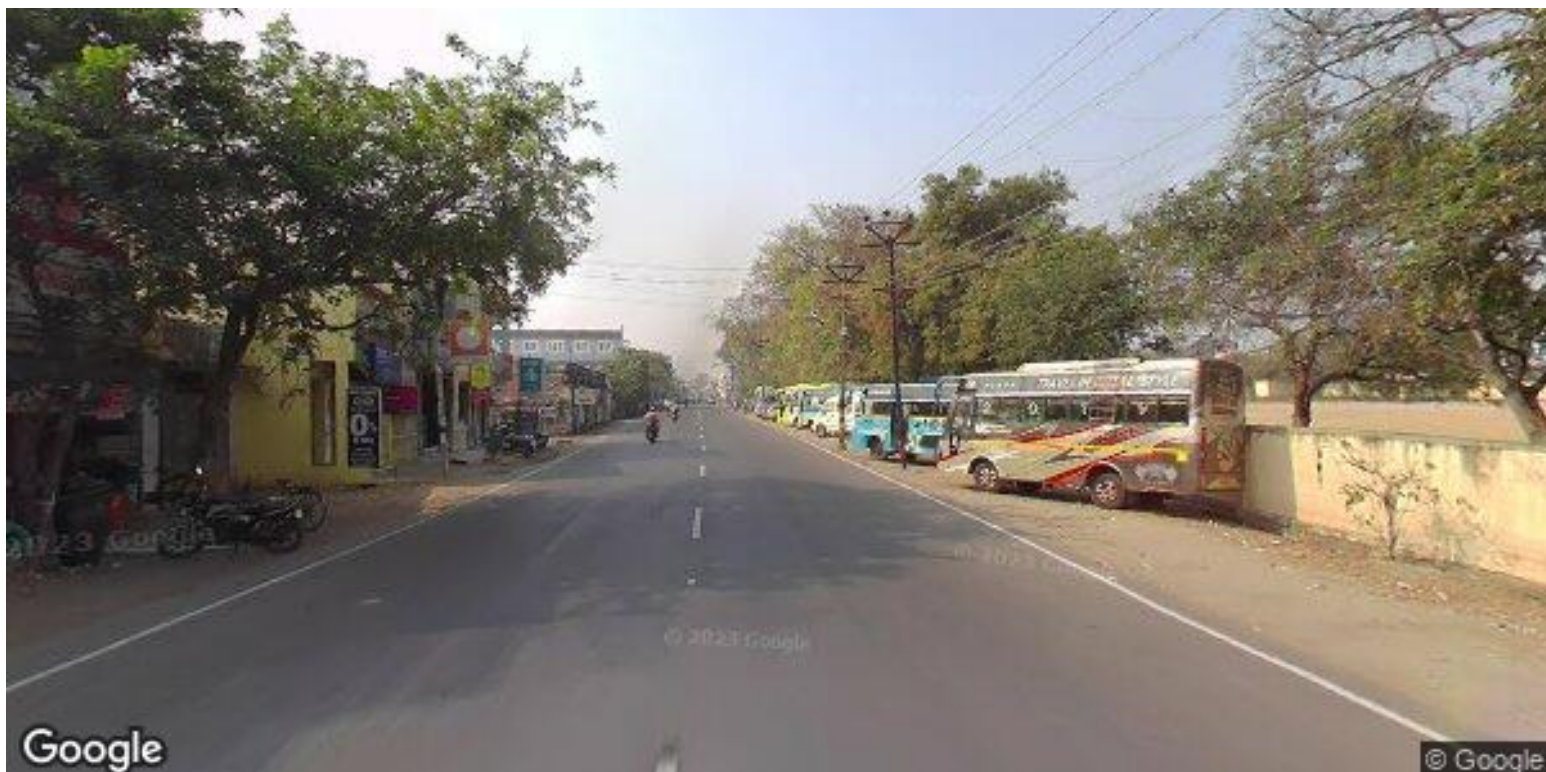
**Risk Type:** Blind Spot  
**Risk Level:** Blind Spot  
**Speed Limit:** 10 KM/Hr  
**Coordinates:** 11.44979, 77.68549

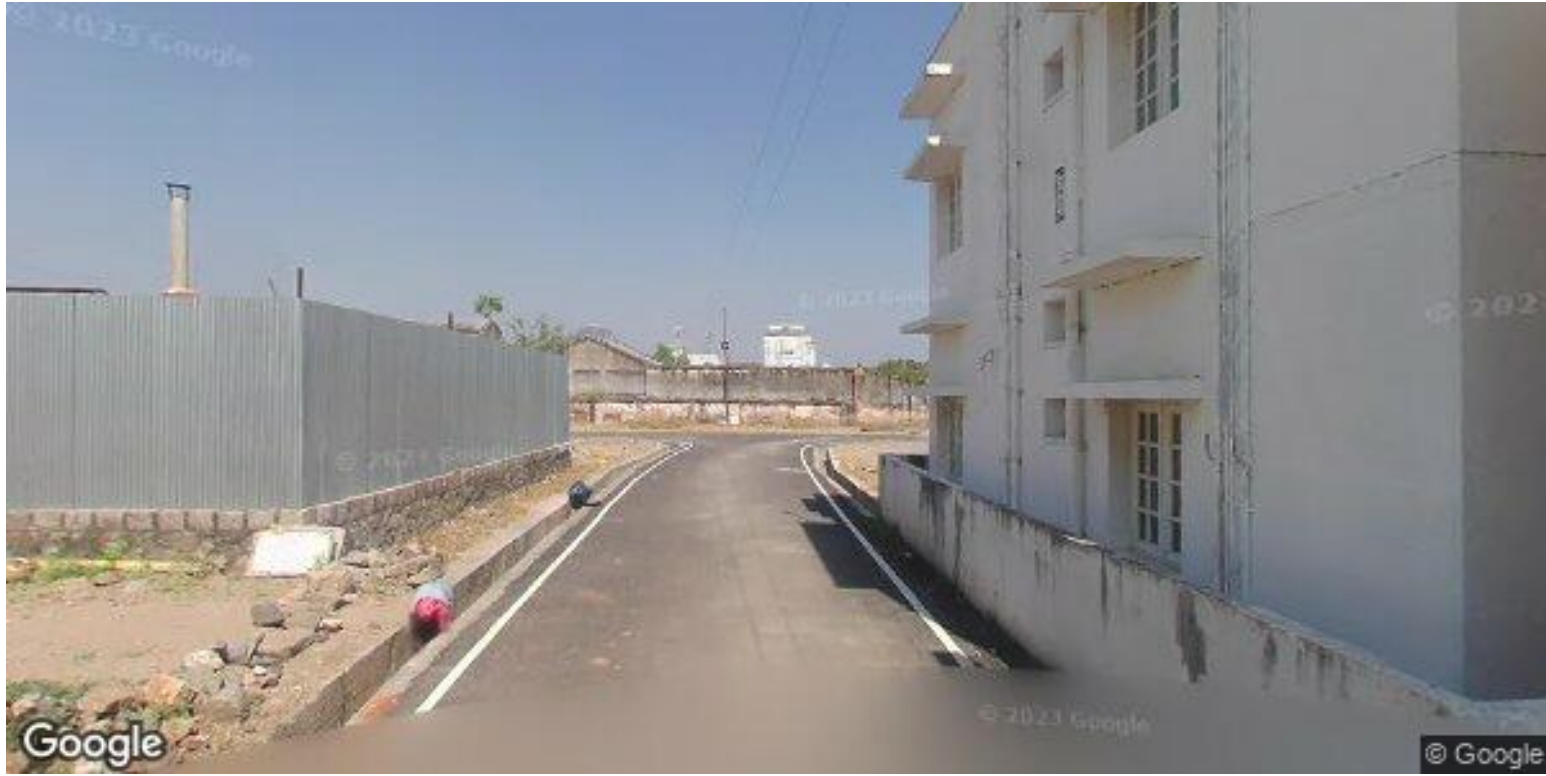
**Risk Type:** Turn  
**Risk Level:** High  
**Speed Limit:** 15 KM/Hr  
**Coordinates:** 11.44947, 77.68646

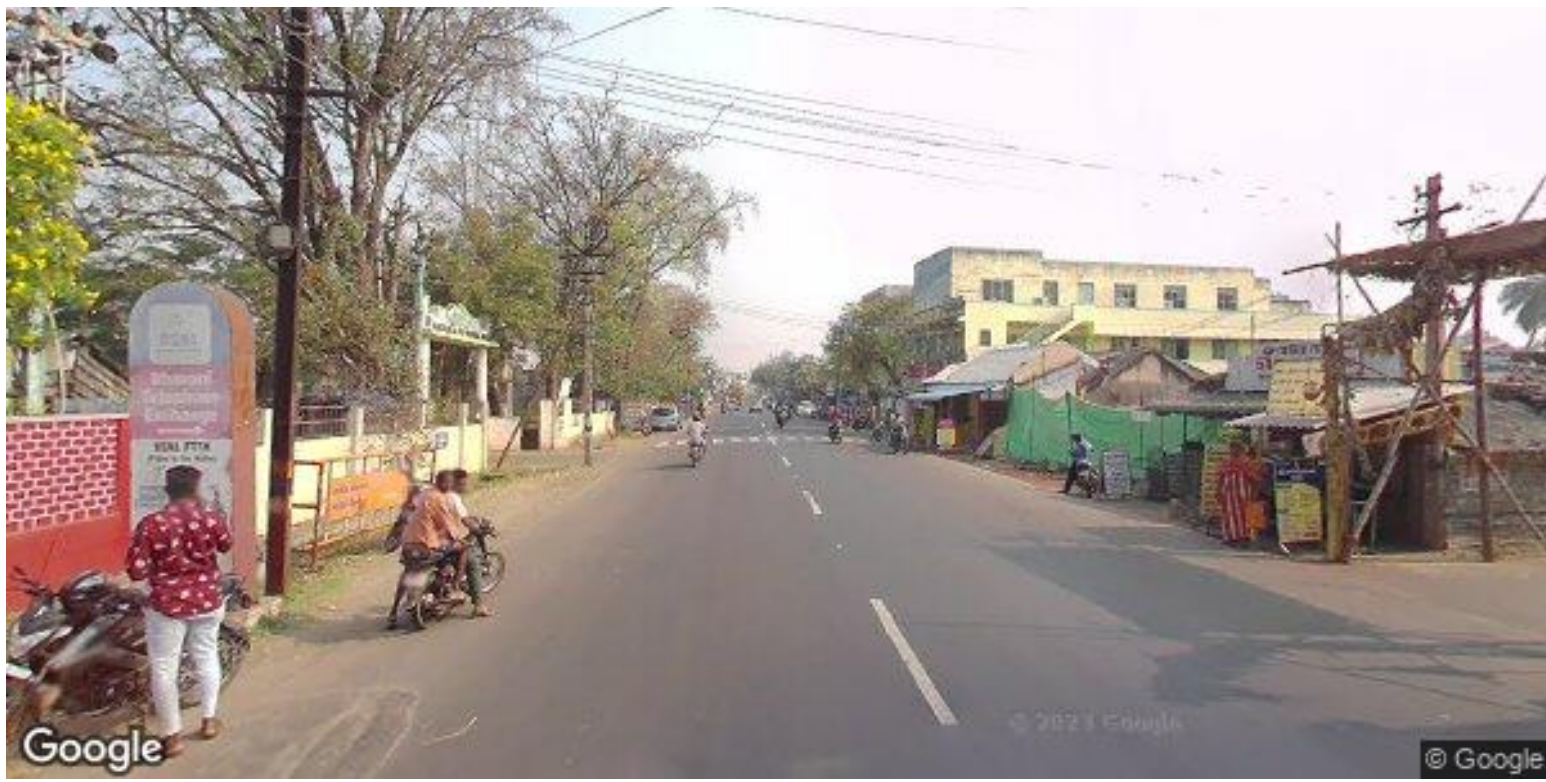
**Coordinates:** 11.44842, 77.68473

**Risk Type:** Blind Spot

**Risk Level:** Blind Spot

**Speed Limit:** 10 KM/Hr

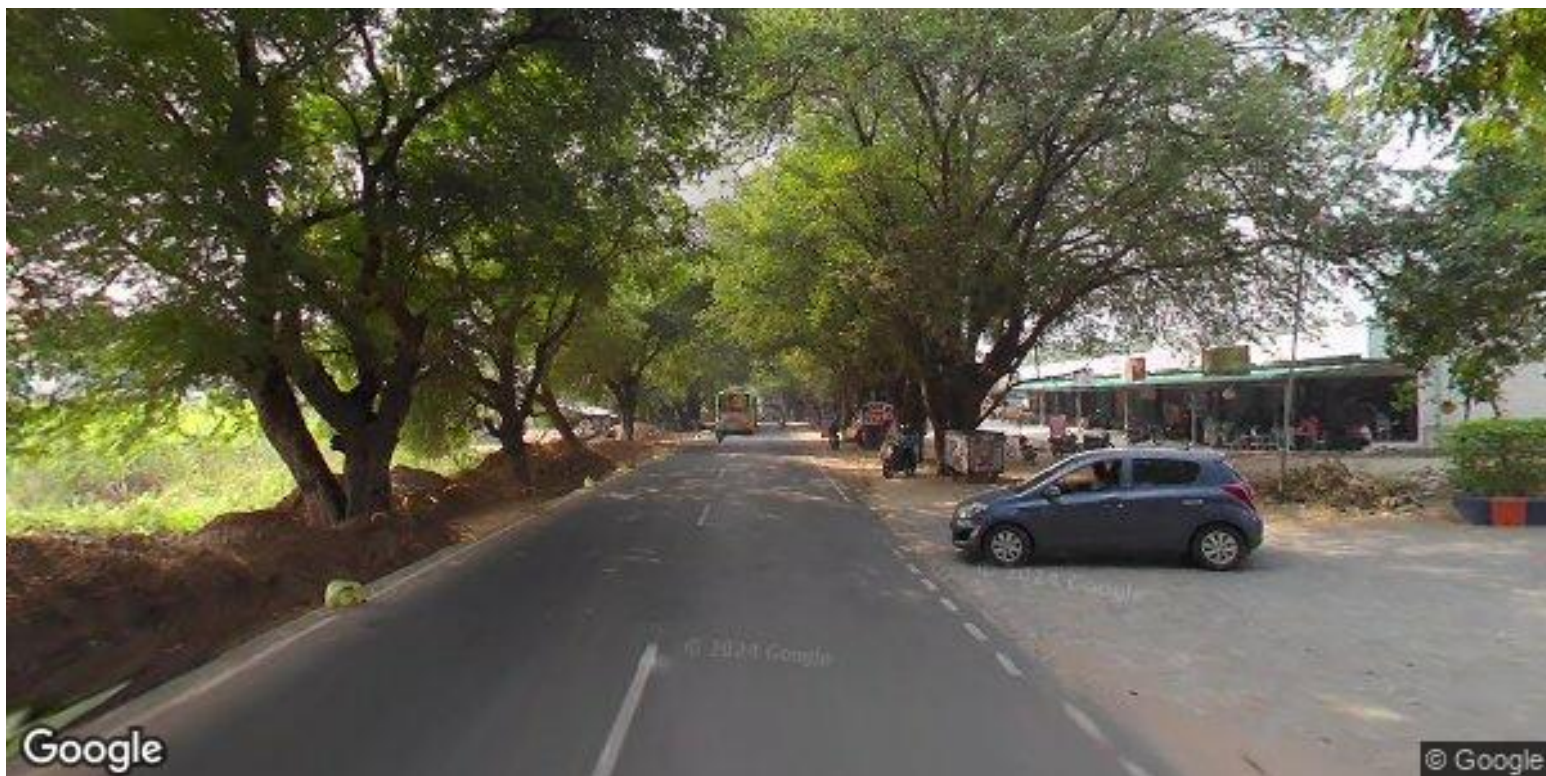
**Coordinates:** 11.49574, 77.69838

**Risk Type:** Turn

**Risk Level:** High

**Speed Limit:** 15 KM/Hr
