# IndianOil

## JOURNEY RISK MANAGEMENT (JRM) STUDY

### Salem Terminal to ANITHA AUTO SERVICE

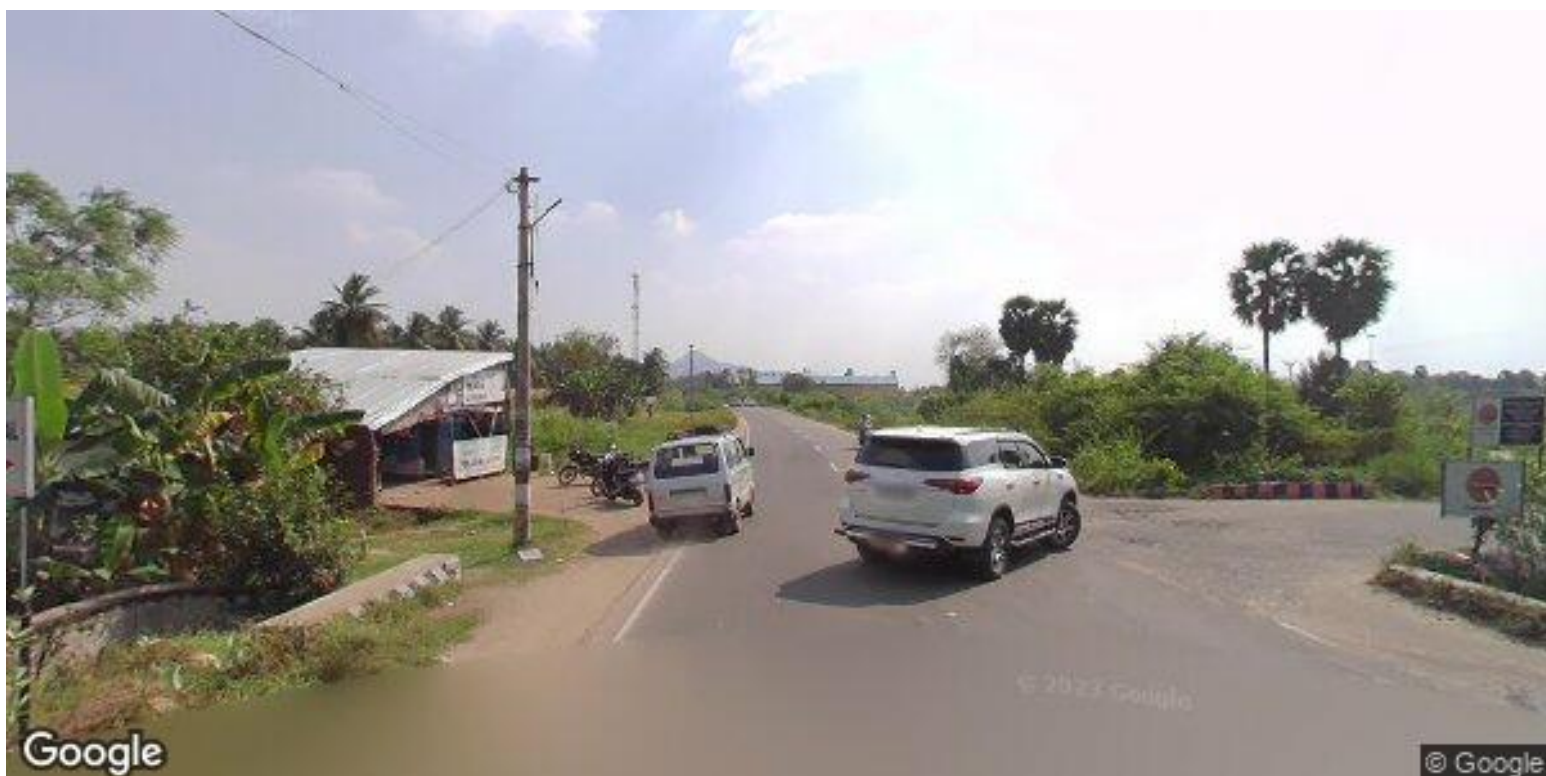
**Coordinates:** 11.44029, 77.87544

**Risk Type:** Turn

**Risk Level:** High

**Speed Limit:** 15 KM/Hr

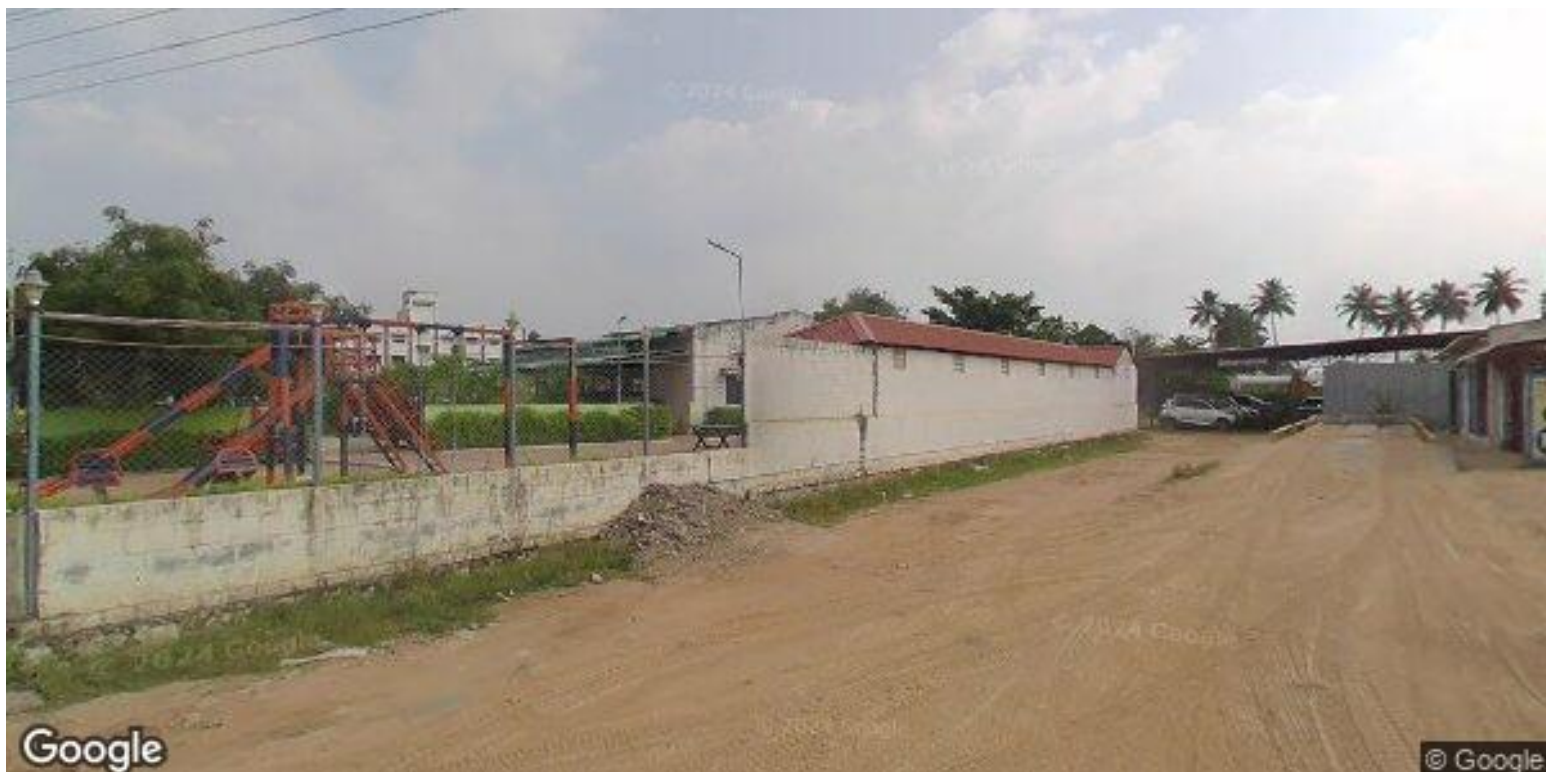
**Risk Type:** Turn  
**Risk Level:** High  
**Speed Limit:** 15 KM/Hr  
**Coordinates:** 11.44377, 77.71562

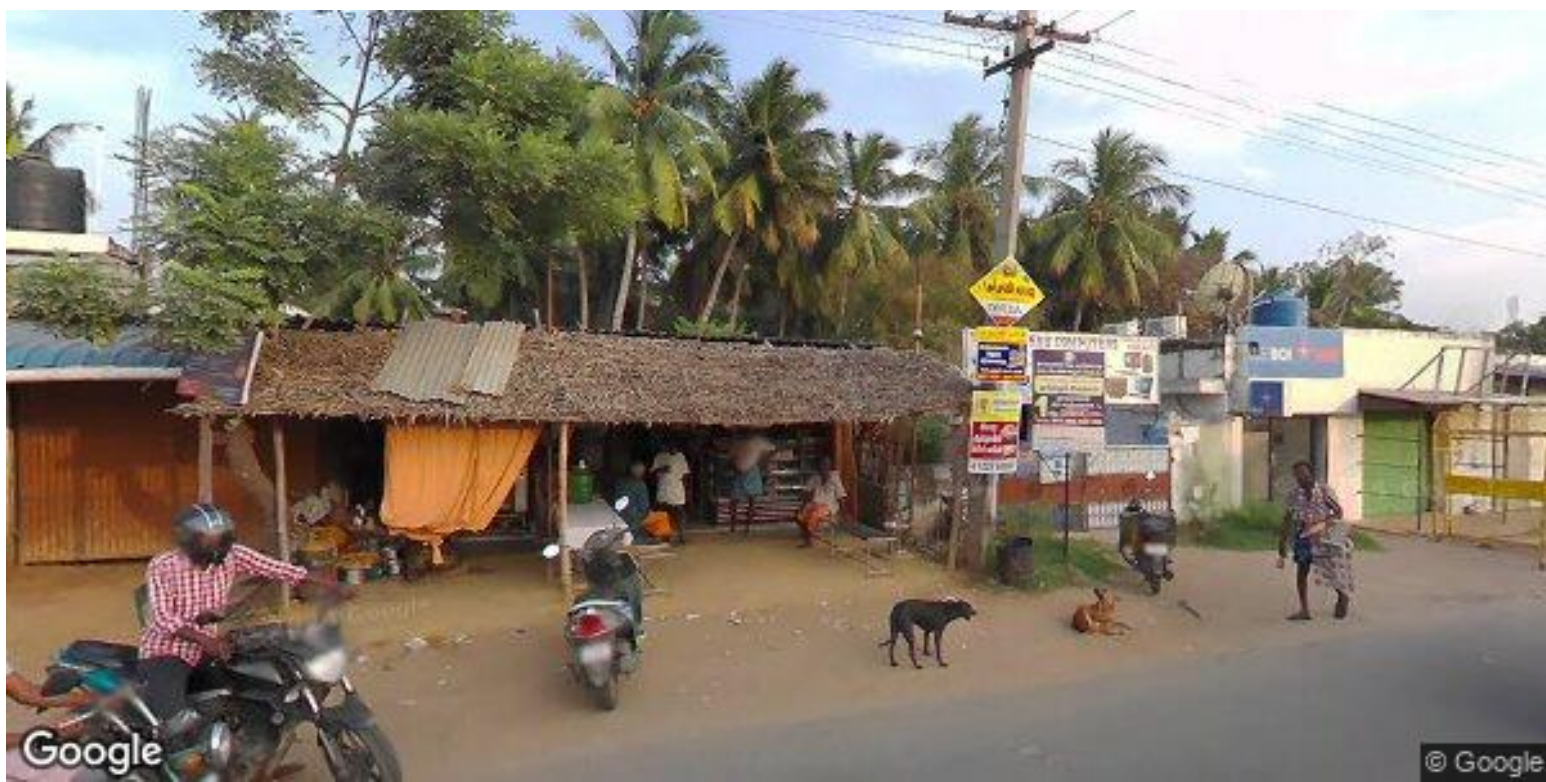
**Coordinates:** 11.44985, 77.69520

**Risk Type:** Turn

**Risk Level:** High

**Speed Limit:** 15 KM/Hr

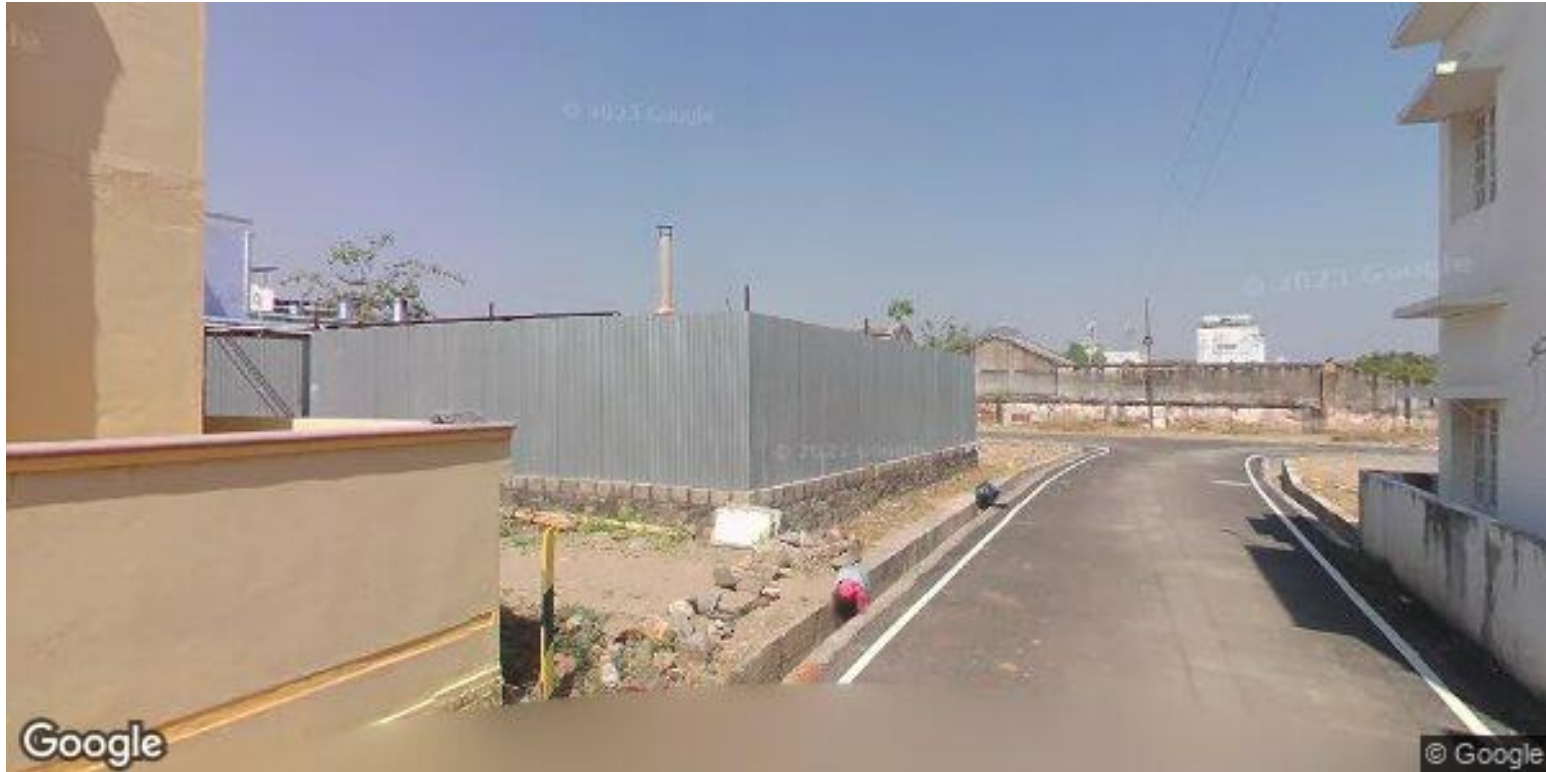
**Risk Type:** Turn  
**Risk Level:** High  
**Speed Limit:** 15 KM/Hr  
**Coordinates:** 11.44948, 77.68645
