# IndianOil

## JOURNEY RISK MANAGEMENT (JRM) STUDY

### Salem Terminal TO ROYAL AGENCIES SALEM

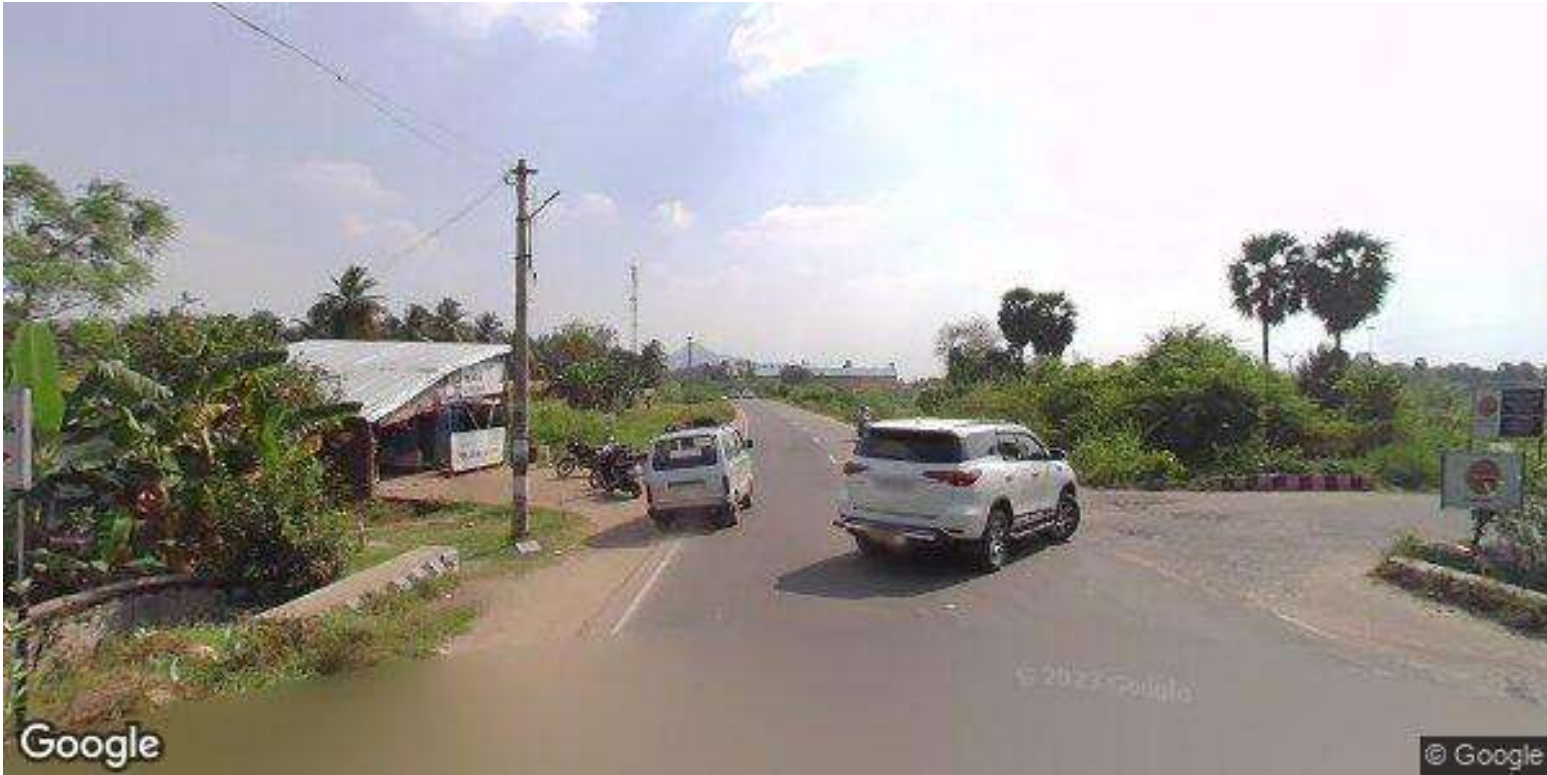
Coordinates: 11.44029, 77.87544

Risk Type: Turn

Risk Level: High

Speed Limit: 15 KM/Hr

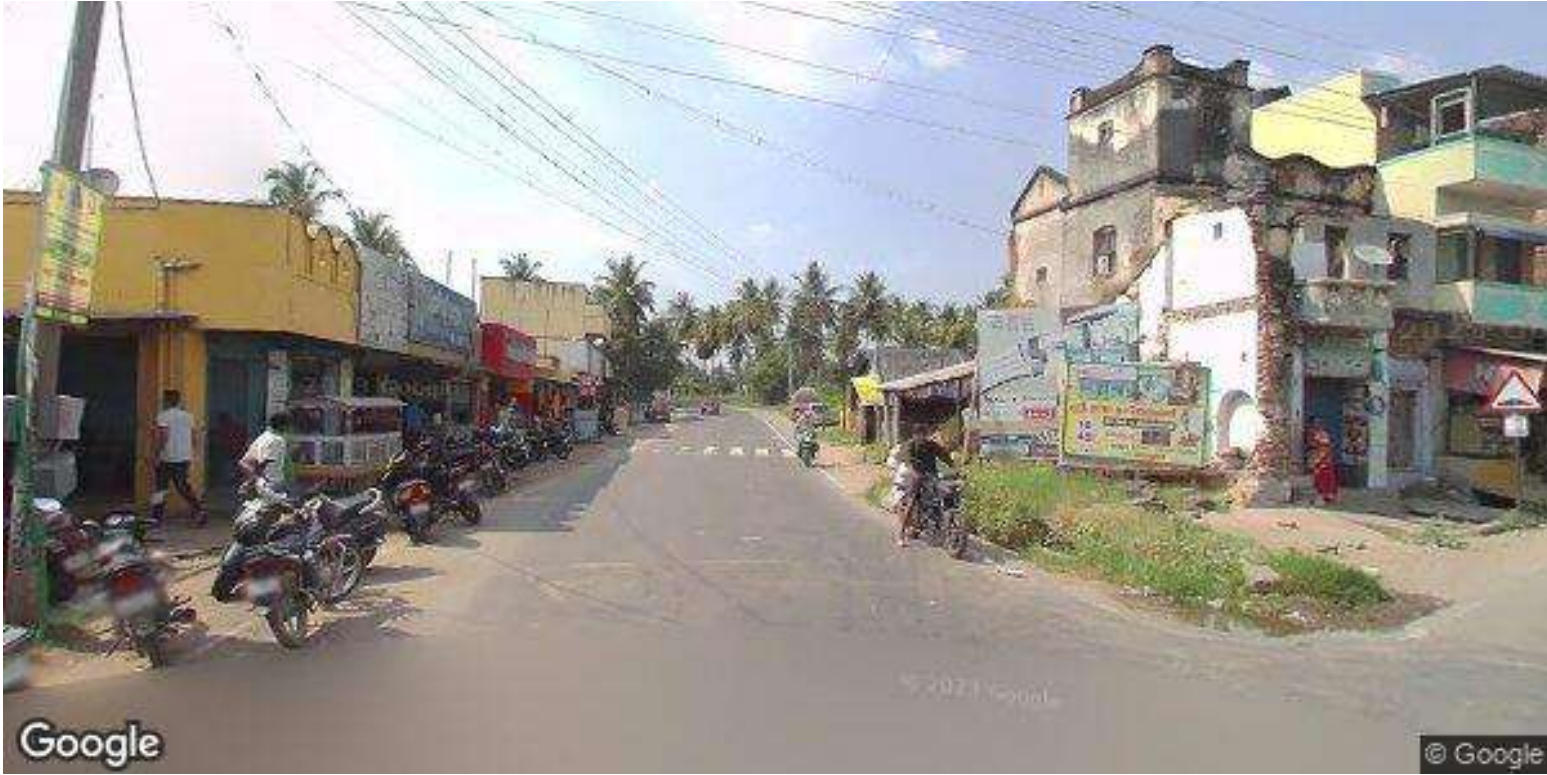
Risk Type: Turn

Risk Level: High

Speed Limit: 15 KM/Hr  
Coordinates: 11.45007, 77.87201

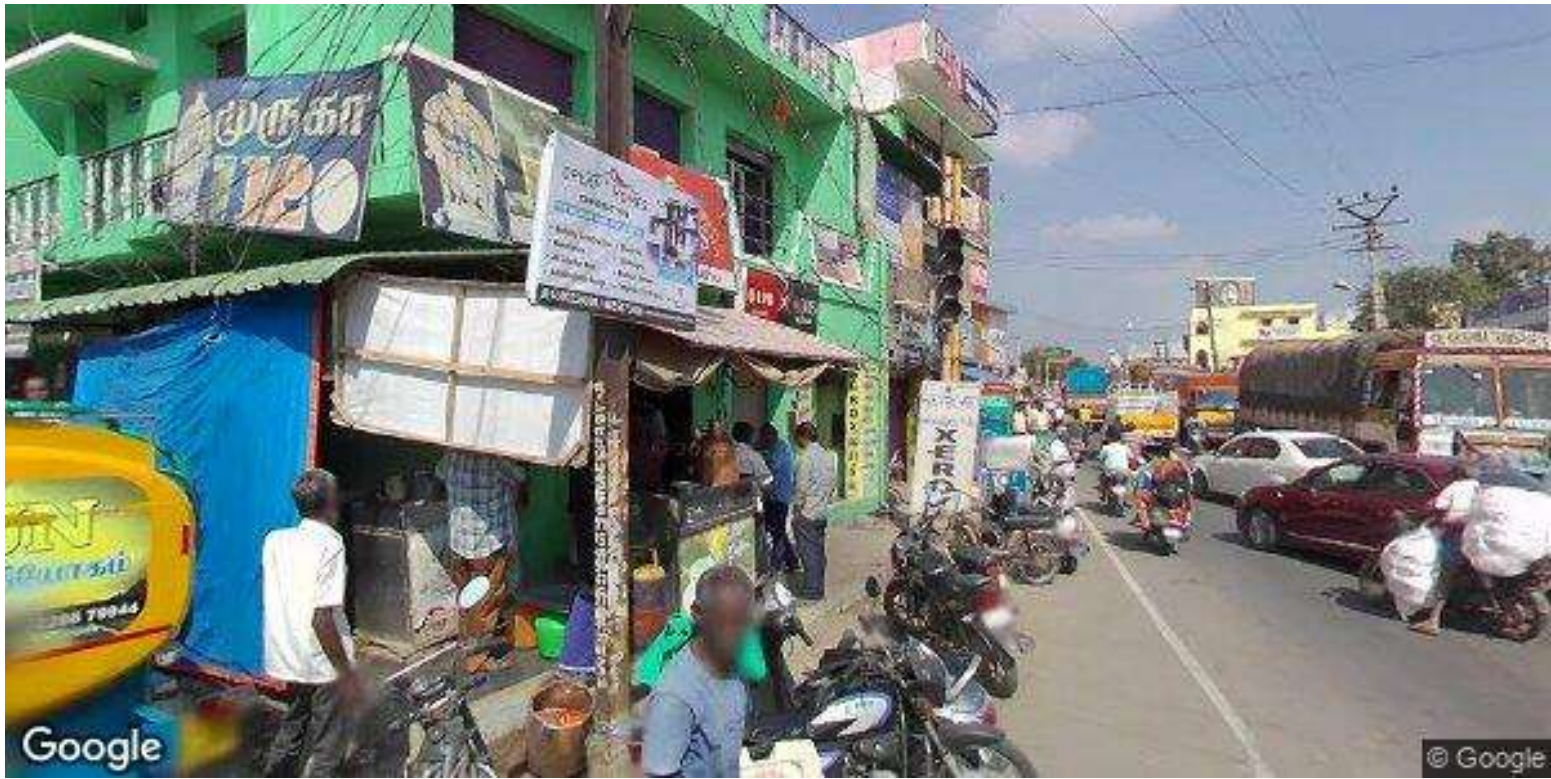
Risk Type: Turn  
Risk Level: High  
Speed Limit: 15 KM/Hr  
Coordinates: 11.47407, 77.86839

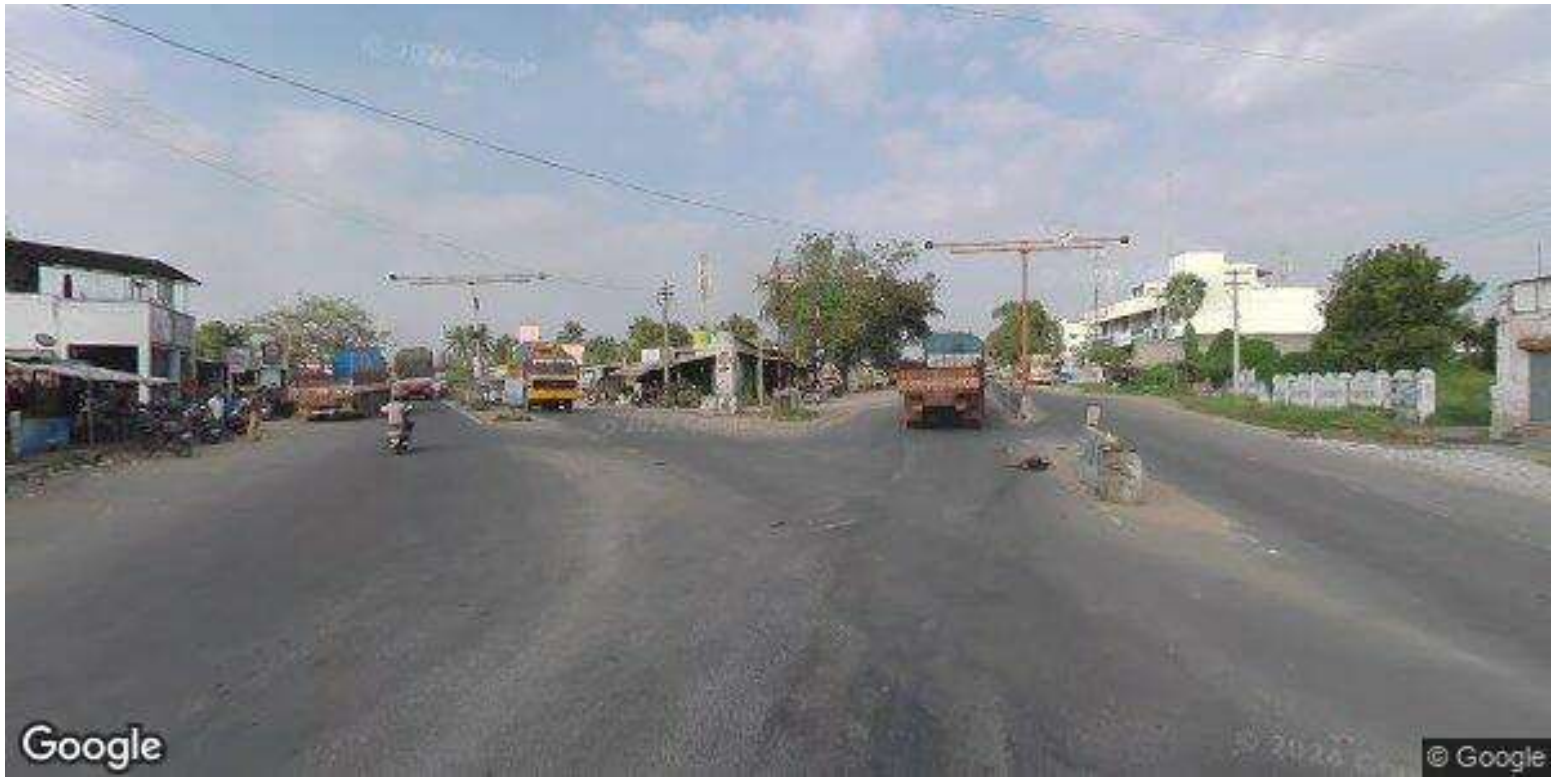
Risk Type: Turn  
Risk Level: Medium  
Speed Limit: 30 KM/Hr  
Coordinates: 11.48366, 77.88781

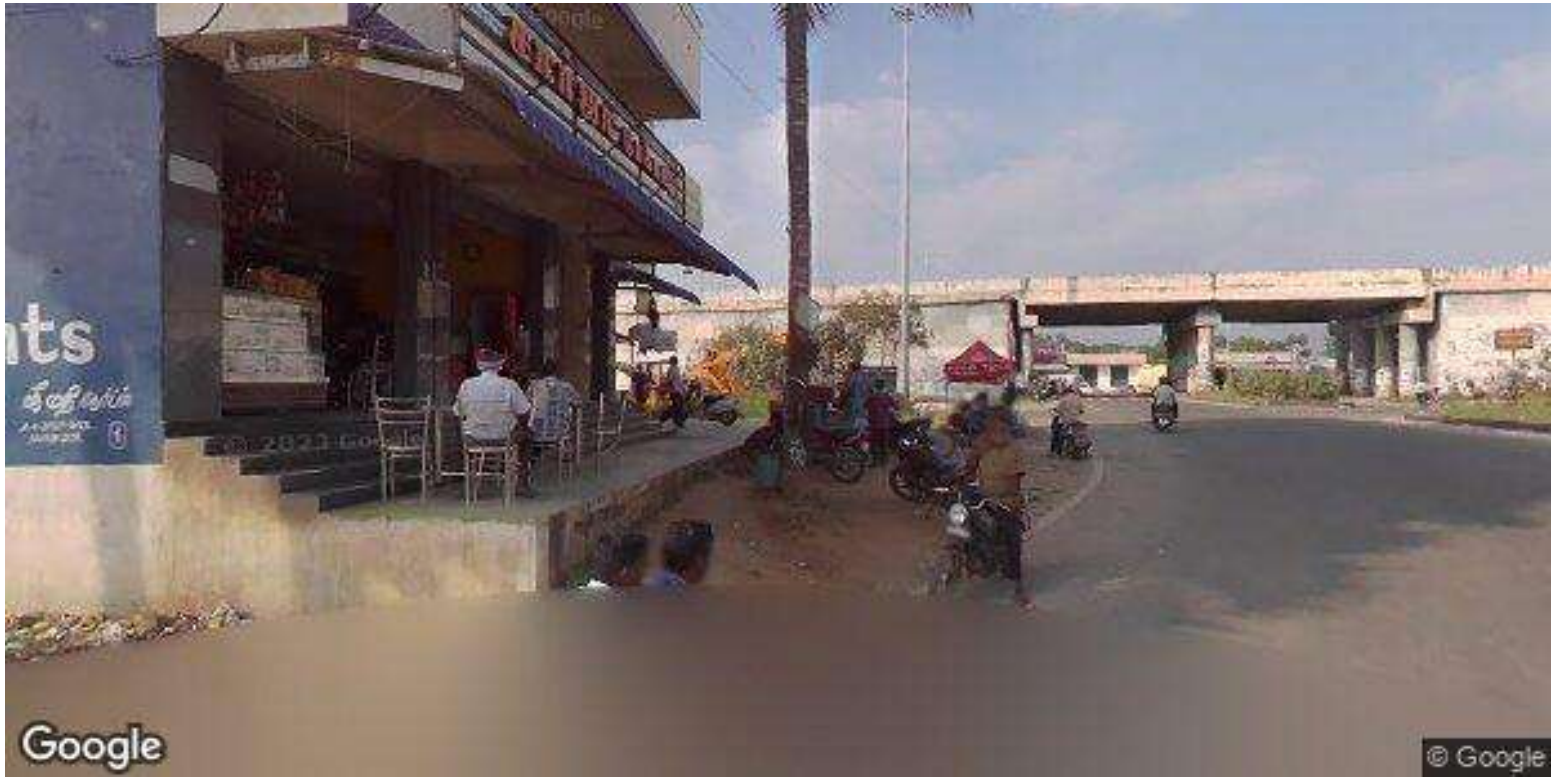
Risk Type: Turn  
Risk Level: High  
Speed Limit: 15 KM/Hr  
Coordinates: 11.49149, 77.89601

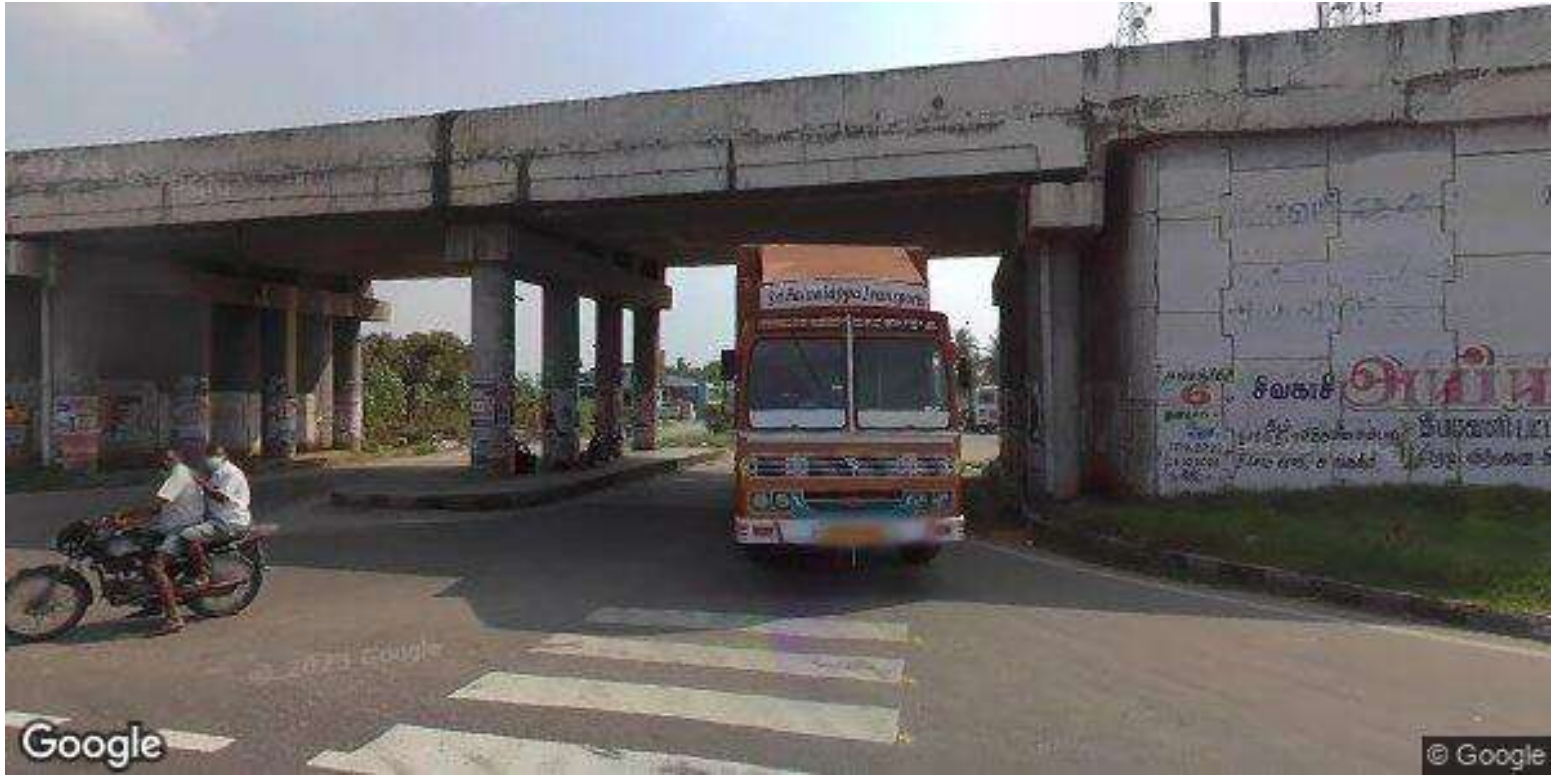
Risk Type: Turn  
Risk Level: High  
Speed Limit: 15 KM/Hr  
Coordinates: 11.49224, 77.89601

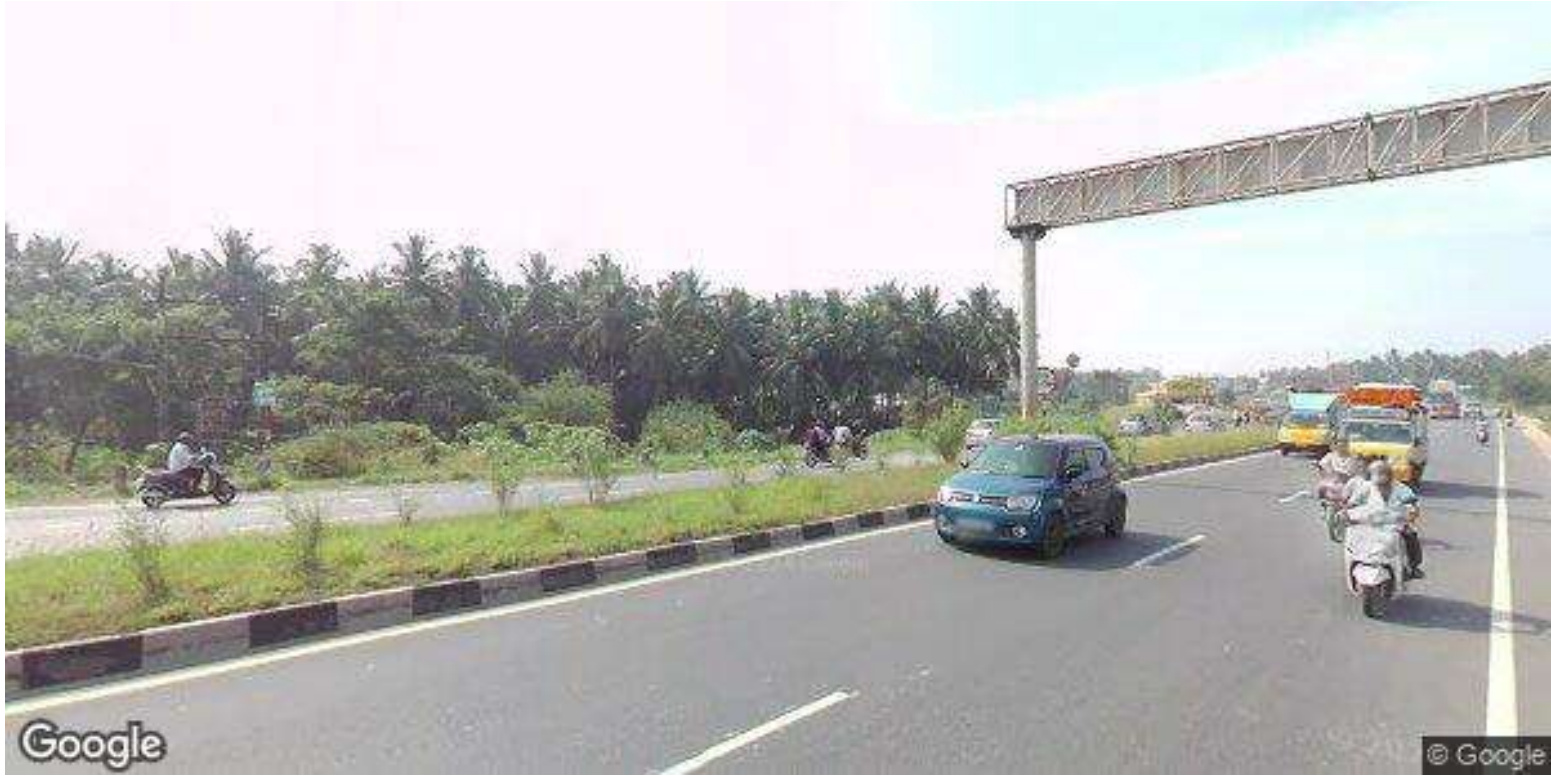
**Risk Type:** Turn  
**Risk Level:** Medium  
**Speed Limit:** 30 KM/Hr  
**Coordinates:** 11.60942, 78.10056

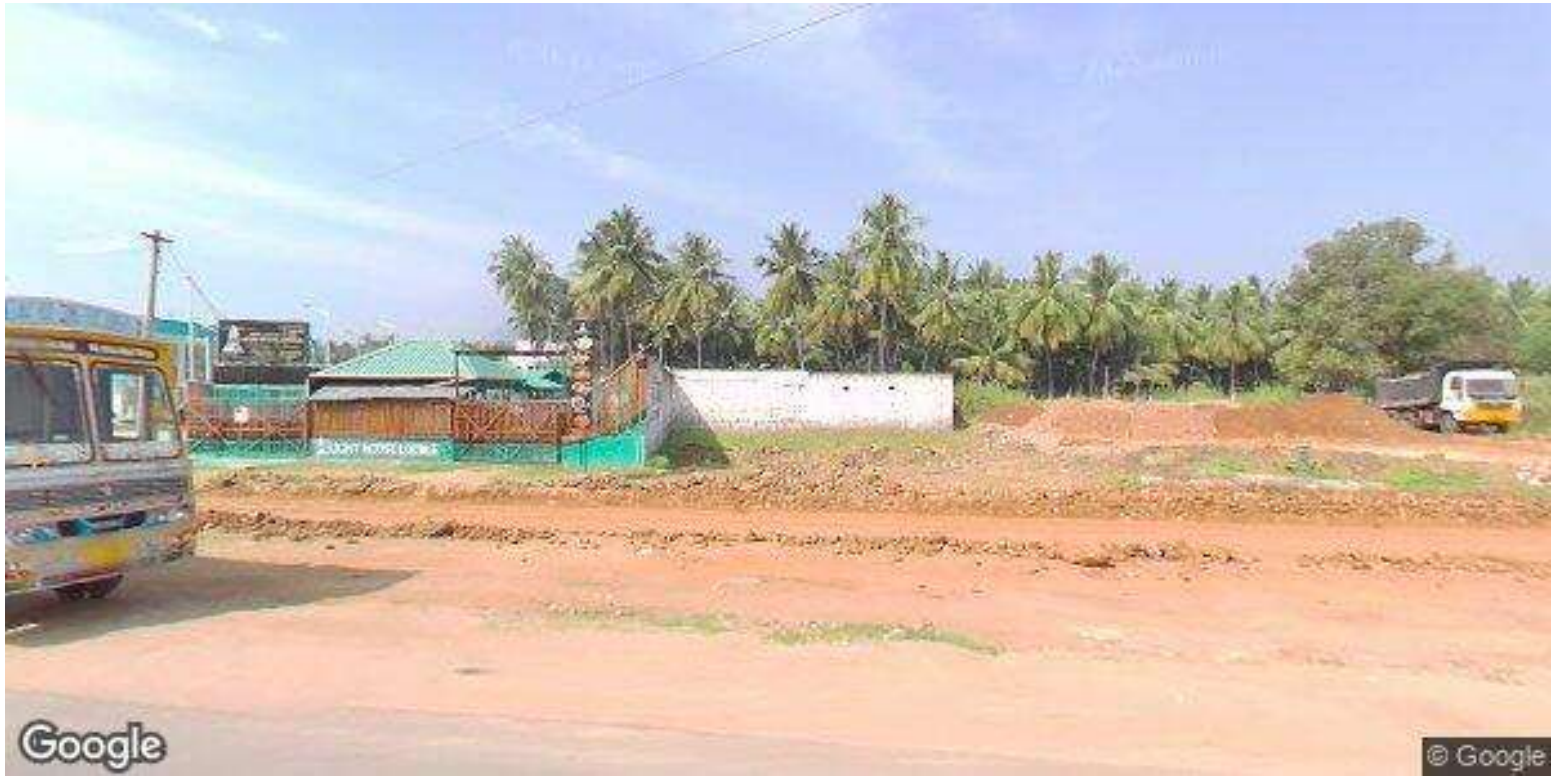
**Risk Type:** Turn  
**Risk Level:** Medium  
**Speed Limit:** 30 KM/Hr  
**Coordinates:** 11.61736, 78.10588

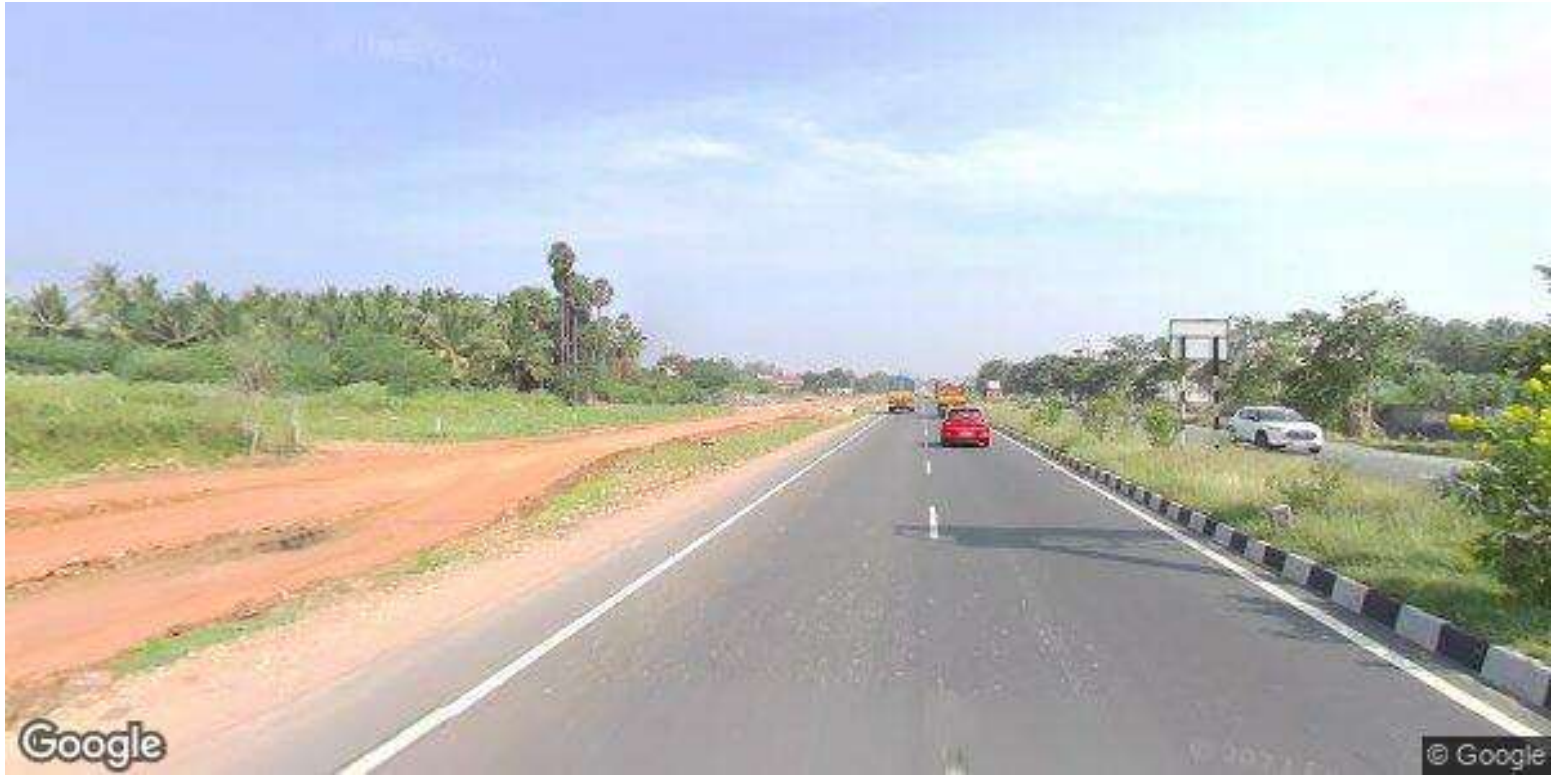
**Risk Type:** Turn  
**Risk Level:** Medium  
**Speed Limit:** 30 KM/Hr  
**Coordinates:** 11.61753, 78.10608

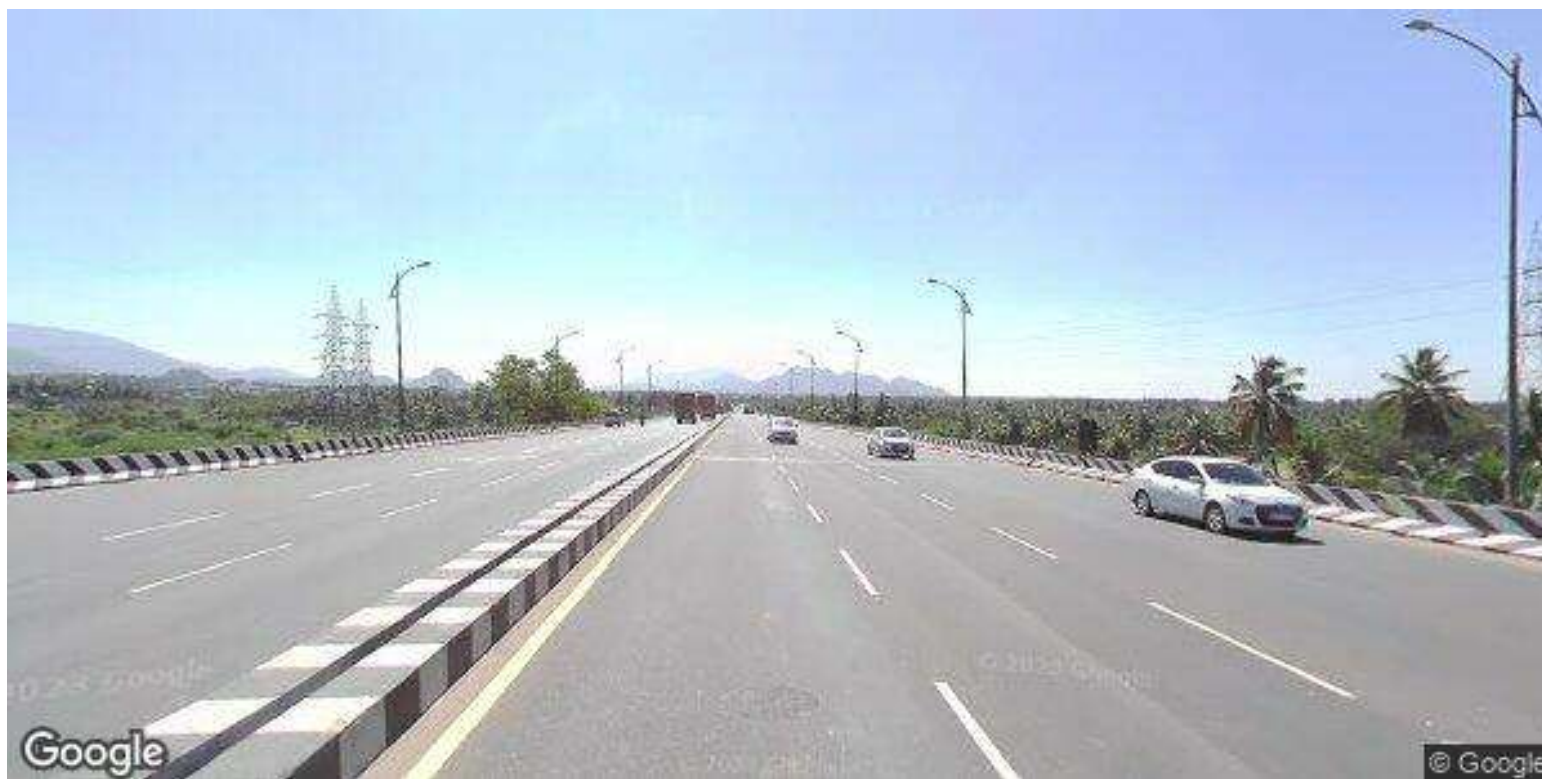
**Coordinates:** 11.64007, 78.11794

**Risk Type:** Turn

**Risk Level:** Medium

**Speed Limit:** 30 KM/Hr

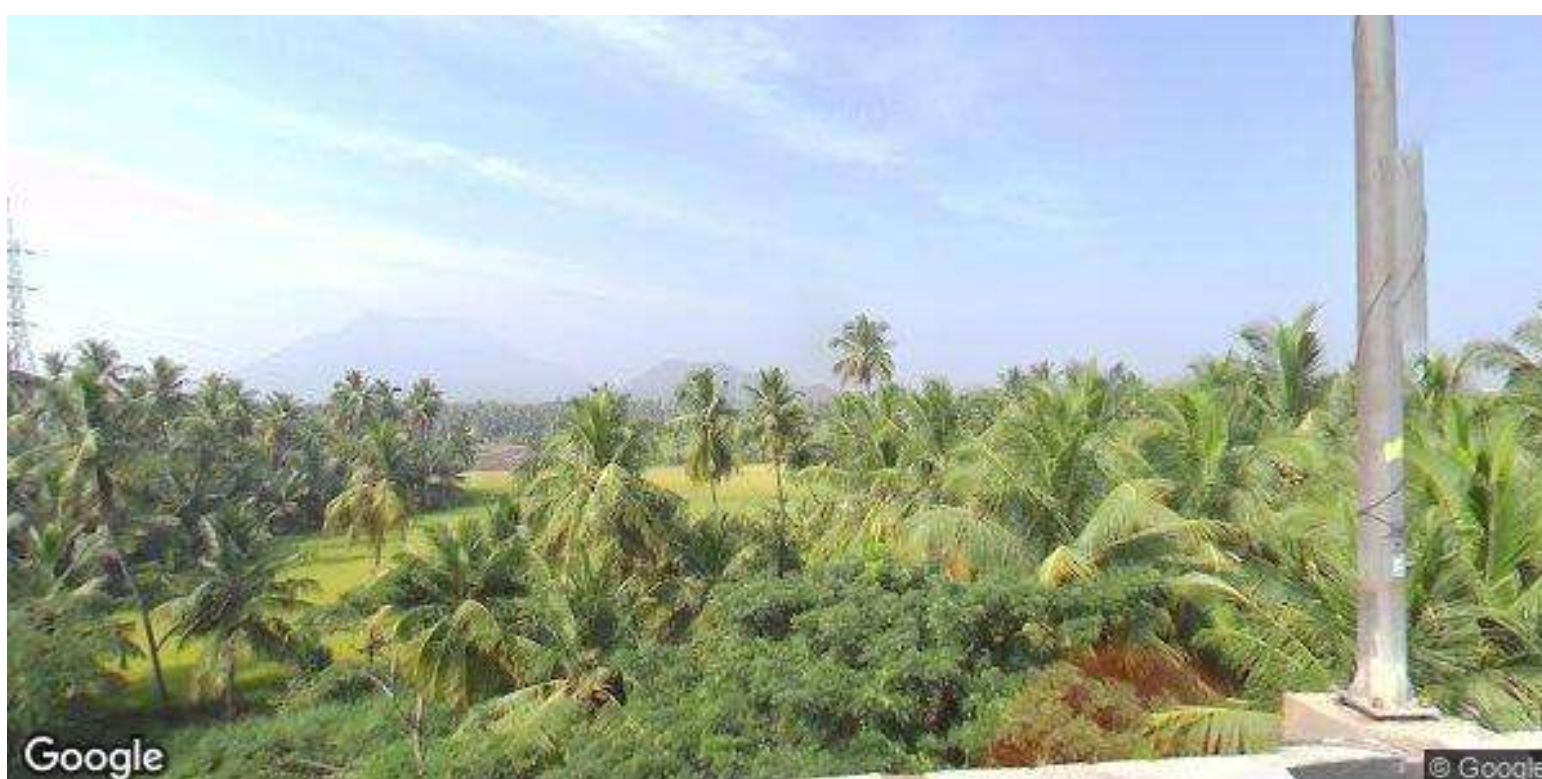
**Coordinates:** 11.64020, 78.11786

**Risk Type:** Turn

**Risk Level:** Medium

**Speed Limit:** 30 KM/Hr

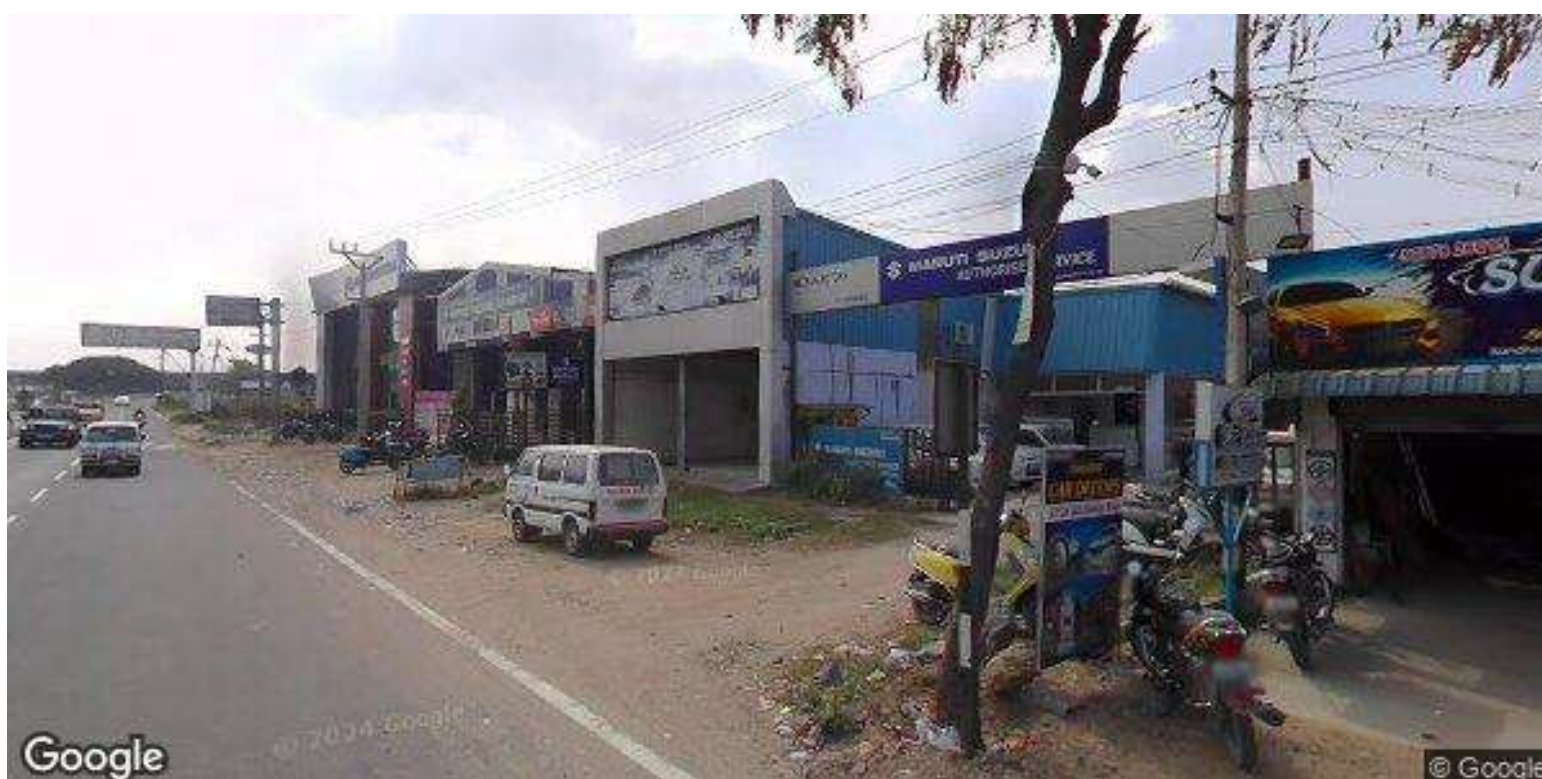
**Coordinates: 11.64497, 78.12028**

**Risk Type: Turn**

**Risk Level: Medium**

**Speed Limit: 30 KM/Hr**

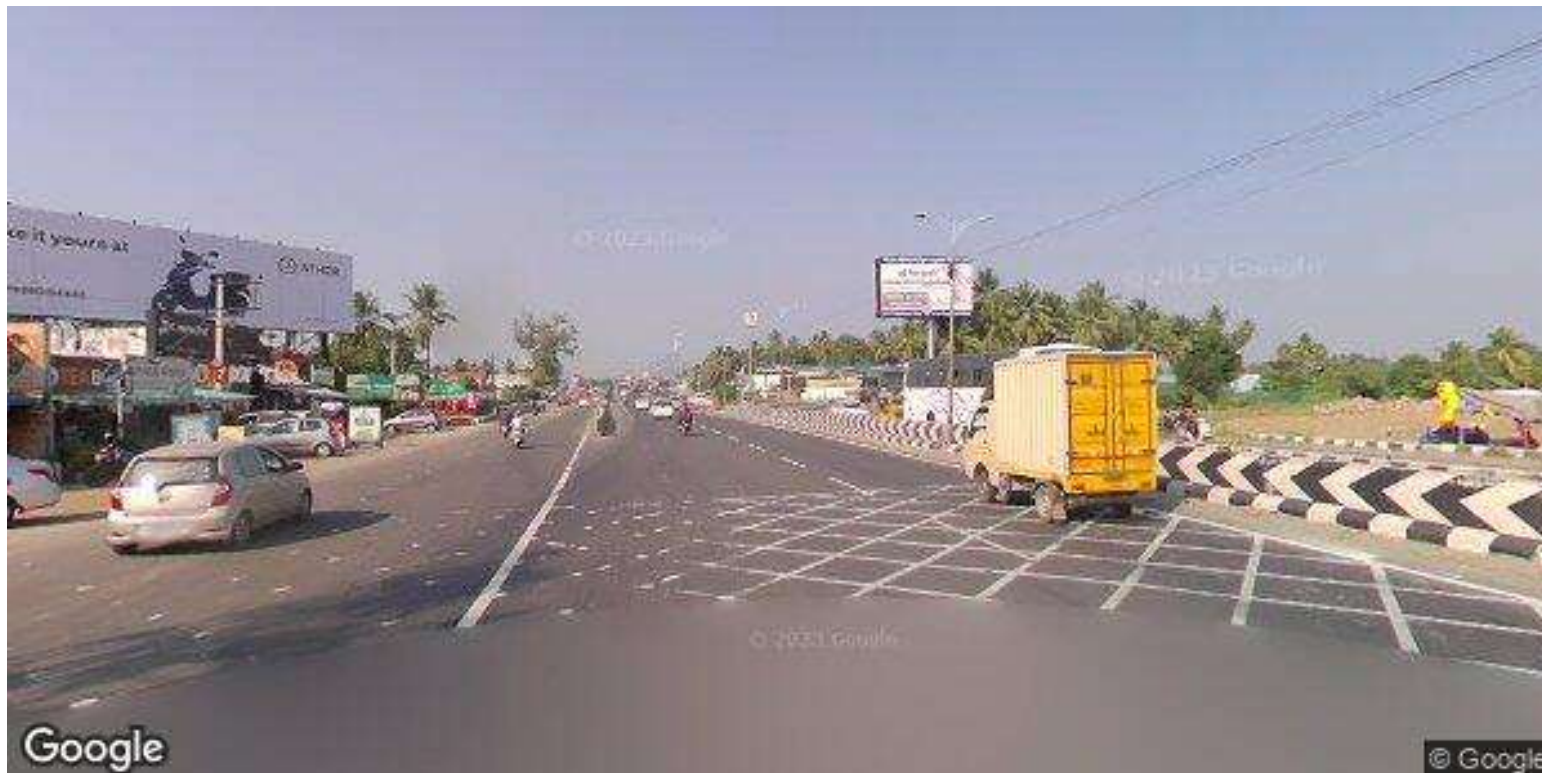
**Coordinates: 11.64503, 78.12034**

**Risk Type: Turn**

**Risk Level: Medium**

**Speed Limit: 30 KM/Hr**

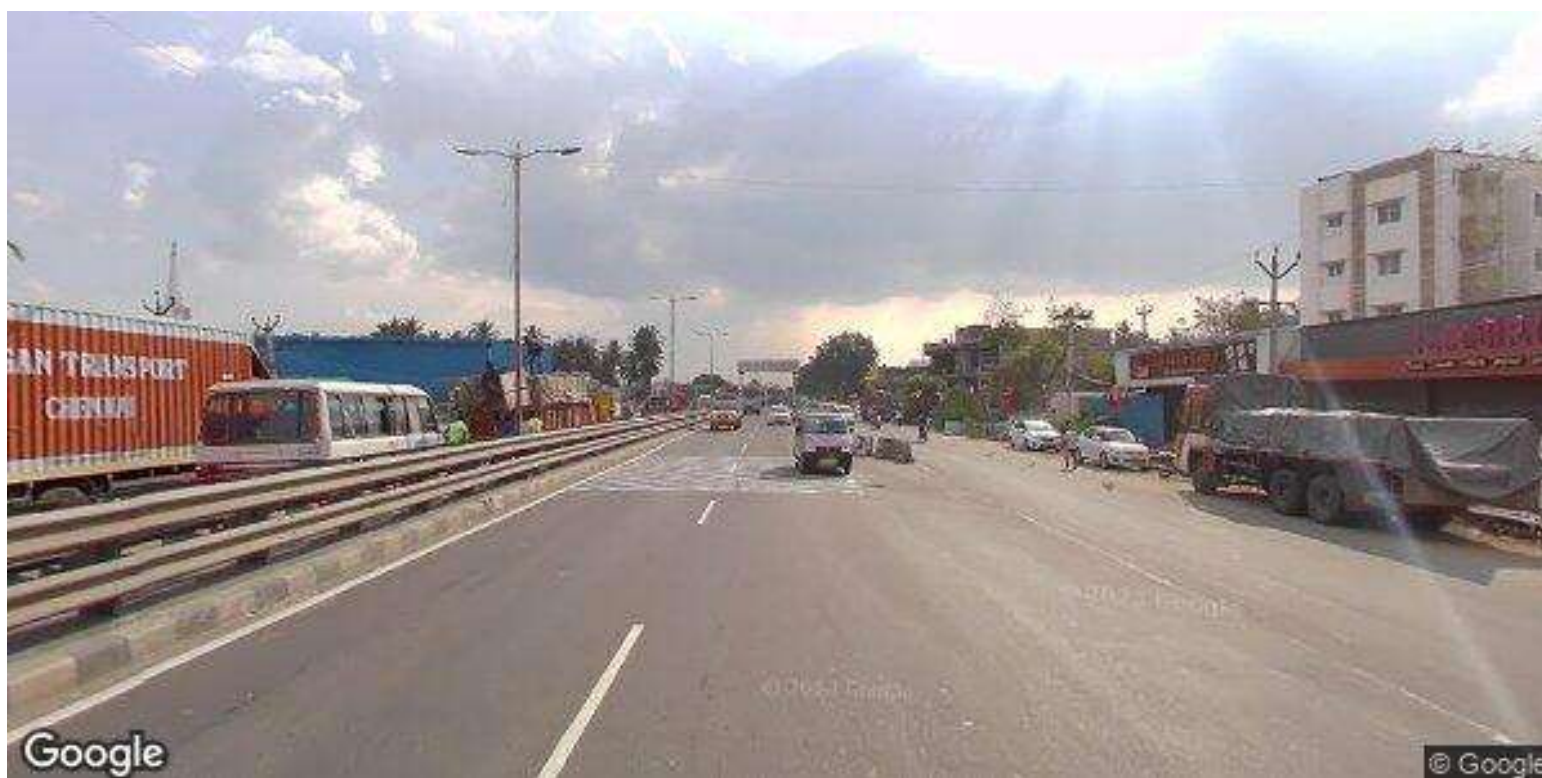
**Coordinates: 11.67074, 78.12668**

**Risk Type: Turn**

**Risk Level: High**

**Speed Limit: 15 KM/Hr**

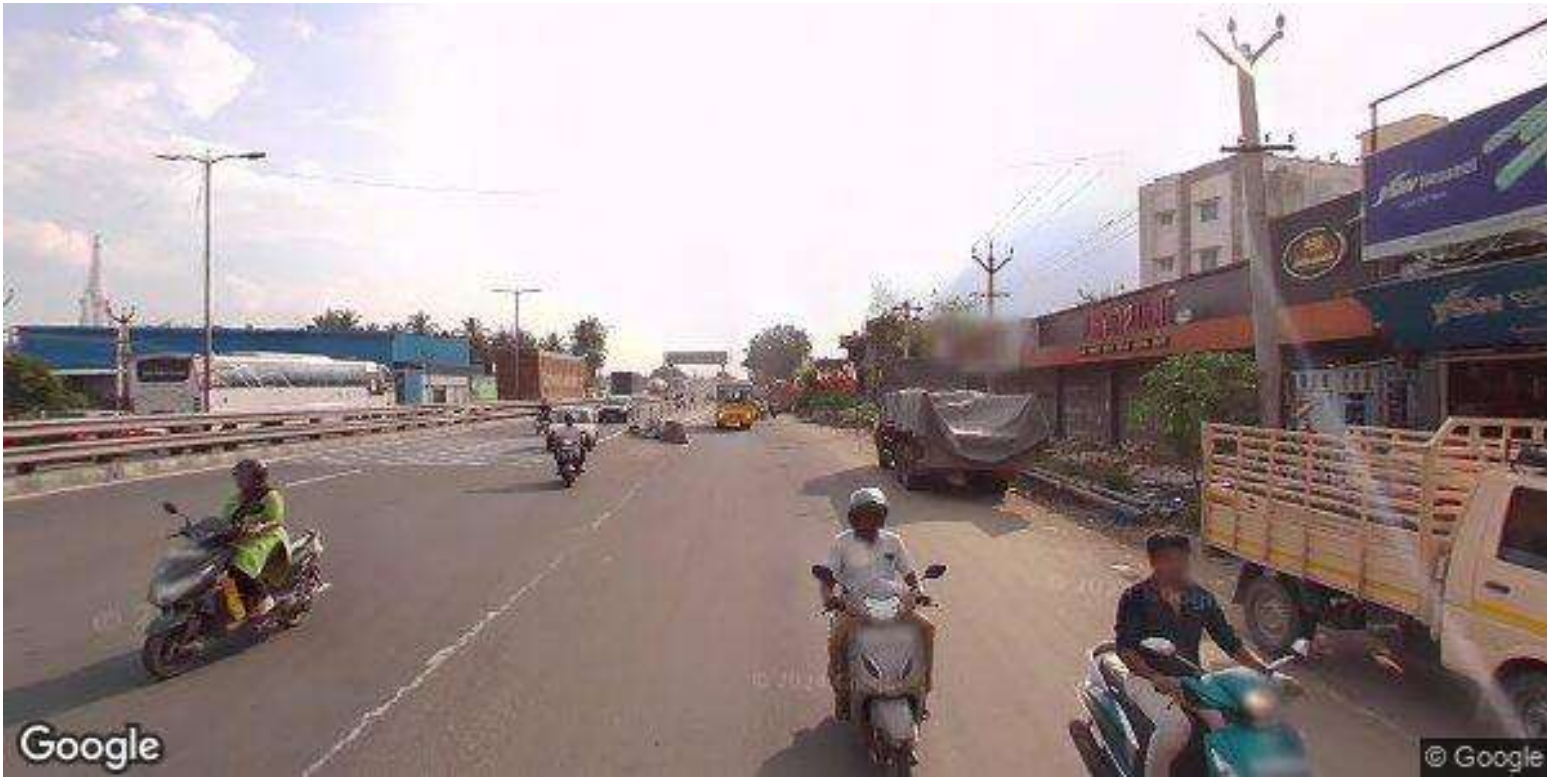
Coordinates: 11.67081, 78.12661

Risk Type: Turn

Risk Level: High

Speed Limit: 15 KM/Hr

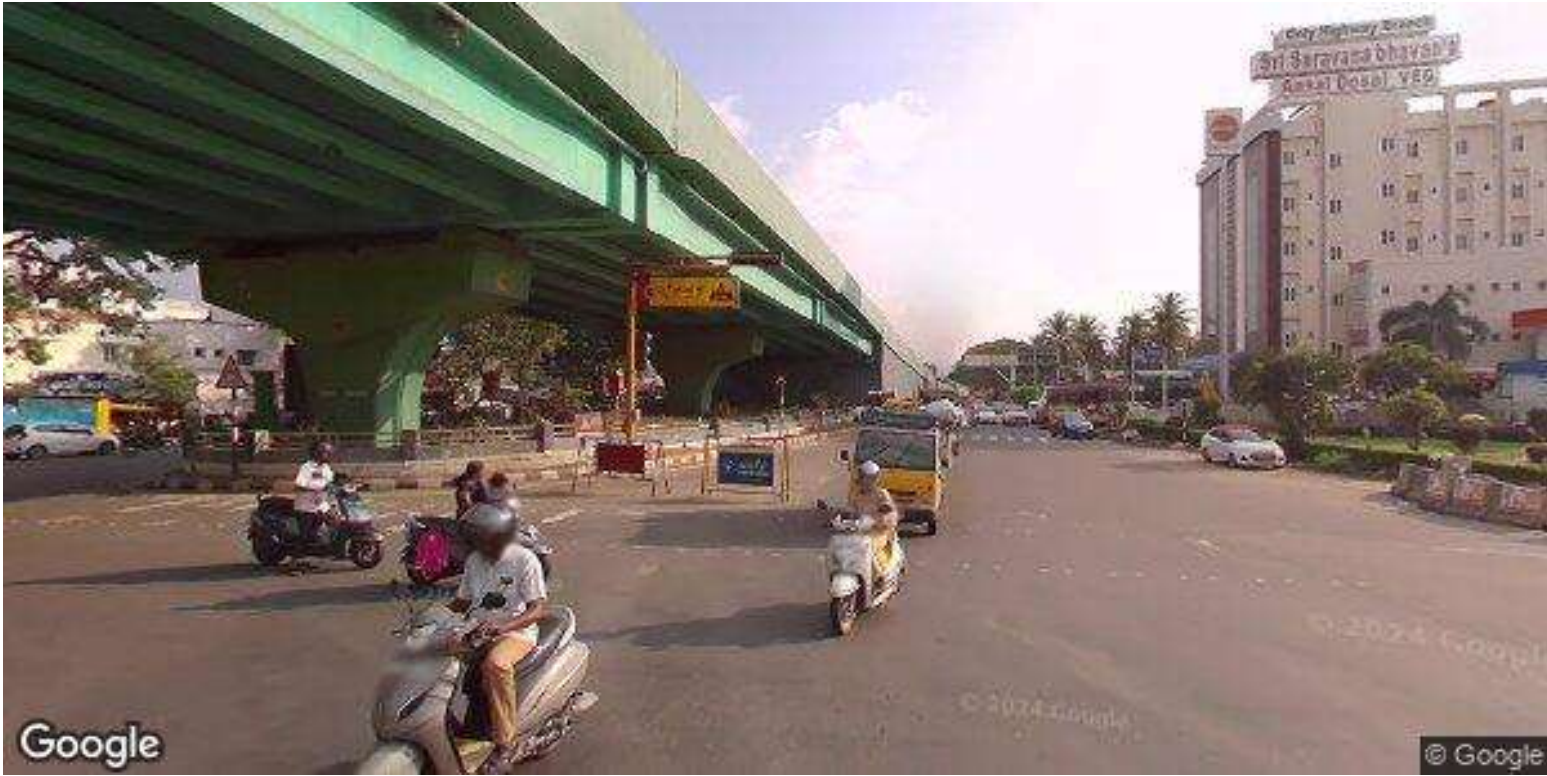
Coordinates: 11.67570, 78.12786

Risk Type: Blind Spot

Risk Level: Blind Spot

Speed Limit: 10 KM/Hr
