# IndianOil

## JOURNEY RISK MANAGEMENT (JRM) STUDY

### Salem Terminal TO KSS ENTERPRISES

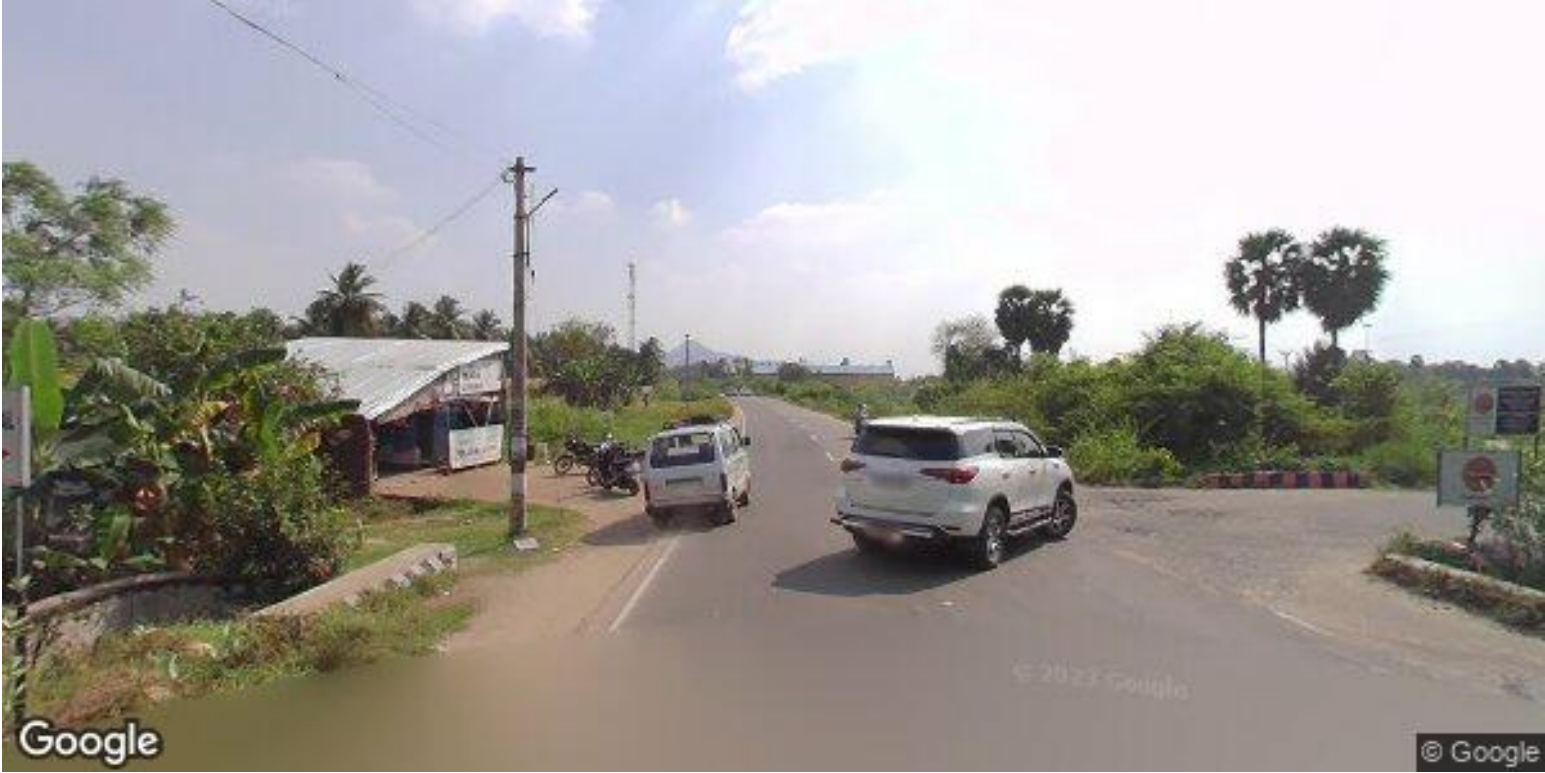
**Speed Limit: 15 KM/Hr**  
**Coordinates: 11.44029, 77.87544**

**Risk Type:** Turn  
**Risk Level:** High

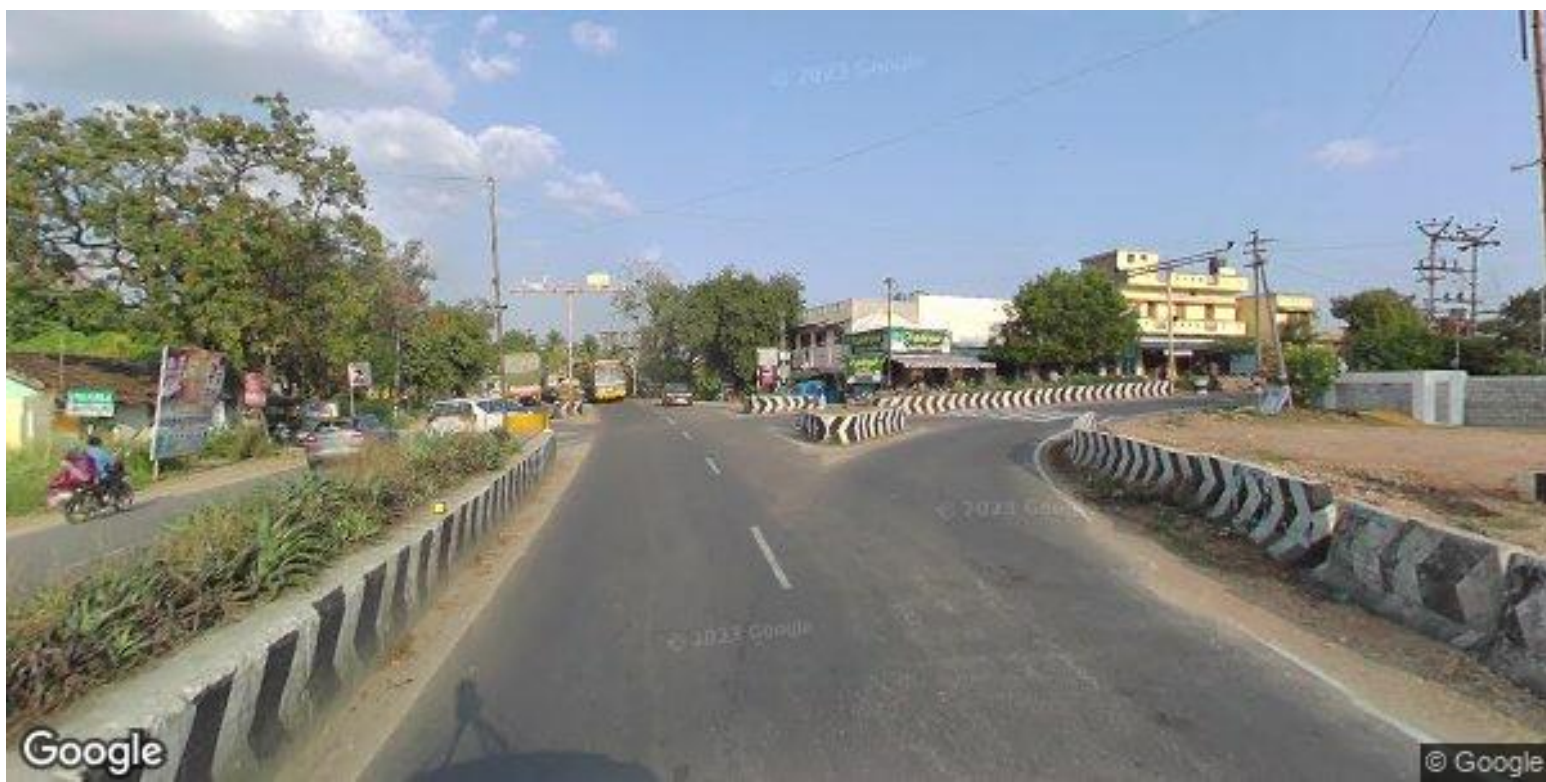
**Coordinates:** 11.46318, 77.84913

**Risk Type:** Turn

**Risk Level:** Medium

**Speed Limit:** 30 KM/Hr

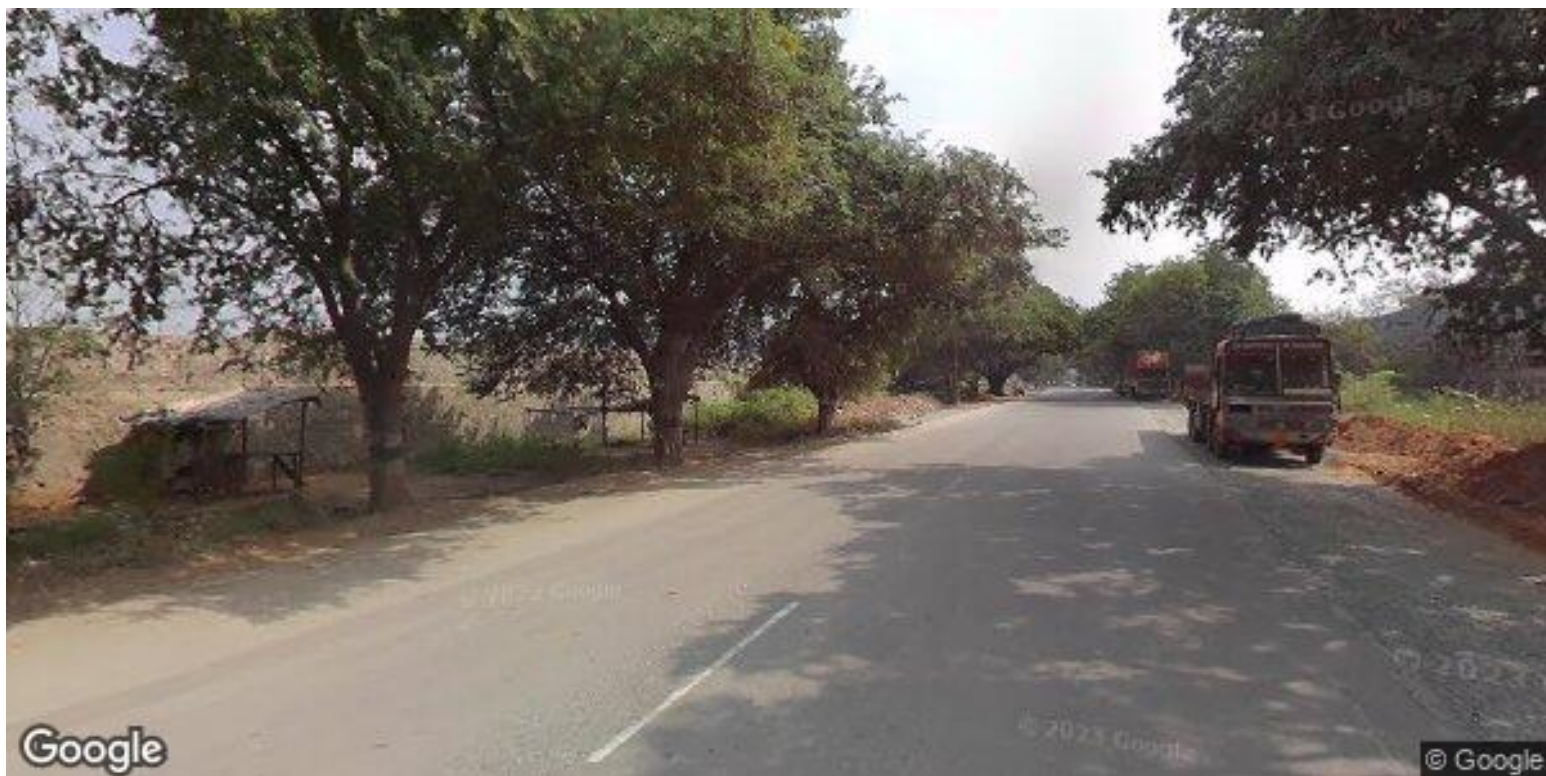
**Coordinates:** 11.45697, 77.82719

**Risk Type:** Turn

**Risk Level:** Medium

**Speed Limit:** 30 KM/Hr

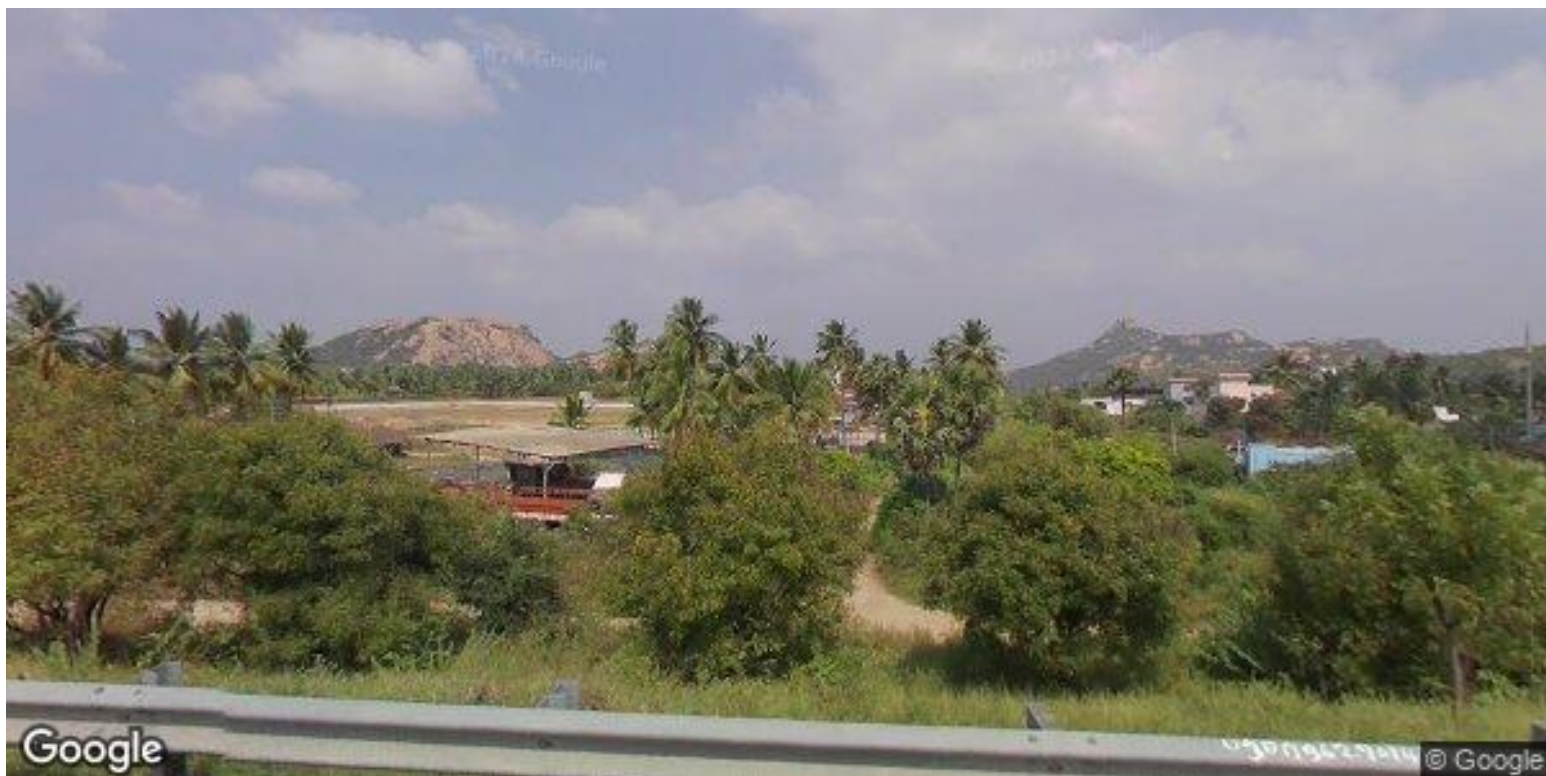
**Coordinates:** 11.49383, 77.88442

**Risk Type:** Turn

**Risk Level:** High

**Speed Limit:** 15 KM/Hr

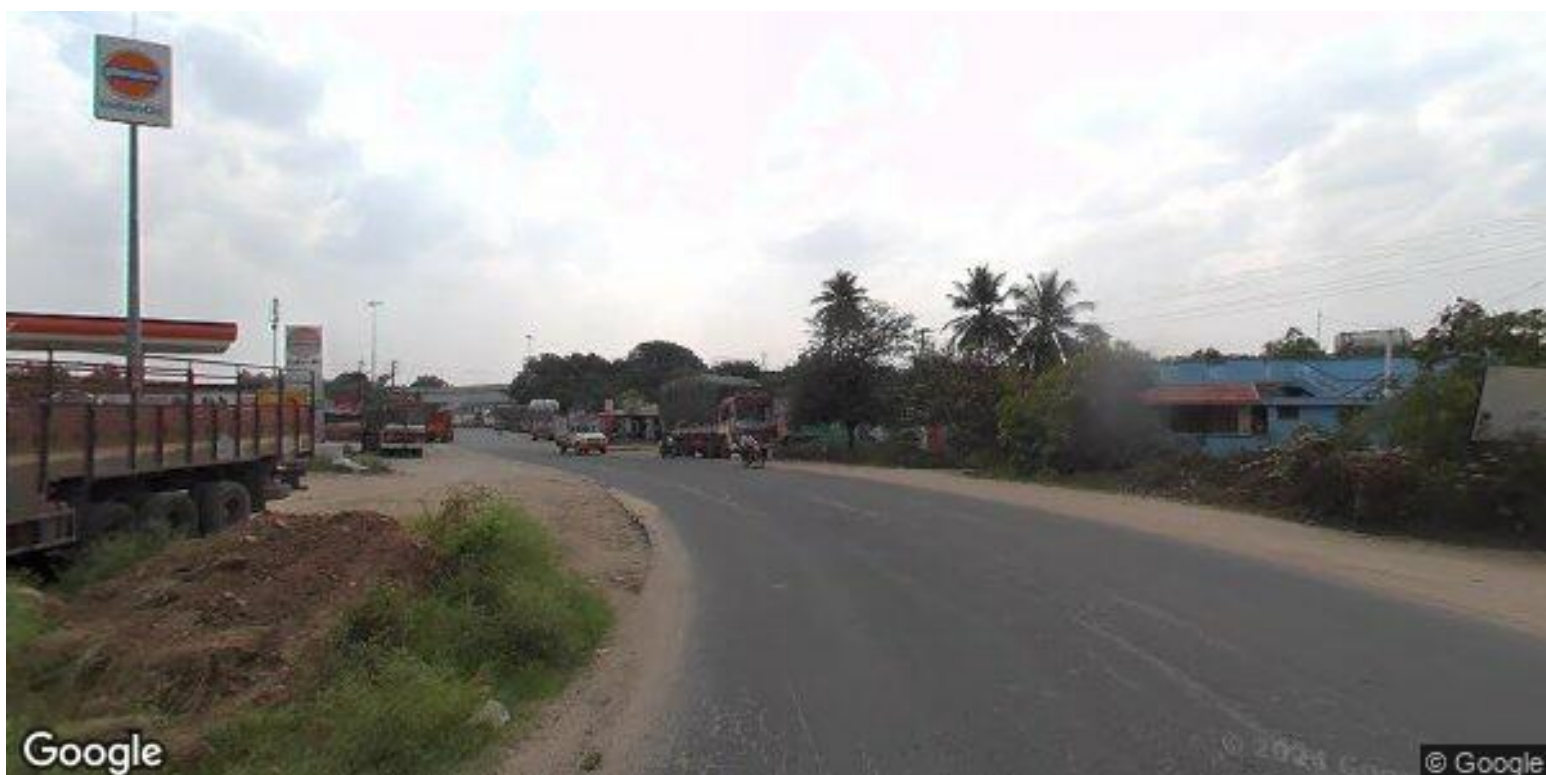
**Coordinates:** 11.49446, 77.88491

**Risk Type:** Turn

**Risk Level:** High

**Speed Limit:** 15 KM/Hr

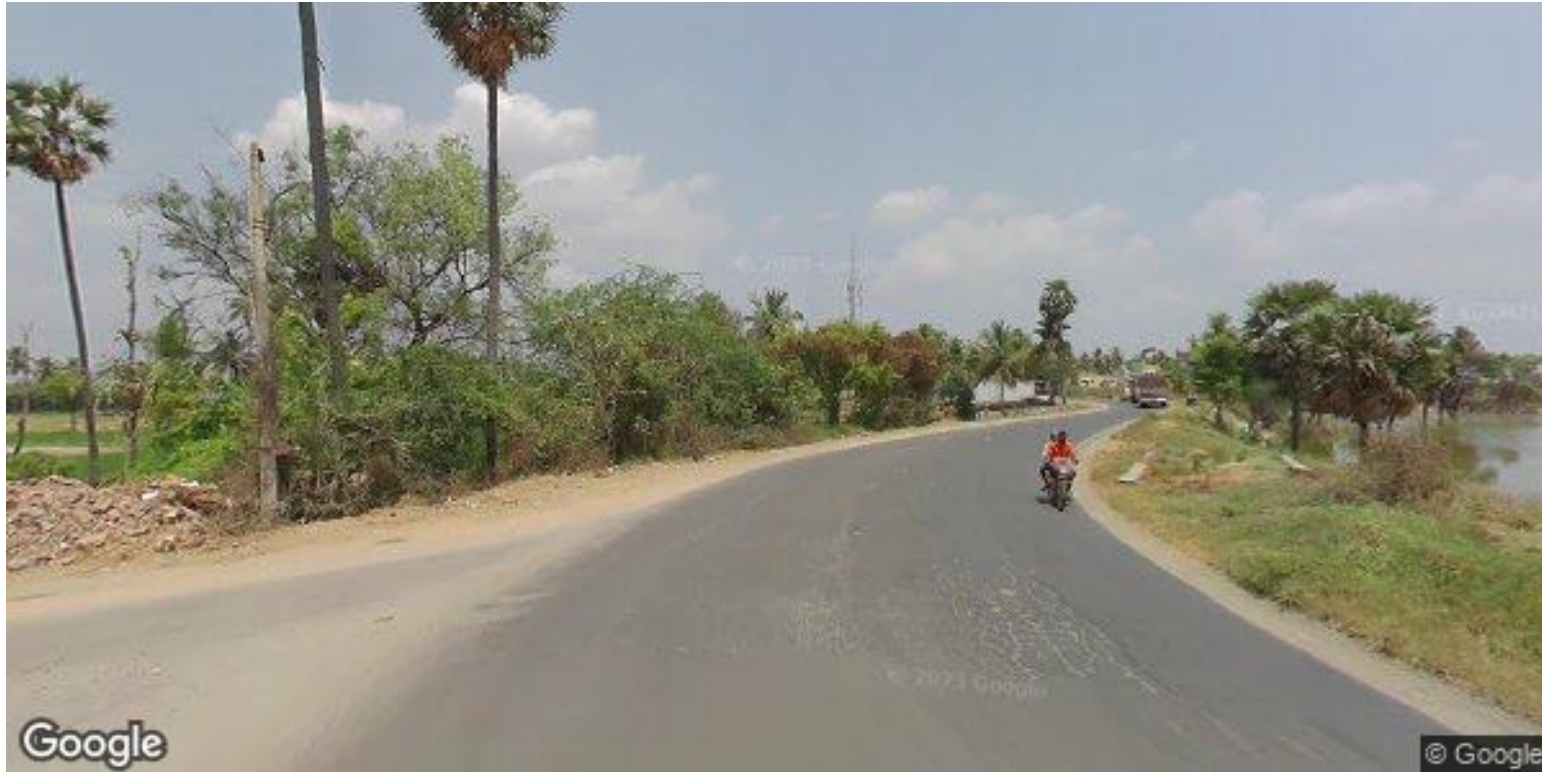
**Coordinates:** 11.56083, 77.89921

**Risk Type:** Turn

**Risk Level:** Medium

**Speed Limit:** 30 KM/Hr
