## JOURNEY RISK MANAGEMENT (JRM) STUDY

### Salem Terminal to JP AGENCIES

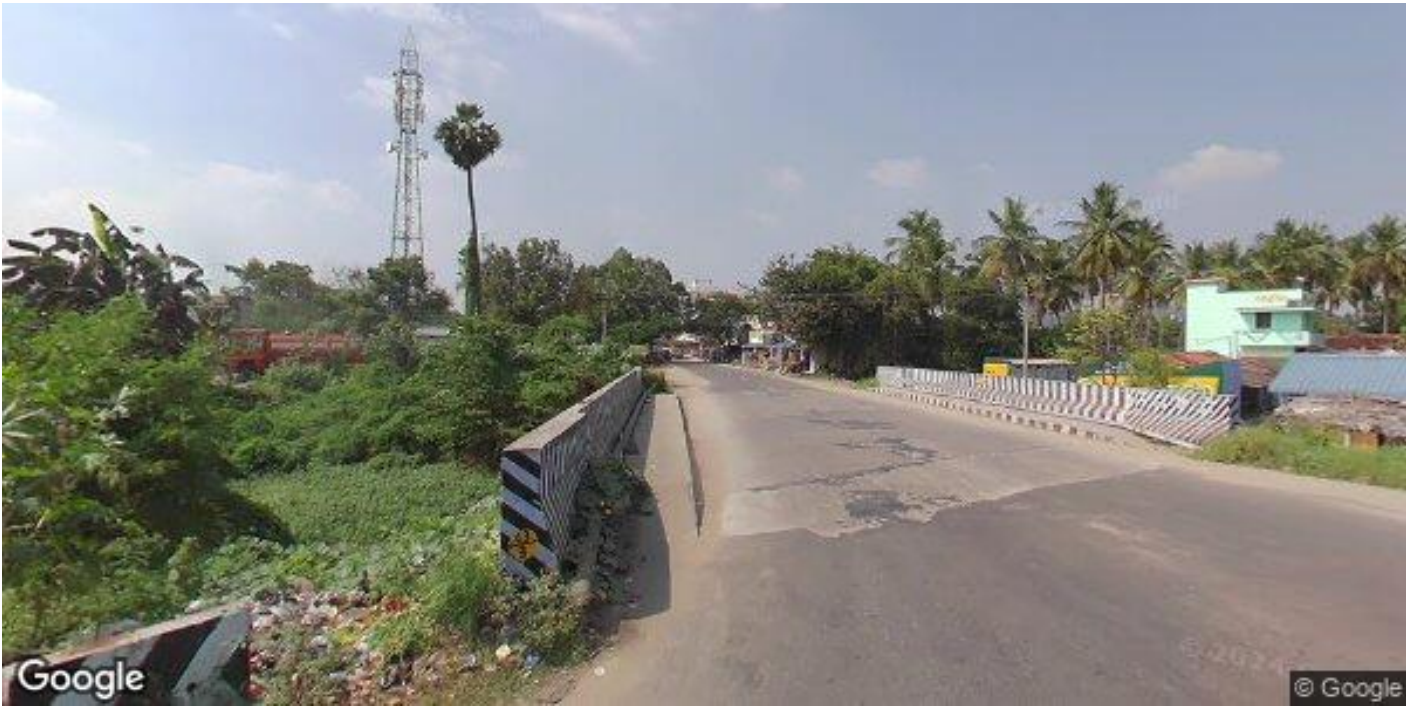
**Risk Type:** Turn  
**Risk Level:** High  
**Speed Limit:** 15 KM/Hr  
**Coordinates:** 11.44900, 77.87406

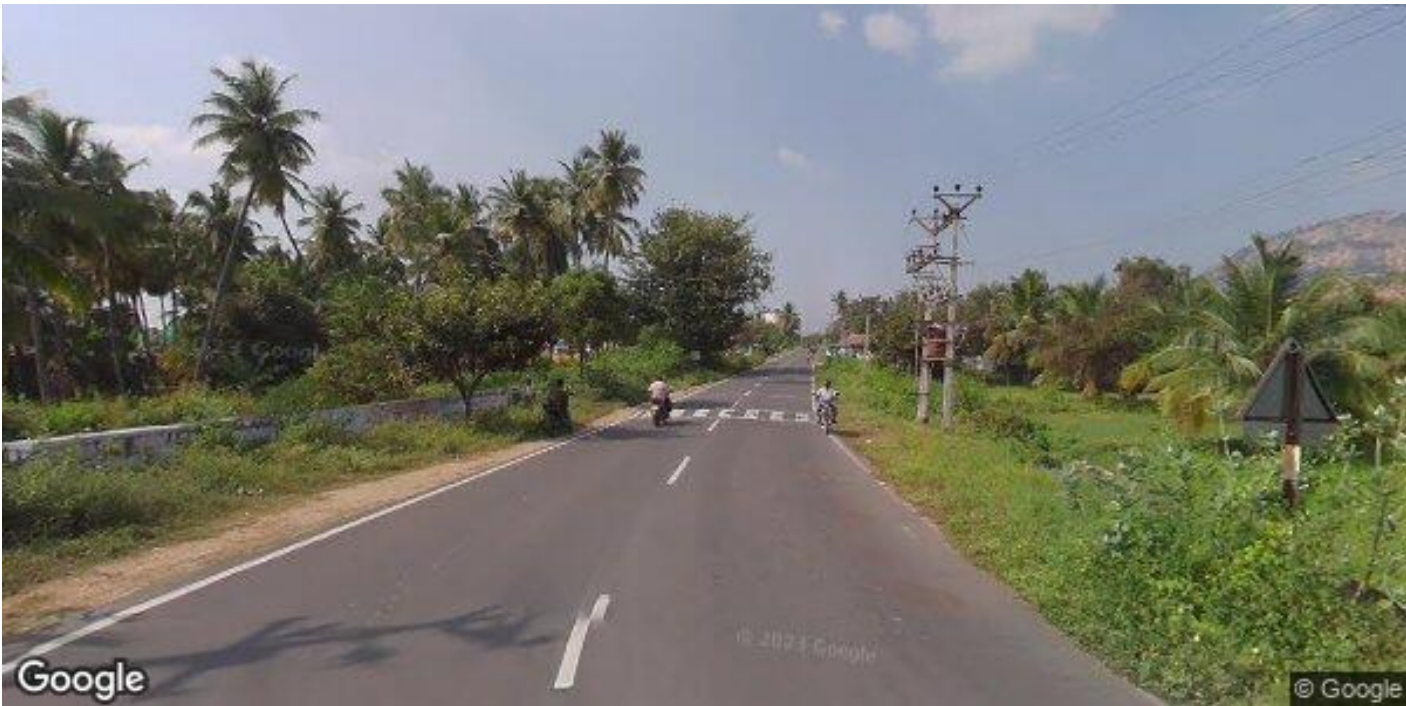
**Risk Type:** Turn  
**Risk Level:** High  
**Speed Limit:** 15 KM/Hr  
**Coordinates:** 11.45353, 77.85697

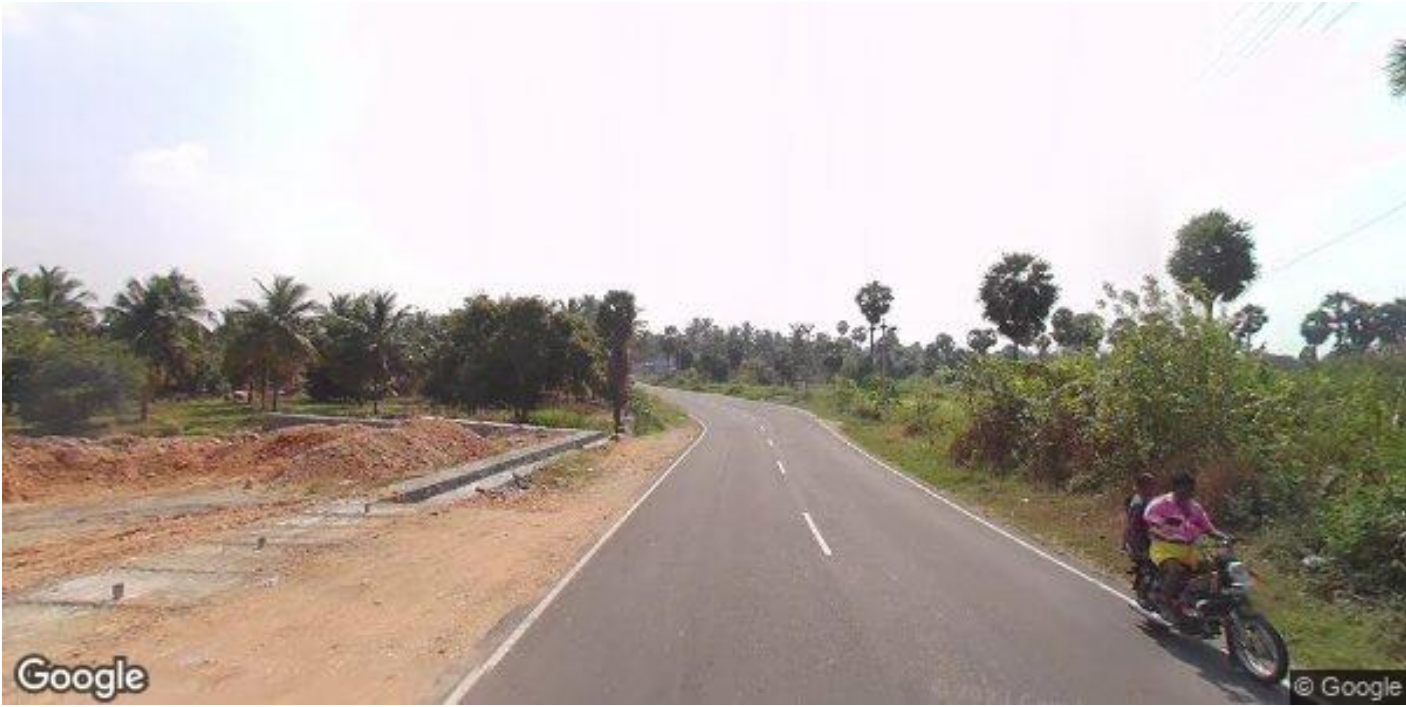
**Risk Type:** Turn  
**Risk Level:** Medium  
**Speed Limit:** 30 KM/Hr  
**Coordinates:** 11.45781, 77.85203

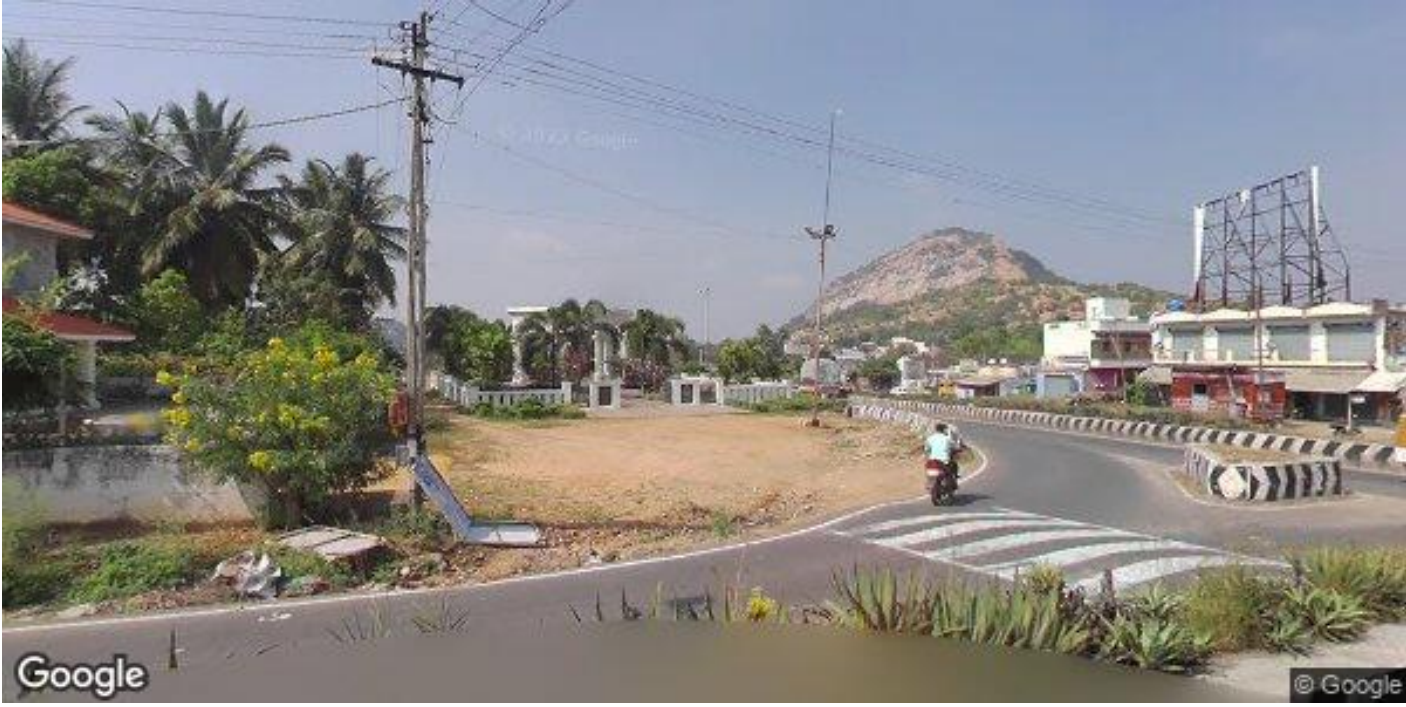
**Risk Type:** Turn  
**Risk Level:** High  
**Speed Limit:** 15 KM/Hr  
**Coordinates:** 11.46307, 77.84941

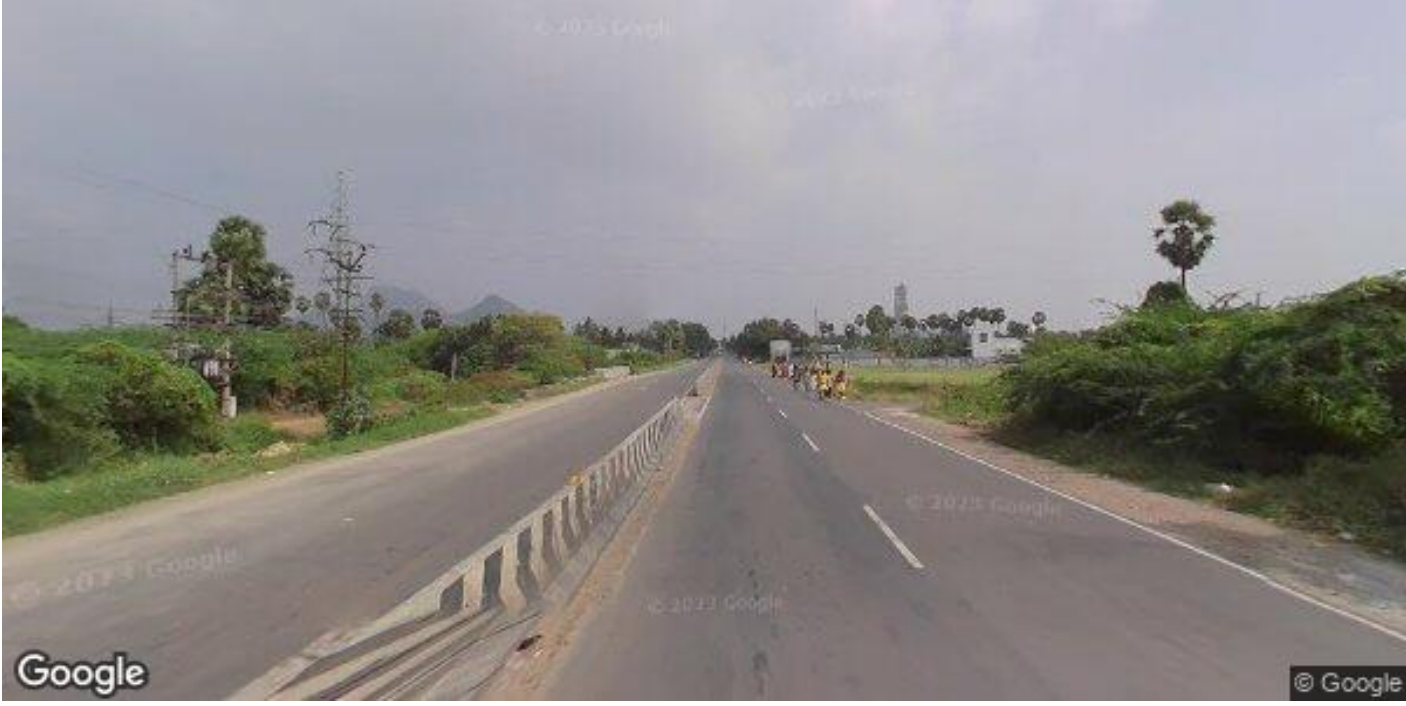
**Risk Type:** Turn  
**Risk Level:** Medium  
**Speed Limit:** 30 KM/Hr  
**Coordinates:** 11.45546, 77.81800

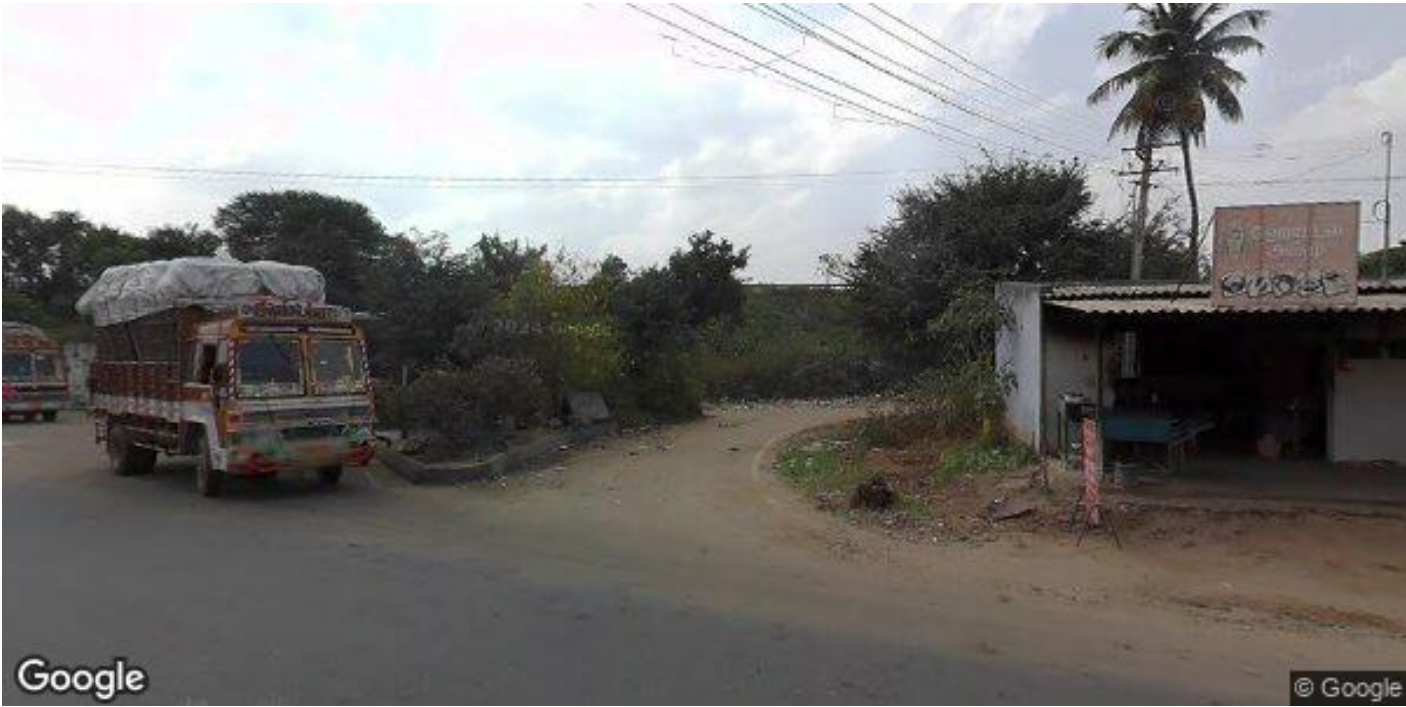
**Risk Type:** Blind Spot  
**Risk Level:** Blind Spot  
**Speed Limit:** 10 KM/Hr  
**Coordinates:** 11.49400, 77.88538

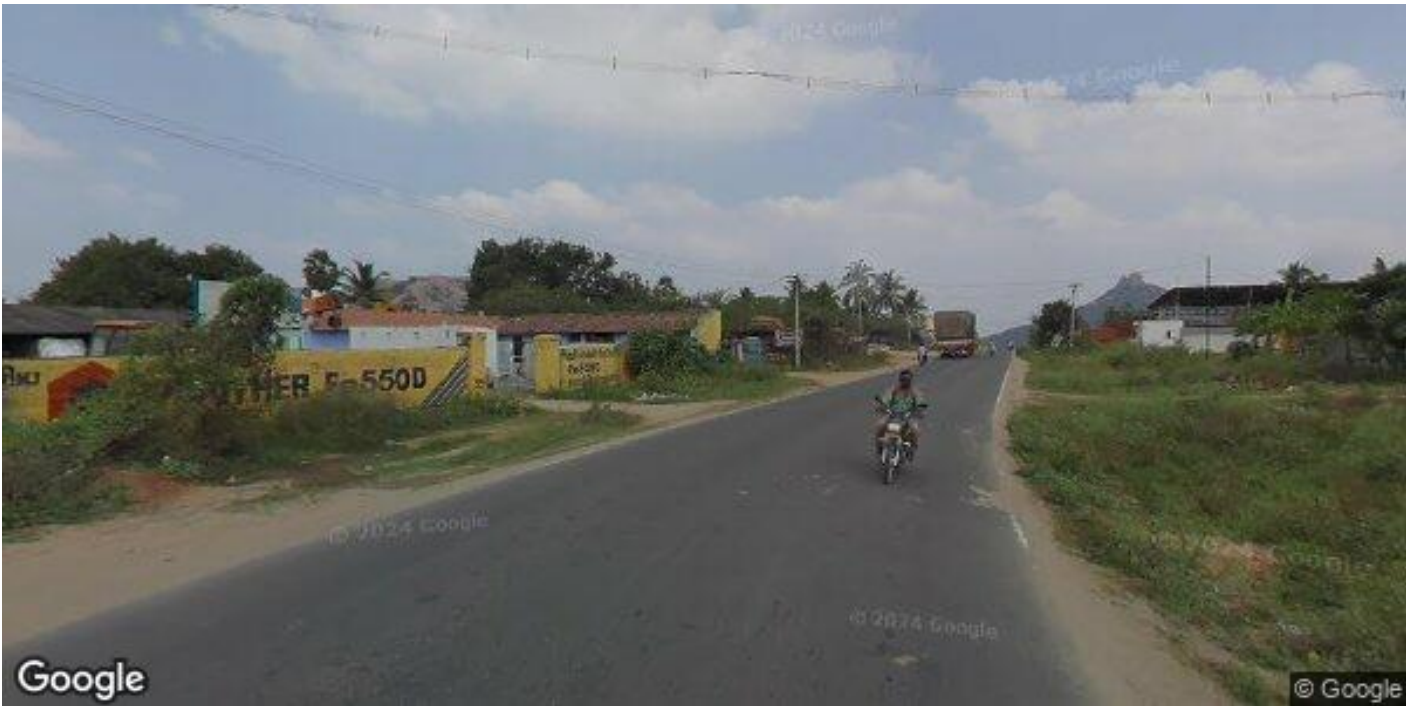
**Risk Type:** Turn  
**Risk Level:** High  
**Speed Limit:** 15 KM/Hr  
**Coordinates:** 11.49469, 77.88488

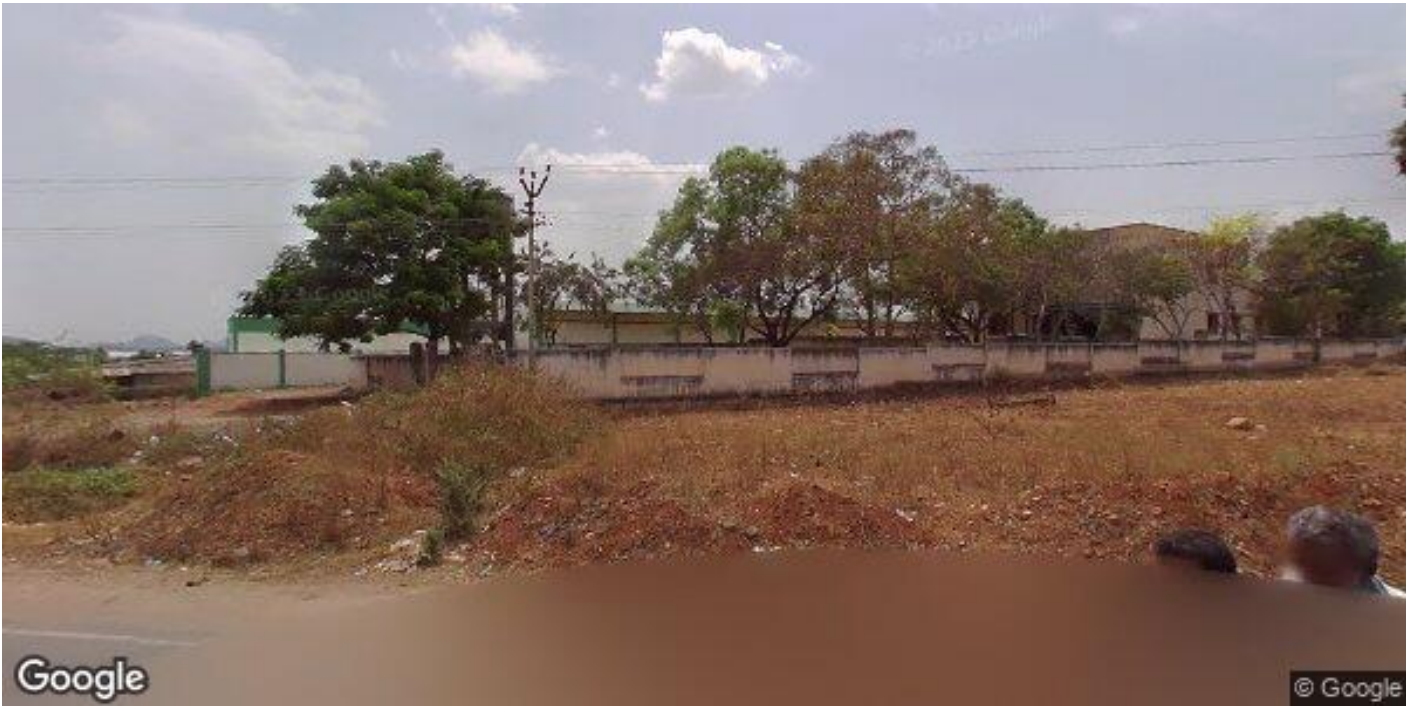
**Risk Type:** Turn  
**Risk Level:** High  
**Speed Limit:** 15 KM/Hr  
**Coordinates:** 11.58330, 77.90642

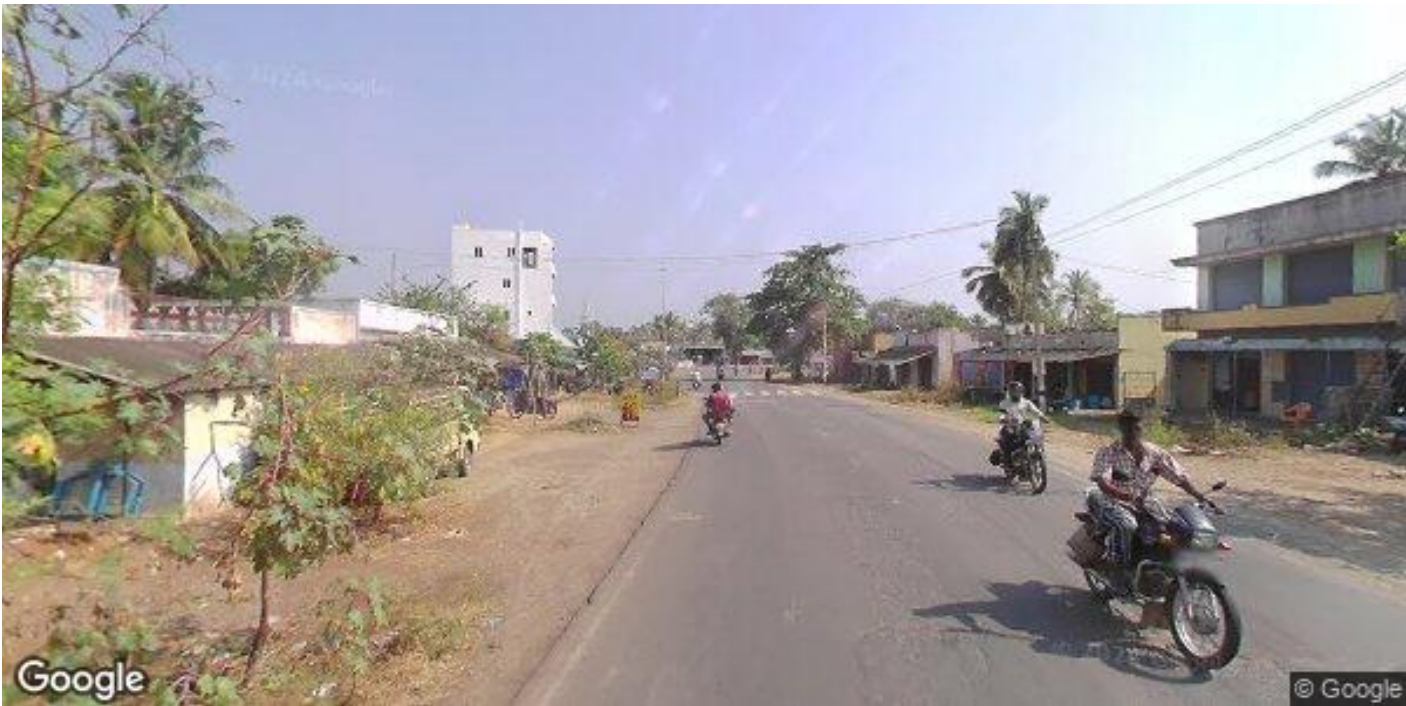
**Risk Type:** Turn  
**Risk Level:** Medium  
**Speed Limit:** 30 KM/Hr  
**Coordinates:** 11.59189, 77.90645

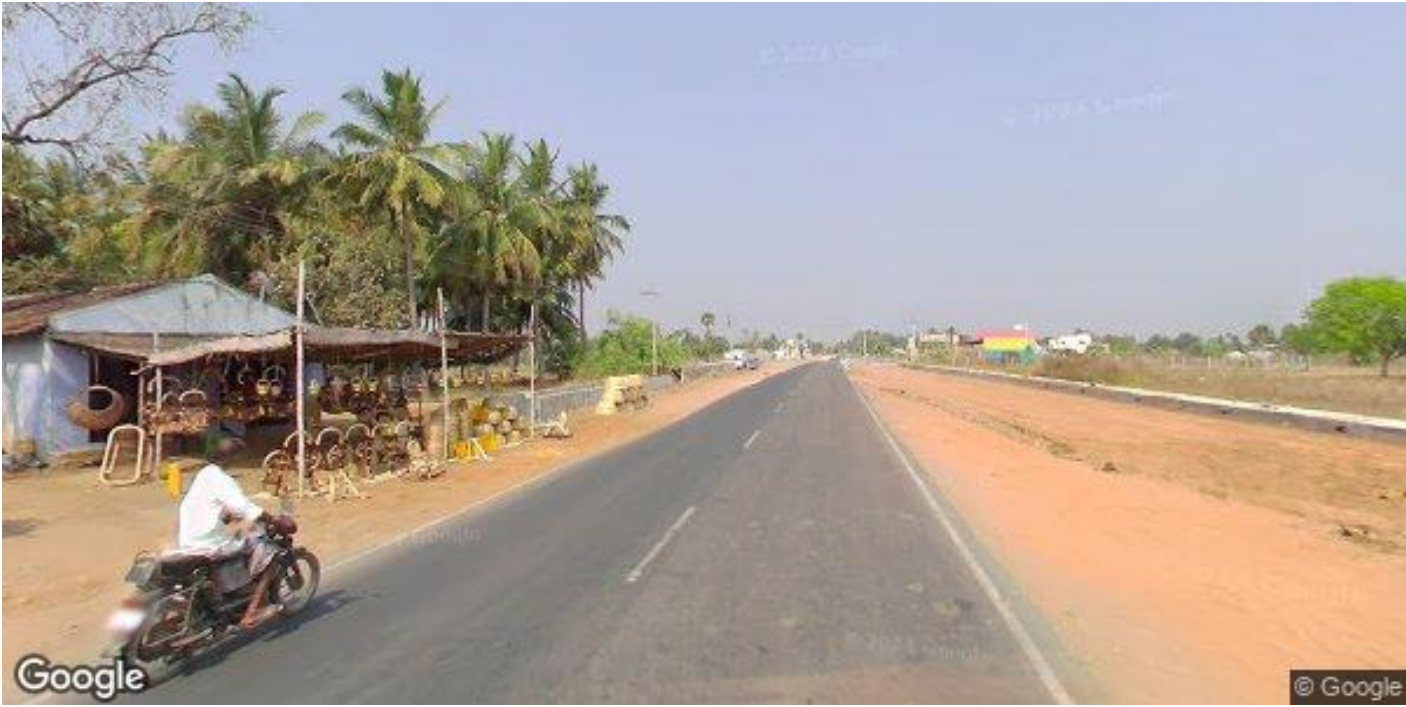
**Risk Type:** Turn  
**Risk Level:** Medium  
**Speed Limit:** 30 KM/Hr  
**Coordinates:** 11.59328, 77.90809

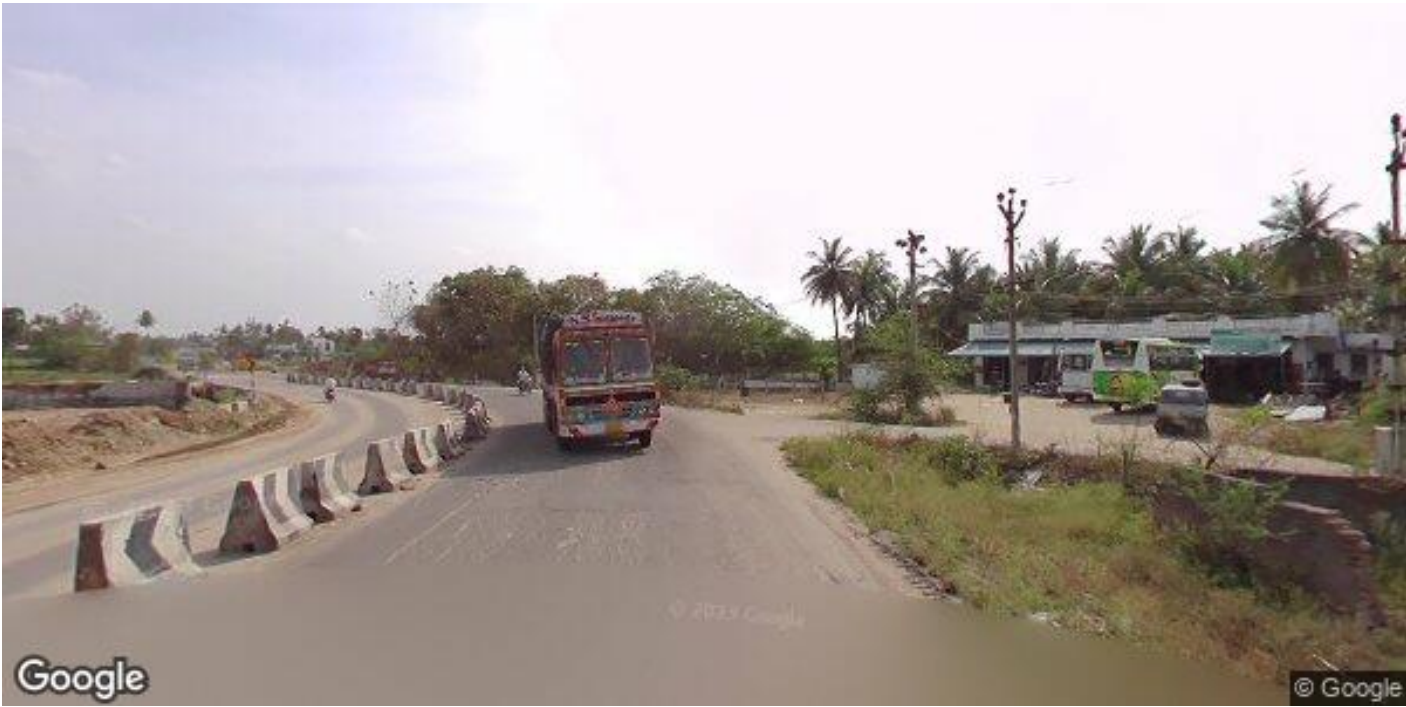
**Risk Type:** Turn  
**Risk Level:** Medium  
**Speed Limit:** 30 KM/Hr  
**Coordinates:** 11.63867, 77.94841

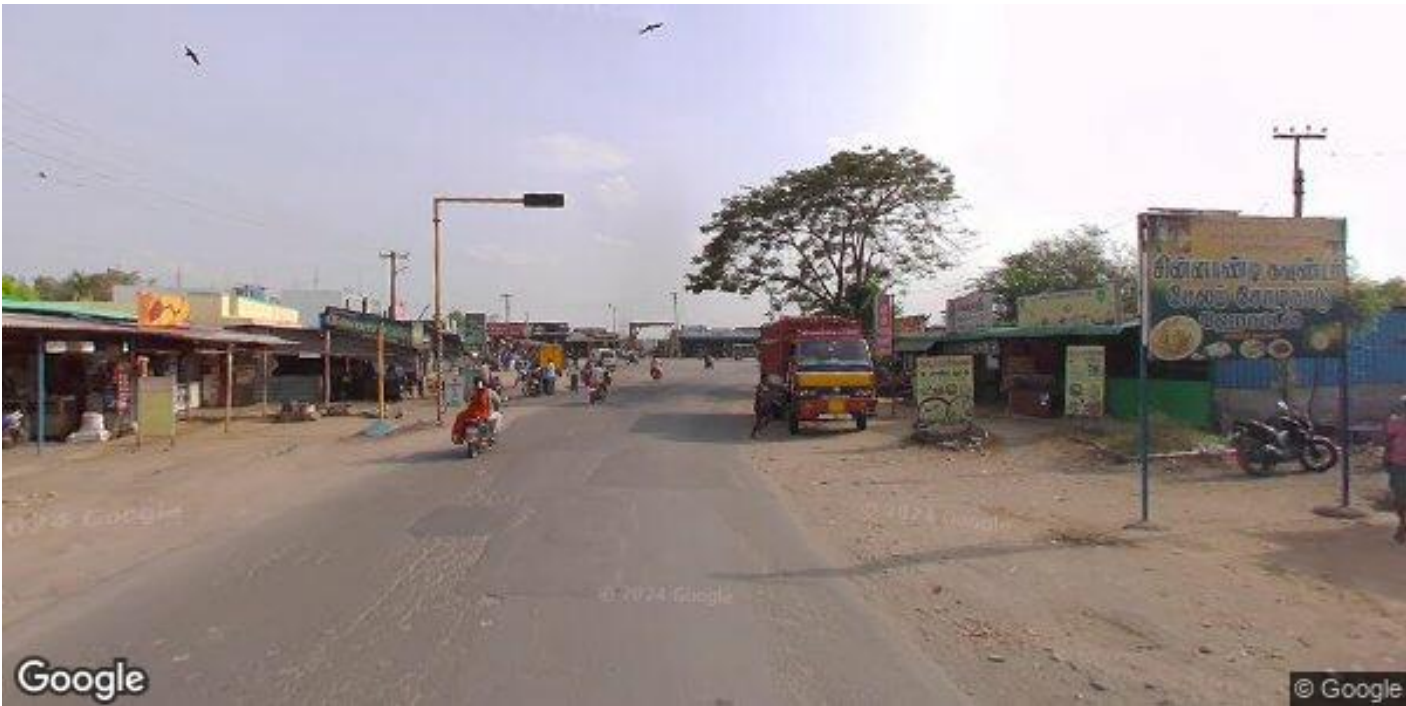
**Risk Type:** Turn  
**Risk Level:** High  
**Speed Limit:** 15 KM/Hr  
**Coordinates:** 11.64217, 77.95200

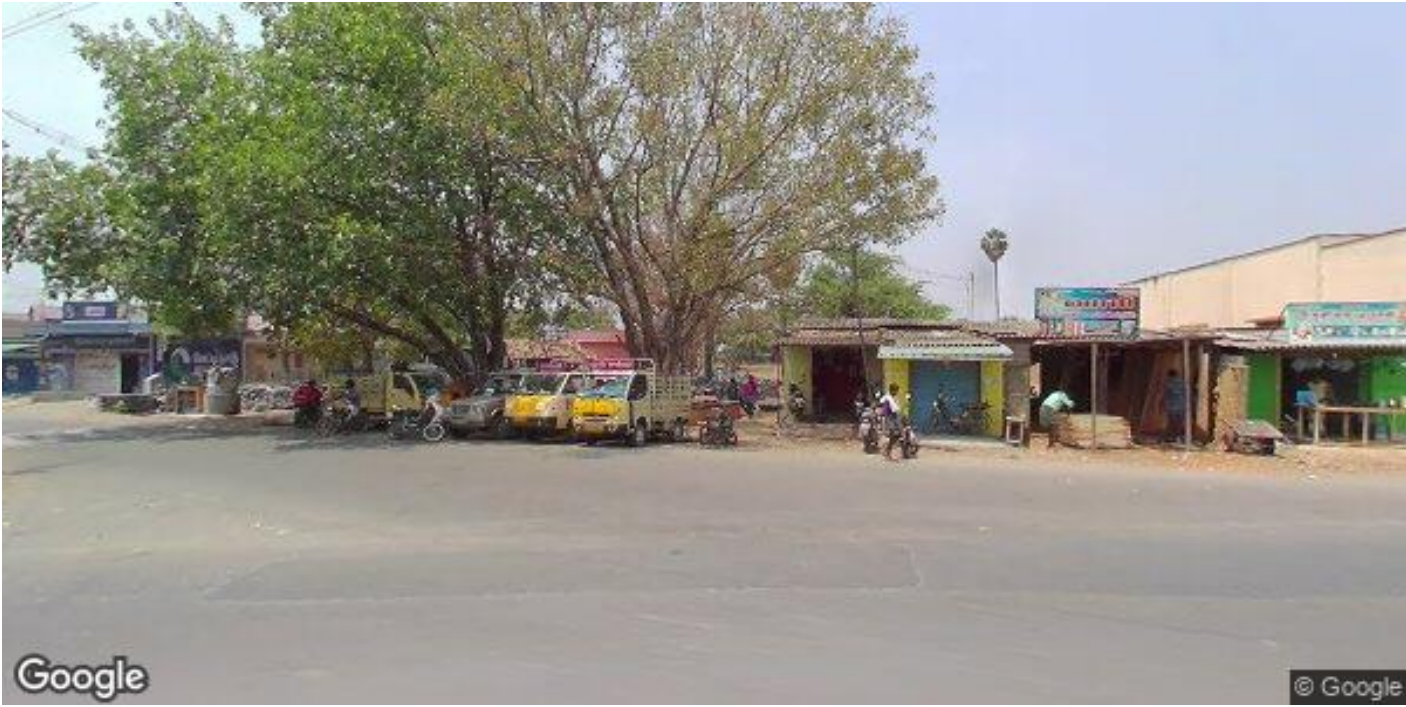
**Risk Type:** Turn  
**Risk Level:** Medium  
**Speed Limit:** 30 KM/Hr  
**Coordinates:** 11.64712, 77.95118

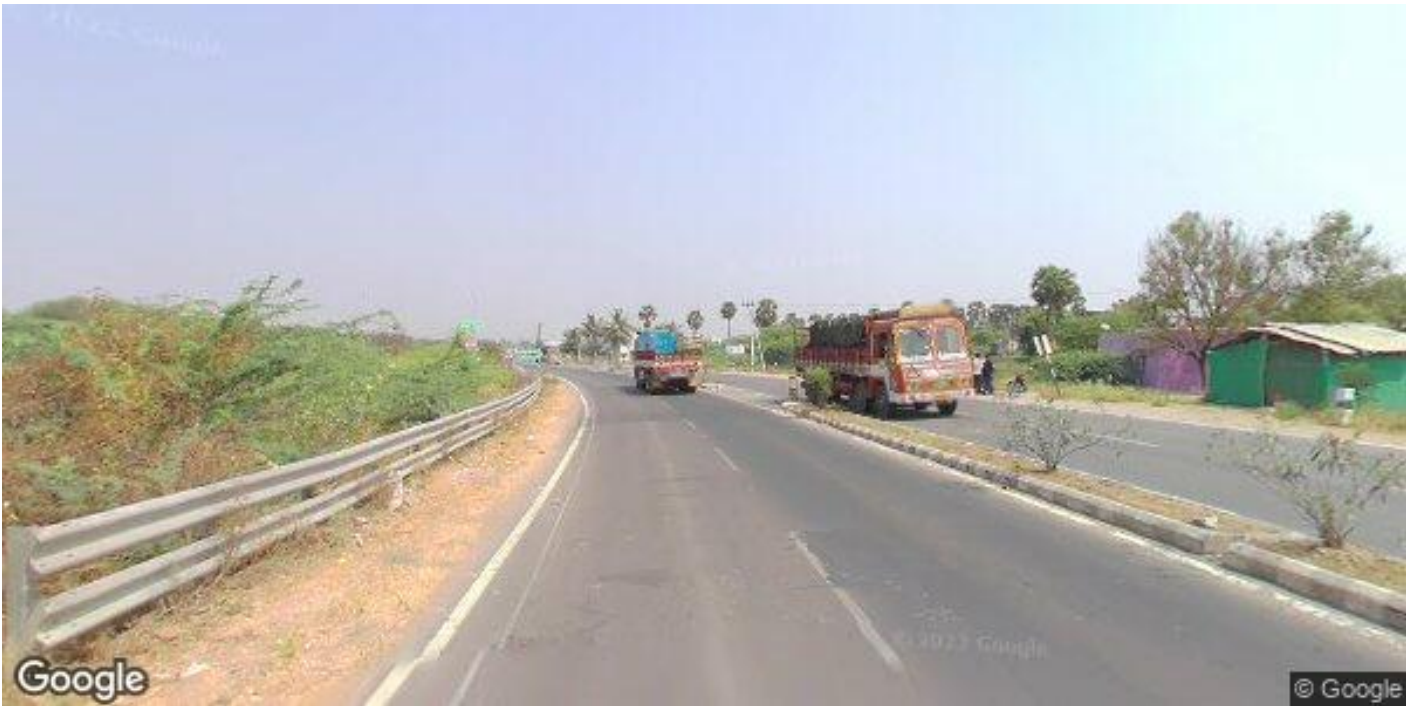
**Risk Type:** Turn  
**Risk Level:** Medium  
**Speed Limit:** 30 KM/Hr  
**Coordinates:** 11.70062, 77.97961

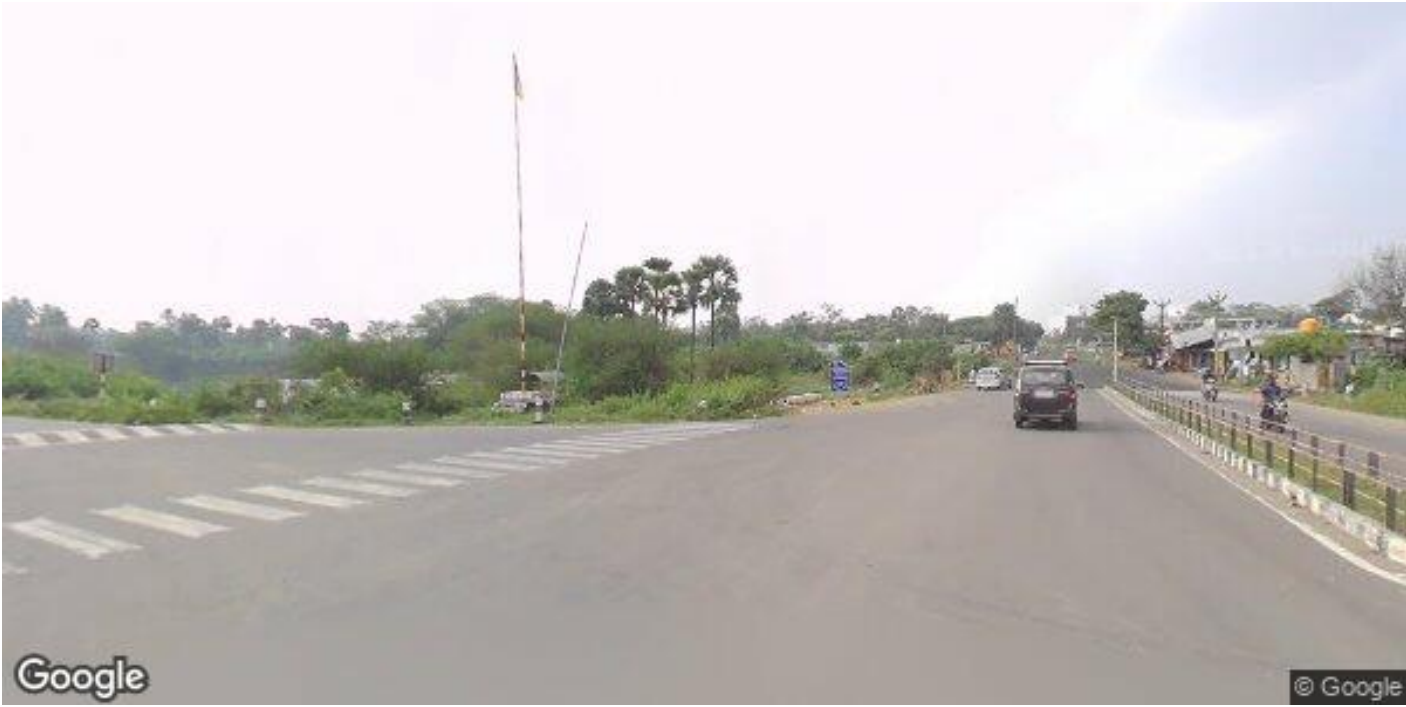
**Risk Type:** Turn  
**Risk Level:** High  
**Speed Limit:** 15 KM/Hr  
**Coordinates:** 11.70218, 77.97866

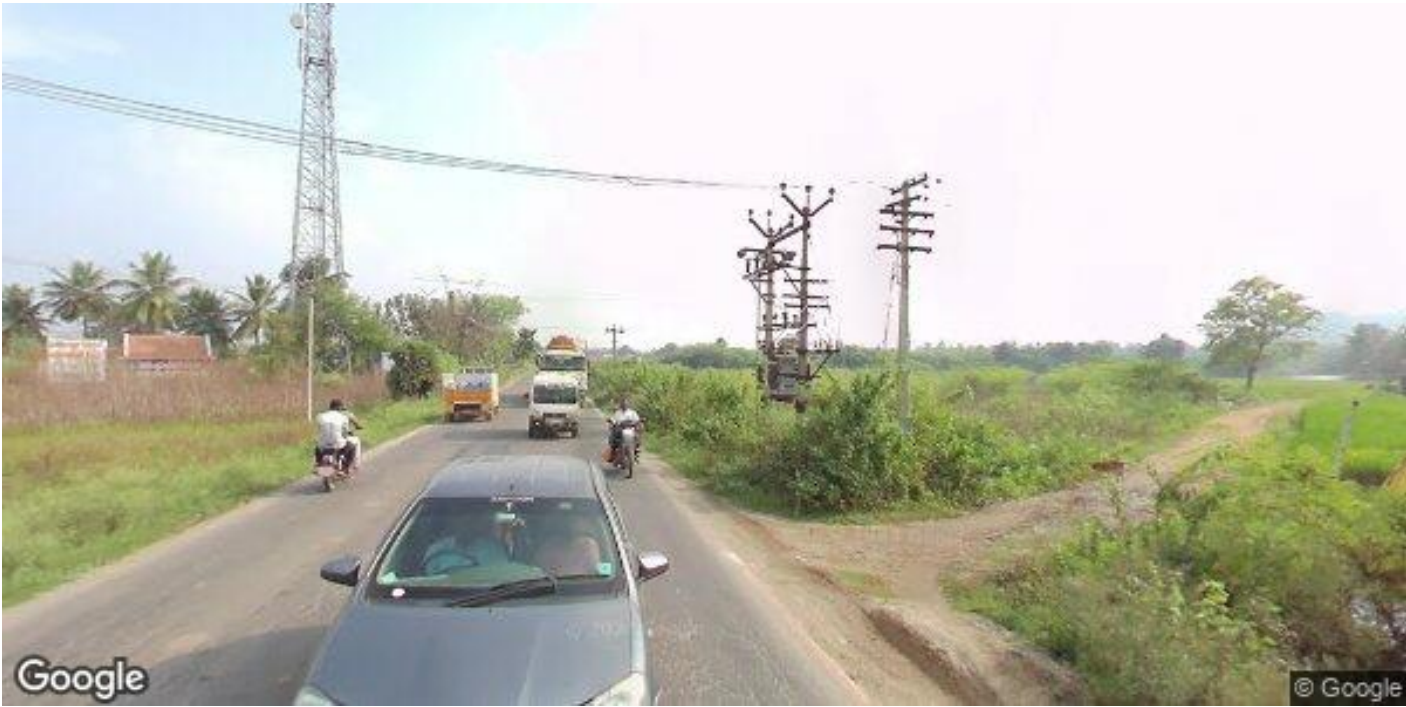
**Risk Type:** Turn  
**Risk Level:** Medium  
**Speed Limit:** 30 KM/Hr  
**Coordinates:** 11.71399, 77.99580

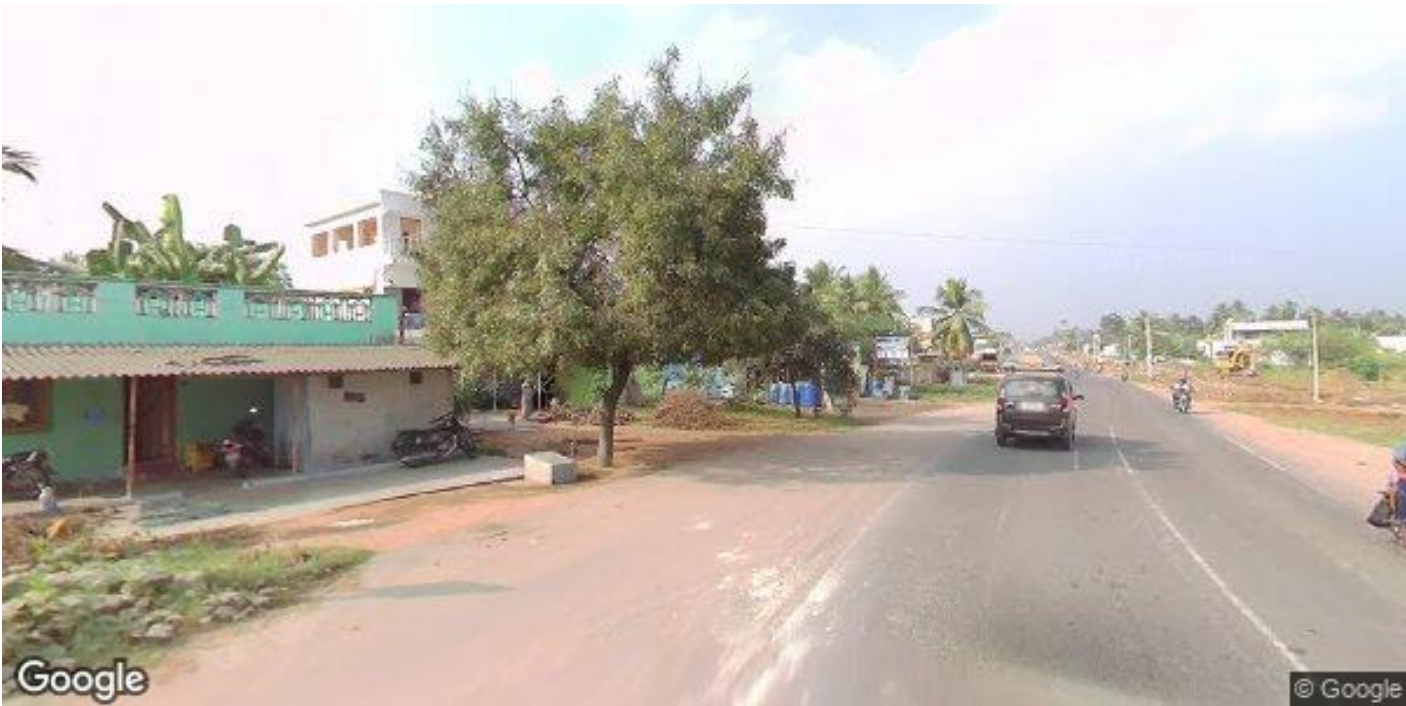
**Risk Type:** Turn  
**Risk Level:** Medium  
**Speed Limit:** 30 KM/Hr  
**Coordinates:** 11.71917, 78.01123

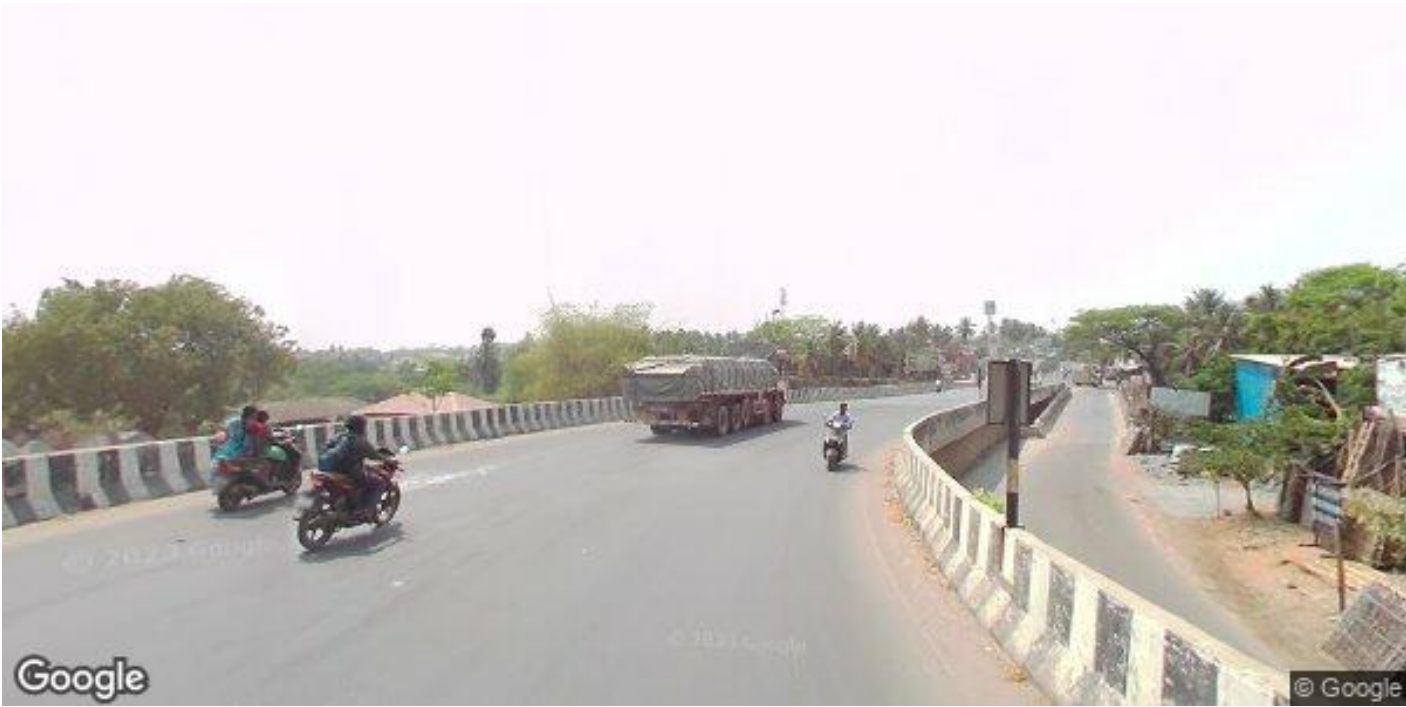
**Risk Type:** Turn  
**Risk Level:** High  
**Speed Limit:** 15 KM/Hr  
**Coordinates:** 11.73651, 78.03871

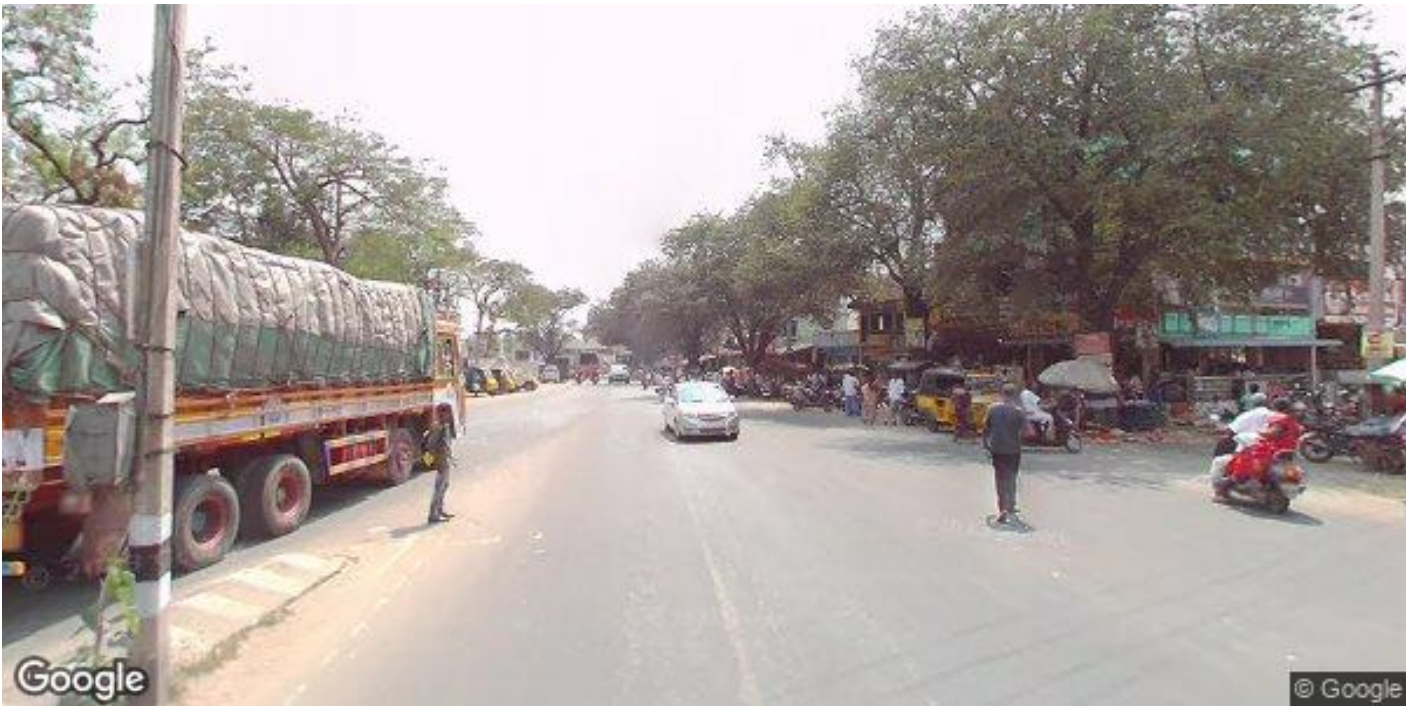
**Risk Type:** Turn  
**Risk Level:** Medium  
**Speed Limit:** 30 KM/Hr  
**Coordinates:** 11.74271, 78.04717

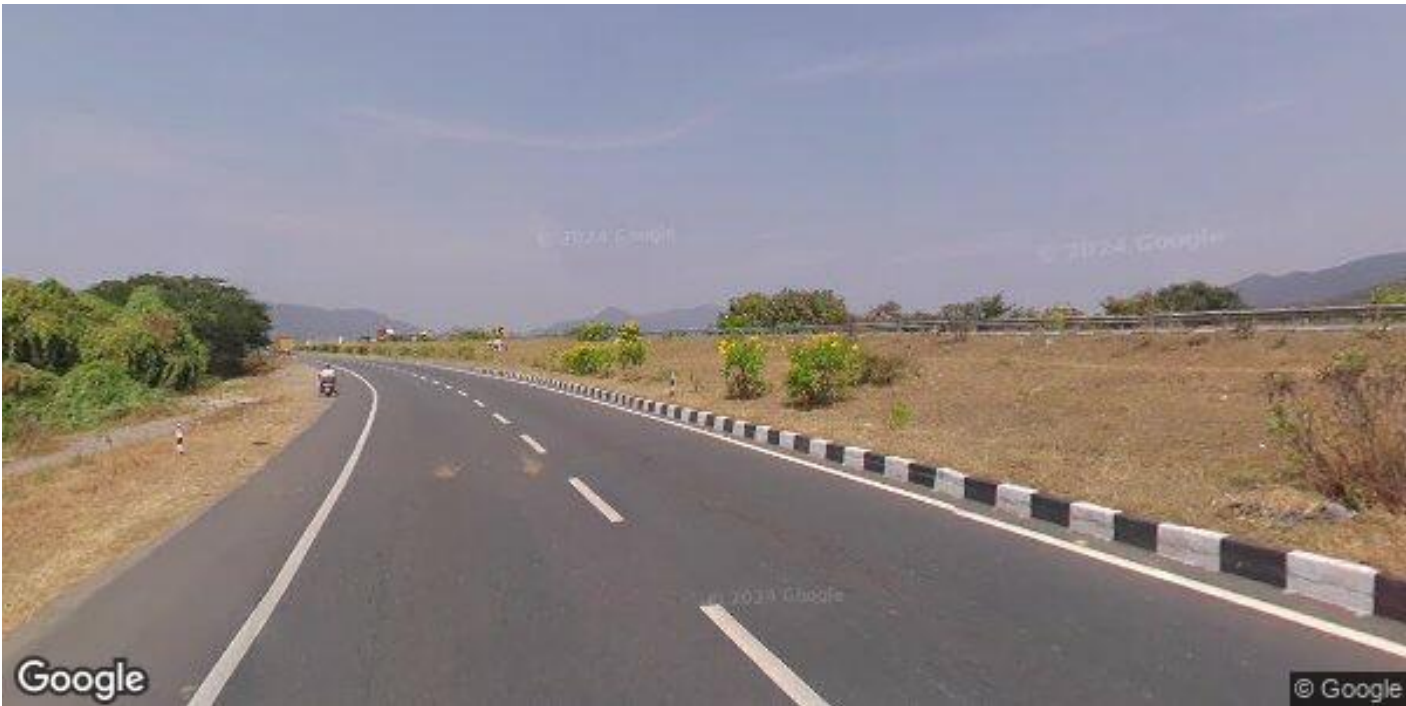
**Risk Type:** Turn  
**Risk Level:** Medium  
**Speed Limit:** 30 KM/Hr  
**Coordinates:** 11.92585, 78.06507

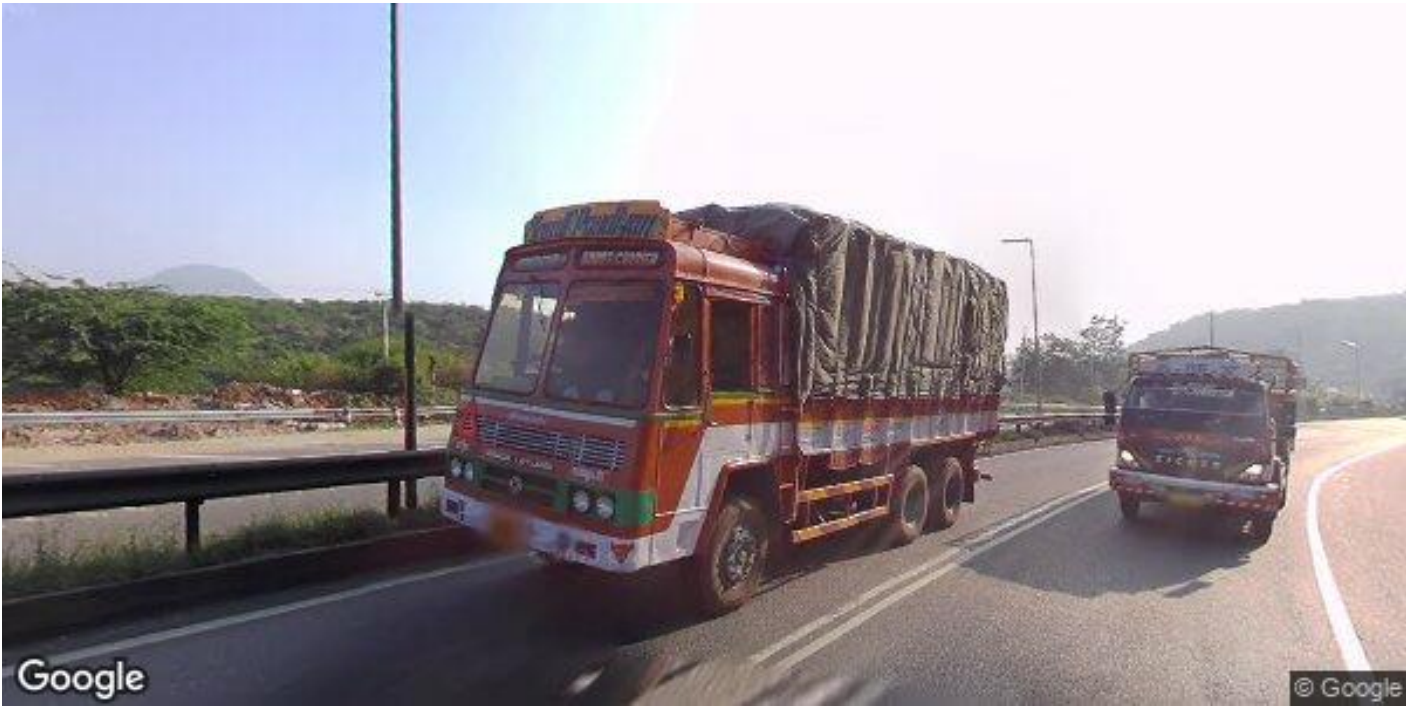
**Risk Type:** Turn  
**Risk Level:** High  
**Speed Limit:** 15 KM/Hr  
**Coordinates:** 11.95818, 78.04978

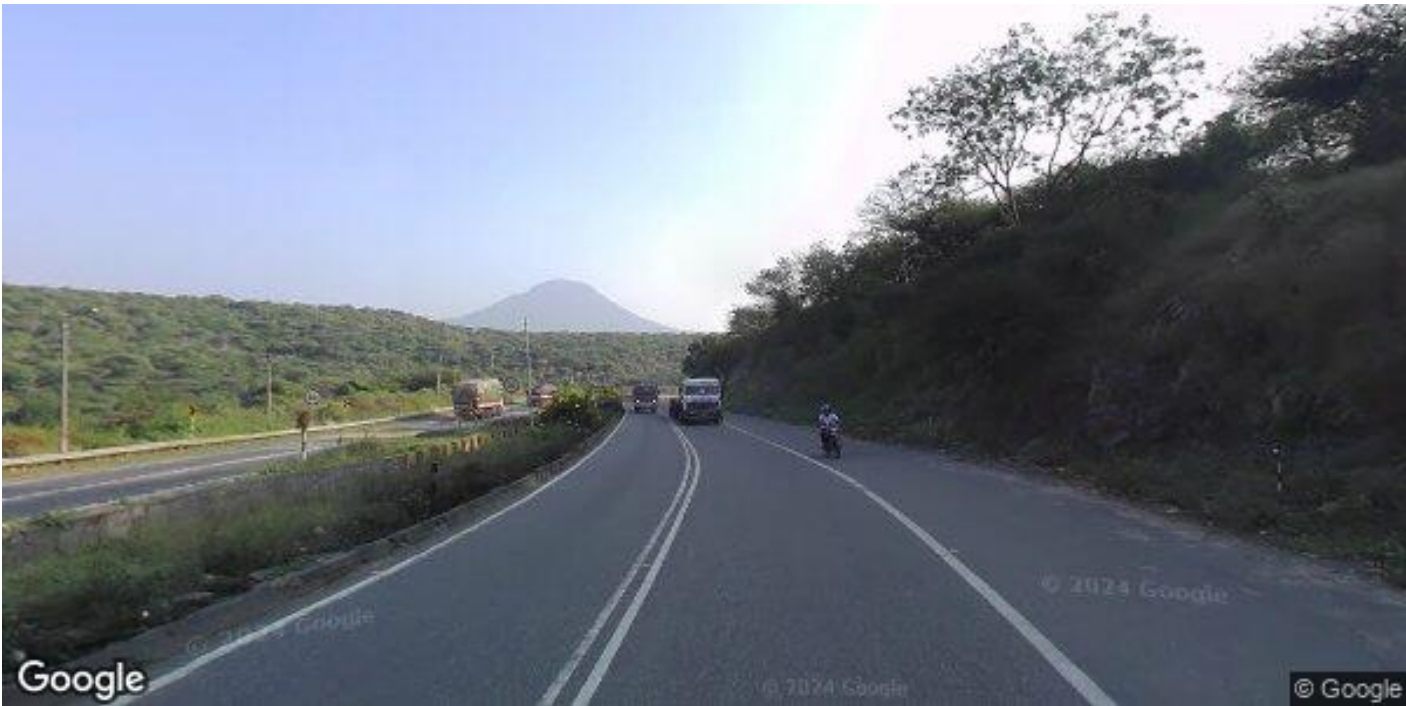
**Risk Type:** Turn  
**Risk Level:** Medium  
**Speed Limit:** 30 KM/Hr  
**Coordinates:** 11.95988, 78.04948
