## JOURNEY RISK MANAGEMENT (JRM) STUDY

### Salem Terminal to JP AGENCIES

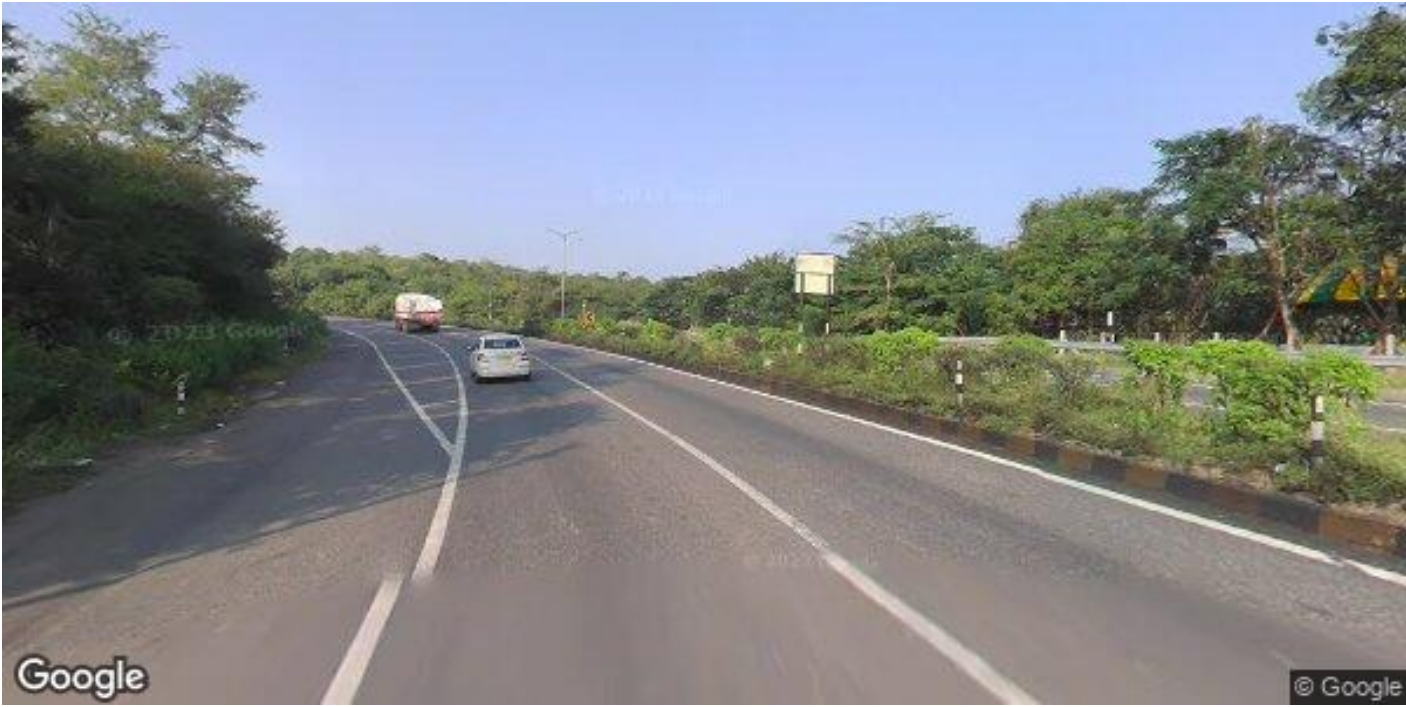
**Risk Type:** Turn  
**Risk Level:** Medium  
**Speed Limit:** 30 KM/Hr  
**Coordinates:** 11.96304, 78.05136

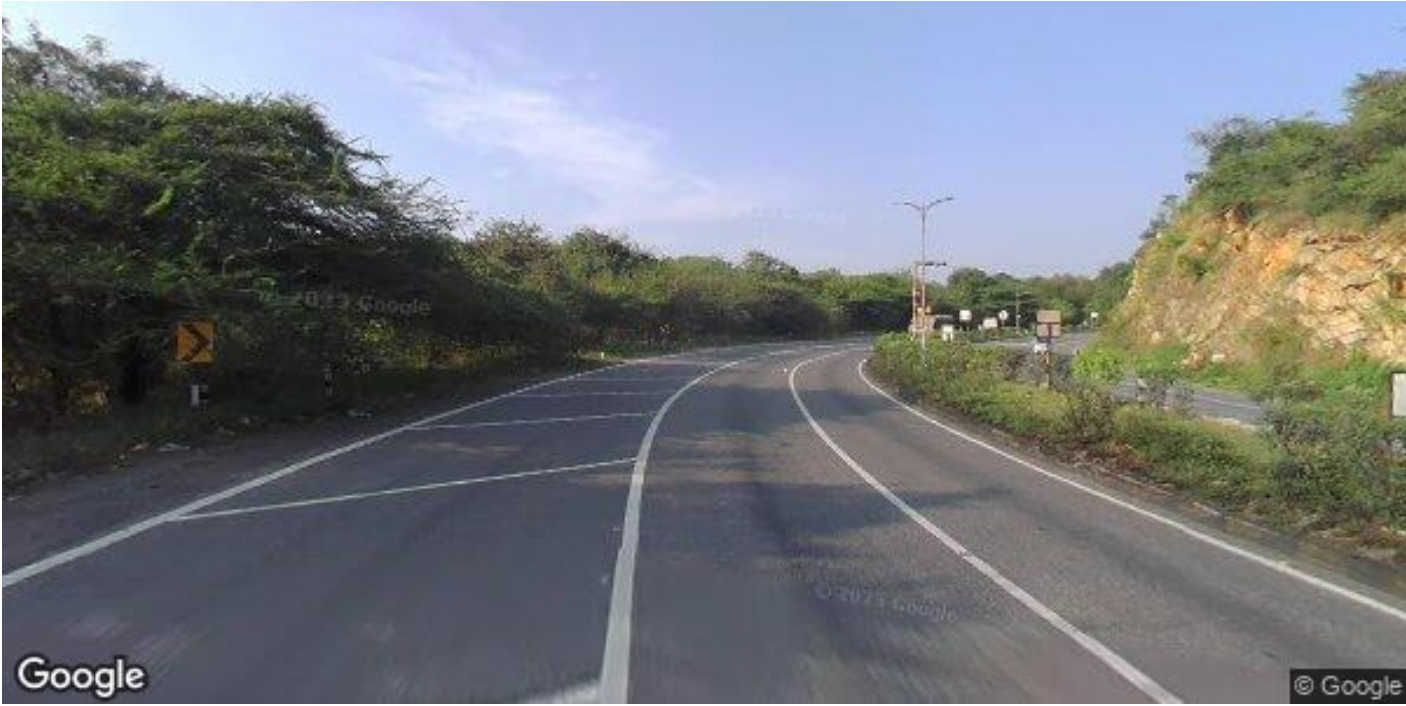
**Risk Type:** Turn  
**Risk Level:** High  
**Speed Limit:** 15 KM/Hr  
**Coordinates:** 11.96580, 78.04923

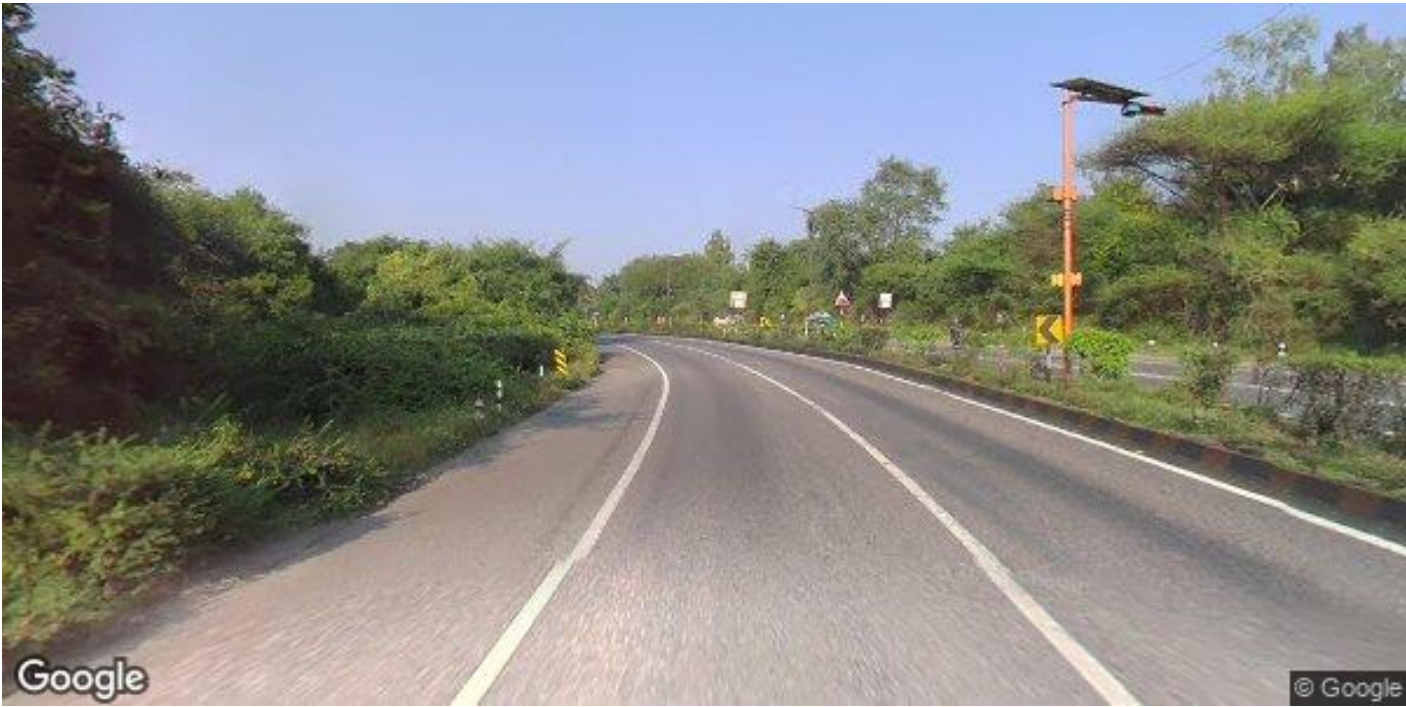
**Risk Type:** Turn  
**Risk Level:** Medium  
**Speed Limit:** 30 KM/Hr  
**Coordinates:** 11.96791, 78.05070

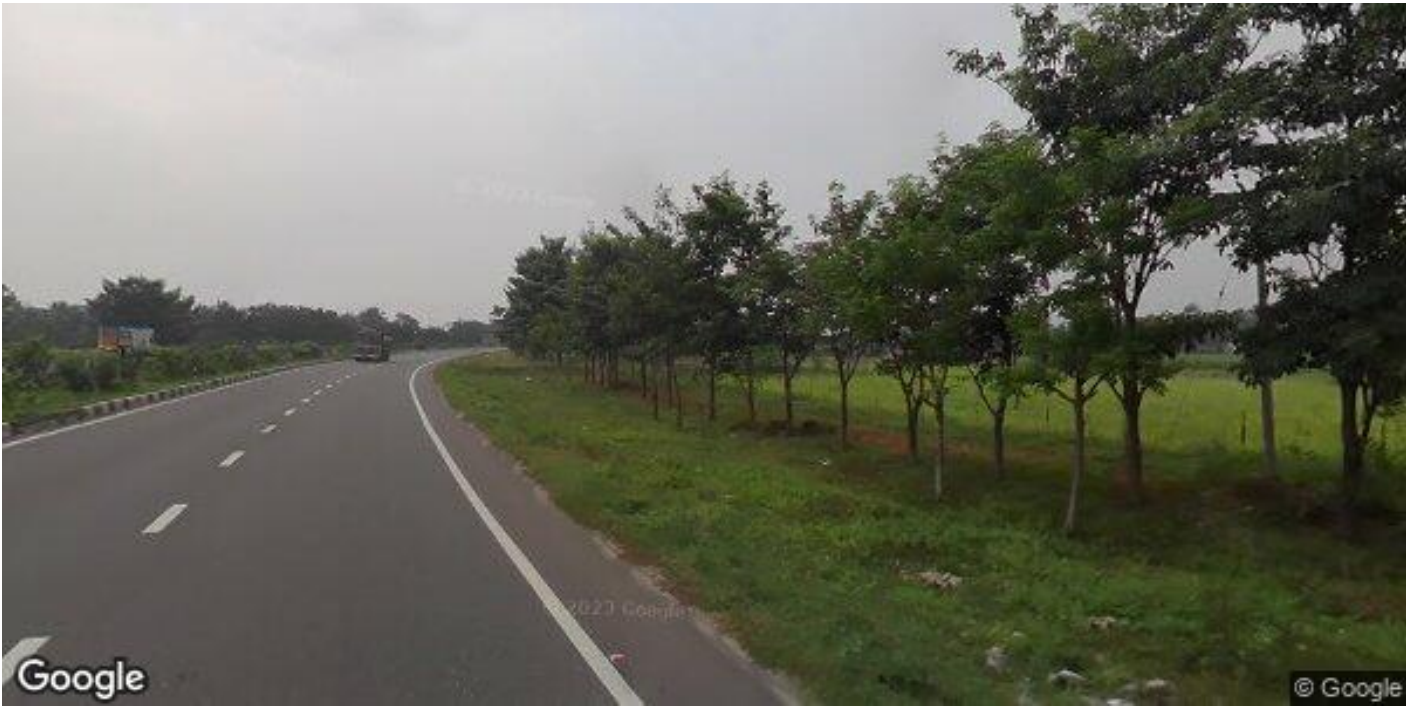
**Risk Type:** Turn  
**Risk Level:** Medium  
**Speed Limit:** 30 KM/Hr  
**Coordinates:** 12.25060, 78.19977

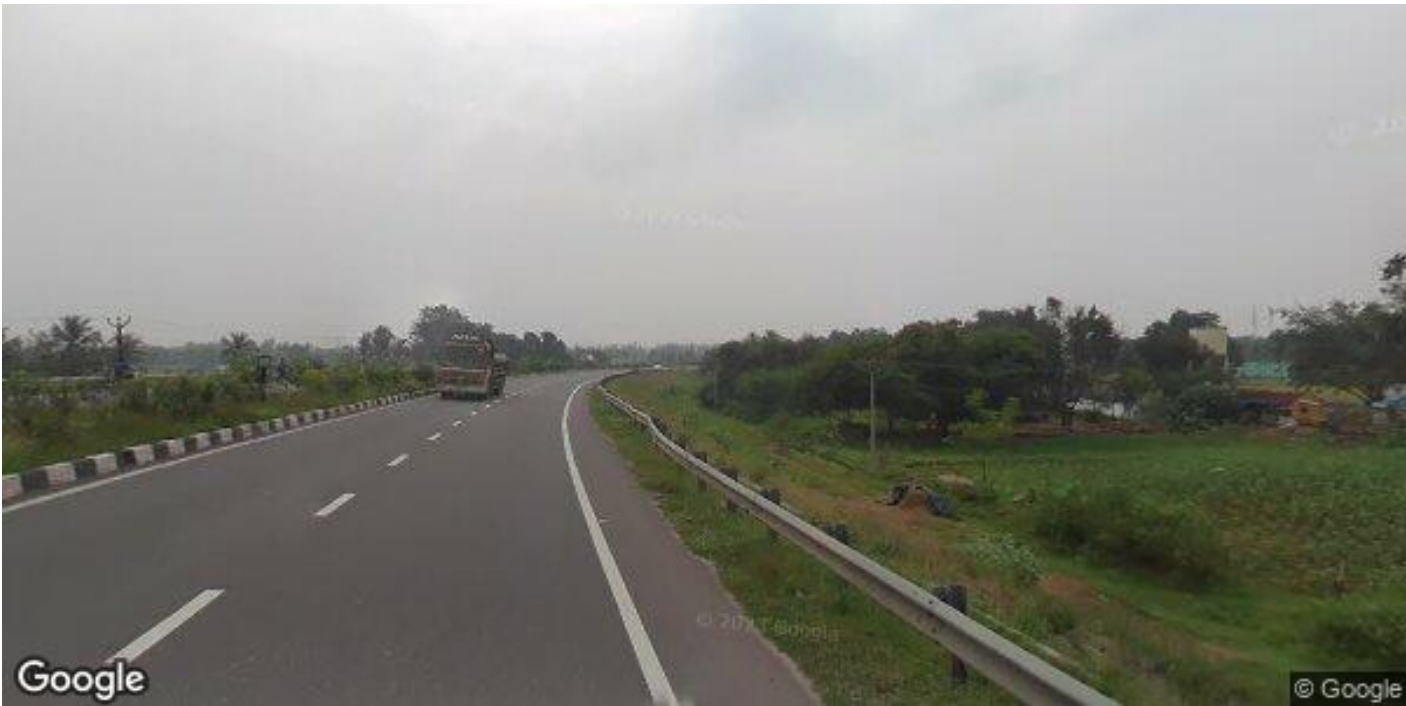
**Risk Type:** Turn  
**Risk Level:** Medium  
**Speed Limit:** 30 KM/Hr  
**Coordinates:** 12.25329, 78.20039

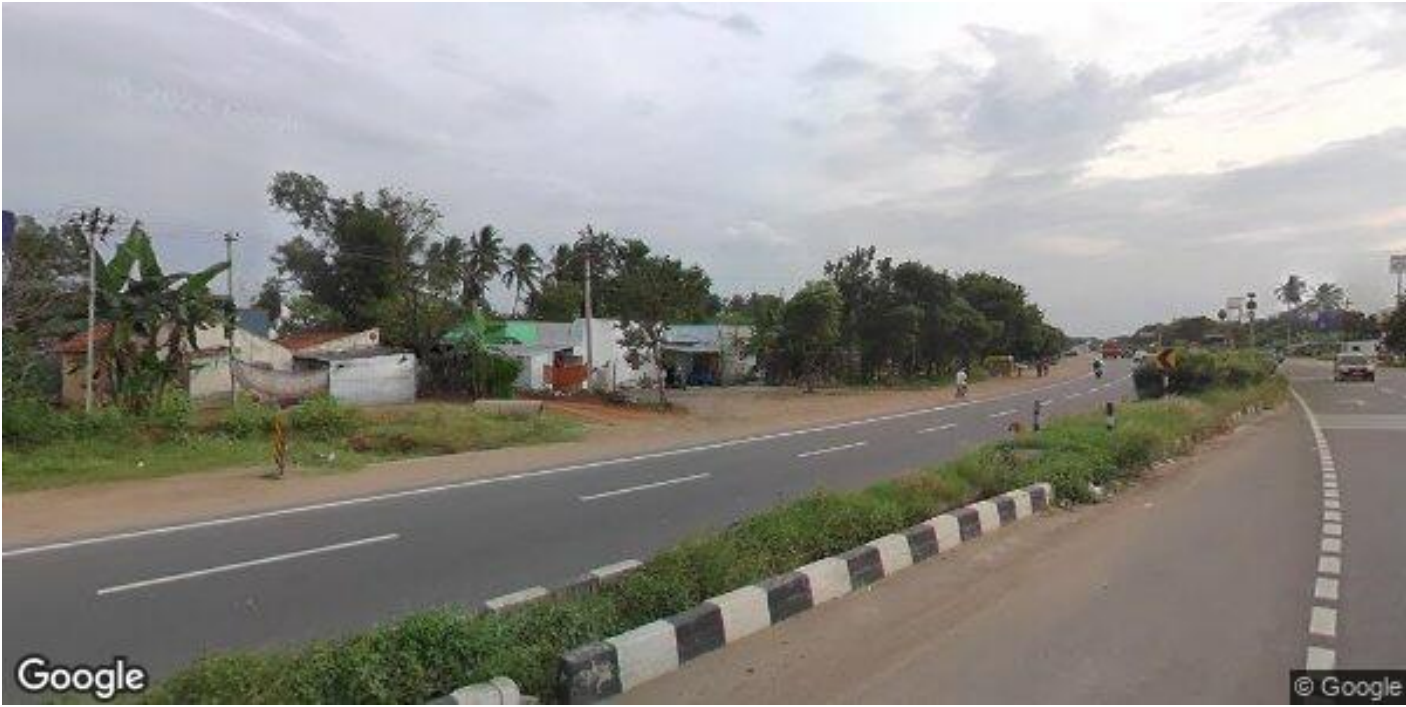
**Risk Type:** Turn  
**Risk Level:** Medium  
**Speed Limit:** 30 KM/Hr  
**Coordinates:** 12.29110, 78.19909

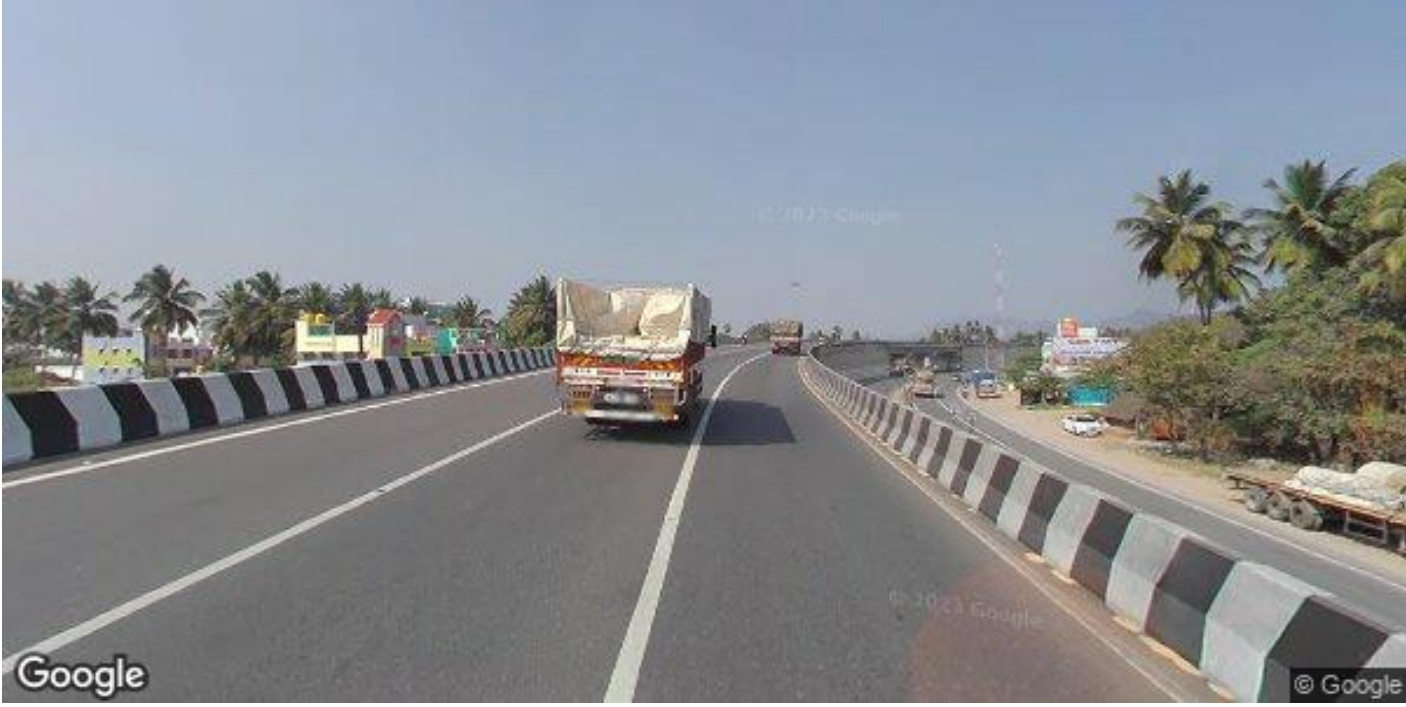
**Risk Type:** Turn  
**Risk Level:** Medium  
**Speed Limit:** 30 KM/Hr  
**Coordinates:** 12.39904, 78.21764

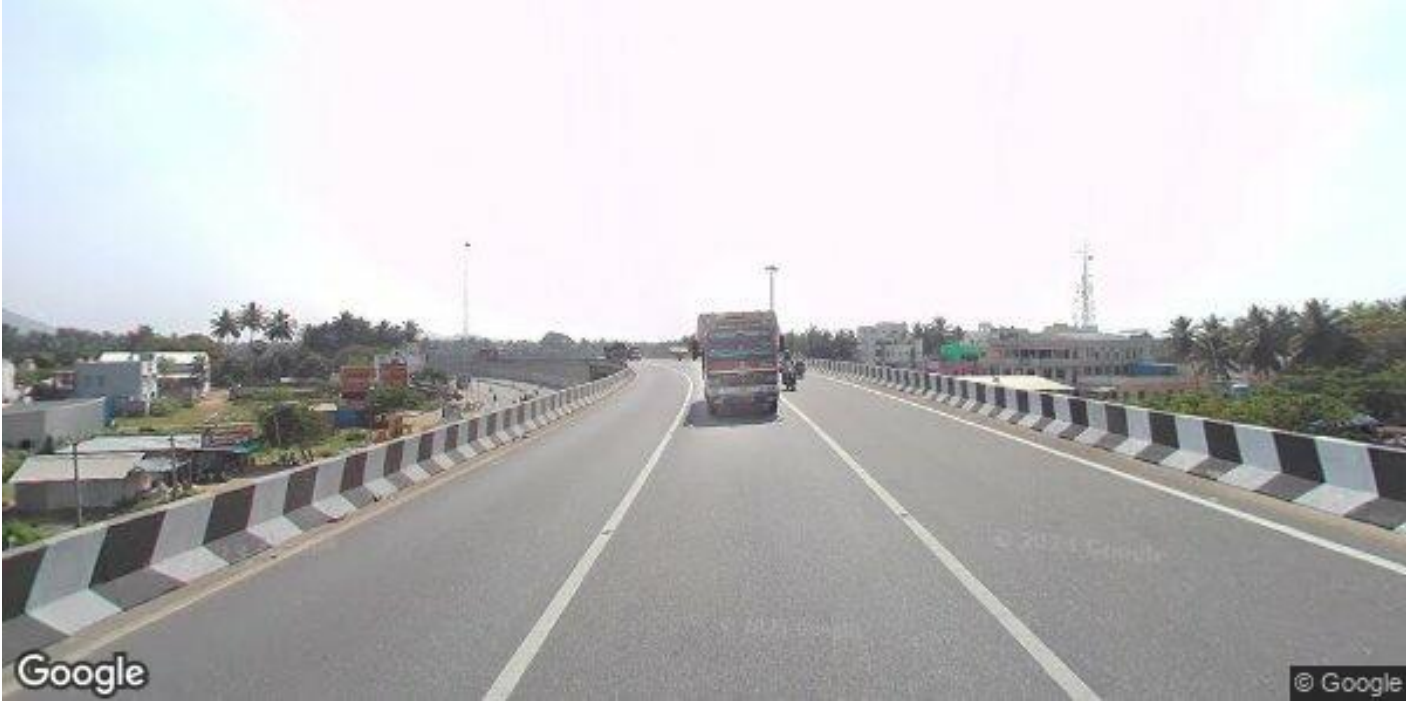
**Risk Type:** Turn  
**Risk Level:** Medium  
**Speed Limit:** 30 KM/Hr  
**Coordinates:** 12.40156, 78.21845

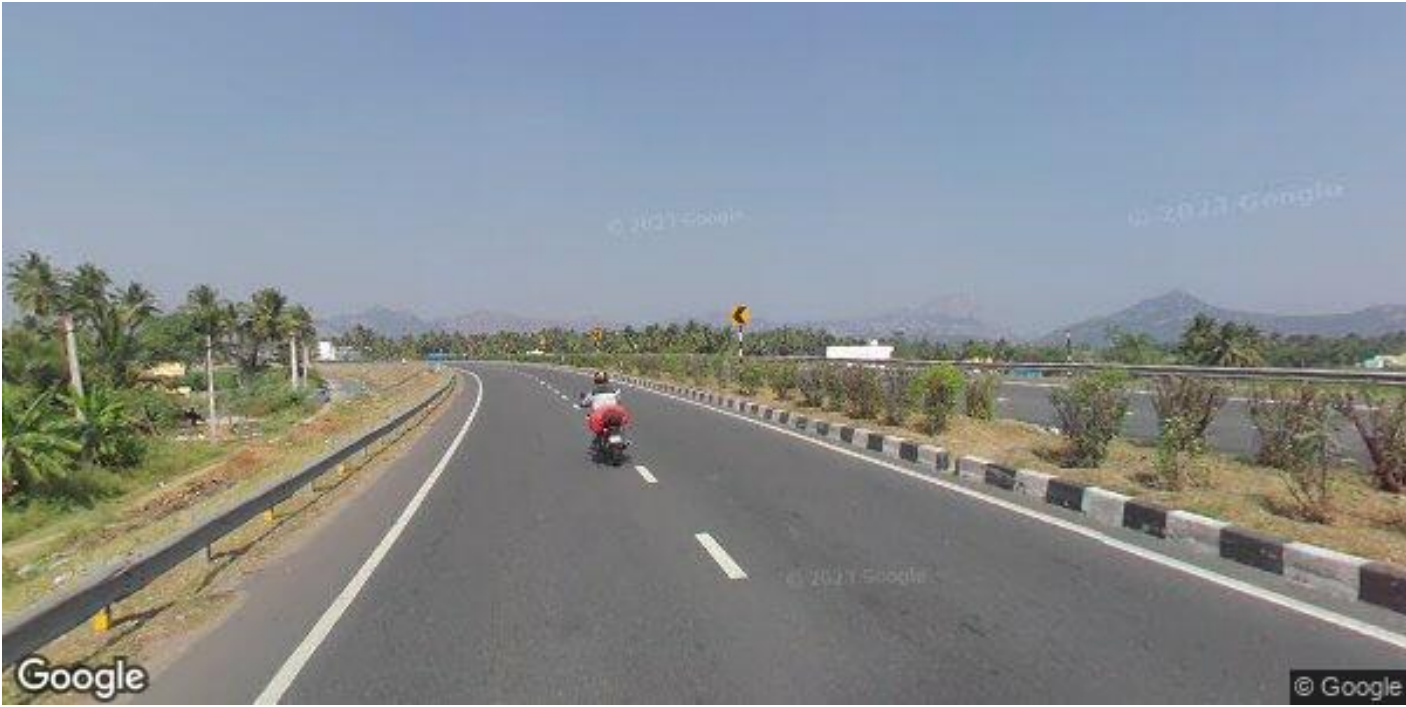
**Risk Type:** Turn  
**Risk Level:** Medium  
**Speed Limit:** 30 KM/Hr  
**Coordinates:** 12.40589, 78.22275

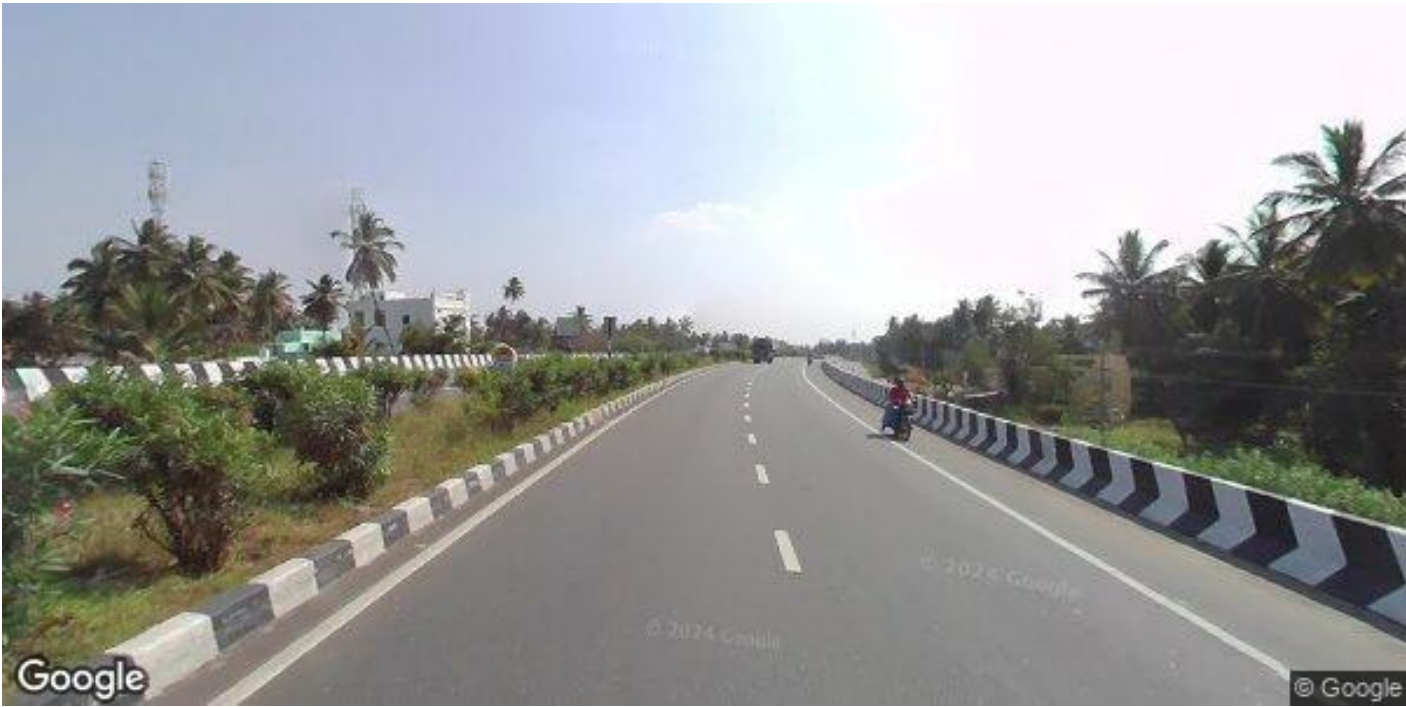
**Risk Type:** Turn  
**Risk Level:** Medium  
**Speed Limit:** 30 KM/Hr  
**Coordinates:** 12.45018, 78.21828

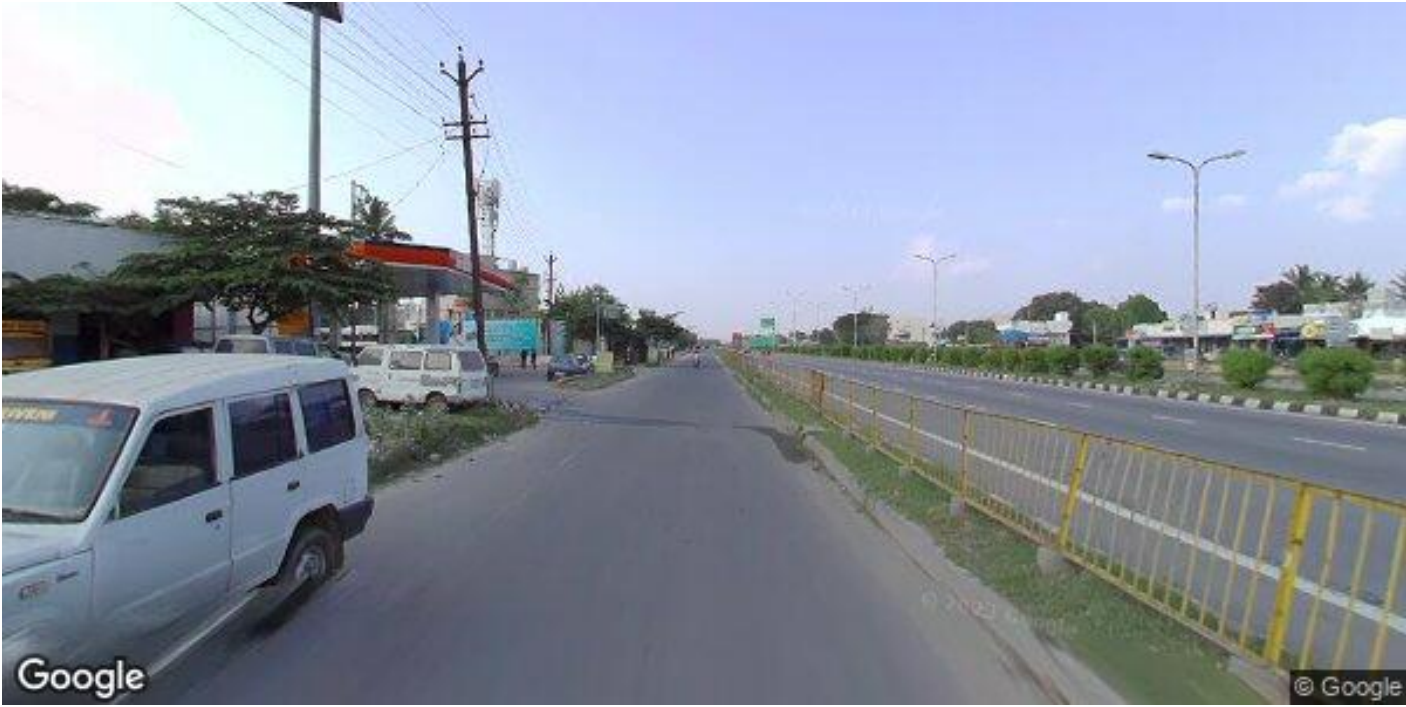
**Risk Type:** Turn  
**Risk Level:** Medium  
**Speed Limit:** 30 KM/Hr  
**Coordinates:** 12.53868, 78.20296
