# IndianOil

## JOURNEY RISK MANAGEMENT (JRM) STUDY

### Salem Terminal TO SRI RANGANATHAR & CO

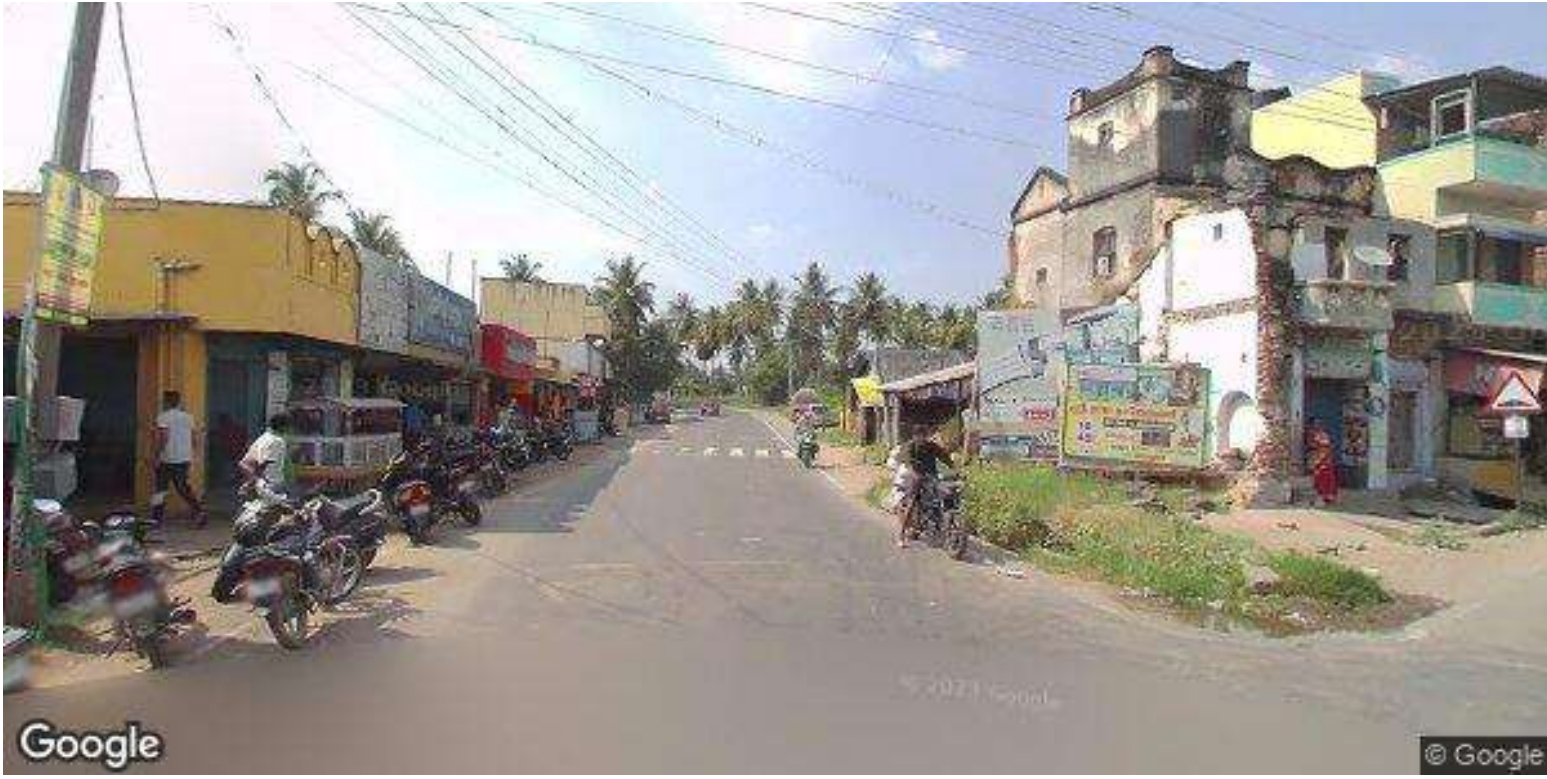
**Risk Type:** Turn  
**Risk Level:** High  
**Speed Limit:** 15 KM/Hr  
**Coordinates:** 11.45007, 77.87201

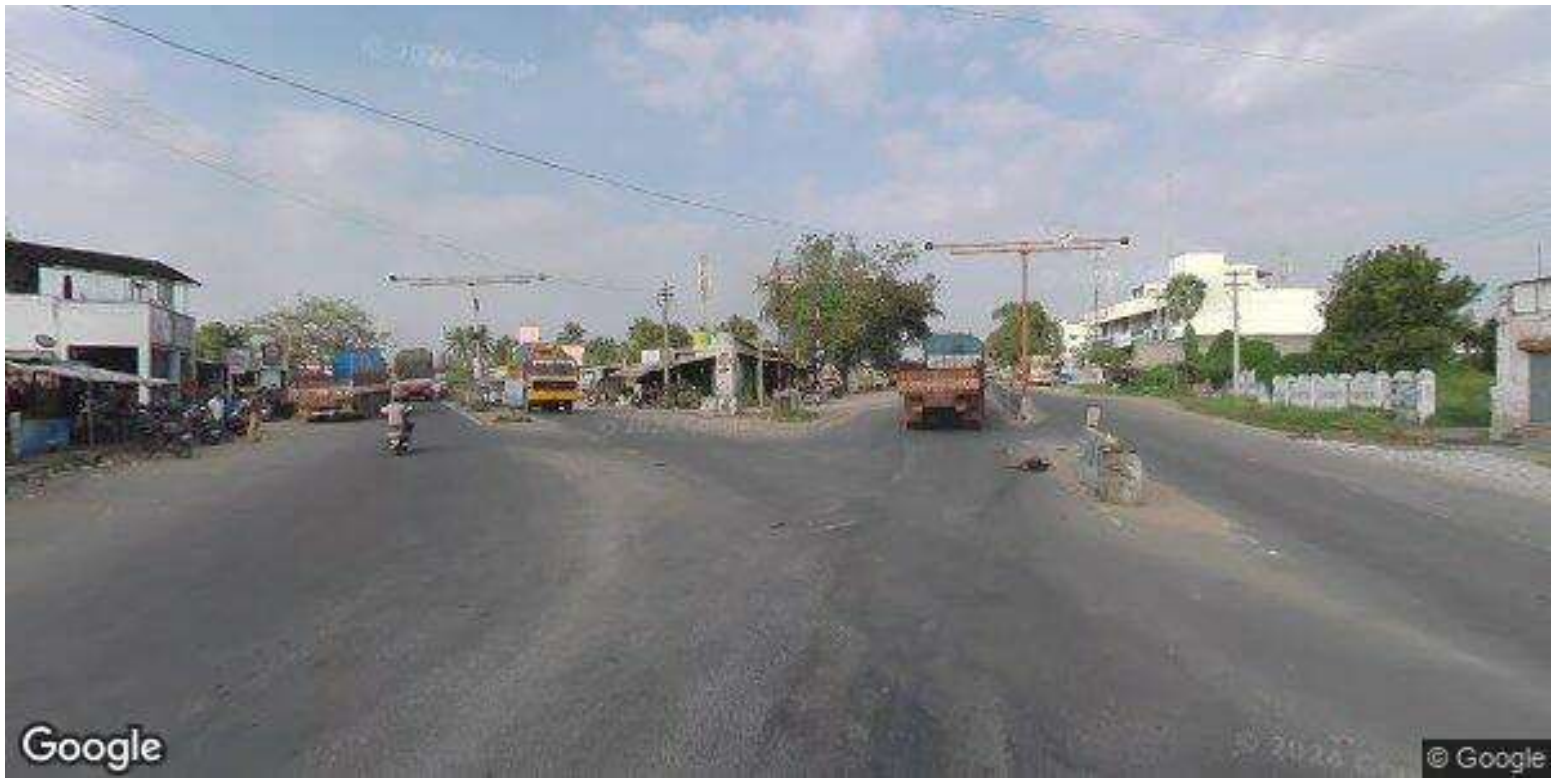
**Risk Type:** Turn  
**Risk Level:** Medium  
**Speed Limit:** 30 KM/Hr  
**Coordinates:** 11.48366, 77.88781

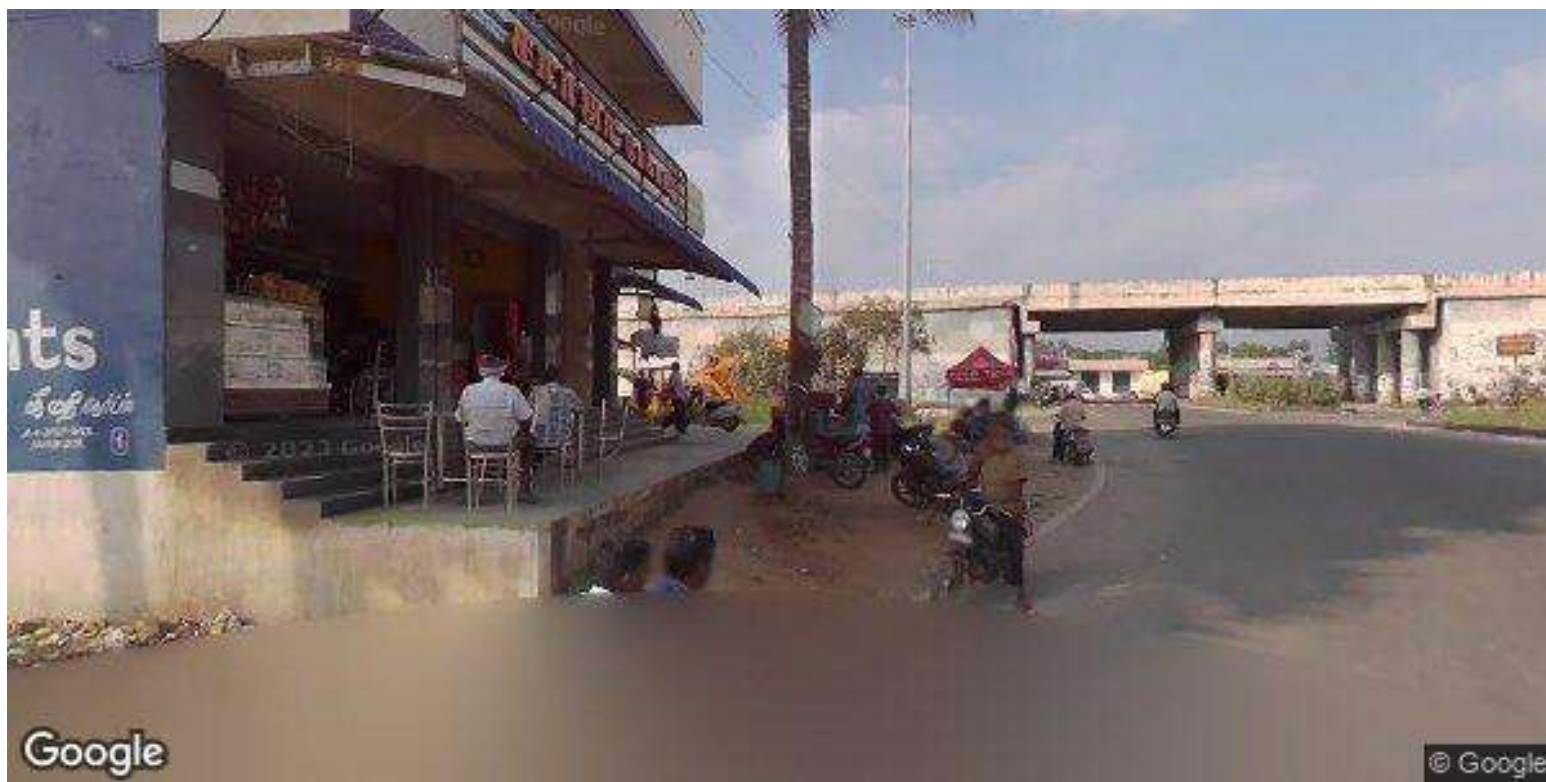
Risk Type: Turn

Risk Level: High

Speed Limit: 15 KM/Hr

Coordinates: 11.49149, 77.89601

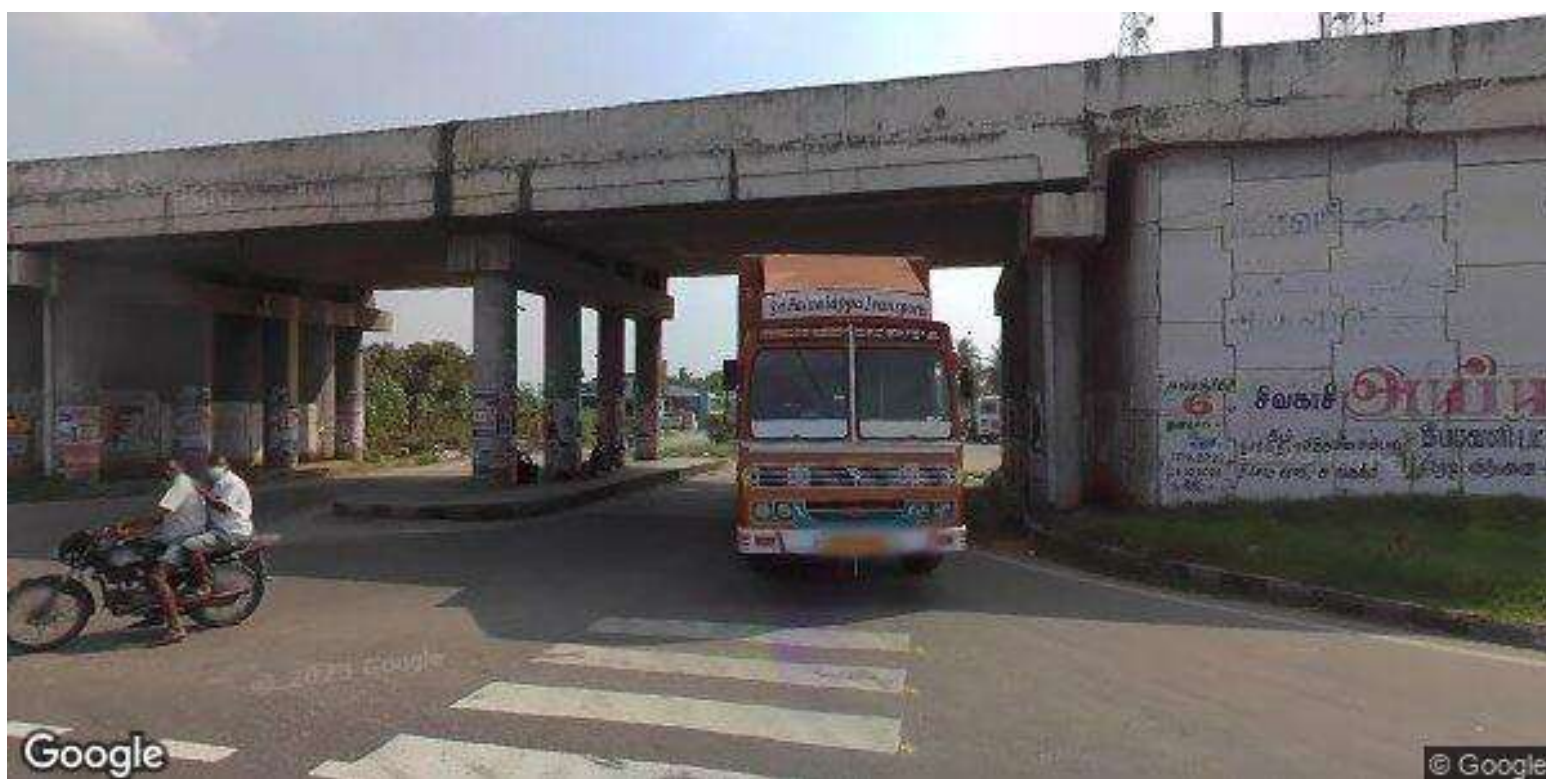
Risk Type: Turn

Risk Level: High

Speed Limit: 15 KM/Hr

Coordinates: 11.49224, 77.89601

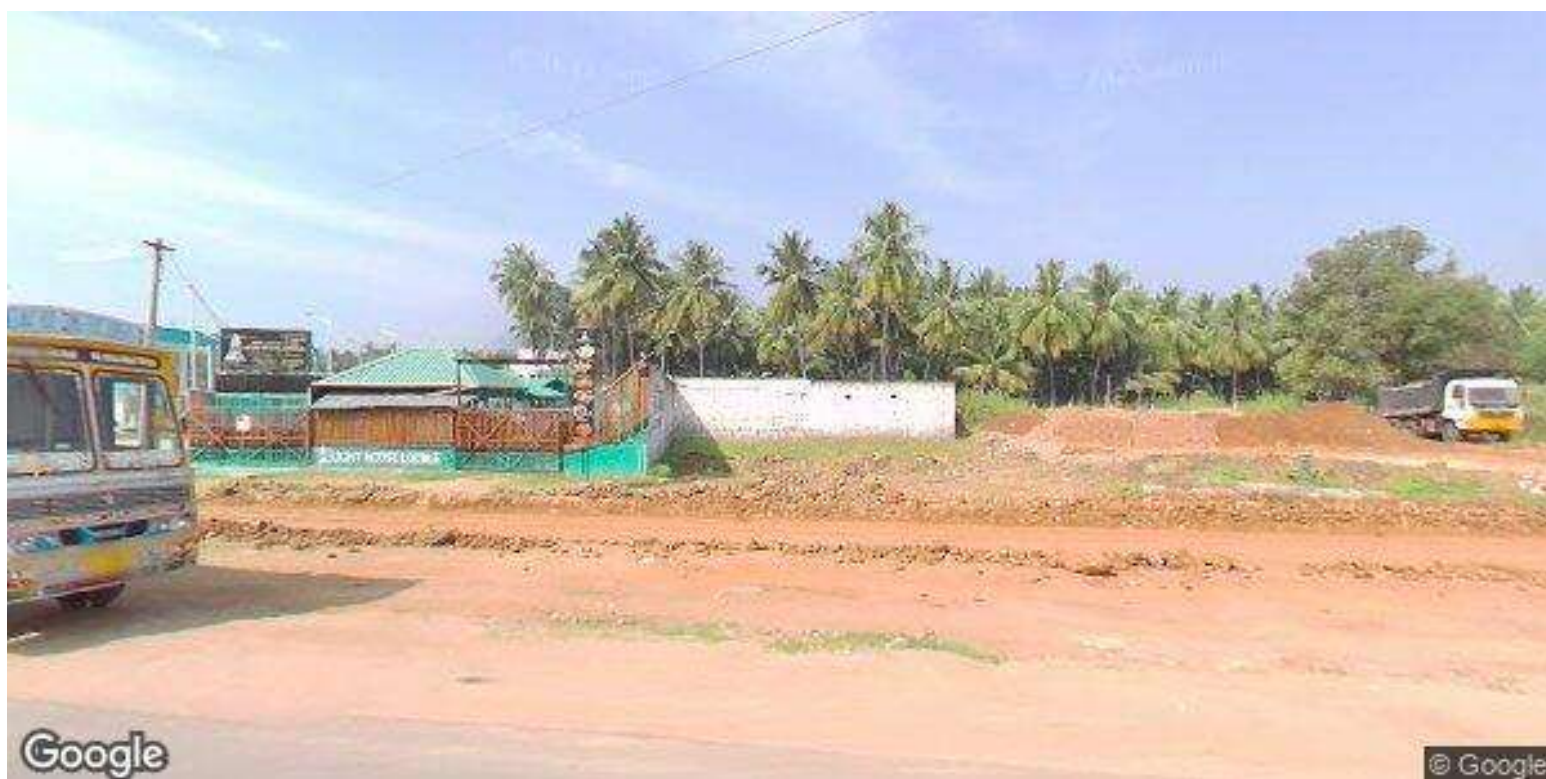
**Risk Type: Turn**

**Risk Level: Medium**

**Speed Limit: 30 KM/Hr**

**Coordinates: 11.61736, 78.10588**

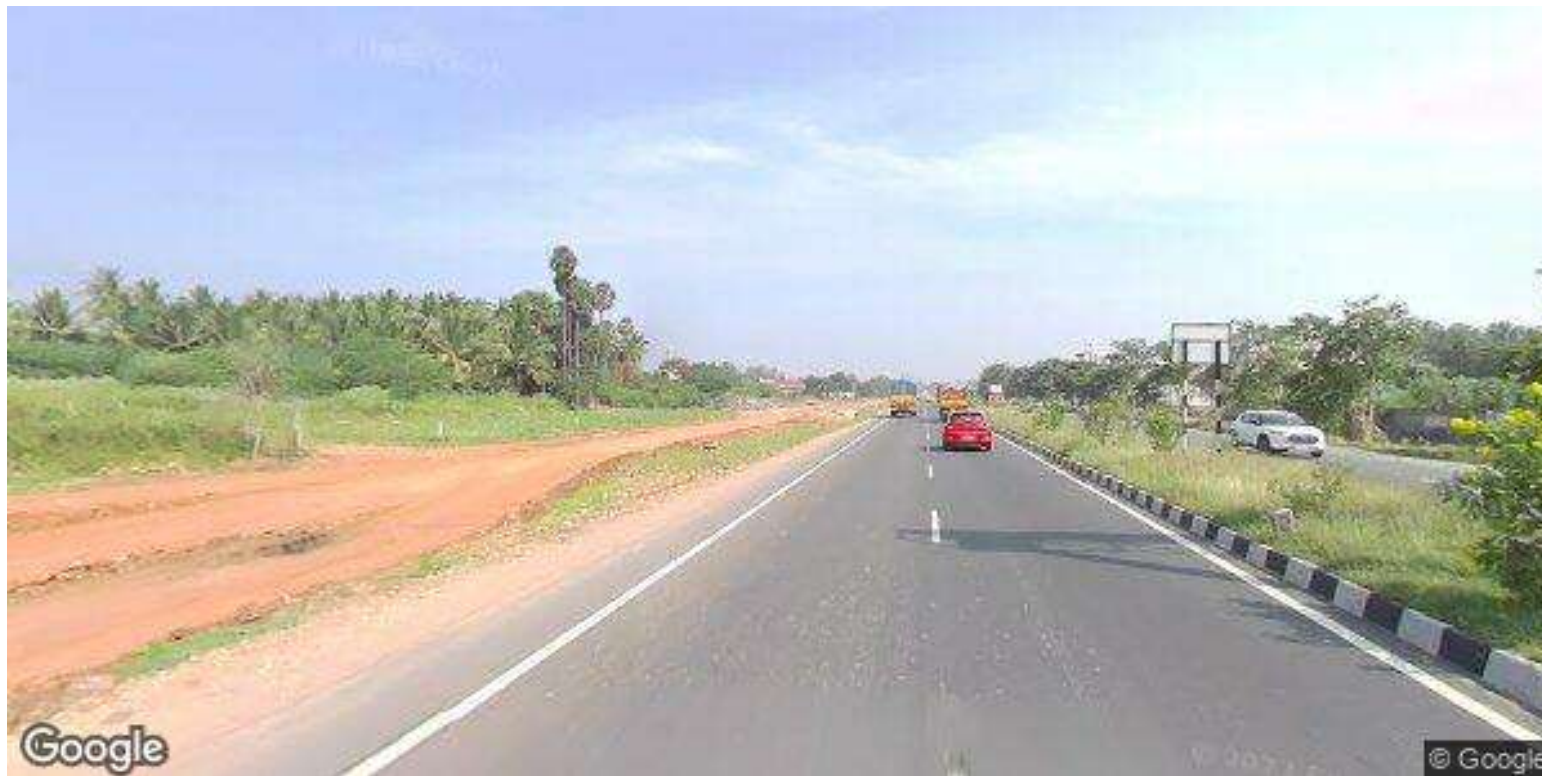
**Risk Type: Turn**

**Risk Level: Medium**

**Speed Limit: 30 KM/Hr**

**Coordinates: 11.61753, 78.10608**

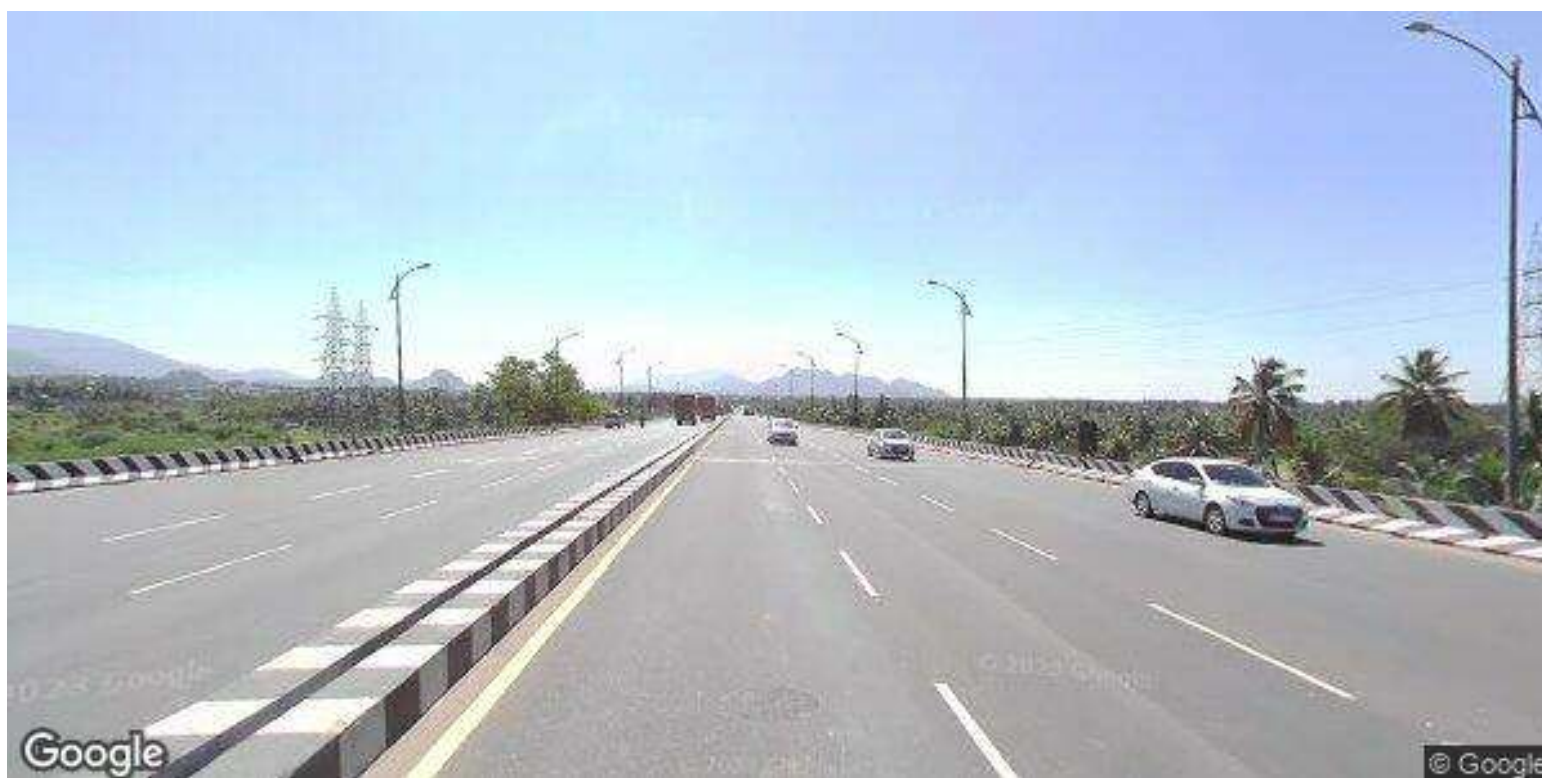
**Risk Type: Turn**

**Risk Level: Medium**

**Speed Limit: 30 KM/Hr**

**Coordinates: 11.64007, 78.11794**

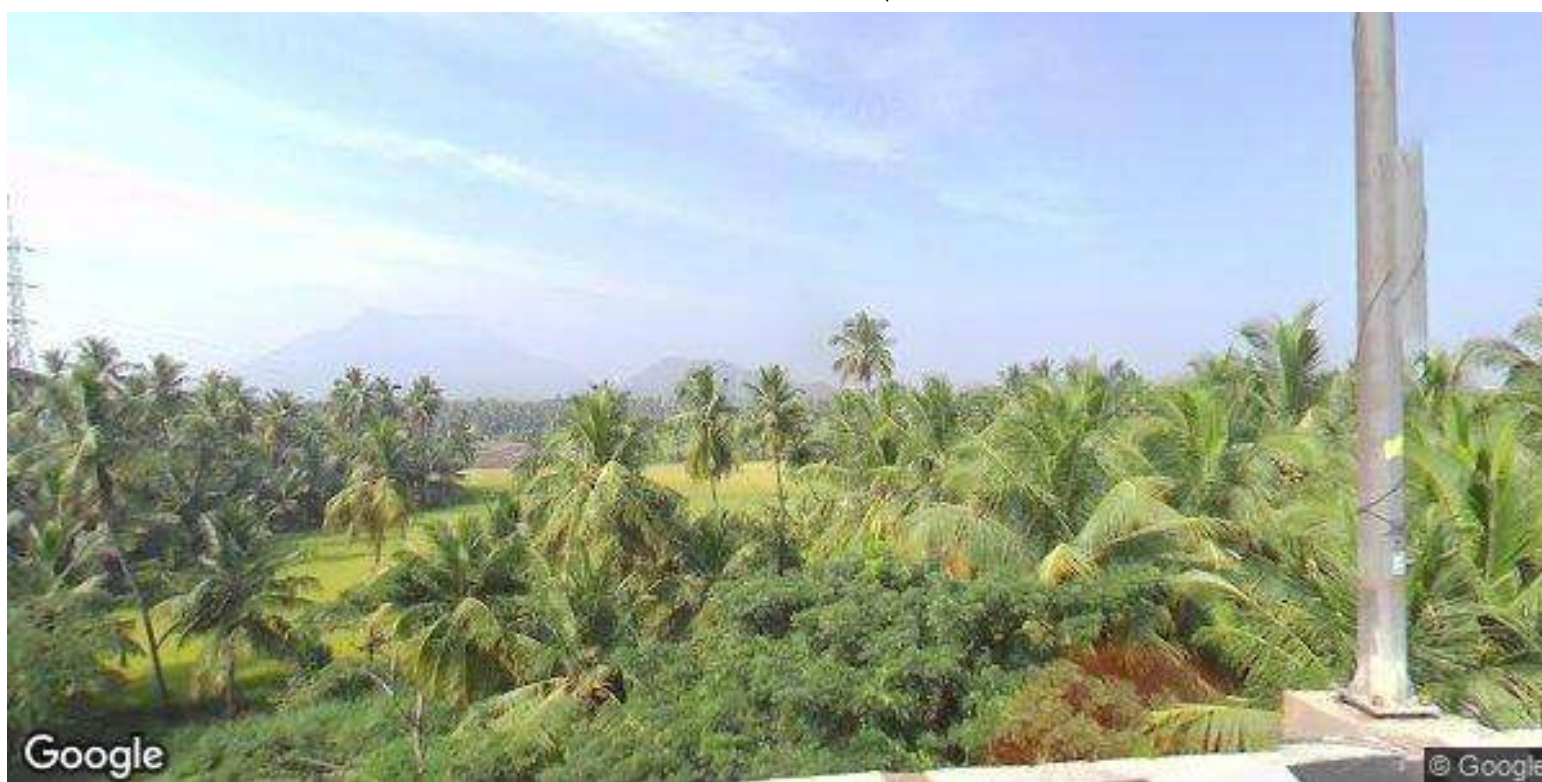
**Risk Type:** Turn

**Risk Level:** Medium

**Speed Limit:** 30 KM/Hr

**Coordinates:** 11.64020, 78.11786

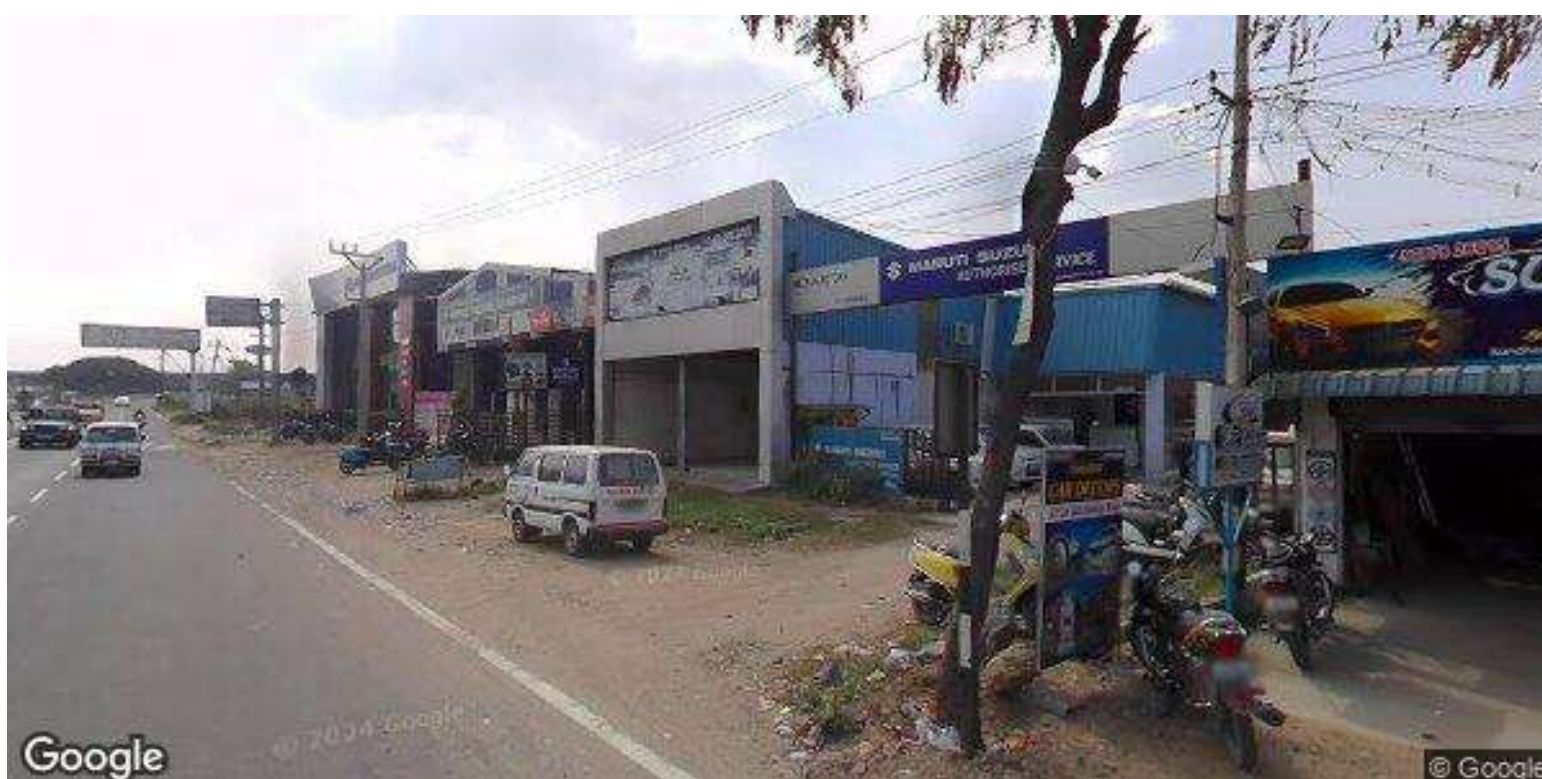
**Risk Type:** Turn

**Risk Level:** Medium

**Speed Limit:** 30 KM/Hr

**Coordinates:** 11.64497, 78.12028

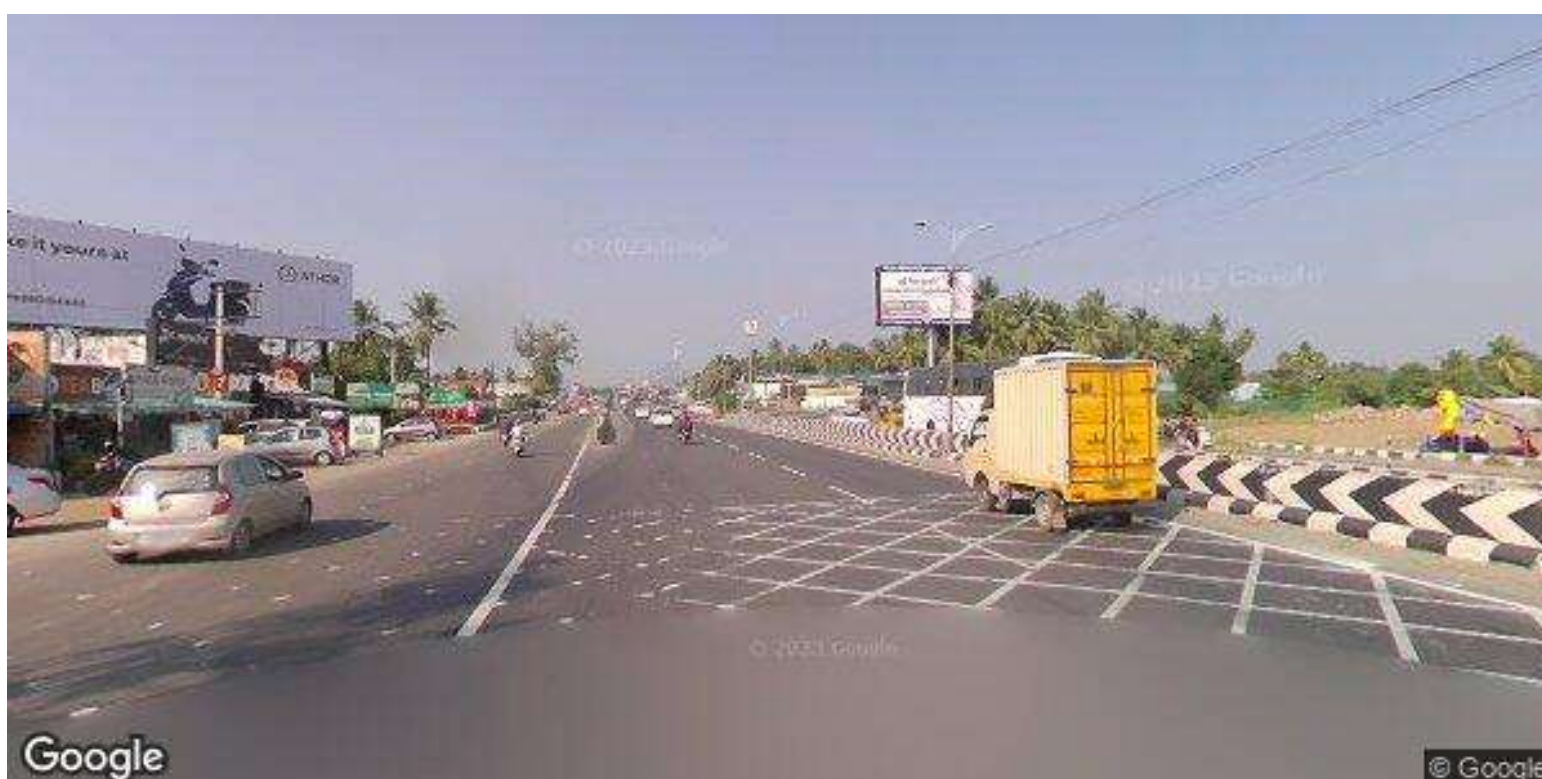
**Risk Type: Turn**

**Risk Level: Medium**

**Speed Limit: 30 KM/Hr**

**Coordinates: 11.64503, 78.12034**

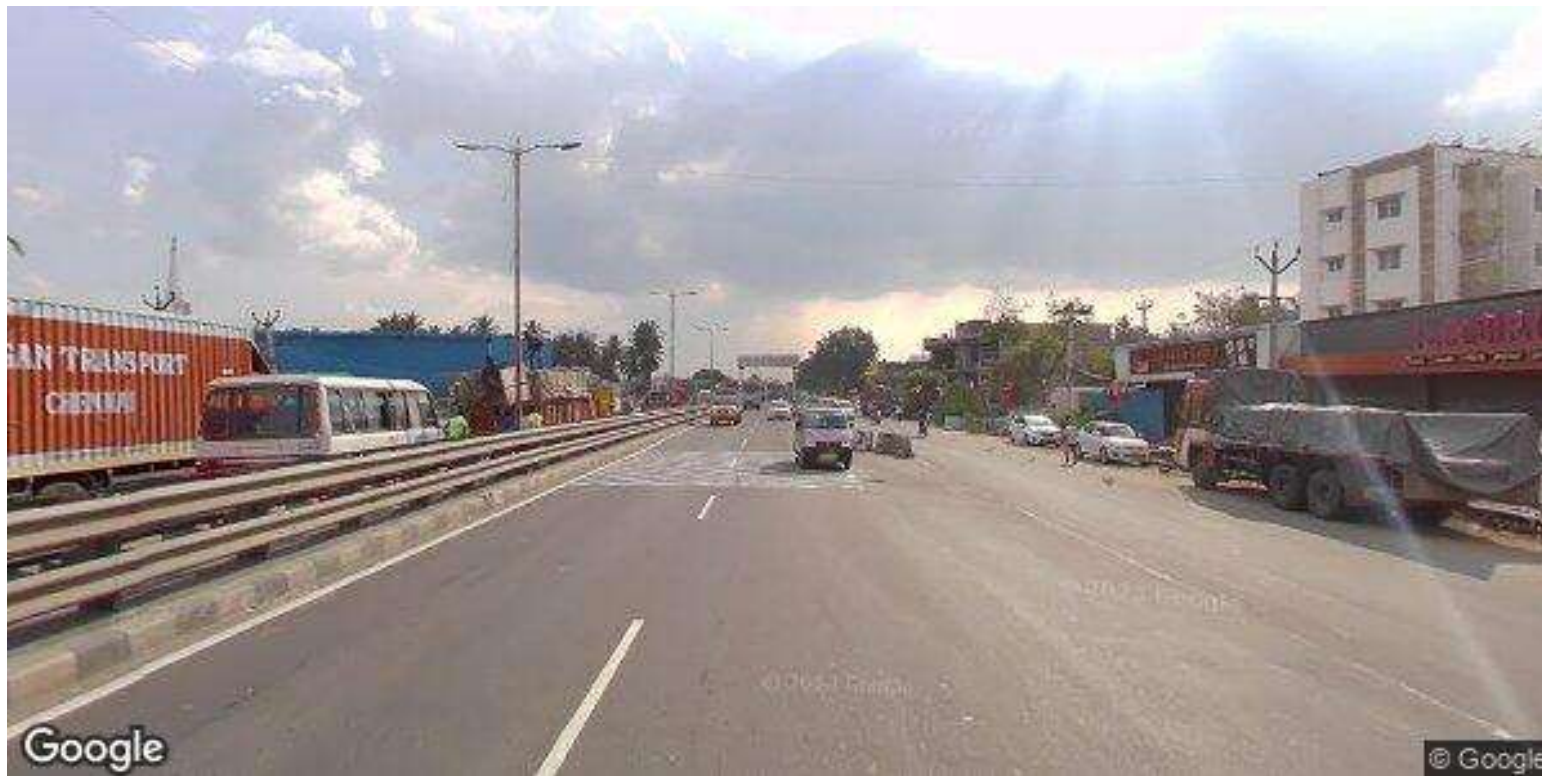
**Risk Type: Turn**

**Risk Level: High**

**Speed Limit: 15 KM/Hr**

**Coordinates: 11.67074, 78.12668**

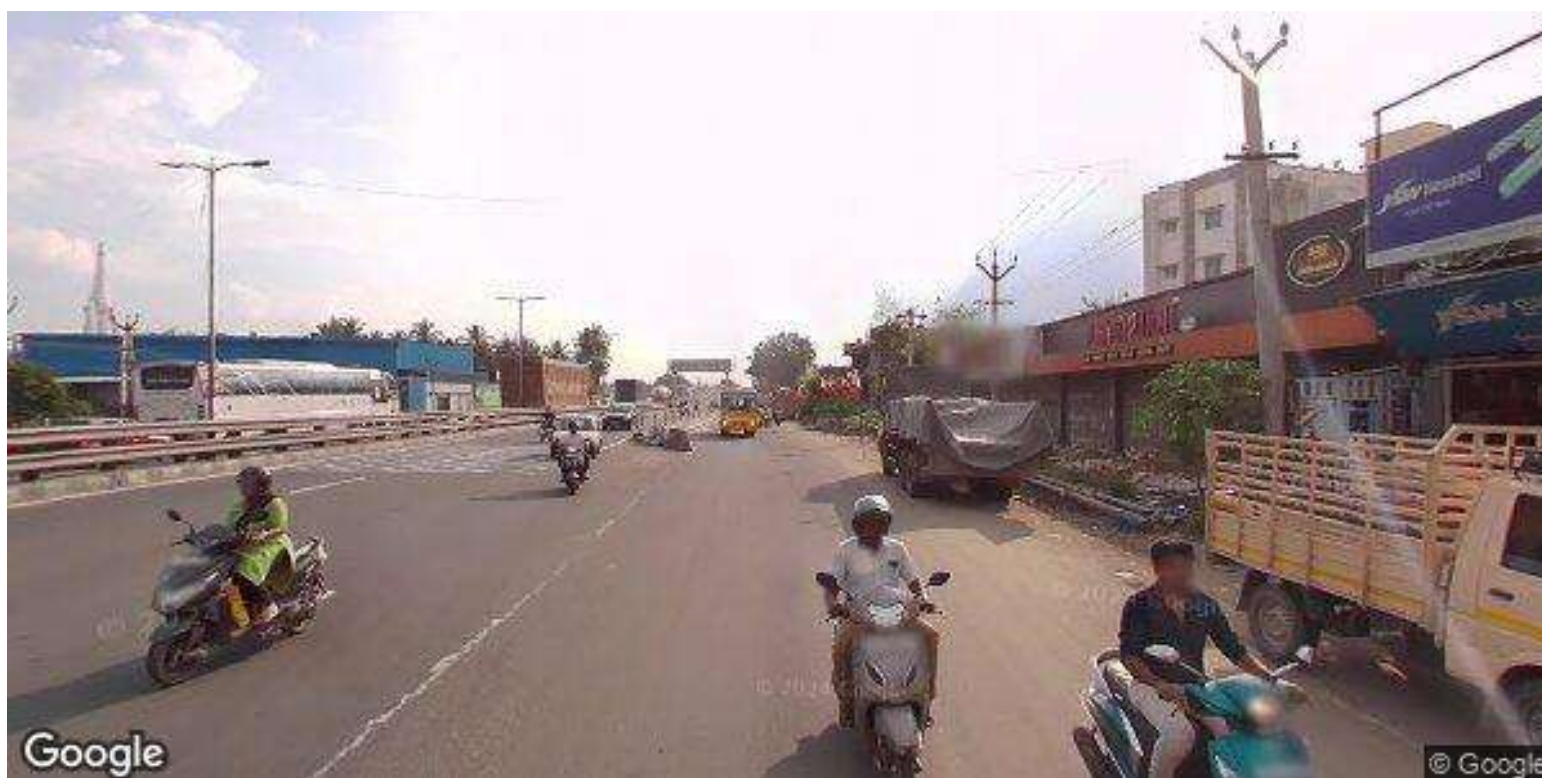
**Risk Type: Turn**

**Risk Level: High**

**Speed Limit: 15 KM/Hr**

**Coordinates: 11.67081, 78.12661**

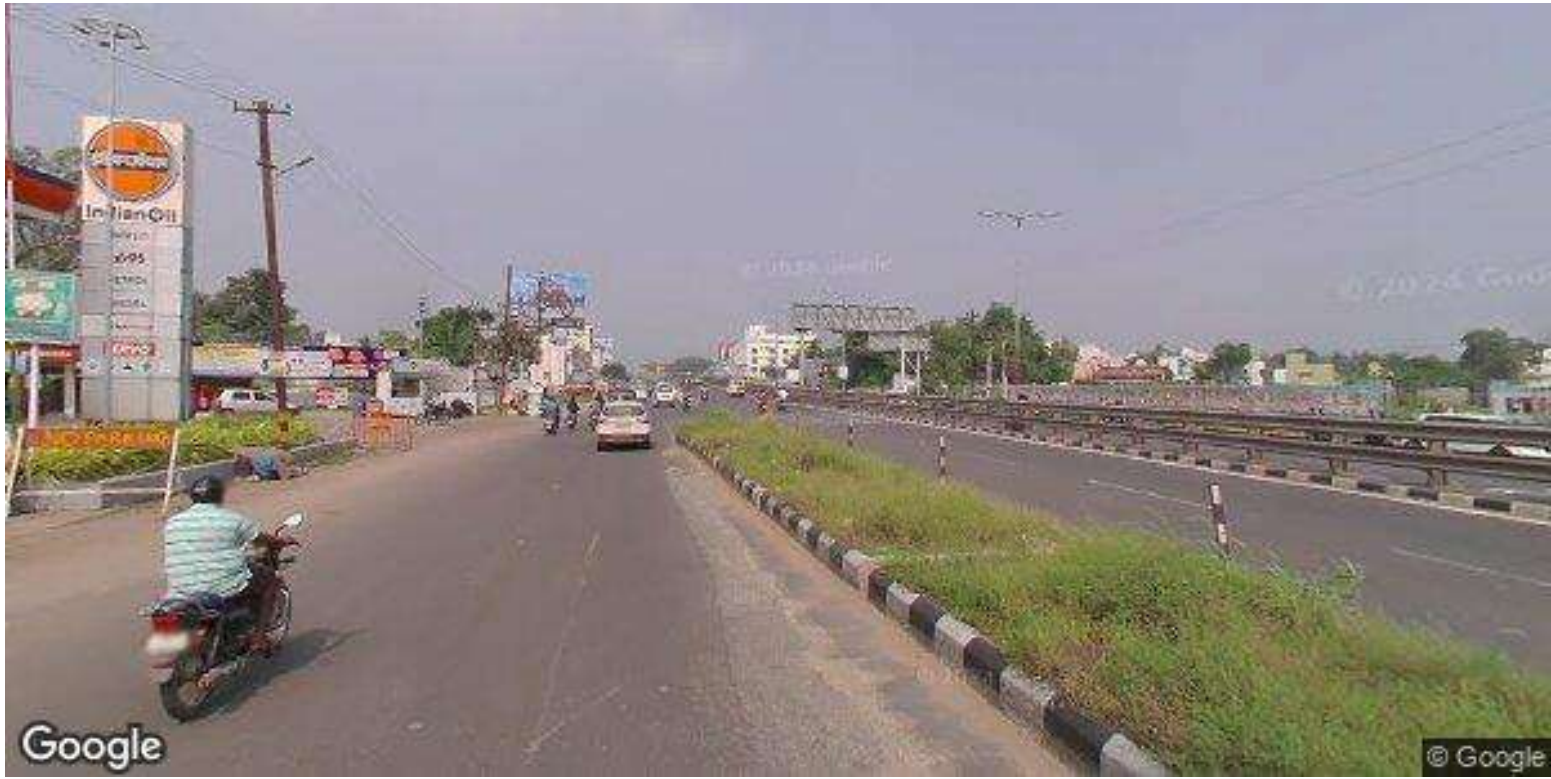
**Risk Type:** Blind Spot  
**Risk Level:** Blind Spot  
**Speed Limit:** 10 KM/Hr  
**Coordinates:** 11.68318, 78.12489
